STRUCTURAL AUDIT REPORT
FOR
“VISHAL SAHYADRI CO – OP HSG. SOC. LTD”,
“A2 – WING”
SITUATED AT
SAHYADRI NAGAR, CHARKOP,
KANDIVALI (W) MUMBAI – 400 067

PREPARED BY
LATESH S. SANKLECHA
CONSULTING STRUCTURAL ENGINEERS

978/B4/LSS/2021

JUNE 24, 2021

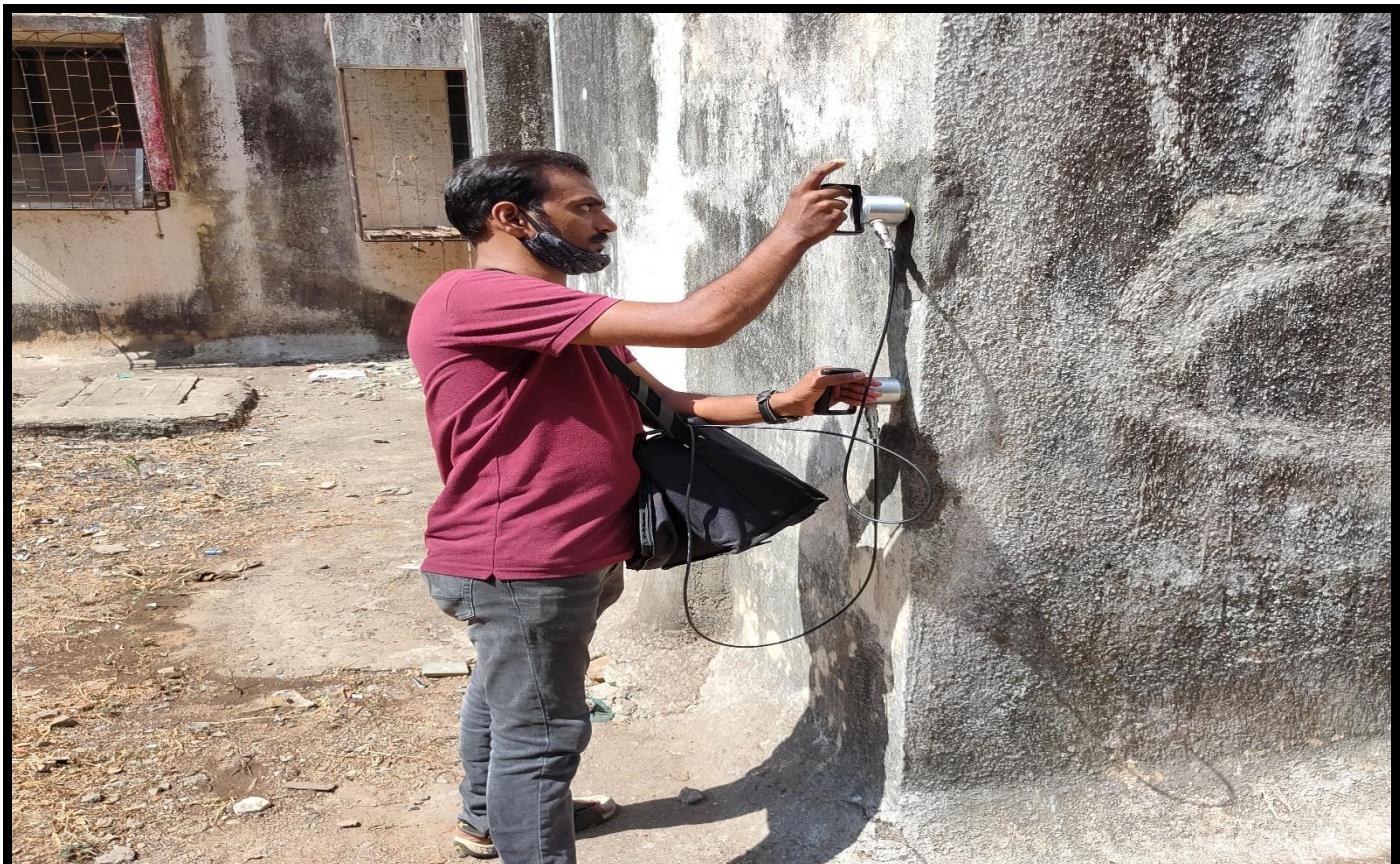
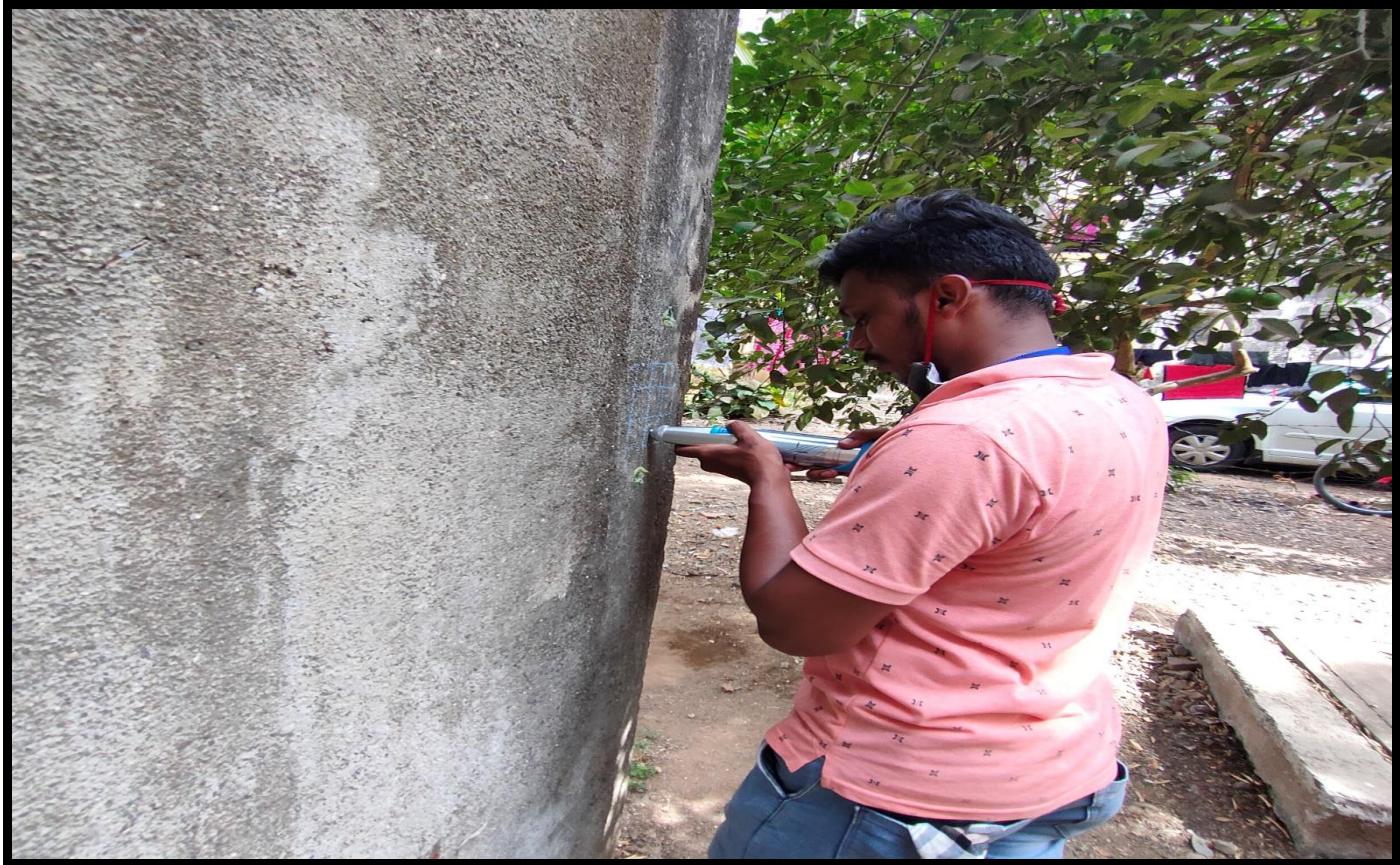
NON -DESTRUCTIVE TEST PHOTO

Rebound Hammer was tested for compressive strength at surface by Schmidt rebound hammer. Results indicate the compressive strength at surface of all the RCC columns is ranging between 17.50 MPa to 26.50 MPa.

The UPV values are ranging between 2.90 Km/Sec to 3.80 Km/Sec.

Out of 4 locations 1 locations was below 3.0 Km/Sec means concrete quality is poor, 2 locations was between 3.0 Km/Sec to 3.75 Km/Sec means concrete quality is doubtful & 1 locations was between 3.75 Km/Sec to 4.40 Km/Sec means concrete quality is good.

This indicates there are progressive internal cracks in the RCC members due to corrosion of reinforced steel. These members are under distress condition.

Half Cell Potential tested for corrosion activity by half – cell potential tests. Values are taken on Column. The result on tested column is – 340 mV.

Carbonation test was conducted to assess carbonation depth. Readings are taken on Column. Result indicates the carbonation penetration depth is 35.00 mm. Carbonation depths have reached to the reinforcement level in all of the RCC elements. It is essential to give a suitable anti-corrosion treatment to all the RCC members to stop further carbonation and corrosion of concrete.

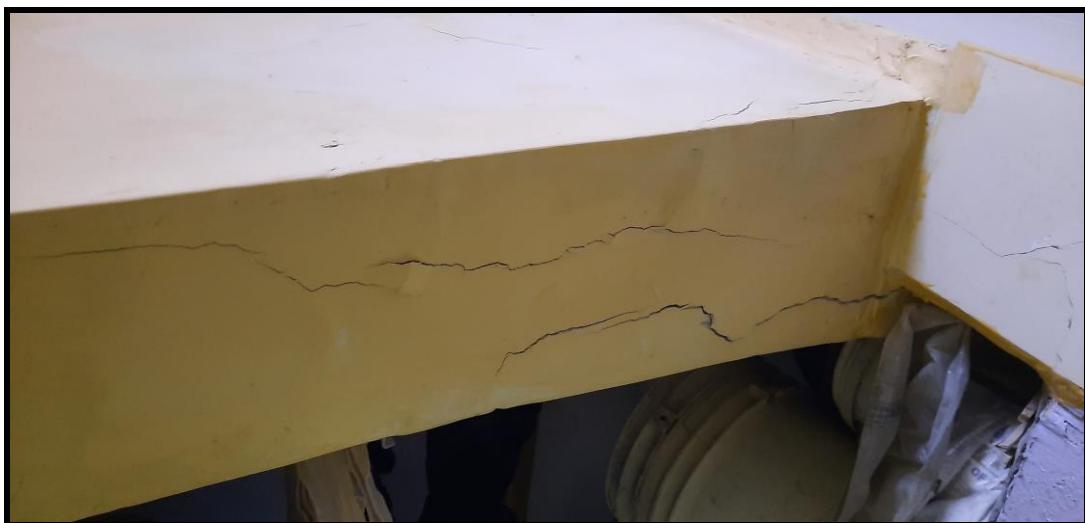
FLAT NO – 08

- ❖ **HALL** – Structural crack observed on beam.
- ❖ **KITCHEN** – O.K.
- ❖ **BEDROOM** – O.K.
- ❖ **PASSAGE** – O.K.
- ❖ **TOILET & BATH ROOM** – O.K.

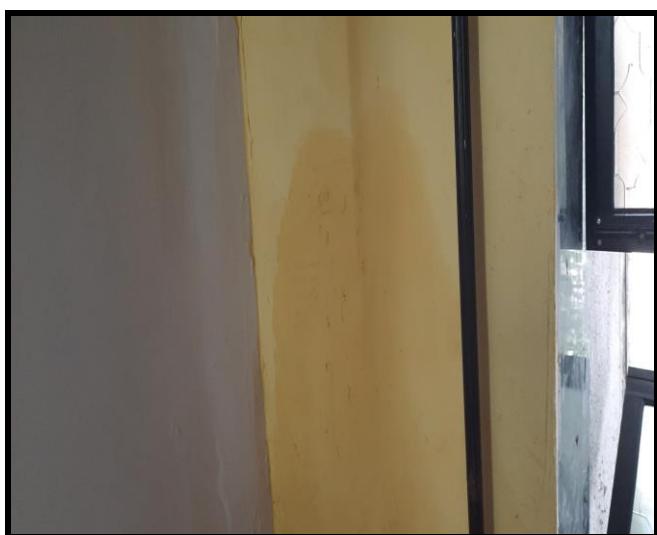
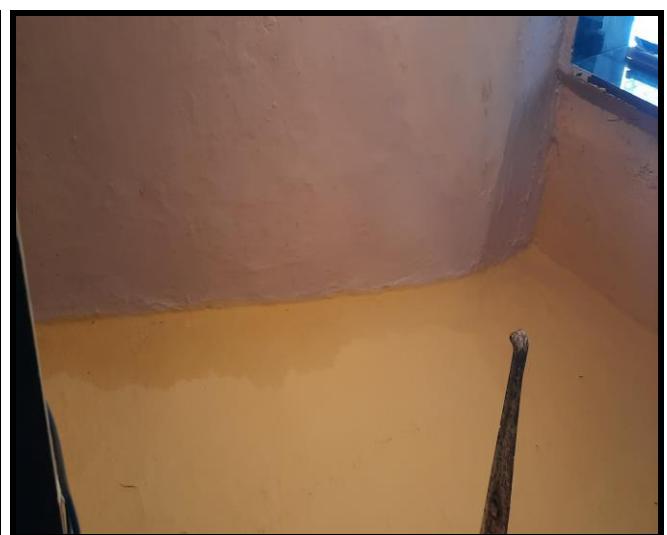
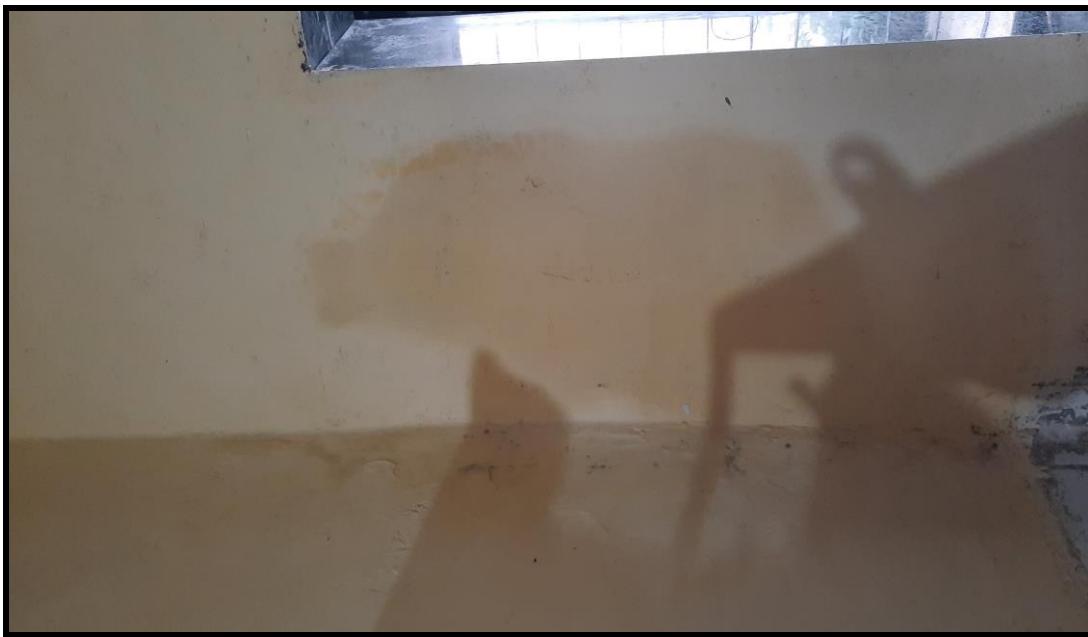
FLAT NO – 10

- ❖ **HALL** – Dampness observed on beam.
- ❖ **KITCHEN** – Dampness observed on wall.
- ❖ **BEDROOM** – O.K.
- ❖ **PASSAGE** – O.K.
- ❖ **TOILET & BATH ROOM** – Dampness observed on wall & ceiling.

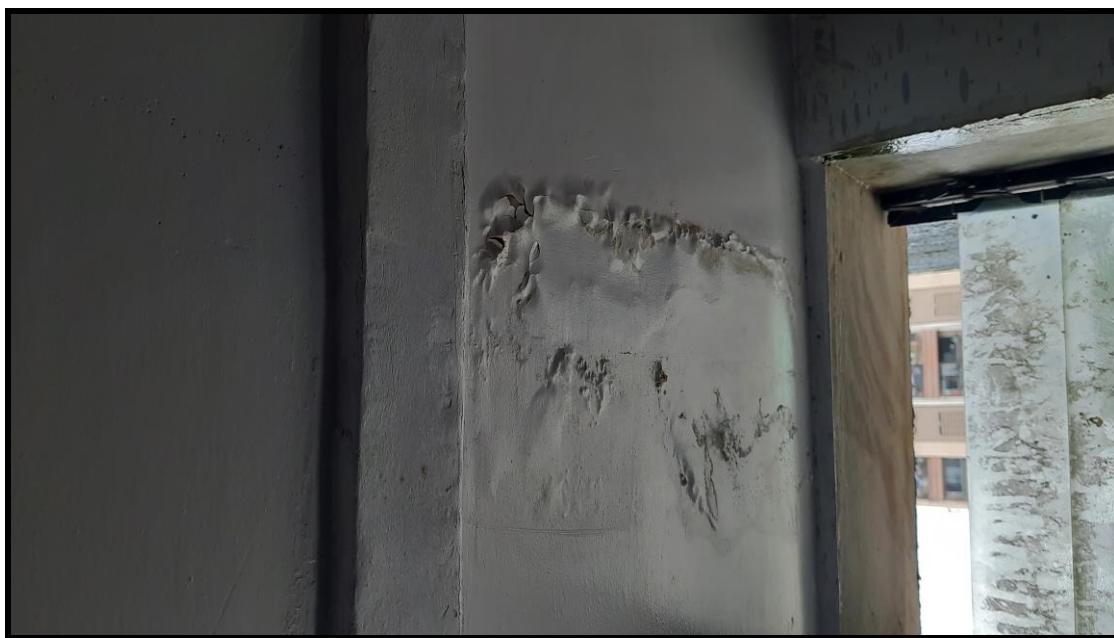
FLAT NO - 12

- ❖ **HALL** – O.K.
- ❖ **KITCHEN** – O.K.
- ❖ **BEDROOM** – O.K.
- ❖ **PASSAGE** – O.K.
- ❖ **TOILET & BATH ROOM** – Leakage mark observed on ceiling.

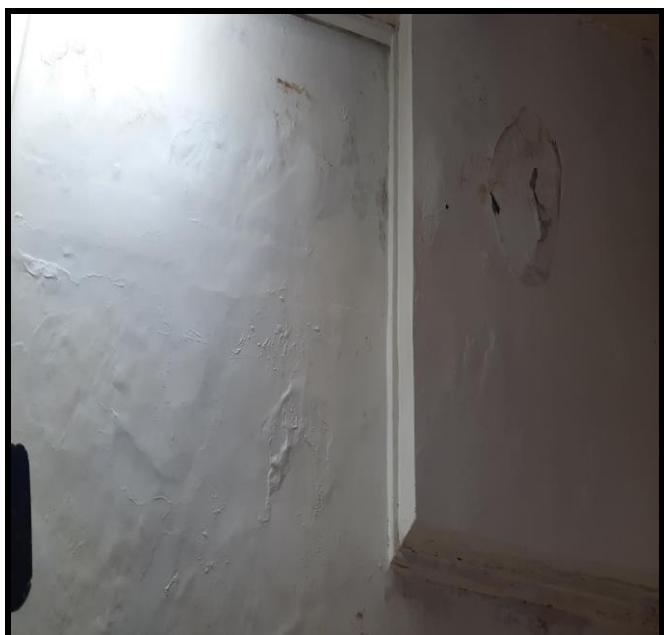
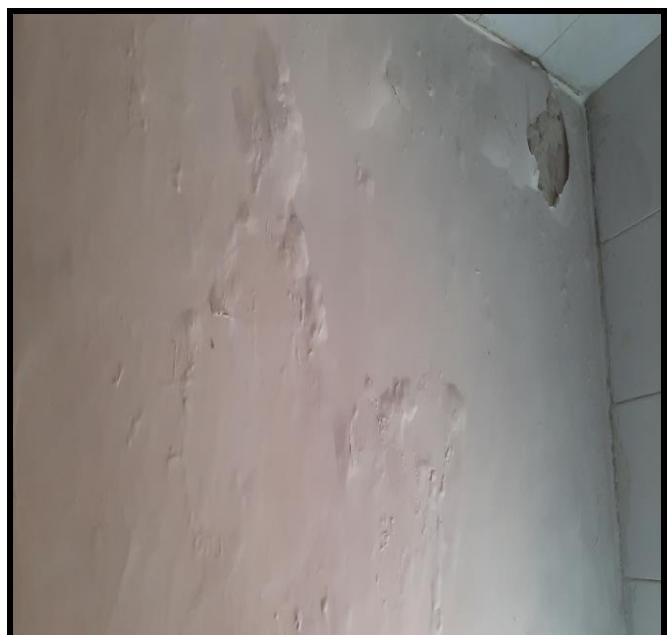
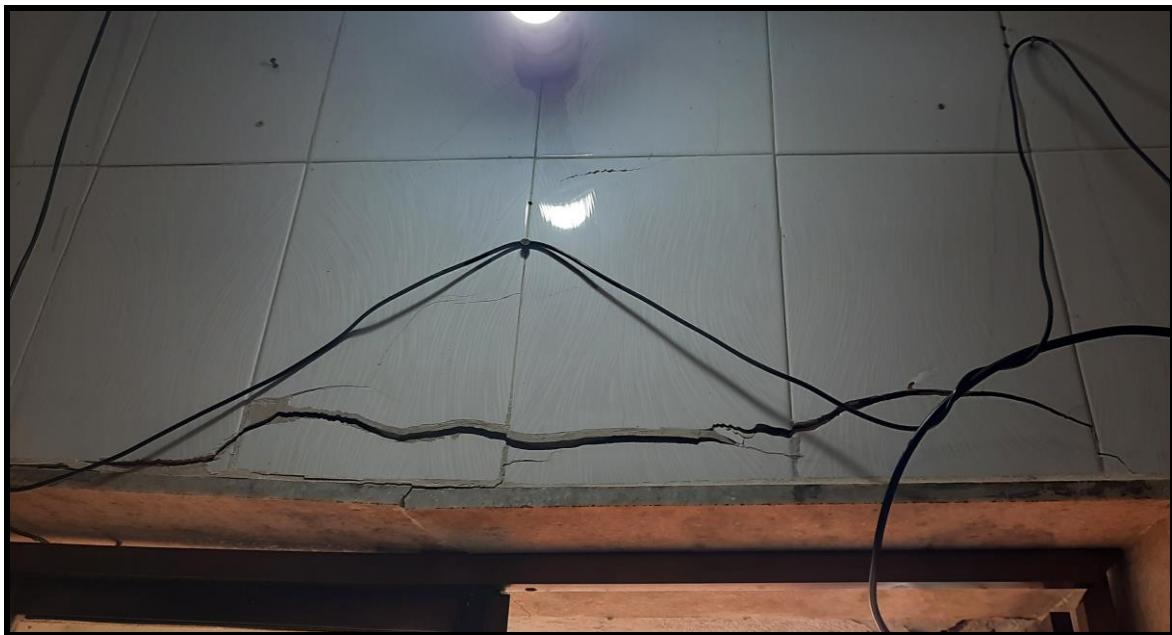
FLAT NO – 18

- ❖ **HALL** – O.K.
- ❖ **KITCHEN** – Leakage mark observed on ceiling.
- ❖ **BEDROOM** – Leakage mark observed on ceiling.
 - Structural crack observed on beam.
- ❖ **PASSAGE** – Leakage mark observed on ceiling.
- ❖ **TOILET & BATH ROOM** – O.K.

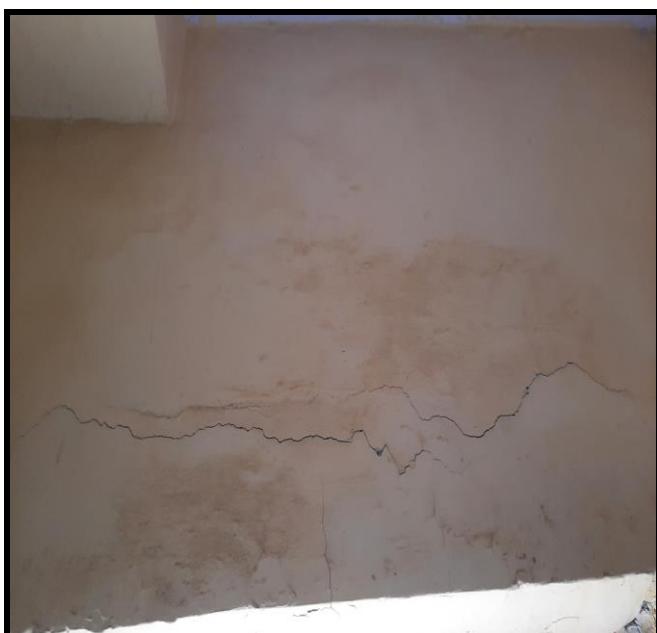
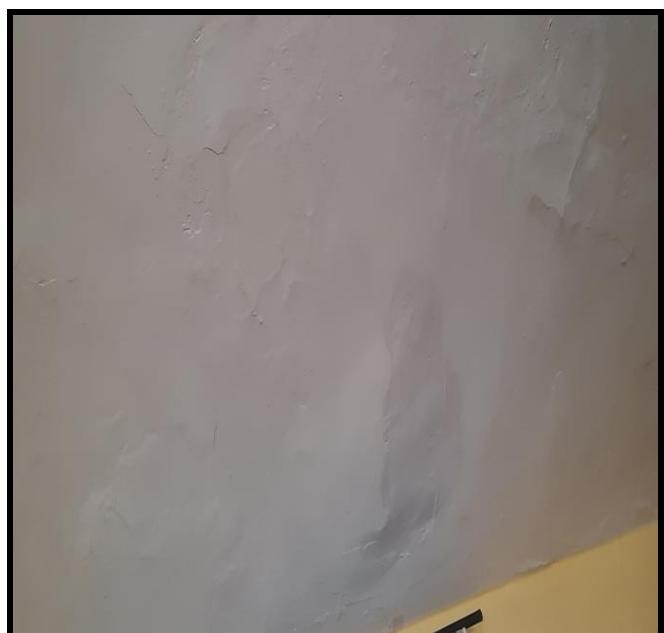
FLAT NO – 23

- ❖ **HALL** – Structural crack observed on ceiling.
- ❖ **KITCHEN** – Structural crack observed on beam.
- ❖ **BEDROOM** – Structural damage observed on ceiling.
- ❖ **PASSAGE** – O.K.
- ❖ **TOILET & BATH ROOM** – O.K.

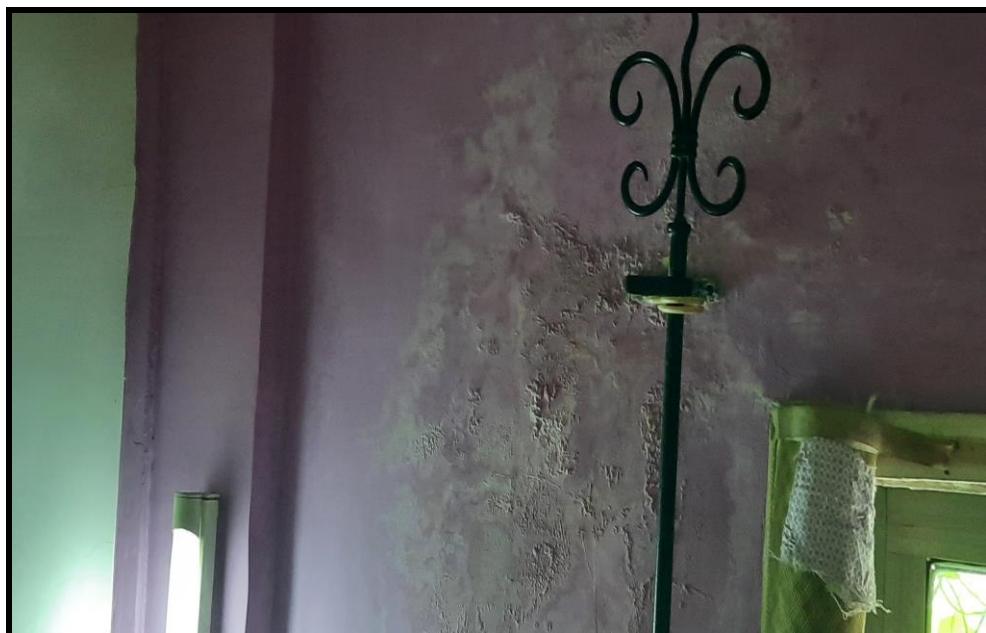
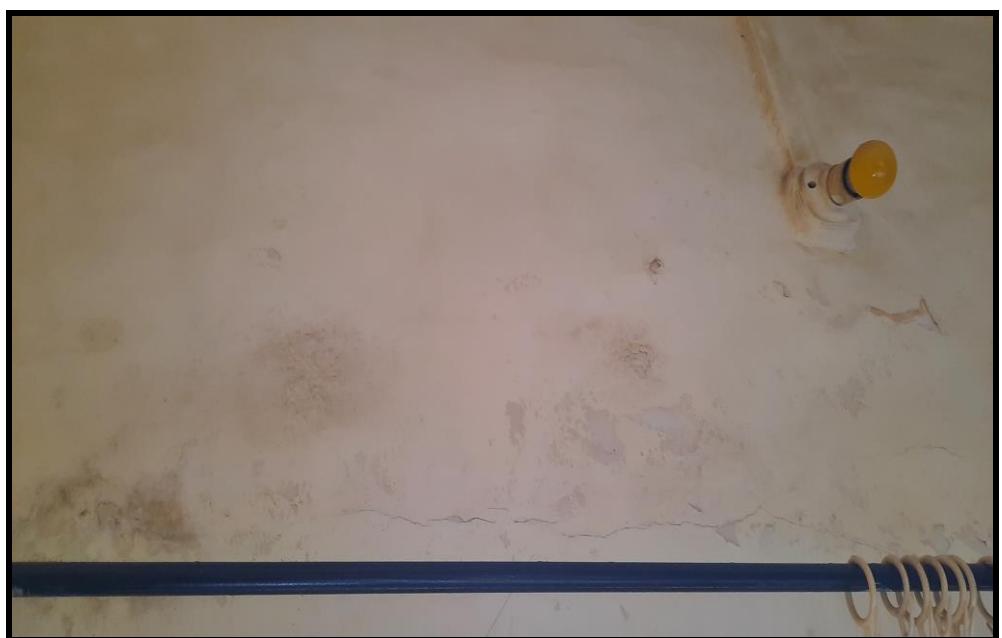
FLAT NO – 26

- ❖ **HALL** – Leakage mark observed on wall.
- ❖ **KITCHEN** – O.K.
- ❖ **BEDROOM** – Leakage mark observed on wall & ceiling.
- ❖ **PASSAGE** – O.K.
- ❖ **TOILET & BATH ROOM** – O.K.

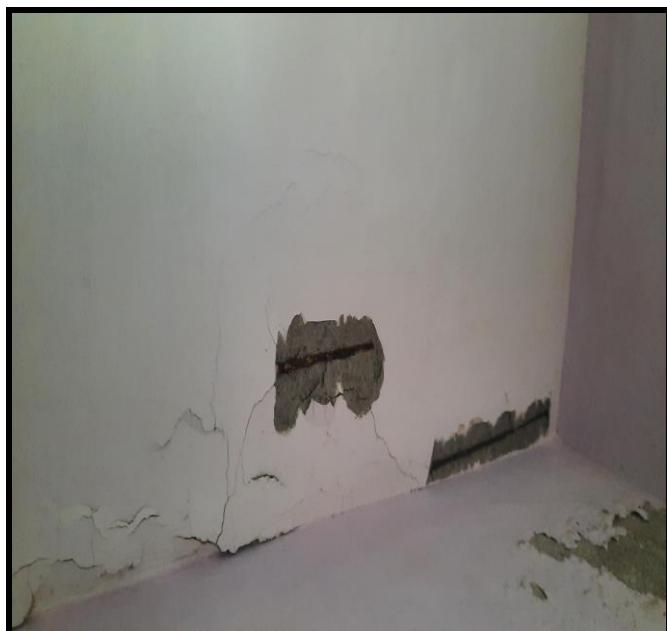
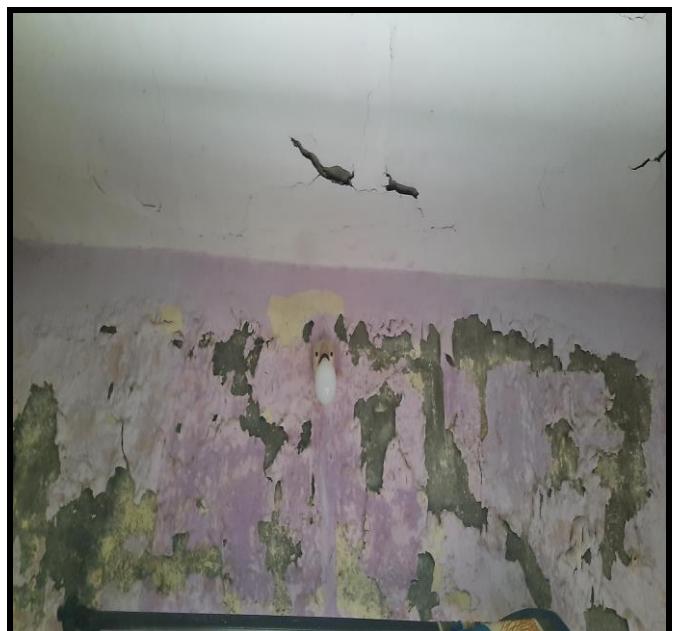
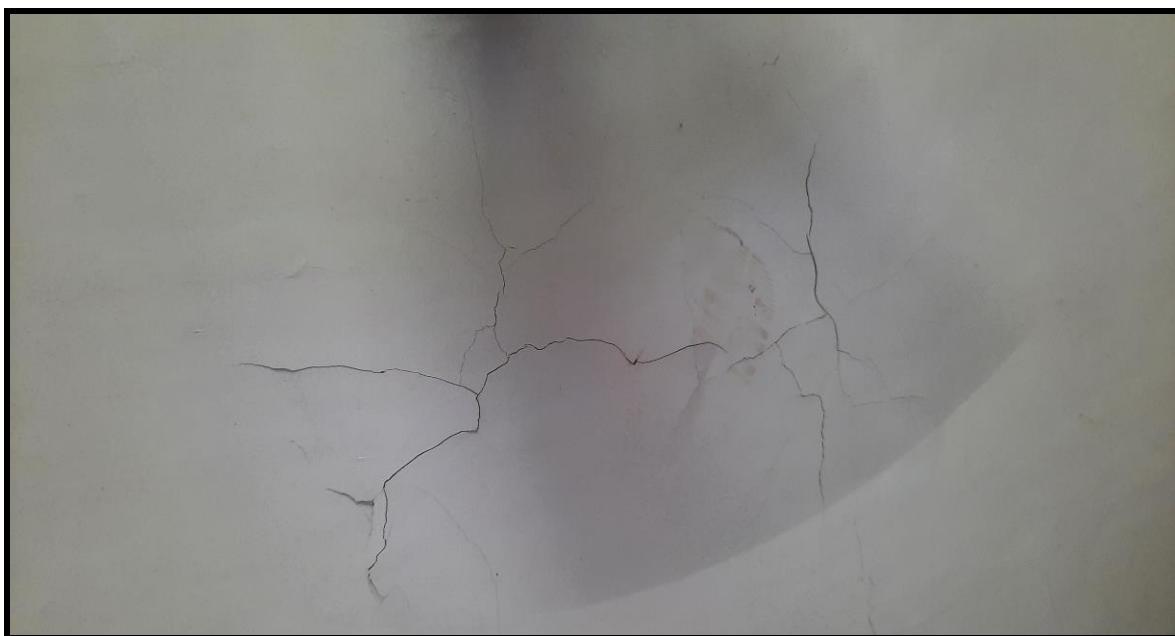
FLAT NO – 27

- ❖ **HALL** – Ceiling plaster get damaged & steel get exposed & corroded.
- ❖ **KITCHEN** – Structural damage observed on ceiling.
- ❖ **BEDROOM** – Leakage mark observed on beam.
 - Ceiling plaster get damaged & steel get exposed & corroded.
- ❖ **PASSAGE** – O.K.
- ❖ **TOILET & BATH ROOM** – O.K.

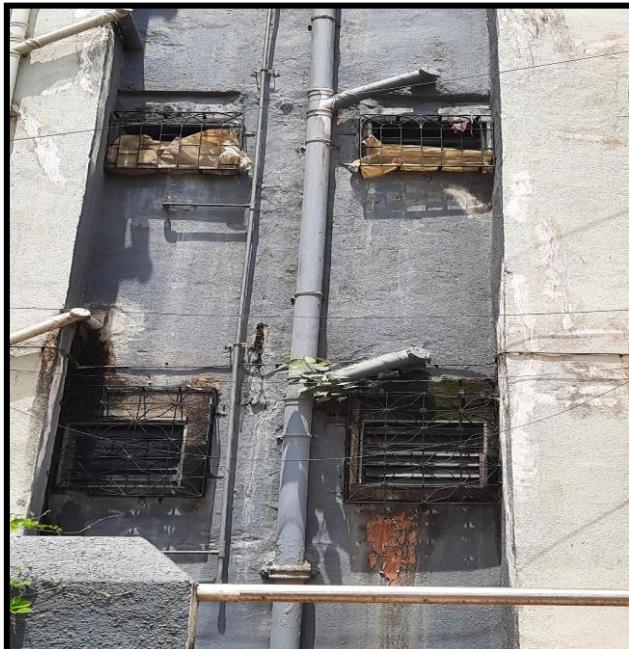
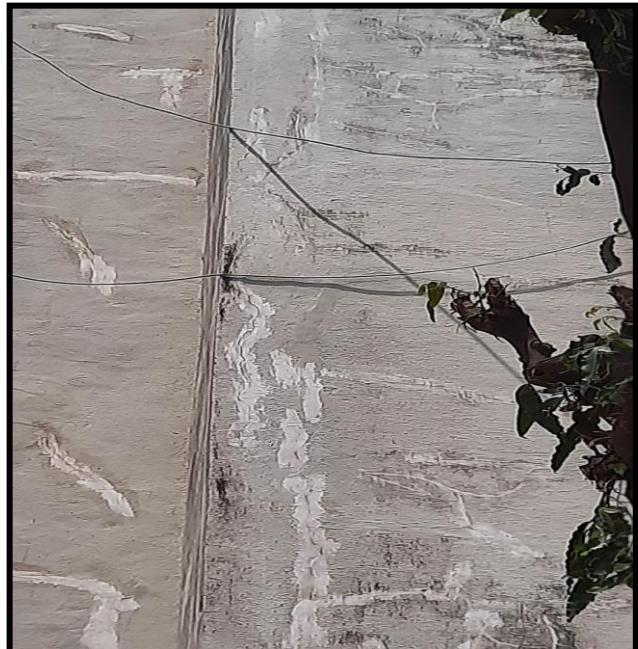
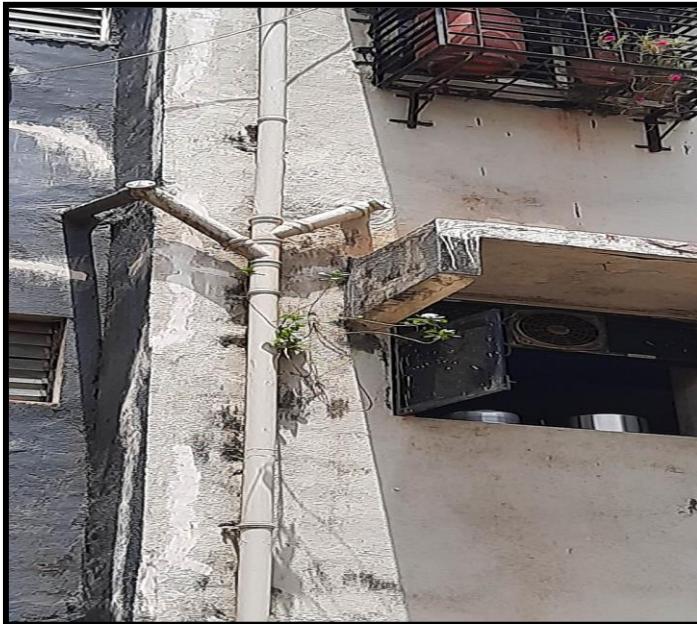
FRONT SIDE

- ❖ Structural crack observed at several places on column.
- ❖ Major crack observed at several places on wall.
- ❖ Vegetation growth observed at several places on wall.

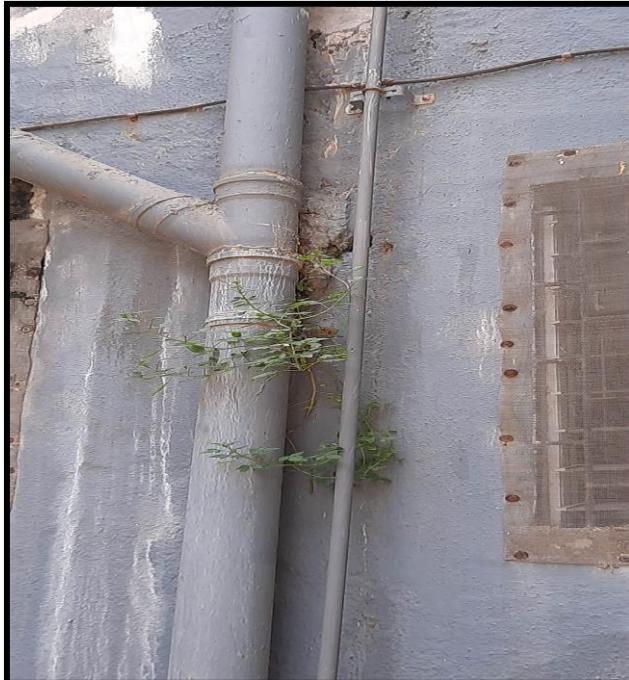
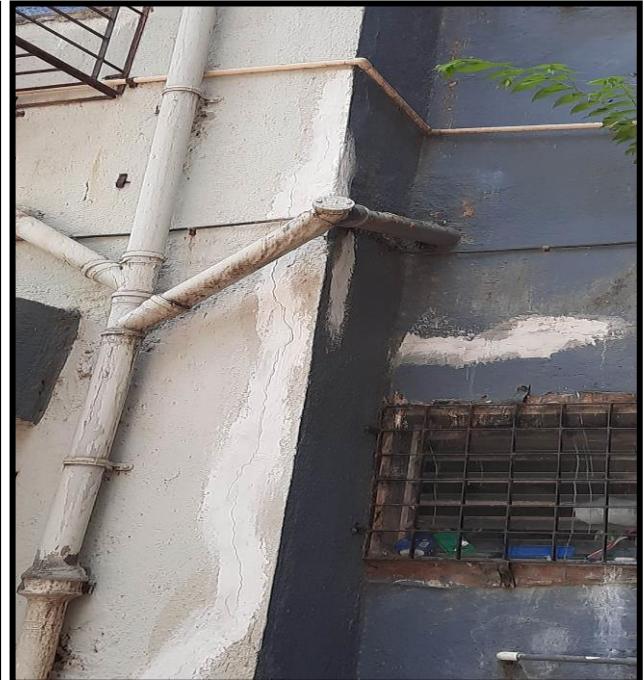
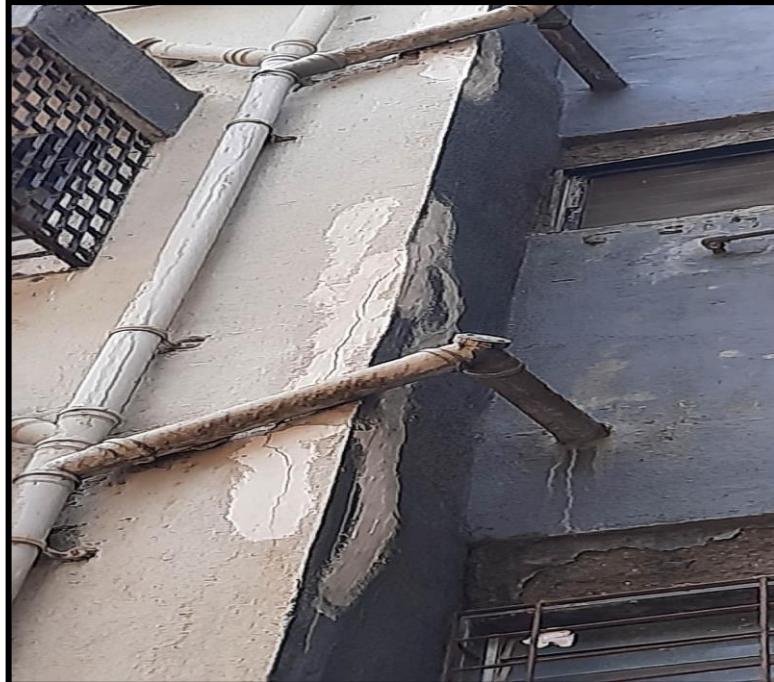
BACK SIDE

- ❖ Structural crack observed at several places on column.
- ❖ Vegetation growth observed at several places on wall.

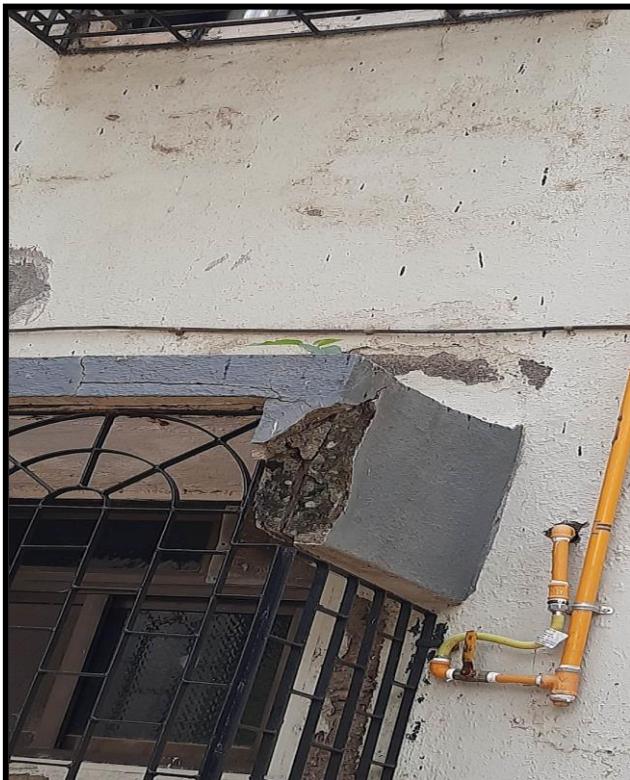
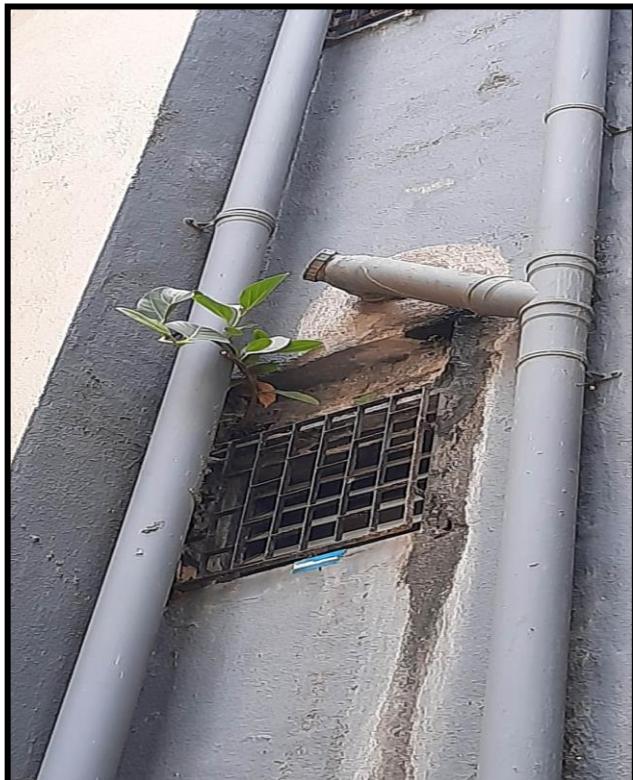
NORTH SIDE

- ❖ Vegetation growth observed at several places on wall.
- ❖ Chajja plaster get damaged & steel get exposed & corroded.
