STRUCTURAL AUDIT REPORT  
FOR  
**“VISHAL SAHYADRI CO – OP HSG. SOC. LTD”,**  
**“D3 –H WING”**  
SITUATED AT  
SAHYADRI NAGAR, CHARKOP,  
KANDIVALI (W) MUMBAI – 400 067

978/D3/LSS/2021

JULY 16, 2021

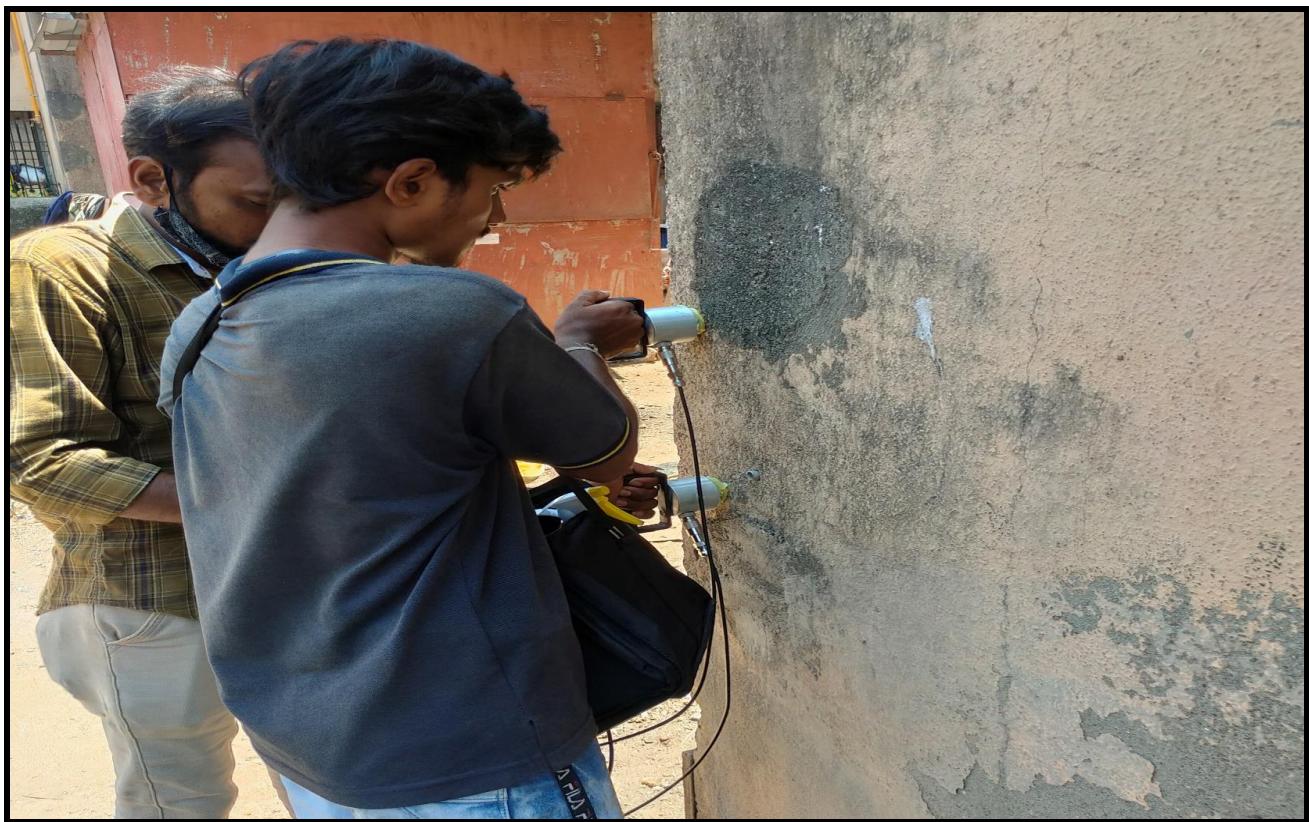
## NON -DESTRUCTIVE TEST PHOTO

Rebound Hammer was tested for compressive strength at surface by Schmidt rebound hammer. Results indicate the compressive strength at surface of the RCC columns & beam in is ranging between 13.70 MPa to 18.90 MPa.

Out of 4 locations 2 locations was below 3.0 Km/Sec means concrete quality is poor and 2 location ranging between 3.0 to 3.75 Km/Sec means concrete quality is doubtful.

This indicates there are progressive internal cracks in the RCC members due to corrosion of reinforced steel. These members are under distress condition.

Half Cell Potential tested for corrosion activity by half – cell potential tests. Value is taken on Column. The result on tested column is – 349 mV.

Carbonation test was conducted to assess carbonation depth. Readings are taken on Column. Result indicates the carbonation penetration depth is 35.00 mm. Carbonation depths have reached to the reinforcement level in all of the RCC elements. It is essential to give a suitable anti-corrosion treatment to all the RCC members to stop further carbonation and corrosion of concrete.

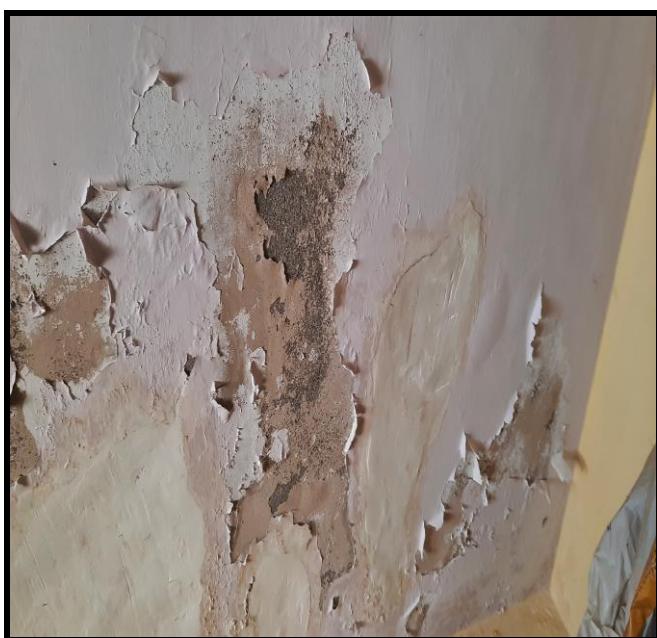
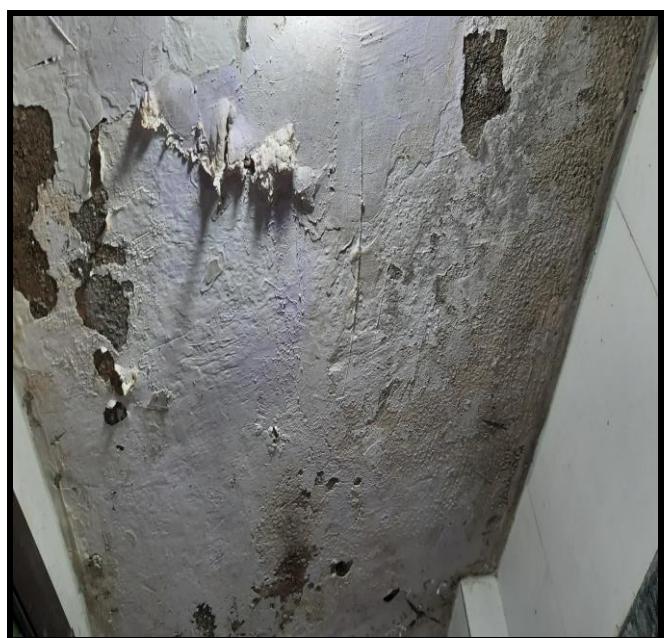
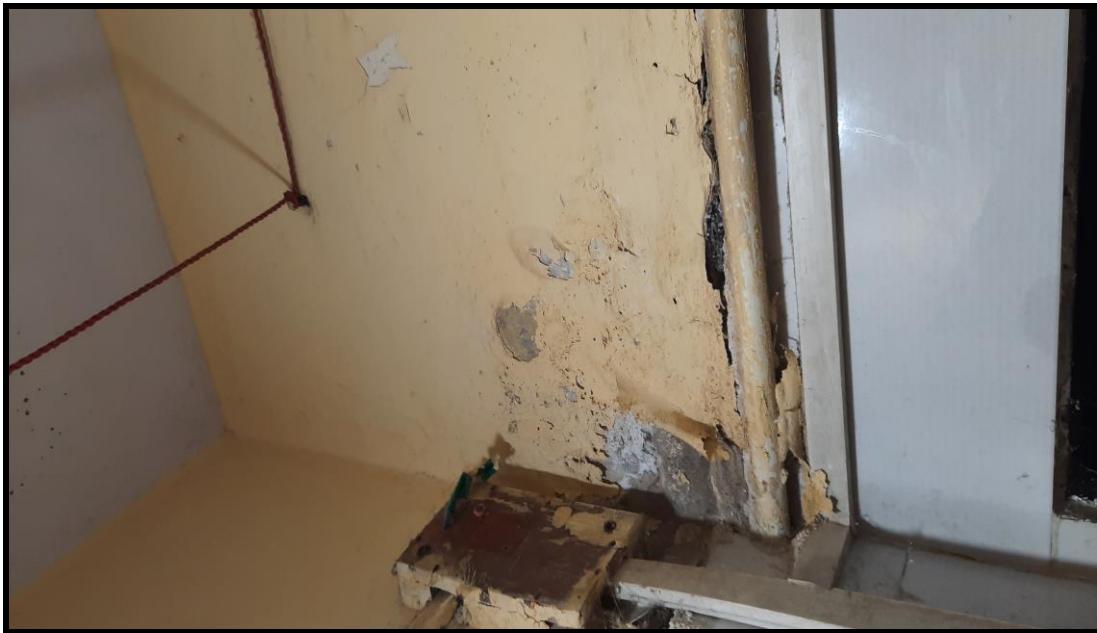
##### FLAT NO – 01

- ❖ **HALL** – Leakage mark observed on ceiling.
- ❖ **KITCHEN** – Leakage observed on ceiling in monsoon.
- ❖ **PASSAGE** – Leakage mark observed on wall.
- ❖ **TOILET & BATH ROOM** – Leakage mark observed on ceiling.

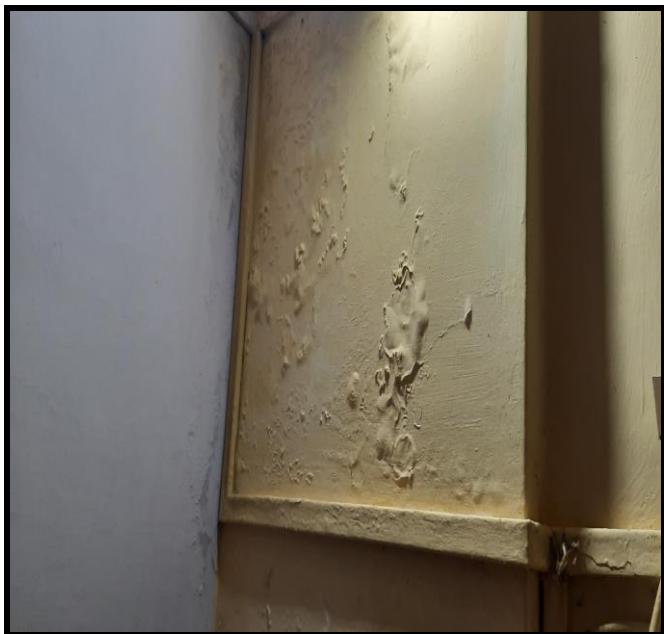
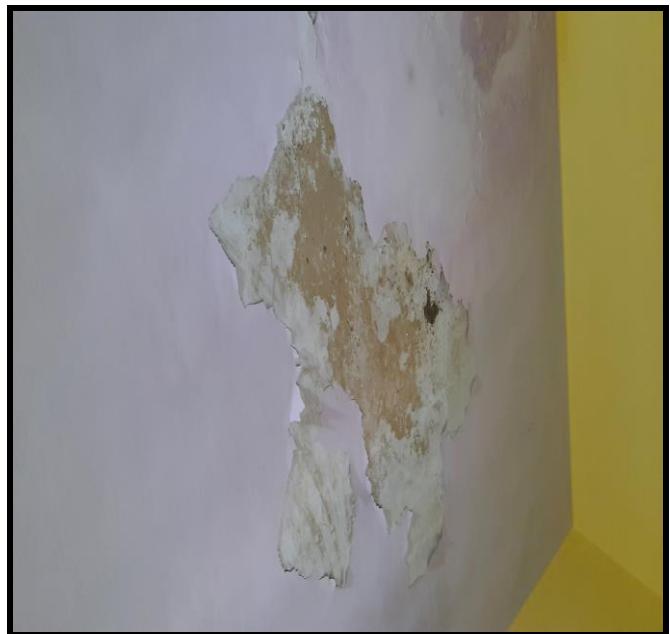
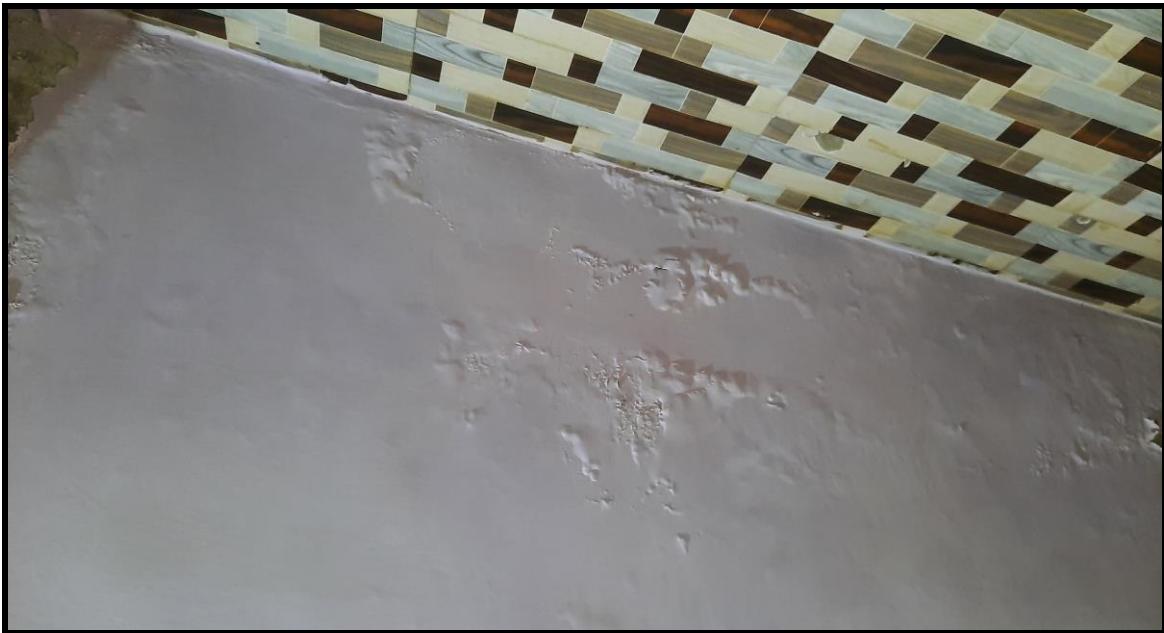
### FLAT NO – 05

- ❖ **HALL** – Leakage mark observed on wall & ceiling.
- ❖ **KITCHEN** – Leakage mark observed on ceiling.
- ❖ **PASSAGE** – Leakage mark observed on ceiling.
- ❖ **TOILET & BATH ROOM** – O.K.

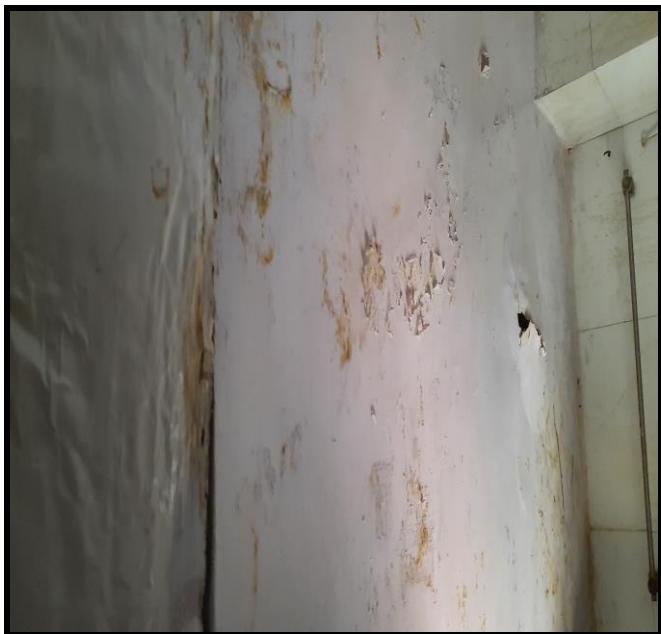
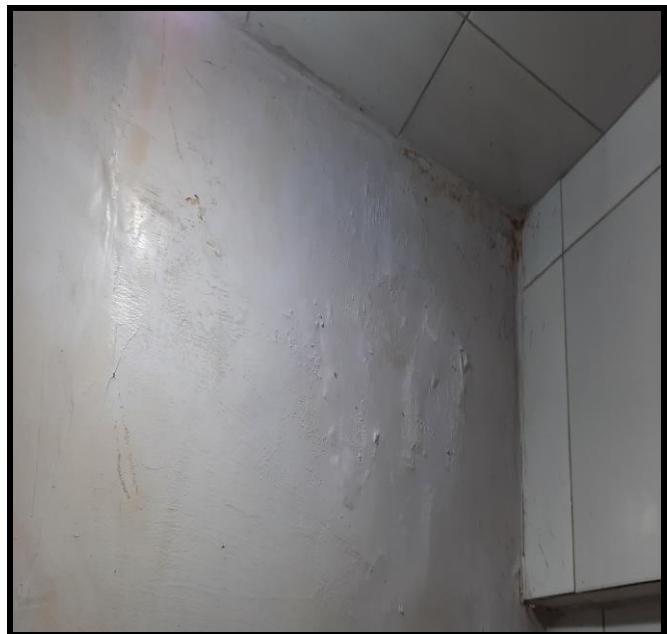
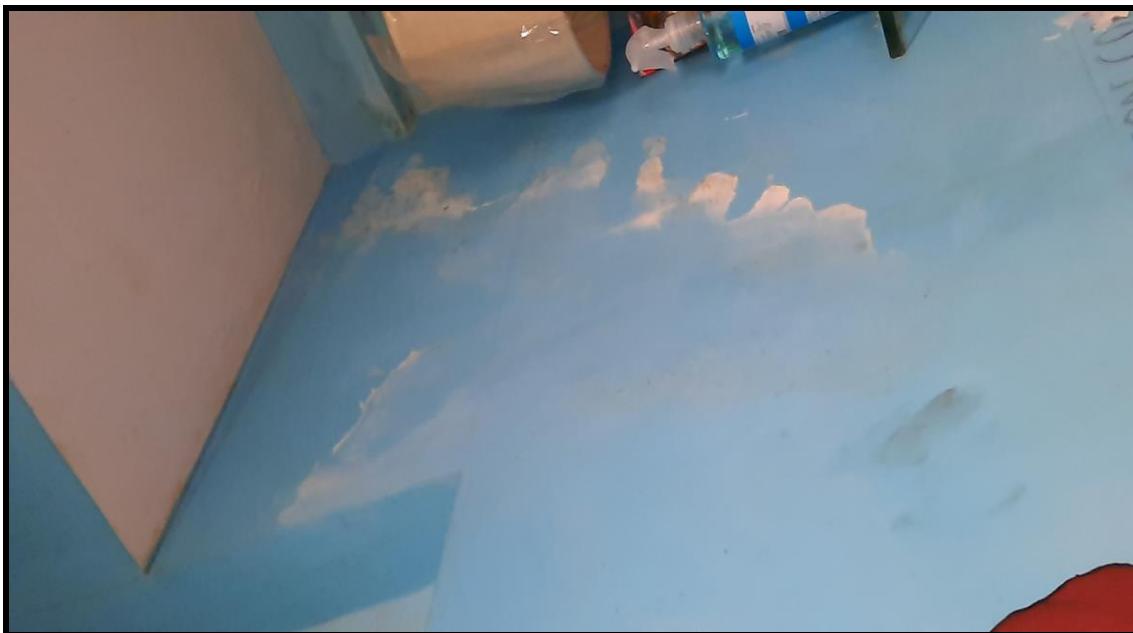
### FLAT NO – 09

- ❖ **HALL** – O.K.
- ❖ **KITCHEN** – Leakage mark observed on ceiling.
- ❖ **PASSAGE** – O.K.
- ❖ **TOILET & BATH ROOM** – Leakage mark observed on ceiling.

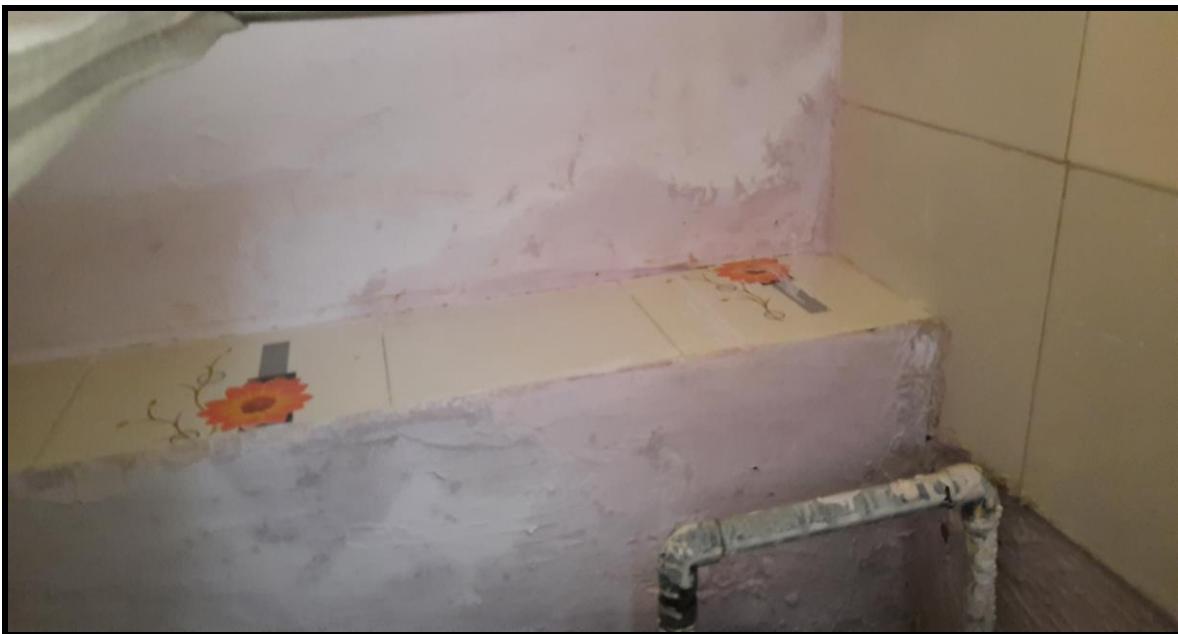
### FLAT NO – 14

- ❖ **HALL** – Leakage mark observed on wall.
- ❖ **KITCHEN** – O.K.
- ❖ **PASSAGE** – Leakage mark observed on ceiling.
- ❖ **TOILET & BATH ROOM** – O.K.

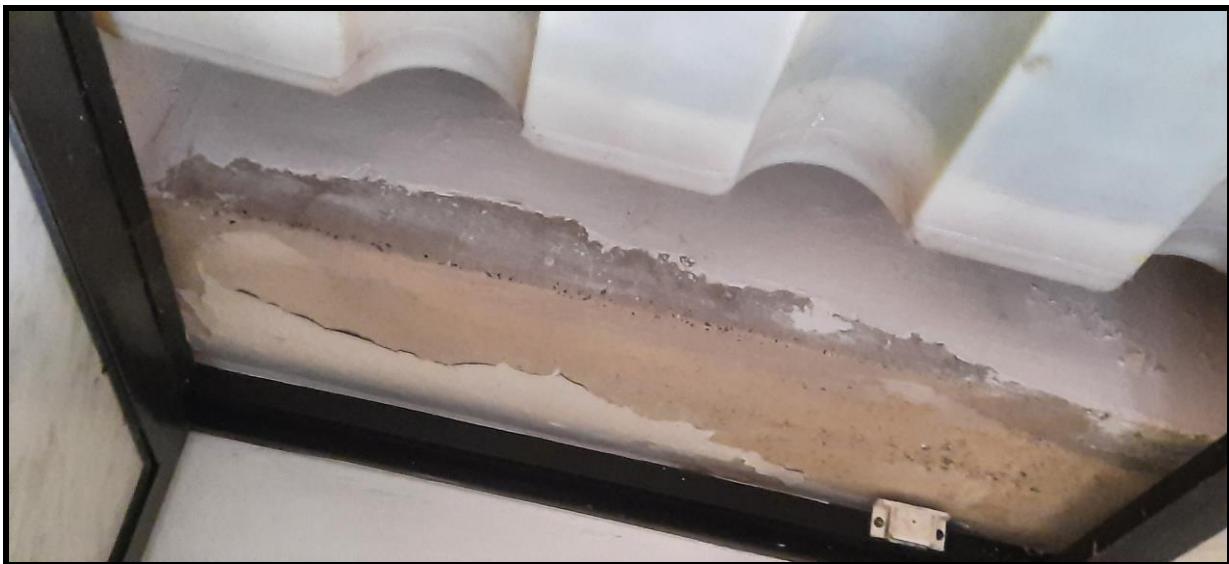
### FLAT NO – 17

- ❖ **HALL** – O.K.
- ❖ **KITCHEN** – Leakage observed on wall in monsoon.
- ❖ **PASSAGE** – Leakage mark observed on ceiling.
- ❖ **TOILET & BATH ROOM** – O.K.

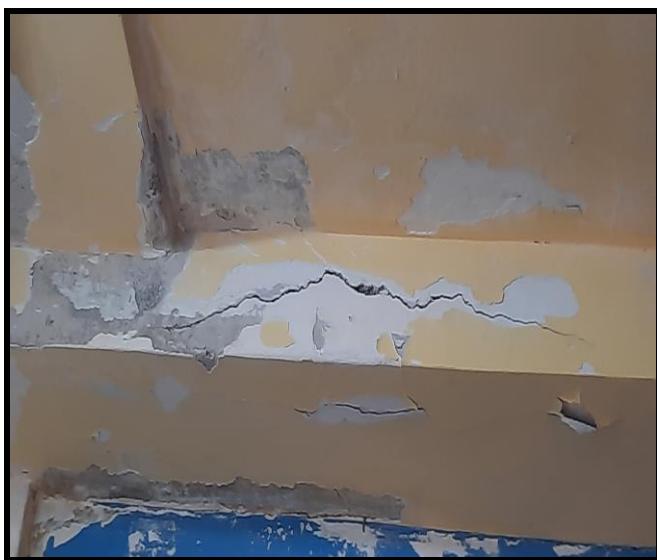
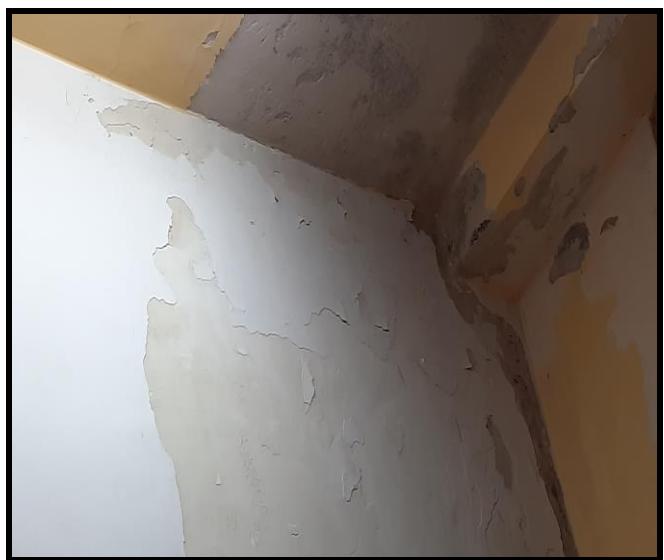
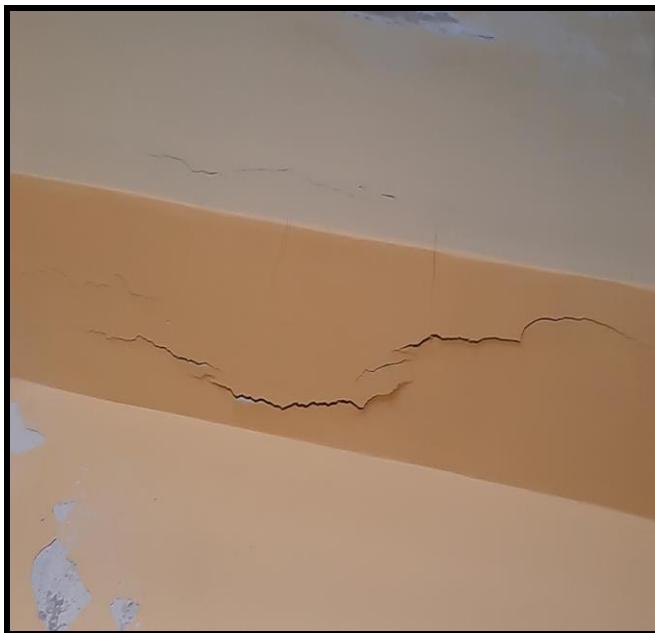
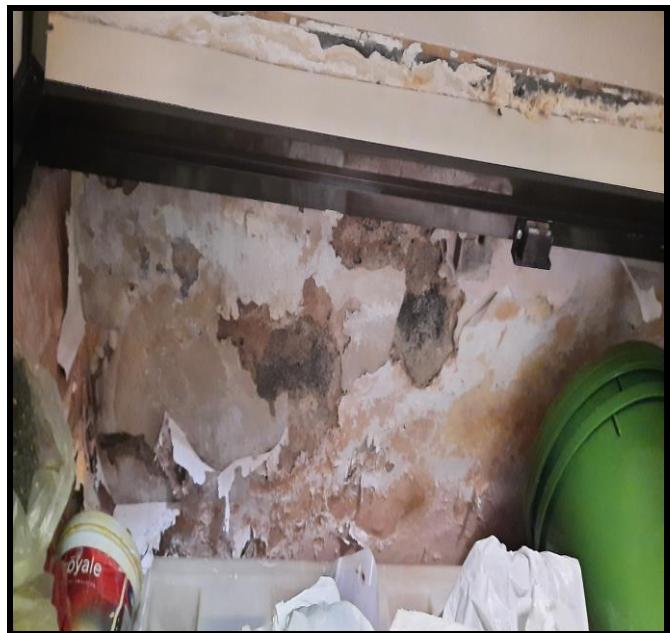
### FLAT NO – 18

- ❖ **HALL** – O.K.
- ❖ **KITCHEN** – Leakage mark observed on wall & ceiling.
  - Structural crack observed on column.
- ❖ **PASSAGE** – Leakage mark observed on ceiling.
- ❖ **TOILET & BATH ROOM** – O.K.

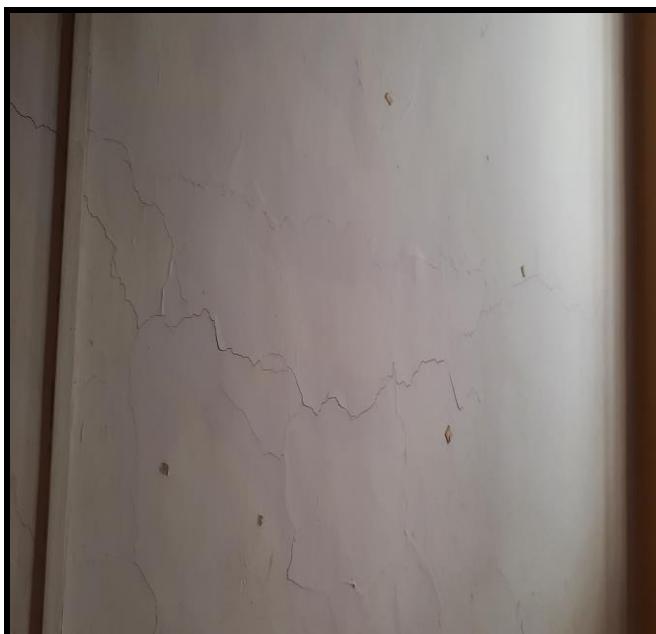
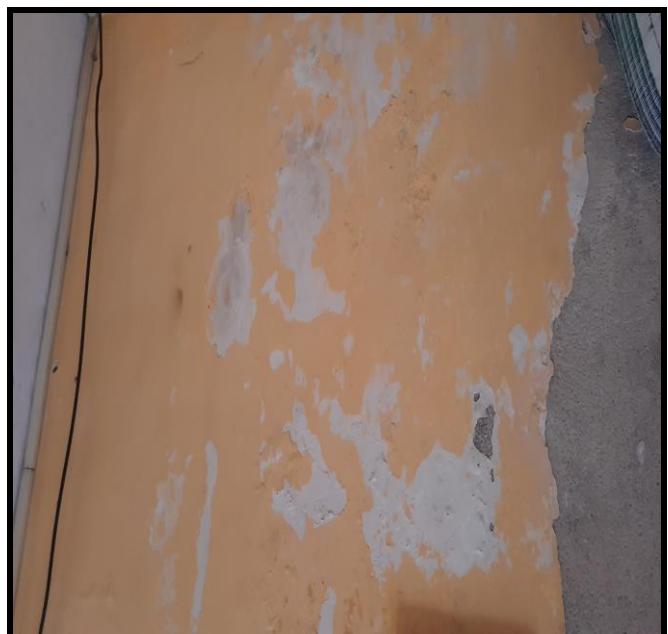
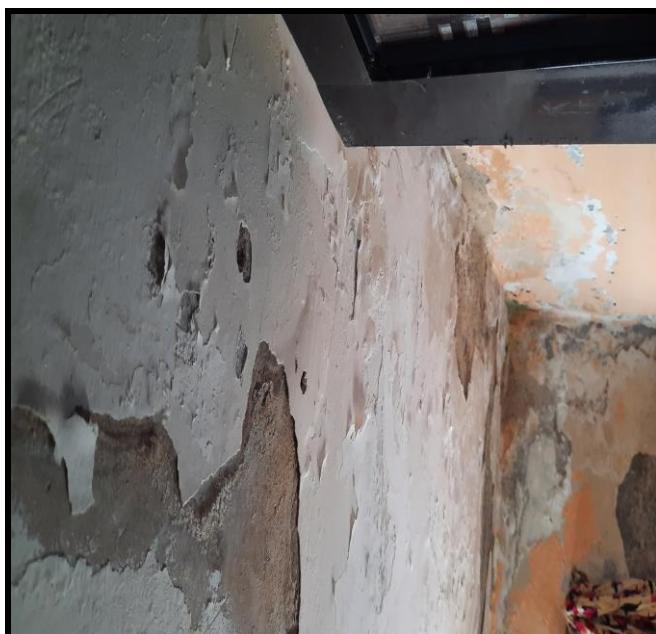
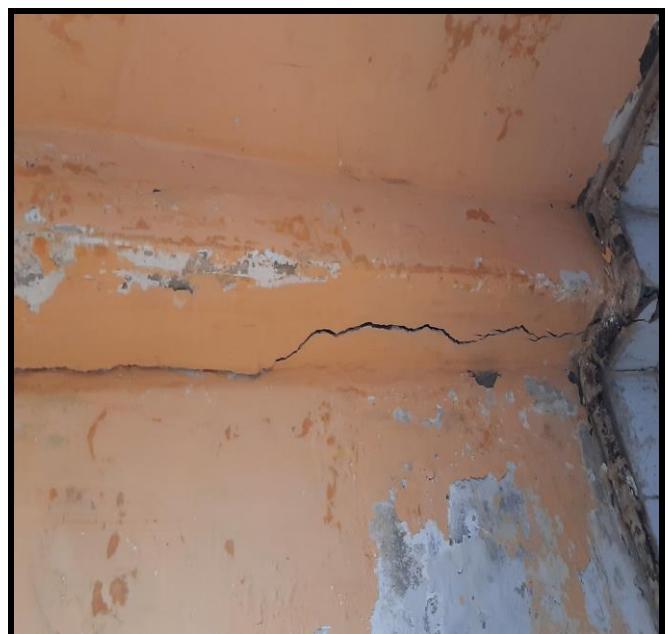
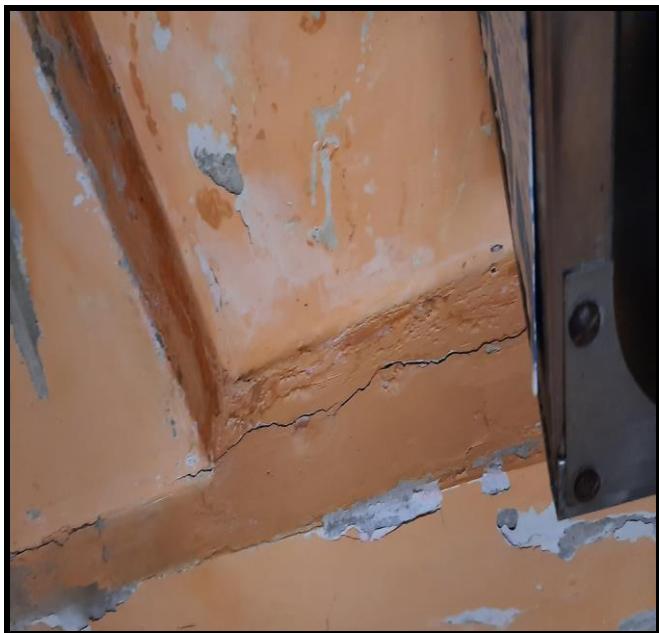
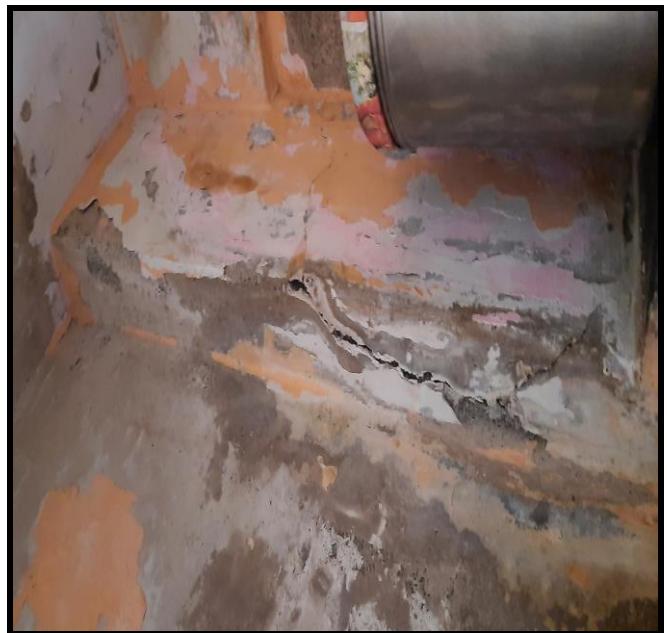
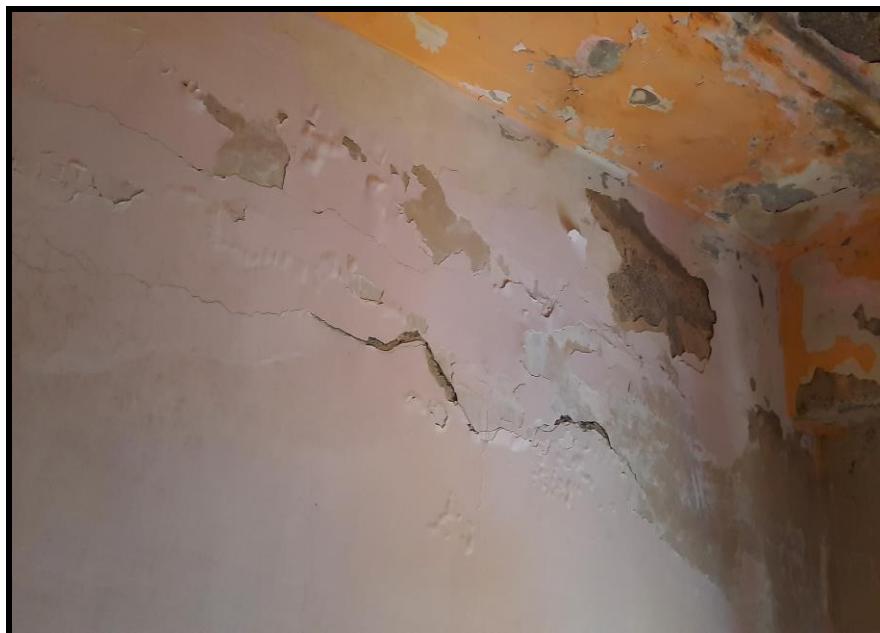
### FLAT NO - 21

- ❖ **HALL** – Leakage mark observed on wall.
  - Structural crack observed on ceiling.
- ❖ **KITCHEN** – Structural crack observed on column & ceiling.
  - Leakage mark observed on wall & ceiling.
- ❖ **PASSAGE** – O.K.
- ❖ **TOILET & BATH ROOM** – Structural crack observed on column.
  - Leakage mark observed on wall & ceiling.

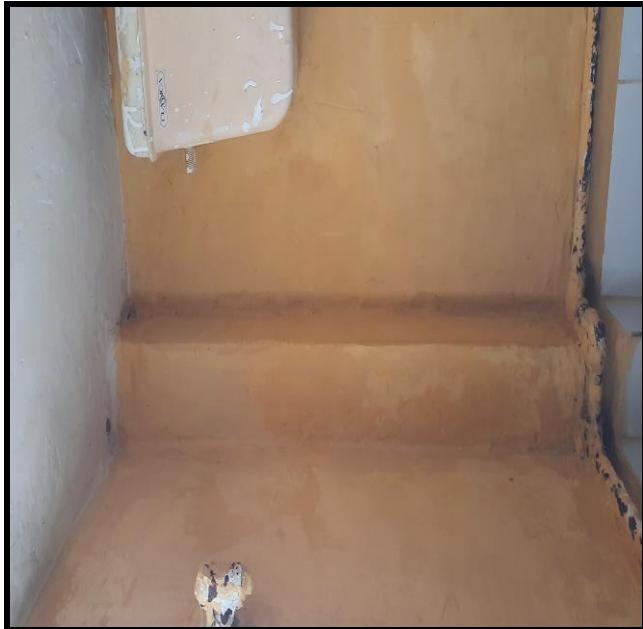
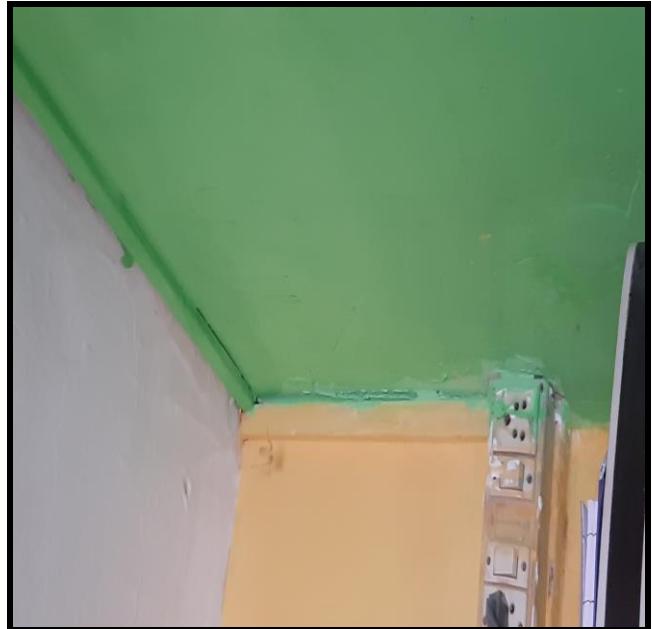
## FLAT NO – 22

- ❖ **HALL** – Leakage mark observed on wall.
- ❖ **KITCHEN** – O.K.
- ❖ **PASSAGE** – O.K.
- ❖ **TOILET & BATH ROOM** – Leakage mark observed on wall.

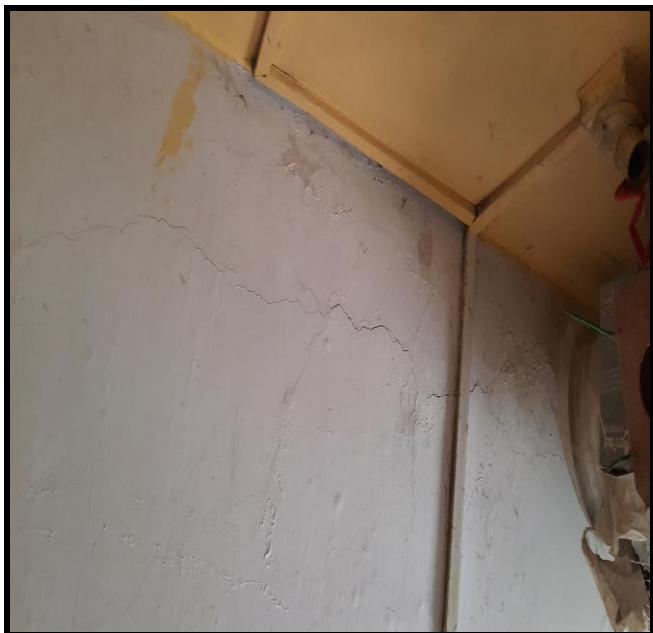
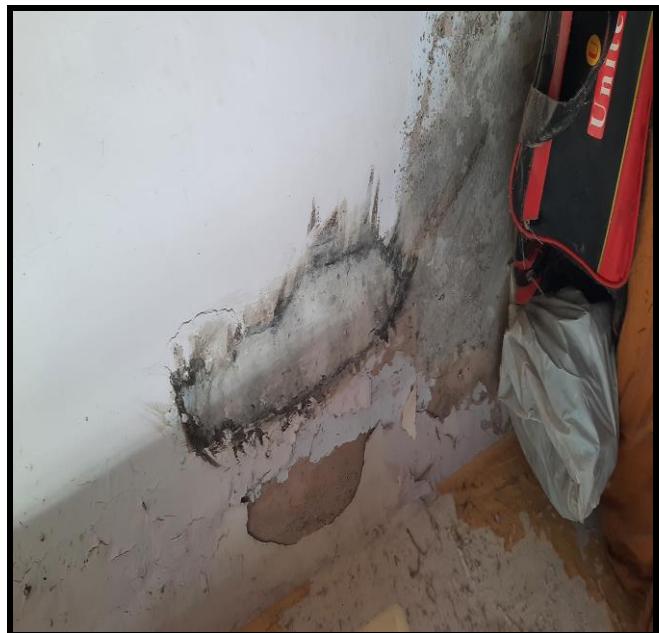
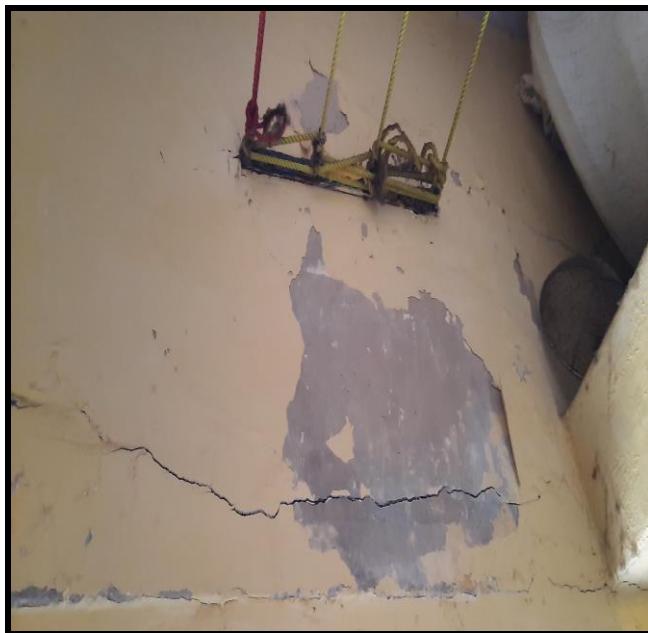
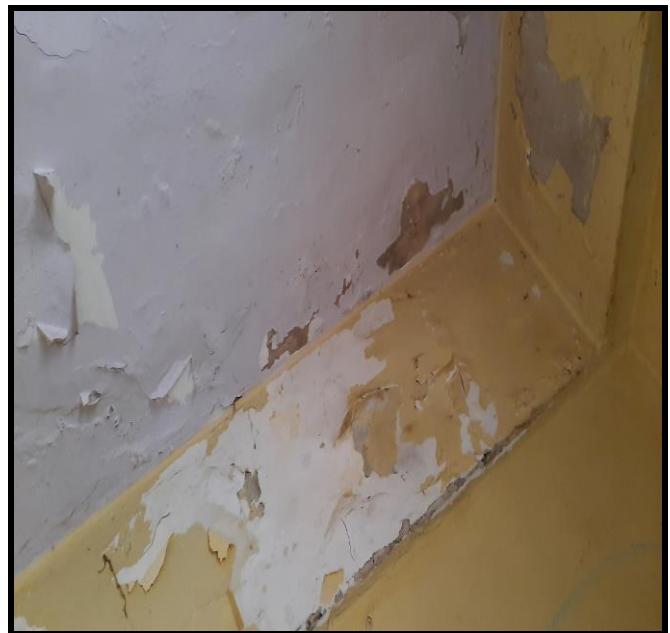
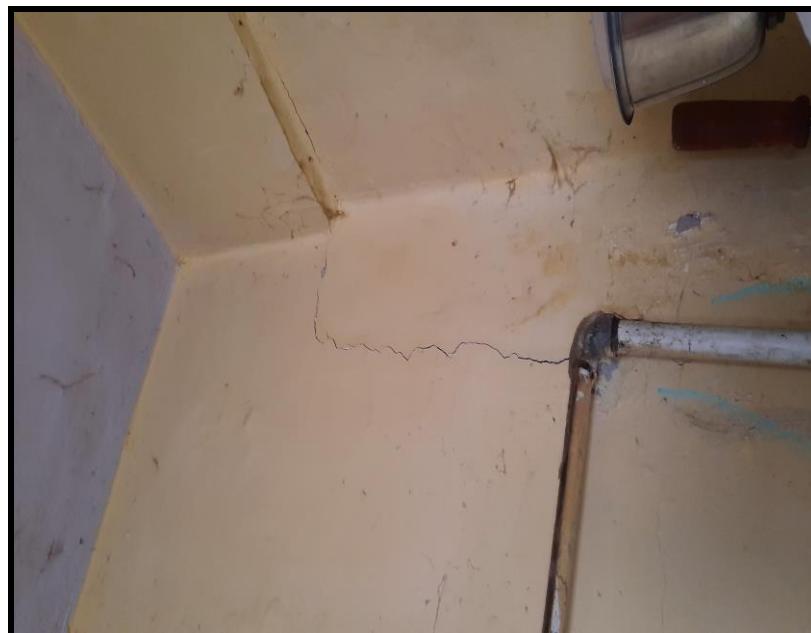
### FLAT NO – 32

- ❖ **HALL** – Structural crack observed on ceiling.
  - Leakage mark observed on ceiling.
- ❖ **KITCHEN** – Leakage mark observed on wall & ceiling.
  - Structural crack observed on column & beam.
- ❖ **PASSAGE** – Leakage mark observed on ceiling.
- ❖ **TOILET & BATH ROOM** – O.K.

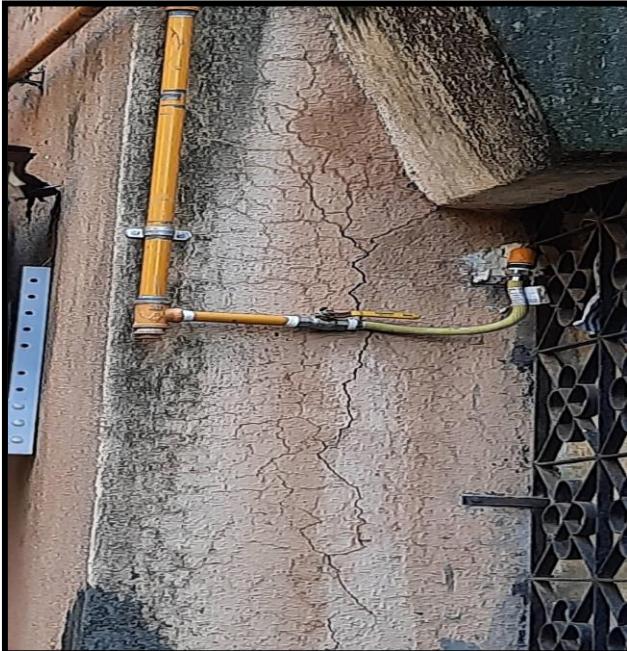
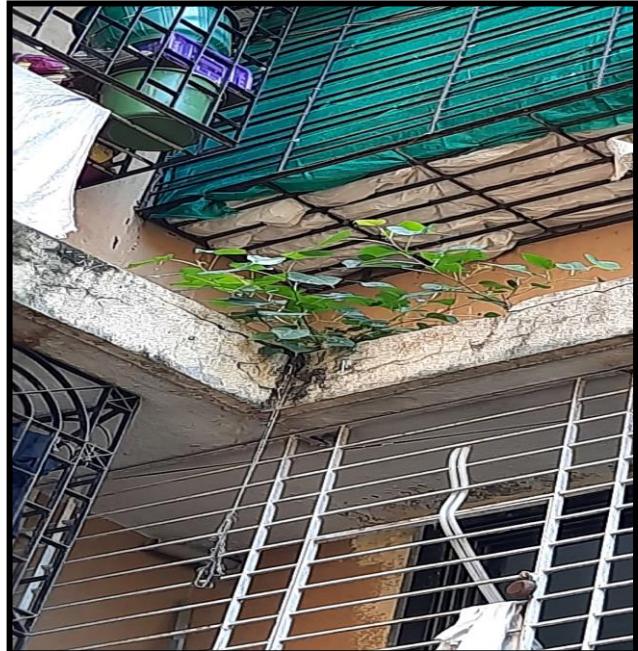
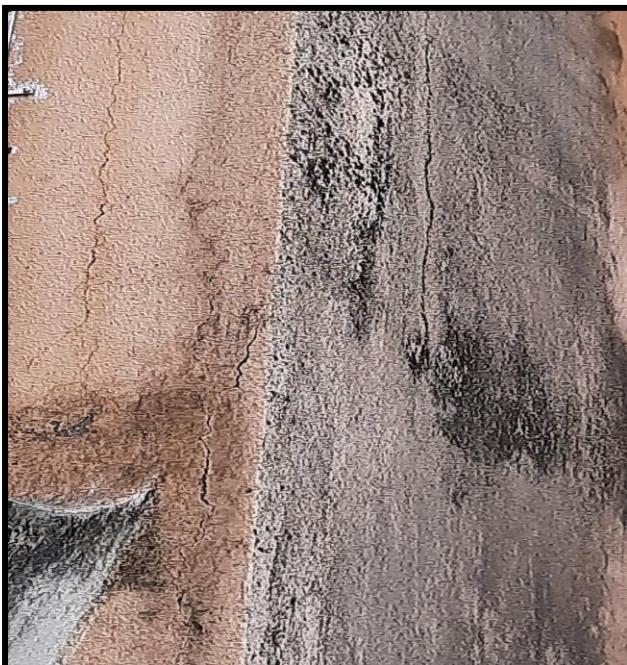
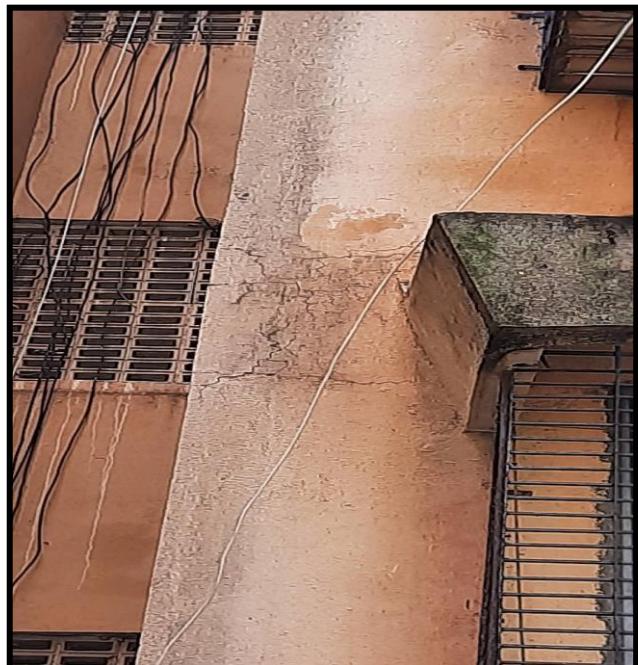
### FRONT SIDE

- ❖ Structural crack observed at several places on column & chajjas.
- ❖ Vegetation growth observed at several places on chajjas.

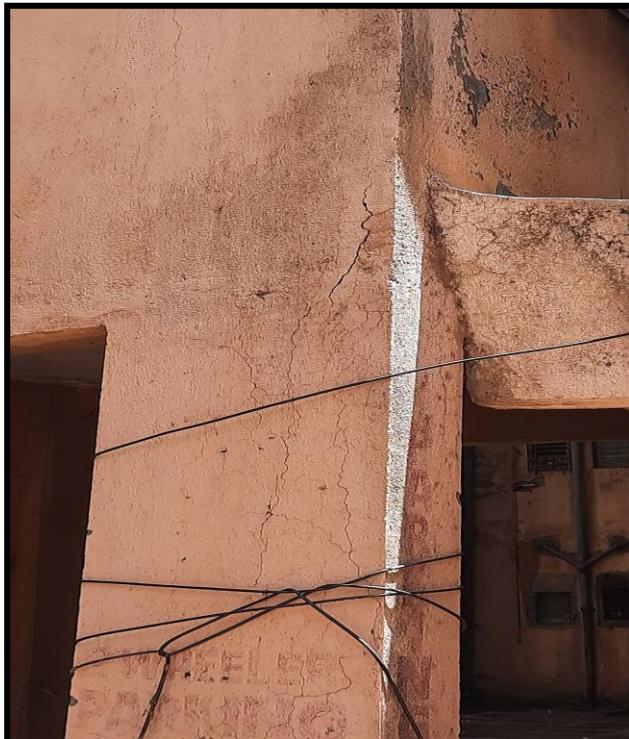
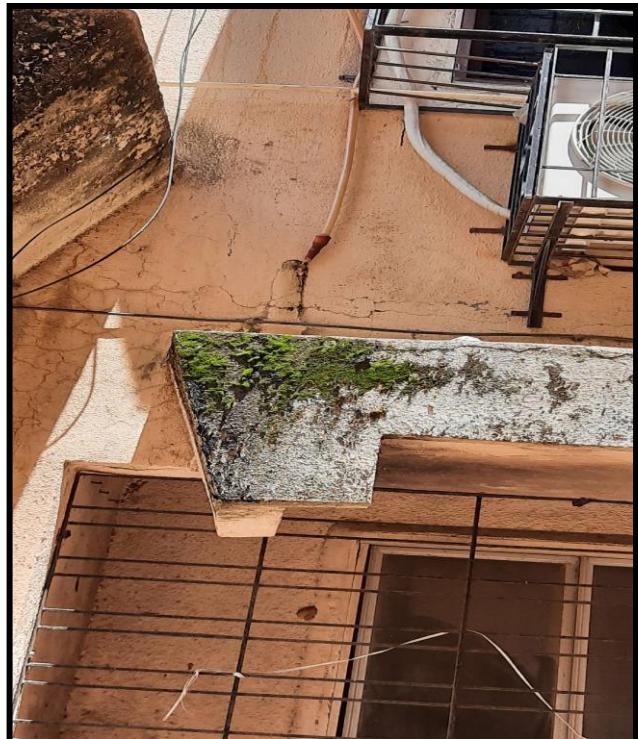
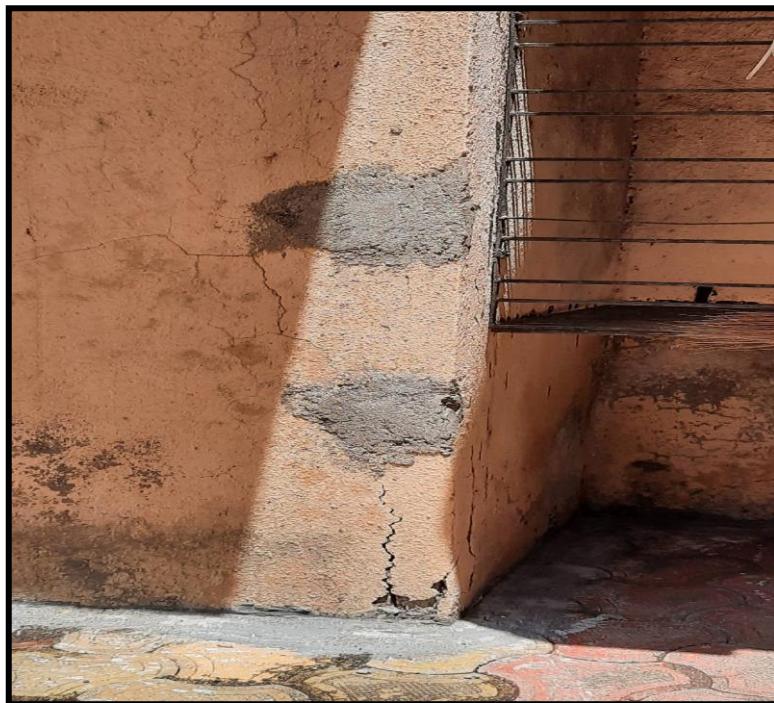
## BACK SIDE

- ❖ Structural crack observed at several places on column.
- ❖ Algae observed at several places on chajjas.

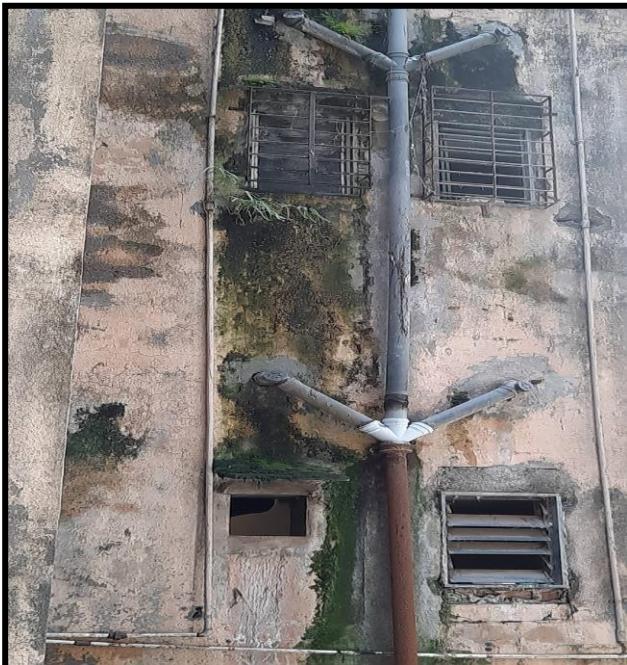
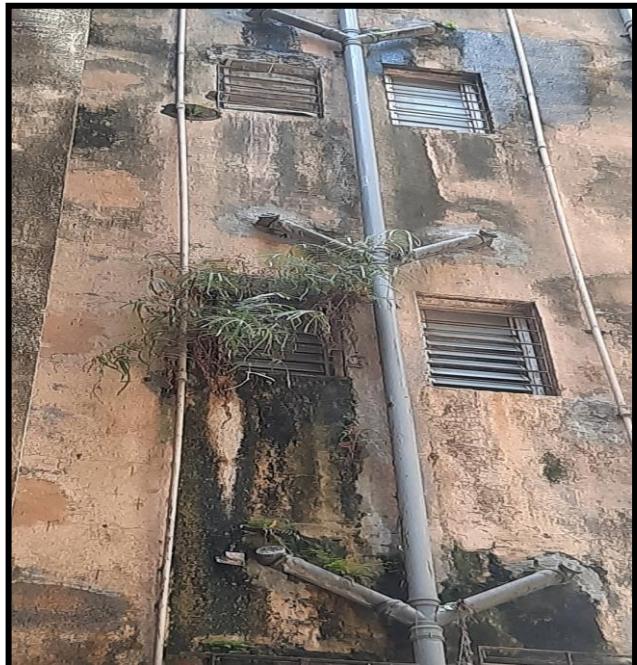
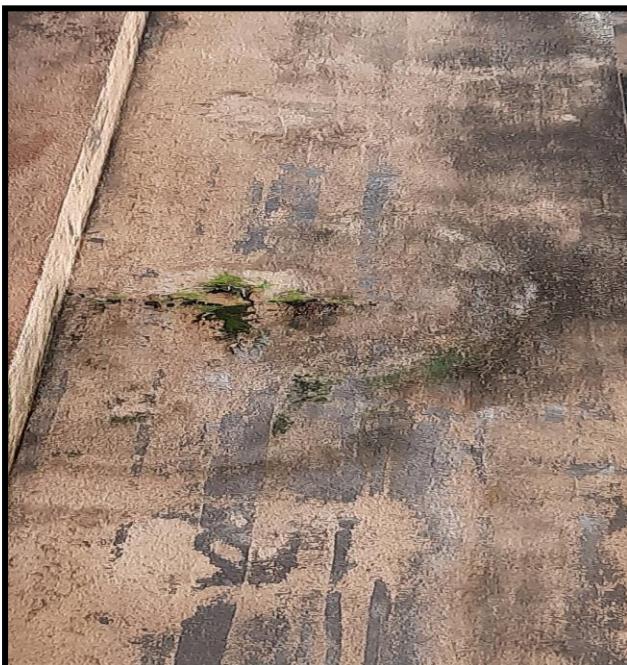
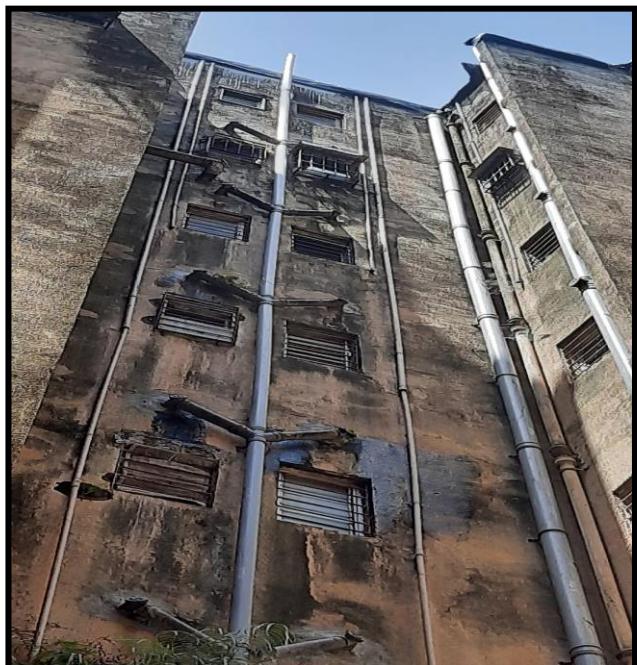
## NORTH SIDE

- ❖ Algae observed at several places on wall.
- ❖ Vegetation growth observed at several places on wall.

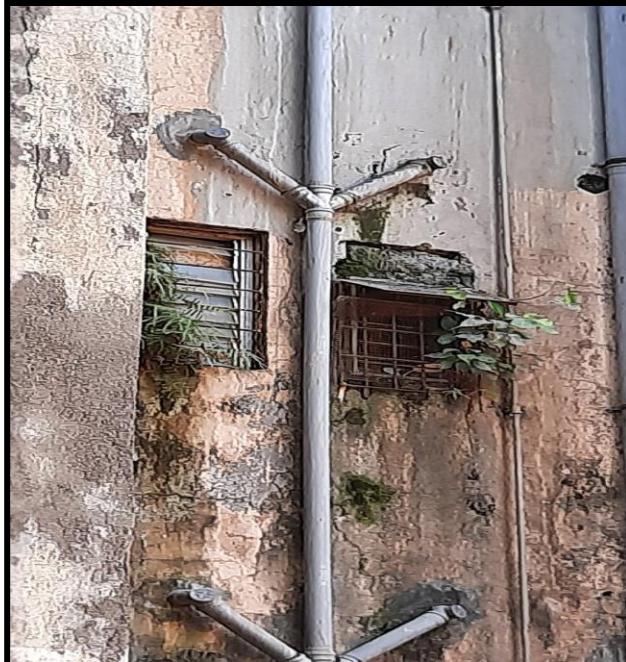
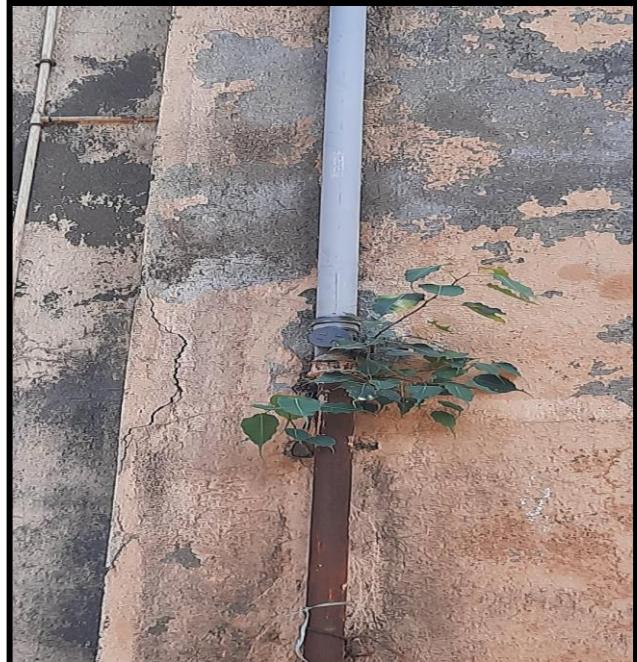
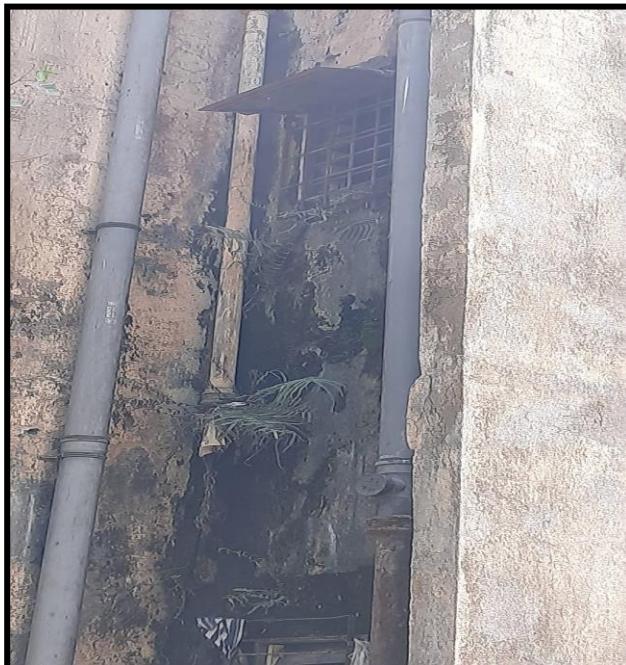
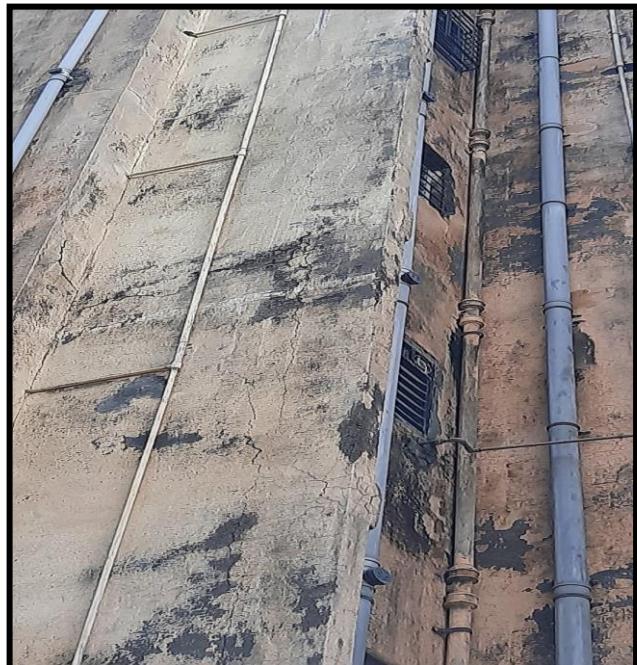
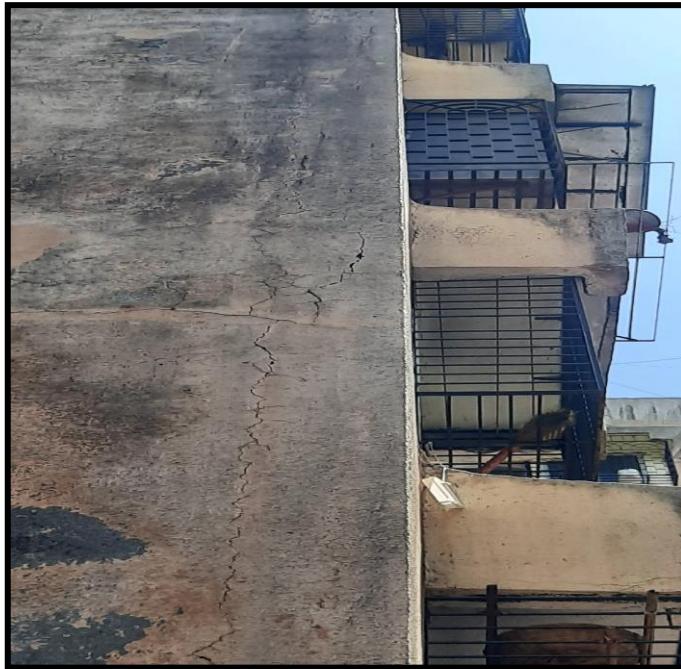
## SOUTH SIDE

- ❖ Structural crack observed at several places on column.
- ❖ Major crack observed at several places on wall.
- ❖ Algae observed at several places on wall.
- ❖ Vegetation growth observed at several places on wall.
