STRUCTURAL AUDIT REPORT
FOR
“VISHAL SAHYADRI CO – OP HSG. SOC. LTD”,
“D2 – A WING”
SITUATED AT
SAHYADRI NAGAR, CHARKOP,
KANDIVALI (W) MUMBAI – 400 067

PREPARED BY
LATESH S. SANKLECHA
CONSULTING STRUCTURAL ENGINEERS

978/D2/LSS/2021

JULY 24, 2021

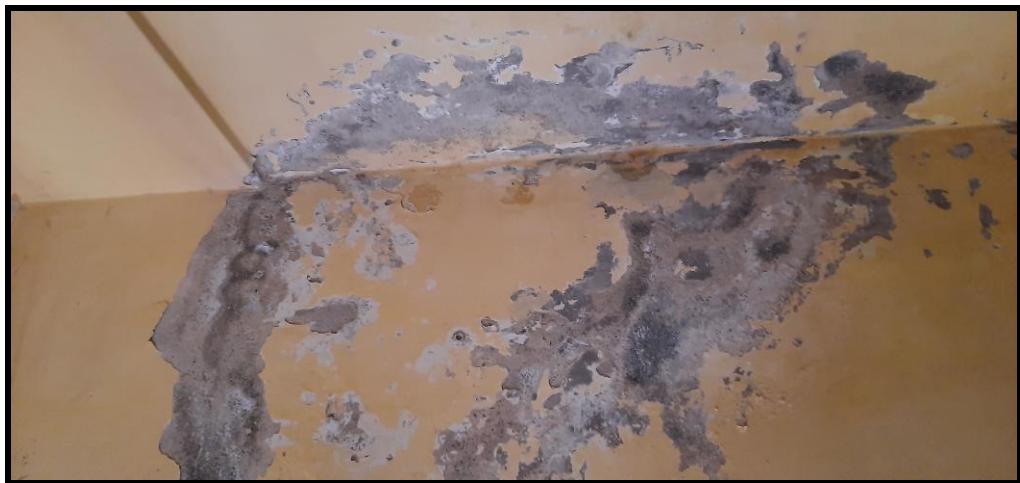
FLAT NO – 101

- ❖ **HALL** – Leakage mark observed on wall.
- ❖ **KITCHEN** – O.K.
- ❖ **PASSAGE** – O.K.
- ❖ **TOILET & BATH ROOM** – O.K.

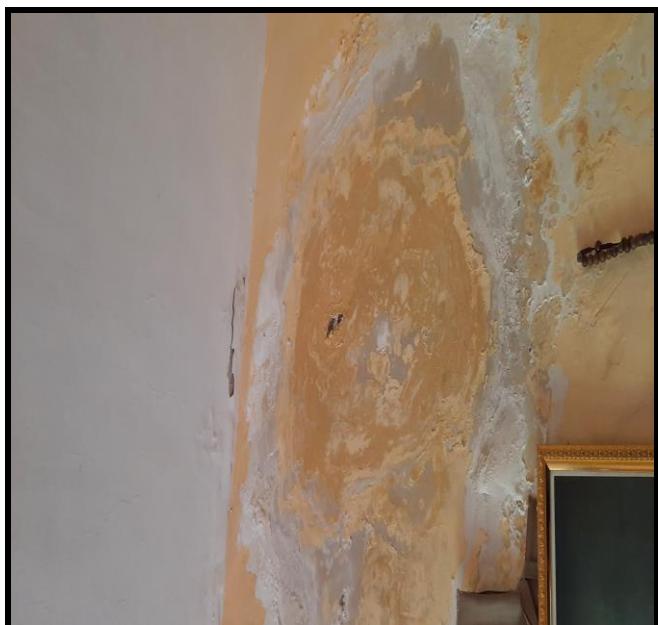
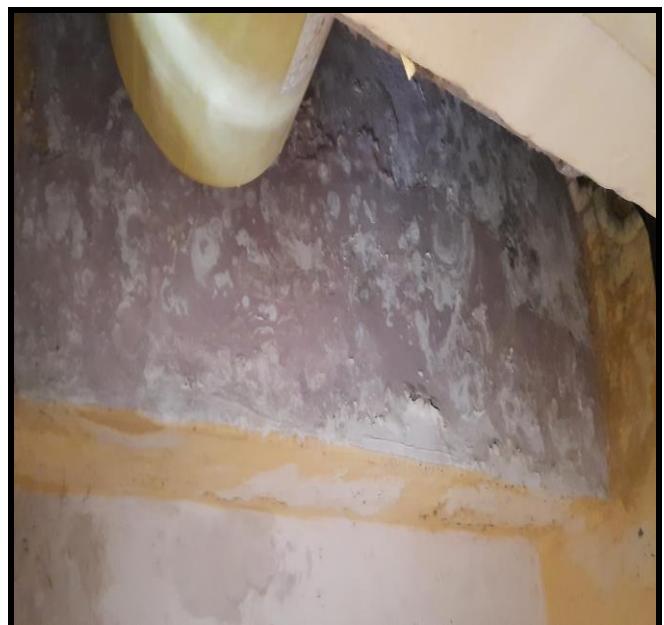
FLAT NO – 103

- ❖ **HALL** – Leakage mark observed on wall.
- ❖ **KITCHEN** – Leakage mark observed on wall.
 - Structural crack observed on column.
- ❖ **PASSAGE** – Leakage mark observed on ceiling.
- ❖ **TOILET & BATH ROOM** – Leakage mark observed on wall & ceiling.

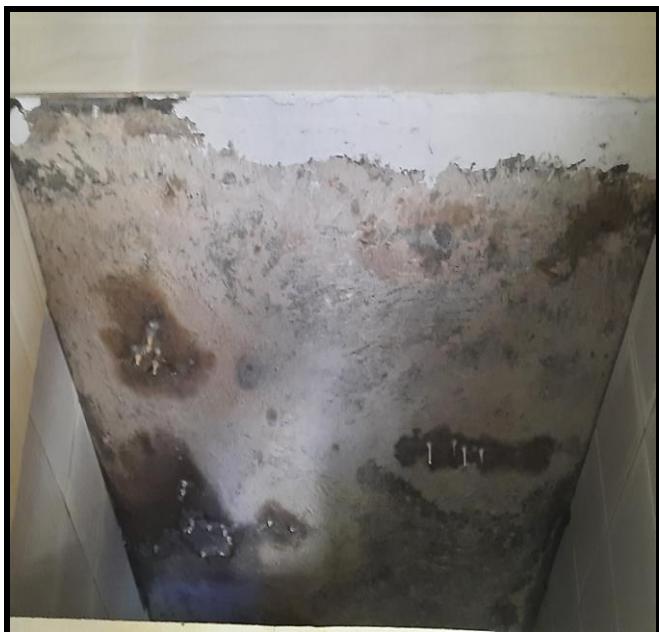
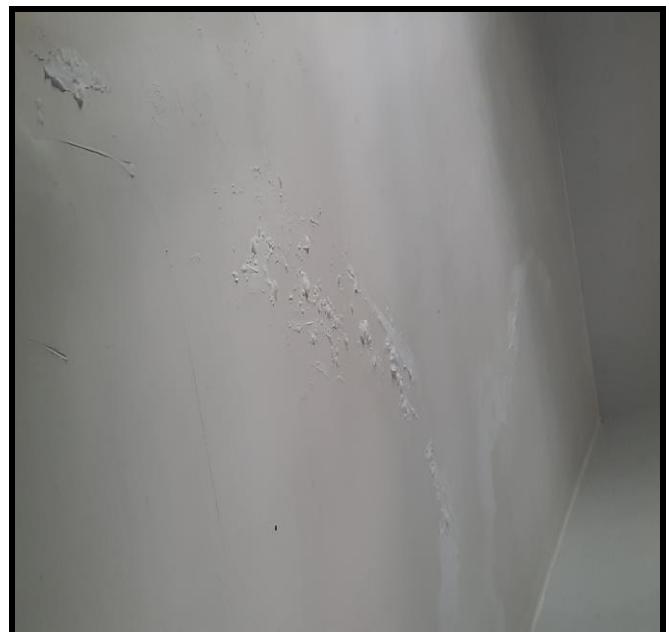
FLAT NO – 303

- ❖ **HALL** – Dampness observed on wall in monsoon.
- ❖ **KITCHEN** – O.K.
- ❖ **PASSAGE** – Leakage observed on ceiling.
- ❖ **TOILET & BATH ROOM** – Leakage mark observed on ceiling.

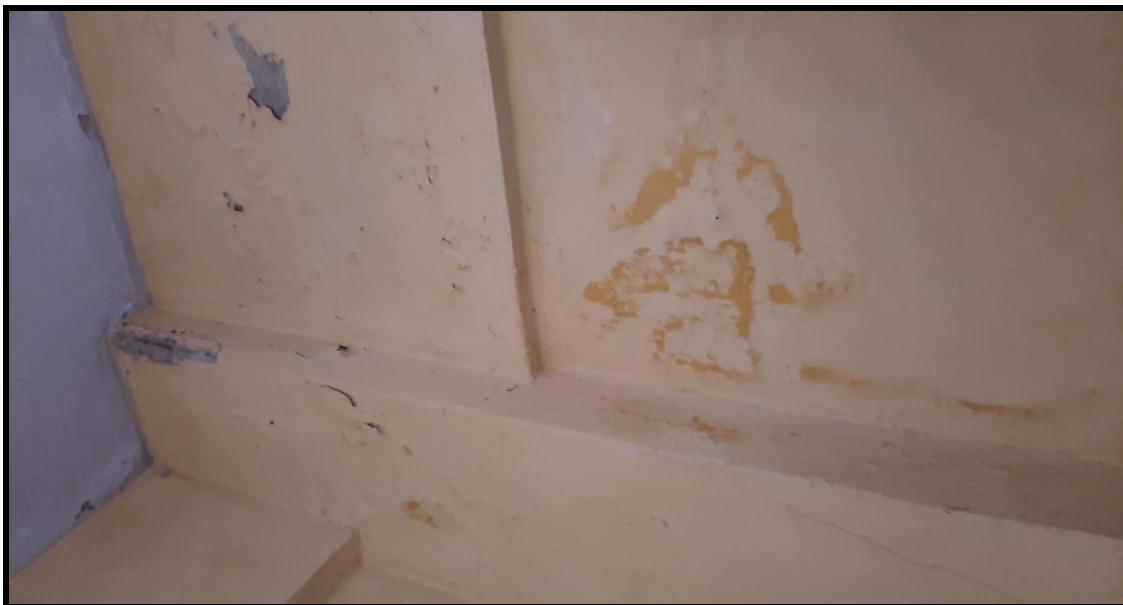
FLAT NO – 402

- ❖ **HALL** – Dampness observed on wall in monsoon.
- ❖ **KITCHEN** – Leakage mark observed on wall.
- ❖ **PASSAGE** – O.K.
- ❖ **TOILET & BATH ROOM** – O.K.

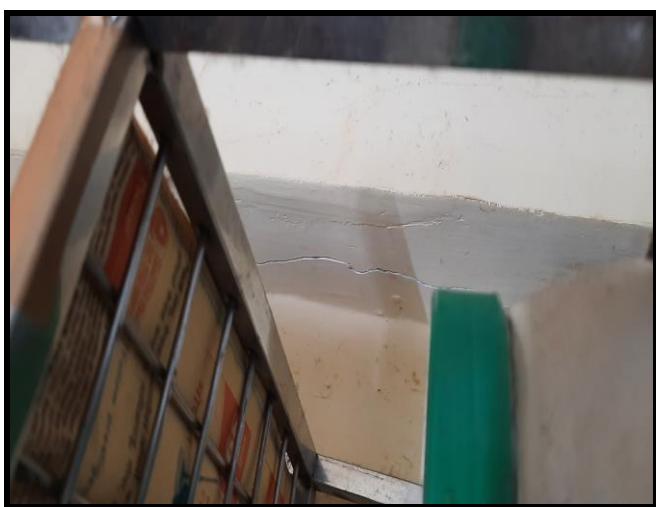
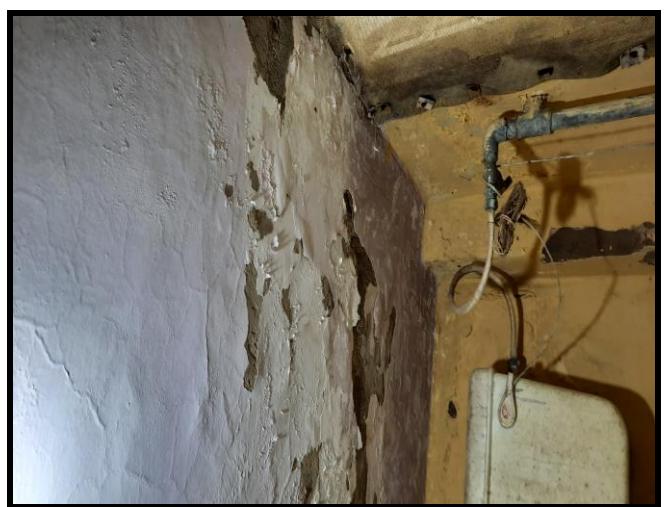
FLAT NO – 403

- ❖ **HALL** – Dampness observed on wall in monsoon.
- ❖ **KITCHEN** – Dampness observed on ceiling in monsoon.
 - Structural crack observed on column.
- ❖ **PASSAGE** – O.K.
- ❖ **TOILET & BATH ROOM** – Leakage mark observed on wall & ceiling.

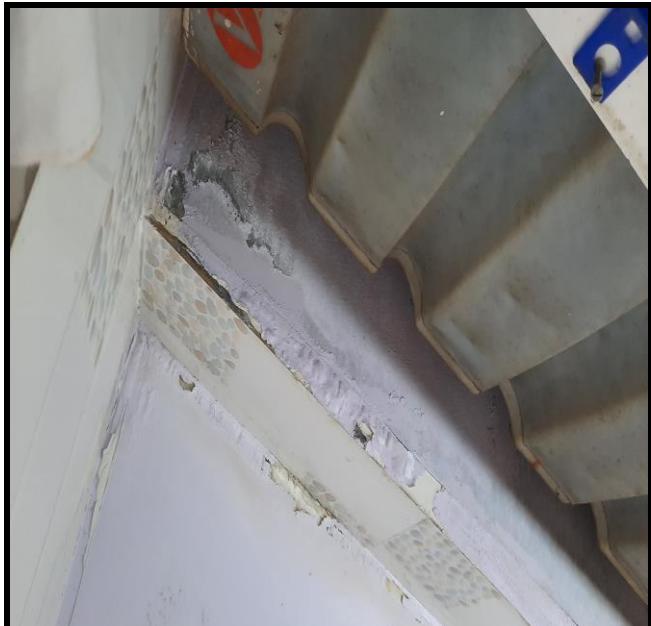
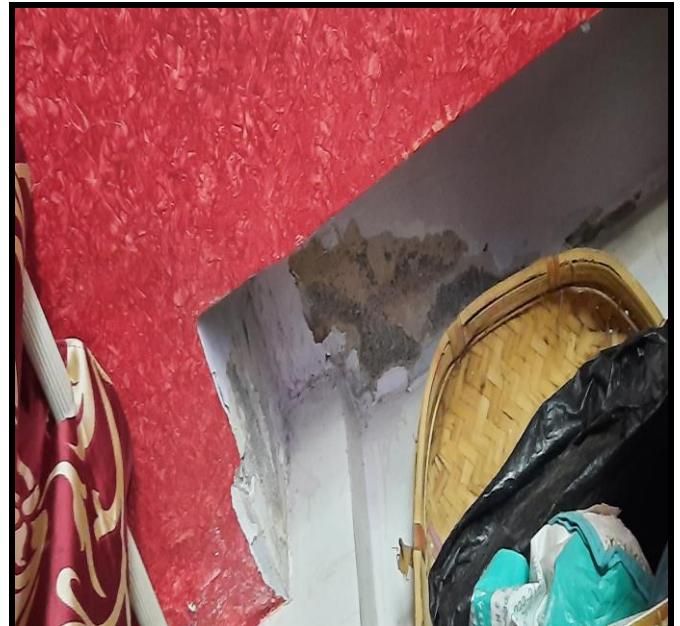
FLAT NO – 501

- ❖ **HALL** – O.K.
- ❖ **KITCHEN** – Leakage mark observed on ceiling.
- ❖ **PASSAGE** – Leakage mark observed on ceiling.
- ❖ **TOILET & BATH ROOM** – O.K.

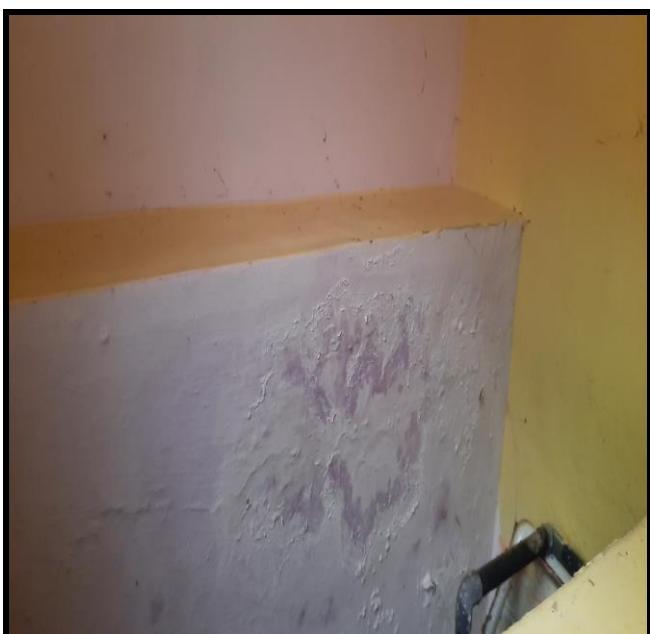
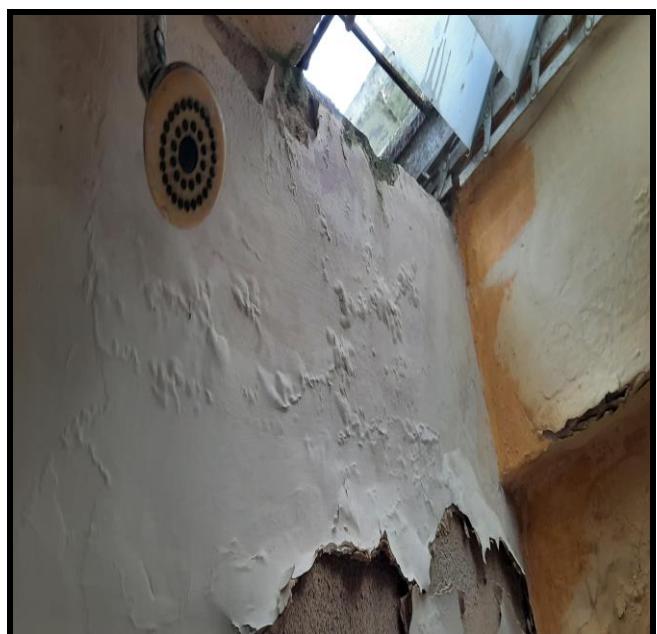
FLAT NO – 604

- ❖ **HALL** – O.K.
- ❖ **KITCHEN** – O.K.
- ❖ **PASSAGE** – Leakage mark observed on ceiling.
- ❖ **TOILET & BATH ROOM** – Leakage mark observed on ceiling.

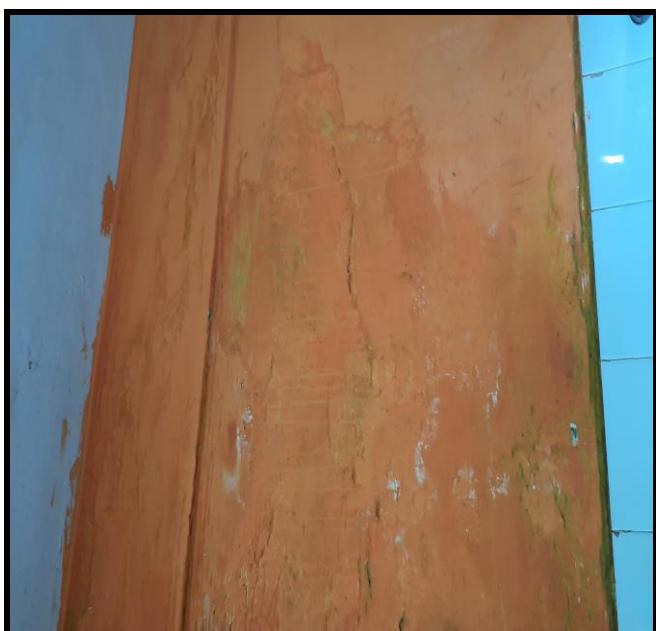
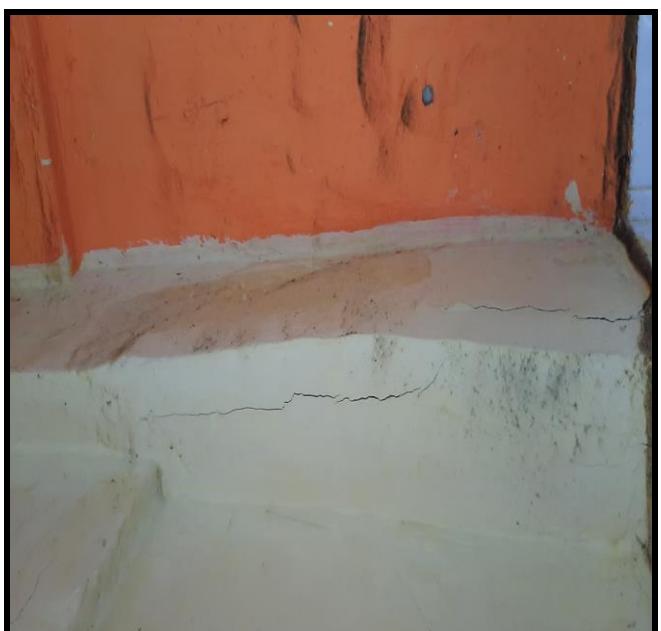
FLAT NO – 701

- ❖ **HALL** – Dampness observed on wall in monsoon.
- ❖ **KITCHEN** – Leakage mark observed on wall & ceiling.
 - Structural crack observed on column.
- ❖ **PASSAGE** – O.K.
- ❖ **TOILET & BATH ROOM** – O.K.

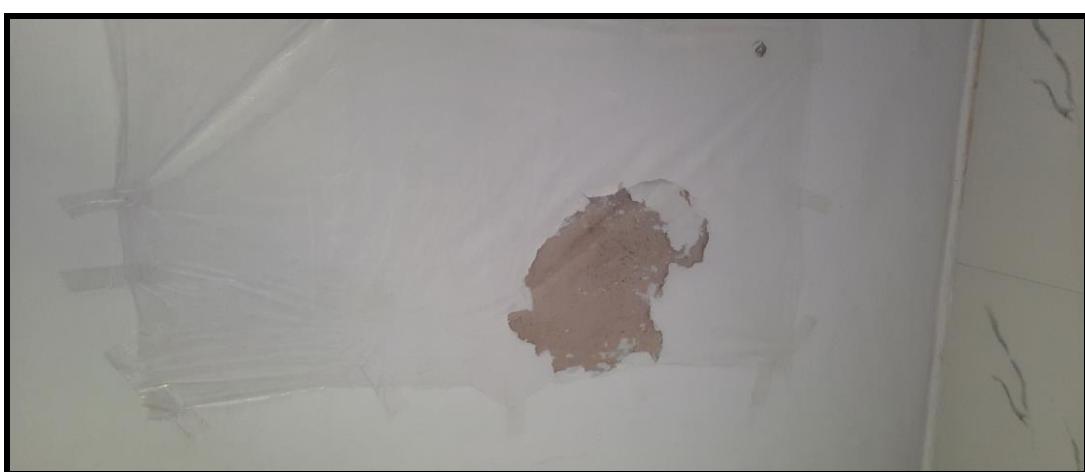
FLAT NO – 702

- ❖ **HALL** – Leakage mark observed on ceiling.
- ❖ **KITCHEN** – Leakage mark observed on ceiling.
- ❖ **PASSAGE** – O.K.
- ❖ **TOILET & BATH ROOM** – O.K.

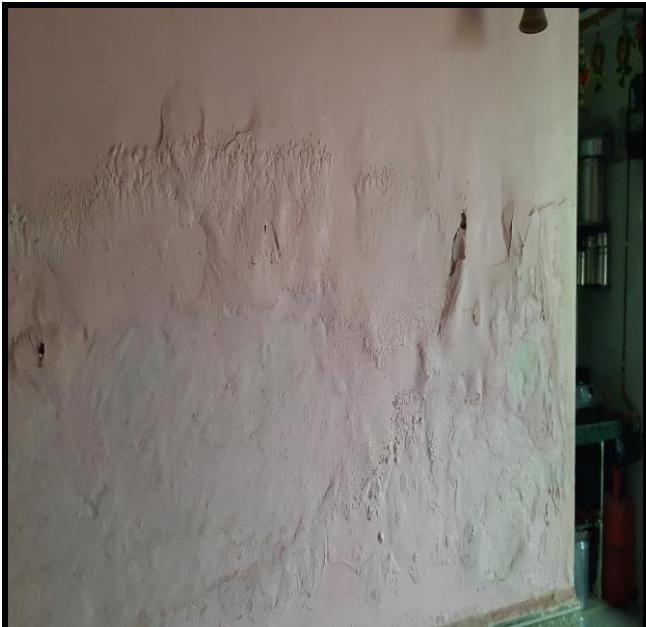
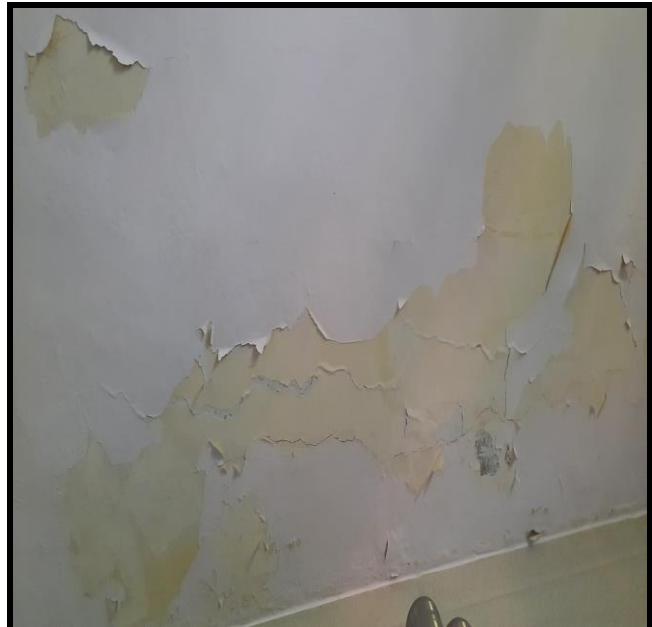
FLAT NO – 704

- ❖ **HALL** – Leakage mark observed on wall.
- ❖ **KITCHEN** – Leakage mark observed on ceiling.
 - Structural crack observed on ceiling.
- ❖ **PASSAGE** – O.K.
- ❖ **TOILET & BATH ROOM** – O.K.

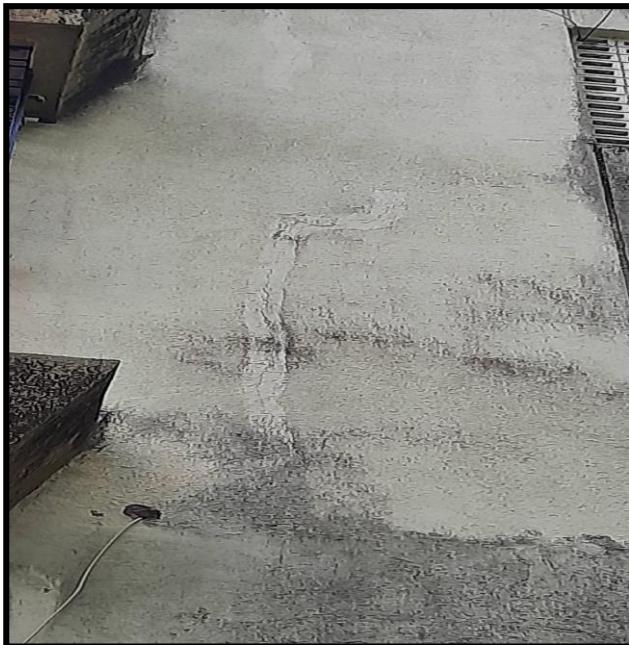
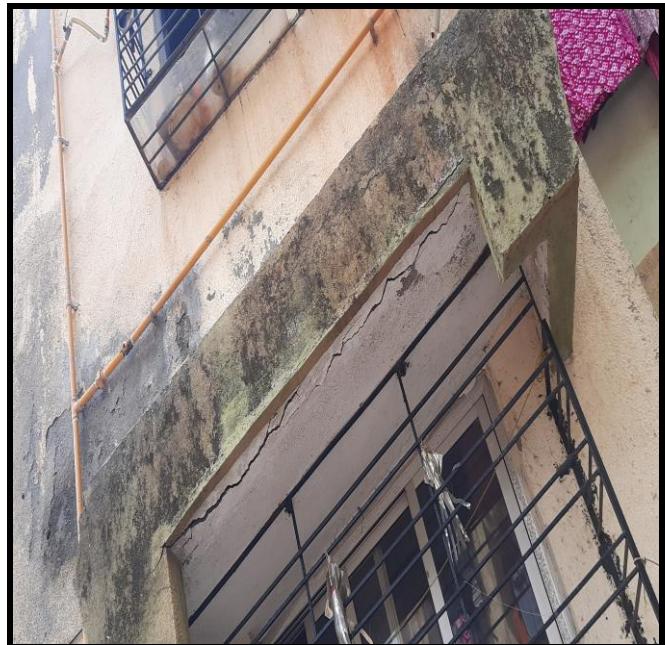
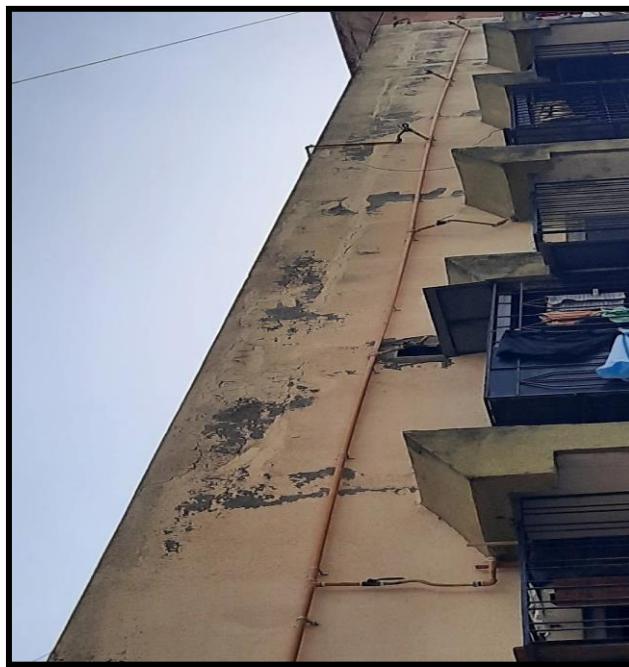
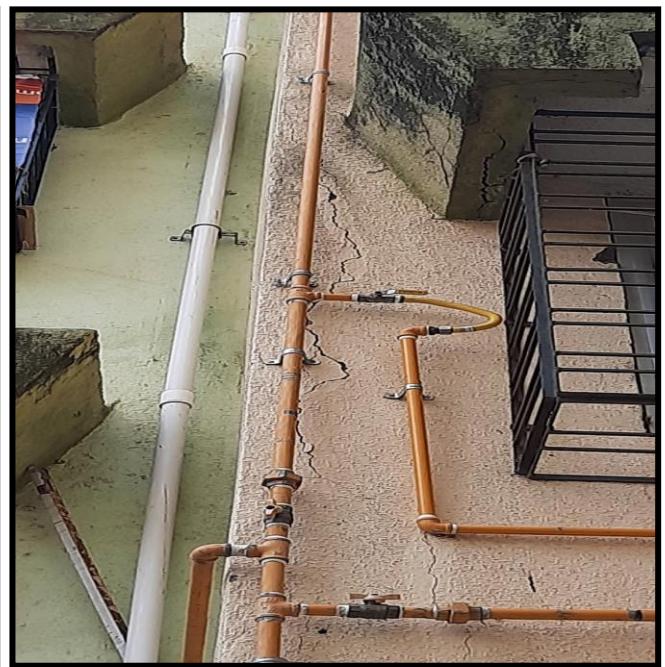
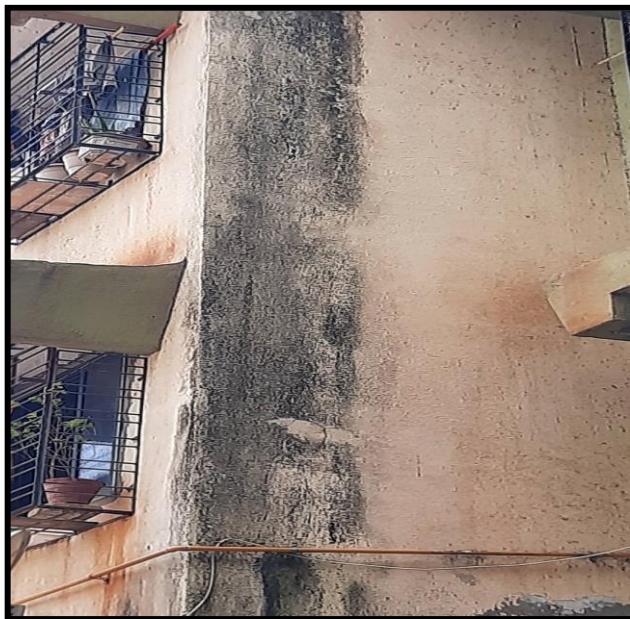
FRONT SIDE

- ❖ Structural crack observed at several places on column & chajjas.
- ❖ Major crack observed at several places on wall.

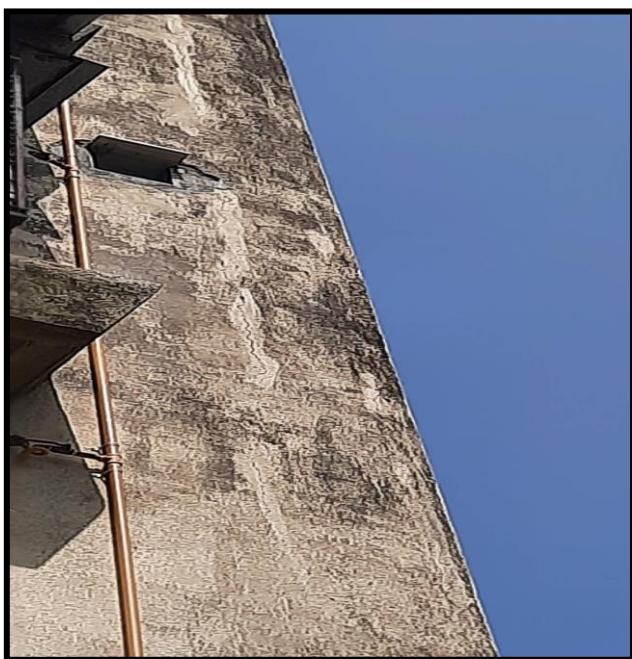
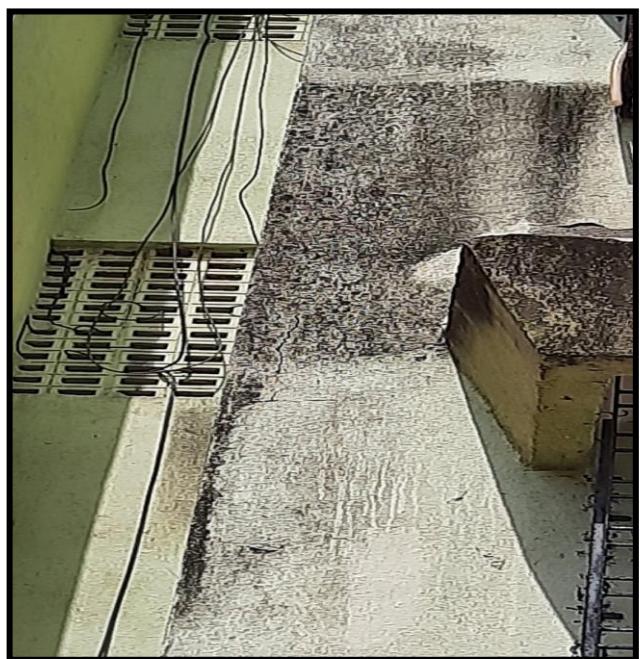
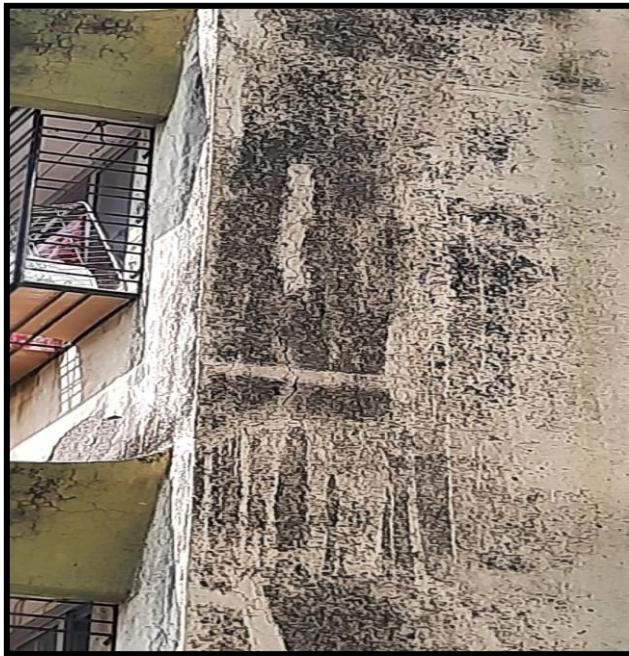
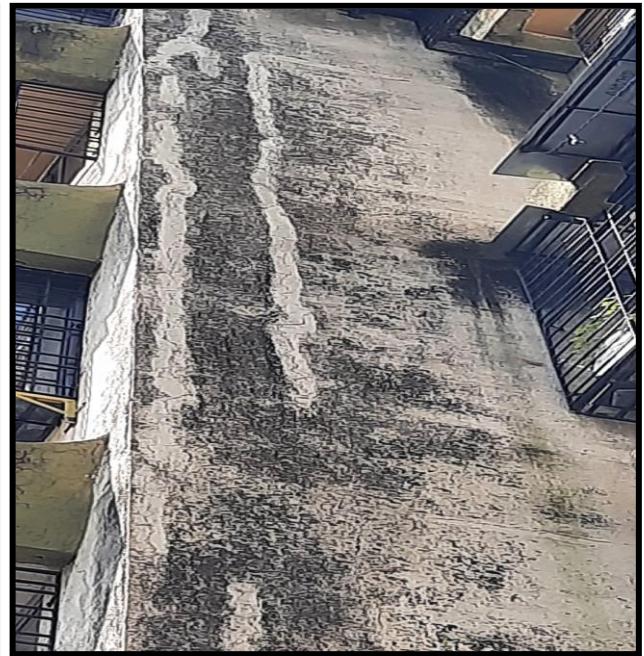
BACK SIDE

- ❖ Structural crack observed at several places on column & chajjas.
- ❖ Major crack observed at several places on wall.
- ❖ Algae observed at several places on wall.

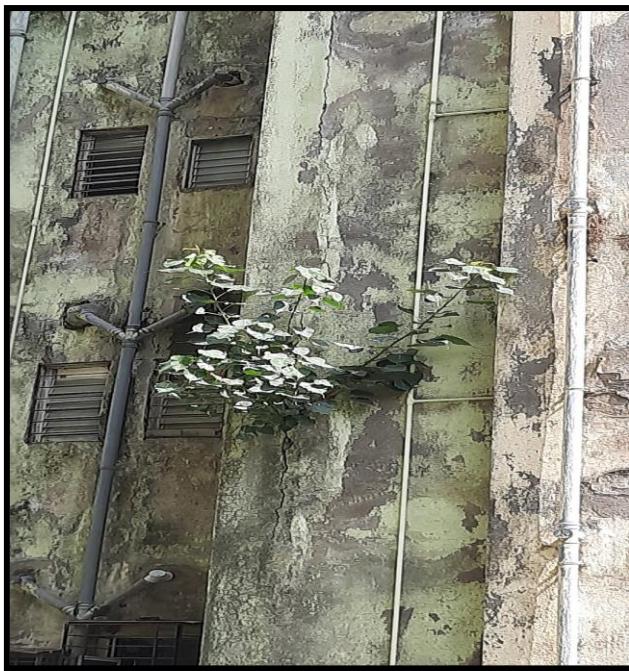
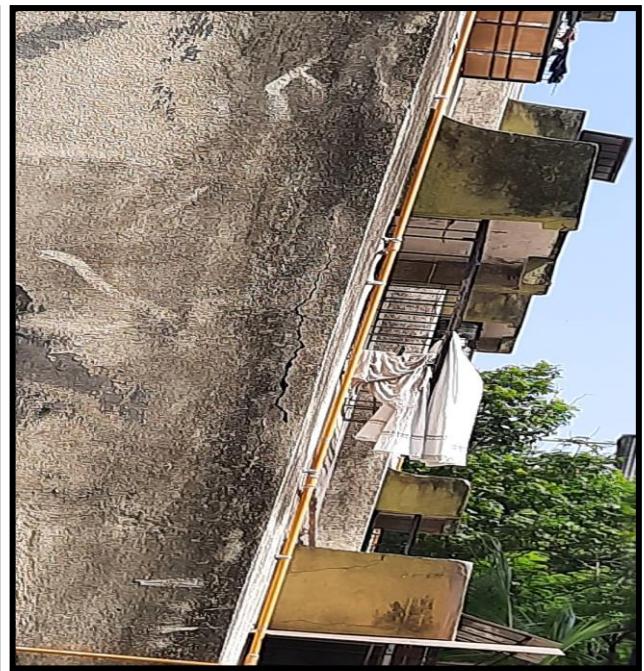
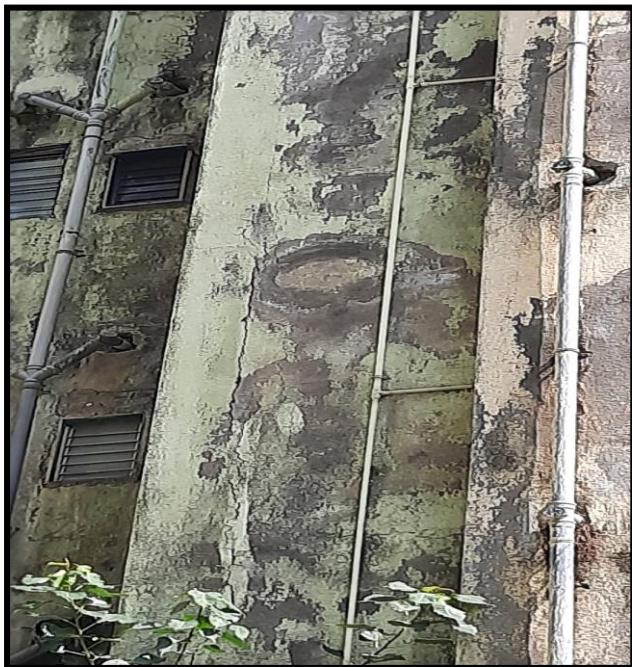
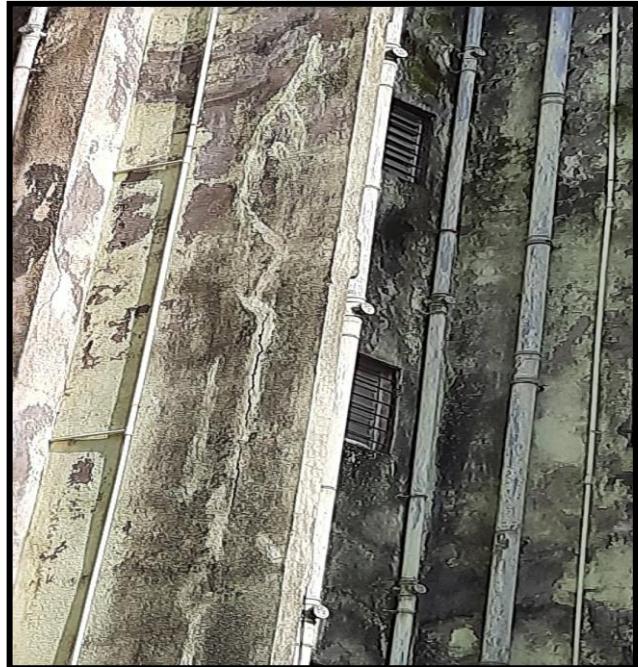
NORTH SIDE

- ❖ Structural crack observed at several places on column.
- ❖ Major crack observed at several places on wall.
- ❖ Vegetation growth observed at several places on wall.

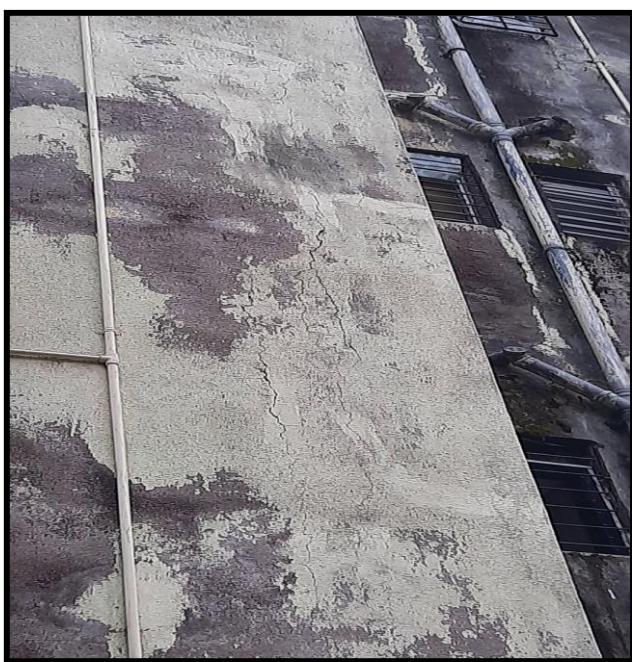
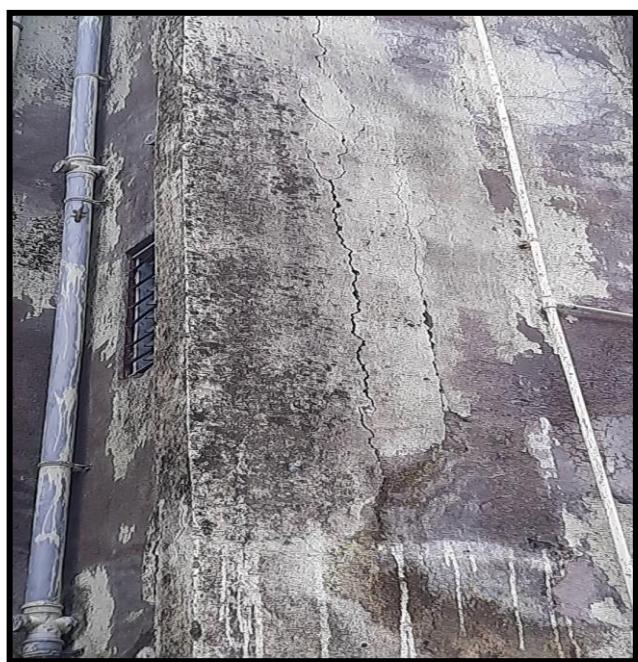
SOUTH SIDE

- ❖ Structural crack observed at several places on column & chajjas.
- ❖ Major crack observed at several places on wall.
- ❖ Algae observed at several places on wall.
