STRUCTURAL AUDIT REPORT  
FOR  
**“VISHAL SAHYADRI CO – OP HSG. SOC. LTD”,**  
**“D3 – G WING”**  
SITUATED AT  
SAHYADRI NAGAR, CHARKOP,  
KANDIVALI (W) MUMBAI – 400 067

978/D3/LSS/2021

JULY 16, 2021

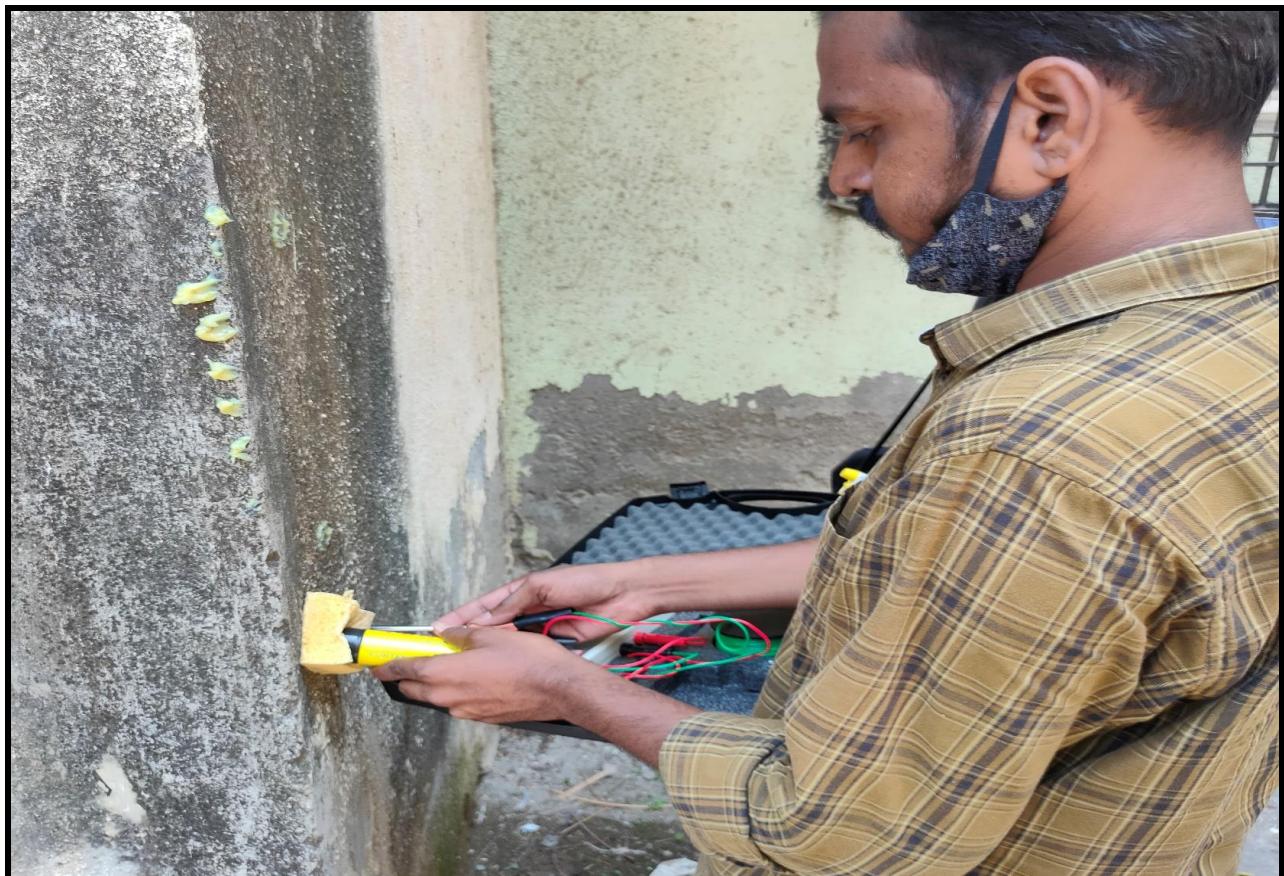
## NON -DESTRUCTIVE TEST PHOTO

Rebound Hammer was tested for compressive strength at surface by Schmidt rebound hammer. Results indicate the compressive strength at surface of the RCC columns & beam in is ranging between 13.70 MPa to 18.90 MPa.

The UPV values are ranging between 2.60 Km/Sec to 3.20 Km/Sec.

Out of 4 locations 2 locations was below 3.0 Km/Sec means concrete quality is poor and 2 location ranging between 3.0 to 3.75 Km/Sec means concrete quality is doubtful.

This indicates there are progressive internal cracks in the RCC members due to corrosion of reinforced steel. These members are under distress condition.

Half Cell Potential tested for corrosion activity by half – cell potential tests. Value is taken on Column. The result on tested column is – 349 mV.

Carbonation test was conducted to assess carbonation depth. Readings are taken on Column. Result indicates the carbonation penetration depth is 35.00 mm. Carbonation depths have reached to the reinforcement level in all of the RCC elements. It is essential to give a suitable anti-corrosion treatment to all the RCC members to stop further carbonation and corrosion of concrete.

RCC elements indicating UPV values less than 3 Km/sec needs immediate attention.

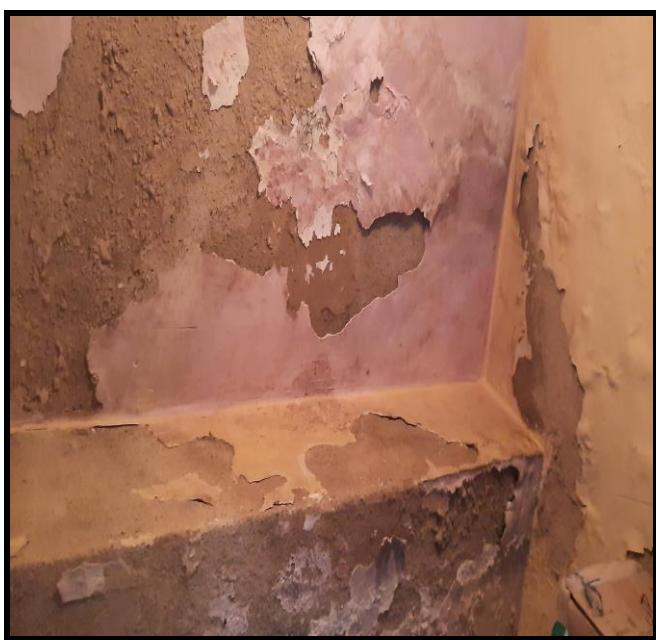
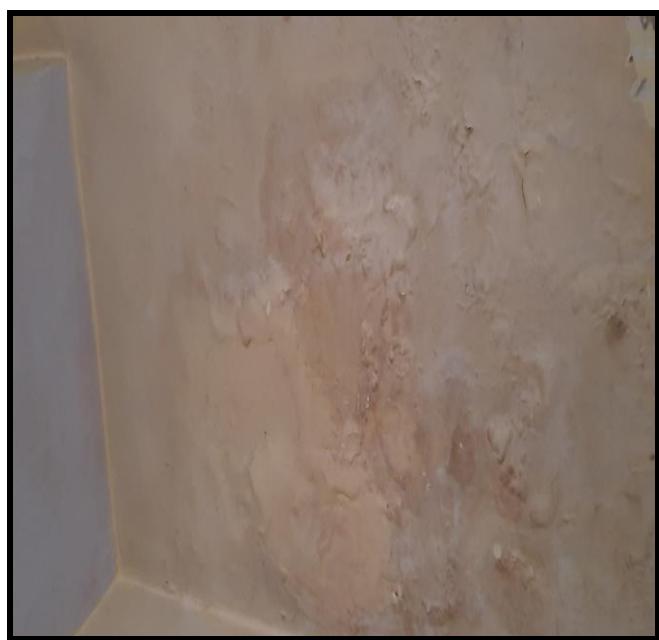
##### FLAT NO – 02

- ❖ **HALL** – O.K.
- ❖ **KITCHEN** – Leakage mark observed on wall.
- ❖ **PASSAGE** – Leakage mark observed on ceiling.
- ❖ **TOILET & BATH ROOM** – O.K.

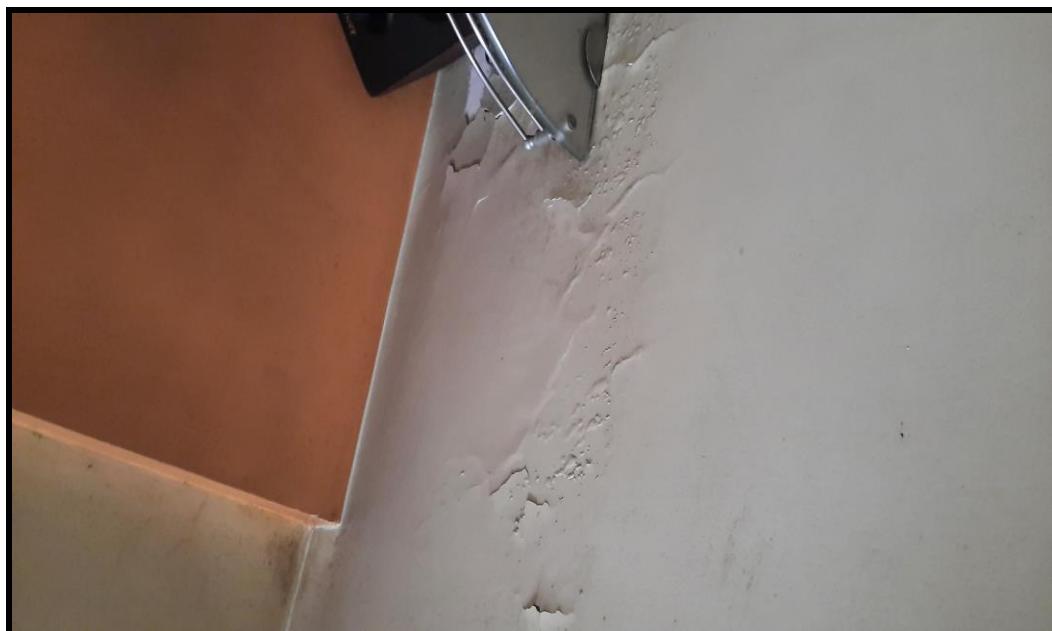
### FLAT NO – 13

- ❖ **HALL** – Leakage mark observed on wall.
- ❖ **KITCHEN** – O.K.
- ❖ **PASSAGE** – O.K.
- ❖ **TOILET & BATH ROOM** – O.K.

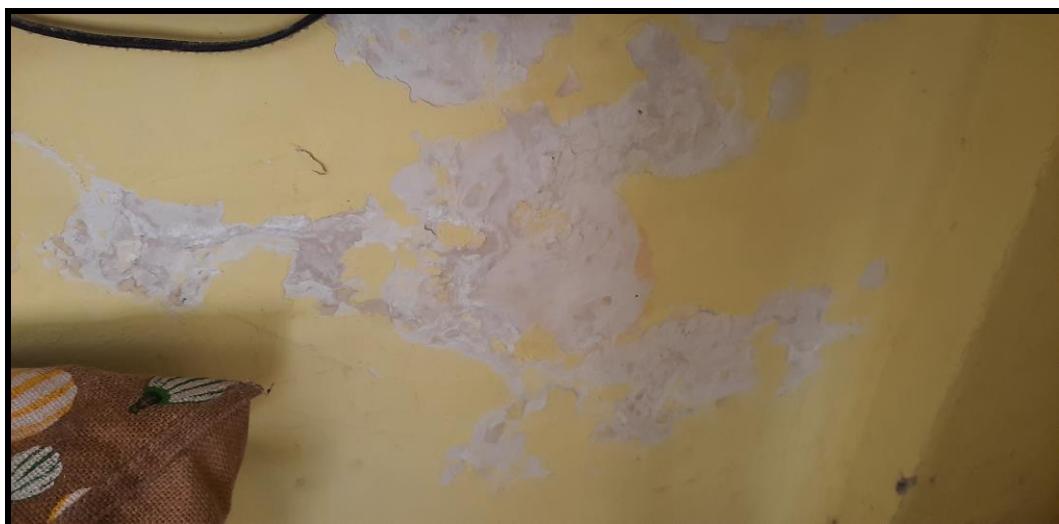
### FLAT NO – 15

- ❖ **HALL** – Leakage mark observed on wall.
- ❖ **KITCHEN** – O.K.
- ❖ **PASSAGE** – O.K.
- ❖ **TOILET & BATH ROOM** – O.K.

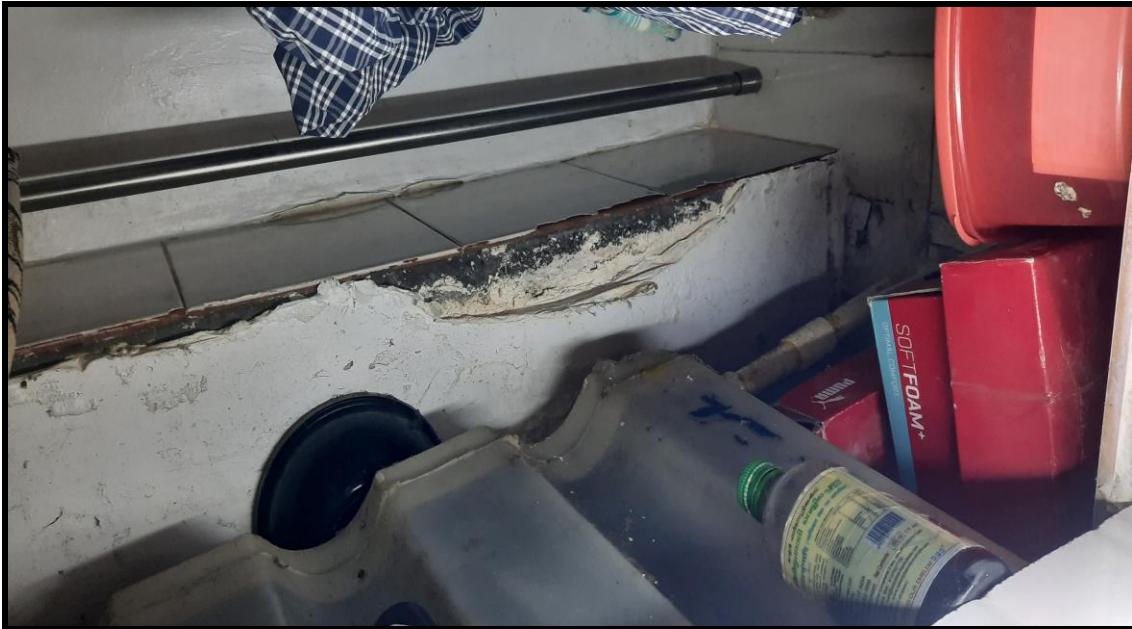
## FLAT NO – 16

- ❖ **HALL** – Leakage mark observed on ceiling.
- ❖ **KITCHEN** – O.K.
- ❖ **PASSAGE** – Leakage mark observed on ceiling.
- ❖ **TOILET & BATH ROOM** – O.K.

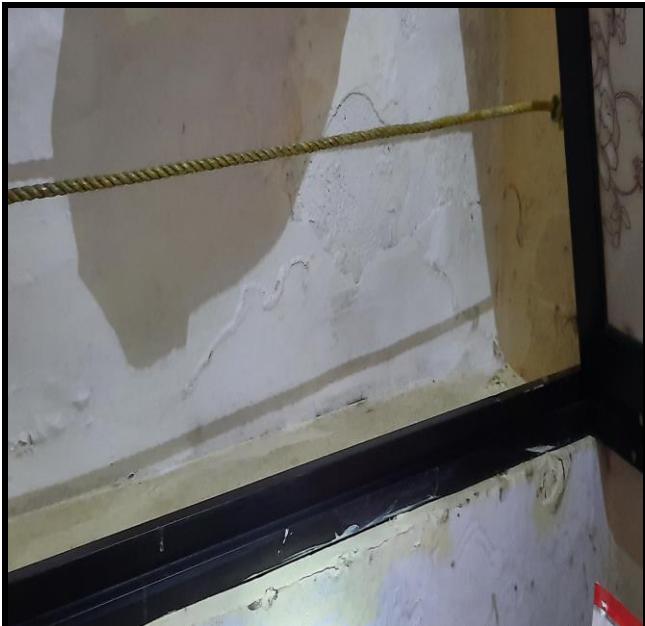
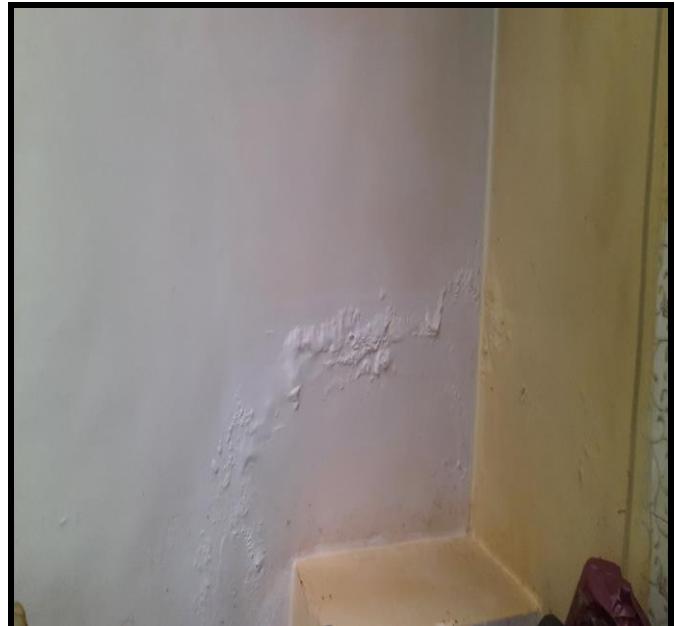
### FLAT NO – 18

- ❖ **HALL** – O.K.
- ❖ **KITCHEN** – Leakage mark observed on ceiling.
- ❖ **PASSAGE** – Leakage mark observed on ceiling.
- ❖ **TOILET & BATH ROOM** – Leakage mark observed on ceiling.

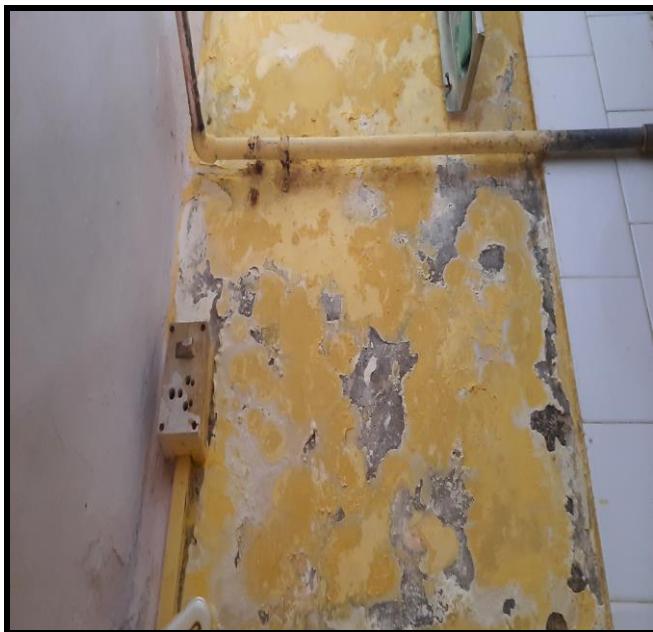
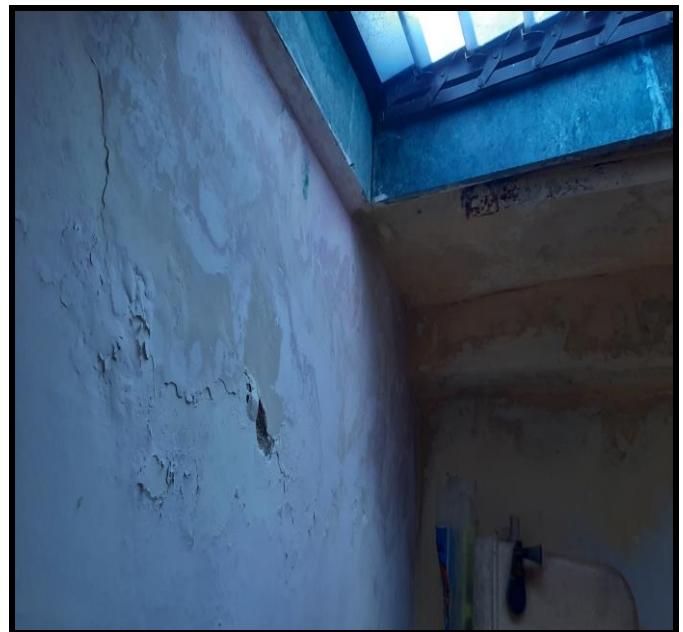
### FLAT NO – 21

- ❖ **HALL** – Leakage observed on wall in monsoon.
- ❖ **KITCHEN** – Leakage observed on wall in monsoon.
- ❖ **PASSAGE** – O.K.
- ❖ **TOILET & BATH ROOM** – Leakage mark observed on wall & ceiling.

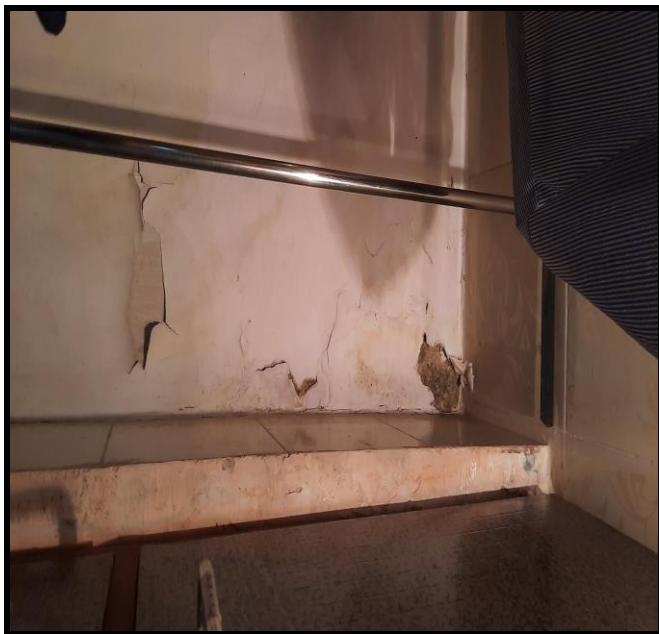
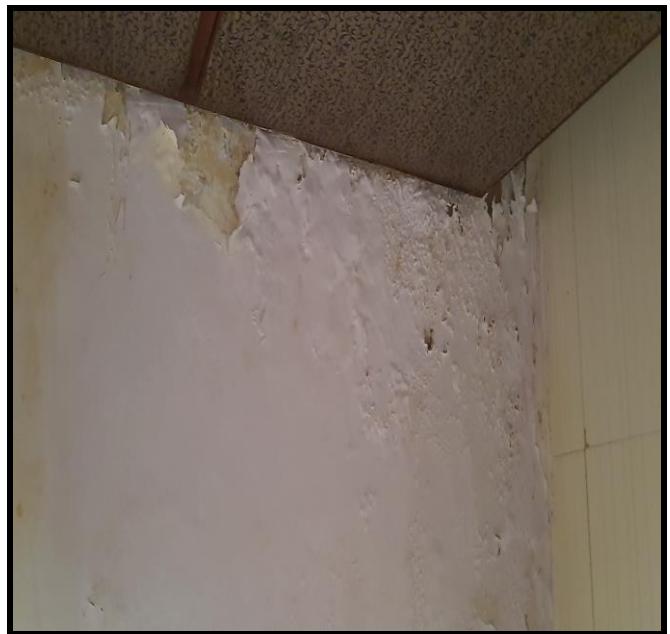
### FLAT NO – 26

- ❖ **HALL** – O.K.
- ❖ **KITCHEN** – Leakage mark observed on ceiling.
- ❖ **PASSAGE** – Leakage mark observed on ceiling.
- ❖ **TOILET & BATH ROOM** – O.K.

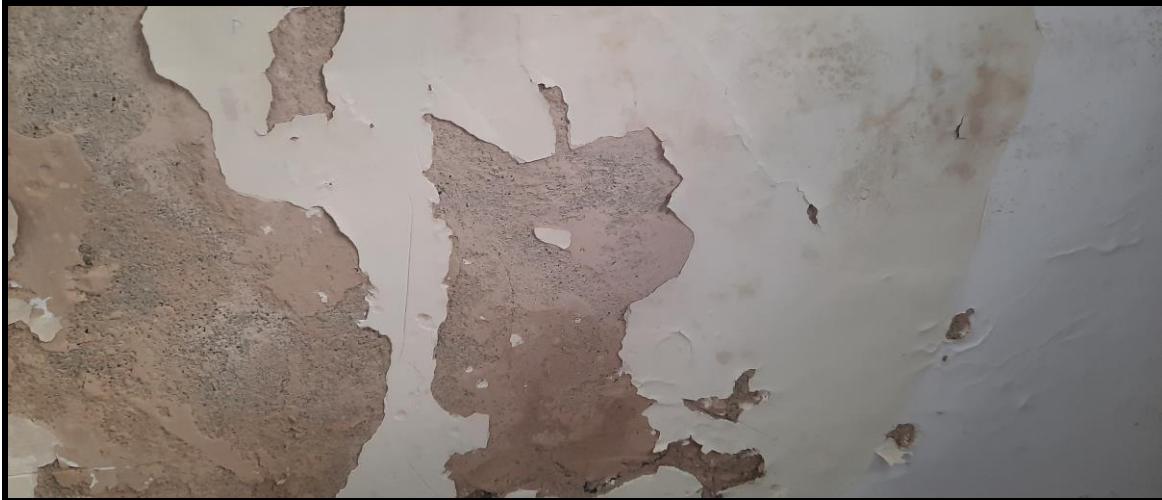
## FLAT NO – 28

- ❖ **HALL** – O.K.
- ❖ **KITCHEN** – Leakage mark observed on ceiling.
- ❖ **PASSAGE** – O.K.
- ❖ **TOILET & BATH ROOM** – O.K.

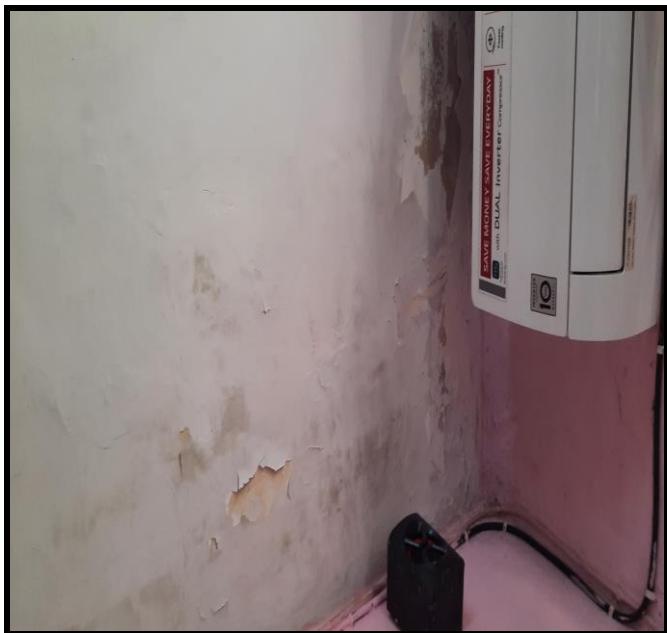
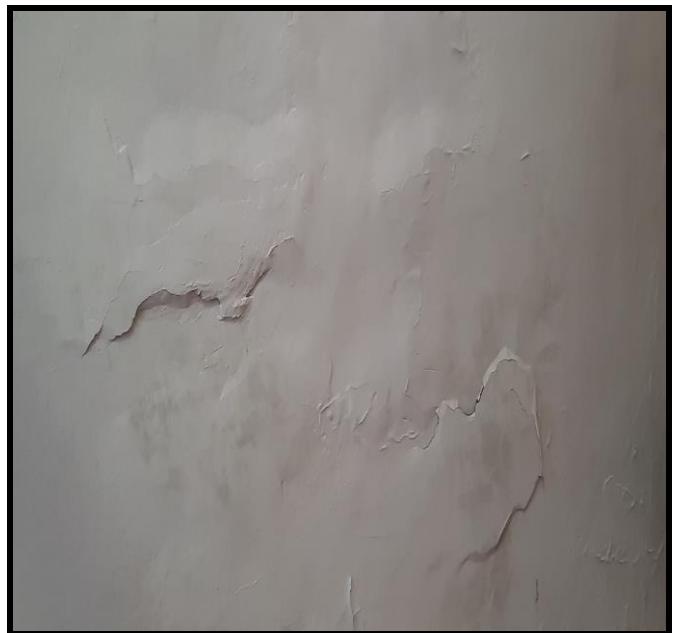
### FLAT NO – 30

- ❖ **HALL** – Leakage mark observed on ceiling.
  - Structural damage observed on ceiling.
- ❖ **KITCHEN** – Leakage observed on ceiling in monsoon.
- ❖ **PASSAGE** – O.K.
- ❖ **TOILET & BATH ROOM** – O.K.

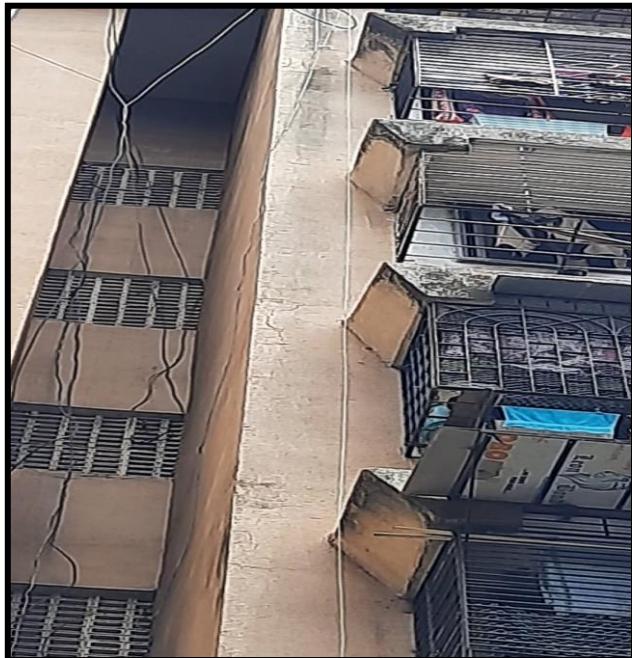
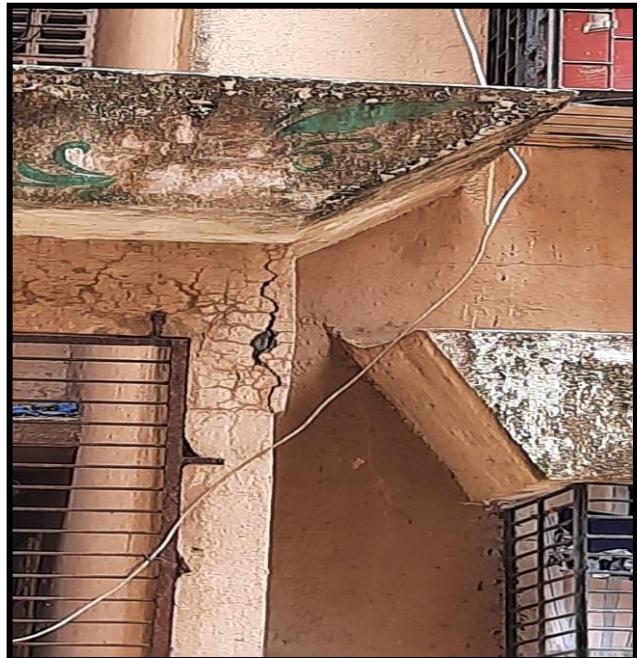
### FRONT SIDE

- ❖ Structural crack observed at several places on column & chajjas.

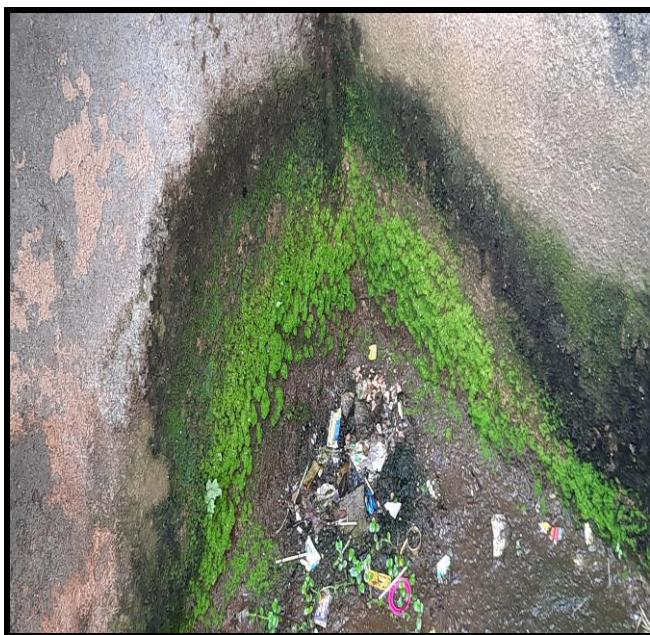
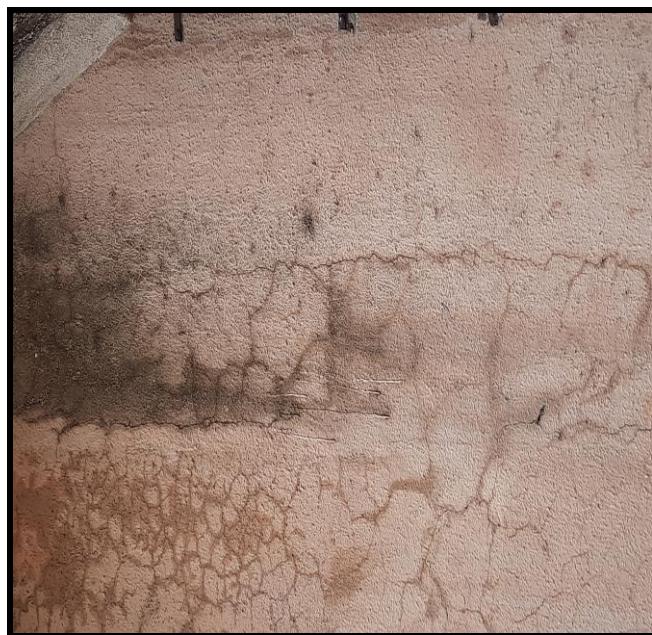
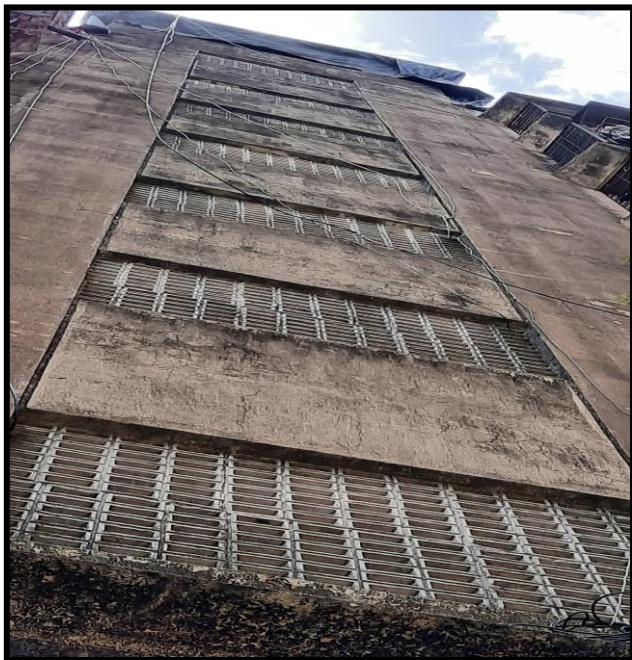
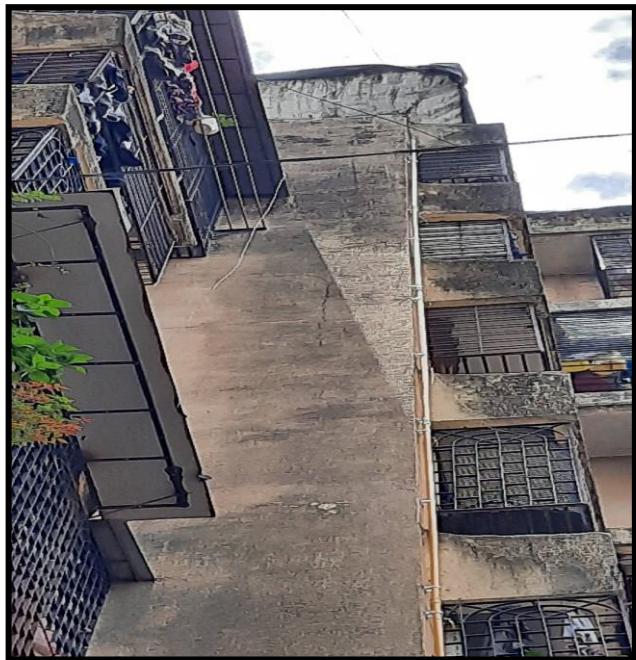
### BACK SIDE

- ❖ Major crack observed at several places on wall.
- ❖ Algae observed at several places on wall.

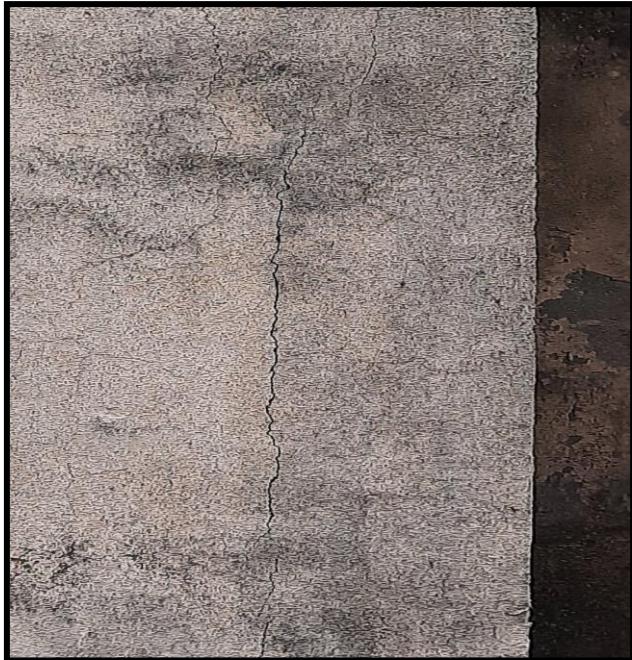
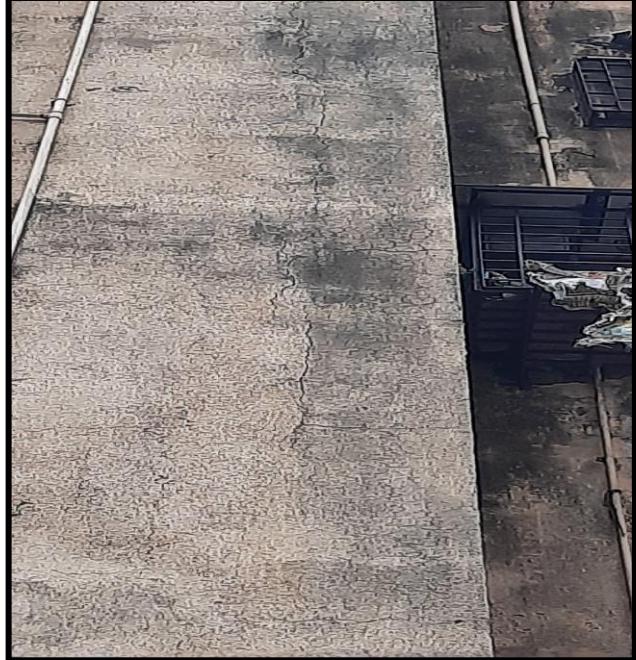
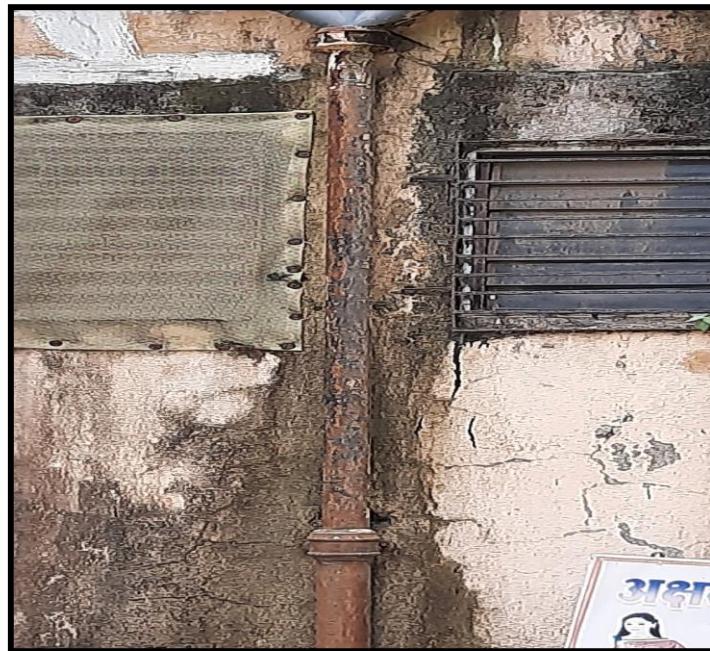
## NORTH SIDE

- ❖ Major crack observed at several places on wall.
- ❖ Algae observed at several places on wall.

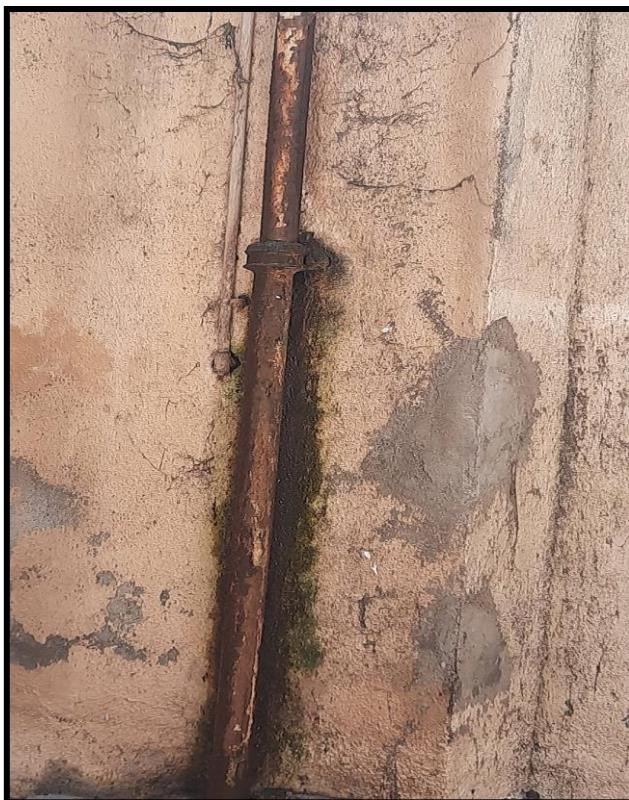
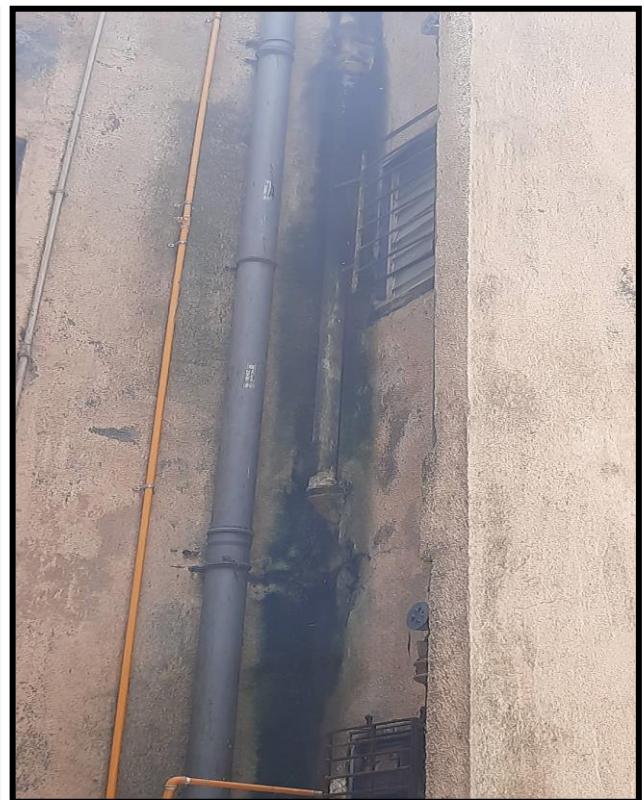
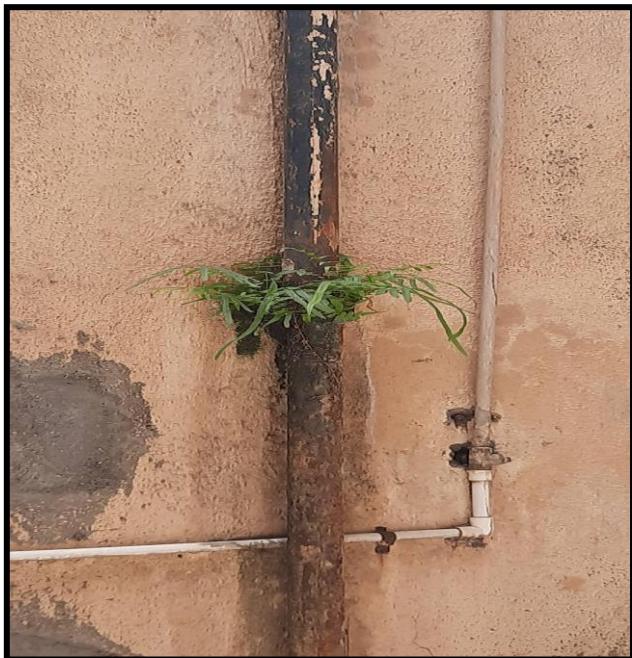
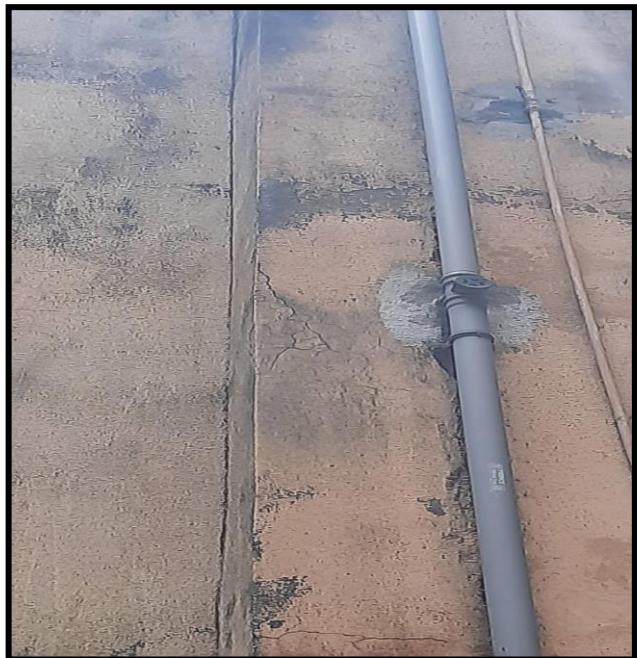
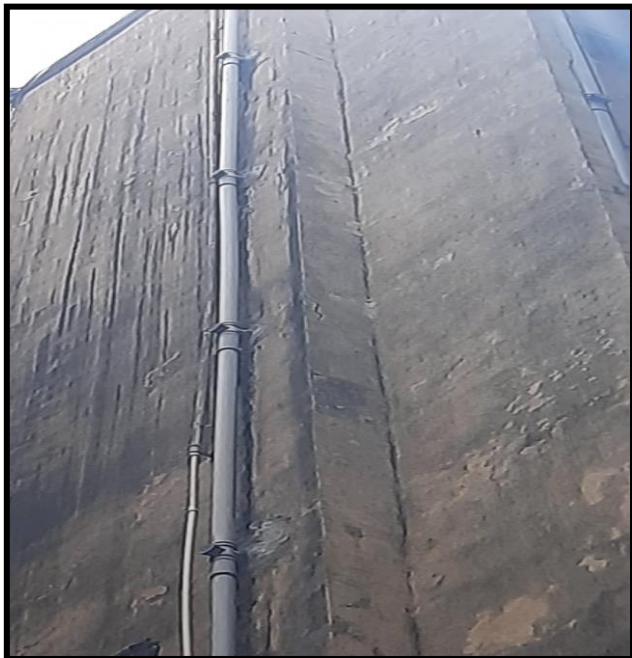
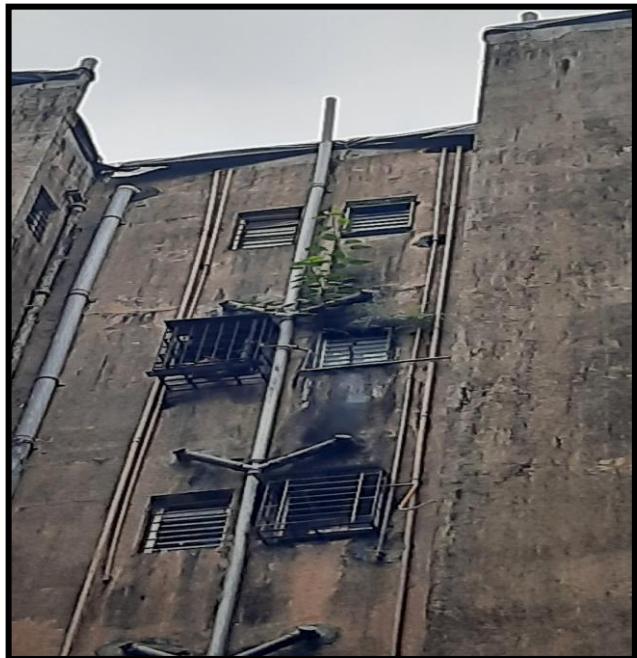
## SOUTH SIDE

- ❖ Structural crack observed at several places on column.
- ❖ Algae observed at several places on wall.
- ❖ Vegetation growth observed at several places on wall.
