STRUCTURAL AUDIT REPORT
FOR
“VISHAL SAHYADRI CO – OP HSG. SOC. LTD”,
“C1 – WING”
SITUATED AT
SAHYADRI NAGAR, CHARKOP,
KANDIVALI (W) MUMBAI – 400 067

PREPARED BY
LATESH S. SANKLECHA
CONSULTING STRUCTURAL ENGINEERS

978/C1/LSS/2021

JUNE 21, 2021

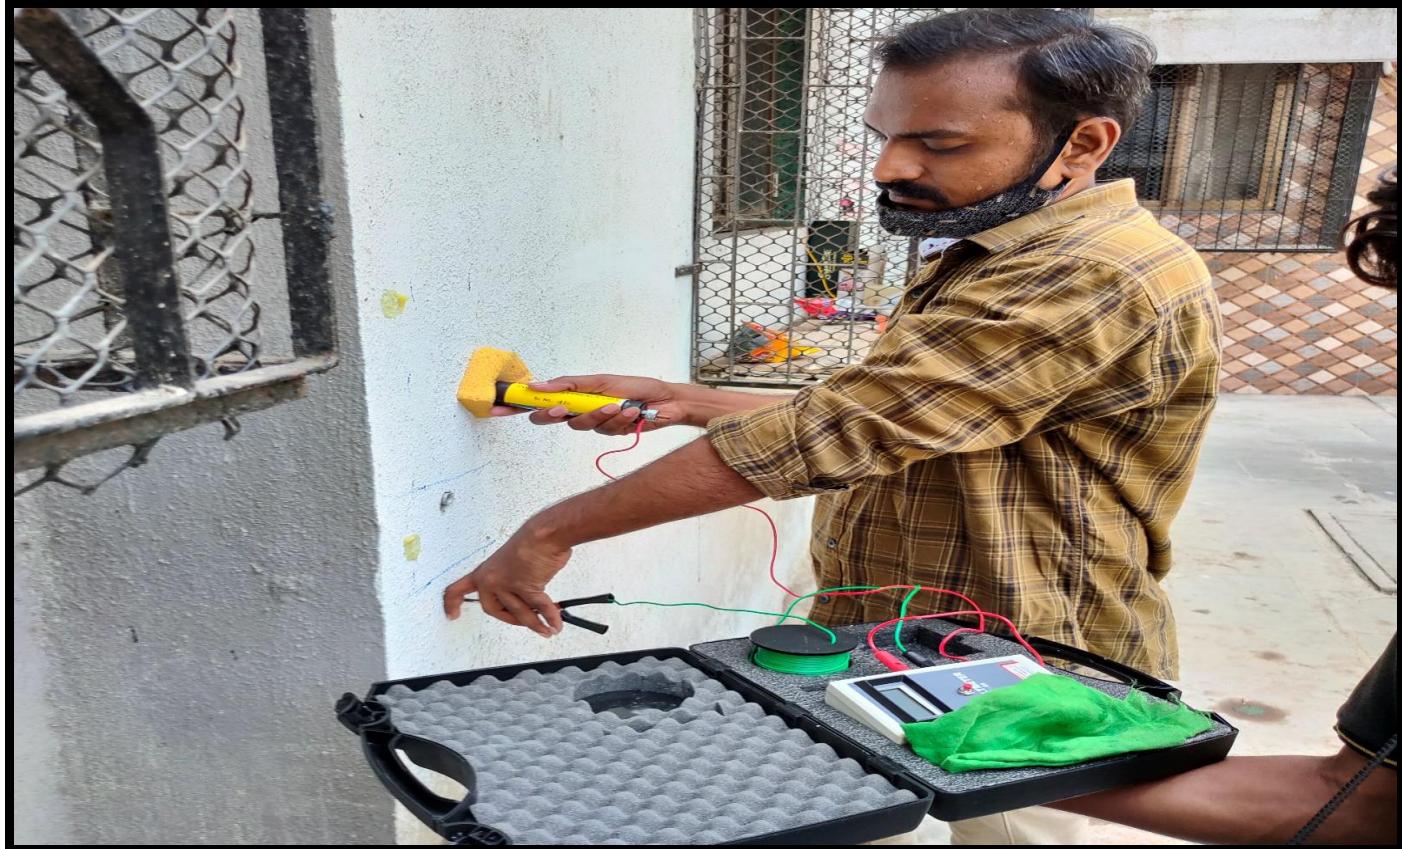
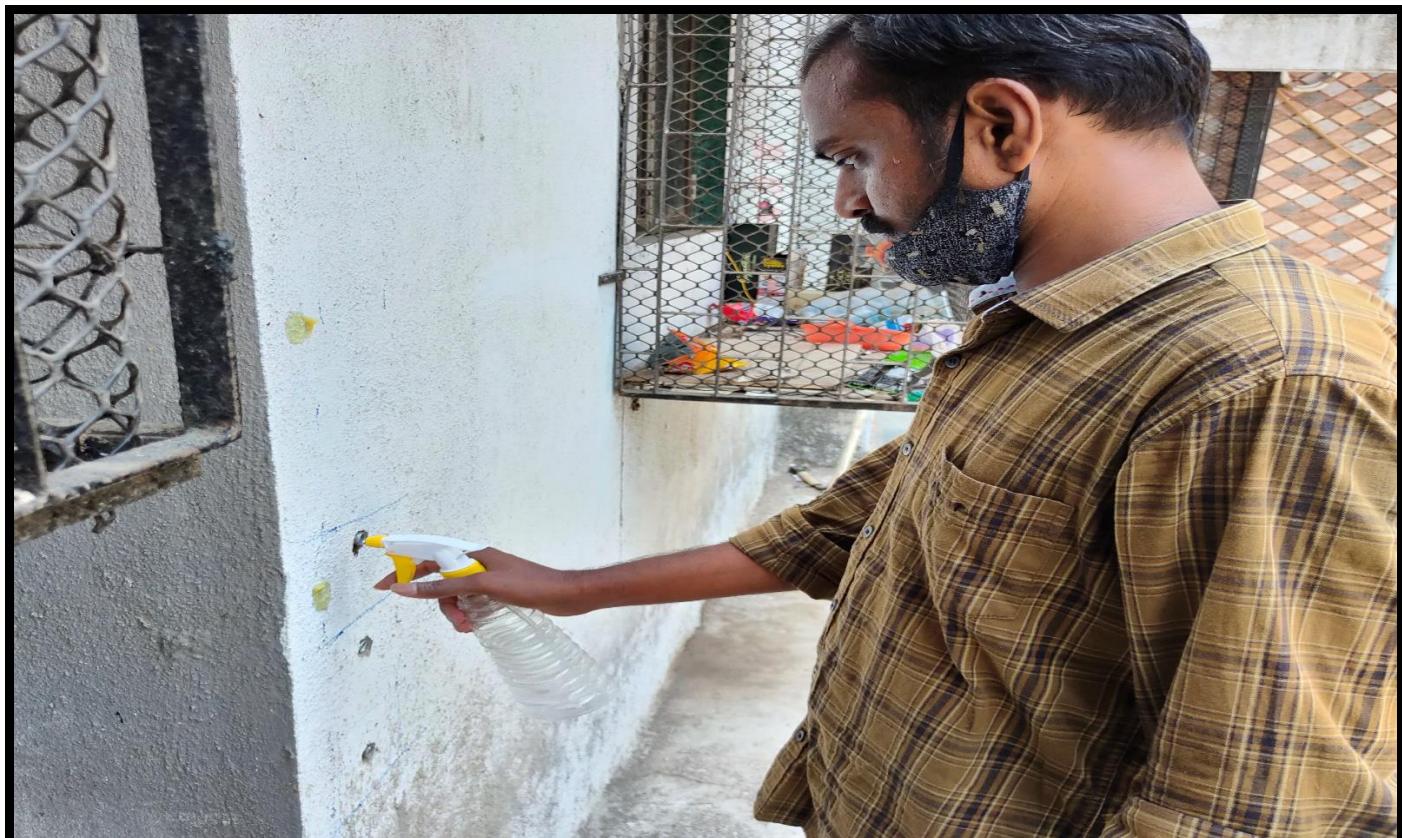
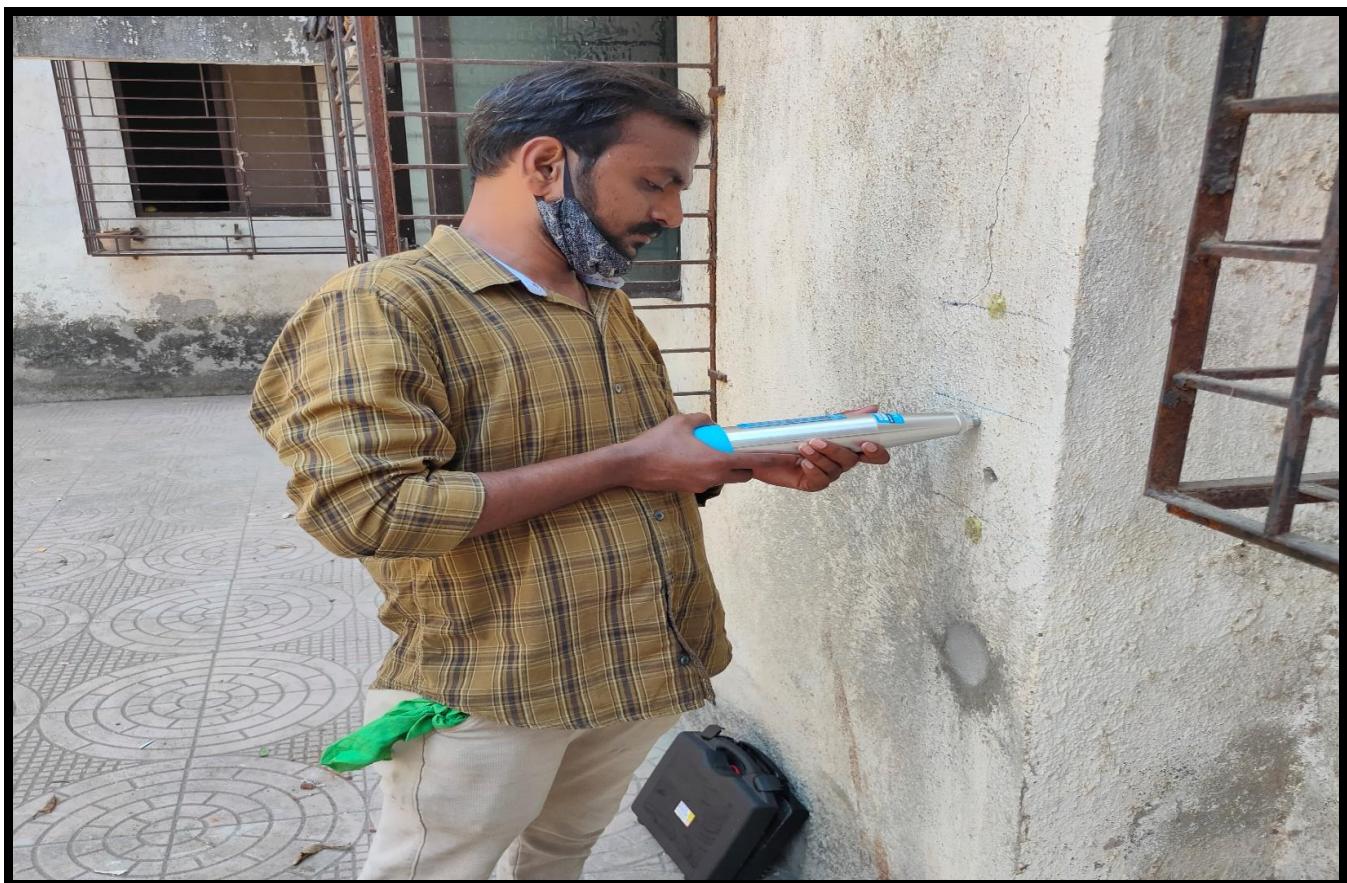
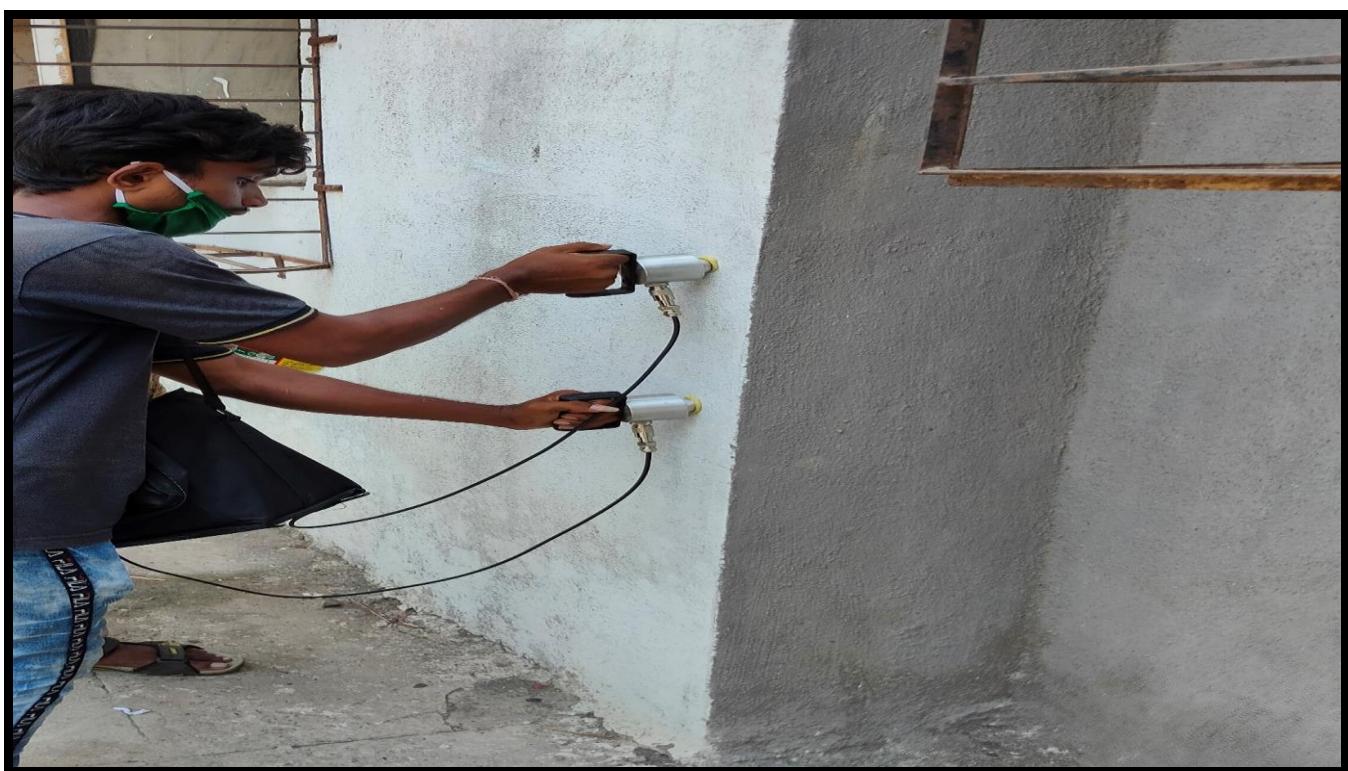
NON -DESTRUCTIVE TEST PHOTO

Rebound Hammer was tested for compressive strength at surface by Schmidt rebound hammer. Results indicate the compressive strength at surface of the RCC columns & beam in is ranging between 13.70 MPa to 20.30 MPa.

The UPV values are ranging between 2.60 Km/Sec to 3.10 Km/Sec.

Out of 4 locations 2 locations was below 3.0 Km/Sec means concrete quality is poor and 2 location ranging between 3.0 to 3.75 Km/Sec means concrete quality is doubtful.

This indicates there are progressive internal cracks in the RCC members due to corrosion of reinforced steel. These members are under distress condition.

Half Cell Potential tested for corrosion activity by half – cell potential tests. Value is taken on Column. The result on tested column is – 329 mV.

This indicates the probability of corrosion is 50% on tested column steel reinforcement.

Carbonation test was conducted to assess carbonation depth. Readings are taken on Column. Result indicates the carbonation penetration depth is 35.00 mm. Carbonation depths have reached to the reinforcement level in all of the RCC elements. It is essential to give a suitable anti-corrosion treatment to all the RCC members to stop further carbonation and corrosion of concrete.

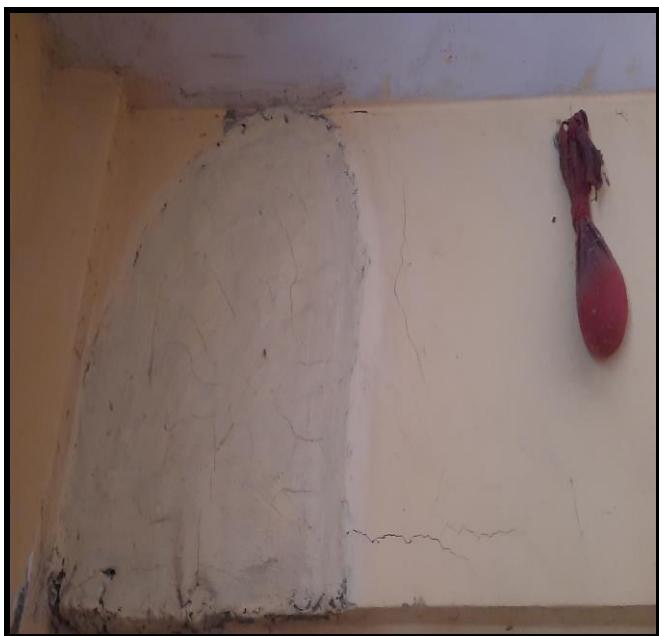
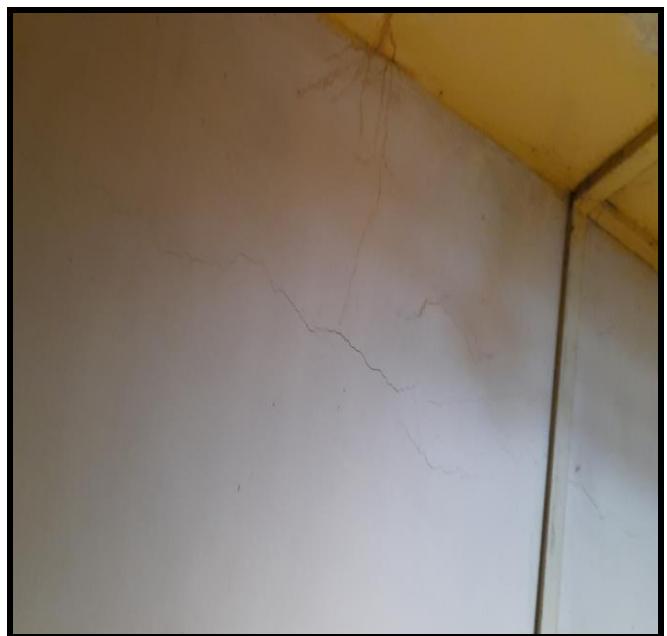
FLAT NO – 04

- ❖ **HALL** – Structural crack observed on beam & ceiling.
- ❖ **KITCHEN** – Structural damage observed on ceiling.
 - Leakage mark observed on ceiling.
- ❖ **PASSAGE** – O.K.
- ❖ **TOILET & BATH ROOM** – O.K.

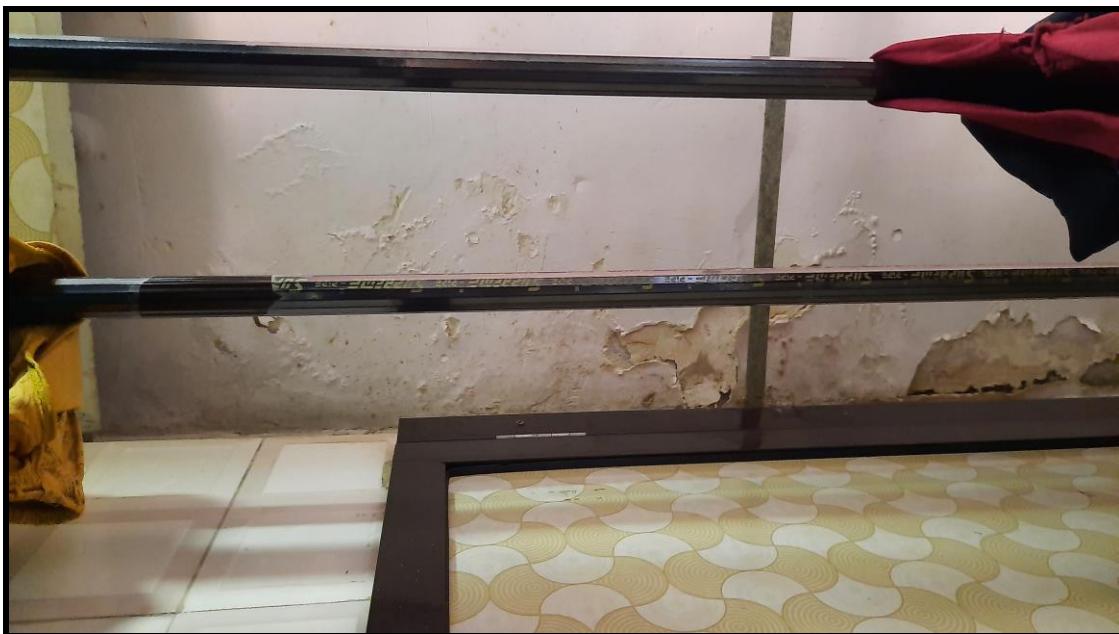
FLAT NO – 15

- ❖ **HALL** – O.K.
- ❖ **KITCHEN** – Leakage mark observed on ceiling.
- ❖ **PASSAGE** – O.K.
- ❖ **TOILET & BATH ROOM** – O.K.

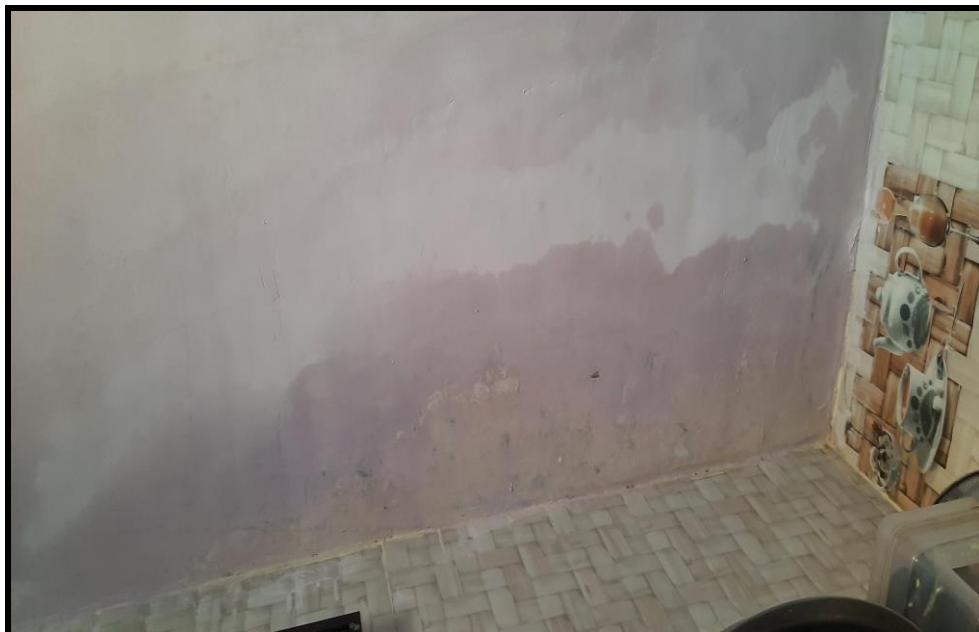
FLAT NO – 19

- ❖ **HALL** – O.K.
- ❖ **KITCHEN** – Leakage mark observed on ceiling.
- ❖ **PASSAGE** – O.K.
- ❖ **TOILET & BATH ROOM** – O.K.

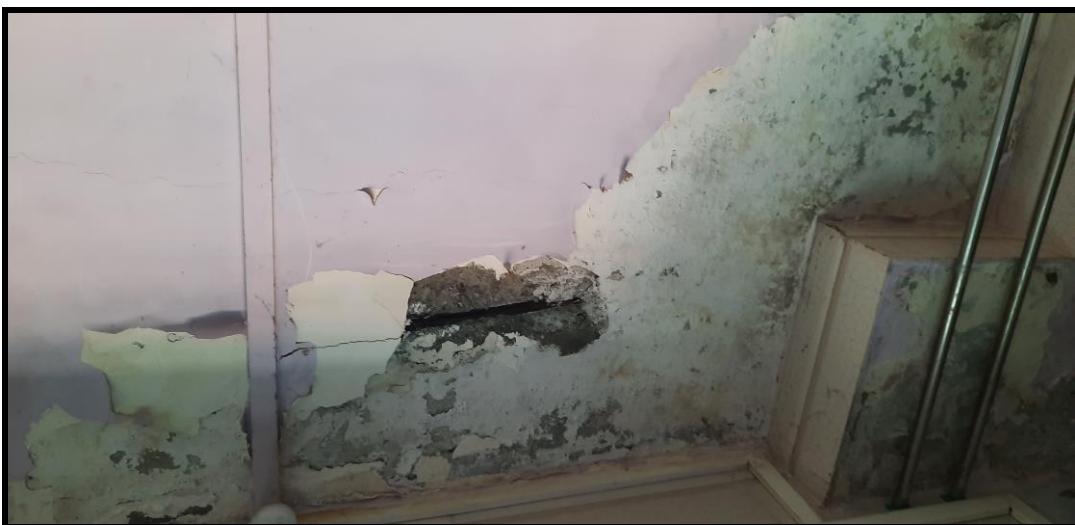
FLAT NO – 27

- ❖ **HALL** – O.K.
- ❖ **KITCHEN** – Leakage mark observed on ceiling.
- ❖ Ceiling plaster get damaged & steel get exposed & corroded.
- ❖ **PASSAGE** – O.K.
- ❖ **TOILET & BATH ROOM** – O.K.

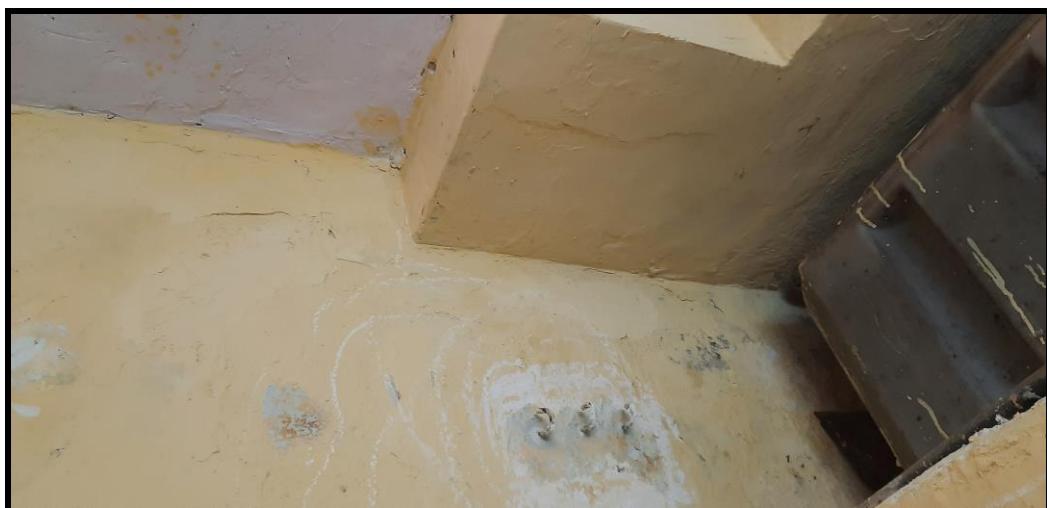
FLAT NO – 29

- ❖ **HALL** – O.K.
- ❖ **KITCHEN** – Leakage mark observed on wall.
- ❖ **PASSAGE** – O.K.
- ❖ **TOILET & BATH ROOM** – O.K.

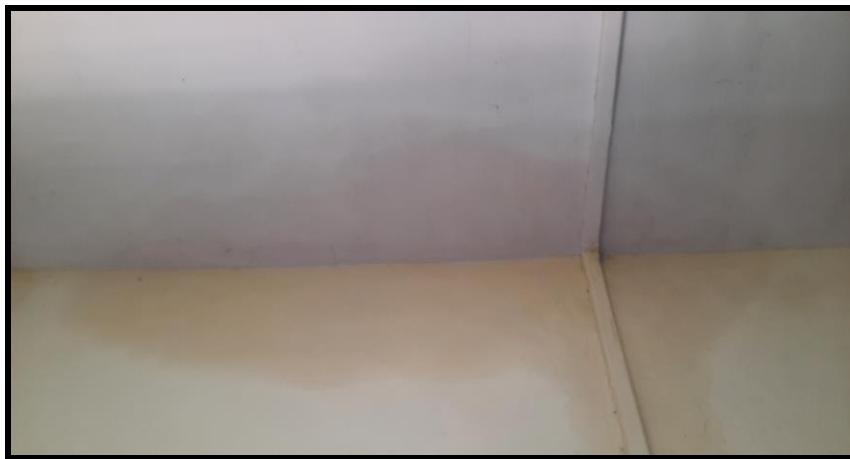
FLAT NO – 34

- ❖ **HALL** – dampness observed on wall.
- ❖ **KITCHEN** – O.K.
- ❖ **PASSAGE** – O.K.
- ❖ **TOILET & BATH ROOM** – O.K.

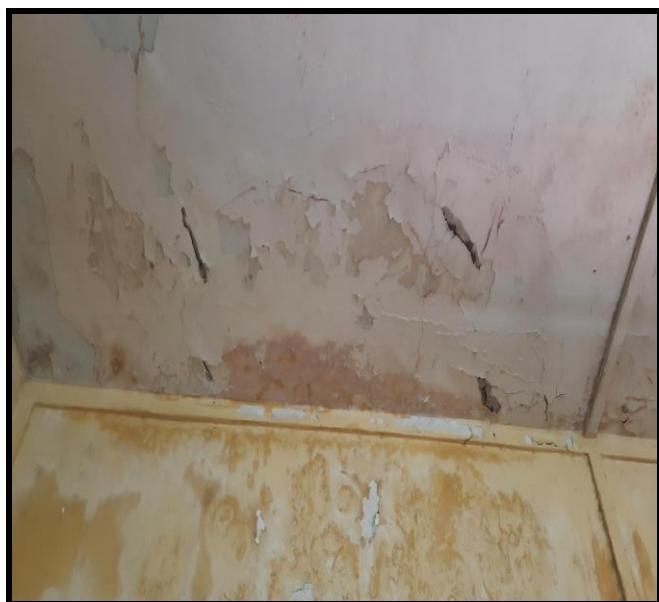
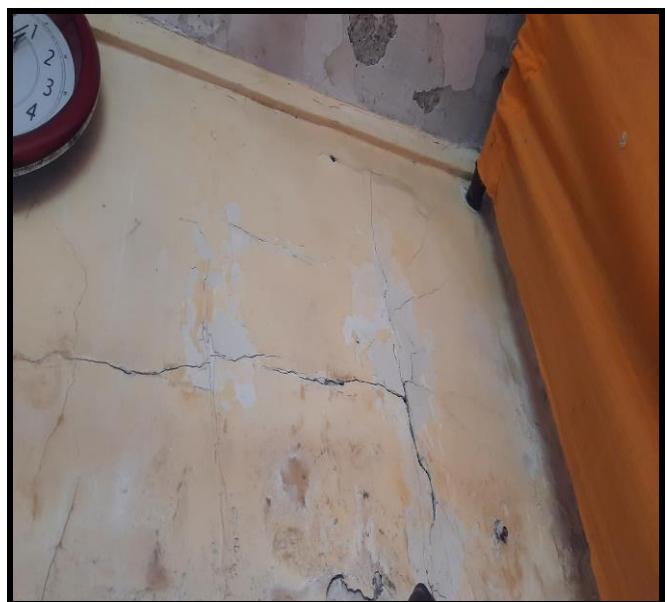
FLAT NO – 39

- ❖ **HALL** – Leakage mark observed on wall & ceiling.
- ❖ Structural crack observed on beam.
- ❖ **KITCHEN** – Leakage mark observed on ceiling.
- ❖ **PASSAGE** – O.K.
- ❖ **TOILET & BATH ROOM** – O.K.

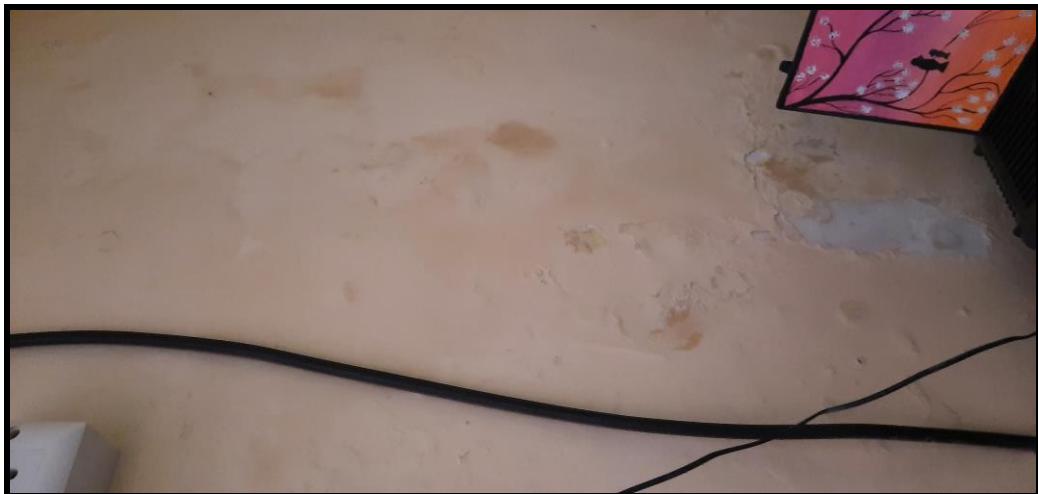
FLAT NO – 43

- ❖ **HALL** – Dampness observed on wall.
- ❖ **KITCHEN** – Dampness observed on ceiling.
- ❖ **PASSAGE** – O.K.
- ❖ **TOILET & BATH ROOM** – O.K.

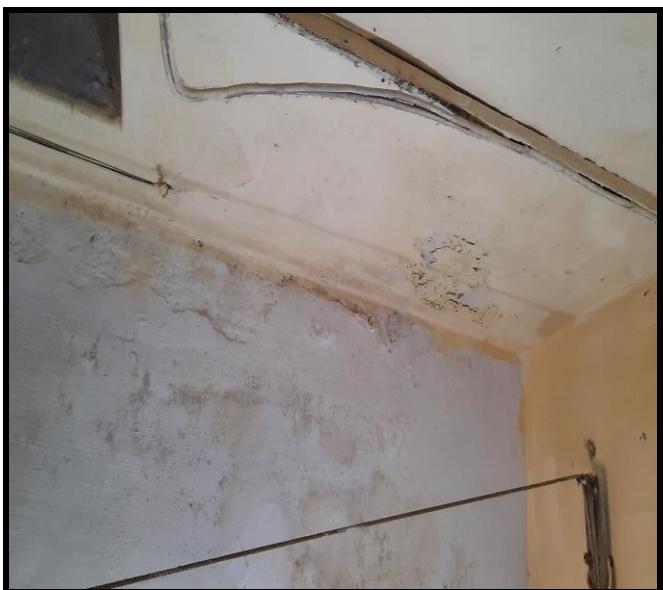
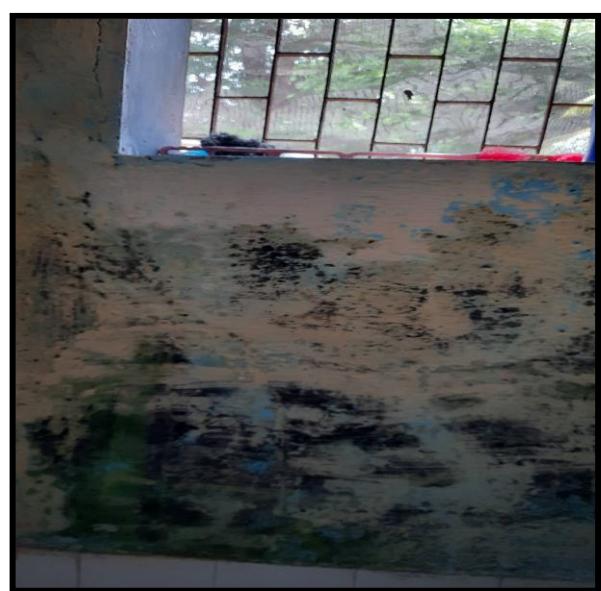
FLAT NO – 44

- ❖ **HALL** – O.K.
- ❖ **KITCHEN** – Leakage observed on ceiling in monsoon.
- ❖ **PASSAGE** – O.K.
- ❖ **TOILET & BATH ROOM** – Algae observed on wall.

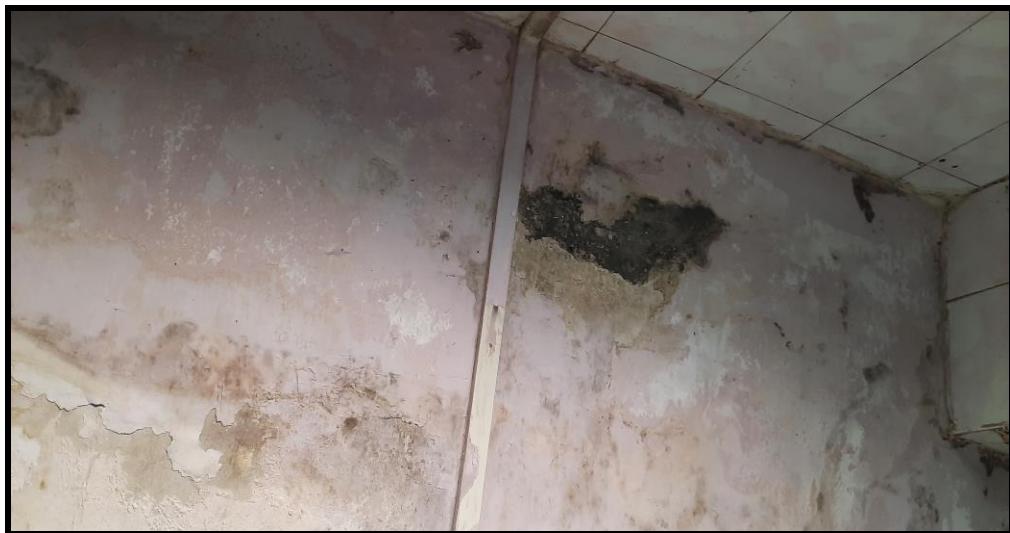
FLAT NO – 54

- ❖ **HALL** – O.K.
- ❖ **KITCHEN** – Leakage observed on ceiling.
- ❖ **PASSAGE** – O.K.
- ❖ **TOILET & BATH ROOM** – O.K.

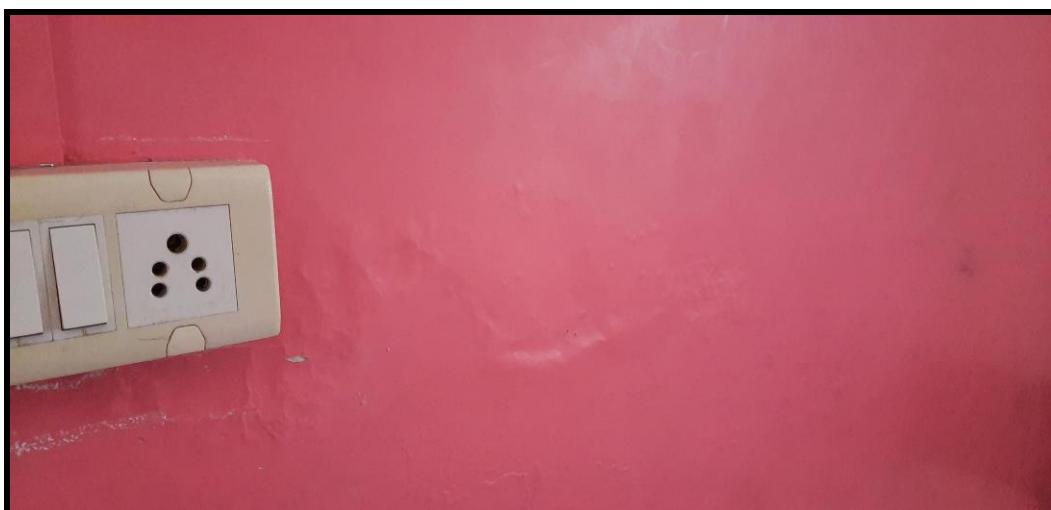
FLAT NO – 56

- ❖ **HALL** – Leakage observed on wall in monsoon.
- ❖ **KITCHEN** – O.K.
- ❖ **PASSAGE** – O.K.
- ❖ **TOILET & BATH ROOM** – O.K.

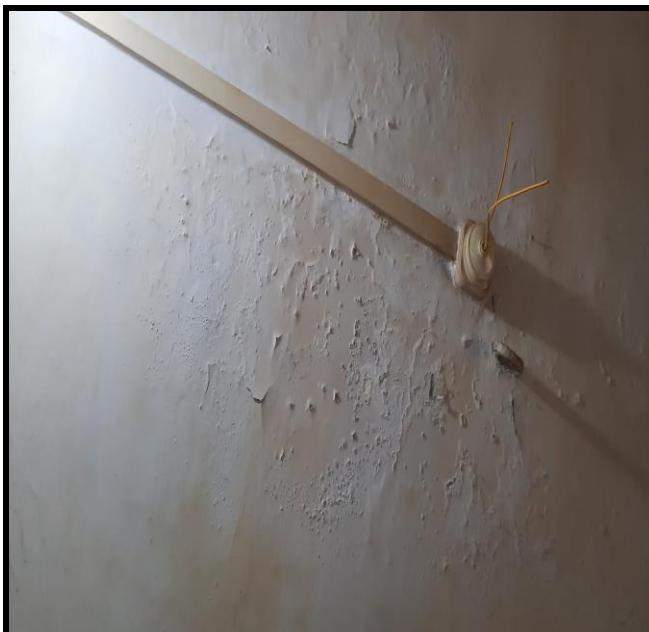
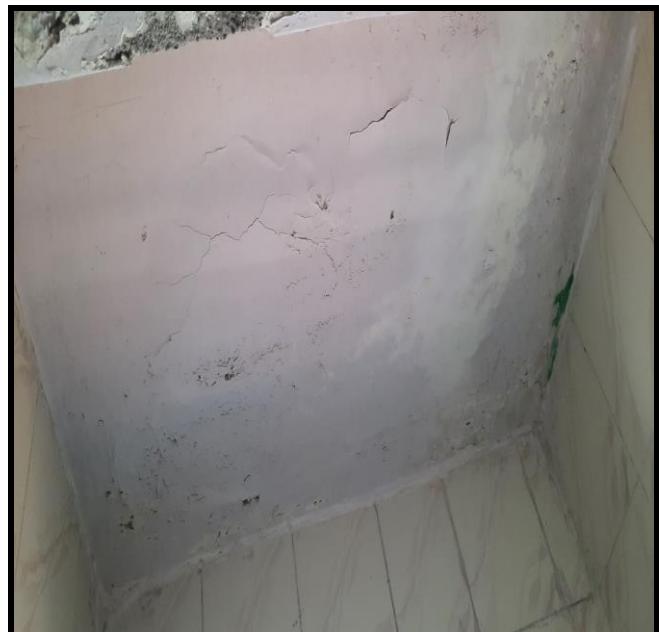
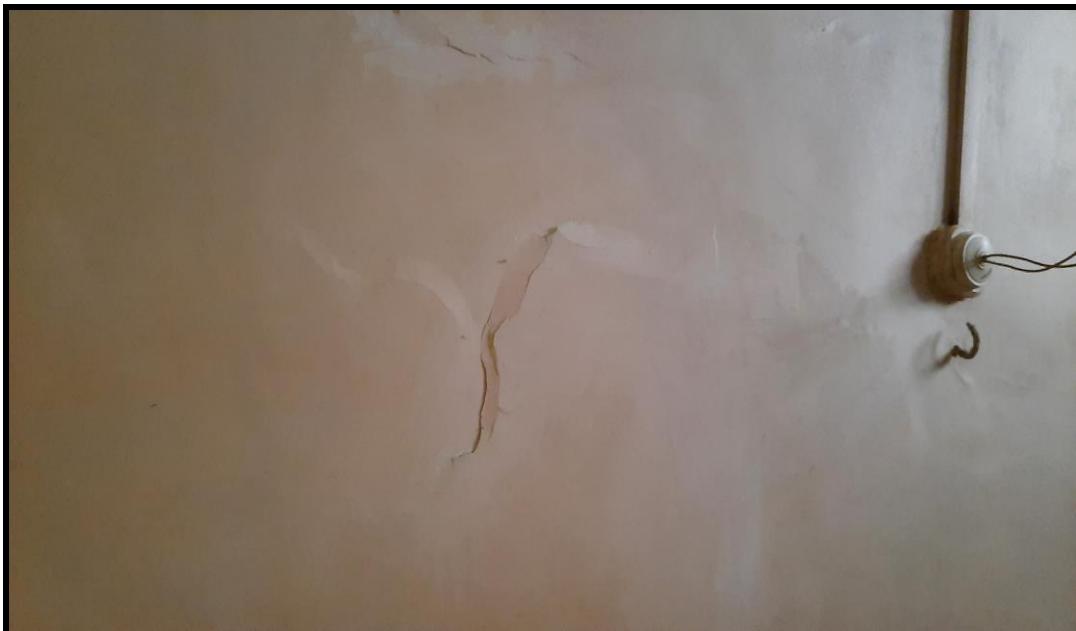
FLAT NO – 66

- ❖ **HALL** – Structural damage observed on ceiling.
- ❖ **KITCHEN** – Leakage mark observed on ceiling.
- ❖ **PASSAGE** – O.K.
- ❖ **TOILET & BATH ROOM** – Leakage mark observed on ceiling.

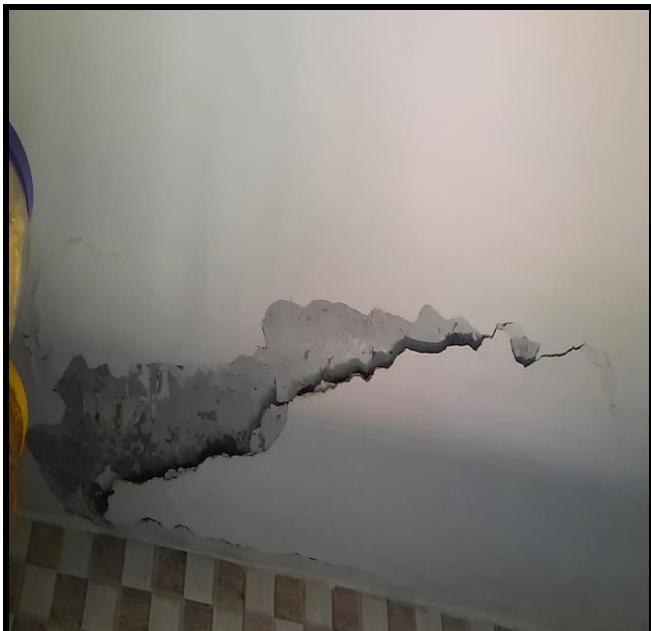
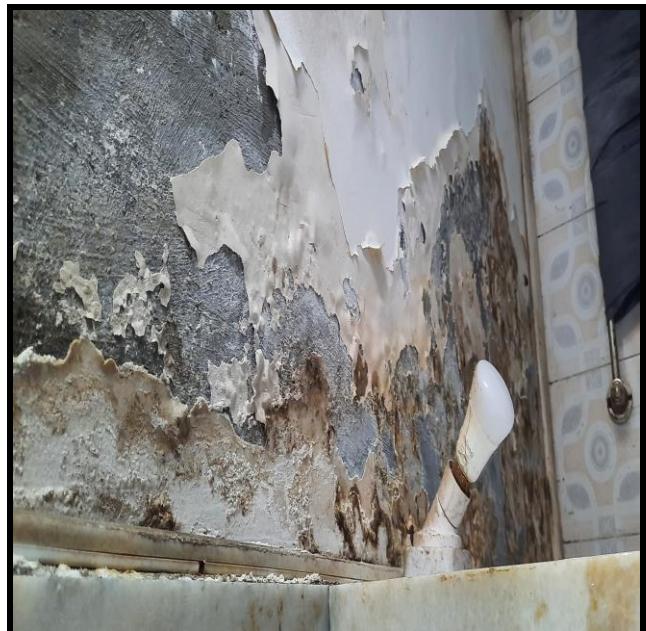
FLAT NO – 67

- ❖ **HALL** – O.K.
- ❖ **KITCHEN** – Structural damage observed on ceiling.
- ❖ **PASSAGE** – O.K.
- ❖ **TOILET & BATH ROOM** – Leakage mark observed on ceiling.

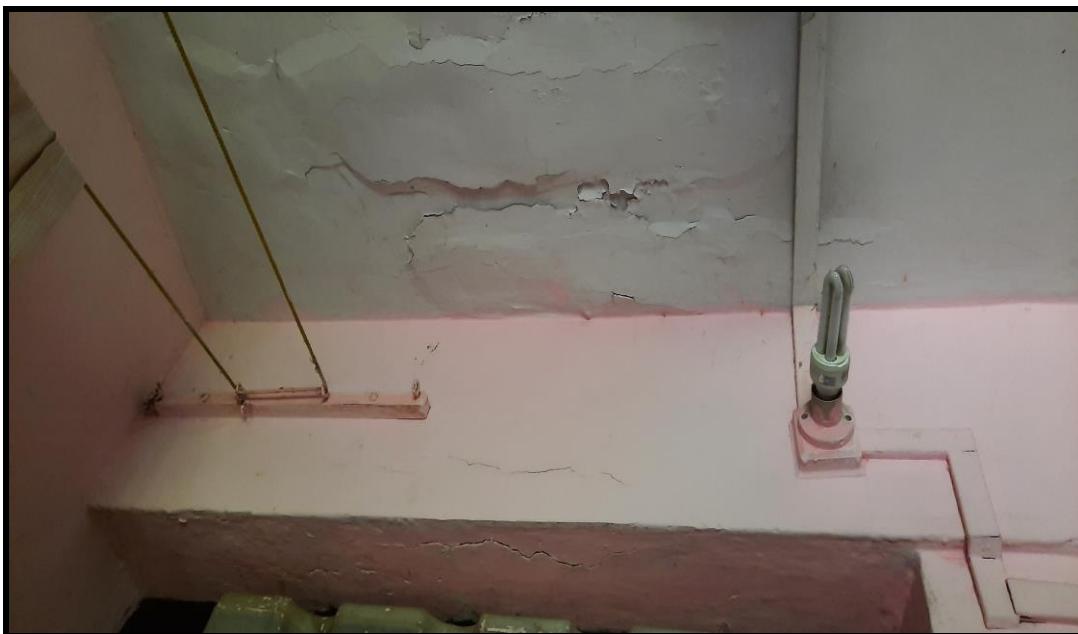
FLAT NO – 79

- ❖ **HALL** – O.K.
- ❖ **KITCHEN** – Structural crack observed on beam & ceiling.
- ❖ **PASSAGE** – O.K.
- ❖ **TOILET & BATH ROOM** – O.K.

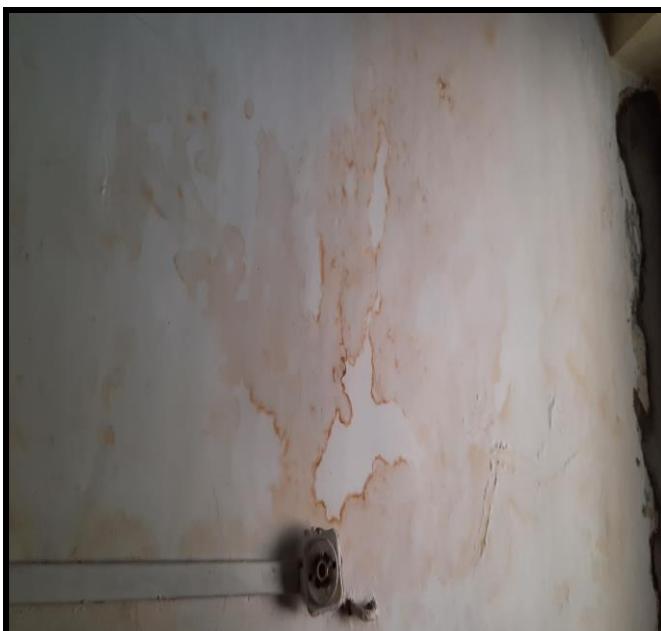
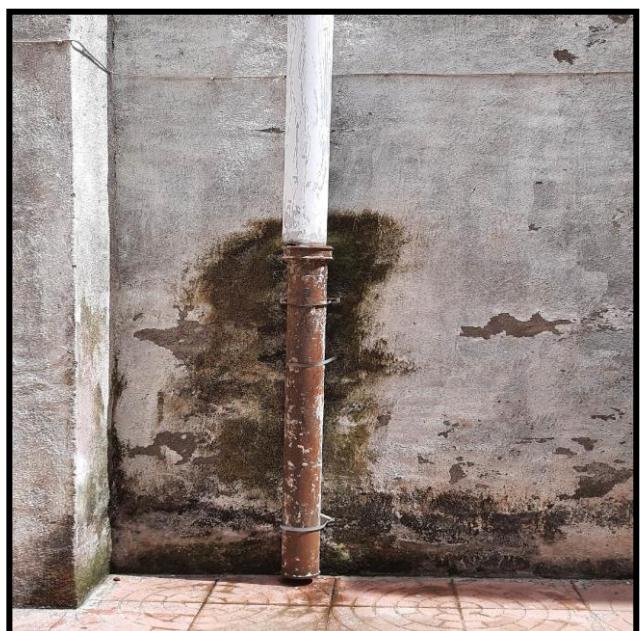
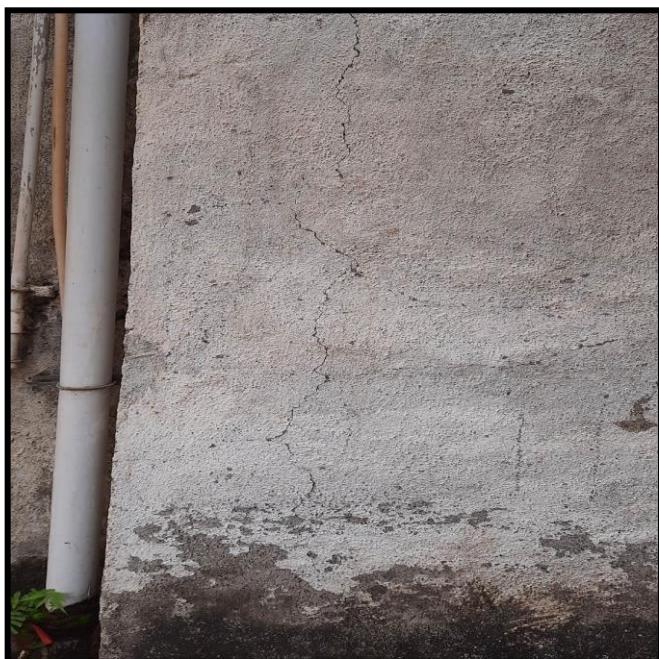
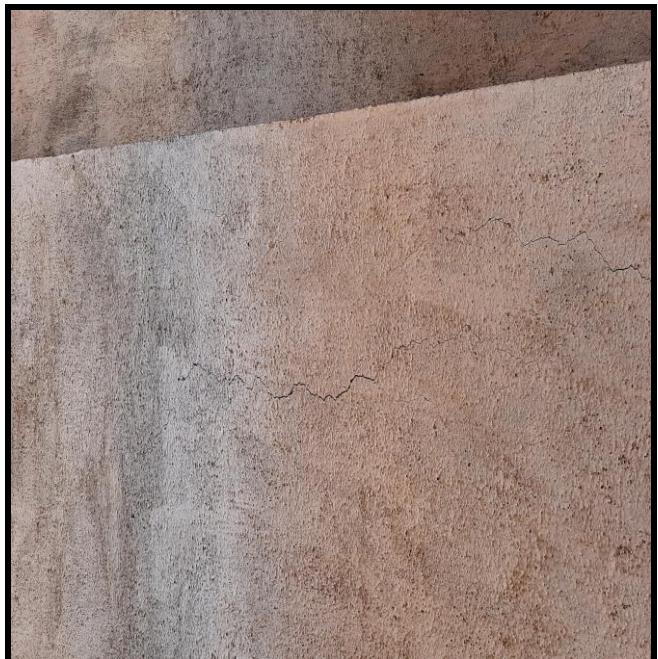
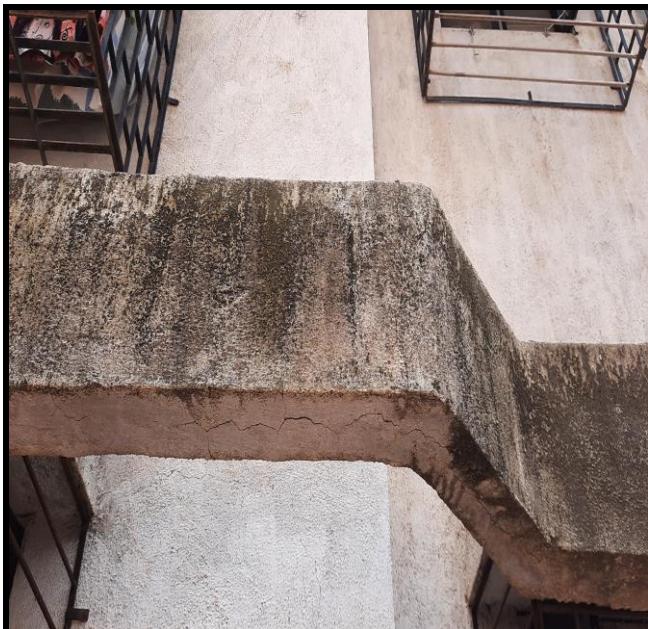
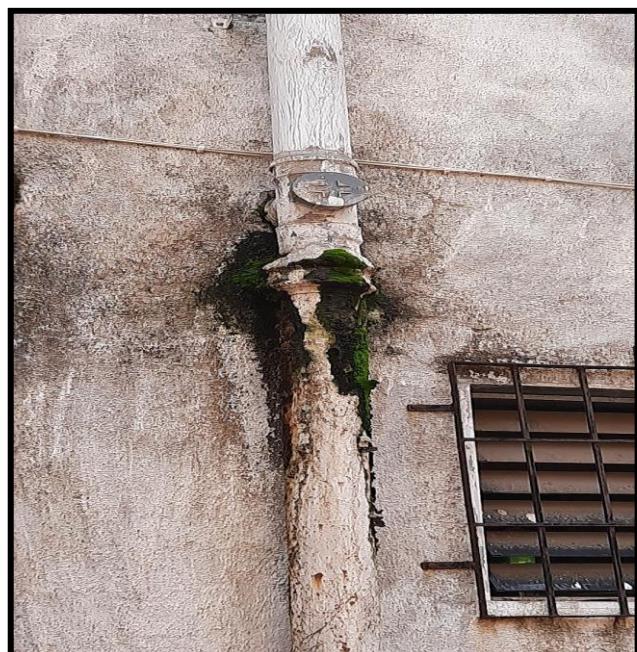
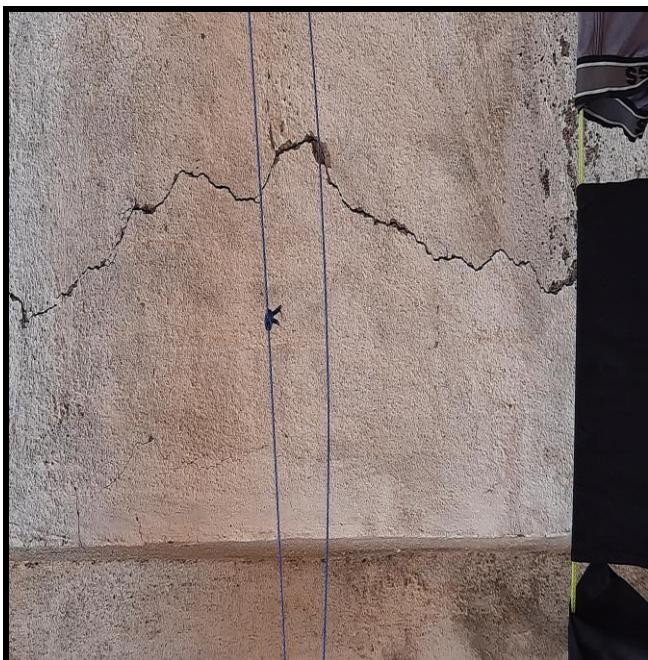
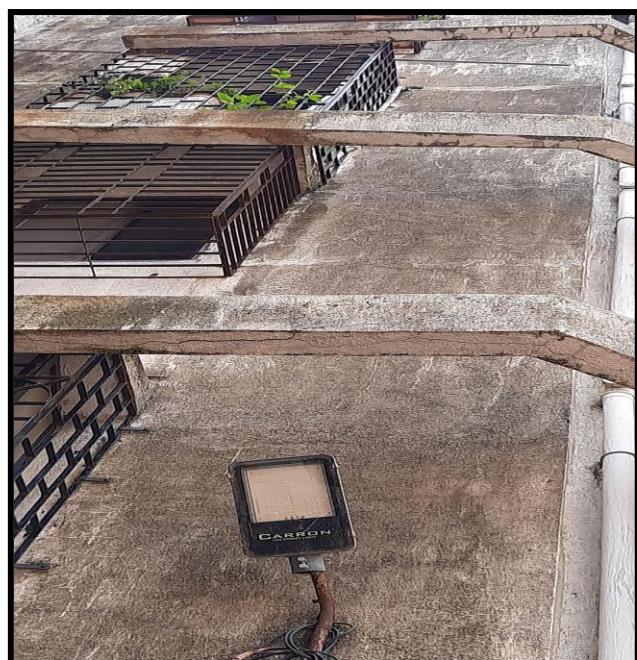
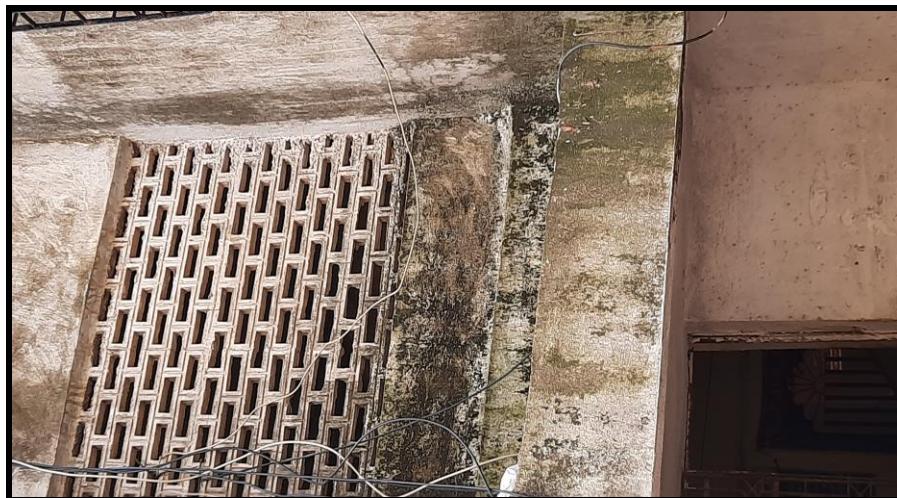
FRONT SIDE

- ❖ Structural crack observed at several places on column & chajjas.
- ❖ Major crack observed at several places on wall.
- ❖ Algae observed at several places on wall.

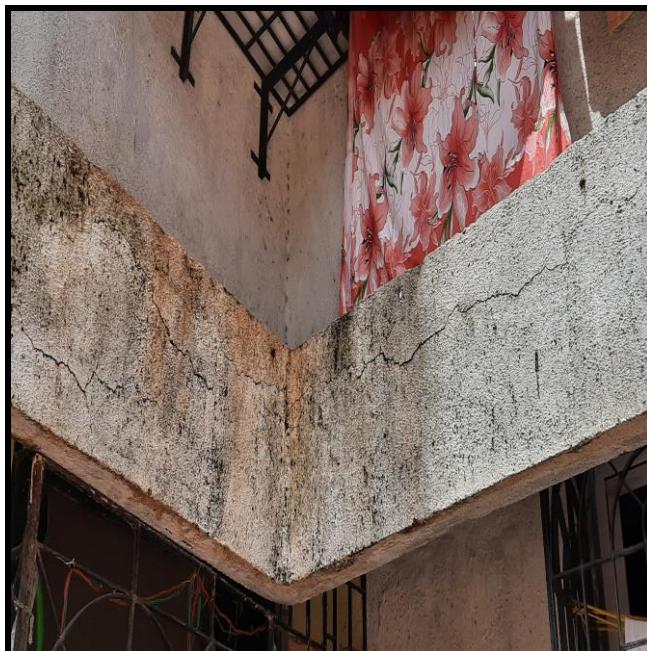
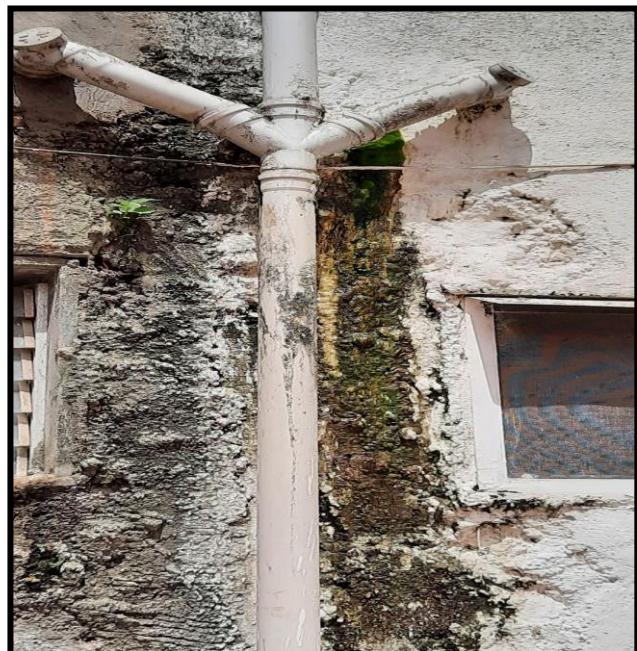
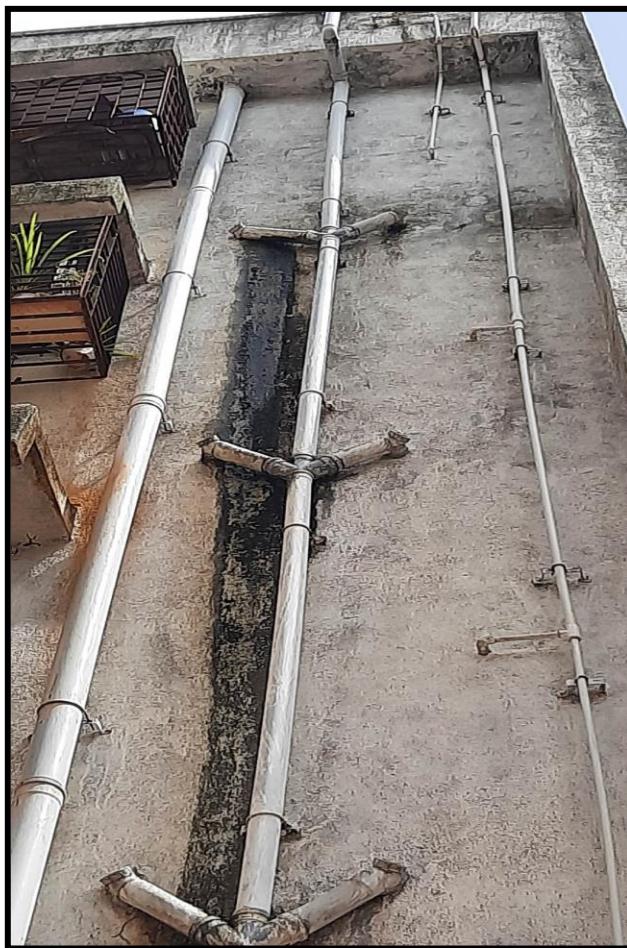
BACK SIDE

- ❖ Structural crack observed at several places on chajjas.
- ❖ Major crack observed at several places on wall.
- ❖ Algae observed at several places on wall.

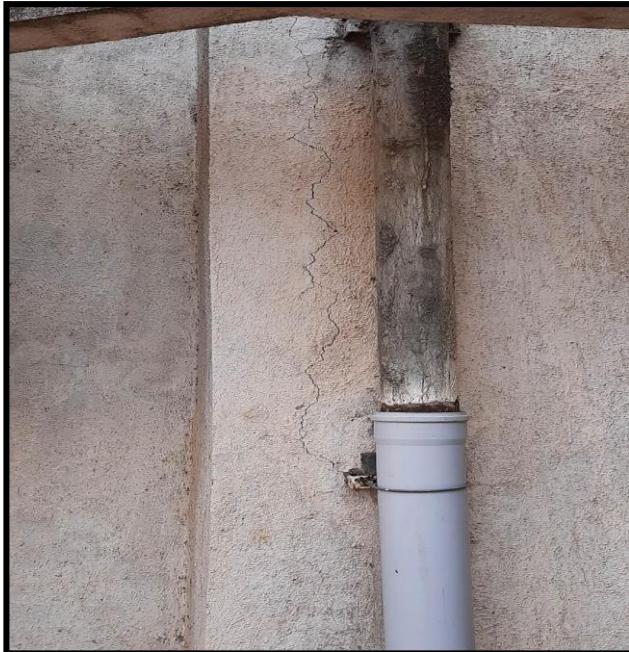
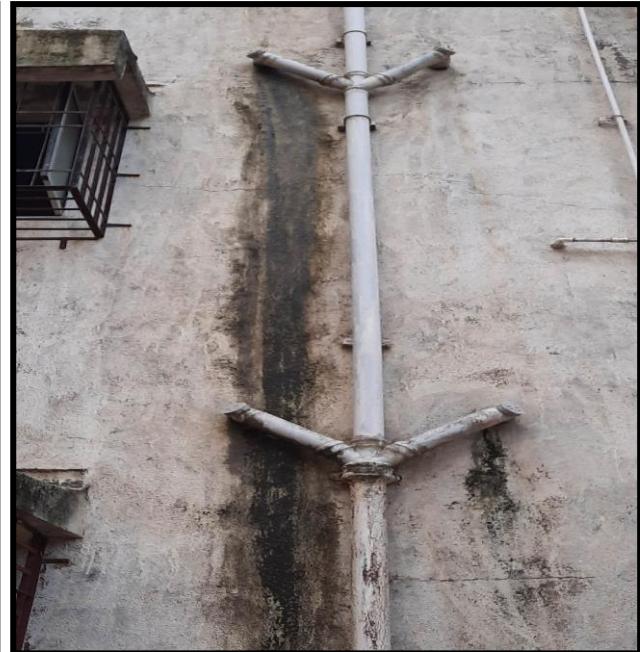
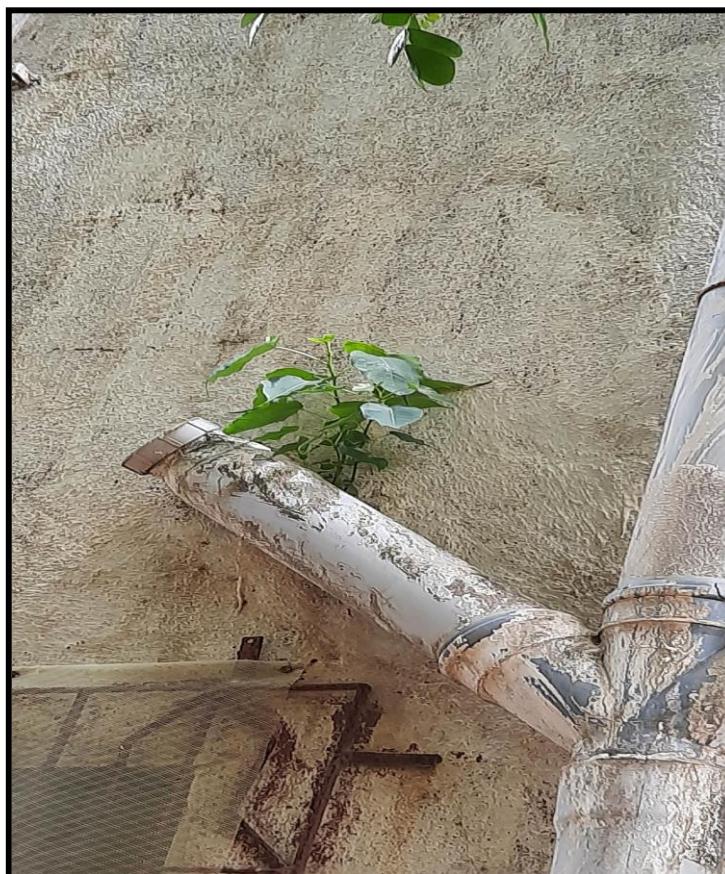
NORTH SIDE

- ❖ Structural crack observed at several places on column.
- ❖ Algae observed at several places on wall.
- ❖ Vegetation growth observed at several places on wall.
