STRUCTURAL AUDIT REPORT
FOR
“VISHAL SAHYADRI CO – OP HSG. SOC. LTD”,
“C1 – WING”
SITUATED AT
SAHYADRI NAGAR, CHARKOP,
KANDIVALI (W) MUMBAI – 400 067

PREPARED BY
LATESH S. SANKLECHA
CONSULTING STRUCTURAL ENGINEERS

978/C1/LSS/2021

JUNE 21, 2021

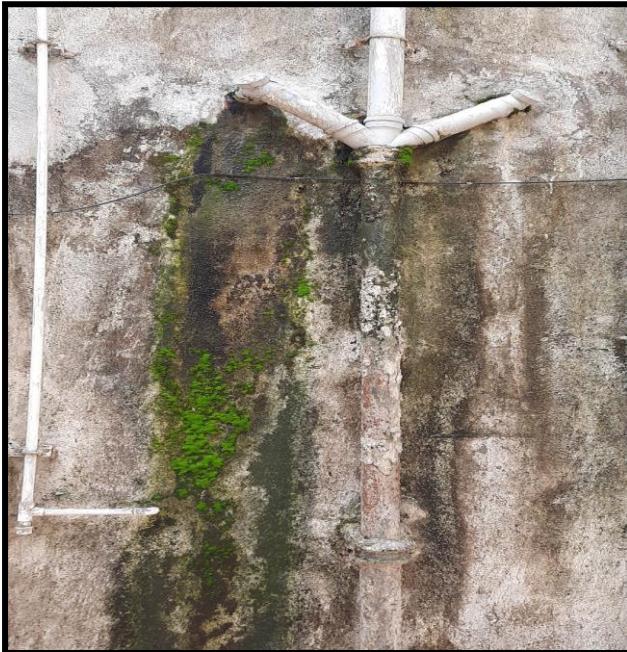
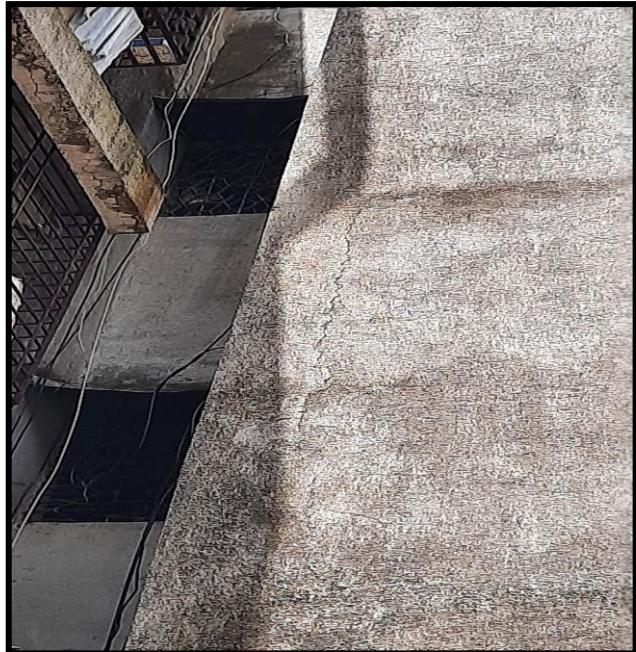
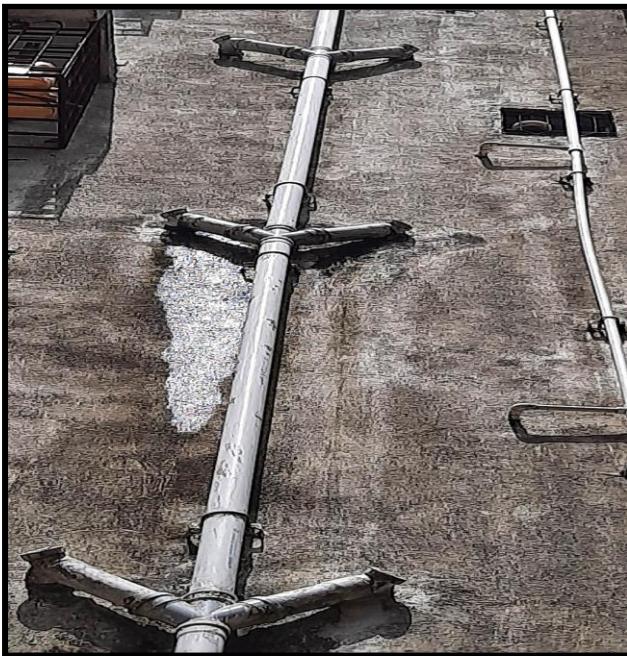
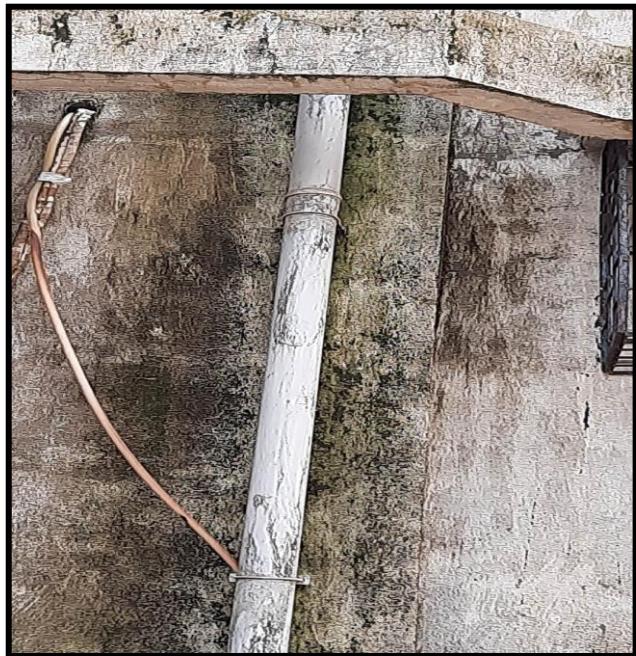
SOUTH SIDE

- ❖ Structural crack observed at several places on column.
- ❖ Major crack observed at several places on wall.
- ❖ Algae observed at several places on wall.
