STRUCTURAL AUDIT REPORT  
FOR  
**“VISHAL SAHYADRI CO – OP HSG. SOC. LTD”,**  
**“D2 – D WING”**  
SITUATED AT  
SAHYADRI NAGAR, CHARKOP,  
KANDIVALI (W) MUMBAI – 400 067

978/D2/LSS/2021

JULY 24, 2021

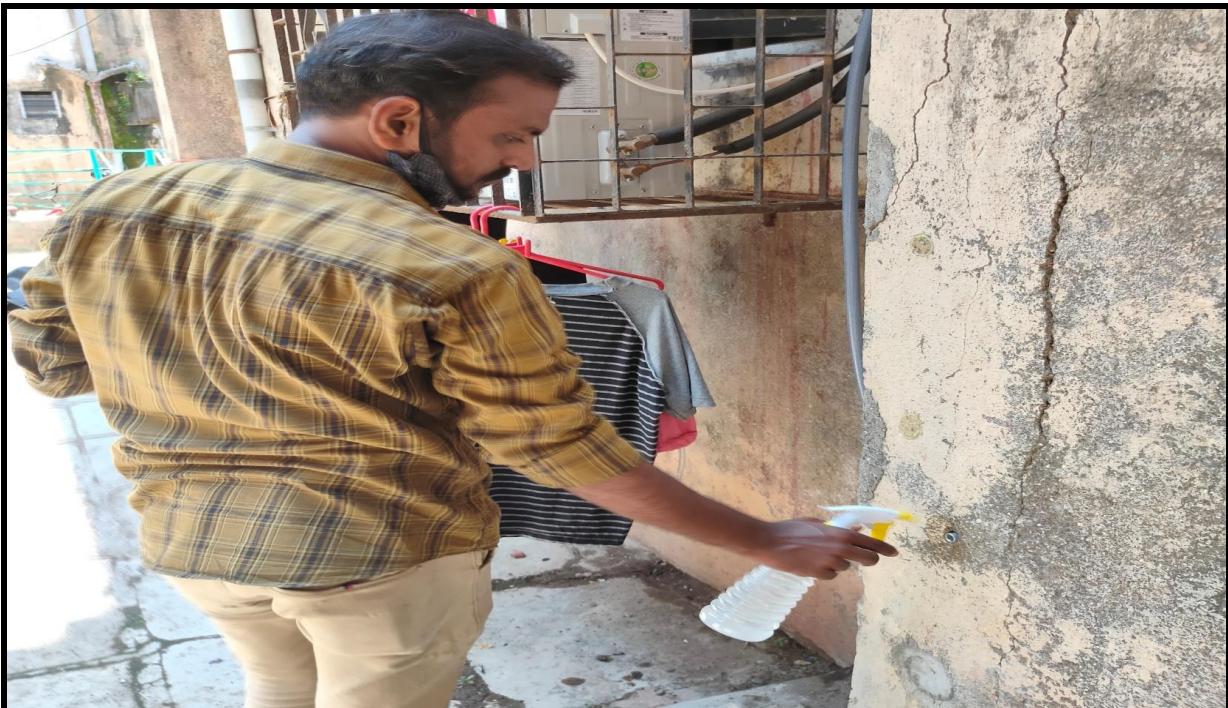
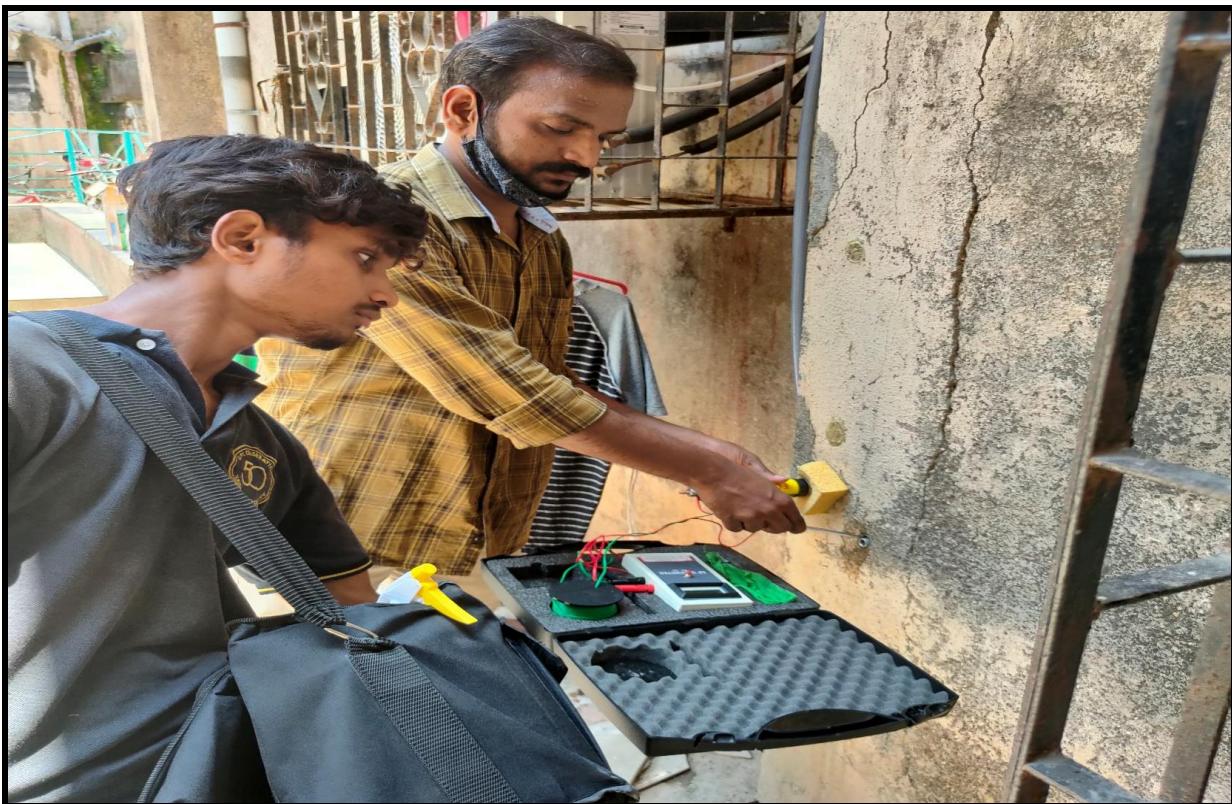
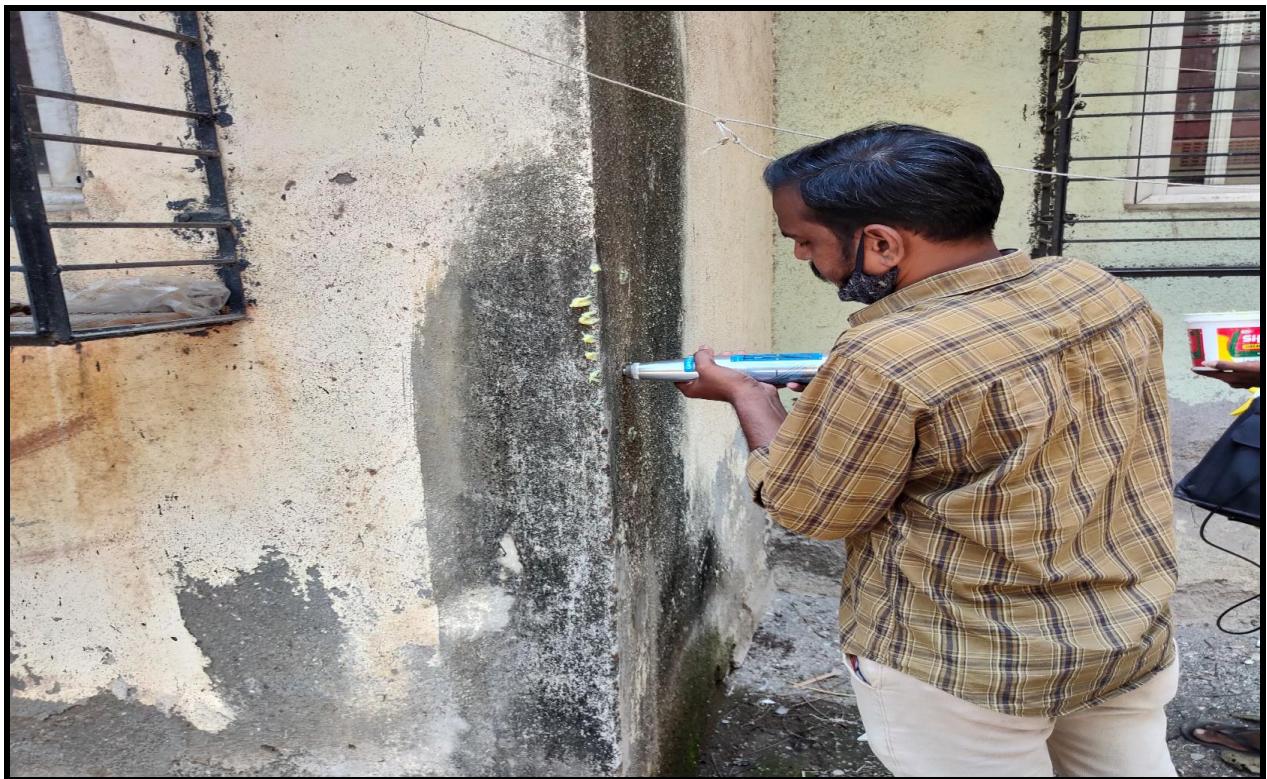
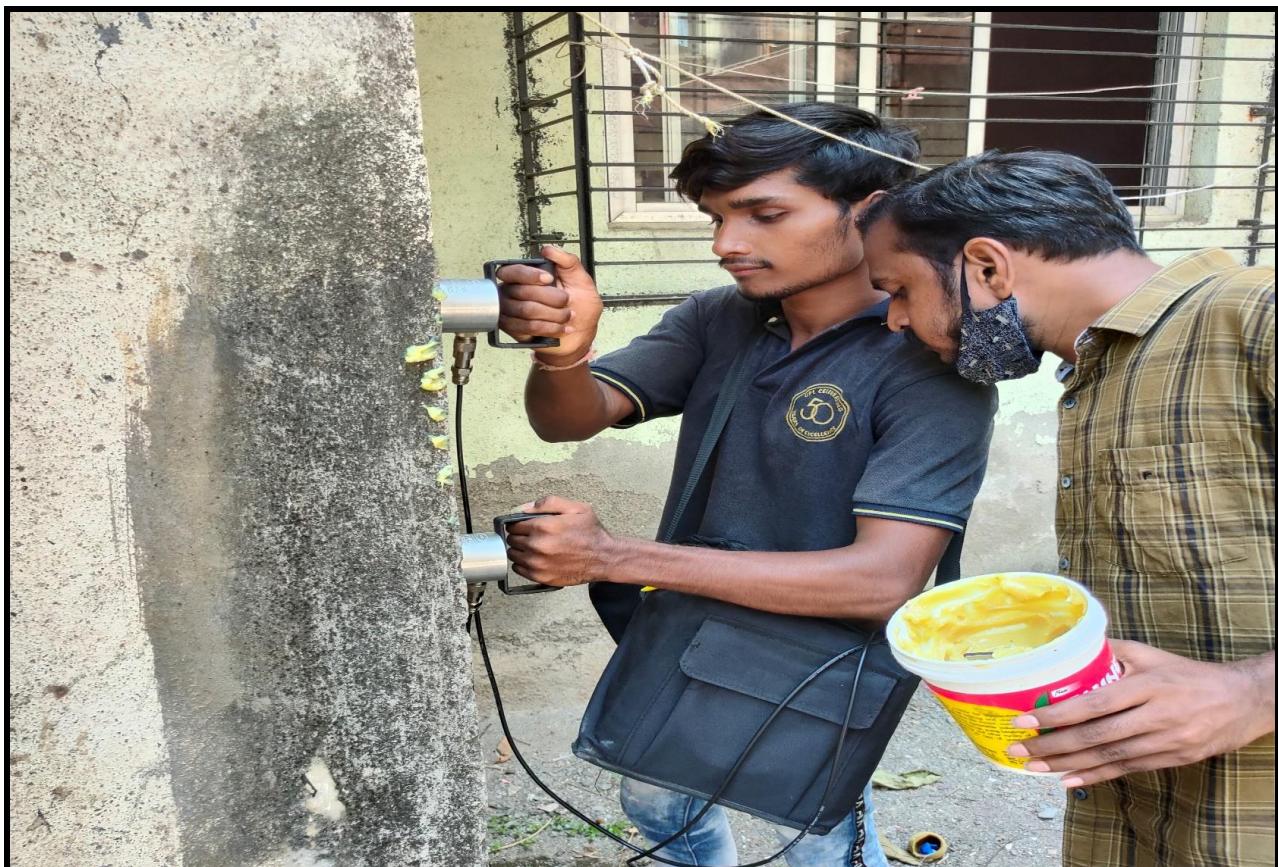
## NON -DESTRUCTIVE TEST PHOTO

Rebound Hammer was tested for compressive strength at surface by Schmidt rebound hammer. Results indicate the compressive strength at surface of the RCC columns & beam in is ranging between 14.90 MPa to 20.30 MPa.

Out of 4 locations 2 locations was below 3.0 Km/Sec means concrete quality is poor and 2 location ranging between 3.0 to 3.75 Km/Sec means concrete quality is doubtful.

This indicates there are progressive internal cracks in the RCC members due to corrosion of reinforced steel. These members are under distress condition.

RCC elements indicating UPV values less than 3 Km/sec needs immediate attention.

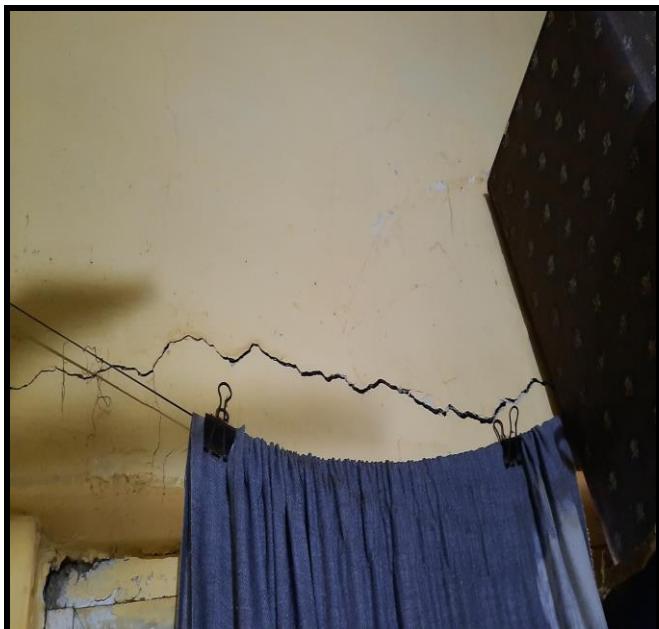
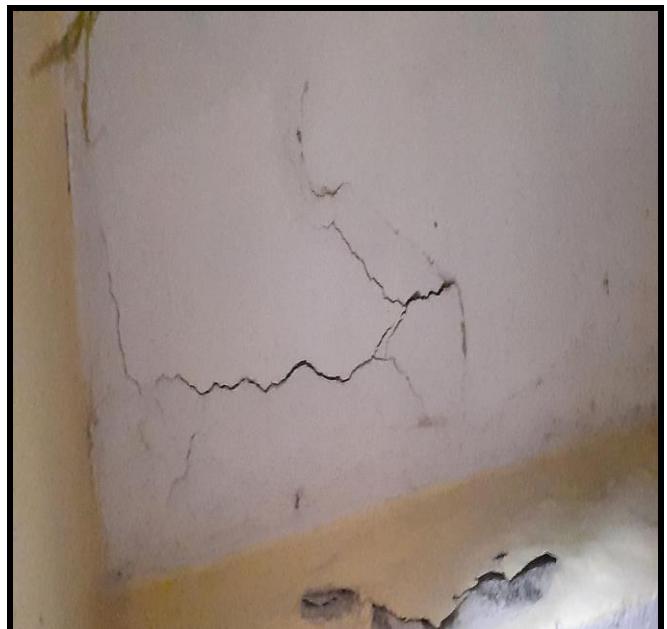
### FLAT NO – 102

- ❖ **HALL** – O.K.
- ❖ **KITCHEN** – Structural crack observed on beam.
- ❖ **PASSAGE** – Structural crack observed on ceiling.
- ❖ **TOILET & BATH ROOM** – O.K.

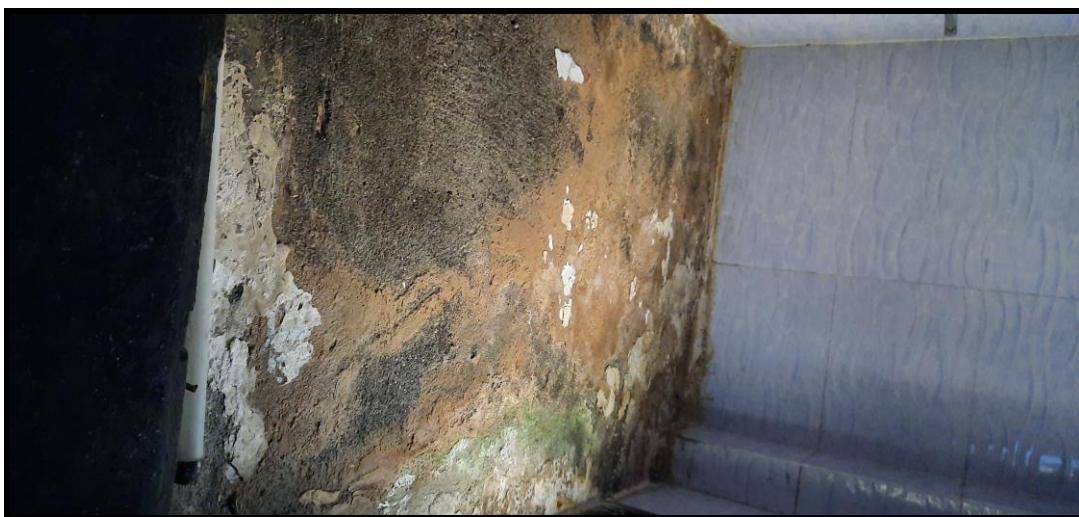
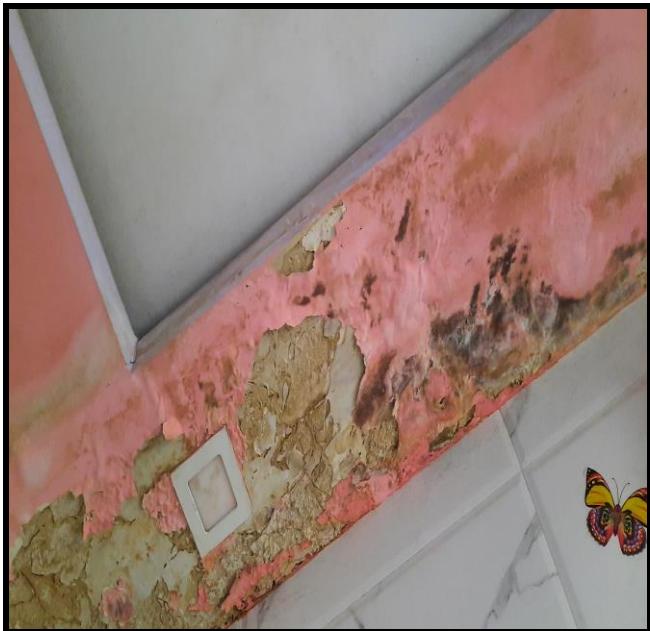
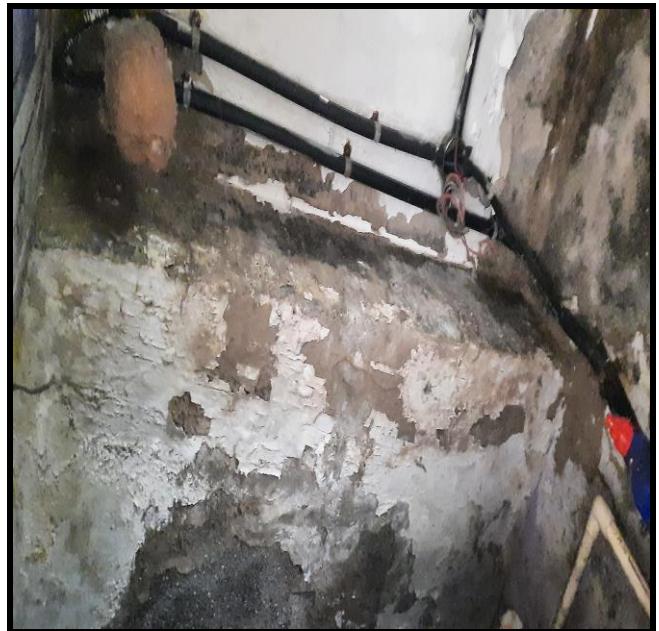
### FLAT NO – 104

- ❖ **HALL** – Leakage mark observed on ceiling.
- ❖ **KITCHEN** – O.K.
- ❖ **PASSAGE** – Dampness observed on ceiling.
- ❖ **TOILET & BATH ROOM** – Dampness observed on ceiling.

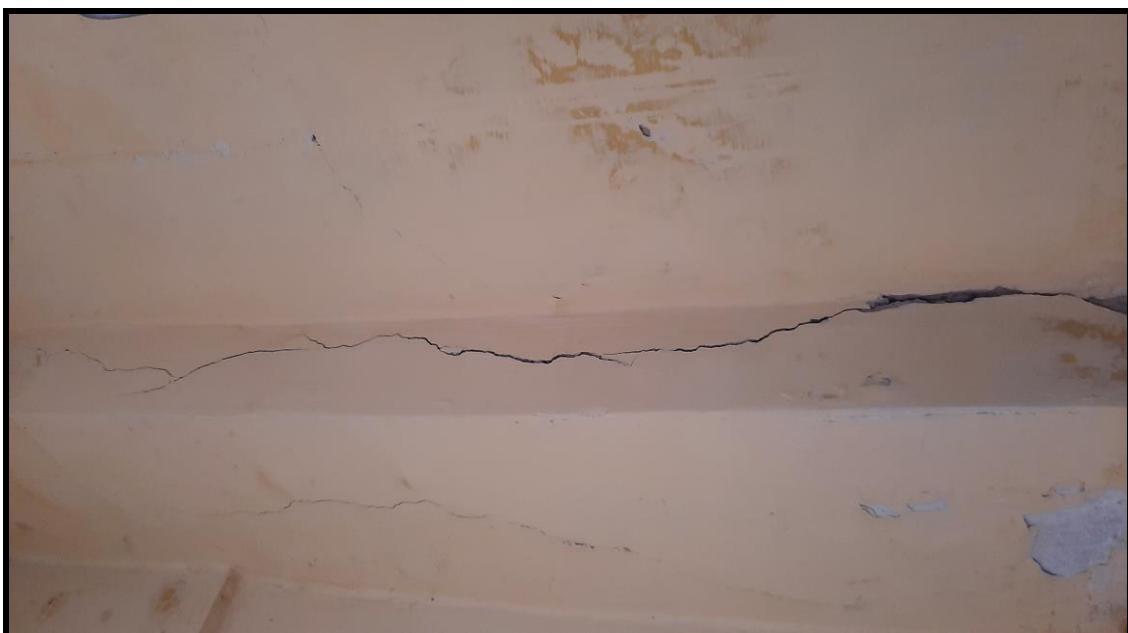
### FLAT NO – 304

- ❖ **HALL** – O.K.
- ❖ **KITCHEN** – Dampness observed on wall & ceiling in monsoon.
  - Structural crack observed on column.
- ❖ **PASSAGE** – O.K.
- ❖ **TOILET & BATH ROOM** – O.K.

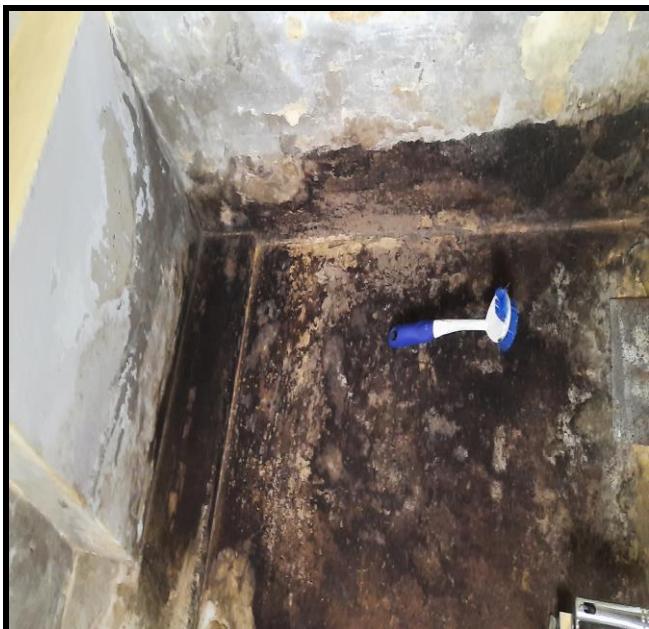
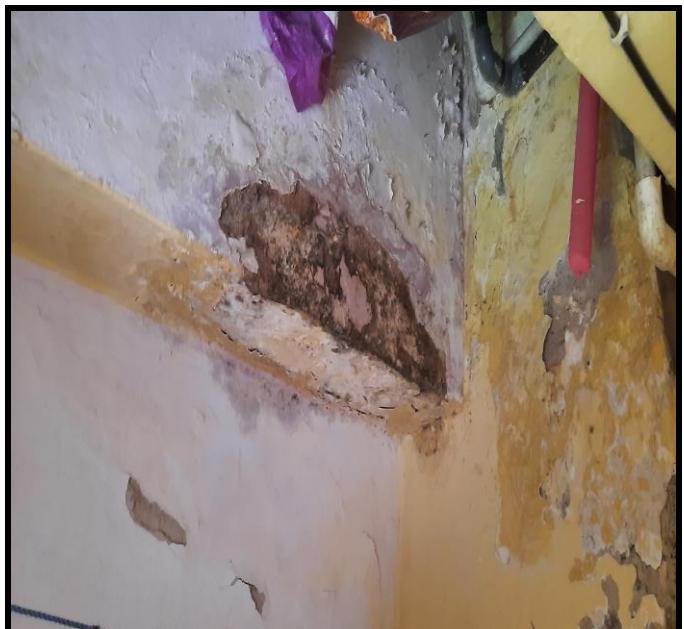
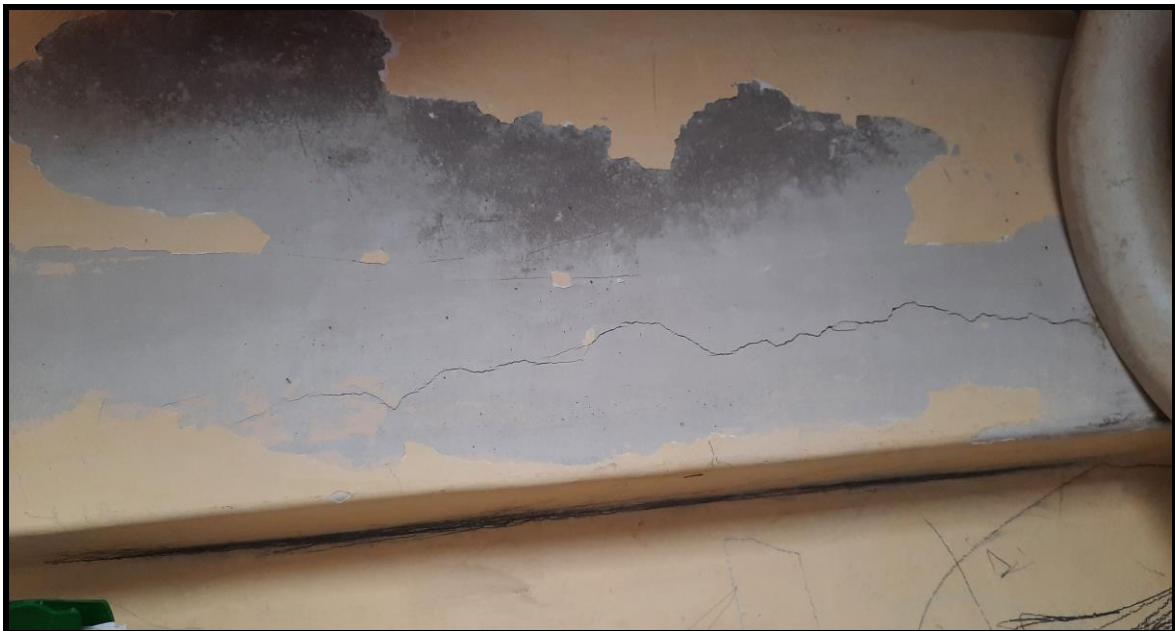
### FLAT NO – 401

- ❖ **HALL** – Structural crack observed on column.
- ❖ **KITCHEN** – Dampness observed on wall.
- ❖ **PASSAGE** – Dampness observed on ceiling.
- ❖ **TOILET & BATH ROOM** – O.K.

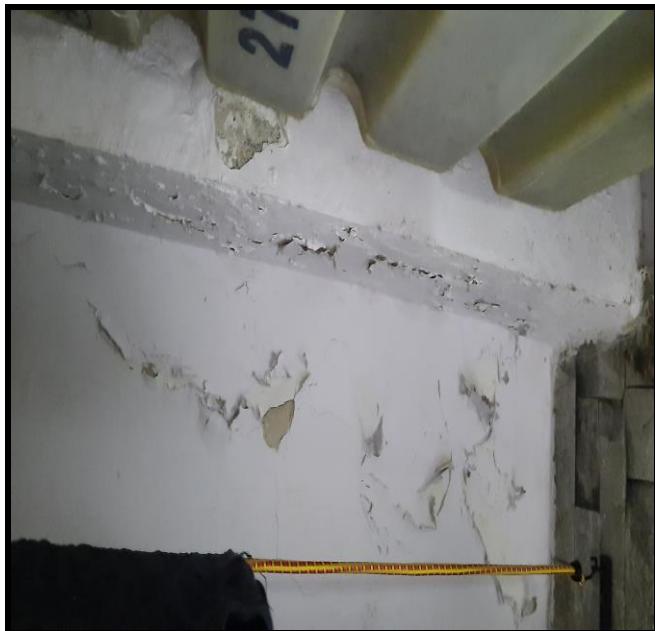
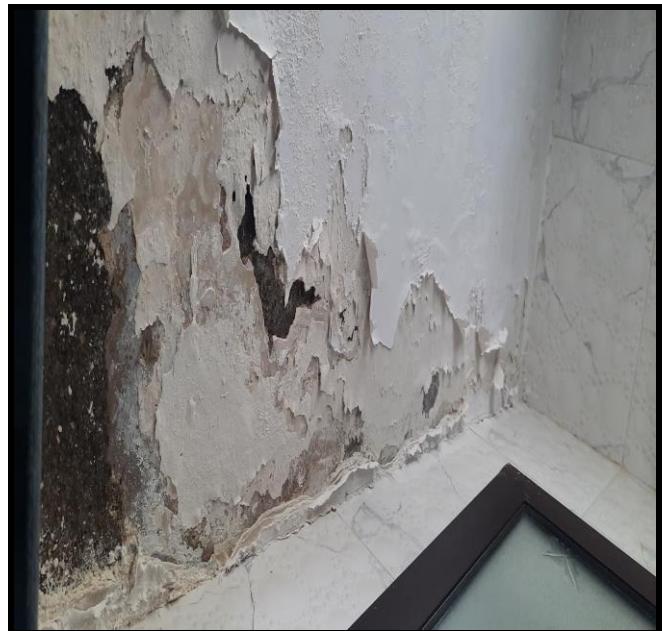
## FLAT NO – 403

- ❖ **HALL** – O.K.
- ❖ **KITCHEN** – O.K.
- ❖ **PASSAGE** – Leakage mark observed on ceiling.
- ❖ **TOILET & BATH ROOM** – Leakage mark observed on ceiling.

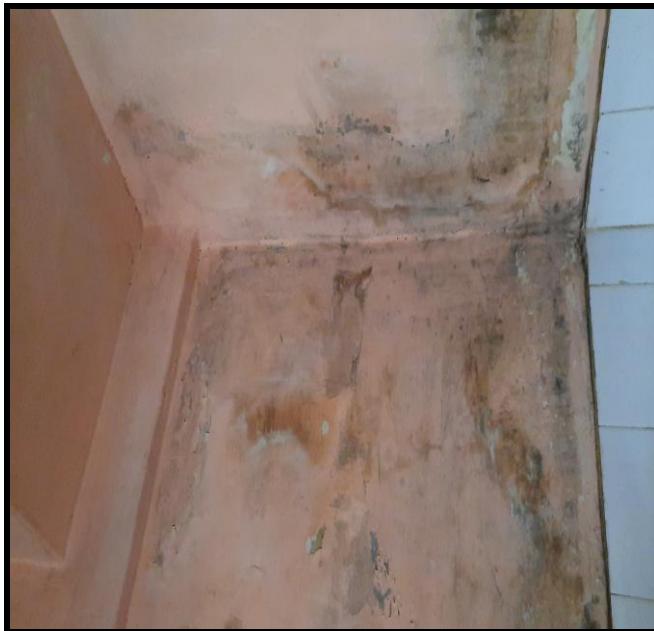
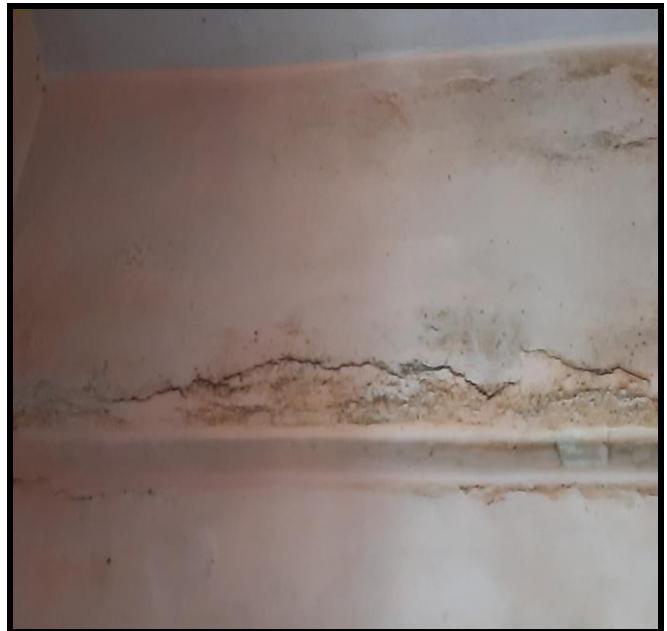
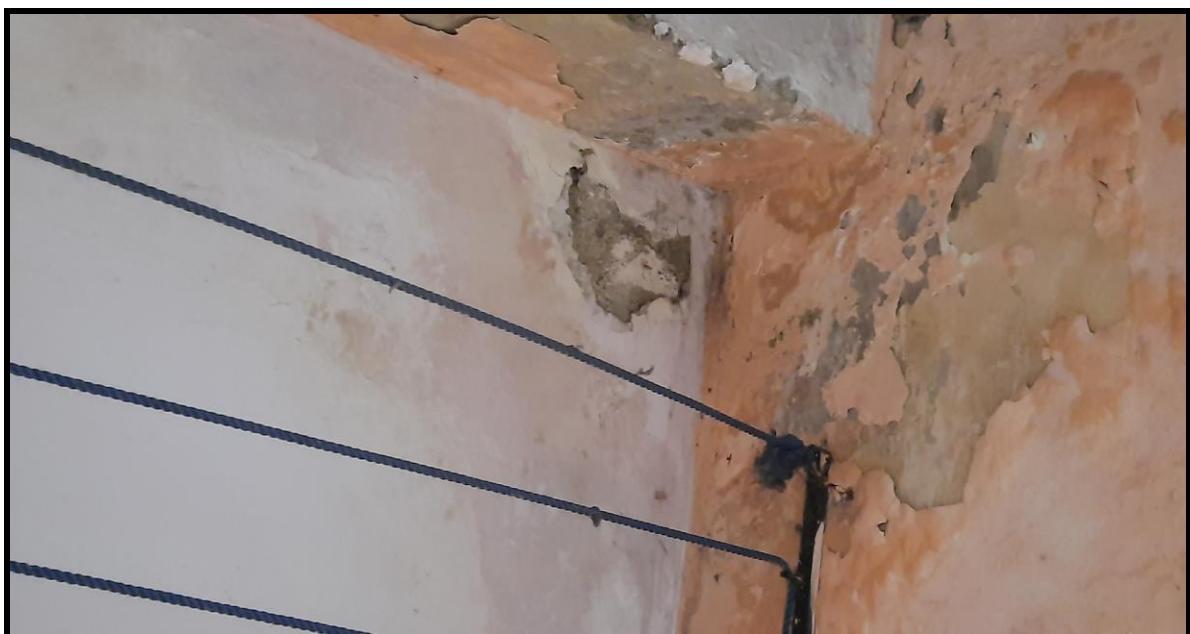
- ❖ **HALL** – Leakage mark observed on wall.
- ❖ **KITCHEN** – Leakage mark observed on wall.
  - Structural crack observed on beam.
- ❖ **PASSAGE** – Leakage mark observed on ceiling.
- ❖ **TOILET & BATH ROOM** – O.K.

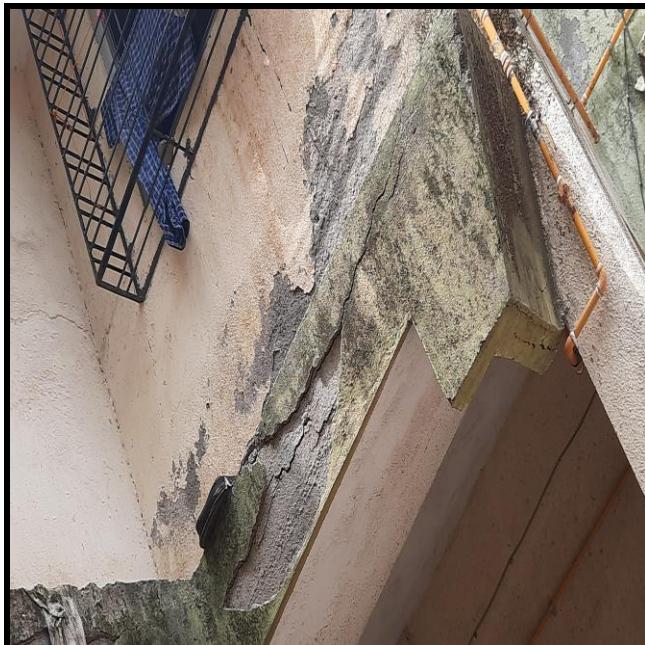
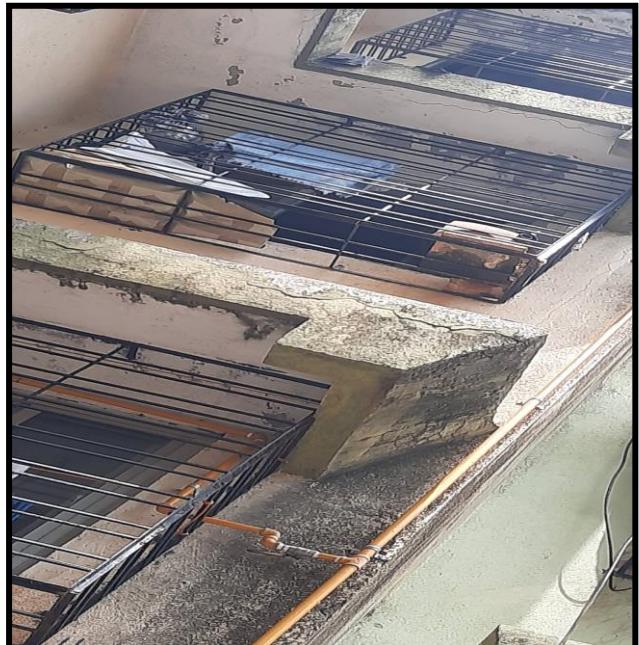
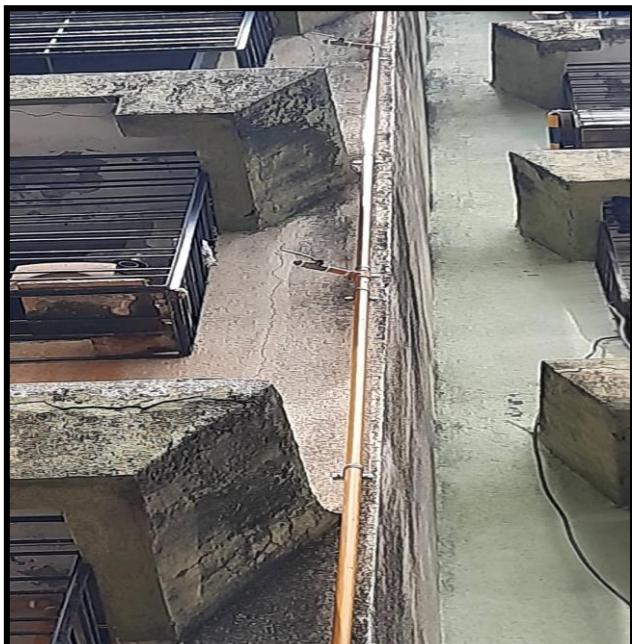
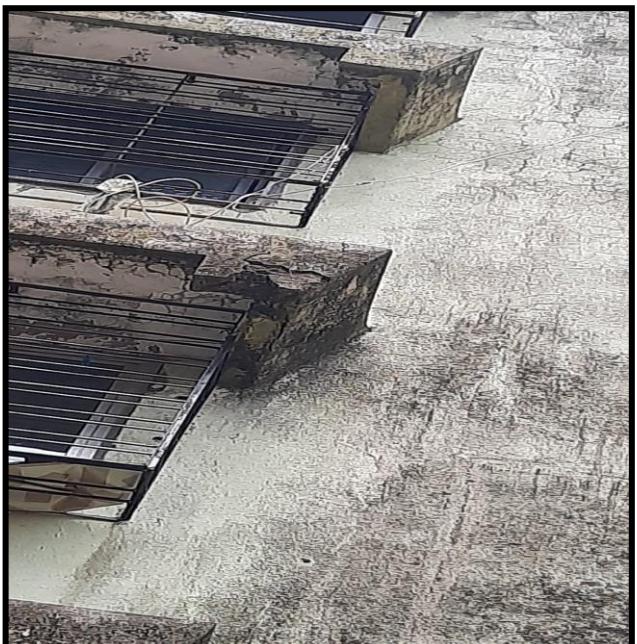
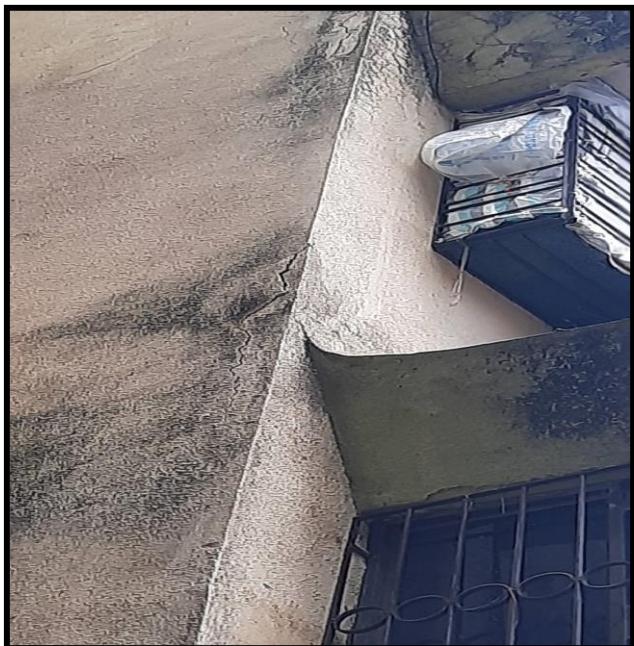
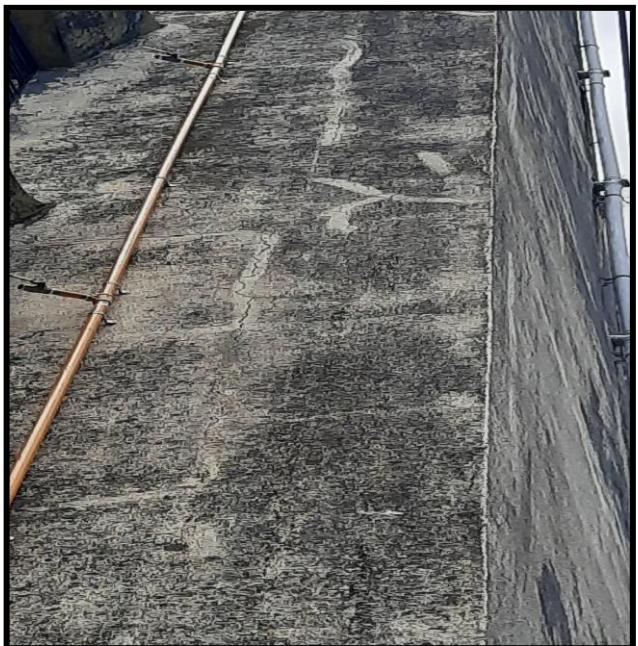
### FRONT SIDE

- ❖ Structural crack observed at several places on column.
- ❖ Major crack observed at several places on wall.
- ❖ Vegetation growth observed at several places on wall.

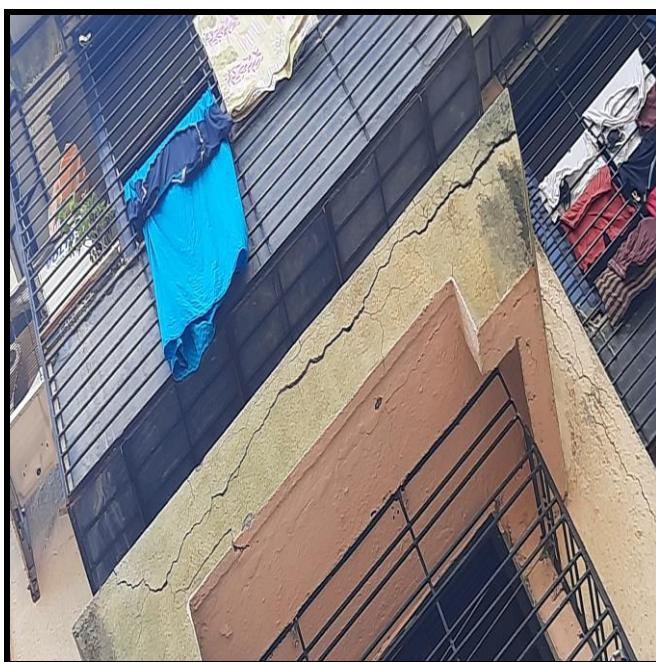
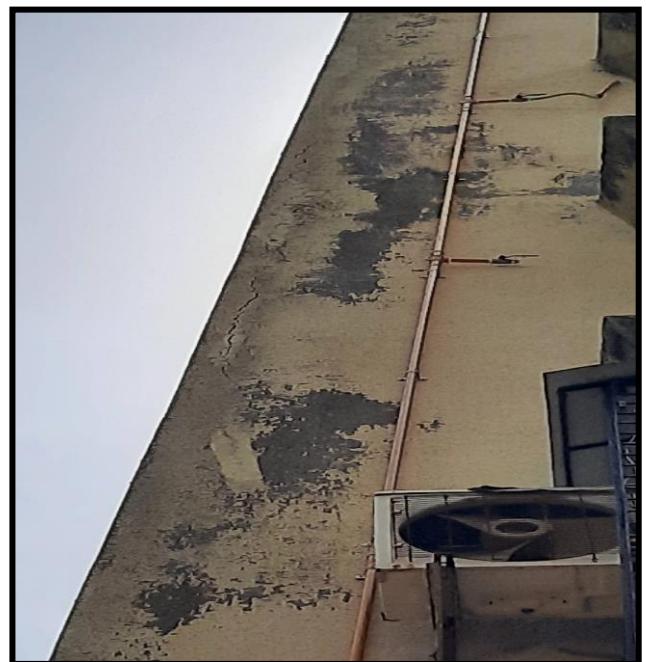
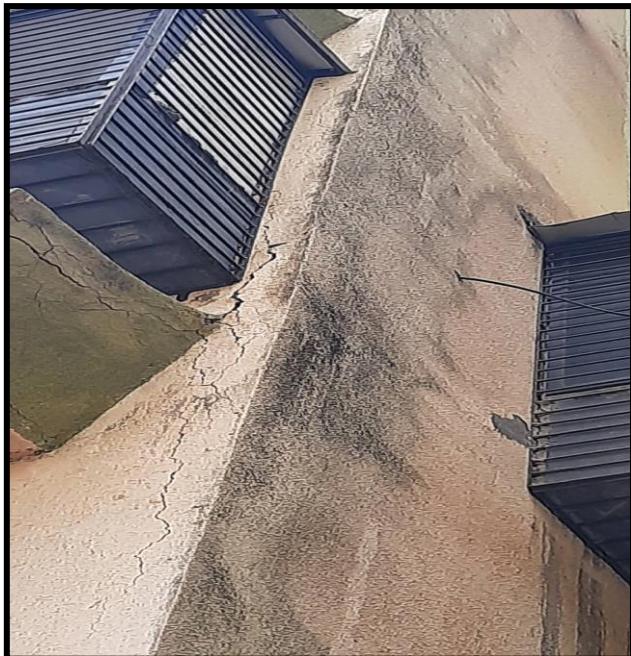
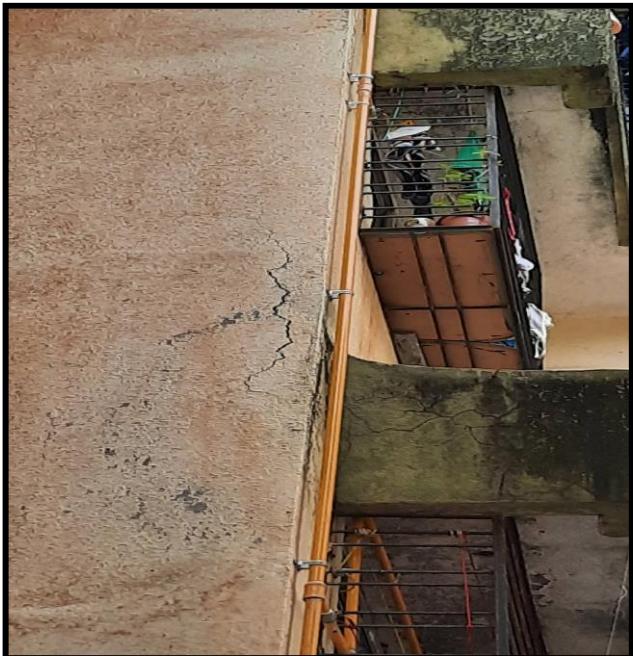
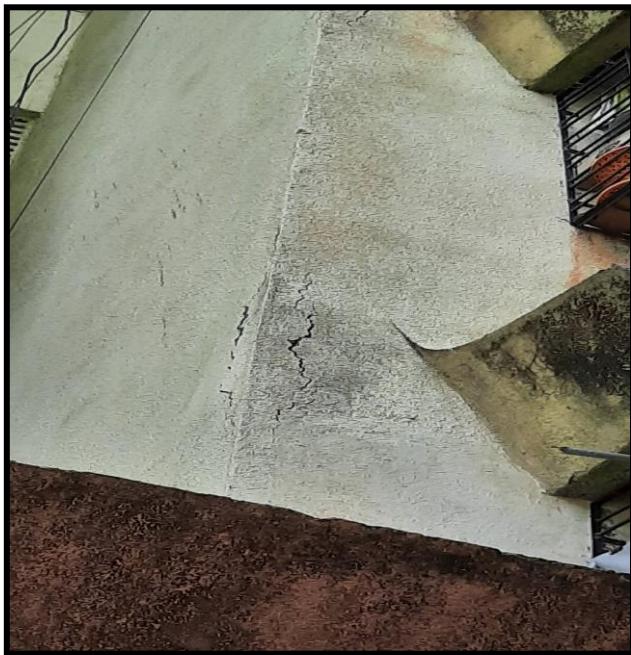
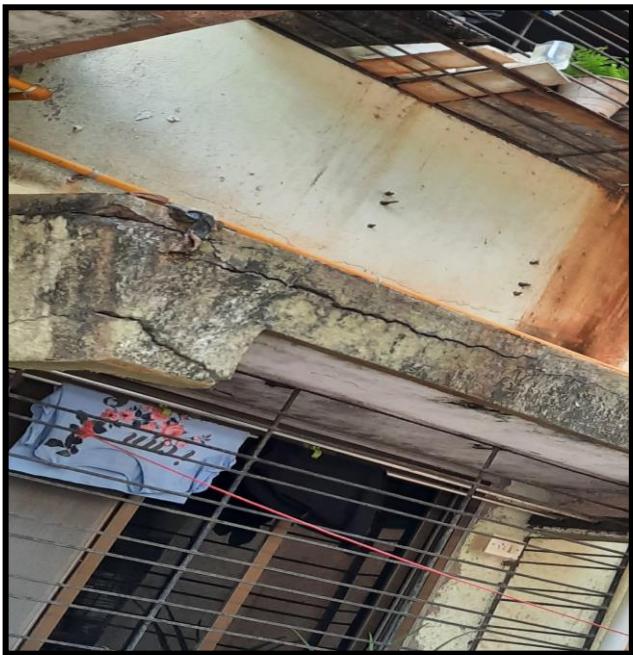
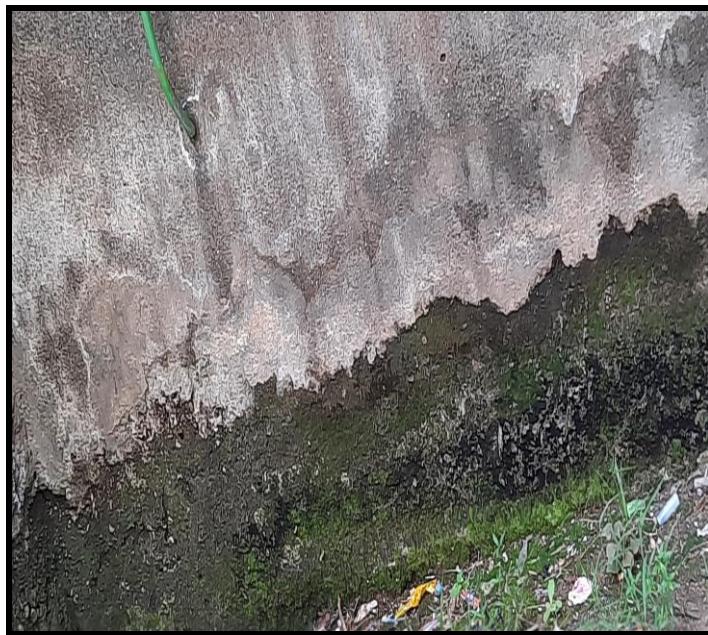
## BACK SIDE

- ❖ Structural crack observed at several places on column & chajjas.
- ❖ Major crack observed at several places on wall.
- ❖ Vegetation growth observed at several places on wall.

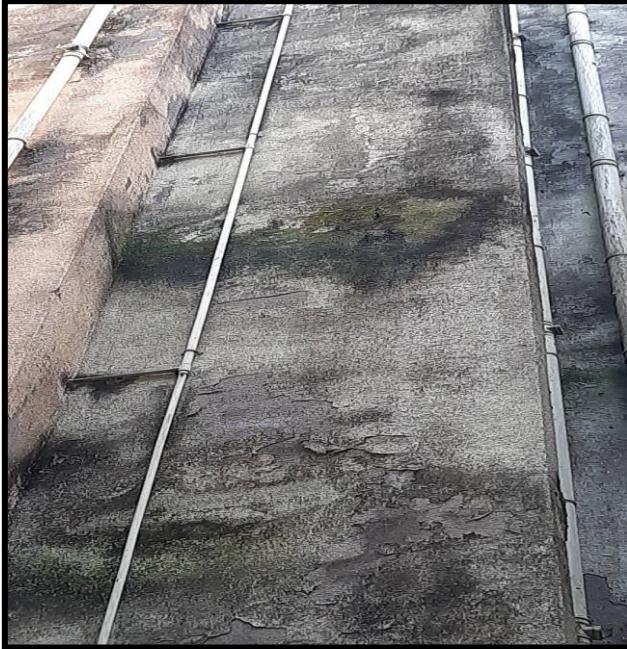
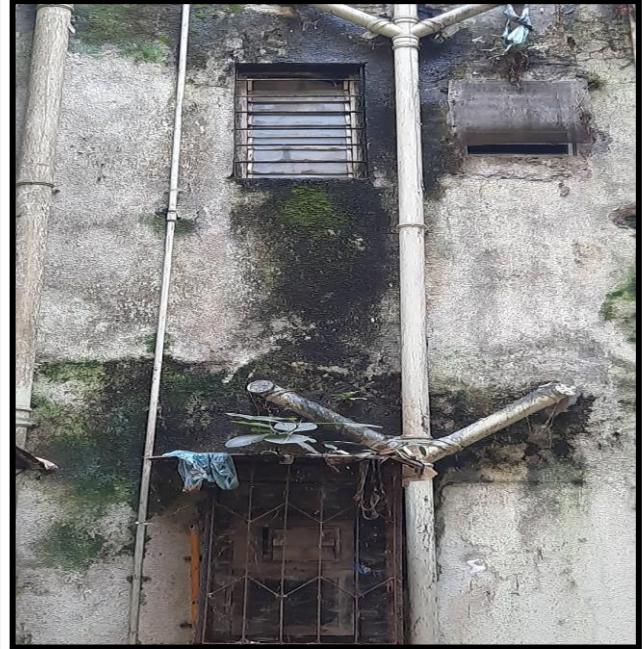
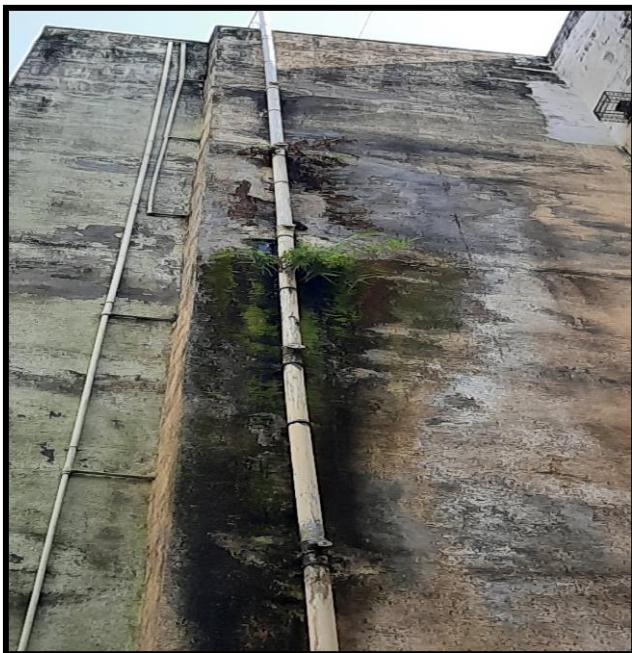
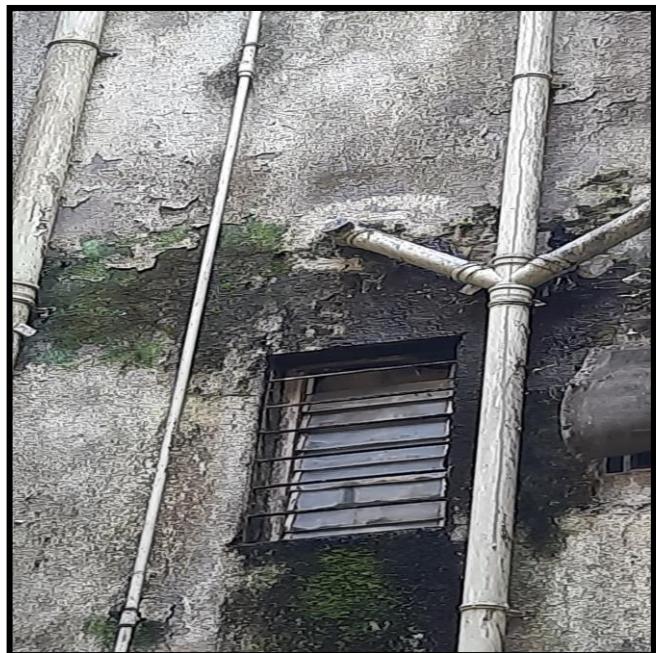
## NORTH SIDE

- ❖ Structural crack observed at several places on column.
- ❖ Major crack observed at several places on wall.

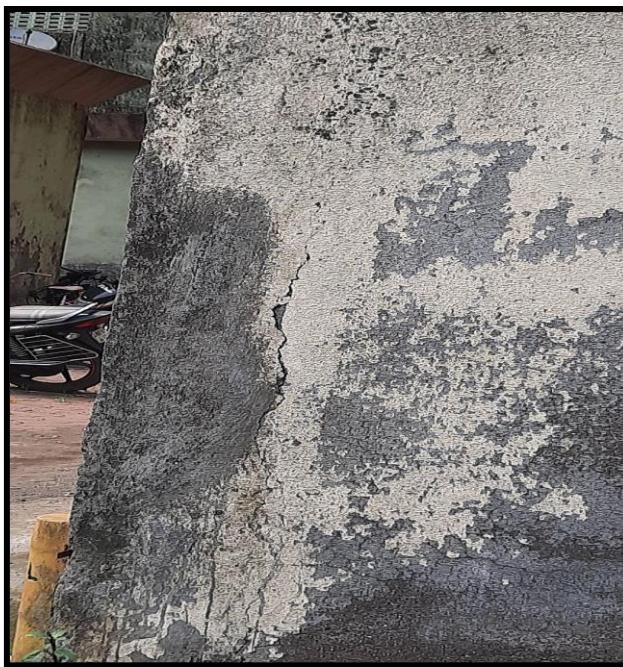
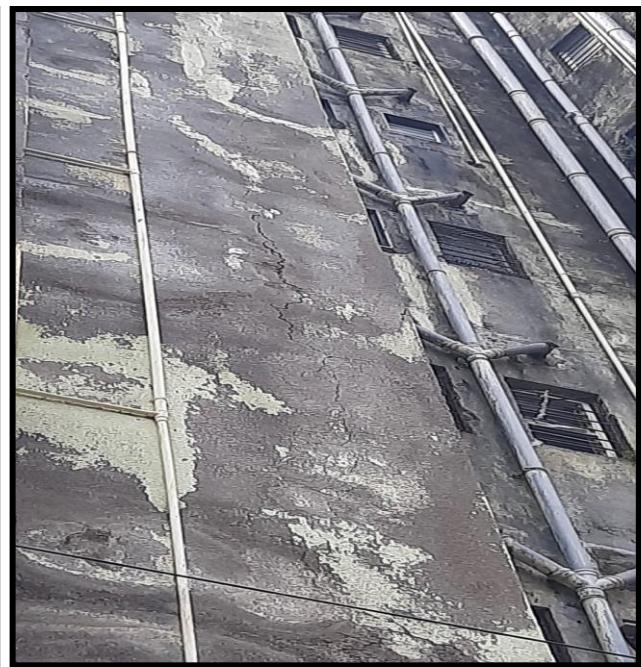
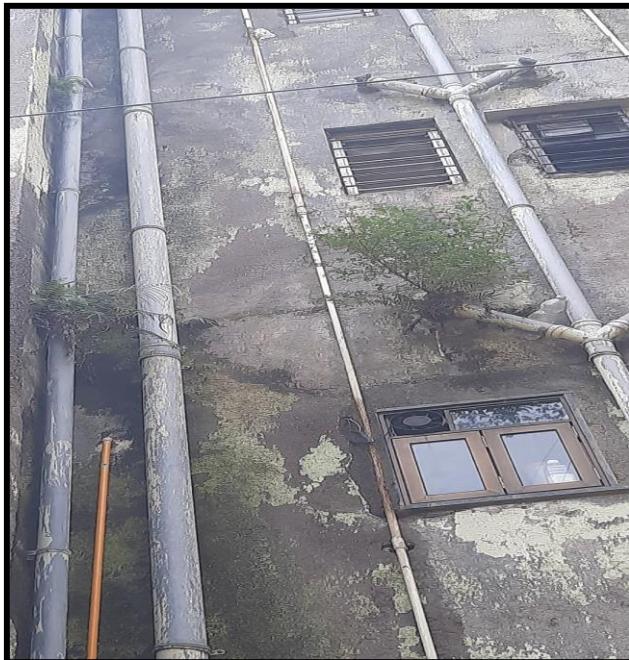
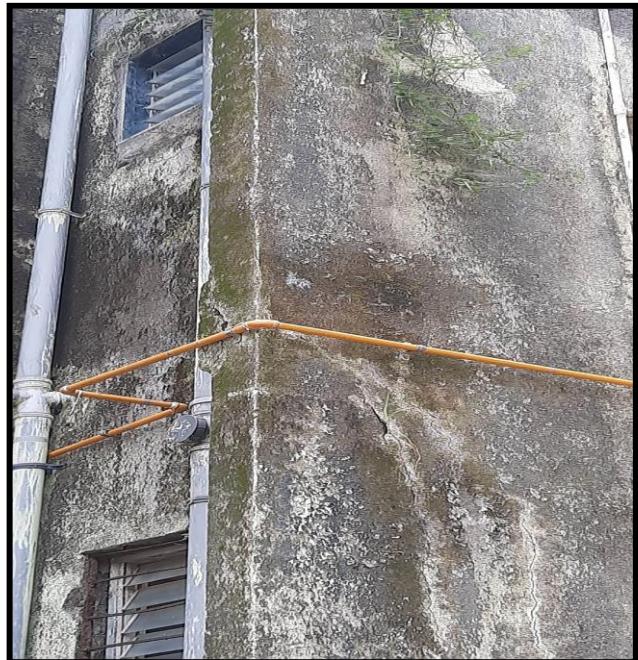
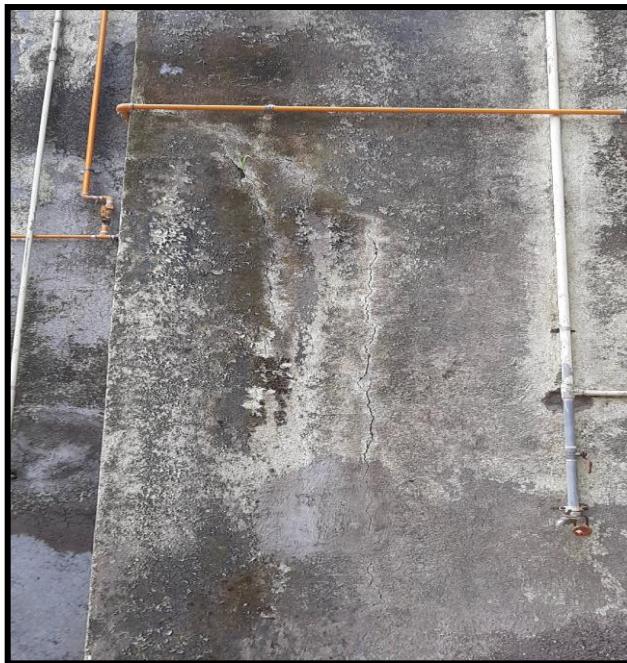
## SOUTH SIDE

- ❖ Structural crack observed at several places on column & chajjas.
- ❖ Major crack observed at several places on wall.
- ❖ Vegetation growth observed at several places on wall.
