STRUCTURAL AUDIT REPORT
FOR
“VISHAL SAHYADRI CO – OP HSG. SOC. LTD”,
“D3 – B WING”
SITUATED AT
SAHYADRI NAGAR, CHARKOP,
KANDIVALI (W) MUMBAI – 400 067

PREPARED BY
LATESH S. SANKLECHA
CONSULTING STRUCTURAL ENGINEERS

"Vishal Sahyadri Co – Operative Housing Soc. Ltd", "D3 – B WING" Regi. No. BOM/HSG/5697/1979 Situated at Sahyadri Nagar, Charkop, Kandivali (W) Mumbai – 400 067 had requested to **Latesh S. Sanklecha, Consulting Structural Engineer** to inspect the structures.

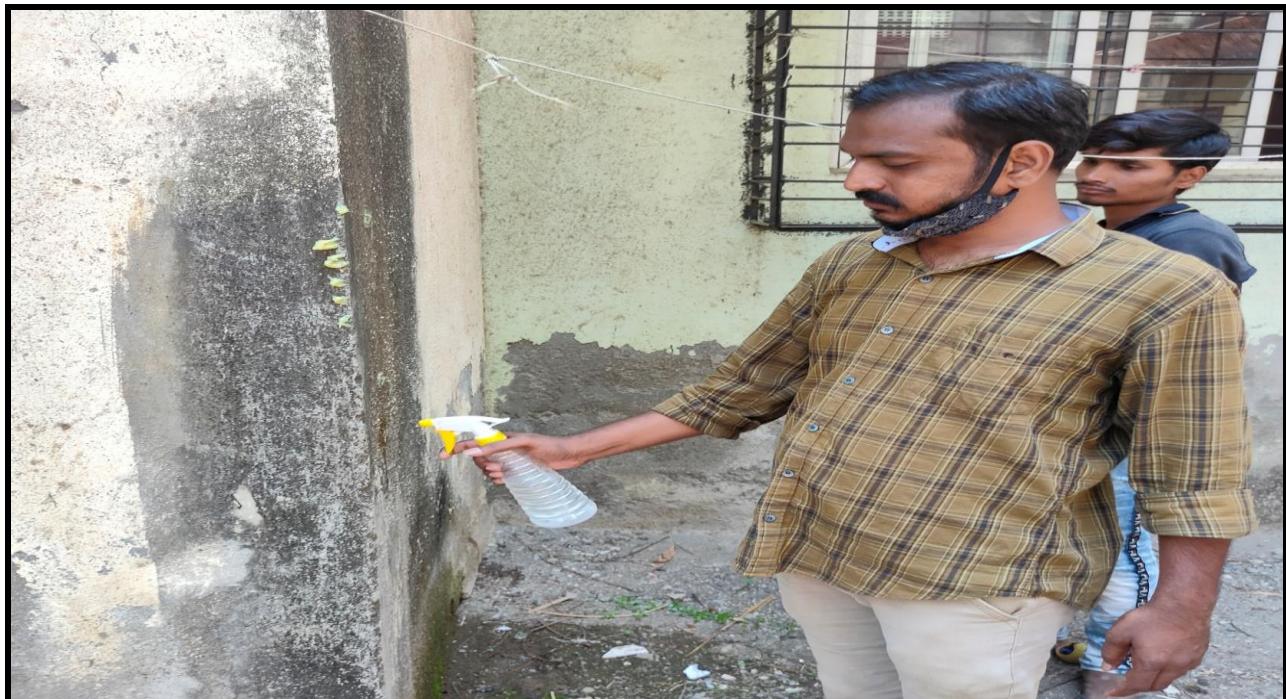
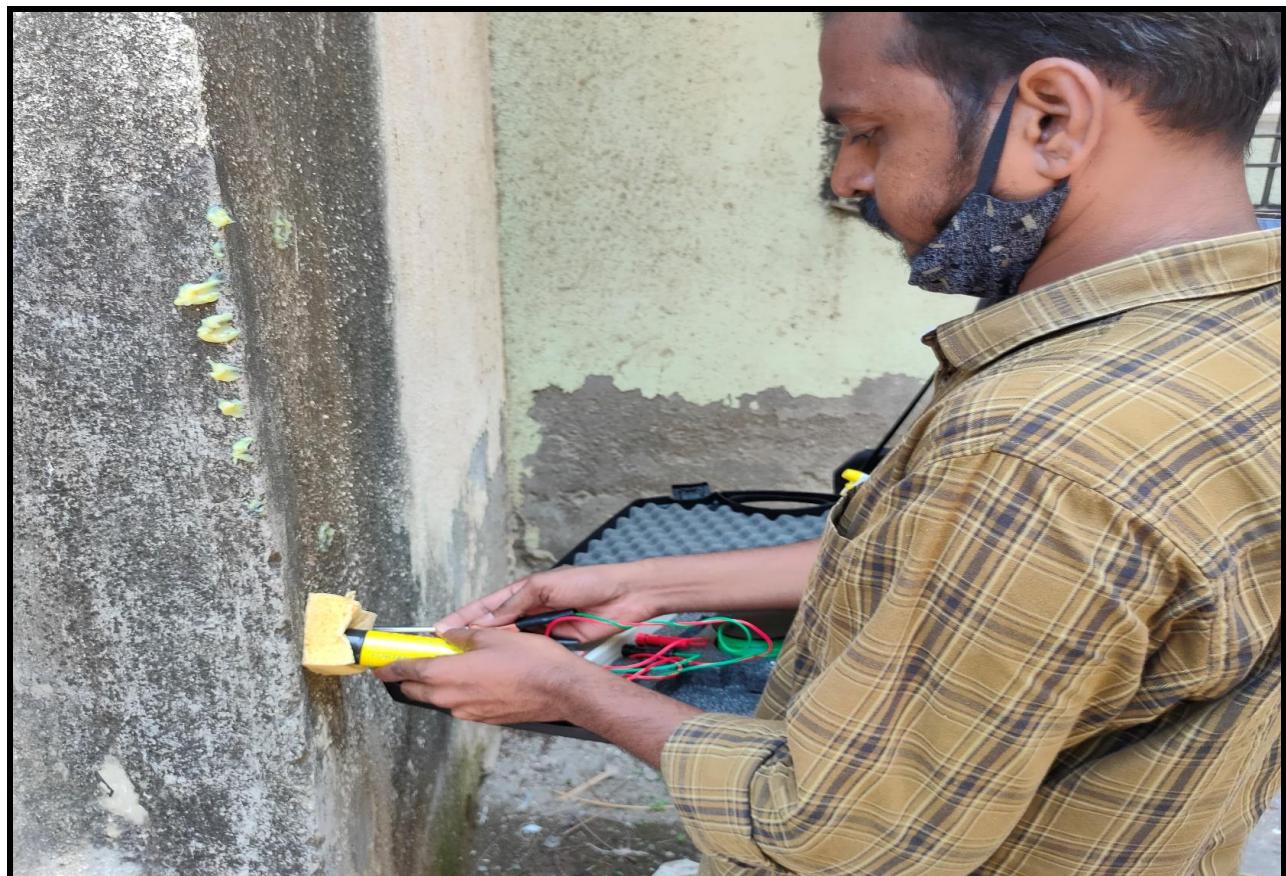
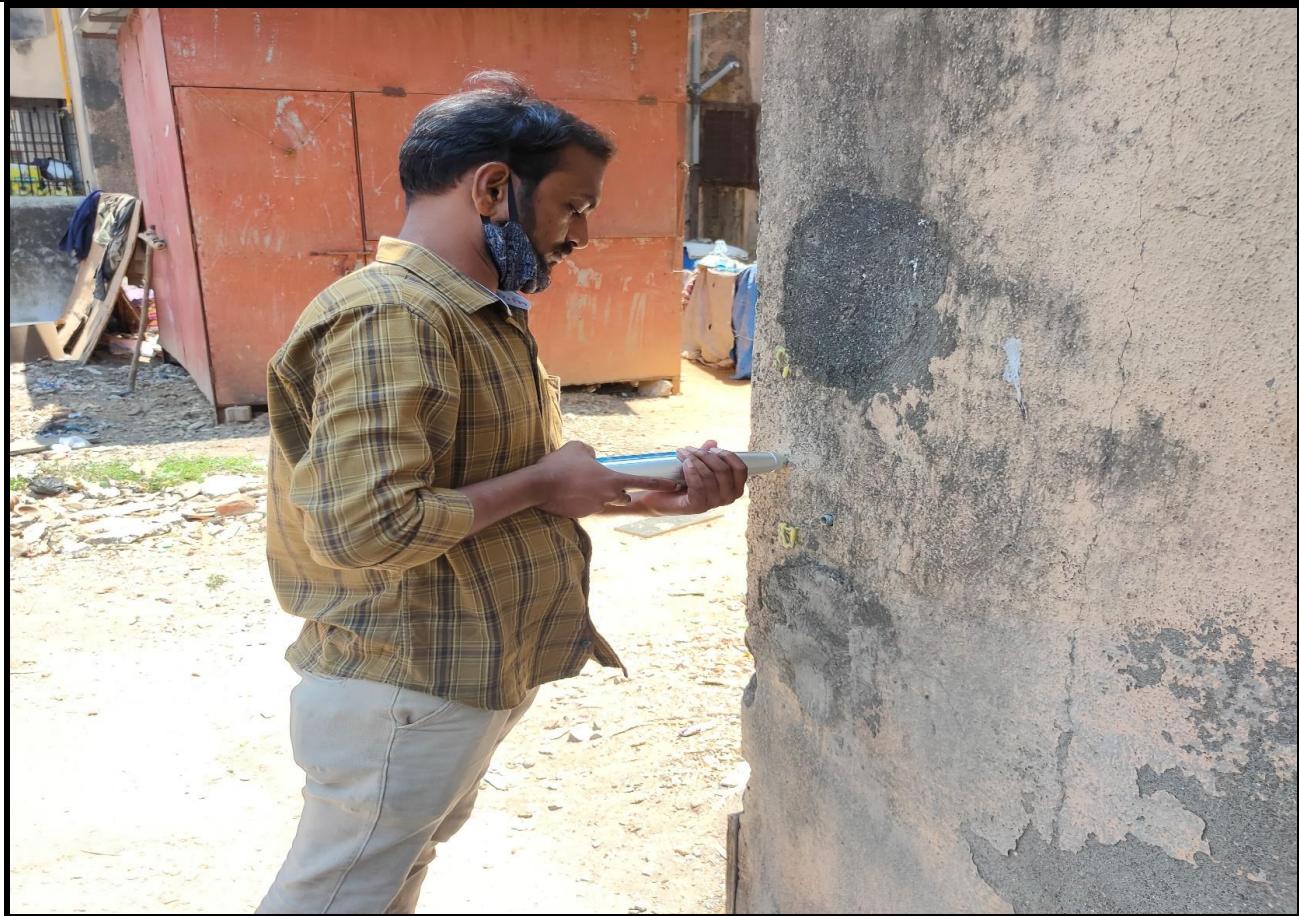
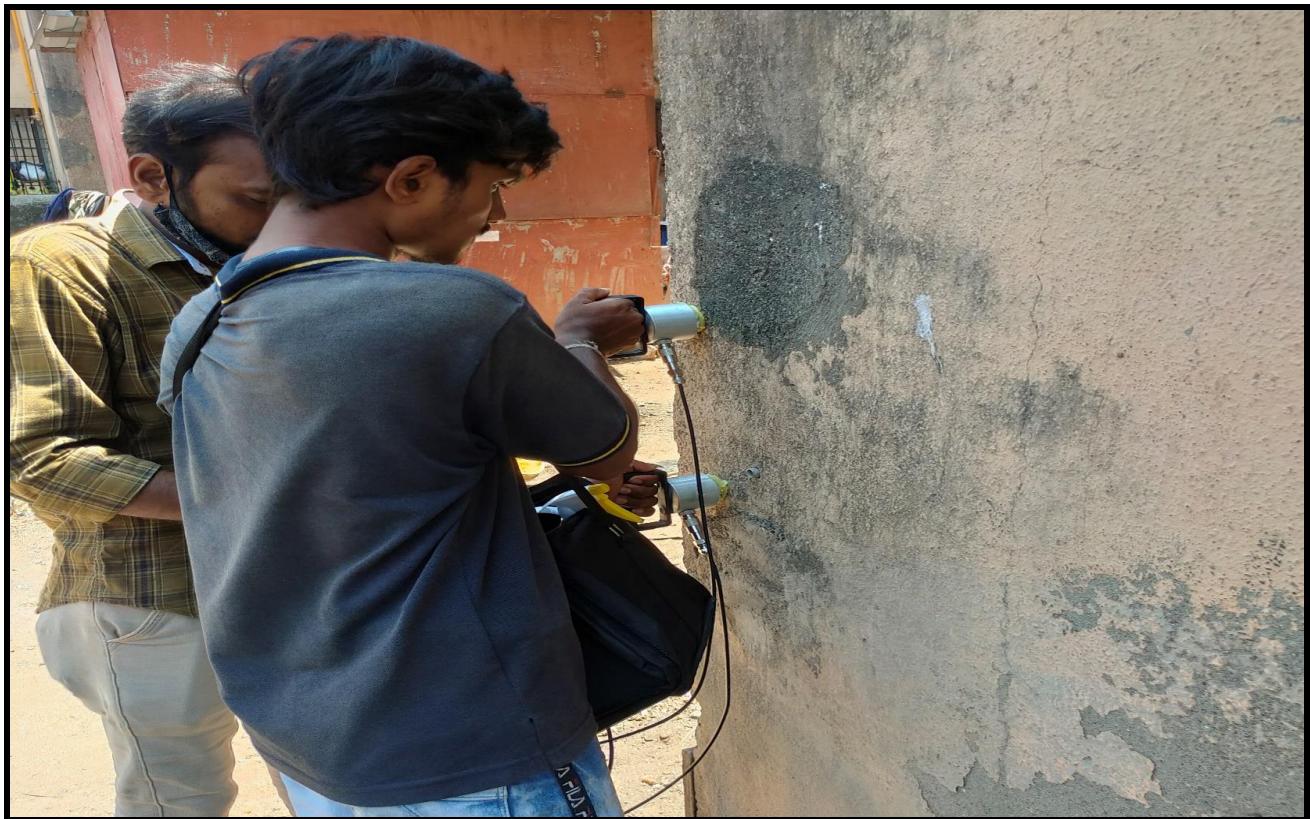
NON -DESTRUCTIVE TEST PHOTO

Rebound Hammer was tested for compressive strength at surface by Schmidt rebound hammer. Results indicate the compressive strength at surface of the RCC columns & beam in is ranging between 13.70 MPa to 18.90 MPa.

Out of 4 locations 2 locations was below 3.0 Km/Sec means concrete quality is poor and 2 location ranging between 3.0 to 3.75 Km/Sec means concrete quality is doubtful.

This indicates there are progressive internal cracks in the RCC members due to corrosion of reinforced steel. These members are under distress condition.

RCC elements indicating UPV values less than 3 Km/sec needs immediate attention.

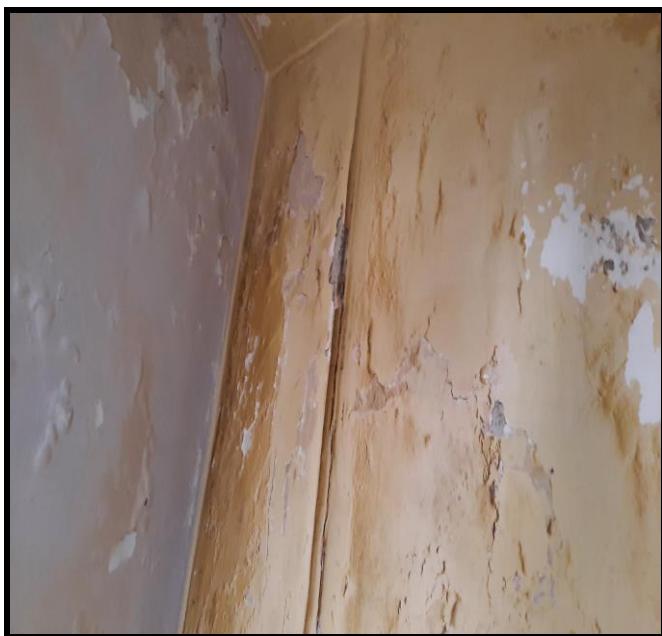
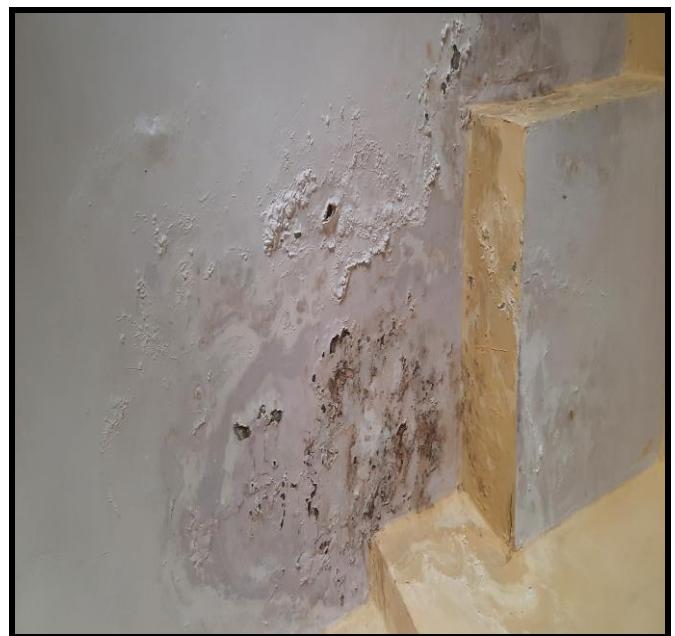
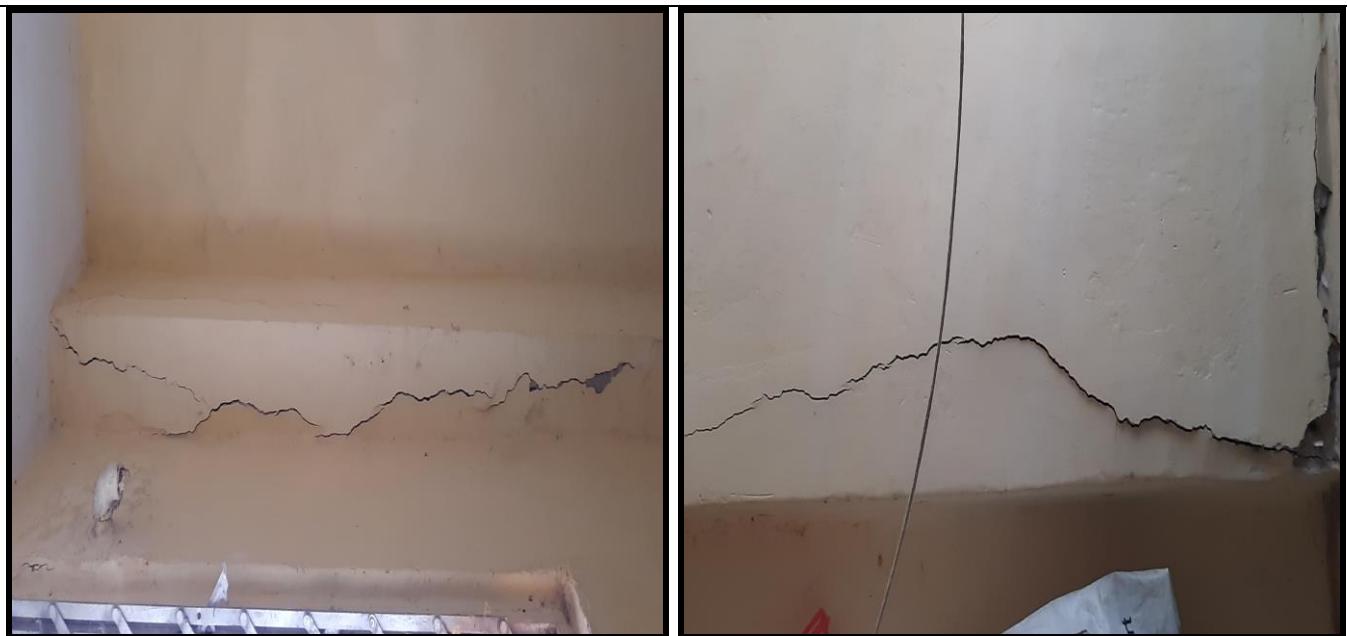
FLAT NO – 02

- ❖ **HALL** – O.K.
- ❖ **KITCHEN** – Leakage mark observed on wall & ceiling.
 - Structural crack observed on beam.
- ❖ **PASSAGE** – O.K.
- ❖ **TOILET & BATH ROOM** – Structural crack observed on column.

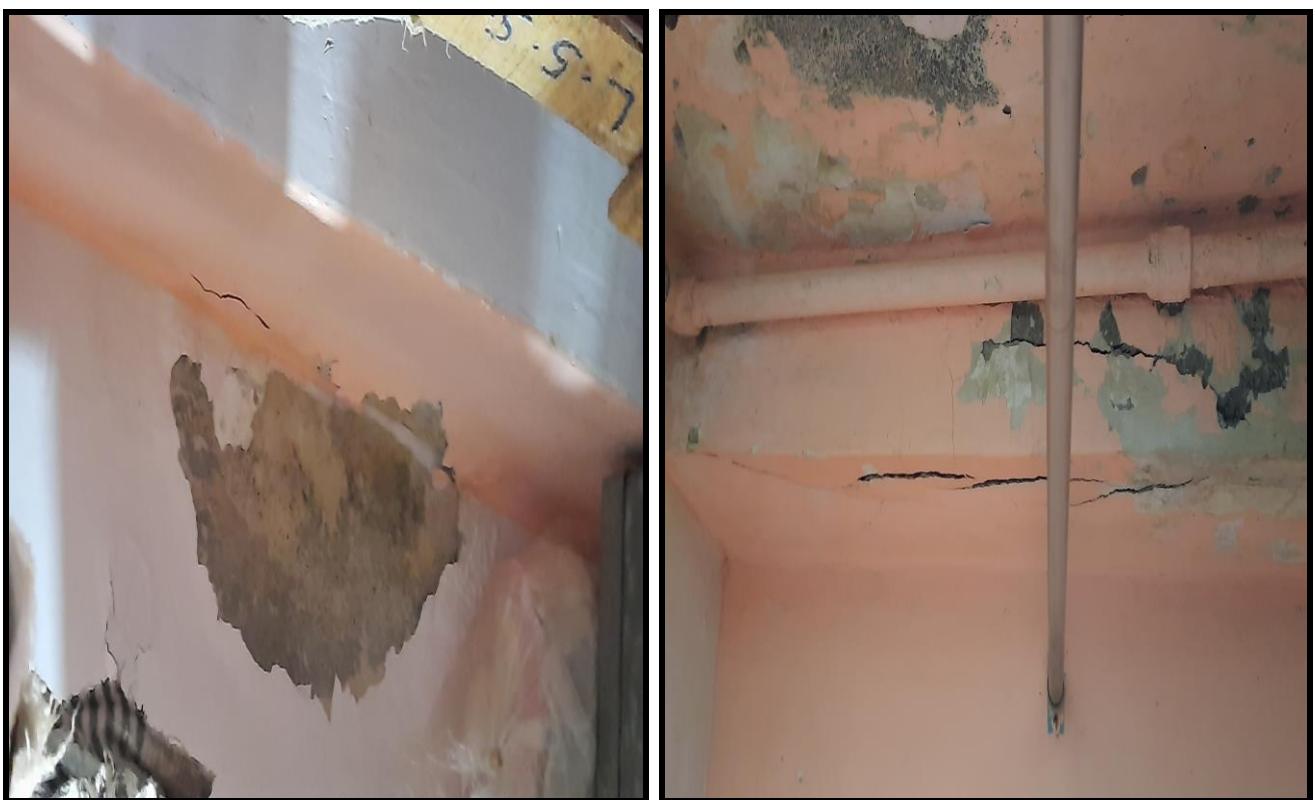
FLAT NO – 03

- ❖ **HALL** – O.K.
- ❖ **KITCHEN** – O.K.
- ❖ **PASSAGE** Leakage mark observed on ceiling.
- ❖ **TOILET & BATH ROOM** – Leakage mark observed on wall.
 - Structural crack observed on column.

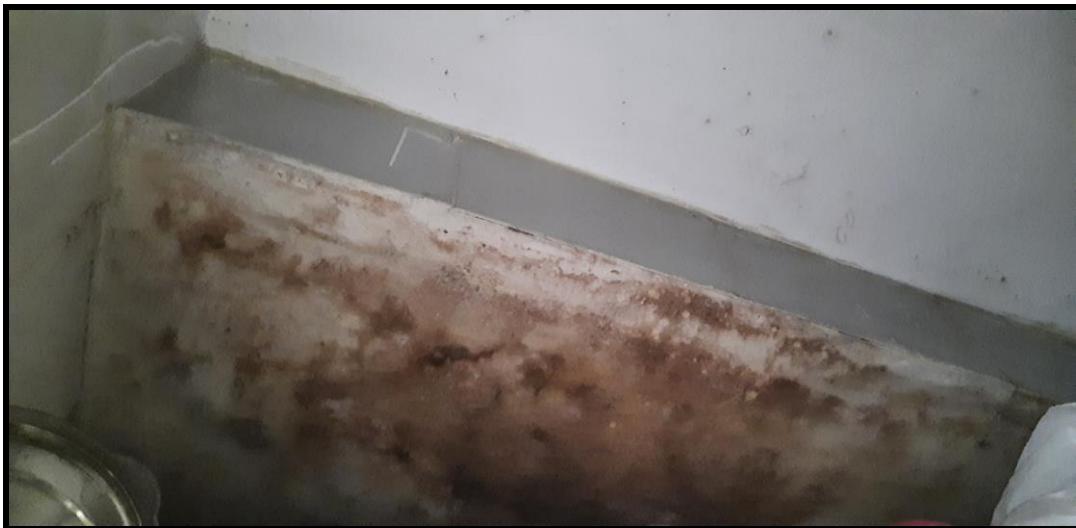
FLAT NO – 06

- ❖ **HALL** – O.K.
- ❖ **KITCHEN** – Leakage observed on wall in kitchen.
- ❖ **PASSAGE** – Leakage mark observed on ceiling.
- ❖ **TOILET & BATH ROOM** – Leakage mark observed on ceiling.

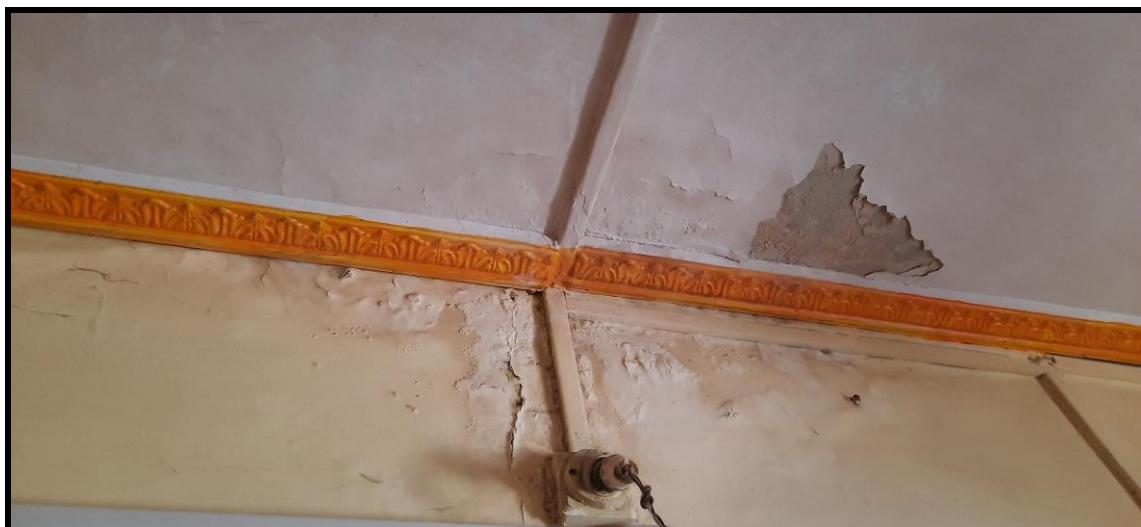
FLAT NO – 08

- ❖ **HALL** – Leakage mark observed on wall.
- ❖ **KITCHEN** – O.K.
- ❖ **PASSAGE** – O.K.
- ❖ **TOILET & BATH ROOM** – O.K.

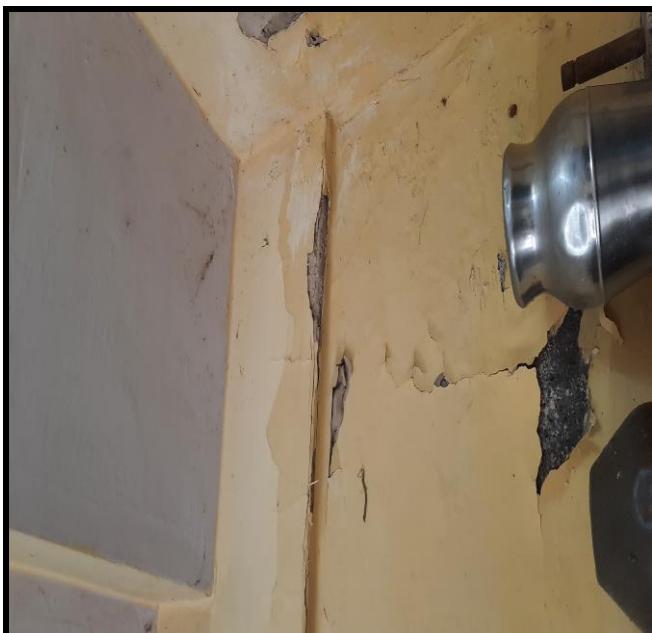
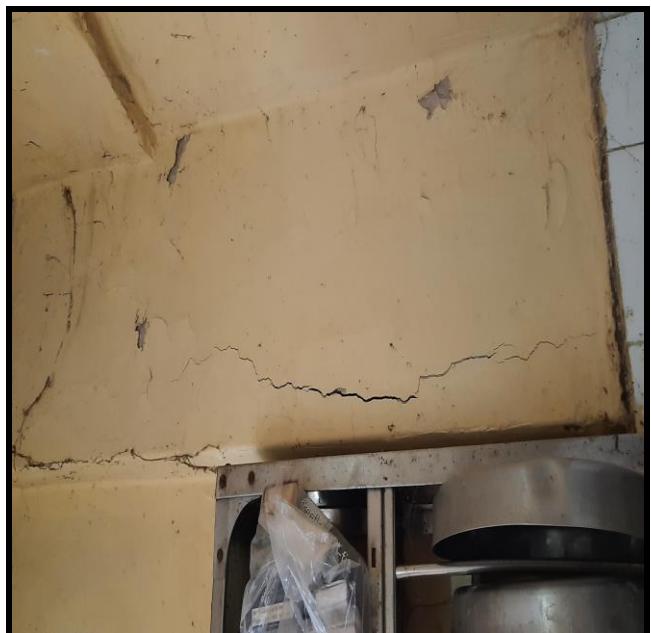
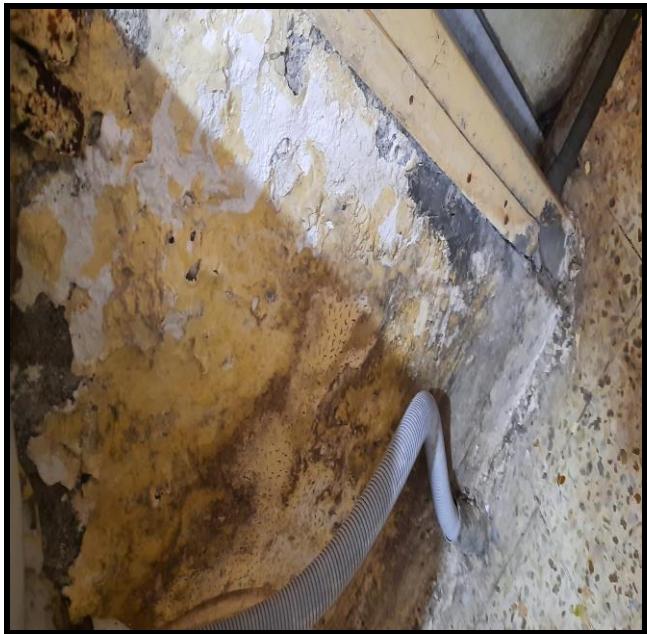
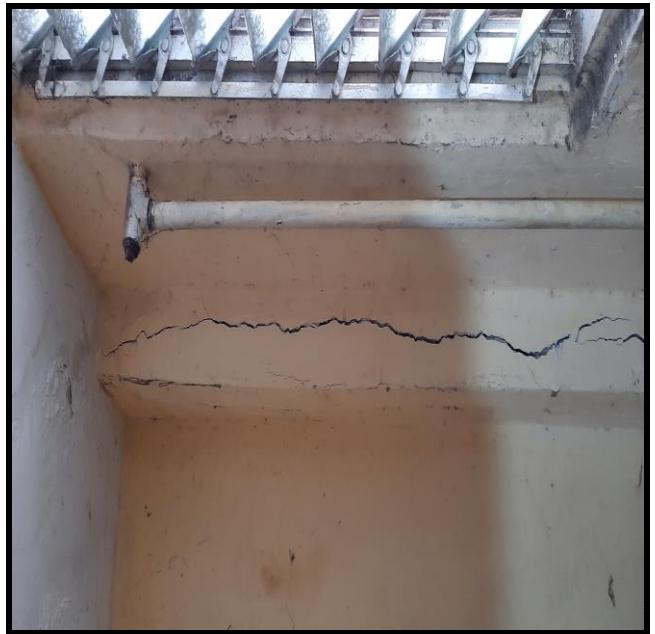
FLAT NO – 09

- ❖ **HALL** – O.K.
- ❖ **KITCHEN** – Leakage mark observed on wall.
 - Structural crack observed on column.
- ❖ **PASSAGE** – O.K.
- ❖ **TOILET & BATH ROOM** – Structural crack observed on column.

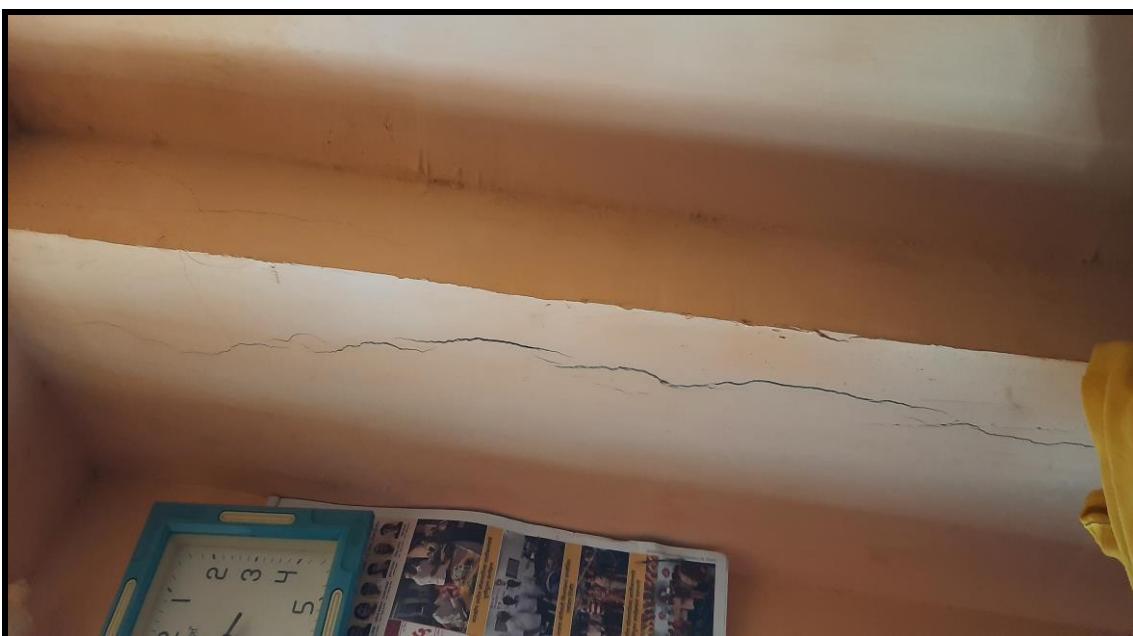
FLAT NO – 14

- ❖ **HALL** – O.K.
- ❖ **KITCHEN** – Structural crack observed on column.
 - Leakage observed on ceiling in monsoon.
- ❖ **PASSAGE** – O.K.
- ❖ **TOILET & BATH ROOM** – O.K.

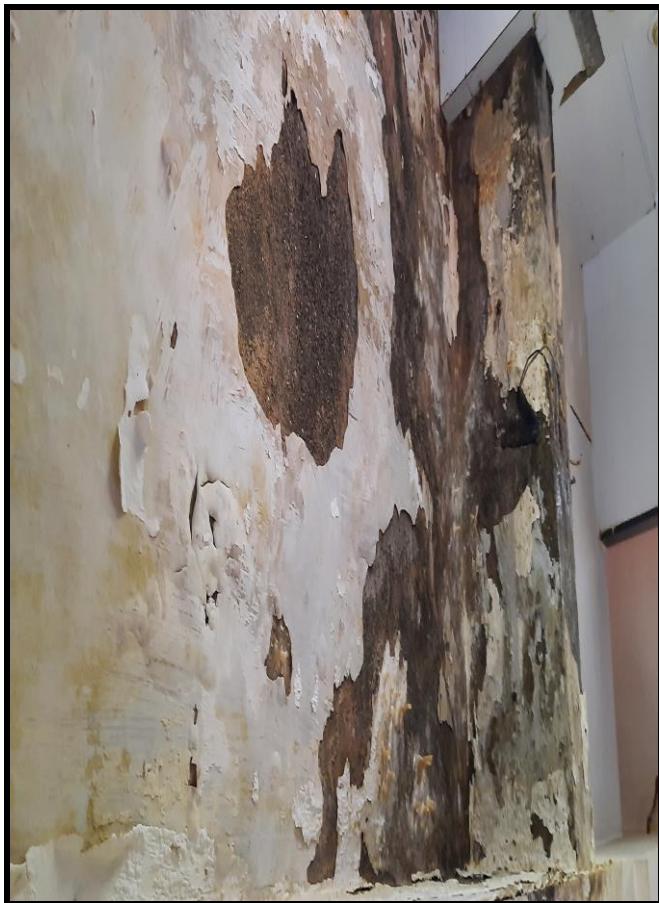
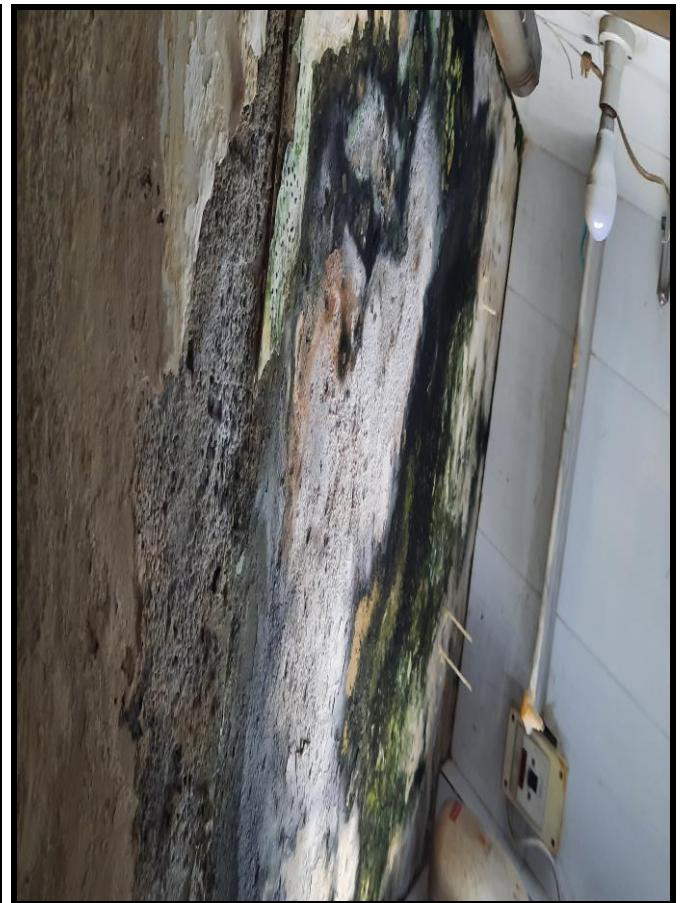
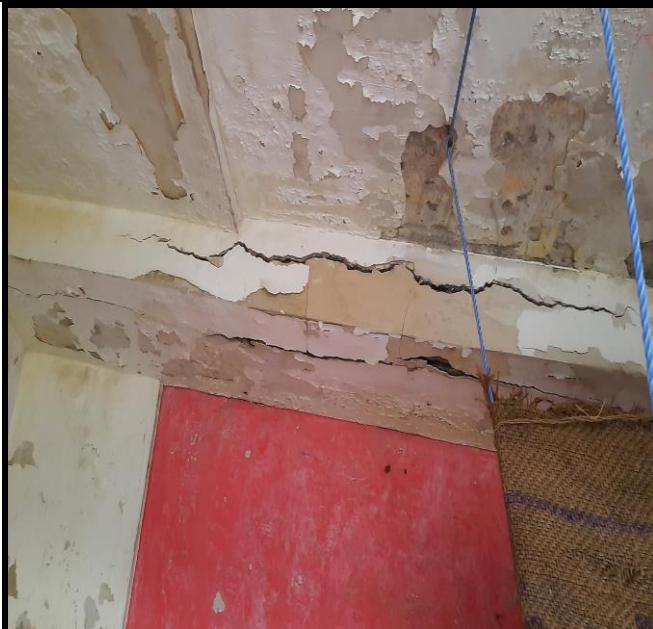
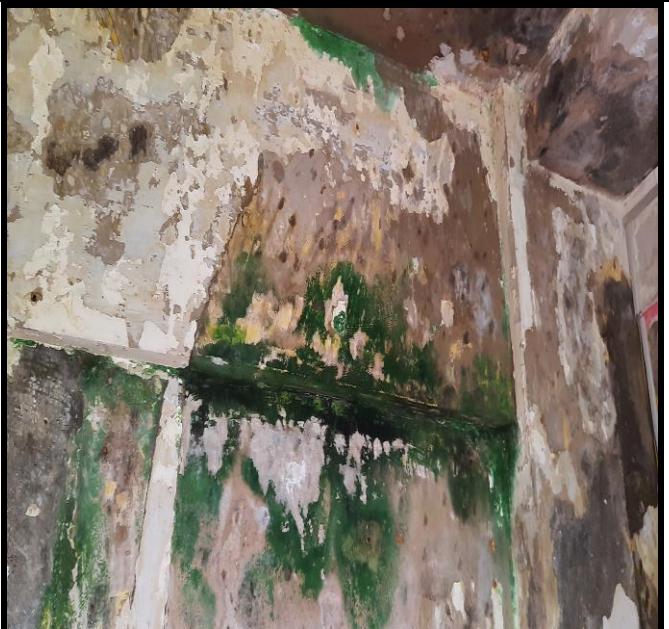
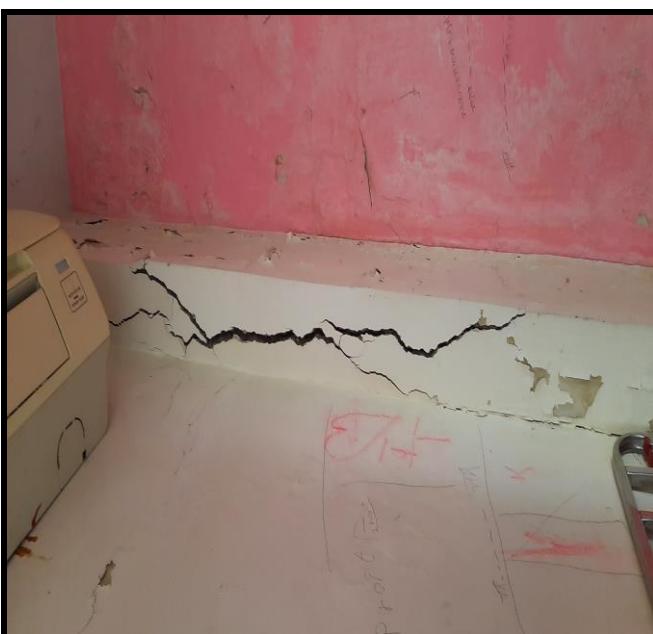
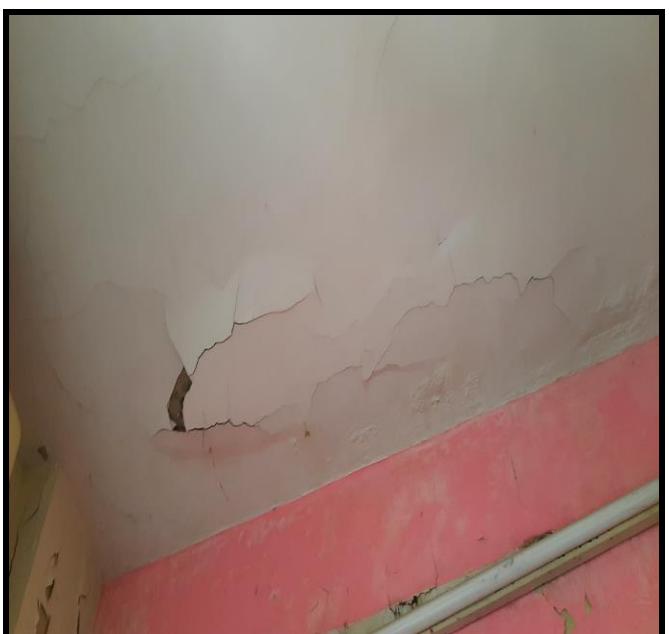
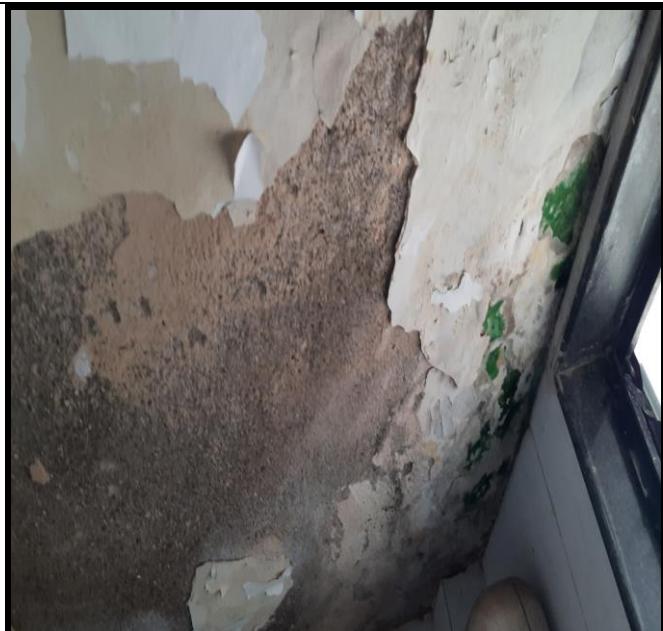
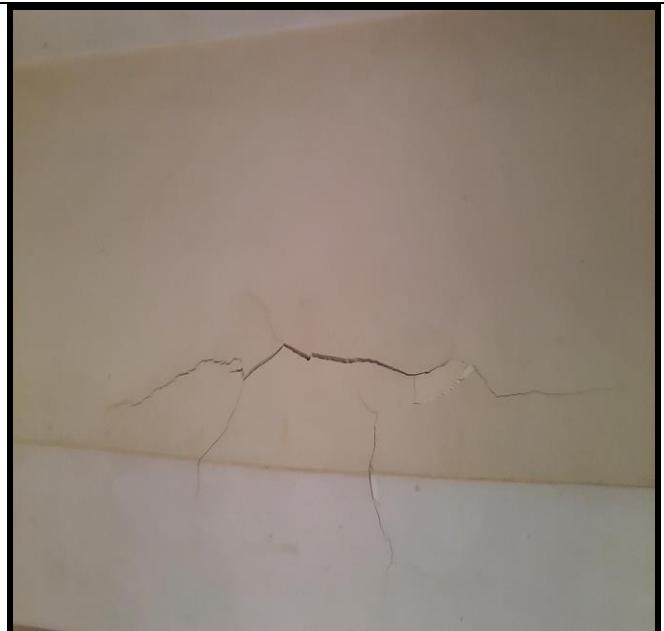
FLAT NO – 17 & 18

- ❖ **HALL** – O.K.
- ❖ **KITCHEN** – Leakage observed on ceiling.
 - Structural crack observed on beam.
- ❖ **BED ROOM NO. 01** – Structural crack observed on column.
 - Leakage mark observed on wall & ceiling.
 - Algae observed on wall.
- ❖ **BED ROOM NO. 02** – Structural crack observed on column & ceiling.
 - Leakage observed on wall in monsoon.
- ❖ **PASSAGE** – O.K.
- ❖ **TOILET & BATH ROOM** – Leakage mark observed on ceiling.
 - Algae observed on wall.

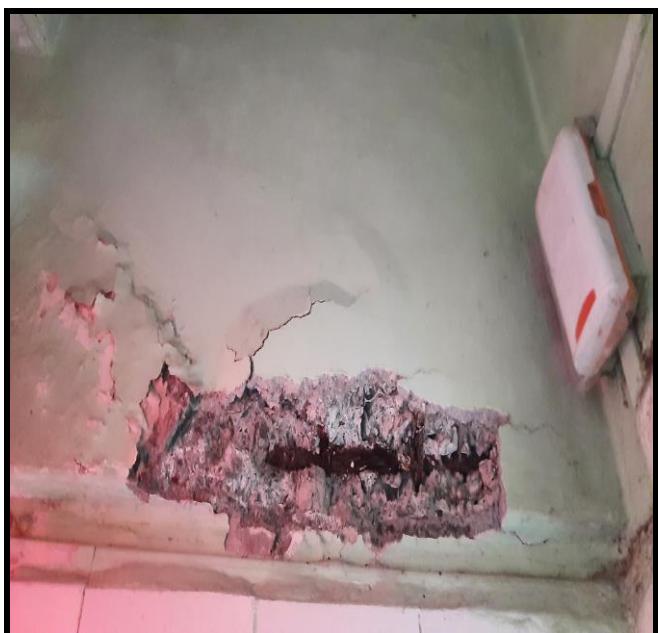
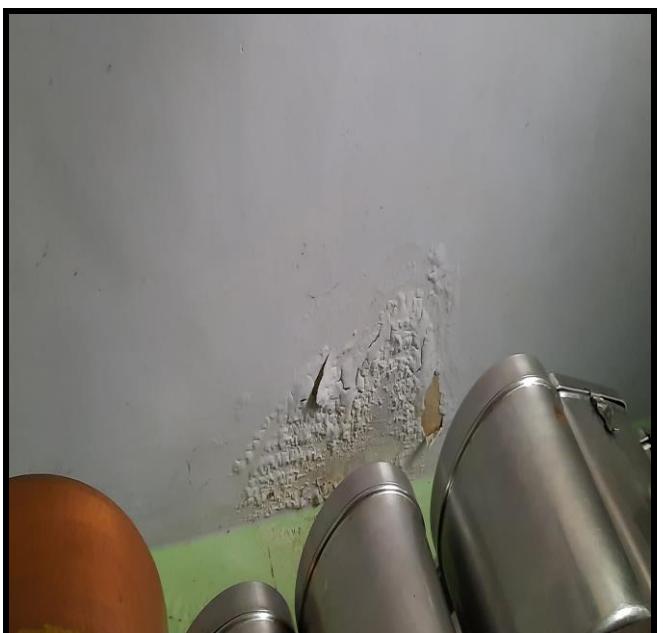
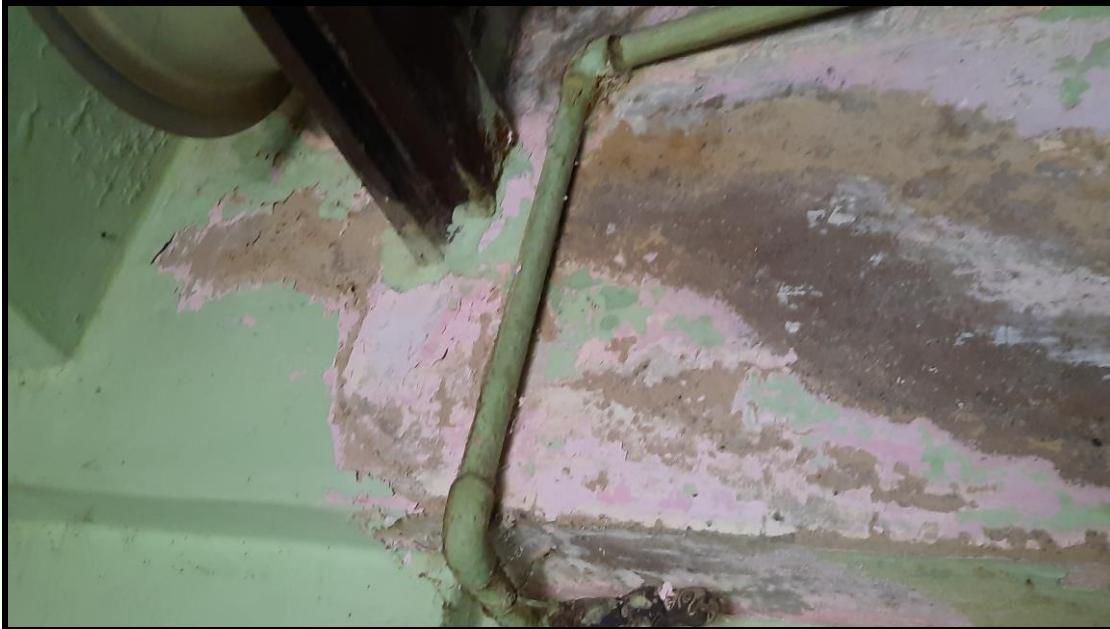
FLAT NO – 20

- ❖ **HALL** – O.K.
- ❖ **KITCHEN** – Leakage mark observed on ceiling.
- ❖ **PASSAGE** – Beam plaster get damaged & steel get exposed & corroded.
- ❖ **TOILET & BATH ROOM** – Leakage mark observed on ceiling.

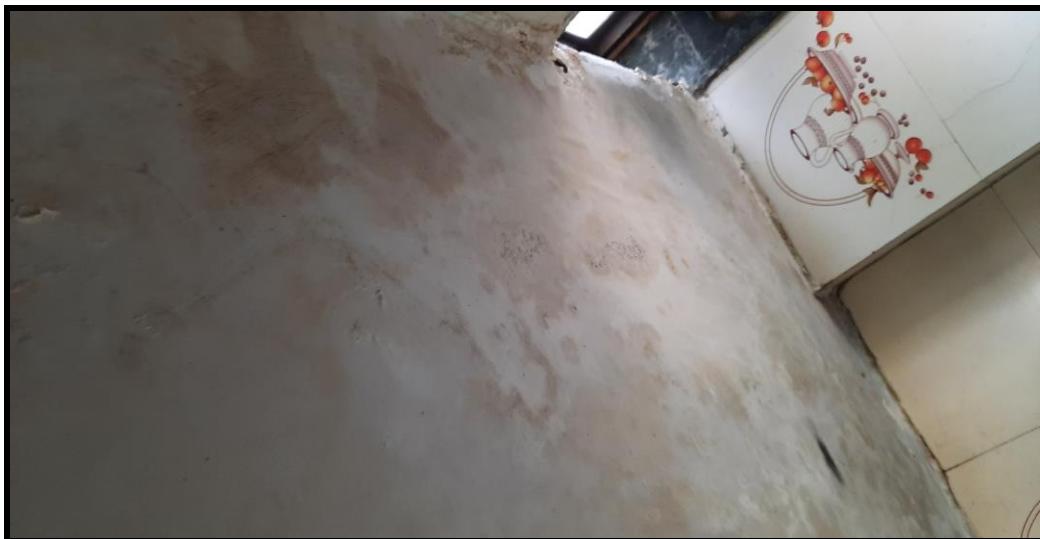
FLAT NO – 22

- ❖ **HALL** – O.K.
- ❖ **KITCHEN** – Leakage observed on ceiling in monsoon.
- ❖ **PASSAGE** – O.K.
- ❖ **TOILET & BATH ROOM** – Leakage observed on ceiling in monsoon.

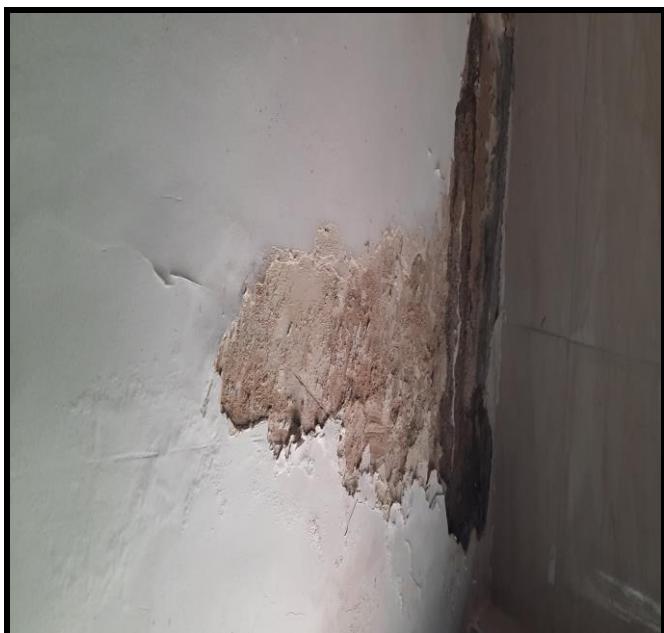
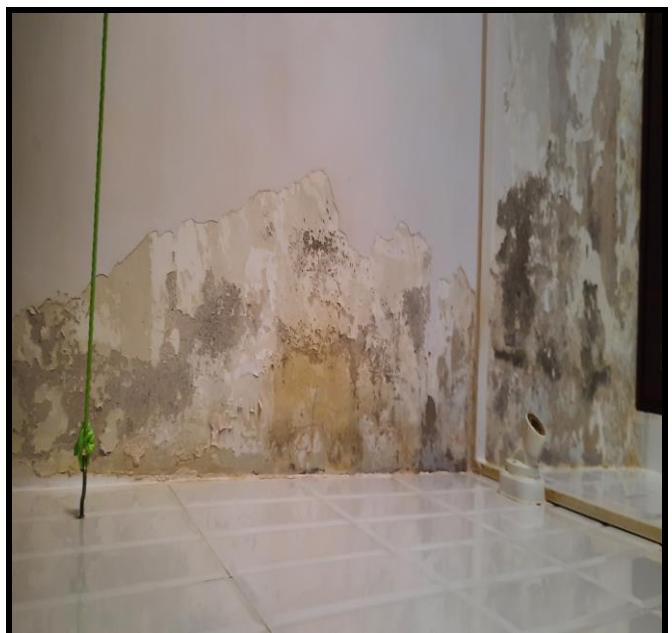
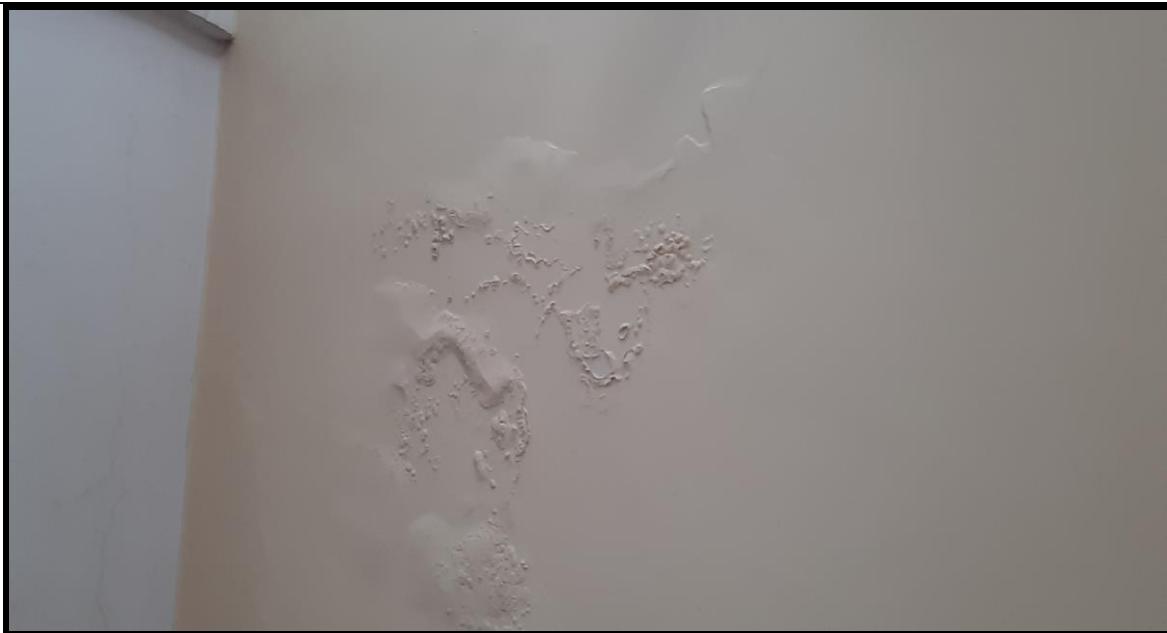
FLAT NO – 24

- ❖ **HALL** – Leakage mark observed on wall.
- ❖ **KITCHEN** – Leakage mark observed on wall.
- ❖ **PASSAGE** – O.K.
- ❖ **TOILET & BATH ROOM** – Leakage mark observed on ceiling.

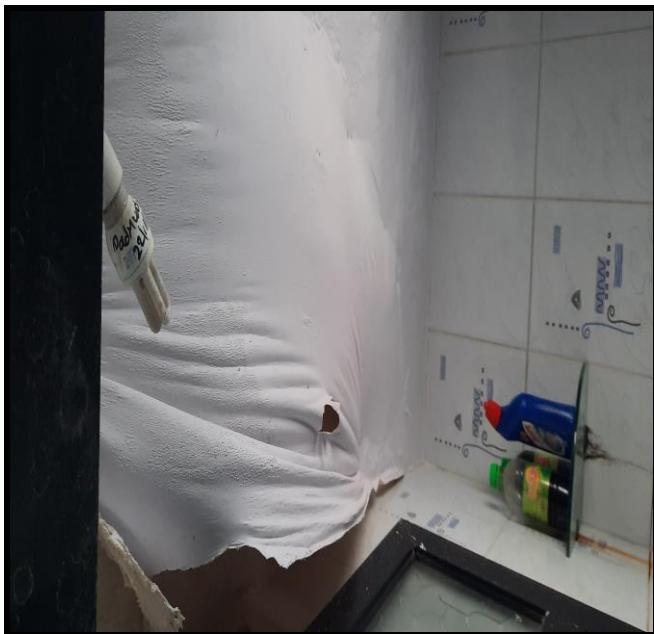
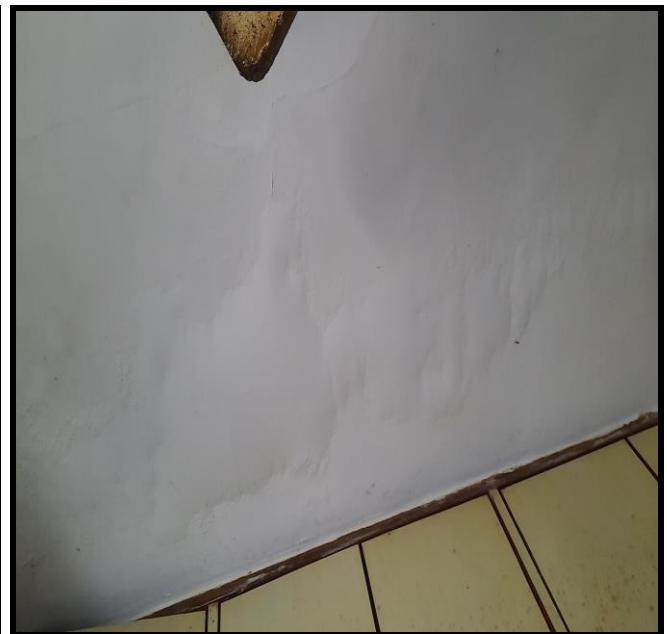
FLAT NO – 25

- ❖ **HALL** – O.K.
- ❖ **KITCHEN** – Leakage mark observed on ceiling.
- ❖ **PASSAGE** – O.K.
- ❖ **TOILET & BATH ROOM** – Leakage mark observed on ceiling.

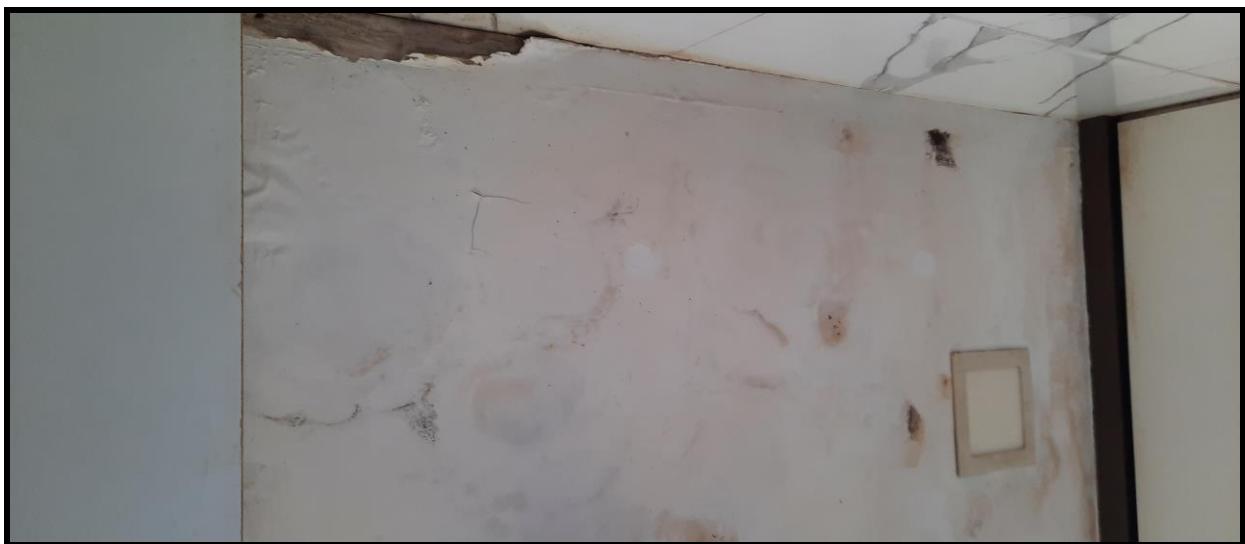
FLAT NO – 27

- ❖ **HALL** – Leakage mark observed on wall.
- ❖ **KITCHEN** – Leakage mark observed on ceiling.
- ❖ **PASSAGE** – O.K.
- ❖ **TOILET & BATH ROOM** – O.K.

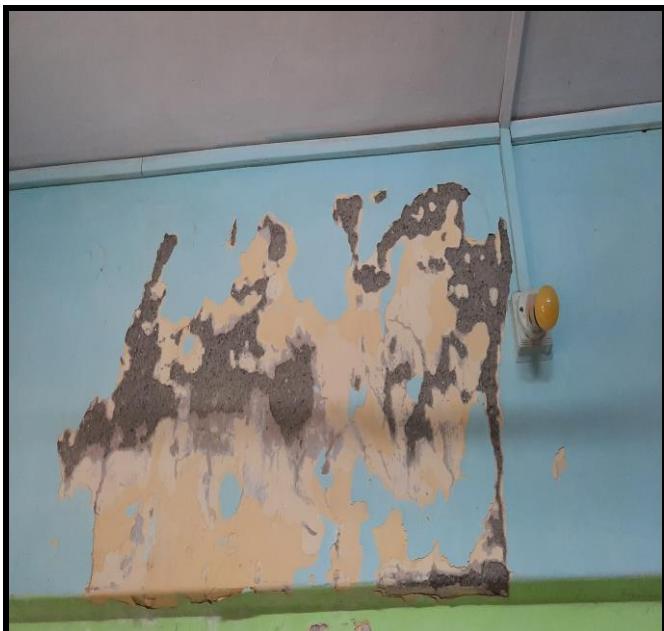
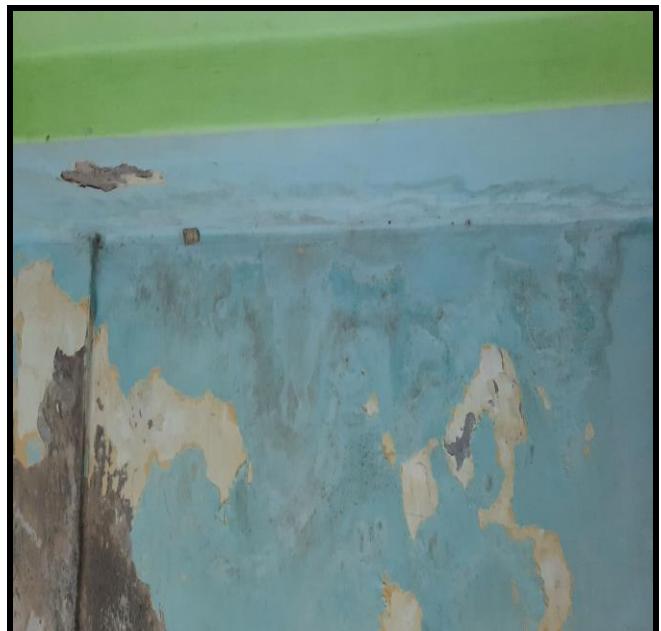
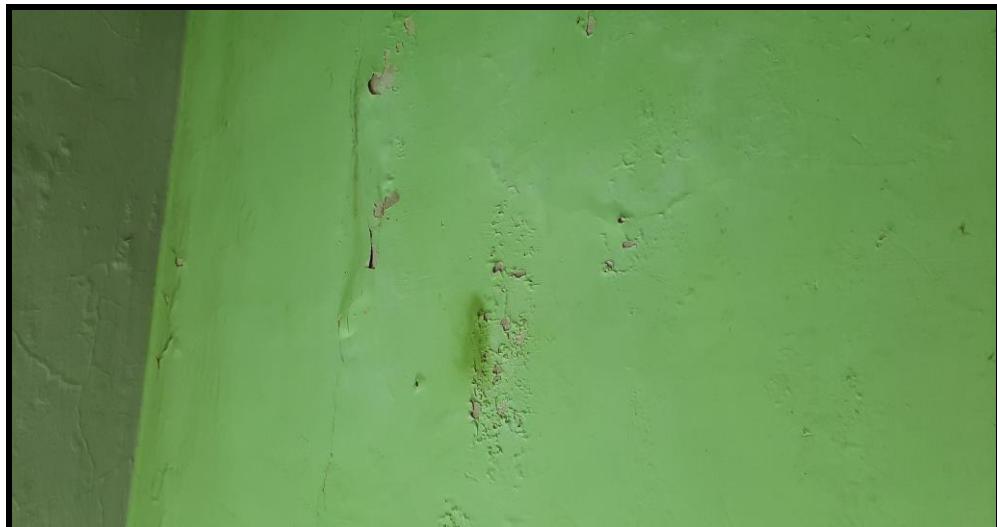
FLAT NO – 32

- ❖ **HALL** – Leakage mark observed on wall.
- ❖ **KITCHEN** – Leakage mark observed on wall.
- ❖ **PASSAGE** – O.K.
- ❖ **TOILET & BATH ROOM** – O.K.

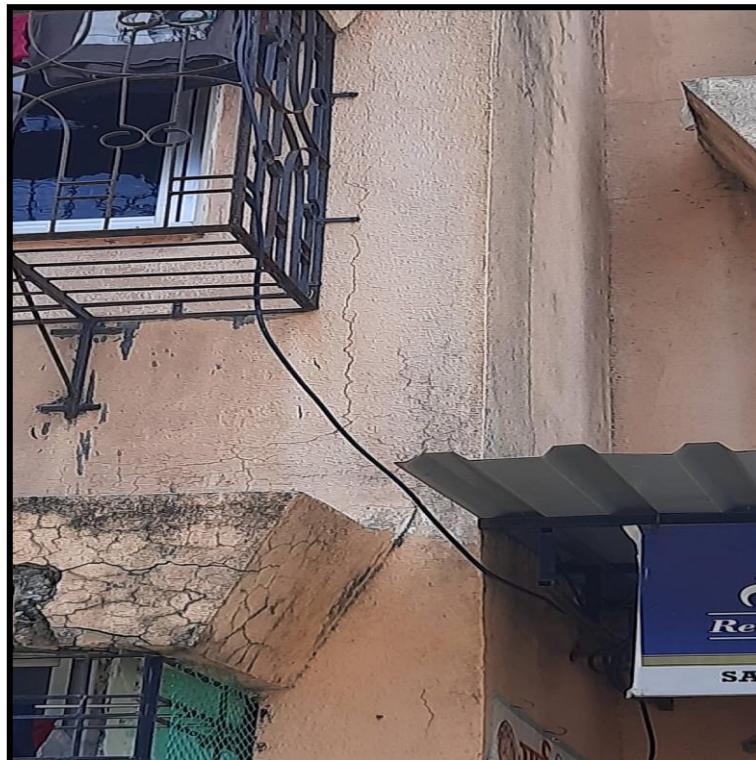
FRONT SIDE

- ❖ Structural crack observed on column.
- ❖ Algae observed at several places on wall.
