STRUCTURAL AUDIT REPORT
FOR
“VISHAL SAHYADRI CO – OP HSG. SOC. LTD”,
“D3 – B WING”
SITUATED AT
SAHYADRI NAGAR, CHARKOP,
KANDIVALI (W) MUMBAI – 400 067

PREPARED BY
LATESH S. SANKLECHA
CONSULTING STRUCTURAL ENGINEERS

"Vishal Sahyadri Co – Operative Housing Soc. Ltd", "D3 – B WING" Regi. No. BOM/HSG/5697/1979 Situated at Sahyadri Nagar, Charkop, Kandivali (W) Mumbai – 400 067 had requested to **Latesh S. Sanklecha, Consulting Structural Engineer** to inspect the structures.

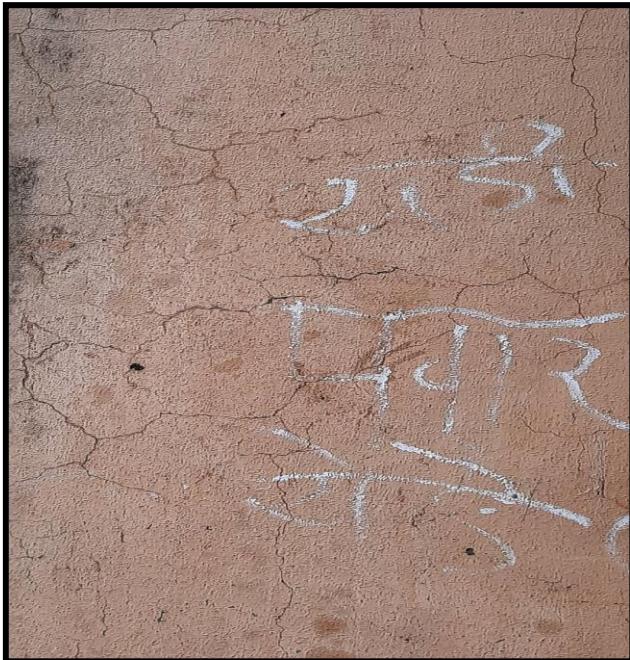
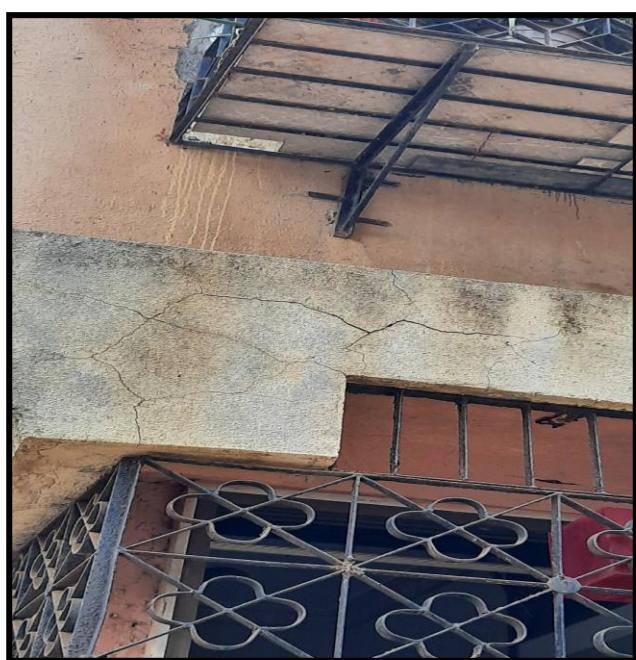
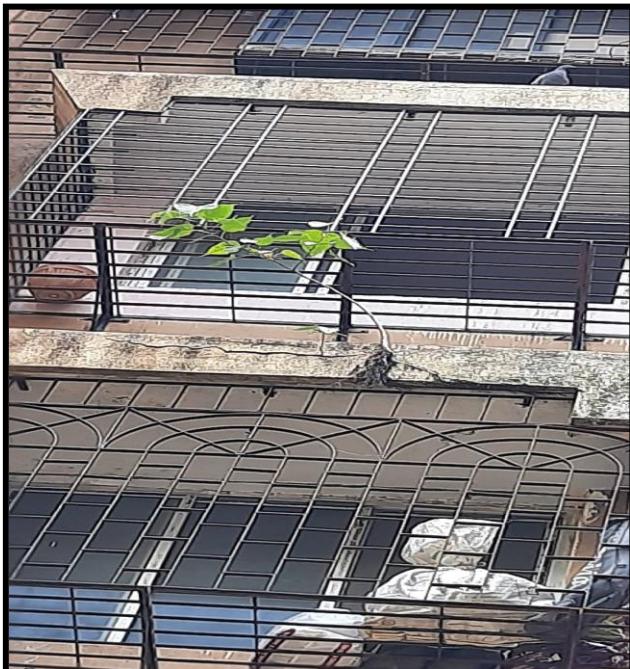
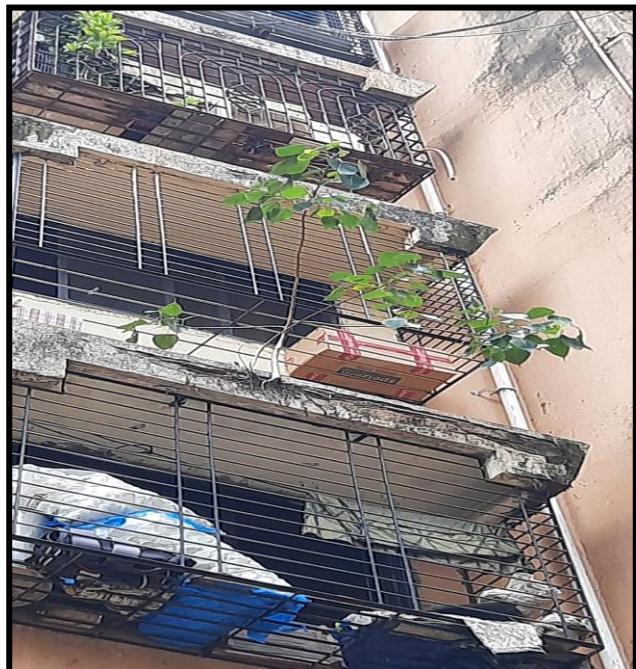
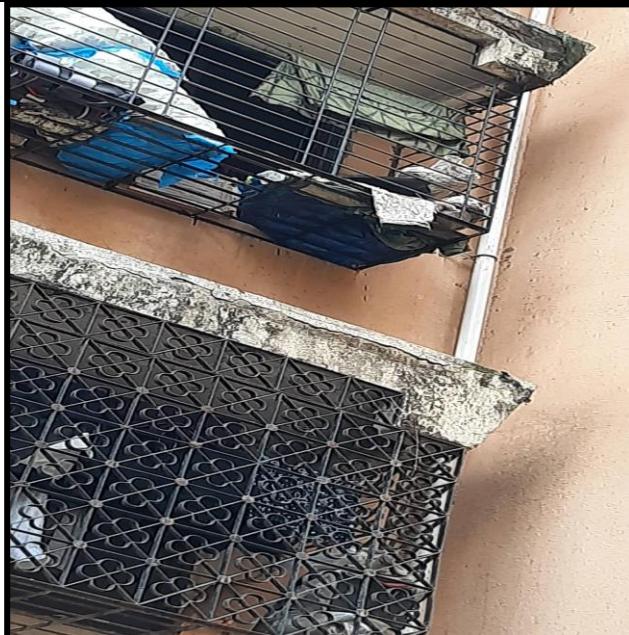
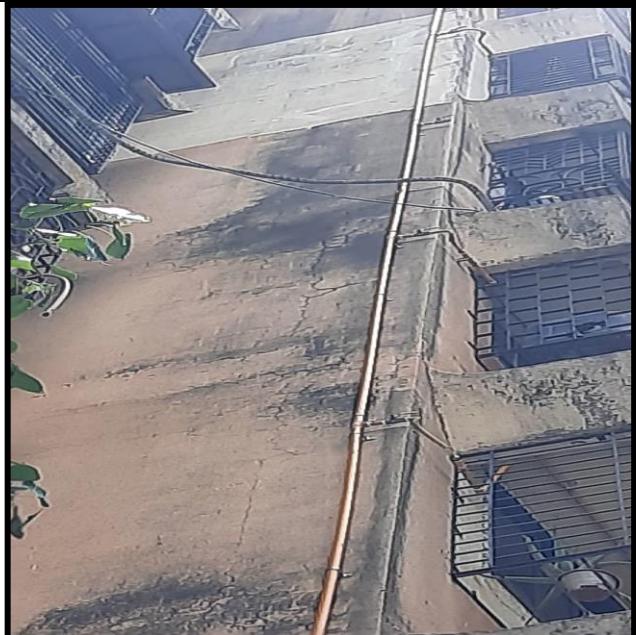
BACK SIDE

- ❖ Structural crack observed at several places on column & chajjas.
- ❖ Vegetation growth observed at several places on chajjas.

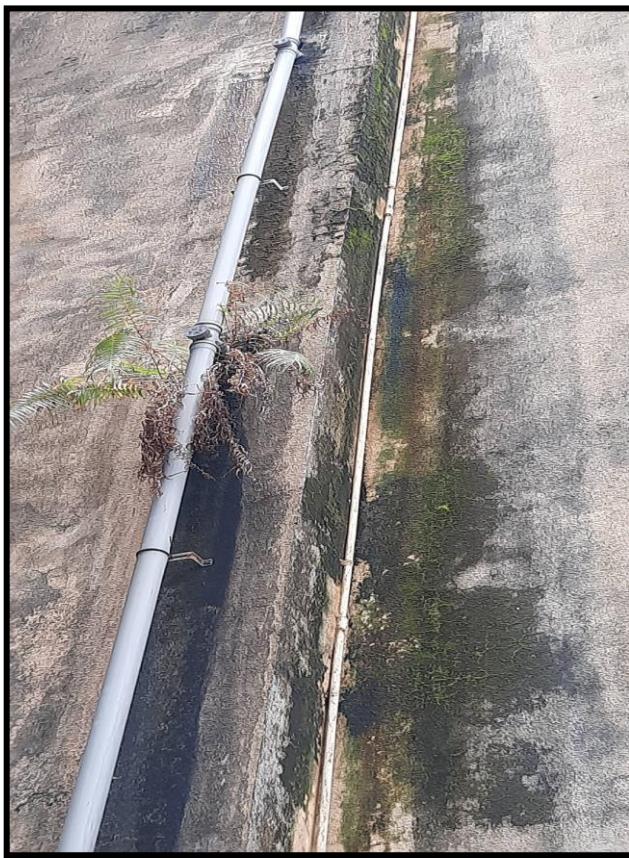
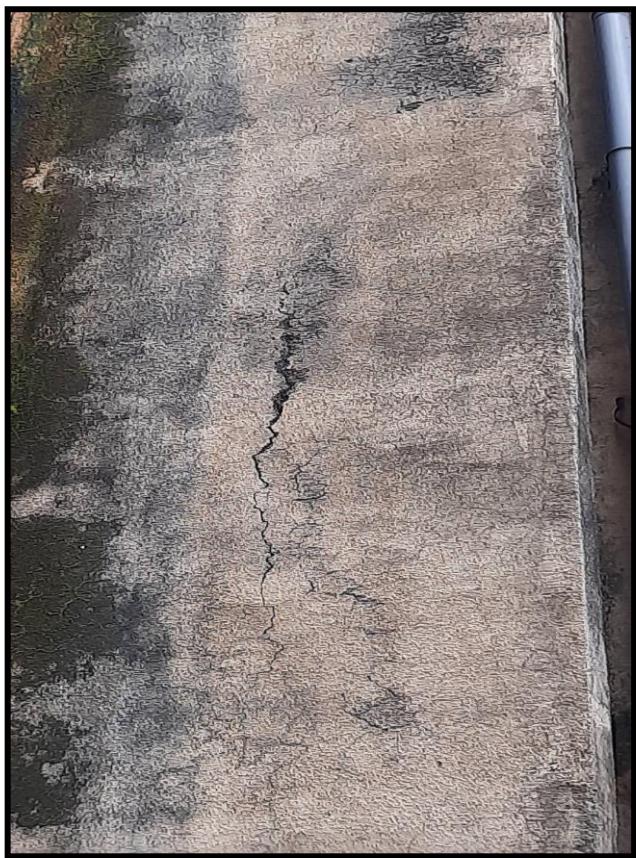
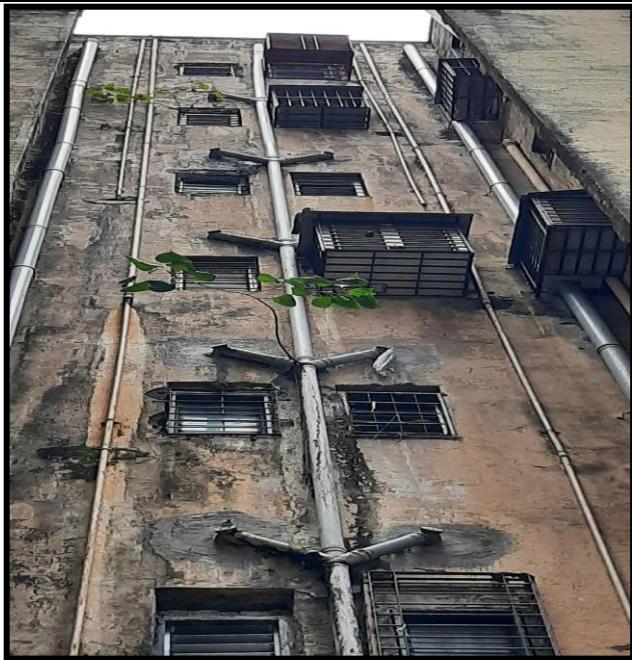
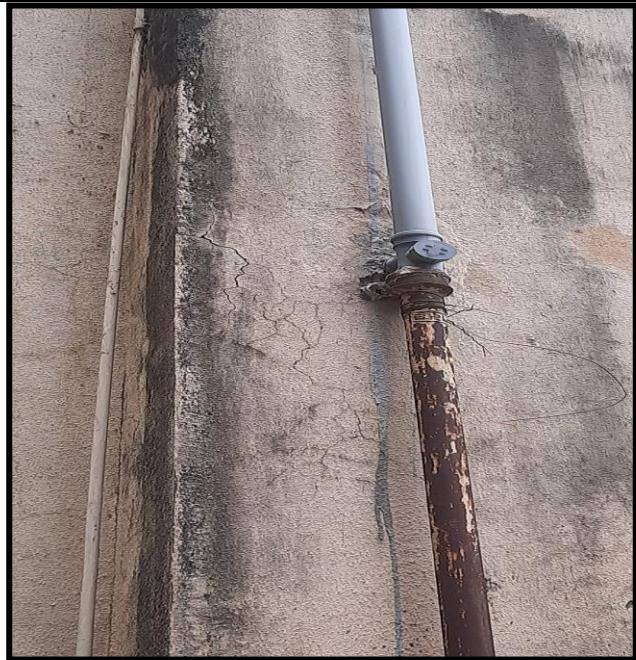
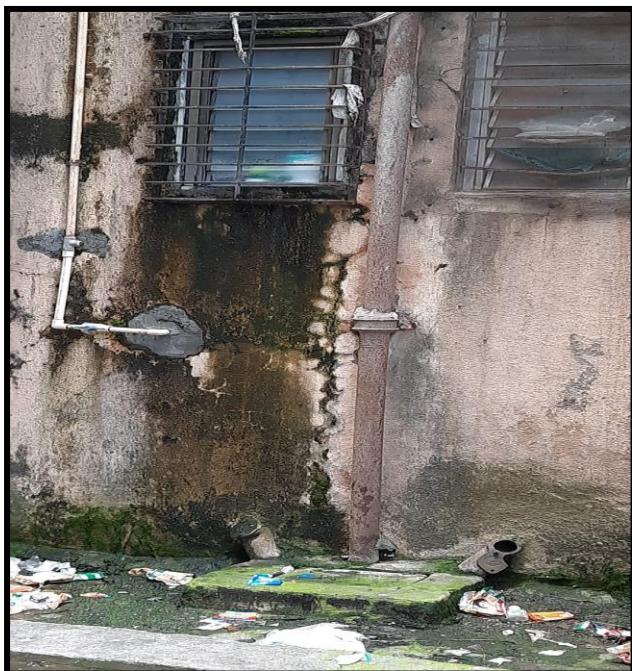
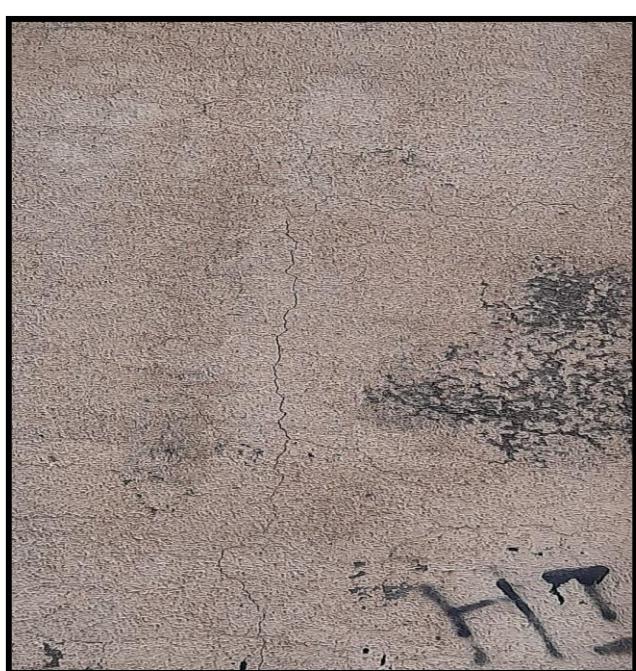
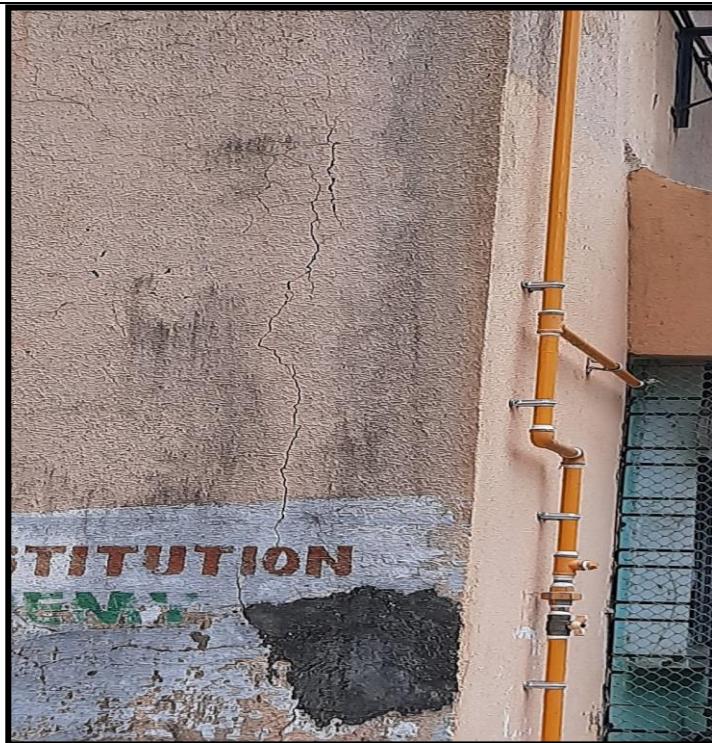
NORTH SIDE

- ❖ Structural crack observed at several places on column.
- ❖ Vegetation growth observed at several places on wall.
- ❖ Algae observed at several places on wall.

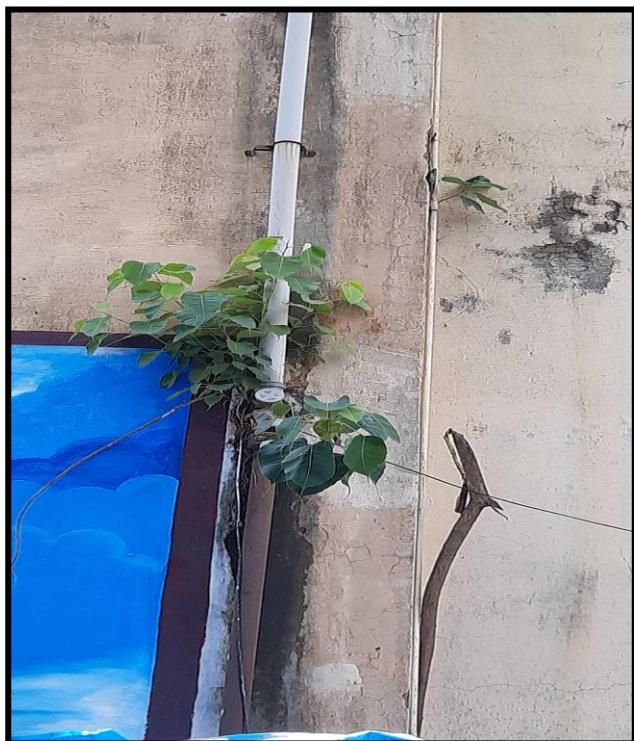
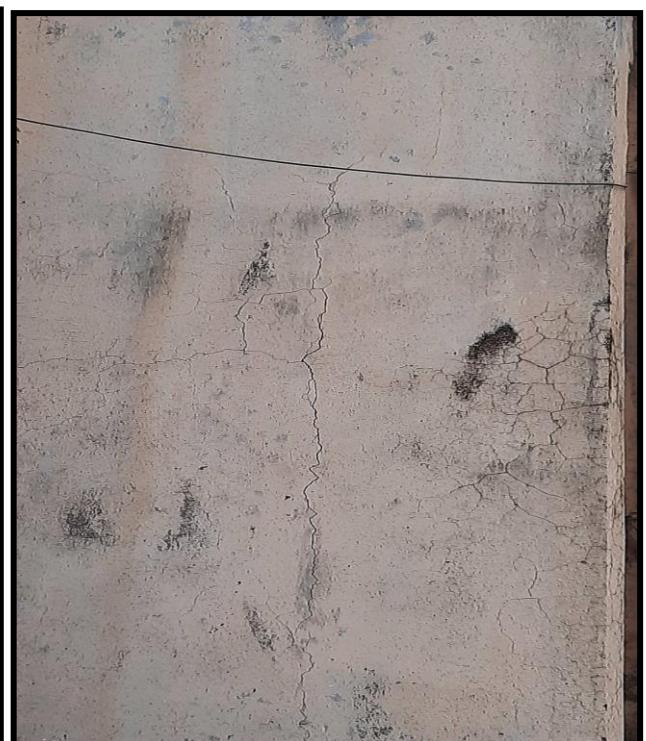
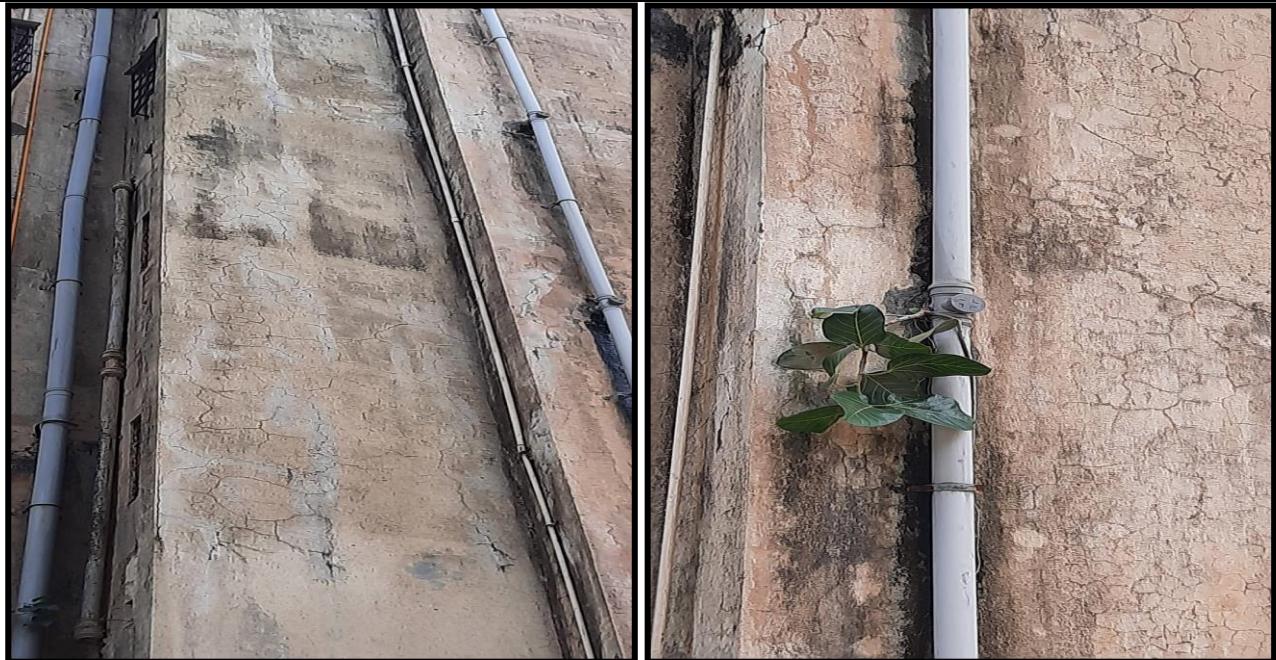
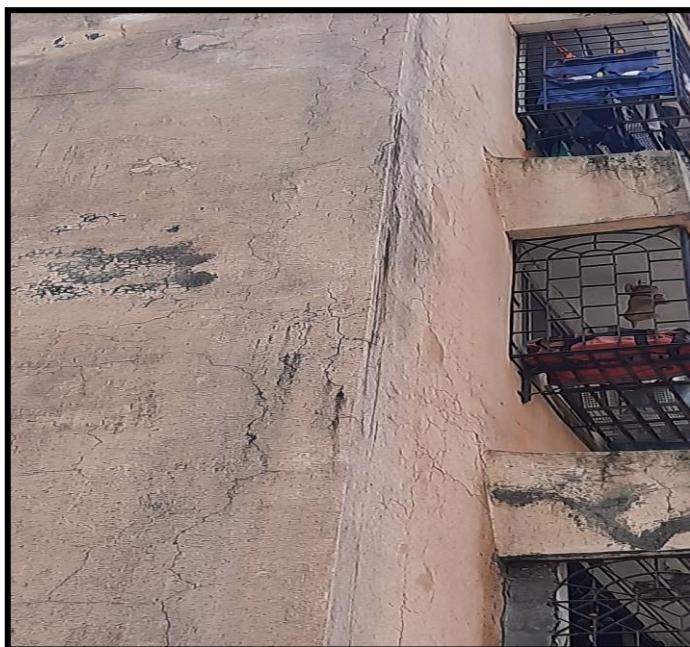
SOIUTH SIDE

- ❖ Structural crack observed at several places on column & chajjas.
- ❖ Major crack observed at several places on wall.
- ❖ Vegetation growth observed at several places on wall.
