STRUCTURAL AUDIT REPORT  
FOR  
**“VISHAL SAHYADRI CO – OP HSG. SOC. LTD”,**  
**“C22 – WING”**  
SITUATED AT  
SAHYADRI NAGAR, CHARKOP,  
KANDIVALI (W) MUMBAI – 400 067

978/B1/LSS/2021

JUNE 24, 2021

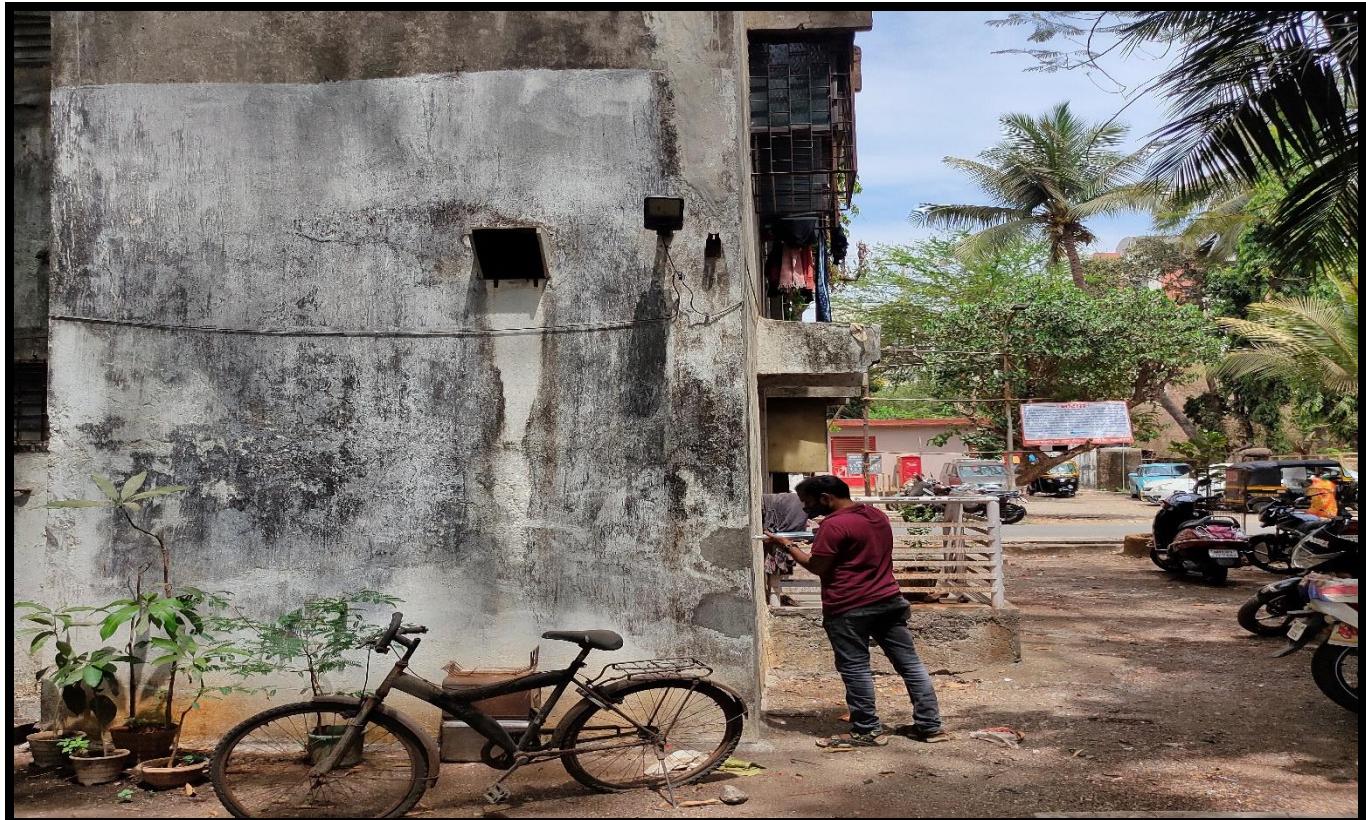
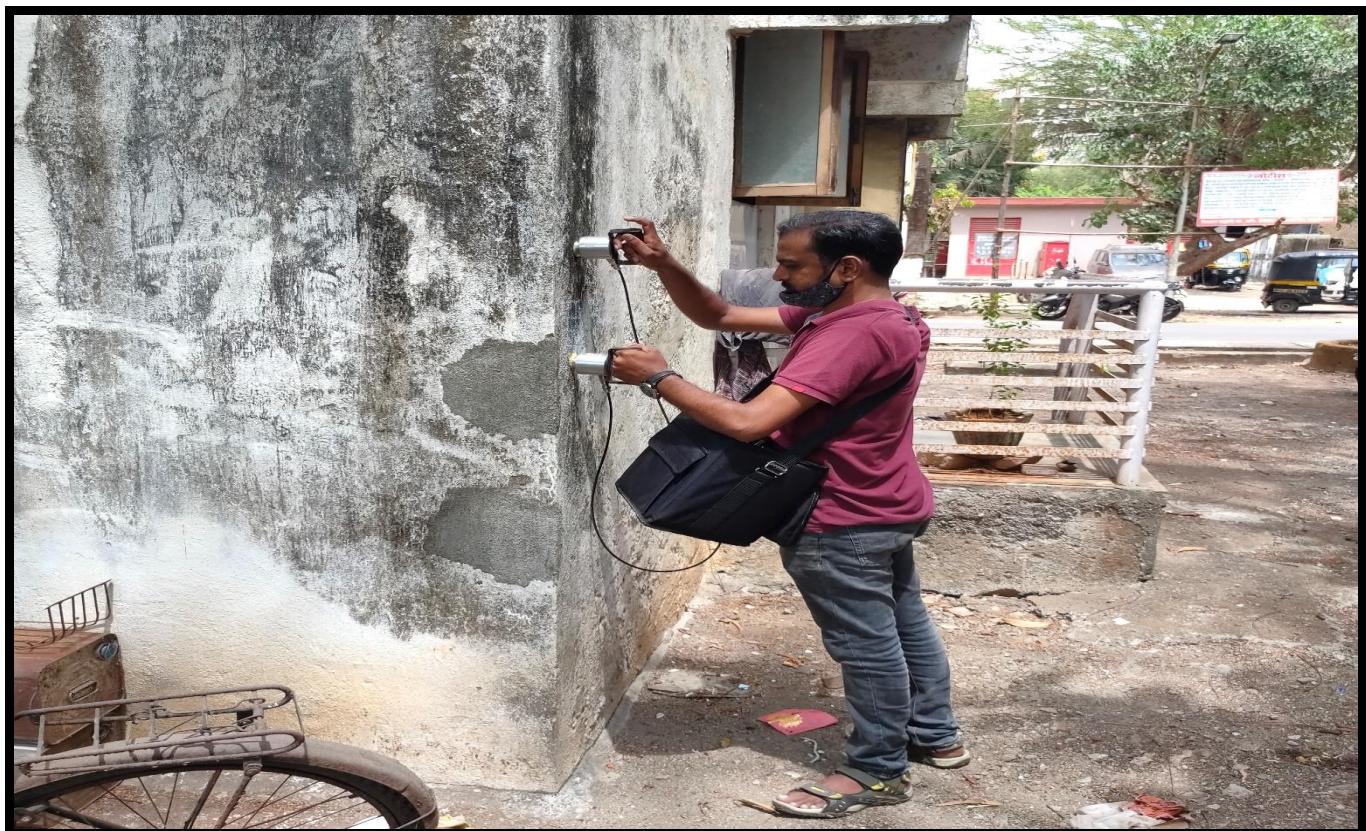
## NON -DESTRUCTIVE TEST PHOTO

Half Cell Potential tested for corrosion activity by half – cell potential tests. Value is taken on Column. The result on tested column is – 401 mV.

This indicates the probability of corrosion is 90% on tested column steel reinforcement.

Carbonation test was conducted to assess carbonation depth. Readings are taken on Column. Result indicates the carbonation penetration depth is 40.00 mm. Carbonation depths have reached to the reinforcement level in all of the RCC elements. It is essential to give a suitable anti-corrosion treatment to all the RCC members to stop further carbonation and corrosion of concrete.

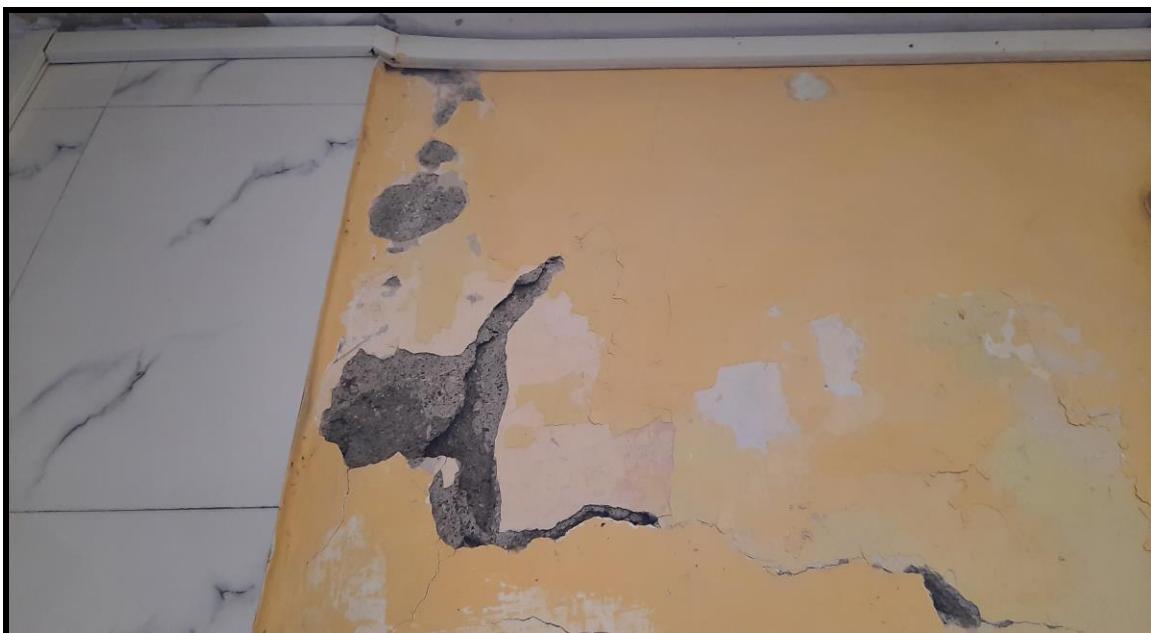
##### **FLAT NO – 02**

- ❖ **HALL** – Structural damage observed on beam.
  - Leakage observed on wall & ceiling in monsoon.
- ❖ **KITCHEN** – Leakage observed on ceiling in monsoon.
- ❖ **PASSAGE** – O.K.
- ❖ **TOILET & BATH ROOM** – O.K.

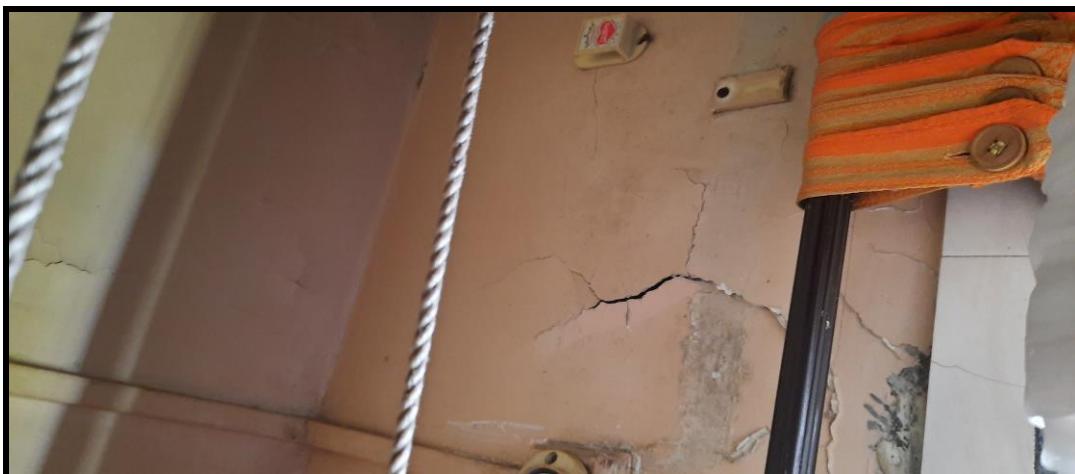
## FLAT NO – 04

- ❖ **HALL** – Structural crack observed on beam.
- ❖ **KITCHEN** – O.K.
- ❖ **PASSAGE** – O.K.
- ❖ **TOILET & BATH ROOM** – O.K.

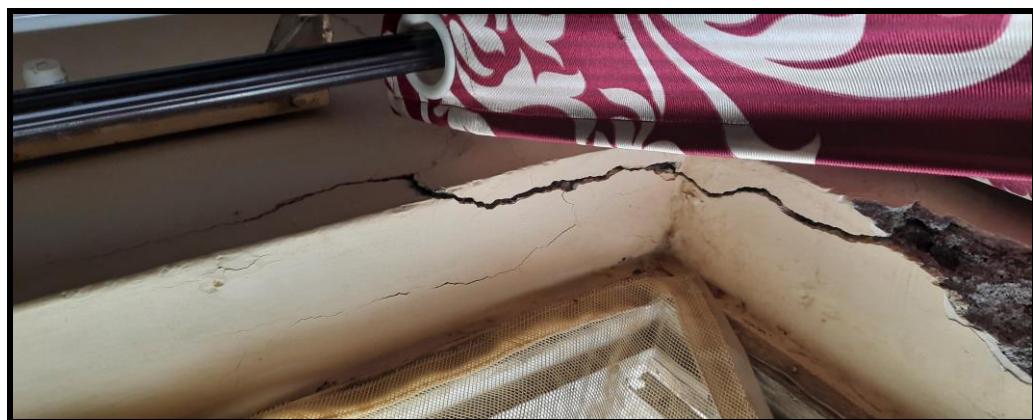
## FLAT NO – 07

- ❖ **HALL** – Structural crack observed on beam.
- ❖ **KITCHEN** – Leakage mark observed on ceiling.
  - Ceiling plaster get damaged & steel get exposed & corroded.
- ❖ **PASSAGE** – O.K.
- ❖ **TOILET & BATH ROOM** – O.K.

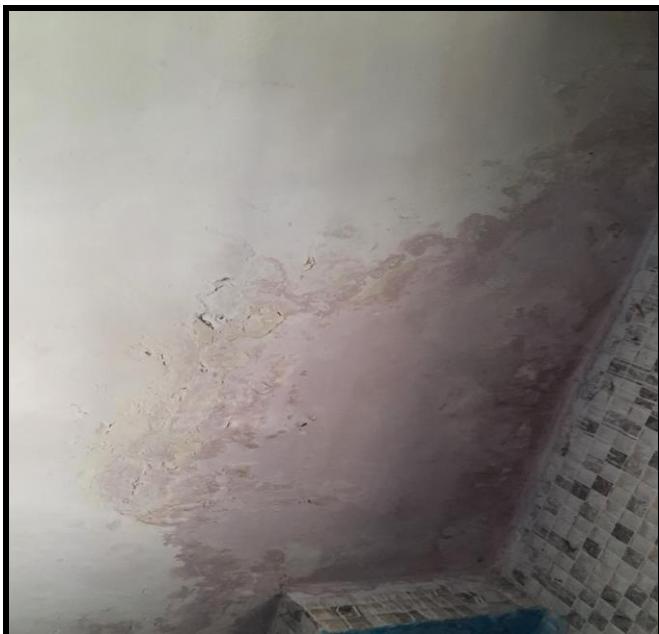
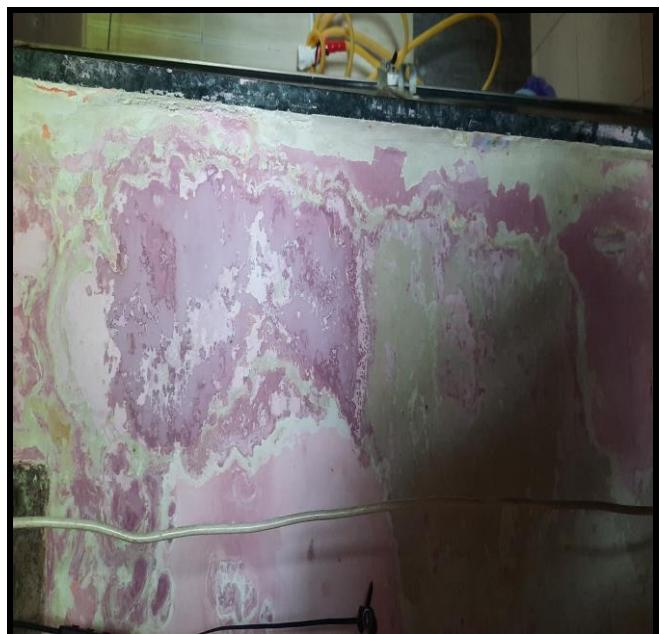
### FLAT NO – 10

- ❖ **HALL** – O.K.
- ❖ **KITCHEN** – Dampness observed on ceiling.
- ❖ **PASSAGE** – O.K.
- ❖ **TOILET & BATH ROOM** – O.K.

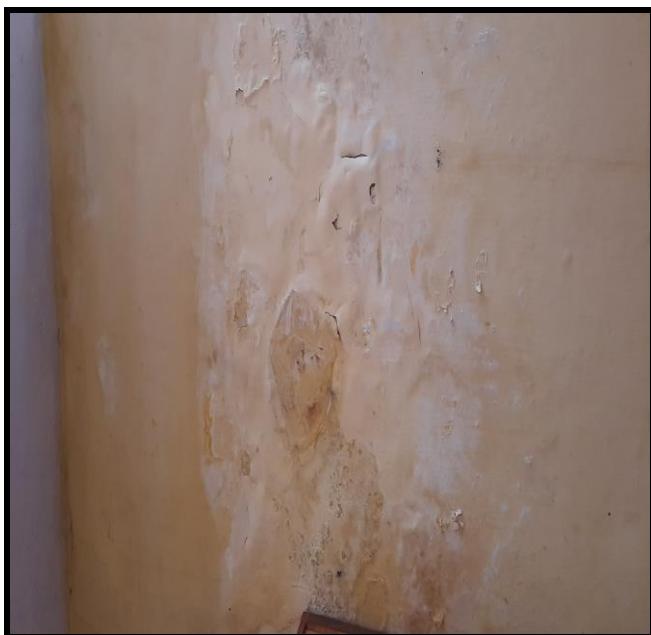
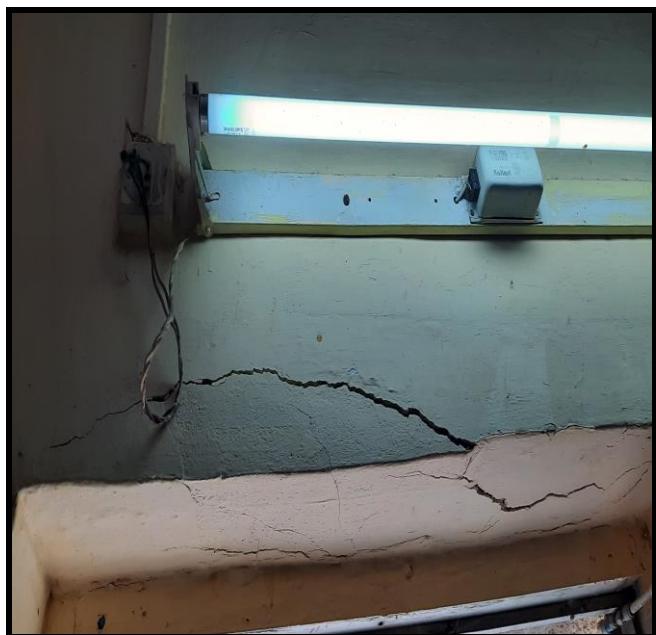
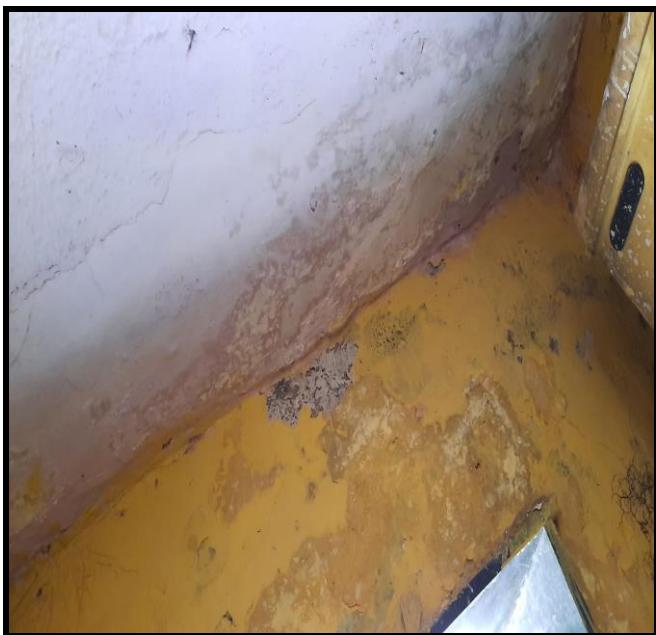
### FLAT NO – 17

- ❖ **HALL** – Leakage mark observed on wall.
  - Structural crack observed on beam.
- ❖ **KITCHEN** – Structural damage observed on beam.
  - Leakage mark observed on wall.
- ❖ **PASSAGE** – O.K.
- ❖ **TOILET & BATH ROOM** – Dampness observed on wall & ceiling.

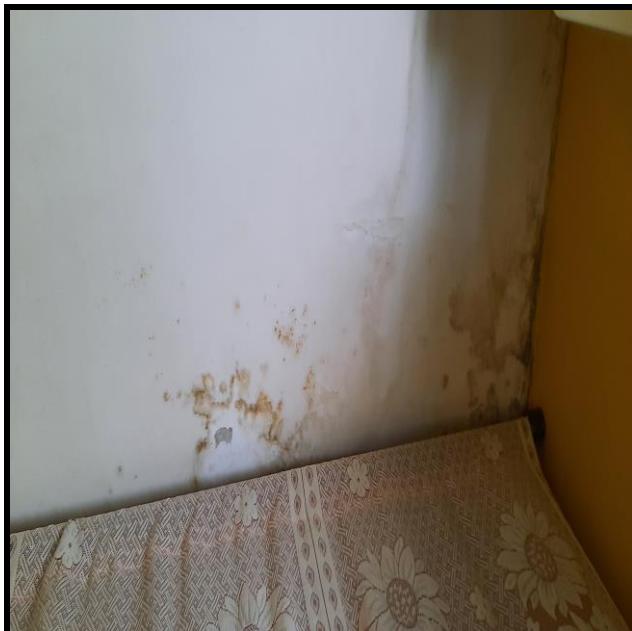
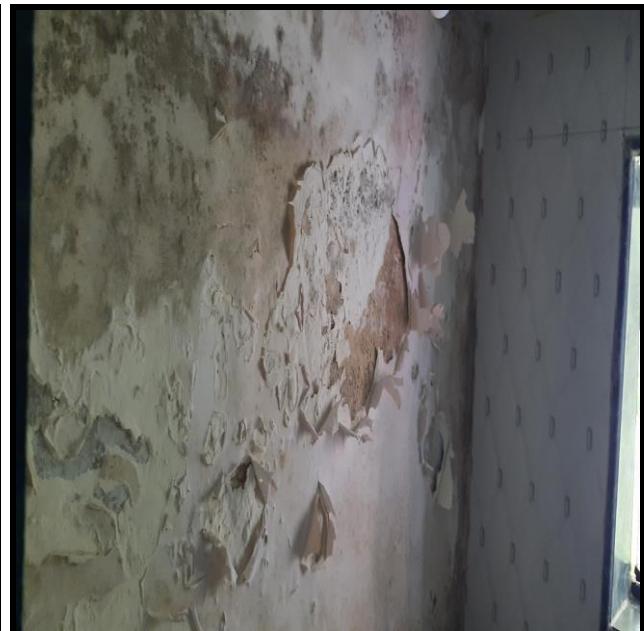
## FLAT NO – 20

- ❖ **HALL** – Leakage mark observed on ceiling.
- ❖ **KITCHEN** – Leakage mark observed on ceiling.
- ❖ **PASSAGE** – O.K.
- ❖ **TOILET & BATH ROOM** – Leakage mark observed on ceiling.

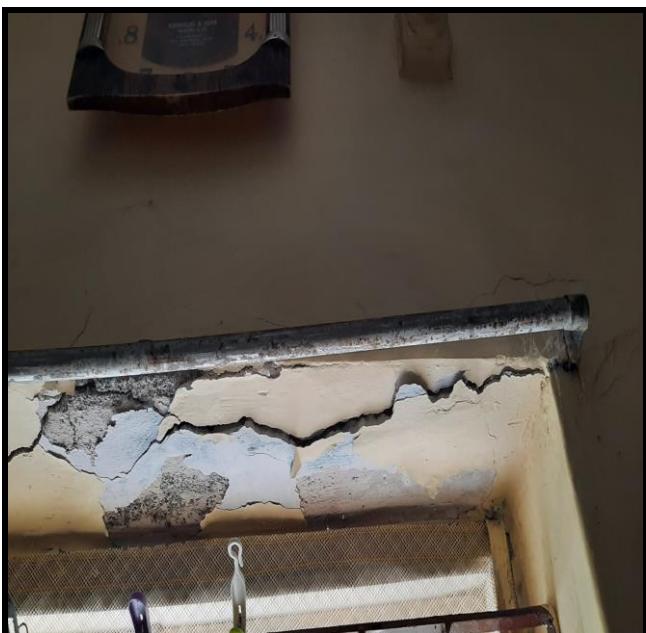
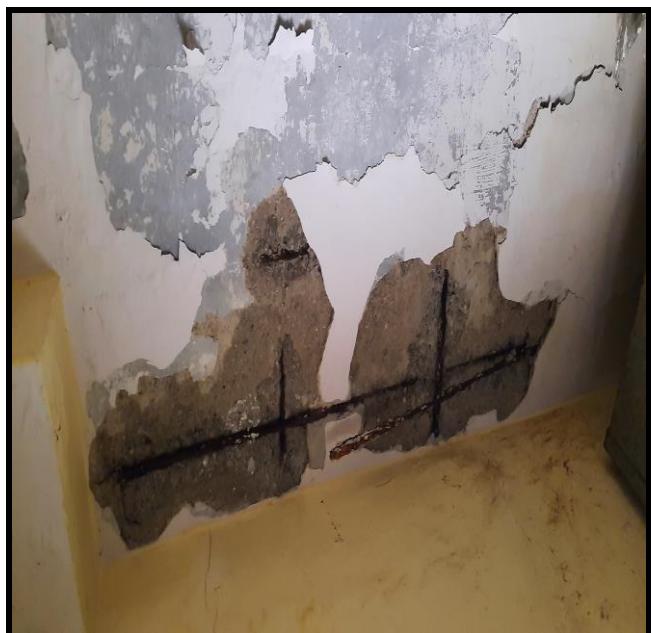
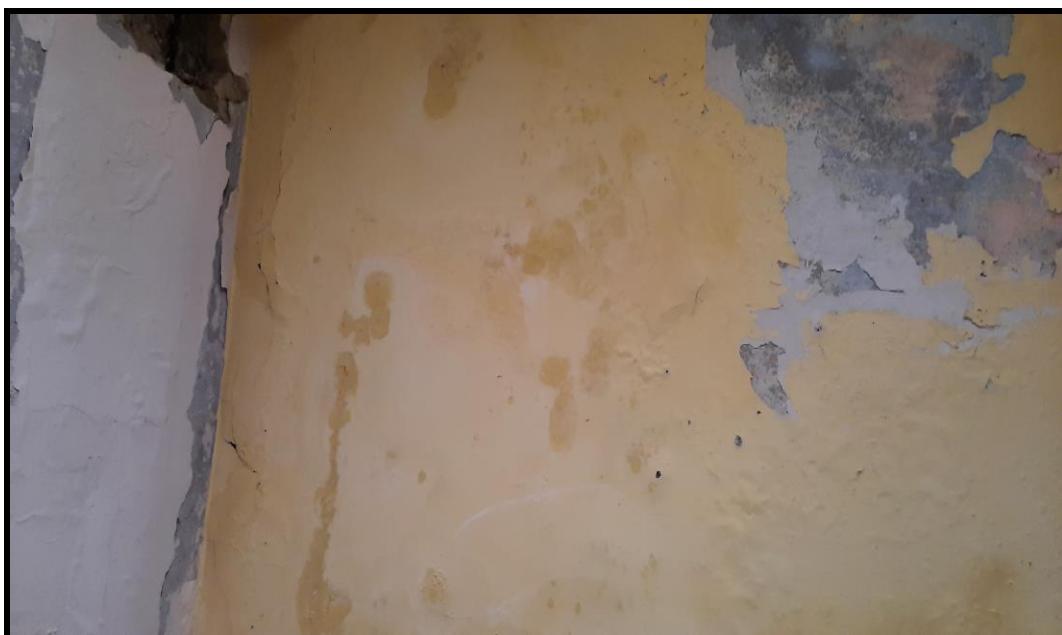
### FLAT NO – 26

- ❖ **HALL** – Structural crack observed on beam.
- ❖ **KITCHEN** – Leakage mark observed on wall.
  - Structural crack observed on beam.
  - Ceiling plaster get damaged & steel get exposed & corroded.
- ❖ **PASSAGE** – O.K.
- ❖ **TOILET & BATH ROOM** – O.K.

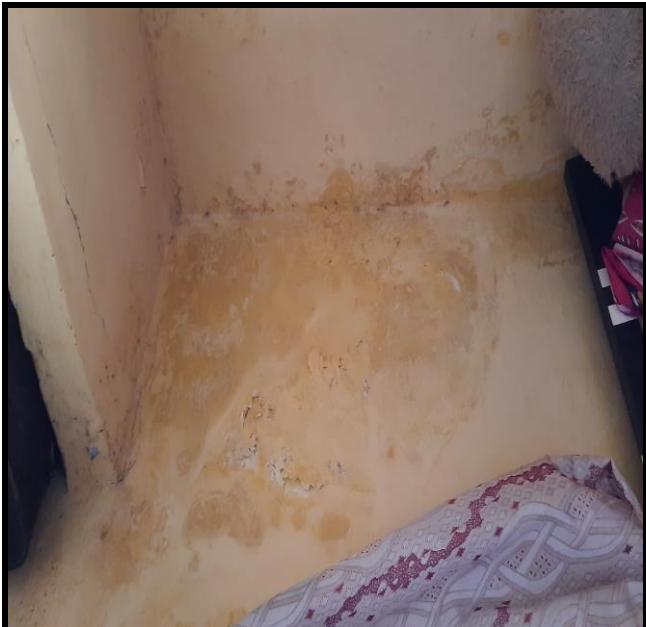
## FLAT NO – 27

- ❖ **HALL** – Leakage mark observed on wall.
- ❖ **KITCHEN** – Leakage mark observed on wall.
  - Structural crack observed on beam.
- ❖ **PASSAGE** – O.K.
- ❖ **TOILET & BATH ROOM** – Leakage mark observed on wall.

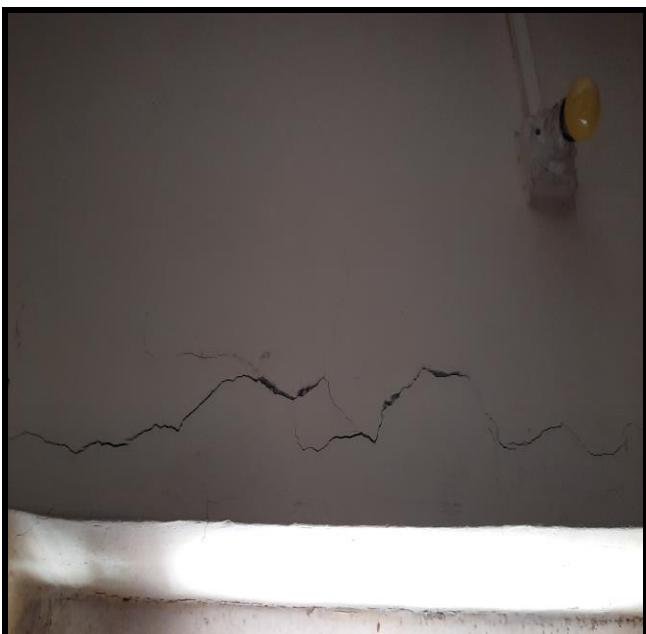
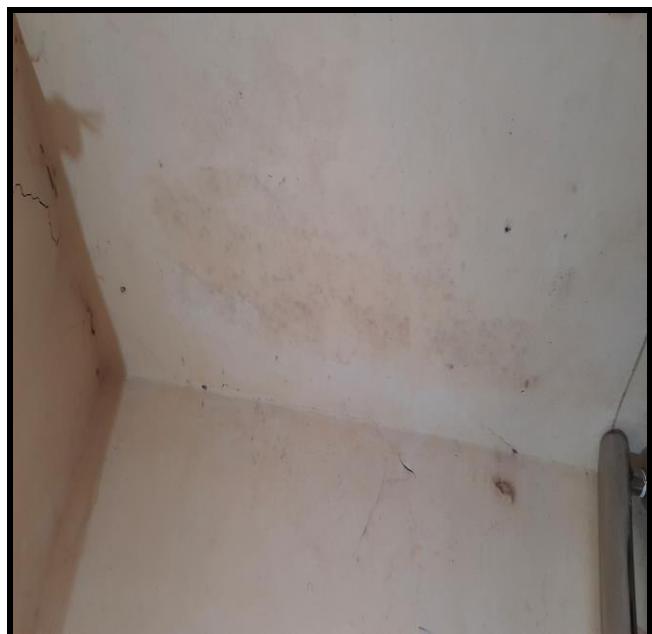
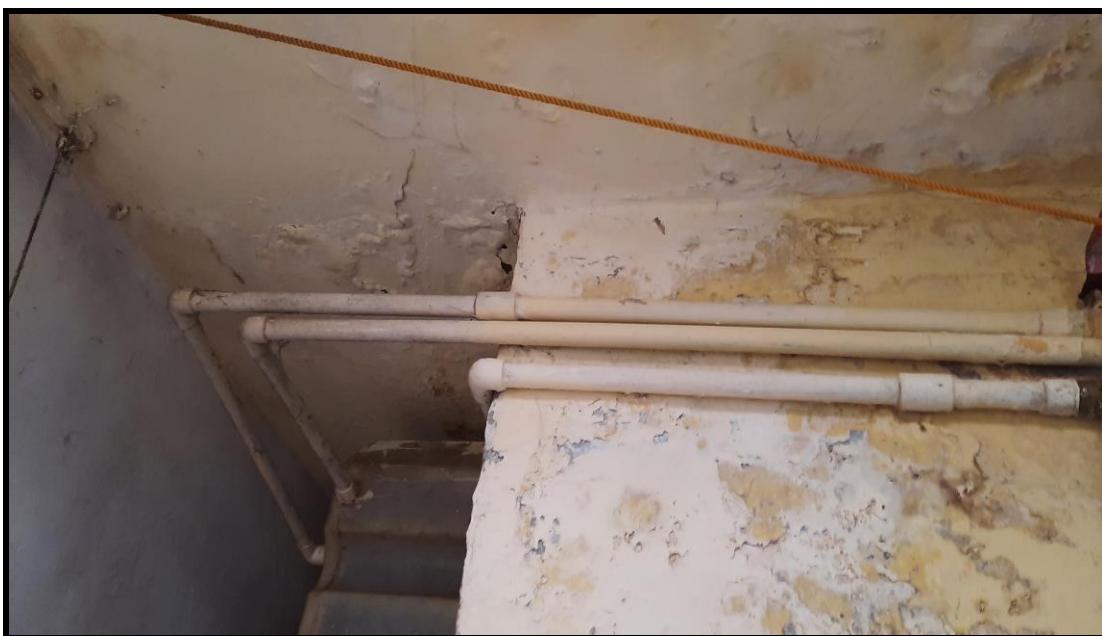
## FLAT NO – 30

- ❖ **HALL** – Leakage mark observed on wall.
  - Structural crack observed on beam.
- ❖ **KITCHEN** – Leakage mark observed on wall.
  - Structural crack observed on beam.
- ❖ **PASSAGE** – O.K.
- ❖ **TOILET & BATH ROOM** – O.K.

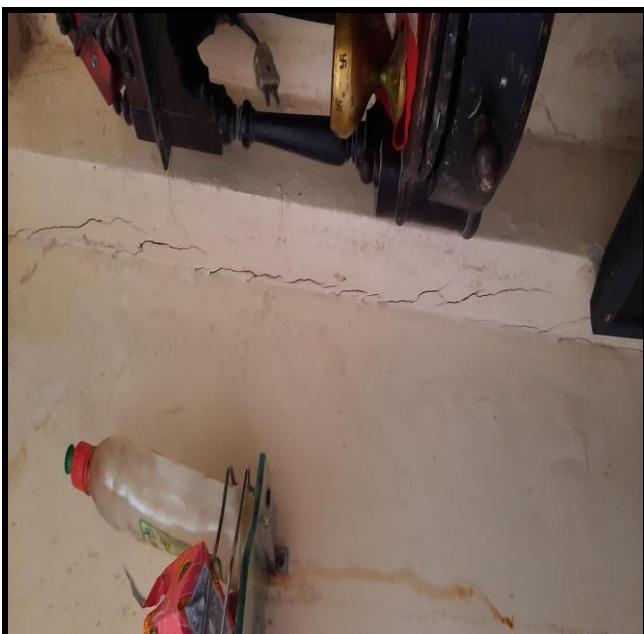
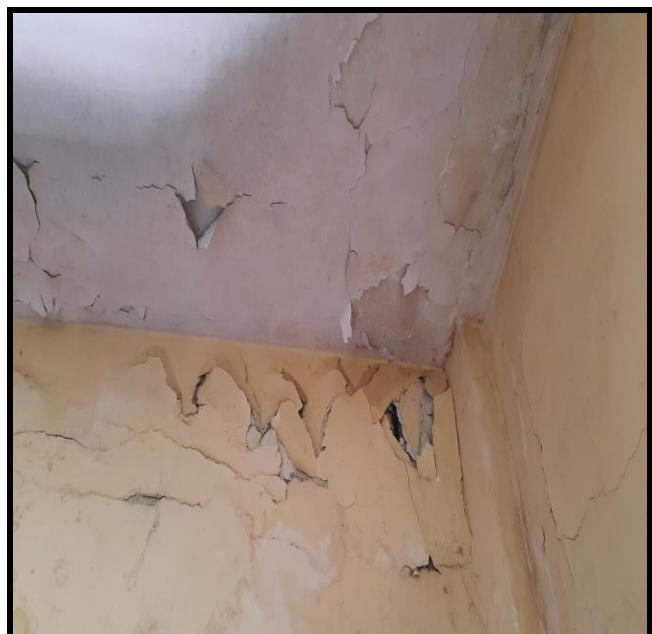
## FLAT NO – 32

- ❖ **HALL** – Structural crack observed on column.
  - Beam plaster get damaged & steel get exposed & corroded.
  - Leakage observed on wall & ceiling in monsoon.
- ❖ **KITCHEN** – O.K.
- ❖ **PASSAGE** – O.K.
- ❖ **TOILET & BATH ROOM** – O.K.

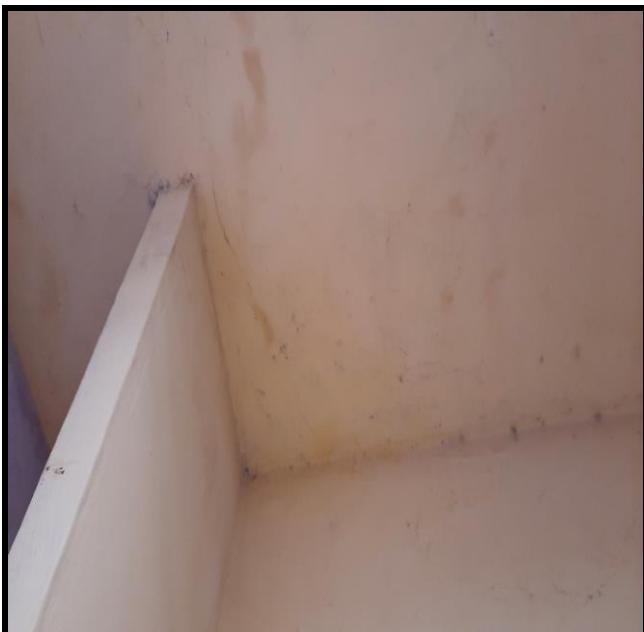
### FLAT NO – 38

- ❖ **HALL** – Leakage mark observed on wall & ceiling.
- ❖ **KITCHEN** – Dampness observed on wall.
- ❖ **PASSAGE** – O.K.
- ❖ **TOILET & BATH ROOM** – O.K.

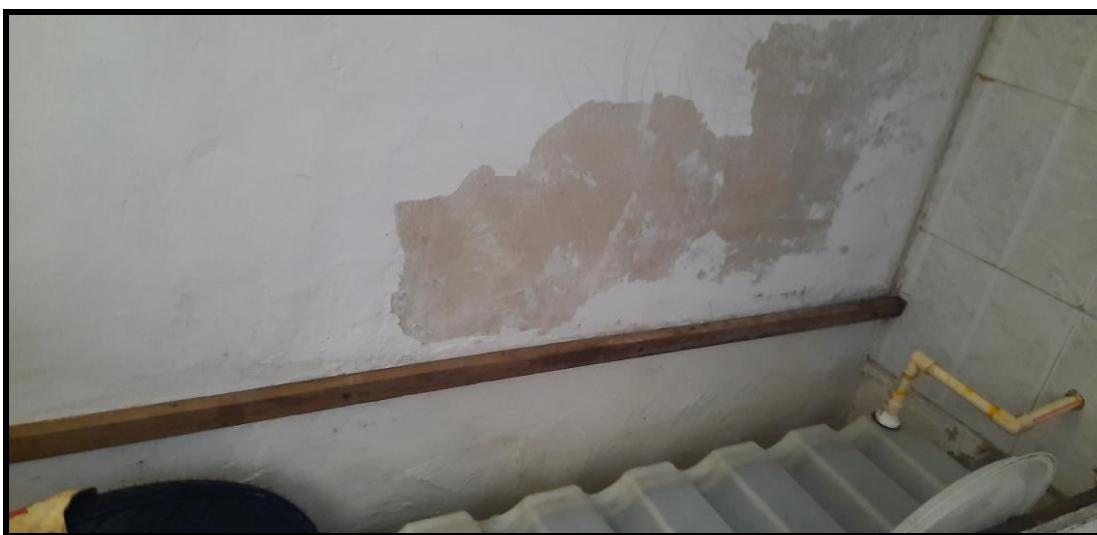
### FLAT NO – 39

- ❖ **HALL** – Structural crack observed on beam.
- ❖ **KITCHEN** – Leakage mark observed on ceiling.
- ❖ **PASSAGE** – O.K.
- ❖ **TOILET & BATH ROOM** – O.K.

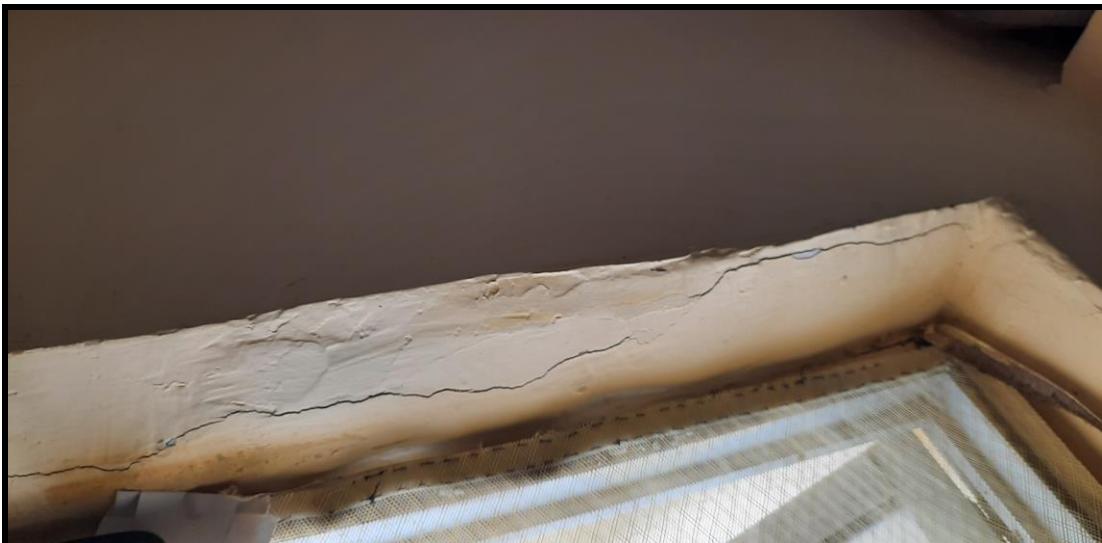
#### FLAT NO – 41

- ❖ **HALL** – O.K.
- ❖ **KITCHEN** – Structural crack observed on beam.
- ❖ **PASSAGE** – O.K.
- ❖ **TOILET & BATH ROOM** – O.K.

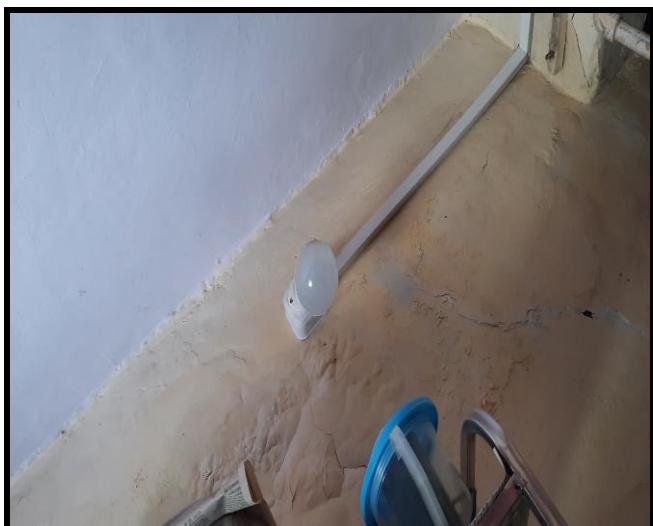
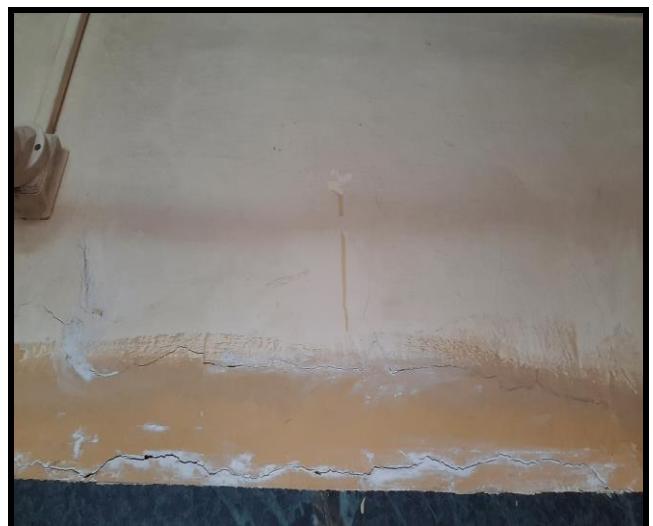
#### FLAT NO – 42

- ❖ **HALL** – Structural crack observed on beam.
- ❖ **KITCHEN** – Leakage mark observed on wall.
- ❖ **PASSAGE** – O.K.
- ❖ **TOILET & BATH ROOM** – O.K.

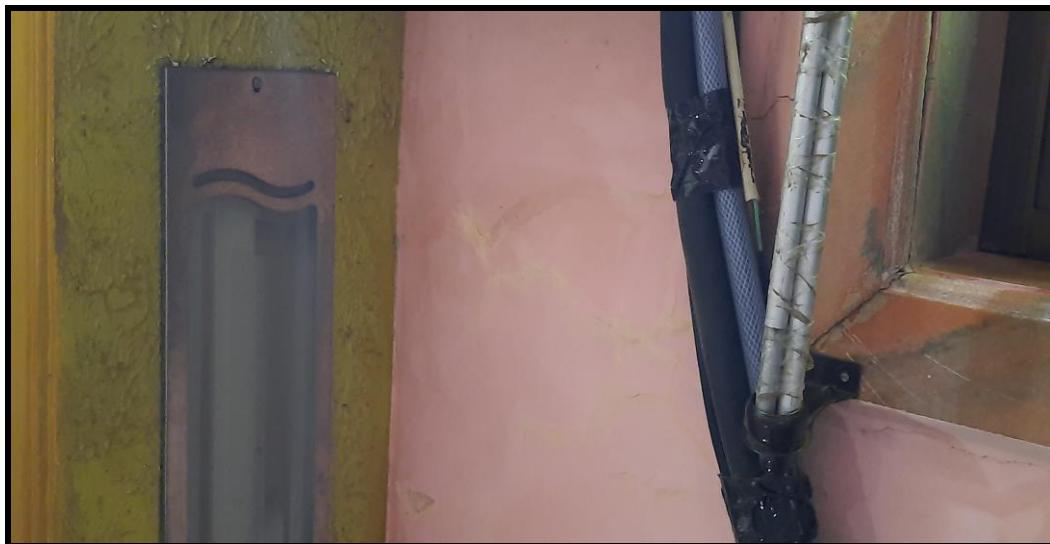
## FLAT NO – 44

- ❖ **HALL** – Structural damage observed on beam.
- ❖ **KITCHEN** – O.K.
- ❖ **PASSAGE** – O.K.
- ❖ **TOILET & BATH ROOM** – O.K.

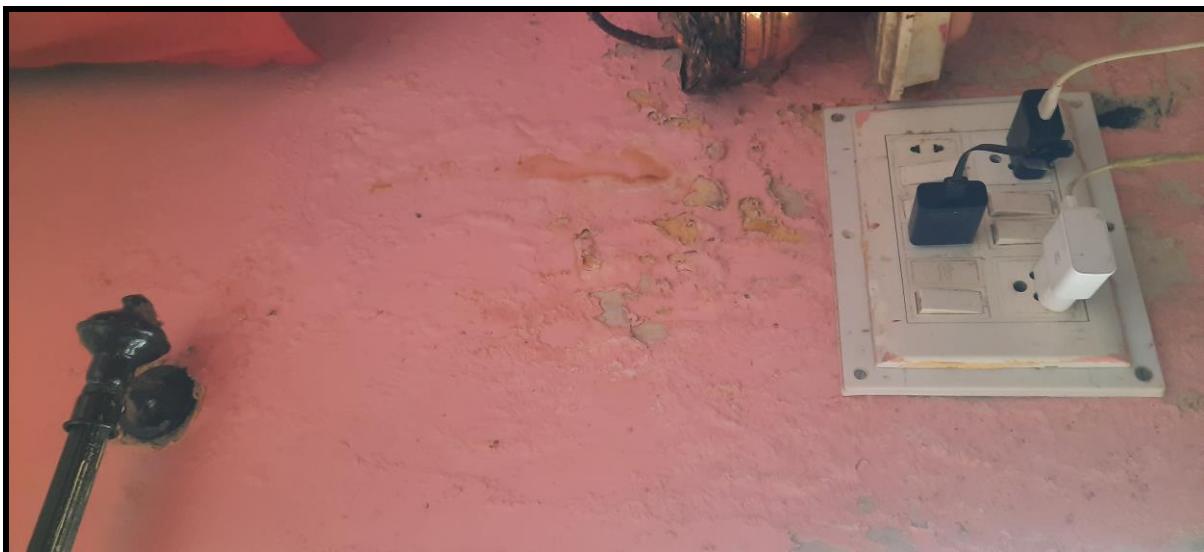
## FLAT NO – 48

- ❖ **HALL** – Leakage mark observed on wall.
- ❖ **KITCHEN** – O.K.
- ❖ **PASSAGE** – O.K.
- ❖ **TOILET & BATH ROOM** – O.K.

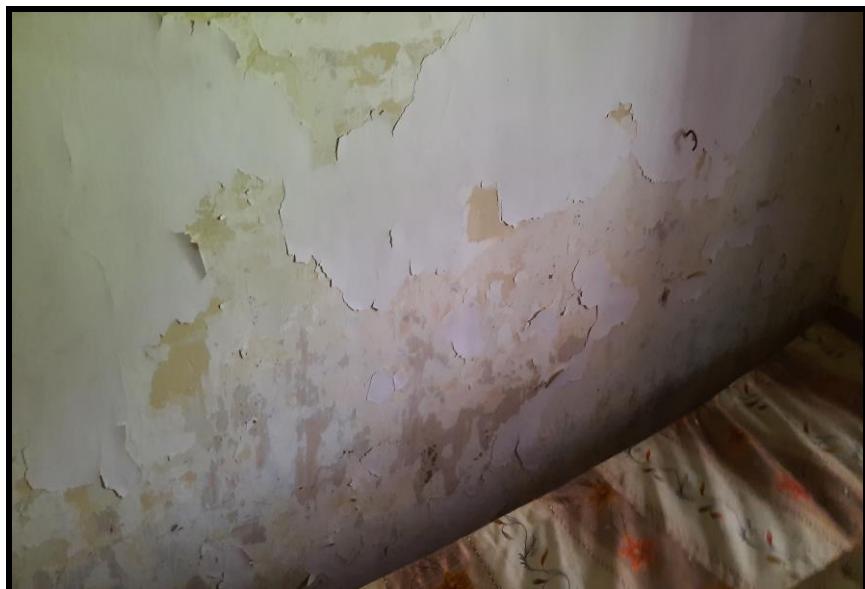
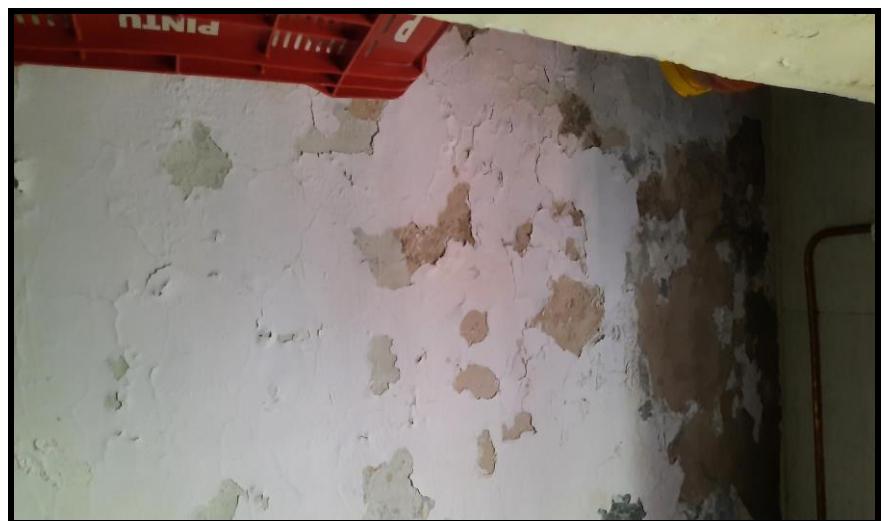
### FLAT NO – 53

- ❖ **HALL** – Leakage mark observed on ceiling.
- ❖ **KITCHEN** – Leakage mark observed on ceiling.
- ❖ **PASSAGE** – O.K.
- ❖ **TOILET & BATH ROOM** – O.K.

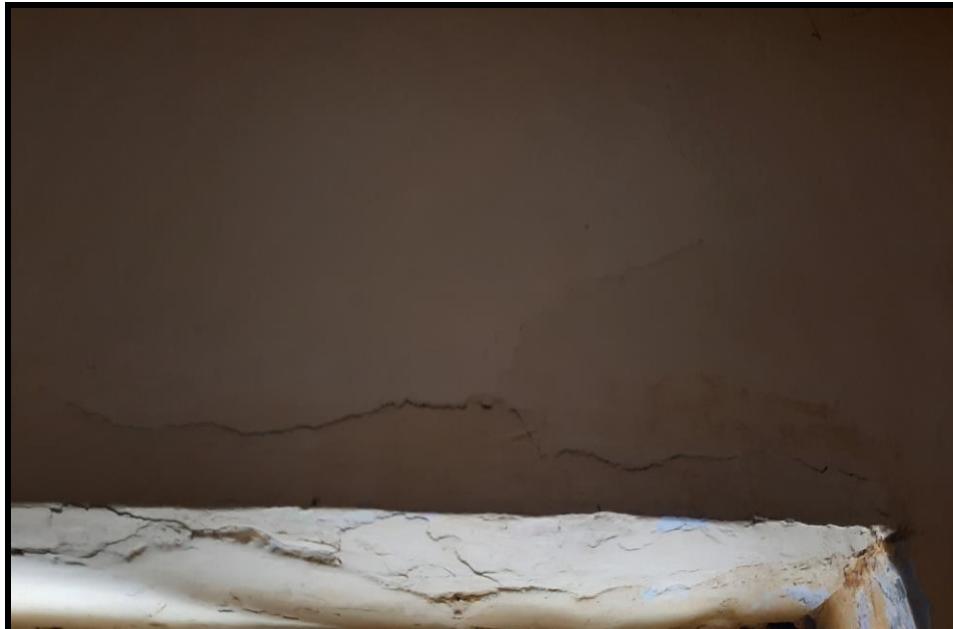
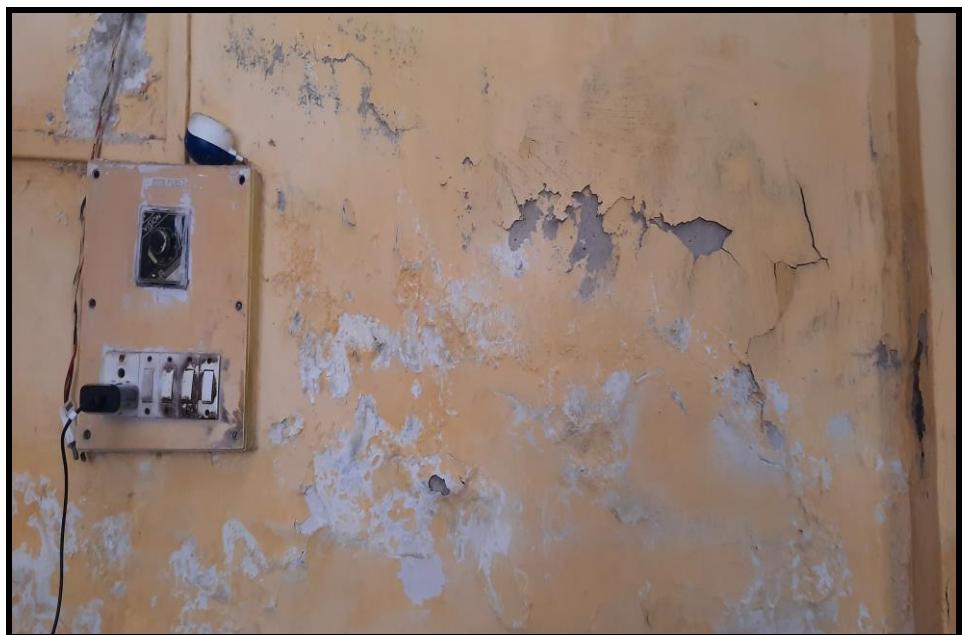
## FLAT NO – 56

- ❖ **HALL** – O.K.
- ❖ **KITCHEN** – Leakage mark observed on wall.
  - Structural crack observed on beam.
- ❖ **PASSAGE** – O.K.
- ❖ **TOILET & BATH ROOM** – O.K.

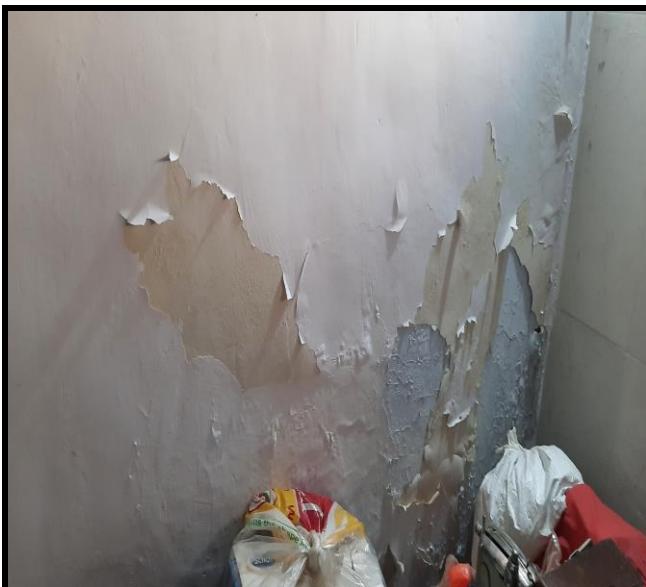
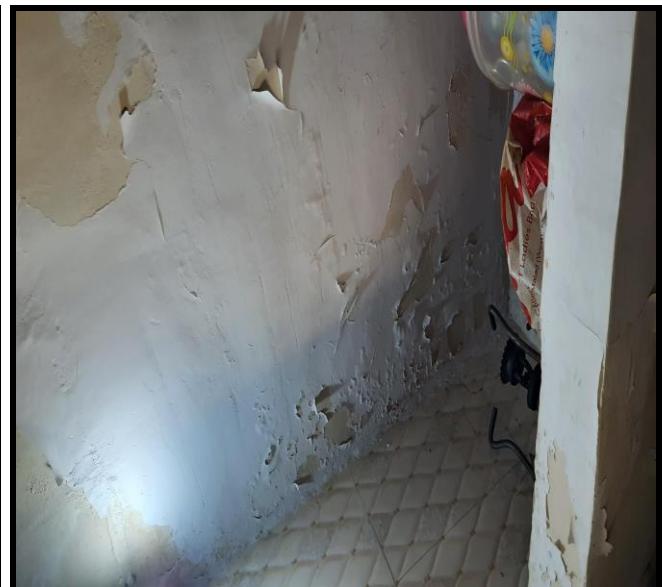
### FLAT NO – 59

- ❖ **HALL** – Leakage mark observed on ceiling.
- ❖ **KITCHEN** – Leakage mark observed on ceiling.
- ❖ **PASSAGE** – O.K.
- ❖ **TOILET & BATH ROOM** – Leakage mark observed on ceiling.

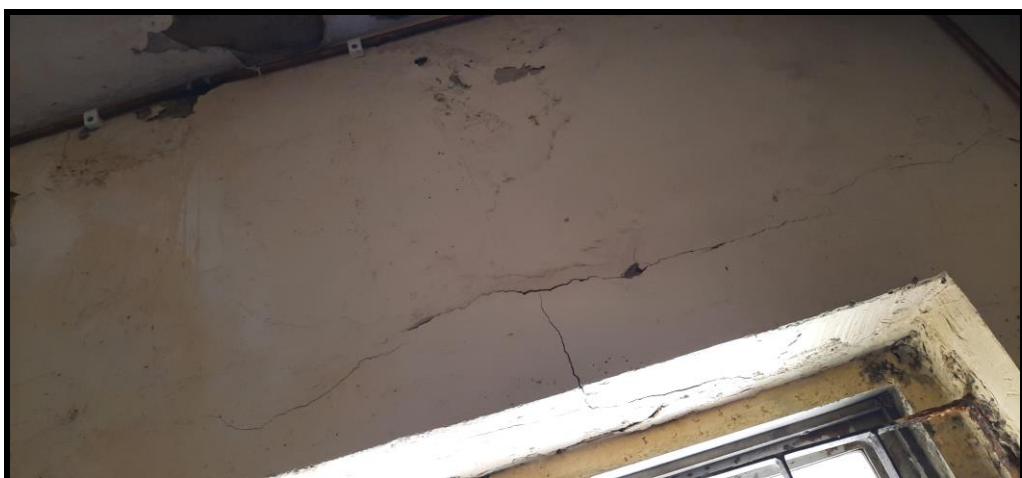
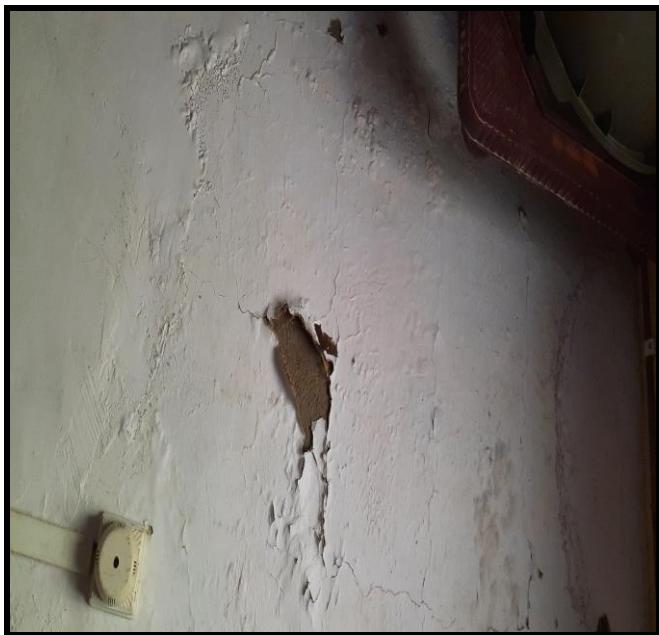
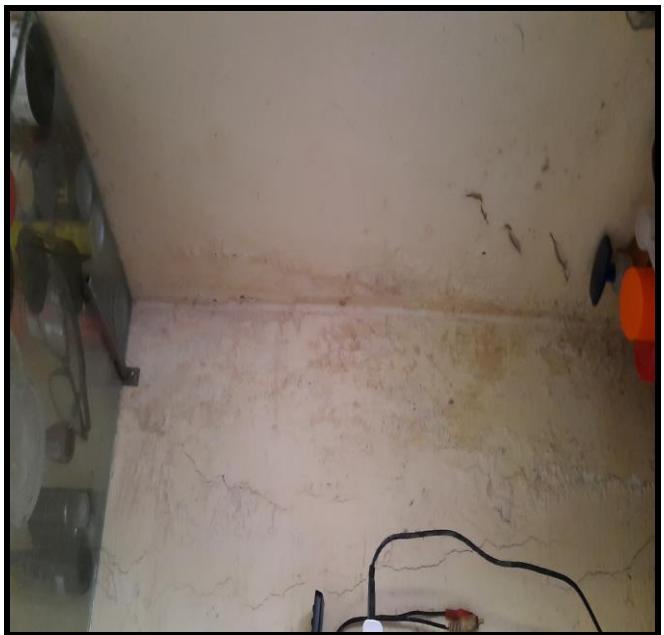
### FLAT NO – 61

- ❖ **HALL** – Leakage mark observed on wall.
  - Structural crack observed on beam.
- ❖ **KITCHEN** – Leakage mark observed on wall & ceiling.
  - Structural crack observed on beam.
- ❖ **PASSAGE** – O.K.
- ❖ **TOILET & BATH ROOM** – O.K.

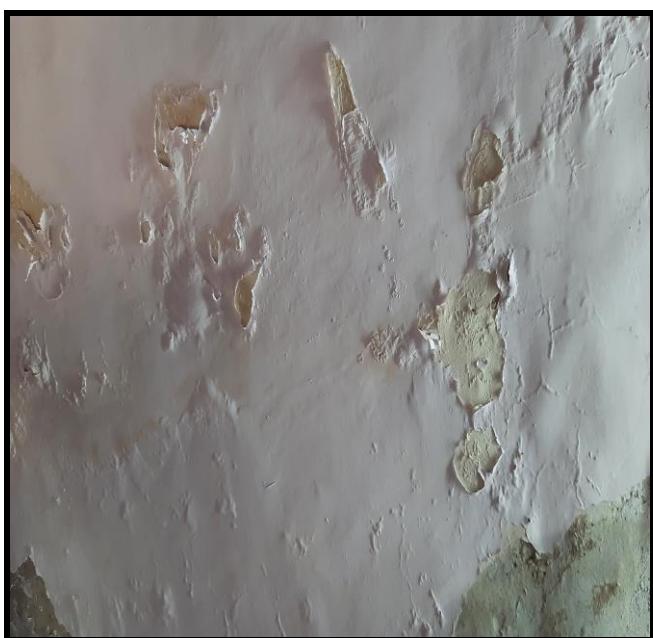
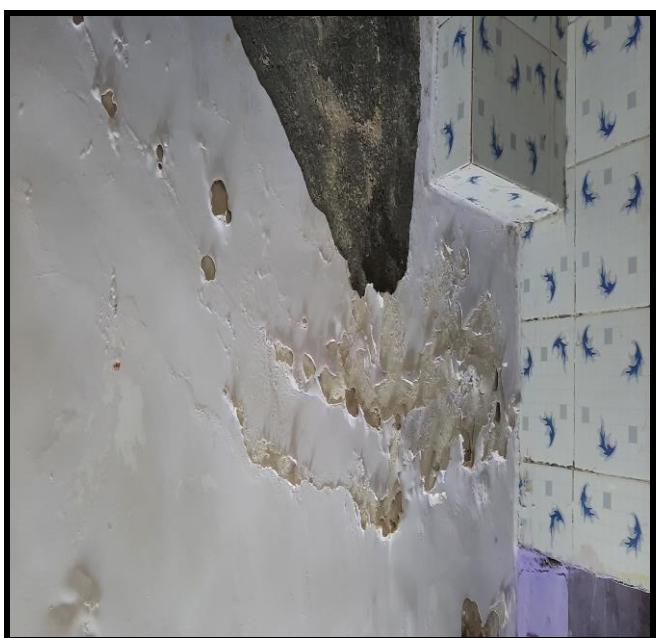
## FLAT NO – 63

- ❖ **HALL** – Leakage mark observed on ceiling.
- ❖ **KITCHEN** – Leakage mark observed on ceiling.
- ❖ **PASSAGE** – O.K.
- ❖ **TOILET & BATH ROOM** – O.K.

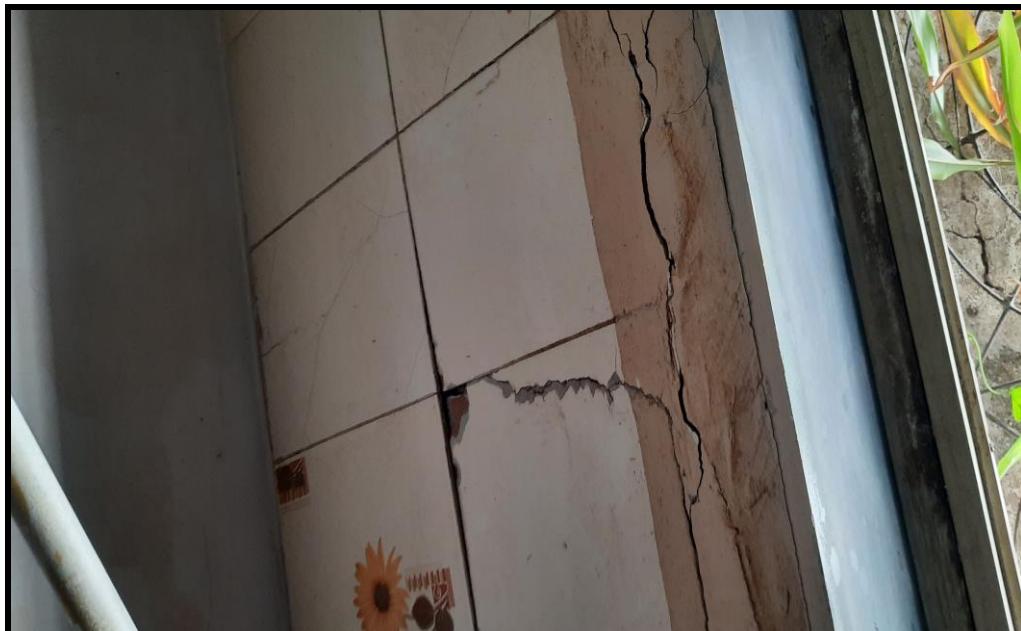
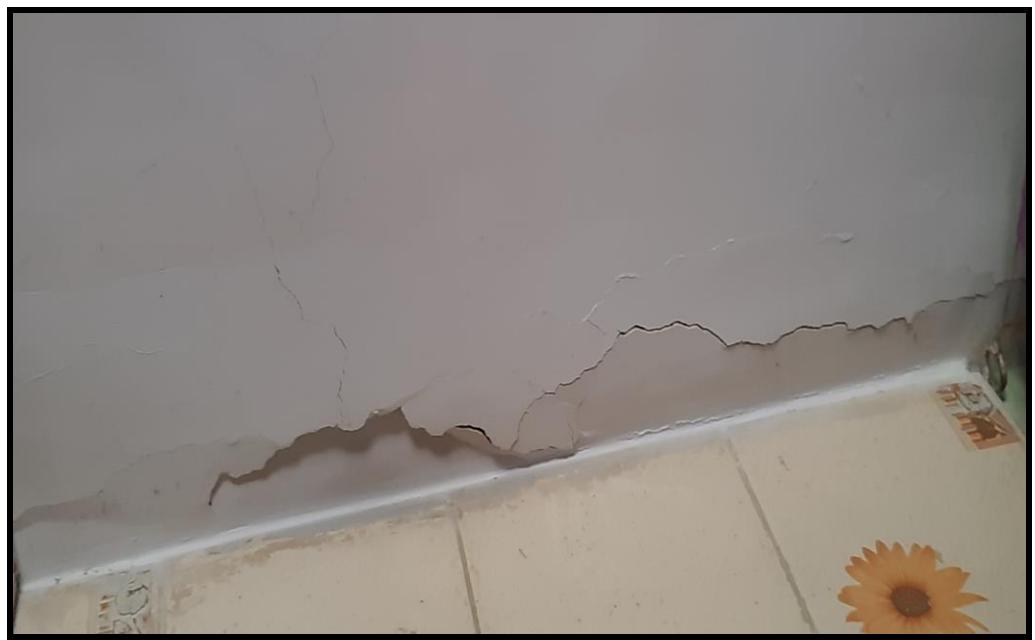
## FLAT NO – 64

- ❖ **HALL** – Leakage observed on wall in monsoon.
- ❖ **KITCHEN** – Structural crack observed on beam & ceiling.
- ❖ **PASSAGE** – O.K.
- ❖ **TOILET & BATH ROOM** – O.K.

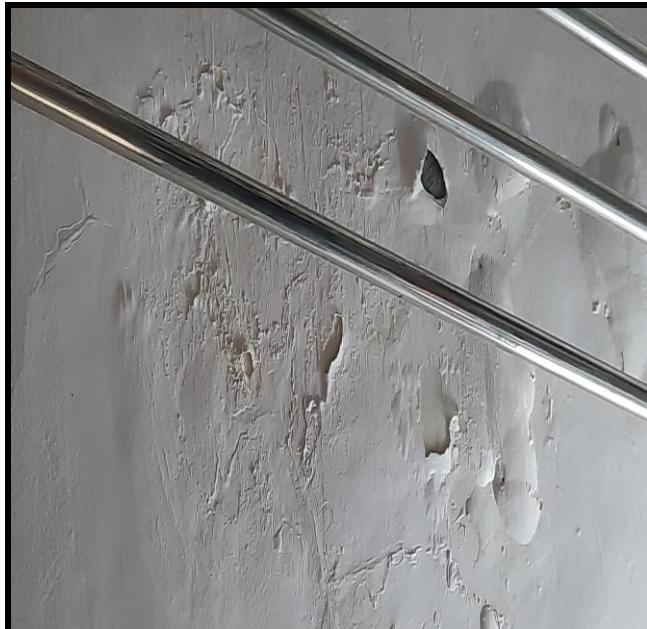
### FLAT NO – 66

- ❖ **HALL** – Structural crack observed on column.
- ❖ **KITCHEN** – Leakage mark observed on ceiling.
- ❖ **PASSAGE** – O.K.
- ❖ **TOILET & BATH ROOM** – O.K.
