STRUCTURAL AUDIT REPORT  
FOR  
**“VISHAL SAHYADRI CO – OP HSG. SOC. LTD”,**  
**“C22 – WING”**  
SITUATED AT  
SAHYADRI NAGAR, CHARKOP,  
KANDIVALI (W) MUMBAI – 400 067

978/B1/LSS/2021

JUNE 24, 2021

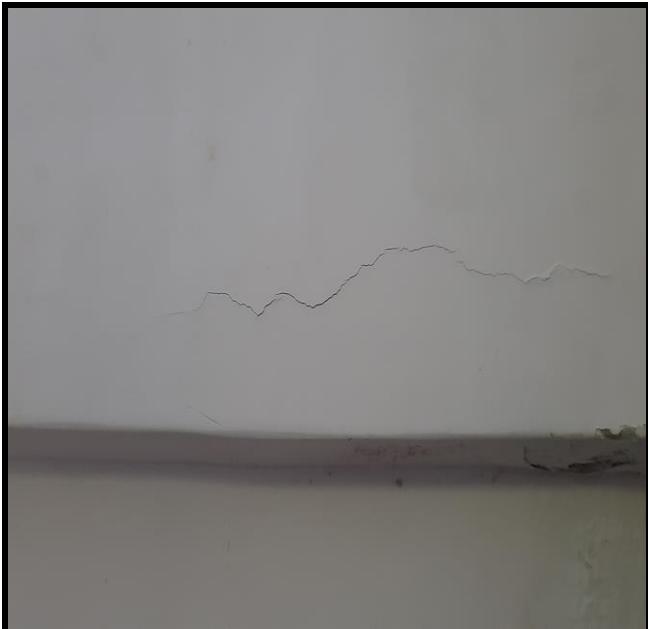
### FLAT NO – 66

- ❖ **HALL** – Structural crack observed on column.
- ❖ **KITCHEN** – Leakage mark observed on ceiling.
- ❖ **PASSAGE** – O.K.
- ❖ **TOILET & BATH ROOM** – O.K.

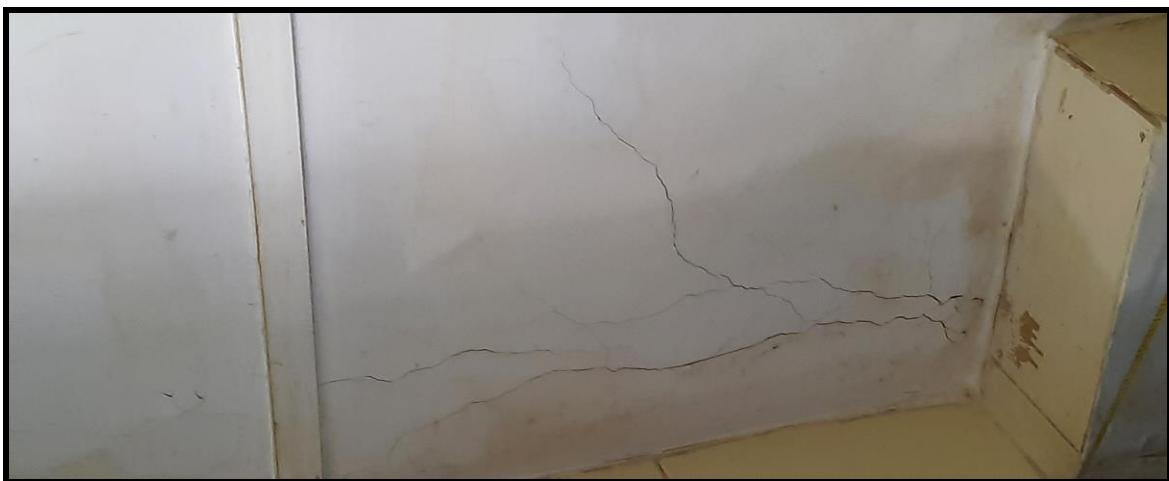
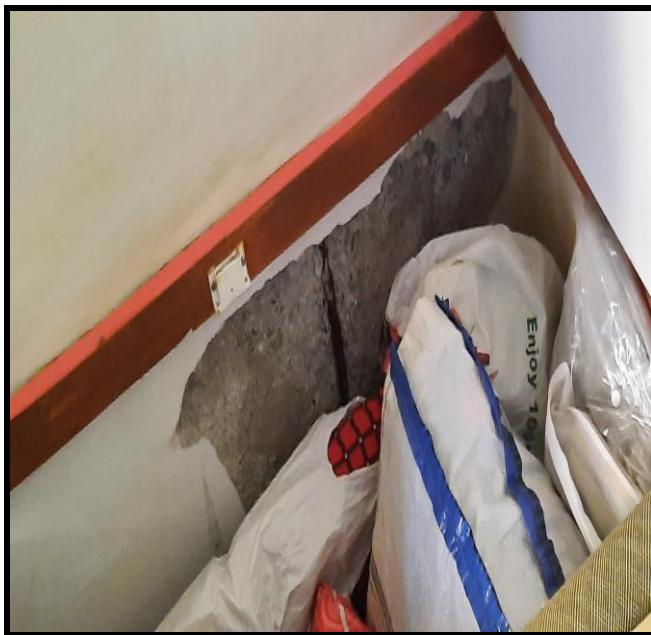
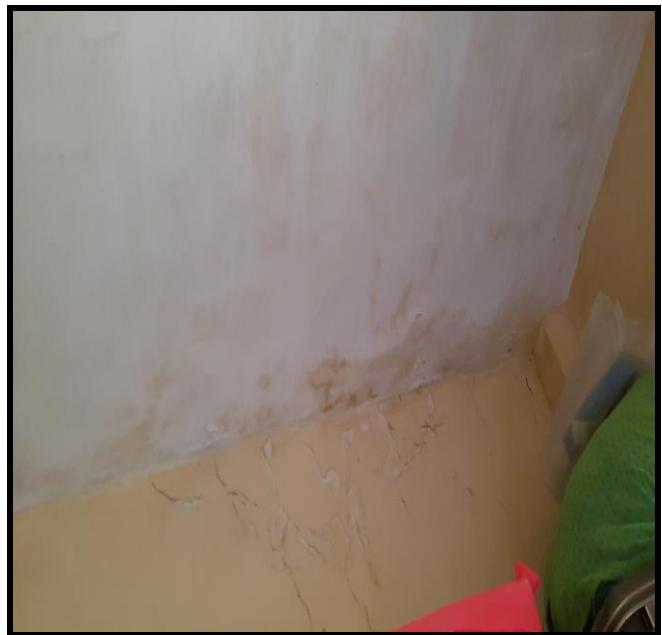
### FLAT NO – 68

- ❖ **HALL** – Leakage mark observed on wall & ceiling.
- ❖ Ceiling plaster get damaged & steel get exposed & corroded.
- ❖ **KITCHEN** – Structural crack observed on ceiling.
- ❖ **PASSAGE** – O.K.
- ❖ **TOILET & BATH ROOM** – Structural crack observed on ceiling.

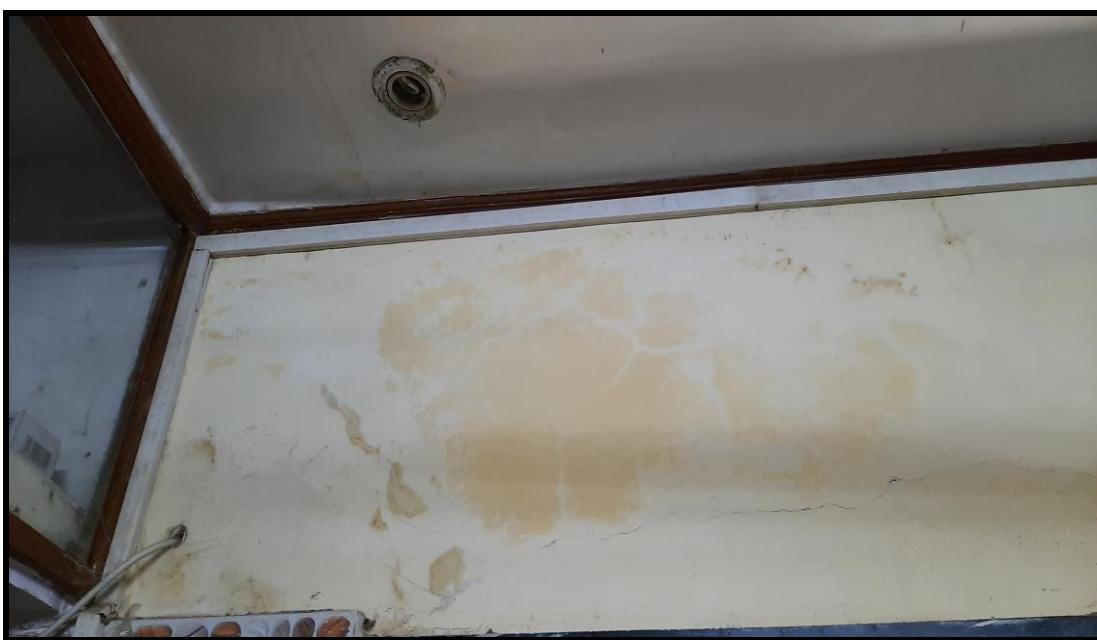
## FLAT NO – 69

- ❖ **HALL** – Leakage mark observed on wall.
- ❖ **KITCHEN** – Leakage mark observed on ceiling.
- ❖ **PASSAGE** – O.K.
- ❖ **TOILET & BATH ROOM** – O.K.

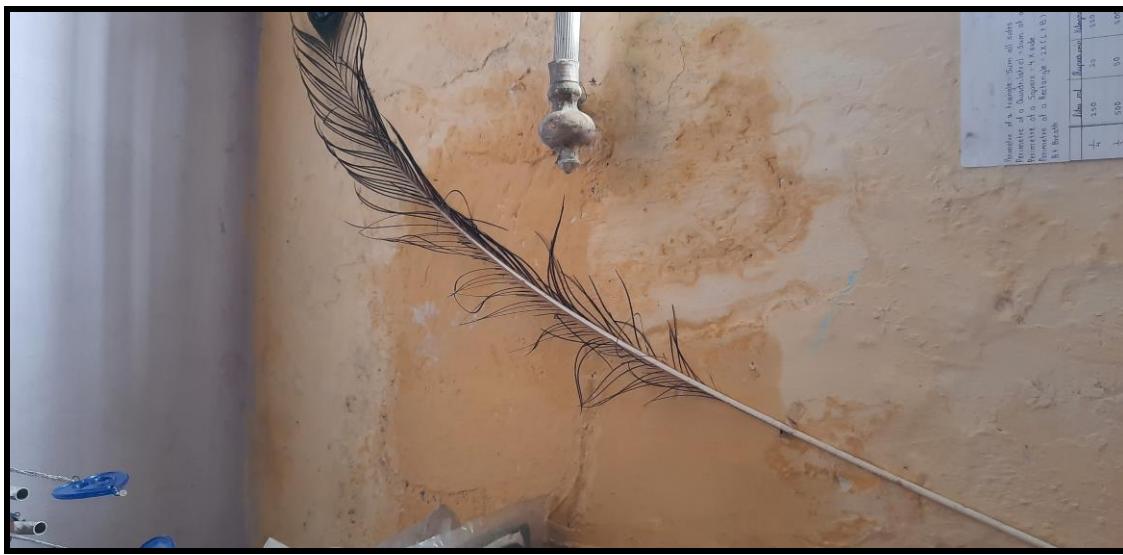
**FLAT NO - 80**

- ❖ **HALL** – Leakage mark observed on wall.
    - Structural damage observed on beam.
  - ❖ **KITCHEN** – Leakage observed on wall in monsoon.
  - ❖ **PASSAGE** – O.K.
  - ❖ **TOILET & BATH ROOM** – O.K.

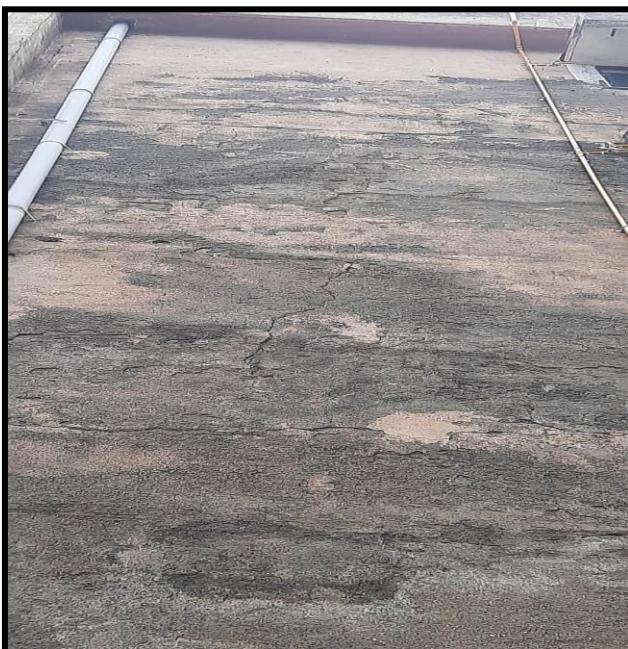
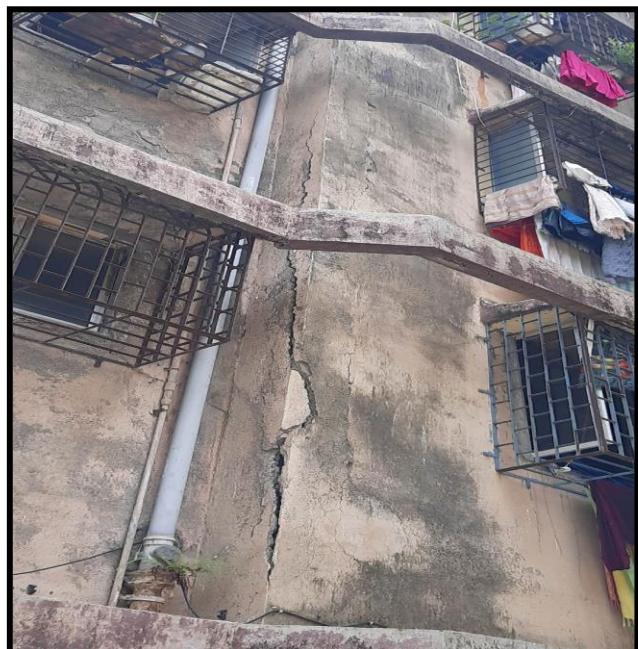
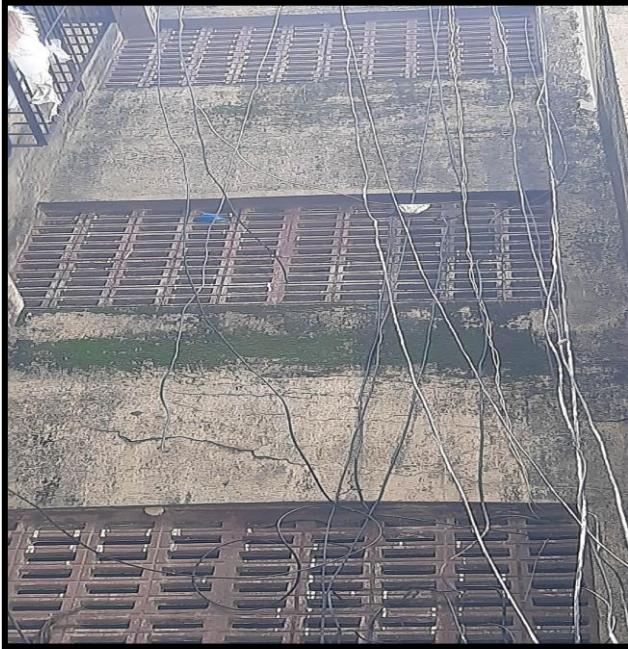
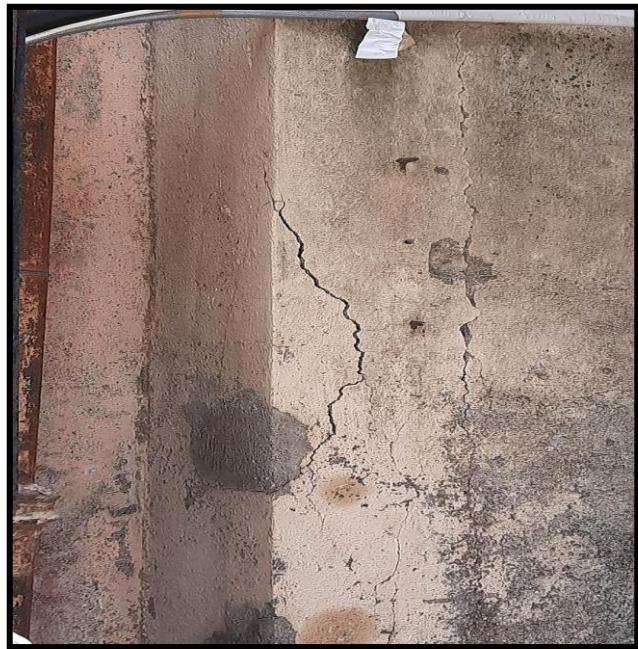
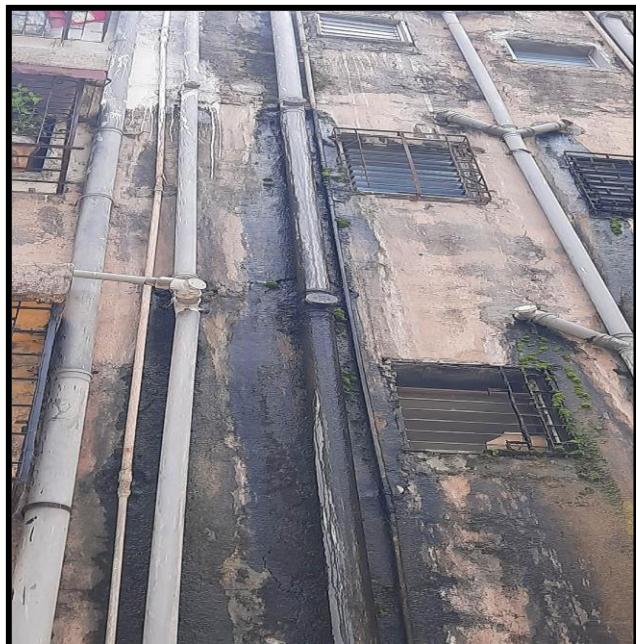
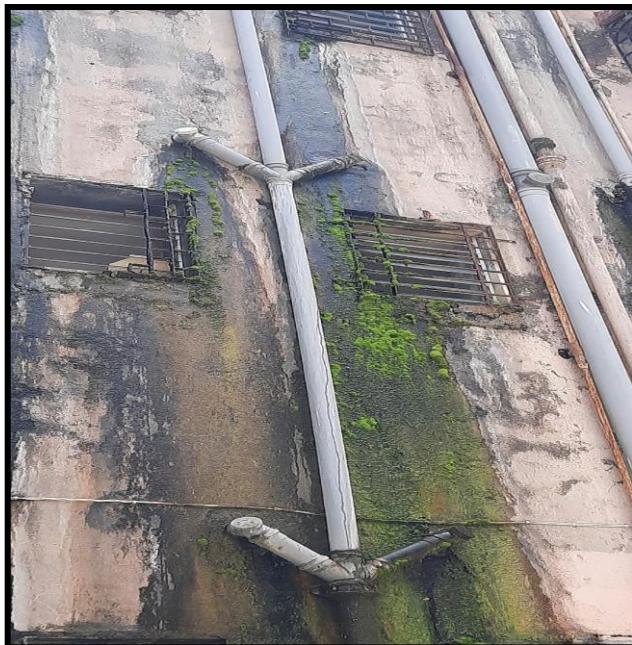
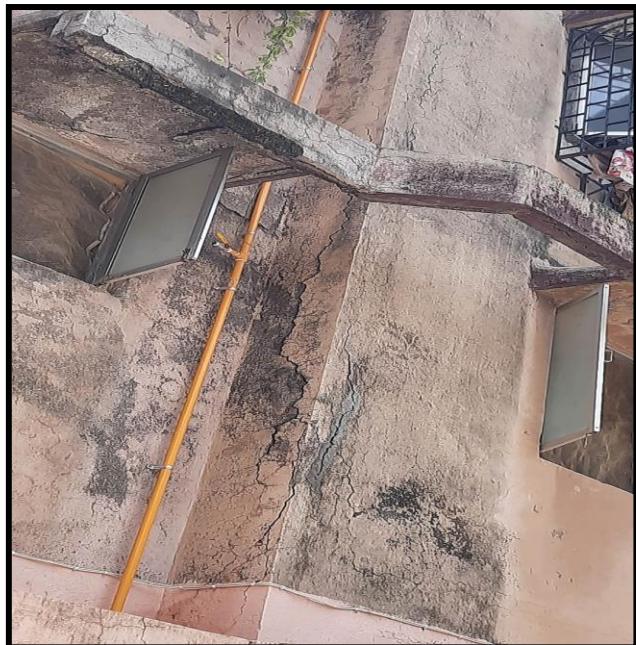
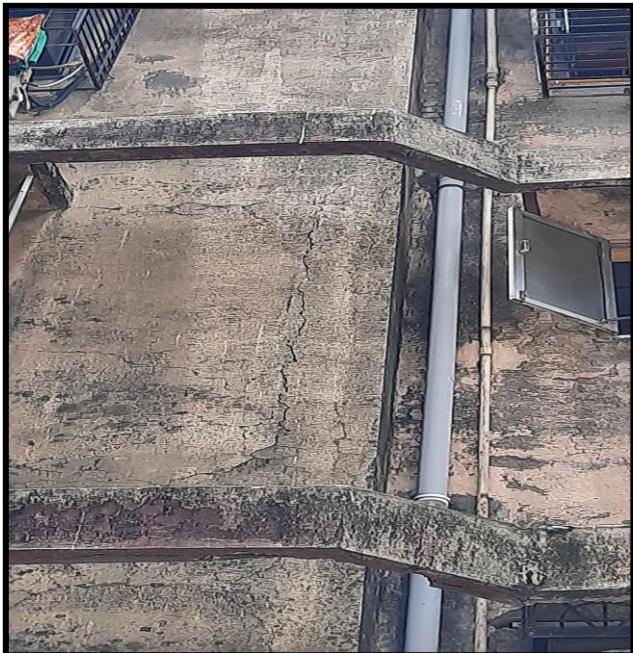
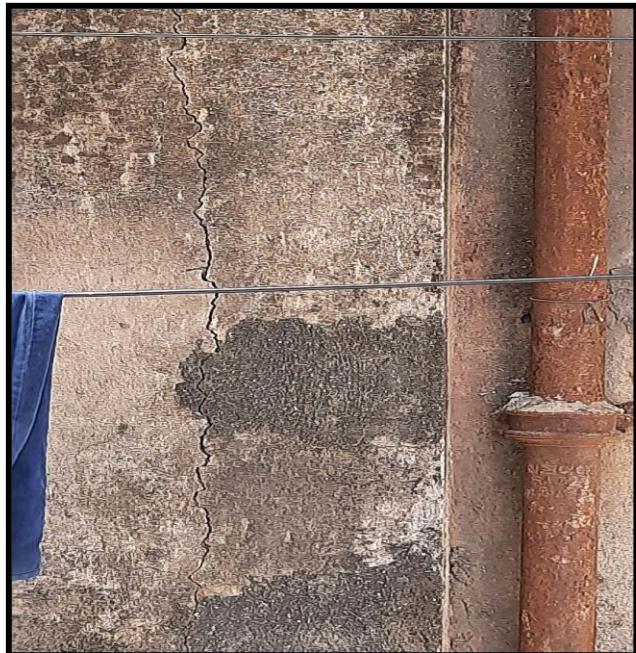
#### FRONT SIDE

- ❖ Structural crack observed at several places on column.
- ❖ Major crack observed at several places on wall.
- ❖ Vegetation growth observed at several places on wall.
- ❖ Column & chajja plaster get damaged & steel get exposed & corroded.
- ❖ Algae observed at several places on wall.

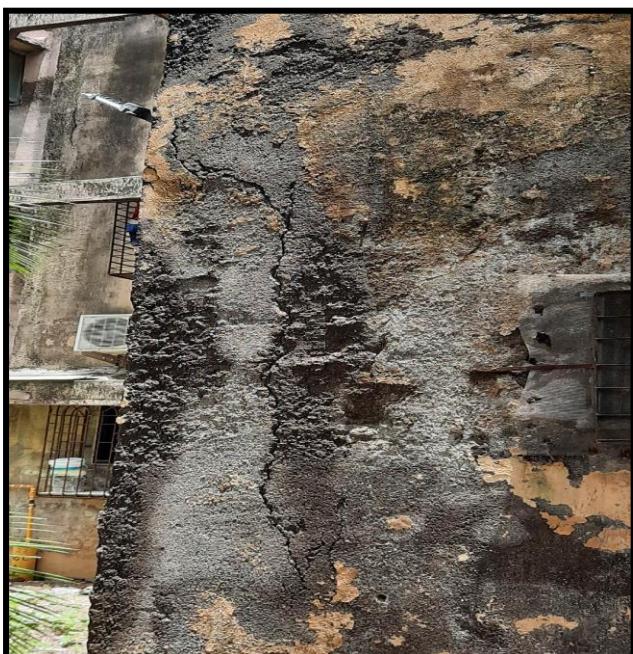
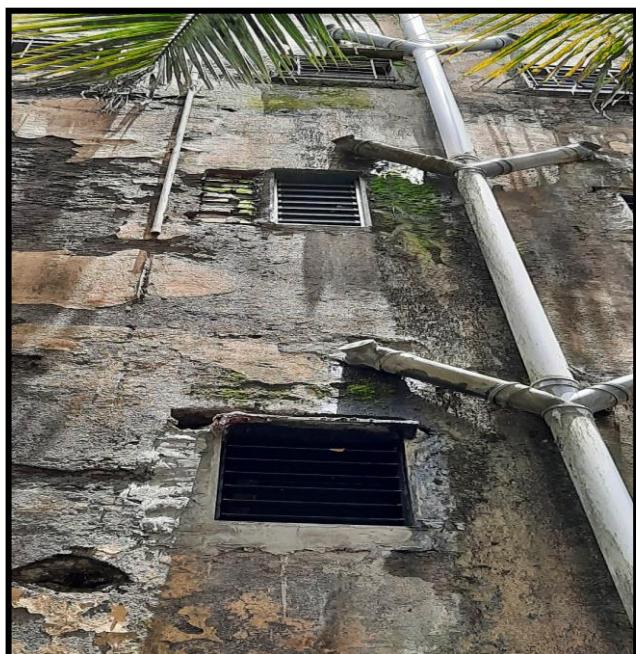
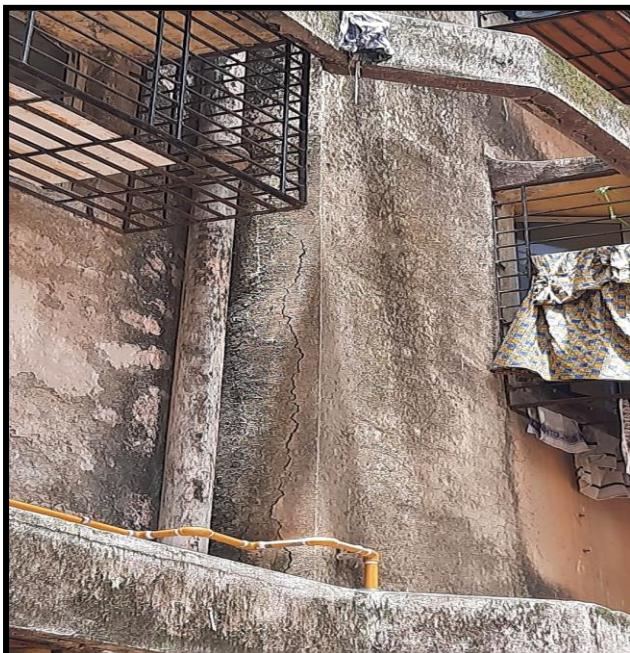
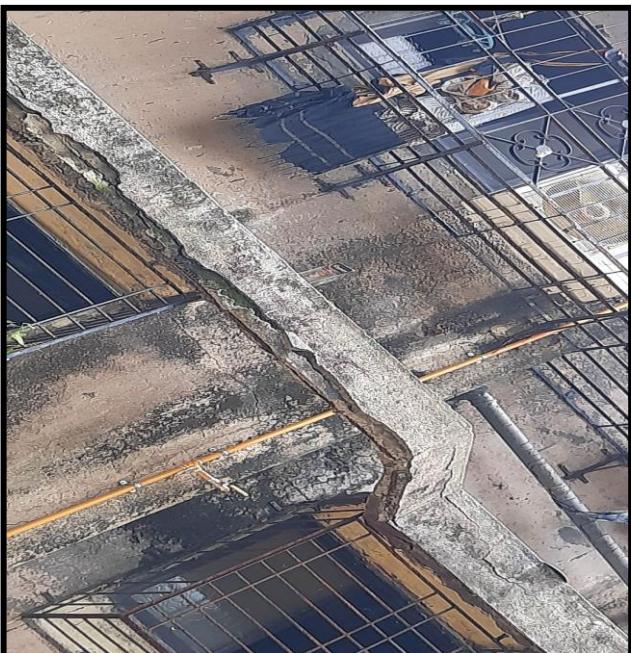
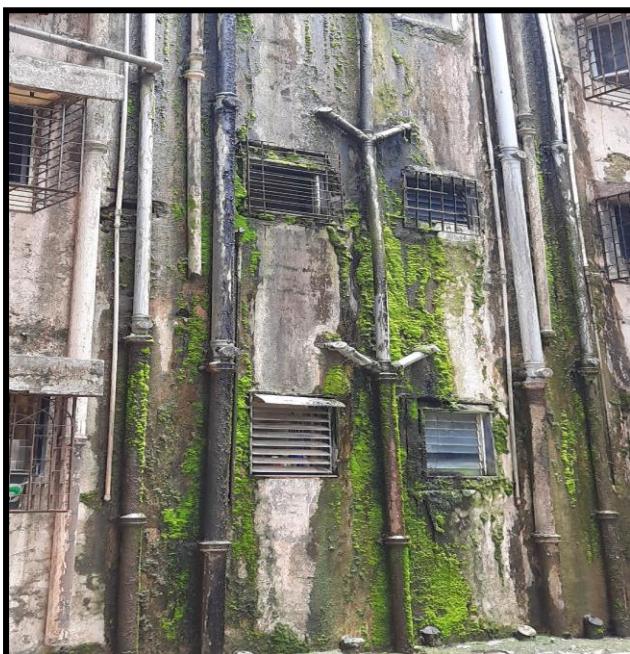
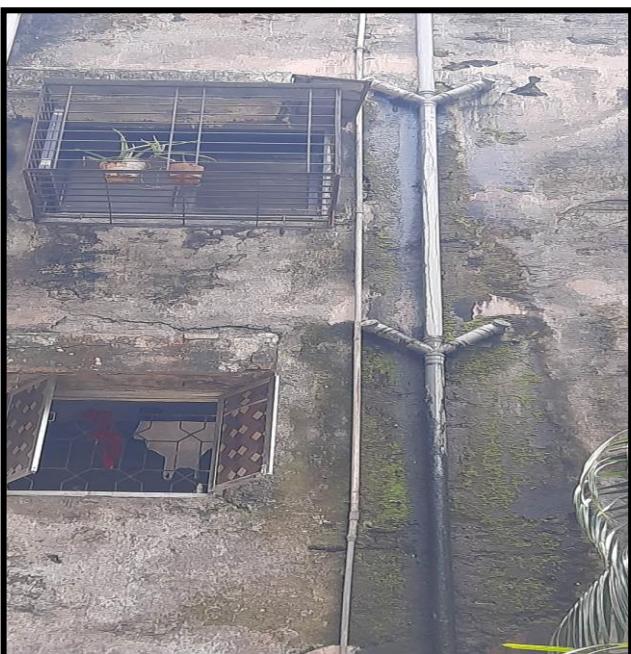
## BACK SIDE

- ❖ Structural crack observed at several places on column.
- ❖ Major crack observed at several places on wall.
- ❖ Vegetation growth observed at several places on wall.
- ❖ Column & chajja plaster get damaged & steel get exposed & corroded.
- ❖ Algae observed at several places on wall.

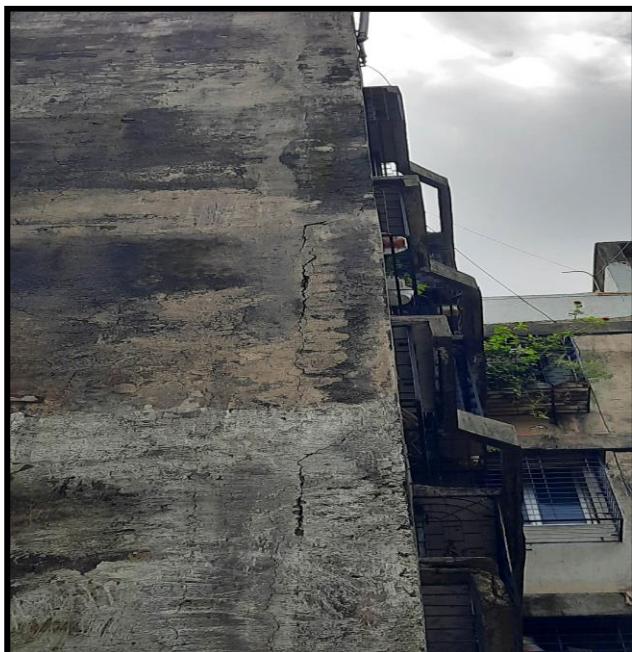
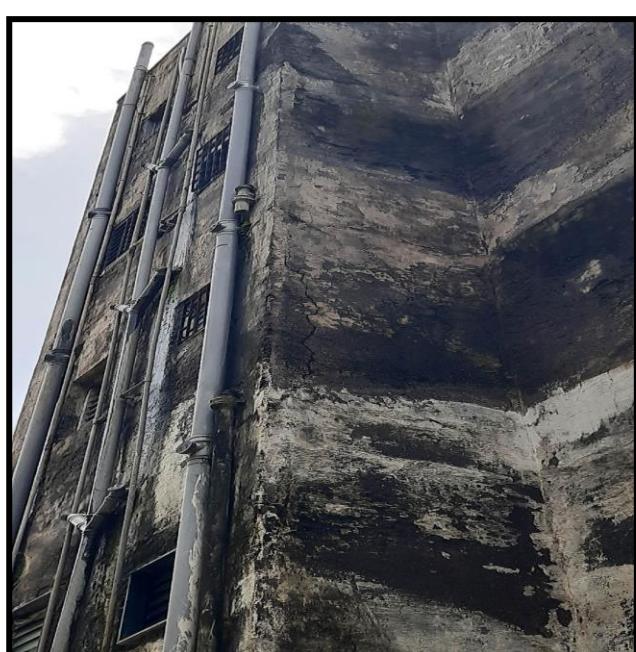
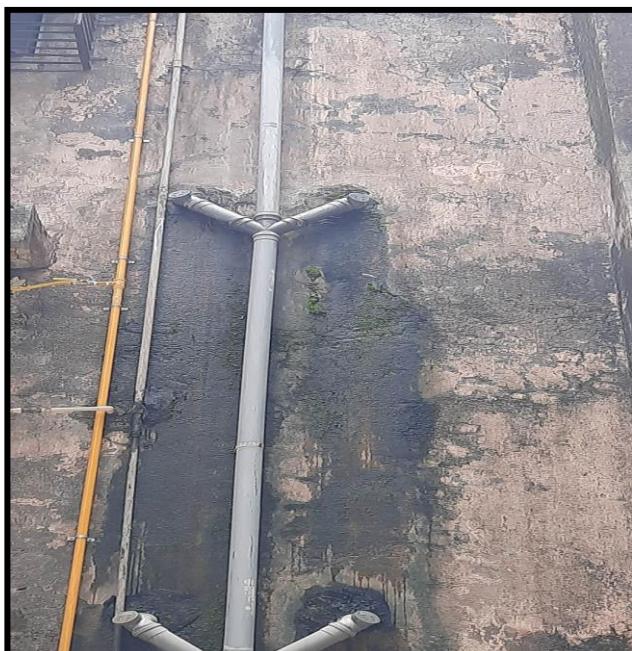
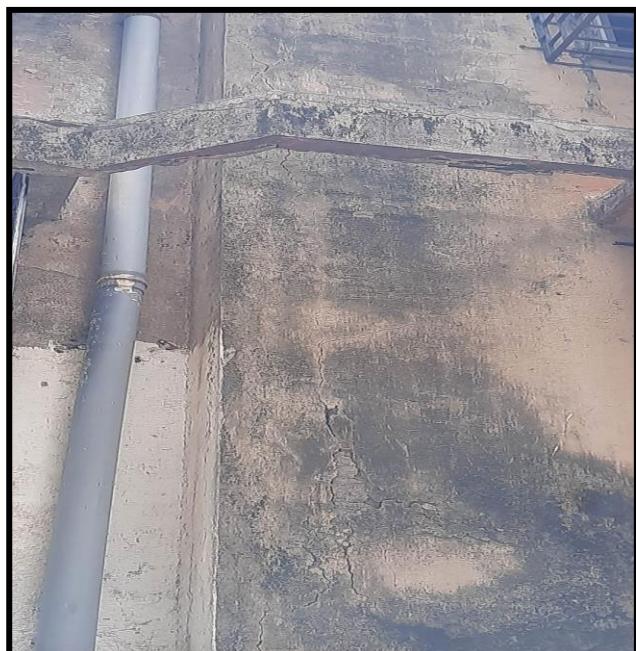
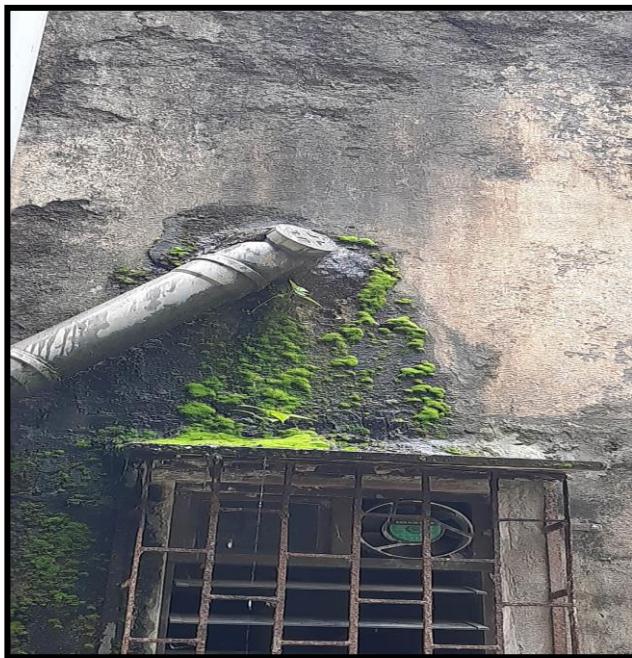
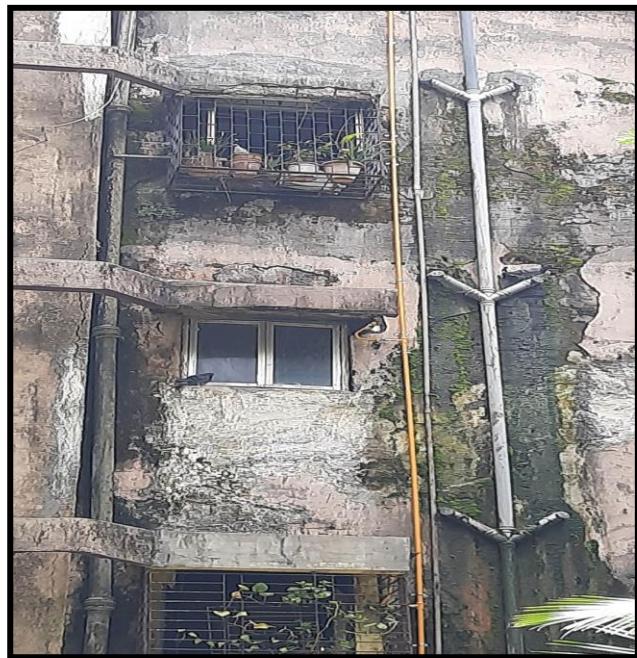
## EAST SIDE

- ❖ Structural crack observed at several places on column & chajjas.
- ❖ Major crack observed at several places on wall.
- ❖ Vegetation growth observed at several places on wall.
- ❖ Algae observed at several places on wall.

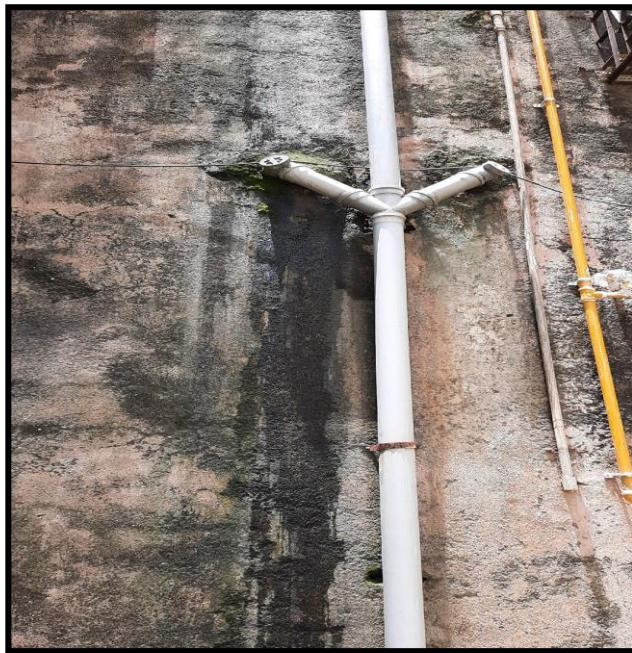
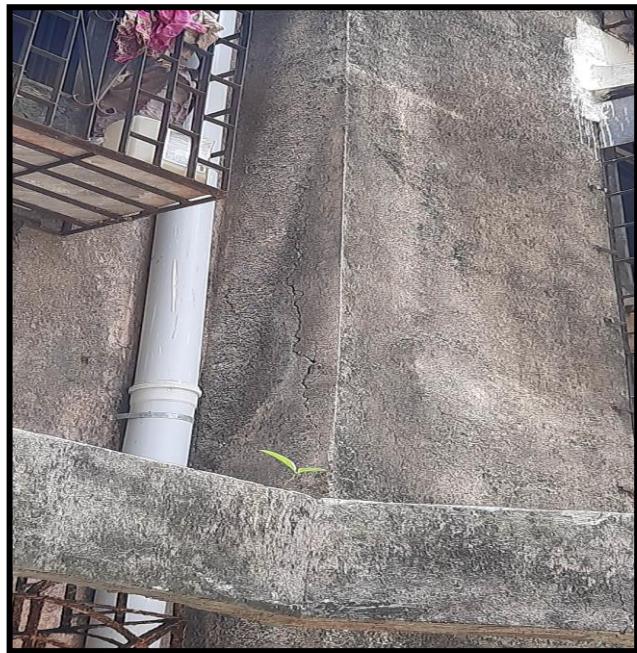
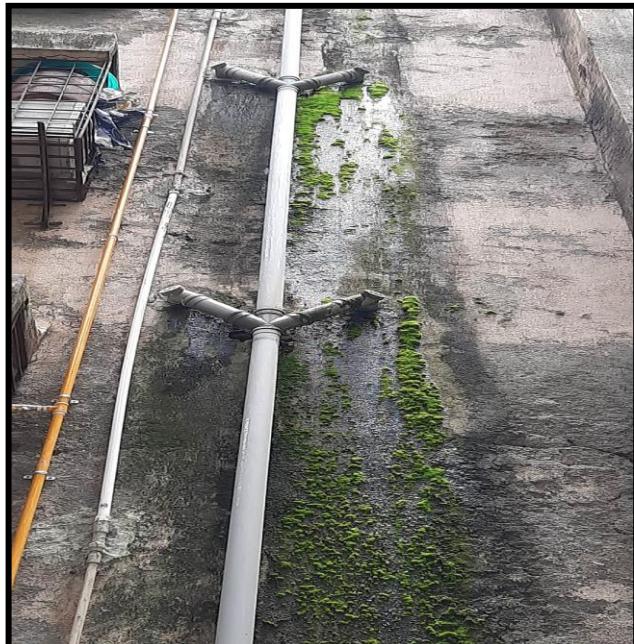
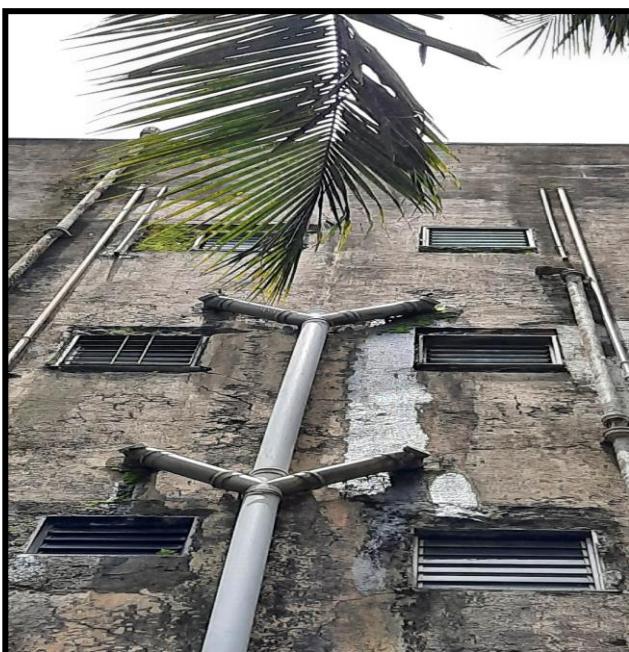
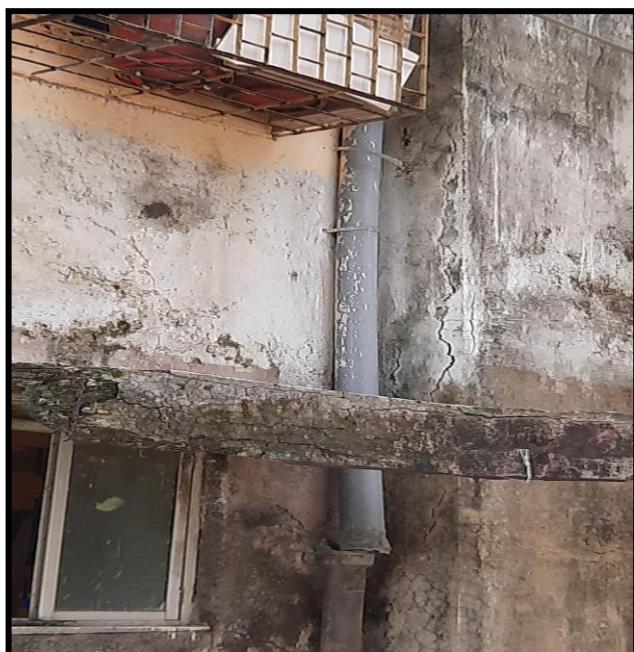
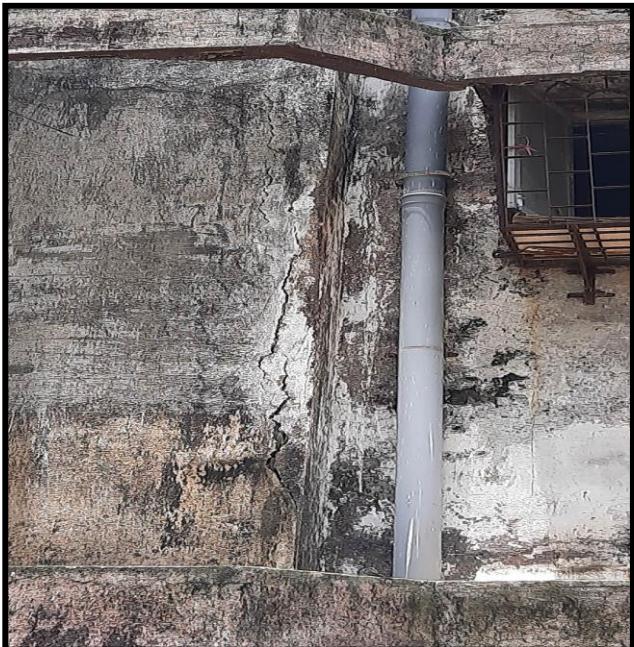
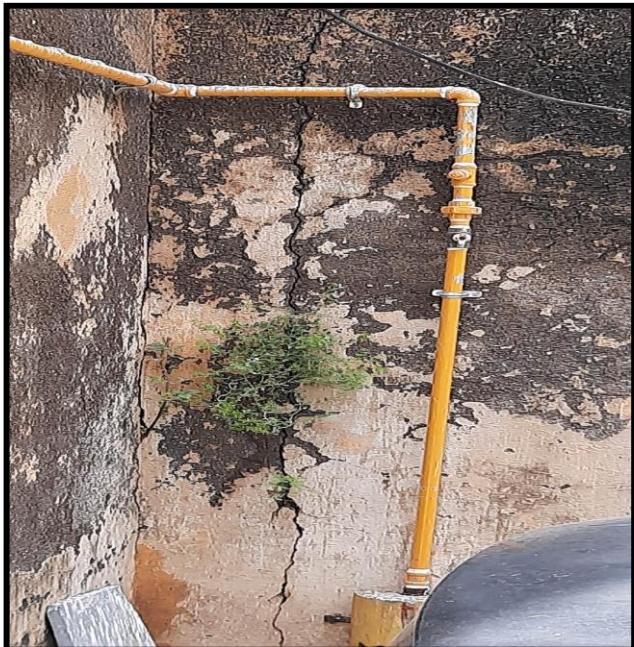
## WEST SIDE

- ❖ Structural crack observed at several places on column & chajjas.
- ❖ Major crack observed at several places on wall.
- ❖ Vegetation growth observed at several places on wall.
- ❖ Algae observed at several places on wall.
