STRUCTURAL AUDIT REPORT
FOR
“VISHAL SAHYADRI CO – OP HSG. SOC. LTD”,
“B5 – WING”
SITUATED AT
SAHYADRI NAGAR, CHARKOP,
KANDIVALI (W) MUMBAI – 400 067

978/B5/LSS/2021

JULY 19, 2021

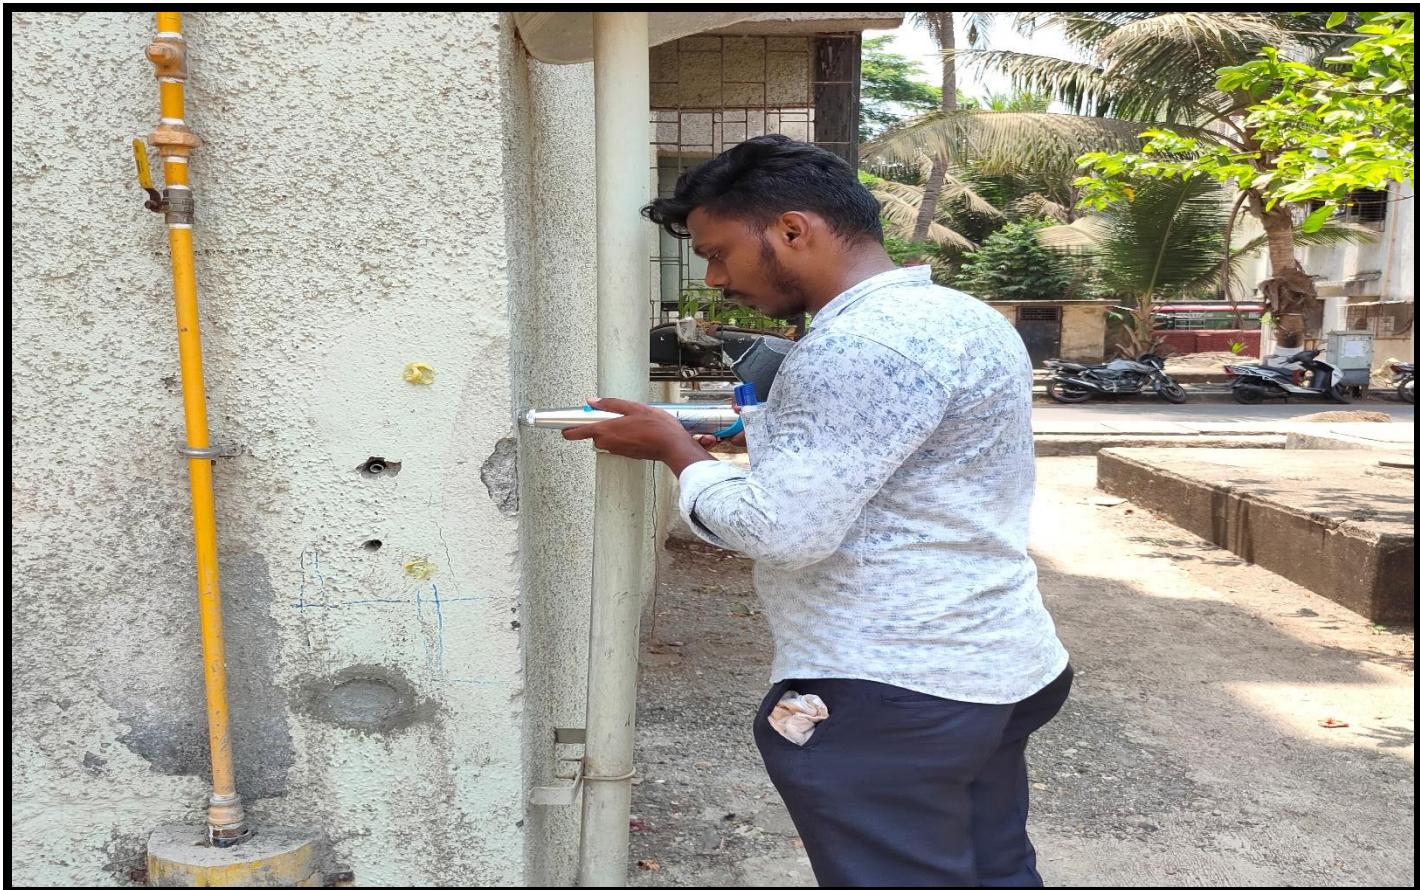
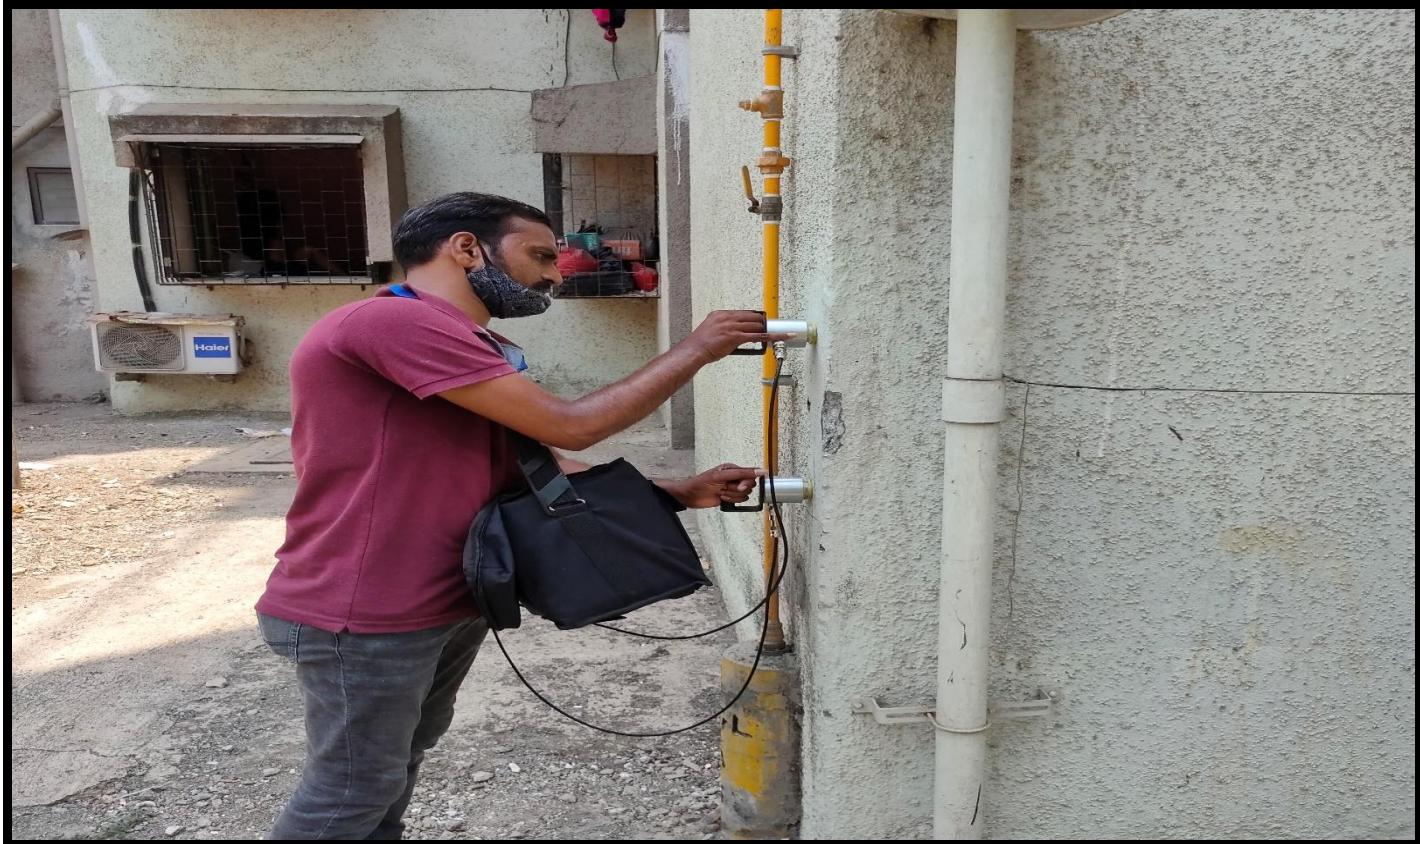
NON -DESTRUCTIVE TEST PHOTO

Rebound Hammer was tested for compressive strength at surface by Schmidt rebound hammer. Results indicate the compressive strength at surface of all the RCC columns is ranging between 12.50 MPa to 18.90 MPa.

The UPV values are ranging between 1.60 Km/Sec to 2.30 Km/Sec.

Out of 4 locations all 4 locations was below 3.0 Km/Sec means concrete quality is poor.

This indicates there are progressive internal cracks in the RCC members due to corrosion of reinforced steel. These members are under distress condition.

Half Cell Potential tested for corrosion activity by half – cell potential tests. Values are taken on Column. The result on tested column is – 330 mV.

This indicates the probability of corrosion is 50% on tested column steel reinforcement.

Carbonation test was conducted to assess carbonation depth. Readings are taken on Column. Result indicates the carbonation penetration depth is 35.00 mm. Carbonation depths have reached to the reinforcement level in all of the RCC elements. It is essential to give a suitable anti-corrosion treatment to all the RCC members to stop further carbonation and corrosion of concrete.

RCC elements indicating UPV values less than 3 Km/sec needs immediate attention.

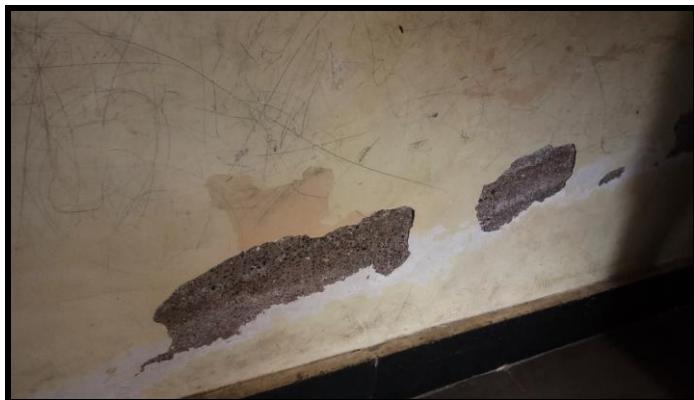
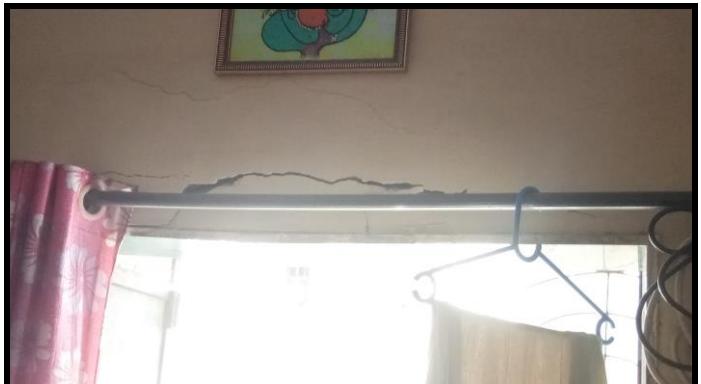
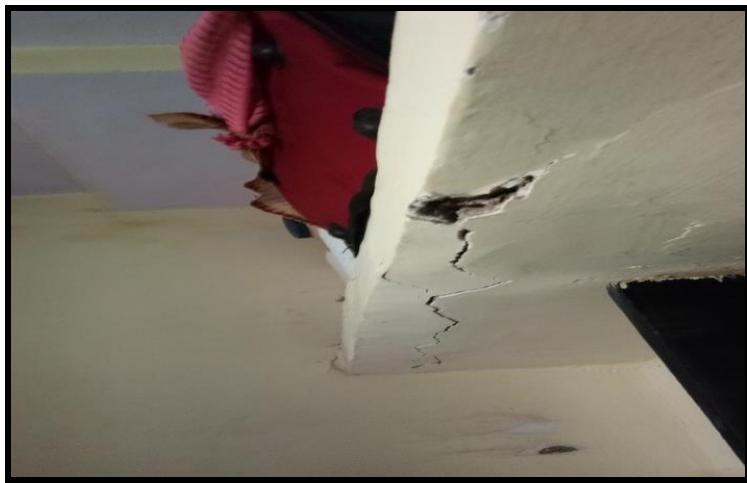
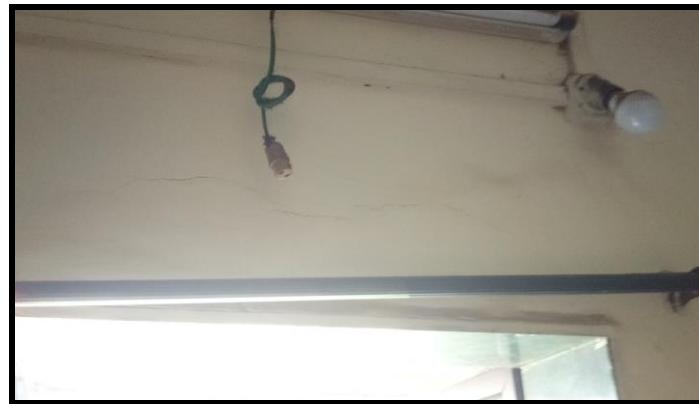
FLAT NO – 08

- ❖ **HALL** – Hallow sound observed on South side wall after during tapping. (**It may fall**)
 - Major structural crack observed on column.
 - Major structural crack observed on wall.
- ❖ **KITCHEN** – Peeling of paint observed on wall.
- ❖ **PASSAGE** – O.K.
- ❖ **TOILET & BATH ROOM** – Dampness observed on wall.

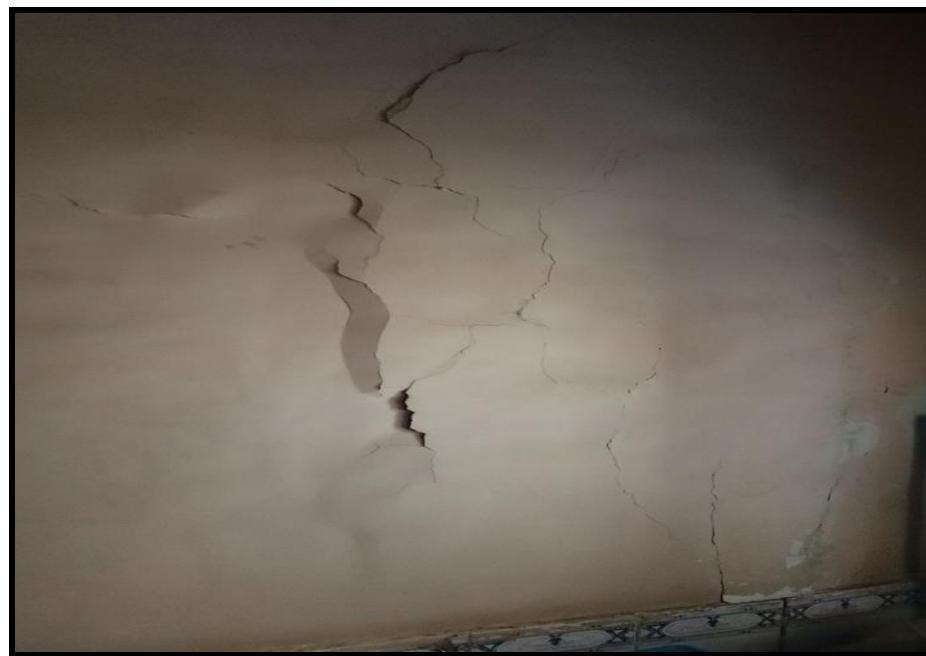
FLAT NO – 10

- ❖ **HALL** – Steel exposed and gets corroded. (**It may fall**)
 - Hallow sound observed on South side wall after during tapping. (**It may fall**)
 - Crack observed on North side wall.
 - Major structural crack observed on column.
- ❖ **KITCHEN** – Steel exposed and gets corroded. (**It may fall**)
- ❖ **PASSAGE** – Hallow sound observed on South side wall after during tapping. (**It may fall**)
 - Structural crack observed on North side wall.
 - Seepage mark observed on wall.
- ❖ **TOILET & BATH ROOM** – Steel exposed and gets corroded. (**It may fall**)

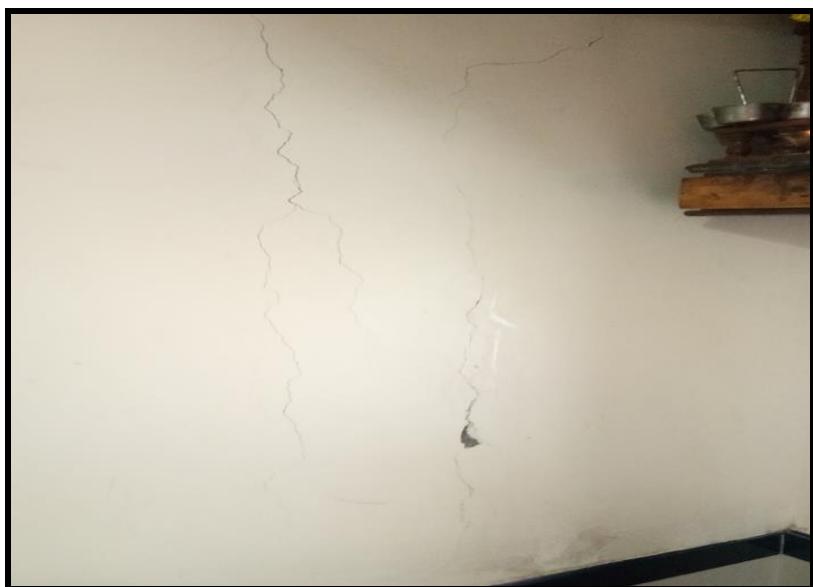
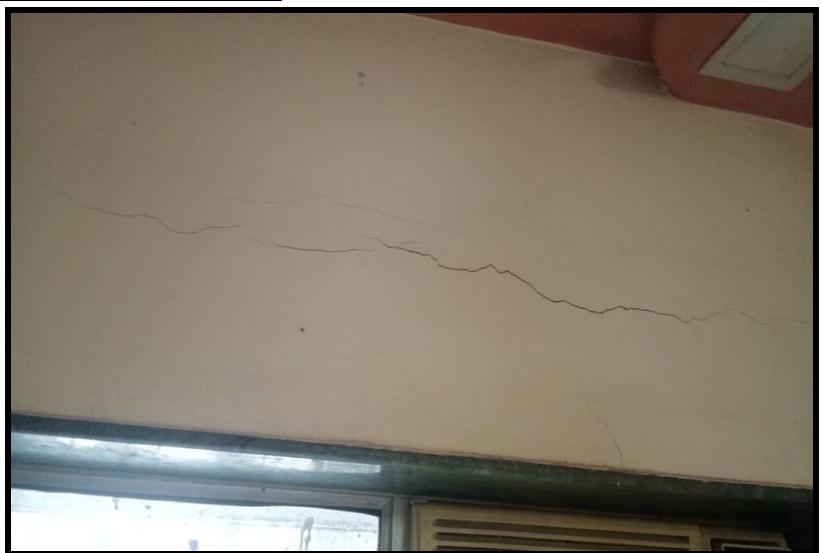
FLAT NO - 14

- ❖ **HALL** – Hallow sound observed on wall after during tapping. (**It may fall**)
 - Major structural crack observed on column.
- ❖ **KITCHEN** – Steel exposed and gets corroded. (**It may fall**)
- ❖ **PASSAGE** – Steel exposed and gets corroded. (**It may fall**)
 - Hallow sound observed on South side wall after during tapping. (**It may fall**)
- ❖ **TOILET & BATH ROOM** – Dampness observed on South side wall during monsoon.

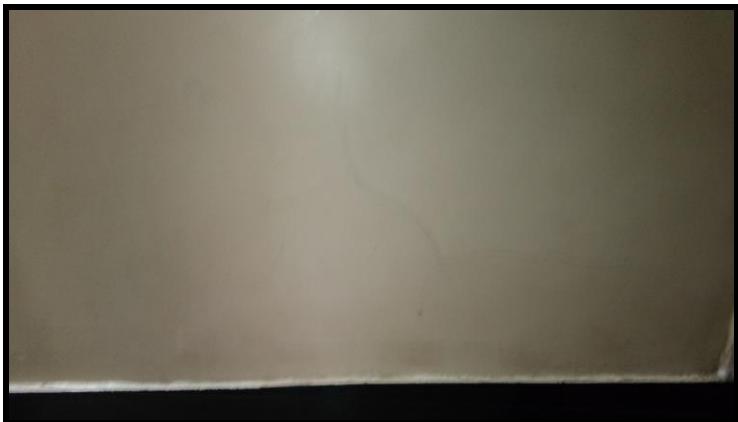
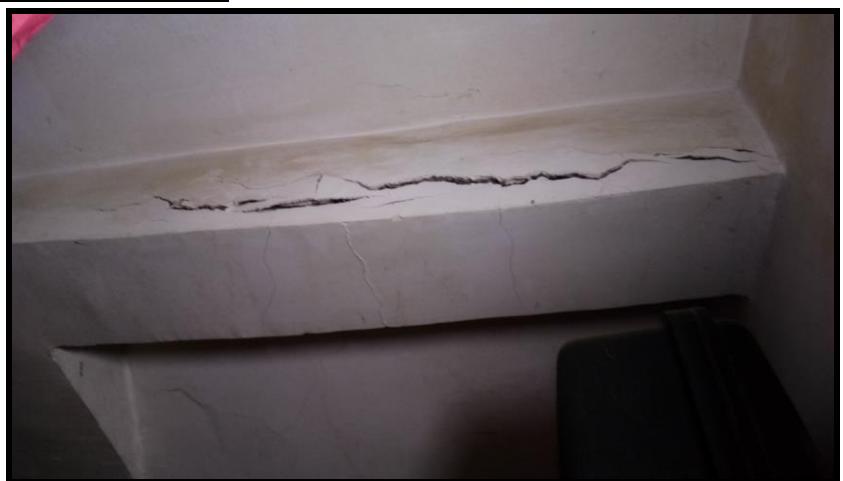
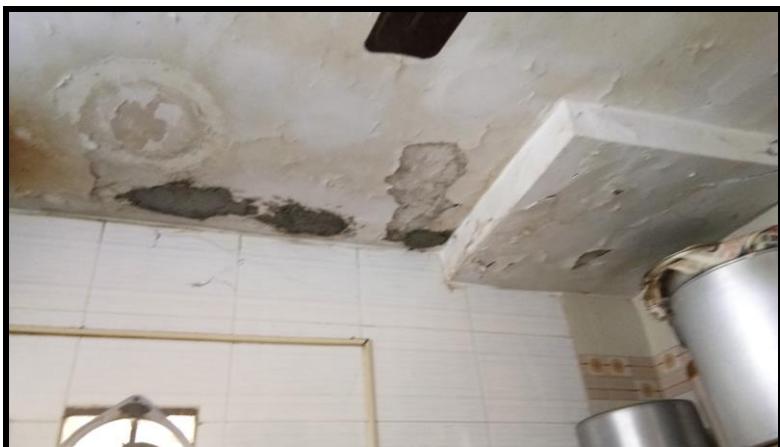
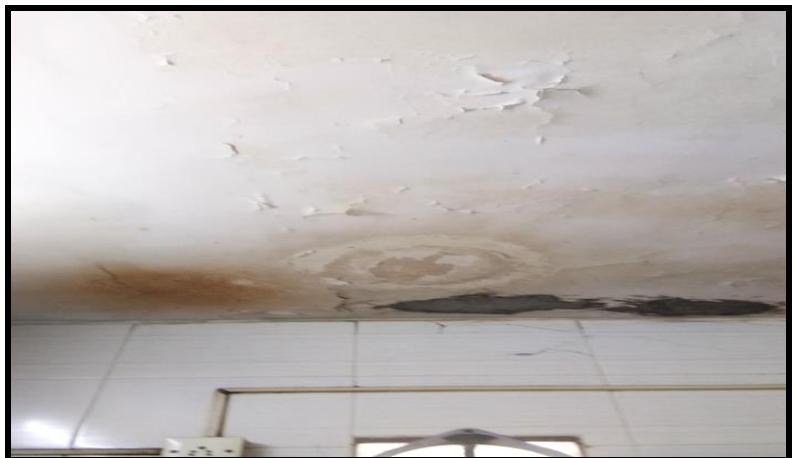
FLAT NO – 17

- ❖ **HALL** – Structural crack observed on North side wall.
- ❖ **KITCHEN** – Peeling of paint observed on ceiling.
- ❖ **PASSAGE** – O.K.
- ❖ **TOILET & BATH ROOM** – Dampness observed on wall during monsoon.

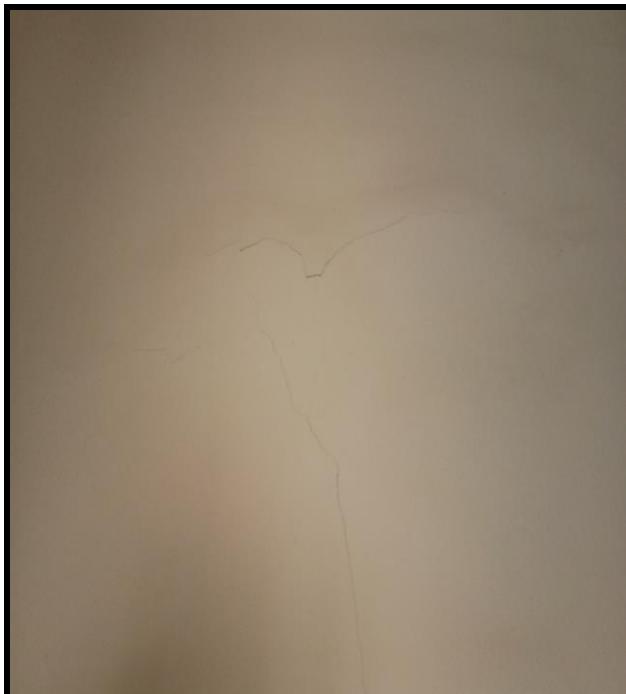
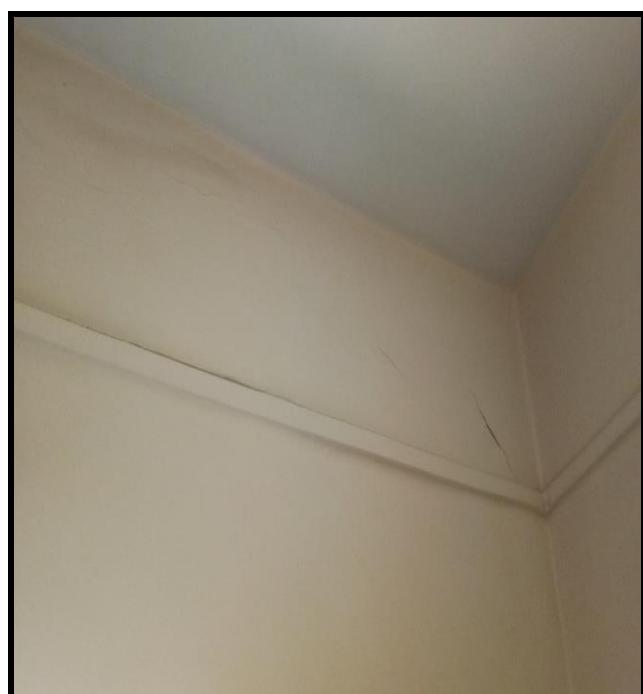
FLAT NO – 21

- ❖ **HALL** – Peeling of paint observed on wall.
- ❖ **KITCHEN** – Major structural crack observed on beam.
 - Hallow sound observed on South side wall after during tapping.
- ❖ **PASSAGE** – O.K.
- ❖ **TOILET & BATH ROOM** – O.K.

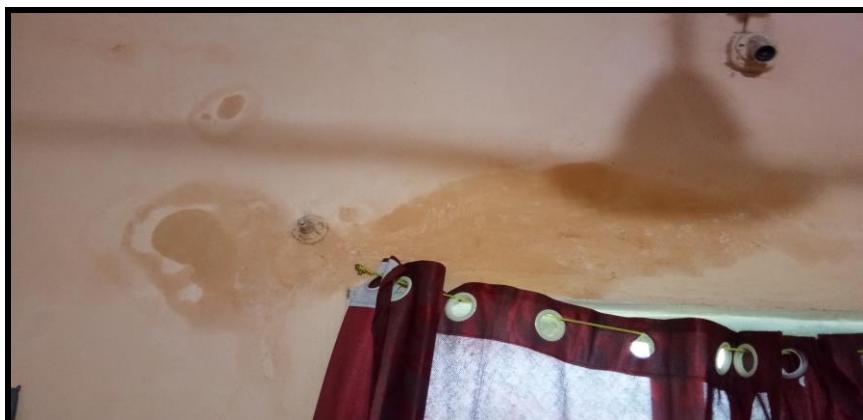
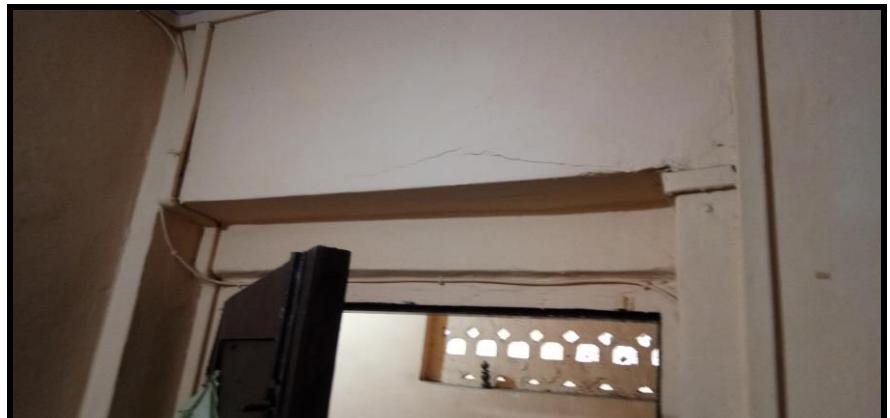
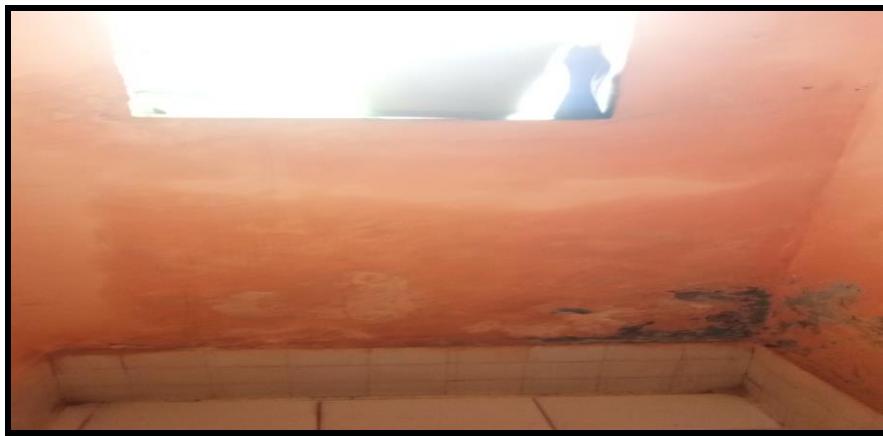
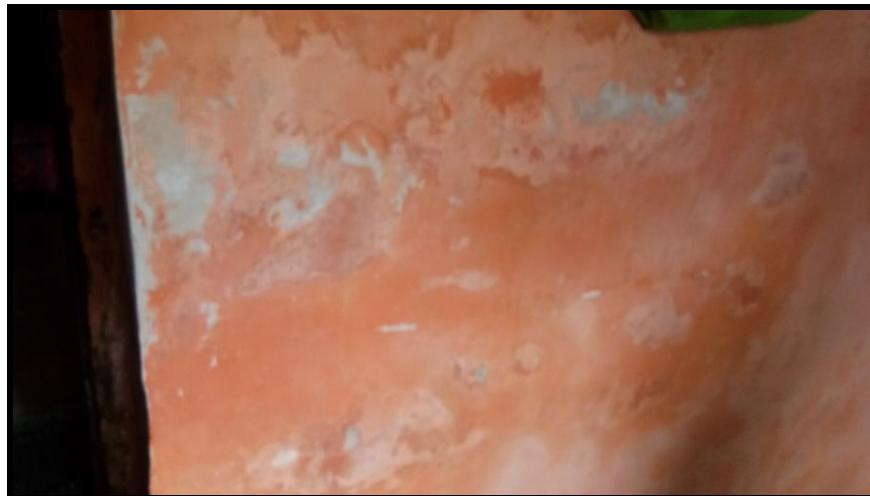
FLAT NO – 25

- ❖ **HALL** – Major leakage mark observed on ceiling during monsoon.
- ❖ Major leakage mark observed on wall during monsoon.
- ❖ **KITCHEN** – Peeling of paint observed on ceiling.
- ❖ **PASSAGE** – Seepage mark observed on wall.
- ❖ **TOILET & BATH ROOM** – O.K.

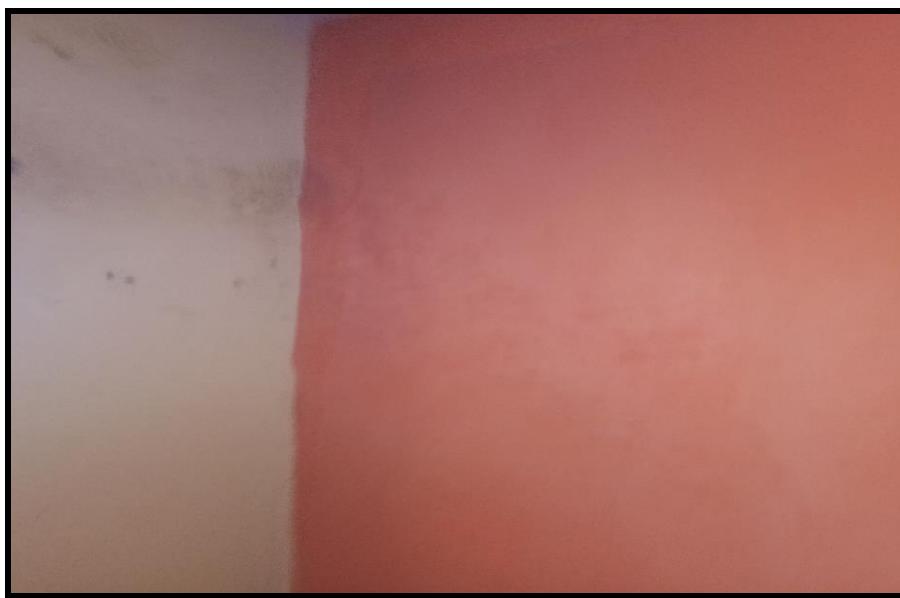
FLAT NO – 29

- ❖ **HALL** – Major leakage mark observed on ceiling during monsoon.
- ❖ Major leakage mark observed on wall during monsoon.
- ❖ **KITCHEN** – Major leakage mark observed on ceiling during monsoon
- ❖ Hollow sound observed on wall after during tapping.
- ❖ **PASSAGE** – OK.
- ❖ **TOILET & BATH ROOM** – Seepage mark observed on ceiling.

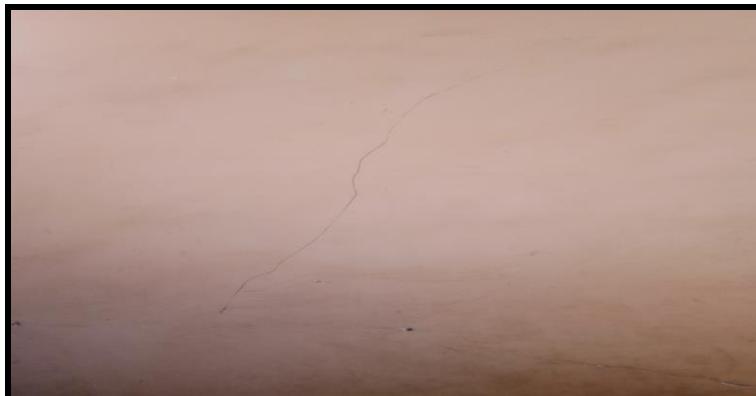
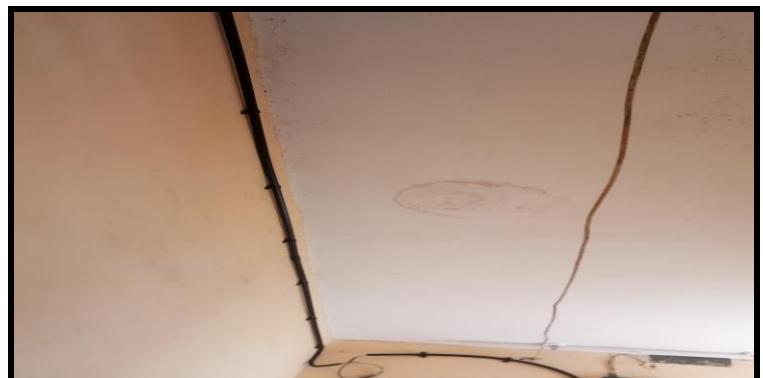
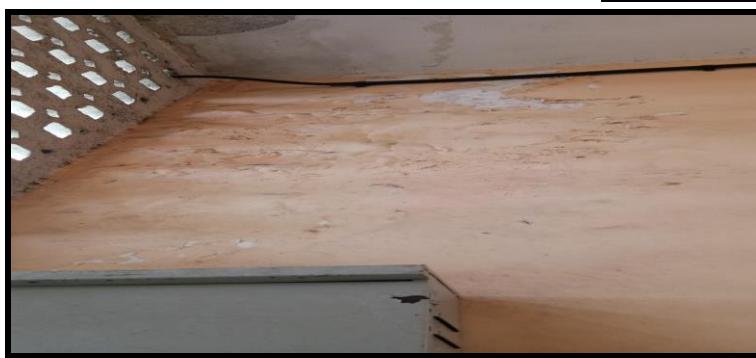
Terrace to Fourth floor:-

- ❖ Seepage mark observed on ceiling.
- ❖ Peeling of paint observed on wall.
- ❖ Plaster gets removed from ceiling observed.

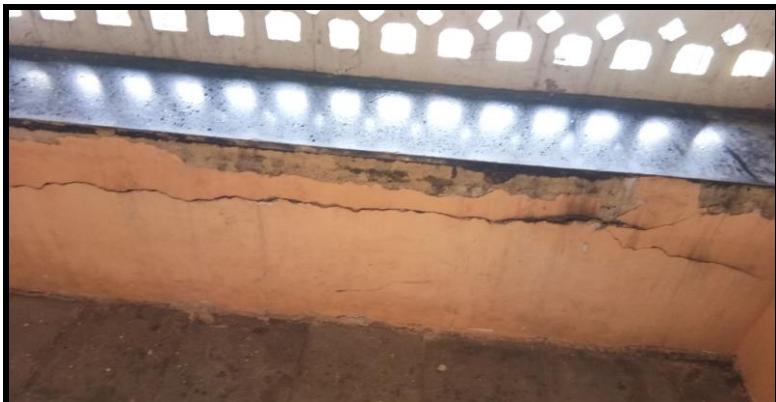
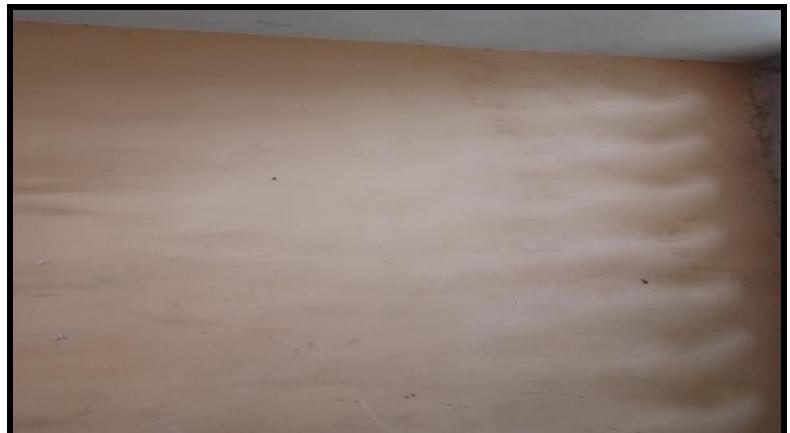
Fourth floor to Third floor:-

- ❖ Crack observed on cantilever beam.
- ❖ Seepage mark observed on wall.

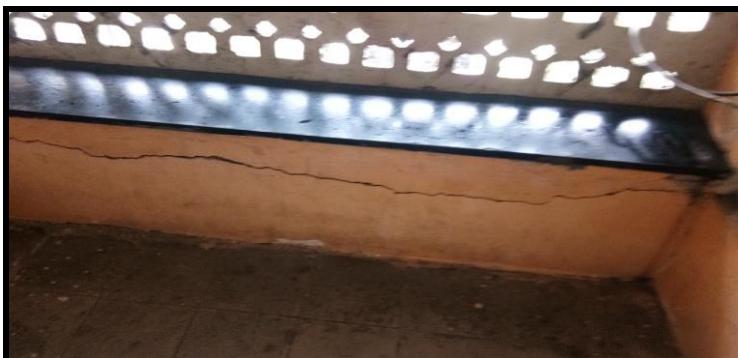
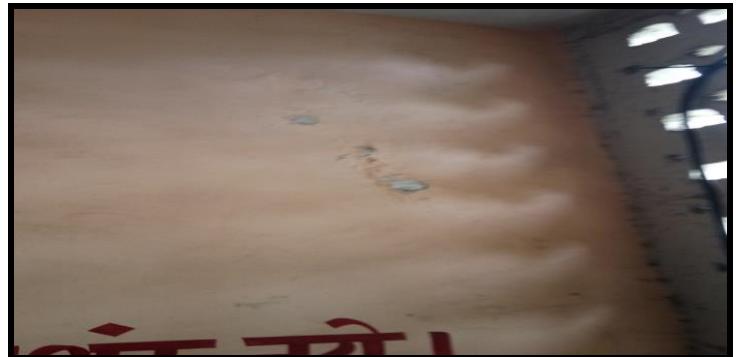
Third floor to Second floor:-

- ❖ Crack observed on cantilever beam.
- ❖ Seepage mark observed on wall.
- ❖ Peeling of paint observed on wall.

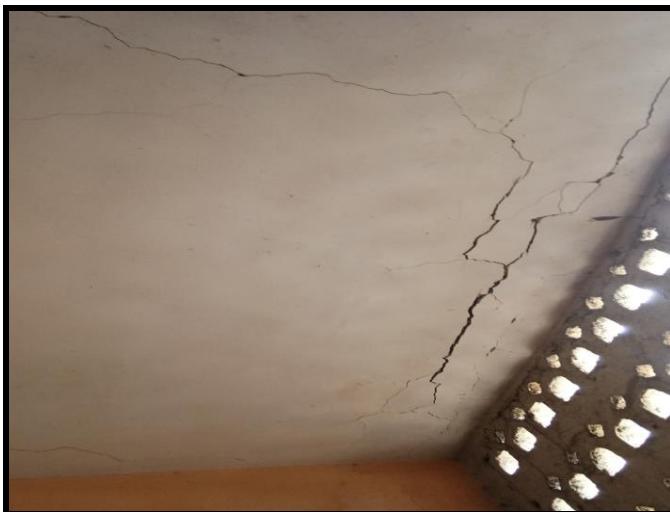
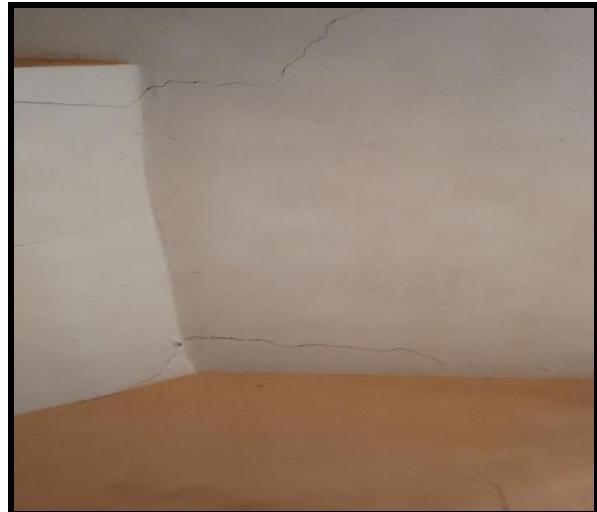
Second floor to First floor:-

- ❖ Crack observed on wall.
- ❖ Crack observed on ceiling.
- ❖ Hallow sound observed on ceiling after tapping.

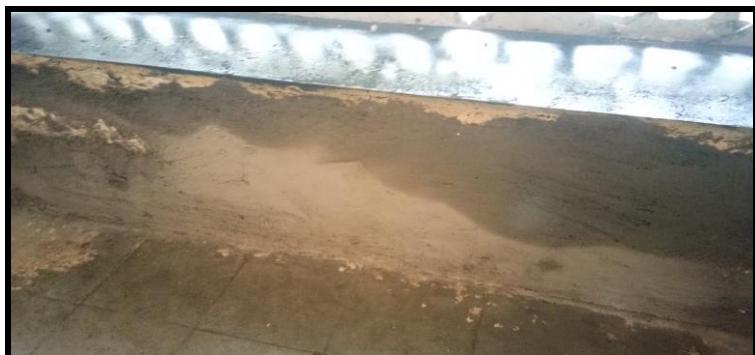
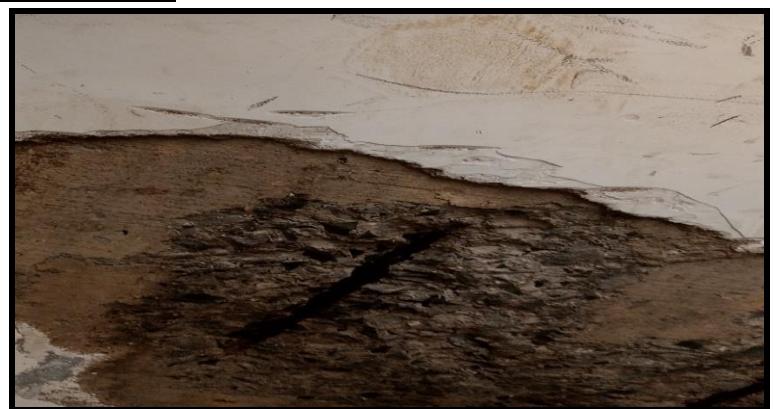
First floor to Ground floor:-

- ❖ Plaster work observed on wall.
- ❖ Plaster gets removed and steel gets exposed. (It may fall)

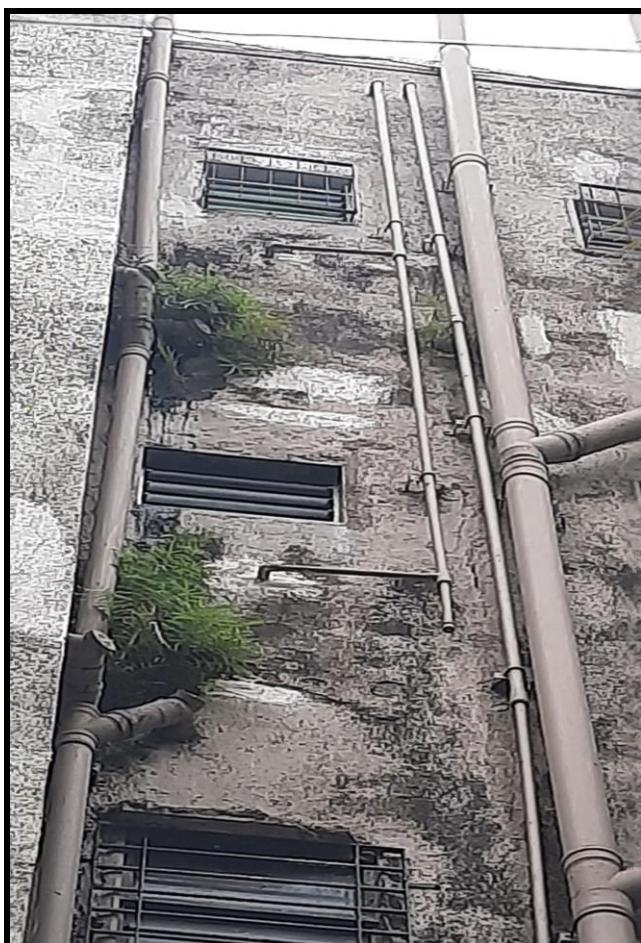
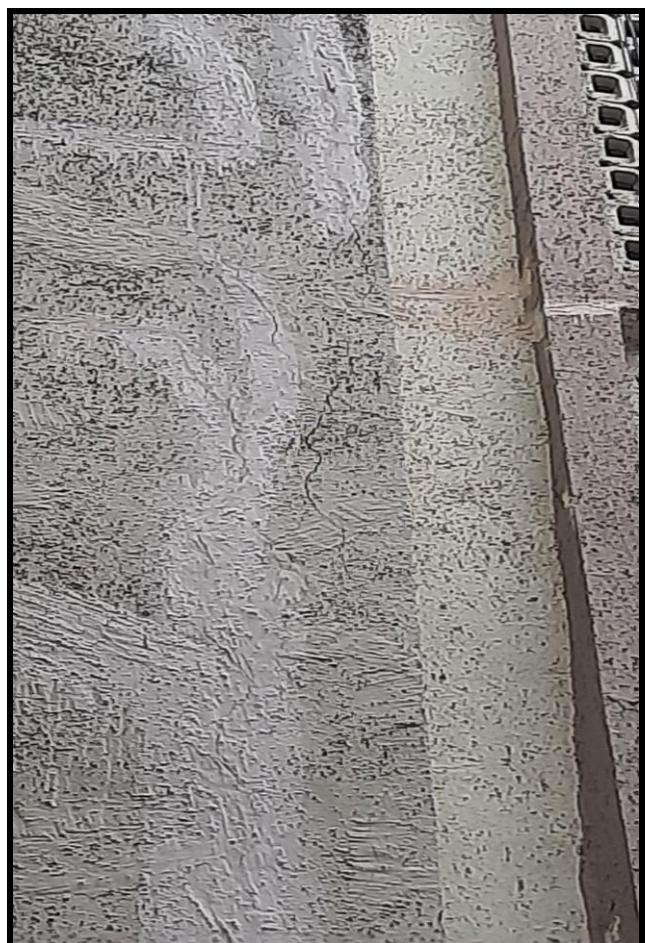
FRONT SIDE

- ❖ Structural crack observed at several places on column.
- ❖ Vegetation growth observed at several places on wall.

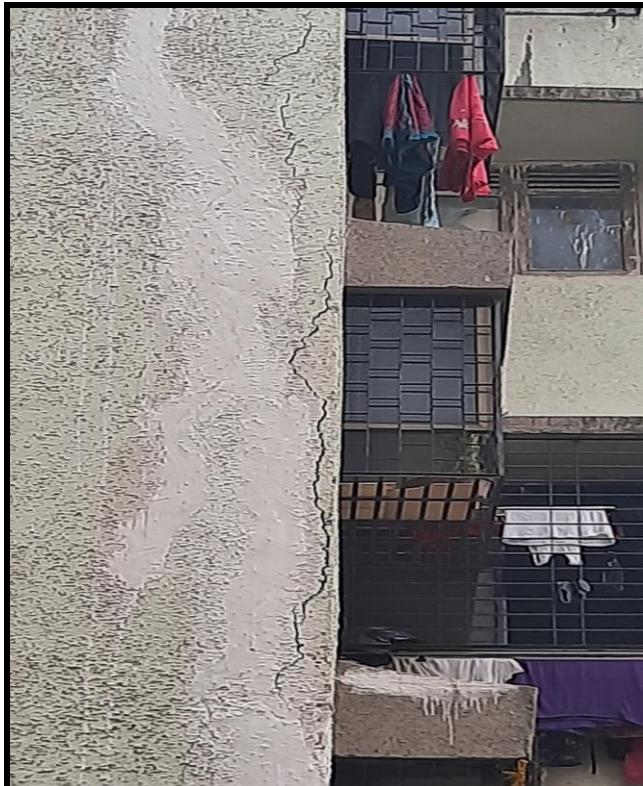
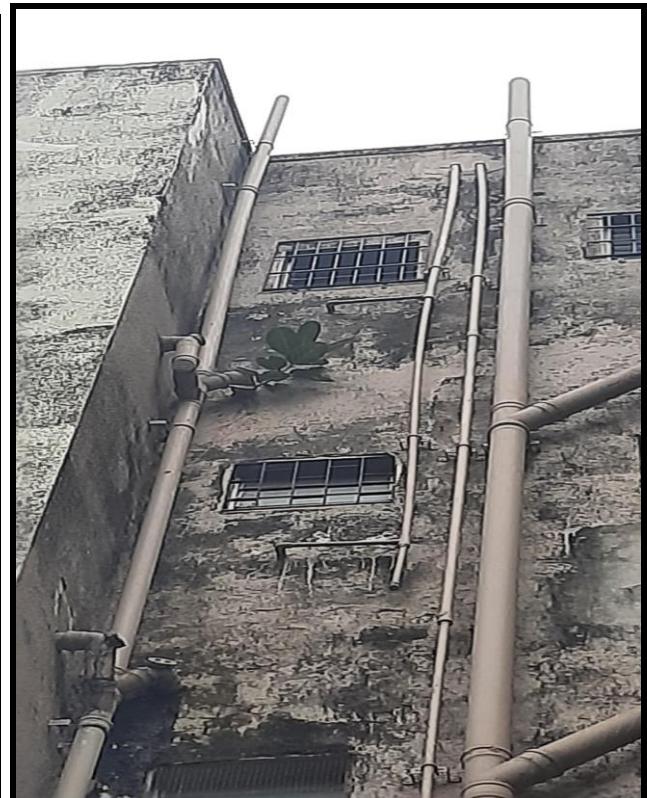
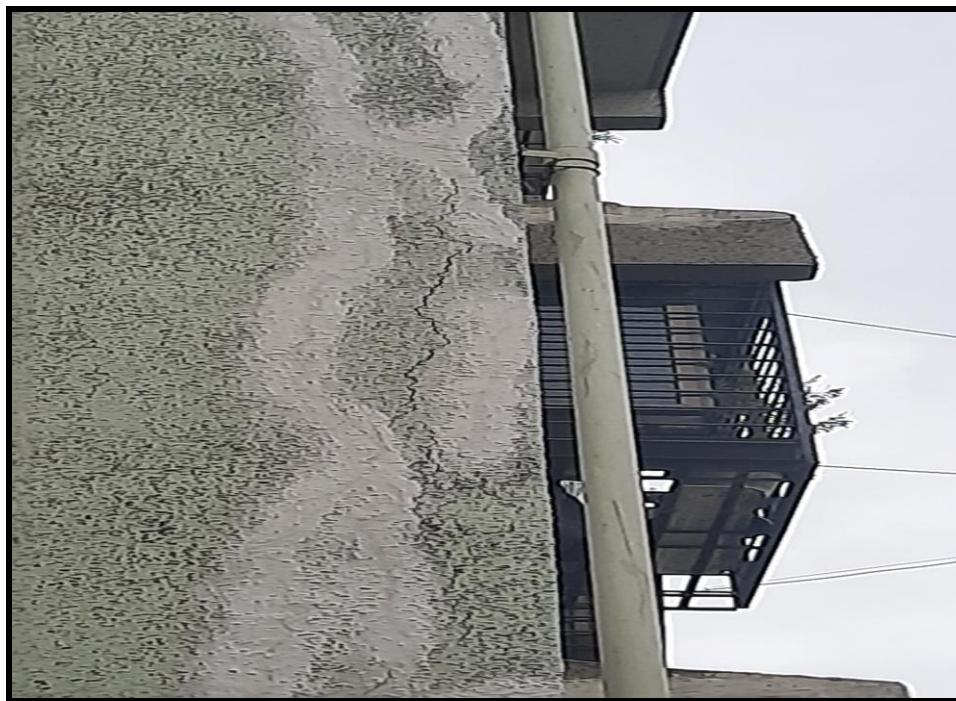
BACK SIDE

- ❖ Structural crack observed at several places on column.
- ❖ Vegetation growth observed at several places on wall.

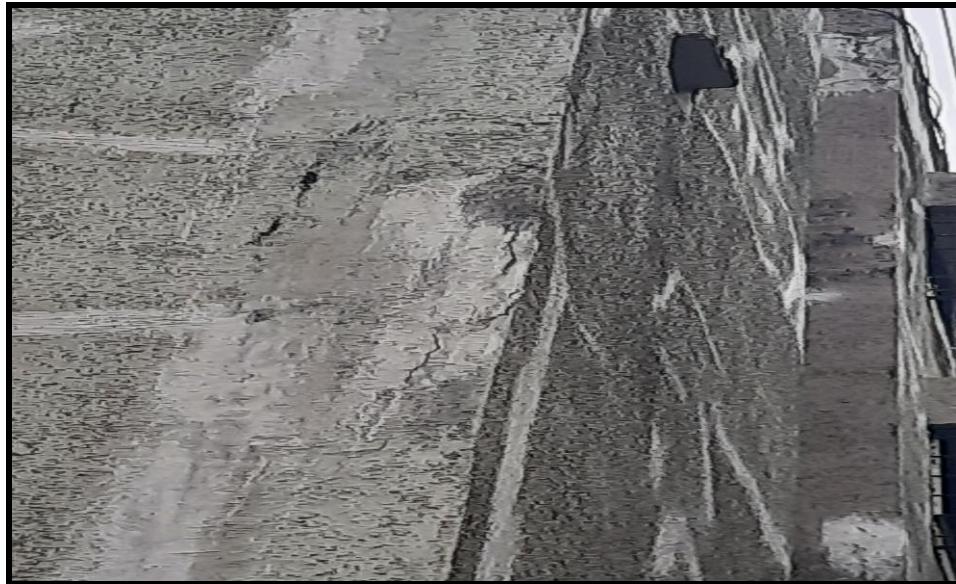
NORTH SIDE

- ❖ Structural crack observed at several places on column.
- ❖ Major crack observed at several places on wall.
- ❖ Vegetation growth observed at several places on wall.
- ❖ Column & chajja plaster get damaged & steel get exposed & corroded.

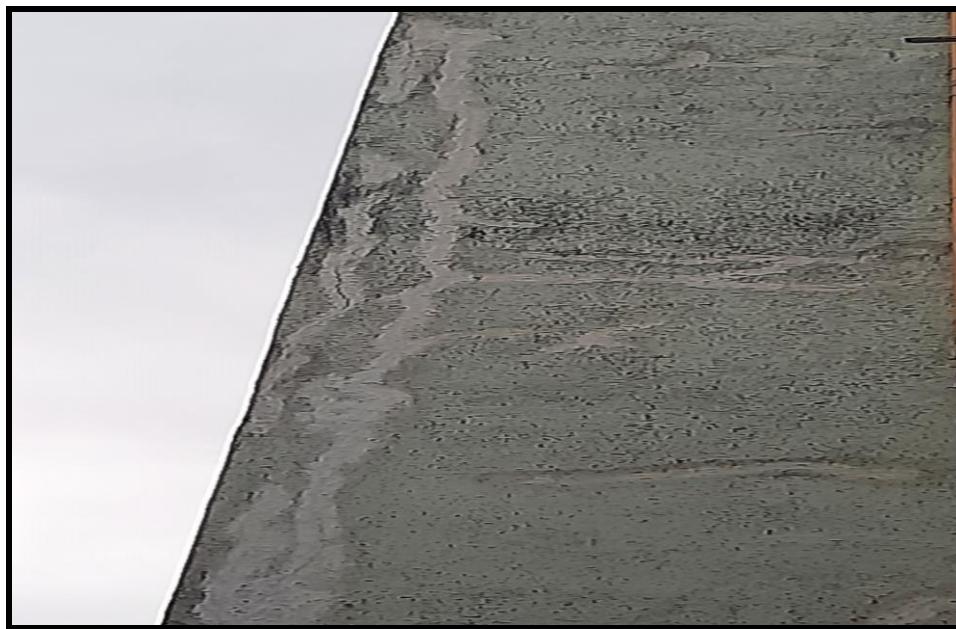
SOUTH SIDE

- ❖ Structural crack observed at several places on column.
- ❖ Major crack observed at several places on wall.
- ❖ Vegetation growth observed at several places on wall.
- ❖ Column & chajja plaster get damaged & steel get exposed & corroded.
