STRUCTURAL AUDIT REPORT  
**“VISHAL SAHYADRI CO – OP HSG. SOC. LTD”,**  
**“B12 – WING”**  
SITUATED AT  
SAHYADRI NAGAR, CHARKOP,  
KANDIVALI (W) MUMBAI – 400 067

978/B12/LSS/2021

JULY 24, 2021

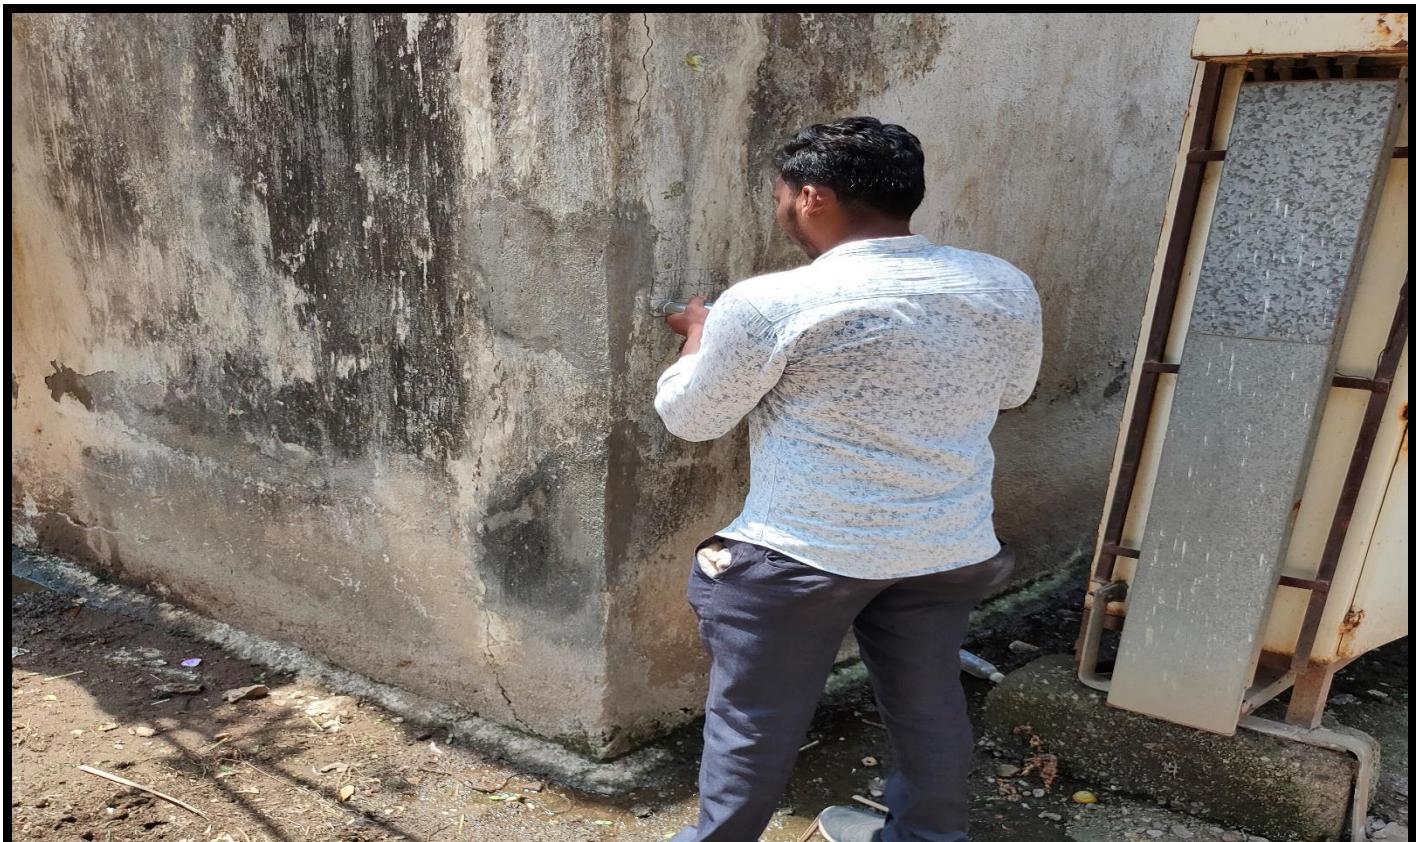
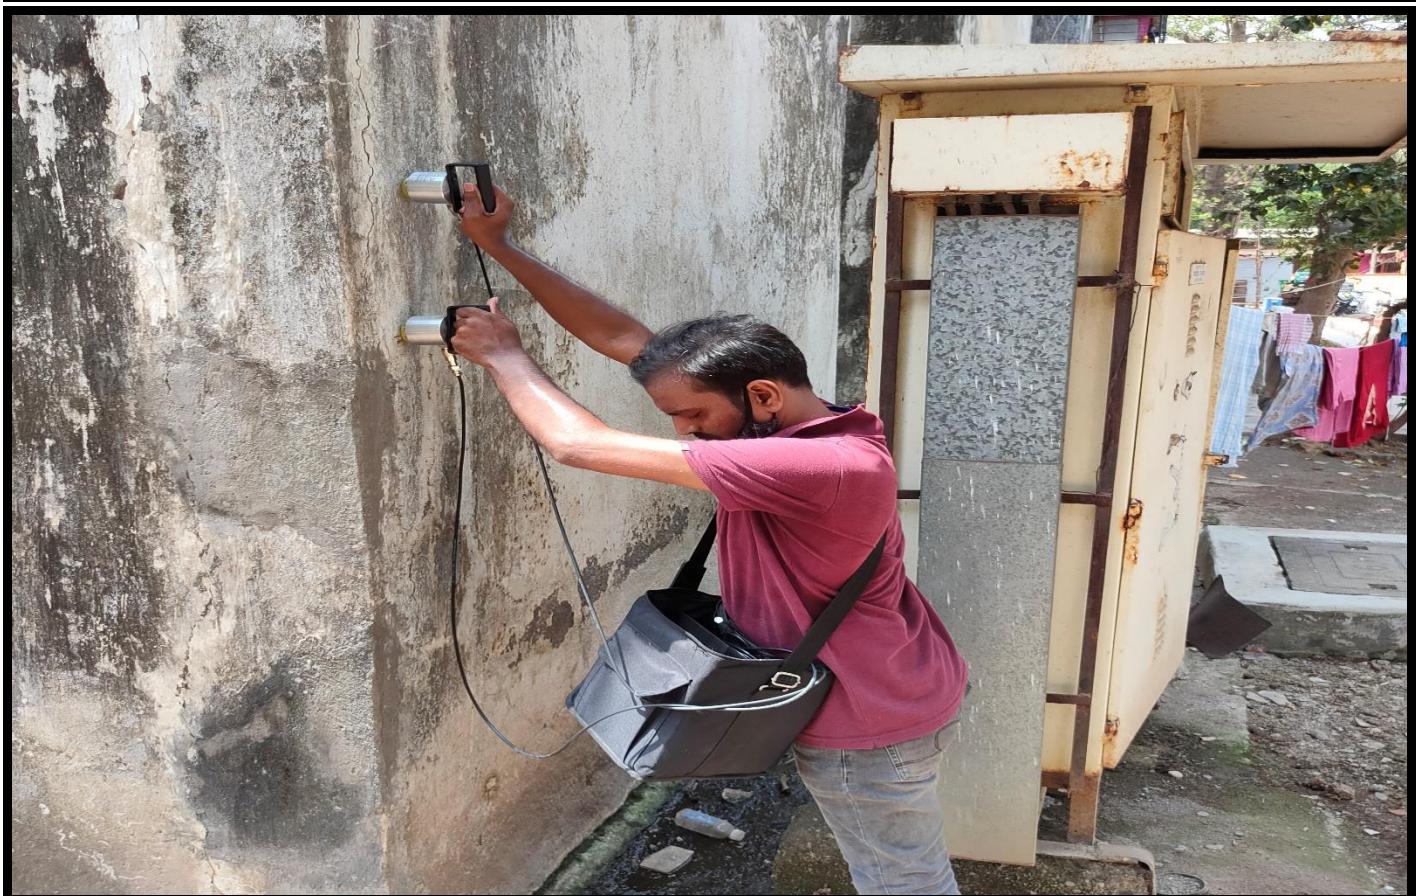
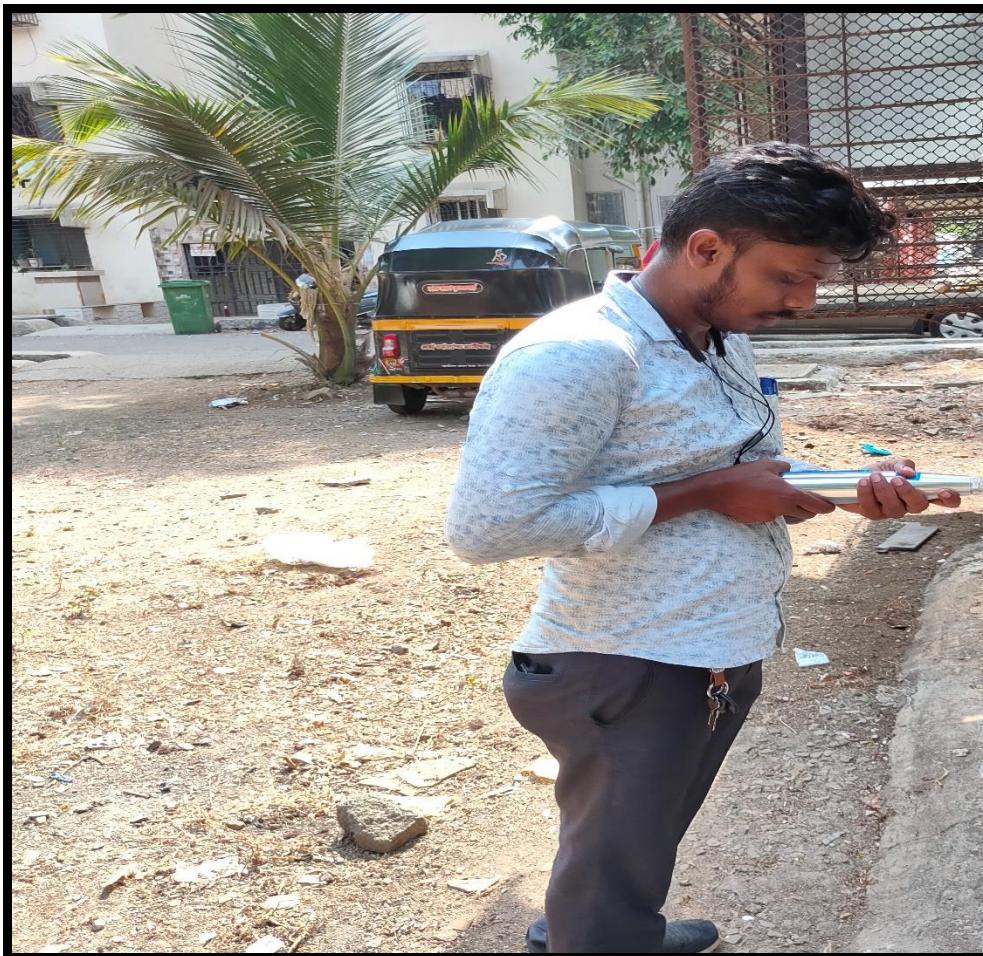
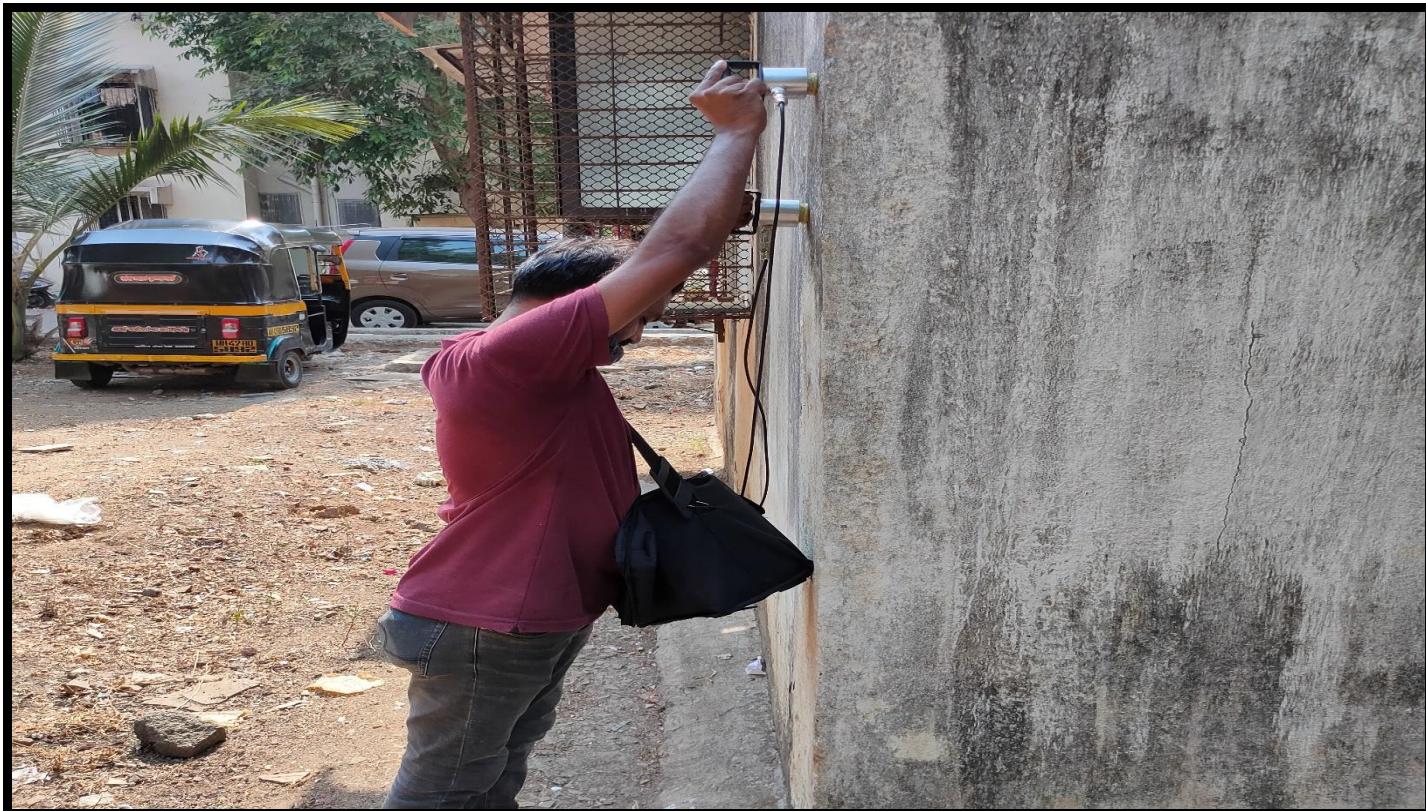
## NON -DESTRUCTIVE TEST PHOTO

Rebound Hammer was tested for compressive strength at surface by Schmidt rebound hammer. Results indicate the compressive strength at surface of all the RCC columns is ranging between 12.50 MPa to 23.30 MPa.

The UPV values are ranging between 2.2 Km/Sec to 3.73 Km/Sec.

Out of 4 locations 3 locations was below 3.0 Km/Sec means concrete quality is poor and 1 location ranging between 3.0 to 3.75 Km/Sec means concrete quality is doubtful.

This indicates there are progressive internal cracks in the RCC members due to corrosion of reinforced steel. These members are under distress condition.

Half Cell Potential tested for corrosion activity by half – cell potential tests. Values are taken on Column. The result on tested column is – 340 mV.

Carbonation test was conducted to assess carbonation depth. Readings are taken on Column. Result indicates the carbonation penetration depth is 40.00 mm. Carbonation depths have reached to the reinforcement level in all of the RCC elements. It is essential to give a suitable anti-corrosion treatment to all the RCC members to stop further carbonation and corrosion of concrete.

RCC elements indicating UPV values less than 3 Km/sec needs immediate attention.

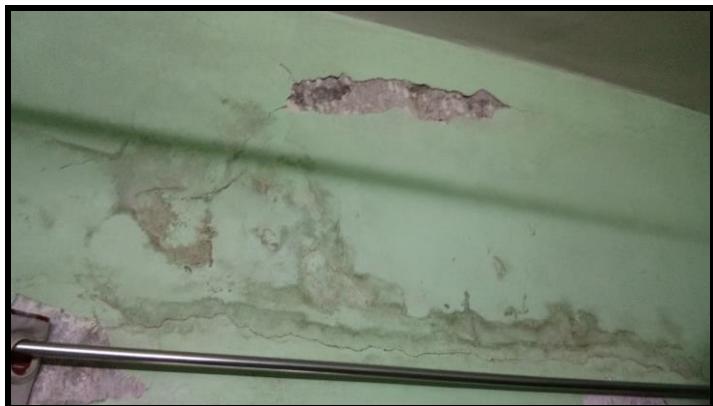
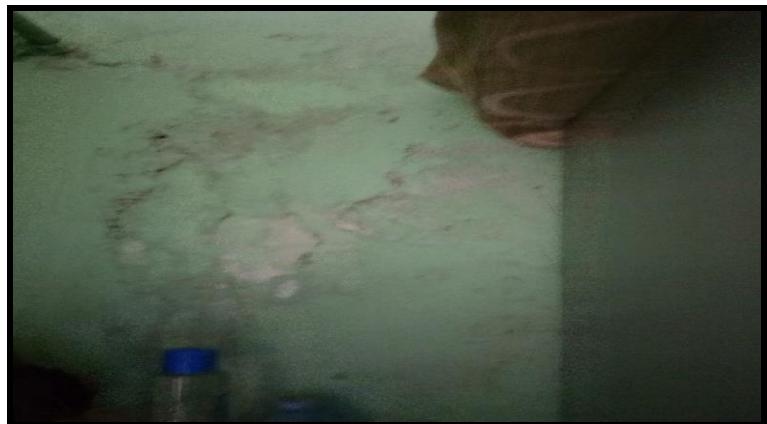
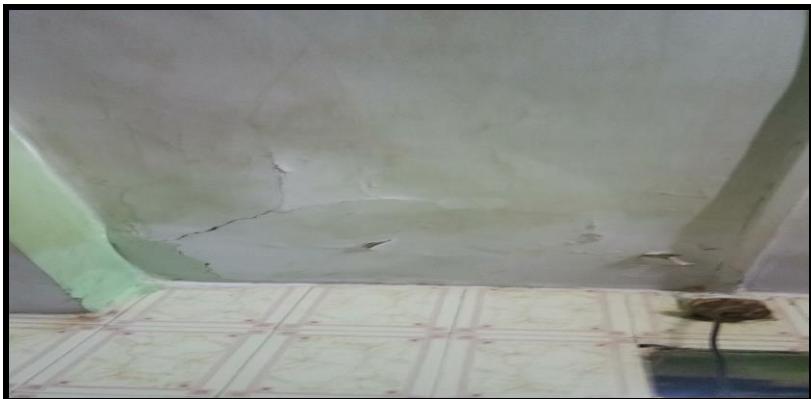
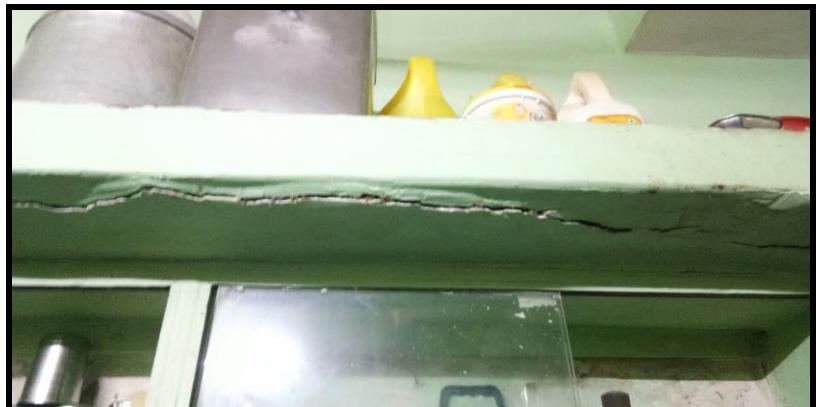
#### **FLAT NO – 03**

- ❖ **HALL** – Major structural crack observed on wall. (It may fall)
  - Seepage mark observed beam.
  - Peeling of paint observed on ceiling.
- ❖ **KITCHEN** – Hallow sound observed on wall after tapping.
  - Hallow sound observed on ceiling.
- ❖ **PASSAGE** – O.K.
- ❖ **TOILET AND BATHROOM** – Seepage mark observed on ceiling.

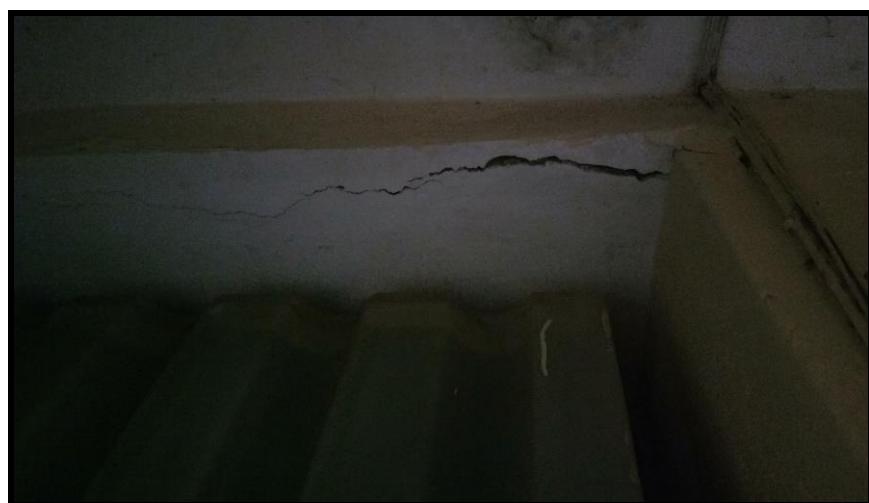
## FLAT NO - 04

- ❖ **HALL** – Leakage mark observed on wall.
  - Seepage mark observed on ceiling.
- ❖ **KITCHEN** – Major structural crack observed on beam.
  - Major structural crack observed on ceiling.
- ❖ **PASSAGE** – Major structural crack observed on beam.
- ❖ **TOILET AND BATHROOM** – Seepage mark observed on wall.

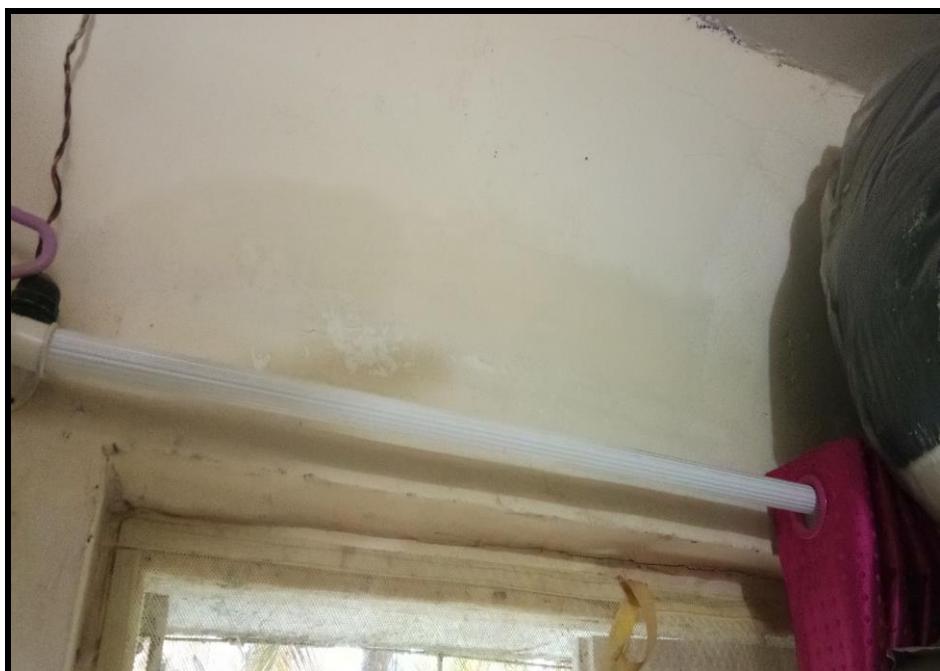
### **FLAT NO – 10**

- ❖ **HALL** – Leakage mark observed on wall.
  - Leakage mark observed on beam.
- ❖ **KITCHEN** – Seepage mark observed on wall.
  - Seepage mark observed on wall.
- ❖ **PASSAGE** – Peeling of paint observed on ceiling.
- ❖ **TOILET AND BATHROOM** – Crack observed on wall.

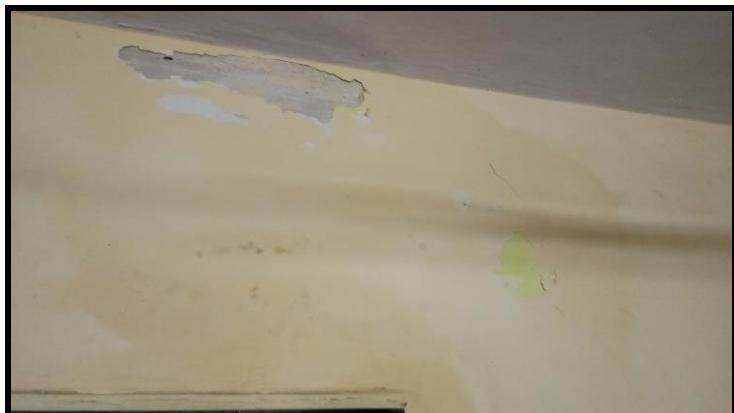
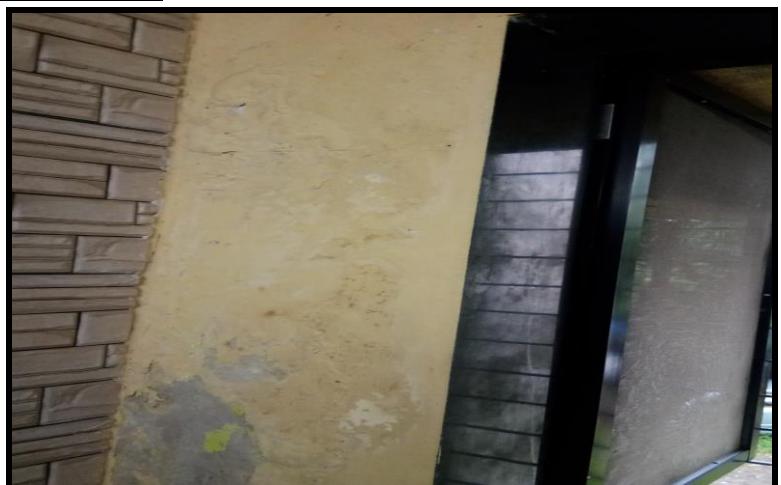
### **FLAT NO – 15**

- ❖ **HALL** – Major leakage mark observed on ceiling.
  - Peeling of paint observed on ceiling.
- ❖ **KITCHEN** – Leakage mark observed on wall.
- ❖ **PASSAGE** – Seepage mark observed on wall.
- ❖ **TOILET AND BATHROOM** – Dampness observed on wall.

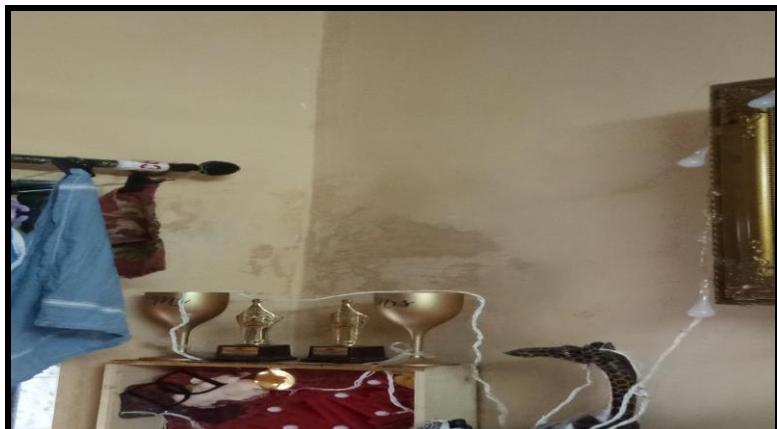
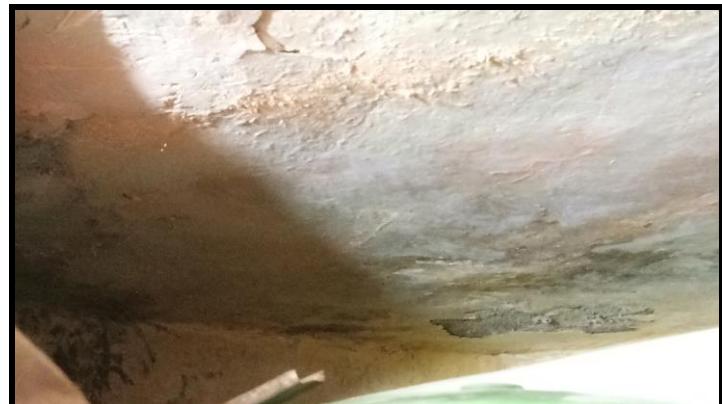
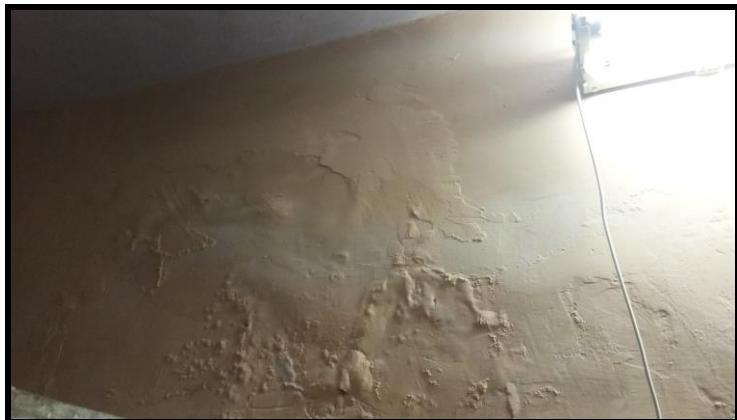
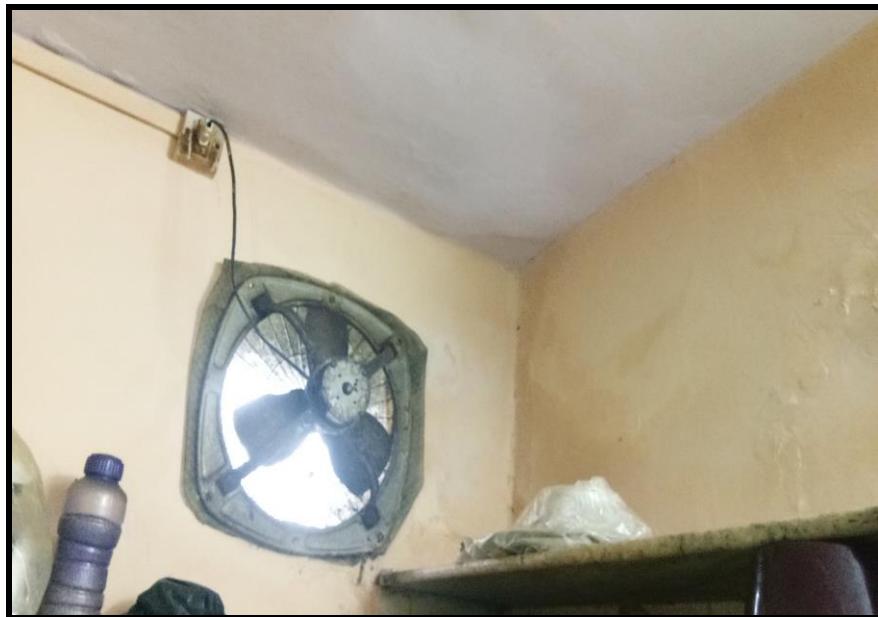
### FLAT NO – 21

- ❖ **HALL** – Major leakage mark observed on wall.
  - Major seepage mark observed on ceiling.
- ❖ **KITCHEN** – Peeling of paint observed on ceiling.
  - Peeling of paint observed on wall.
- ❖ **PASSAGE** – Hallow sound observed on ceiling.
- ❖ **TOILET AND BATHROOM** – Seepage mark observed on ceiling.
  - Peeling of paint observed on wall.

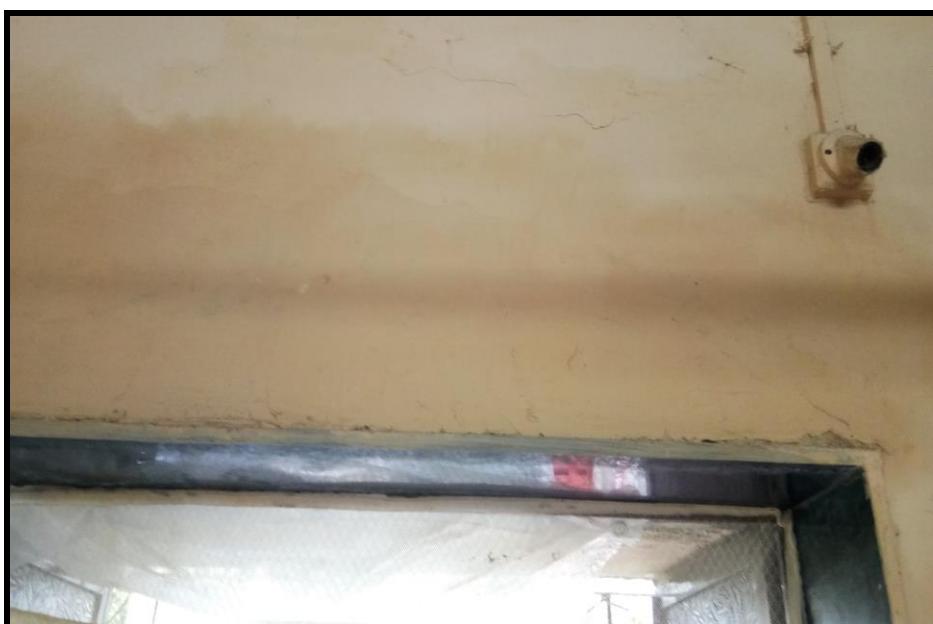
## FLAT NO - 22

- ❖ **HALL** – Major leakage mark observed on wall.
  - Peeling of paint observed on ceiling.
- ❖ **KITCHEN** – Hallow sound observed on ceiling.
- ❖ **PASSAGE** – Seepage mark observed on ceiling.
- ❖ **TOILET AND BATHROOM** – Major leakage mark observed on wall.
  - Major leakage mark observed on ceiling.

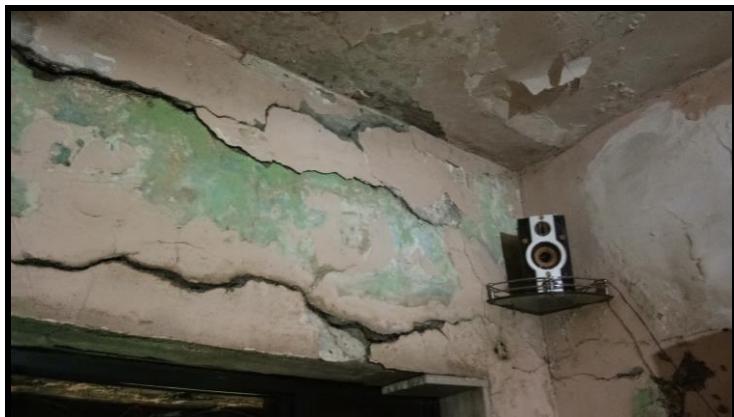
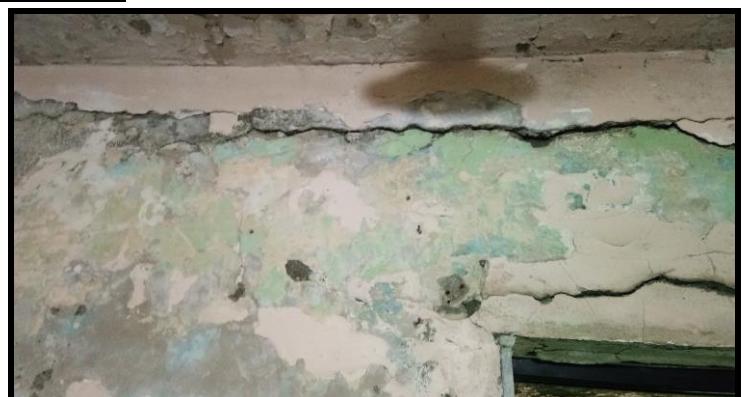
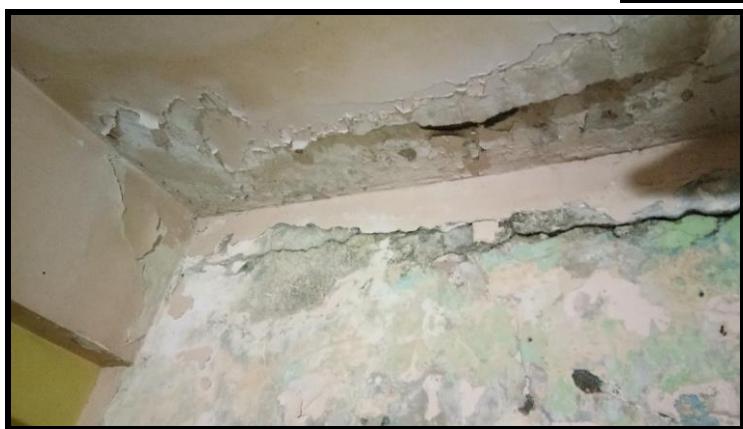
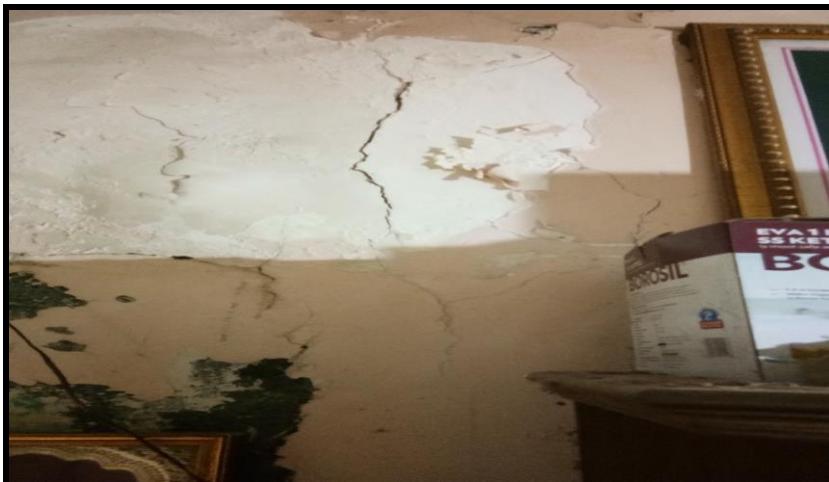
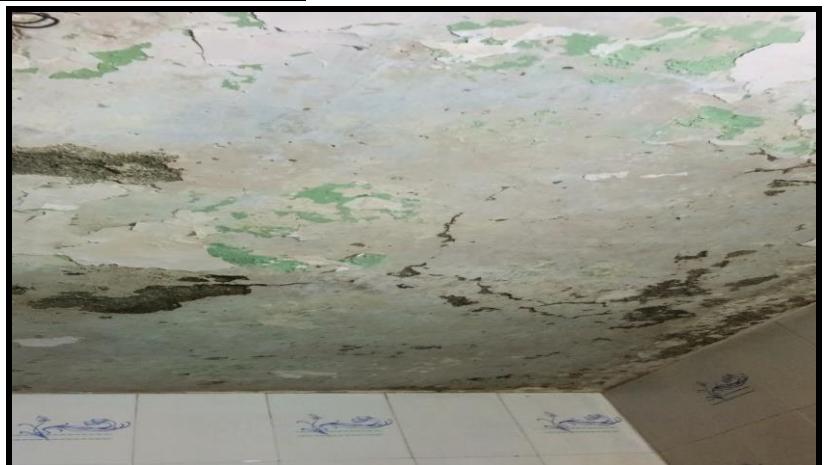
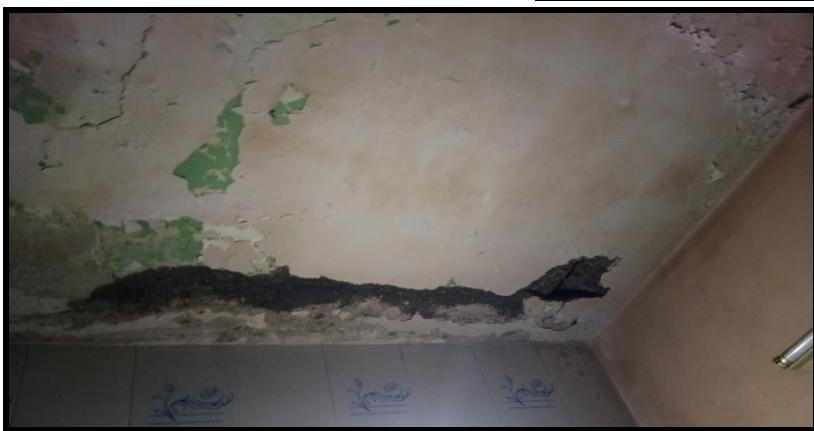
### FLAT NO – 27

- ❖ **HALL** – Major structural crack observed on wall. (**It may fall**)
  - Major structural crack observed on beam. (**It may fall**)
- ❖ **KITCHEN** – Seepage mark observed on wall.
- ❖ **PASSAGE** – Major structural crack observed on wall.
  - Major structural crack observed on beam.
  - Major leakage mark observed on wall. (**It may fall**)
- ❖ **TOILET AND BATHROOM** – Major leakage mark observed on wall.

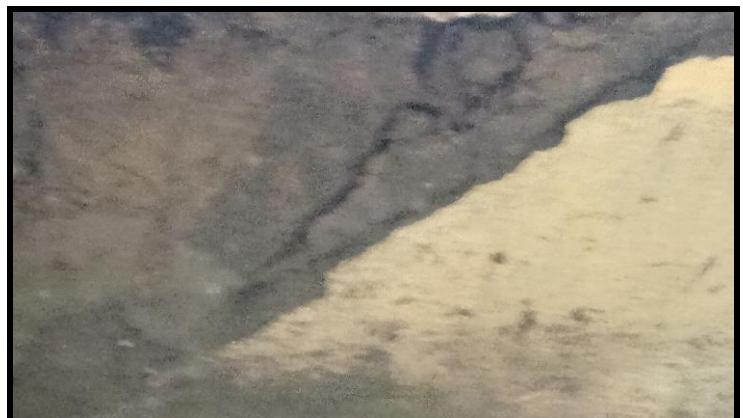
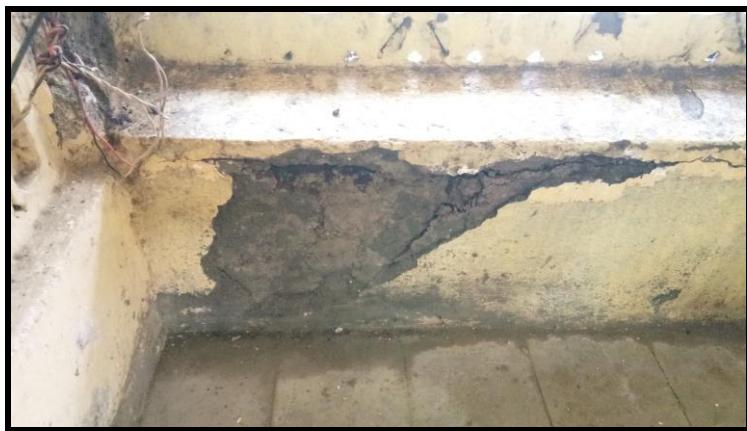
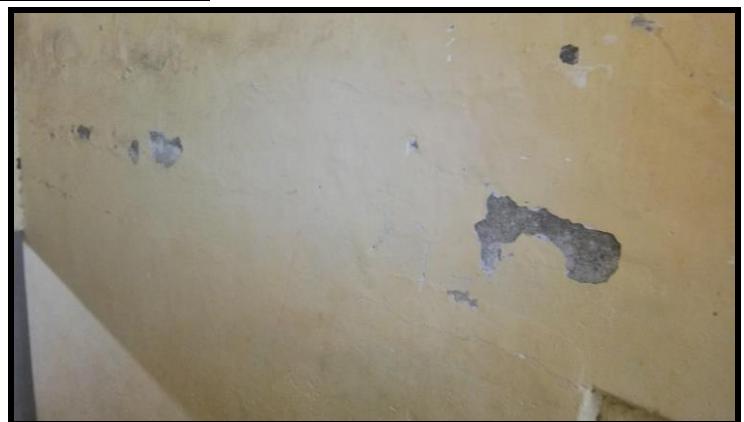
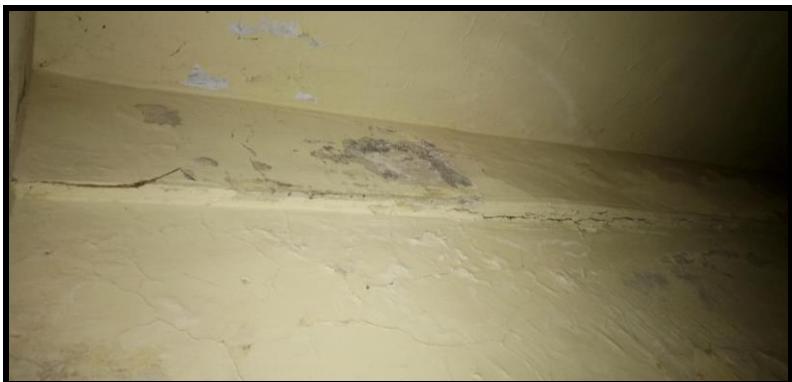
### Terrace to Fourth floor:-

- ❖ Major structural crack observed on wall.
- ❖ Plaster gets removed and steel exposed. (It may fall)
- ❖ Seepage mark observed on wall.
- ❖ Peeling of paint observed on wall.
- ❖ Major structural crack observed on beam.

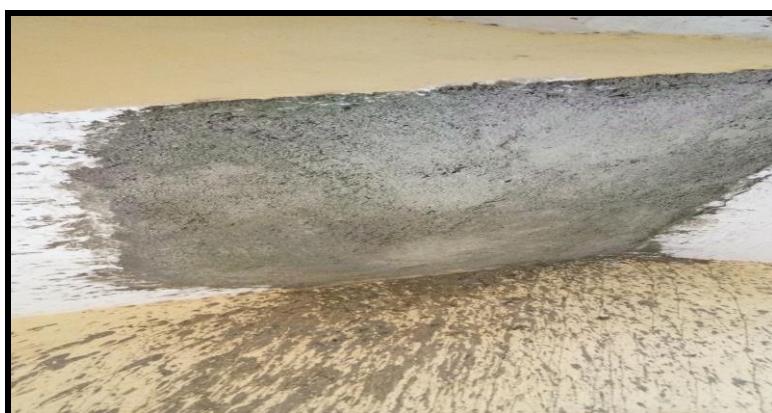
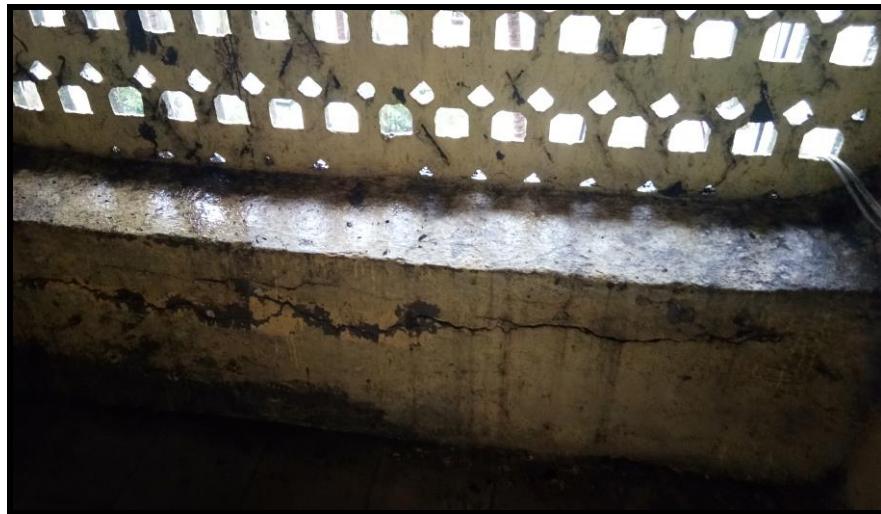
#### **Fourth floor to Third floor:-**

- ❖ Patch work observed on wall.
- ❖ Major structural crack observed on cantilever beam.

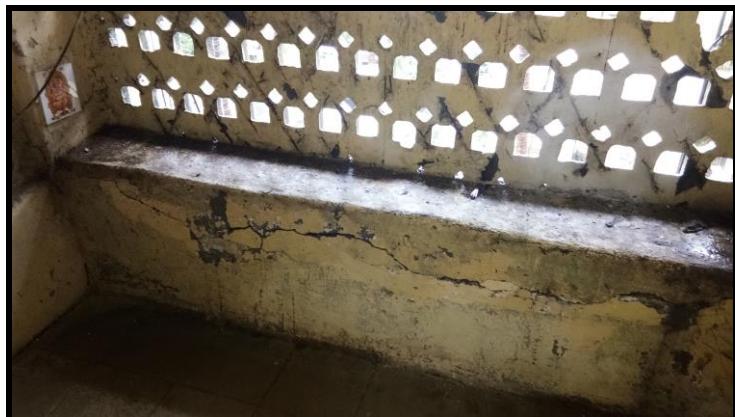
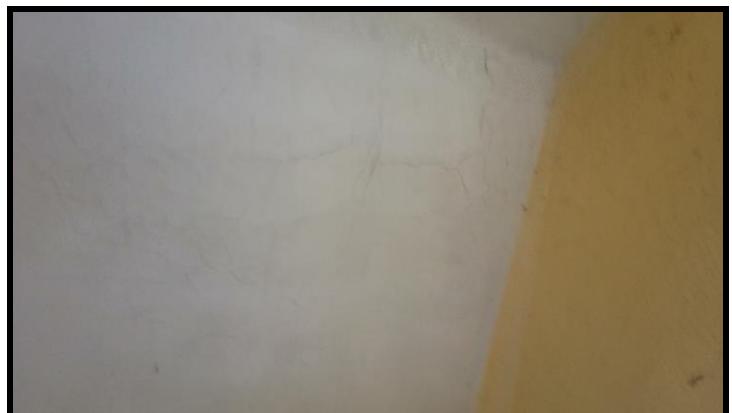
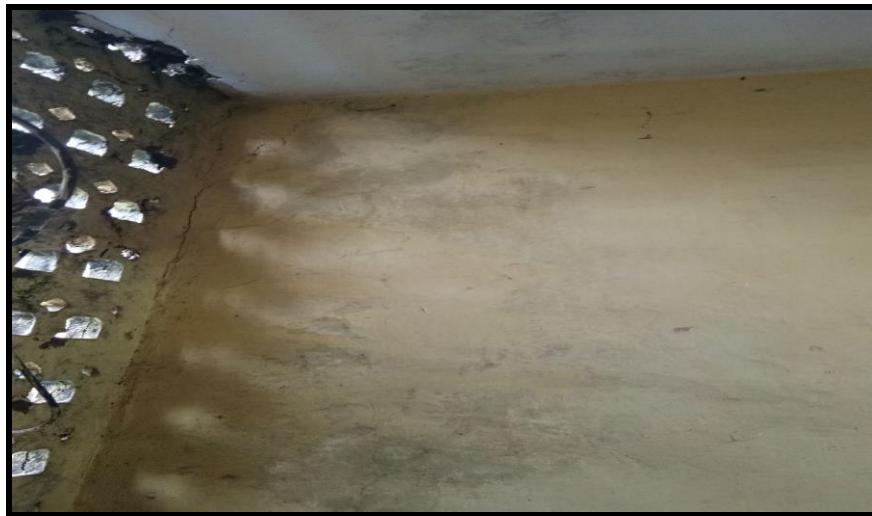
### Third floor to Second floor:-

- ❖ Major structural crack observed on cantilever beam.
- ❖ Major seepage mark observed on wall.

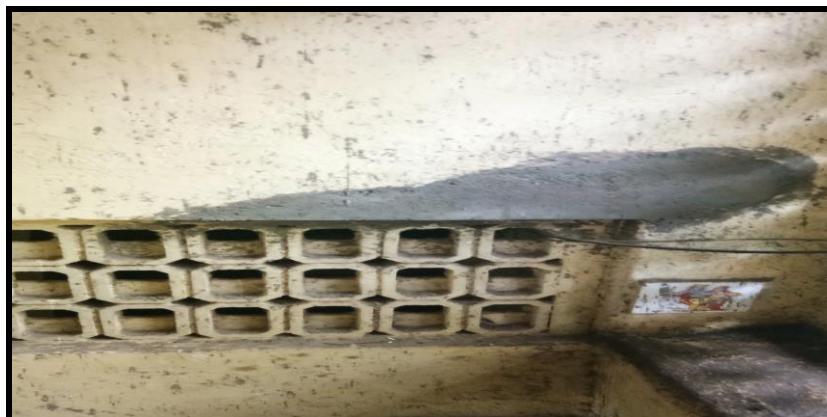
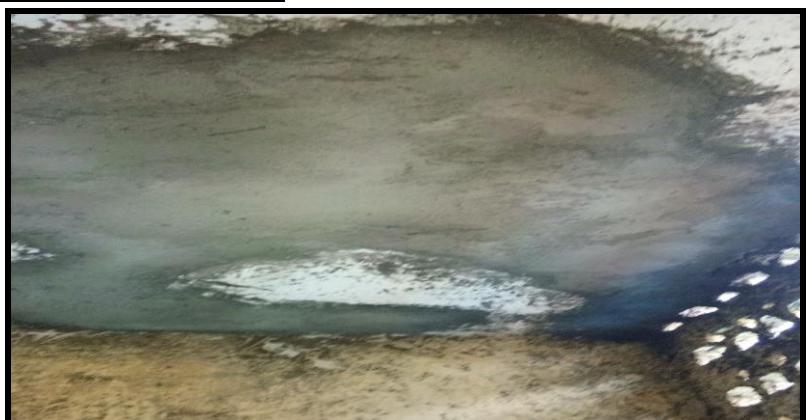
### **Second floor to First floor:-**

- ❖ Patch work observed on wall.
- ❖ Patch work observed on ceiling.

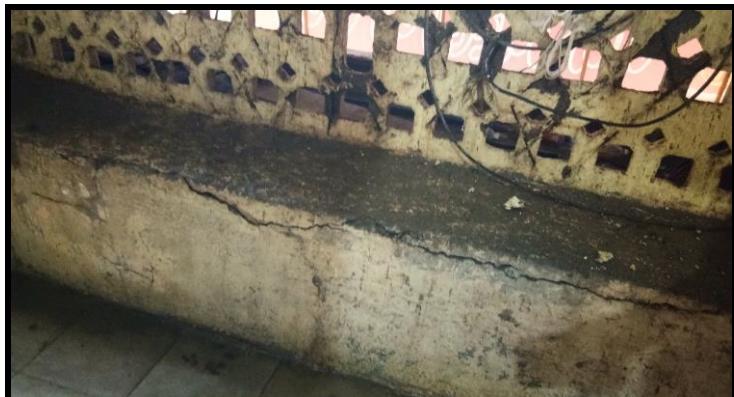
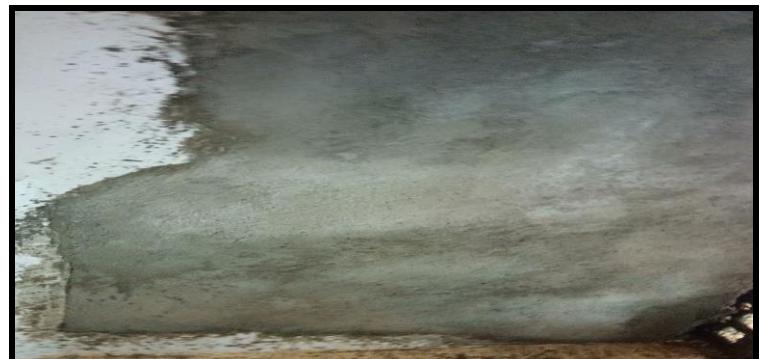
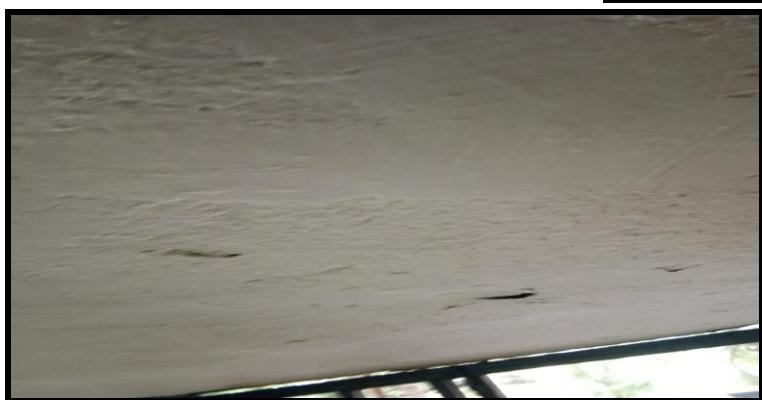
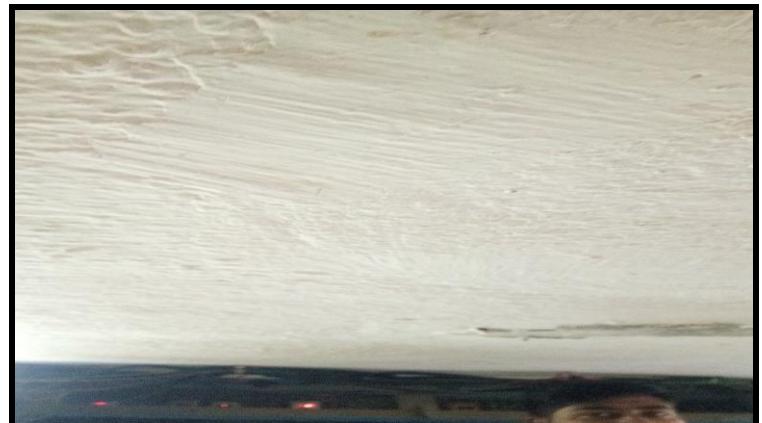
## First floor to Ground floor:-

- ❖ Major structural crack observe on cantilever beam.
- ❖ Patch work observed on ceiling.
- ❖ Hallow sound observed on wall.

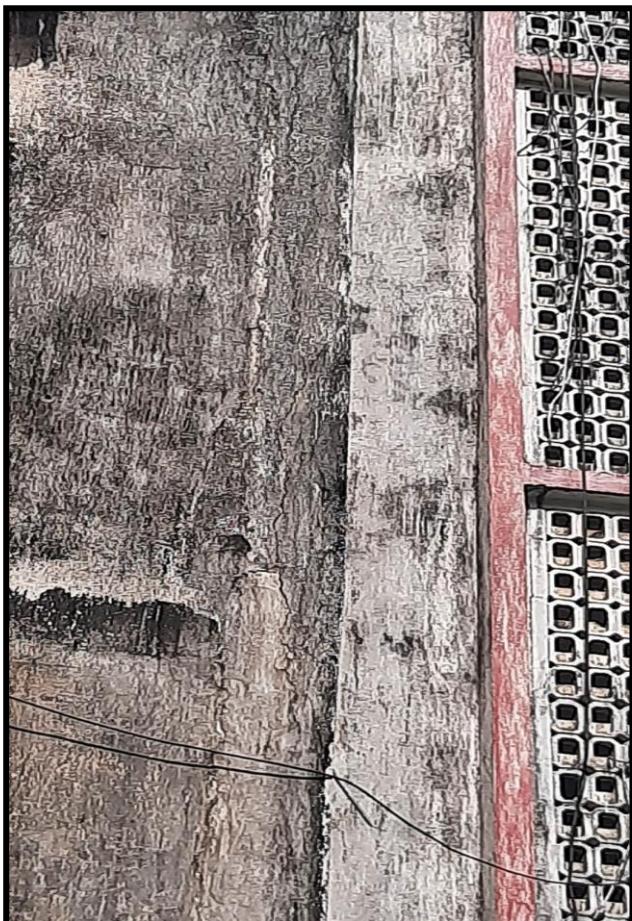
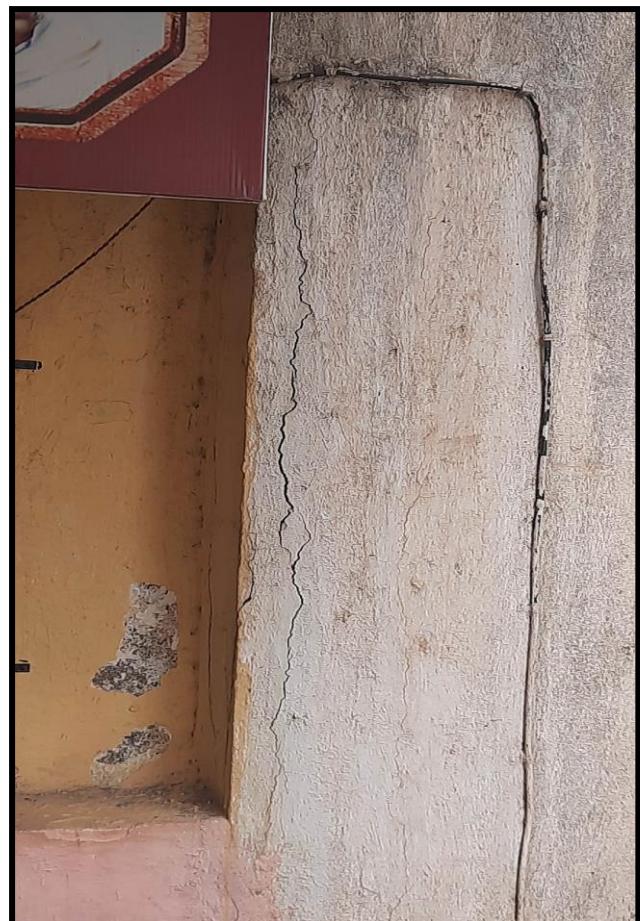
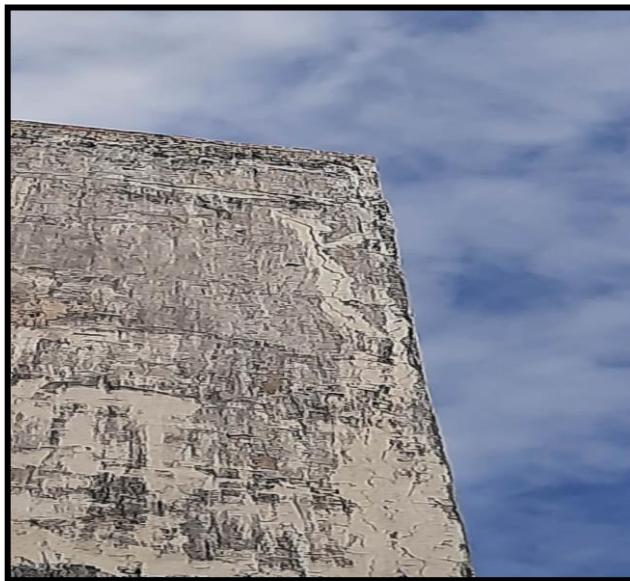
#### FRONT SIDE

- ❖ Structural crack observed at several places on column.
- ❖ Major crack observed at several places on wall.

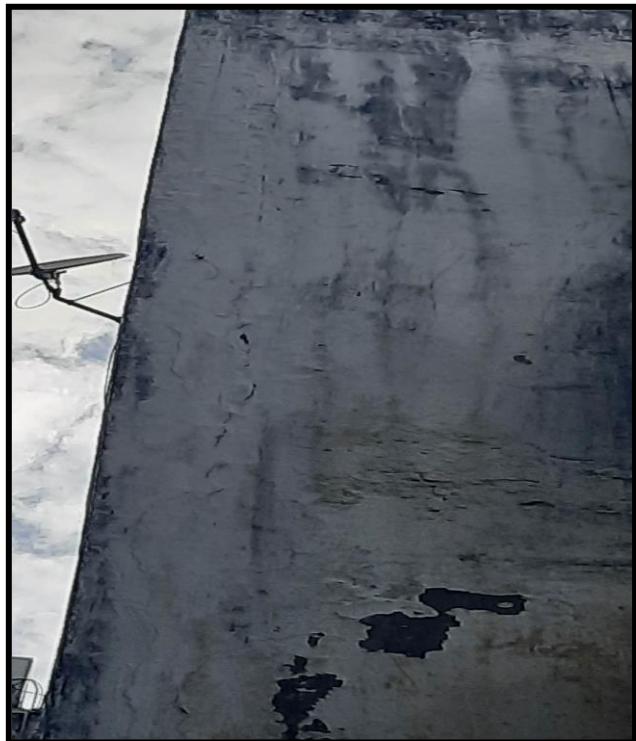
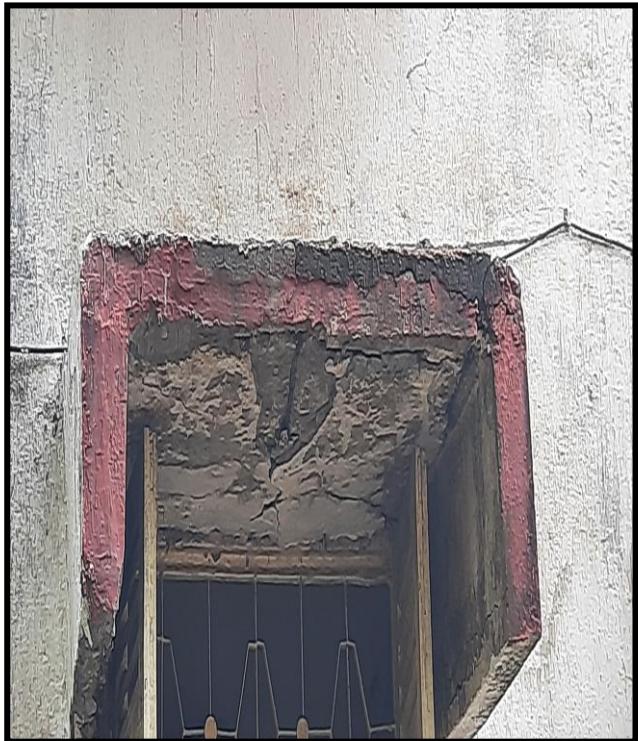
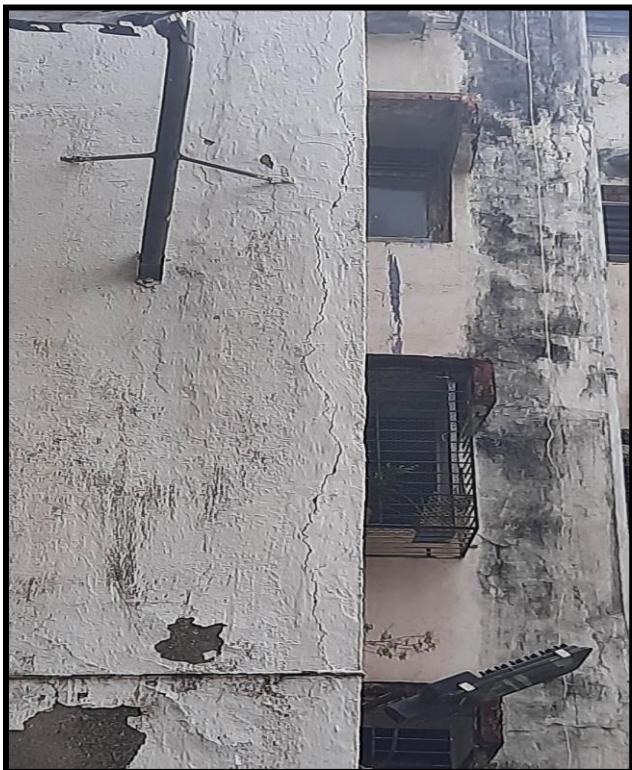
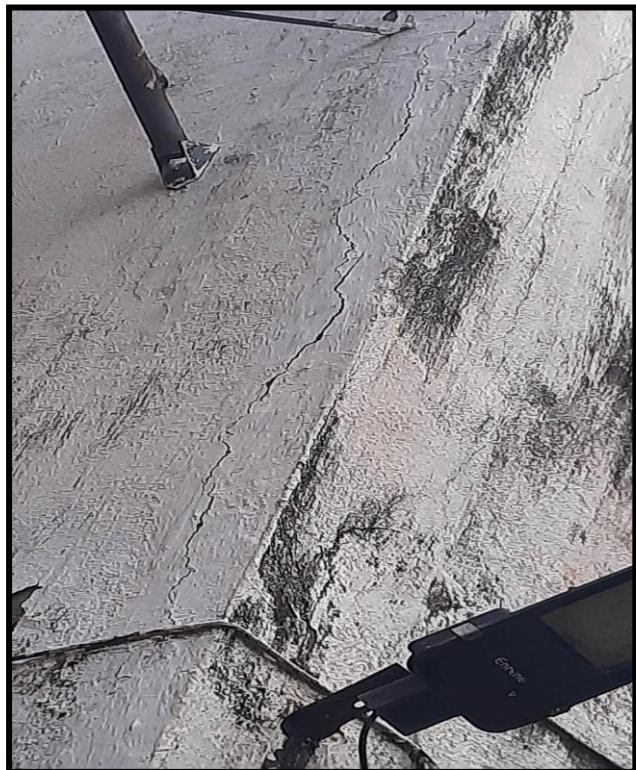
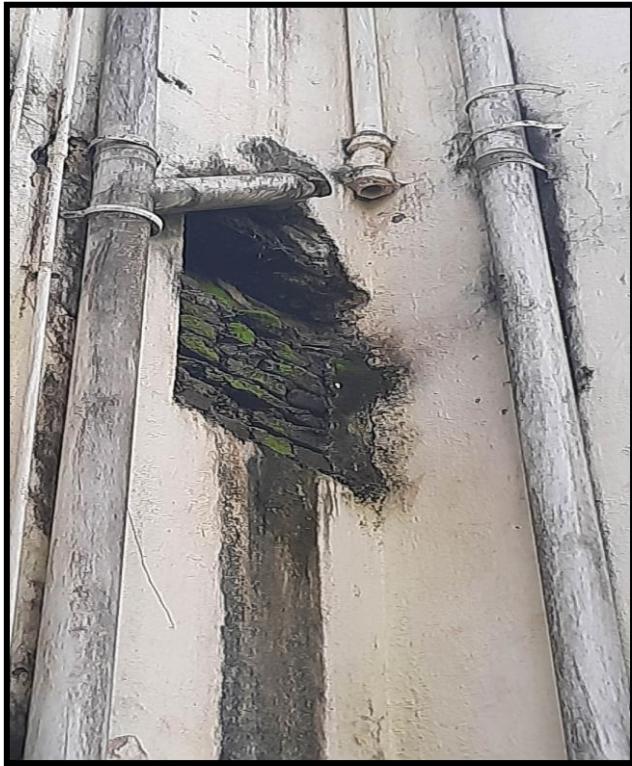
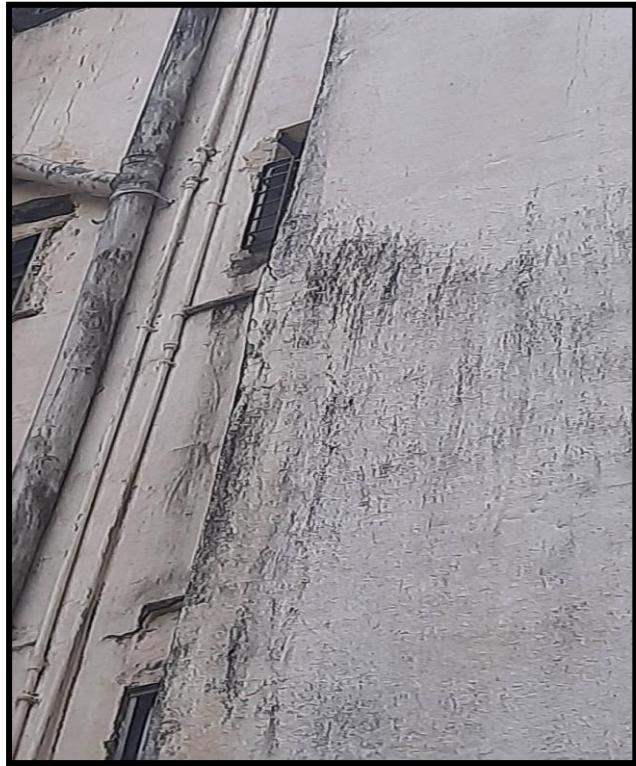
## BACK SIDE

- ❖ Structural crack observed at several places on column.
- ❖ Major crack observed at several places on wall.

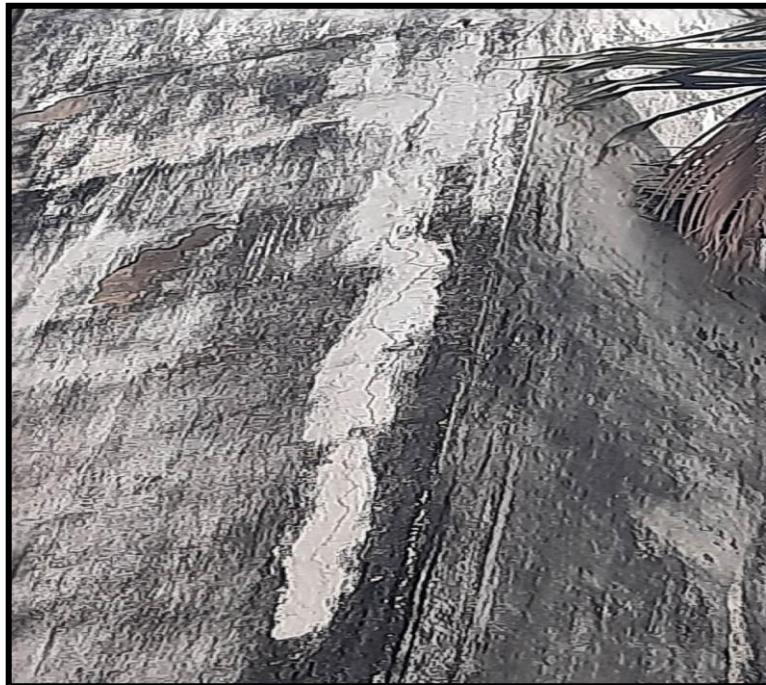
## NORTH SIDE

- ❖ Structural crack observed at several places on column.
- ❖ Major crack observed at several places on wall.
