STRUCTURAL AUDIT REPORT  
**“VISHAL SAHYADRI CO – OP HSG. SOC. LTD”,**  
**“B12 – WING”**  
SITUATED AT  
SAHYADRI NAGAR, CHARKOP,  
KANDIVALI (W) MUMBAI – 400 067

978/B12/LSS/2021

JULY 24, 2021

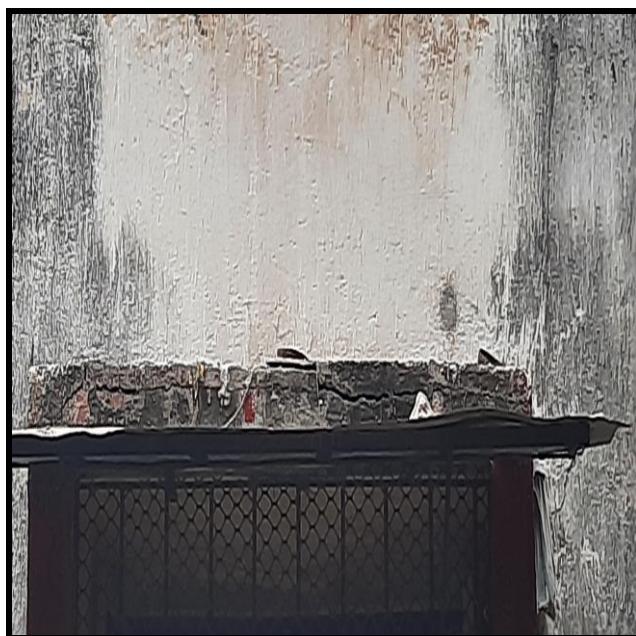
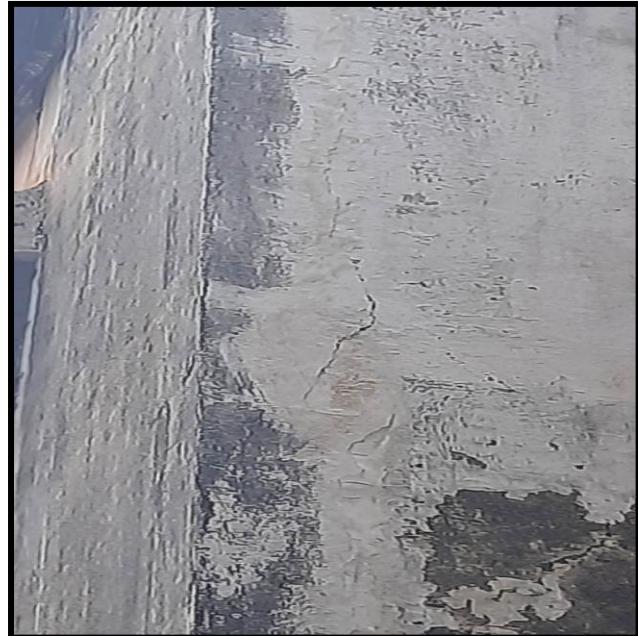
## SOUTH SIDE

- ❖ Structural crack observed at several places on column.
- ❖ Major crack observed at several places on wall.
- ❖ Vegetation growth observed at several places on wall.
