STRUCTURAL AUDIT REPORT
FOR
“VISHAL SAHYADRI CO – OP HSG. SOC. LTD”,
“B13 – WING”
SITUATED AT
SAHYADRI NAGAR, CHARKOP,
KANDIVALI (W) MUMBAI – 400 067

978/B13/LSS/2021

JULY 24, 2021

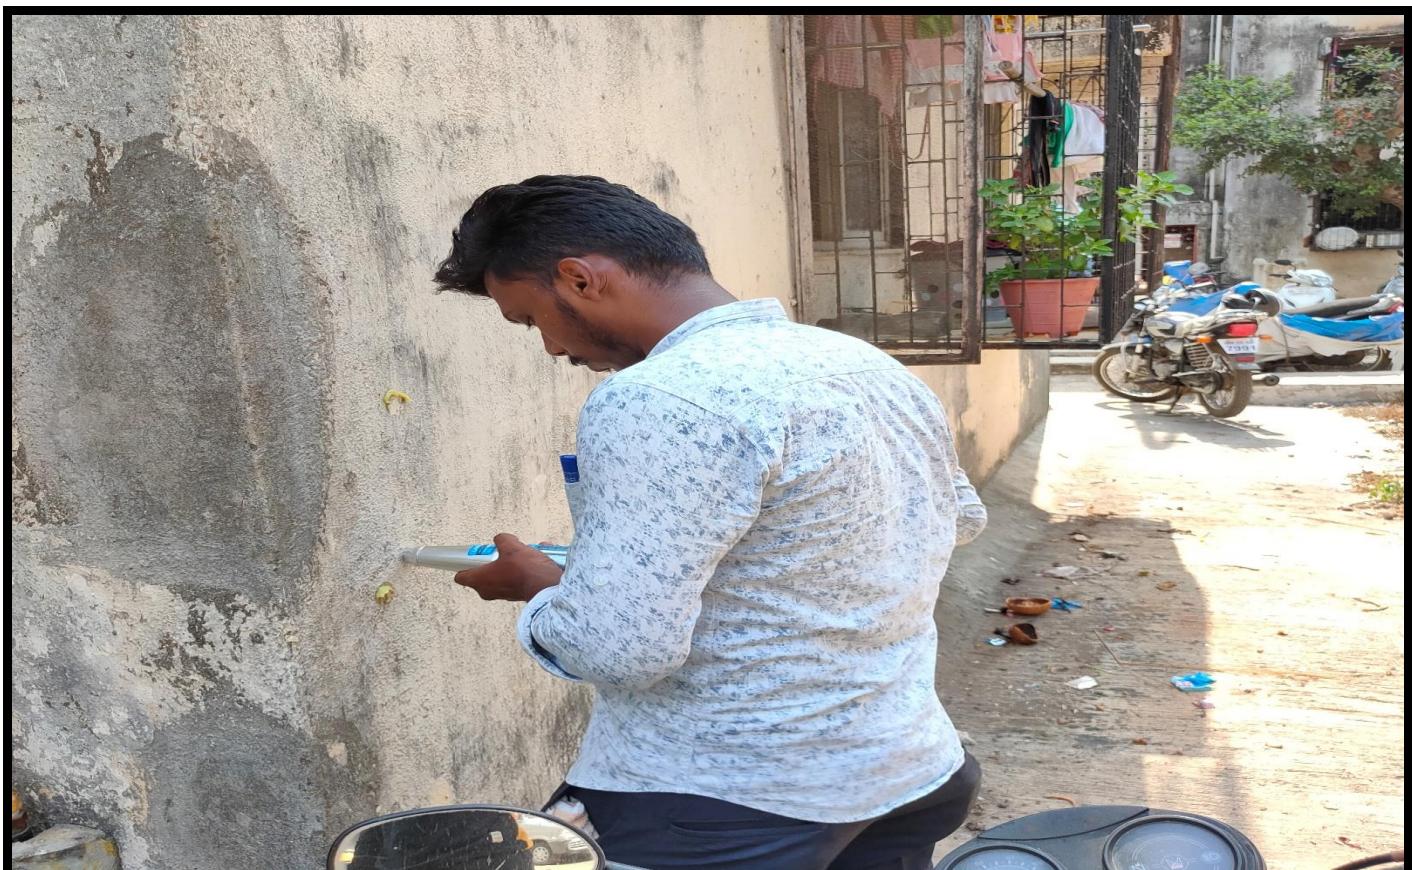
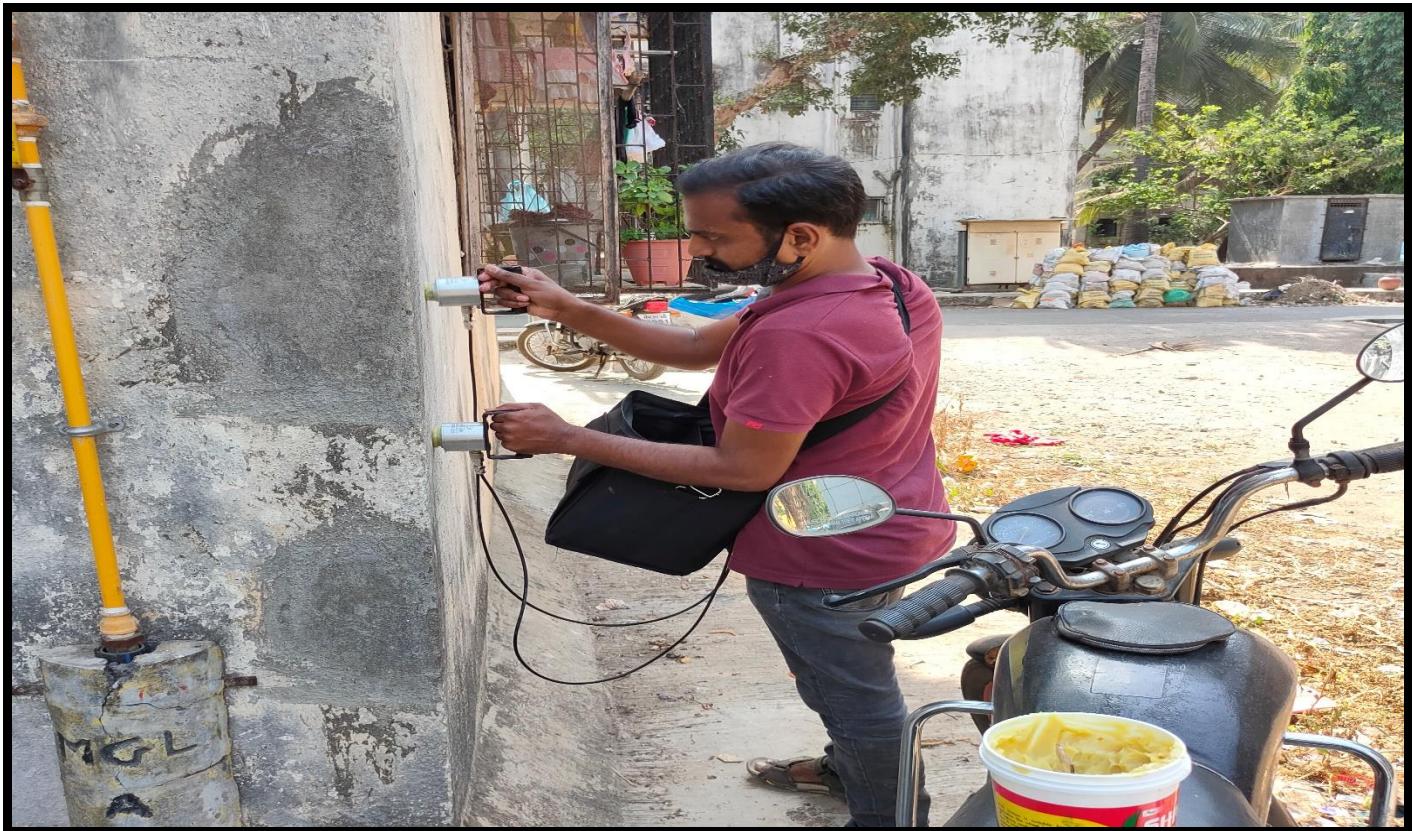
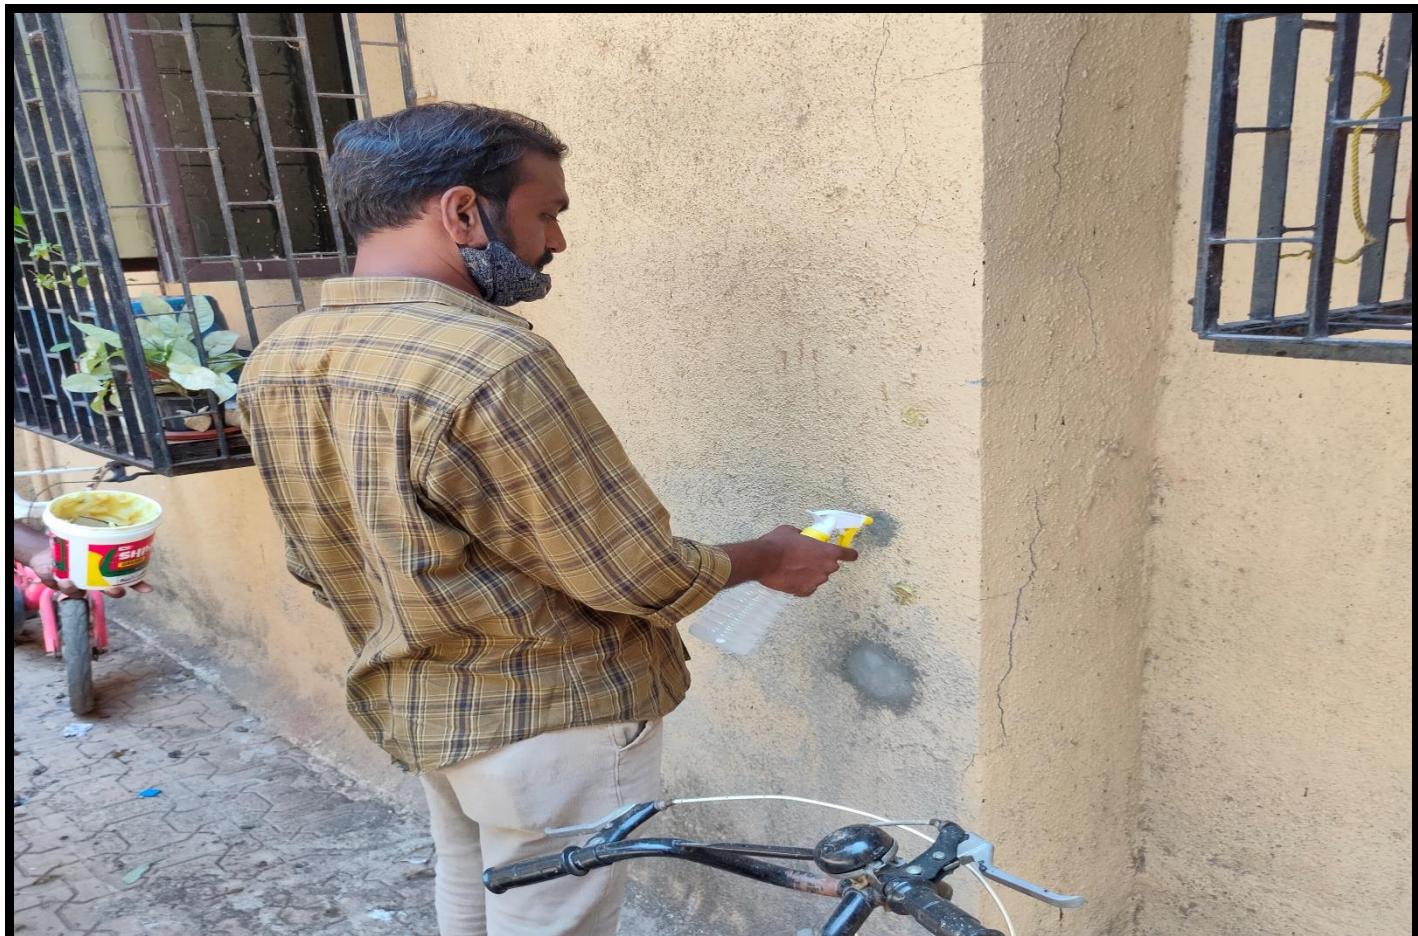
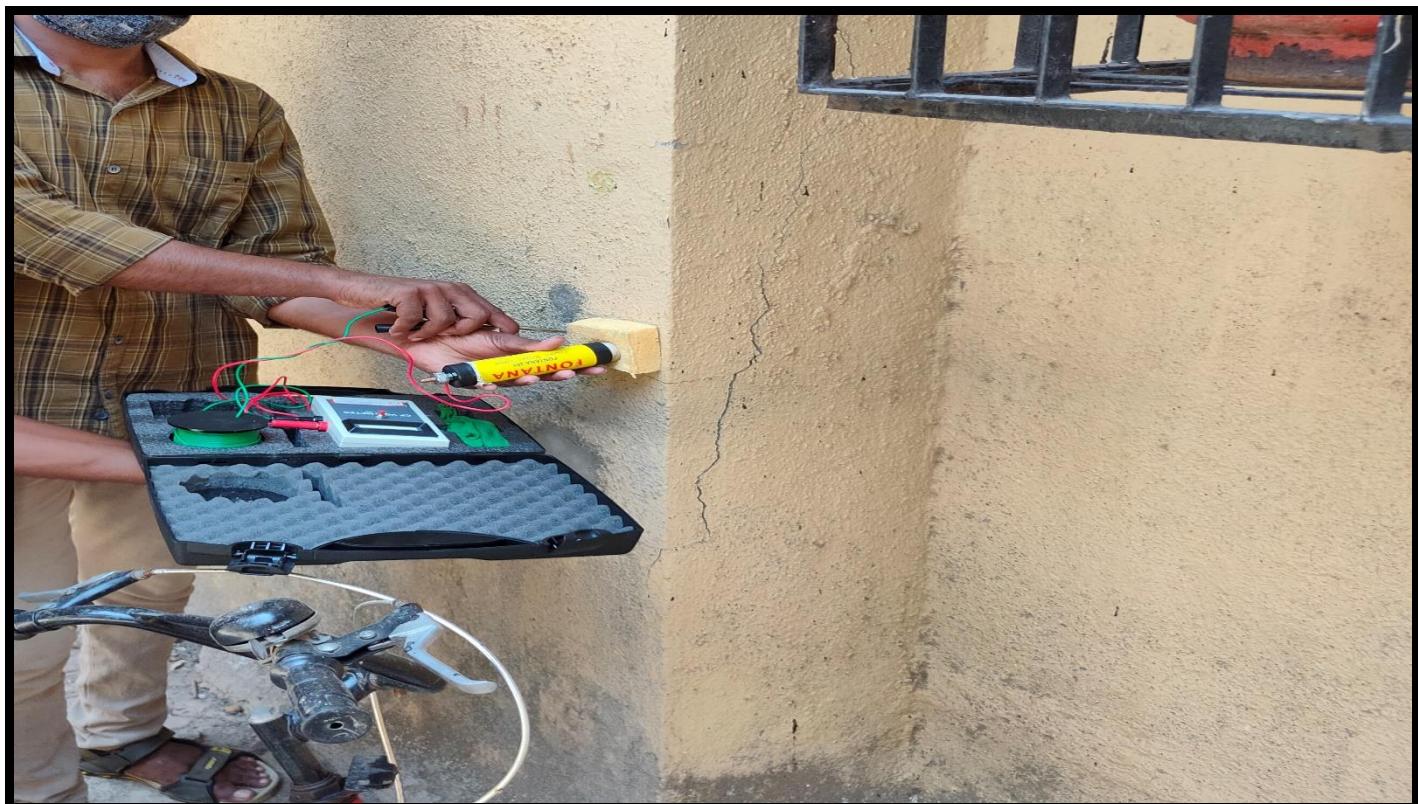
NON -DESTRUCTIVE TEST PHOTO

Rebound Hammer was tested for compressive strength at surface by Schmidt rebound hammer. Results indicate the compressive strength at surface of all the RCC columns is ranging between 13.70 MPa to 20.30 MPa.

The UPV values are ranging between 2.10 Km/Sec to 3.40 Km/Sec.

Out of 4 locations 3 locations was below 3.0 Km/Sec means concrete quality is poor and 1 location ranging between 3.0 to 3.75 Km/Sec means concrete quality is doubtful.

Half Cell Potential tested for corrosion activity by half – cell potential tests. Values are taken on Column. The result on tested column is – 360 mV.

Carbonation test was conducted to assess carbonation depth. Readings are taken on Column. Result indicates the carbonation penetration depth is 40.00 mm. Carbonation depths have reached to the reinforcement level in all of the RCC elements. It is essential to give a suitable anti-corrosion treatment to all the RCC members to stop further carbonation and corrosion of concrete.

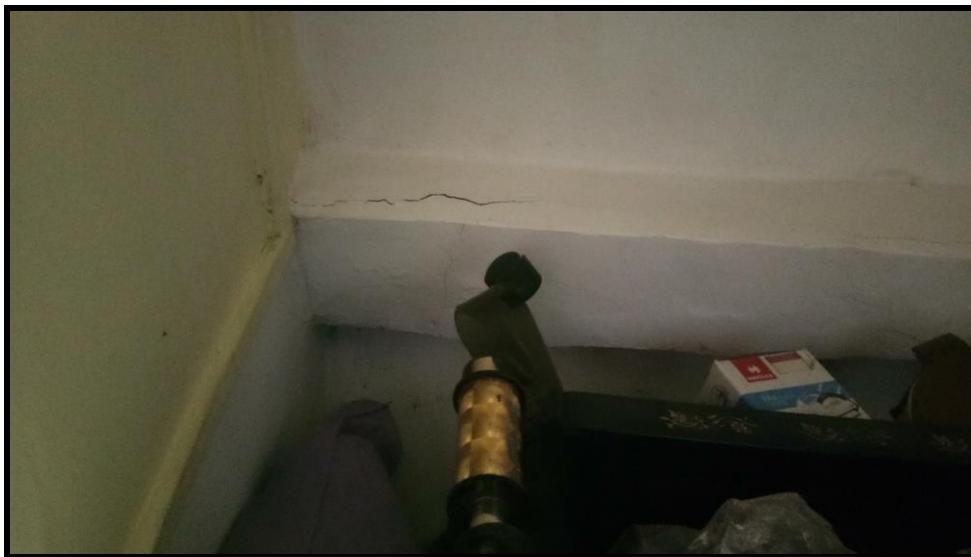
FLAT NO – 21

- ❖ **HALL** – Seepage mark observed on ceiling.
 - Major structural crack observed on beam.
 - Major structural crack observed on column.
- ❖ **KITCHEN** – Seepage mark observed on ceiling.
- ❖ **PASSAGE** – Major structural crack observed on beam.
- ❖ **TOILET & BATH ROOM** – Peeling of paint observed on wall.

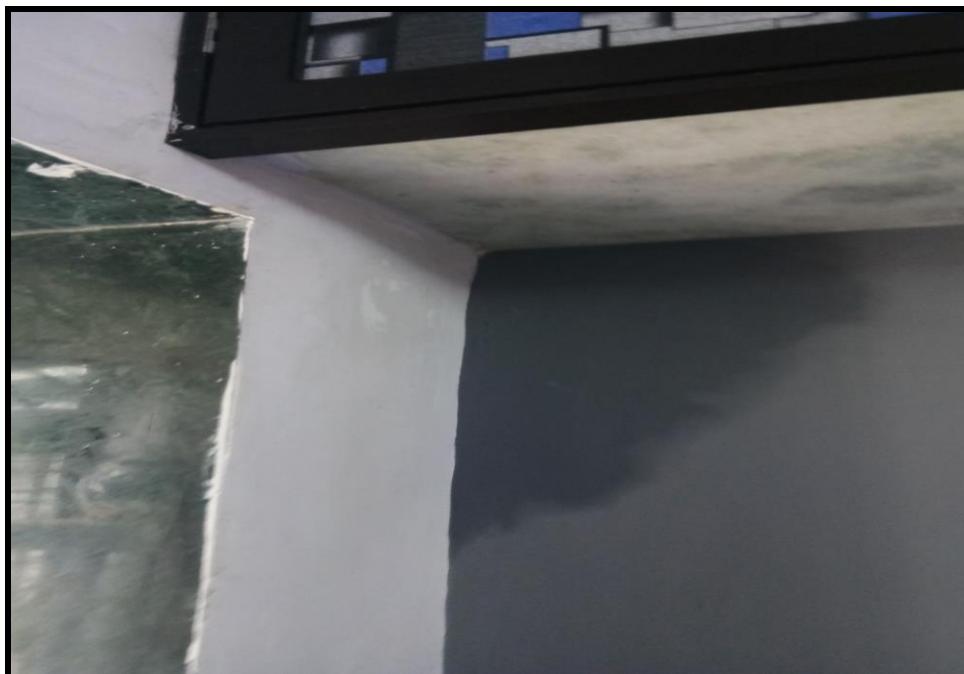
FLAT NO – 27

- ❖ **HALL** – Major structural crack observed on wall.
 - Major leakage mark observed on wall.
 - Seepage mark observed on ceiling.
- ❖ **KITCHEN** – Leakage mark observed on ceiling.
 - Seepage mark observed on ceiling.
- ❖ **PASSAGE** – Dampness observed on ceiling.
- ❖ **TOILET & BATH ROOM** – Peeling of paint observed on ceiling.

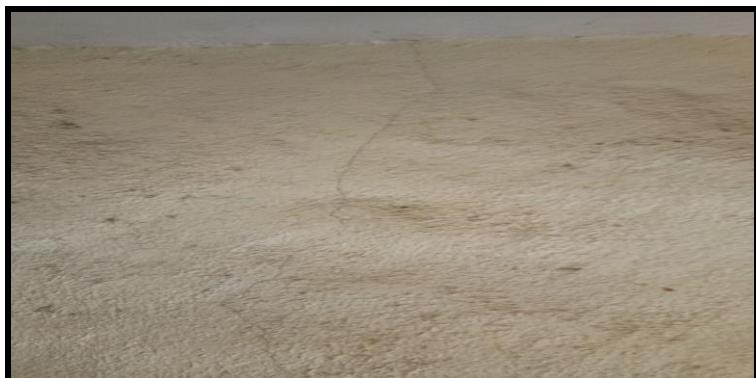
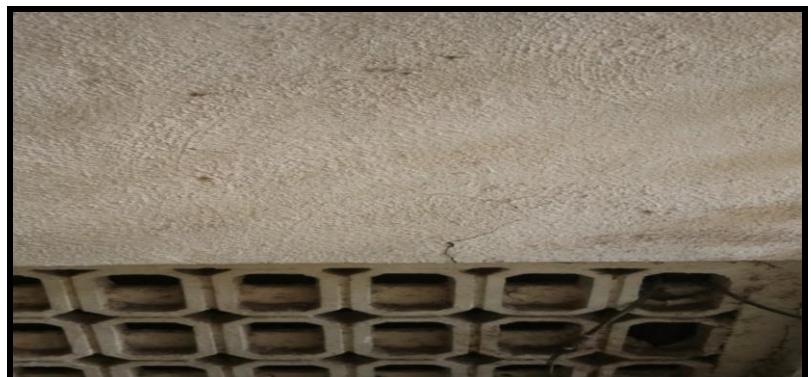
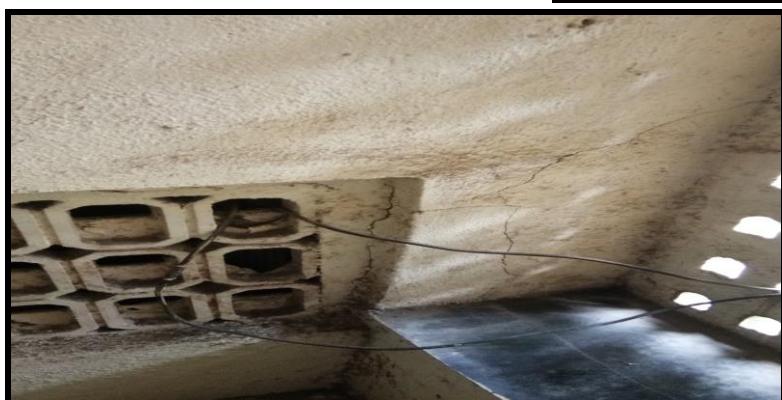
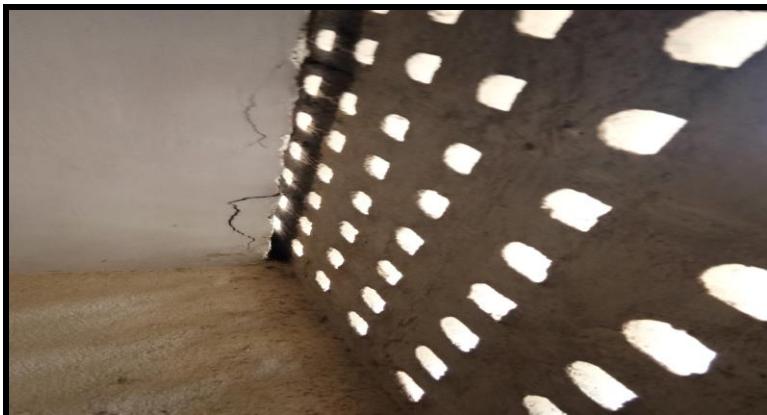
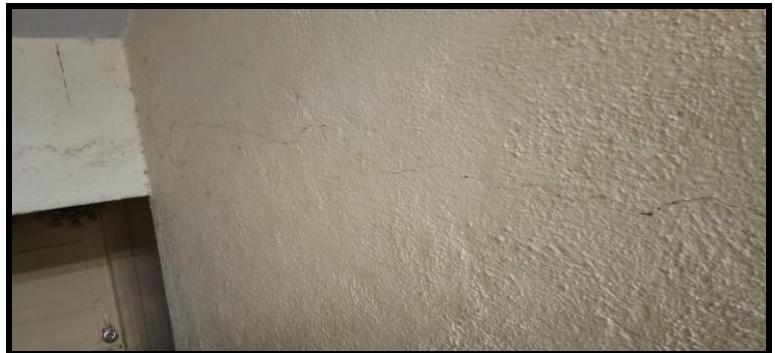
Second floor to First floor:-

- ❖ Crack observed on wall.
- ❖ Major structural crack observed on wall.
- ❖ Seepage mark observed on ceiling.

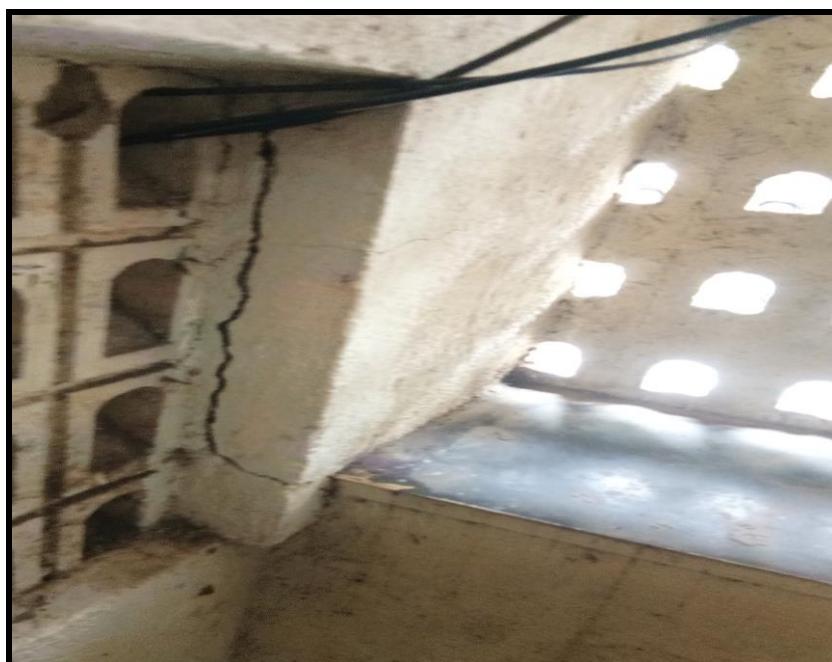
First floor to Ground floor:-

- ❖ Crack observed on wall.
- ❖ Seepage mark observed on ceiling.
- ❖ Major structural crack observed on wall.

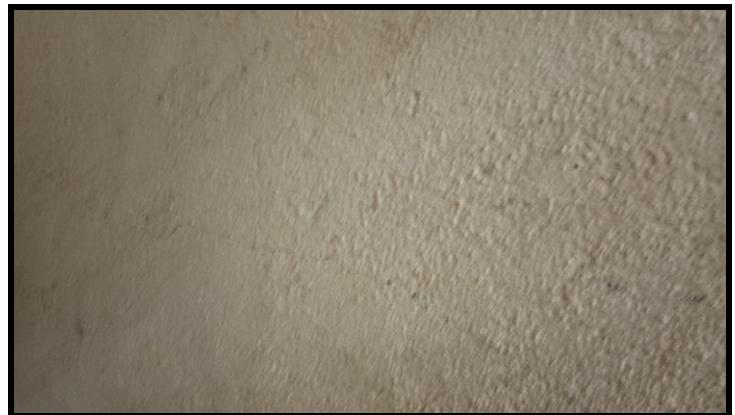
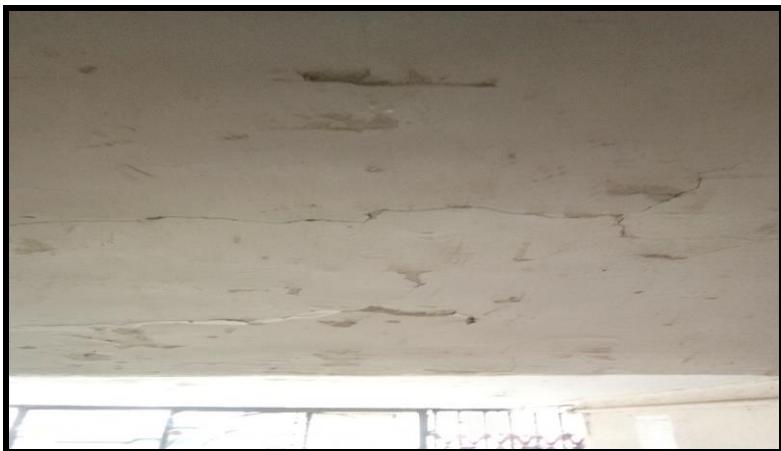
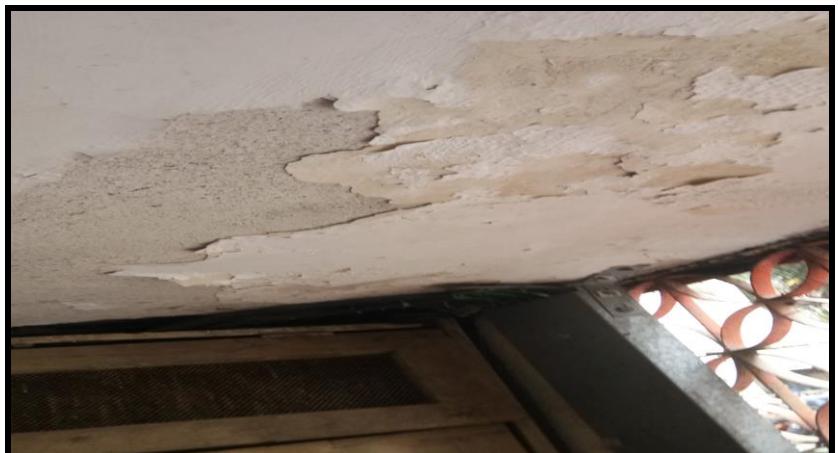
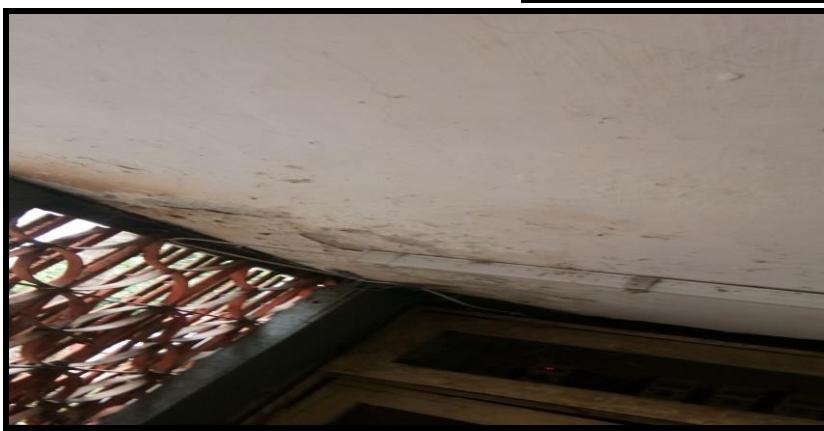
B – 13

EXTERNAL OBSERVATION

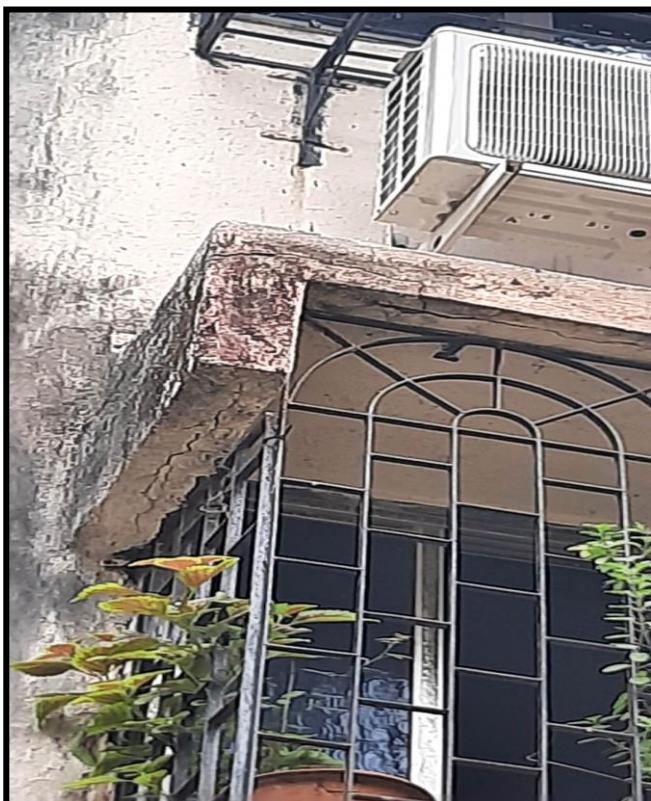
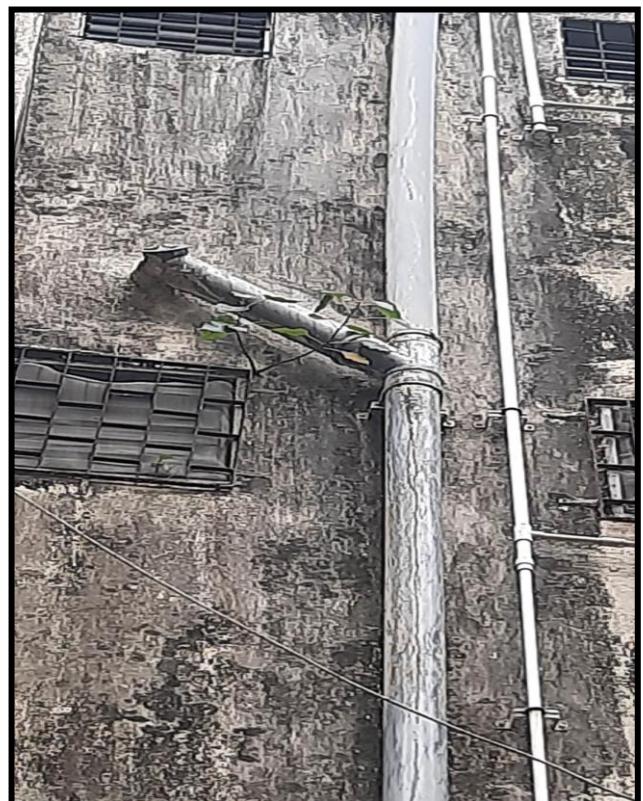
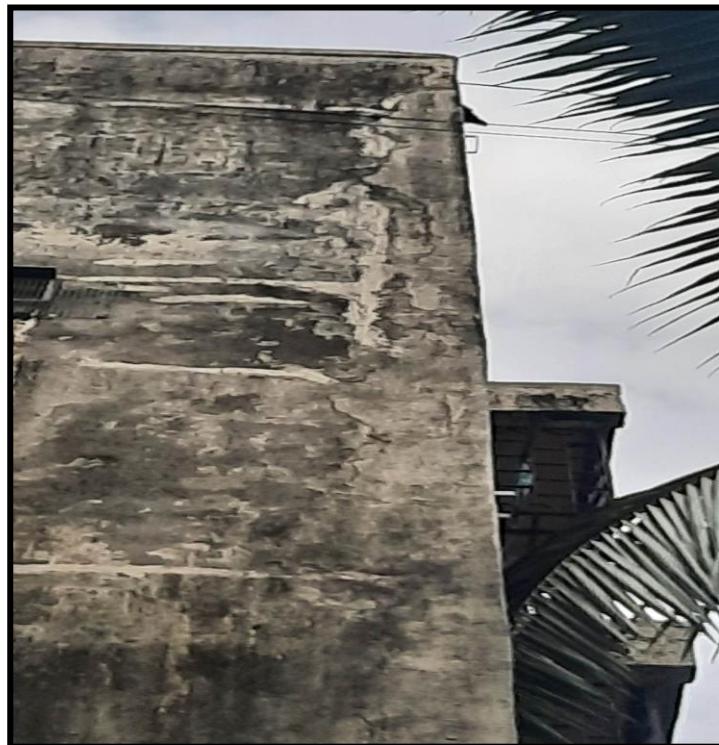
FRONT SIDE

- ❖ Structural crack observed at several places on column.
- ❖ Major crack observed at several places on wall.
- ❖ Vegetation growth observed at several places on wall.

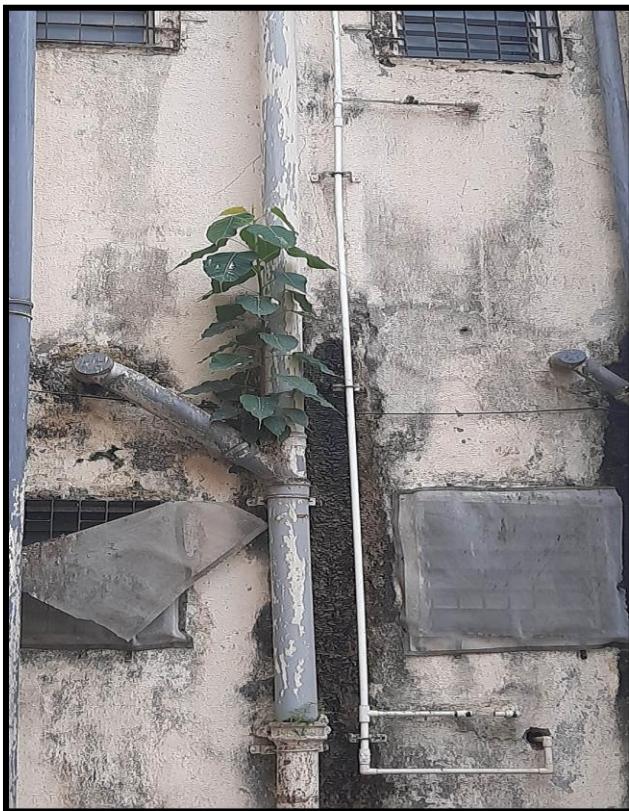
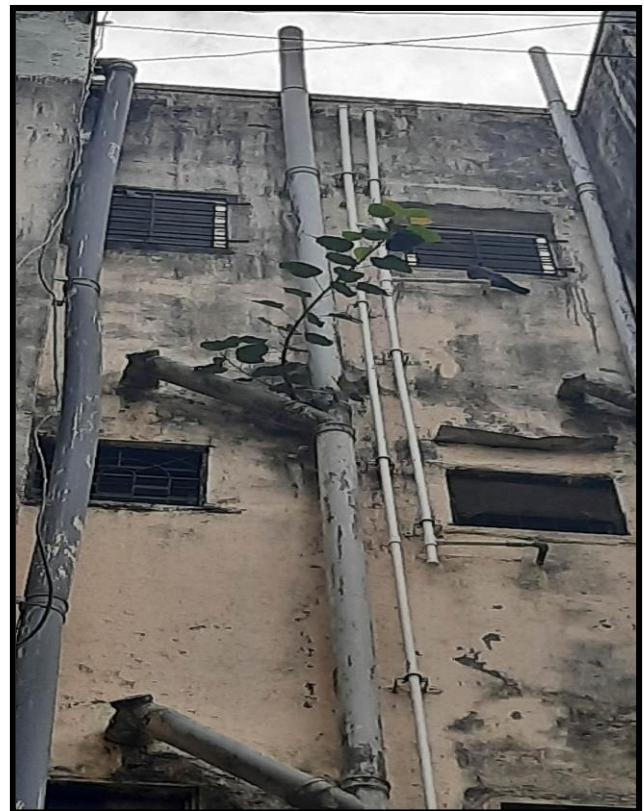
BACK SIDE

- ❖ Vegetation growth observed at several places on wall.

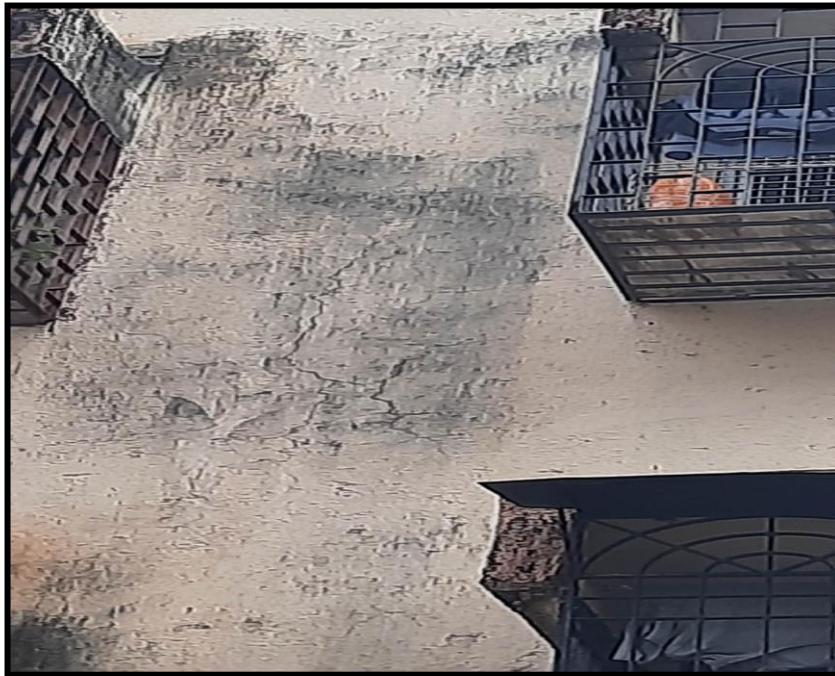
NORTH SIDE

- ❖ Major crack observed at several places on wall.

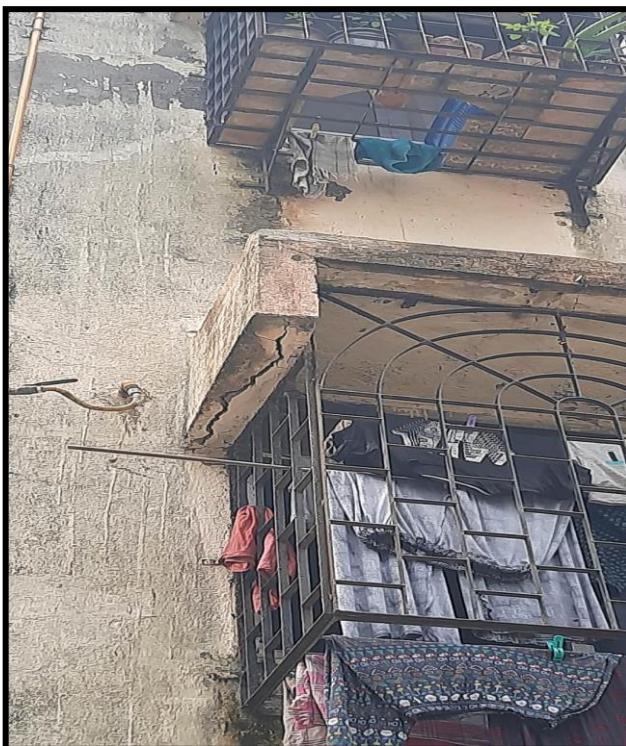
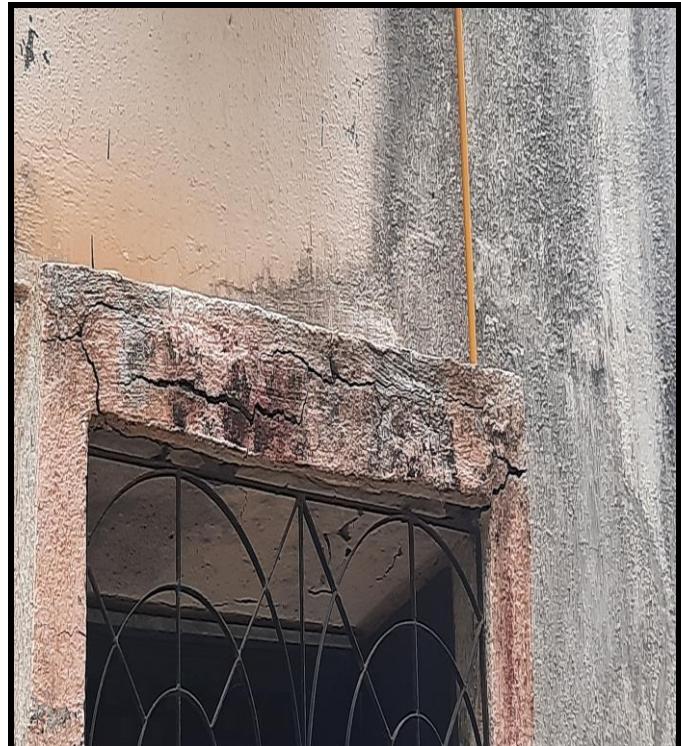
SOUTH SIDE

- ❖ Structural crack observed at several places on column.
- ❖ Major crack observed at several places on wall.
