STRUCTURAL AUDIT REPORT
FOR
“VISHAL SAHYADRI CO – OP HSG. SOC. LTD”,
“C3 – WING”
SITUATED AT
SAHYADRI NAGAR, CHARKOP,
KANDIVALI (W) MUMBAI – 400 067

PREPARED BY
LATESH S. SANKLECHA
CONSULTING STRUCTURAL ENGINEERS

978/C3/LSS/2021

JUNE 21, 2021

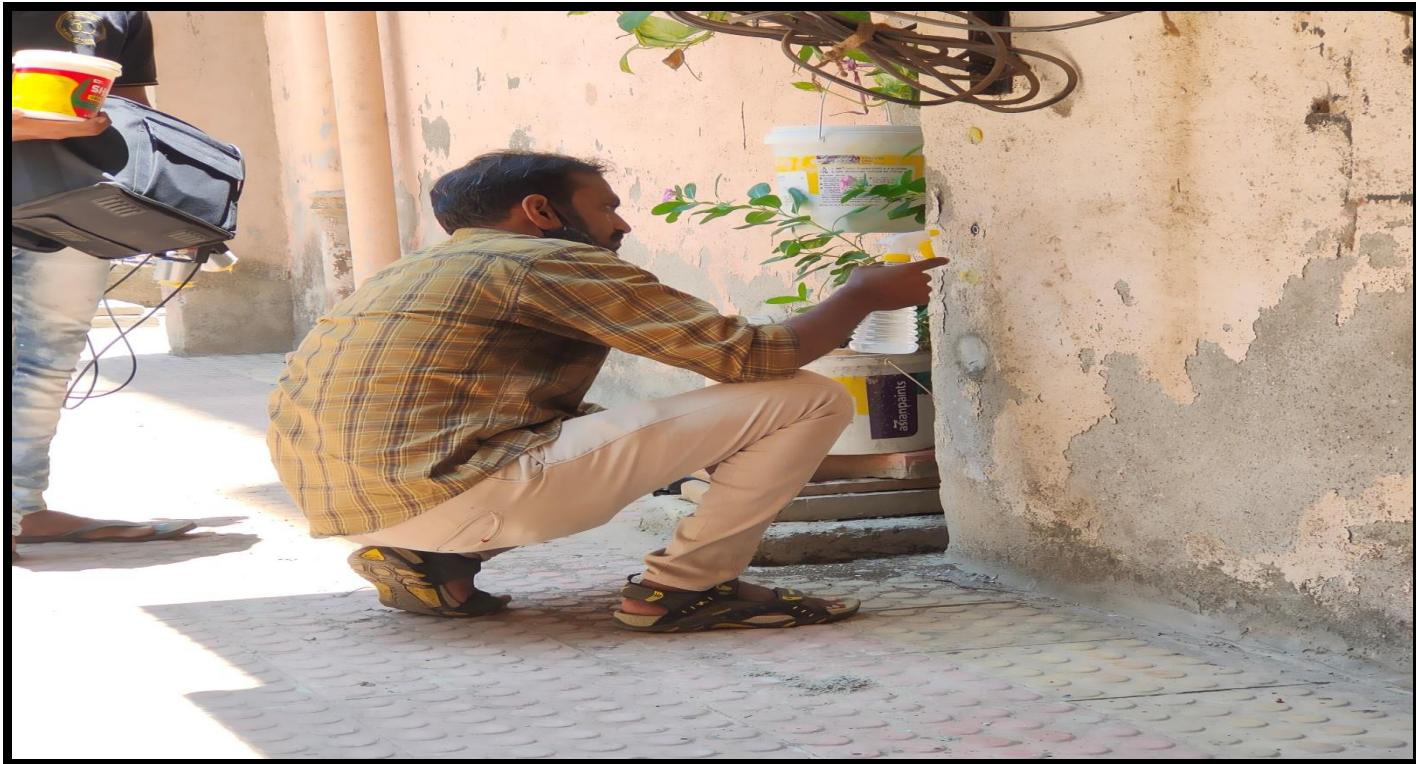
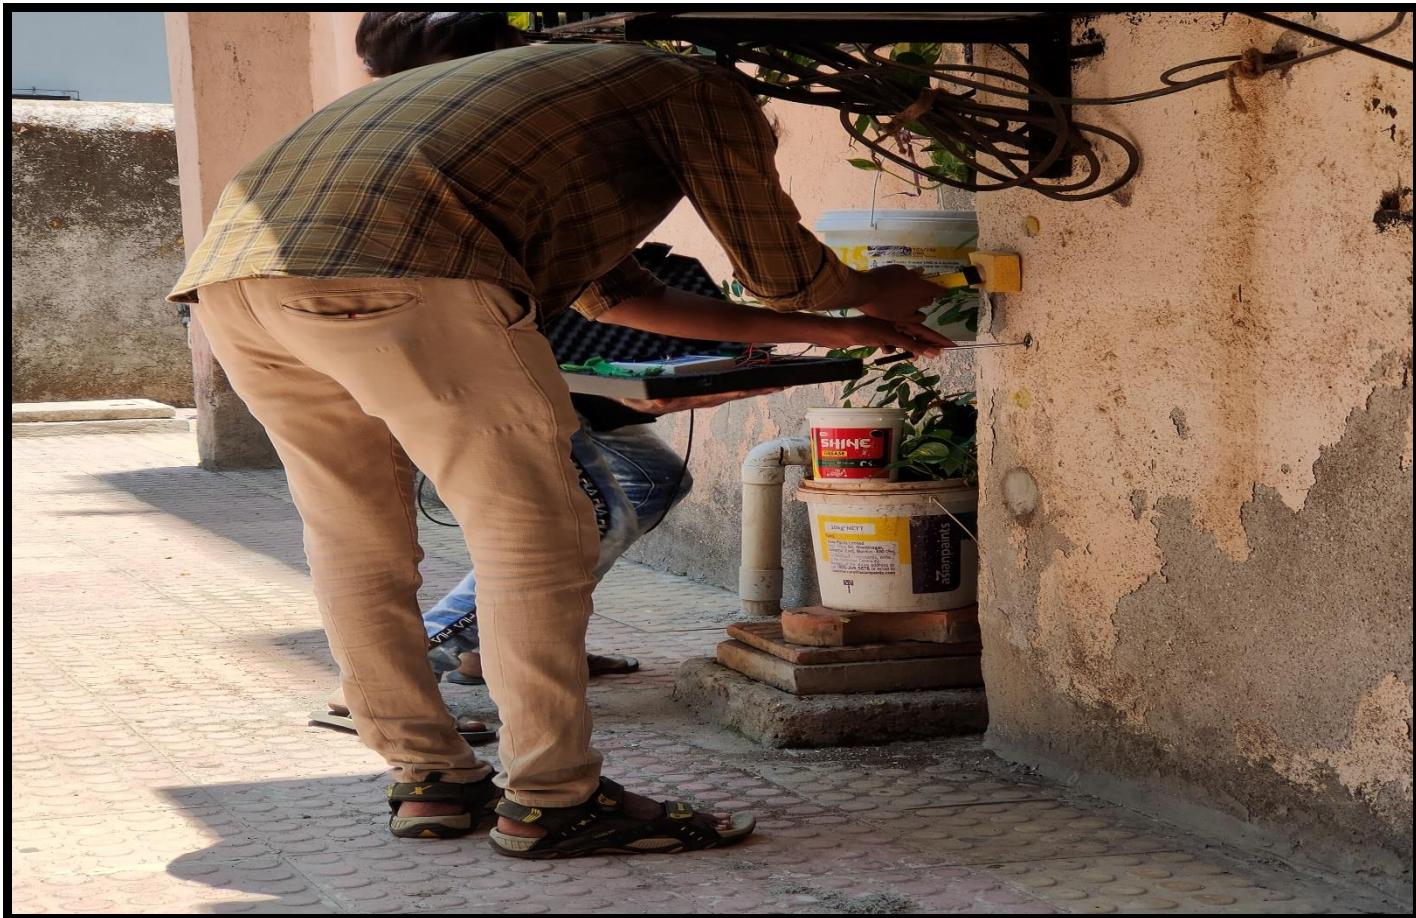
NON -DESTRUCTIVE TEST PHOTO

Rebound Hammer was tested for compressive strength at surface by Schmidt rebound hammer. Results indicate the compressive strength at surface of the RCC columns & beam is ranging between 10.30 MPa to 17.50 MPa.

Half Cell Potential tested for corrosion activity by half – cell potential tests. Value is taken on Column. The result on tested column is – 383 mV.

Carbonation test was conducted to assess carbonation depth. Readings are taken on Column. Result indicates the carbonation penetration depth is 40.00 mm. Carbonation depths have reached to the reinforcement level in all of the RCC elements. It is essential to give a suitable anti-corrosion treatment to all the RCC members to stop further carbonation and corrosion of concrete.

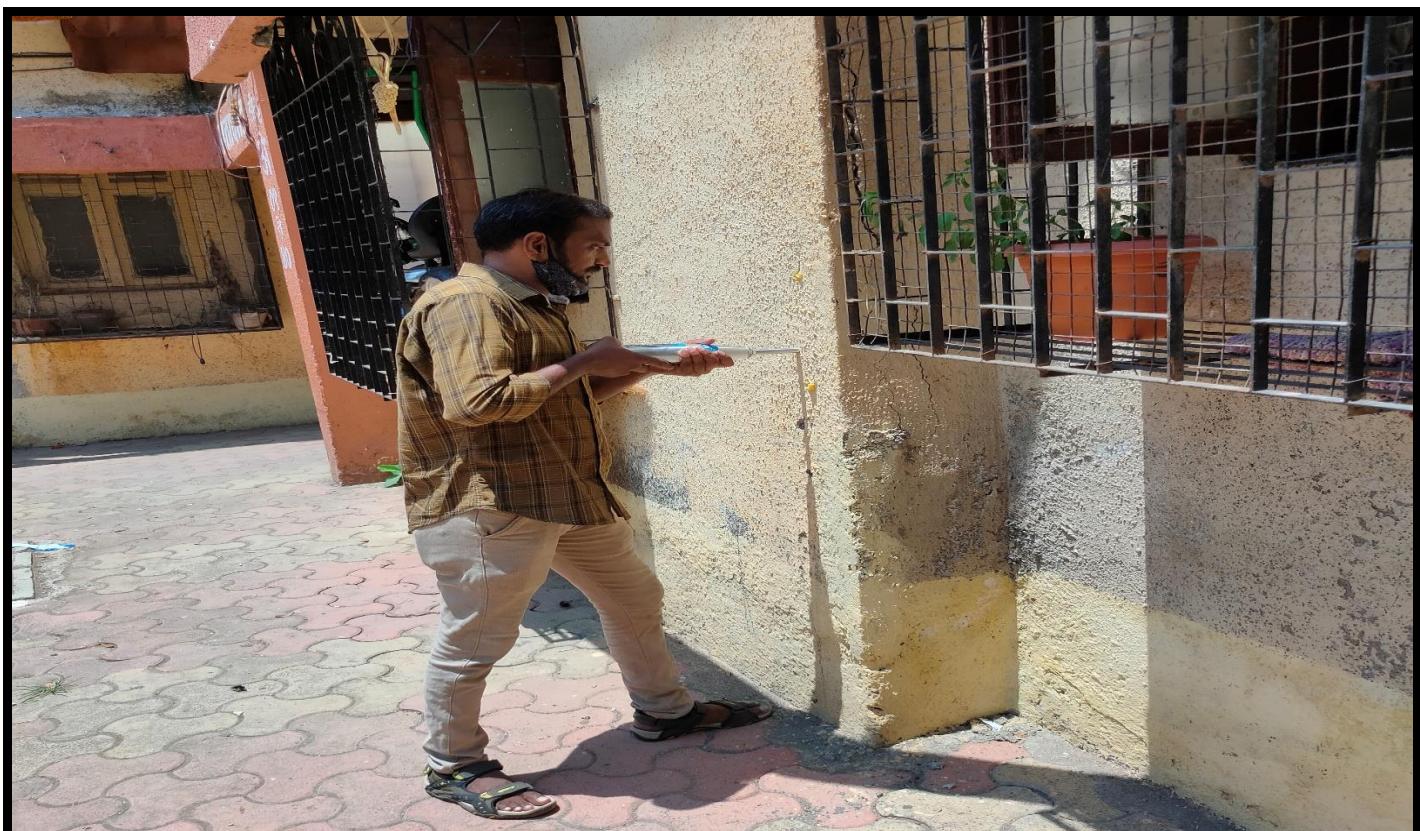
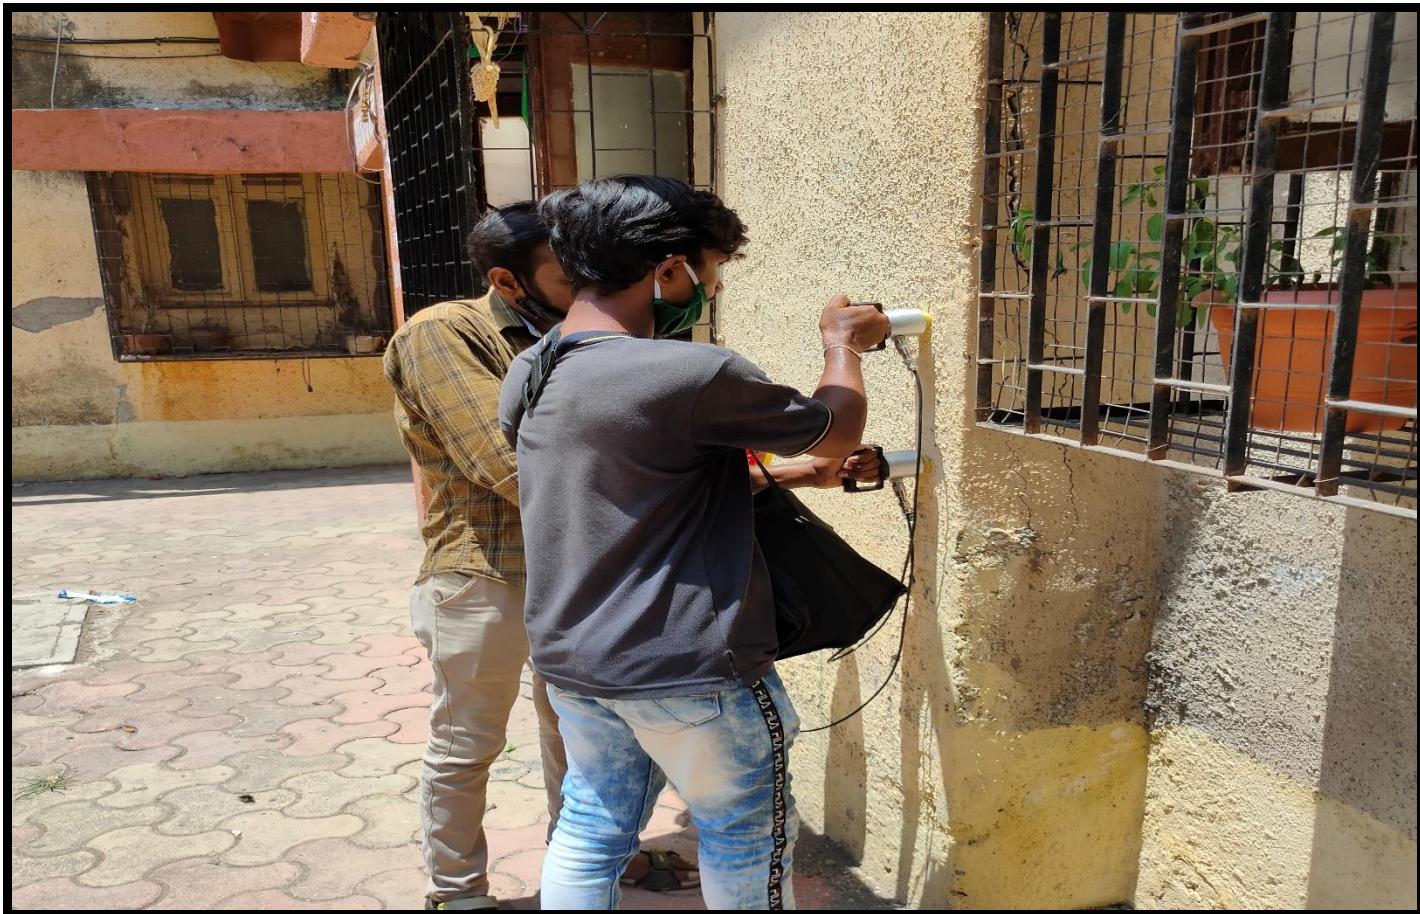
This indicates the probability of corrosion is 90% on tested column steel reinforcement.

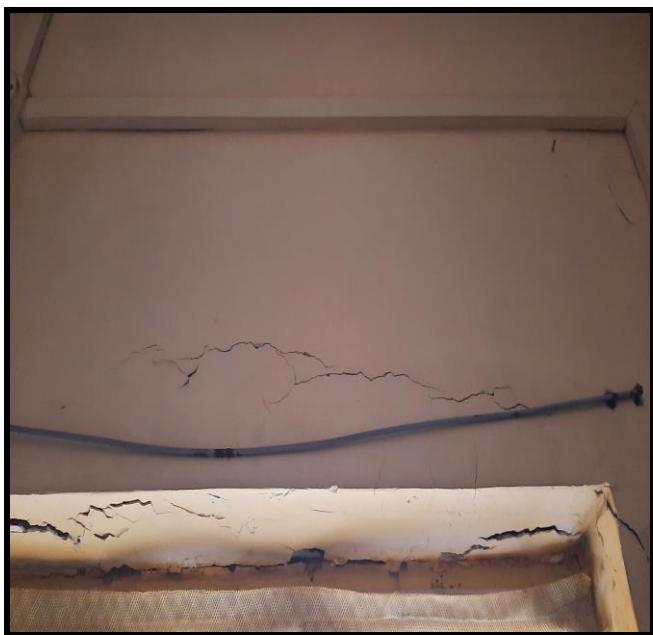
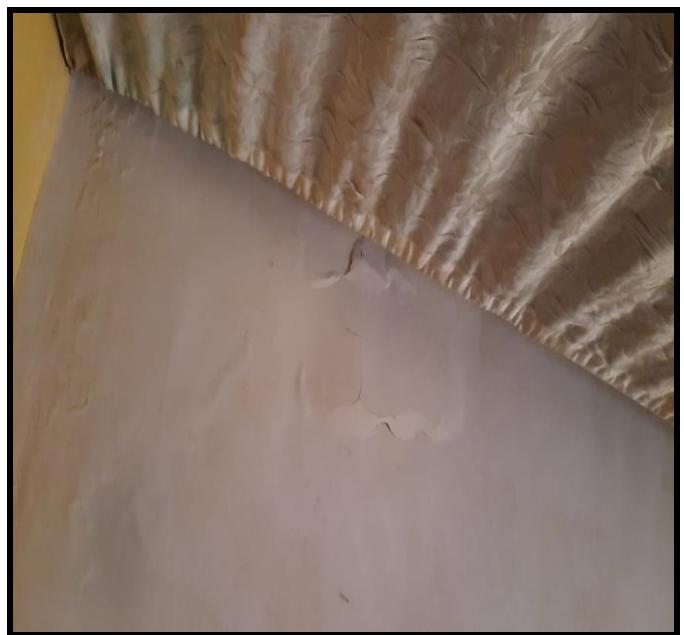
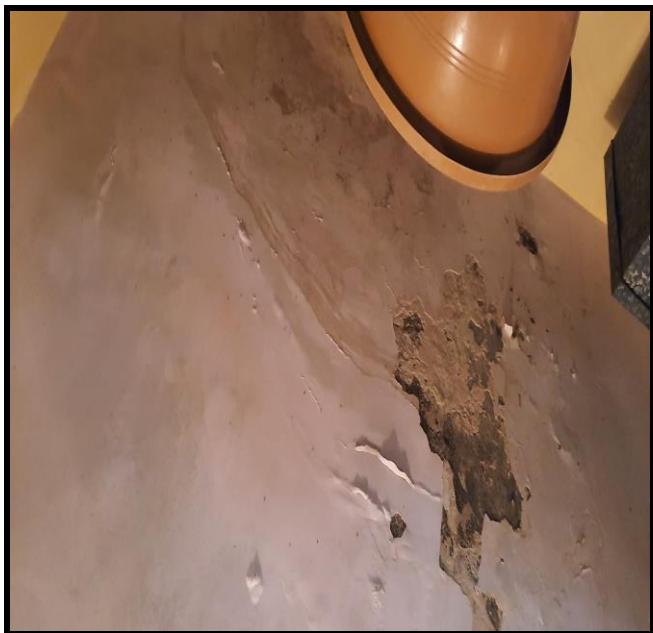
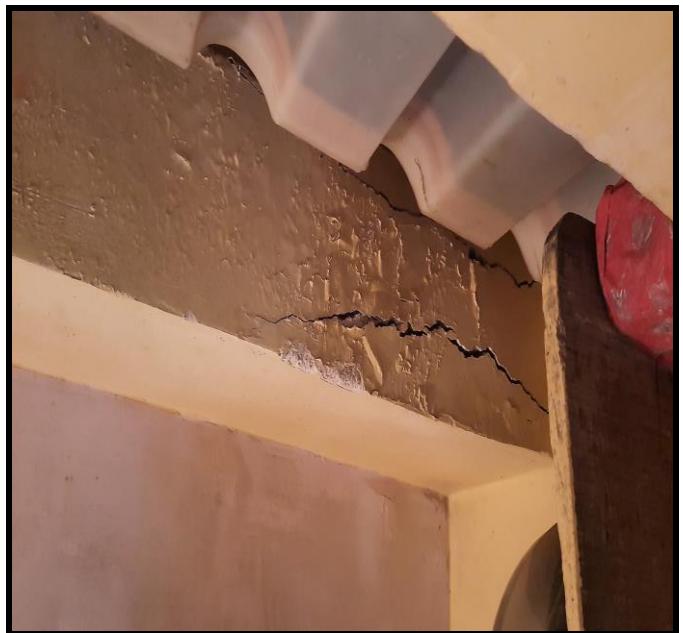
FLAT NO – 01

- ❖ **HALL** – Structural crack observed on beam.
 - Structural damage observed on ceiling.
- ❖ **KITCHEN** – Structural crack observed on beam.
 - Leakage mark observed on ceiling.
- ❖ **PASSAGE** – O.K.
- ❖ **TOILET & BATH ROOM** – O.K.

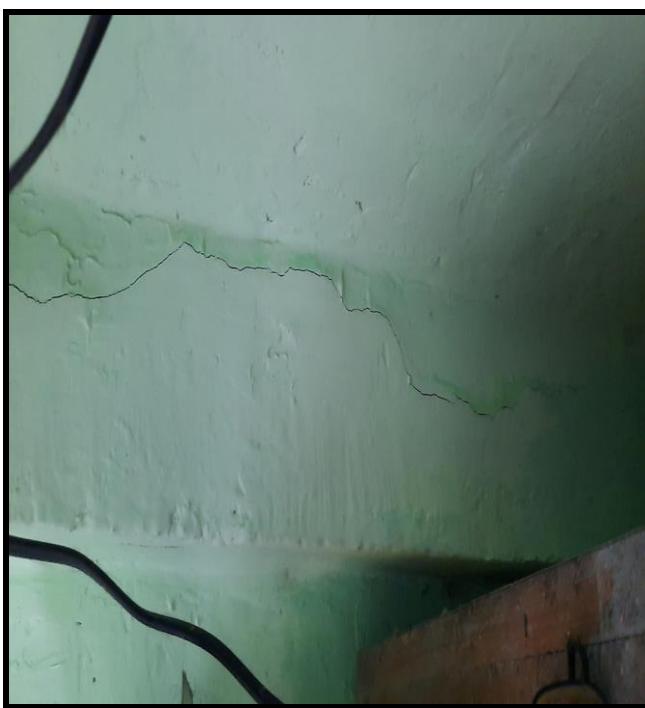
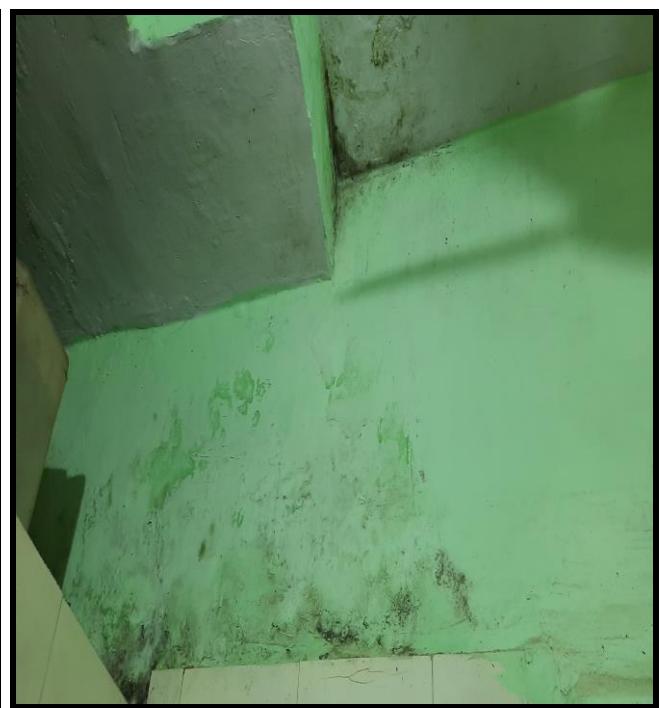
FLAT NO - 04

- ❖ **HALL** – Structural crack observed on column.
- ❖ **KITCHEN** – Leakage mark observed on ceiling & wall.
- ❖ **PASSAGE** – O.K.
- ❖ **TOILET & BATH ROOM** – O.K.

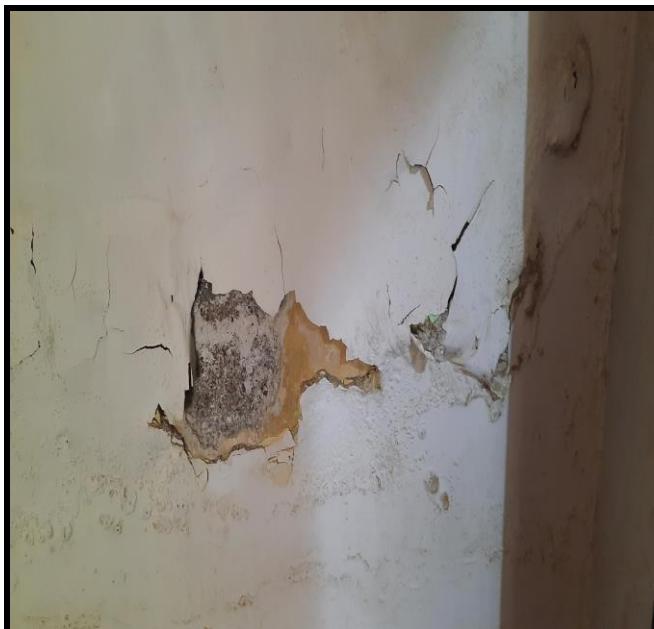
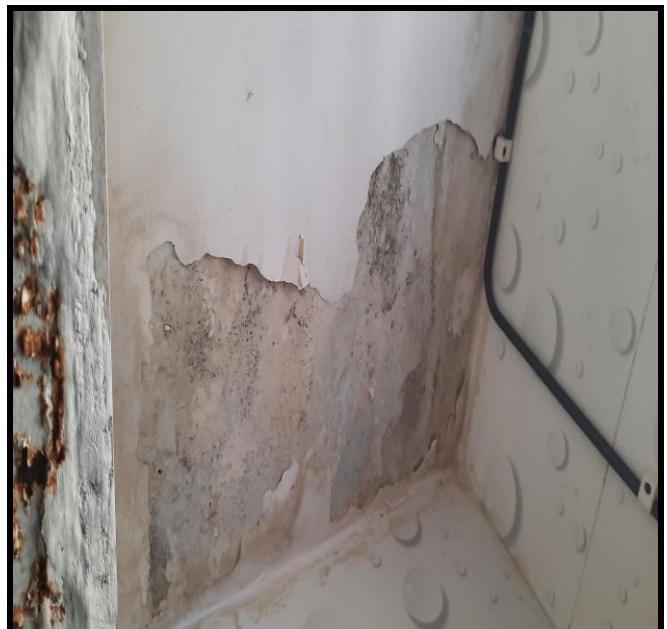
FLAT NO – 10

- ❖ **HALL** – Seepage observed on wall.
- ❖ **KITCHEN** – Structural crack observed on ceiling.
- ❖ **PASSAGE** – O.K.
- ❖ **TOILET & BATH ROOM** – Leakage mark observed on ceiling.

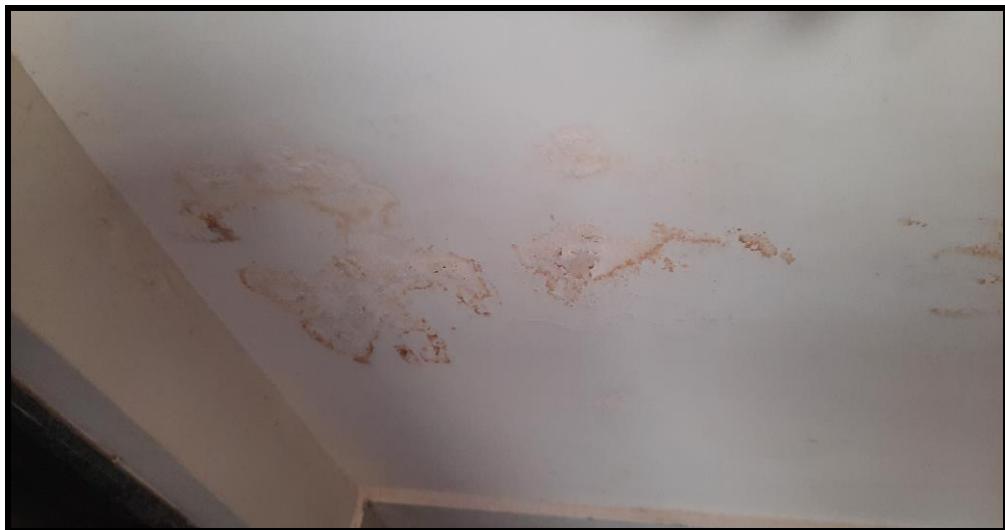
FLAT NO – 13

- ❖ **HALL** – Seepage observed on wall.
- ❖ **KITCHEN** – O.K.
- ❖ **PASSAGE** – O.K.
- ❖ **TOILET & BATH ROOM** – O.K.

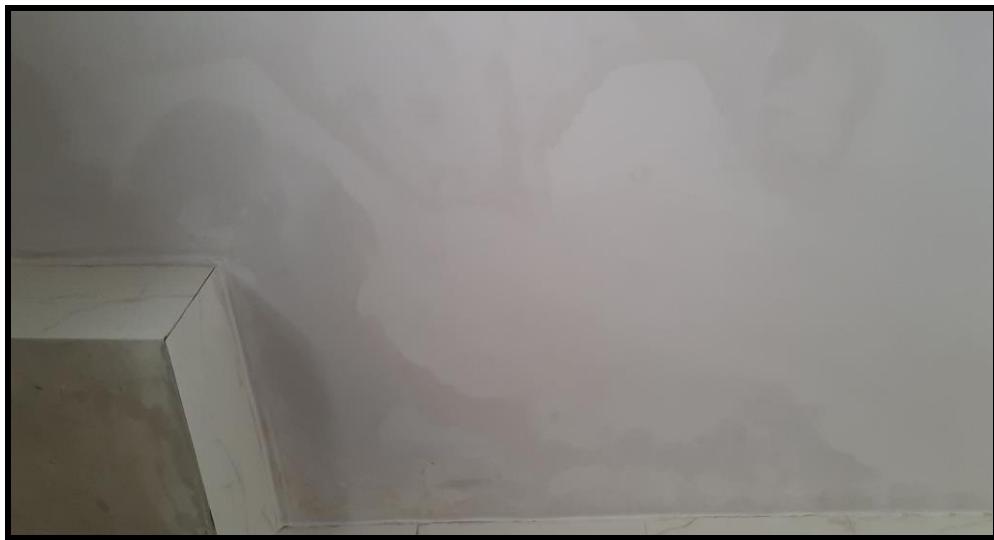
FLAT NO – 19

- ❖ **HALL** – O.K.
- ❖ **KITCHEN** – Dampness observed on ceiling.
- ❖ **PASSAGE** – O.K.
- ❖ **TOILET & BATH ROOM** – O.K.

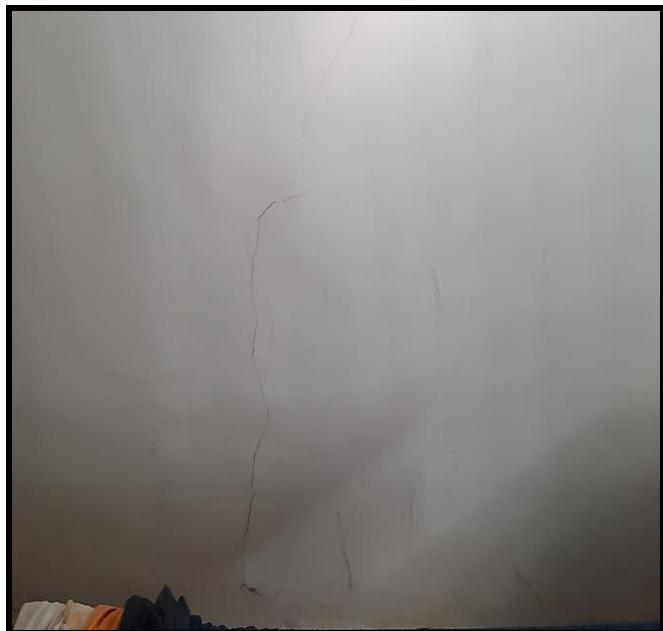
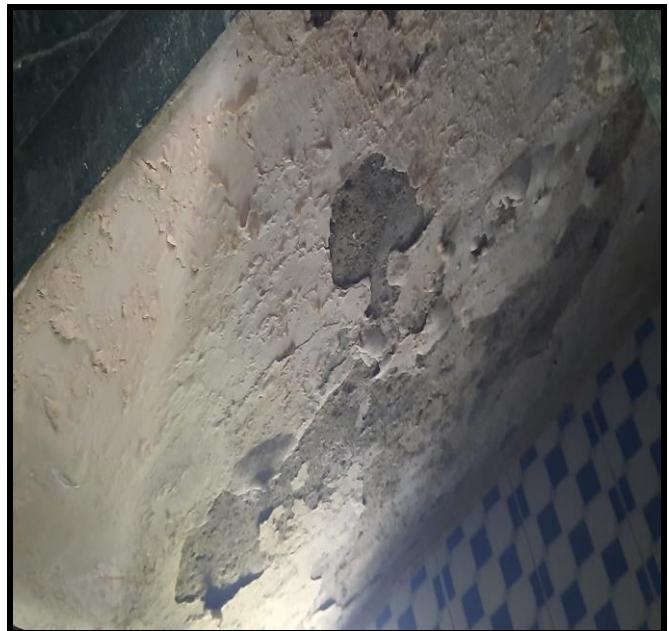
FLAT NO – 20

- ❖ **HALL** – O.K.
- ❖ **KITCHEN** – Structural crack observed on ceiling.
- ❖ **PASSAGE** – O.K.
- ❖ **TOILET & BATH ROOM** – Leakage mark observed on ceiling.

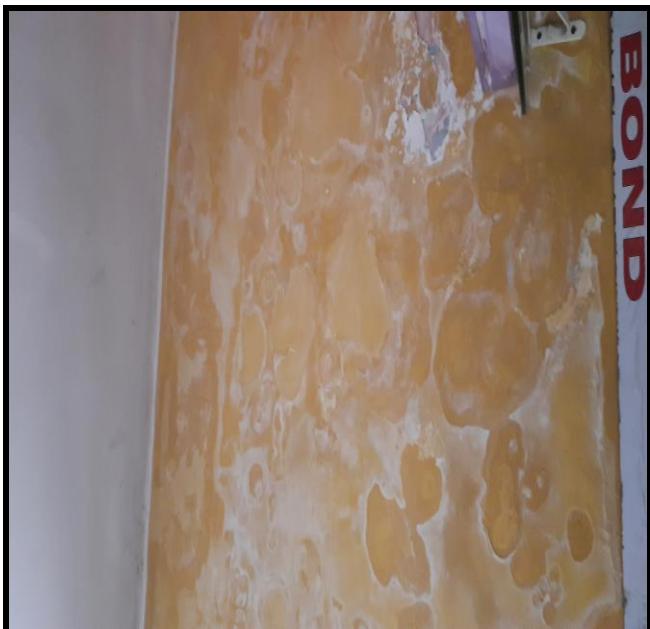
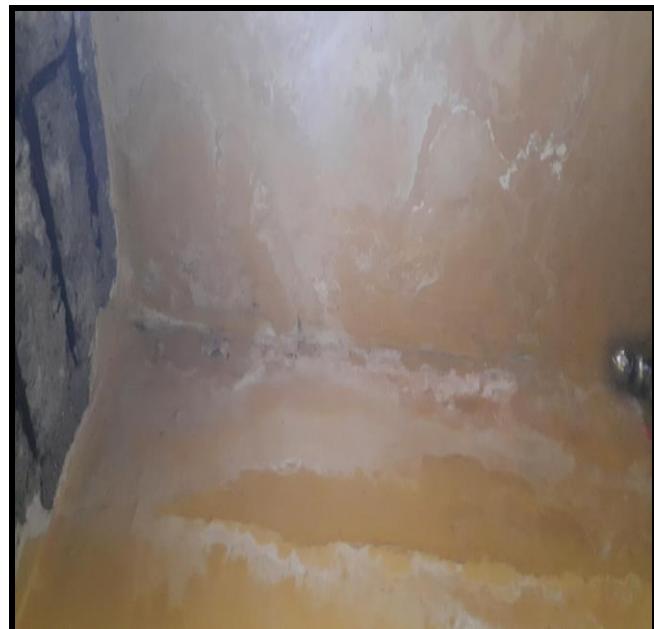
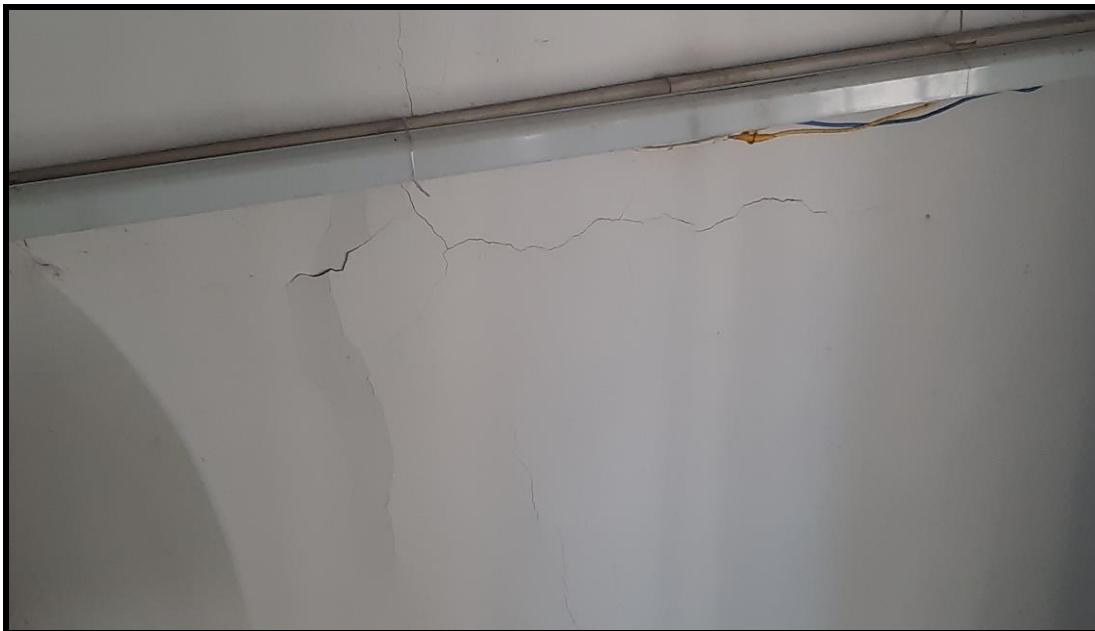
FLAT NO – 36

- ❖ **HALL** – Leakage mark observed on wall.
- ❖ **KITCHEN** – Structural crack observed on ceiling.
- ❖ **PASSAGE** – O.K.
- ❖ **TOILET & BATH ROOM** – O.K.

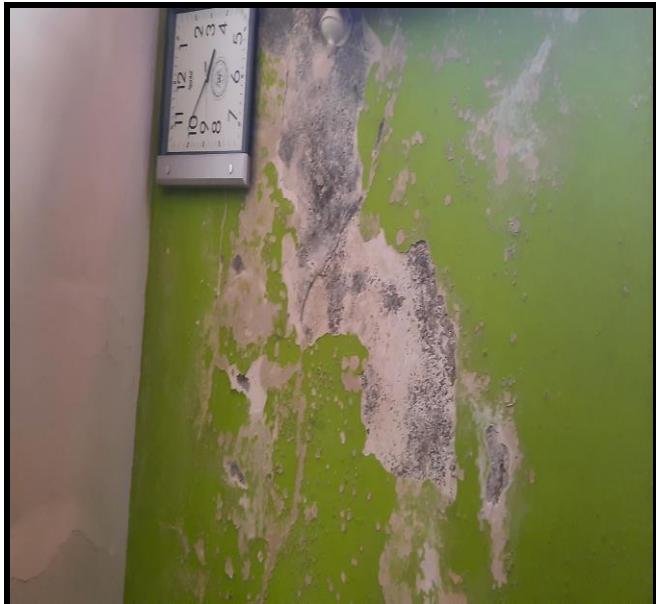
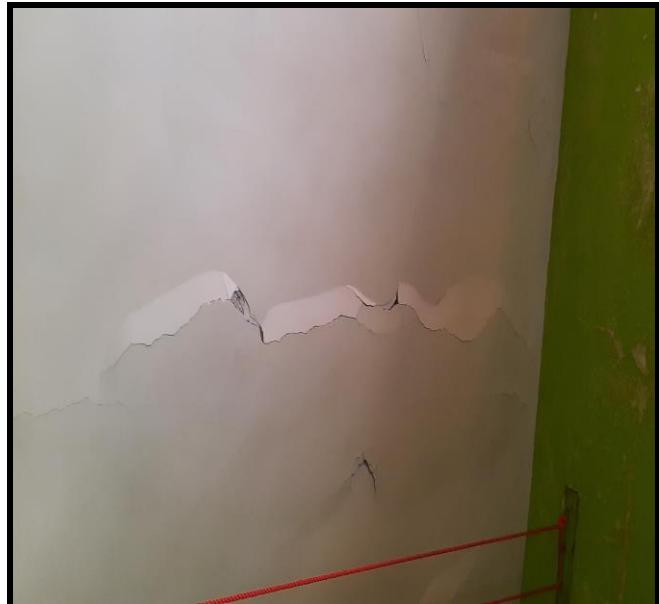
FLAT NO – 37

- ❖ **HALL** – Leakage mark observed on wall.
 - Structural damage observed on ceiling.
- ❖ **KITCHEN** – O.K.
- ❖ **PASSAGE** – O.K.
- ❖ **TOILET & BATH ROOM** – O.K.

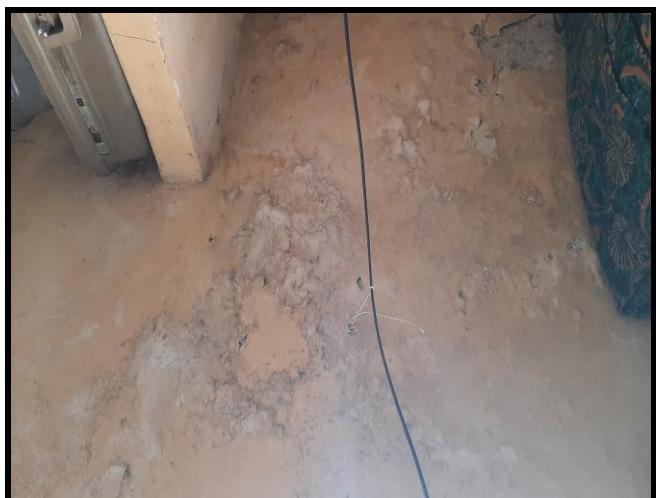
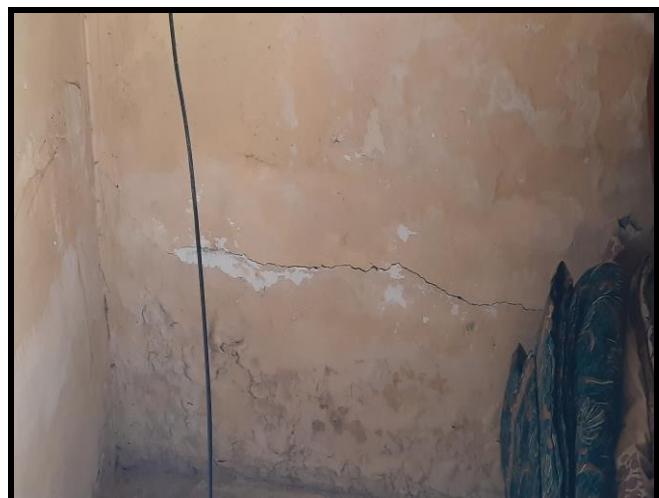
FLAT NO – 39

- ❖ **HALL** – Leakage mark observed on wall.
 - Structural crack observed on column.
- ❖ **KITCHEN** – O.K.
- ❖ **PASSAGE** – O.K.
- ❖ **TOILET & BATH ROOM** – O.K.

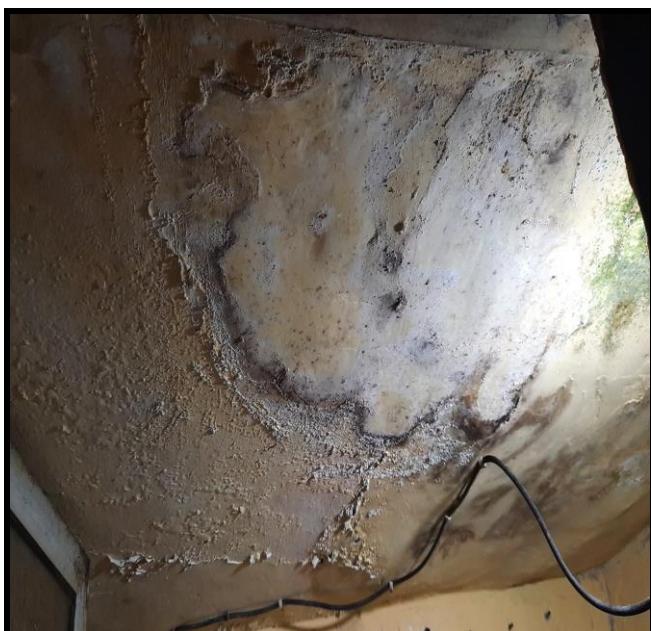
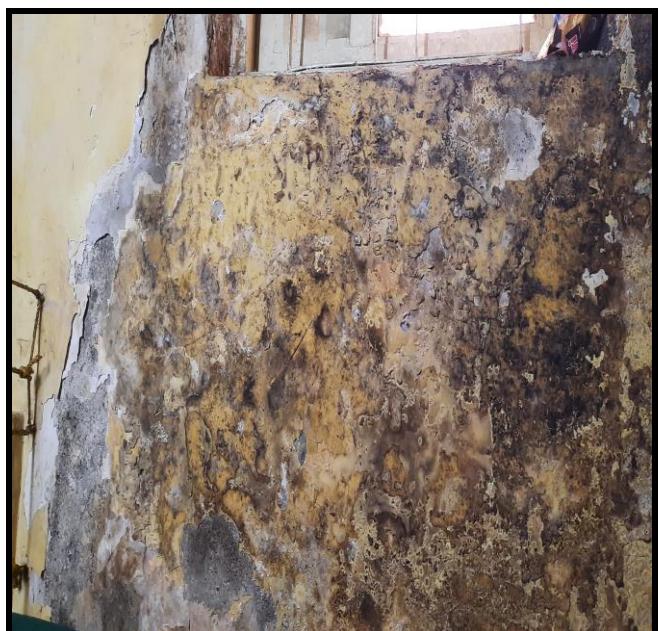
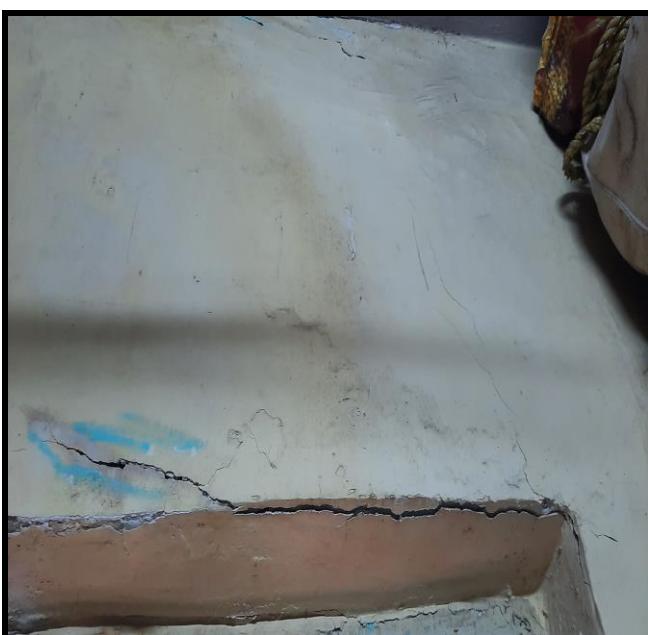
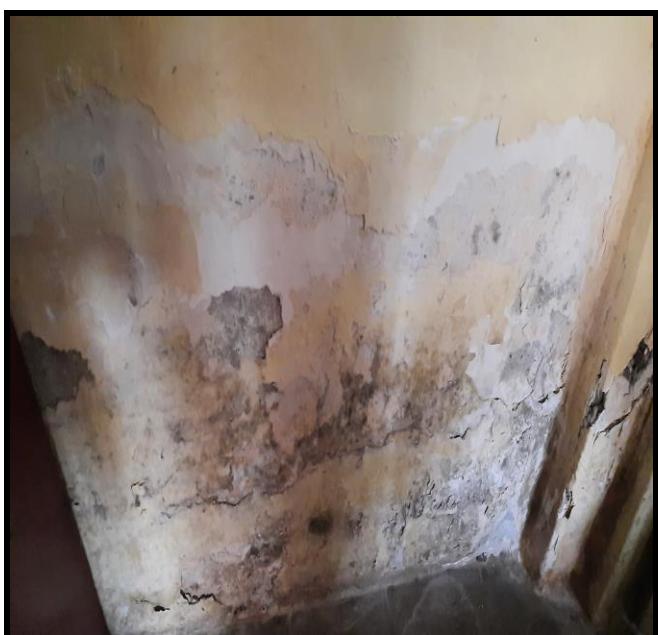
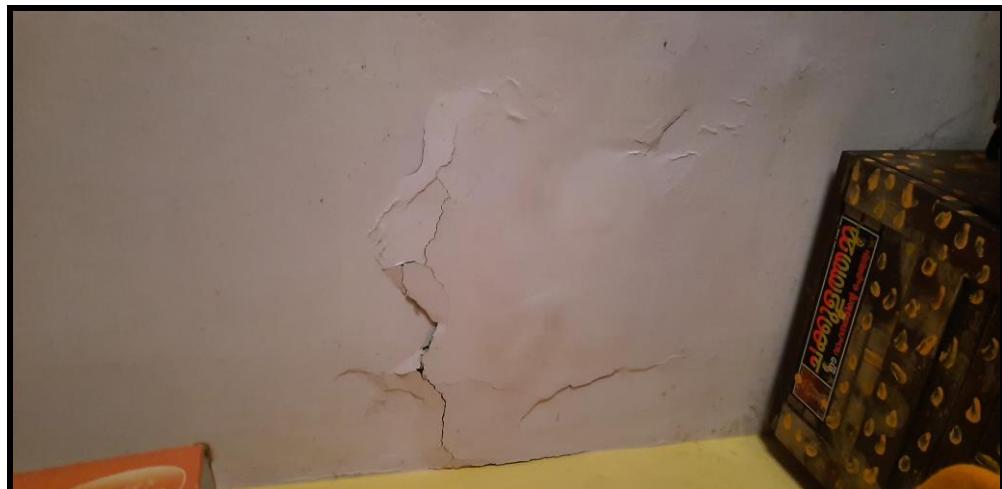
FLAT NO – 44

- ❖ **HALL** – Structural damage observed on ceiling
- ❖ **KITCHEN** – Leakage mark observed on wall & ceiling.
 - Structural crack observed on beam.
- ❖ **PASSAGE** – O.K.
- ❖ **TOILET & BATH ROOM** – O.K.

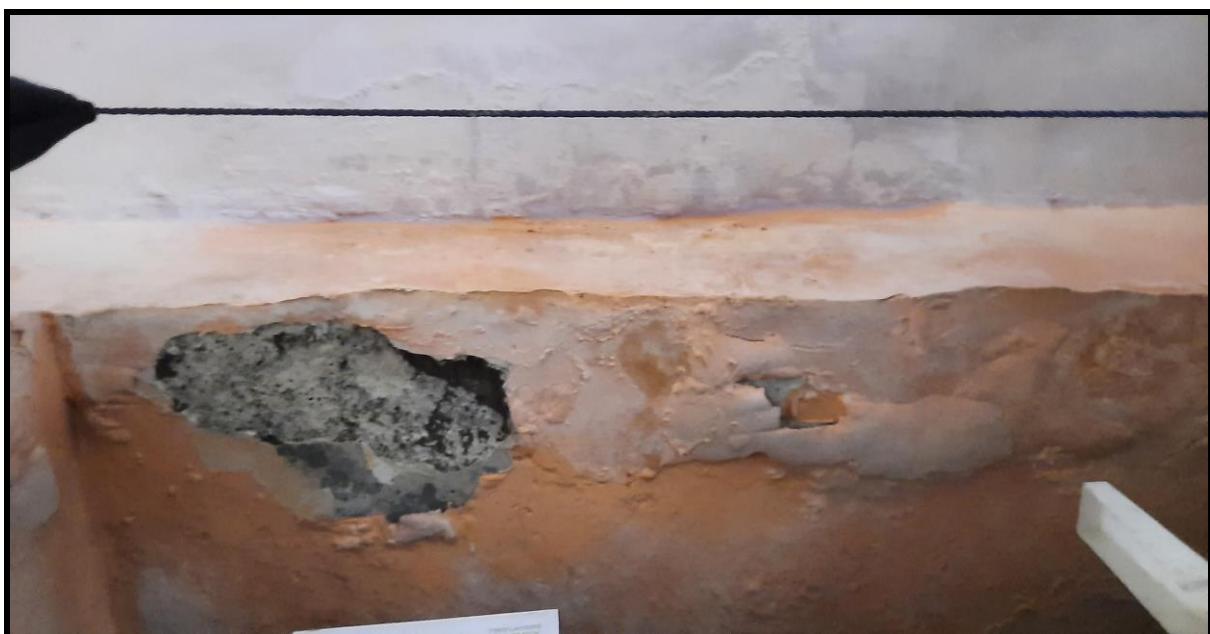
**FLAT NO - 46**

- ❖ **HALL** – O.K.
- ❖ **KITCHEN** – Leakage mark observed on ceiling.
- ❖ **PASSAGE** – O.K.
- ❖ **TOILET & BATH ROOM** – O.K.

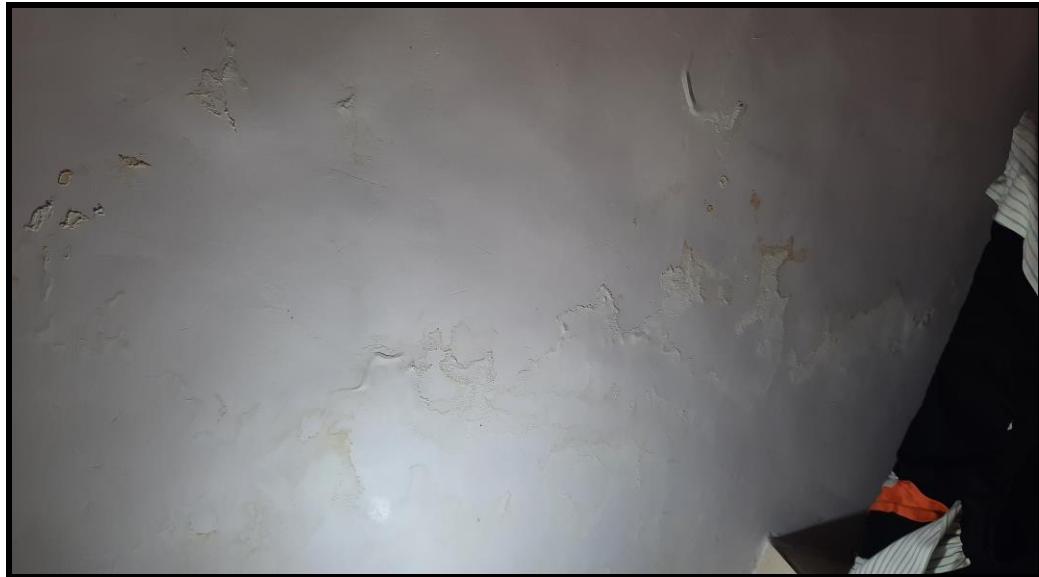
FLAT NO – 51

- ❖ **HALL** – O.K.
- ❖ **KITCHEN** – Leakage mark observed on ceiling.
- ❖ **PASSAGE** – O.K.
- ❖ **TOILET & BATH ROOM** – O.K.

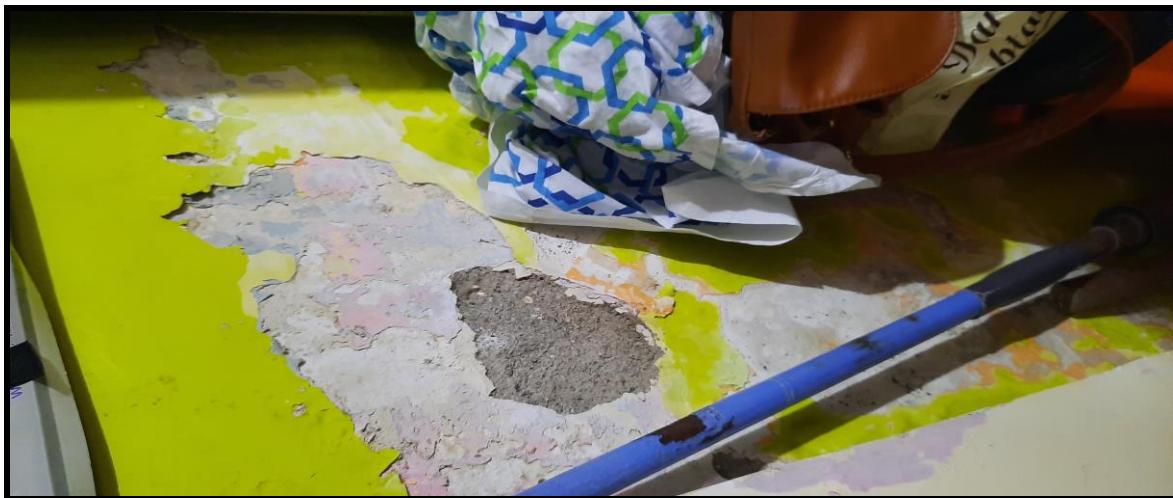
FLAT NO – 54

- ❖ **HALL** – Leakage observed on wall in monsoon.
- ❖ **KITCHEN** – O.K.
- ❖ **PASSAGE** – O.K.
- ❖ **TOILET & BATH ROOM** – O.K.

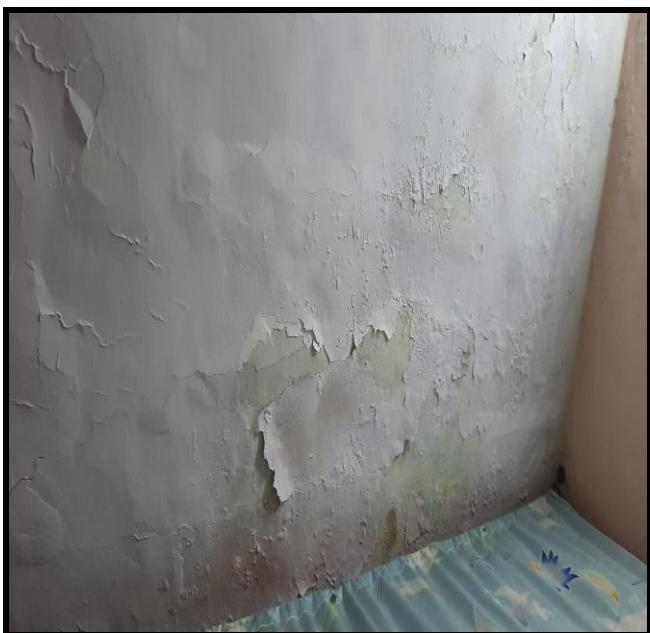
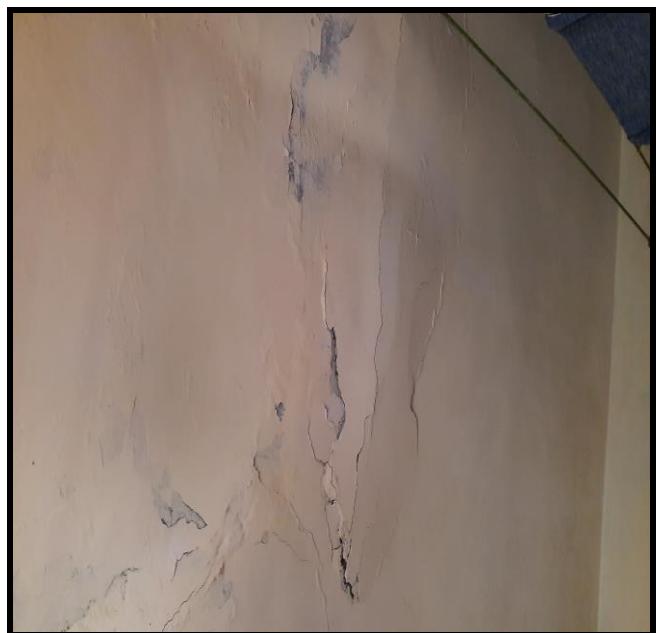
FLAT NO – 58

- ❖ **HALL** – Leakage mark observed on ceiling.
- ❖ **KITCHEN** – Leakage mark observed on ceiling.
 - Structural crack observed on ceiling.
 - Ceiling & beam plaster get damaged & steel get exposed & corroded.
- ❖ **PASSAGE** – O.K.
- ❖ **TOILET & BATH ROOM** – O.K.

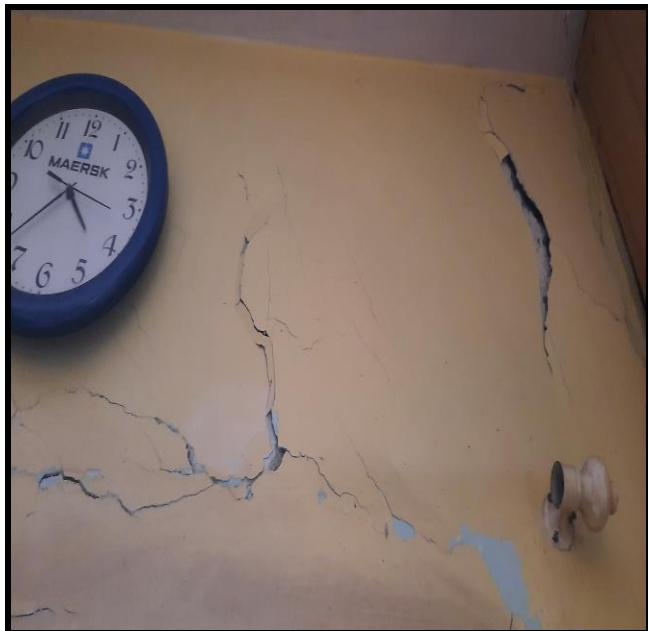
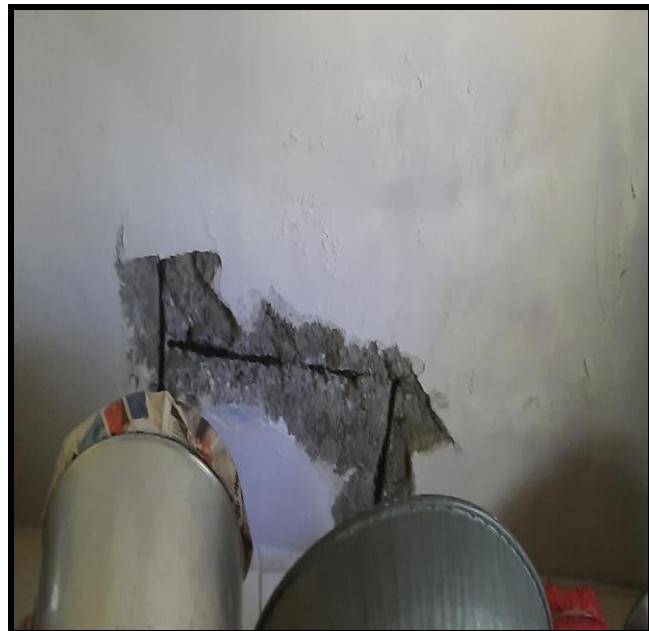
FLAT NO – 63

- ❖ **HALL** – structural crack observed on beam & column.
- ❖ **KITCHEN** – Ceiling plaster get damaged & steel get exposed & corroded.
- ❖ **PASSAGE** – O.K.
- ❖ **TOILET & BATH ROOM** – O.K.

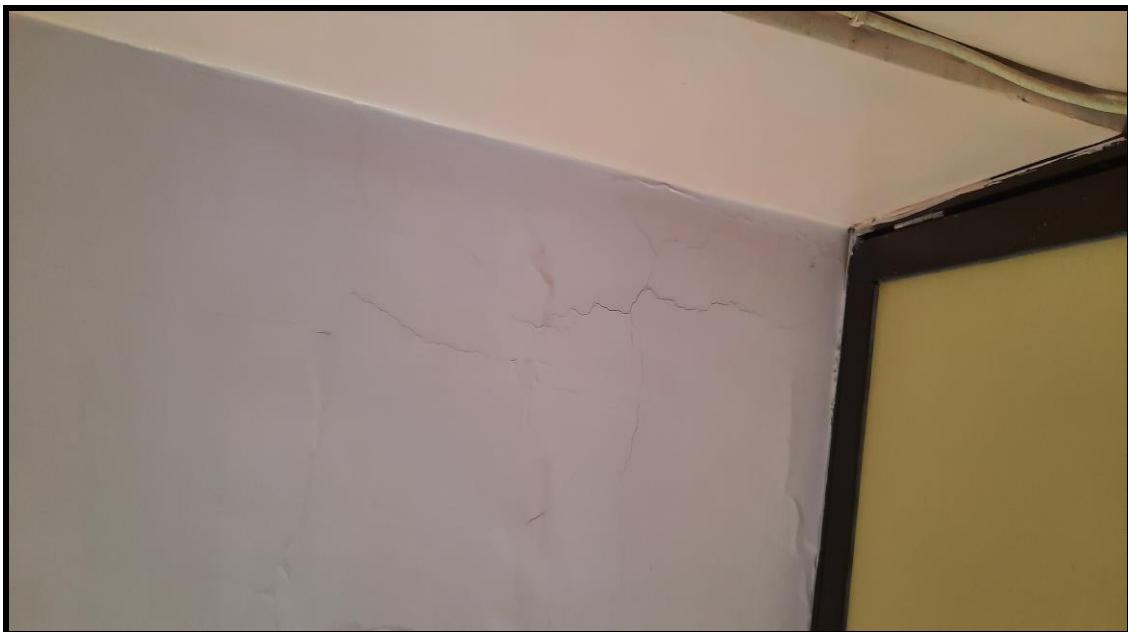
FLAT NO – 67

- ❖ **HALL** – Structural crack observed on ceiling.
- ❖ **KITCHEN** – O.K.
- ❖ **PASSAGE** – O.K.
- ❖ **TOILET & BATH ROOM** – O.K.

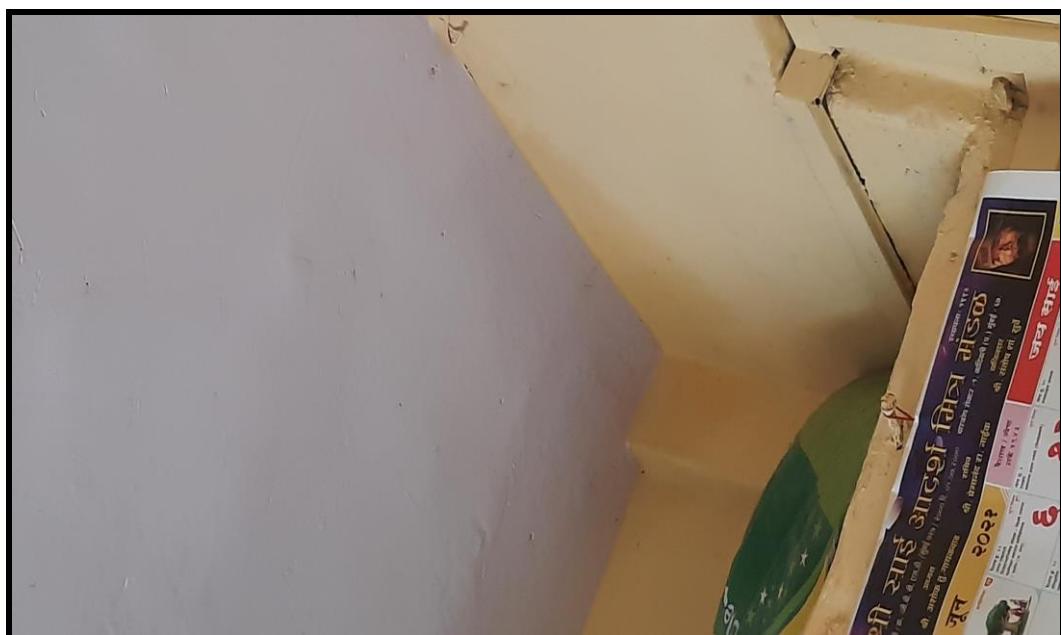
FLAT NO – 73

- ❖ **HALL** – Dampness observed on ceiling.
 - Dampness observed on wall in monsoon.
- ❖ **KITCHEN** – O.K.
- ❖ **PASSAGE** – O.K.
- ❖ **TOILET & BATH ROOM** – O.K.

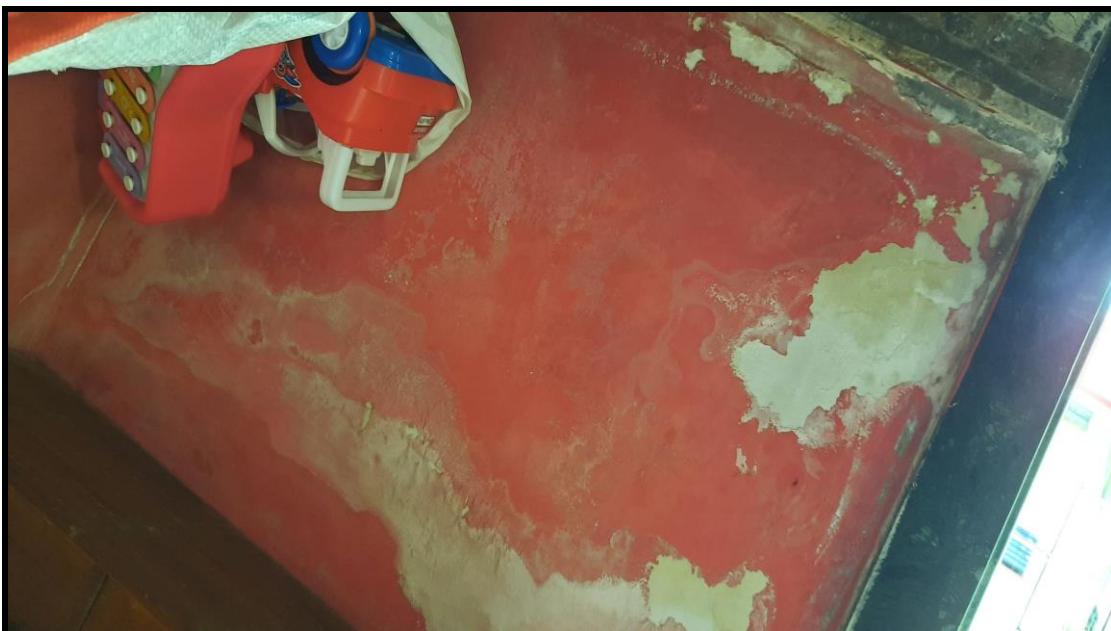
FLAT NO – 77

- ❖ **HALL** – Dampness observed on wall in monsoon.
- ❖ **KITCHEN** – O.K.
- ❖ **PASSAGE** – O.K.
- ❖ **TOILET & BATH ROOM** – O.K.

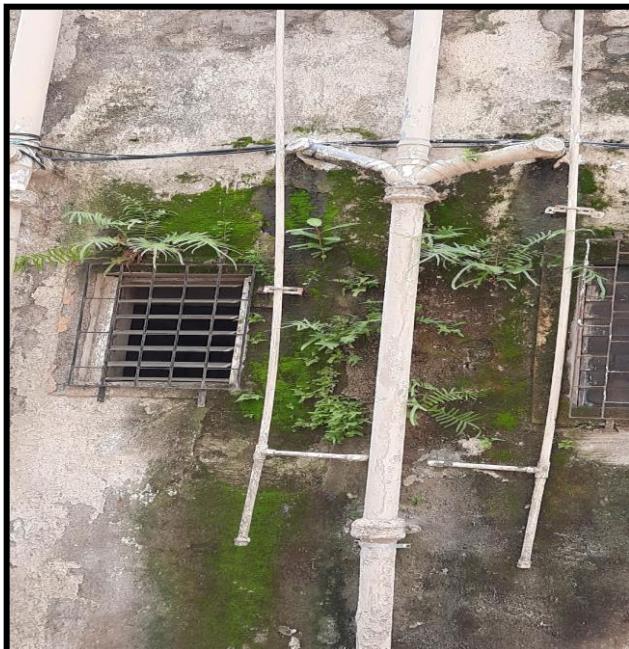
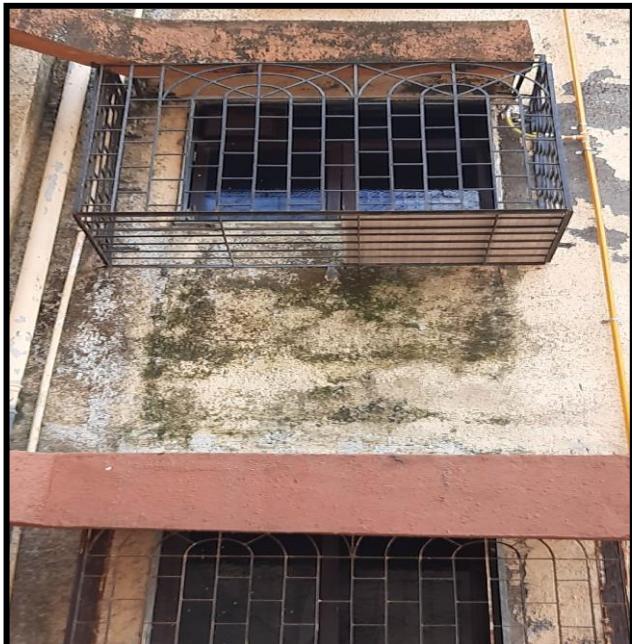
FRONT SIDE

- ❖ Structural crack observed at several places on column & chajjas.
- ❖ Major crack observed at several places on wall.
- ❖ Algae observed at several places on wall.
- ❖ Vegetation growth observed at several places on wall.
