STRUCTURAL AUDIT REPORT
FOR
“VISHAL SAHYADRI CO – OP HSG. SOC. LTD”,
“C3 – WING”
SITUATED AT
SAHYADRI NAGAR, CHARKOP,
KANDIVALI (W) MUMBAI – 400 067

PREPARED BY
LATESH S. SANKLECHA
CONSULTING STRUCTURAL ENGINEERS

978/C3/LSS/2021

JUNE 21, 2021

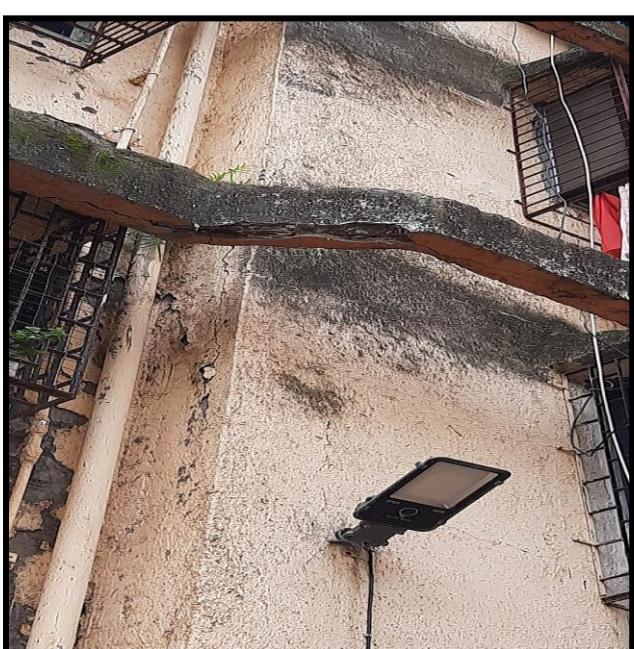
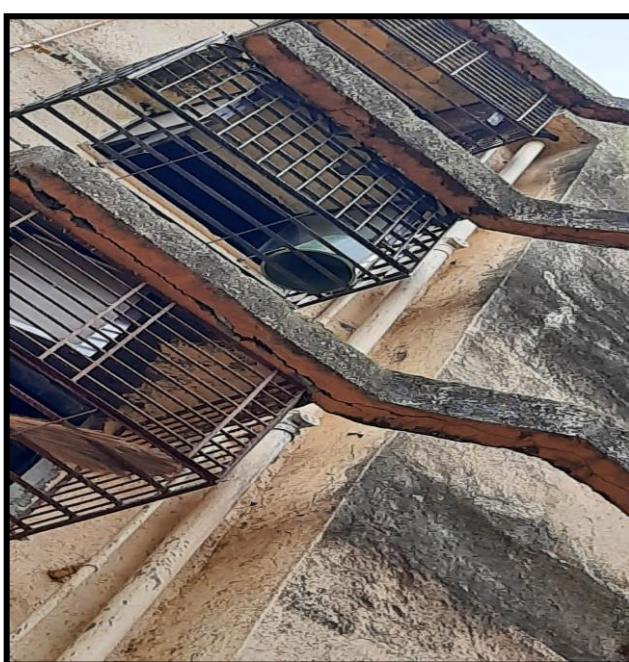
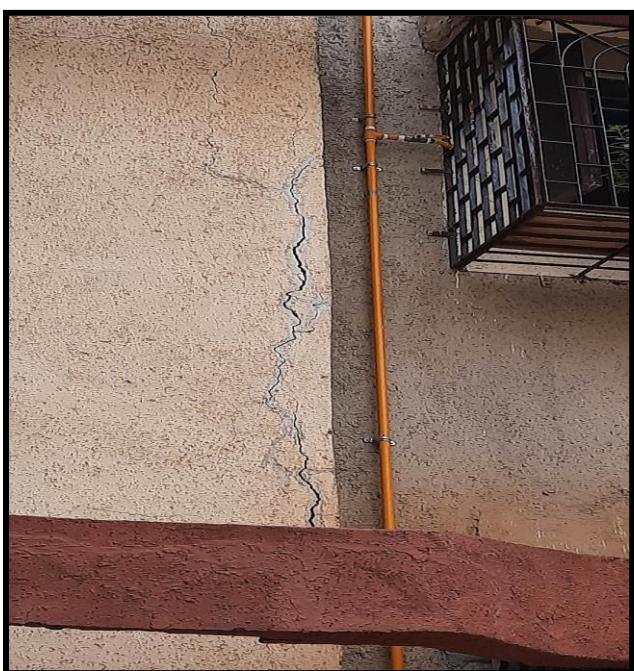
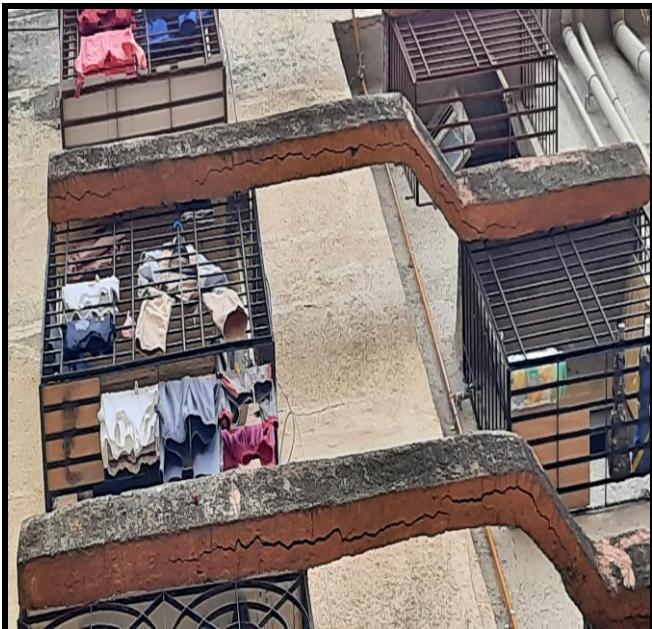
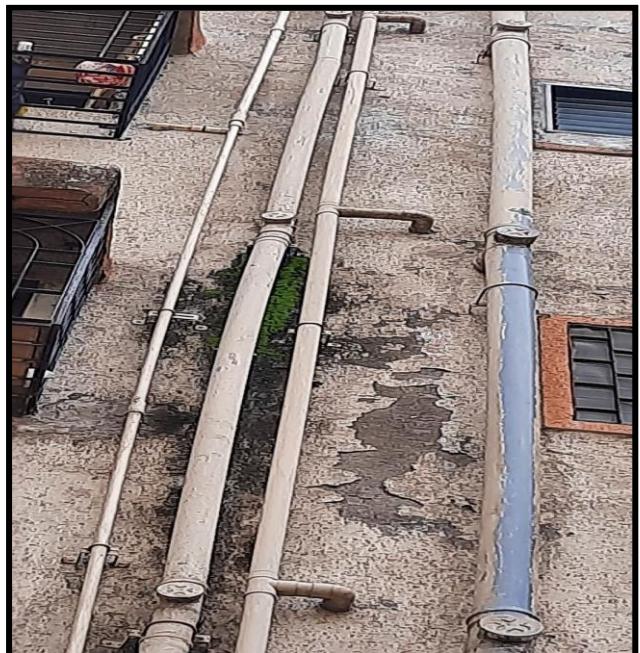
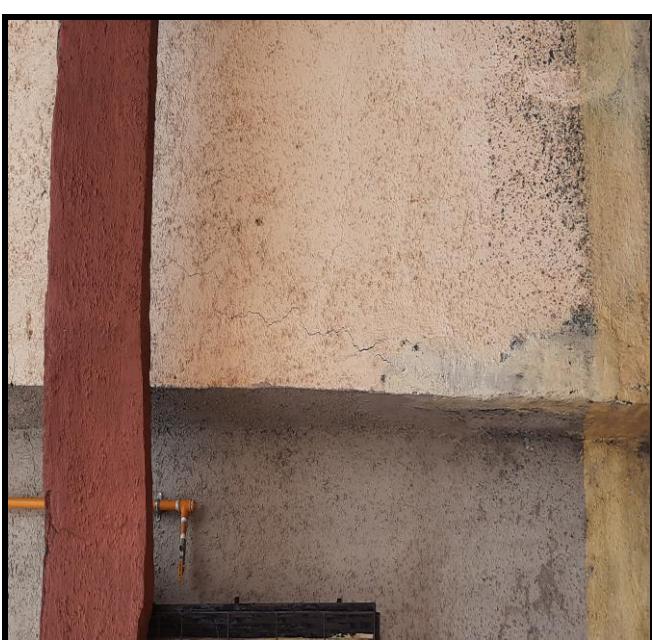
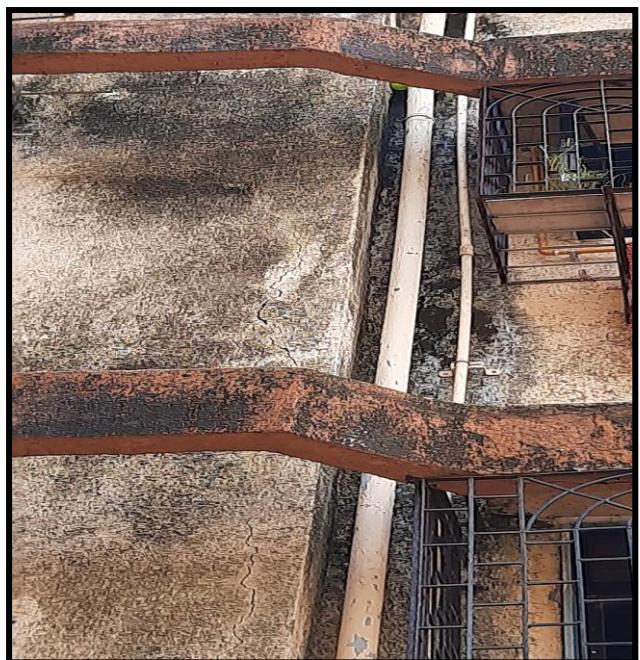
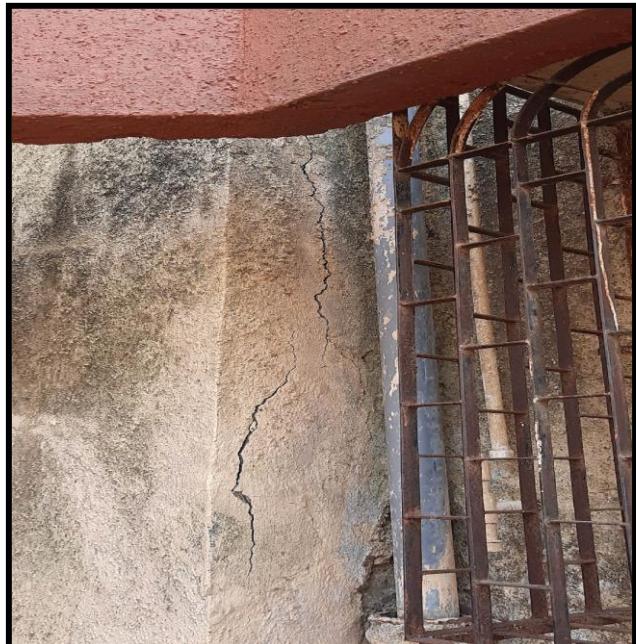
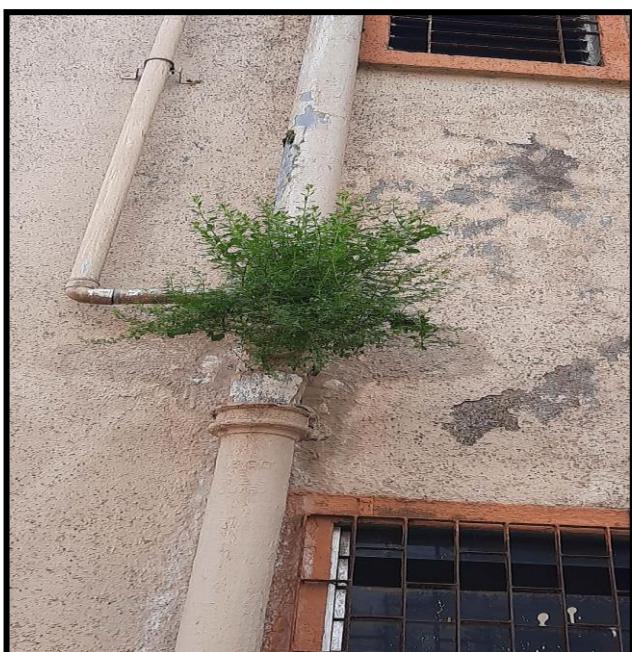
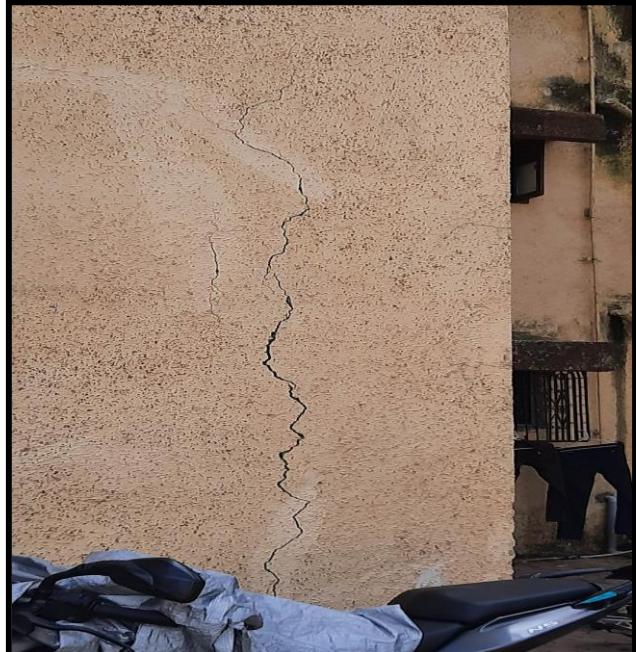
FRONT SIDE

- ❖ Structural crack observed at several places on column & chajjas.
- ❖ Major crack observed at several places on wall.
- ❖ Algae observed at several places on wall.
- ❖ Vegetation growth observed at several places on wall.

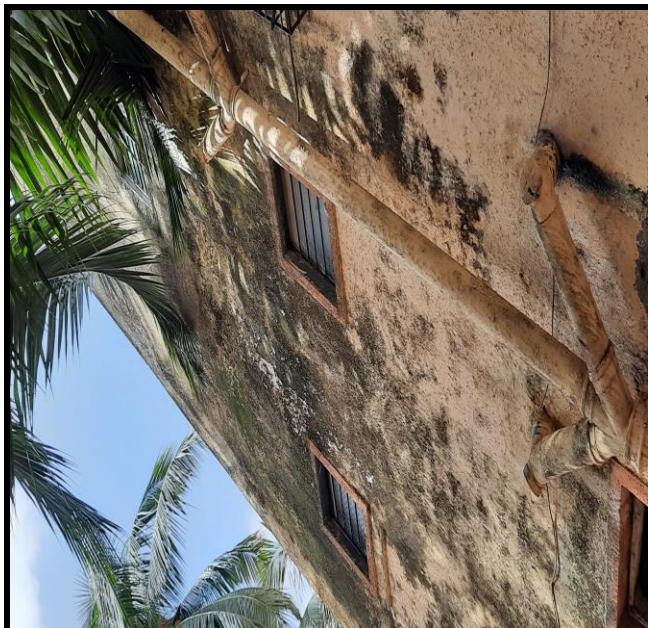
BACK SIDE

- ❖ Structural crack observed at several places on column.
- ❖ Major crack observed at several places on wall.
- ❖ Vegetation growth observed at several places on wall.
- ❖ Algae observed at several places on wall.

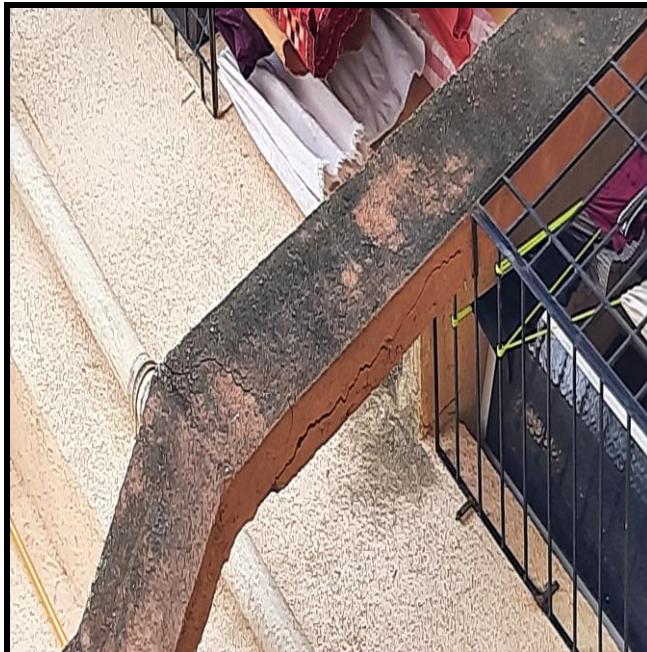
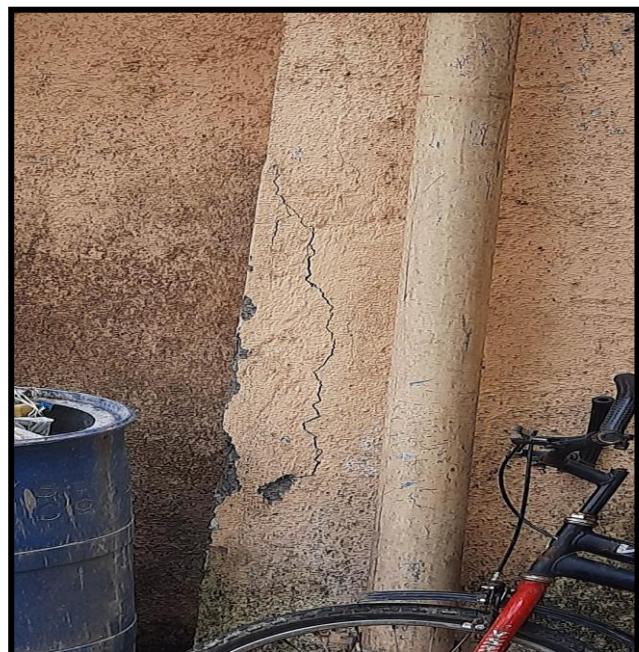
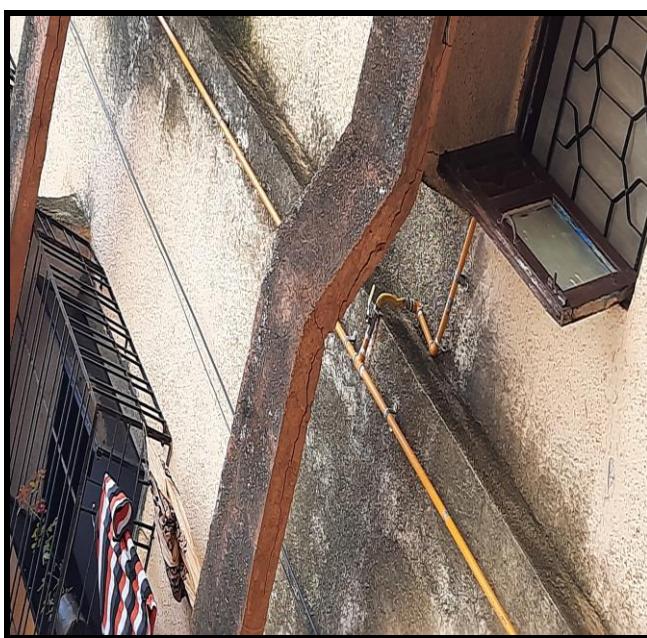
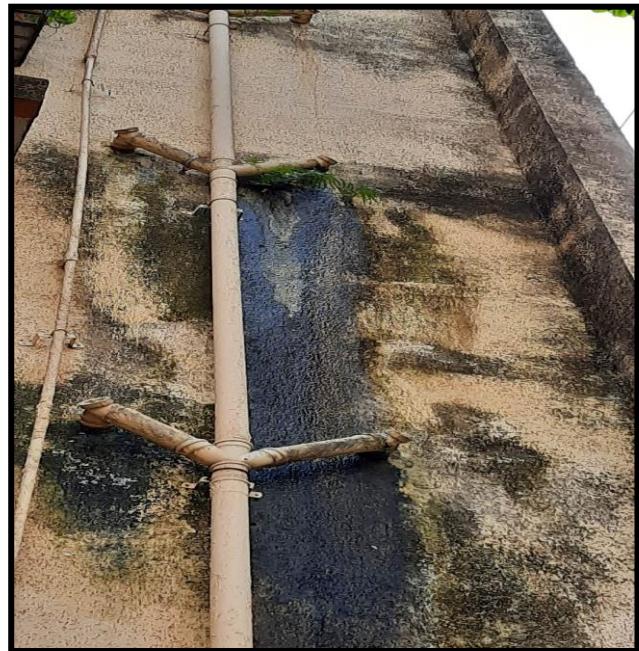
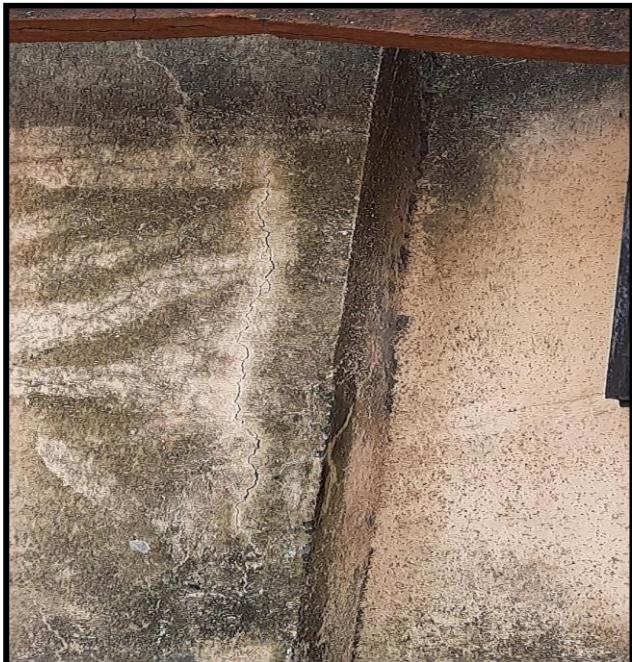
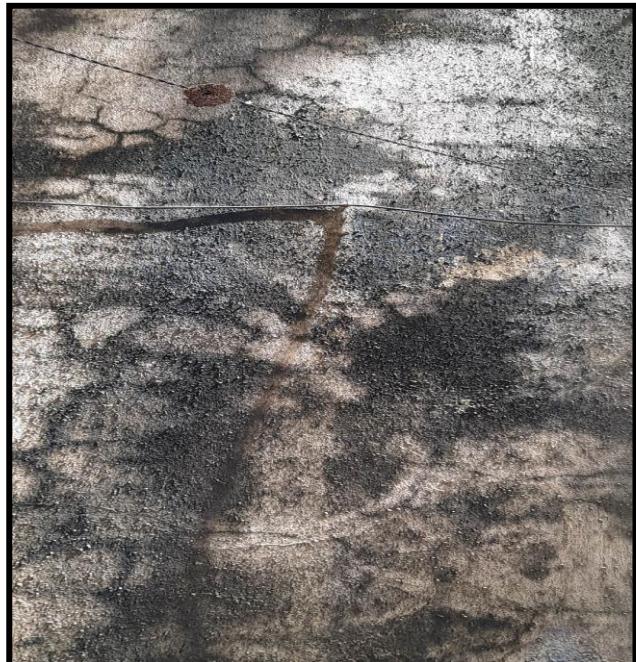
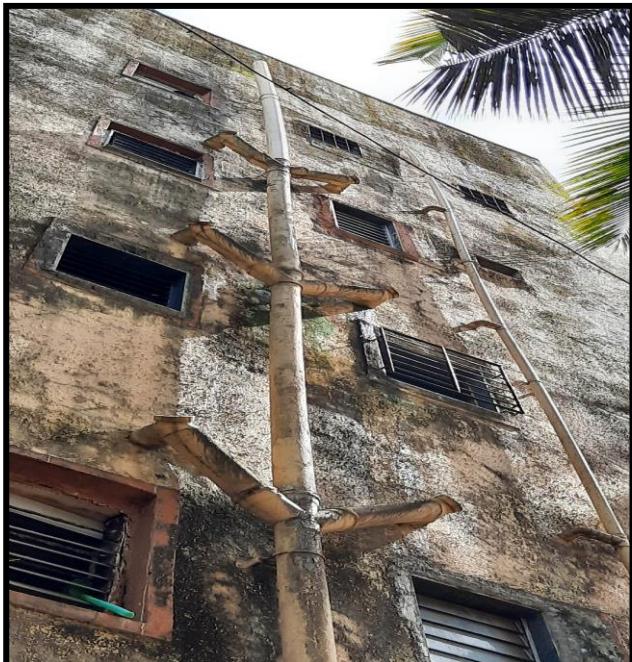
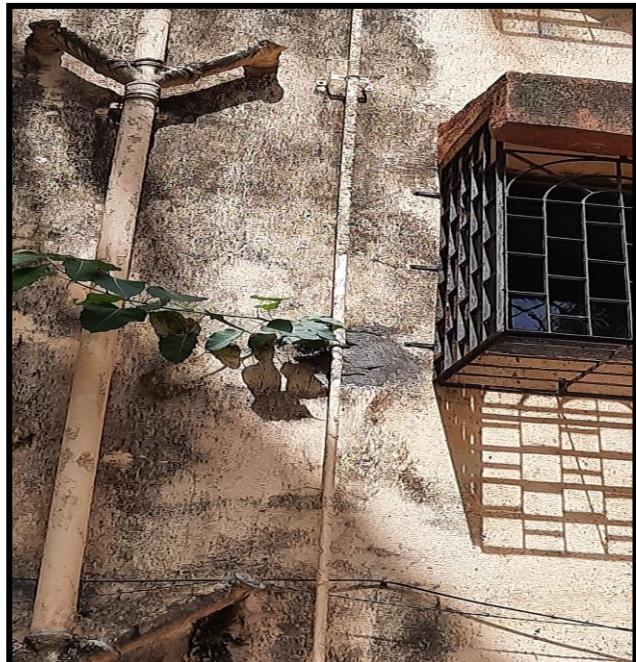
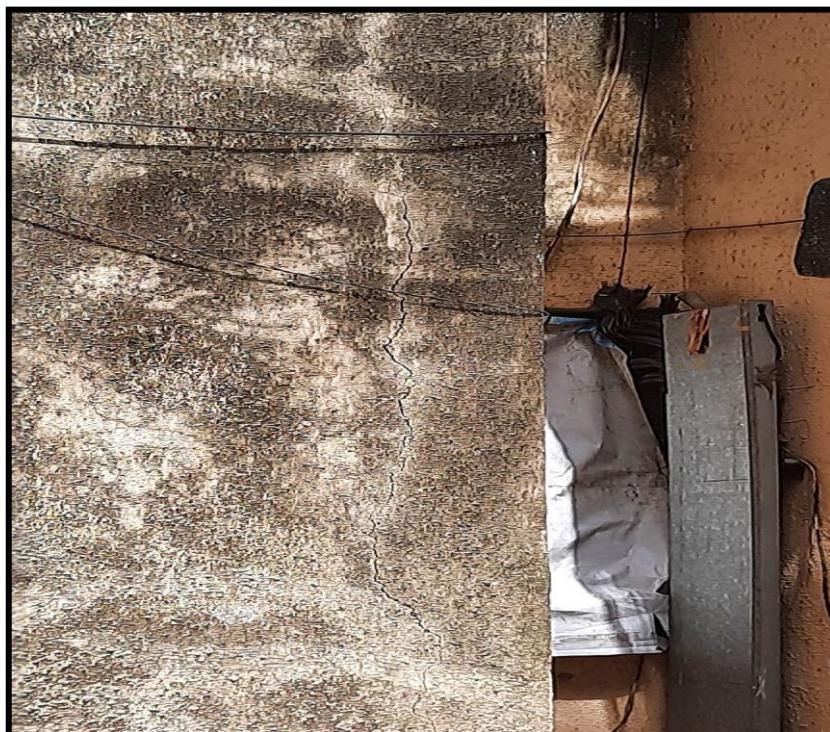
NORTH SIDE

- ❖ Structural crack observed at several places on column.
- ❖ Major crack observed at several places on wall.
- ❖ Vegetation growth observed at several places on wall.

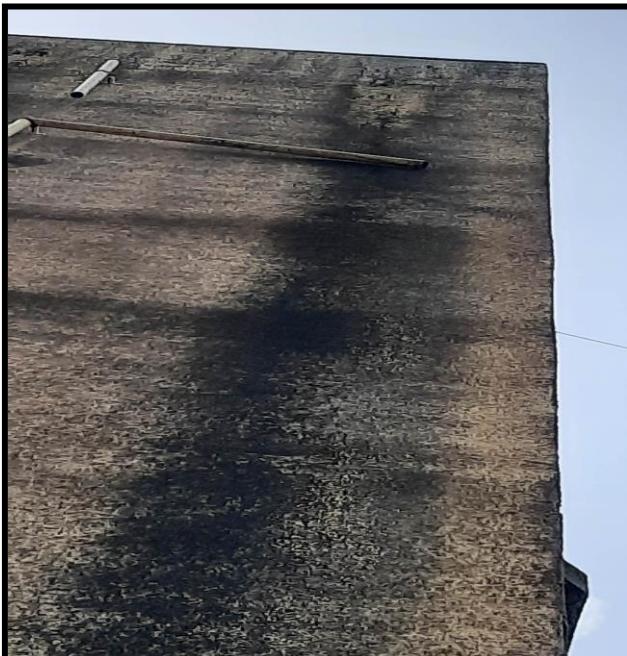
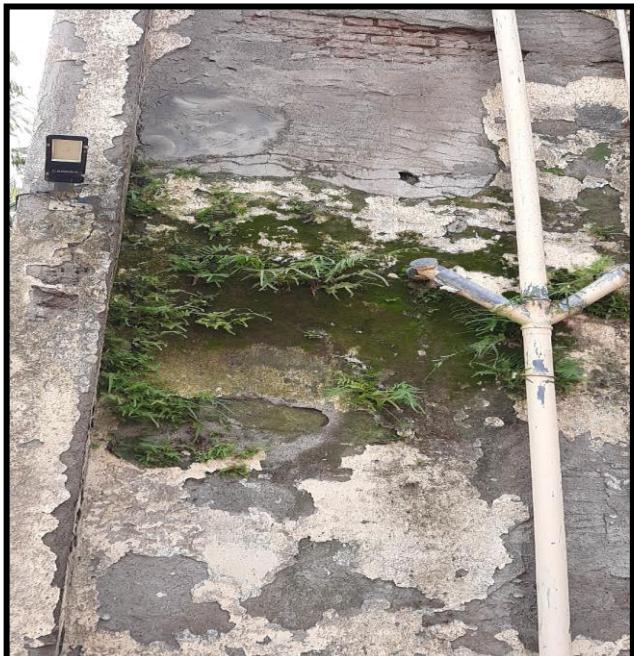
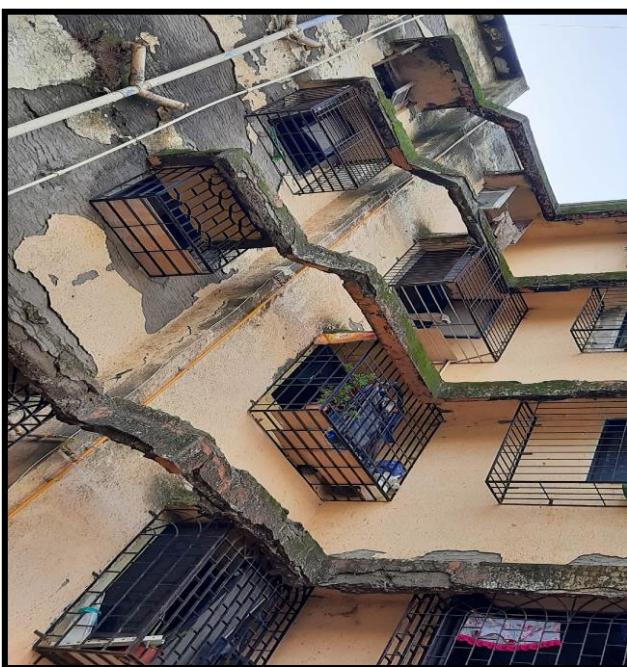
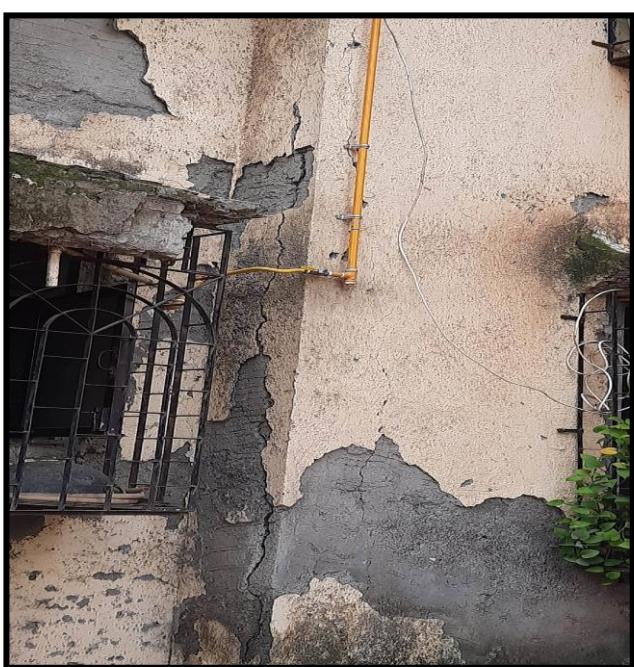
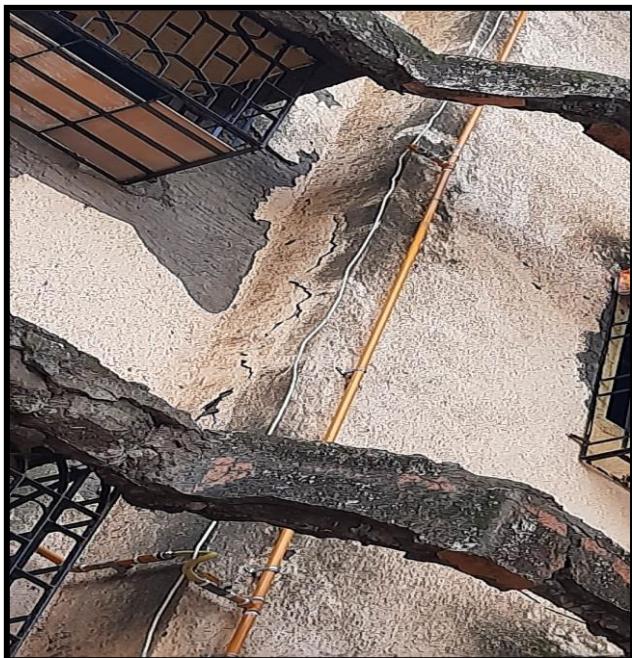
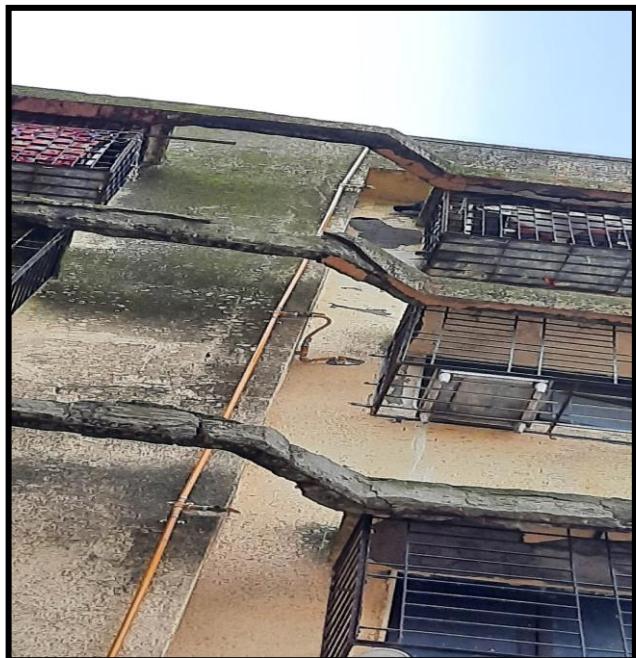
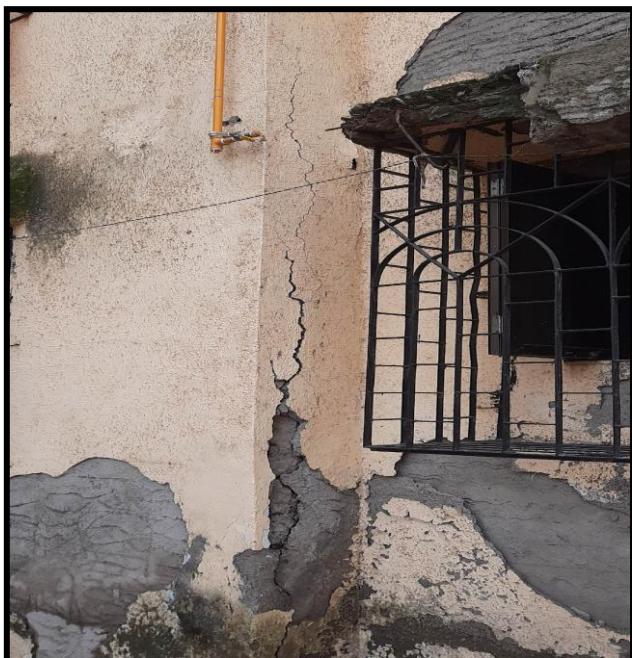
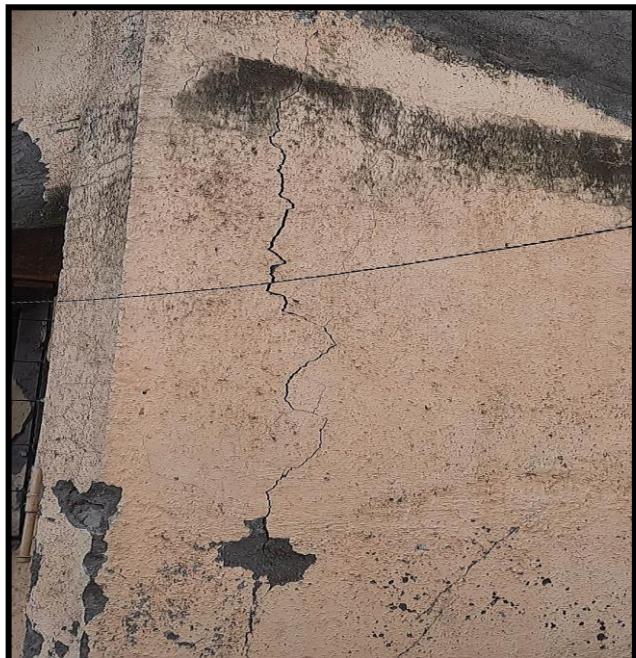
SOUTH SIDE

- ❖ Structural crack observed at several places on column.
- ❖ Major crack observed at several places on wall.
- ❖ Vegetation growth observed at several places on wall.
- ❖ Chajja & column plaster get damaged & steel get exposed & corroded.
- ❖ Algae observed at several places on wall.
