STRUCTURAL AUDIT REPORT
FOR
“VISHAL SAHYADRI CO – OP HSG. SOC. LTD”,
“B10 – WING”
SITUATED AT
SAHYADRI NAGAR, CHARKOP,
KANDIVALI (W) MUMBAI – 400 067

978/B10/LSS/2021

JULY 24, 2021

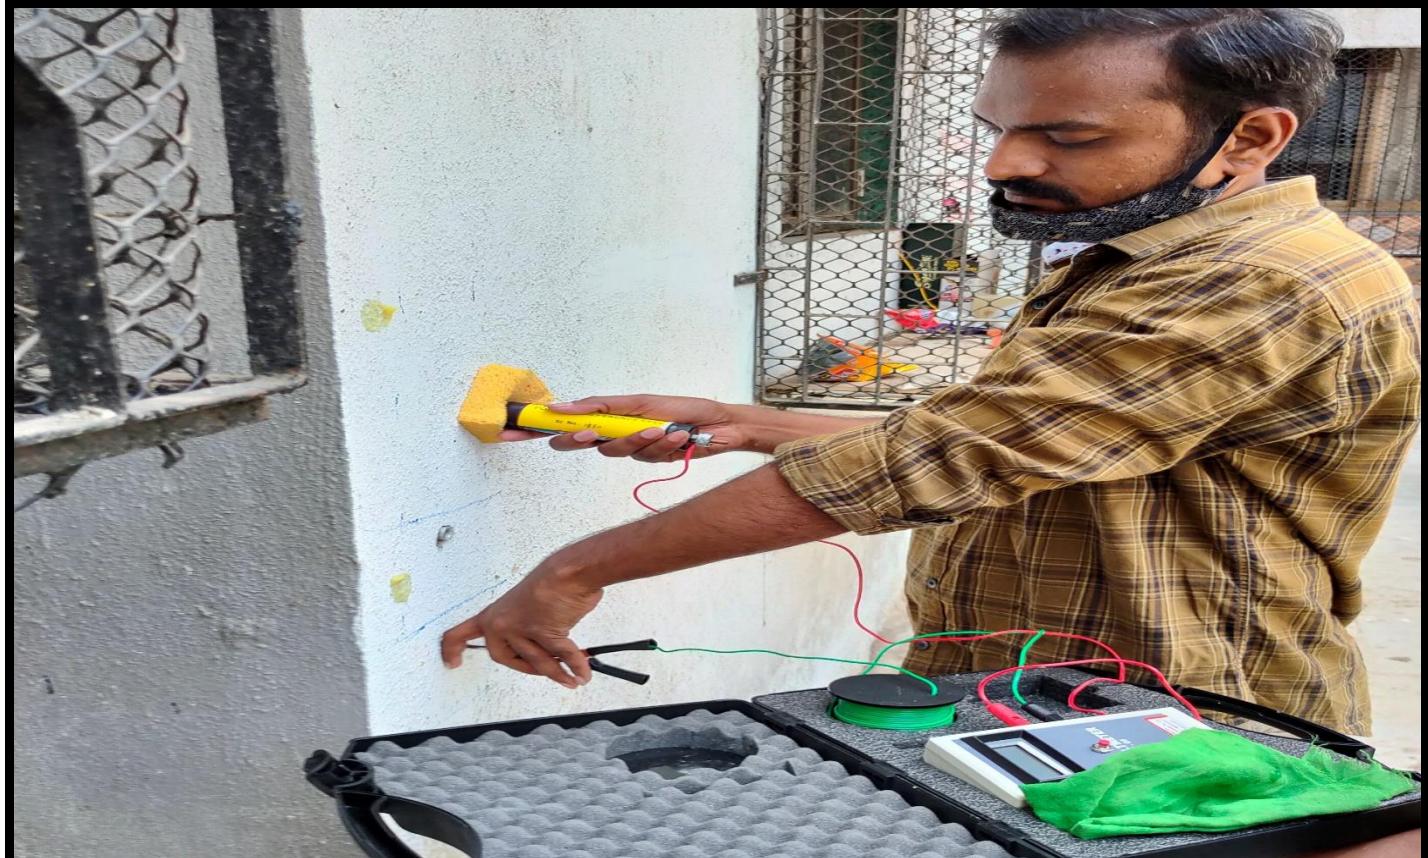
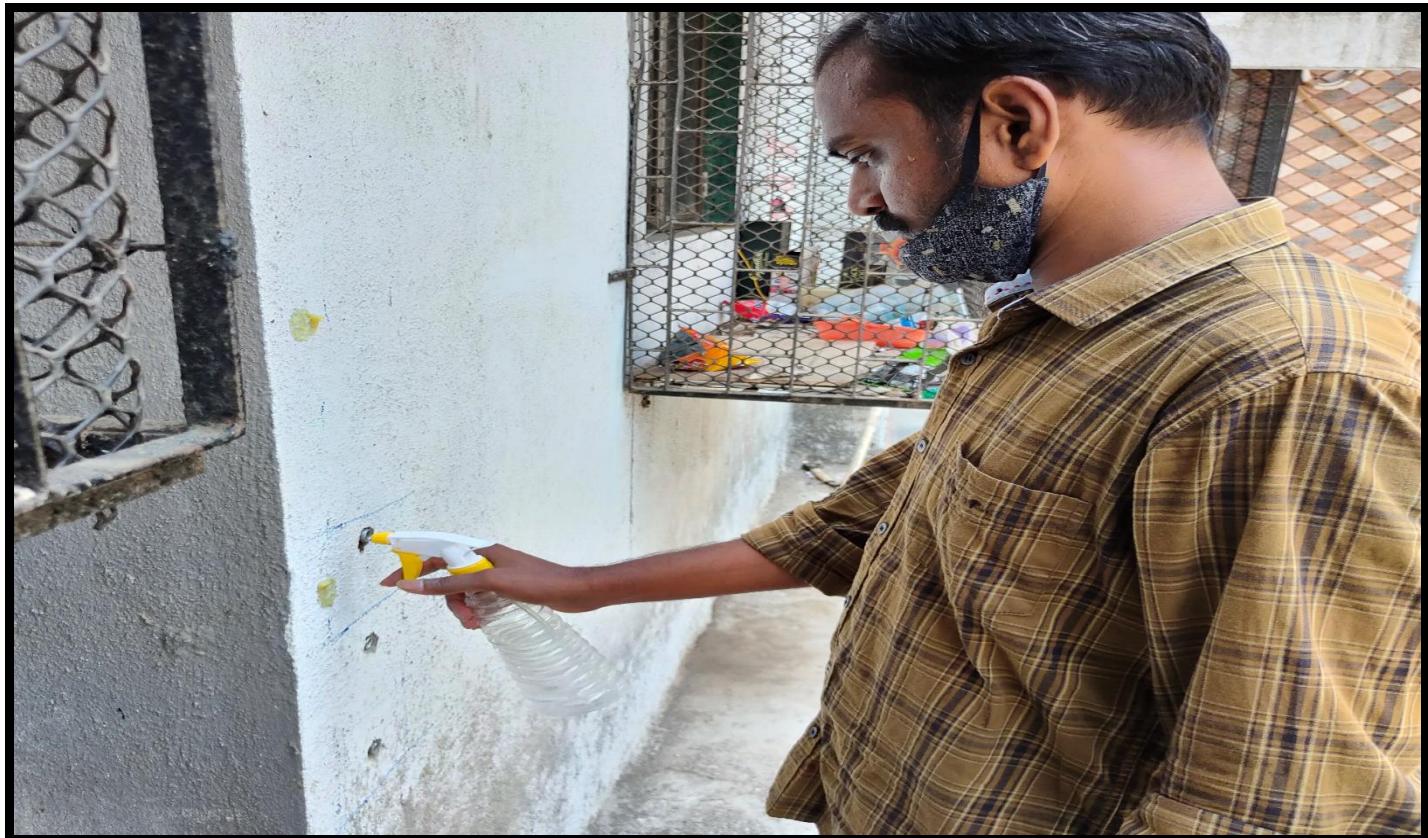
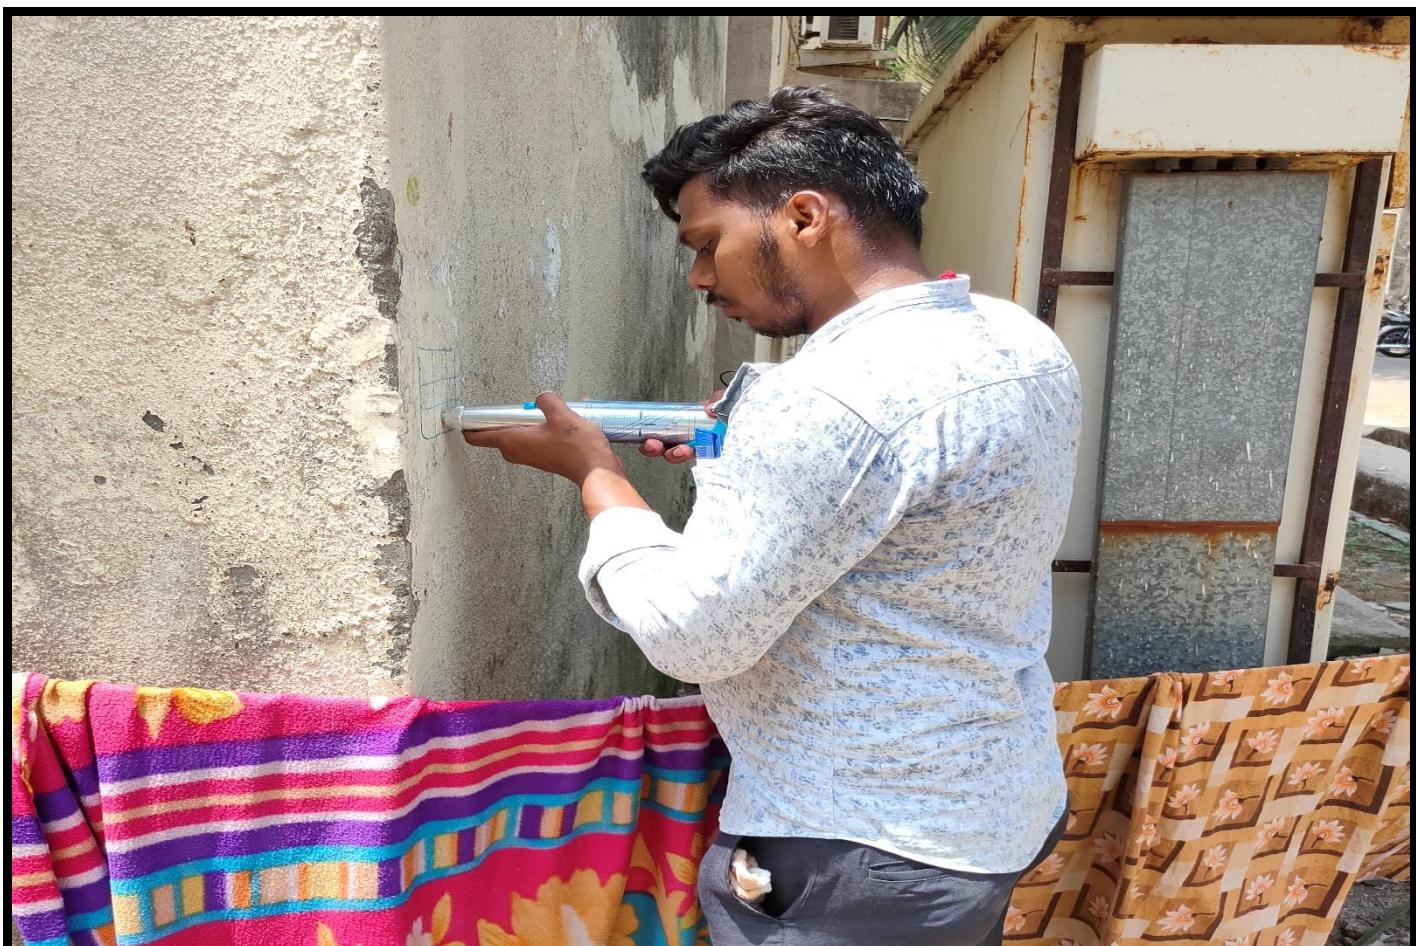
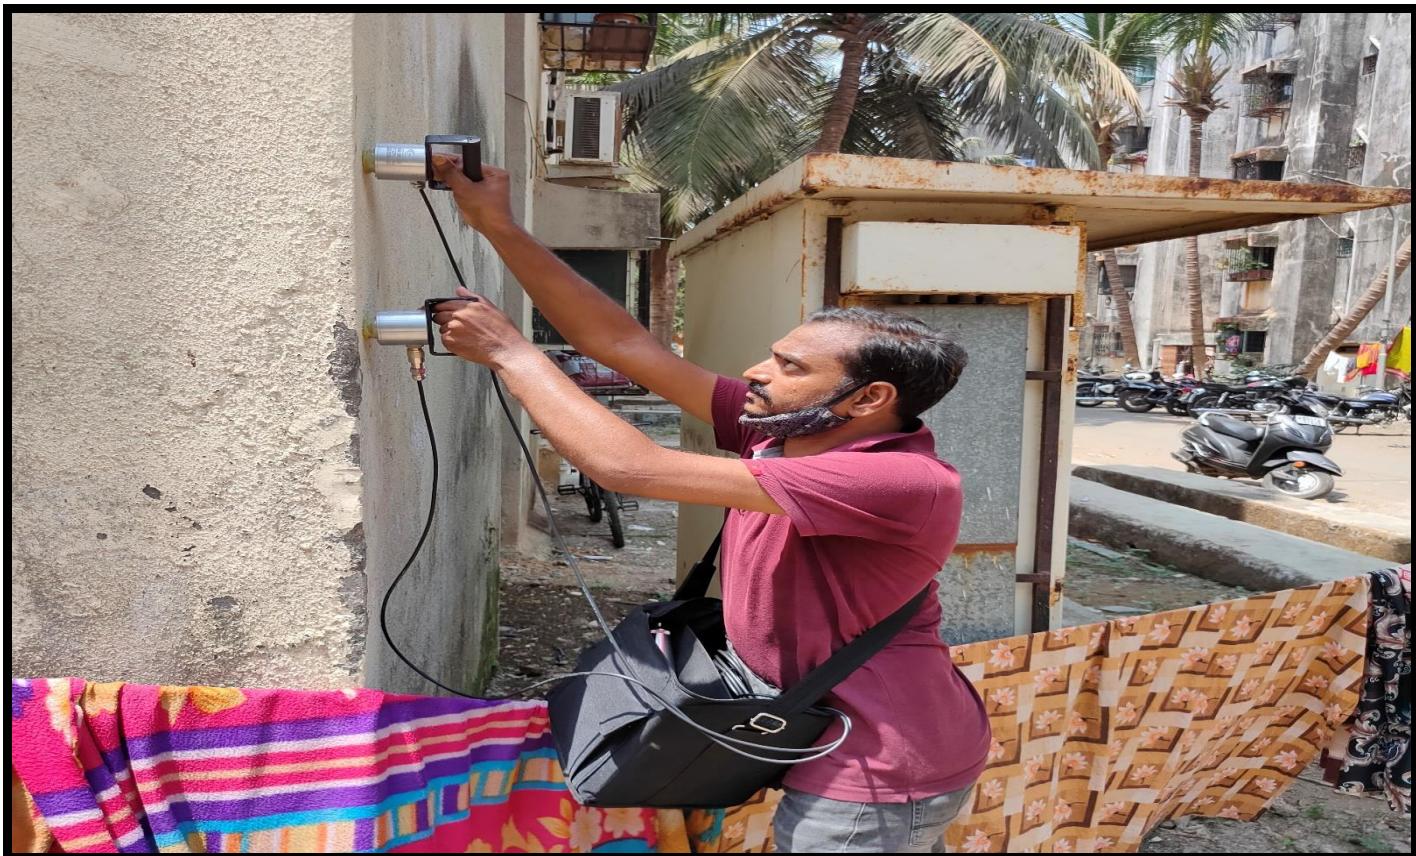
NON -DESTRUCTIVE TEST PHOTO

Rebound Hammer was tested for compressive strength at surface by Schmidt rebound hammer. Results indicate the compressive strength at surface of all the RCC columns is ranging between 13.70 MPa to 17.50 MPa.

Out of 4 locations all 4 locations was below 3.0 Km/Sec means concrete quality is poor.

This indicates there are progressive internal cracks in the RCC members due to corrosion of reinforced steel. These members are under distress condition.

RCC elements indicating UPV values less than 3 Km/sec needs immediate attention.

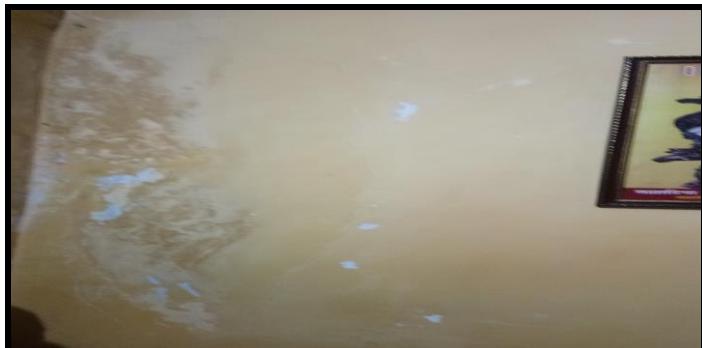
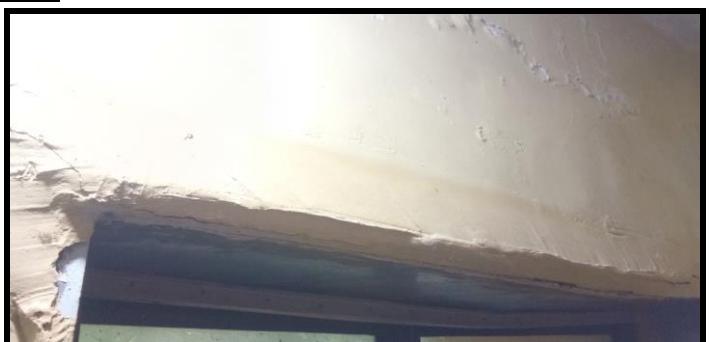
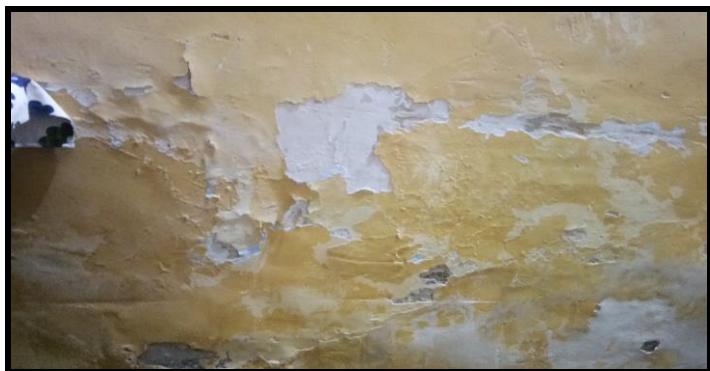
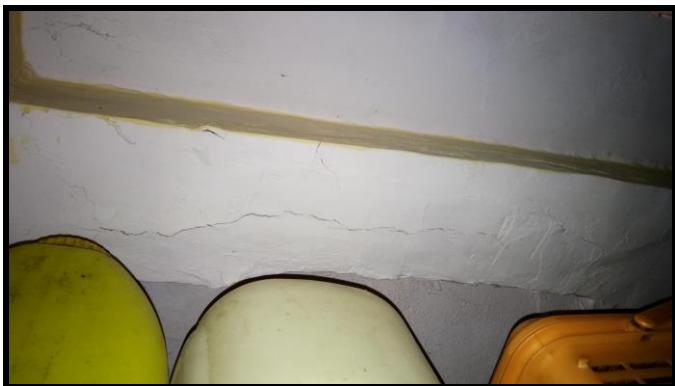
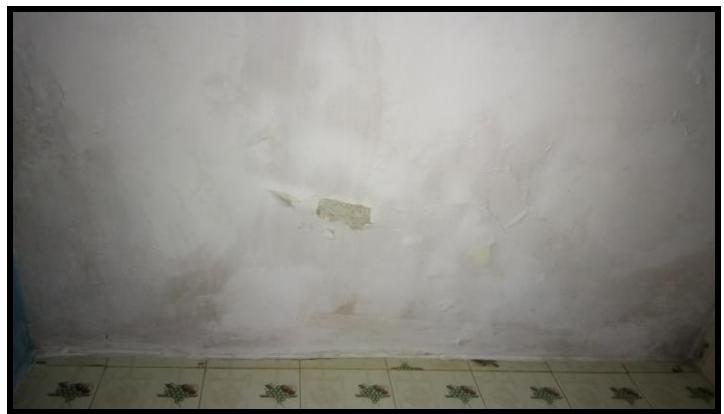
FLAT NO – 03

- ❖ **HALL** – Seepage mark observed on wall.
 - Dampness observed on ceiling.
- ❖ **KITCHEN** – Seepage mark observed on wall.
- ❖ **PASSAGE** – Major structural crack observed on beam.
- ❖ **TOILET & BATH ROOM** – Seepage mark observed on wall.

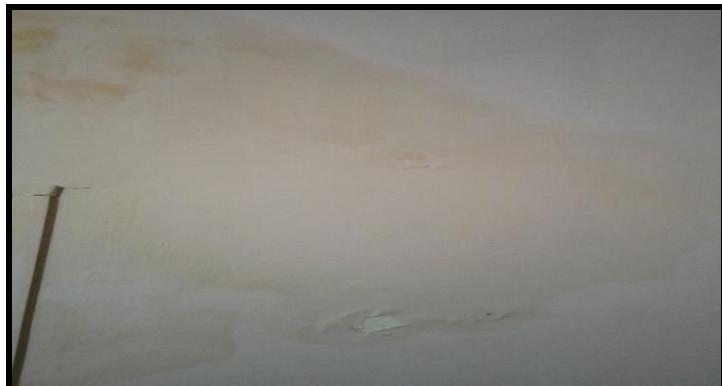
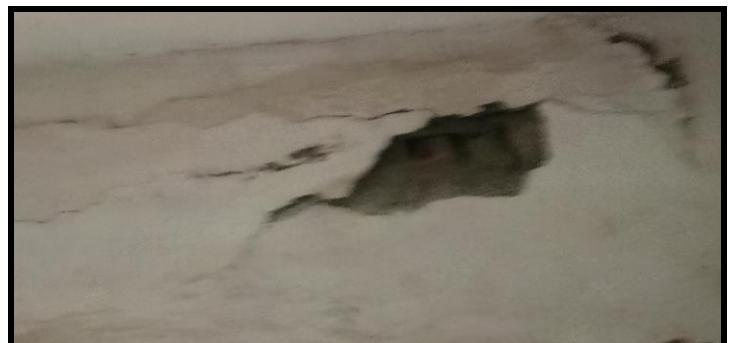
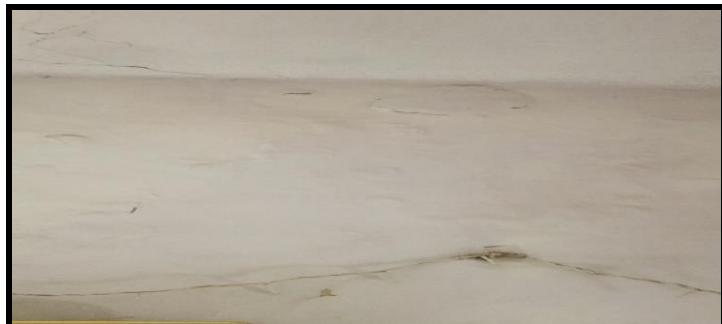
FLAT NO – 16

- ❖ **HALL** – Major structural crack observed on wall. (**It may fall**)
 - Major Structural crack observed on beam. (**It may fall**)
 - Major structural crack observed on column. (**It may fall**)
 - Ceiling gets damage.
 - Hallow sound observed on wall. (**It may fall**)
- ❖ **KITCHEN** – Hallow sound observed on wall. (**It may fall**)
 - Major Structural crack observed on beam. (**It may fall**)
 - Plaster gets removed and steel exposed.
- ❖ **PASSAGE** – Ceiling gets damage.
- ❖ **TOILET & BATH ROOM** – Seepage mark observed on wall.

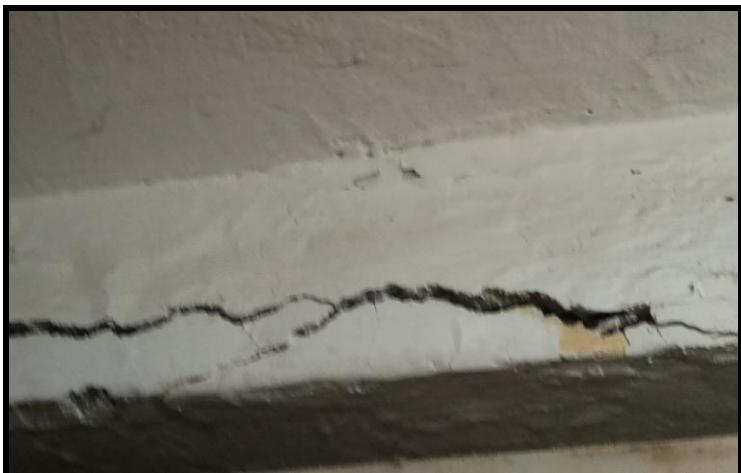
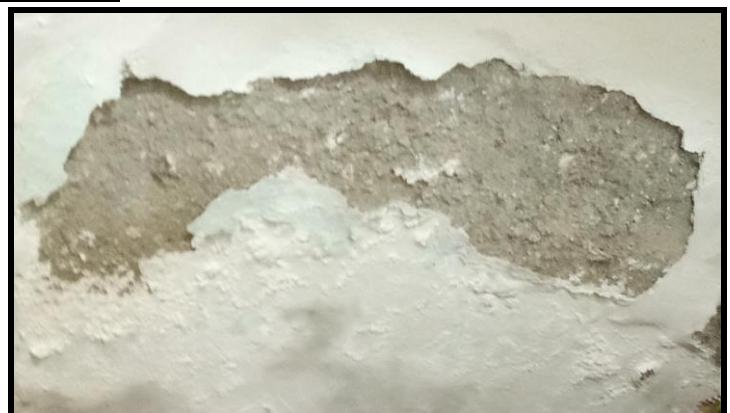
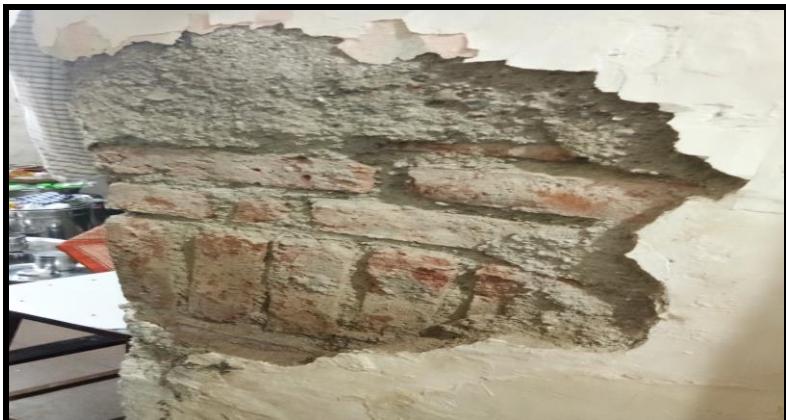
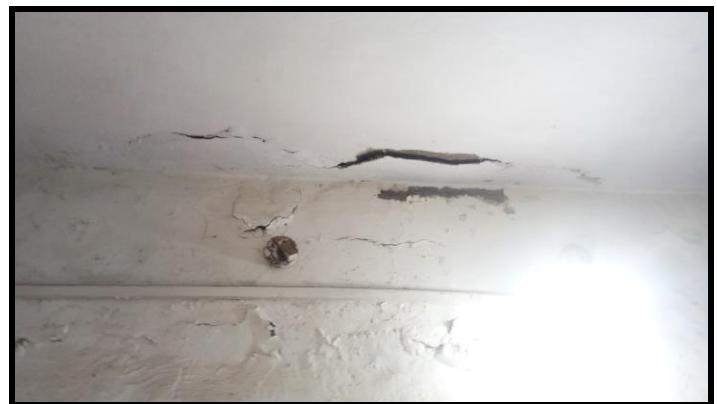
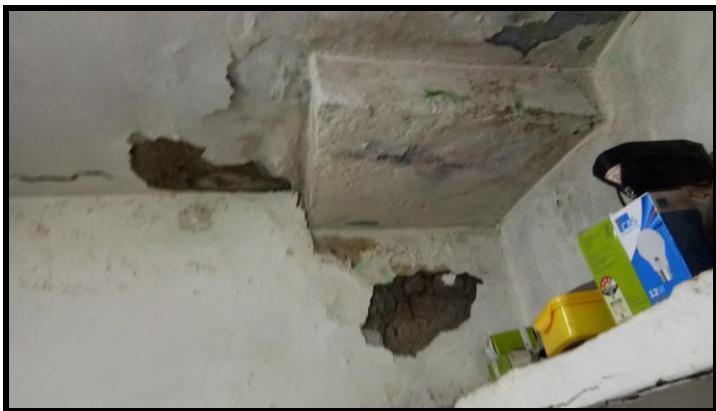
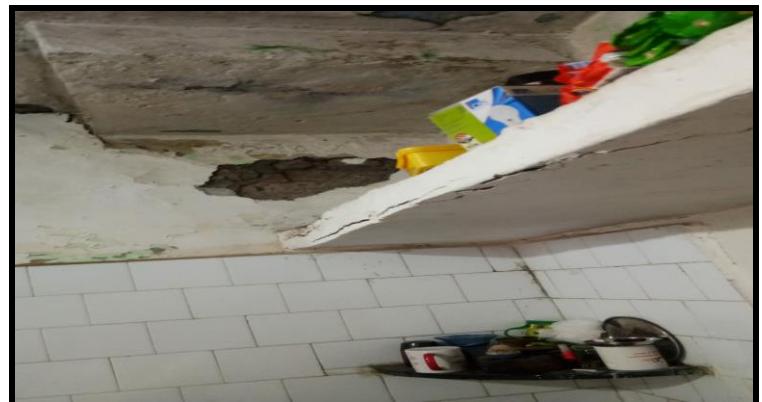
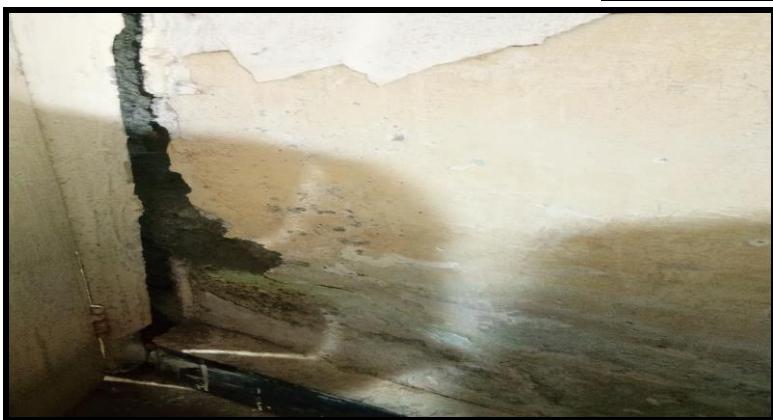
FLAT NO – 15

- ❖ Not permitted.

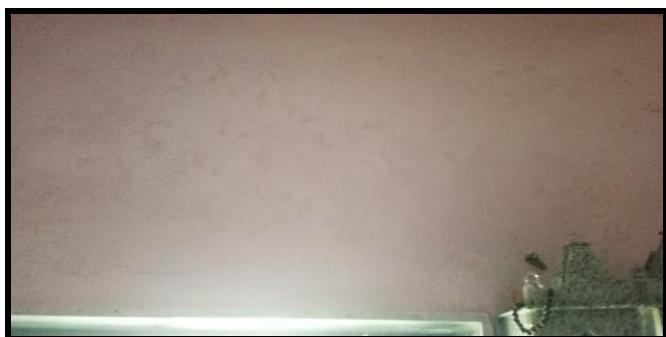
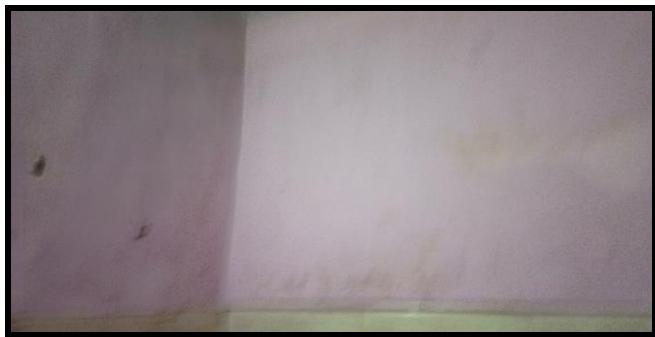
FLAT NO – 20

- ❖ **HALL** – Hallow sound observed on beam. (It may fall)
 - Major leakage mark observed on wall.
- ❖ **KITCHEN** – Seepage mark observed on wall.
- ❖ **PASSAGE** – Dampness observed on wall.
- ❖ **TOILET & BATH ROOM** – Dampness observed on ceiling.

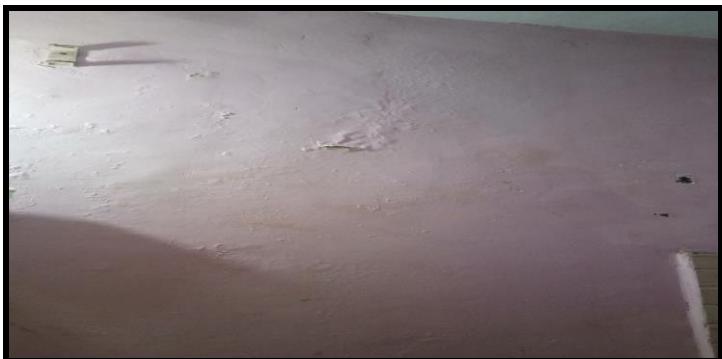
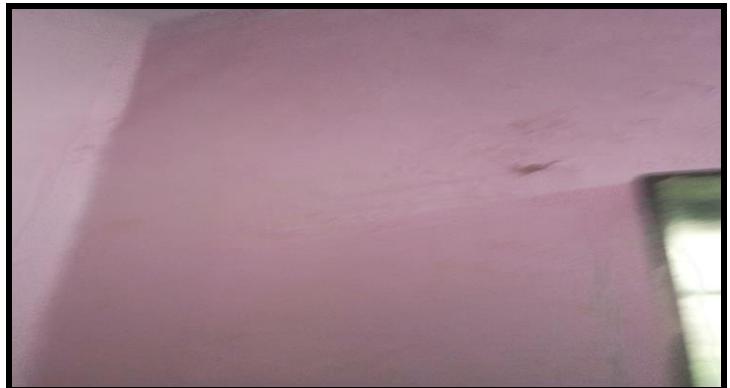
FLAT NO - 19

- ❖ **HALL** – O.K.
- ❖ **KITCHEN** – O.K.
- ❖ **PASSAGE** – O.K.
- ❖ **TOILET & BATH ROOM** – O.K.

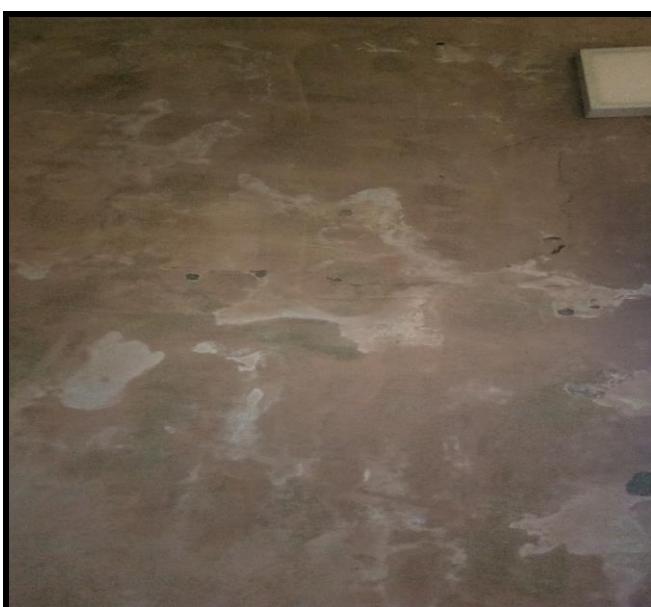
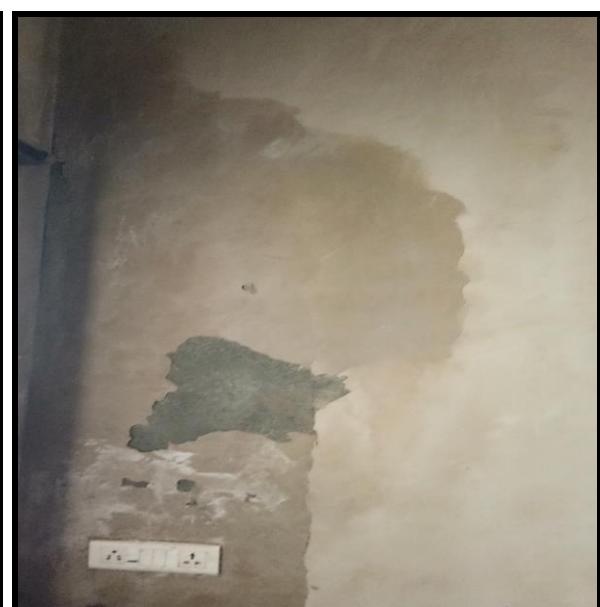
- ❖ **HALL** – major leakage mark observed on wall. (It may fall)
 - Seepage mark observed on wall. (It may fall)
 - Major structural crack observed on wall. (It may fall)

- Seepage mark observed on wall.
- ❖ **KITCHEN** – Plaster gets removed and steel gets exposed.
 - Hallow sound observed on wall after tapping. (It may fall)

- ❖ **PASSAGE NO.01** – Plaster gets removed and steel gets exposed.
 - Seepage mark observed on wall.
- ❖ **PASSAGE NO.02** – Dampness observed on wall.

- Structural crack observed on ceiling.
- ❖ **BEDROOM NO.01** – Leakage mark observed on wall.
 - Peeling of paint observed on ceiling.
 - Major structural crack observed on beam.

- ❖ **BEDROOM NO.02** – Plaster gets removed and steel gets exposed.
 - Hallow sound observed on wall.
 - Major structural crack observed on beam. (It may fall)

- Major structural crack observed on column. (It may fall)
 - ❖ Ceiling gets damage. (It may fall)
- ❖ **Toilet and Bathroom** – Peeling of paint observed on ceiling.

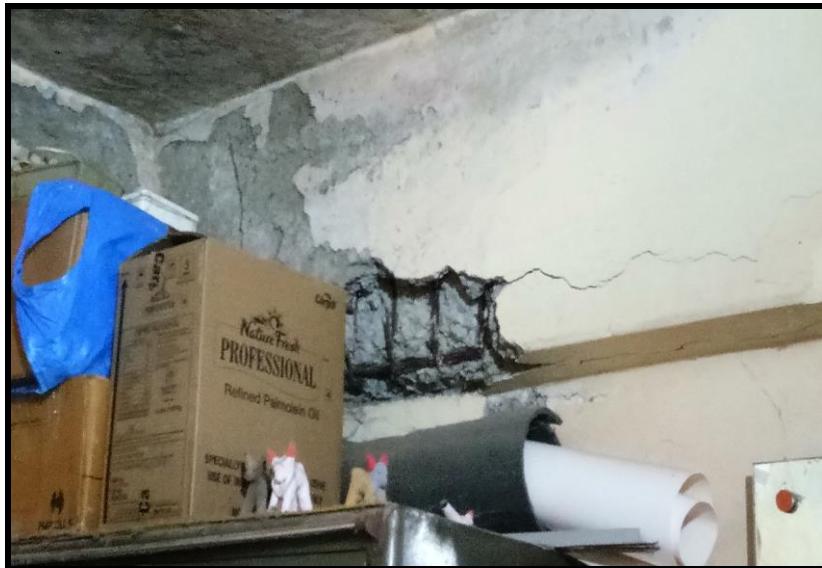
STAIRCASE

Terrace to fourth floor:-

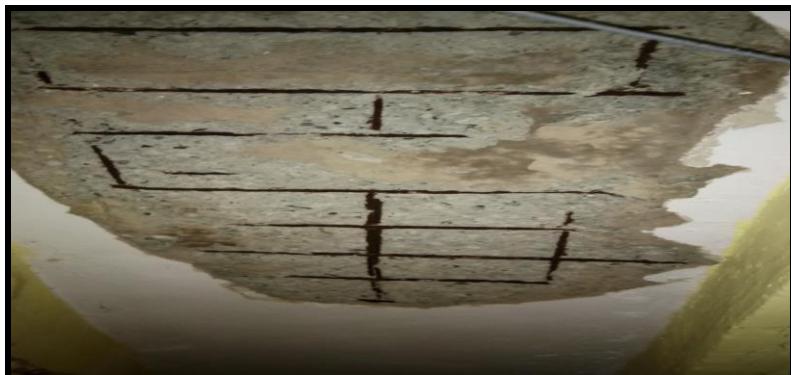
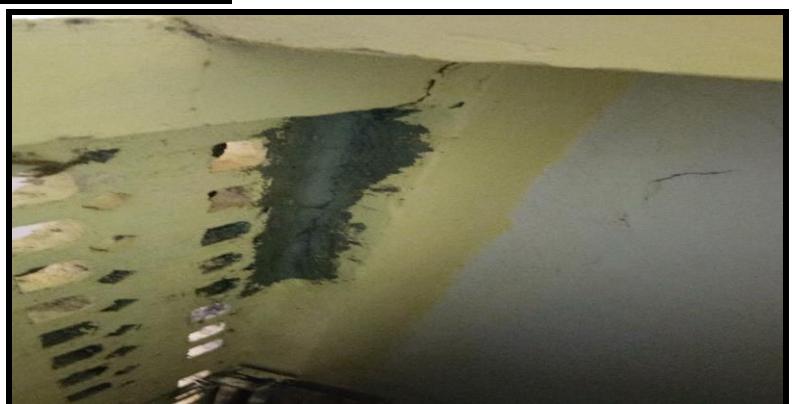
- ❖ Plaster gets removed and steel gets exposed. (It may fall)
- ❖ Crack filling observed on wall.
- ❖ Dampness observed on wall.

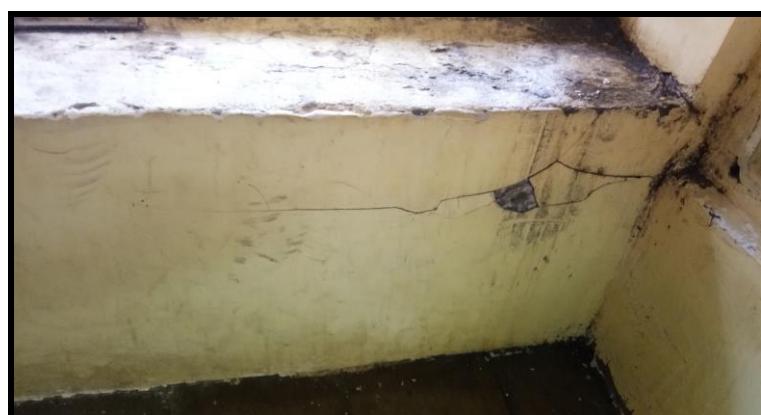
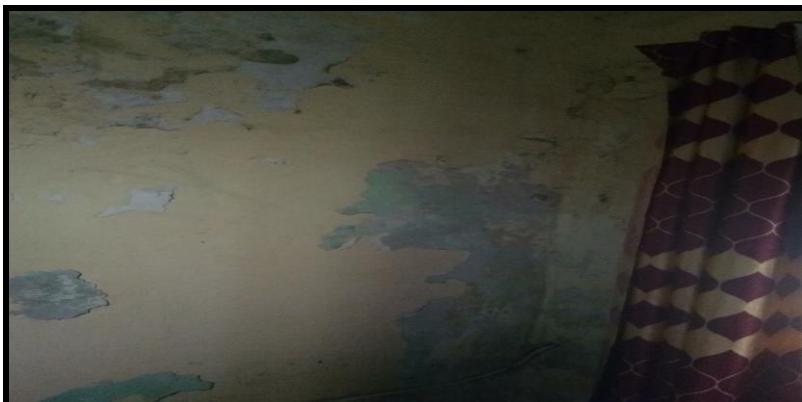
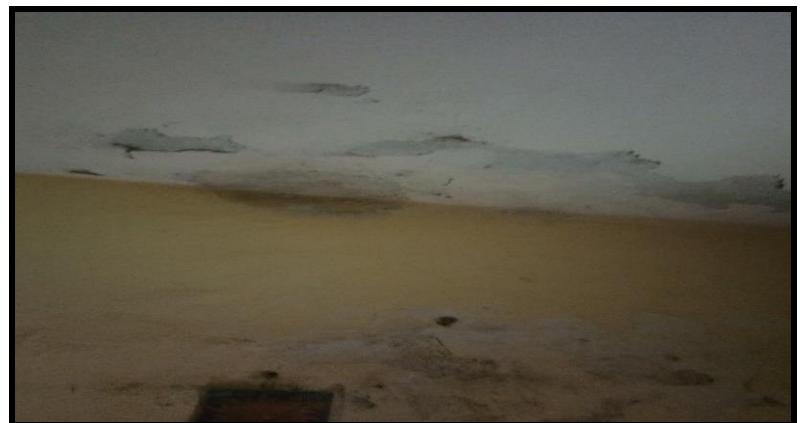
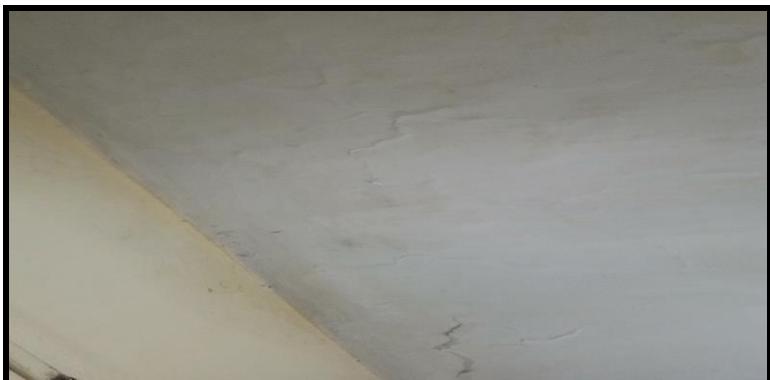
Fourth floor to third floor:-

- ❖ Crack observed on cantilever beam.
- ❖ Peeling of paint observed on wall.
- ❖ Seepage mark observed on wall.
- ❖ Hollow sound observed on wall.

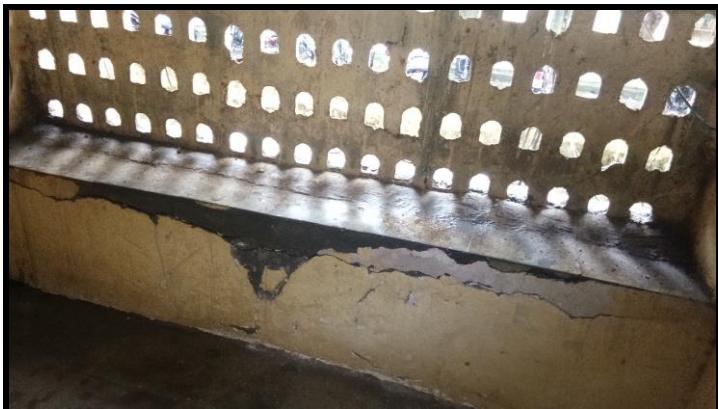
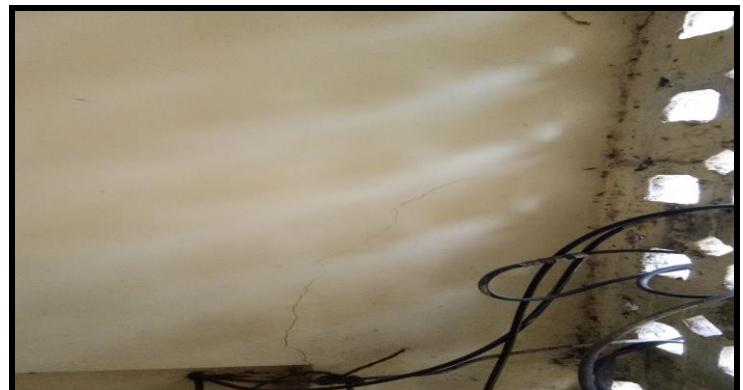
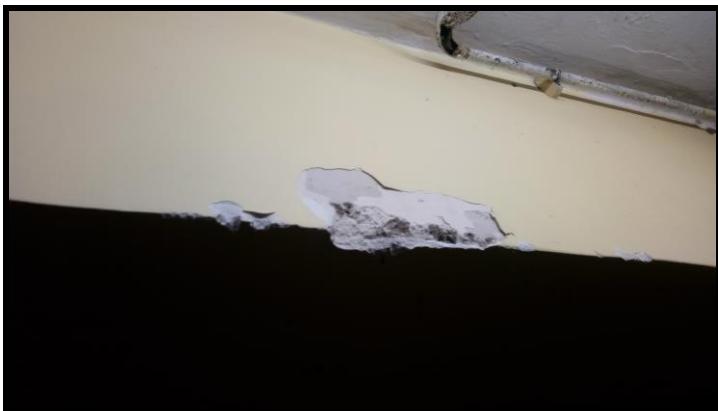
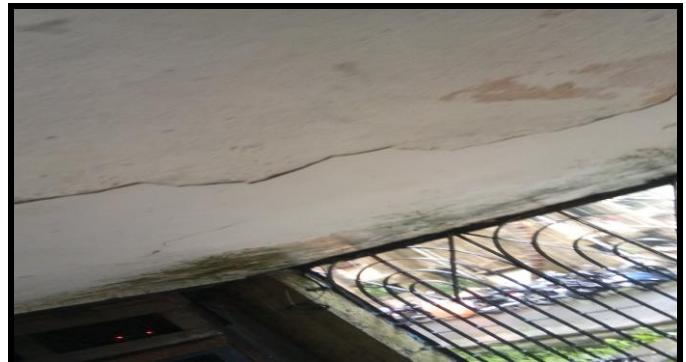
- ❖ Crack observed on cantilever beam.
- ❖ Peeling of paint observed on wall.
- ❖ Seepage mark observed on wall.
- ❖ Hallow sound observed on wall.

- ❖ Plaster gets removed and steel gets exposed. (It may fall)

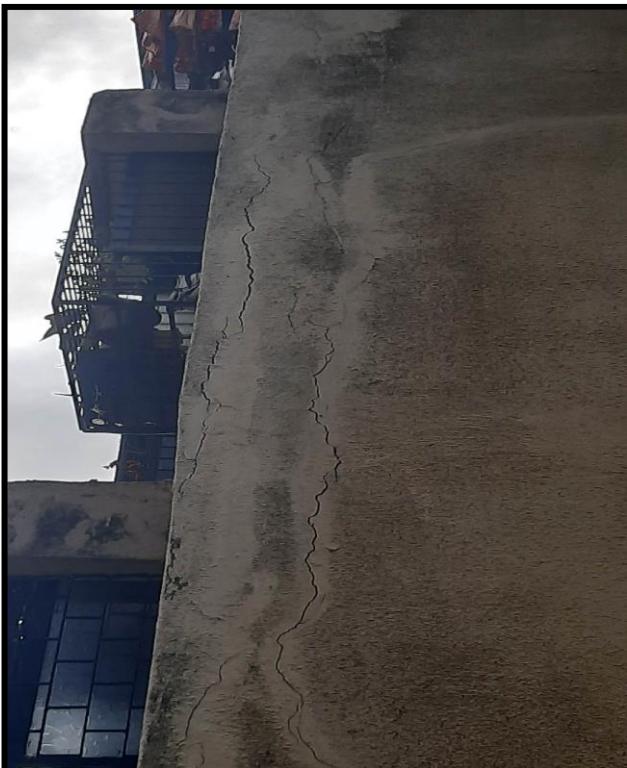
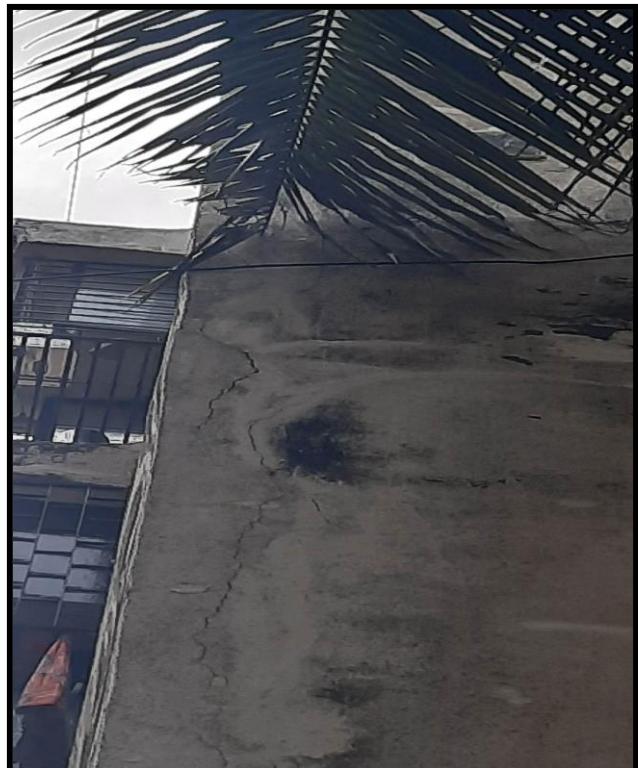
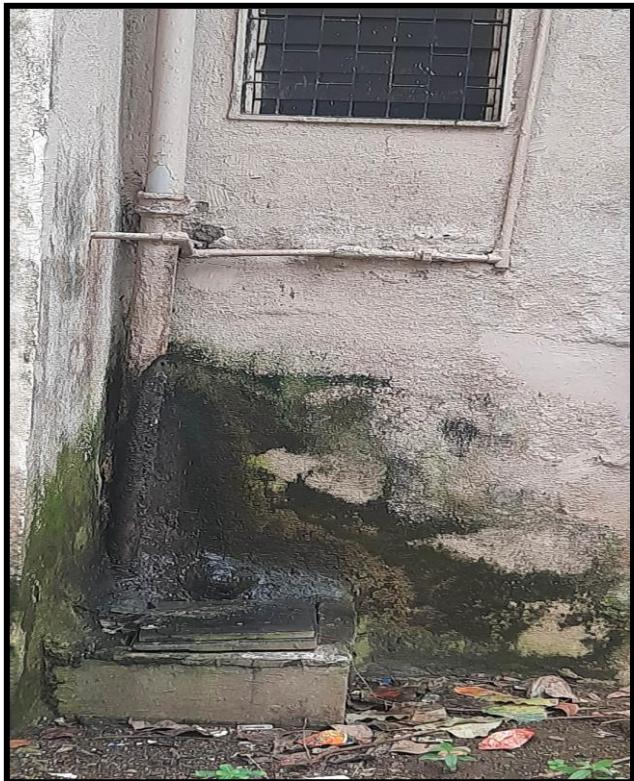
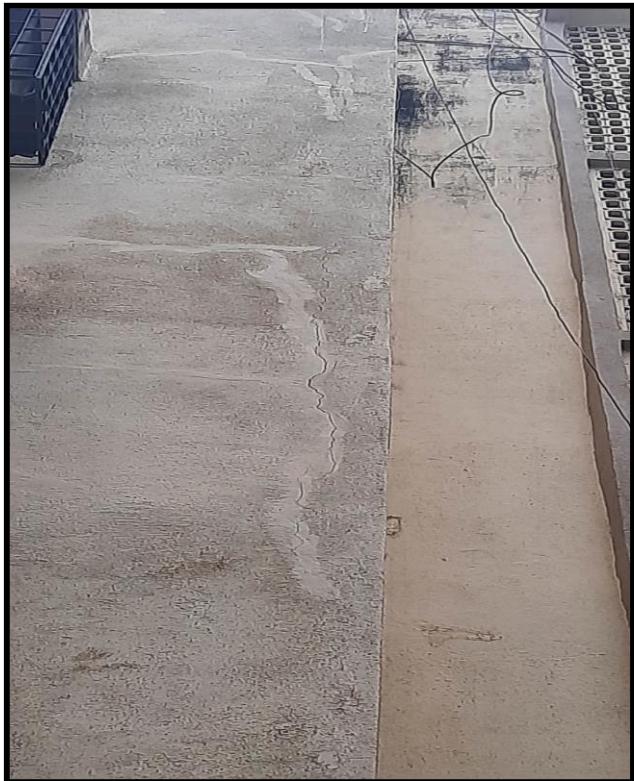
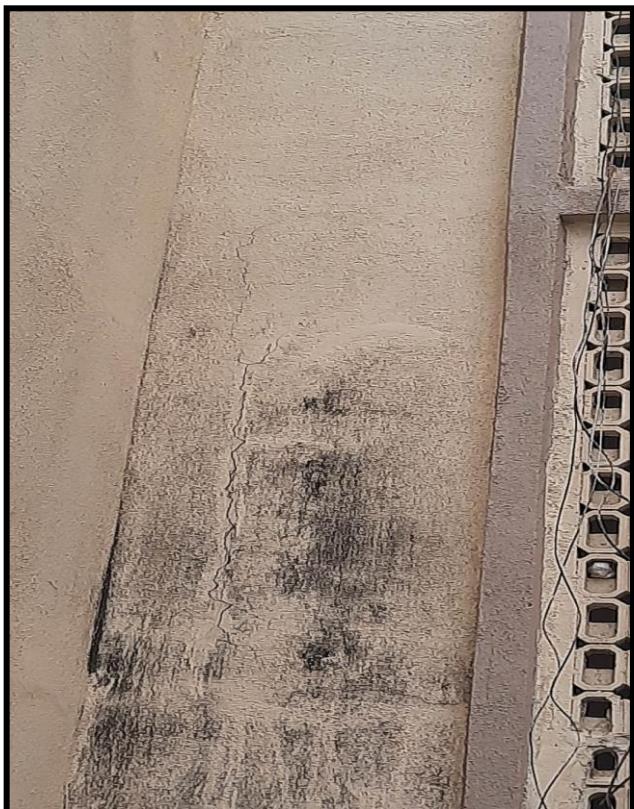
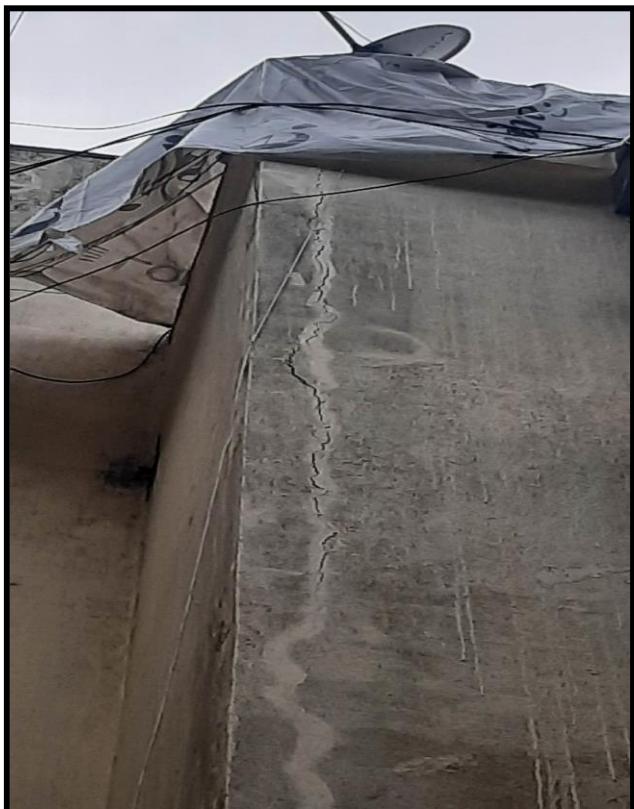
FRONT SIDE

- ❖ Structural crack observed at several places on column.
- ❖ Major crack observed at several places on wall.
- ❖ Vegetation growth observed at several places on wall.

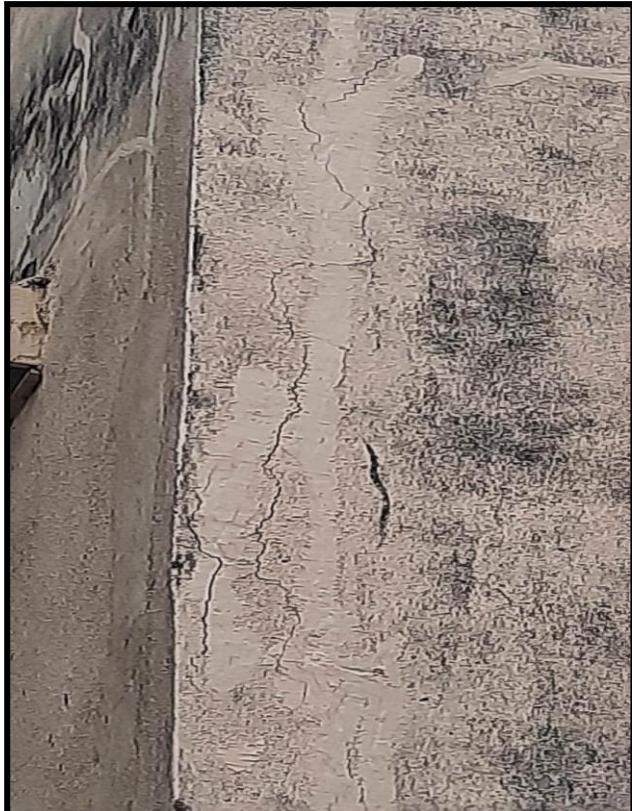
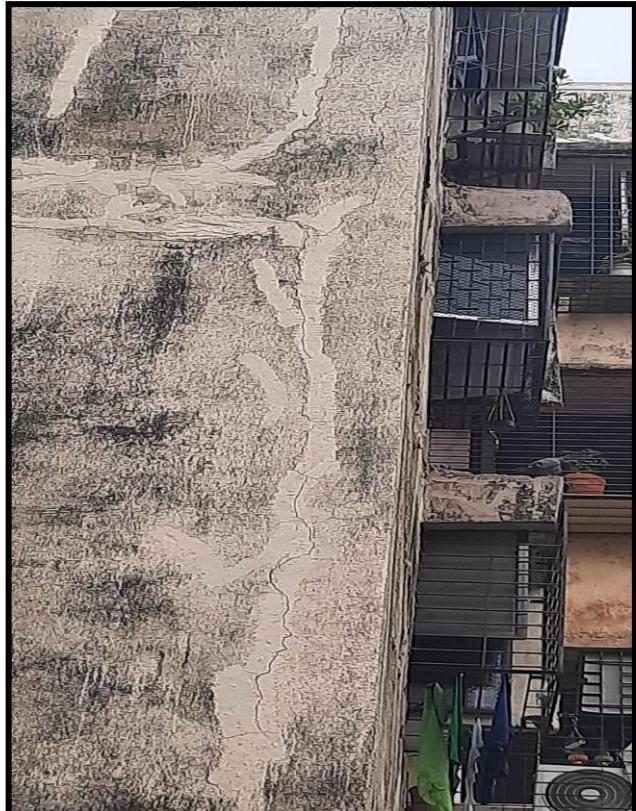
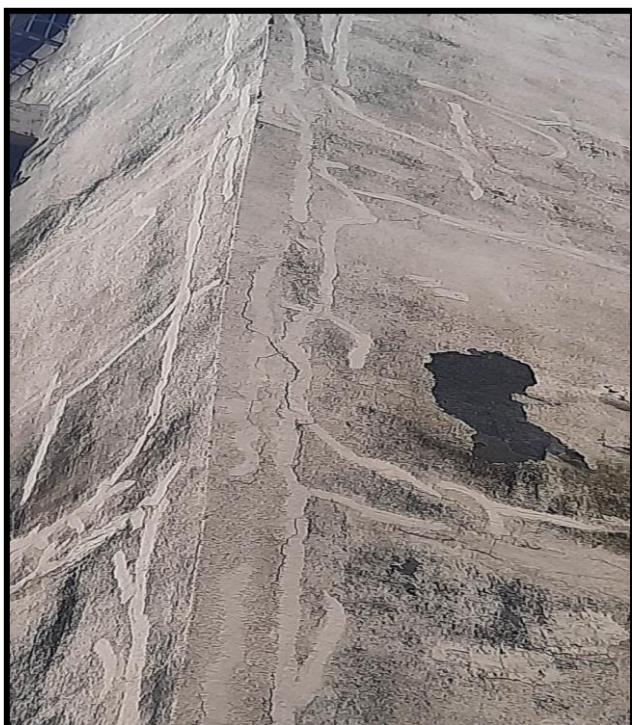
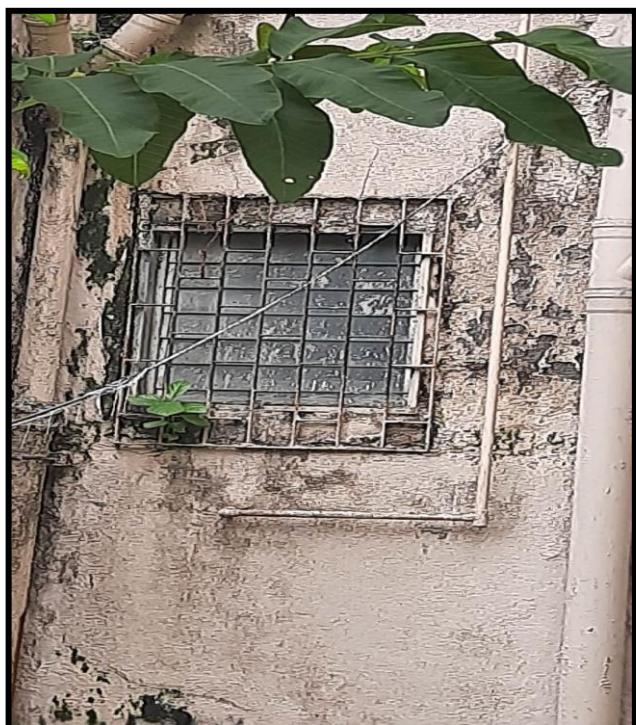
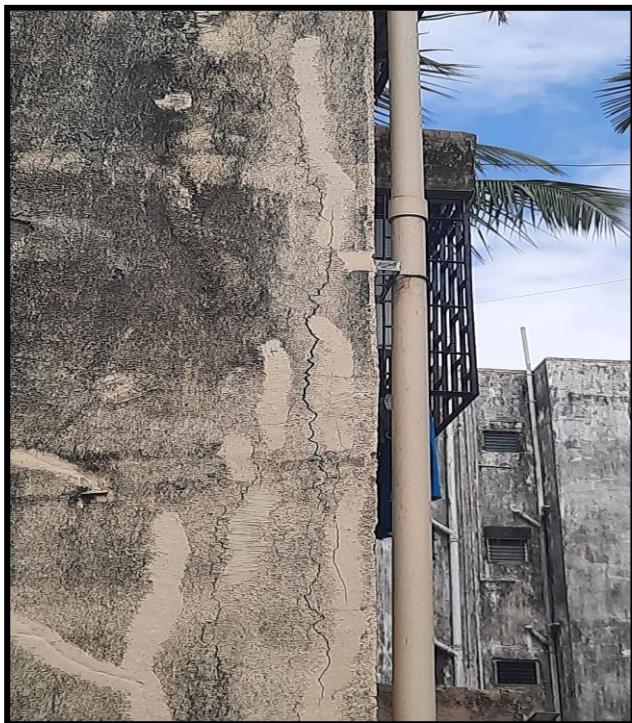
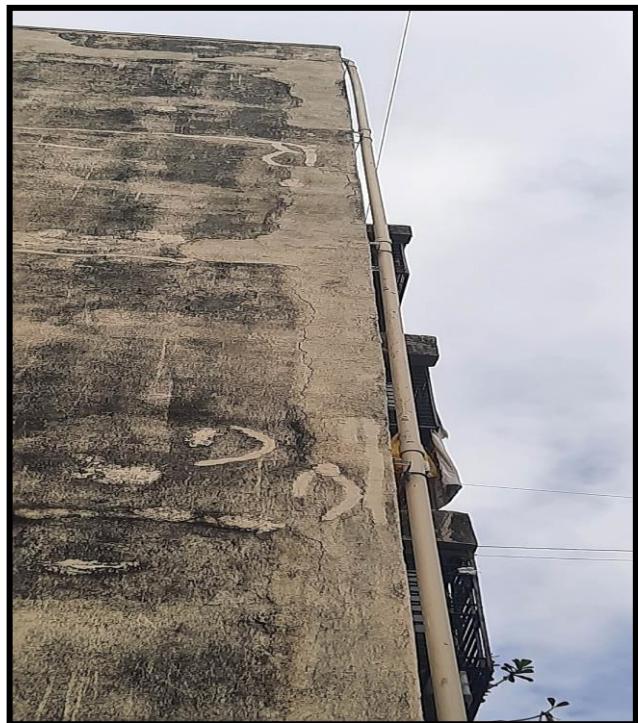
BACK SIDE

- ❖ Structural crack observed at several places on column.
- ❖ Major crack observed at several places on wall.
- ❖ Vegetation growth observed at several places on wall.
