STRUCTURAL AUDIT REPORT
FOR
“VISHAL SAHYADRI CO – OP HSG. SOC. LTD”,
“B10 – WING”
SITUATED AT
SAHYADRI NAGAR, CHARKOP,
KANDIVALI (W) MUMBAI – 400 067

978/B10/LSS/2021

JULY 24, 2021

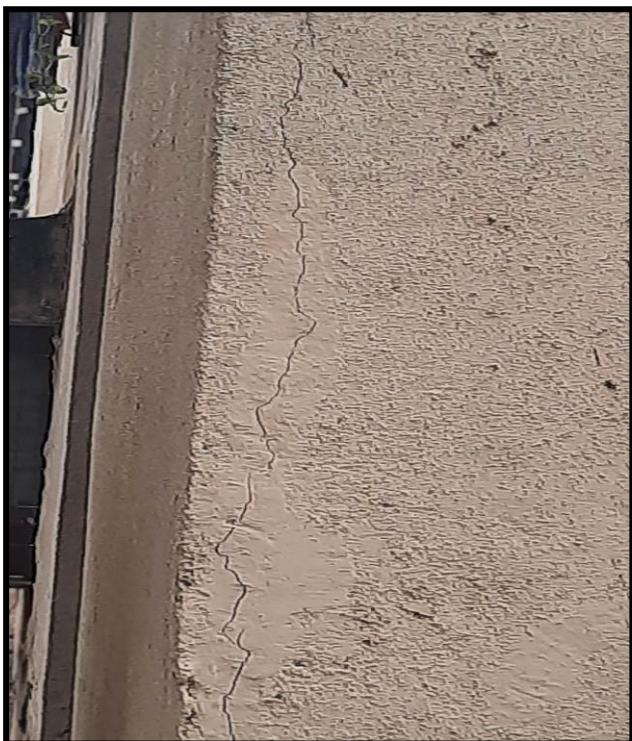
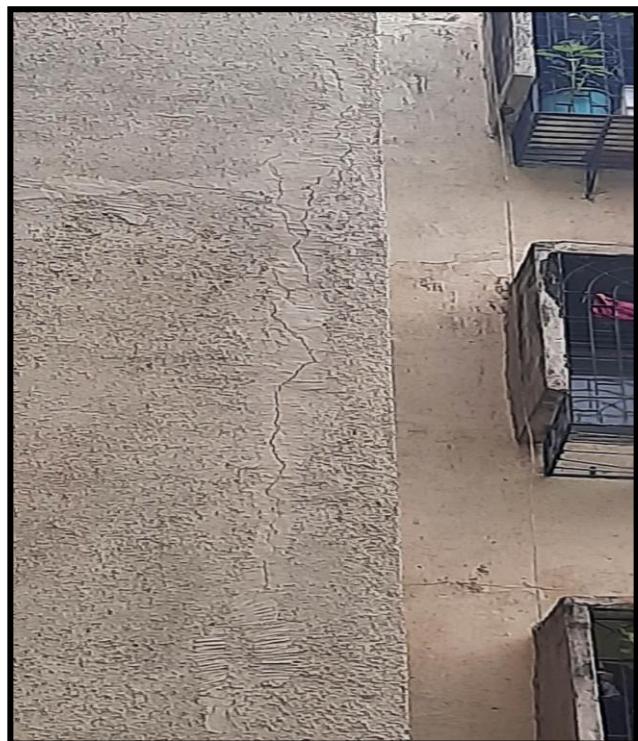
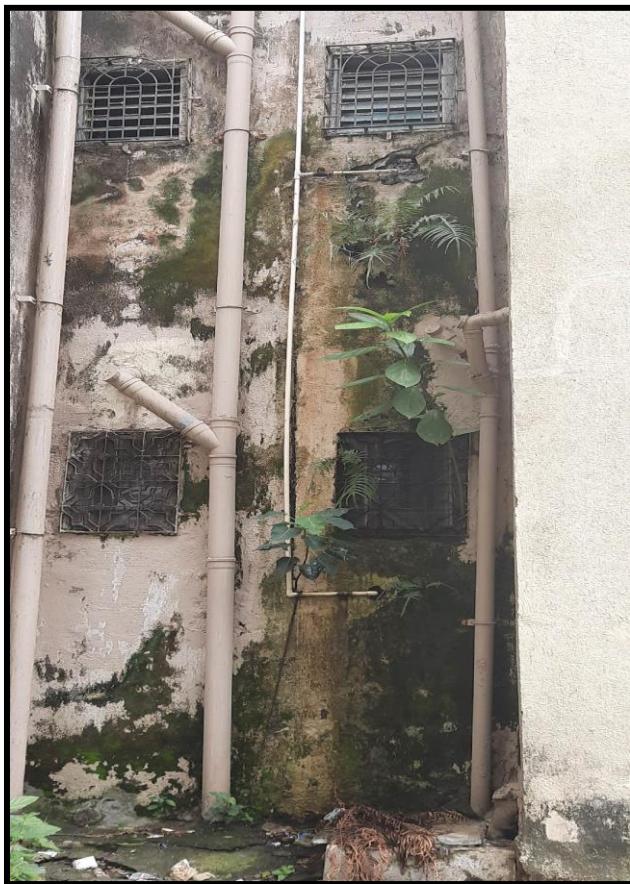
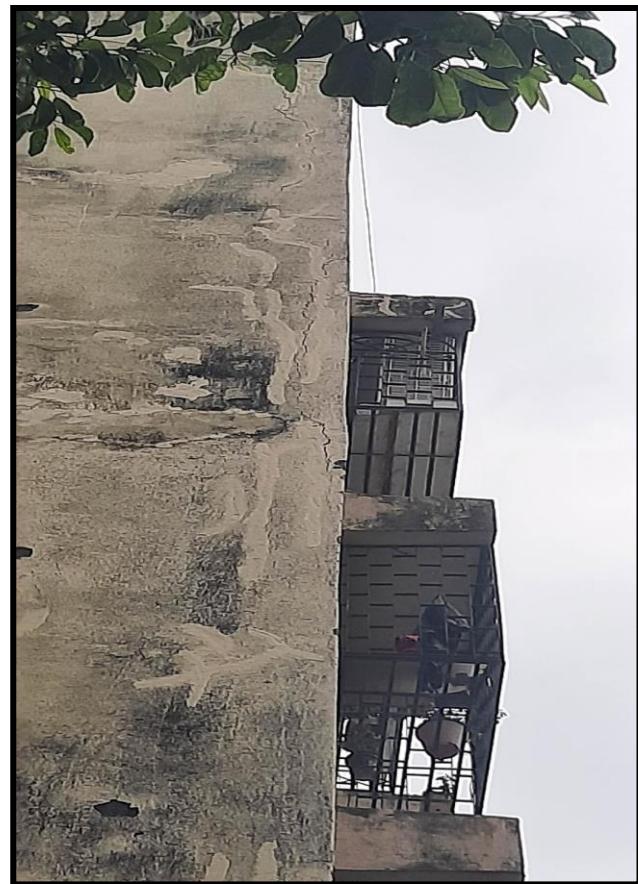
NORTH SIDE

- ❖ Structural crack observed at several places on column.
- ❖ Major crack observed at several places on wall.
- ❖ Vegetation growth observed at several places on wall.

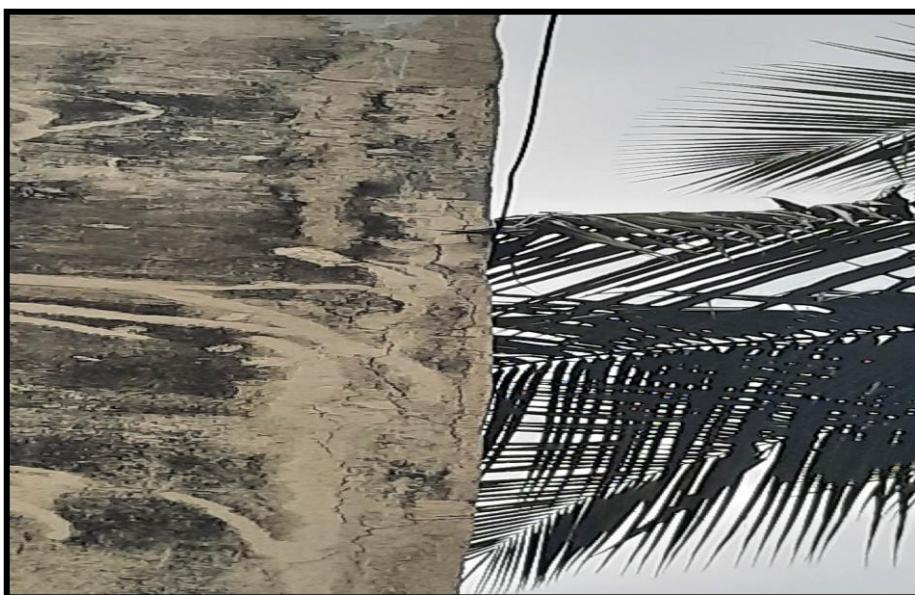
SOUTH SIDE

- ❖ Structural crack observed at several places on column.
- ❖ Major crack observed at several places on wall.
- ❖ Vegetation growth observed at several places on wall.
