STRUCTURAL AUDIT REPORT  
FOR  
**“VISHAL SAHYADRI CO – OP HSG. SOC. LTD”,**  
**“B3 – WING”**  
SITUATED AT  
SAHYADRI NAGAR, CHARKOP,  
KANDIVALI (W) MUMBAI – 400 067

978/B3/LSS/2021

JULY 19, 2021

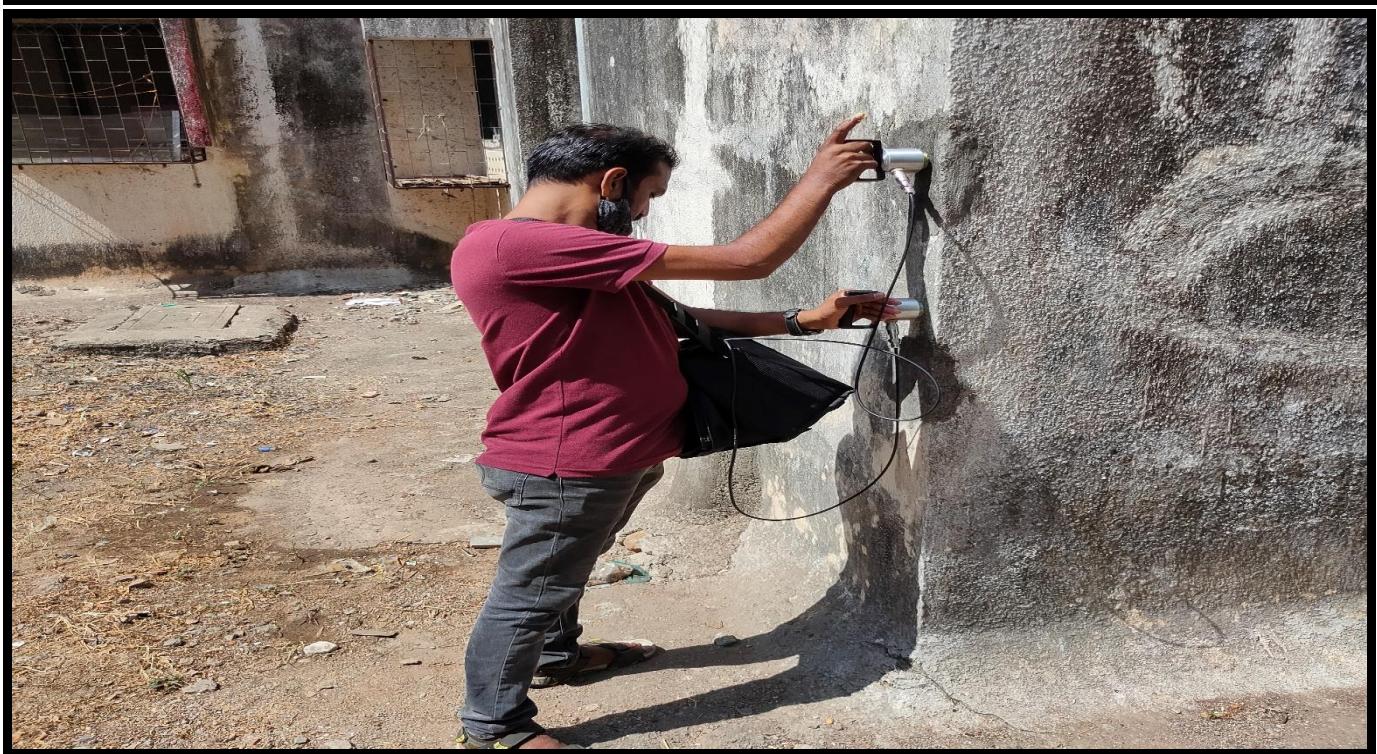
## NON -DESTRUCTIVE TEST PHOTO

Rebound Hammer was tested for compressive strength at surface by Schmidt rebound hammer. Results indicate the compressive strength at surface of all the RCC columns is ranging between 16.20 MPa to 23.30 MPa.

Half Cell Potential tested for corrosion activity by half – cell potential tests. Values are taken on Column. The result on tested column is – 395 mV.

This indicates the probability of corrosion is 90% on tested column steel reinforcement.

Carbonation test was conducted to assess carbonation depth. Readings are taken on Column. Result indicates the carbonation penetration depth is 45.00 mm. Carbonation depths have reached to the reinforcement level in all of the RCC elements. It is essential to give a suitable anti-corrosion treatment to all the RCC members to stop further carbonation and corrosion of concrete.

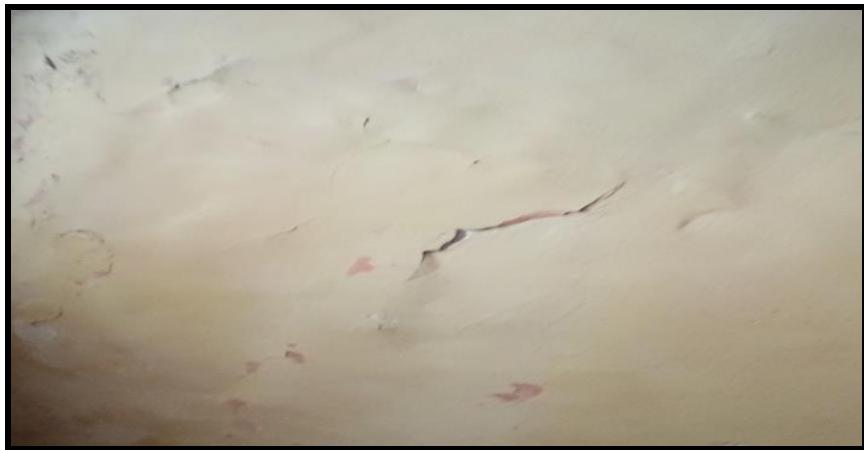
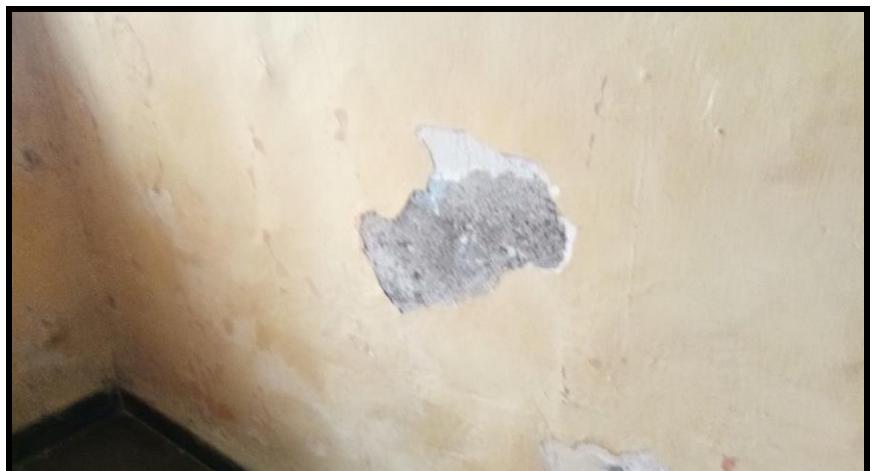
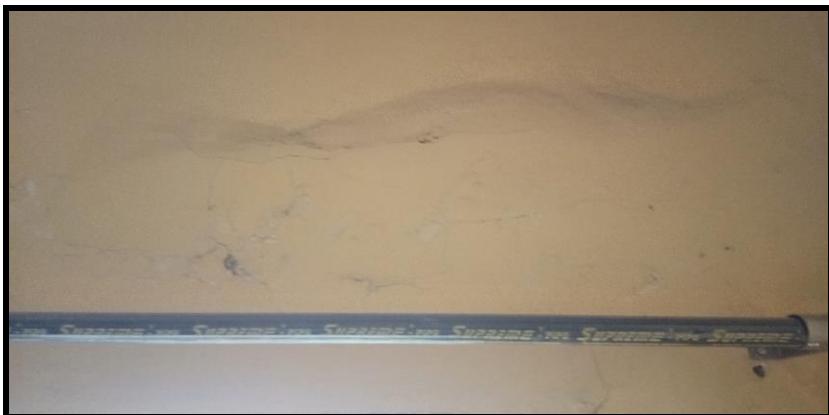
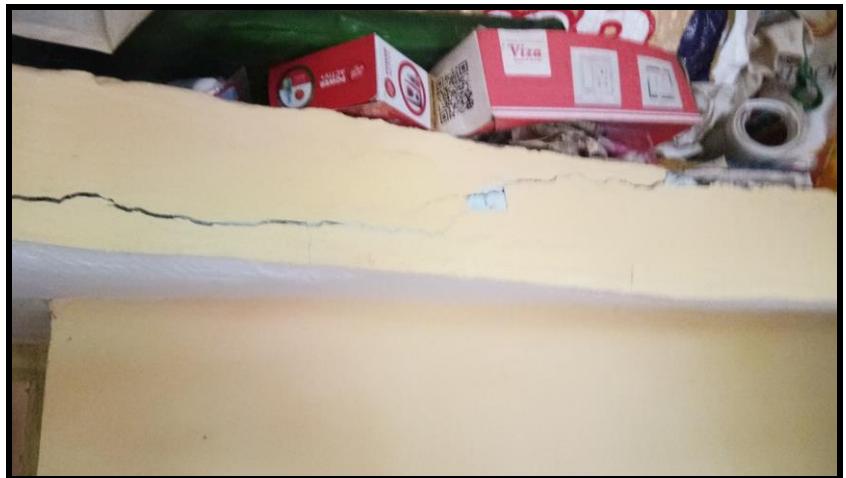
#### **FLAT NO – 03**

- ❖ **HALL** – Hallow sound observed on South side wall after taping. (**It may fall**)
  - Peeling of paint observed on North side wall.
  - Dampness observed on north side wall.
- ❖ **KITCHEN** – O.K.
- ❖ **BED ROOM** – Dampness observed on north side wall.
- ❖ **PASSAGE** – Dampness observed on South side wall.
- ❖ **TOILET & BATH ROOM** – Dampness observed on north side wall.

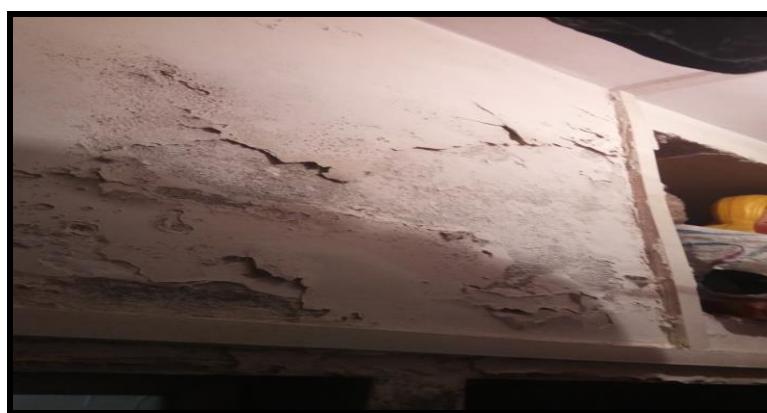
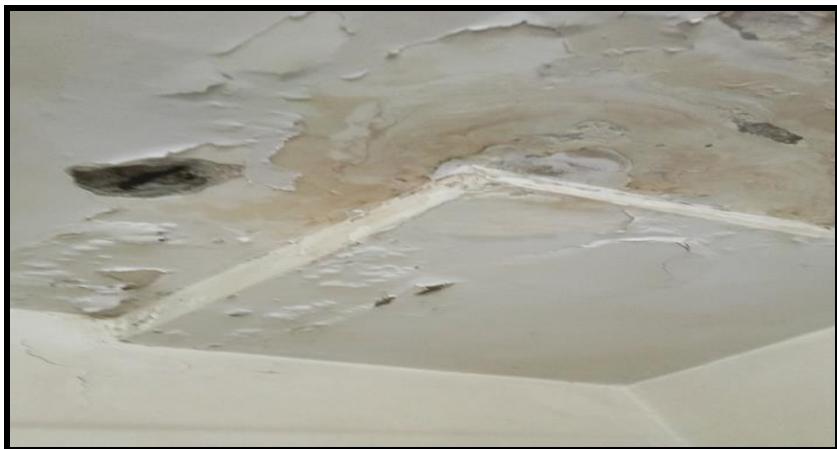
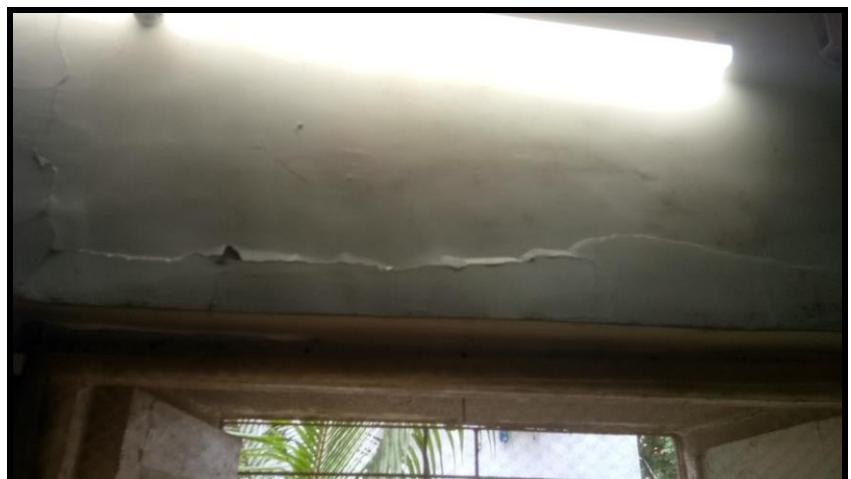
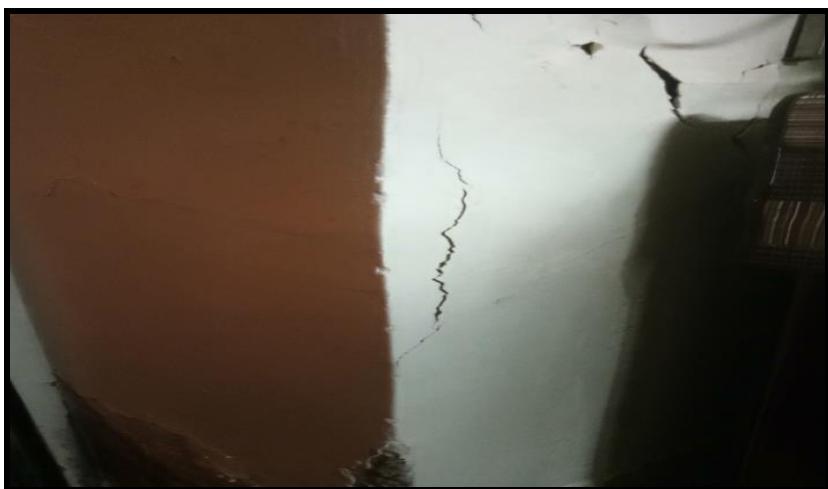
## FLAT NO – 05

- ❖ **HALL** – Peeling of paint observed on North side wall.
- ❖ **KITCHEN** – Hollow sound observed on South side wall after taping. (**It may fall**)
  - Structural crack observed on beam.
  - Steel exposed and get corroded. (**It may fall**)
- ❖ **BED ROOM** – Structural crack observed on beam.
- ❖ **PASSAGE** – Peeling of paint observed on North side wall.
- ❖ **TOILET & BATH ROOM** – Peeling of paint observed on North side wall.

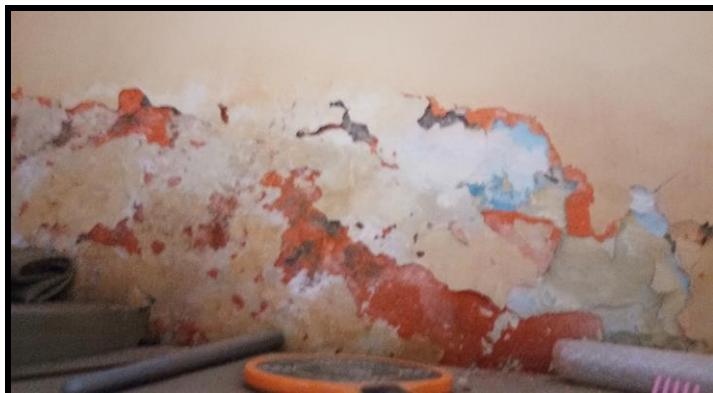
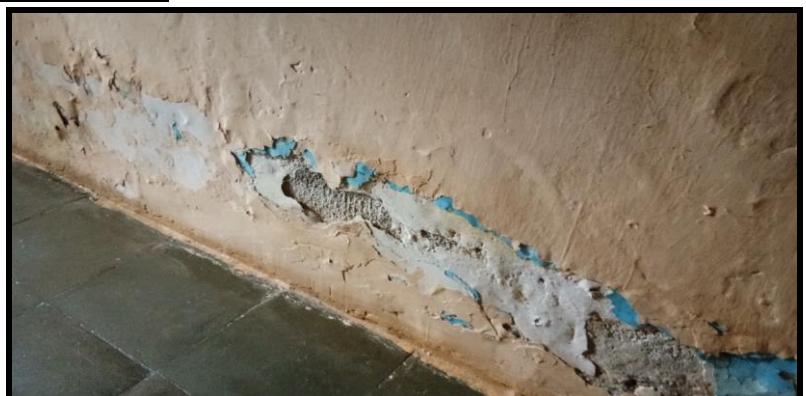
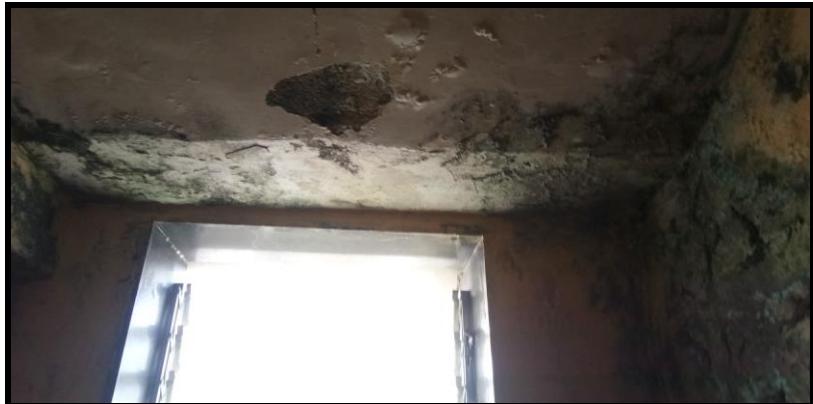
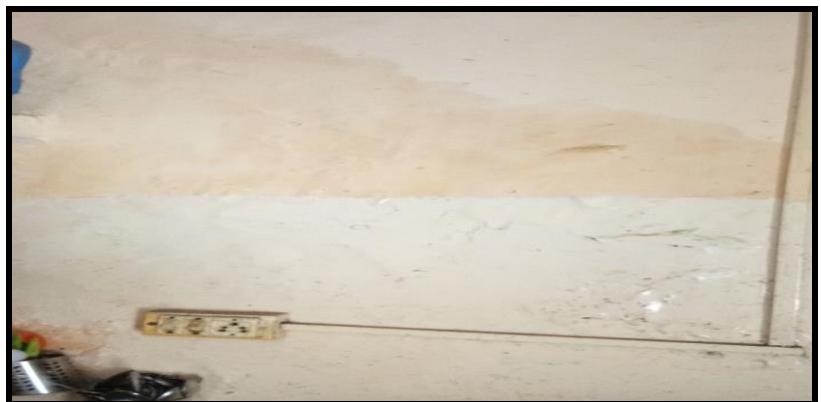
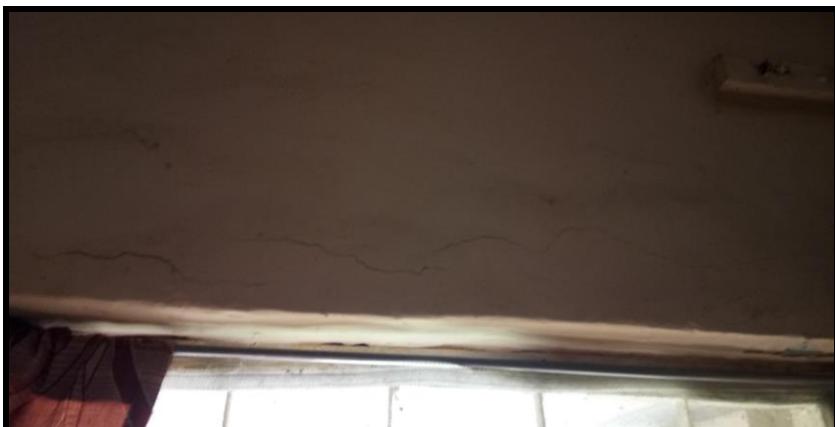
### FLAT NO – 09

- ❖ **HALL** – Peeling of paint observed on North side wall.
  - Dampness observed on north side wall.
  - Seepage mark observed on wall.
- ❖ **KITCHEN** – Hallow sound observed on South side wall after taping. (*It may fall*)
  - Dampness observed on north side wall.
- ❖ **BED ROOM** – Peeling of paint observed on North side wall.
- ❖ **PASSAGE** – Peeling of paint observed on South side wall.
- ❖ **TOILET & BATH ROOM** – Peeling of paint observed on North side wall.

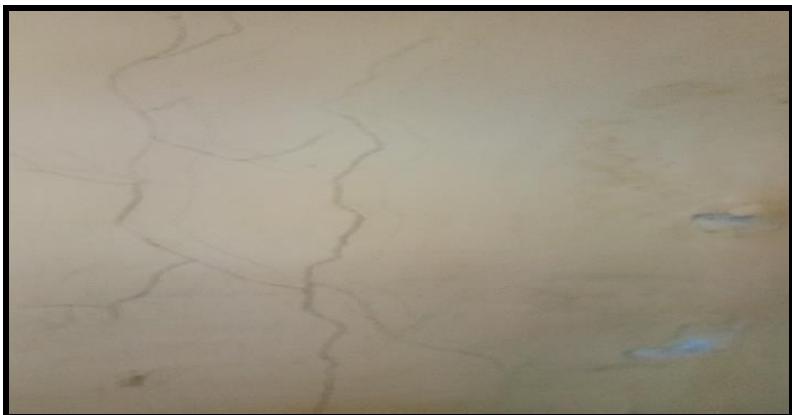
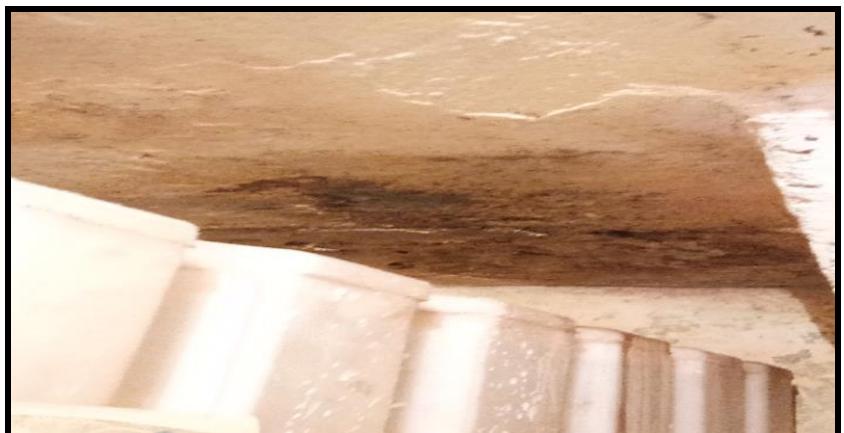
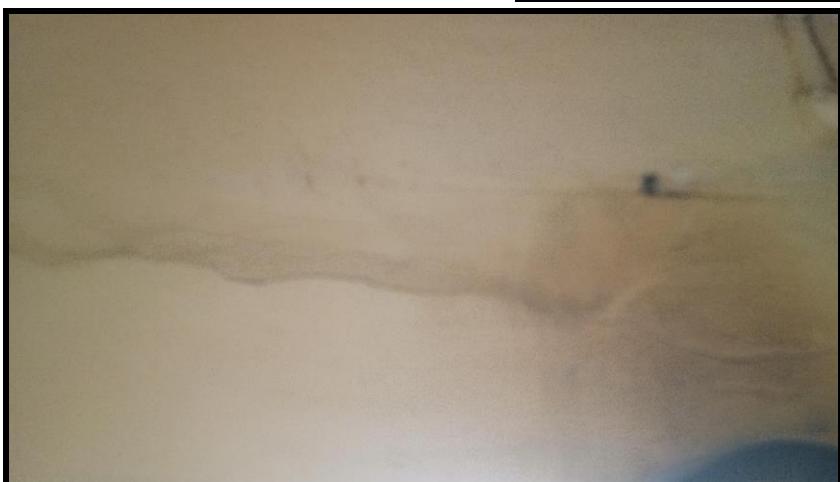
## FLAT NO – 10

- ❖ **HALL** – Hallow sound observed on South side wall after taping. (**It may fall**)
  - Structural crack observed on beam.
- ❖ **KITCHEN** – Hallow sound observed on beam after taping. (**It may fall**)
- ❖ **BED ROOM** – Dampness observed on north side wall.
- ❖ **PASSAGE** – Peeling of paint observed on North side wall
- ❖ **TOILET & BATH ROOM** – Dampness observed on north side wall.

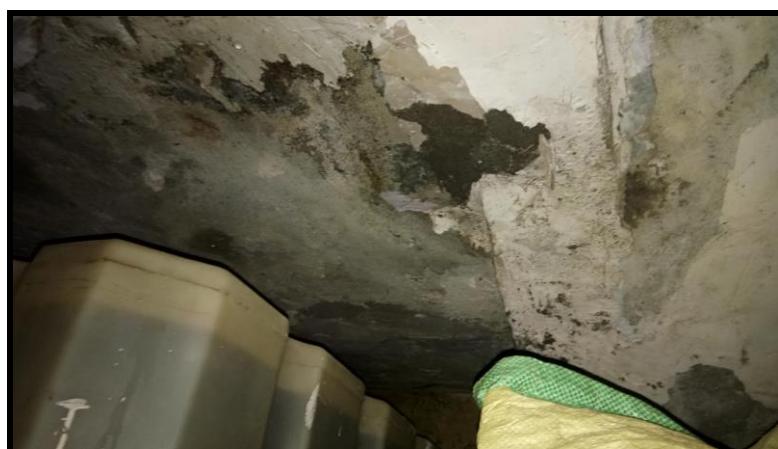
### FLAT NO – 16

- ❖ **HALL** – Structural crack observed on beam.
  - Peeling of paint observed on wall.
- ❖ **KITCHEN** – Peeling of paint observed on wall.
- ❖ **BED ROOM** – O.K.
- ❖ **PASSAGE** – Peeling of paint observed on wall.
- ❖ **TOILET & BATH ROOM** – Peeling of paint observed on wall.

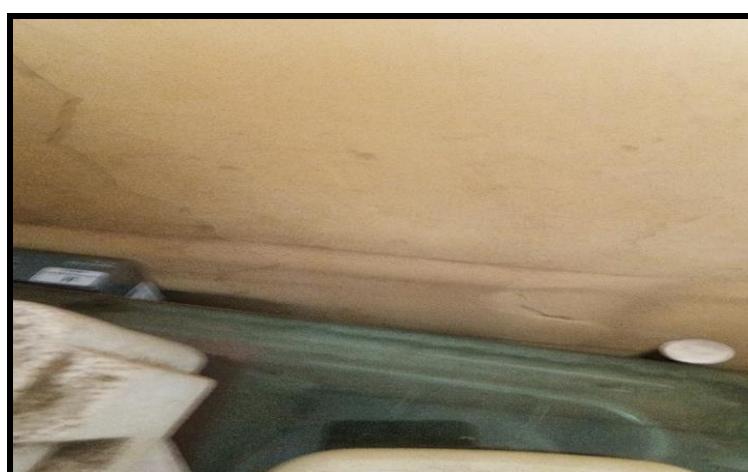
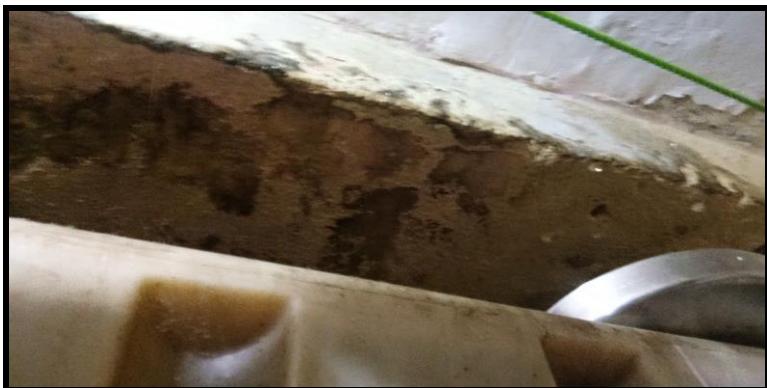
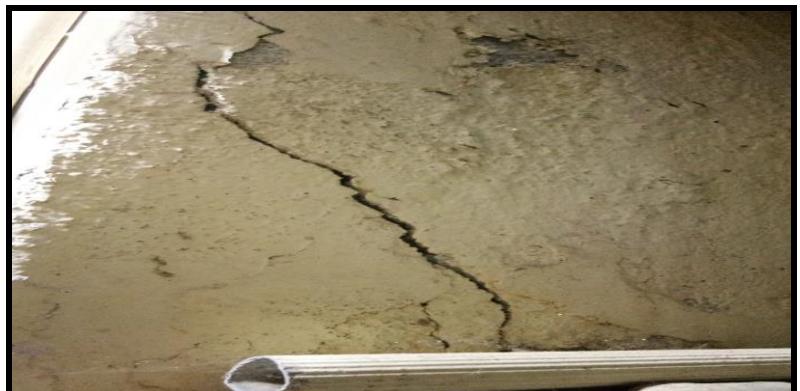
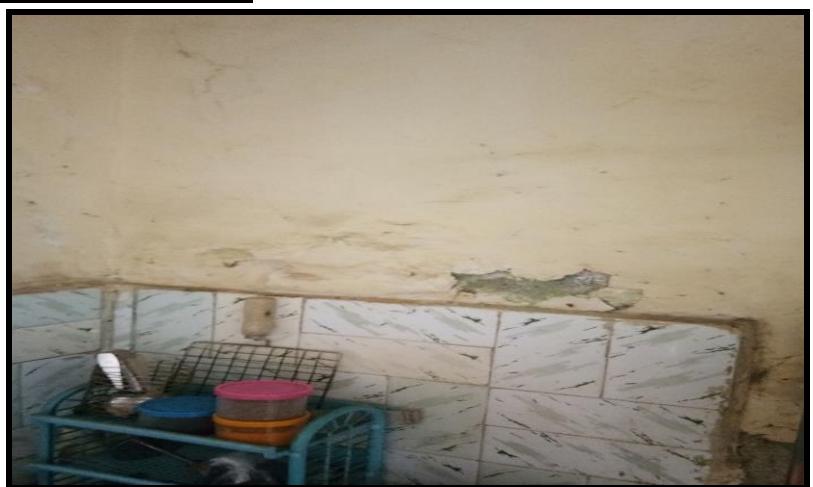
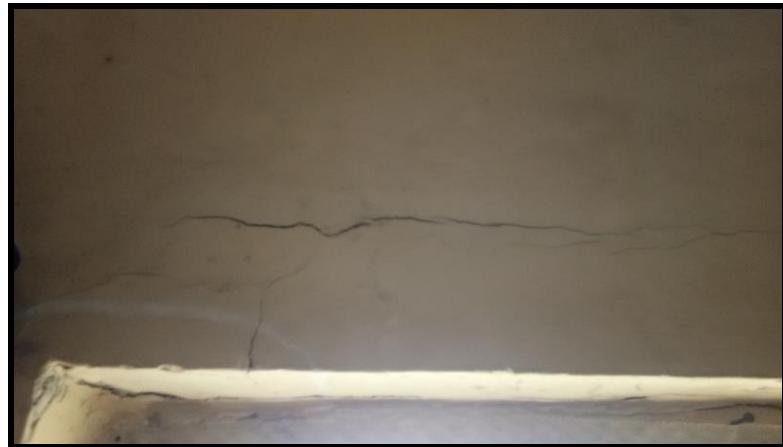
### FLAT NO – 17

- ❖ **HALL** – Hallow sound observed on beam after taping. (**It may fall**)
- ❖ **KITCHEN** – Peeling of paint observed on wall.
- ❖ **BED ROOM** – Dampness observed on South side wall.
- ❖ **PASSAGE** – Hallow sound observed on wall after taping. (**It may fall**)
- ❖ **TOILET & BATH ROOM** – Dampness observed on South side wall.
  - Dampness observed on north side wall.

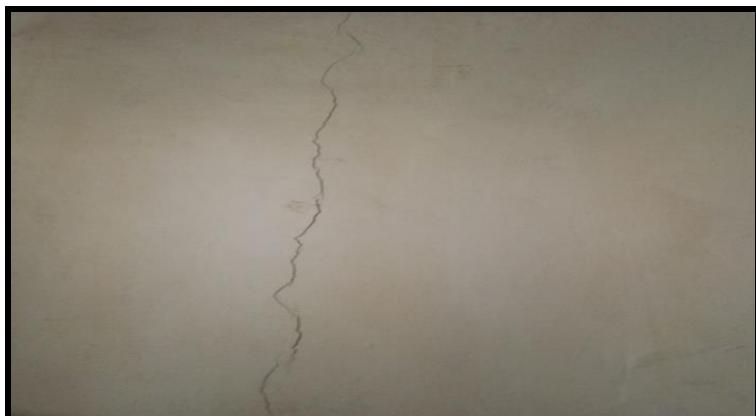
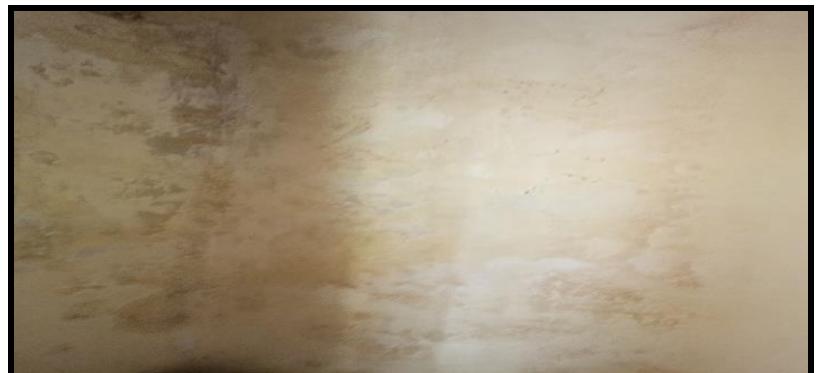
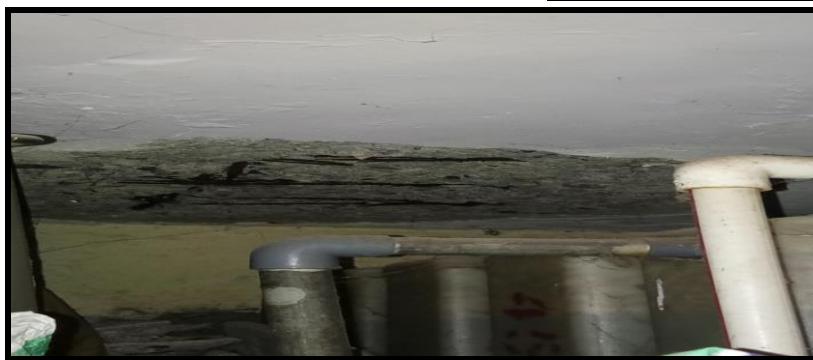
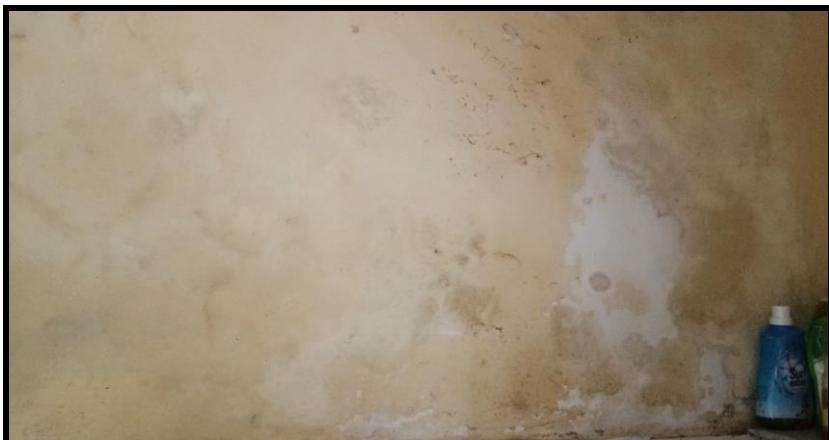
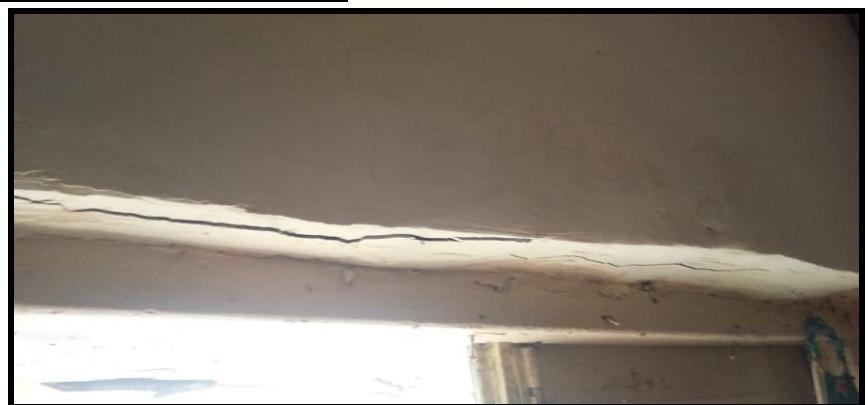
### FLAT NO – 21

- ❖ **HALL** – Structural crack observed on beam.
  - Steel exposed and get corroded. (**It may fall**)
  - Seepage mark observed on wall.
  - Peeling of paint observed on ceiling.
- ❖ **KITCHEN** – Dampness observed on South side wall.
- ❖ **BED ROOM** – O.K,
- ❖ **PASSAGE** – Dampness observed on South side wall.
- ❖ **TOILET & BATH ROOM** – O.K.

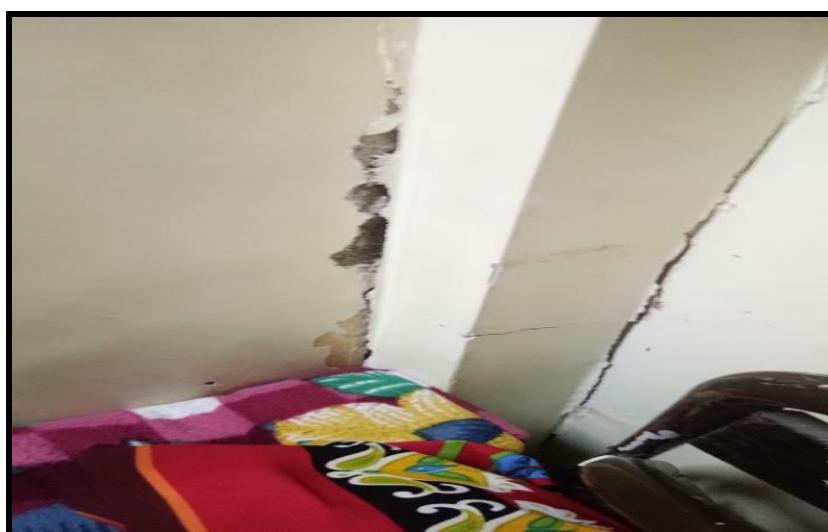
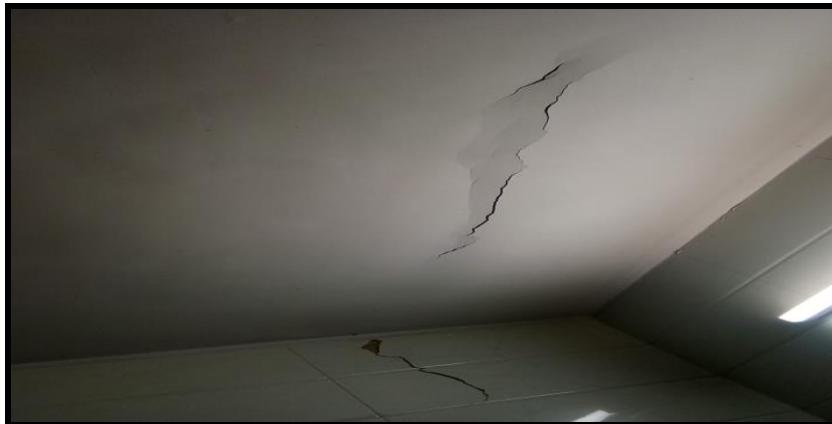
## FLAT NO - 22

- ❖ **HALL** – Structural crack observed on beam.
- ❖ **KITCHEN** – O.K.
- ❖ **BED ROOM** – Hallow sound observed on wall after taping. (**It may fall**)
- ❖ **PASSAGE** – O.K.
- ❖ **TOILET & BATH ROOM** – Seepage mark observed on wall.

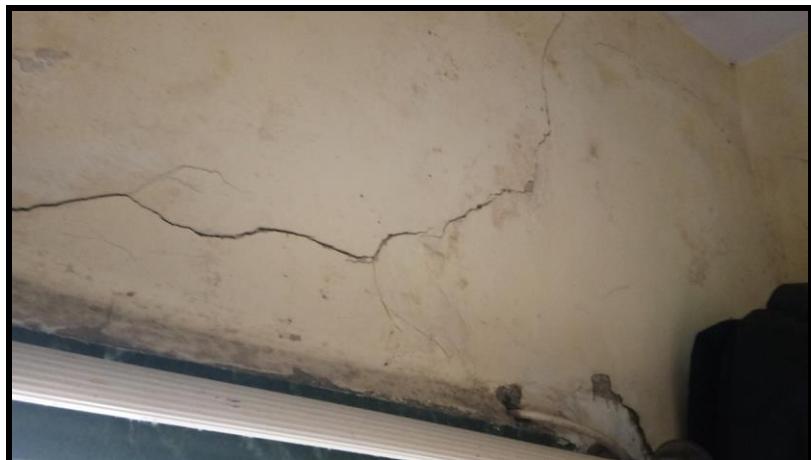
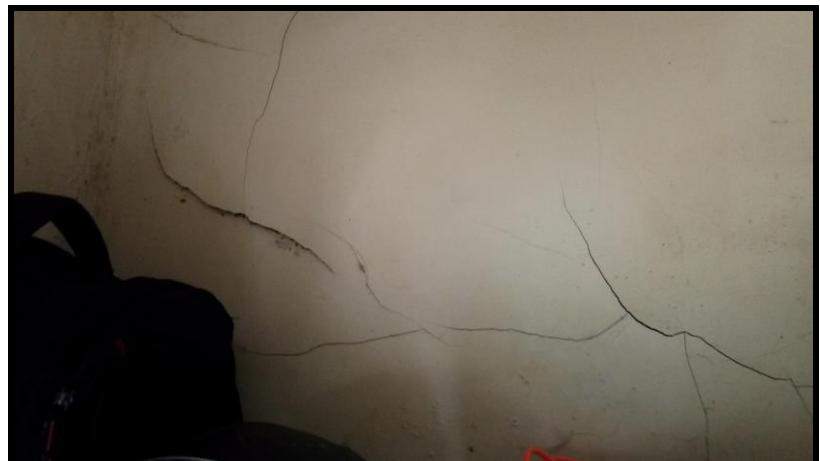
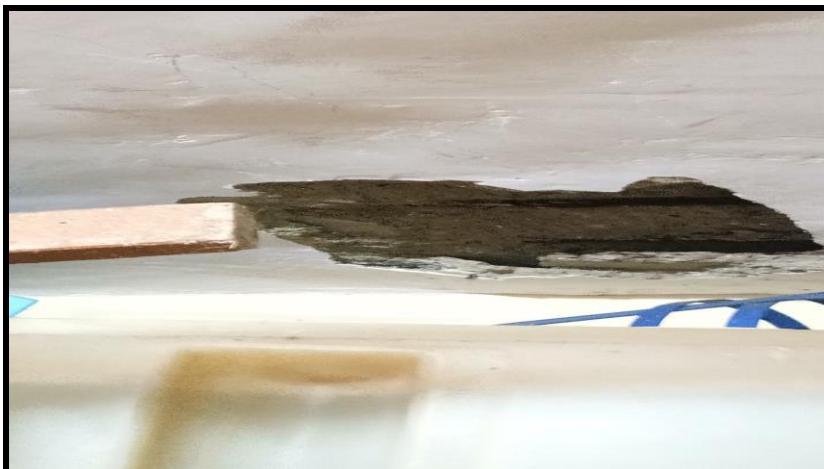
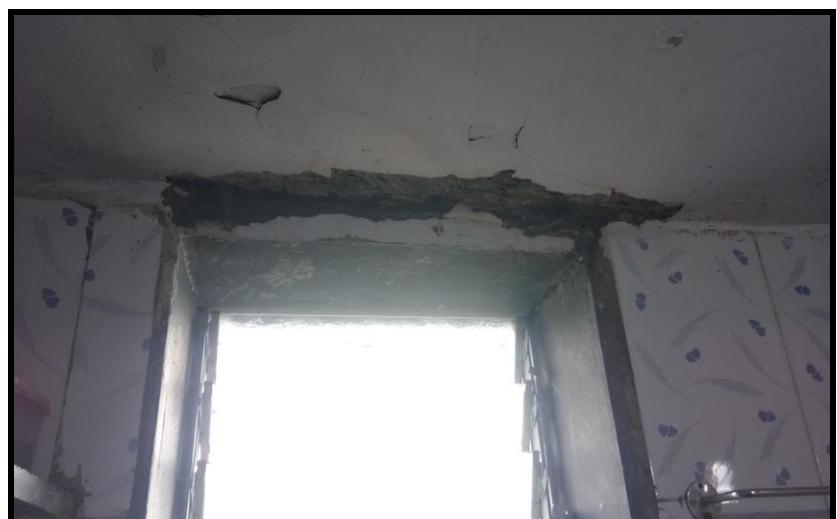
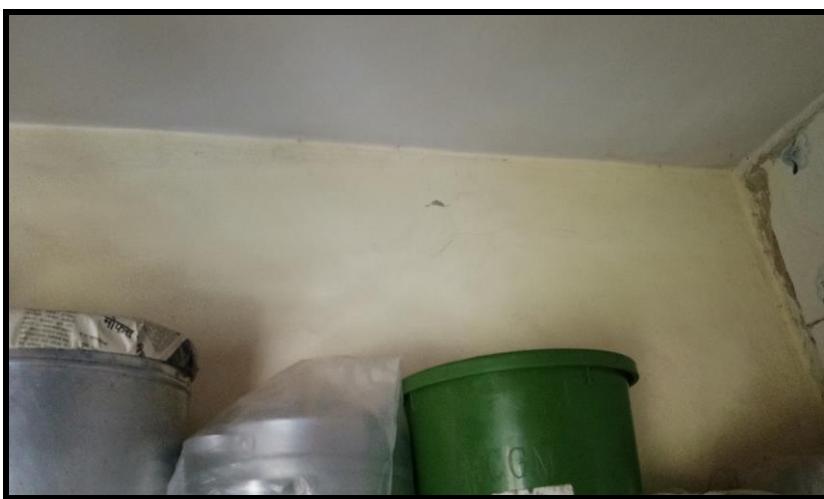
### **FLAT NO – 29**

- ❖ **HALL** – Structural crack observed on column.
- ❖ **KITCHEN** – Hallow sound observed on wall after taping. (**It may fall**)
  - Steel exposed and get corroded. (**It may fall**)
- ❖ **BED ROOM** – Hallow sound observed on wall after taping. (**It may fall**)
- ❖ **PASSAGE** – Hallow sound observed on wall after taping. (**It may fall**)
- ❖ **TOILET & BATH ROOM** – Seepage mark observed on wall.

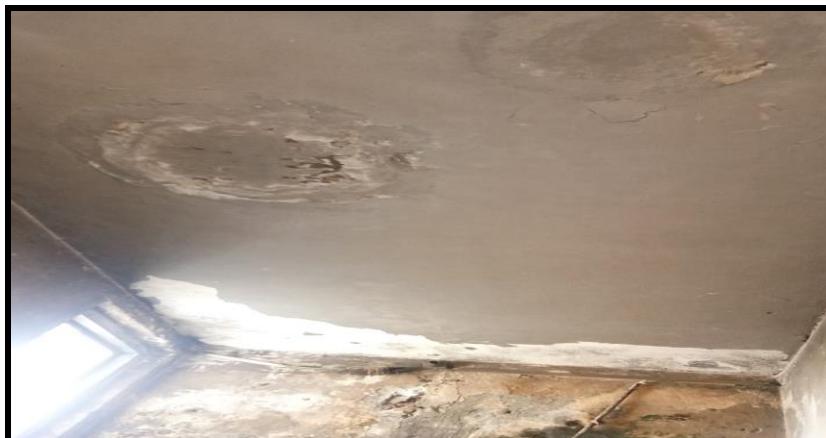
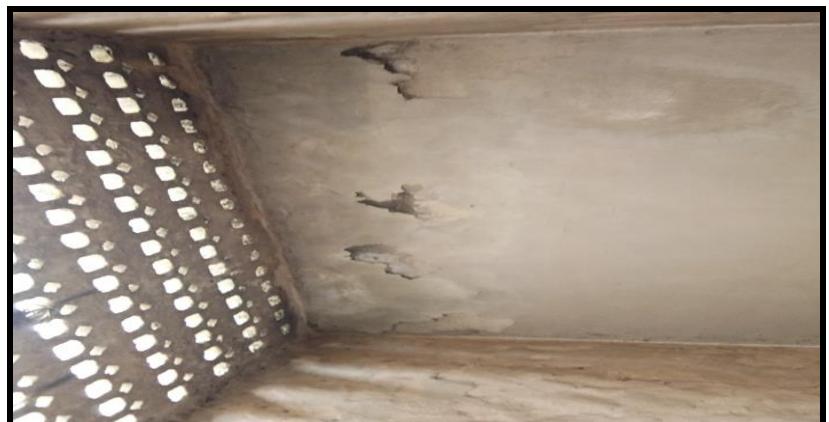
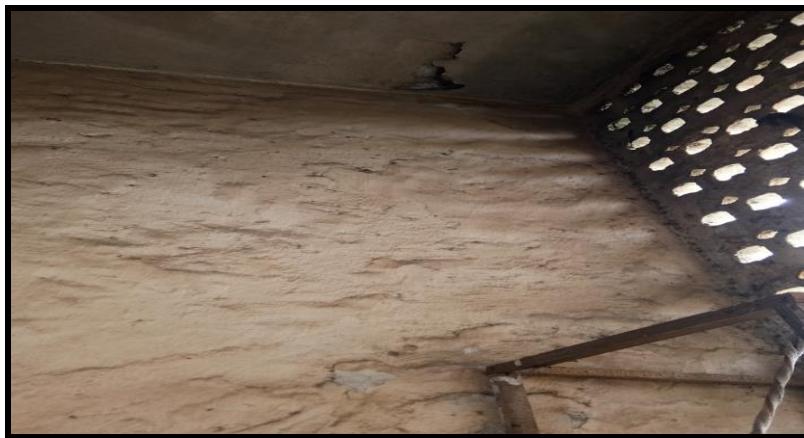
### Terrace to Fourth floor:-

- ❖ Peeling of paint observed on ceiling.
- ❖ Crack observed on ceiling.
- ❖ Leakage mark observed on ceiling.

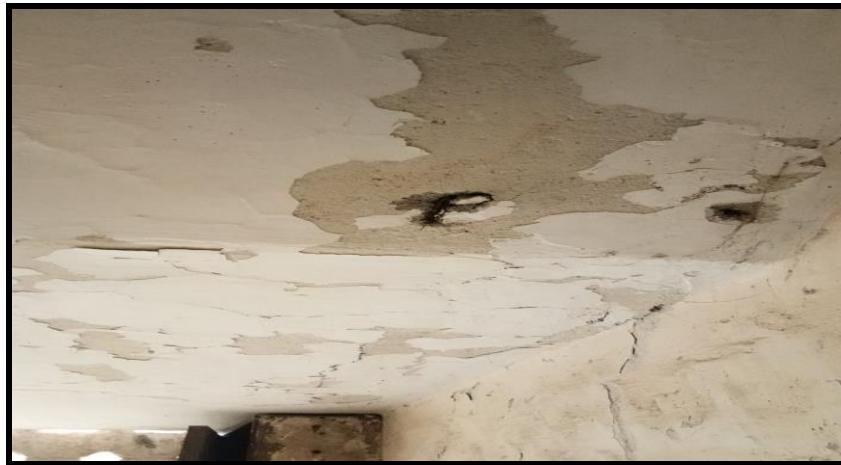
#### **Fourth floor to Third floor:-**

- ❖ Steel exposed and corroded.

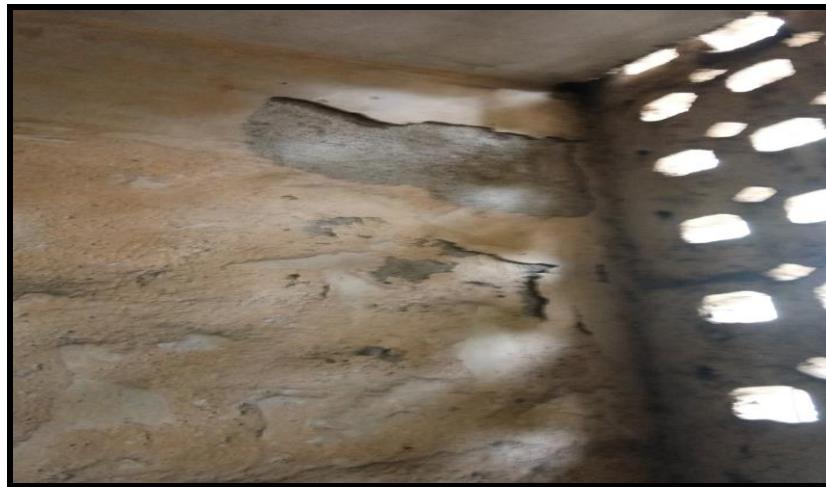
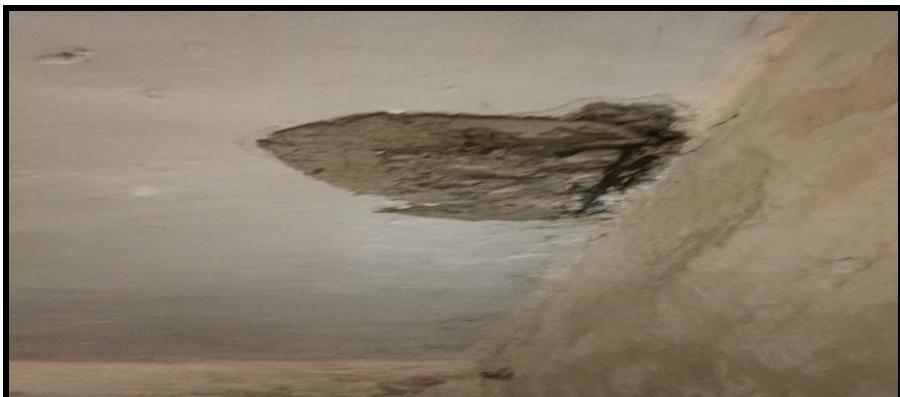
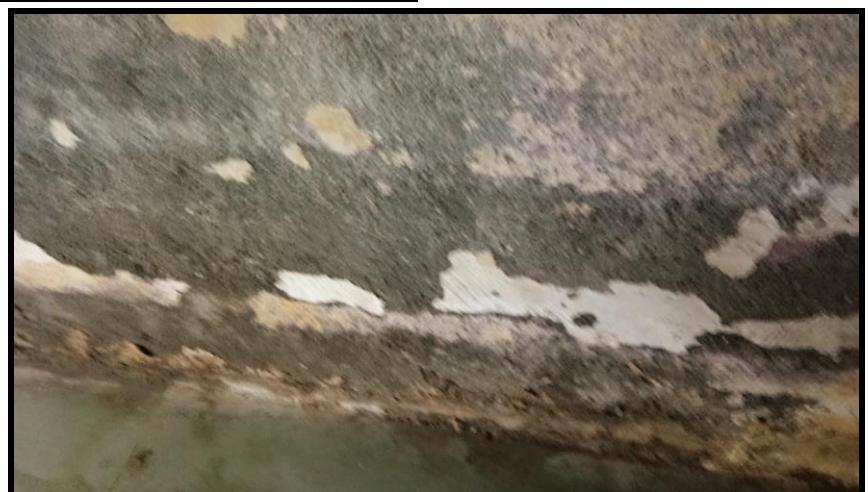
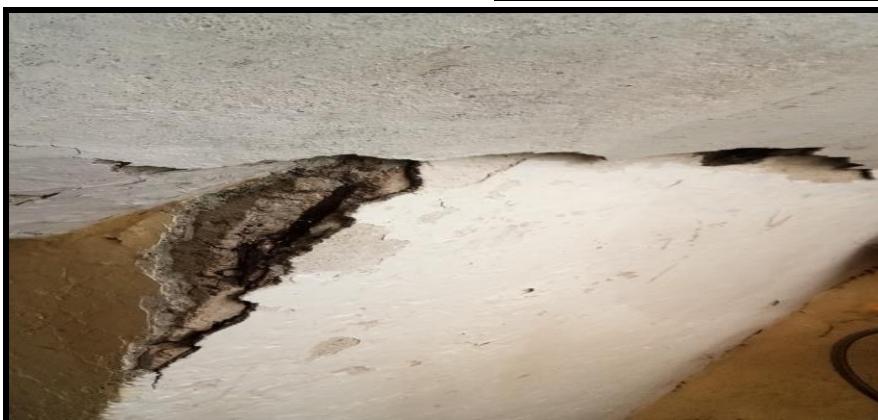
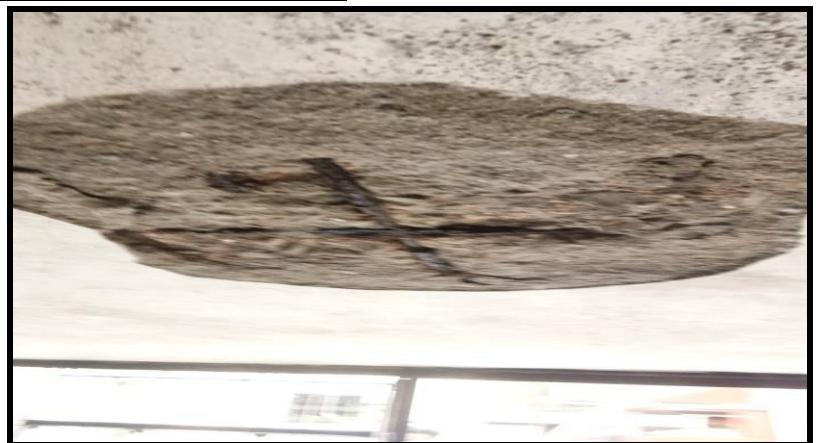
#### **First floor to Ground floor:-**

- ❖ Peeling of paint observed on wall.
- ❖ Plaster gets removed and steel get exposed and corroded.

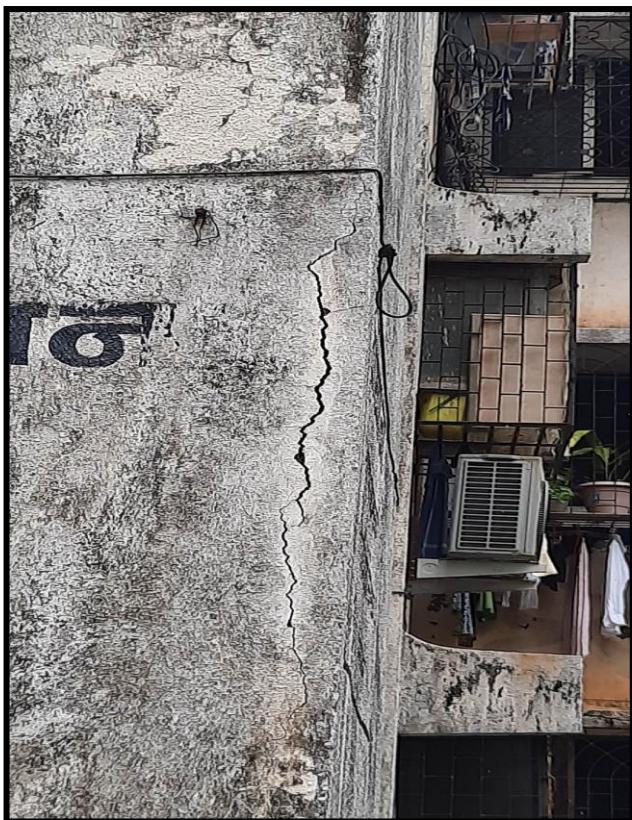
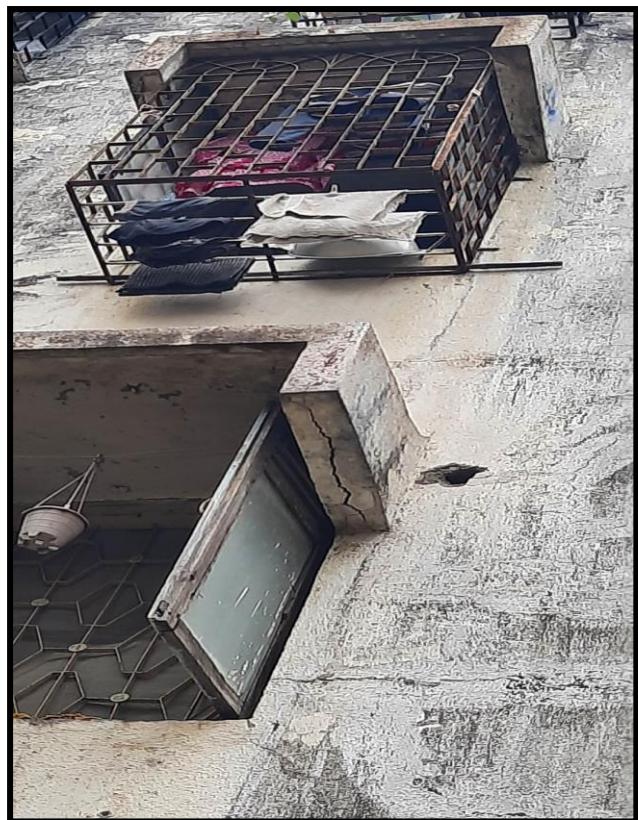
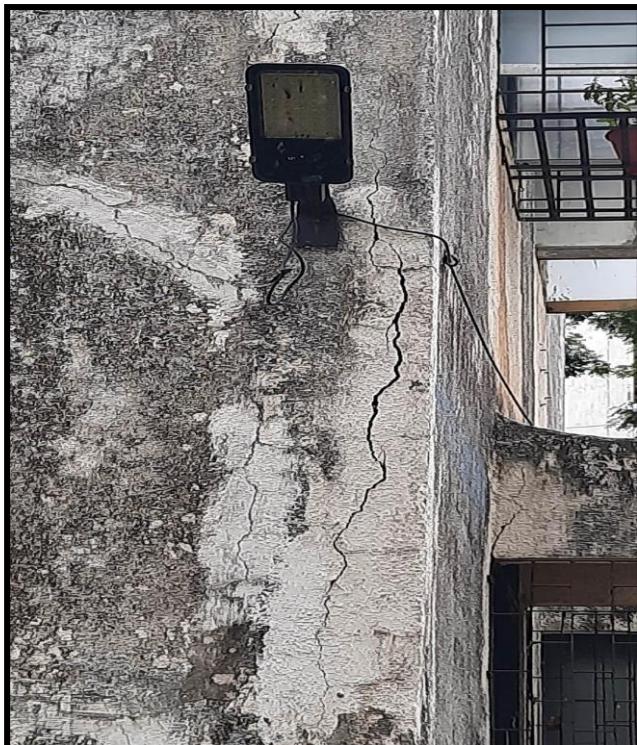
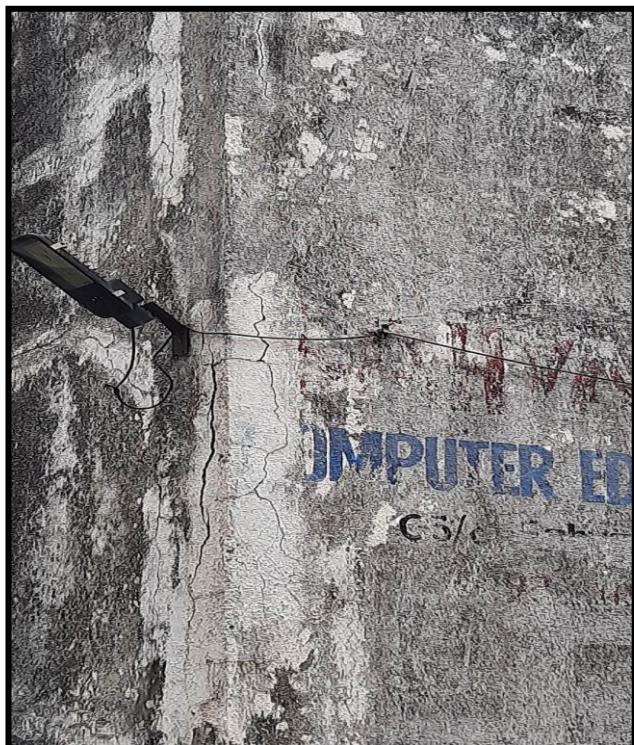
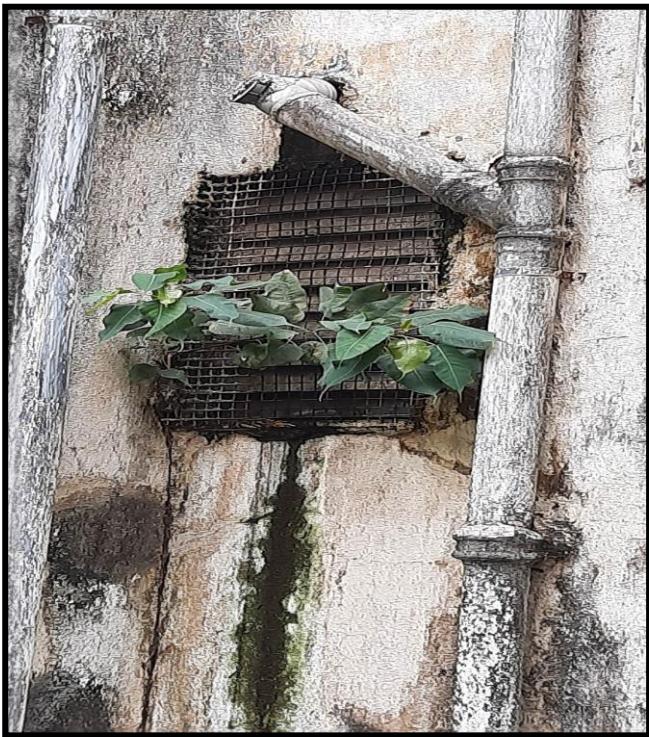
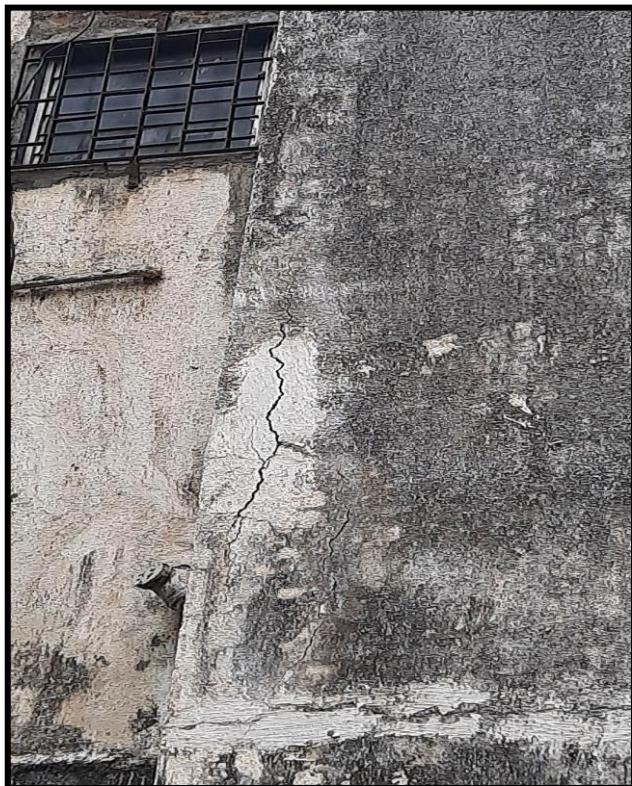
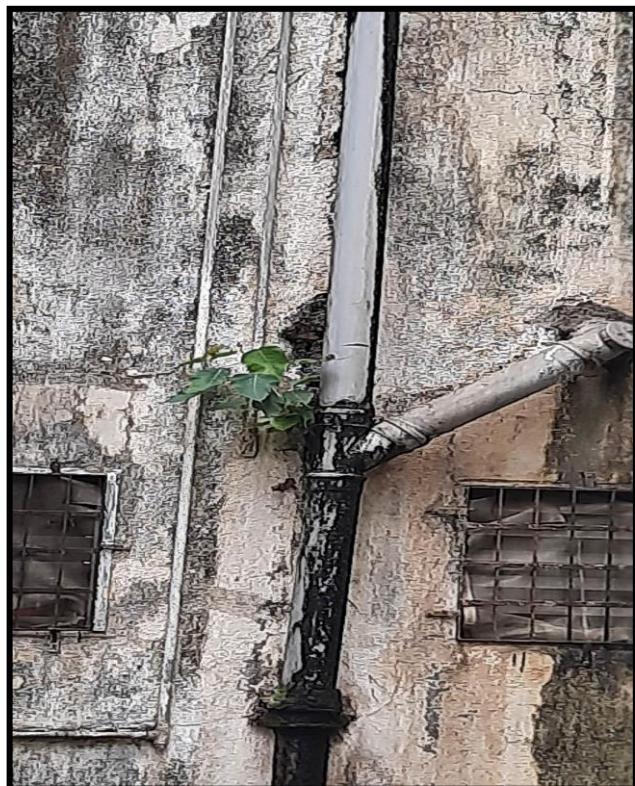
#### **BACK SIDE**

- ❖ Structural crack observed at several places on column.
- ❖ Major crack observed at several places on wall.
- ❖ Vegetation growth observed at several places on wall.
- ❖ Chajja plaster get damaged & steel get exposed & corroded.

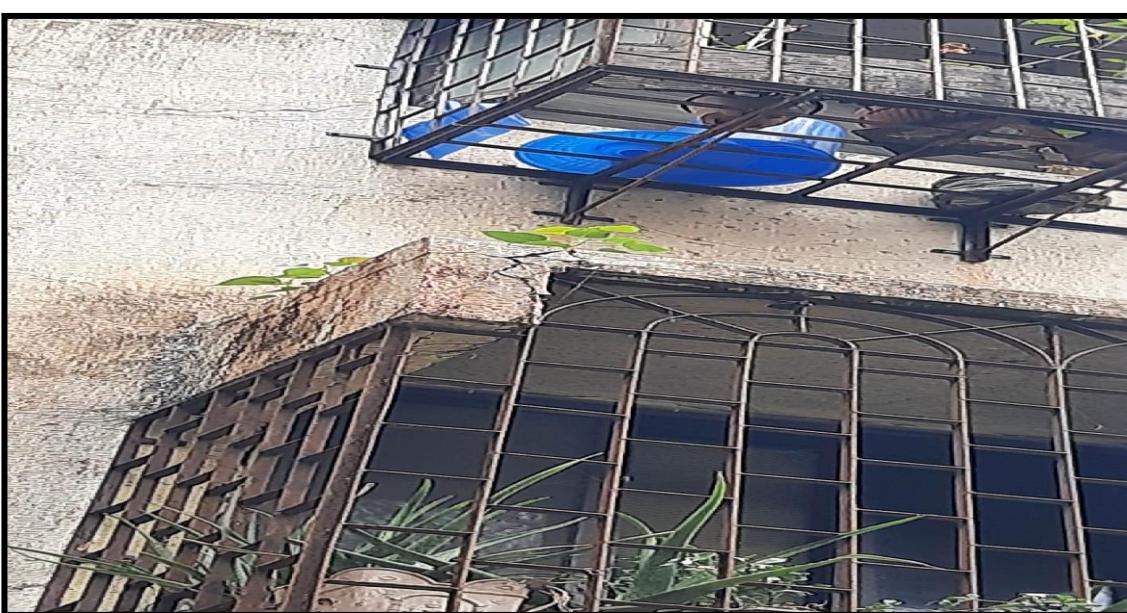
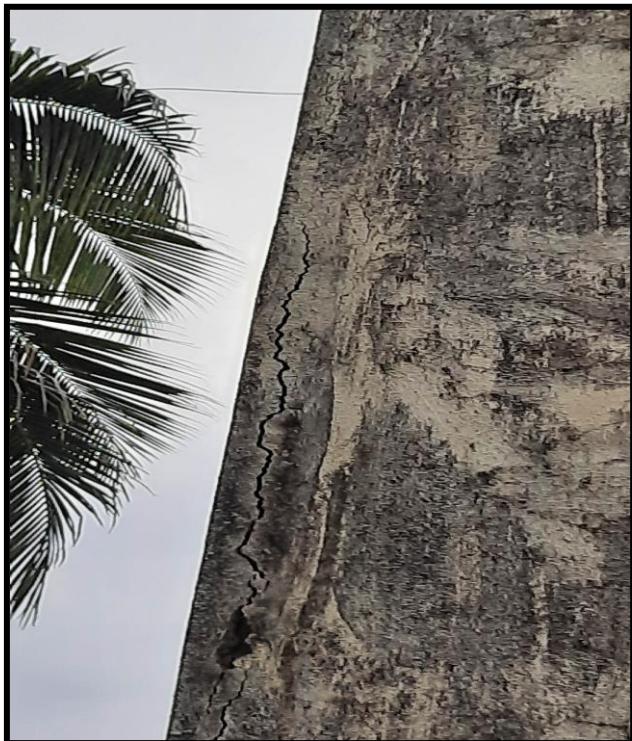
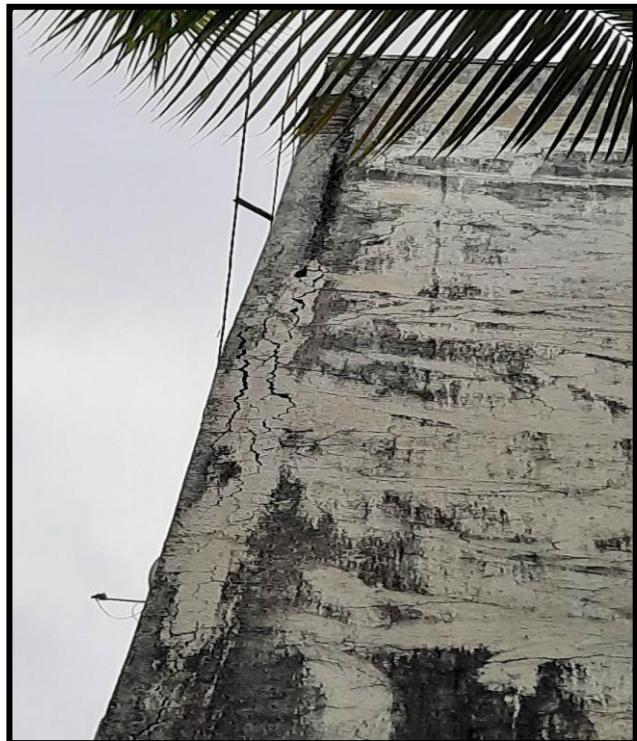
## NORTH SIDE

- ❖ Structural crack observed at several places on column.
- ❖ Major crack observed at several places on wall.
- ❖ Vegetation growth observed at several places on wall.
- ❖ Chajja plaster get damaged & steel get exposed & corroded.
