STRUCTURAL AUDIT REPORT  
FOR  
**“VISHAL SAHYADRI CO – OP HSG. SOC. LTD”,**  
**“B3 – WING”**  
SITUATED AT  
SAHYADRI NAGAR, CHARKOP,  
KANDIVALI (W) MUMBAI – 400 067

978/B3/LSS/2021

JULY 19, 2021

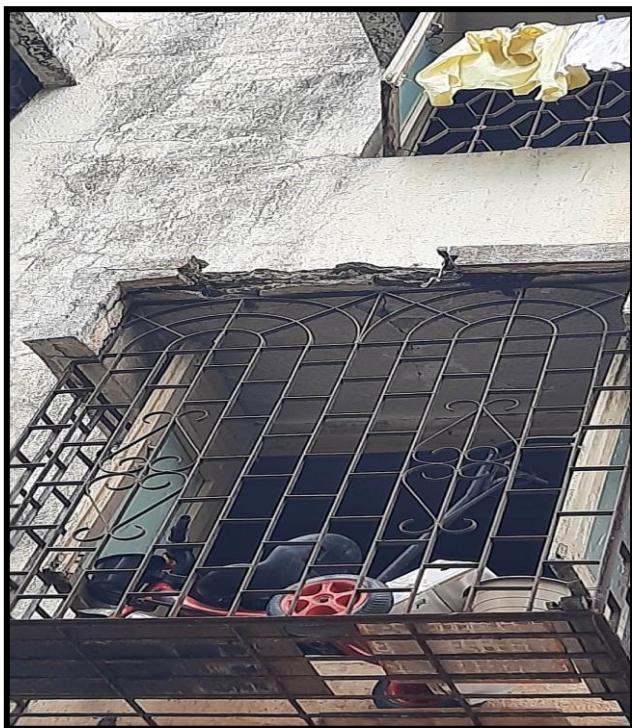
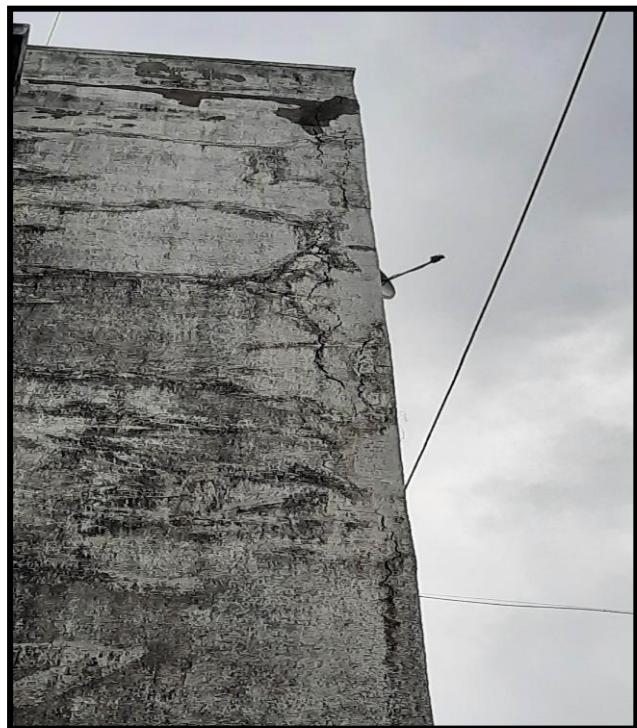
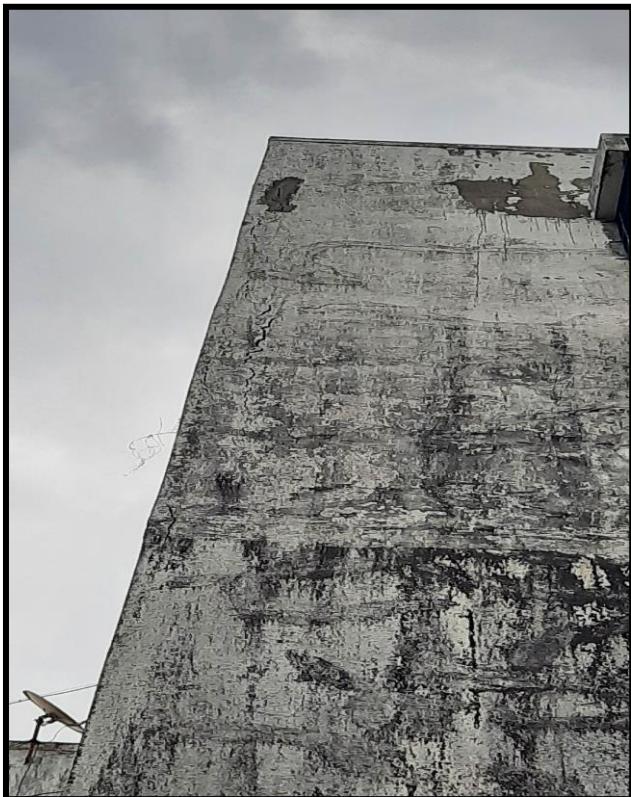
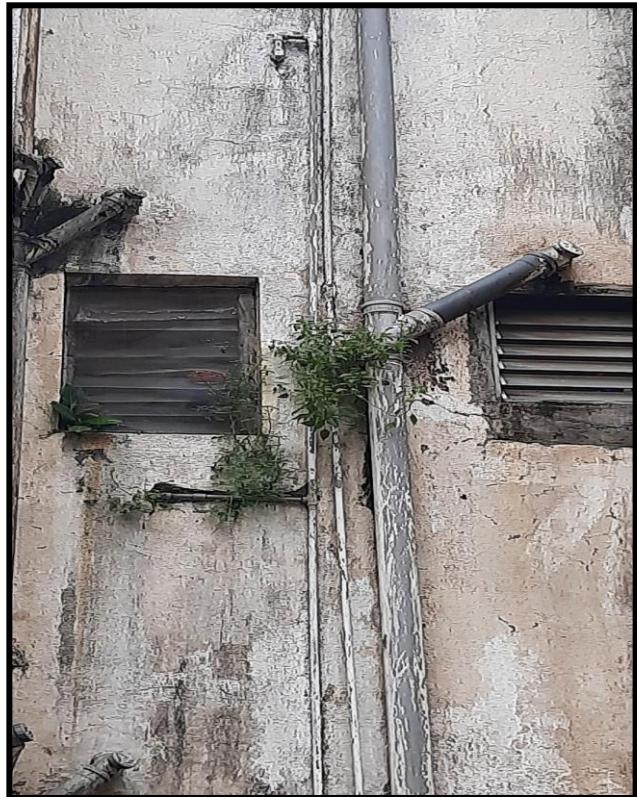
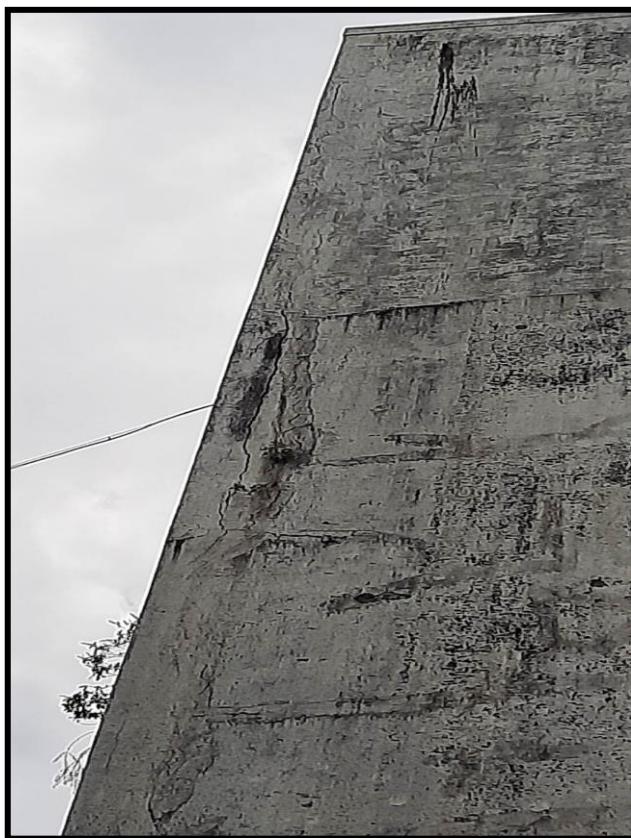
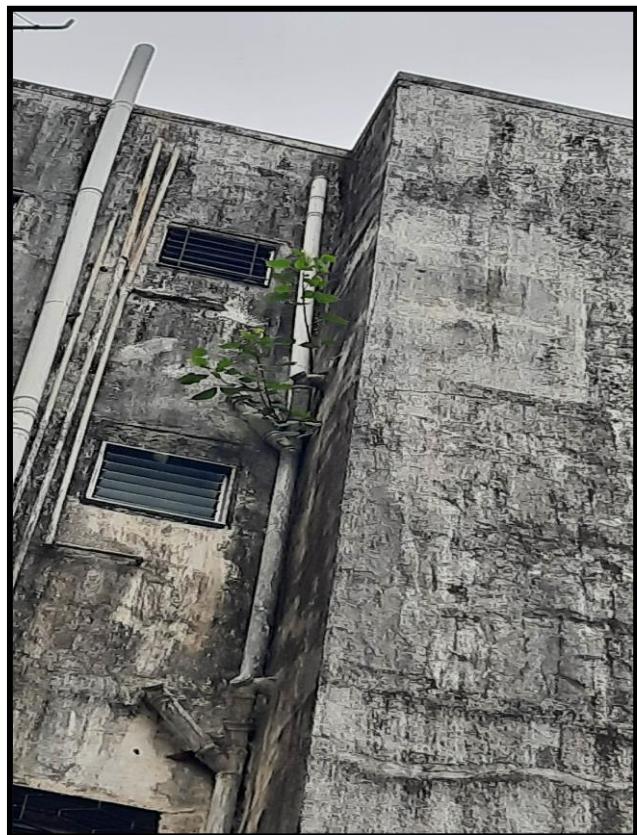
## SOUTH SIDE

- ❖ Structural crack observed at several places on column.
- ❖ Major crack observed at several places on wall.
- ❖ Vegetation growth observed at several places on wall.
- ❖ Chajja plaster get damaged & steel get exposed & corroded.
