STRUCTURAL AUDIT REPORT
FOR
“VISHAL SAHYADRI CO – OP HSG. SOC. LTD”,
“B2 – WING”
SITUATED AT
SAHYADRI NAGAR, CHARKOP,
KANDIVALI (W) MUMBAI – 400 067

978/B2/LSS/2021

JULY 19, 2021

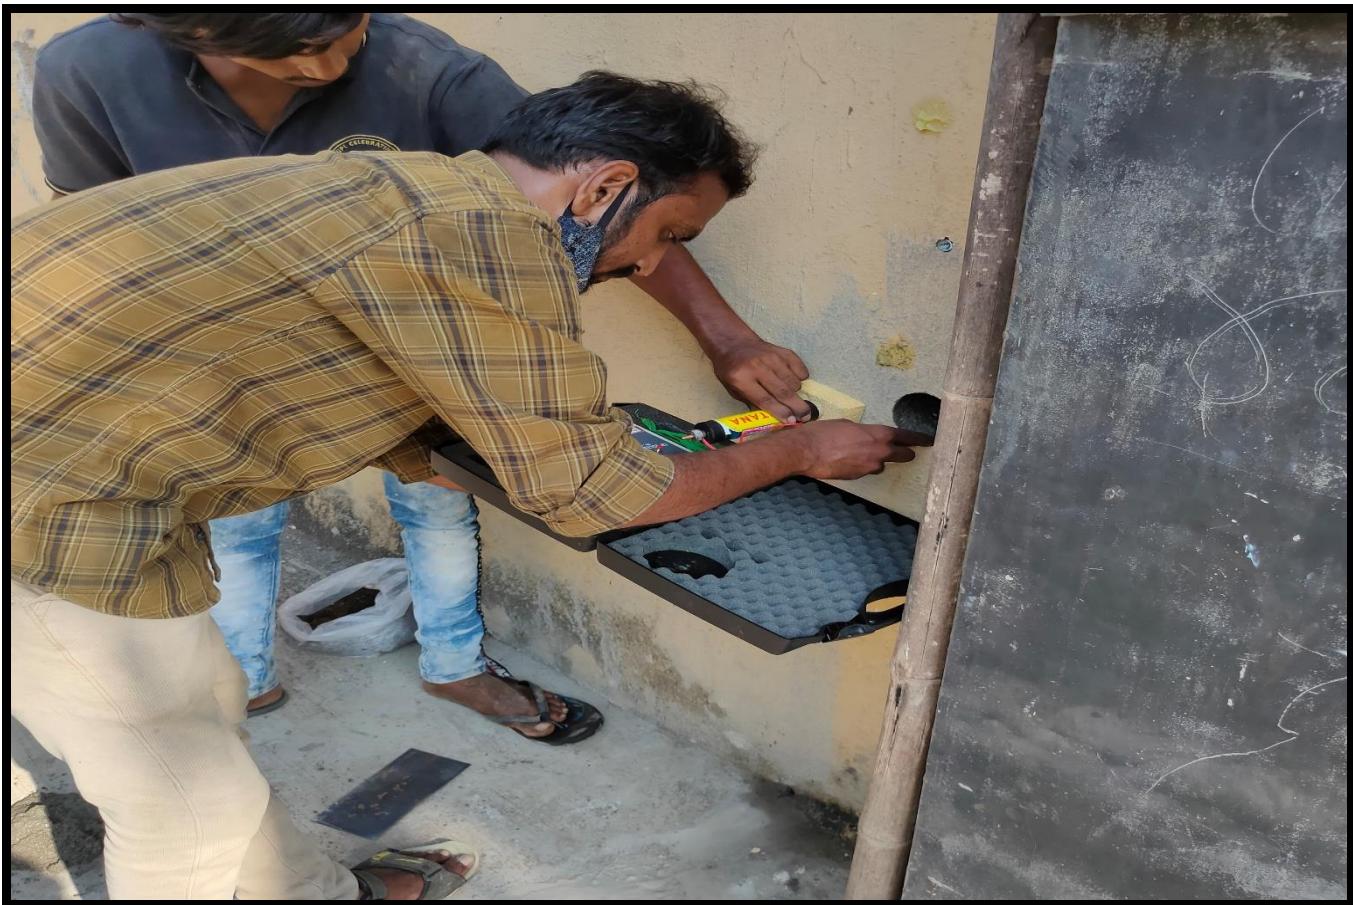
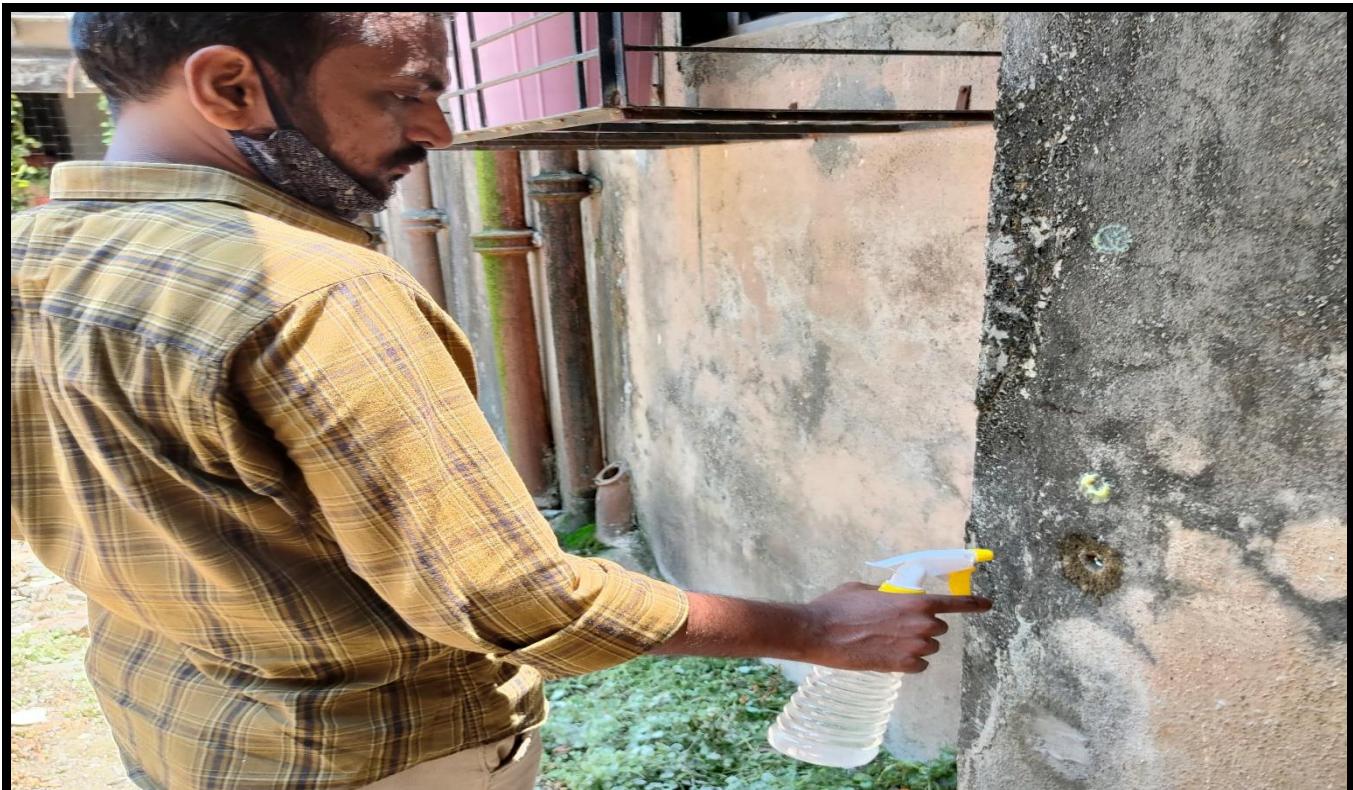
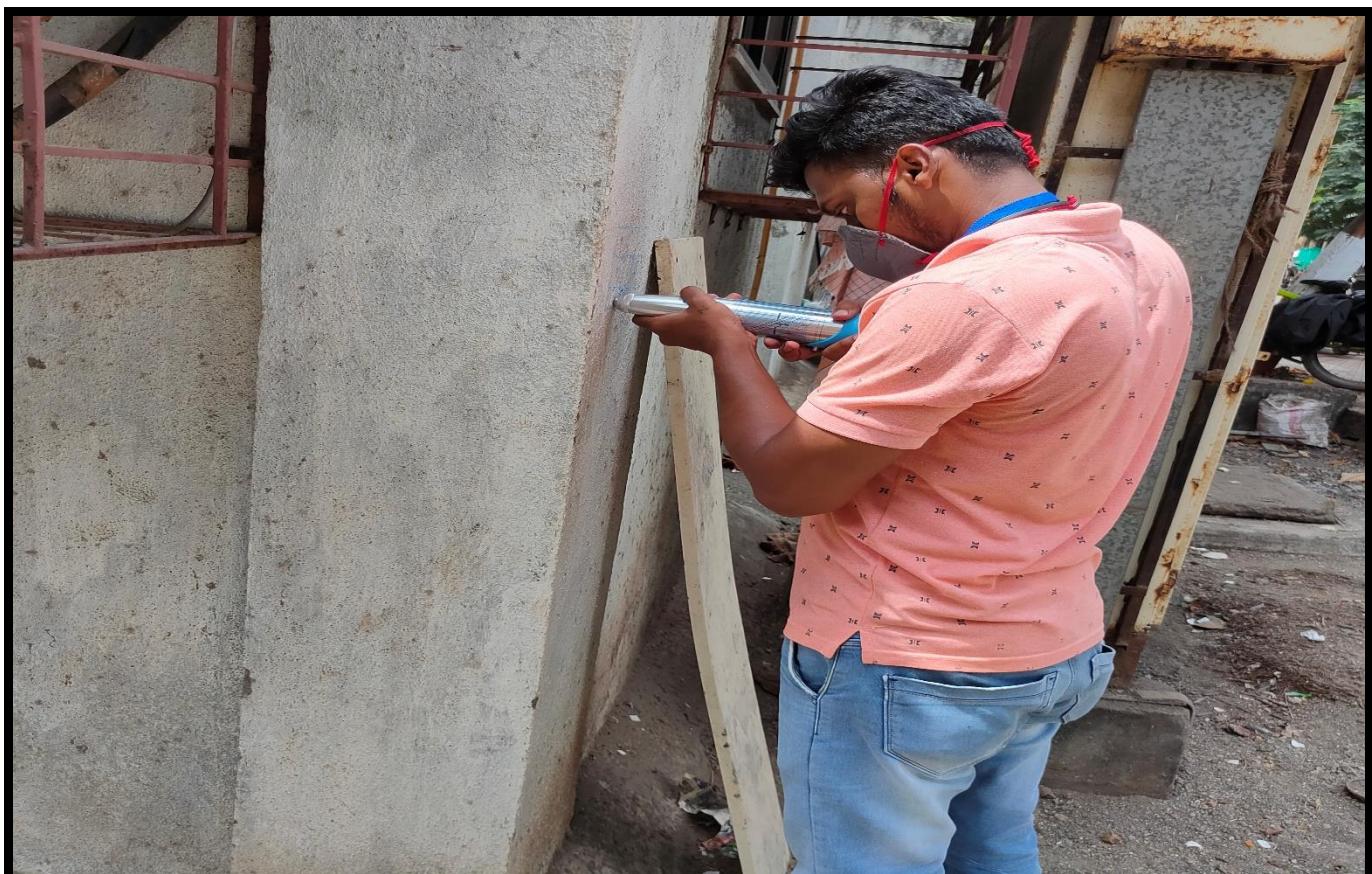
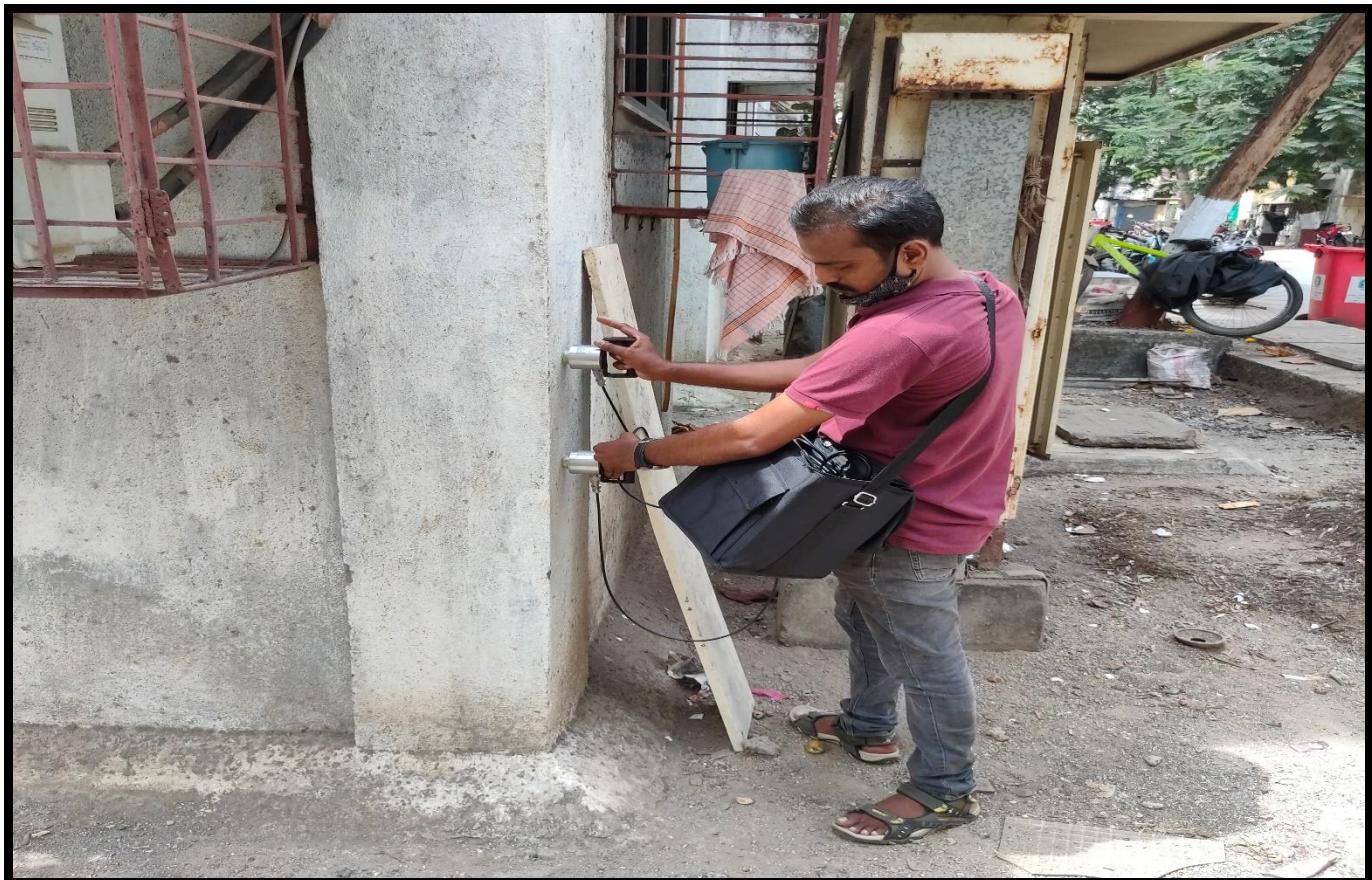
NON -DESTRUCTIVE TEST PHOTO

Rebound Hammer was tested for compressive strength at surface by Schmidt rebound hammer. Results indicate the compressive strength at surface of all the RCC columns is ranging between 10.30 MPa to 23.30 MPa.

The UPV values are ranging between 1.50 Km/Sec to 3.50 Km/Sec.

Out of 4 locations 3 locations was below 3.0 Km/Sec means concrete quality is poor and 1 location ranging between 3.0 to 3.75 Km/Sec means concrete quality is doubtful.

This indicates there are progressive internal cracks in the RCC members due to corrosion of reinforced steel. These members are under distress condition.

Half Cell Potential tested for corrosion activity by half – cell potential tests. Values are taken on Column. The result on tested column is – 320 mV.

Carbonation test was conducted to assess carbonation depth. Readings are taken on Column. Result indicates the carbonation penetration depth is 35.00 mm. Carbonation depths have reached to the reinforcement level in all of the RCC elements. It is essential to give a suitable anti-corrosion treatment to all the RCC members to stop further carbonation and corrosion of concrete.

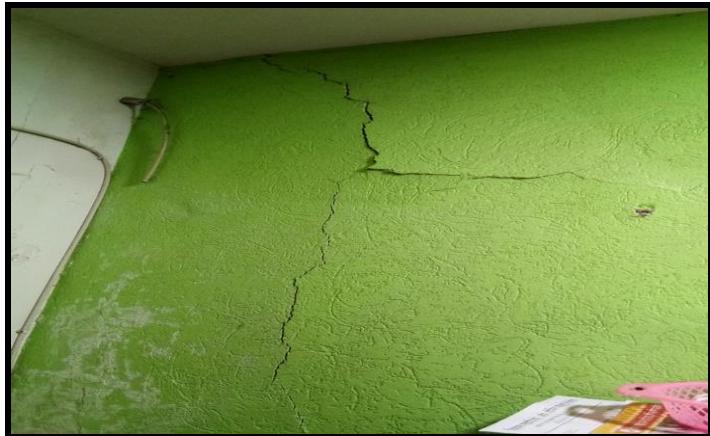
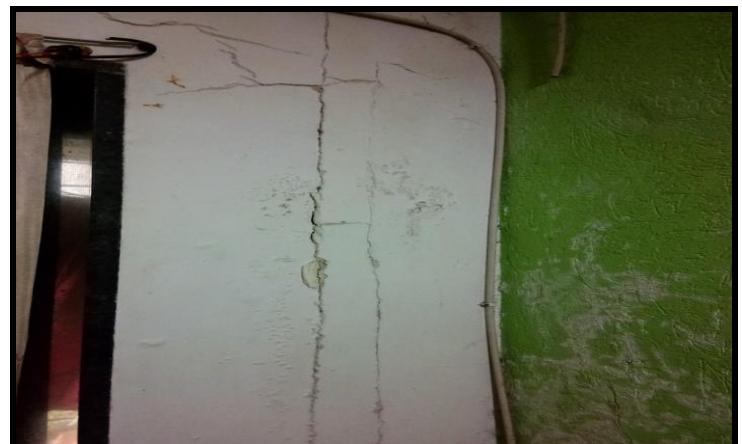
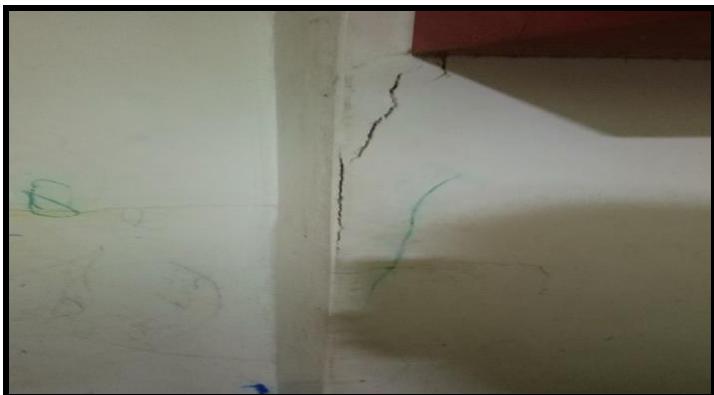
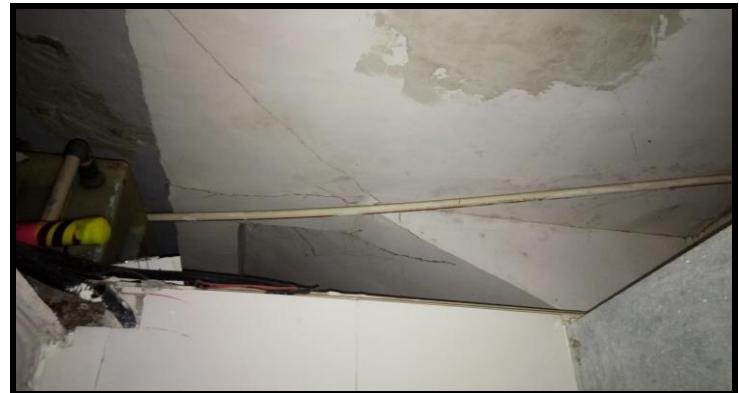
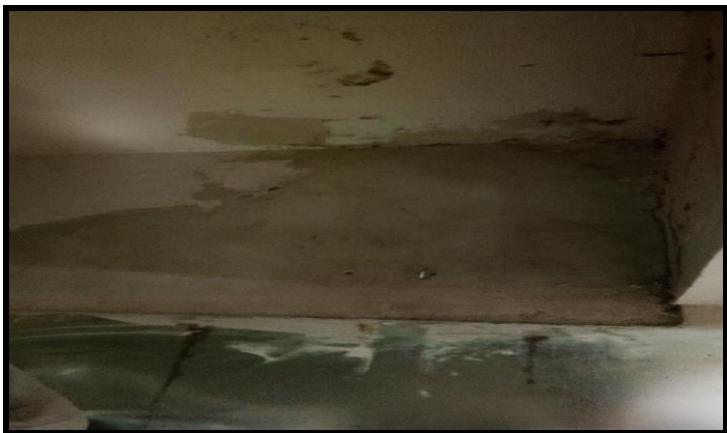
FLAT NO – 03

- ❖ **HALL** – Major structural crack observed on South side wall.
 - Major structural crack observed on Column.
 - Peeling of paint observed on South side wall.
- ❖ **KITCHEN** – Peeling of paint observed on ceiling.
- ❖ **BED ROOM** – O.K.
- ❖ **PASSAGE** – Peeling of paint observed on North side wall.
- ❖ **TOILET & BATH ROOM** – Major structural crack observed on south side wall.

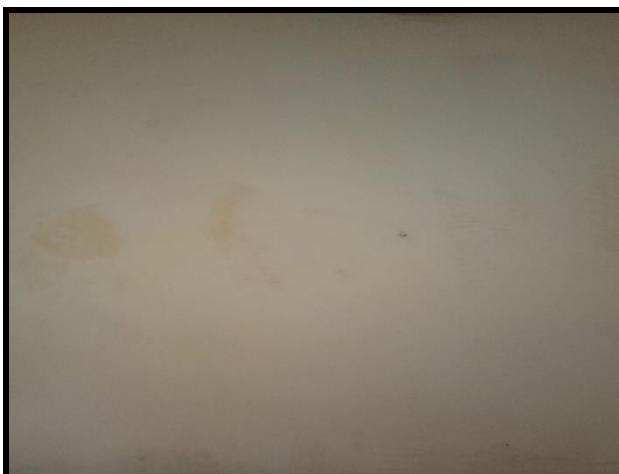
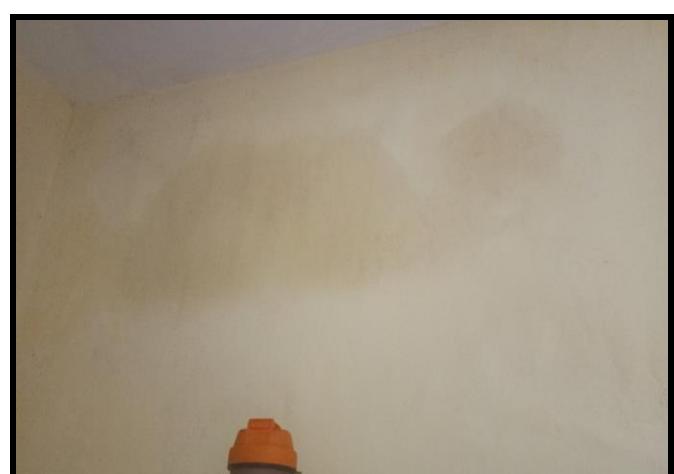
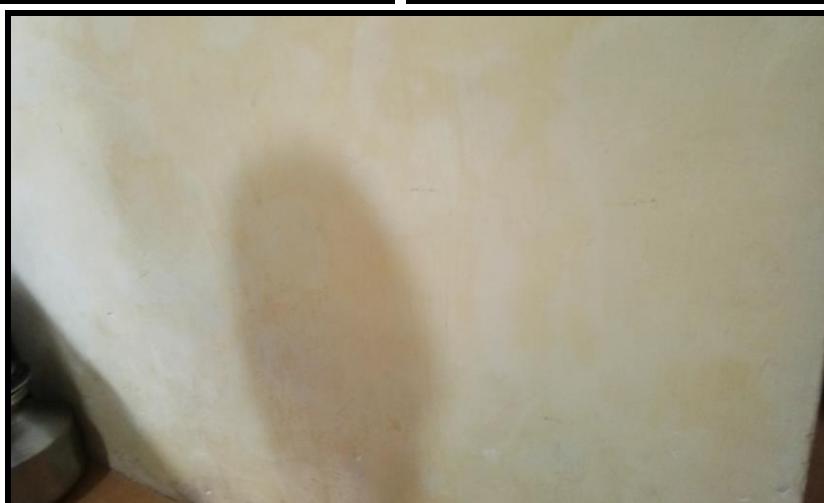
FLAT NO – 07

- ❖ **HALL** – Seepage mark observed on South side wall.
 - Peeling of paint observed on South side wall.
- ❖ **KITCHEN** – Seepage mark observed on North side wall.
- ❖ **BED ROOM** – Dampness observed on ceiling during monsoon.
- ❖ **PASSAGE** – Dampness observed on ceiling during monsoon.
- ❖ **TOILET & BATH ROOM** – Seepage mark observed on window side wall during monsoon.

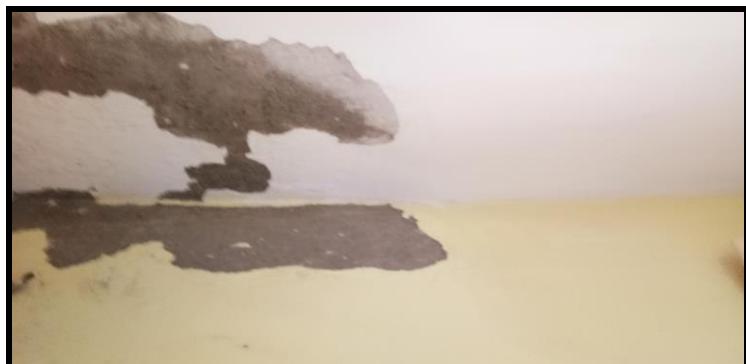
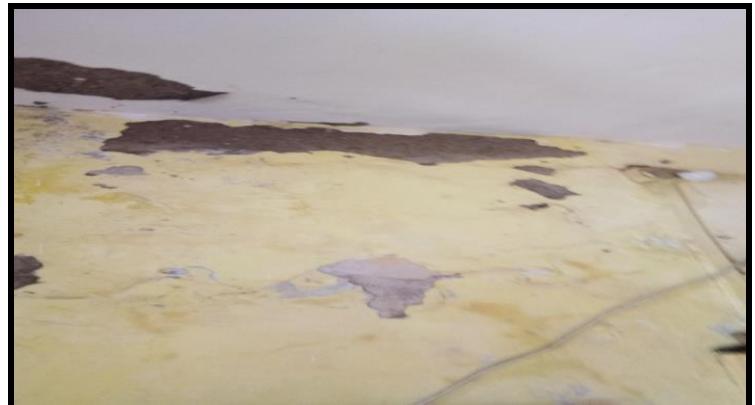
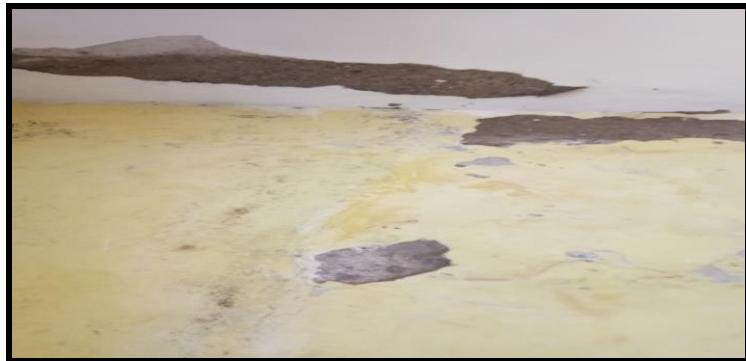
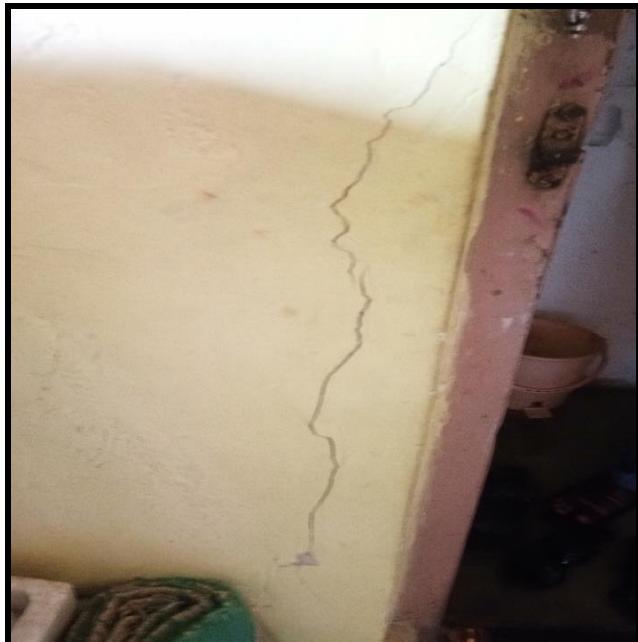
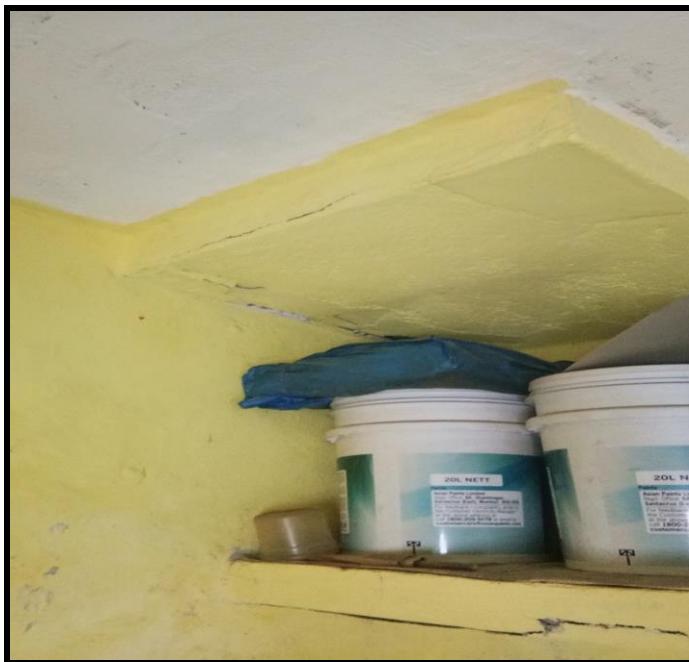
FLAT NO – 24

- ❖ **HALL** – Major structural crack observed beam.
 - Hallow sound observed on South side wall after during tapping. (It may fall)
 - Seepage mark observed on ceiling during monsoon.
 - Peeling of paint observed on South side wall.
- ❖ **KITCHEN** – Peeling of paint observed on South side wall.
- ❖ **BED ROOM** – Dampness observed on North side wall during monsoon.
- ❖ **PASSAGE** – Hallow sound observed on Ceiling. (It may fall)
- ❖ **TOILET & BATH ROOM** – O.K.

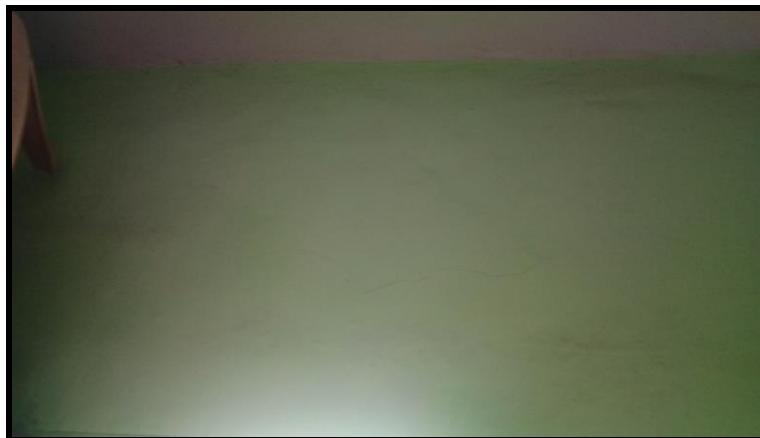
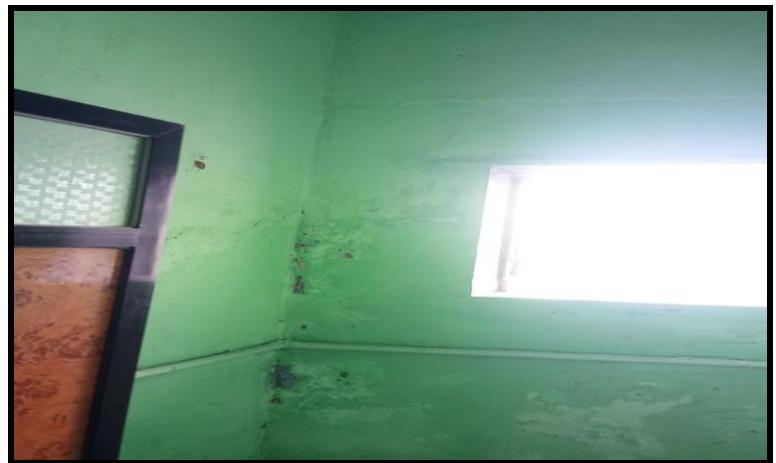
FLAT NO – 27

- ❖ **HALL** – Seepage observed on South side wall.
 - Crack observed on North side wall.
 - Peeling of paint observed on ceiling.
- ❖ **KITCHEN** – Hallow sound observed on Ceiling after tapping. (**It may fall**)
- ❖ Steel exposed and get corroded. (**It may fall**)
- ❖ **BED ROOM** – Seepage mark observed on South side wall.
- ❖ **PASSAGE** – Dampness observed on Ceiling.
- ❖ **TOILET & BATH ROOM** – Dampness observed on South side wall during monsoon.

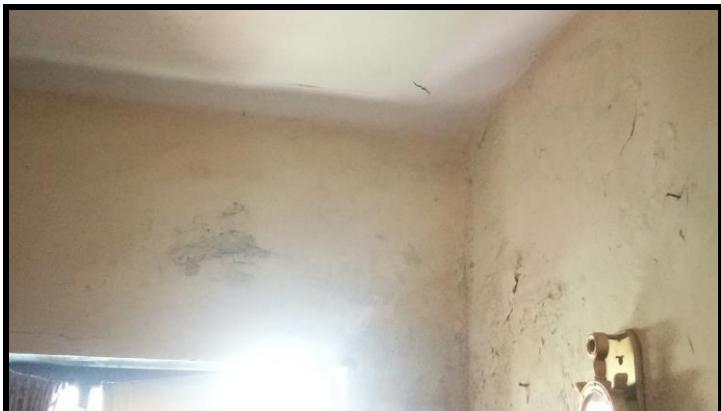
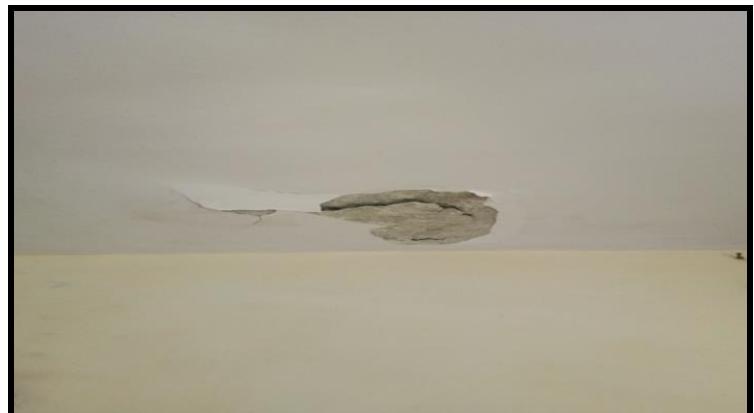
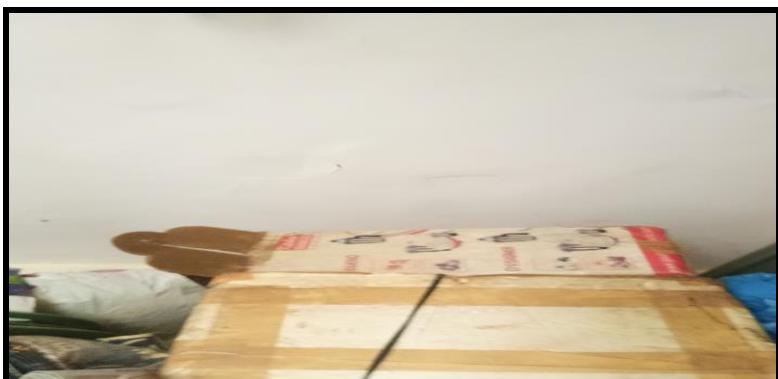
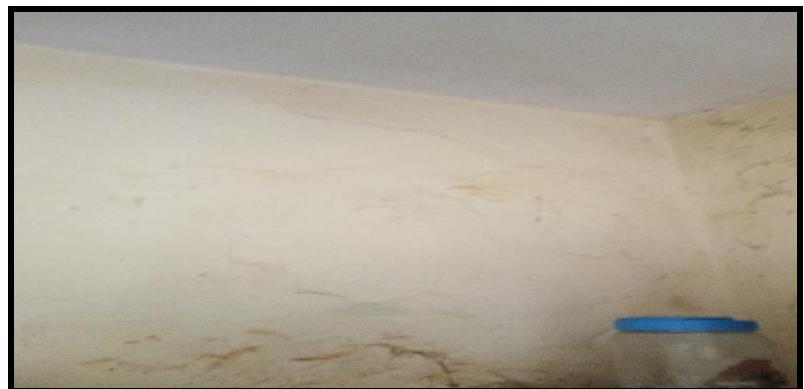
FLAT NO – 26

- ❖ **HALL** – Major leakage mark observed on Ceiling during monsoon.
 - Major leakage mark observed on South side wall during monsoon.
- ❖ **KITCHEN** – Peeling of paint observed on South side wall.
- ❖ **BED ROOM** – Dampness observed on ceiling.

❖ **PASSAGE** – Major structural crack observed on beam.

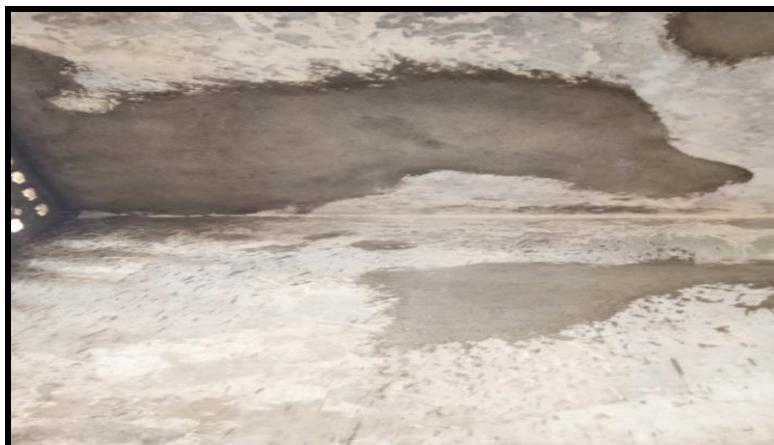
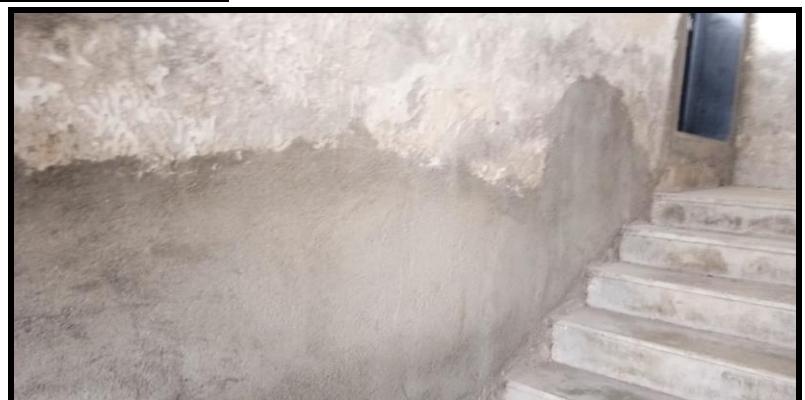
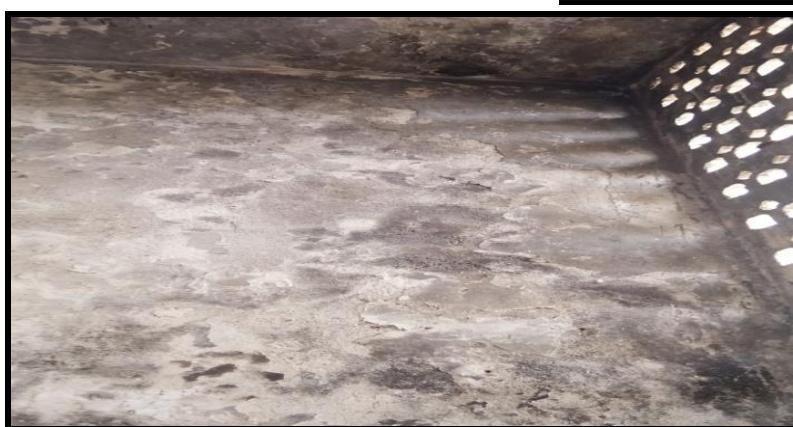
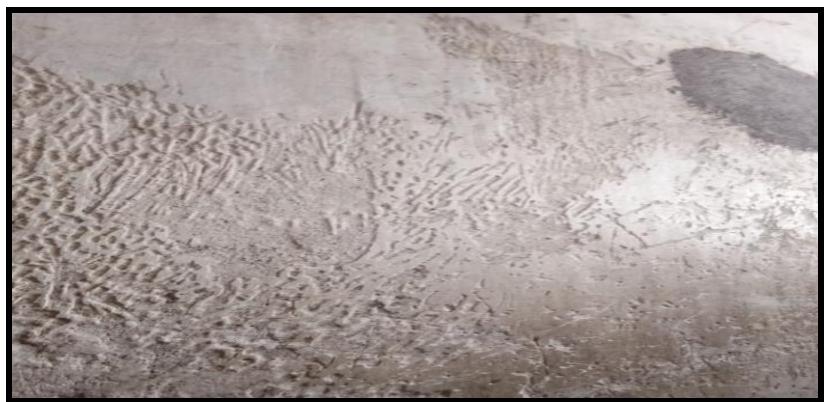
Terrace to Fourth floor:-

- ❖ Patch work observed on ceiling.
- ❖ Patch work observed on South side wall.
- ❖ Peeling of paint observed on Ceiling.
- ❖ Crack filling observed on wall.

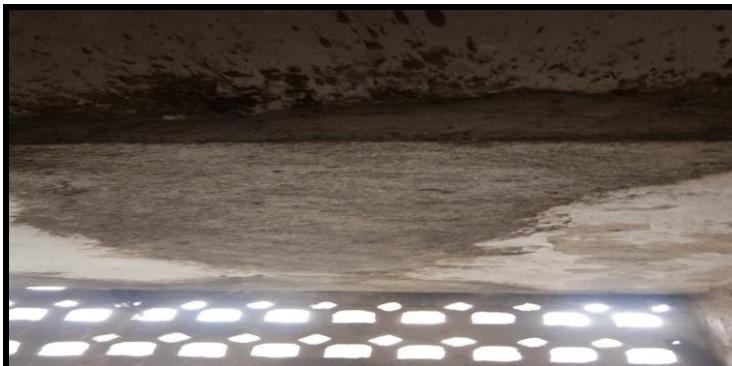
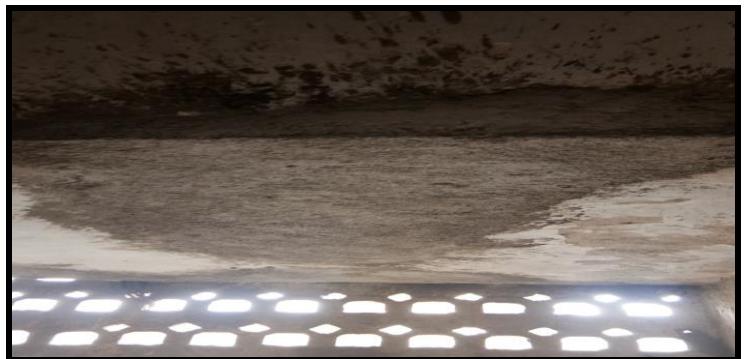
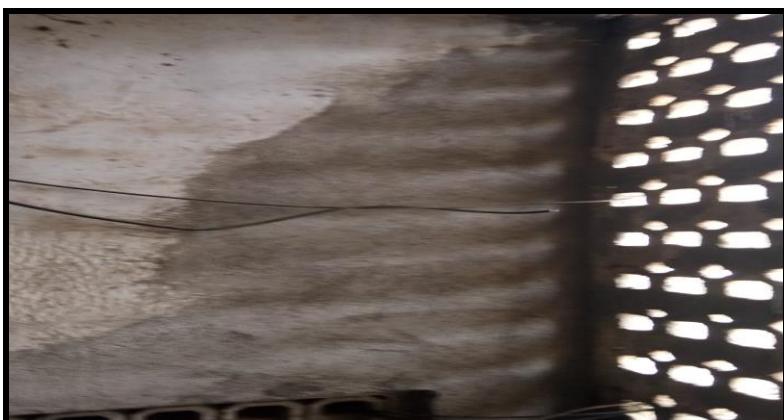
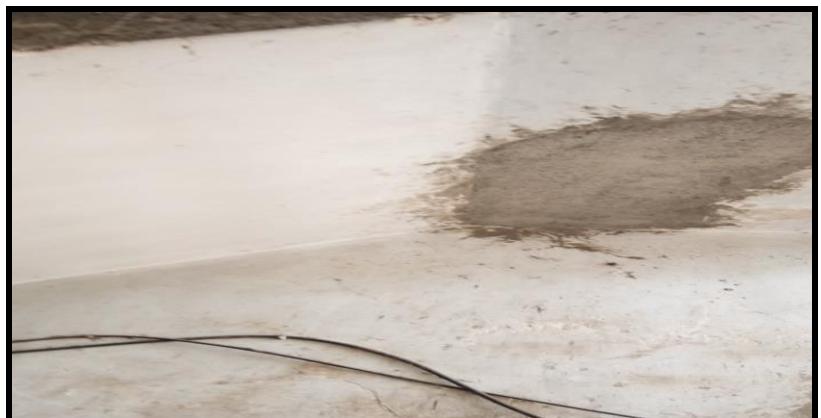
Fourth floor to Third floor:-

- ❖ Patch work observed on wall.
- ❖ Patch work observed on ceiling.
- ❖ Dampness observed on South side wall.

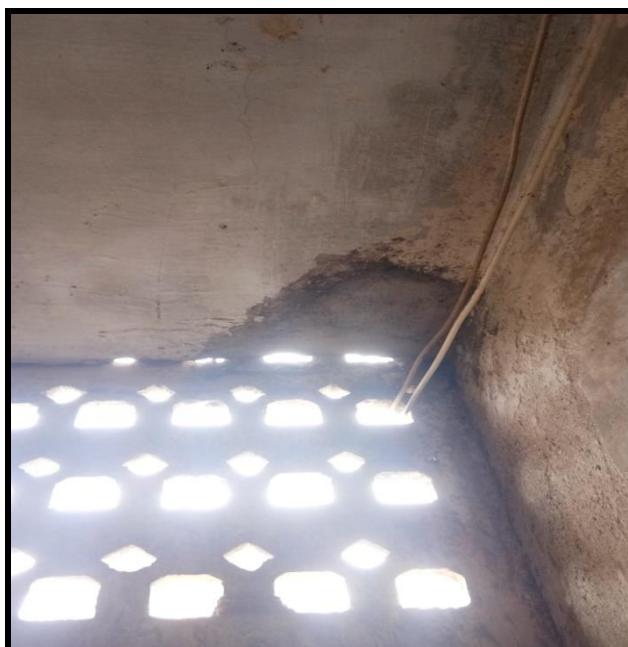
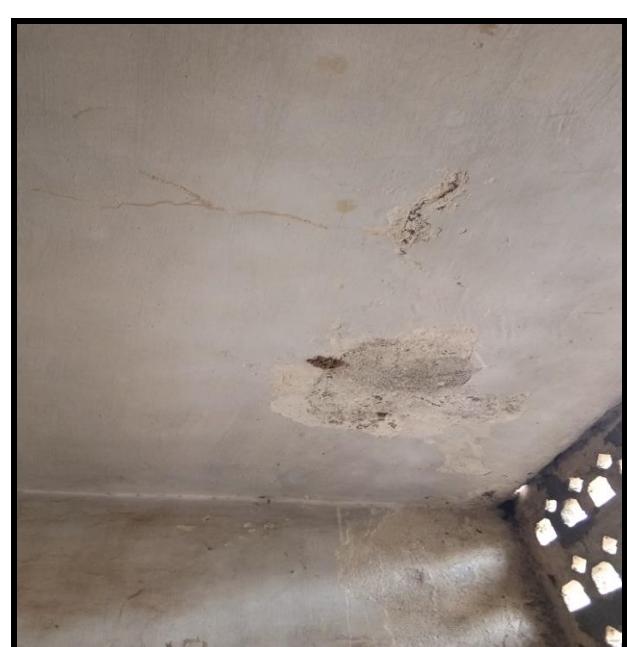
Third floor to Second floor:-

- ❖ Patch work observed on Ceiling.
- ❖ Crack filling work observed on South side wall.

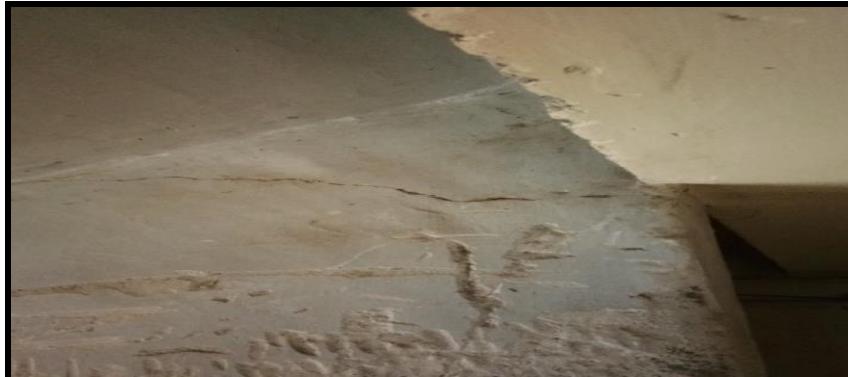
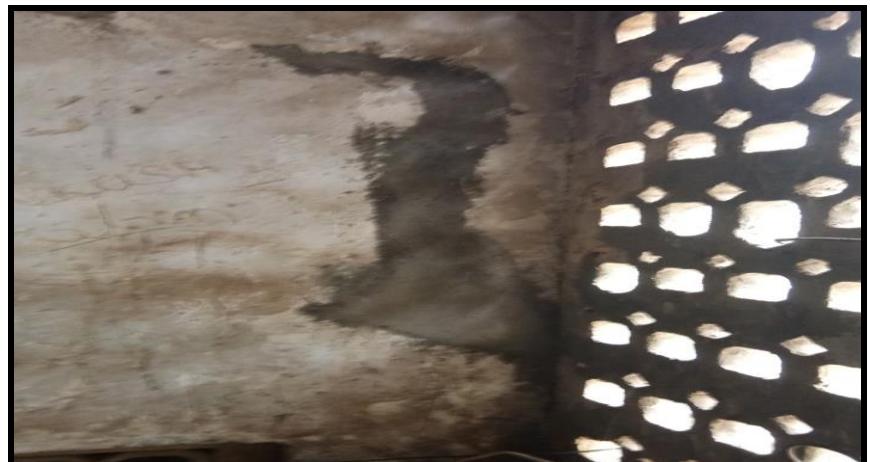
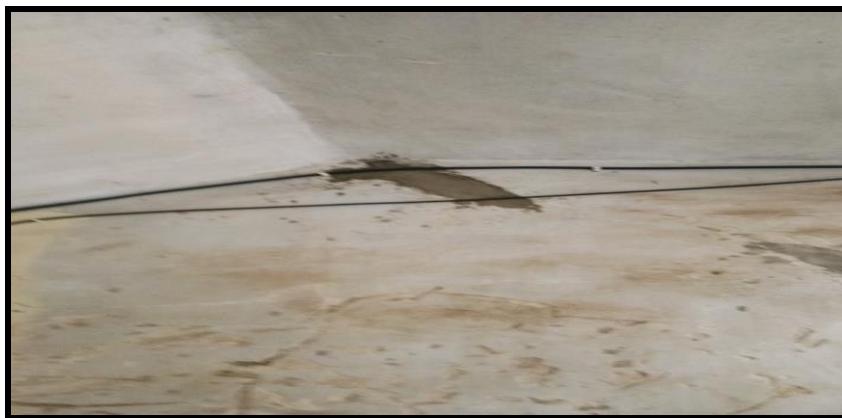
Second floor to First floor:-

- ❖ Crack filling observed on North side wall.
- ❖ Patch work observed on ceiling.
- ❖ Dampness of observed on South side wall during monsoon.

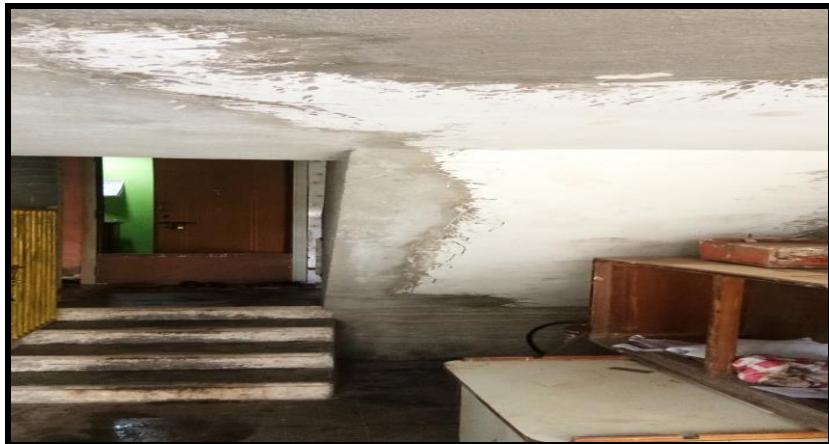
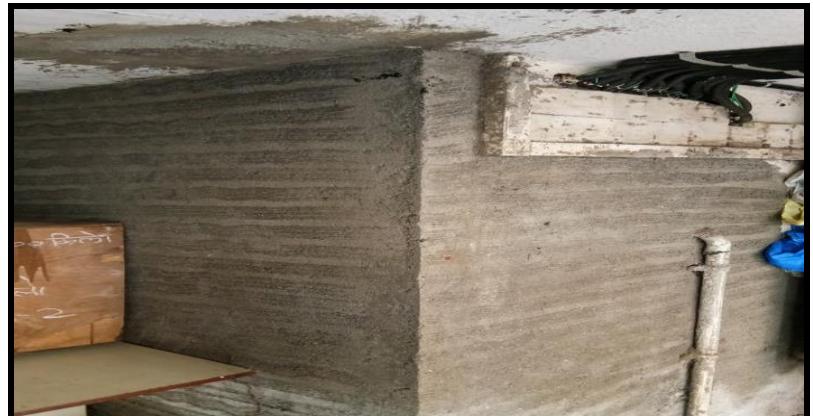
First floor to Ground floor:-

- ❖ Patch work observed on various wall.
- ❖ Leakage mark observed on North side wall.

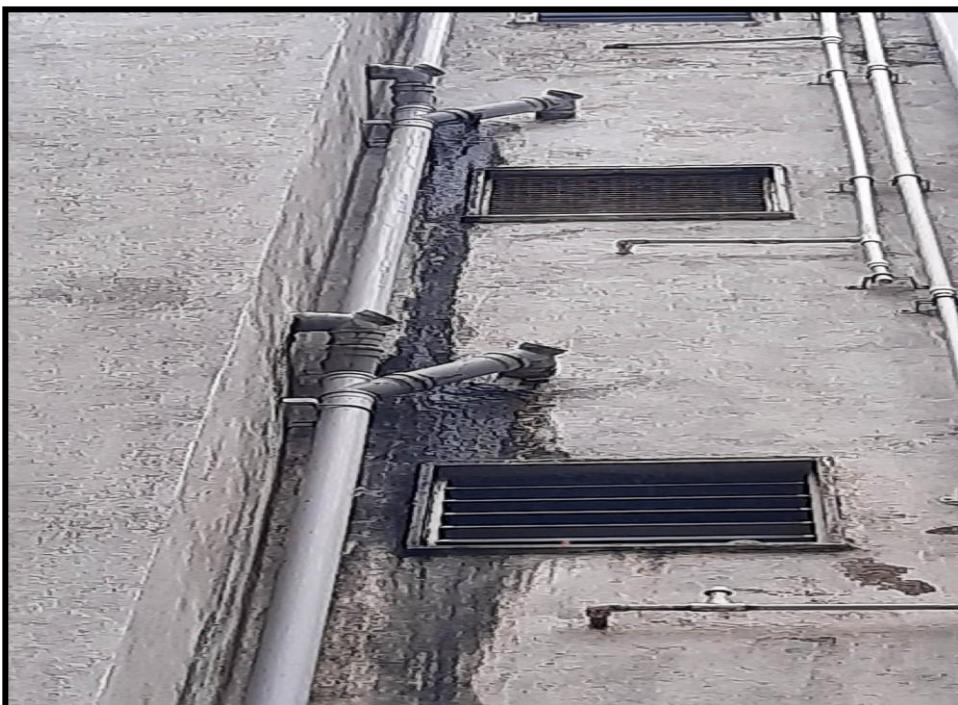
FRONT SIDE

- ❖ Algae observed on wall.

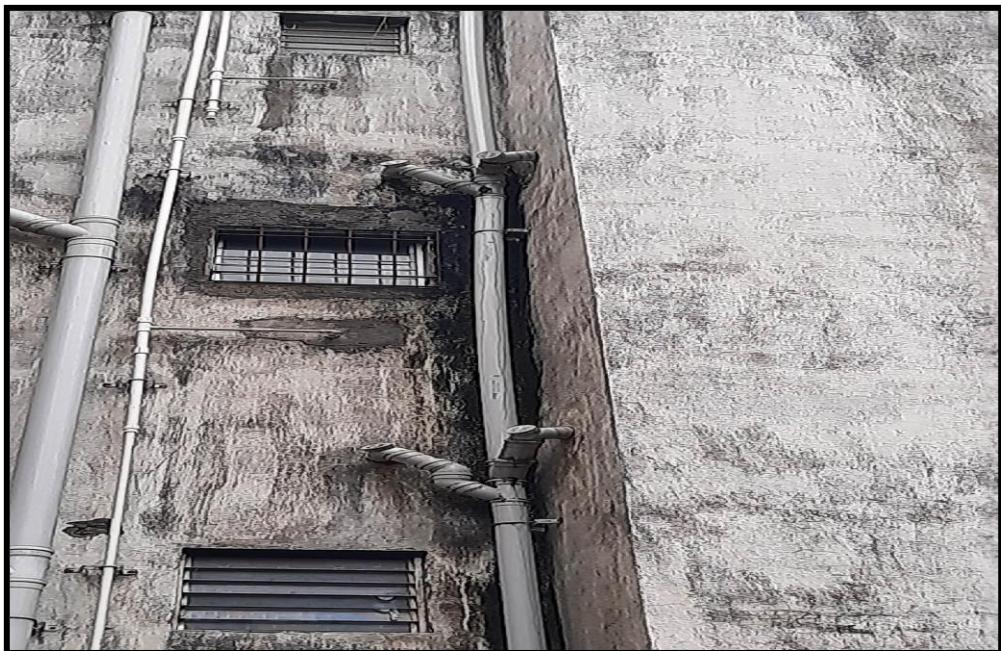
BACK SIDE

- ❖ Algae observed on wall.
