STRUCTURAL AUDIT REPORT  
FOR  
**“VISHAL SAHYADRI CO – OP HSG. SOC. LTD”,**  
**“D2 – E WING”**  
SITUATED AT  
SAHYADRI NAGAR, CHARKOP,  
KANDIVALI (W) MUMBAI – 400 067

PREPARED BY  
**LATESH S. SANKLECHA**  
**CONSULTING STRUCTURAL ENGINEERS**

978/D2/LSS/2021

JULY 24, 2021

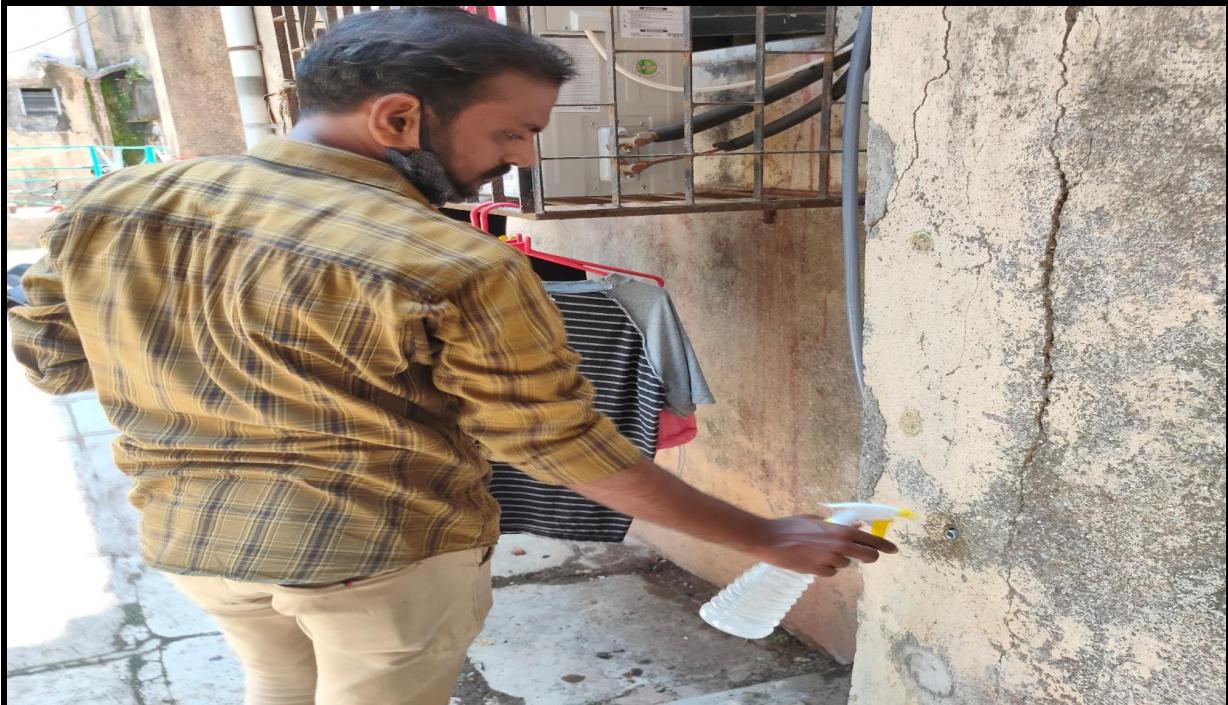
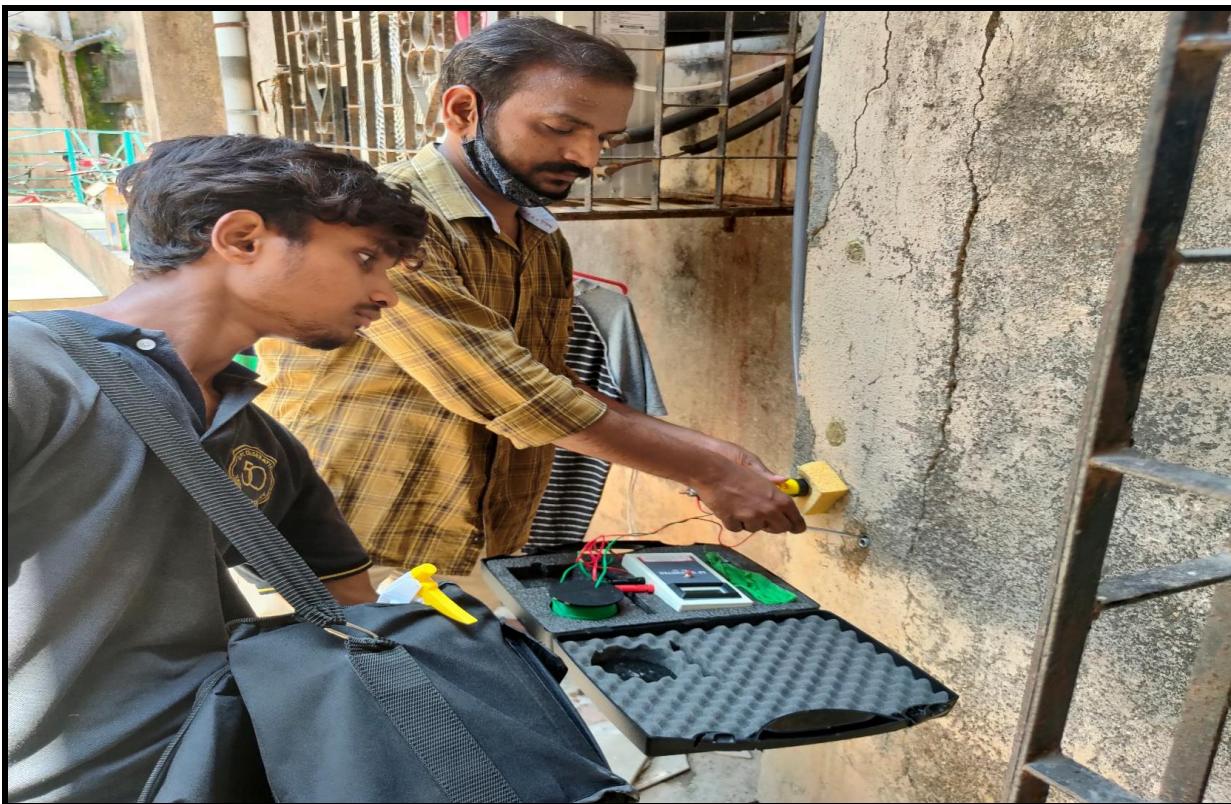
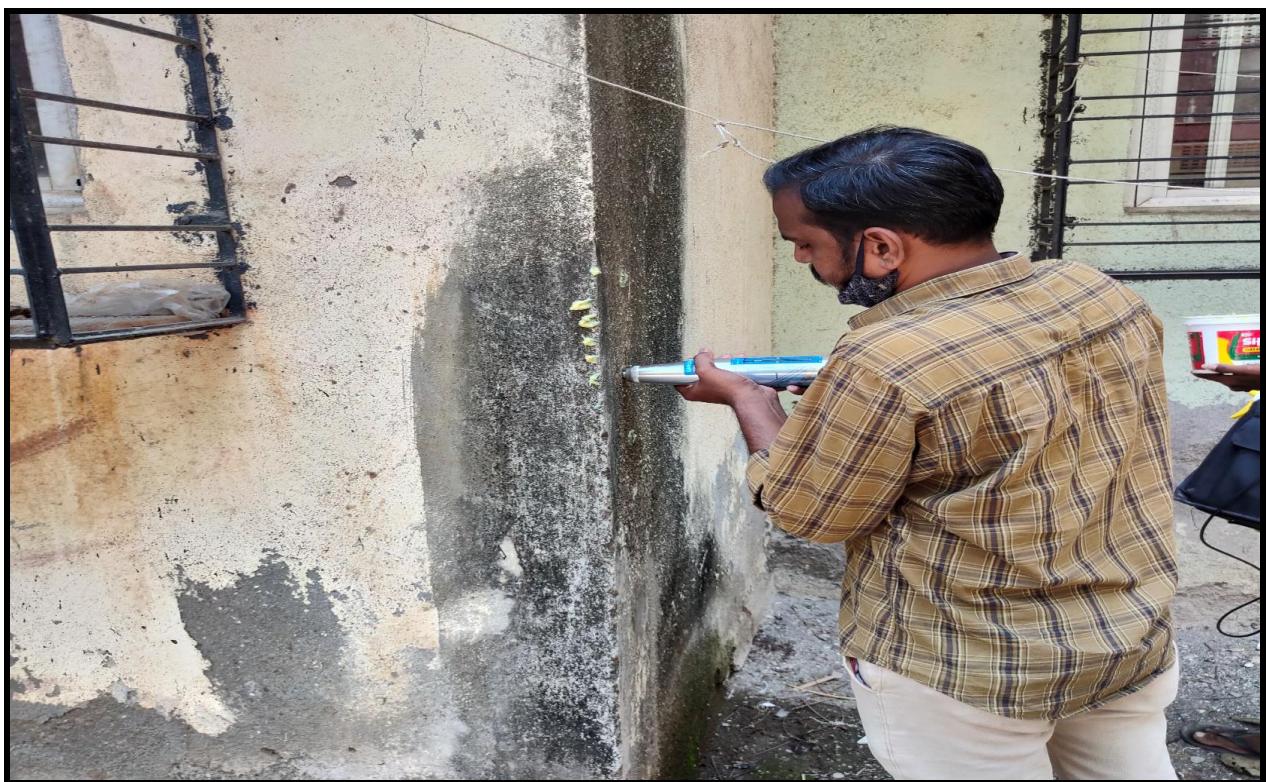
## NON -DESTRUCTIVE TEST PHOTO

Rebound Hammer was tested for compressive strength at surface by Schmidt rebound hammer. Results indicate the compressive strength at surface of the RCC columns & beam in is ranging between 14.90 MPa to 20.30 MPa.

The UPV values are ranging between 2.50 Km/Sec to 3.10 Km/Sec.

Out of 4 locations 2 locations was below 3.0 Km/Sec means concrete quality is poor and 2 location ranging between 3.0 to 3.75 Km/Sec means concrete quality is doubtful.

This indicates there are progressive internal cracks in the RCC members due to corrosion of reinforced steel. These members are under distress condition.

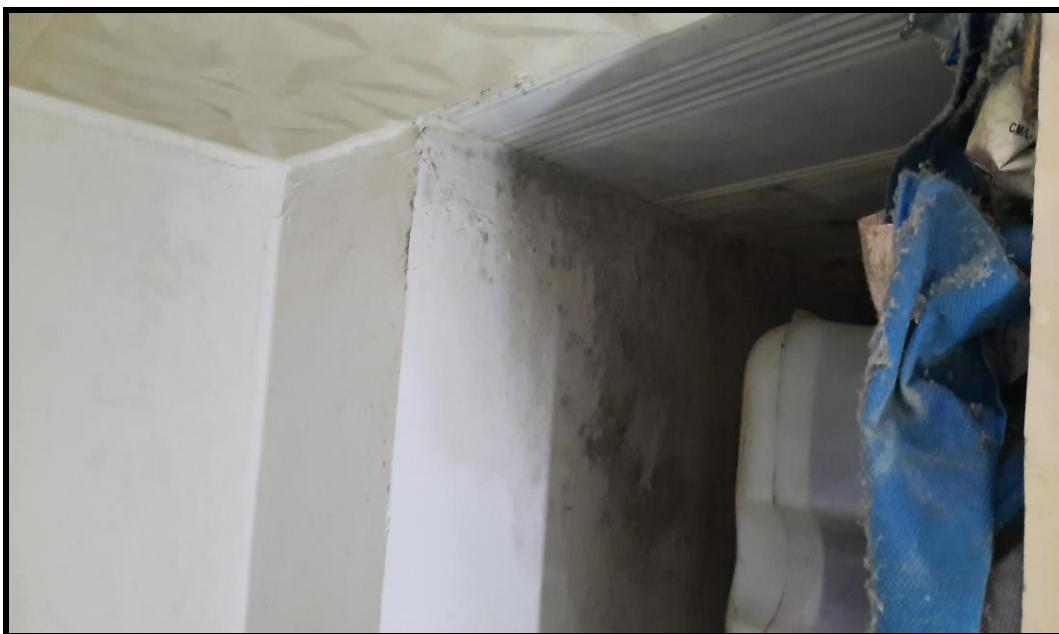
##### **FLAT NO – 01**

- ❖ **HALL** – O.K.
- ❖ **KITCHEN** – O.K.
- ❖ **PASSAGE** – Leakage mark observed on ceiling.
- ❖ **TOILET & BATH ROOM** – O.K.

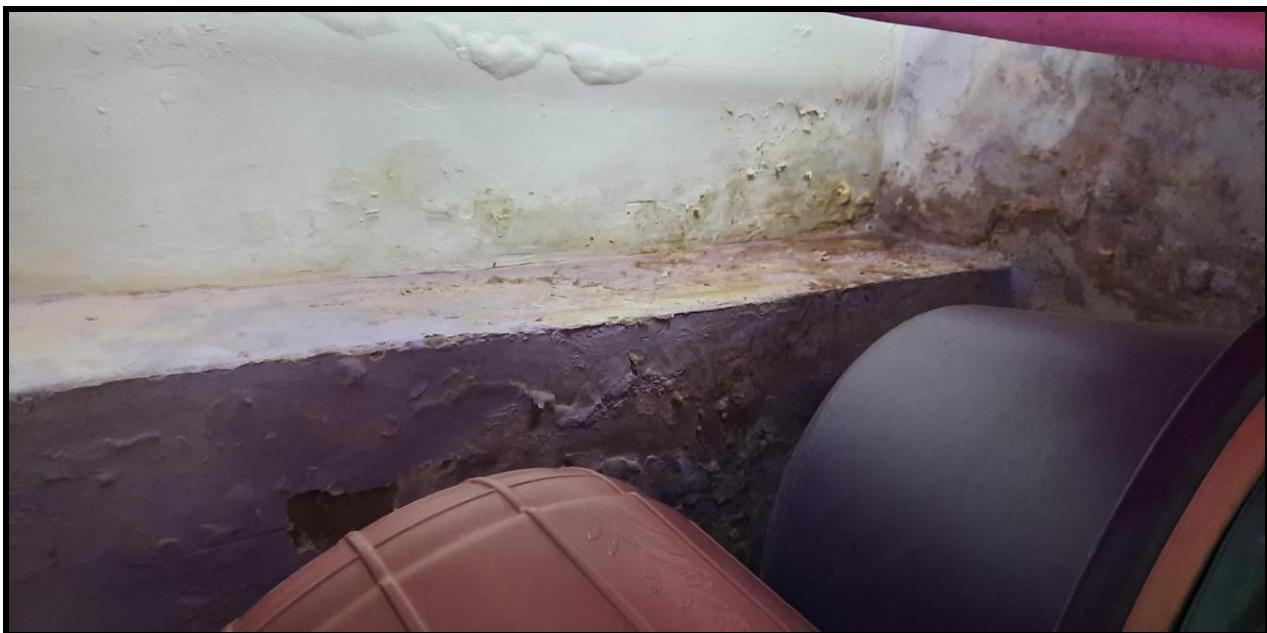
## FLAT NO – 04

- ❖ **HALL** – O.K.
- ❖ **KITCHEN** – O.K.
- ❖ **PASSAGE** – Leakage mark observed on ceiling.
- ❖ **TOILET & BATH ROOM** – O.K.

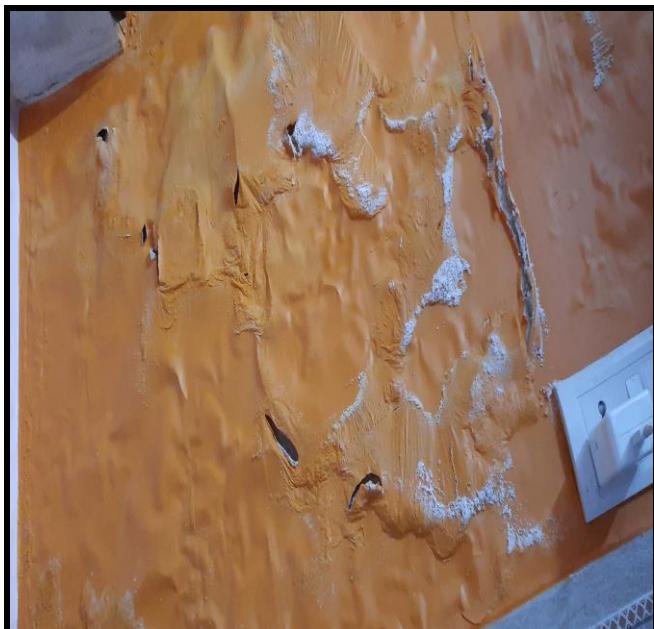
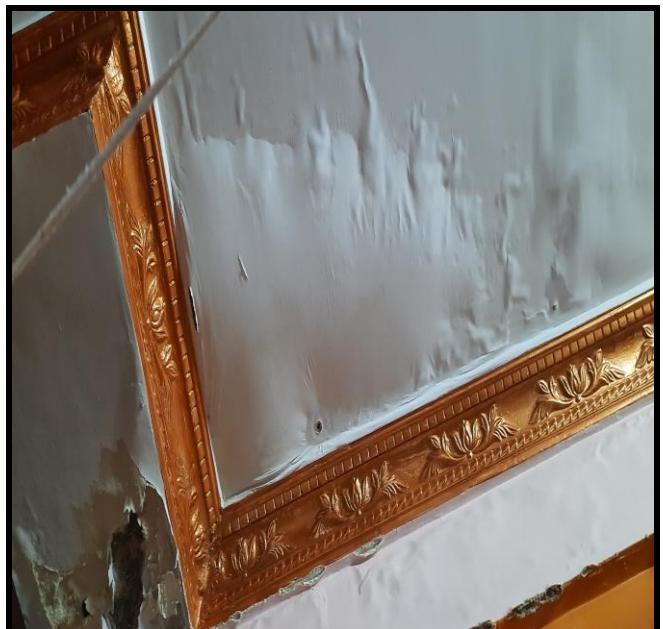
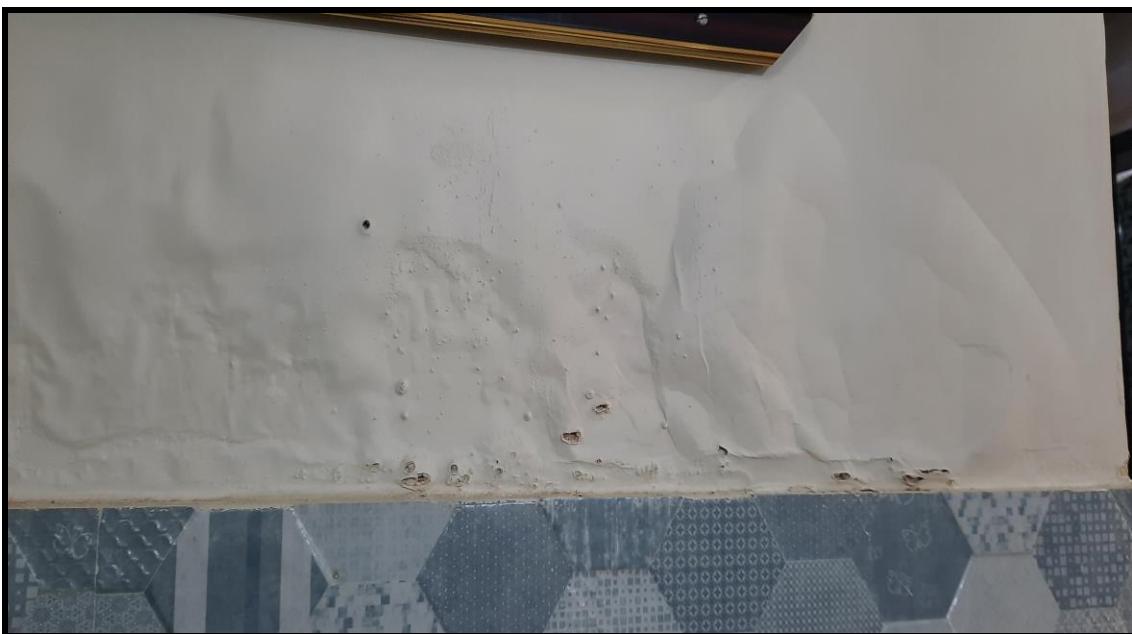
### FLAT NO – 202

- ❖ **HALL** – Seepage observed on wall.
- ❖ **KITCHEN** – Leakage mark observed on wall & ceiling.
- ❖ **PASSAGE** – O.K.
- ❖ **TOILET & BATH ROOM** – O.K.

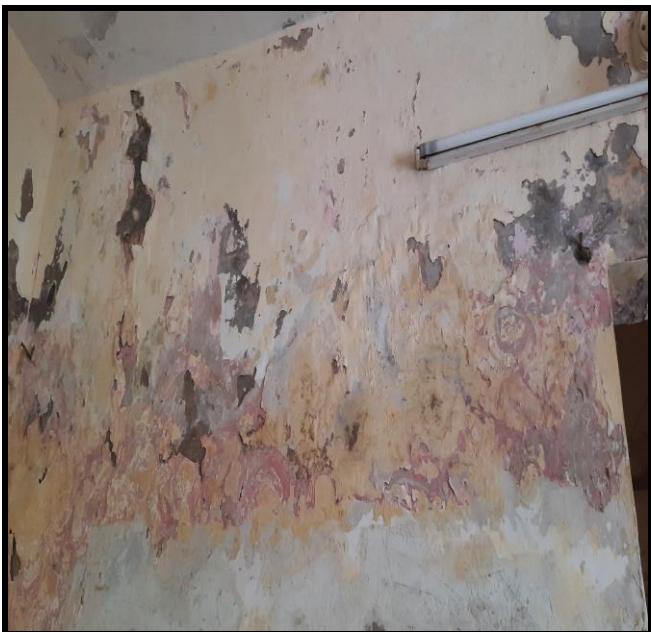
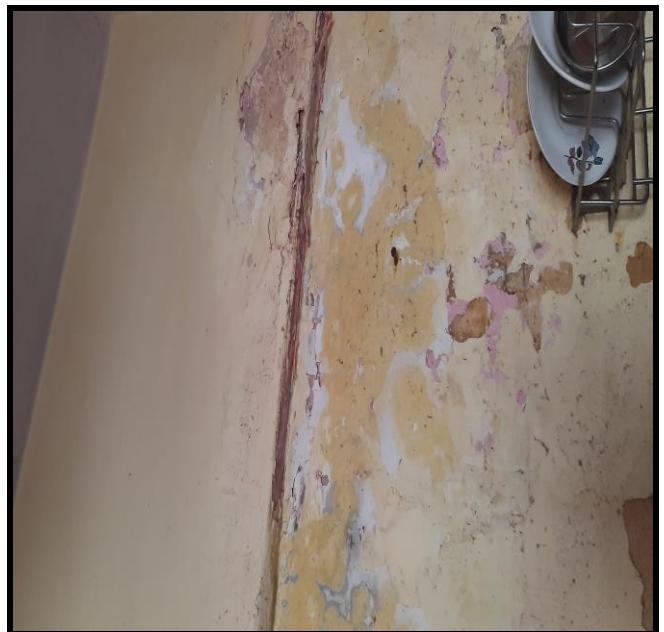
### FLAT NO – 302

- ❖ **HALL** – Leakage mark observed on wall.
- ❖ **KITCHEN** – Leakage mark observed on wall.
- ❖ **PASSAGE** – Leakage mark observed on ceiling.
- ❖ **TOILET & BATH ROOM** – O.K.

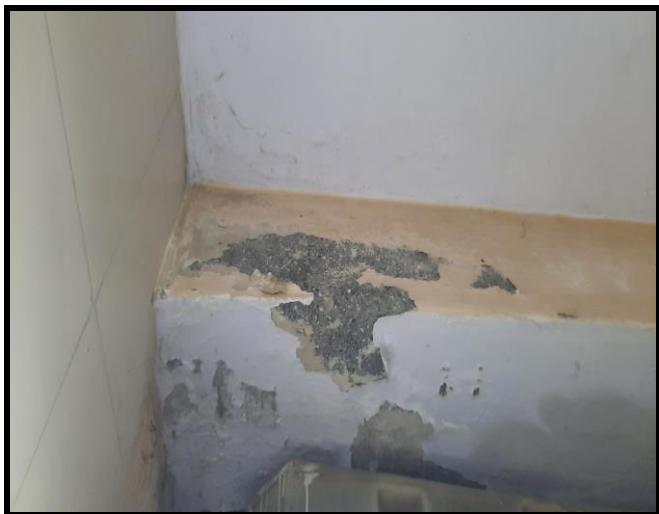
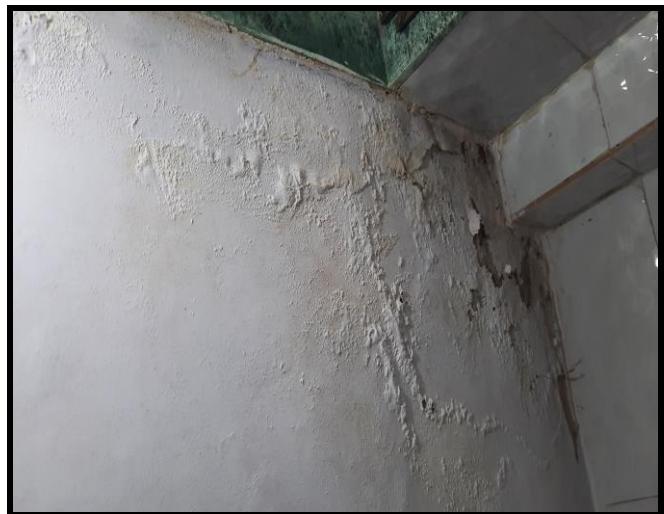
### FLAT NO – 303

- ❖ **HALL** – O.K.
- ❖ **KITCHEN** – O.K.
- ❖ **PASSAGE** – Leakage mark observed on ceiling.
- ❖ **TOILET & BATH ROOM** – Leakage mark observed on ceiling.

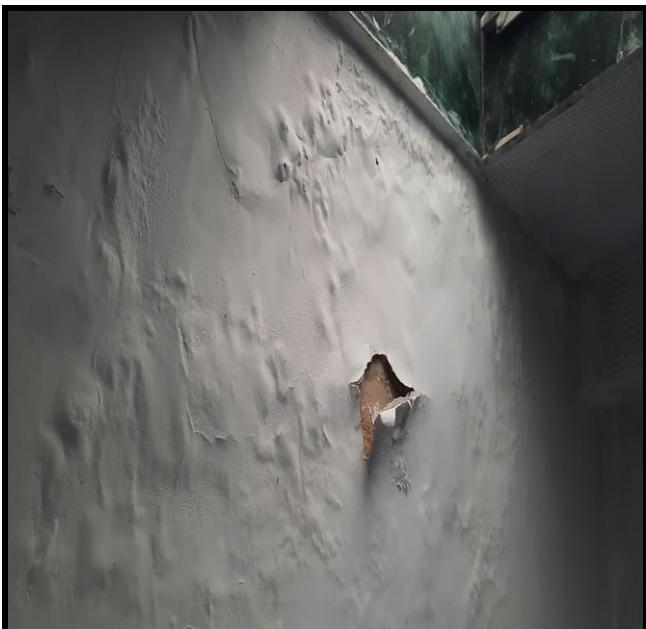
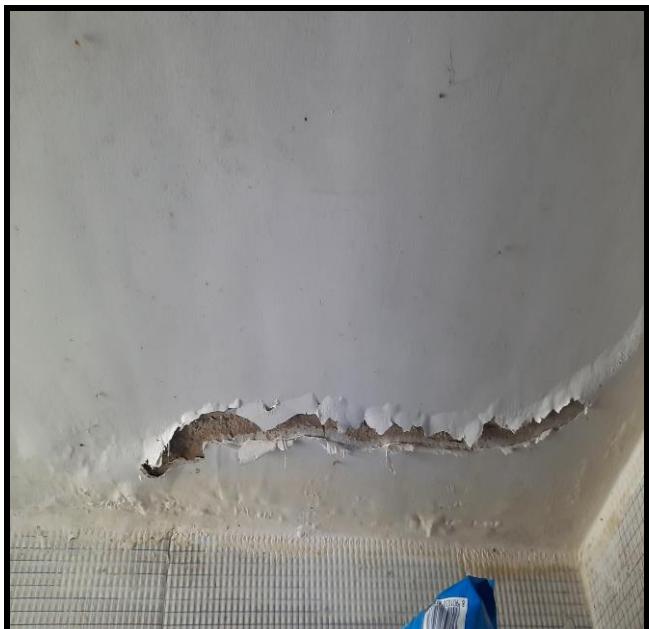
### FLAT NO – 503

- ❖ **HALL** – O.K.
- ❖ **KITCHEN** – O.K.
- ❖ **PASSAGE** – Leakage mark observed on ceiling.
- ❖ **TOILET & BATH ROOM** – Leakage mark observed on ceiling.

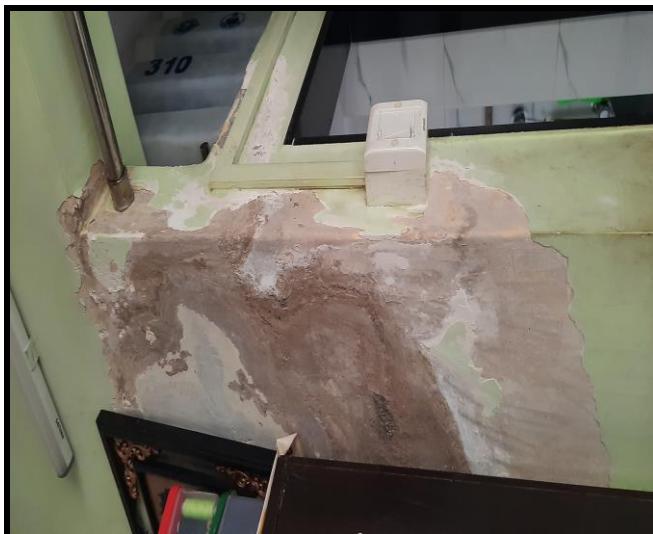
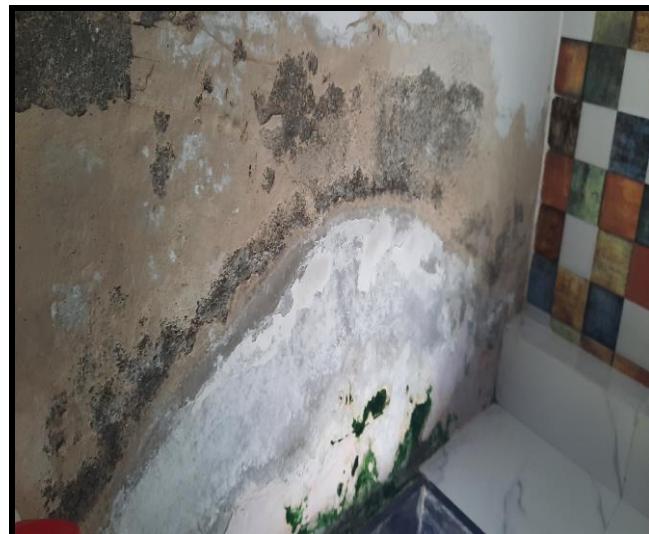
### FLAT NO – 504

- ❖ **HALL** – Leakage mark observed on wall.
- ❖ **KITCHEN** – O.K.
- ❖ **PASSAGE** – O.K.
- ❖ **TOILET & BATH ROOM** – Leakage mark observed on ceiling.

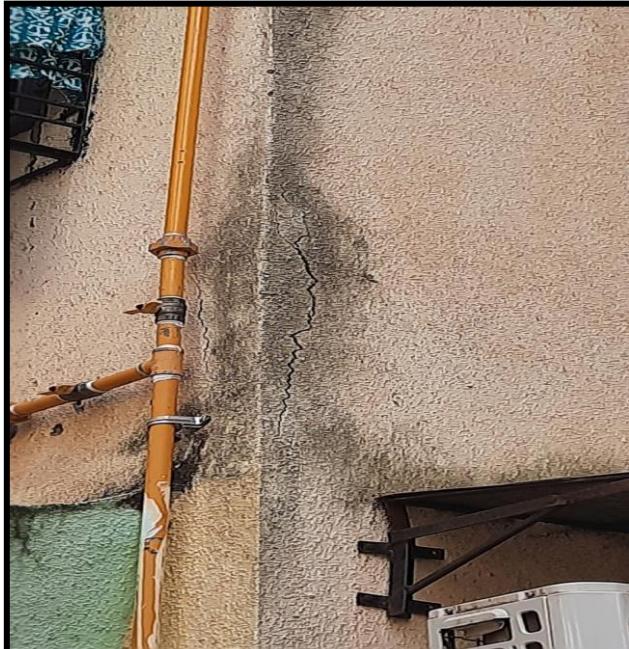
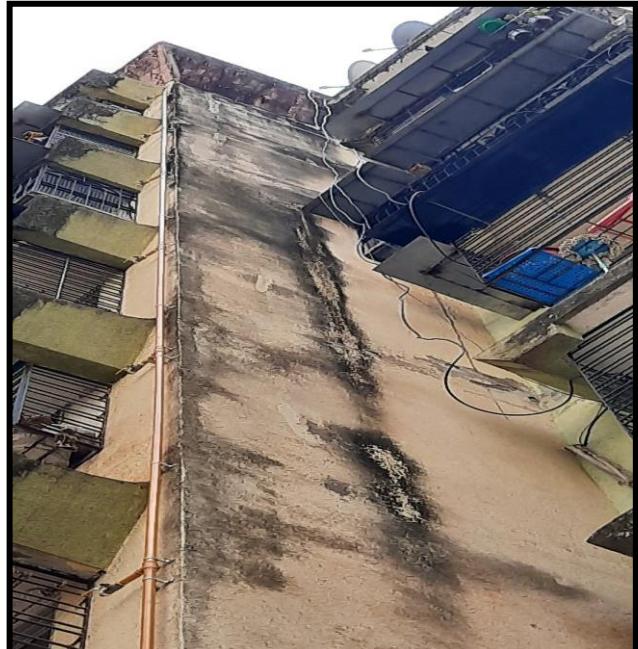
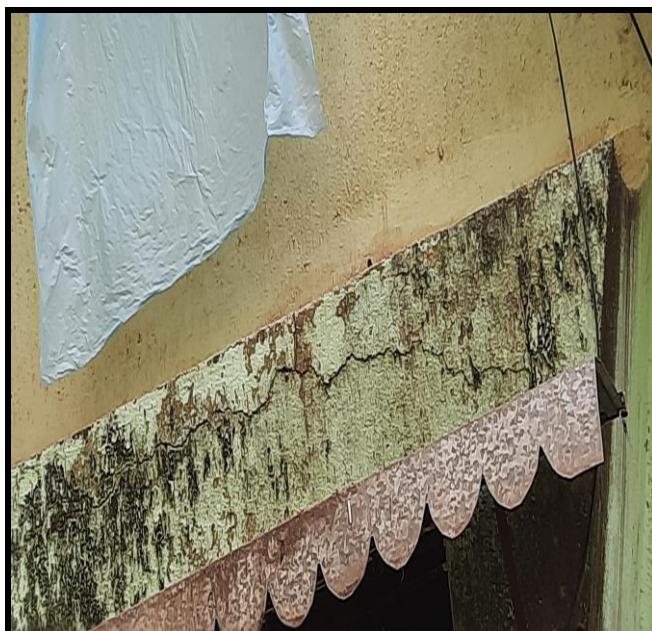
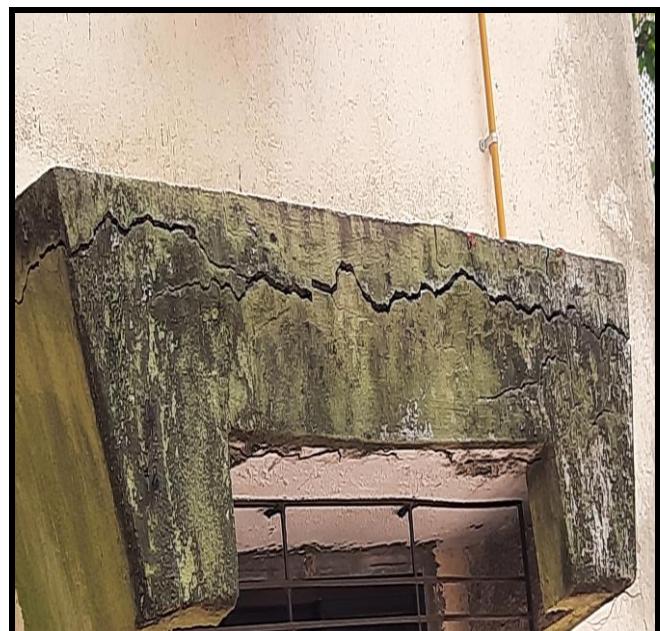
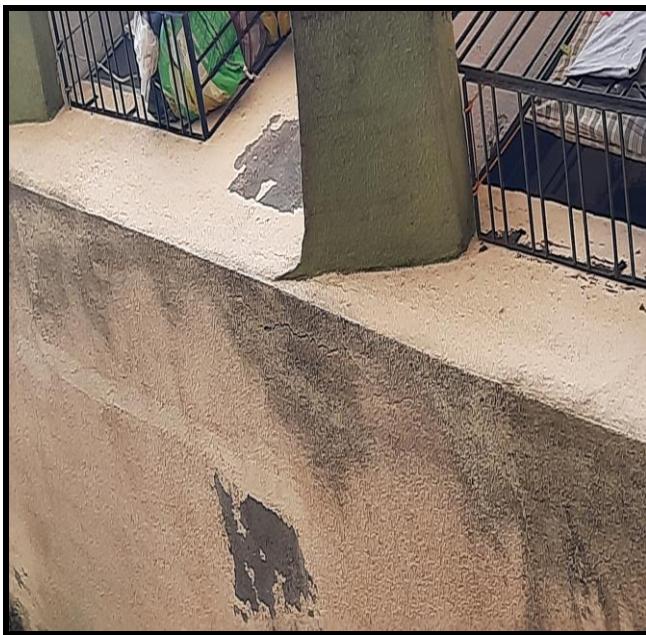
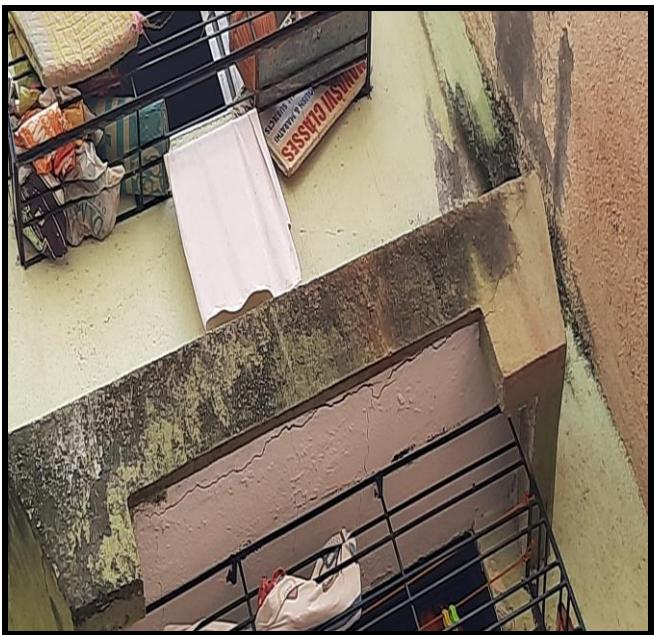
### FRONT SIDE

- ❖ Structural crack observed at several places on column.
- ❖ Major crack observed at several places on wall.
- ❖ Vegetation growth observed at several places on wall.

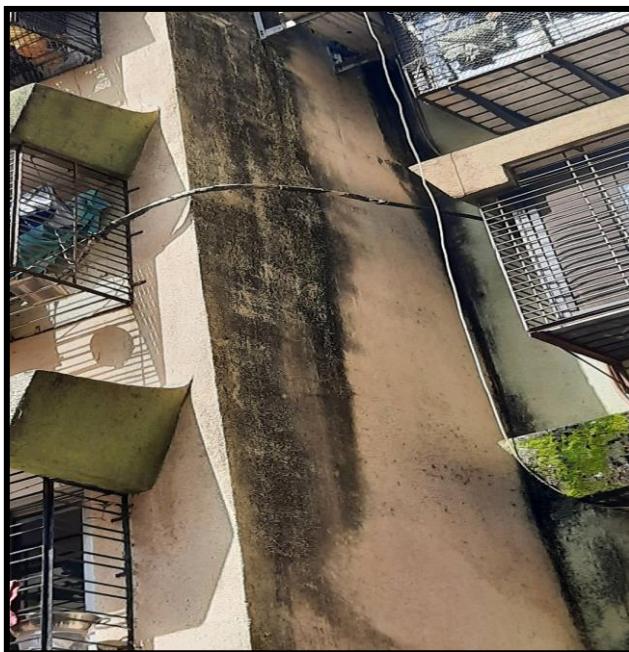
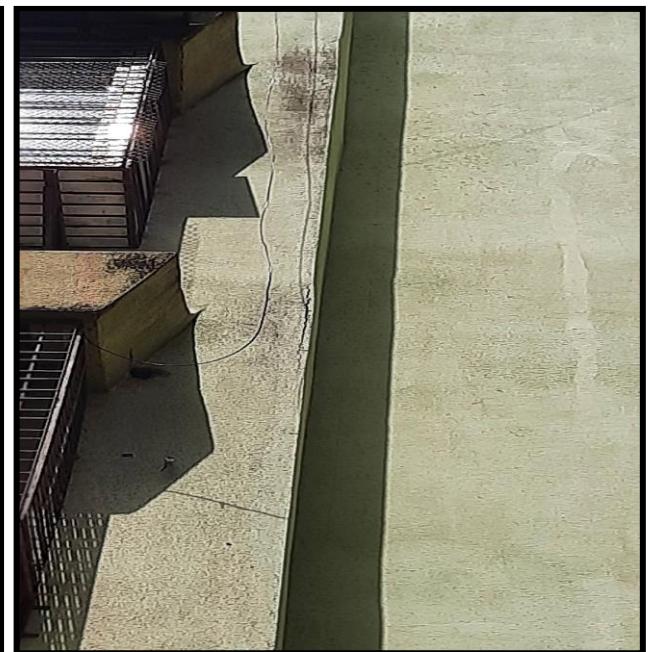
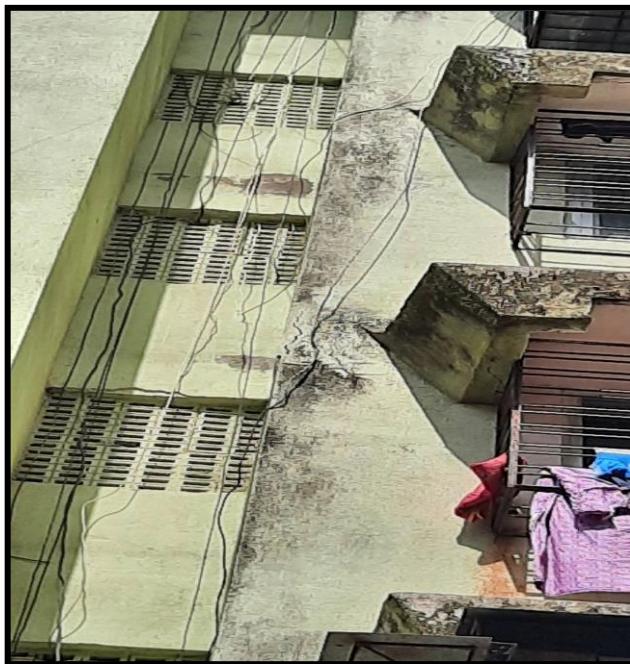
## BACK SIDE

- ❖ Structural crack observed at several places on column & chajjas.
- ❖ Major crack observed at several places on wall.
- ❖ Vegetation growth observed at several places on wall.

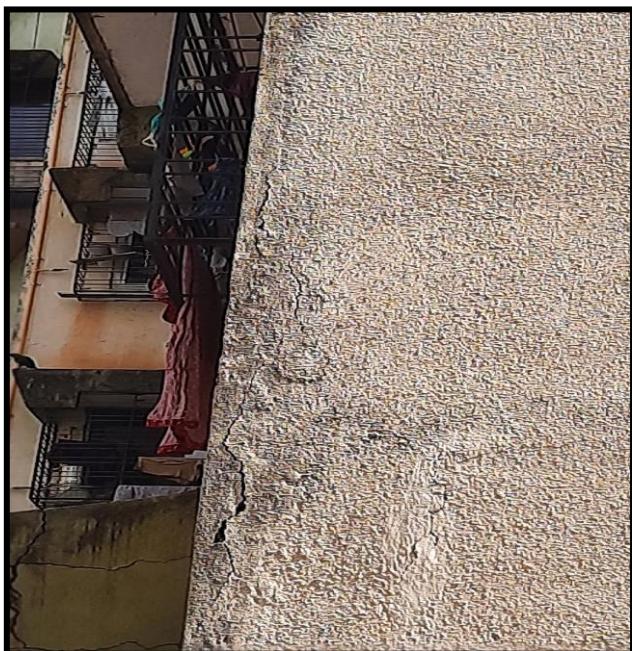
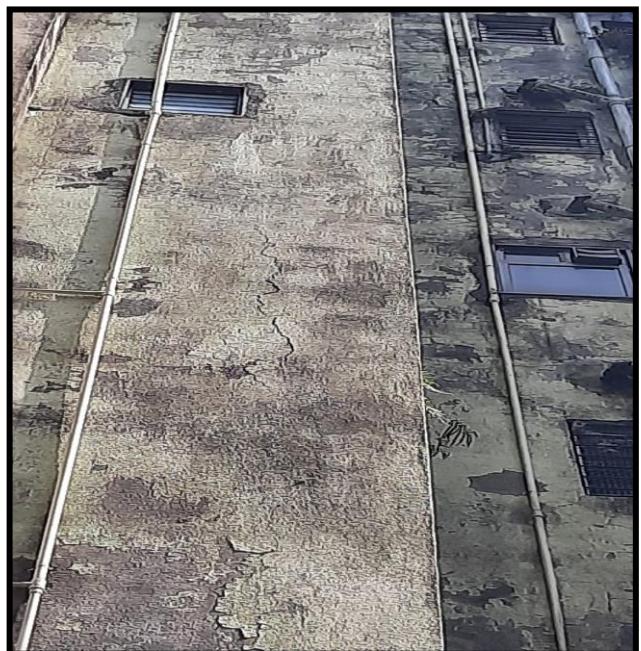
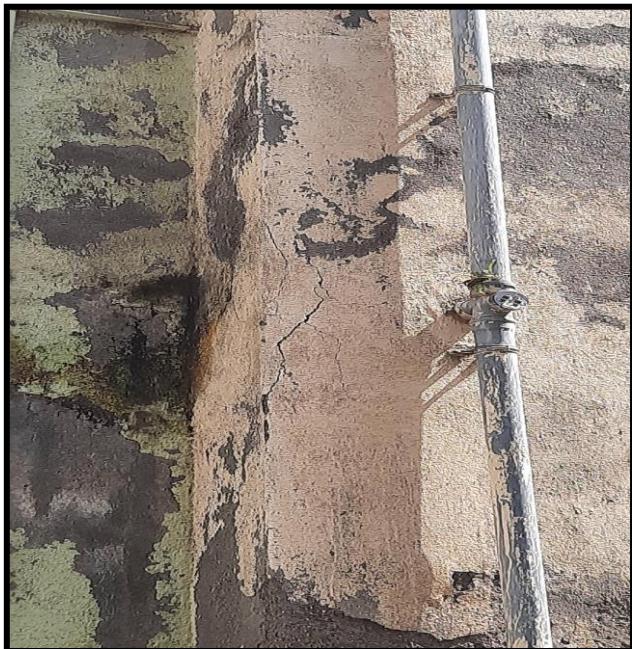
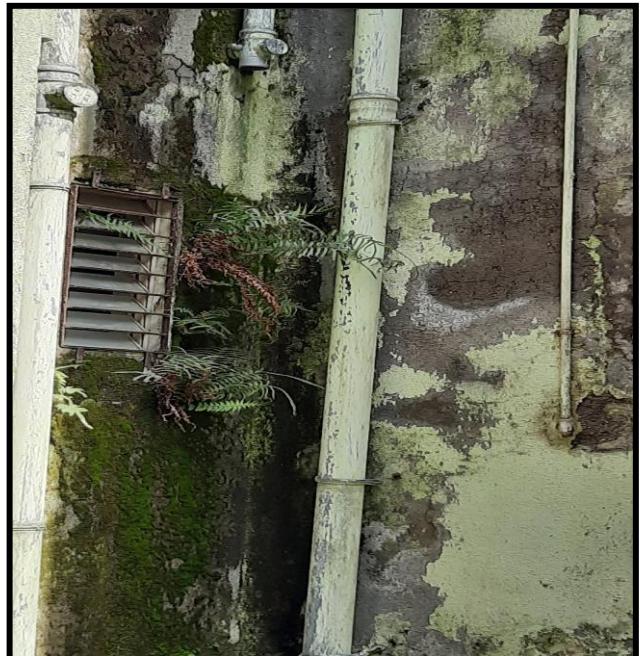
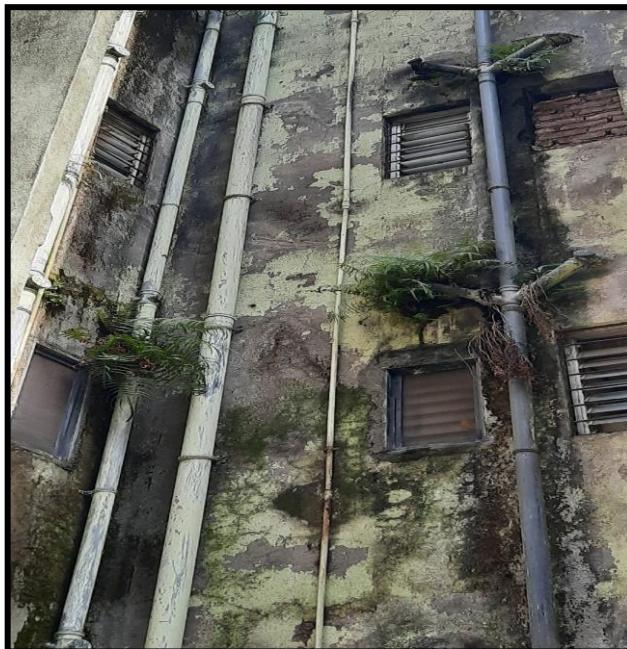
## NORTH SIDE

- ❖ Structural crack observed at several places on column.
- ❖ Major crack observed at several places on wall.

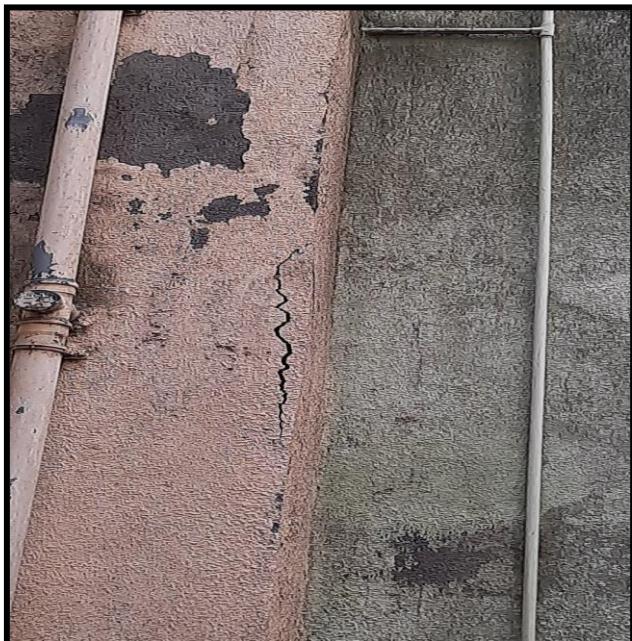
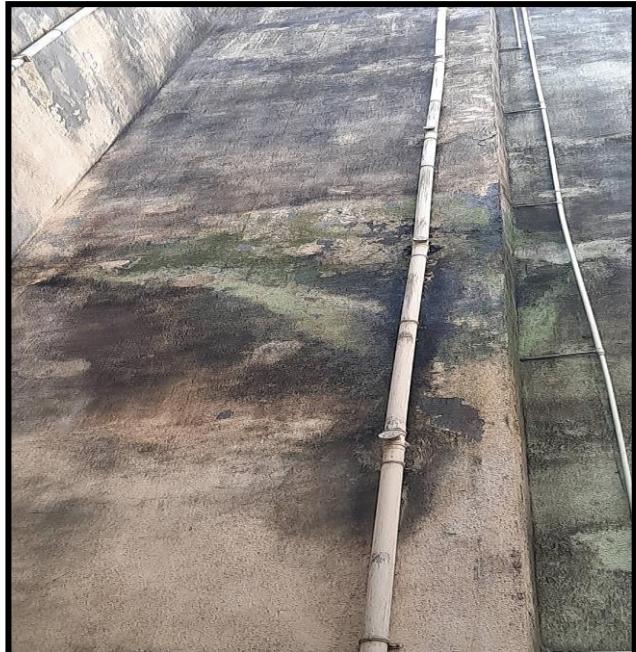
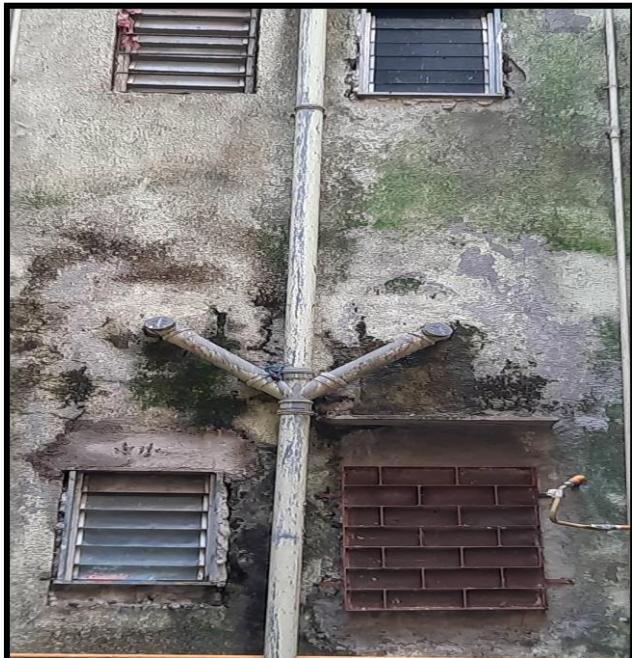
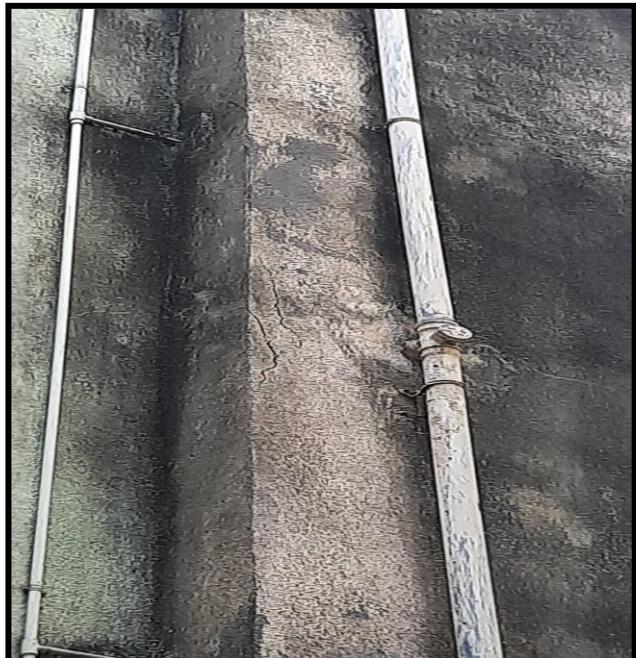
## SOUTH SIDE

- ❖ Structural crack observed at several places on column & chajjas.
- ❖ Major crack observed at several places on wall.
- ❖ Vegetation growth observed at several places on wall.
