STRUCTURAL AUDIT REPORT  
FOR  
**“VISHAL SAHYADRI CO – OP HSG. SOC. LTD”,**  
**“D3 – D WING”**  
SITUATED AT  
SAHYADRI NAGAR, CHARKOP,  
KANDIVALI (W) MUMBAI – 400 067

PREPARED BY  
**LATESH S. SANKLECHA**  
CONSULTING STRUCTURAL ENGINEERS

978/D3/LSS/2021

JULY 16, 2021

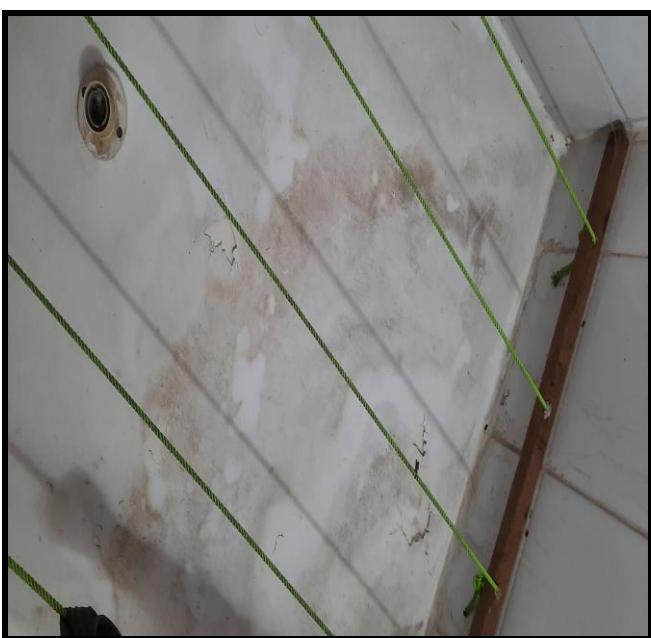
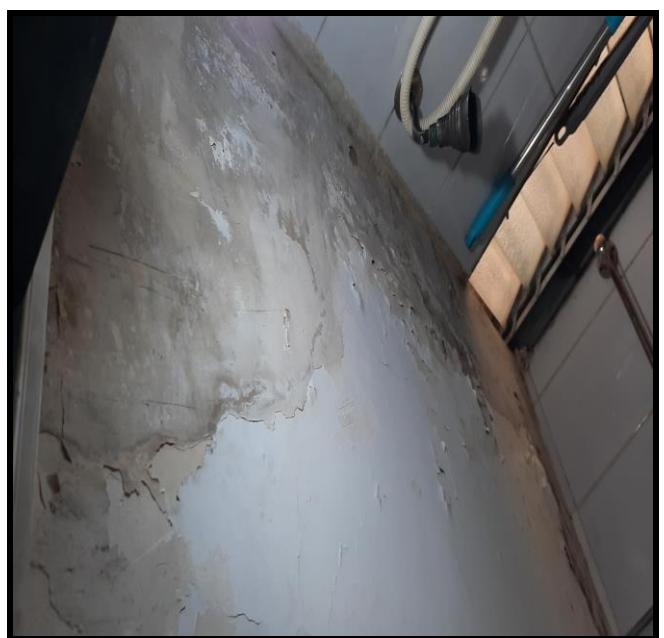
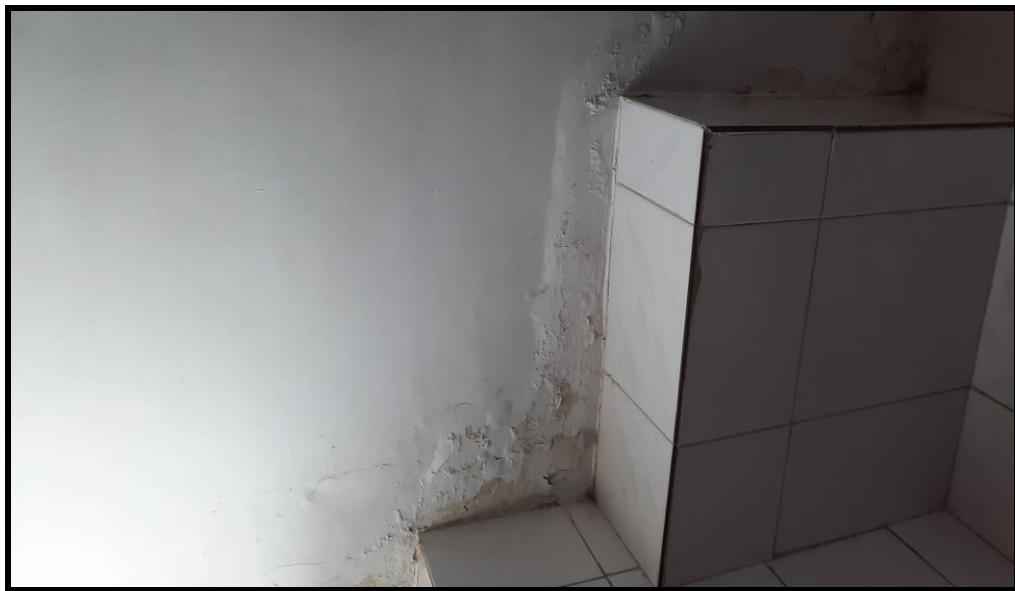
##### FLAT NO – 02

- ❖ **HALL** – Dampness observed on wall in monsoon.
- ❖ **KITCHEN** – Leakage observed on wall & ceiling in monsoon.
- ❖ **PASSAGE** – Leakage mark observed on ceiling.
- ❖ **TOILET & BATH ROOM** – Leakage mark observed on ceiling.

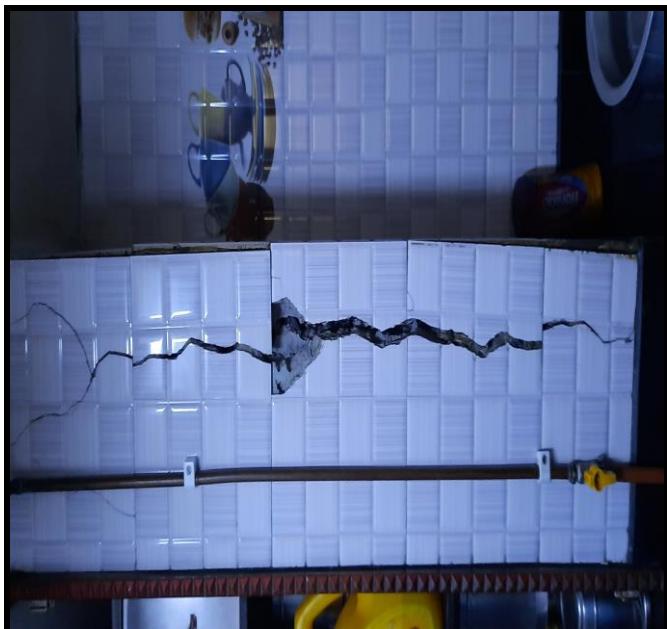
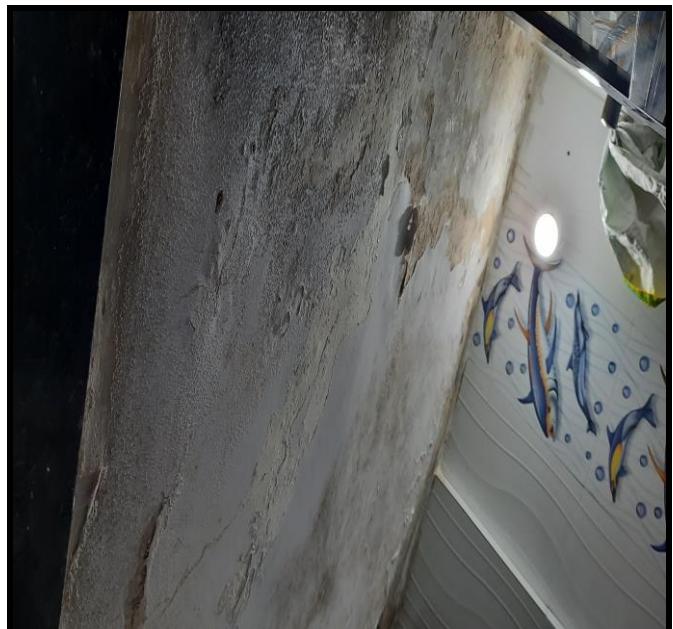
### FLAT NO – 05

- ❖ **HALL** – O.K.
- ❖ **KITCHEN** – Structural crack observed on column.
- ❖ **PASSAGE** – O.K.
- ❖ **TOILET & BATH ROOM** – Leakage mark observed on ceiling.

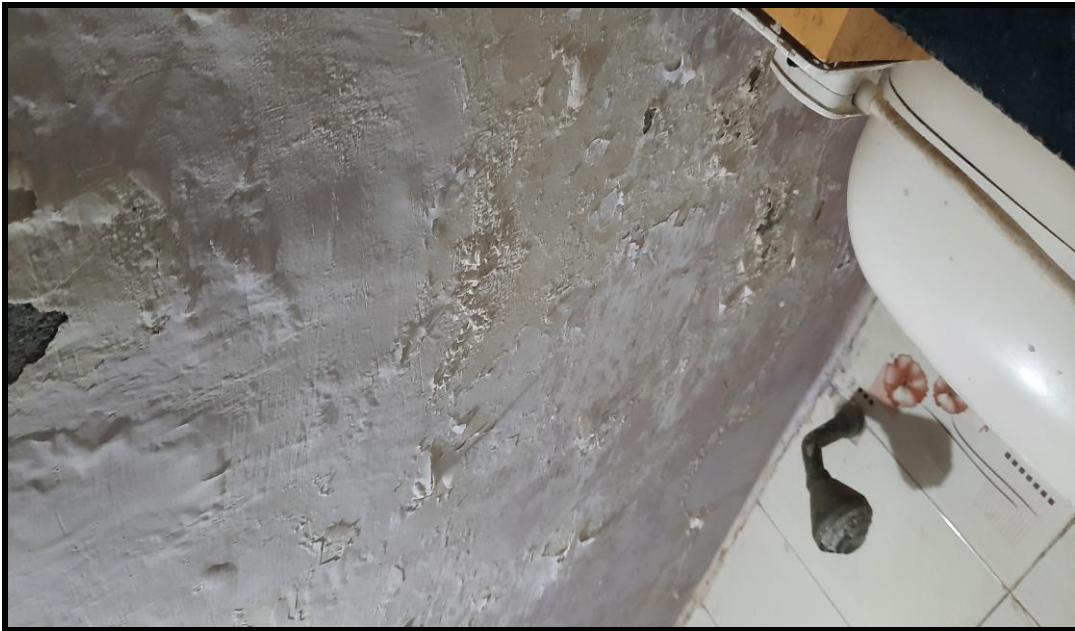
### FLAT NO – 14

- ❖ **HALL** – O.K.
- ❖ **KITCHEN** – O.K.
- ❖ **PASSAGE** – O.K.
- ❖ **TOILET & BATH ROOM** – Leakage mark observed on ceiling.

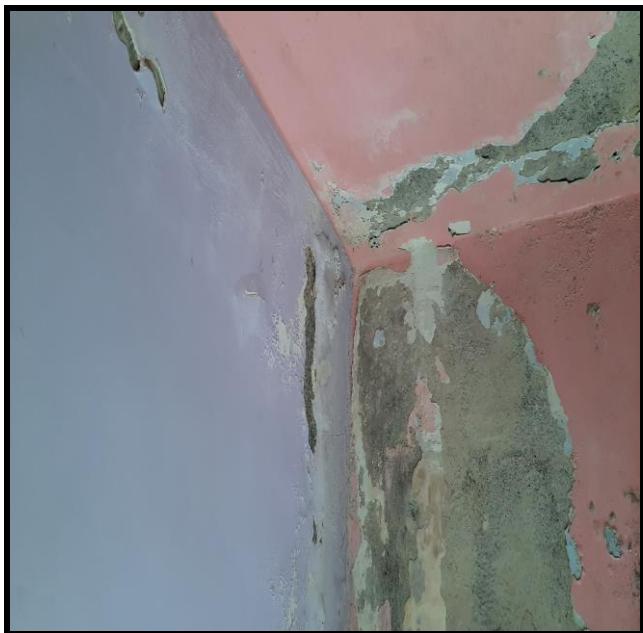
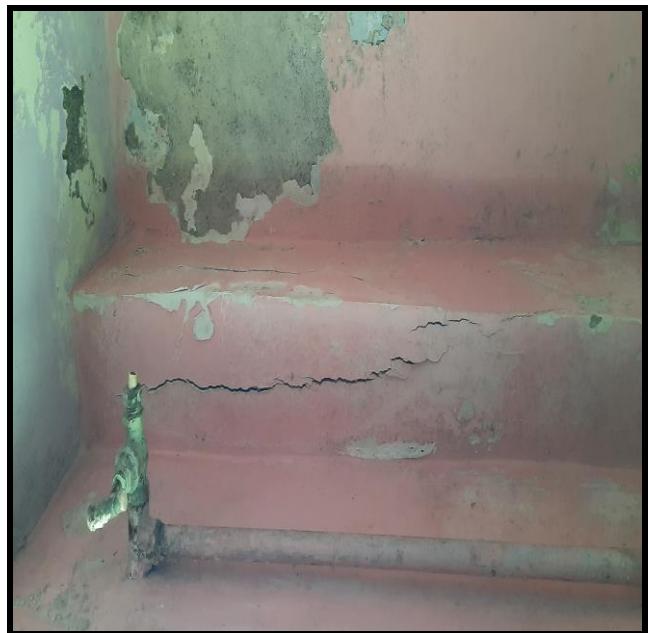
## FLAT NO – 16

- ❖ **HALL** – O.K.
- ❖ **KITCHEN** – Leakage observed on ceiling in monsoon.
- ❖ **PASSAGE** – O.K.
- ❖ **TOILET & BATH ROOM** – Structural crack observed on column.
  - Leakage mark observed on wall.

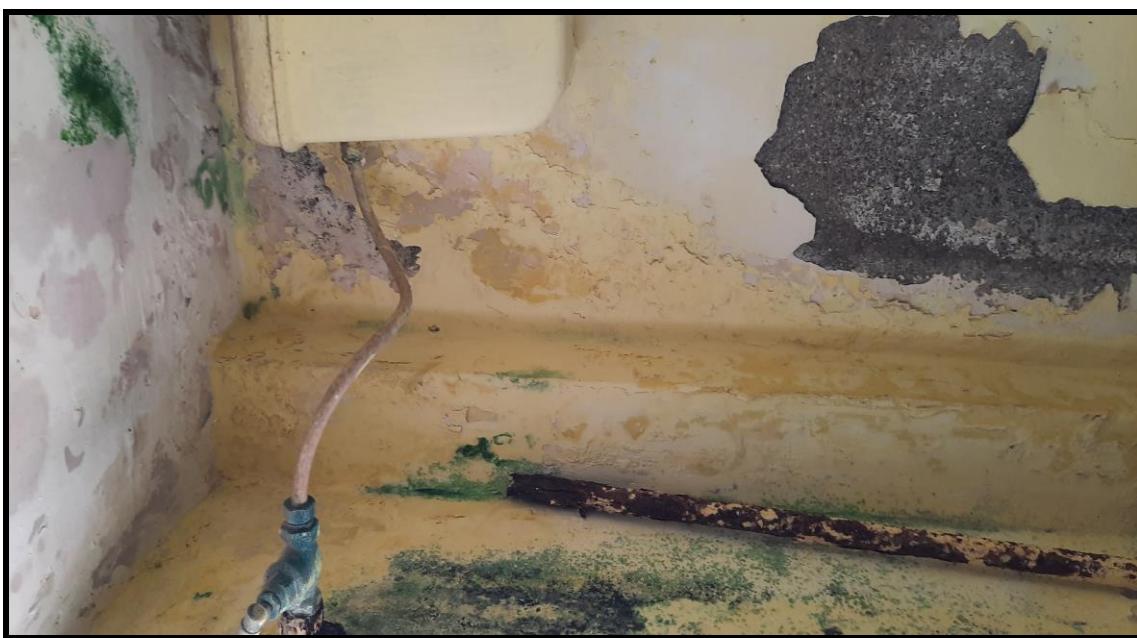
### FLAT NO - 20

- ❖ **HALL** – O.K.
- ❖ **KITCHEN** – O.K.
- ❖ **PASSAGE** – O.K.
- ❖ **TOILET & BATH ROOM** – Leakage mark observed on wall.

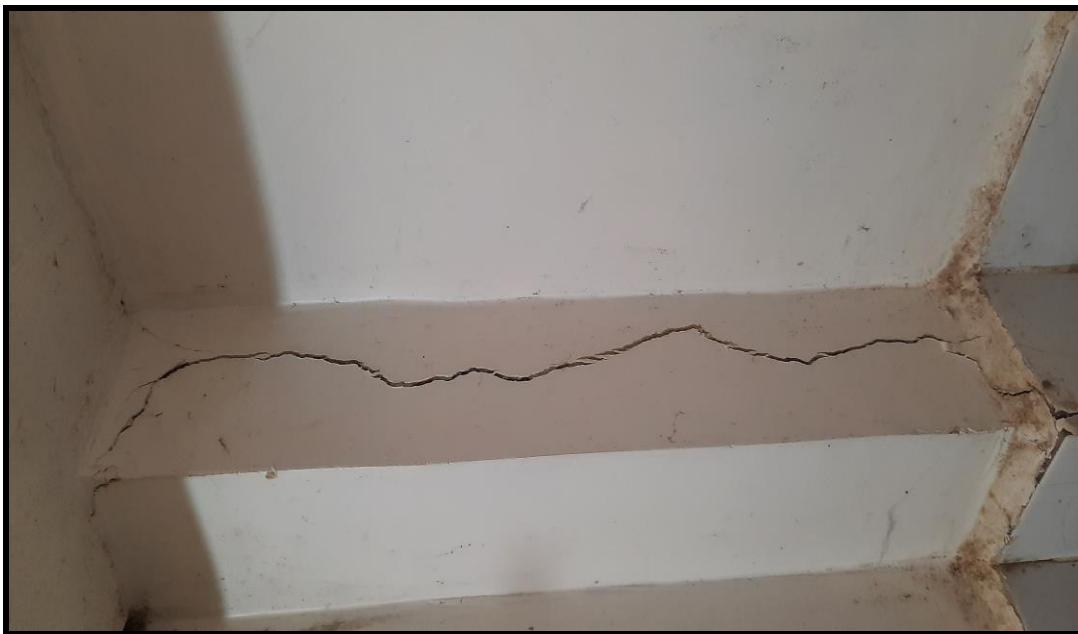
### FLAT NO - 22

- ❖ **HALL** – O.K.
- ❖ **KITCHEN** – O.K.
- ❖ **PASSAGE** – O.K.
- ❖ **TOILET & BATH ROOM** – Structural crack observed on column.

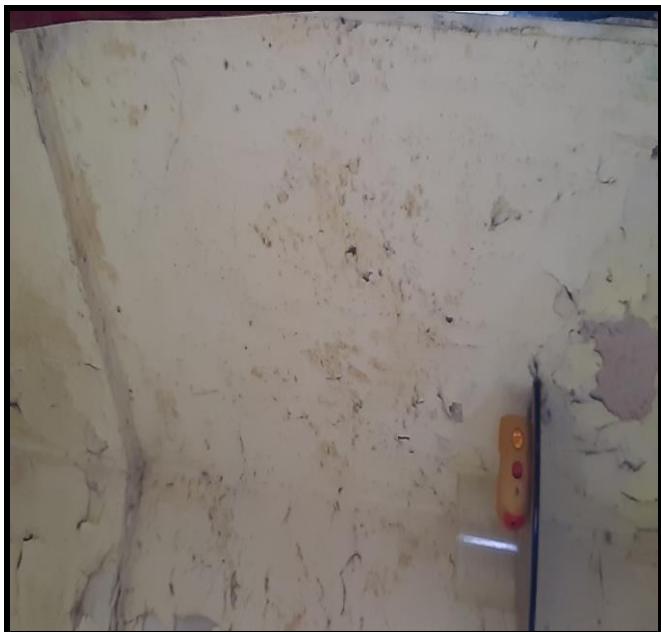
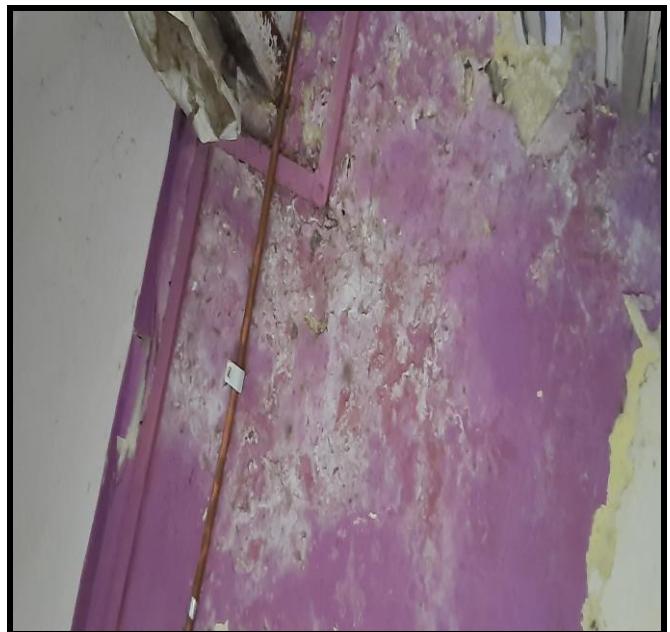
### FLAT NO – 27

- ❖ **HALL** – Leakage mark observed on wall.
- ❖ **KITCHEN** – Leakage mark observed on wall.
- ❖ **PASSAGE** – O.K.
- ❖ **TOILET & BATH ROOM** – O.K.

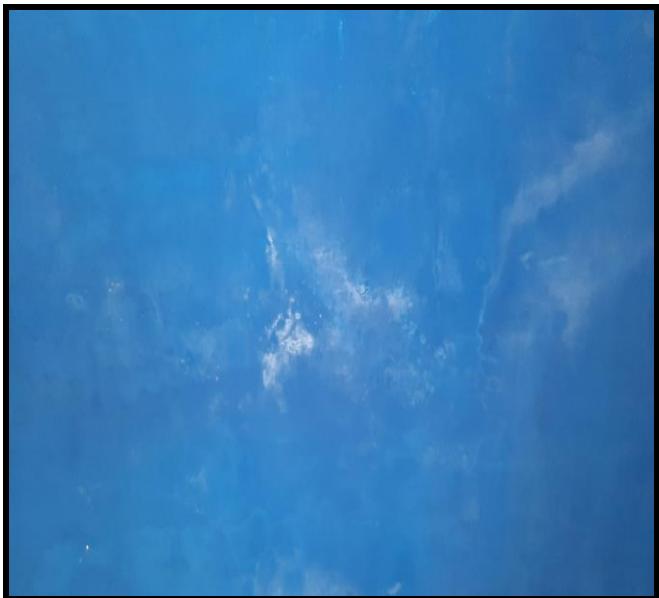
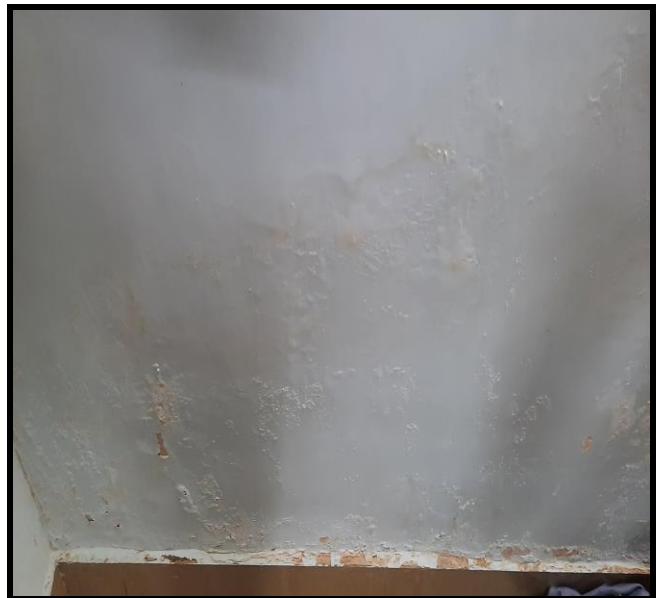
### FLAT NO – 29

- ❖ **HALL** – Leakage observed on wall in monsoon.
- ❖ **KITCHEN** – Leakage mark observed on wall.
- ❖ **PASSAGE** – O.K.
- ❖ **TOILET & BATH ROOM** – O.K.

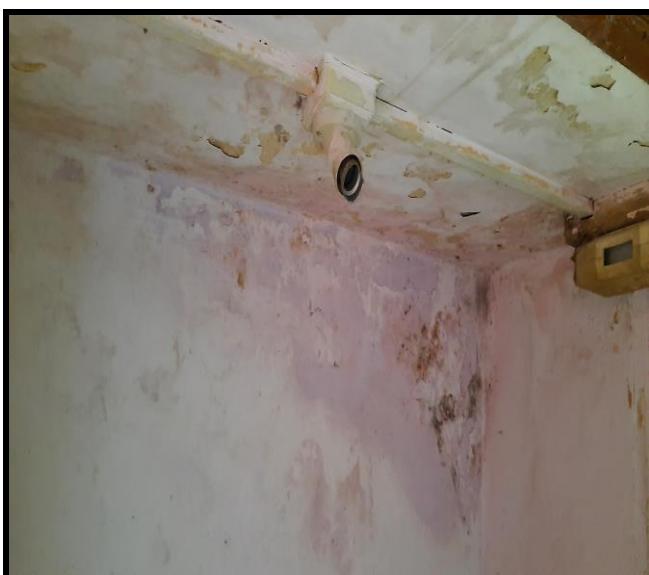
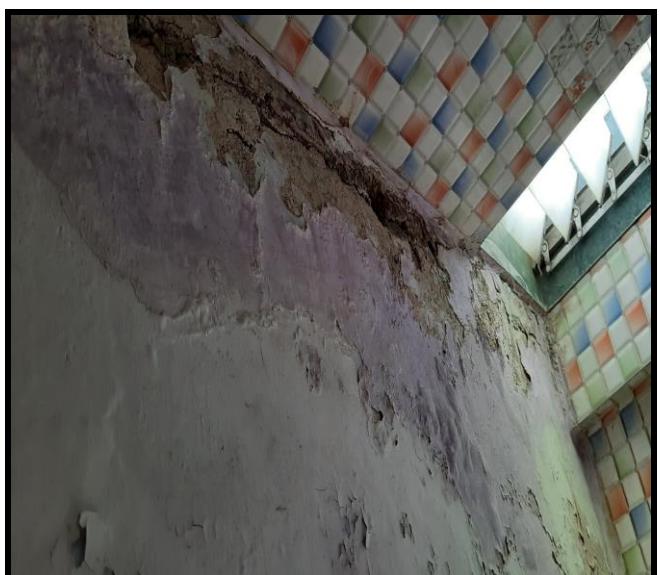
### FLAT NO – 32

- ❖ **HALL** – O.K.
- ❖ **KITCHEN** – Leakage observed on wall in monsoon.
- ❖ **PASSAGE** – Dampness observed on ceiling.
- ❖ **TOILET & BATH ROOM** – Leakage mark observed on ceiling.

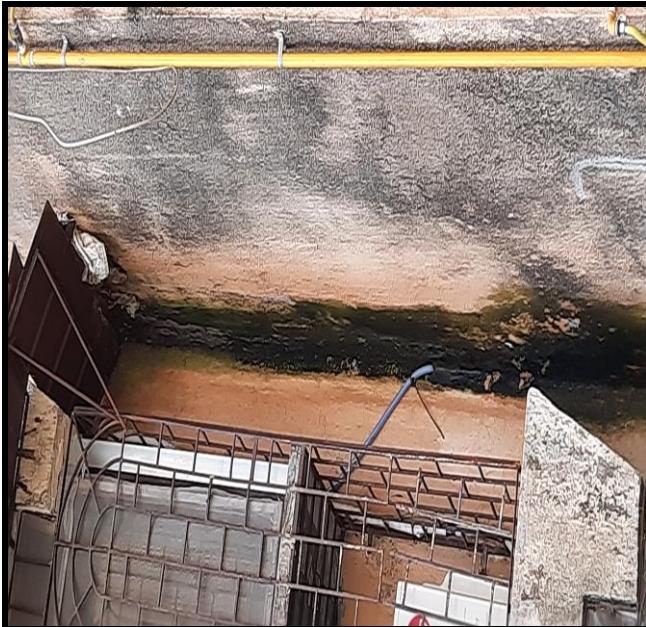
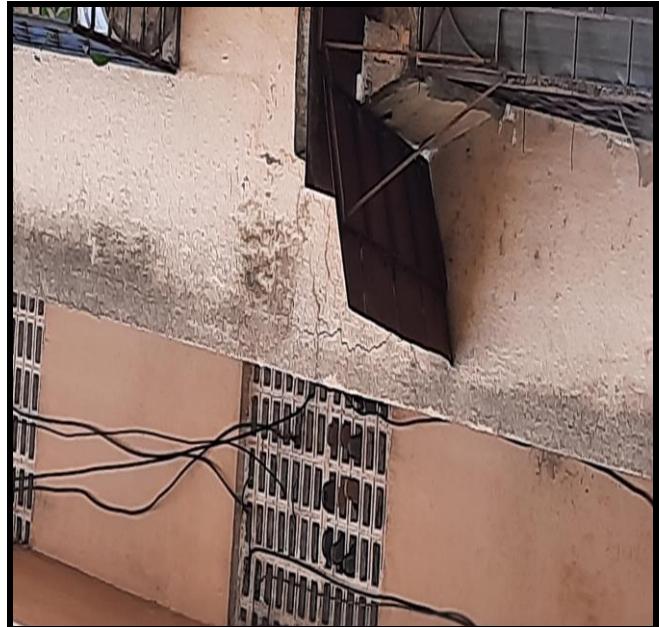
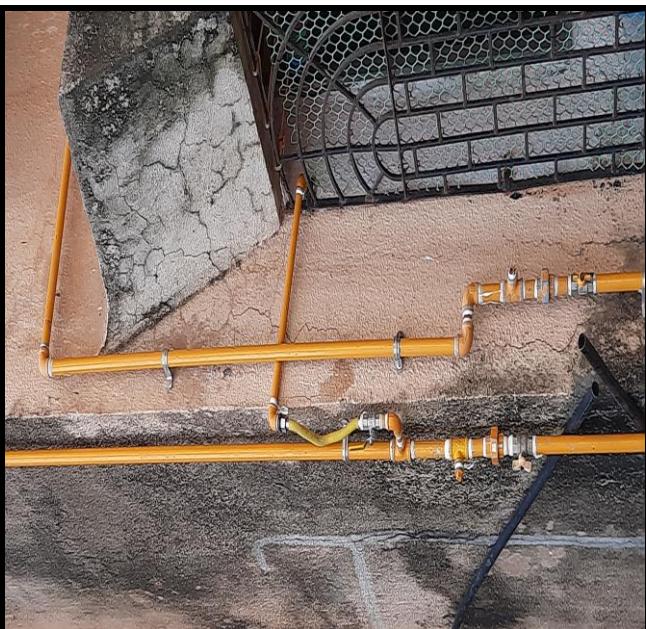
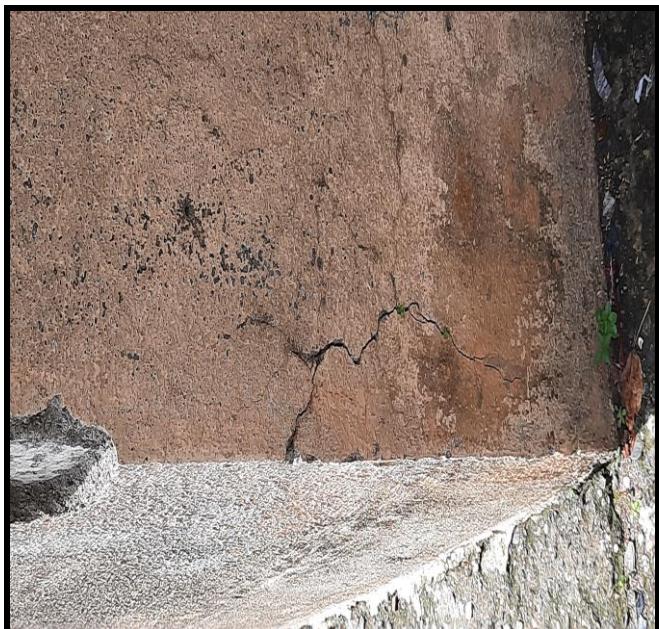
### FRONT SIDE

- ❖ Structural crack observed at several places on column & chajjas.
- ❖ Algae observed at several places on wall.

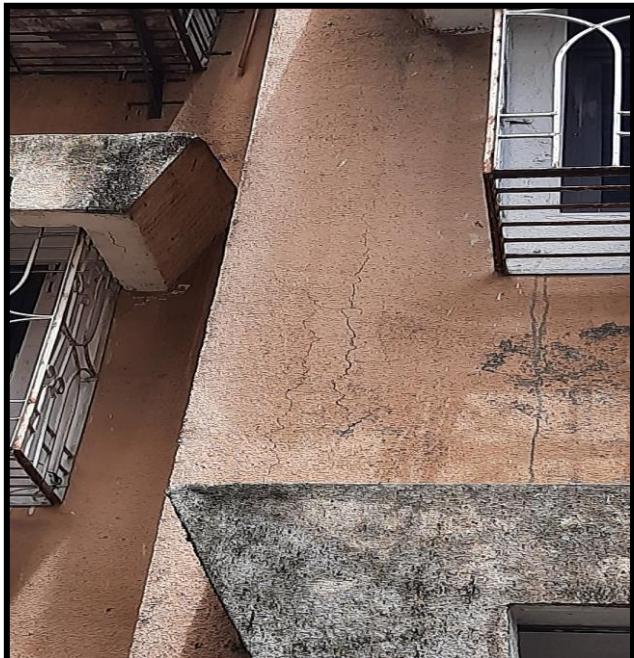
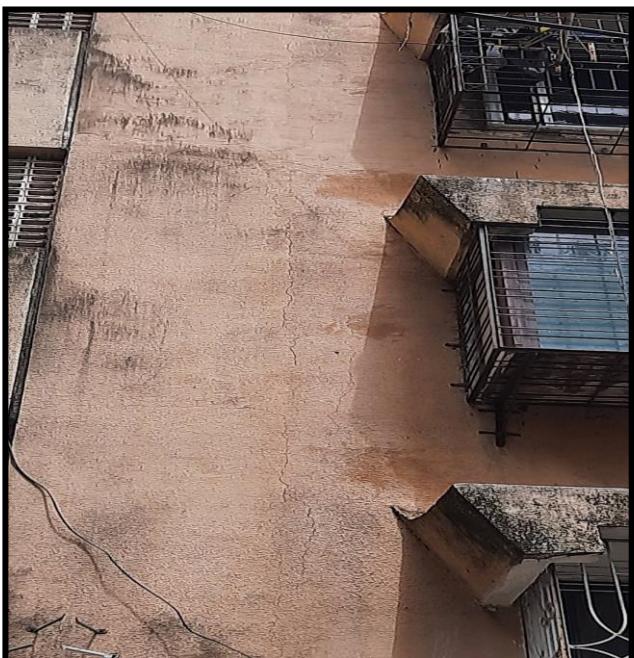
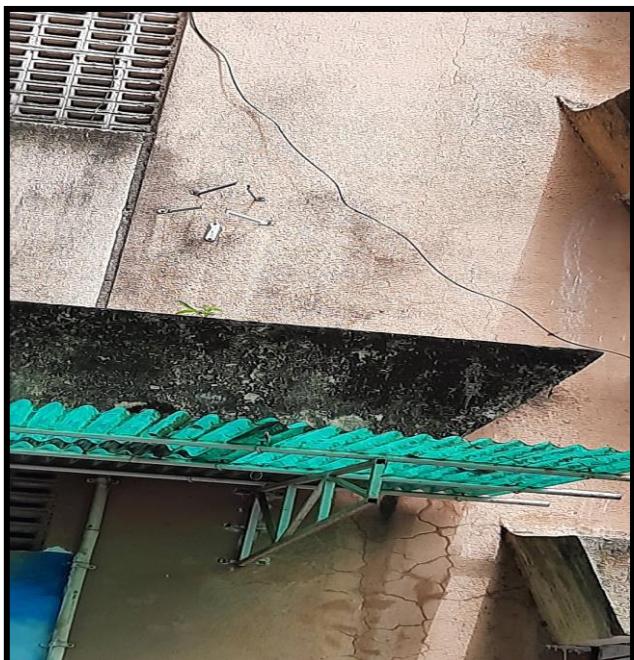
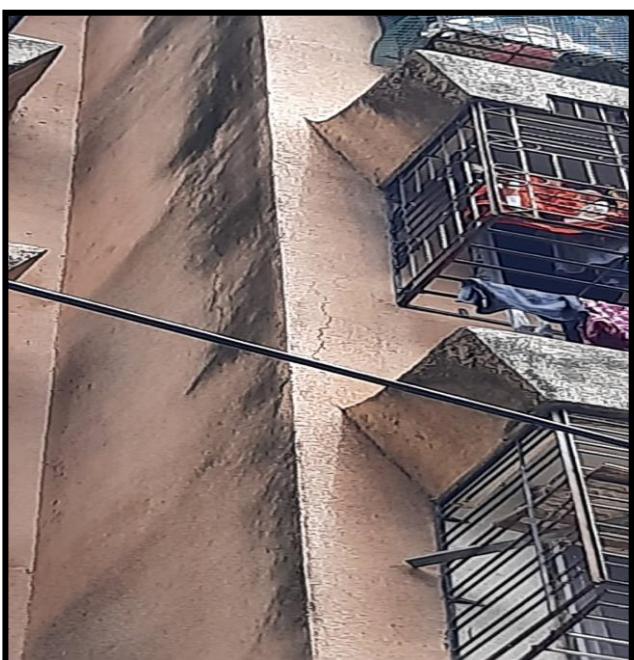
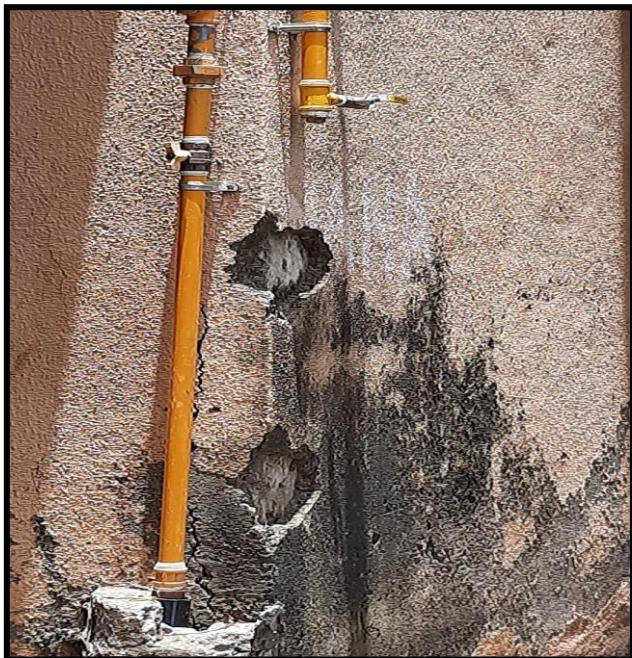
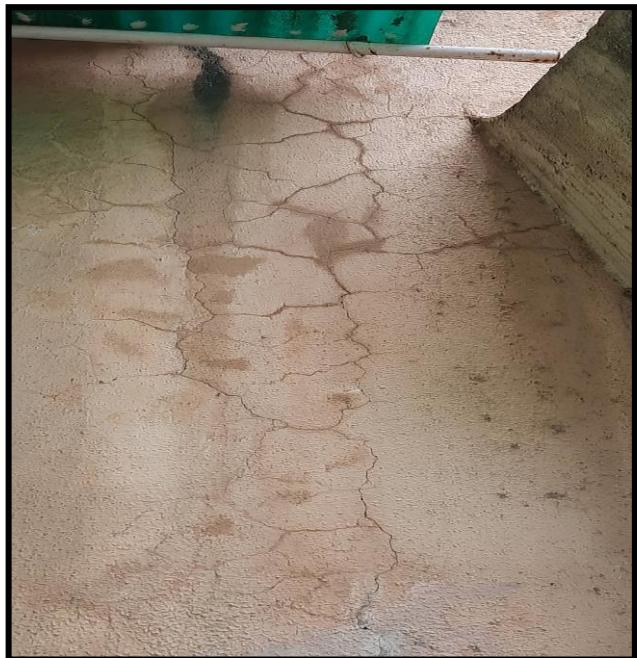
## BACK SIDE

- ❖ Structural crack observed at several places on column & chajjas.
- ❖ Algae observed at several places on wall.

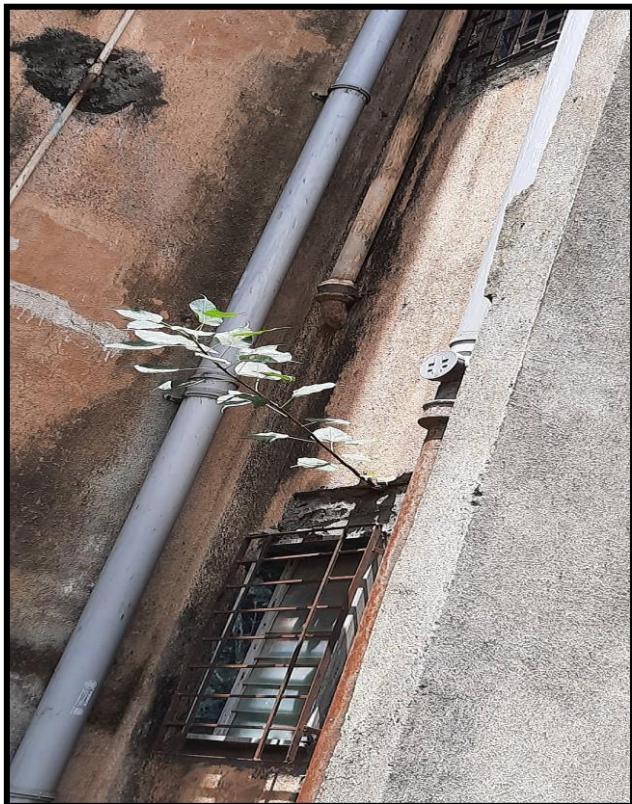
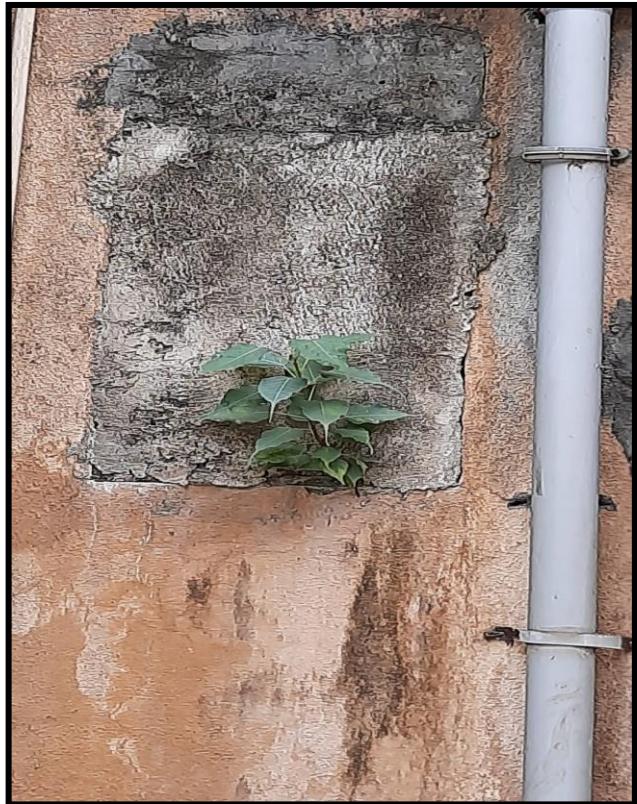
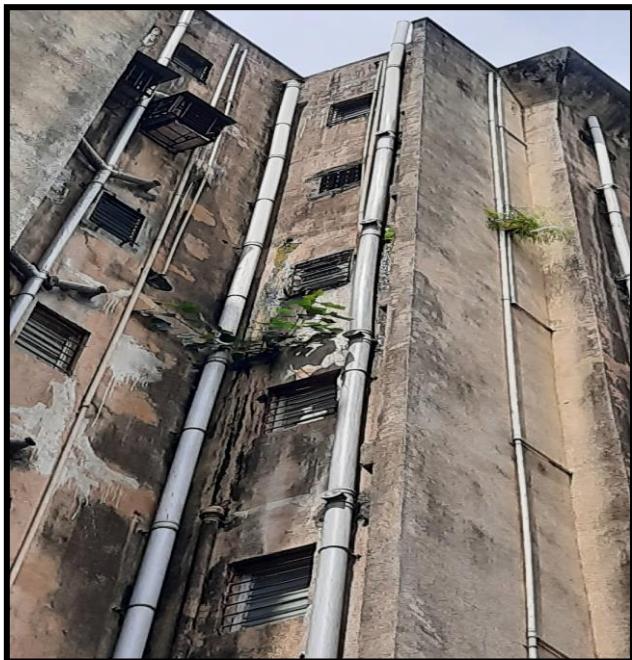
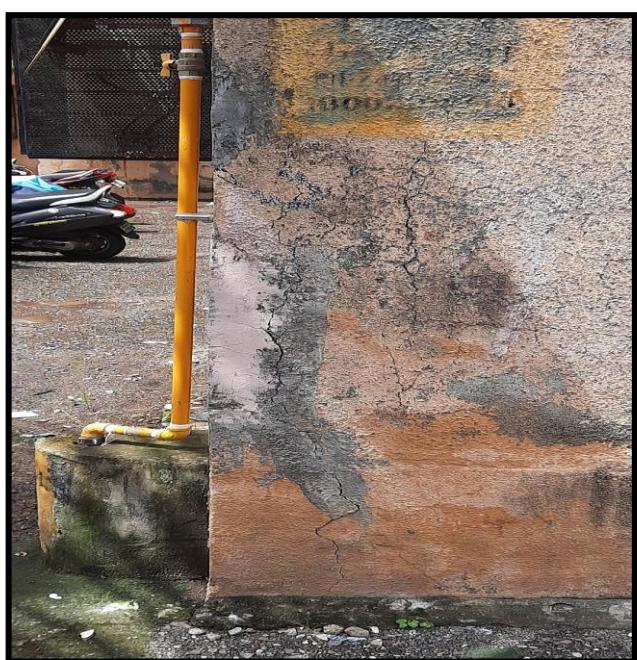
## NORTH SIDE

- ❖ Structural crack observed at several places on column.
- ❖ Vegetation growth observed at several places on wall.

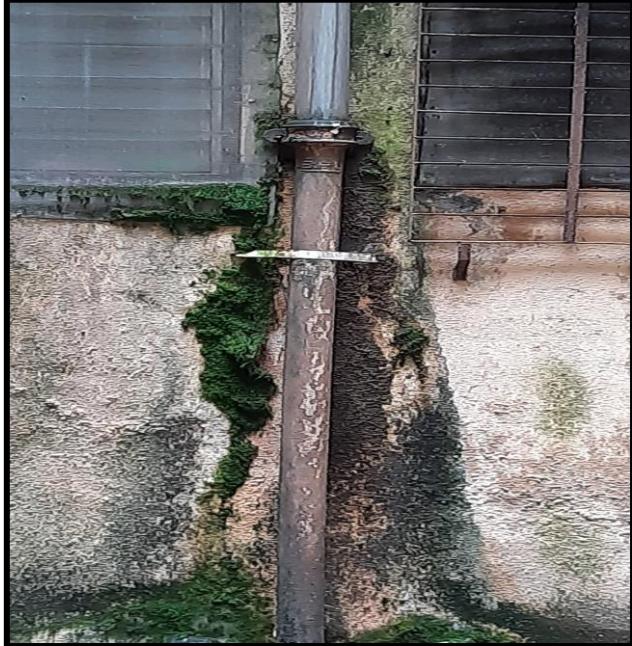
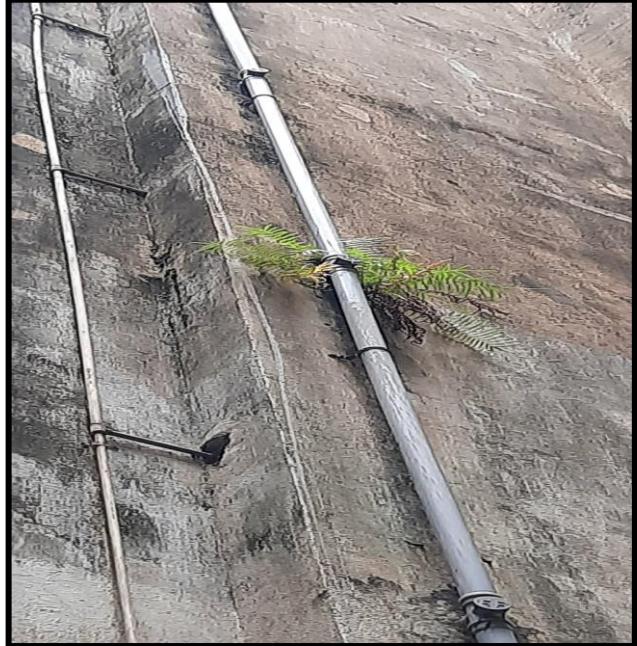
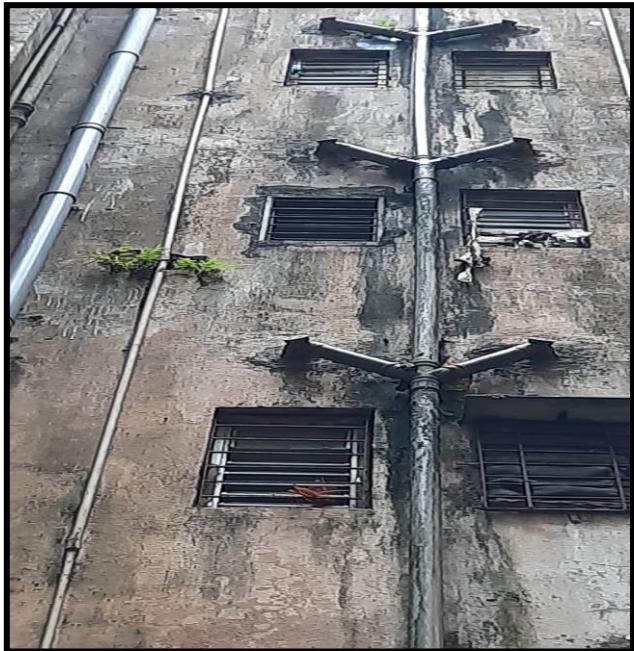
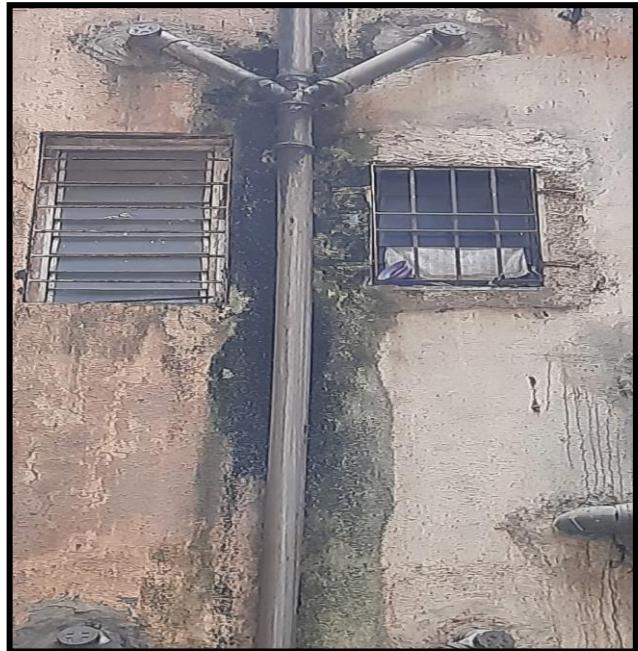
## SOUTH SIDE

- ❖ Algae observed at several places on wall.
- ❖ Vegetation growth observed at several places on wall.
