STRUCTURAL AUDIT REPORT
FOR
“VISHAL SAHYADRI CO – OP HSG. SOC. LTD”,
“C11 – WING”
SITUATED AT
SAHYADRI NAGAR, CHARKOP,
KANDIVALI (W) MUMBAI – 400 067

PREPARED BY
LATESH S. SANKLECHA
CONSULTING STRUCTURAL ENGINEERS

978/B1/LSS/2021

JUNE 21, 2021

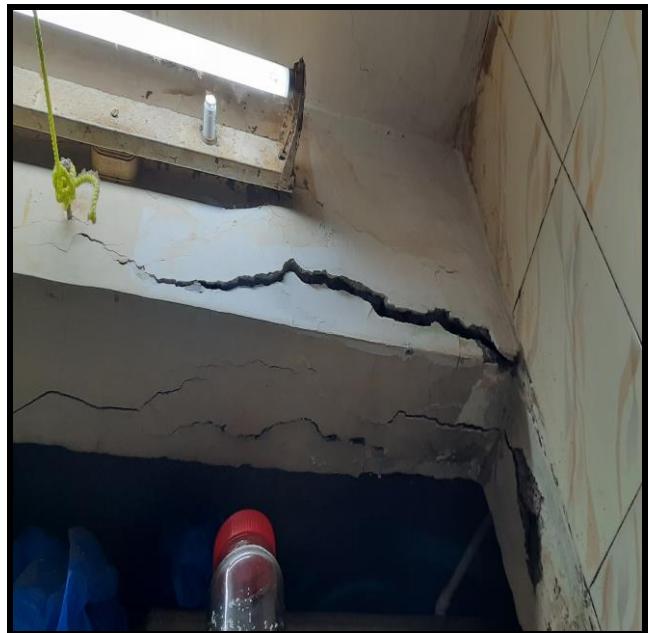
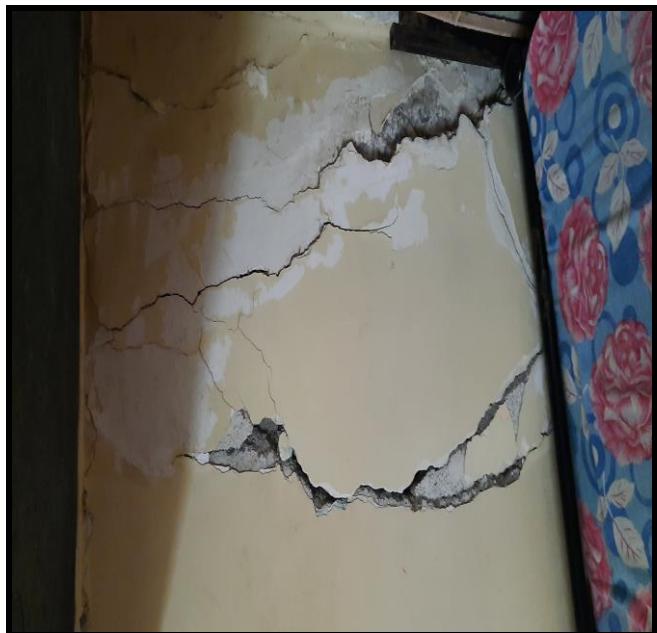
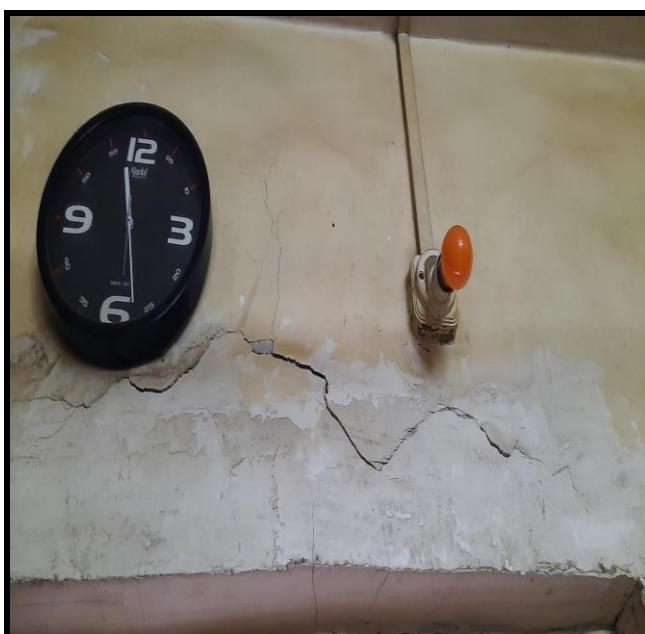
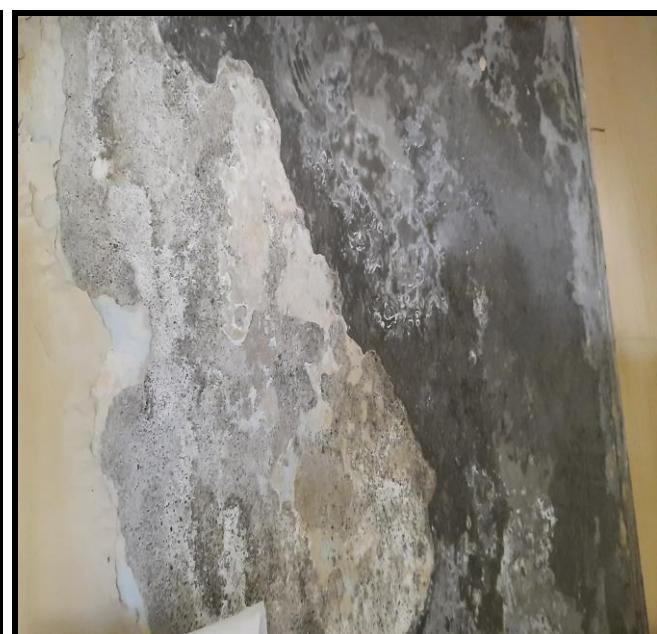
FLAT NO – 02

- ❖ **HALL** – Structural crack observed on beam & column.
 - Leakage mark observed on wall & ceiling.
- ❖ **KITCHEN** – Structural crack observed on beam.
 - Leakage mark observed on ceiling.
 - Ceiling plaster get damaged & steel get exposed & corroded.
- ❖ **PASSAGE** – O.K.
- ❖ **TOILET & BATH ROOM** – O.K.

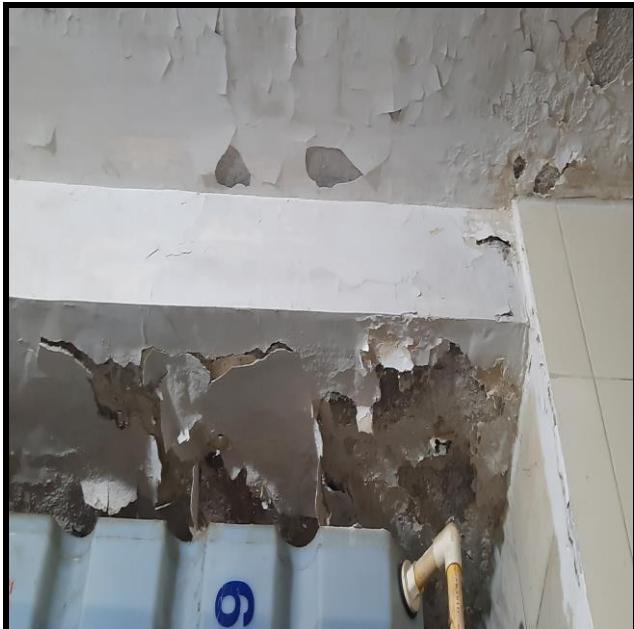
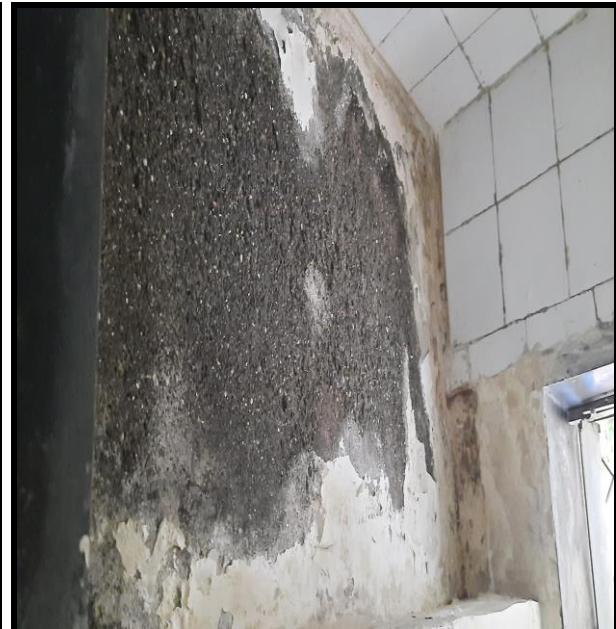
FLAT NO – 03

- ❖ **HALL** – O.K.
- ❖ **KITCHEN** – Leakage mark observed on ceiling.
 - Structural damage observed on ceiling.
- ❖ **PASSAGE** – O.K.
- ❖ **TOILET & BATH ROOM** – O.K.

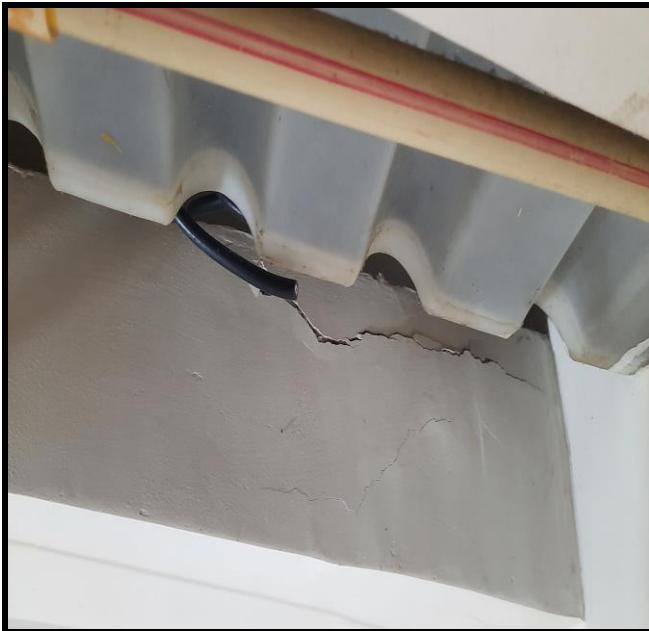
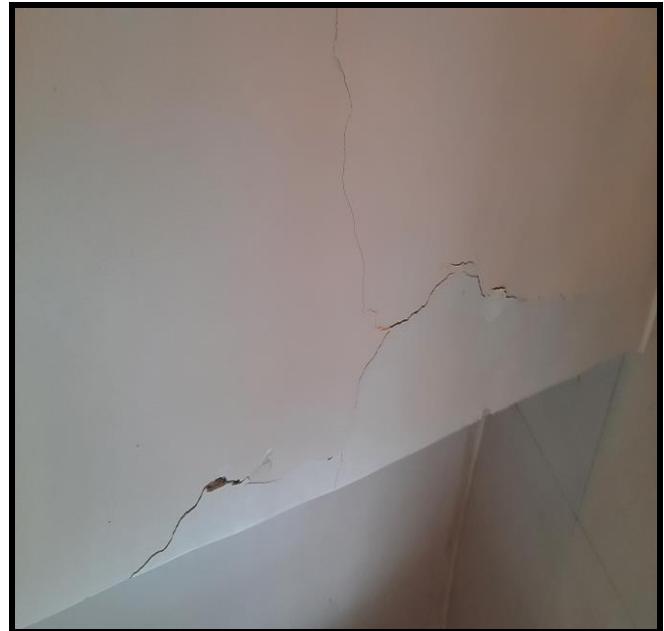
FLAT NO – 9

- ❖ **HALL** – O.K.
- ❖ **KITCHEN** – Structural crack observed on ceiling.
- ❖ **PASSAGE** – O.K.
- ❖ **TOILET & BATH ROOM** – Structural crack observed on ceiling.

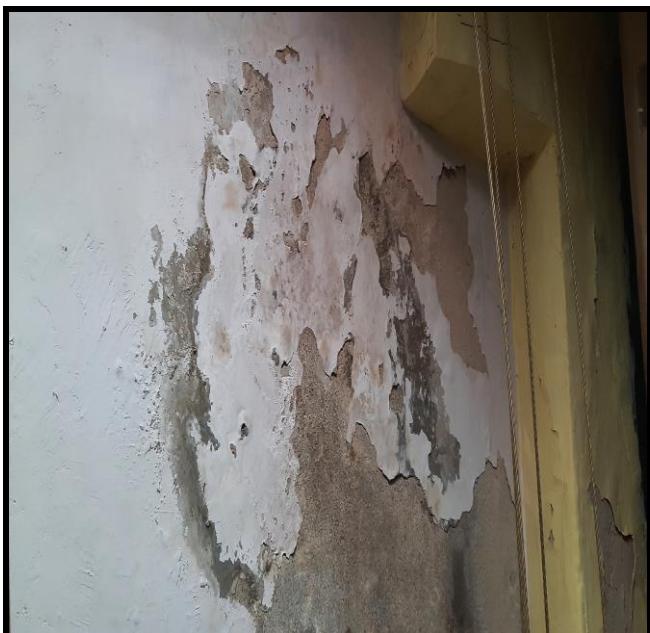
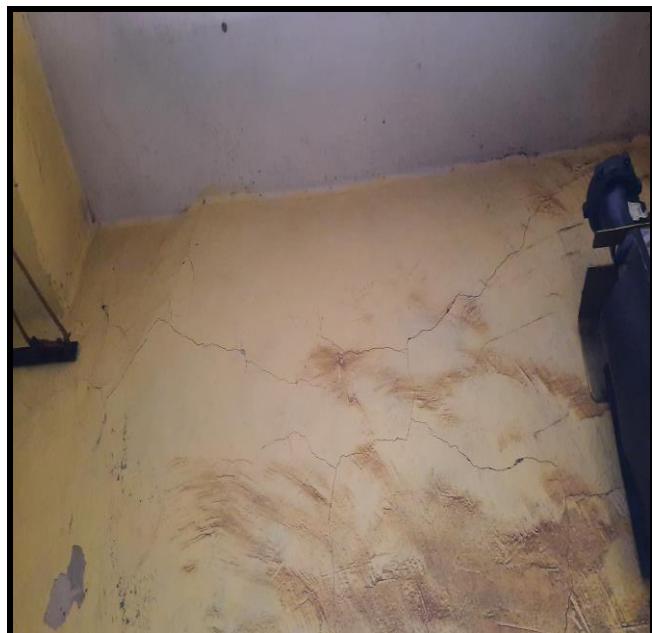
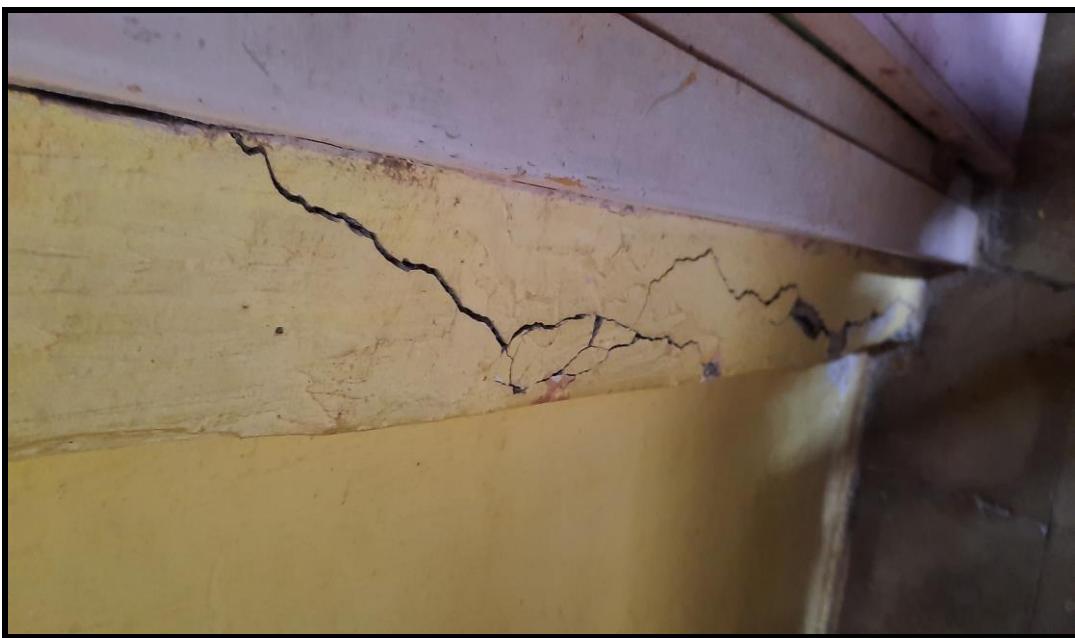
FLAT NO - 14

- ❖ **HALL** – Structural crack observed on column & beam.
- ❖ **KITCHEN** – Leakage mark observed on wall & ceiling.
- ❖ **PASSAGE** – O.K.
- ❖ **TOILET & BATH ROOM** – O.K.

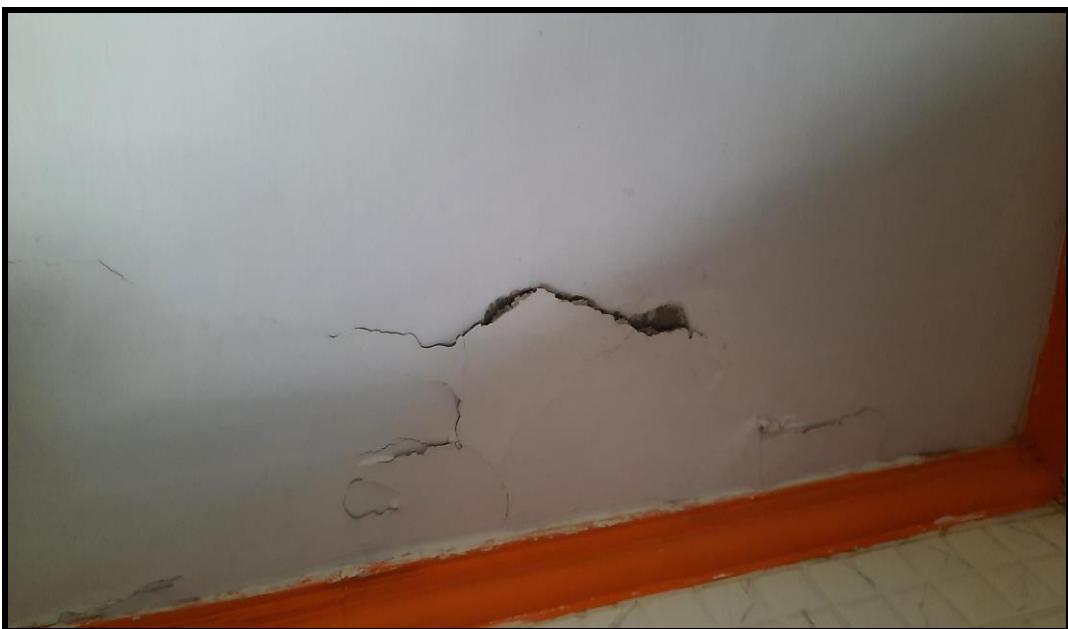
FLAT NO – 18

- ❖ **HALL** – Leakage observed on wall in monsoon.
 - Structural damage observed on ceiling.
- ❖ **KITCHEN** – O.K.
- ❖ **PASSAGE** – O.K.
- ❖ **TOILET & BATH ROOM** – O.K.

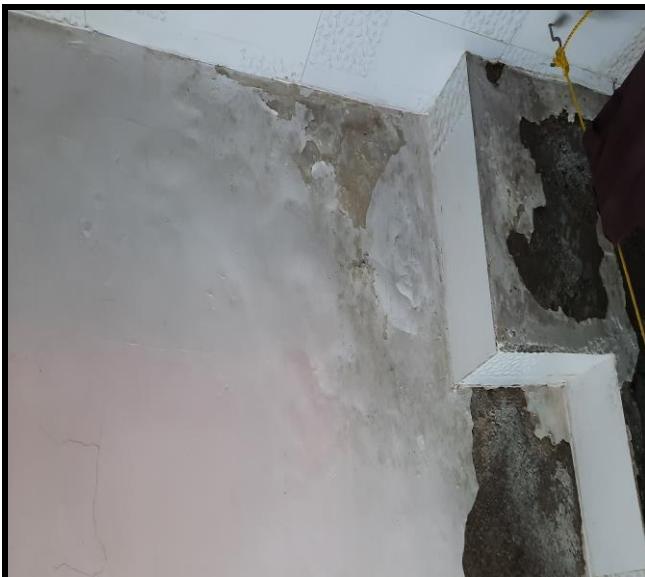
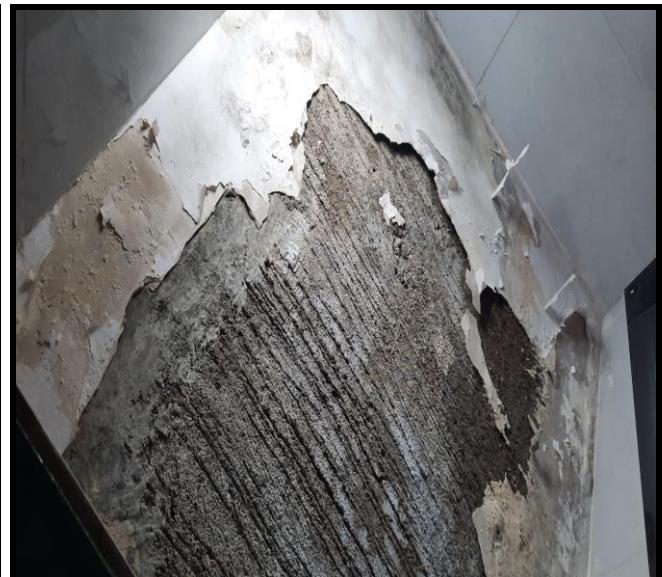
FLAT NO – 20

- ❖ **HALL** – Structural damage observed on ceiling.
- ❖ **KITCHEN** – Leakage mark observed on ceiling.
- ❖ **PASSAGE** – O.K.
- ❖ **TOILET & BATH ROOM** – Leakage mark observed on ceiling.

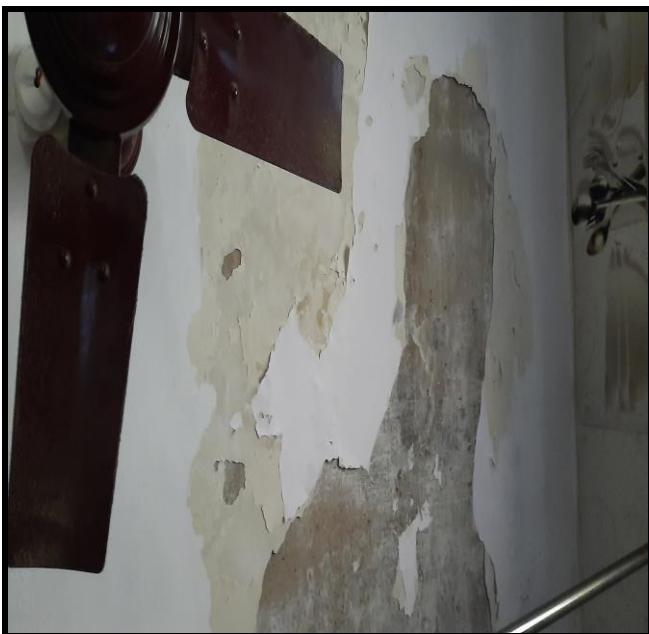
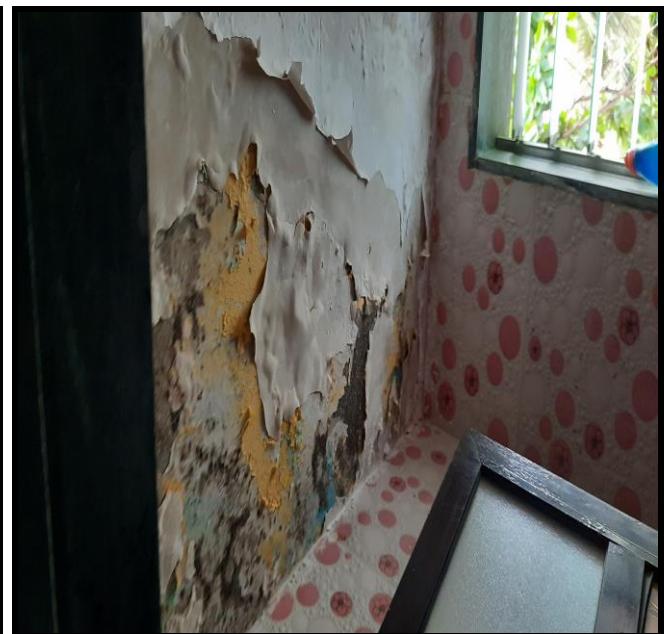
FLAT NO – 28

- ❖ **HALL** – O.K.
- ❖ **KITCHEN** – Leakage mark observed on ceiling.
- ❖ **PASSAGE** – O.K.
- ❖ **TOILET & BATH ROOM** – Leakage mark observed on ceiling.

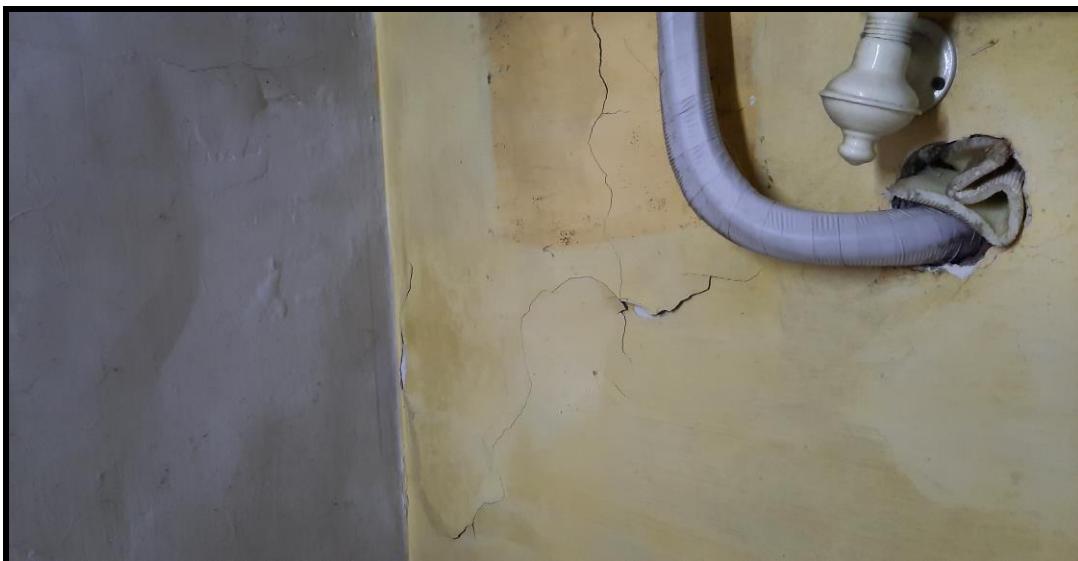
FLAT NO – 31

- ❖ **HALL** – Structural damage observed on beam.
- ❖ **KITCHEN** – O.K.
- ❖ **PASSAGE** – O.K.
- ❖ **TOILET & BATH ROOM** – O.K.

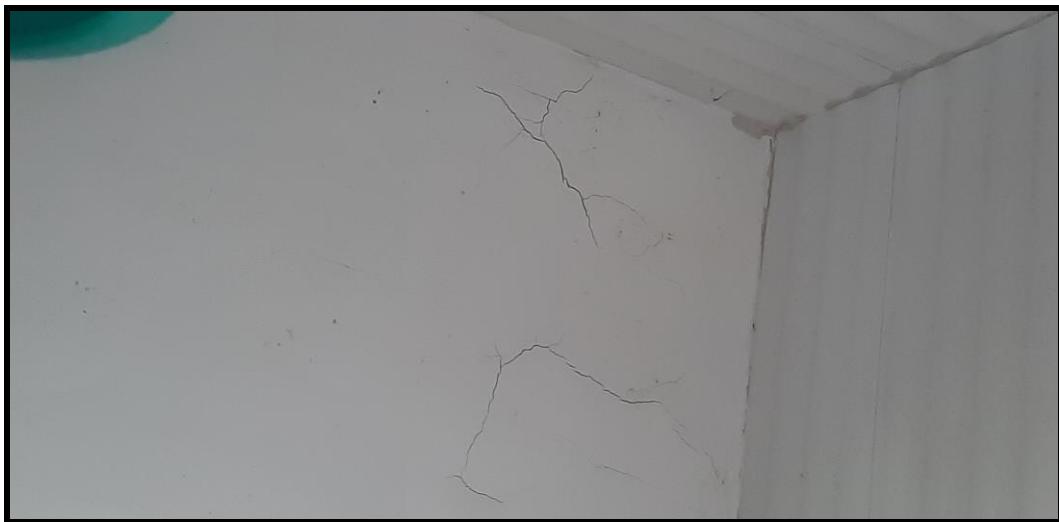
FLAT NO – 33

- ❖ **HALL** – Leakage observed on wall in monsoon.
- ❖ **KITCHEN** – Leakage observed on wall in monsoon.
- ❖ **PASSAGE** – O.K.
- ❖ **TOILET & BATH ROOM** – Structural damage observed on ceiling.

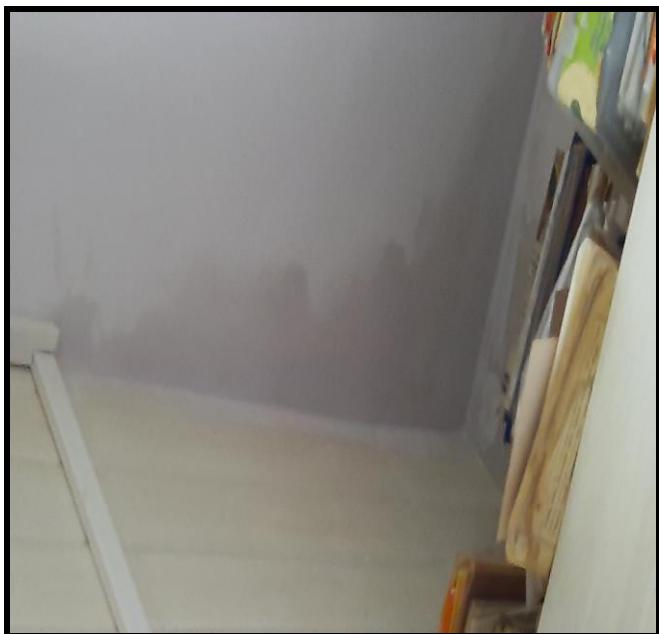
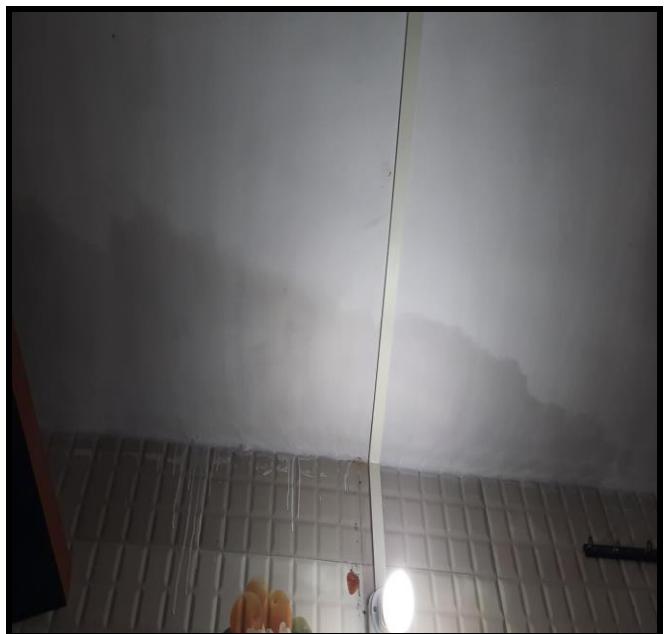
FLAT NO – 35

- ❖ **HALL** – Dampness observed on ceiling.
- ❖ **KITCHEN** – Dampness observed on ceiling.
- ❖ **PASSAGE** – O.K.
- ❖ **TOILET & BATH ROOM** – O.K.

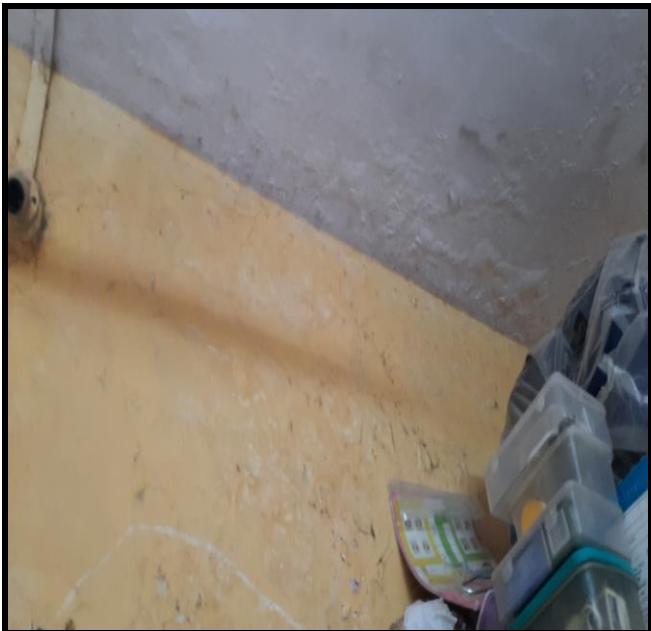
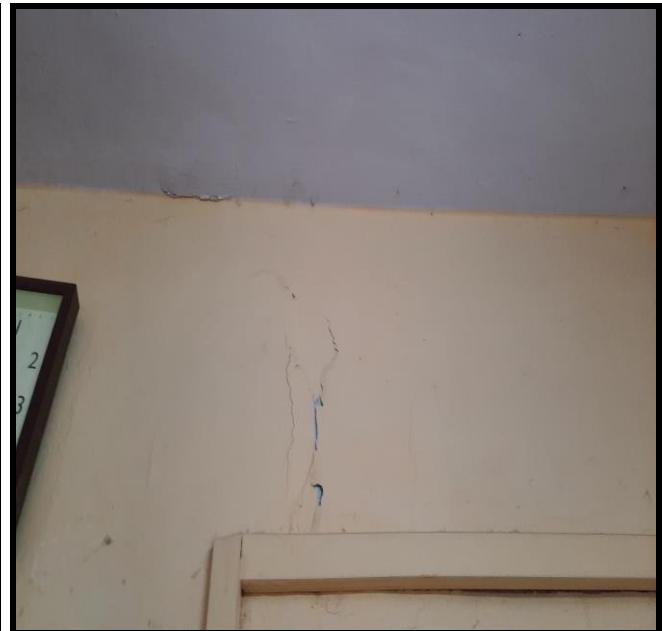
FLAT NO – 40

- ❖ **HALL** – Leakage mark observed on wall.
- ❖ **KITCHEN** – O.K.
- ❖ **PASSAGE** – O.K.
- ❖ **TOILET & BATH ROOM** – O.K.

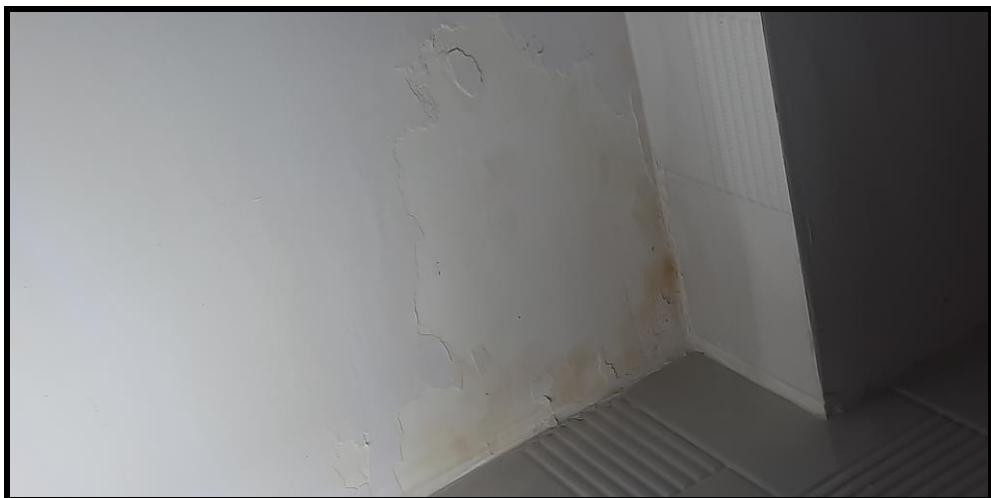
FLAT NO – 46

- ❖ **HALL** – Dampness observed on wall in monsoon.
- ❖ **KITCHEN** – Leakage mark observed on ceiling.
- ❖ **PASSAGE** – O.K.
- ❖ **TOILET & BATH ROOM** – O.K.

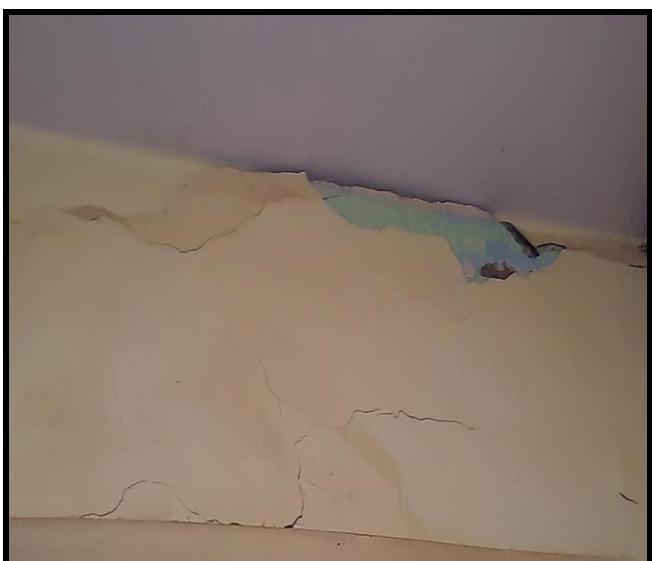
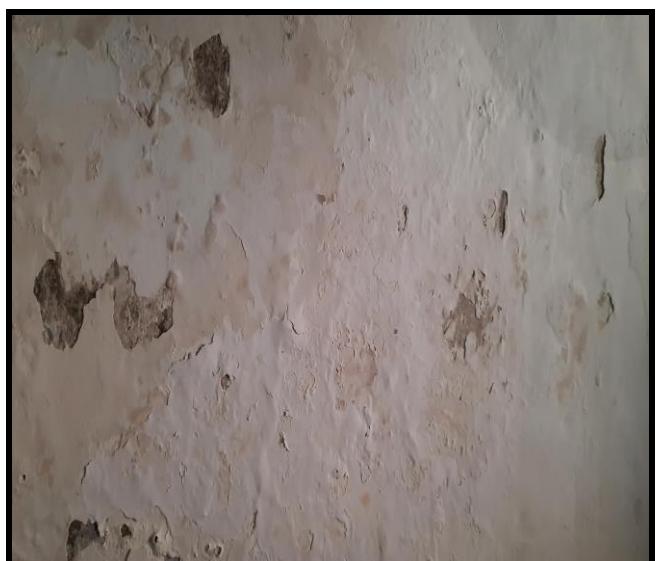
FLAT NO – 48

- ❖ **HALL** – Structural damage observed on beam.
- ❖ **KITCHEN** – Leakage mark observed on ceiling.
- ❖ **PASSAGE** – O.K.
- ❖ **TOILET & BATH ROOM** – O.K.

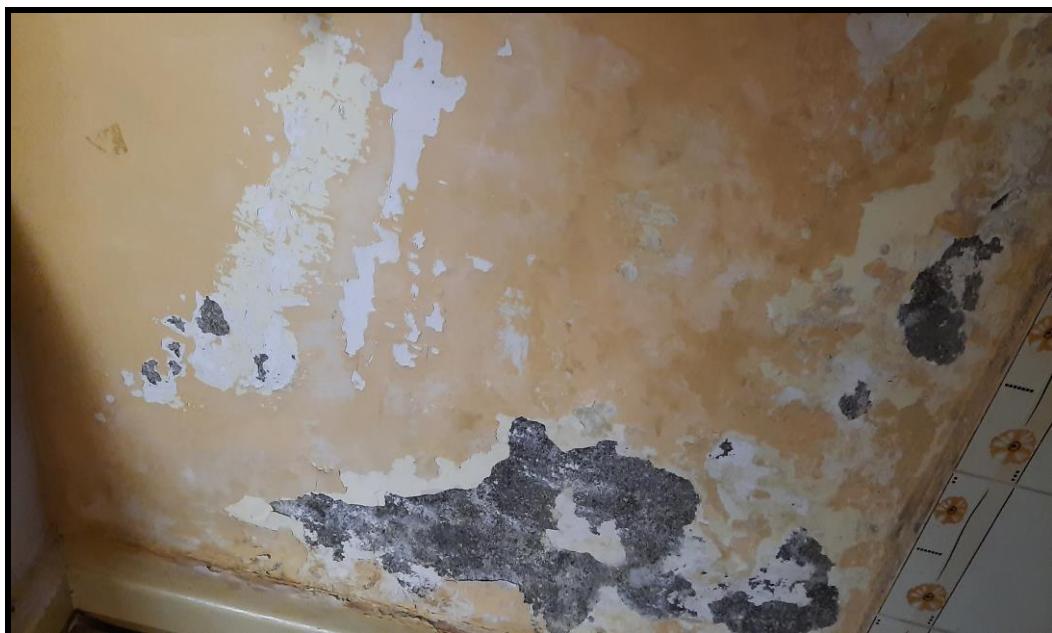
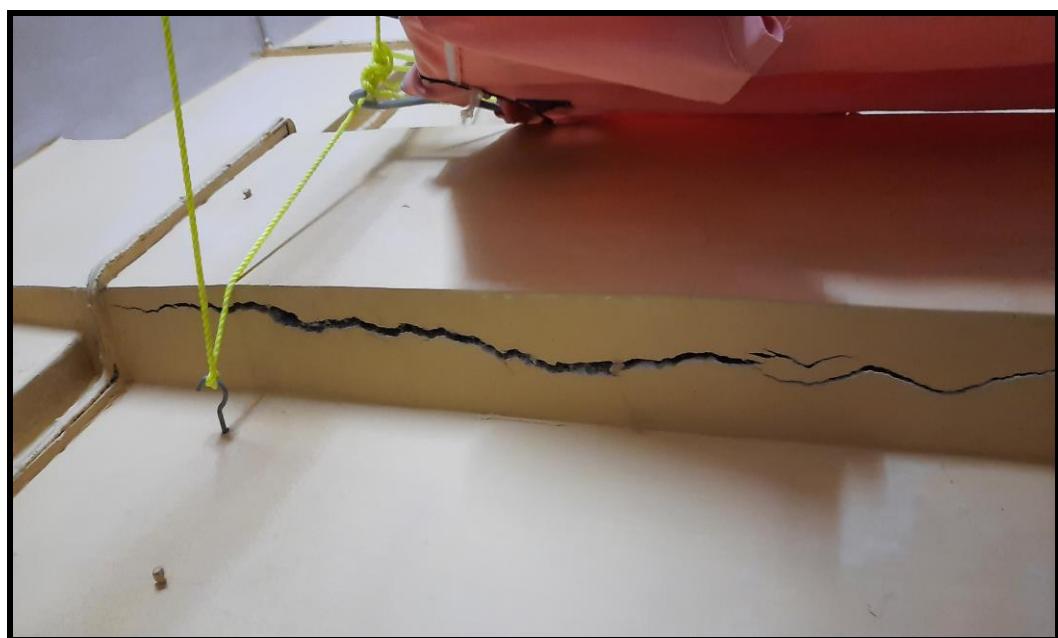
FLAT NO – 50

- ❖ **HALL** – Structural crack observed on column.
 - Leakage mark observed on wall.
- ❖ **KITCHEN** – O.K.
- ❖ **PASSAGE** – O.K.
- ❖ **TOILET & BATH ROOM** – O.K.

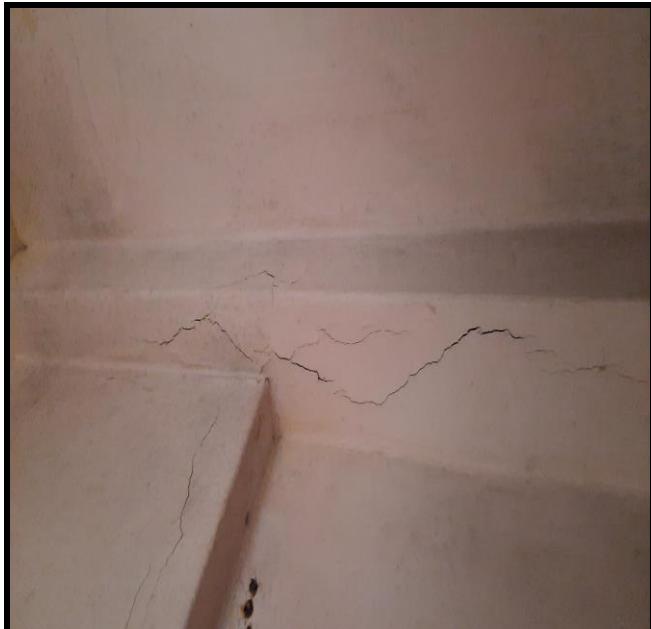
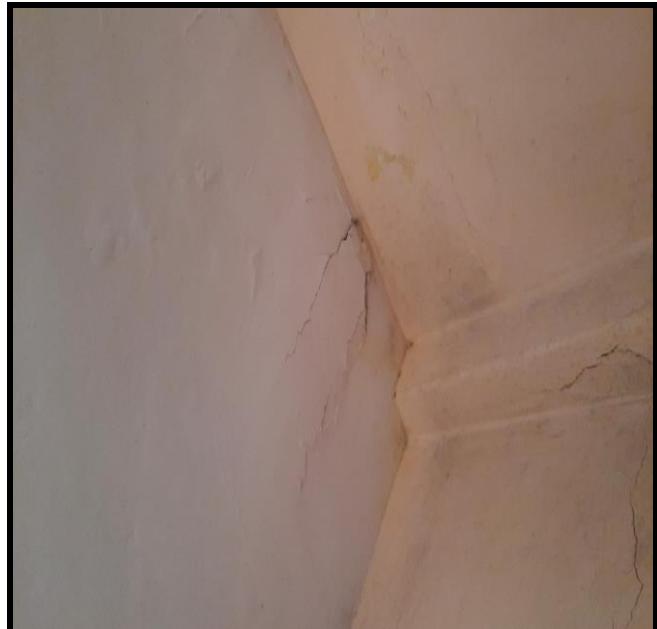
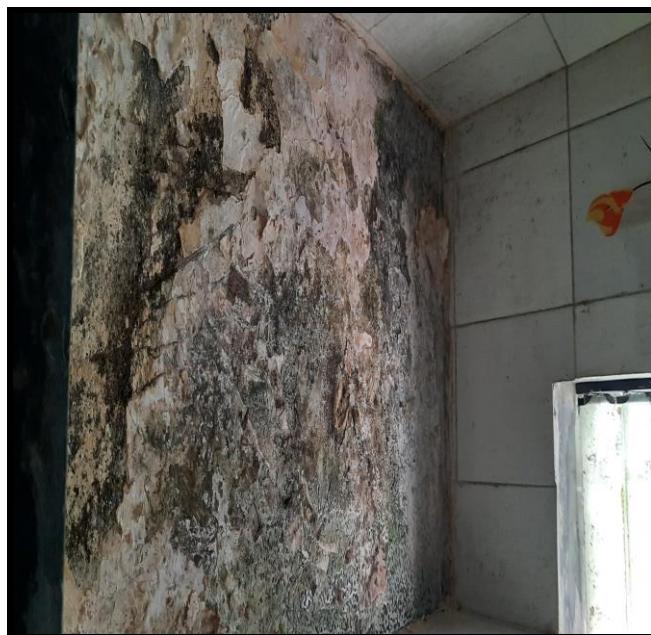
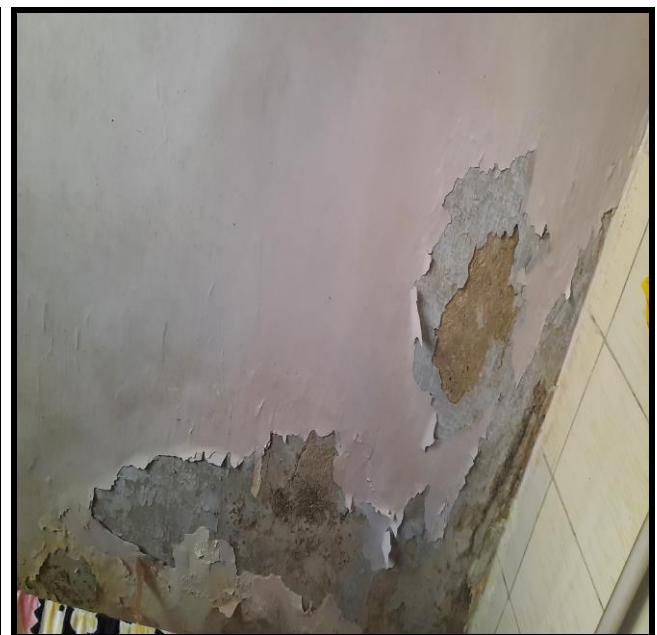
FLAT NO – 52

- ❖ **HALL** – Structural crack observed on column & ceiling.
 - Dampness observed on wall in monsoon.
- ❖ **KITCHEN** – Leakage mark observed on ceiling.
- ❖ **PASSAGE** – O.K.
- ❖ **TOILET & BATH ROOM** – Leakage mark observed on ceiling.

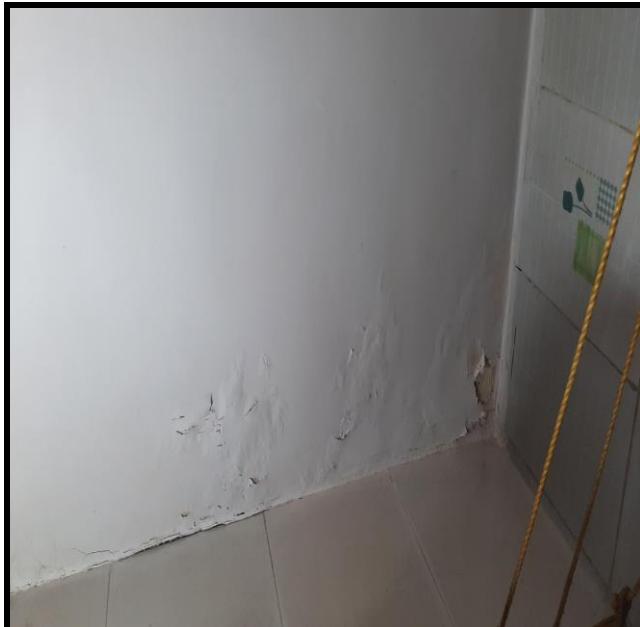
FLAT NO – 53

- ❖ **HALL** – Leakage observed on wall in monsoon.
- ❖ **KITCHEN** – Leakage mark observed on ceiling.
 - Structural crack observed on ceiling.
- ❖ **PASSAGE** – O.K.
- ❖ **TOILET & BATH ROOM** – Leakage mark observed on ceiling.

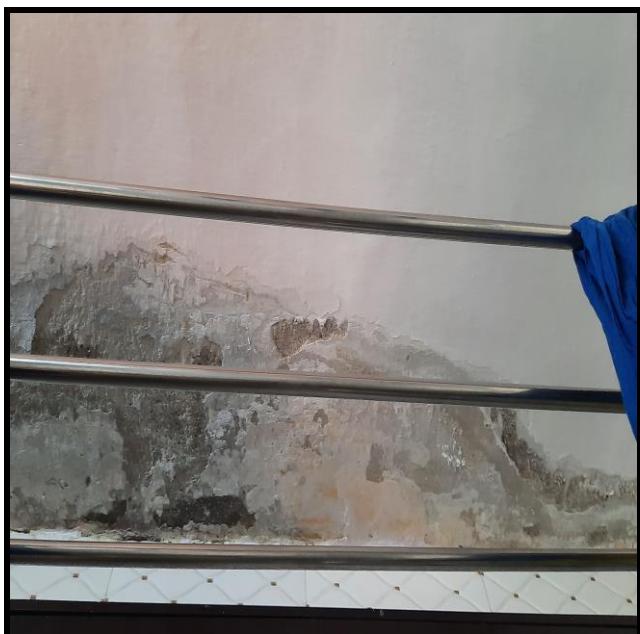
FLAT NO – 56

- ❖ **HALL** – Dampness observed on wall in monsoon.
- ❖ **KITCHEN** – Leakage mark observed on ceiling.
 - Structural damage observed on ceiling.
- ❖ **PASSAGE** – O.K.
- ❖ **TOILET & BATH ROOM** – O.K.

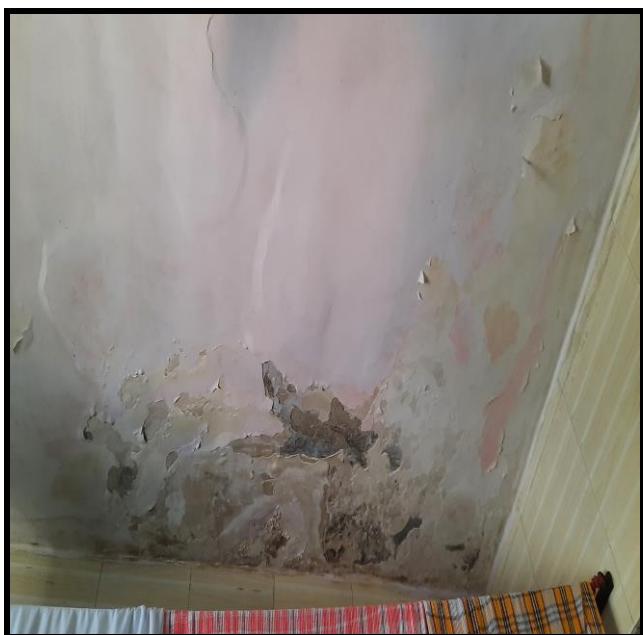
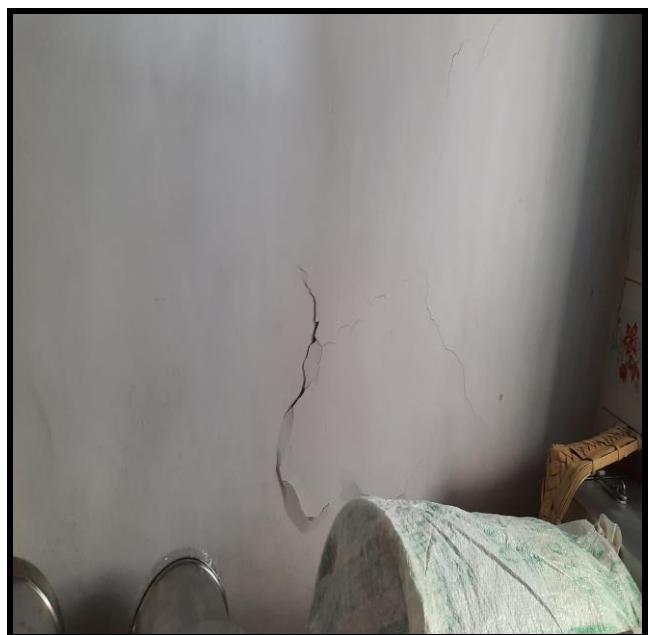
FLAT NO – 60

- ❖ **HALL** – O.K.
- ❖ **KITCHEN** – Structural damage observed on ceiling.
 - Leakage mark observed on ceiling.
- ❖ **PASSAGE** – O.K.
- ❖ **TOILET & BATH ROOM** – O.K.

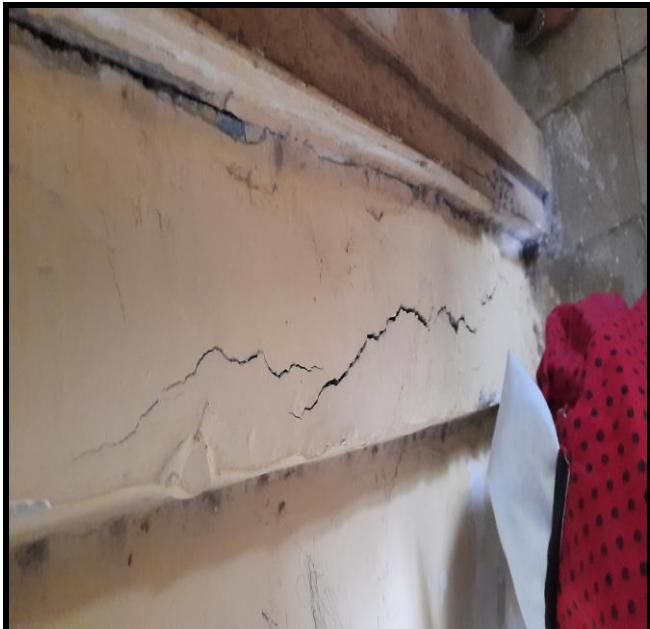
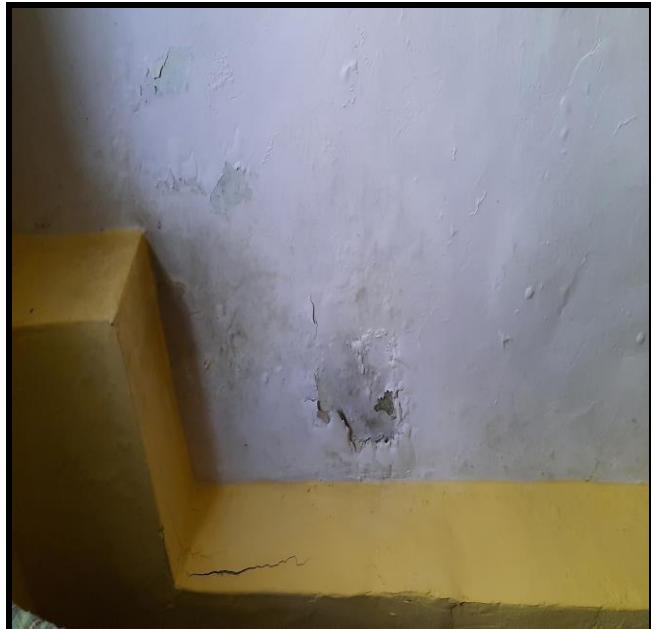
FLAT NO – 62

- ❖ **HALL** – Structural crack observed on column.
- ❖ **KITCHEN** – Leakage mark observed on ceiling.
 - Structural crack observed on beam.
- ❖ **PASSAGE** – O.K.
- ❖ **TOILET & BATH ROOM** – O.K.

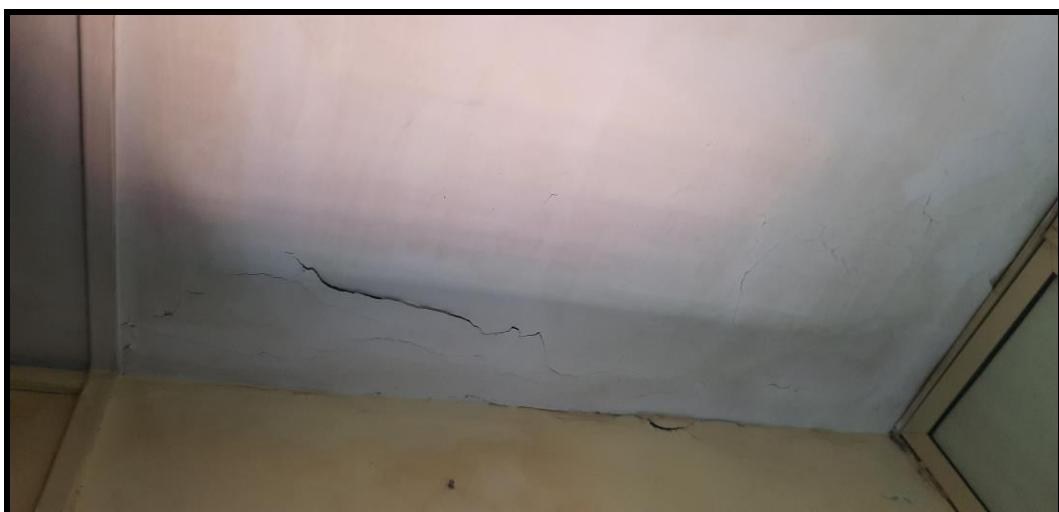
FLAT NO – 64

- ❖ **HALL** – Structural damage observed on ceiling.
 - Dampness observed on wall in monsoon.
- ❖ **KITCHEN** – O.K.
- ❖ **PASSAGE** – O.K.
- ❖ **TOILET & BATH ROOM** – O.K.

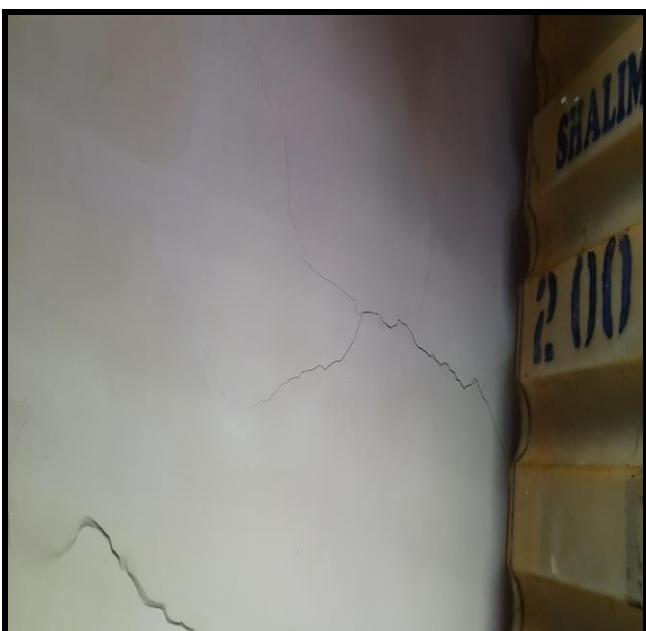
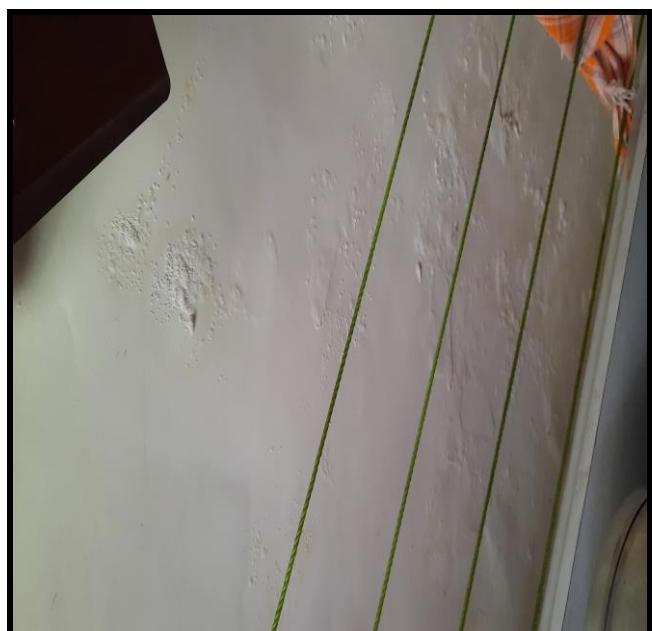
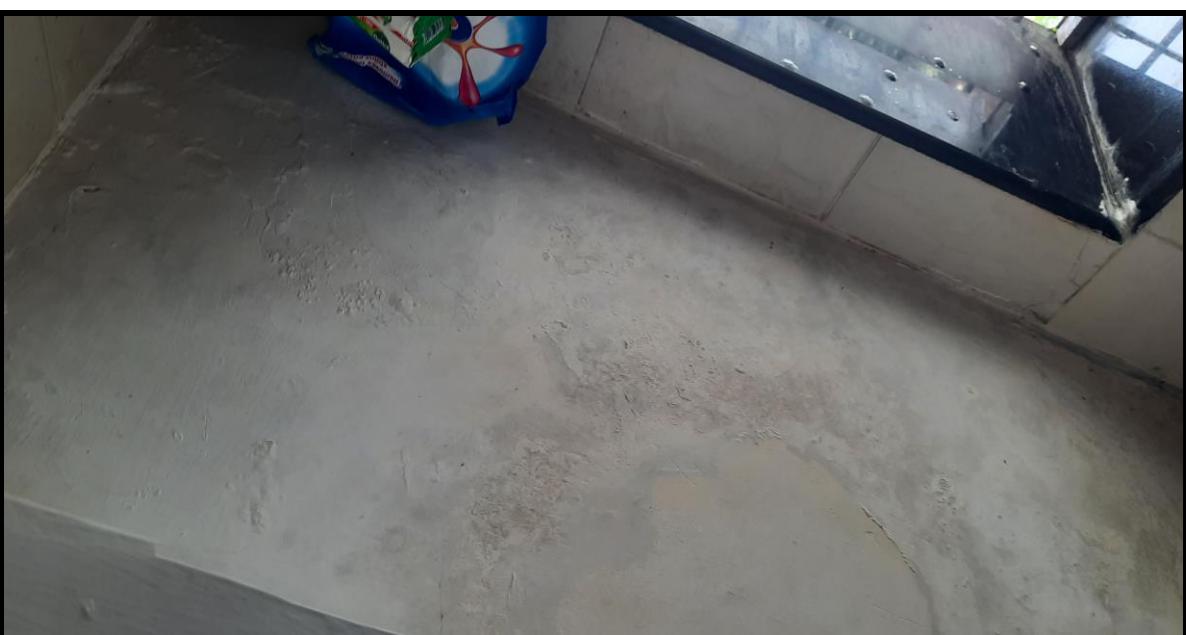
FLAT NO – 66

- ❖ **HALL** – O.K.
- ❖ **KITCHEN** – Structural damage observed on ceiling.
 - Leakage mark observed on ceiling.
- ❖ **PASSAGE** – O.K.
- ❖ **TOILET & BATH ROOM** – Leakage mark observed on ceiling.

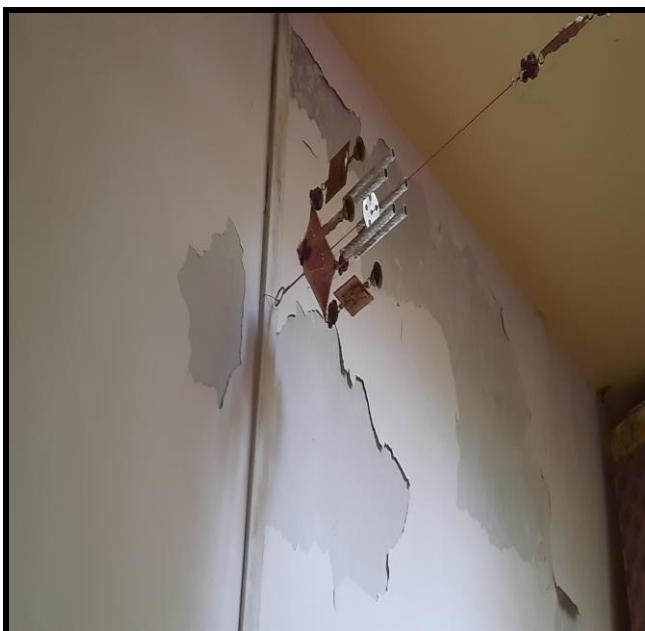
FLAT NO – 67

- ❖ **HALL** – Leakage mark observed on ceiling.
 - Structural crack observed on column.
- ❖ **KITCHEN** – Leakage mark observed on ceiling.
 - Structural damage observed on ceiling.
- ❖ **PASSAGE** – O.K.
- ❖ **TOILET & BATH ROOM** – Leakage mark observed on ceiling.

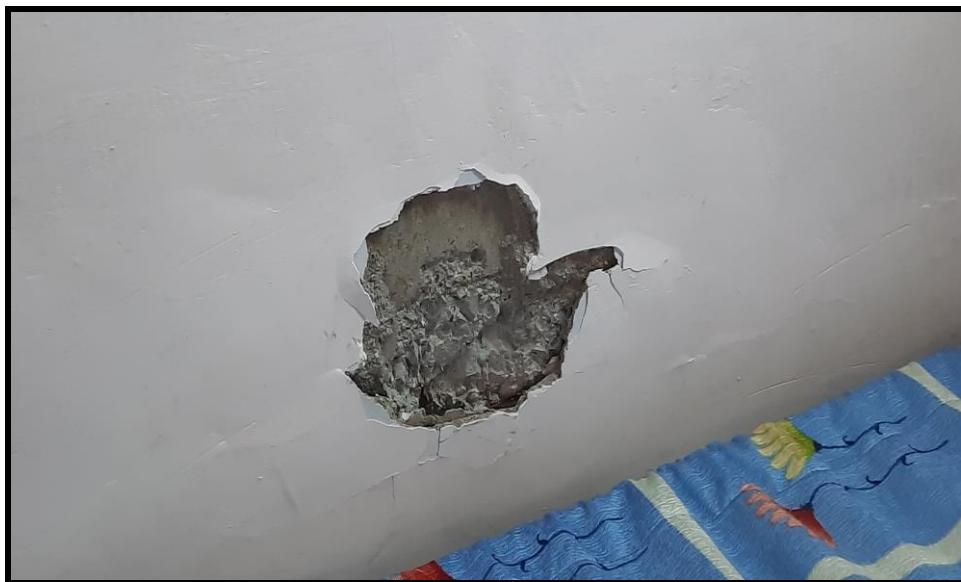
FLAT NO - 70

- ❖ **HALL** – Ceiling plaster get damaged & steel get exposed & corroded.
- ❖ **KITCHEN** – O.K.
- ❖ **PASSAGE** – O.K.
- ❖ **TOILET & BATH ROOM** – O.K.

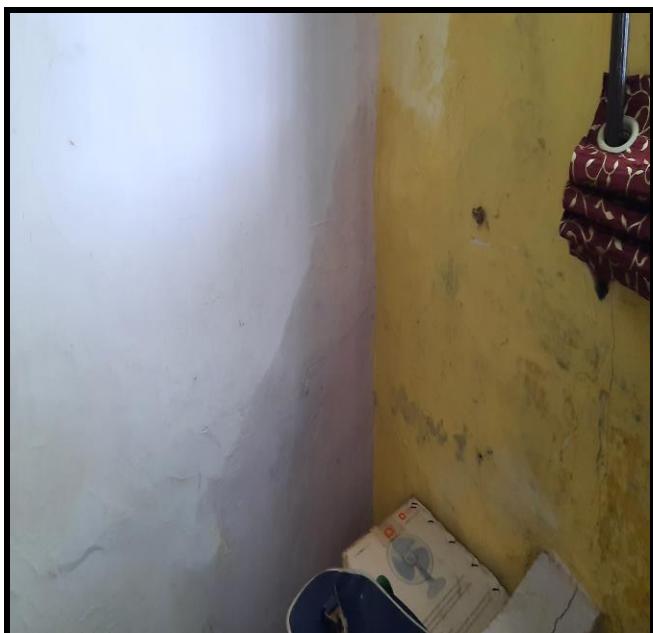
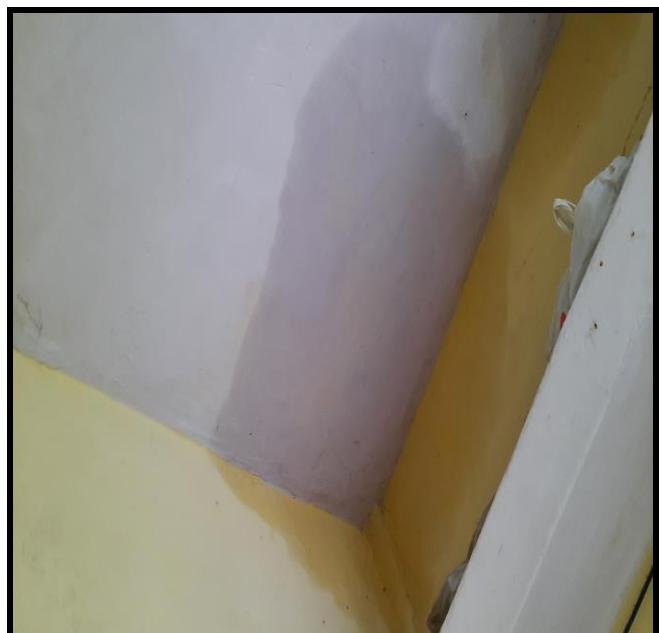
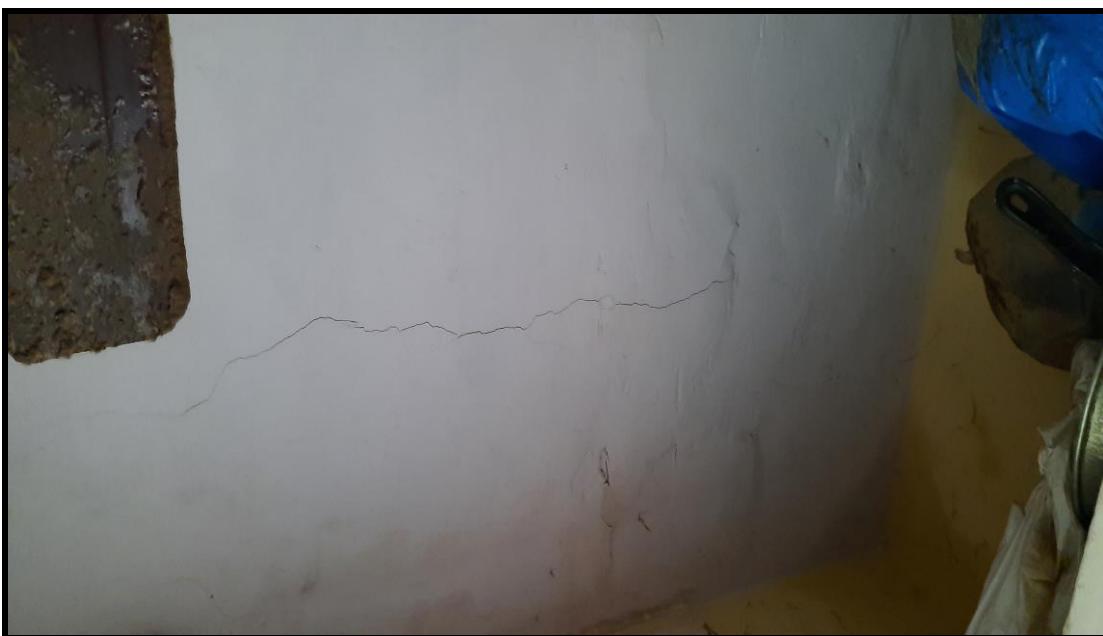
FLAT NO – 75

- ❖ **HALL** – Dampness observed on wall & ceiling.
- ❖ **KITCHEN** – Dampness observed on wall & ceiling.
 - Structural crack observed on ceiling.
- ❖ **PASSAGE** – O.K.
- ❖ **TOILET & BATH ROOM** – O.K.

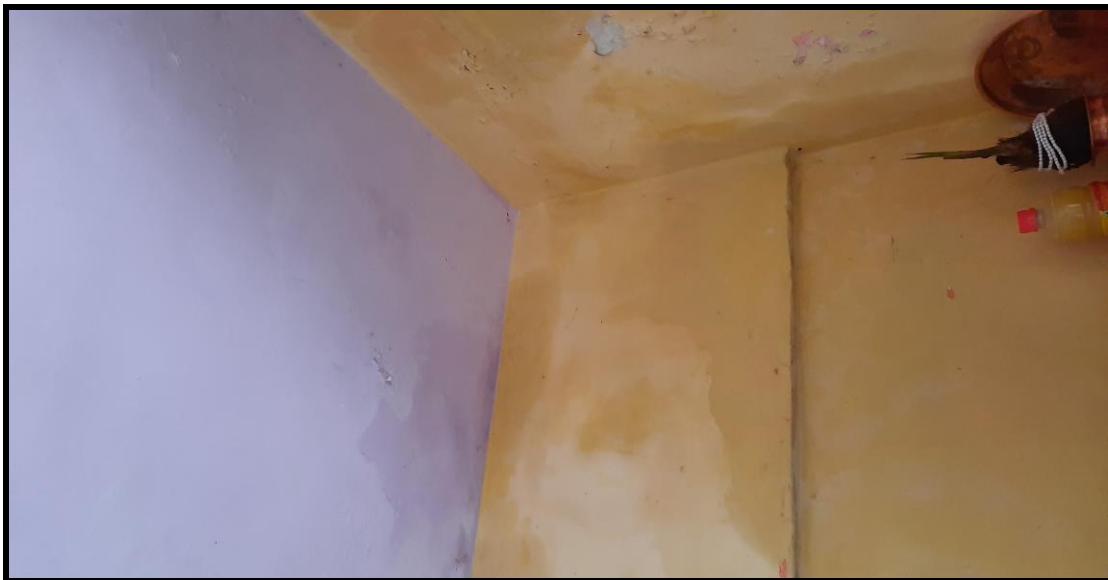
FLAT NO - 76

- ❖ **HALL** – Dampness observed on wall & ceiling.
- ❖ **KITCHEN** – Dampness observed on ceiling.
- ❖ **PASSAGE** – O.K.
- ❖ **TOILET & BATH ROOM** – O.K.
