STRUCTURAL AUDIT REPORT
FOR
“VISHAL SAHYADRI CO – OP HSG. SOC. LTD”,
“C11 – WING”
SITUATED AT
SAHYADRI NAGAR, CHARKOP,
KANDIVALI (W) MUMBAI – 400 067

PREPARED BY
LATESH S. SANKLECHA
CONSULTING STRUCTURAL ENGINEERS

978/B1/LSS/2021

JUNE 21, 2021

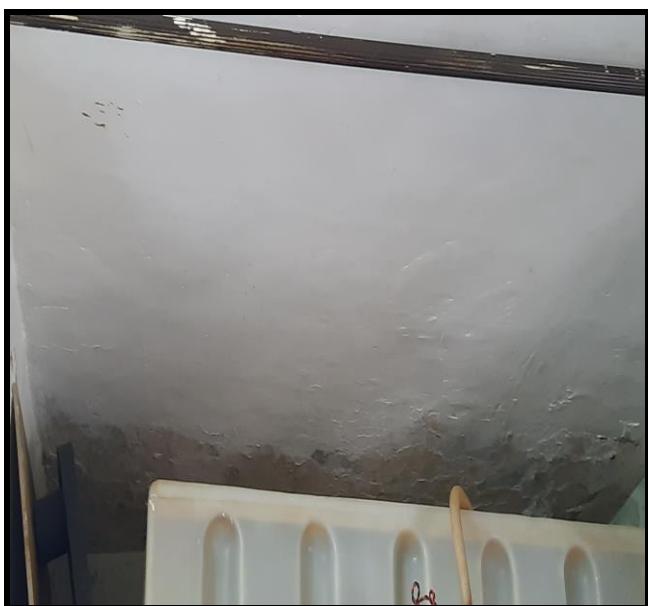
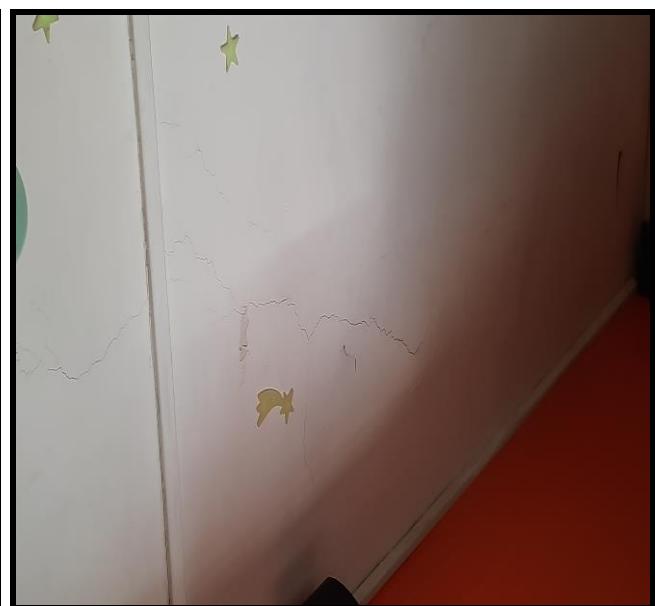
FLAT NO - 77

- ❖ **HALL** – Structural crack observed on ceiling.
- ❖ **KITCHEN** – Structural damage observed on ceiling.
 - Leakage mark observed on ceiling.
- ❖ **PASSAGE** – O.K.
- ❖ **TOILET & BATH ROOM** – O.K.

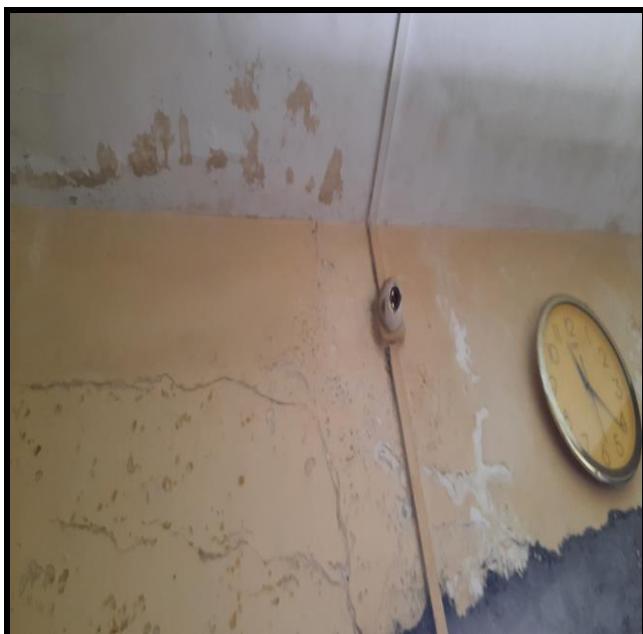
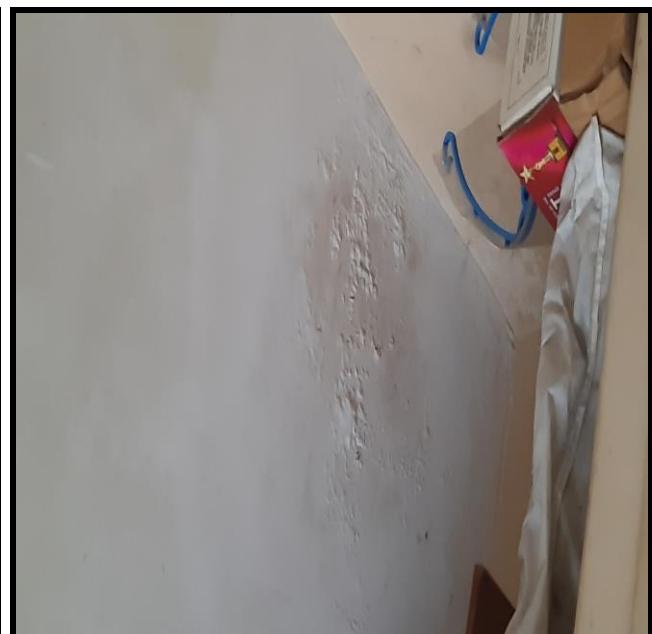
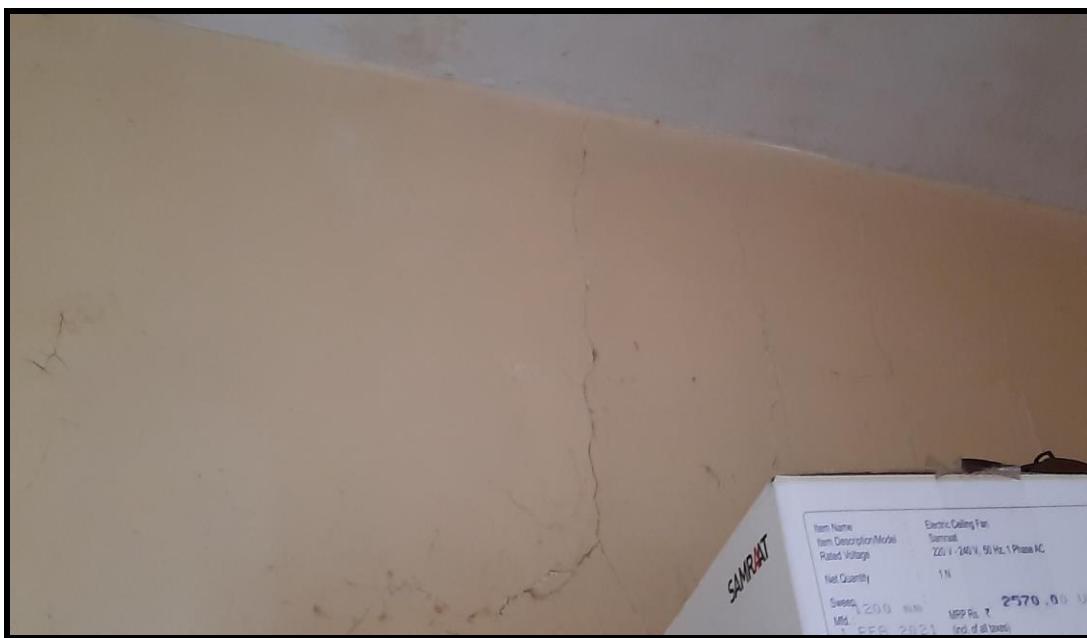
FLAT NO – 80

- ❖ **HALL** – Leakage mark observed on wall & ceiling.
 - Structural crack observed on beam.
- ❖ **KITCHEN** – Structural crack observed on beam.
 - Leakage observed on wall in monsoon.
- ❖ **PASSAGE** – O.K.
- ❖ **TOILET & BATH ROOM** – O.K.

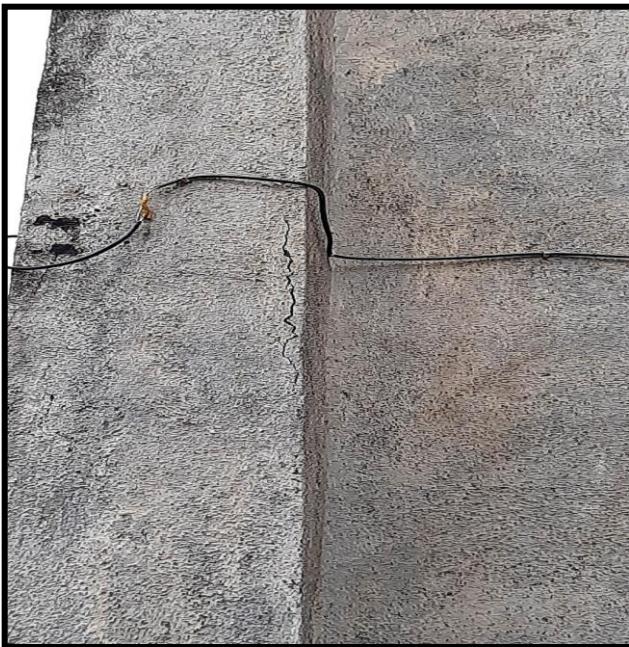
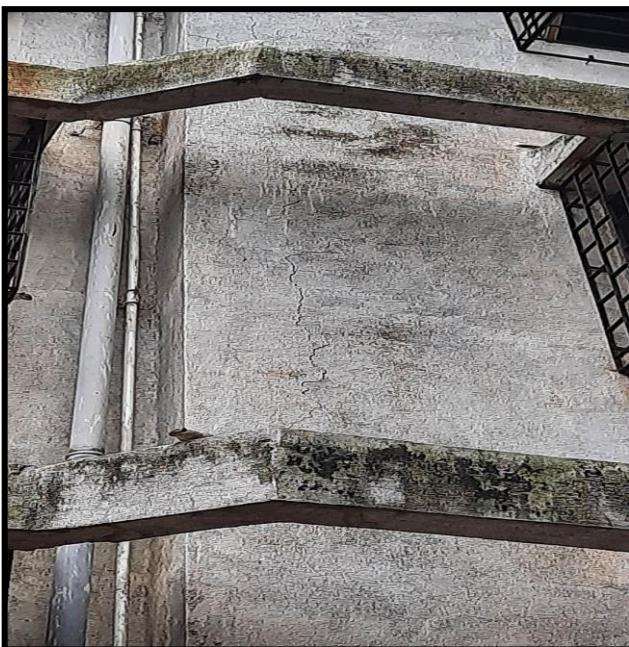
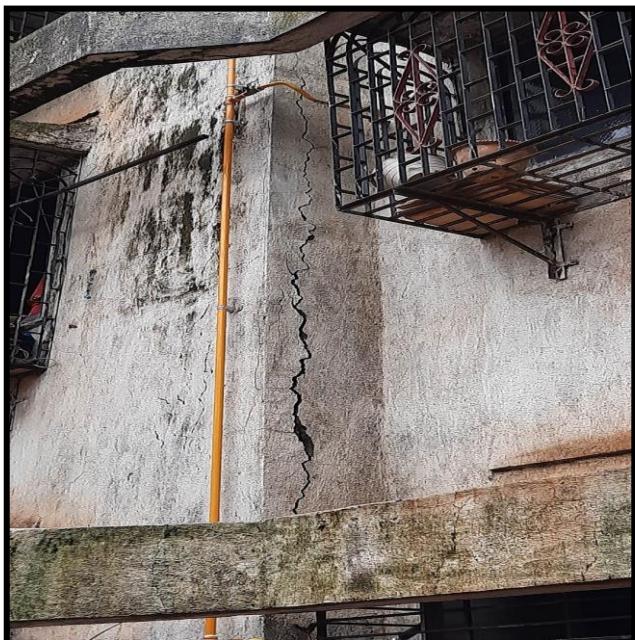
FRONT SIDE

- ❖ Structural crack observed at several places on column & chajjas.
- ❖ Major crack observed at several places on wall.
- ❖ Vegetation growth observed at several places on wall.
- ❖ Algae observed at several places on wall.

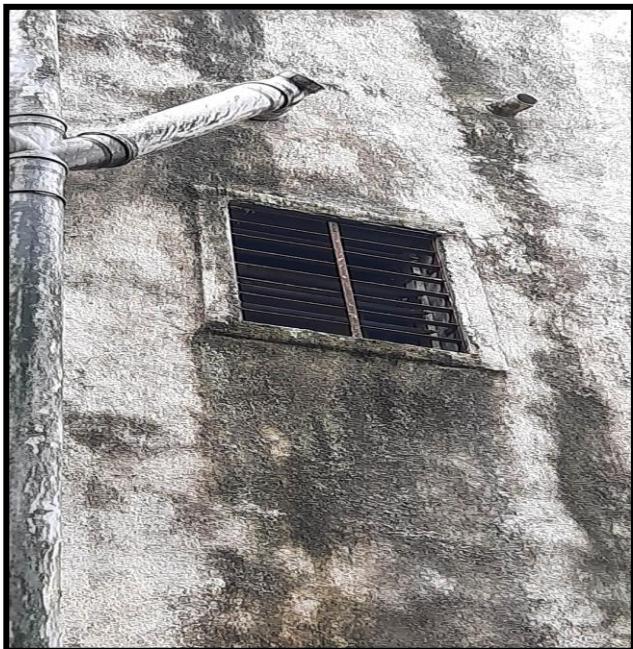
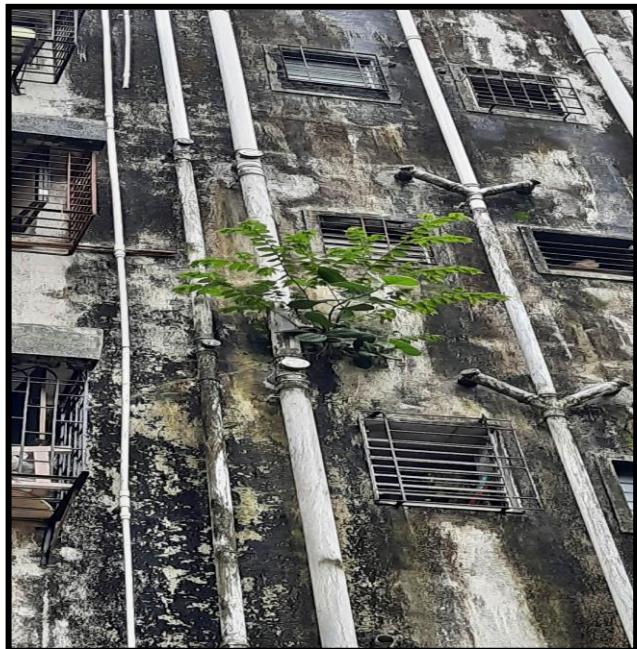
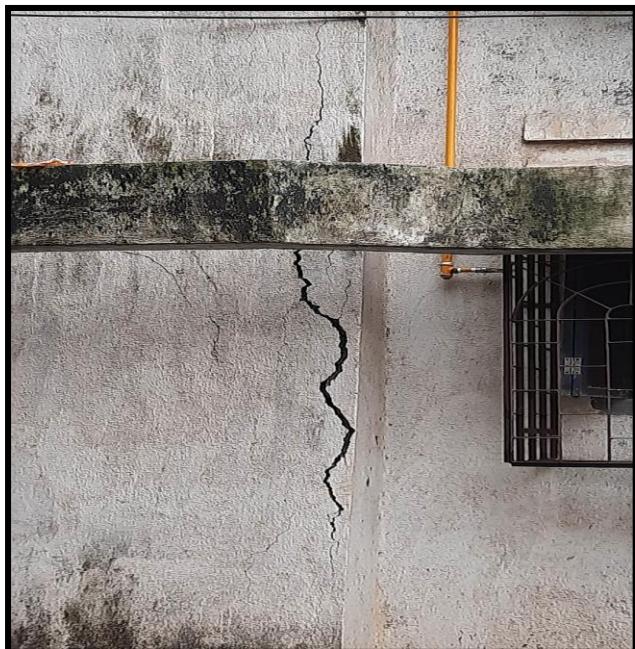
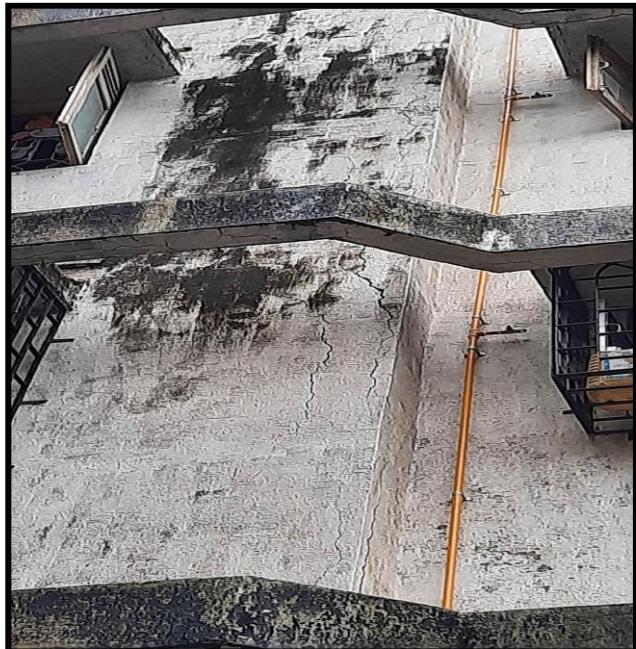
BACK SIDE

- ❖ Structural crack observed at several places on column & chajjas.
- ❖ Major crack observed at several places on wall.
- ❖ Vegetation growth observed at several places on wall.
- ❖ Algae observed at several places on wall.

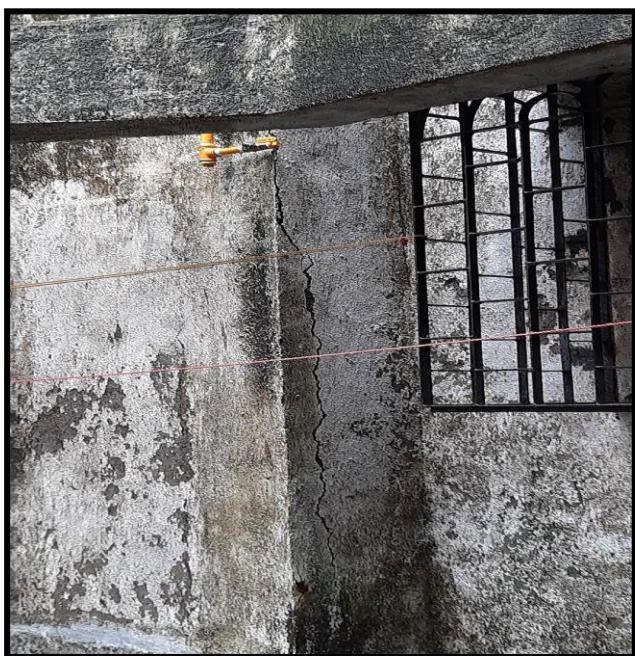
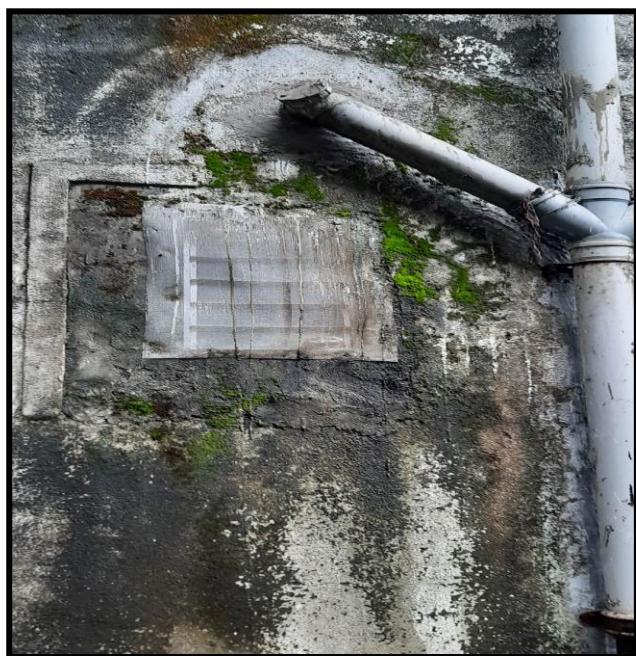
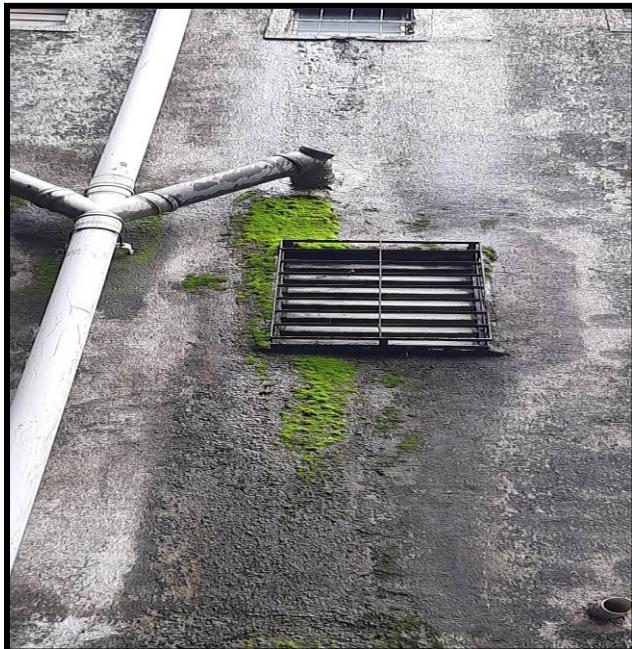
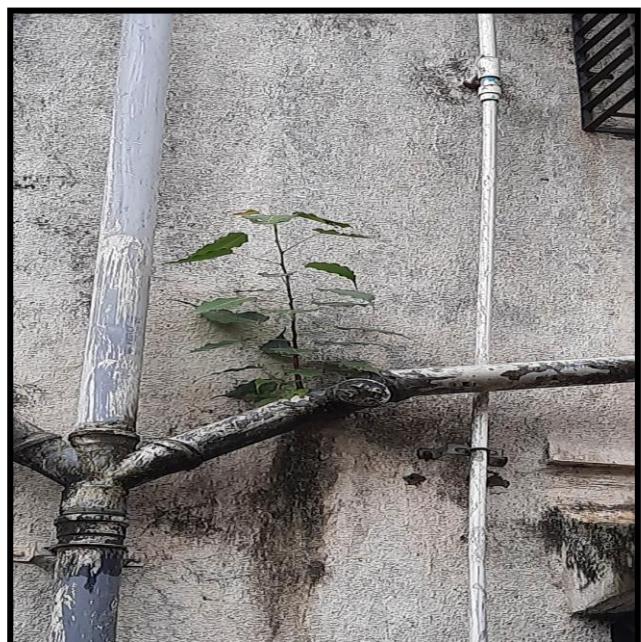
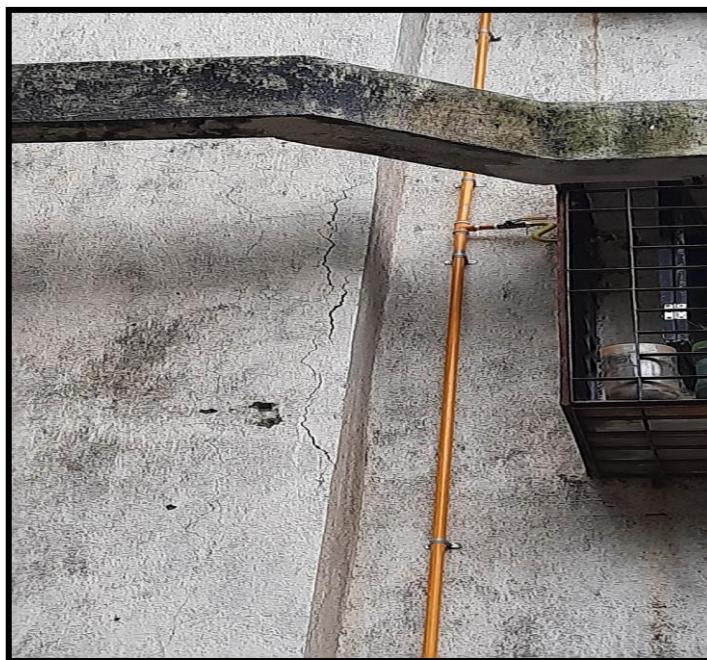
EAST SIDE

- ❖ Structural crack observed at several places on column.
- ❖ Vegetation growth observed at several places on wall.
- ❖ Algae observed at several places on wall.

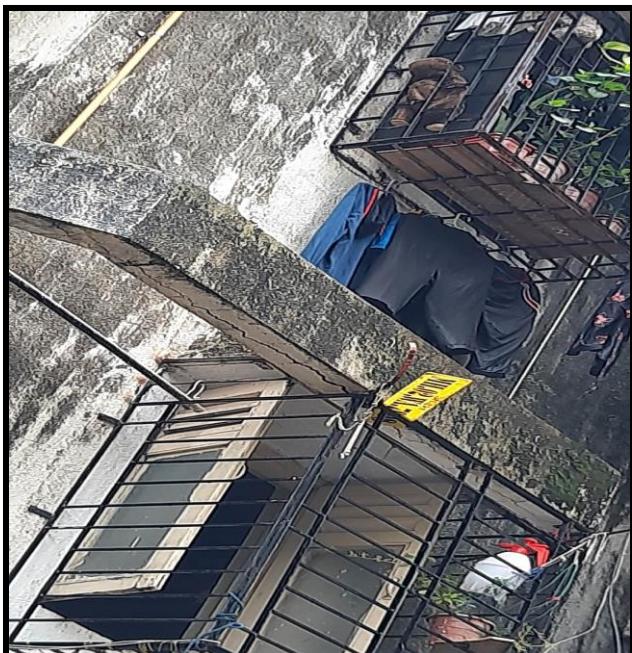
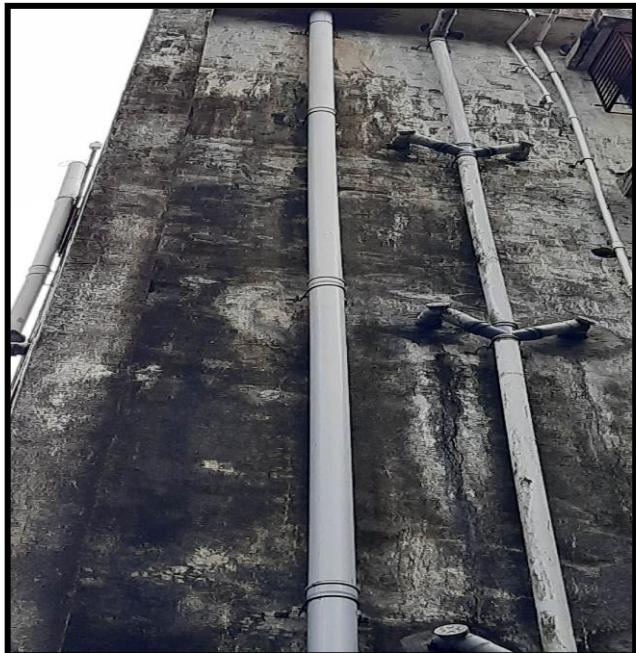
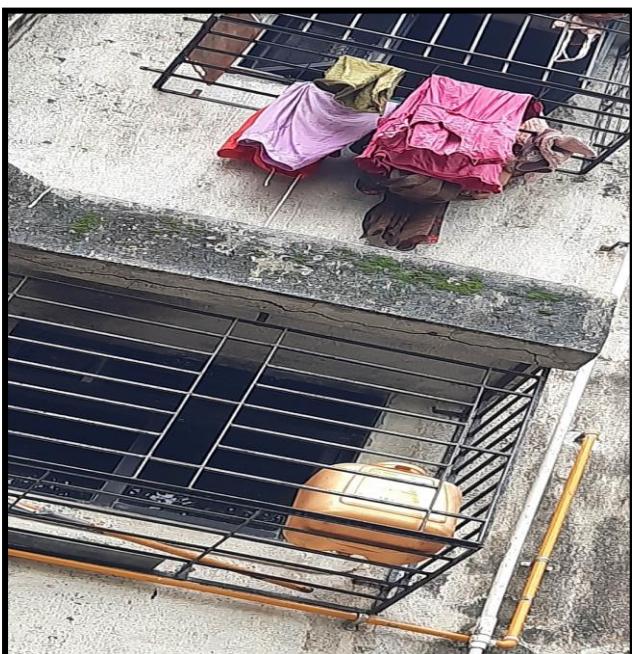
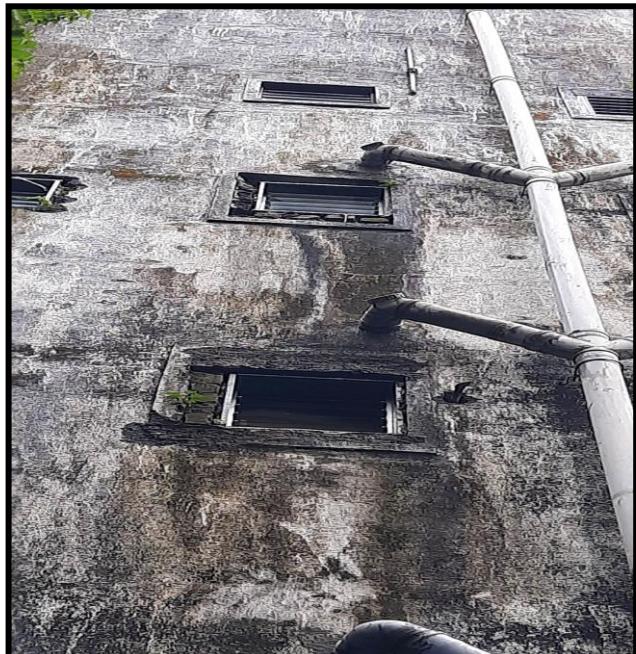
WEST SIDE

- ❖ Structural crack observed at several places on column & chajjas.
- ❖ Major crack observed at several places on wall.
- ❖ Vegetation growth observed at several places on wall.
- ❖ Algae observed at several places on wall.
