STRUCTURAL AUDIT REPORT
FOR
“VISHAL SAHYADRI CO – OP HSG. SOC. LTD”,
“B4 – WING”
SITUATED AT
SAHYADRI NAGAR, CHARKOP,
KANDIVALI (W) MUMBAI – 400 067

978/B4/LSS/2021

JULY 19, 2021

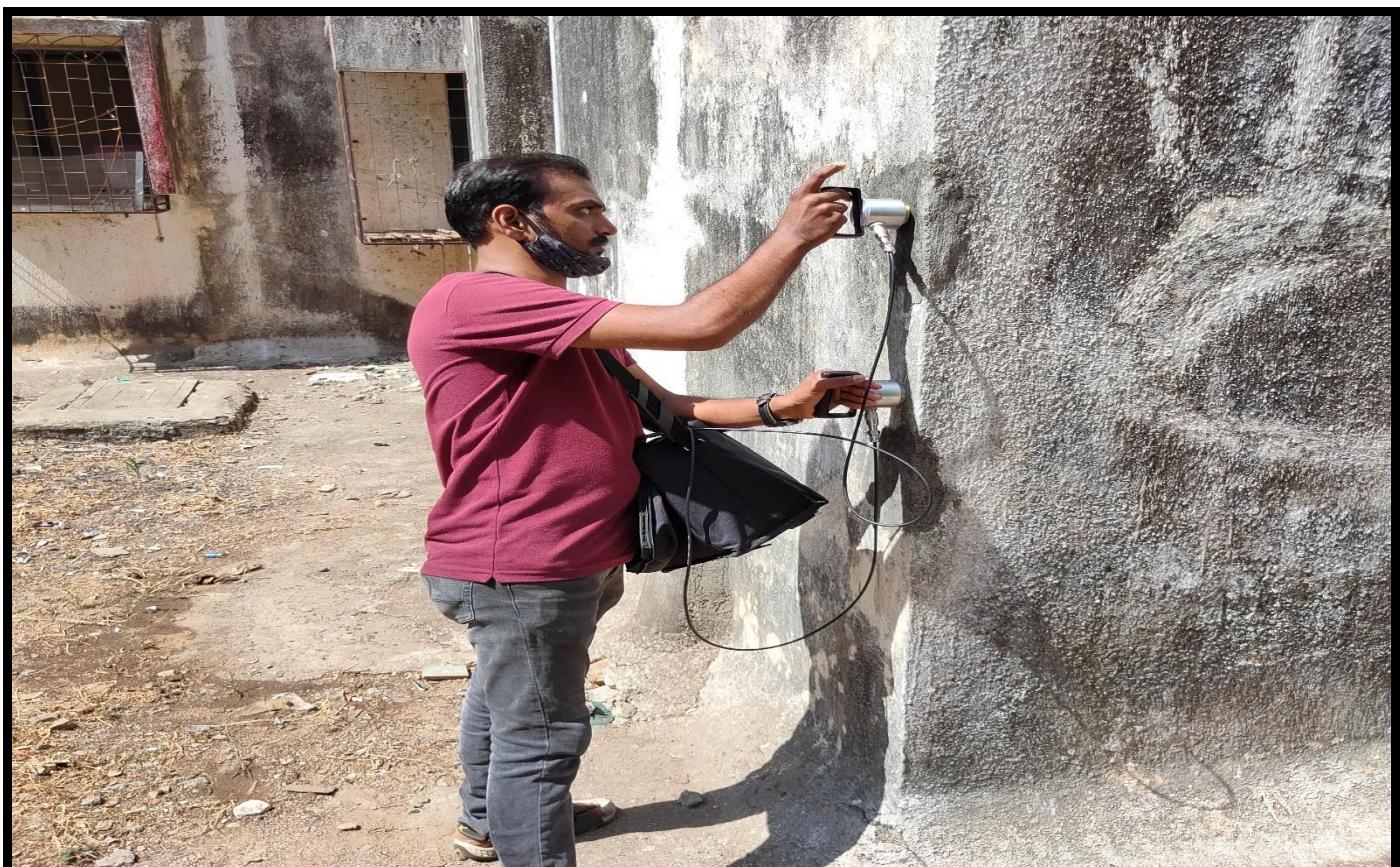
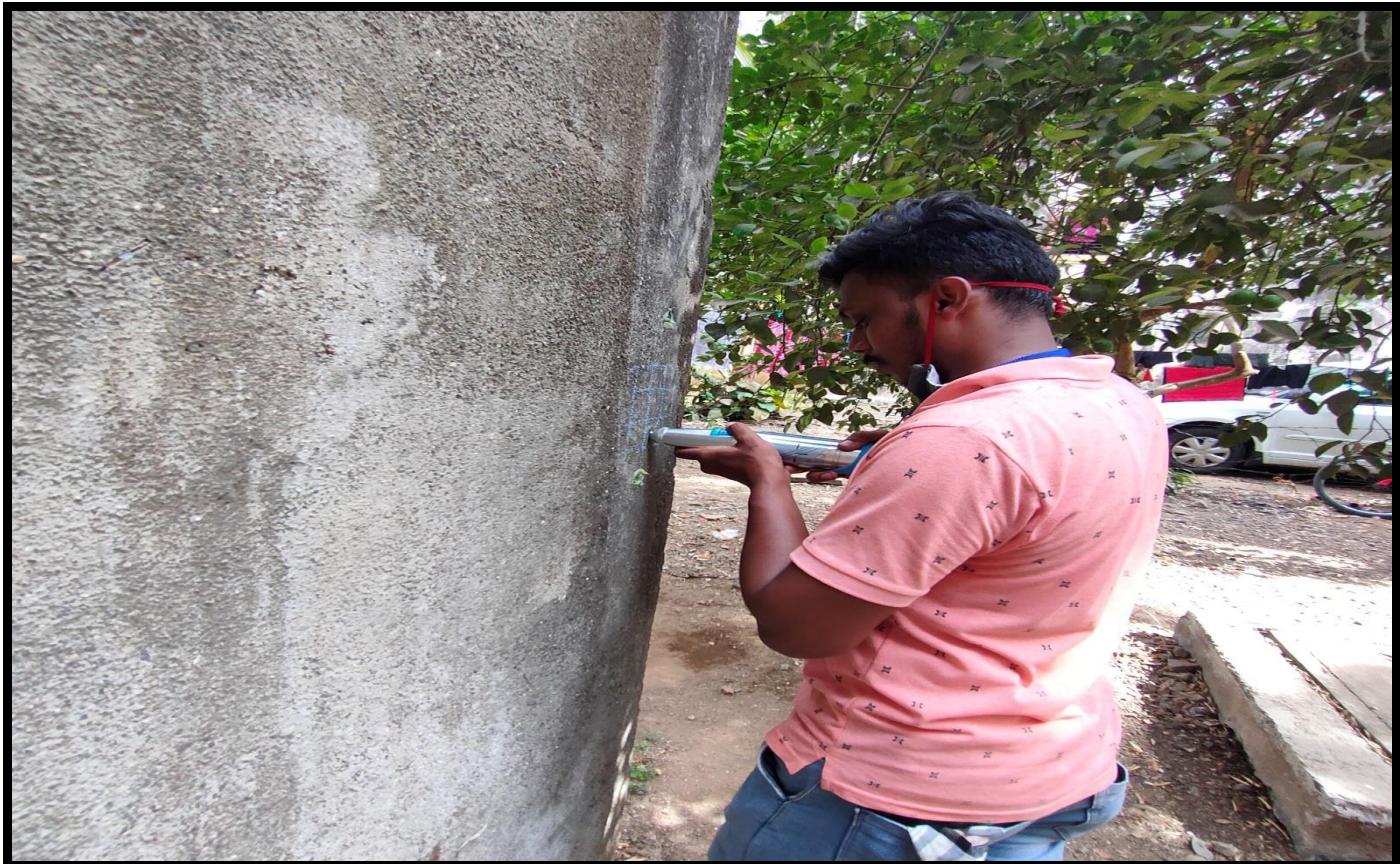
NON -DESTRUCTIVE TEST PHOTO

Rebound Hammer was tested for compressive strength at surface by Schmidt rebound hammer. Results indicate the compressive strength at surface of all the RCC columns is ranging between 11.40 MPa to 14.90 MPa.

The UPV values are ranging between 1.60 Km/Sec to 2.80 Km/Sec.

Out of 4 locations all 4 locations was below 3.0 Km/Sec means concrete quality is poor.

This indicates there are progressive internal cracks in the RCC members due to corrosion of reinforced steel. These members are under distress condition.

Half Cell Potential tested for corrosion activity by half – cell potential tests. Values are taken on Column. The result on tested column is – 378 mV.

This indicates the probability of corrosion is 90% on tested column steel reinforcement.

Carbonation test was conducted to assess carbonation depth. Readings are taken on Column. Result indicates the carbonation penetration depth is 45.00 mm. Carbonation depths have reached to the reinforcement level in all of the RCC elements. It is essential to give a suitable anti-corrosion treatment to all the RCC members to stop further carbonation and corrosion of concrete.

RCC elements indicating UPV values less than 3 Km/sec needs immediate attention.

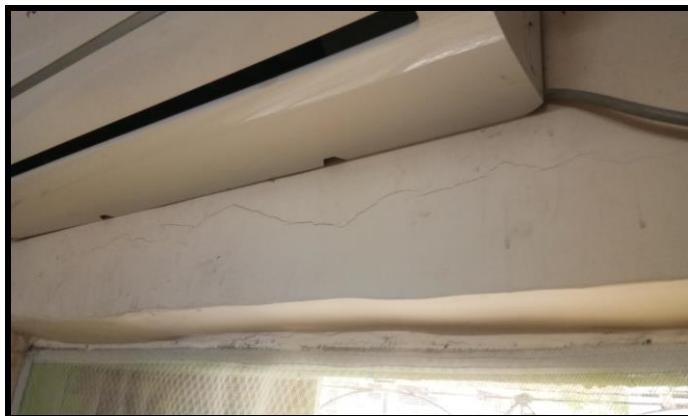
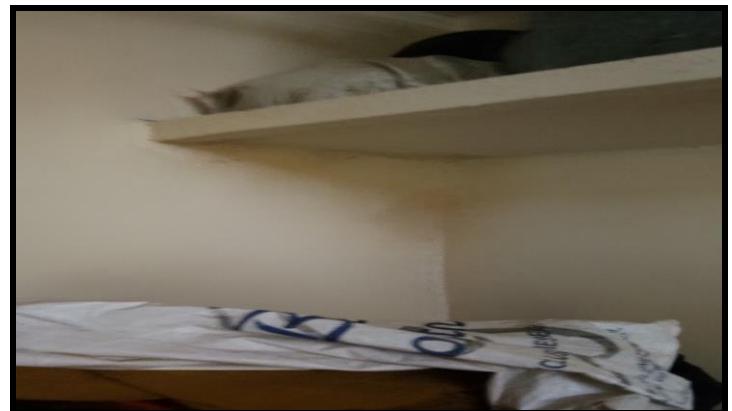
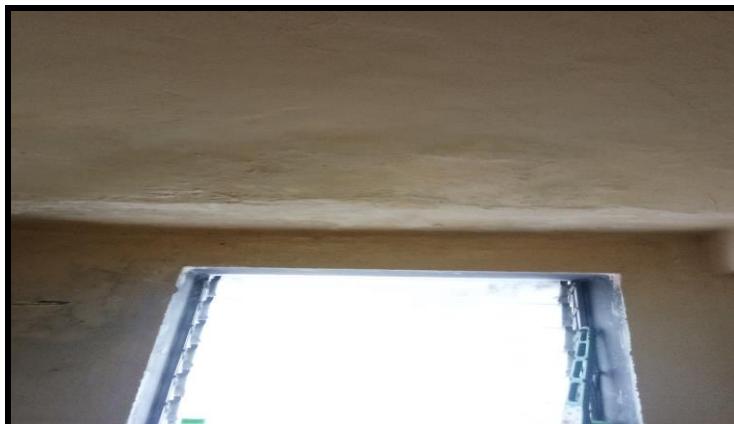
FLAT NO – 02

- ❖ **HALL** – Structural crack observed on beam.
 - Seepage mark observed on wall.
 - Peeling of paint observed on ceiling.
- ❖ **KITCHEN** – Seepage mark observed on wall.
 - Peeling of paint observed on ceiling.
 - Leakage mark observed on ceiling.
- ❖ **PASSAGE** – Dampness observed on ceiling.
- ❖ **TOILET & BATH ROOM** – Dampness observed on ceiling.

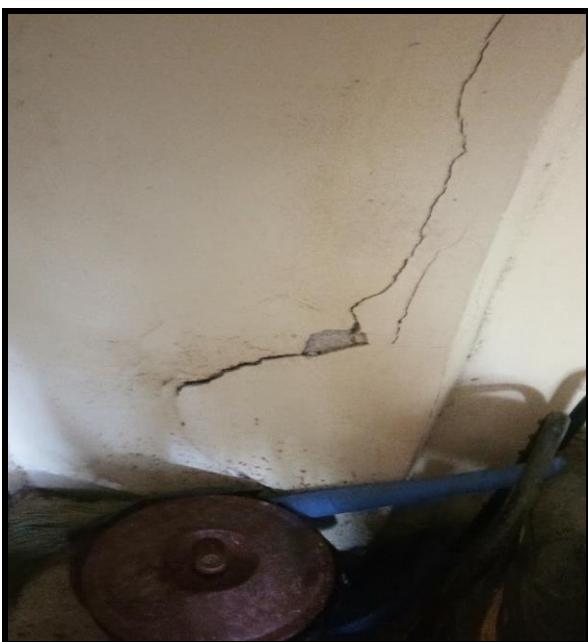
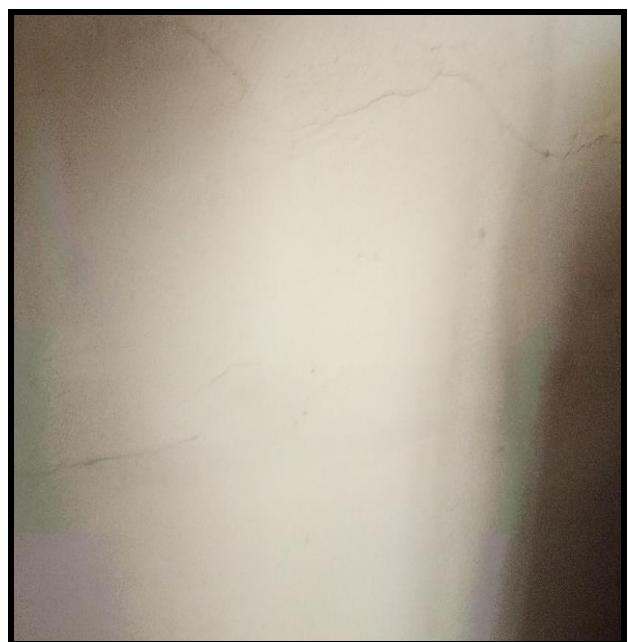
FLAT NO - 04

- ❖ **HALL** – Major Structural crack observed on beam.
 - Structural crack observed on column. (**It may fall**)
 - Hallow sound observed on wall. (**It may fall**)
- ❖ **KITCHEN** – Crack observed on beam. (**It may fall**)
 - Hallow sound observed on wall. (**It may fall**)
 - Leakage mark observed on ceiling.
 - Ceiling gets damage. (**It may fall**)
- ❖ **PASSAGE** – Hallow sound observed on wall. (**It may fall**)
 - Dampness observed on ceiling
- ❖ **TOILET & BATH ROOM** – Dampness observed on various wall.

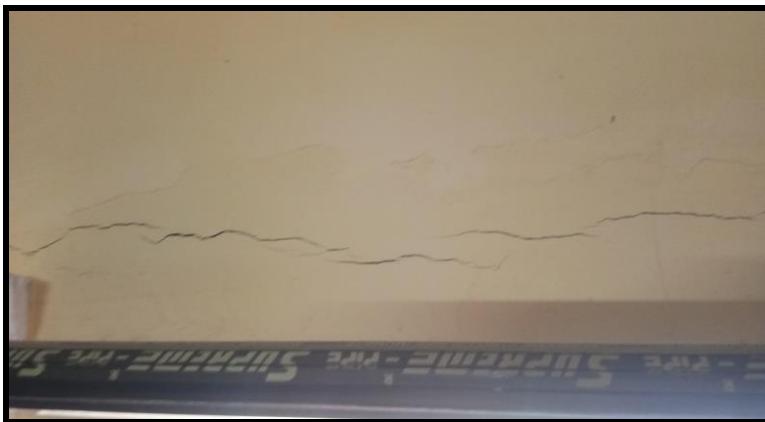
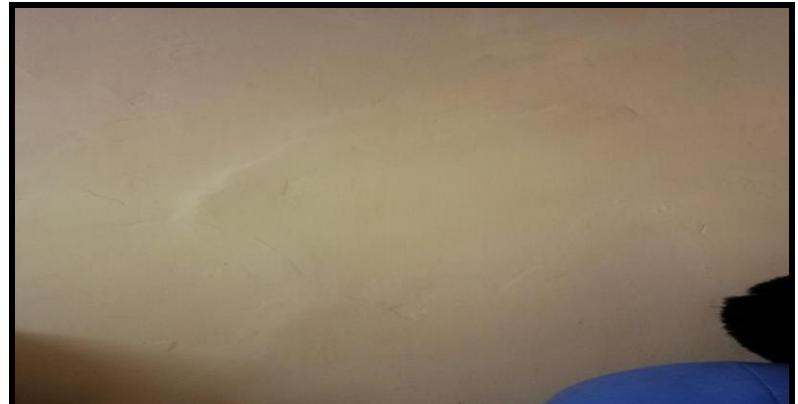
FLAT NO – 10

- ❖ **HALL** – Hallow sound observed on wall.
 - ❖ Structural crack observed on beam.
- ❖ **KITCHEN** – Peeling of paint observed on ceiling.
- ❖ **PASSAGE** – Dampness observed on various wall
- ❖ **TOILET & BATH ROOM** – Seepage mark observed on wall.

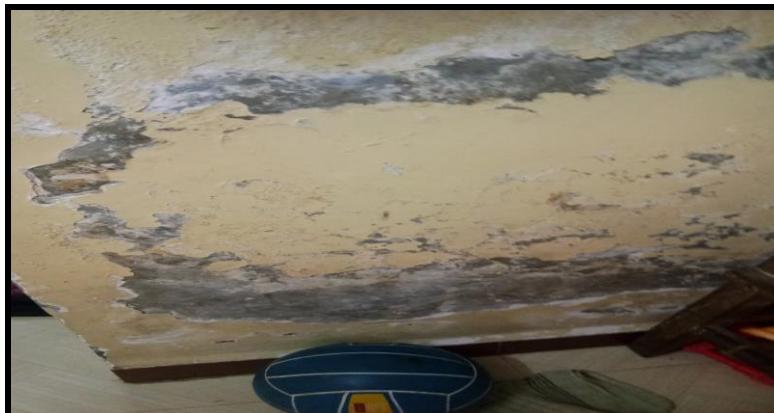
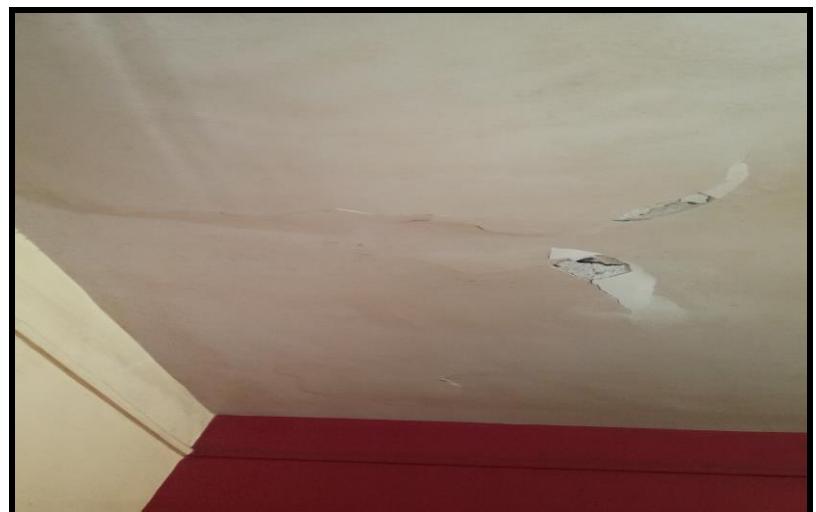
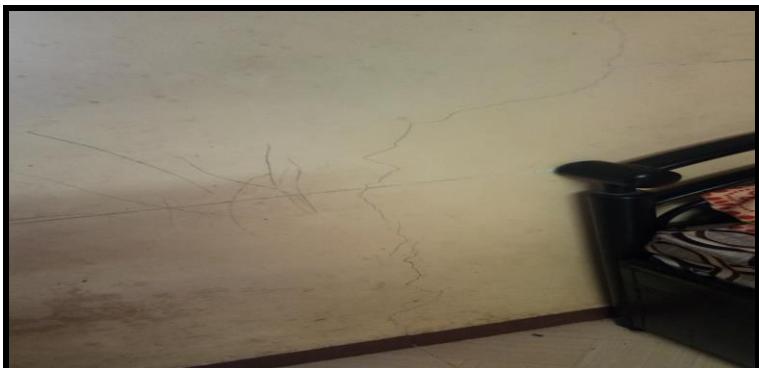
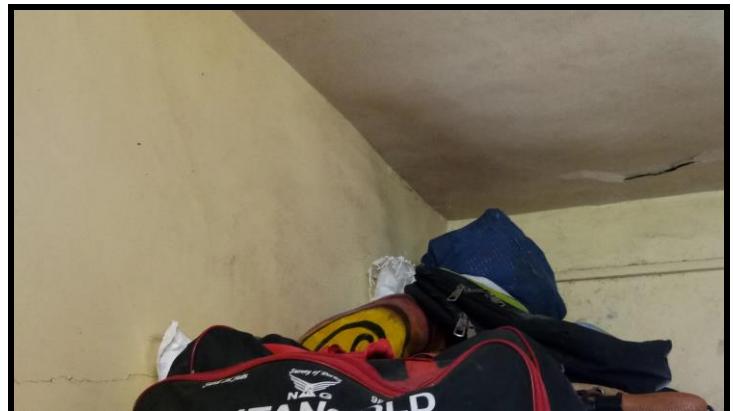
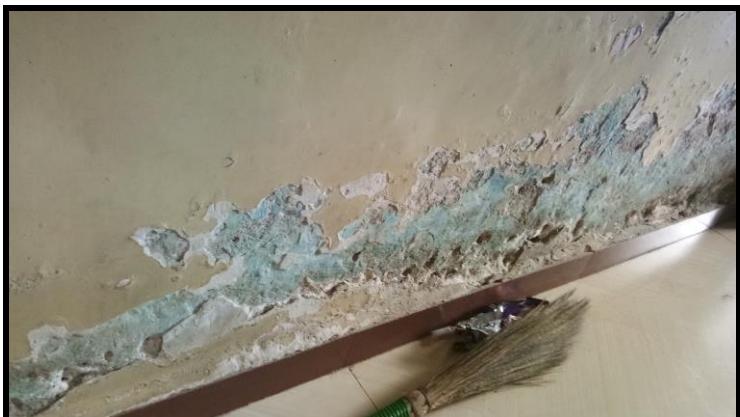
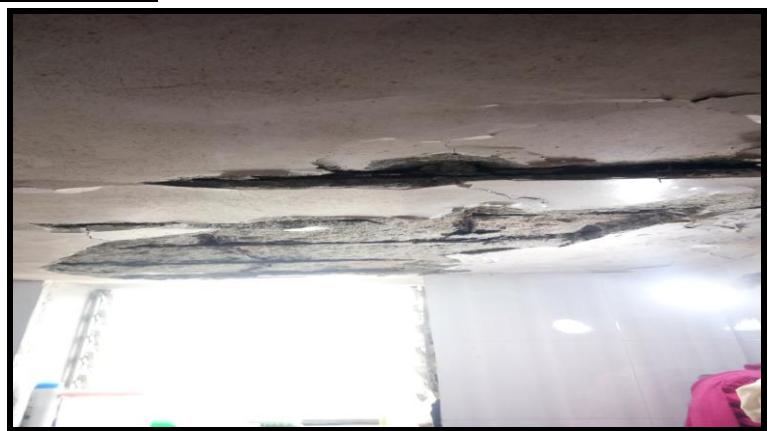
FLAT NO – 26

- ❖ **HALL** – Structural crack observed on beam. (**It may fall**)
- ❖ Ceiling gets damage. (**It may fall**)
- ❖ Hallow sound observed on wall. (**It may fall**)
- ❖ Seepage mark observed on wall.
- ❖ **KITCHEN** – Structural crack observed on wall.
- ❖ Peeling of paint observed on ceiling.
- ❖ **PASSAGE** – O.K.
- ❖ **TOILET & BATH ROOM** – Plaster gets removed and steel gets exposed. (**It may fall**)
- ❖ Seepage mark observed on wall.
- ❖ Structural crack observed on wall.

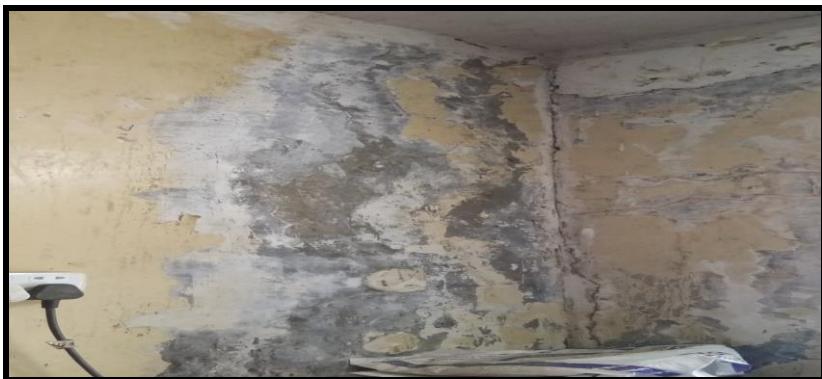
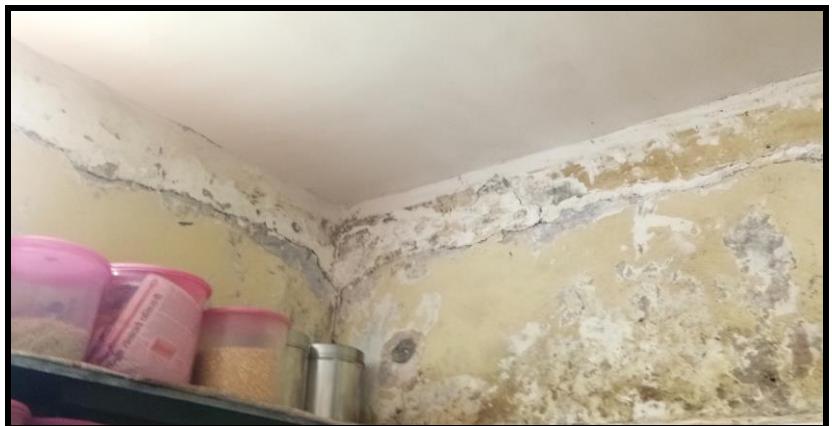
FLAT NO – 29

- ❖ **HALL** – O.K.
- ❖ **KITCHEN** – O.K.
- ❖ **PASSAGE** – O.K.
- ❖ **TOILET & BATH ROOM** – O.K.

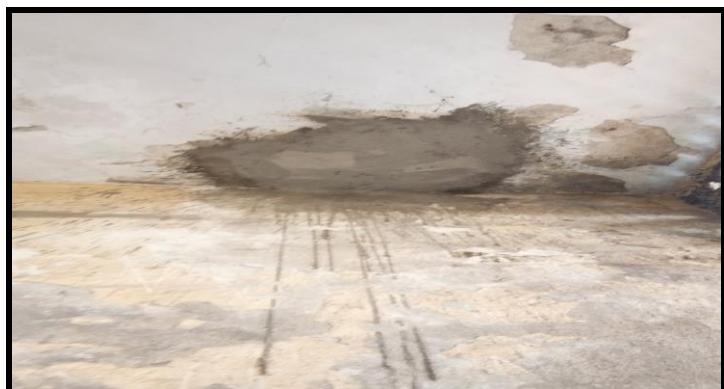
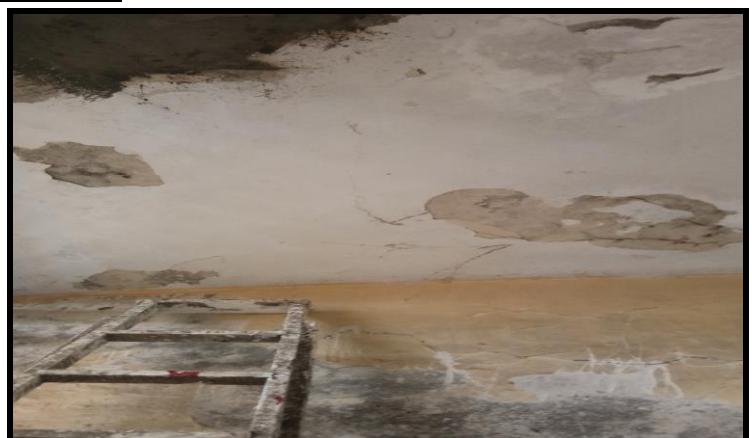
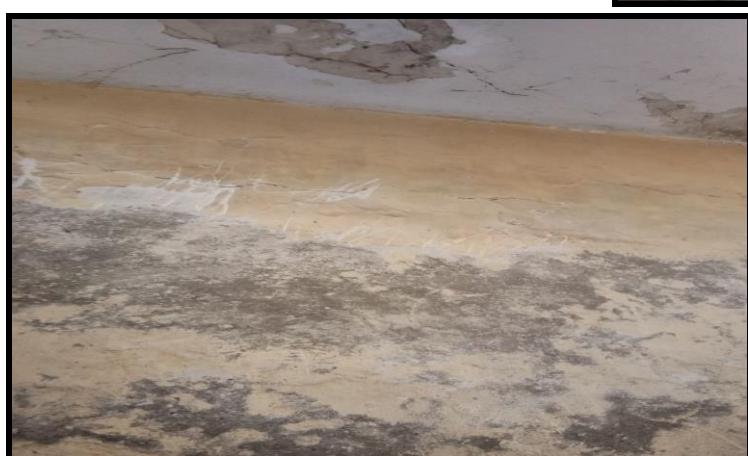
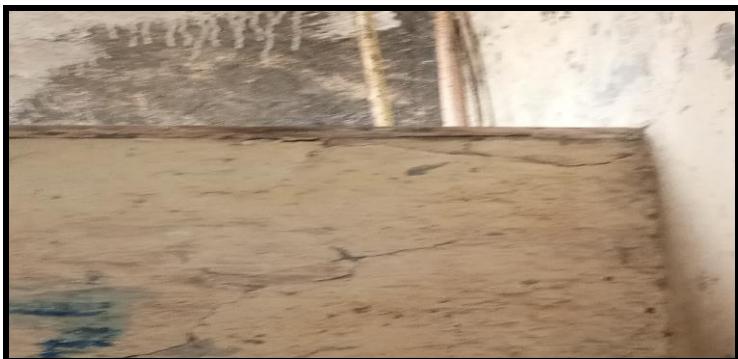
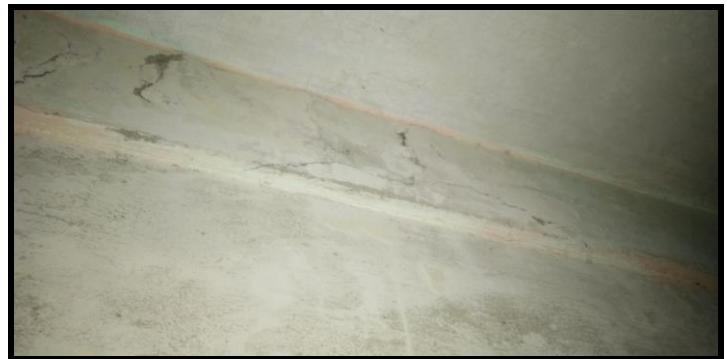
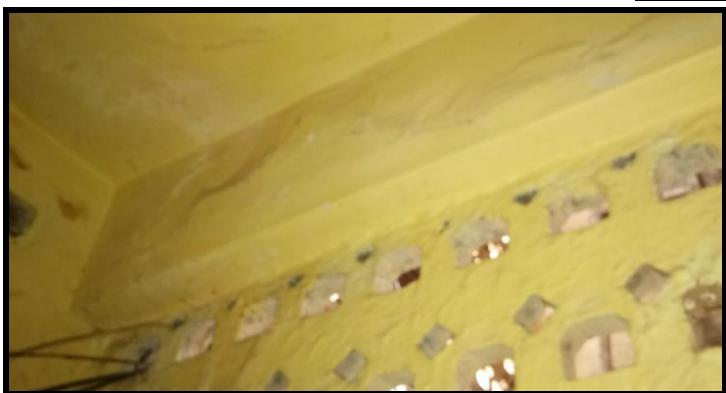
Terrace to fourth floor:-

- ❖ Patch work observed on ceiling.
- ❖ Plaster gets removes observed on wall.
- ❖ Major structural crack observed on wall.
- ❖ Hallow sound observed on wall.
- ❖ Seepage mark observed on wall.
- ❖ Algae formation observed on wall.

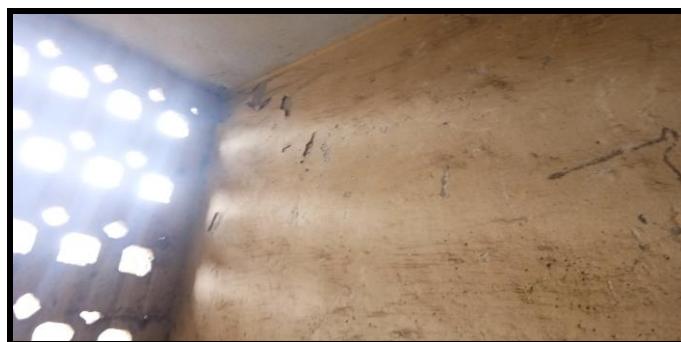
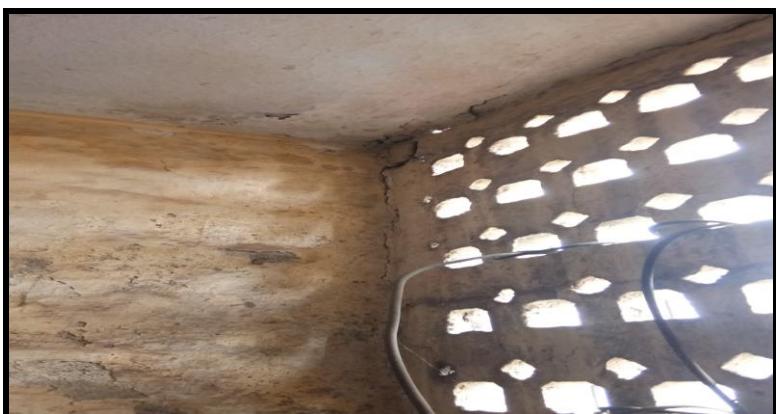
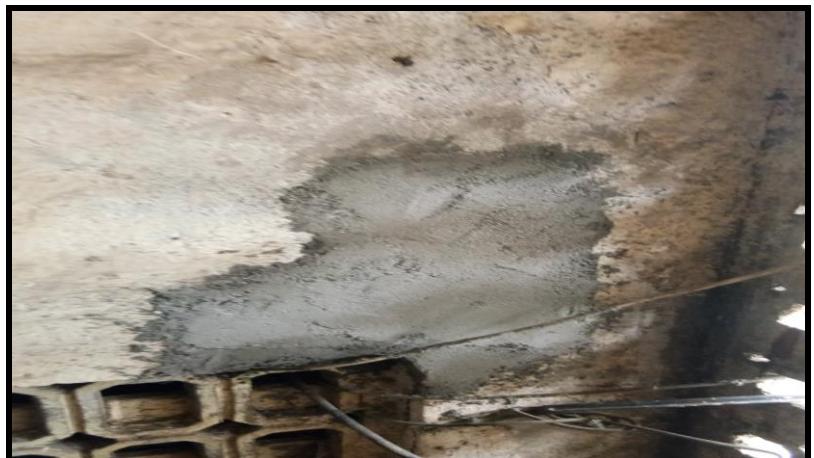
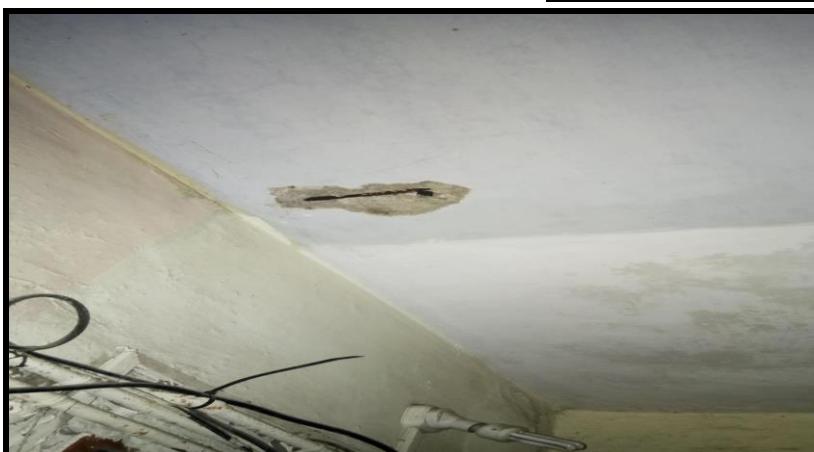
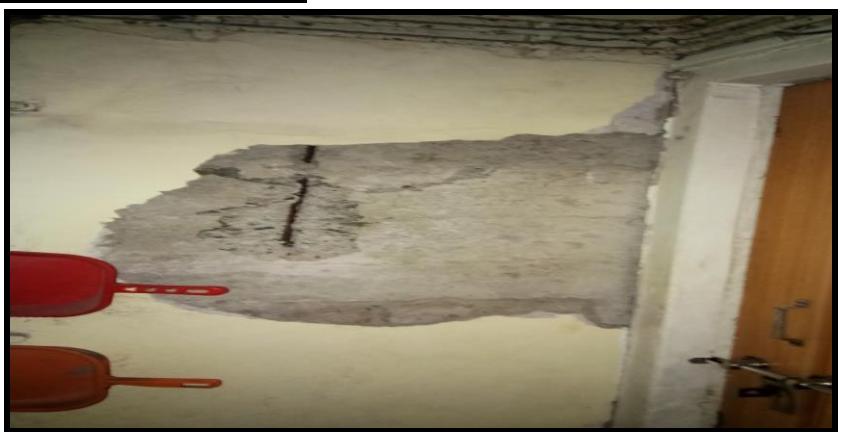
Fourth floor to Third floor:-

- ❖ Hallow sound observed on wall.
- ❖ Hallow sound observed on beam.
- ❖ Structural crack observed on beam.
- ❖ Plaster gets removed and steel gets corroded. (**It may fall**)

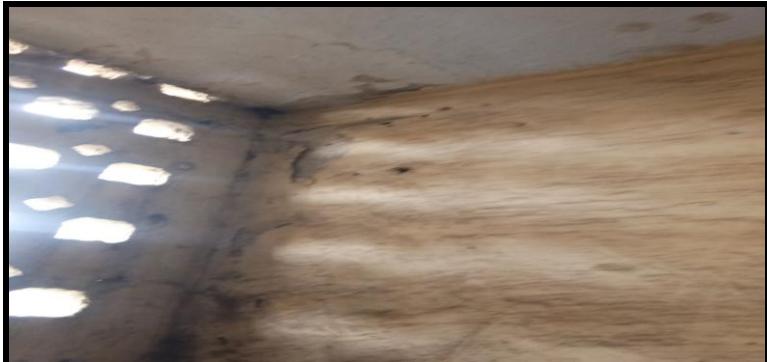
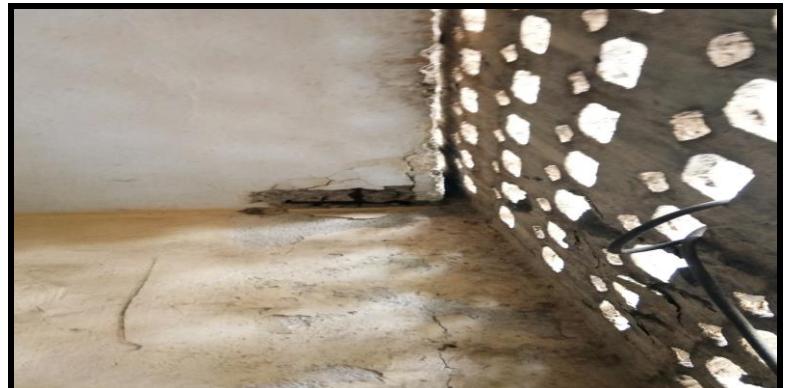
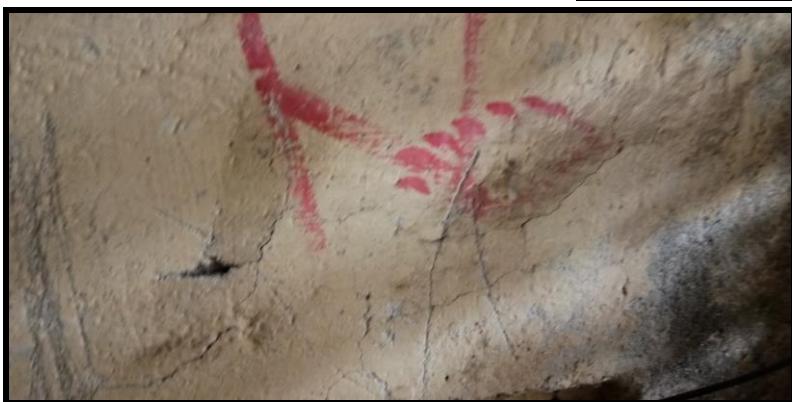
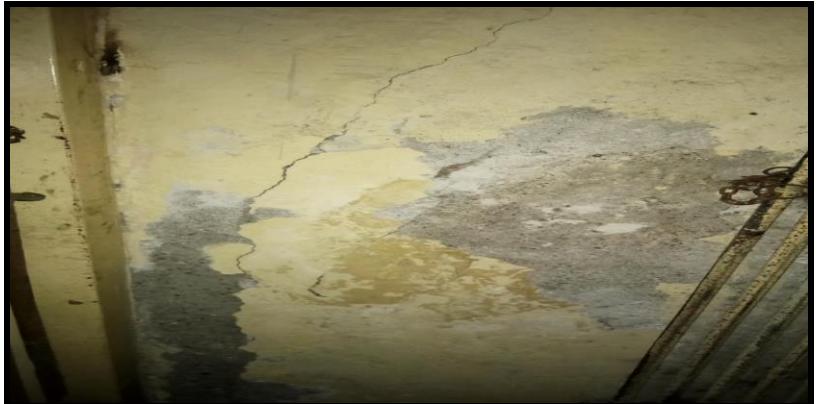
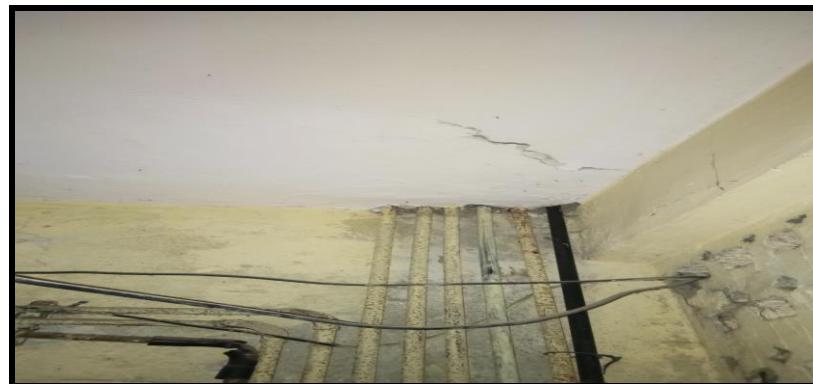
Third floor to Second floor:-

- ❖ Hallow sound observed on beam.
- ❖ Structural crack observed on beam.
- ❖ Plaster gets removed and steel gets corroded. (It may fall)

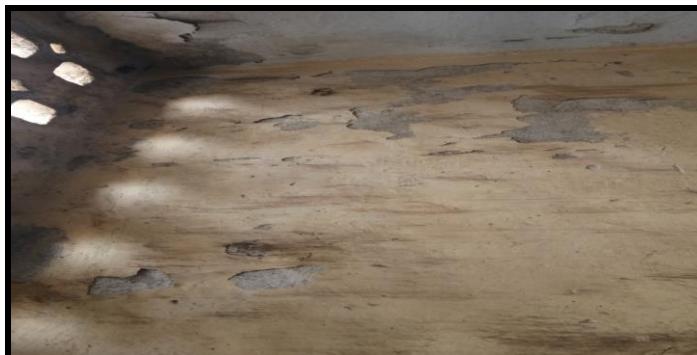
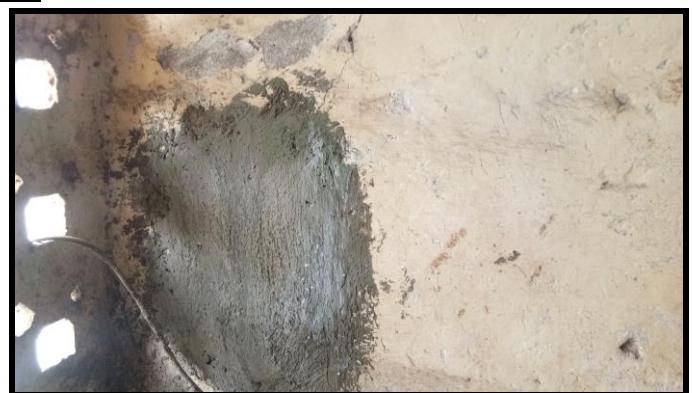
Second floor to First floor:-

- ❖ Hallow sound observed on beam.
- ❖ Seepage mark observed on wall.
- ❖ Algae formation observed on wall.
- ❖ Patch work observed on ceiling.

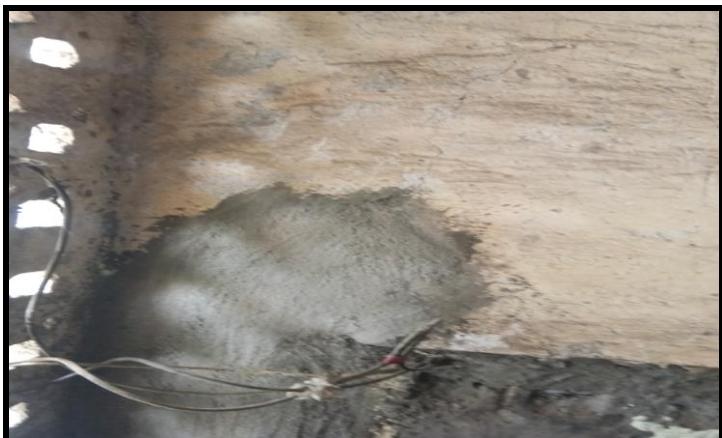
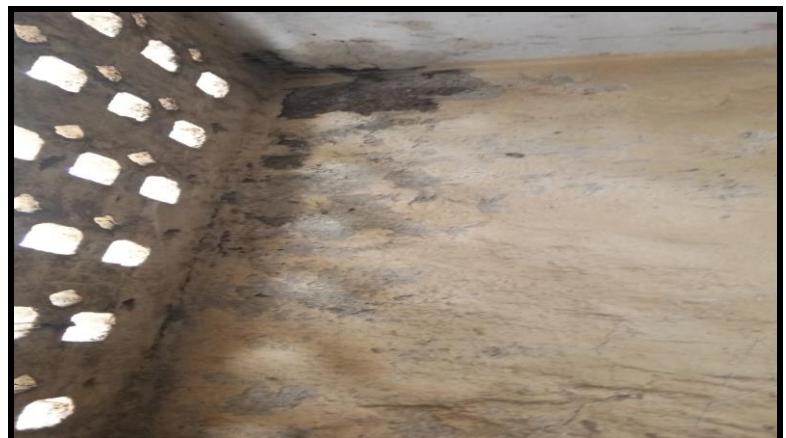
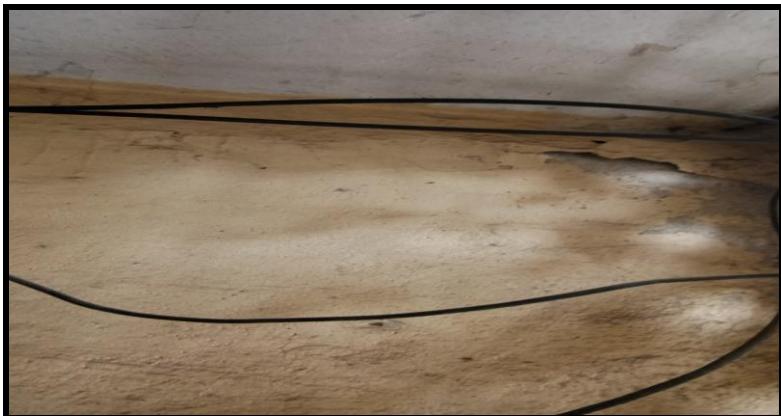
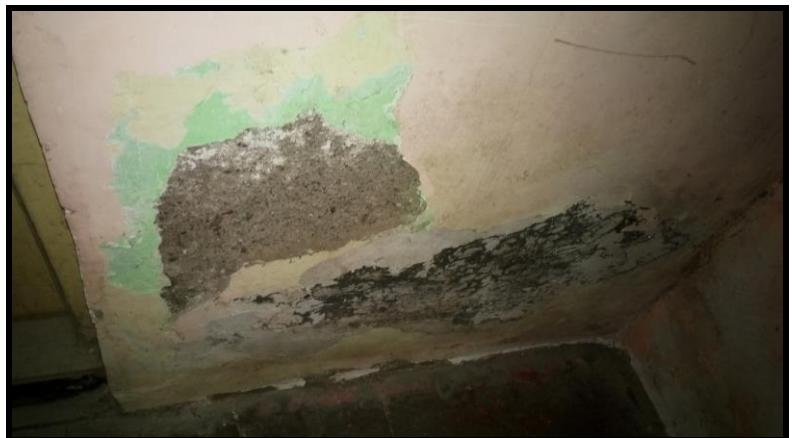
First floor to Ground floor:-

- ❖ Hallow sound observed on beam.
- ❖ Seepage mark observed on wall.
- ❖ Patch work observed on ceiling.
- ❖ Peeling of paint observed on ceiling.
- ❖ Structural crack observed on column.

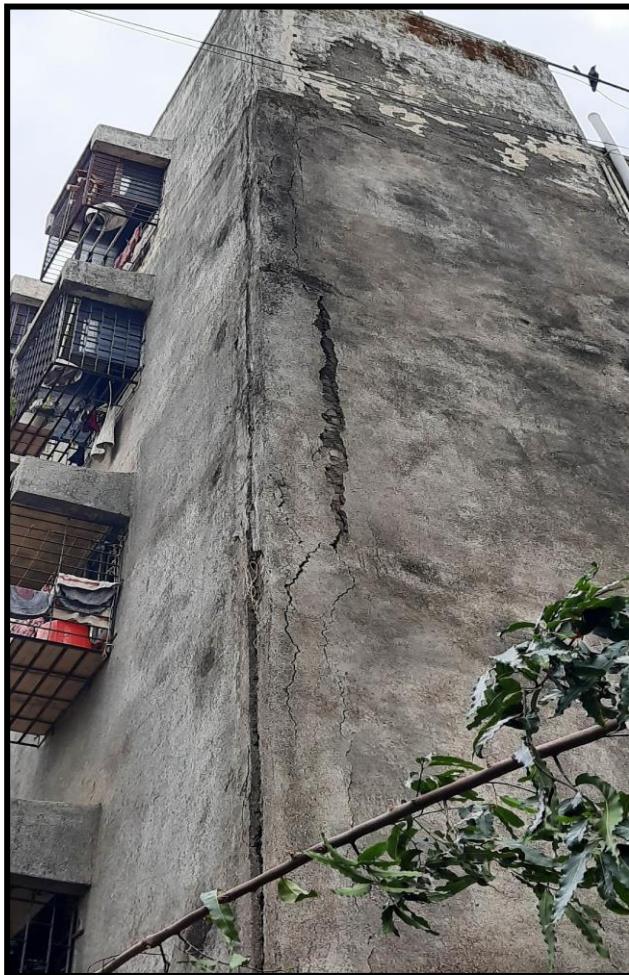
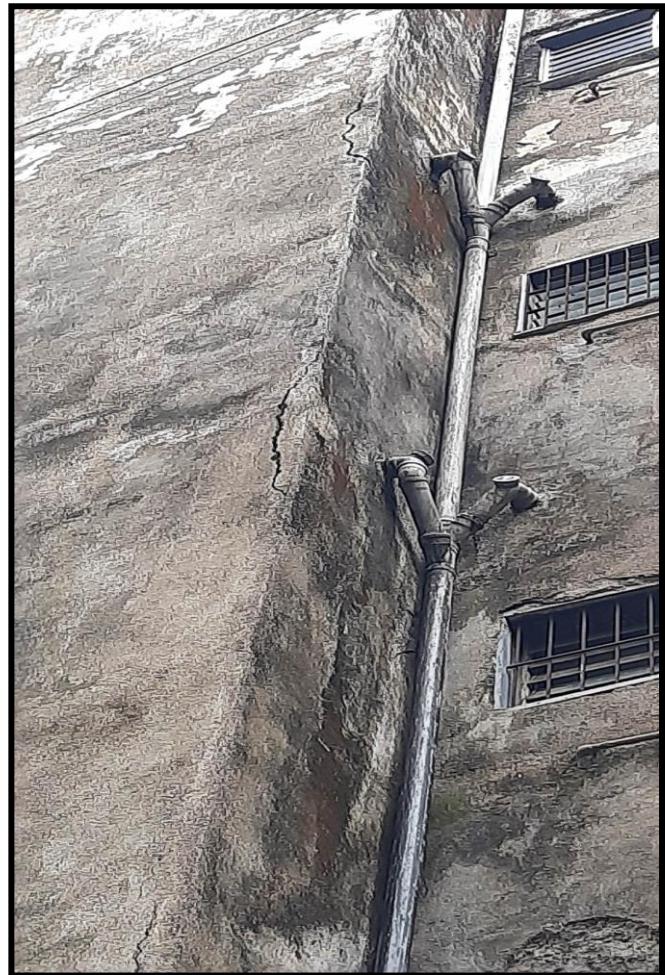
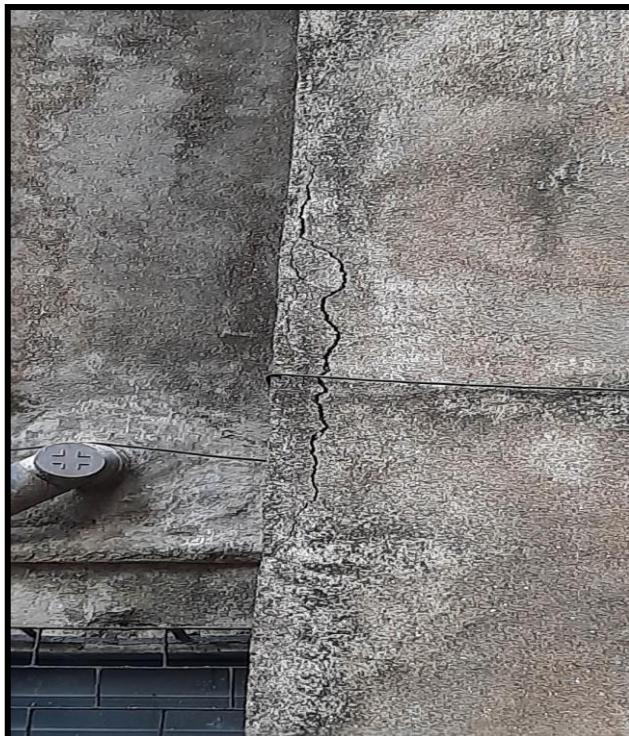
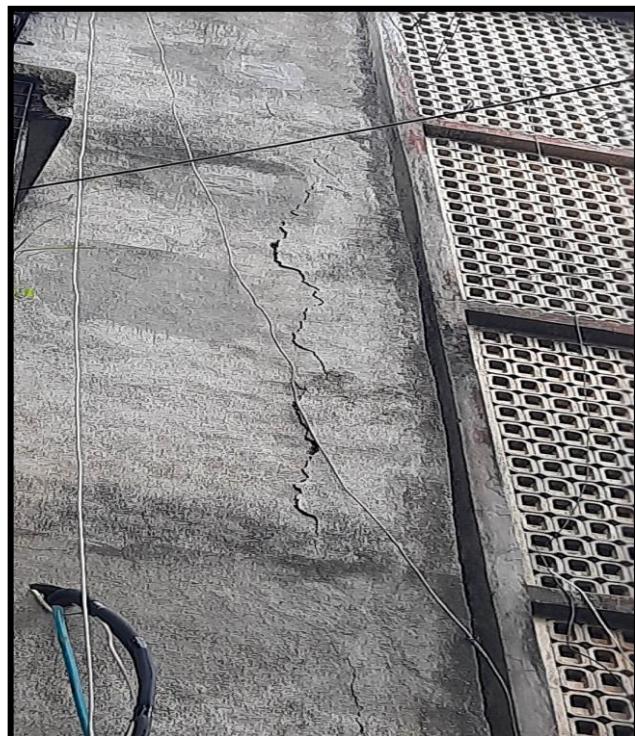
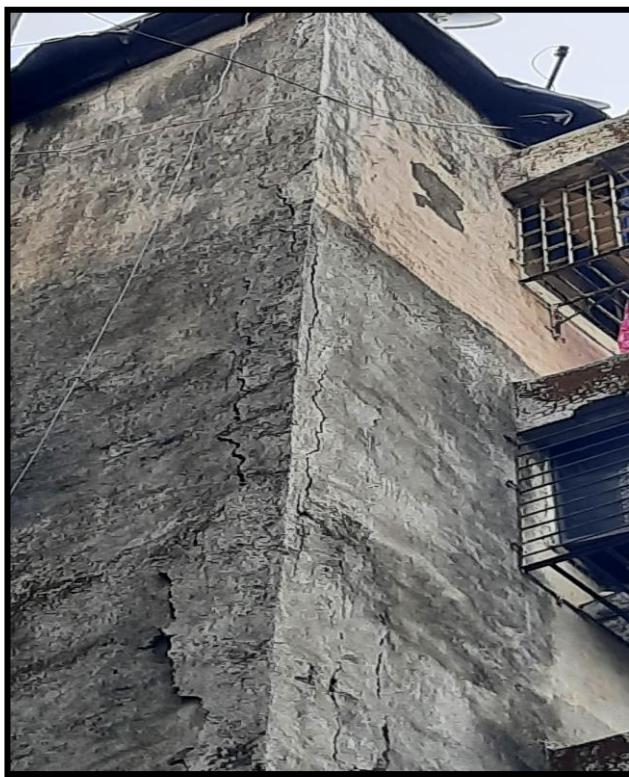
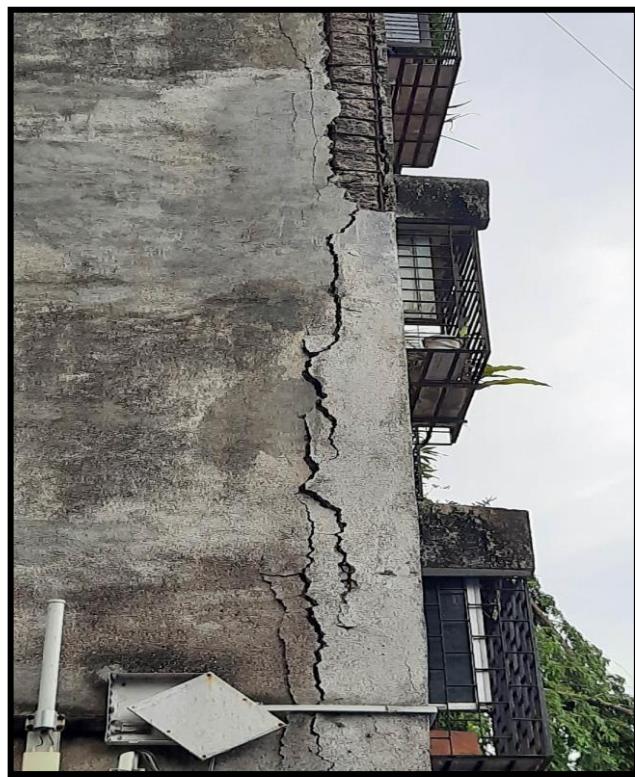
FRONT SIDE

- ❖ Structural crack observed at several places on column.
- ❖ Major crack observed at several places on wall.
- ❖ Vegetation growth observed at several places on wall.
- ❖ Column & chajja plaster get damaged & steel get exposed & corroded.

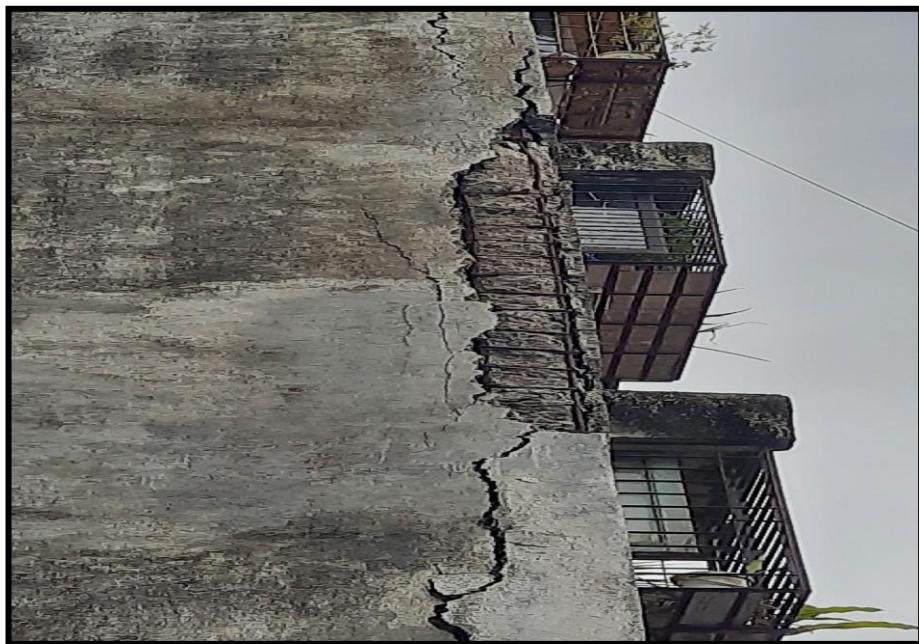
BACK SIDE

- ❖ Structural crack observed at several places on column.
- ❖ Major crack observed at several places on wall.
- ❖ Vegetation growth observed at several places on wall.
- ❖ Column & chajja plaster get damaged & steel get exposed & corroded.

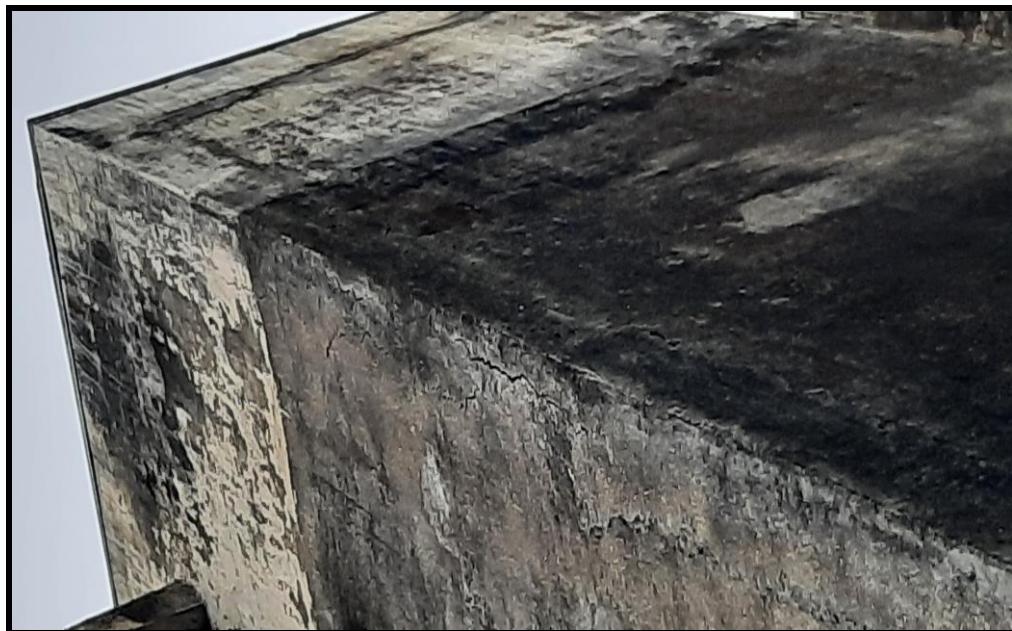
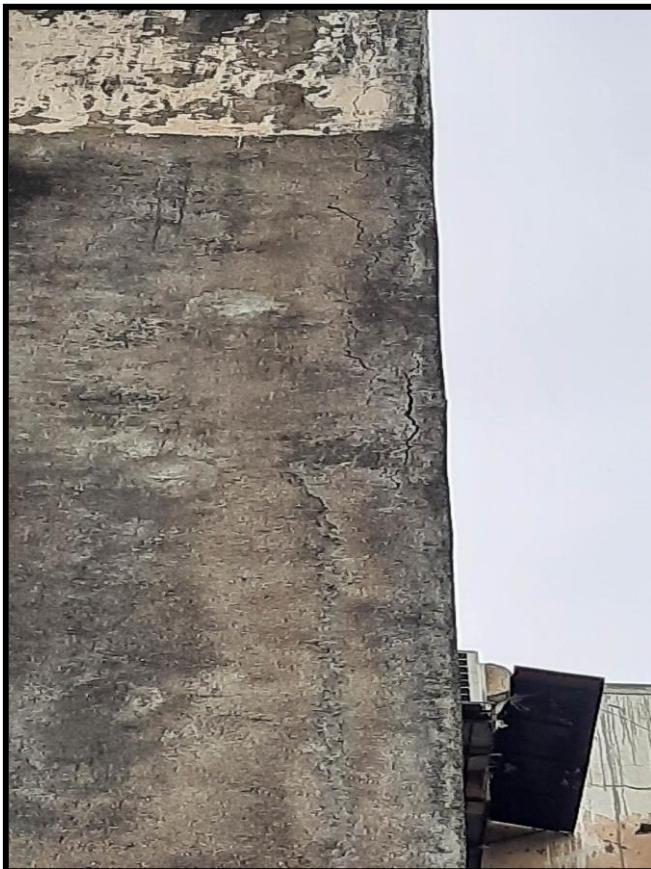
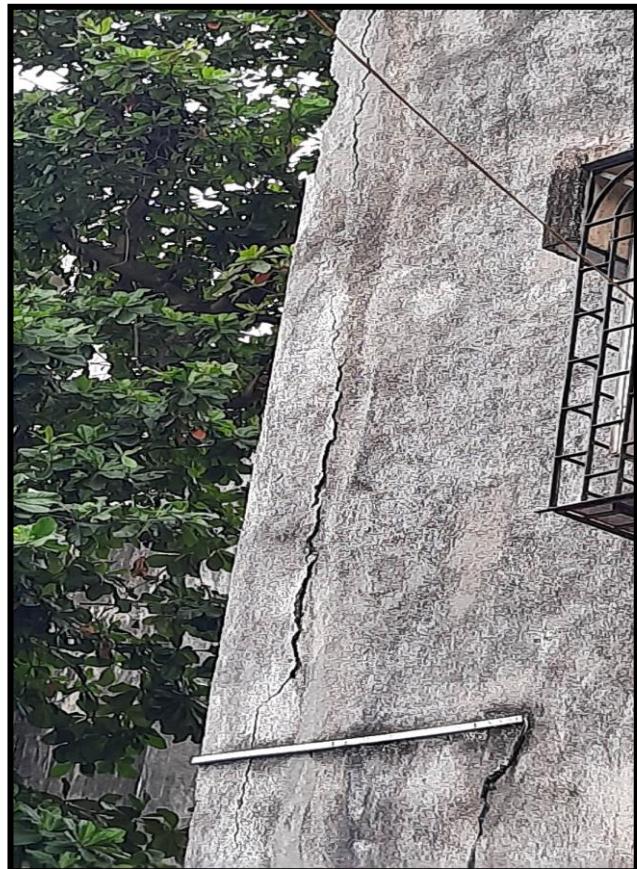
NORTH SIDE

- ❖ Structural crack observed at several places on column.
- ❖ Major crack observed at several places on wall.
- ❖ Vegetation growth observed at several places on wall.
- ❖ Column & chajja plaster get damaged & steel get exposed & corroded.
