STRUCTURAL AUDIT REPORT
FOR
“VISHAL SAHYADRI CO – OP HSG. SOC. LTD”,
“B4 – WING”
SITUATED AT
SAHYADRI NAGAR, CHARKOP,
KANDIVALI (W) MUMBAI – 400 067

978/B4/LSS/2021

JULY 19, 2021

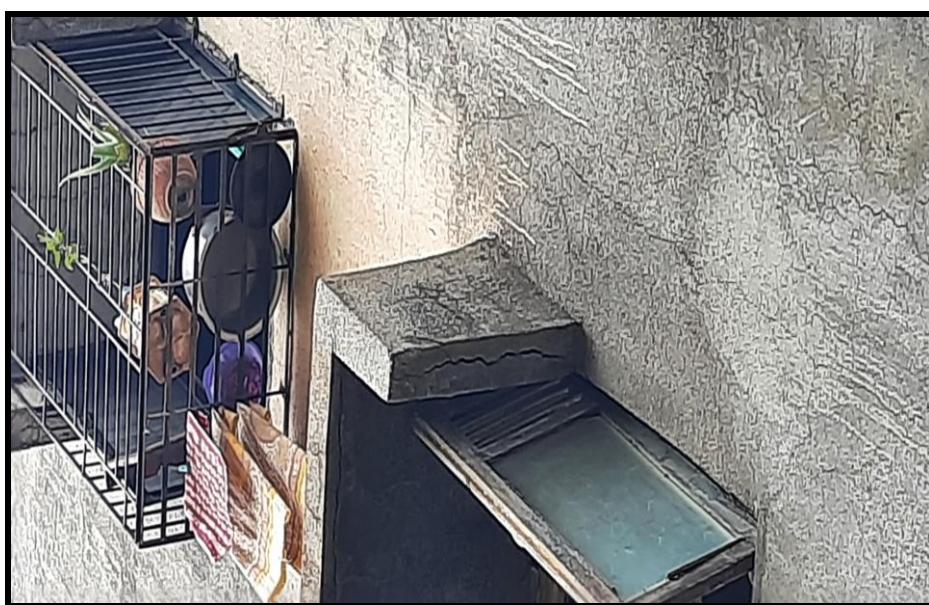
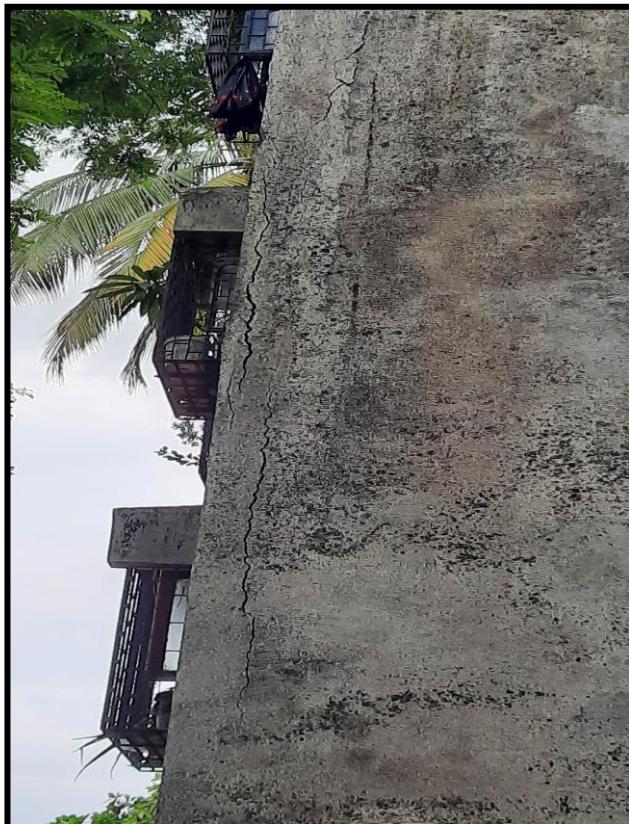
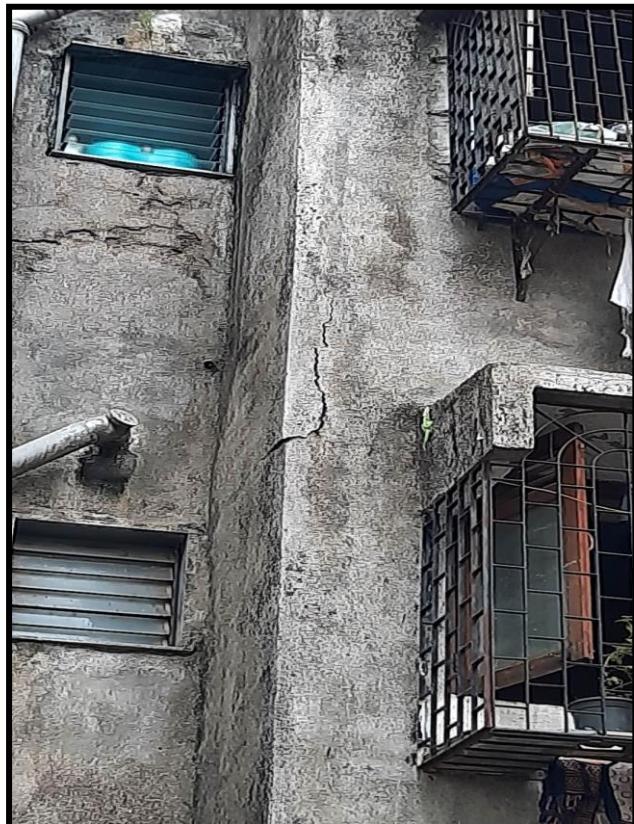
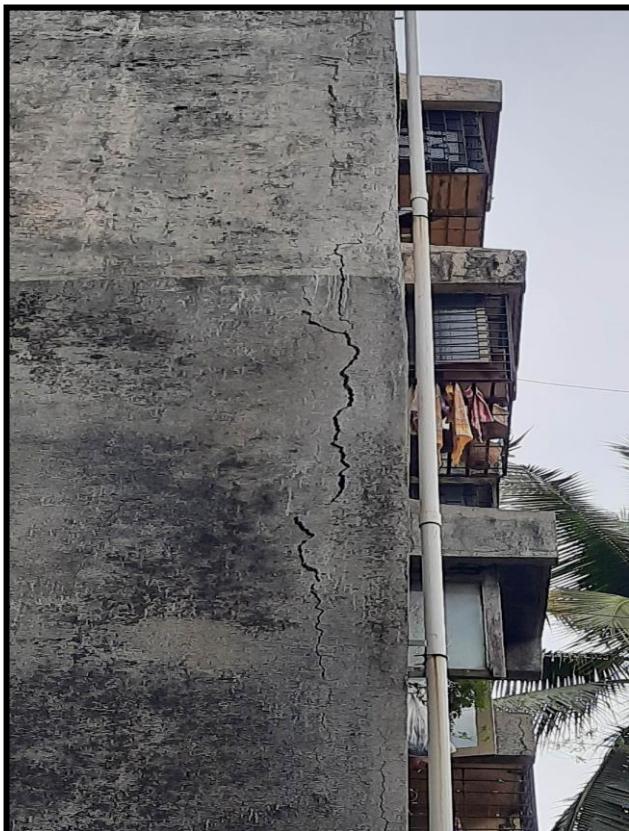
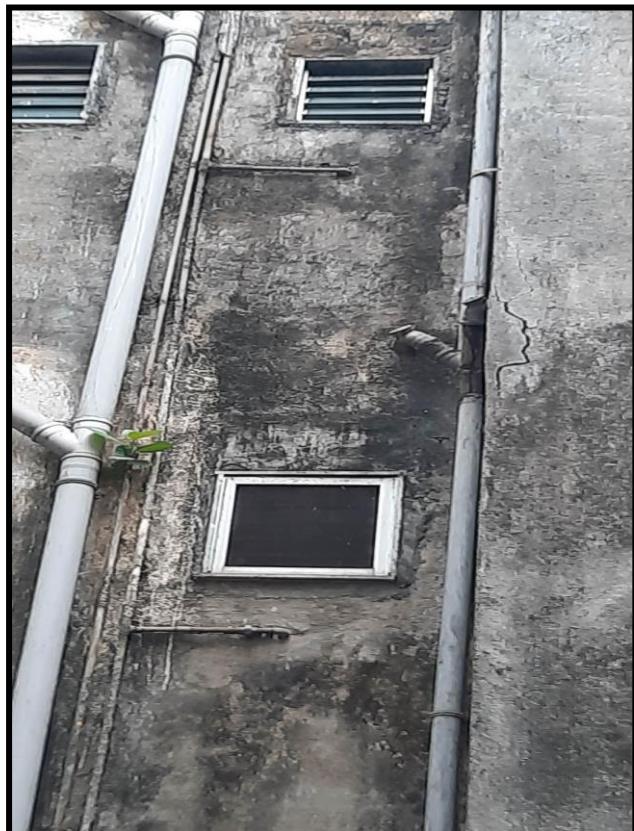
SOUTH SIDE

- ❖ Structural crack observed at several places on column.
- ❖ Major crack observed at several places on wall.
- ❖ Vegetation growth observed at several places on wall.
- ❖ Column & chajja plaster get damaged & steel get exposed & corroded.
