STRUCTURAL AUDIT REPORT
FOR
“VISHAL SAHYADRI CO – OP HSG. SOC. LTD”,
“B9 – WING”
SITUATED AT
SAHYADRI NAGAR, CHARKOP,
KANDIVALI (W) MUMBAI – 400 067

978/B9/LSS/2021

JULY 24, 2021

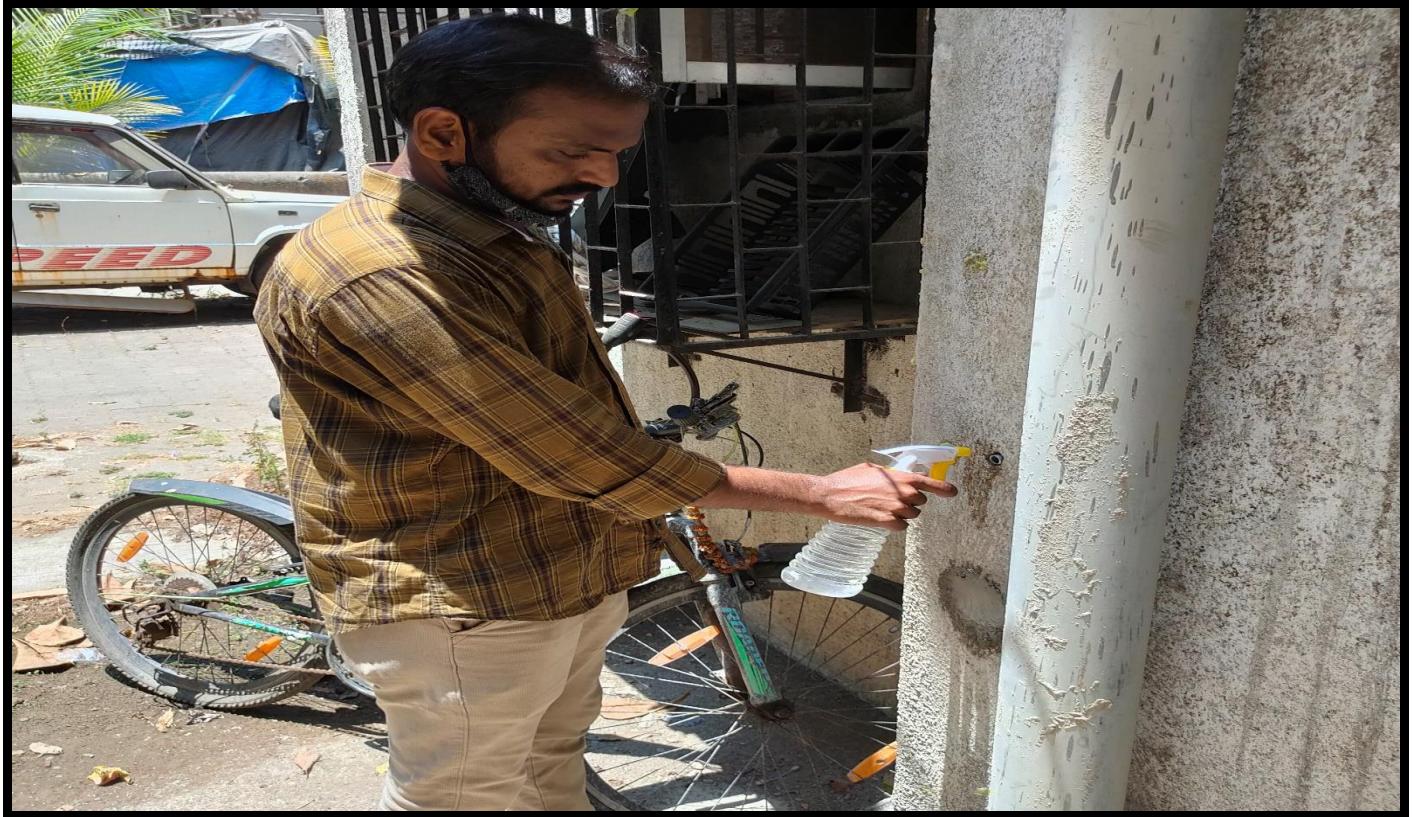
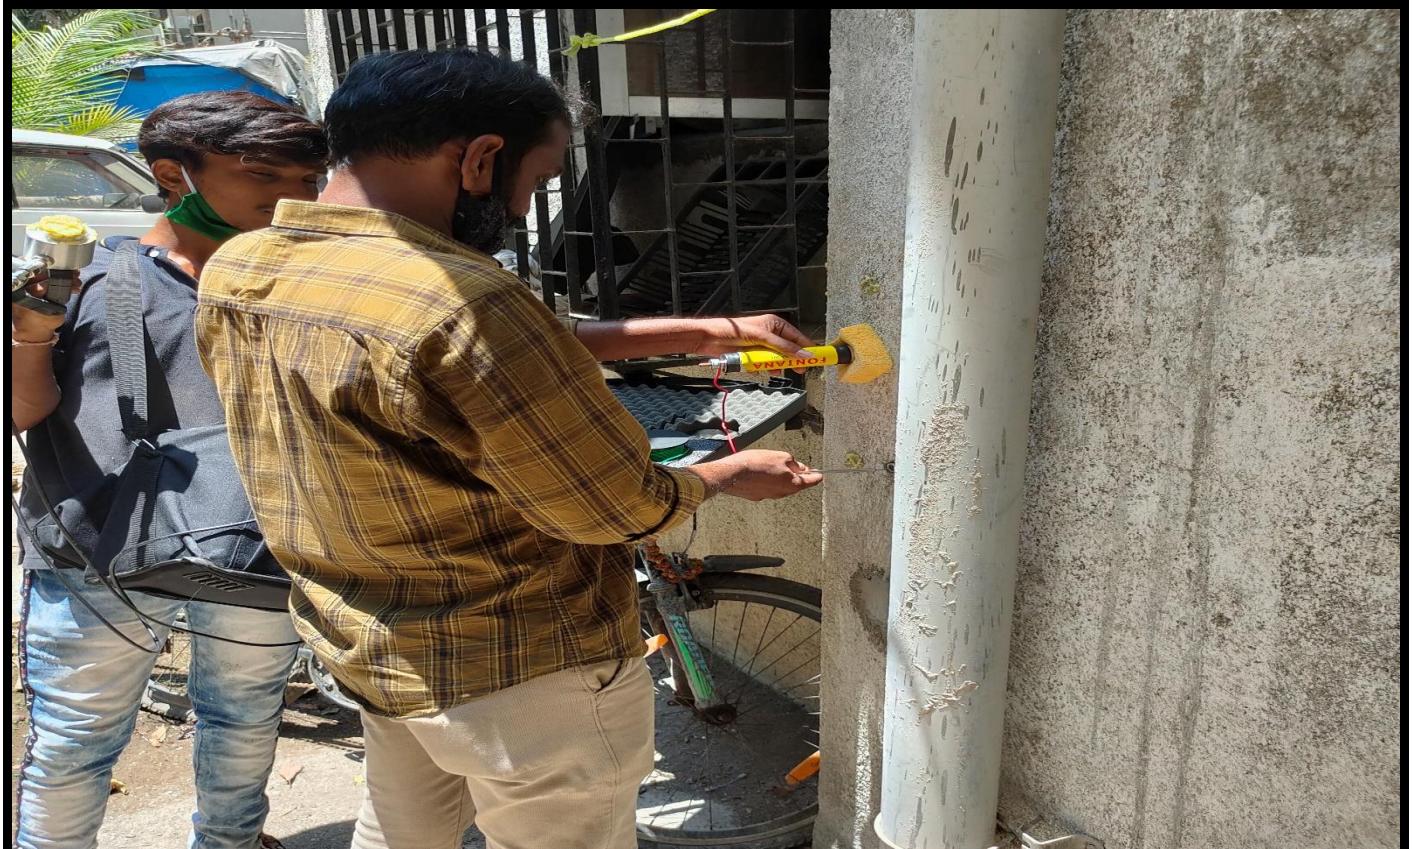
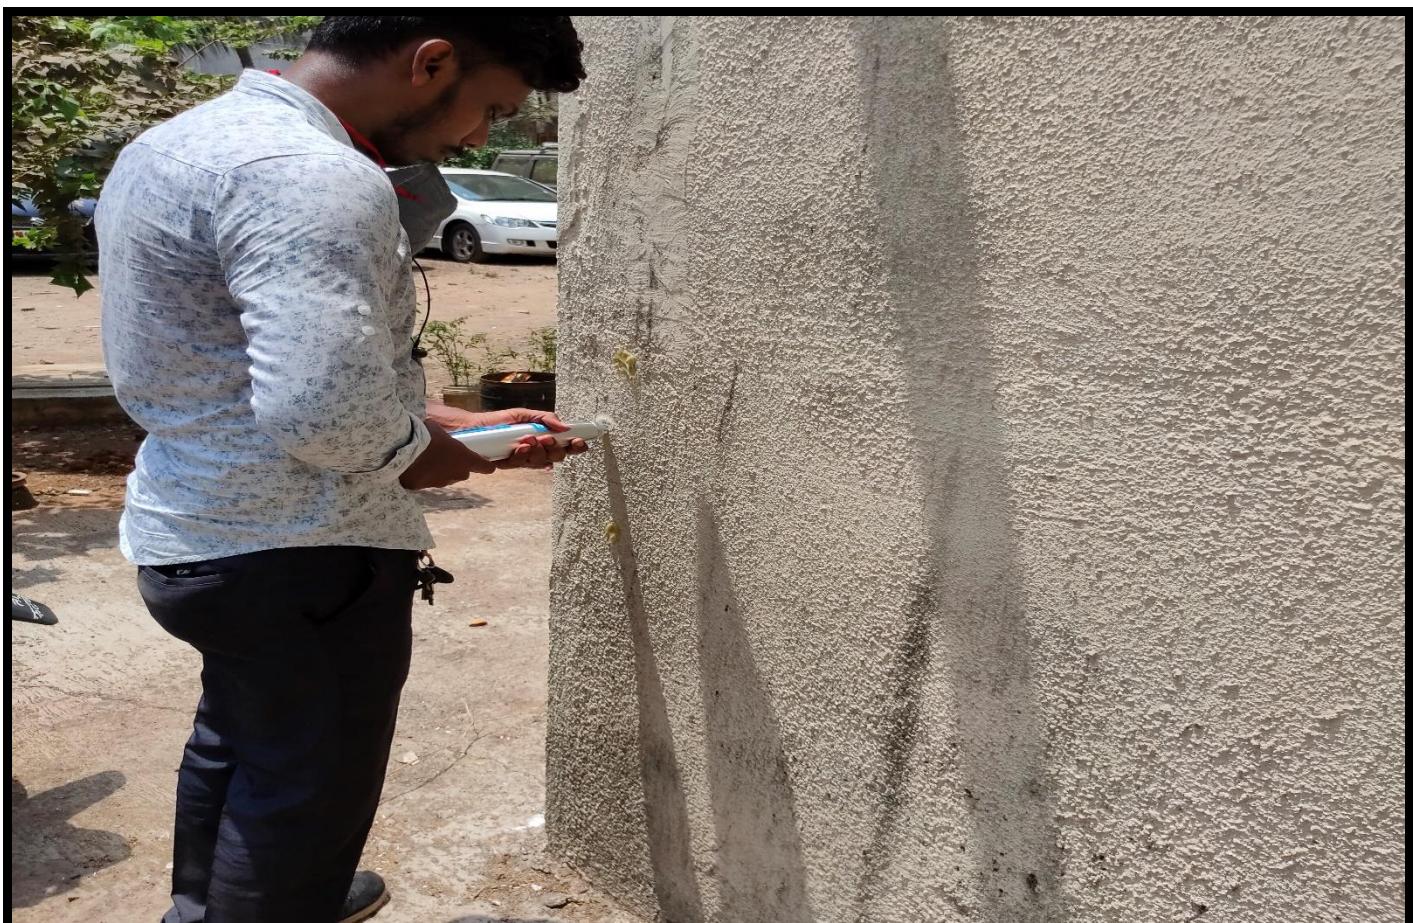
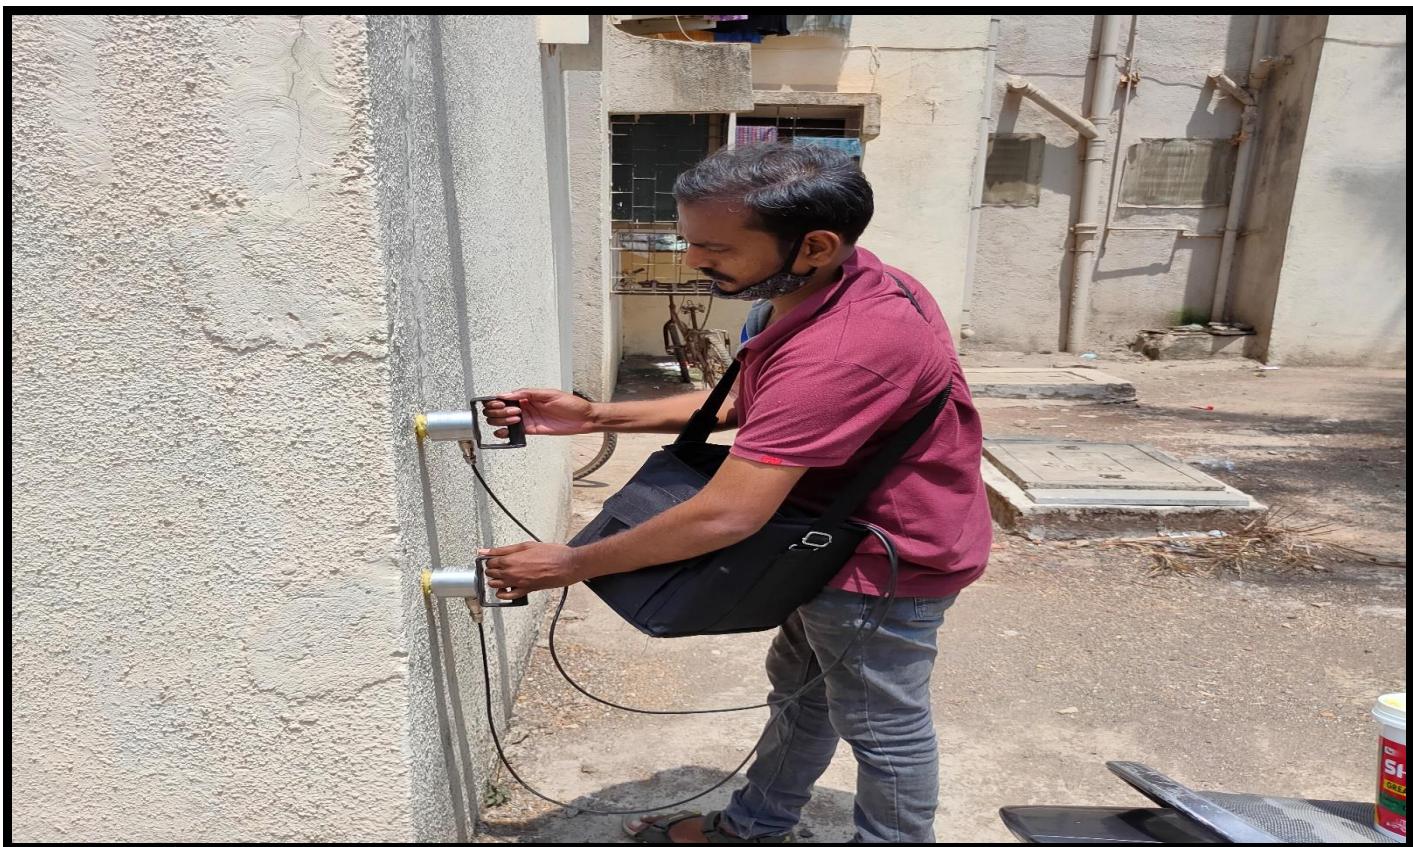
NON -DESTRUCTIVE TEST PHOTO

Rebound Hammer was tested for compressive strength at surface by Schmidt rebound hammer. Results indicate the compressive strength at surface of all the RCC columns is ranging between 10.30 MPa to 16.20 MPa.

Out of 4 locations all 4 locations was below 3.0 Km/Sec means concrete quality is poor.

This indicates there are progressive internal cracks in the RCC members due to corrosion of reinforced steel. These members are under distress condition.

Half Cell Potential tested for corrosion activity by half – cell potential tests. Values are taken on Column. The result on tested column is – 369 mV.

Carbonation test was conducted to assess carbonation depth. Readings are taken on Column. Result indicates the carbonation penetration depth is 40.00 mm. Carbonation depths have reached to the reinforcement level in all of the RCC elements. It is essential to give a suitable anti-corrosion treatment to all the RCC members to stop further carbonation and corrosion of concrete.

RCC elements indicating UPV values less than 3 Km/sec needs immediate attention.

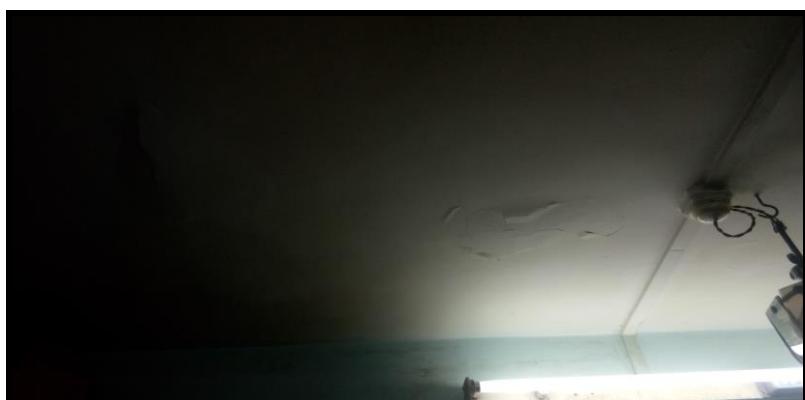
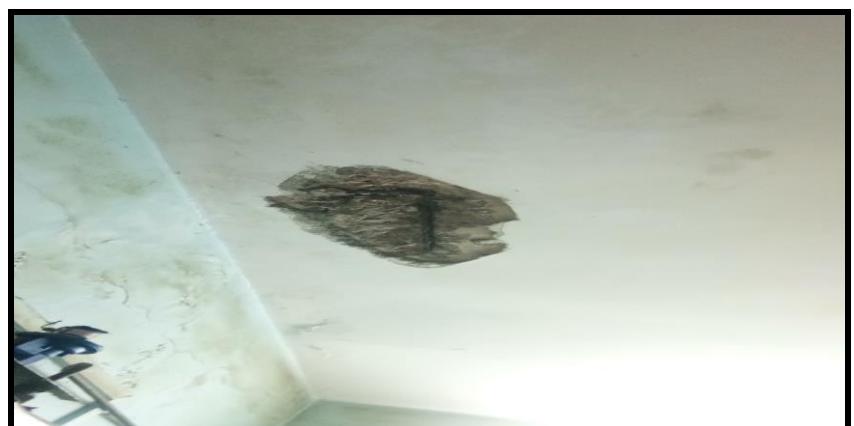
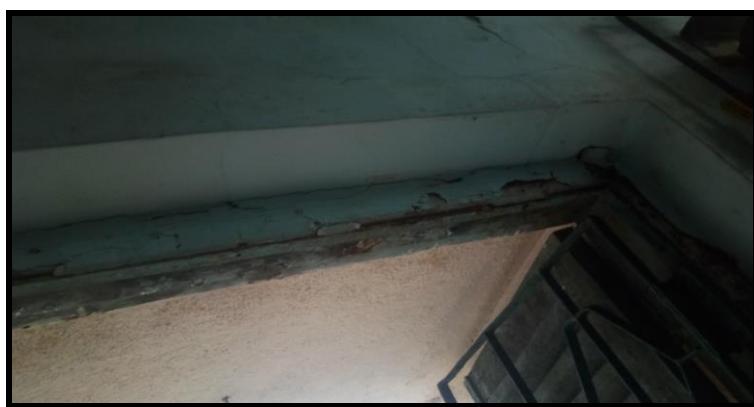
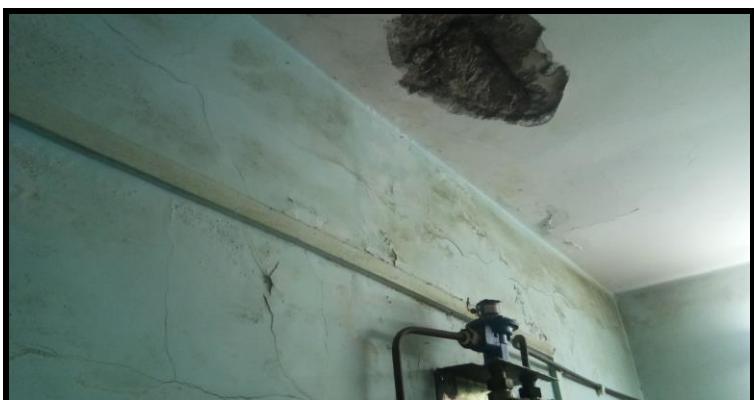
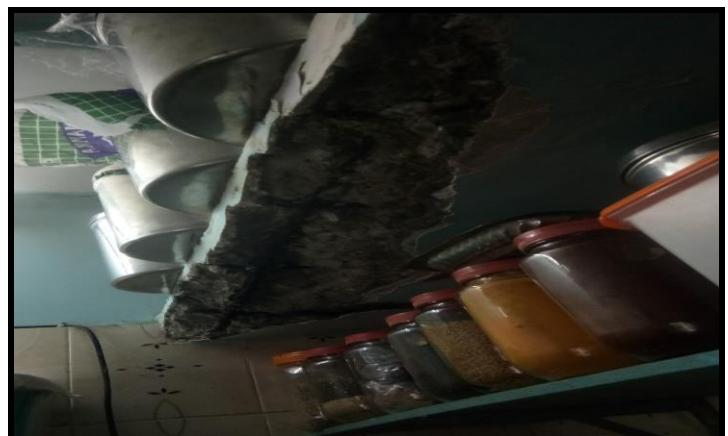
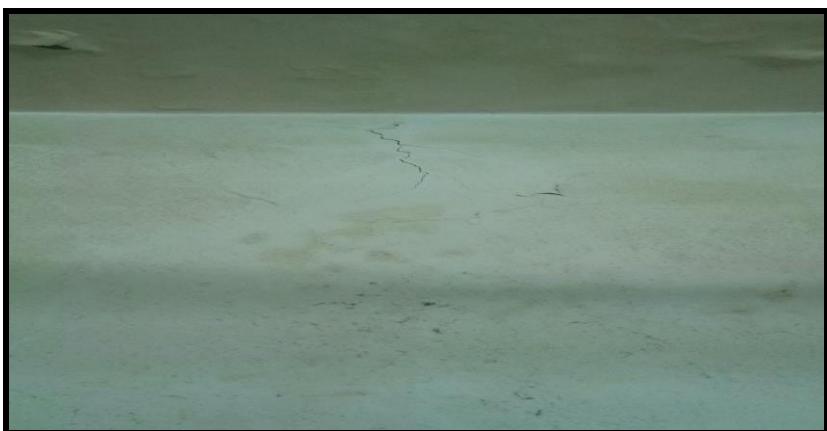
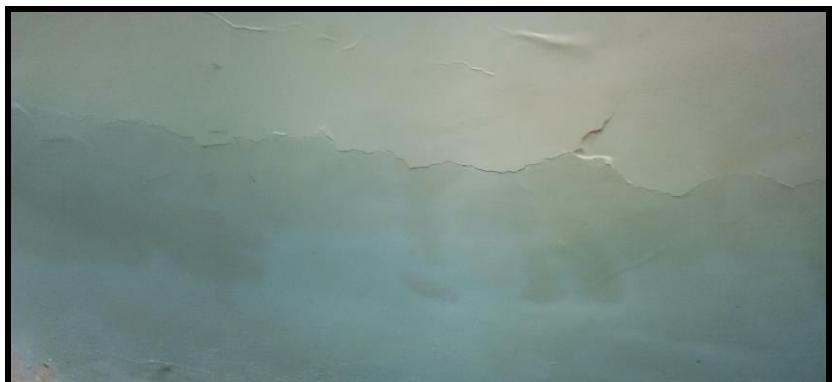
FLAT NO – 16

- ❖ **HALL** – Ceiling gets damage. (**It may fall**)
- ❖ **KITCHEN** – Hallow sound observed on wall.
 - Hallow sound observed on ceiling.
 - Steel gets exposed. (**It may fall**)
- ❖ **PASSAGE** – Hallow sound observed on wall. (**It may fall**)
- ❖ **TOILET & BATH ROOM** – O.K.

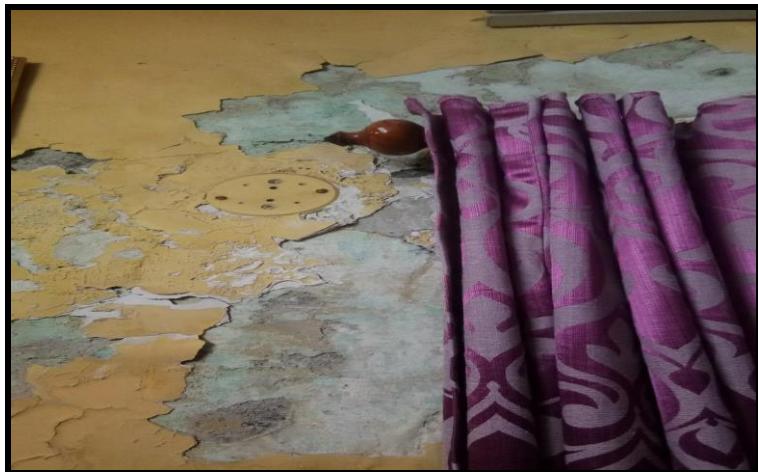
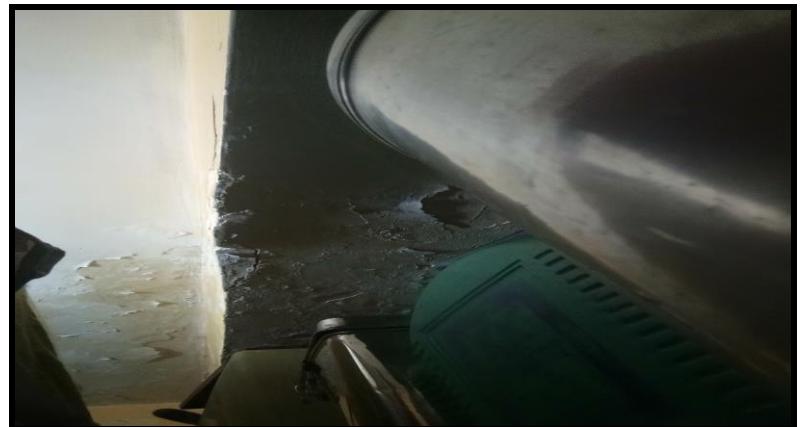
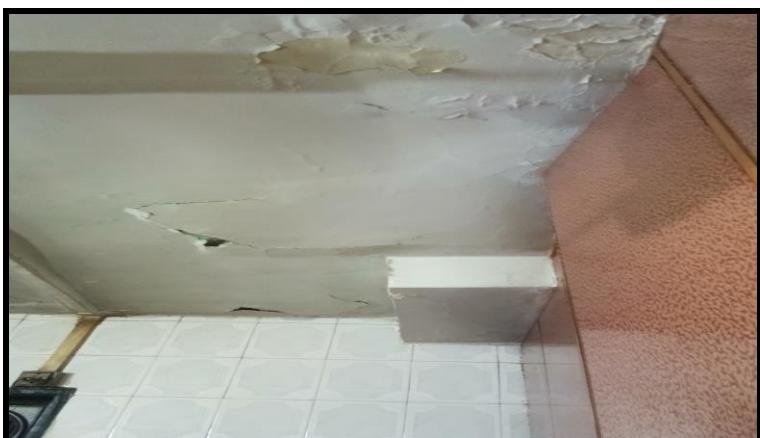
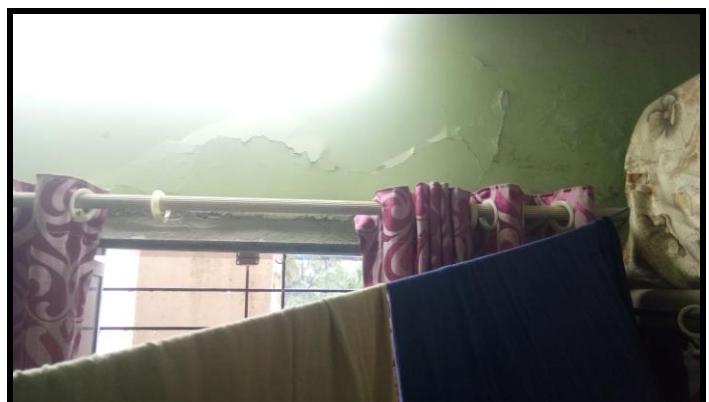
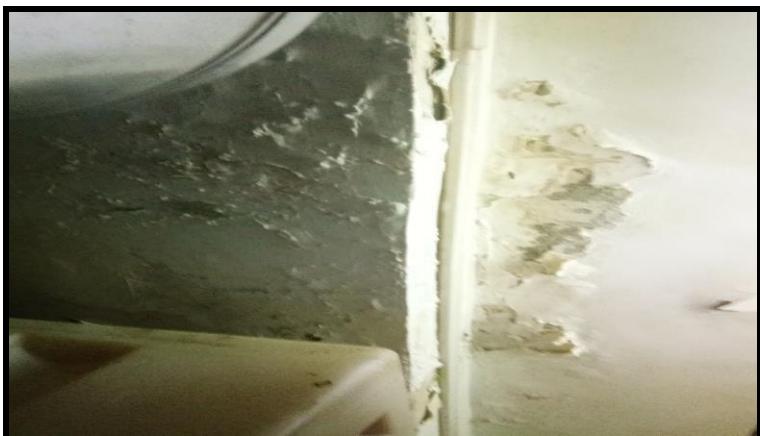
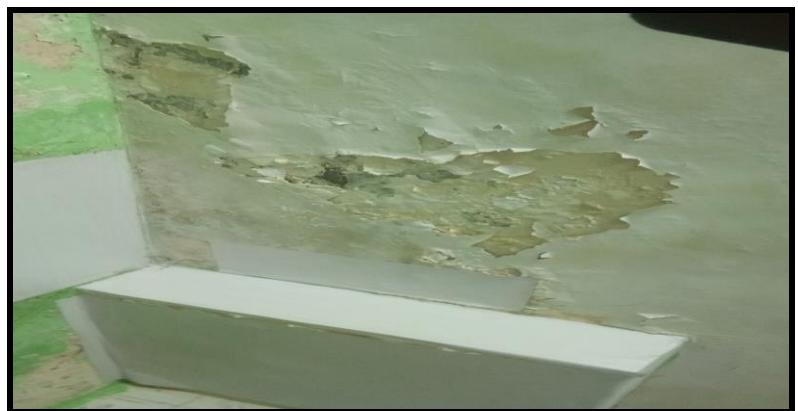
FLAT NO – 17, 18

- ❖ **HALL** – Leakage mark observed on wall.
 - Major structural crack observed on wall.
- ❖ **KITCHEN** – Leakage mark observed on ceiling.
 - Hallow sound observed on ceiling. (**It may fall**)
- ❖ **PASSAGE No.01** – Leakage mark observed on wall.
 - Major leakage mark observed on ceiling.
- ❖ **PASSAGE No.02** – Seepage mark observed on wall.
 - Dampness observed on ceiling.
- ❖ **TOILET & BATH ROOM** – Dampness observed on wall.
- ❖ **BEDROOM NO.01** – Major structural crack observed on wall.
 - Seepage mark observed on ceiling.
- ❖ **BEDROOM NO.02** – Seepage mark observed on ceiling.
 - Crack observed on wall.
 - Leakage mark observed on ceiling.

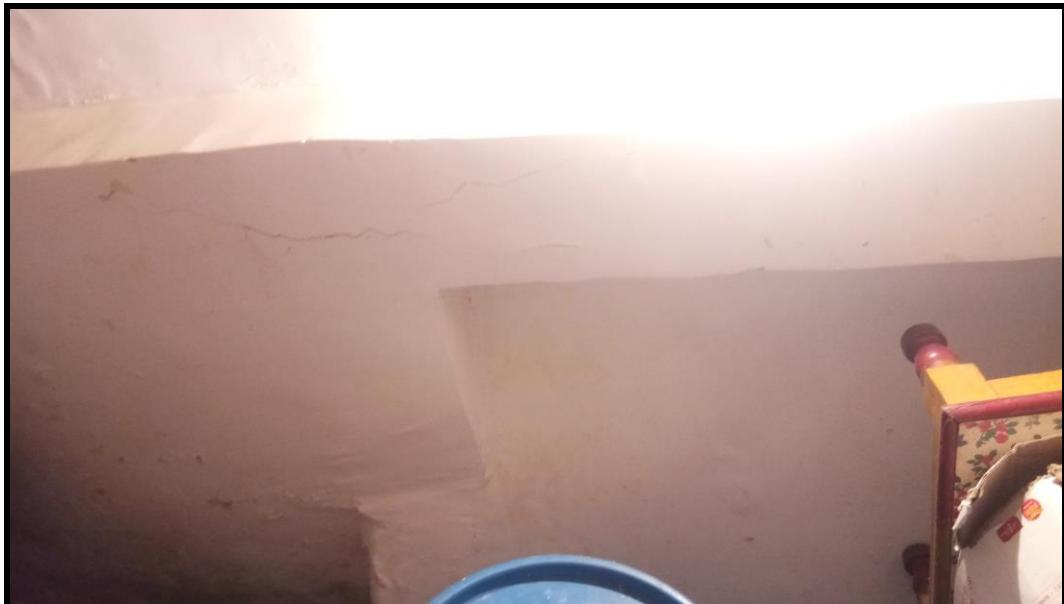
FLAT NO – 20

- ❖ **HALL** – Structural crack observed on wall.
 - Seepage mark observed on ceiling.
- ❖ **KITCHEN** – Leakage mark observed on wall during monsoon.
- ❖ **PASSAGE** – Dampness observed on ceiling.
- ❖ **TOILET & BATH ROOM** – O.K.

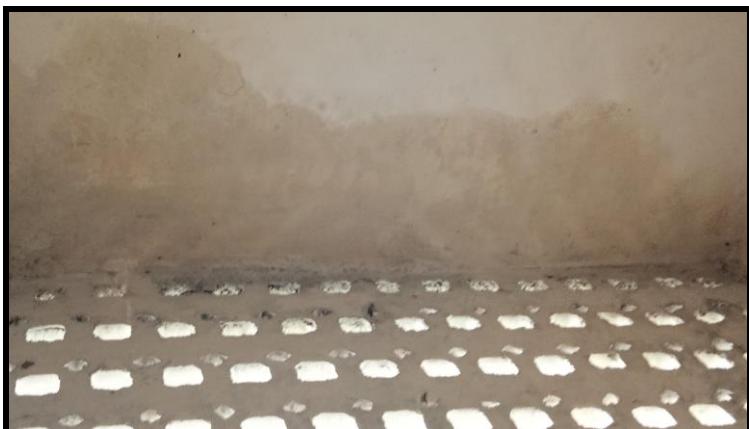
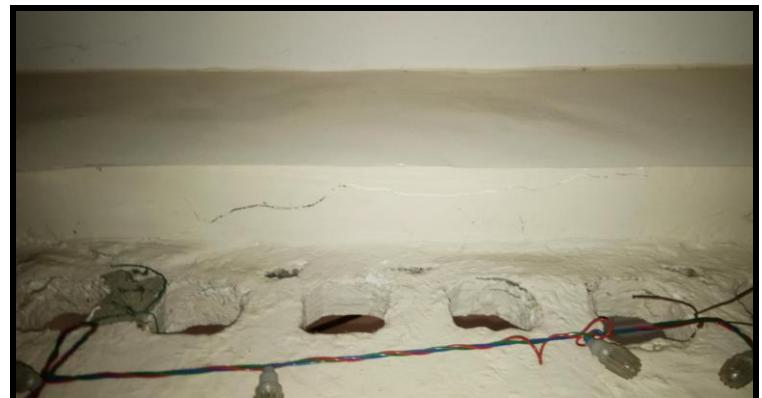
Terrace to Fourth floor:-

- ❖ Major leakage mark observed on ceiling.
- ❖ Major crack observed on wall.

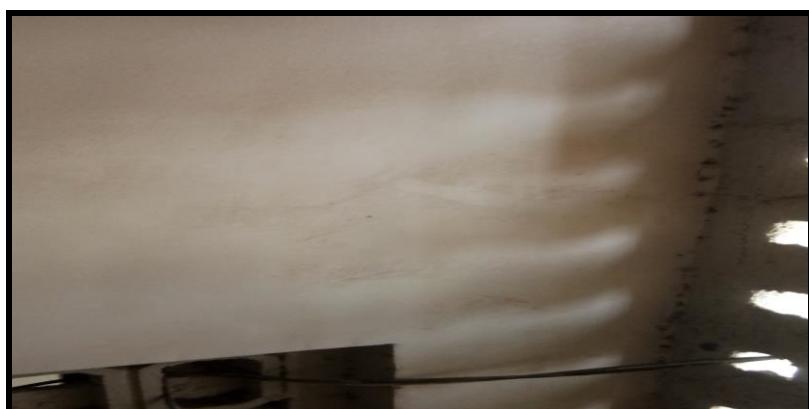
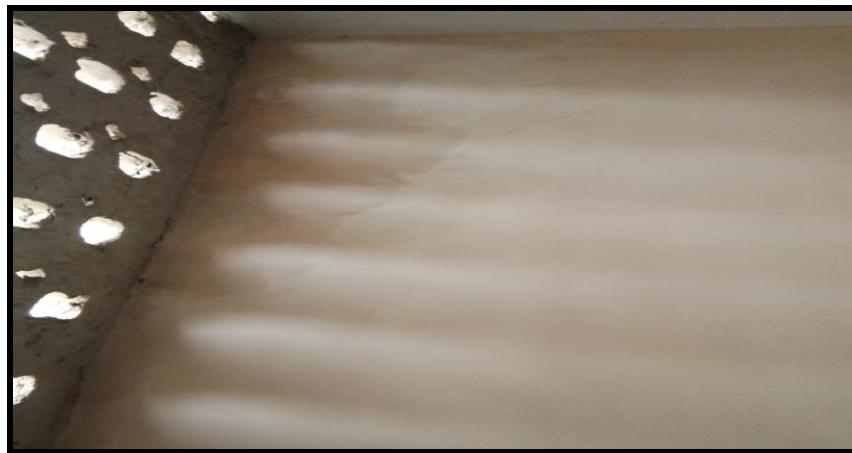
Fourth floor to Third floor:-

- ❖ Leakage mark observed on wall.
- ❖ Seepage mark observed on wall.

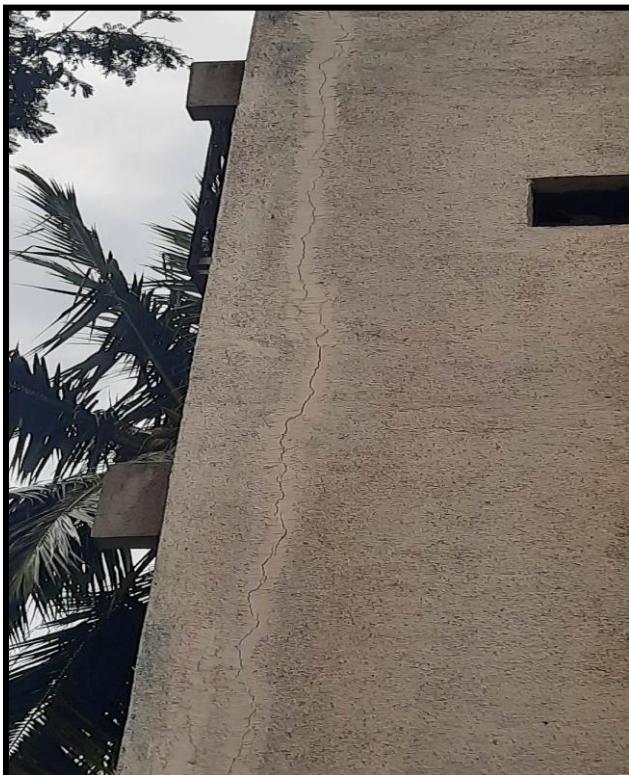
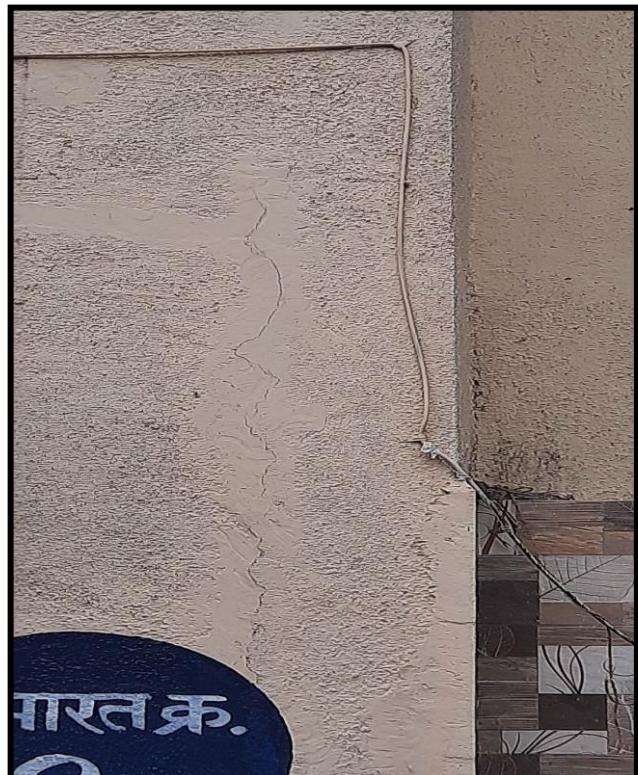
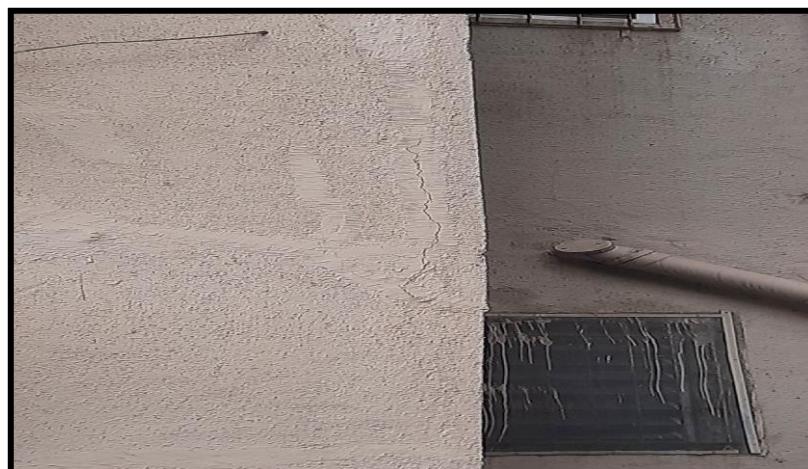
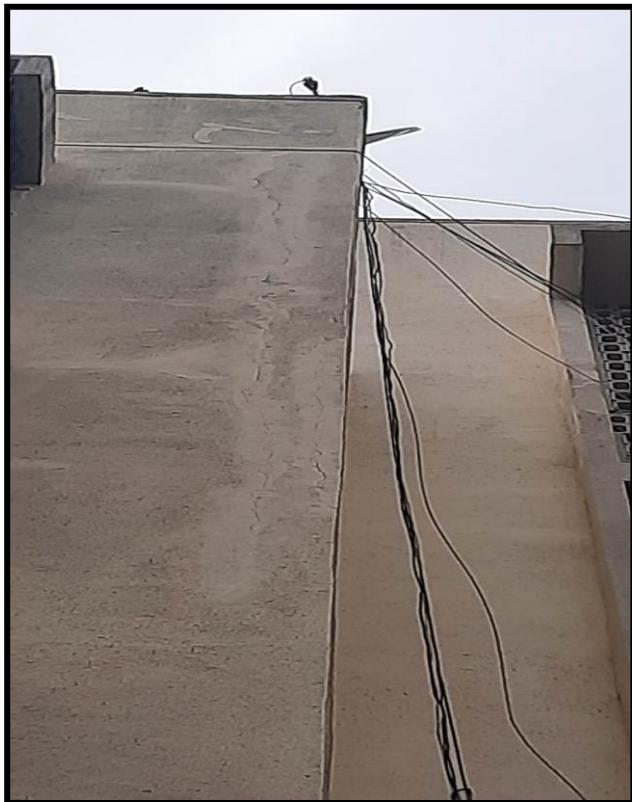
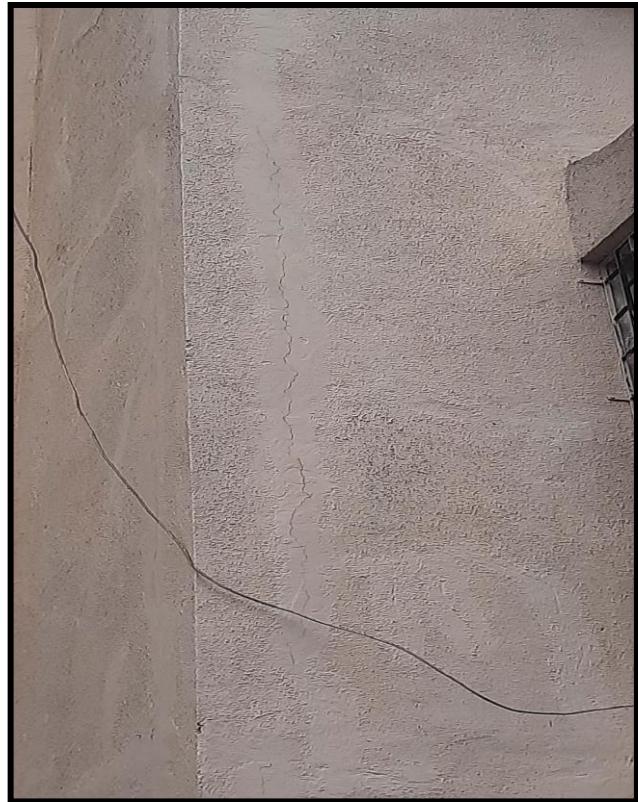
FRONT SIDE

- ❖ Structural crack observed at several places on column.
- ❖ Major crack observed at several places on wall.

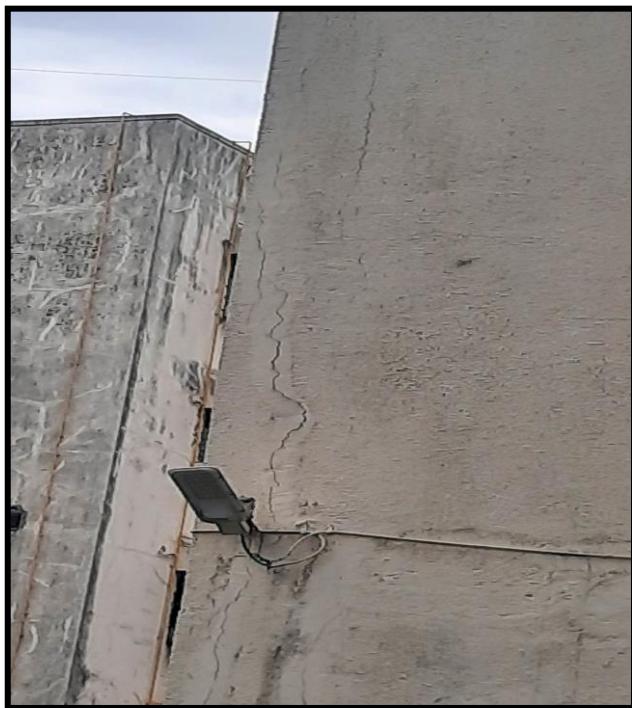
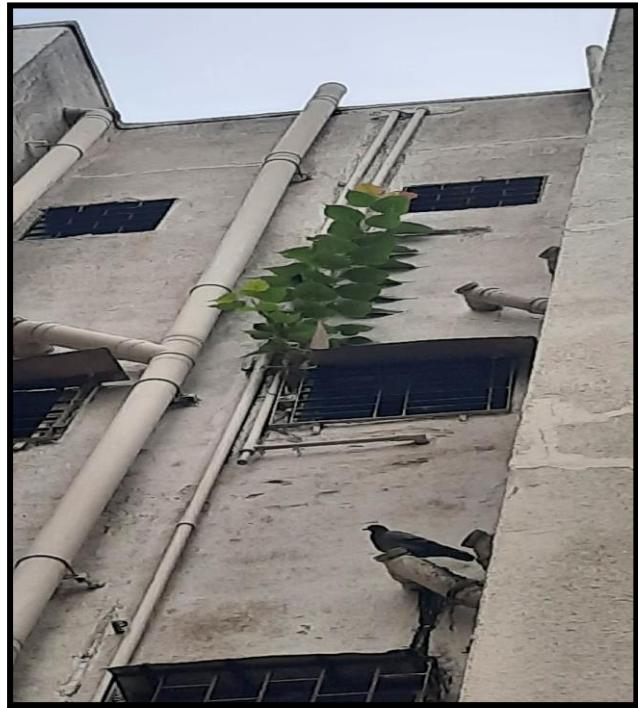
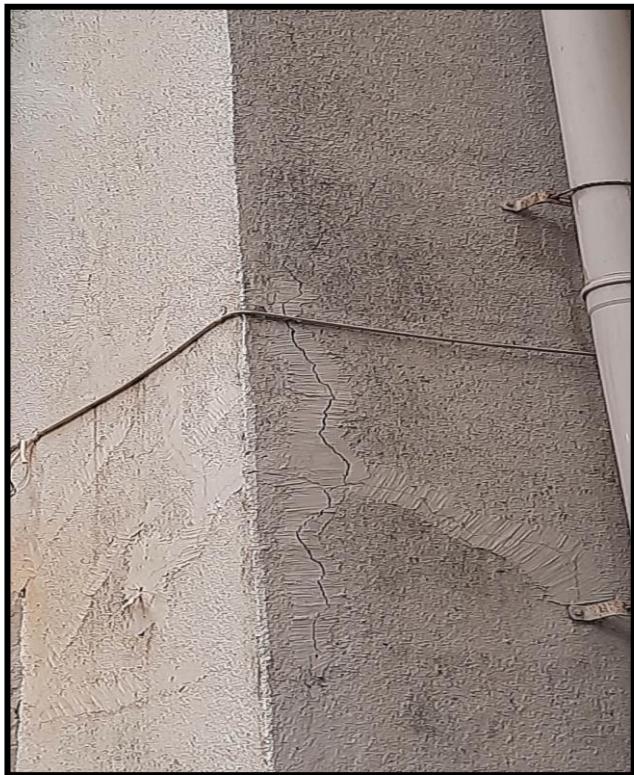
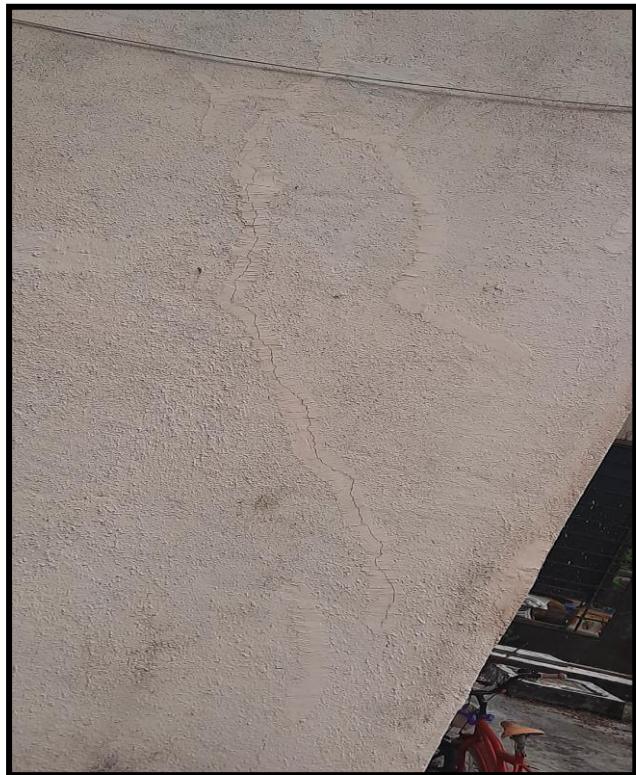
BACK SIDE

- ❖ Structural crack observed at several places on column.
- ❖ Major crack observed at several places on wall.
- ❖ Vegetation growth observed at several places on wall.

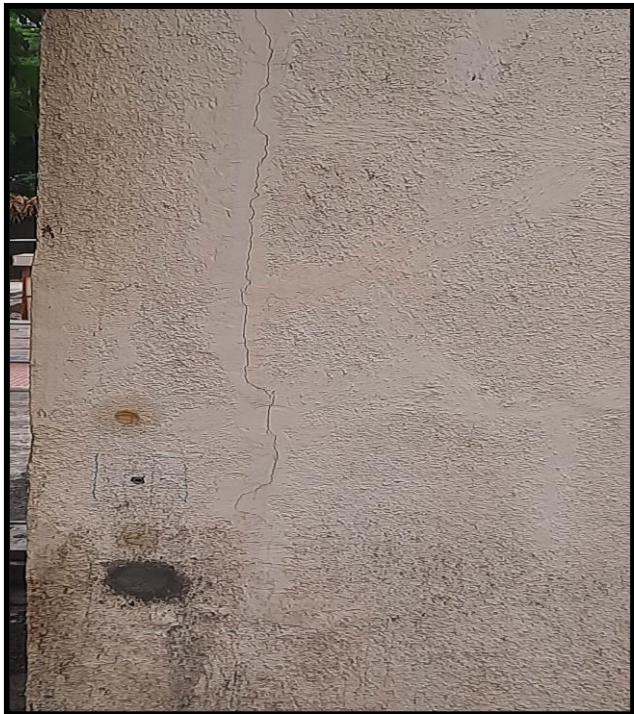
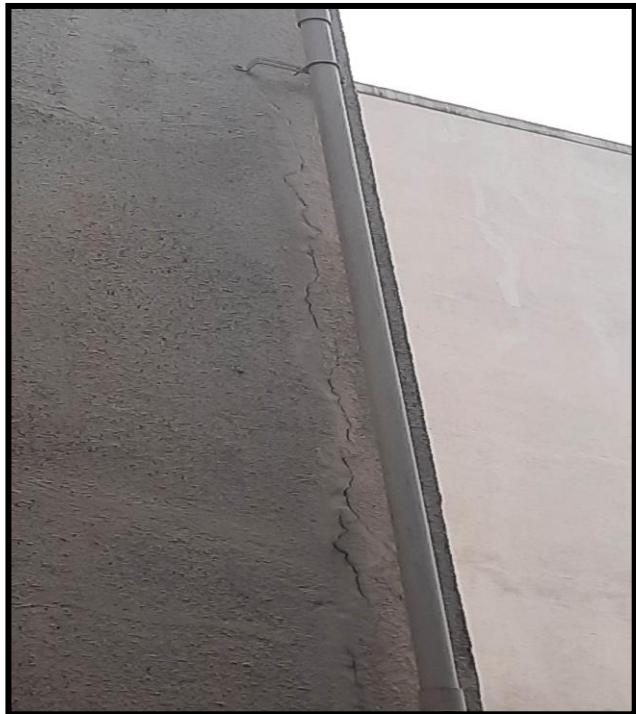
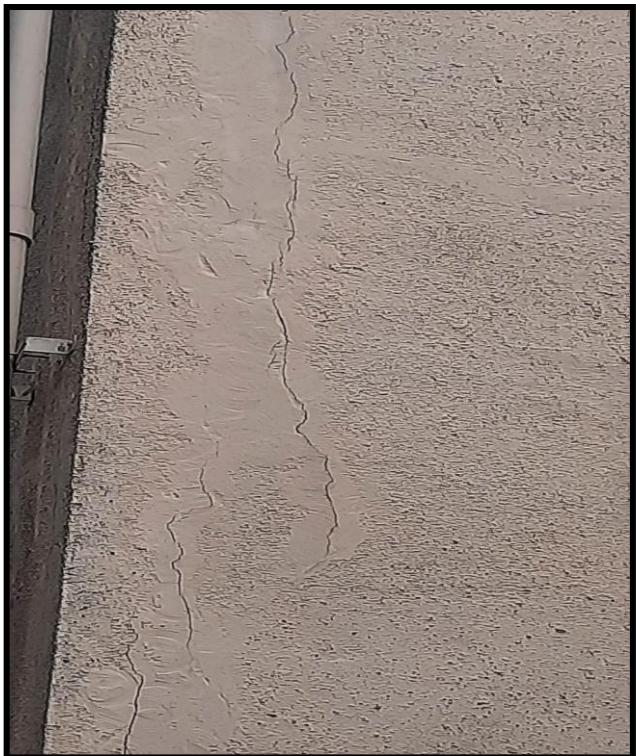
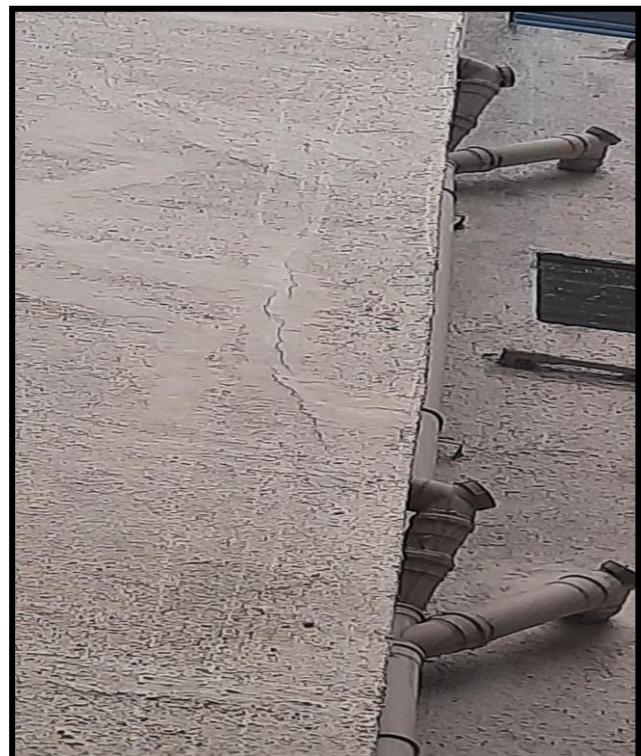
NORTH SIDE

- ❖ Structural crack observed at several places on column.
- ❖ Major crack observed at several places on wall.

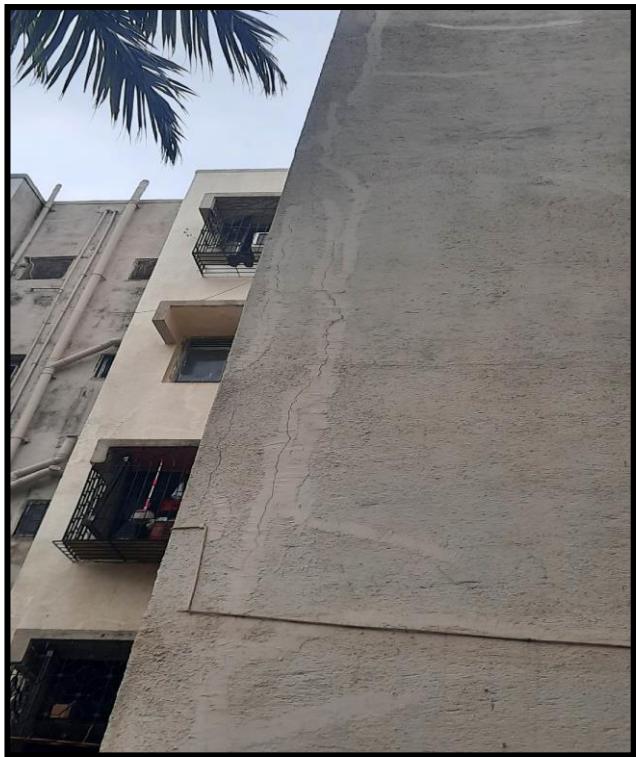
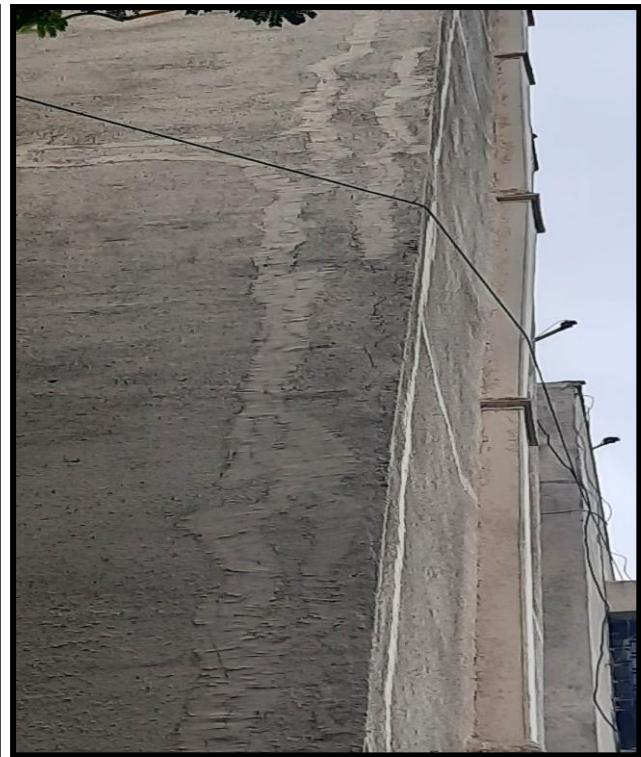
SOUTH SIDE

- ❖ Structural crack observed at several places on column.
- ❖ Major crack observed at several places on wall.
