STRUCTURAL AUDIT REPORT
FOR
“VISHAL SAHYADRI CO – OP HSG. SOC. LTD”,
“D2 – B WING”
SITUATED AT
SAHYADRI NAGAR, CHARKOP,
KANDIVALI (W) MUMBAI – 400 067

978/D2/LSS/2021

JULY 24, 2021

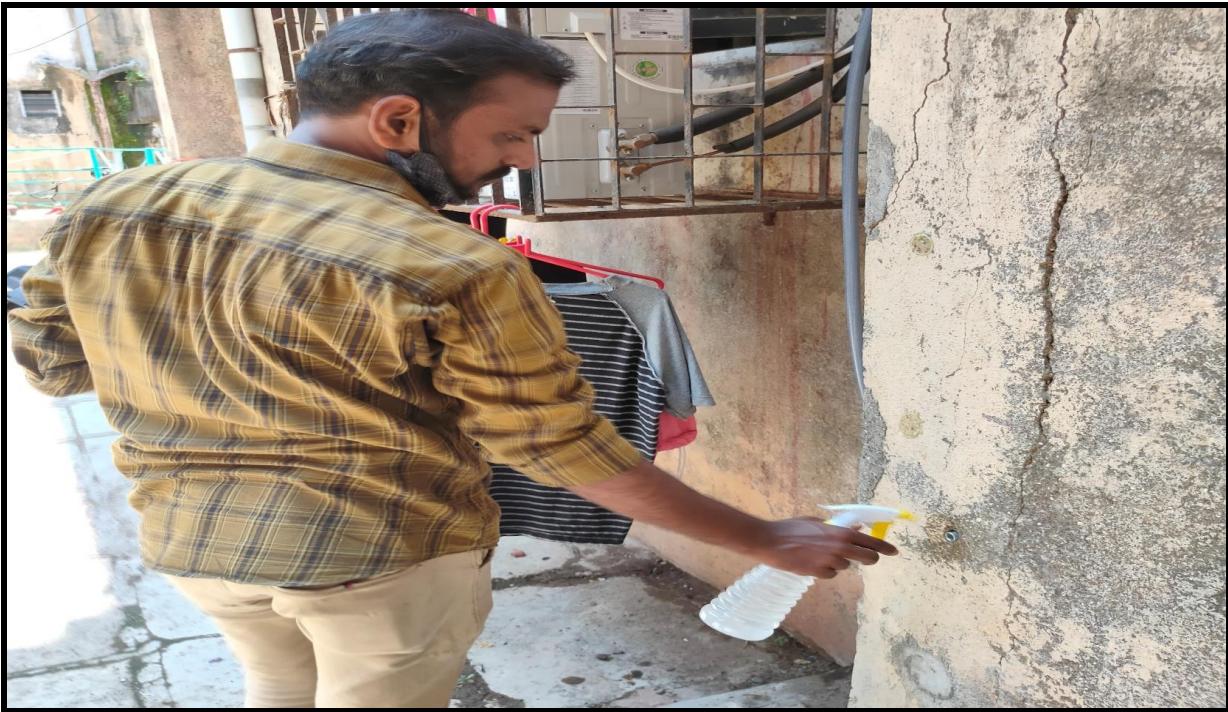
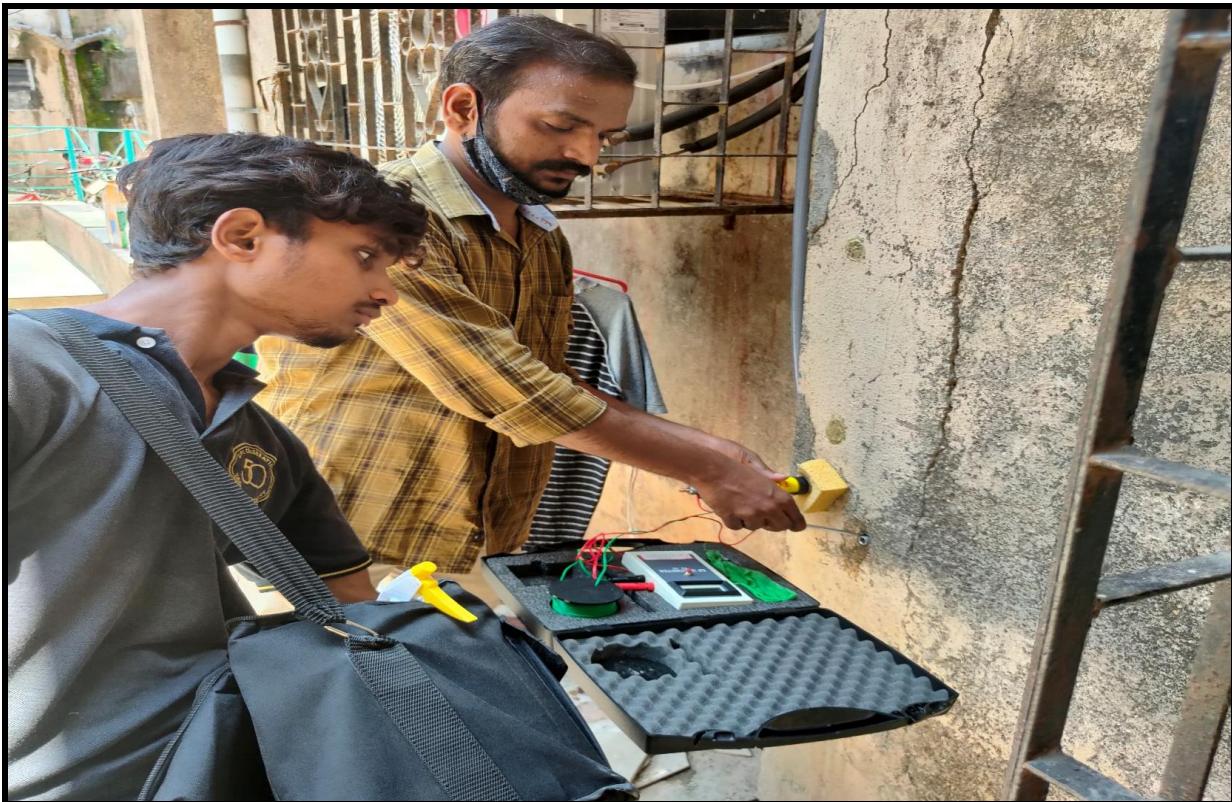
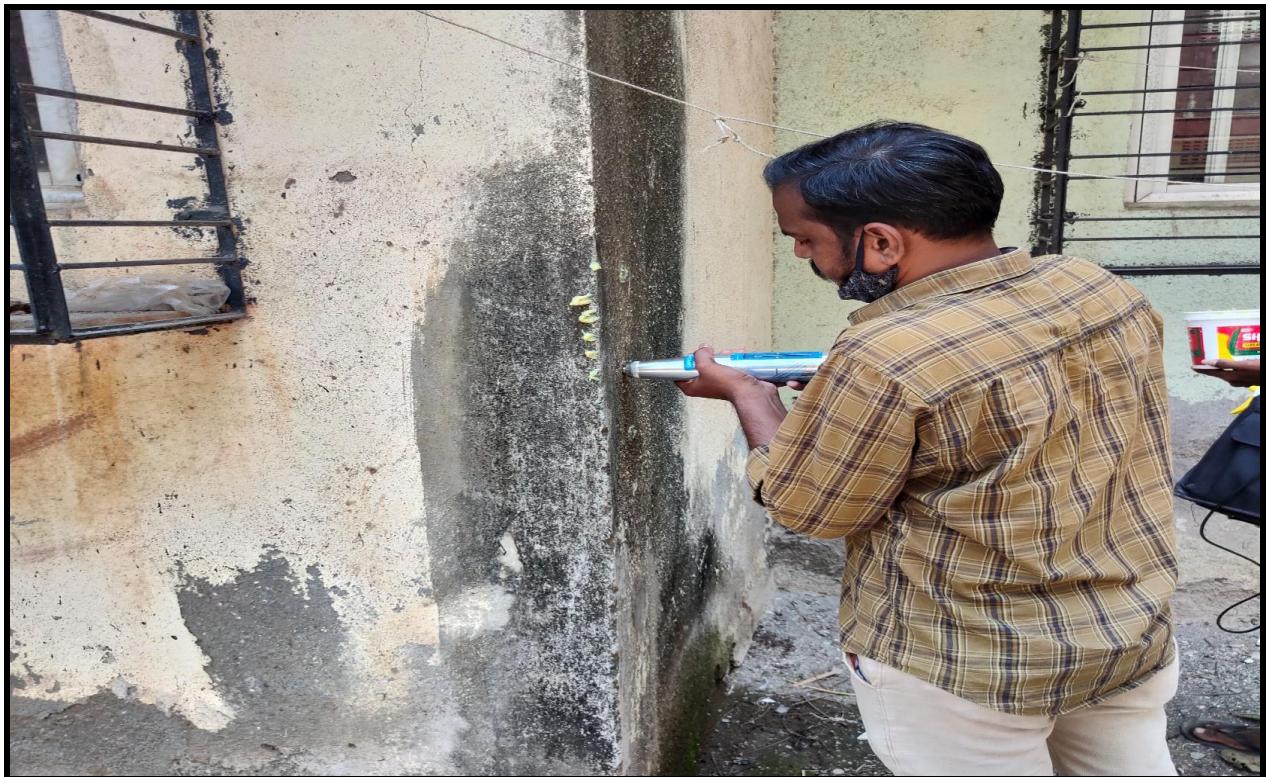
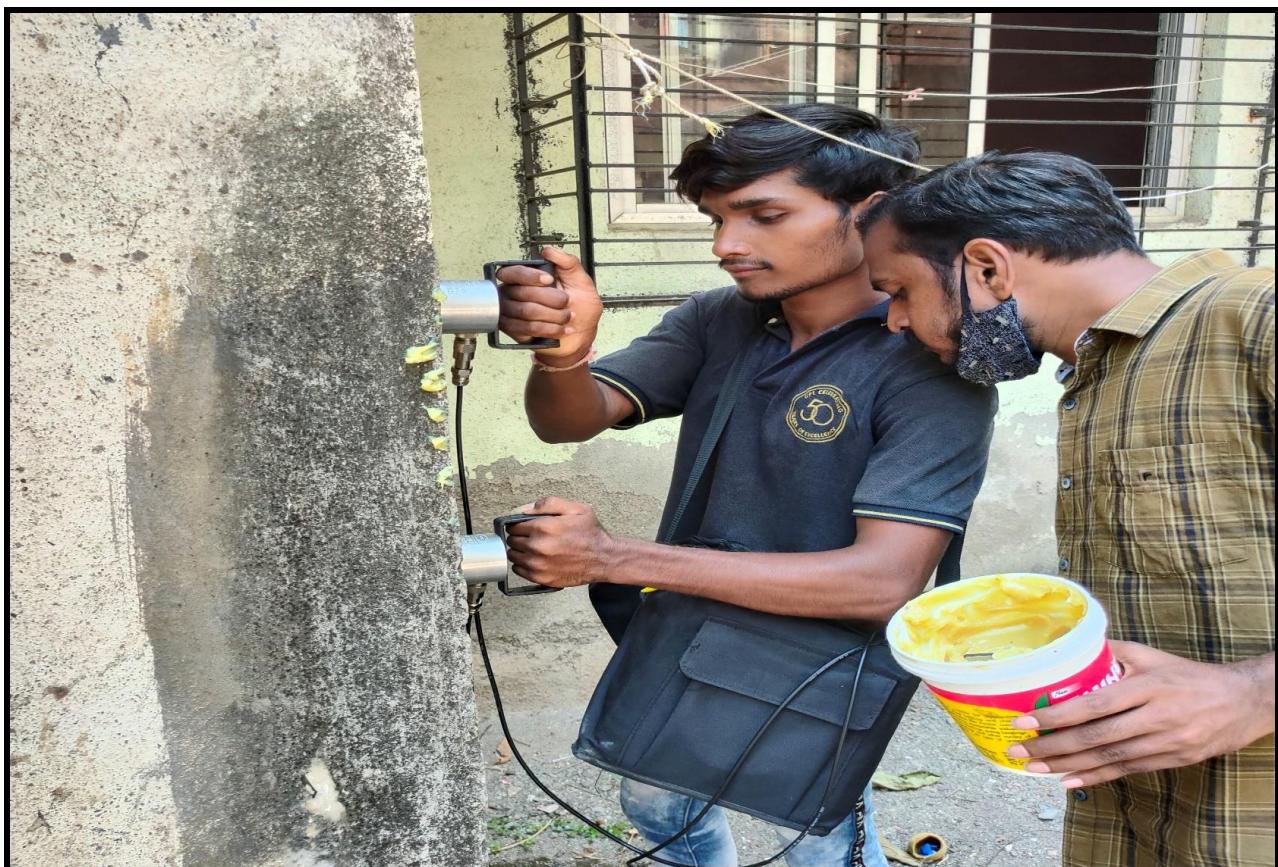
NON -DESTRUCTIVE TEST PHOTO

Rebound Hammer was tested for compressive strength at surface by Schmidt rebound hammer. Results indicate the compressive strength at surface of the RCC columns & beam in is ranging between 14.90 MPa to 20.30 MPa.

The UPV values are ranging between 2.50 Km/Sec to 3.10 Km/Sec.

Half Cell Potential tested for corrosion activity by half – cell potential tests. Value is taken on Column. The result on tested column is – 341 mV.

Carbonation test was conducted to assess carbonation depth. Readings are taken on Column. Result indicates the carbonation penetration depth is 40.00 mm. Carbonation depths have reached to the reinforcement level in all of the RCC elements. It is essential to give a suitable anti-corrosion treatment to all the RCC members to stop further carbonation and corrosion of concrete.

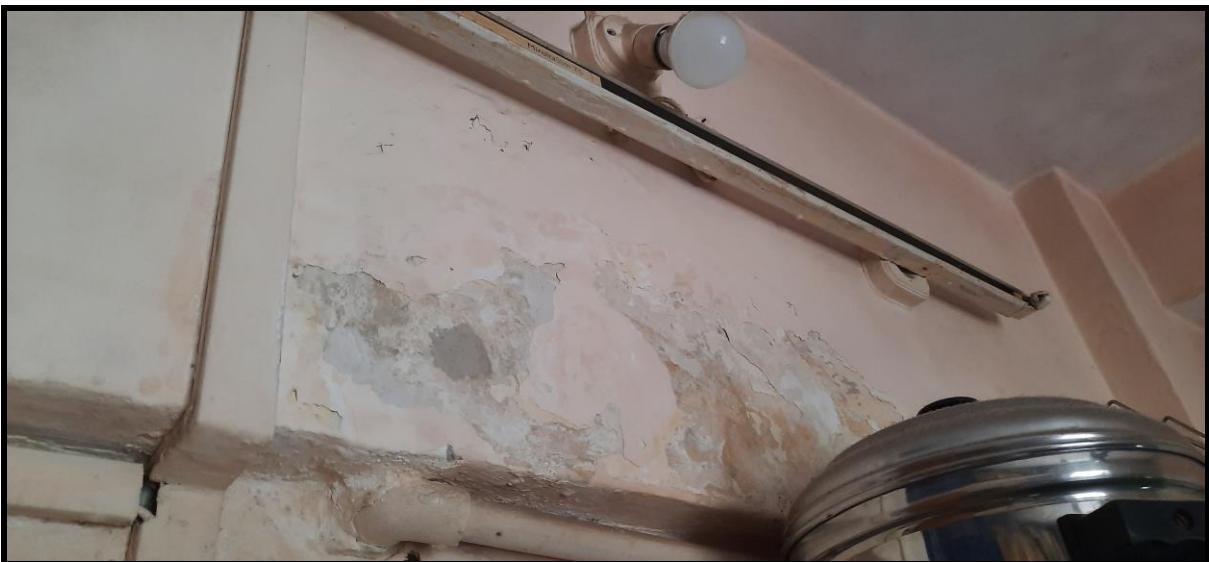
FLAT NO – 102

- ❖ **HALL** – O.K.
- ❖ **KITCHEN** – Leakage mark observed on beam.
- ❖ **PASSAGE** – O.K.
- ❖ **TOILET & BATH ROOM** – O.K.

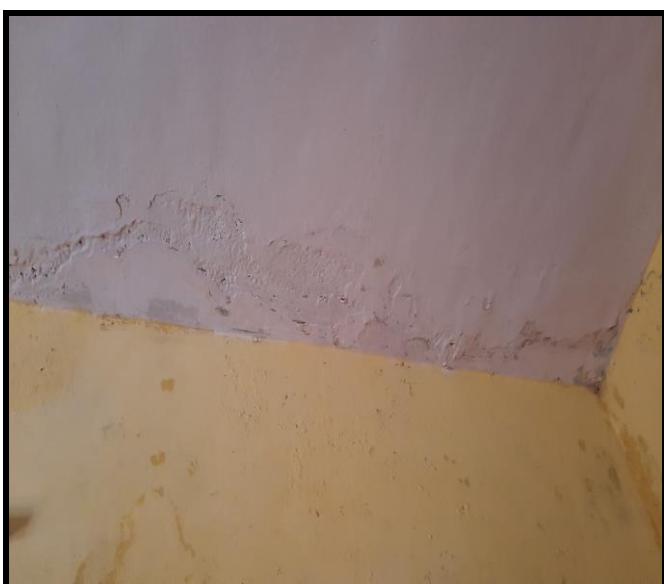
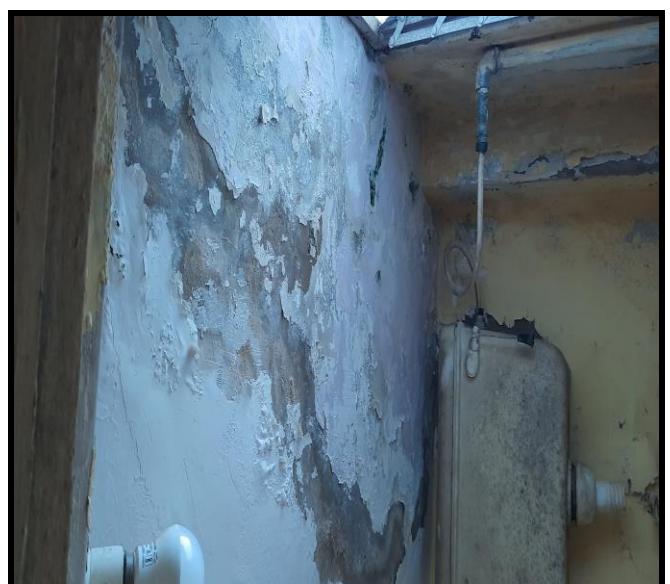
FLAT NO – 103

- ❖ **HALL** – Leakage mark observed on wall & ceiling.
- ❖ **KITCHEN** – Leakage observed on wall in monsoon.
- ❖ **PASSAGE** – O.K.
- ❖ **TOILET & BATH ROOM** – Leakage mark observed on wall & ceiling.

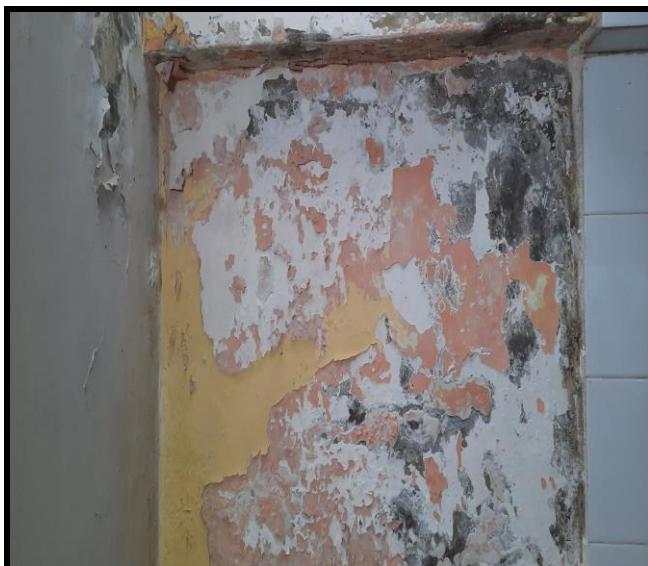
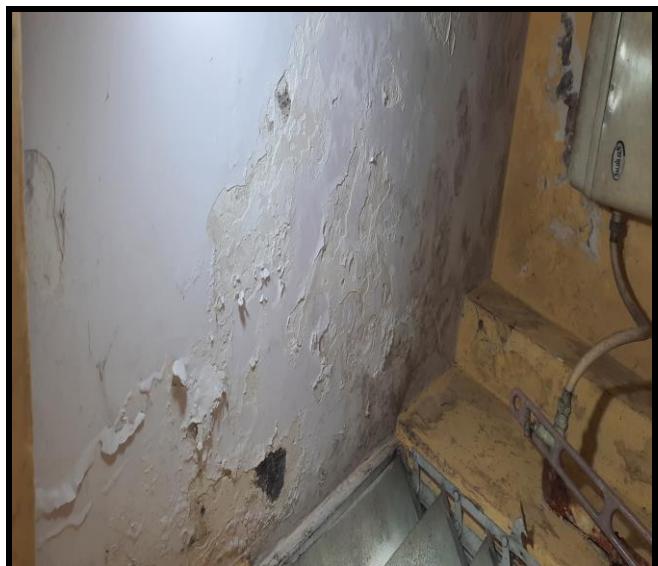
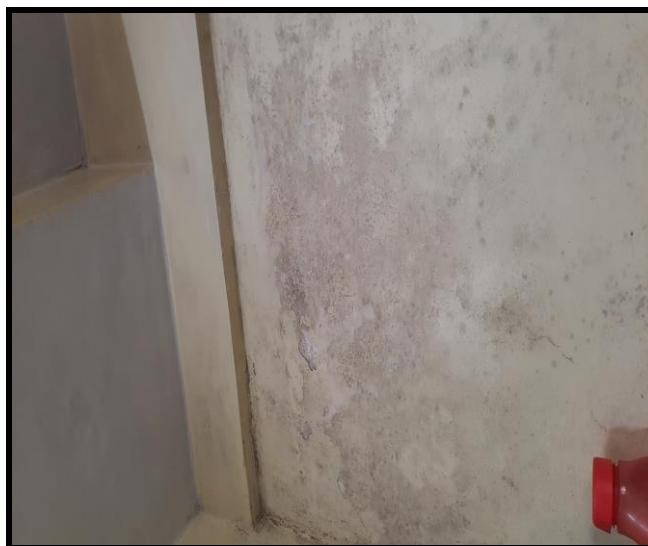
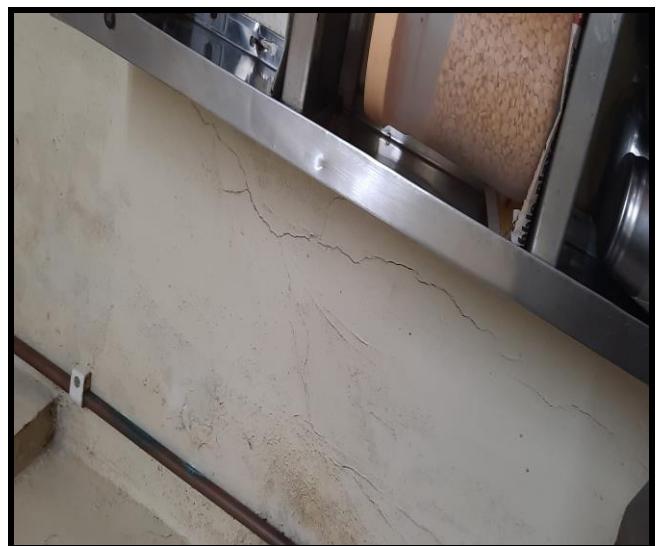
FLAT NO – 204

- ❖ **HALL** – O.K.
- ❖ **KITCHEN** – Leakage mark observed on wall & ceiling.
 - Structural crack observed on column.
- ❖ **PASSAGE** – O.K.
- ❖ **TOILET & BATH ROOM** – Leakage mark observed on wall & ceiling.

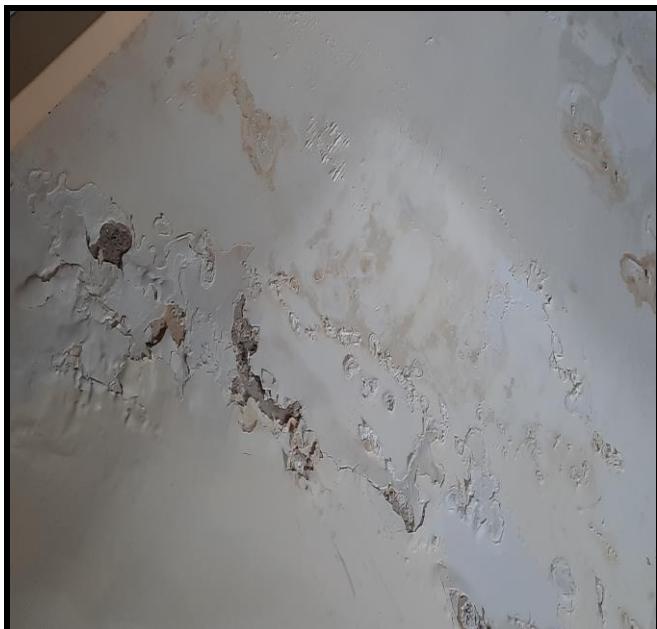
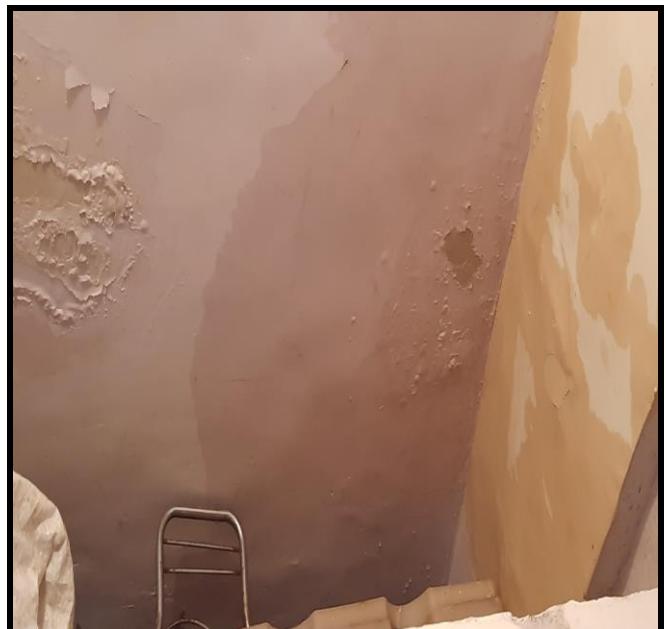
FLAT NO – 401

- ❖ **HALL** – Leakage mark observed on wall.
- ❖ **KITCHEN** – O.K.
- ❖ **PASSAGE** – Leakage observed on ceiling.
- ❖ **TOILET & BATH ROOM** – O.K.

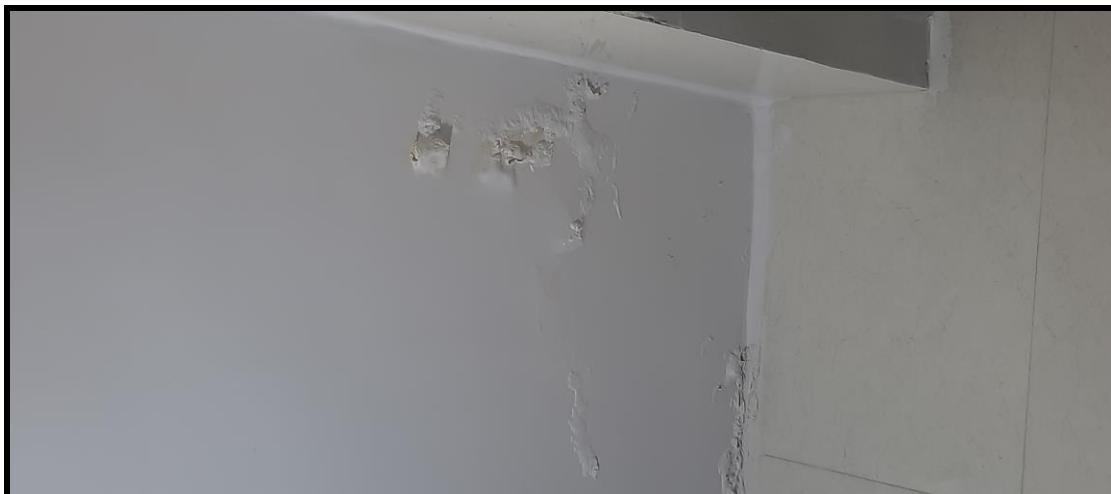
FLAT NO – 403

- ❖ **HALL** – O.K.
- ❖ **KITCHEN** – O.K.
- ❖ **PASSAGE** – Leakage mark observed on ceiling.
- ❖ **TOILET & BATH ROOM** – O.K.

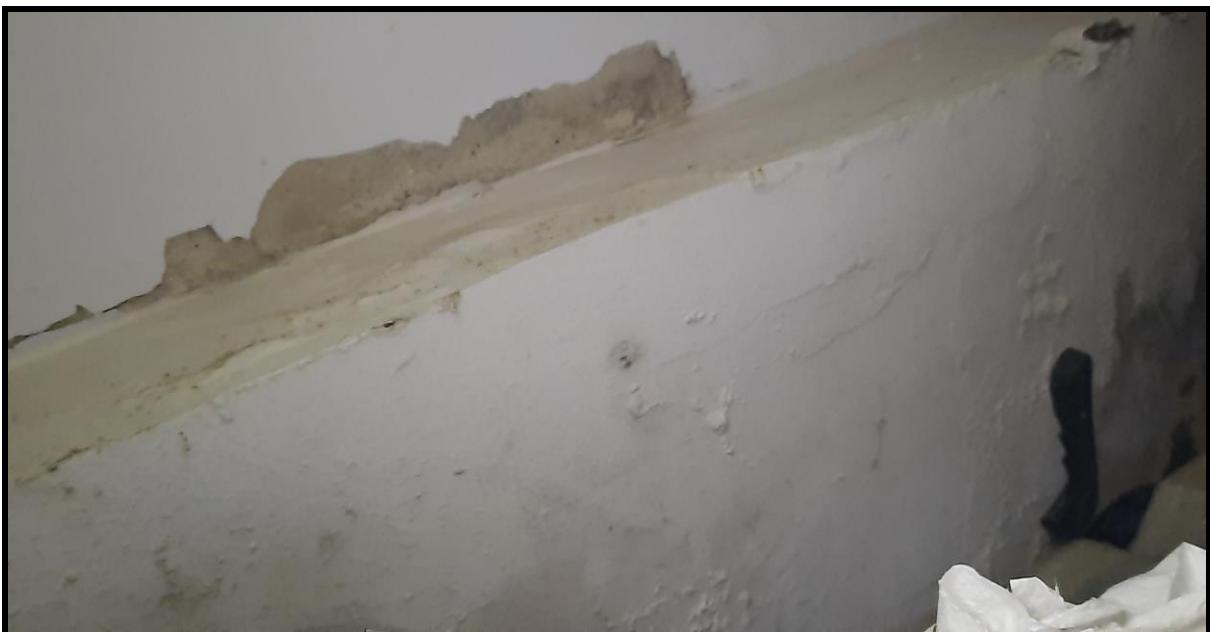
FLAT NO – 504

- ❖ **HALL** – O.K.
- ❖ **KITCHEN** – O.K.
- ❖ **PASSAGE** – Leakage mark observed on ceiling.
- ❖ **TOILET & BATH ROOM** – Leakage mark observed on ceiling.

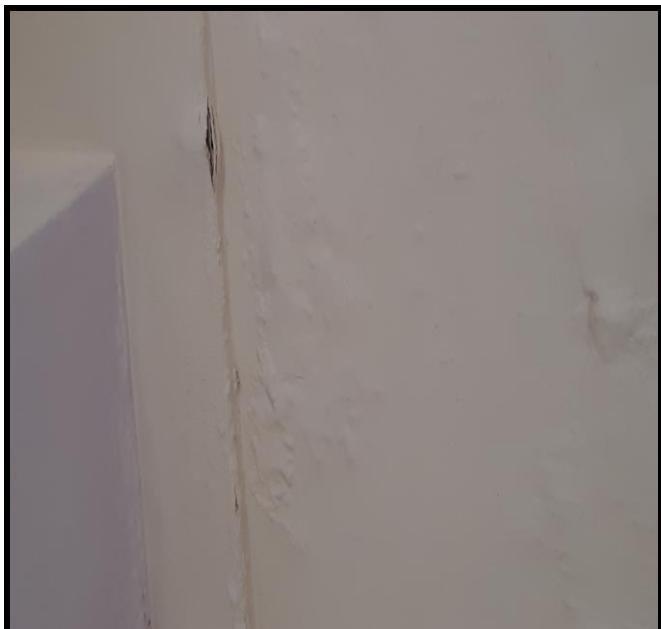
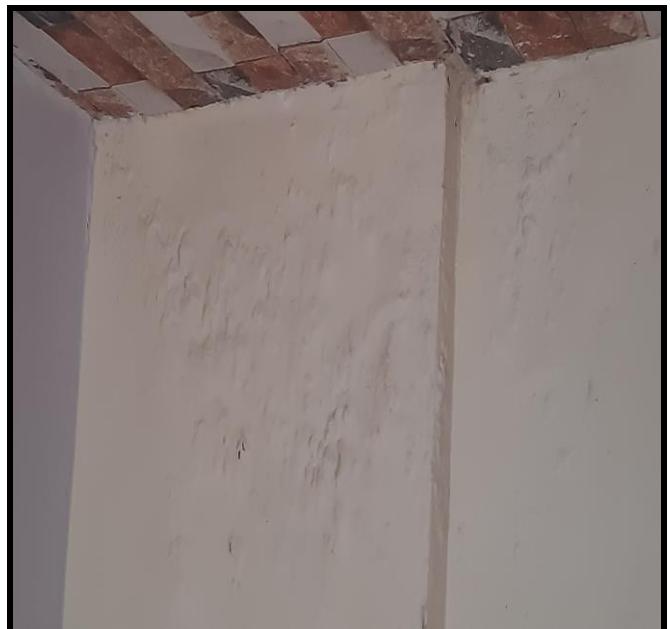
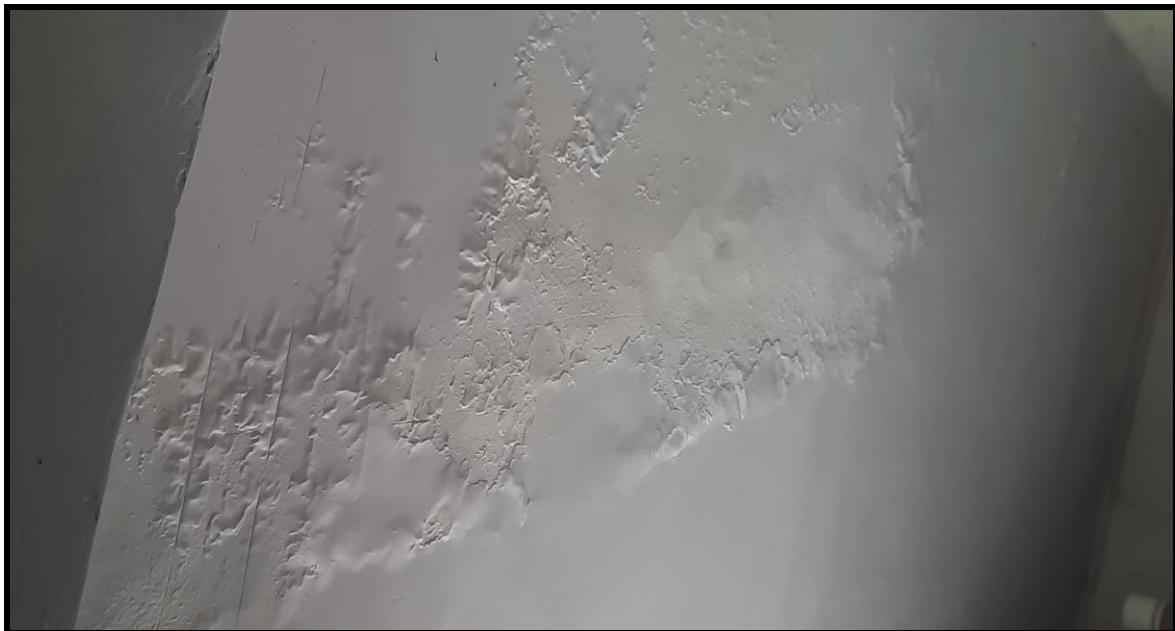
FLAT NO – 602

- ❖ **HALL** – Leakage mark observed on wall.
- ❖ **KITCHEN** – Leakage mark observed on wall.
- ❖ **PASSAGE** – O.K.
- ❖ **TOILET & BATH ROOM** – Leakage mark observed on ceiling.

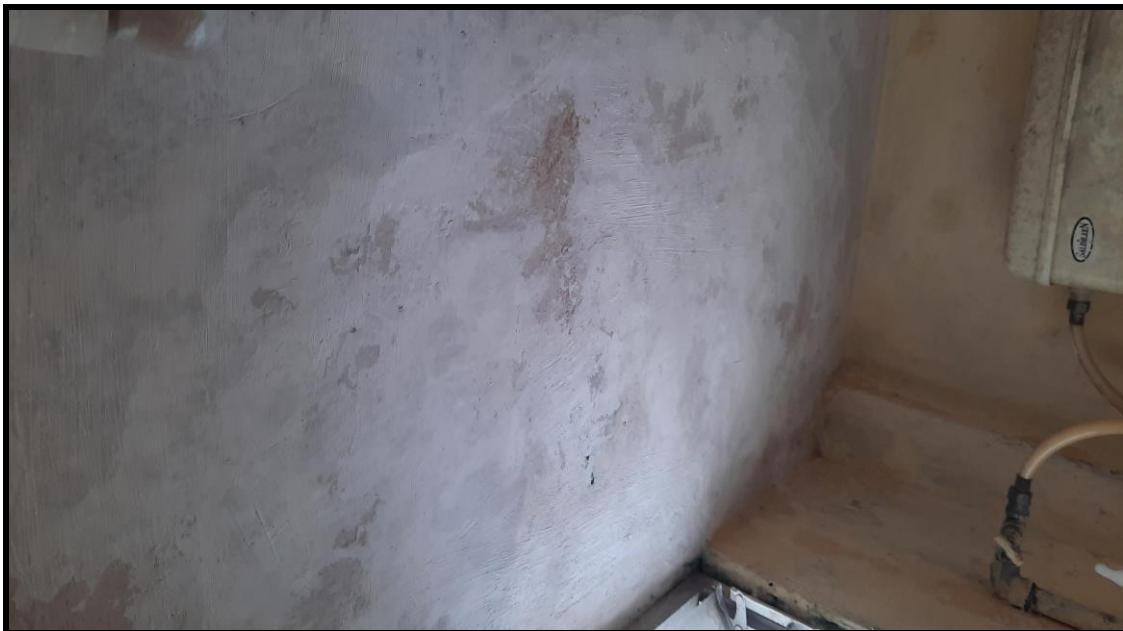
FLAT NO – 604

- ❖ **HALL** – Dampness observed on wall in monsoon.
- ❖ **KITCHEN** – O.K.
- ❖ **PASSAGE** – Dampness observed on wall in monsoon.
- ❖ **TOILET & BATH ROOM** – Leakage mark observed on ceiling.

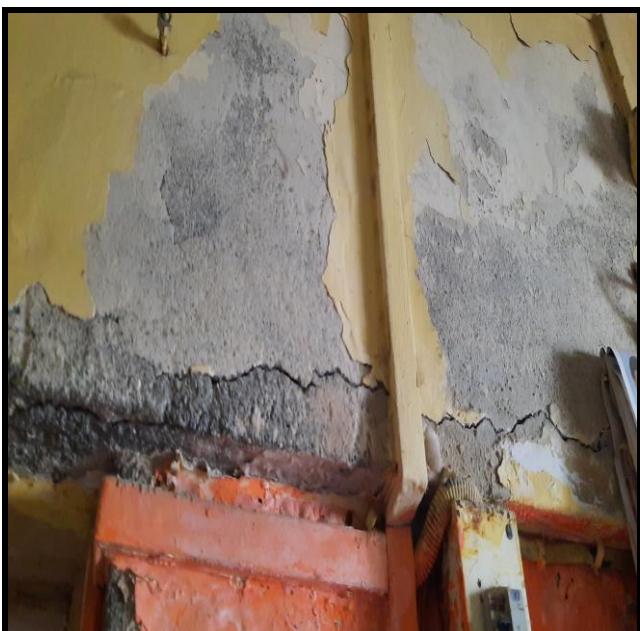
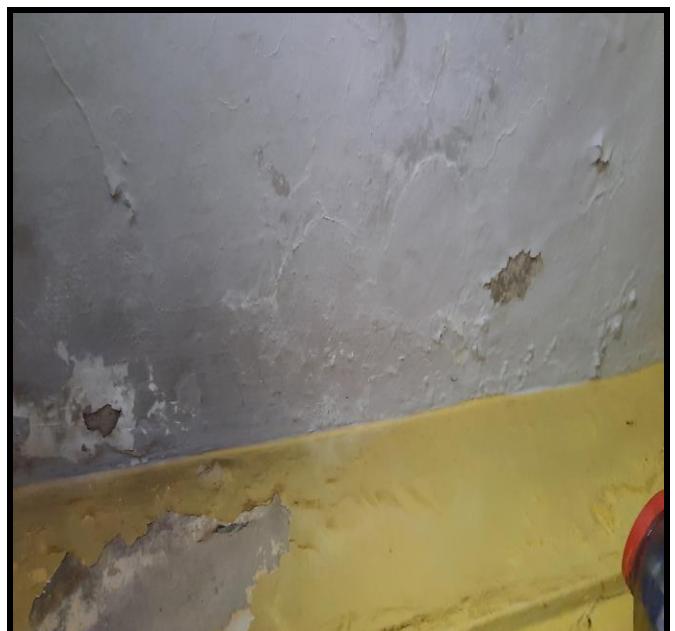
FLAT NO – 701

- ❖ **HALL** – Leakage mark observed on wall.
 - Structural crack observed on beam.
- ❖ **KITCHEN** – Leakage mark observed on wall & ceiling.
- ❖ **PASSAGE** – O.K.
- ❖ **TOILET & BATH ROOM** – O.K.

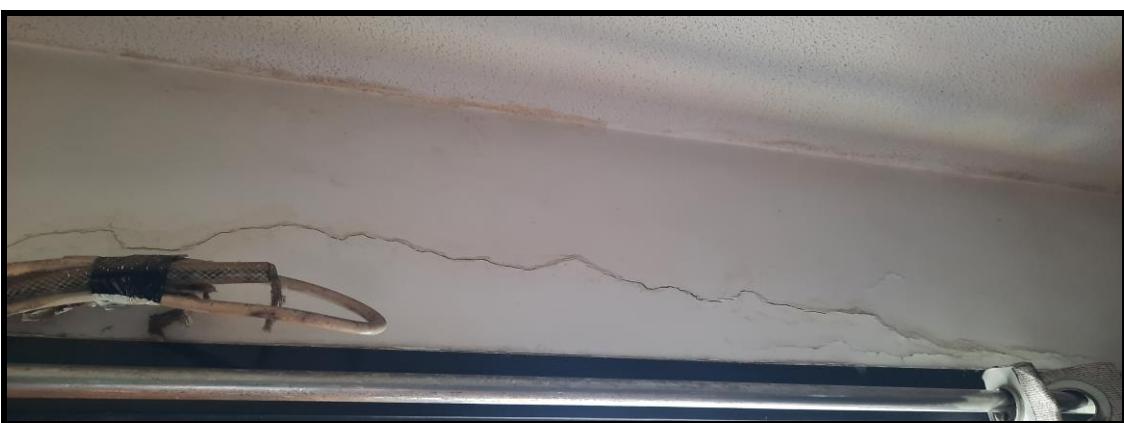
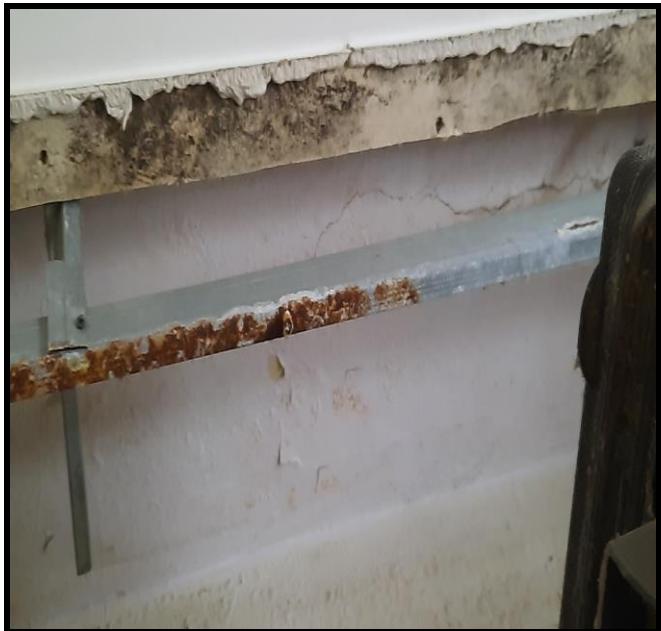
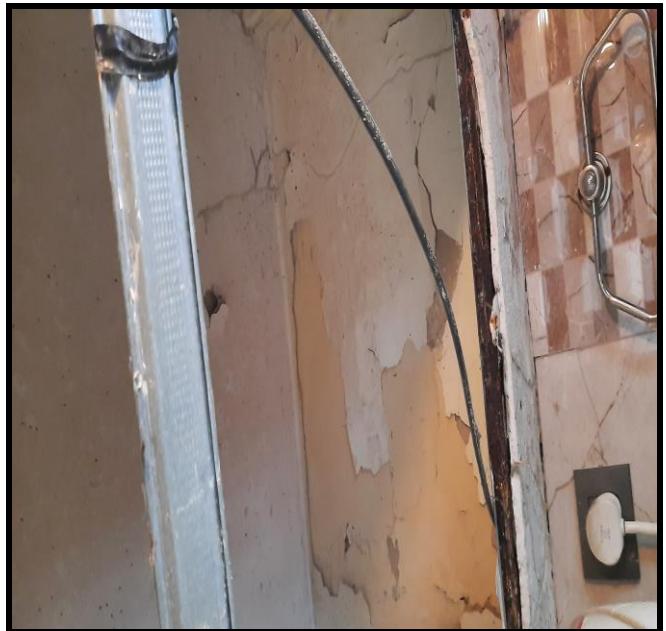
FLAT NO – 703

- ❖ **HALL** – Structural crack observed on beam.
- ❖ **KITCHEN** – Leakage mark observed ceiling.
 - Structural crack observed on ceiling.
- ❖ **PASSAGE** – O.K.
- ❖ **TOILET & BATH ROOM** – Leakage mark observed ceiling.

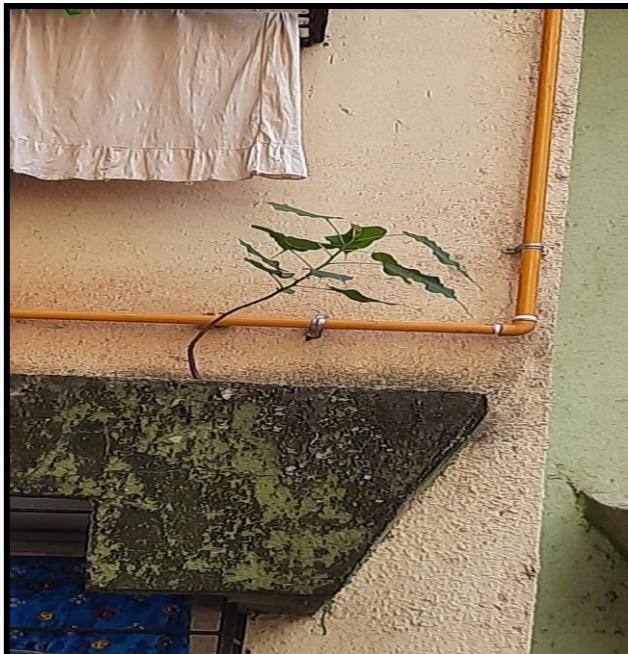
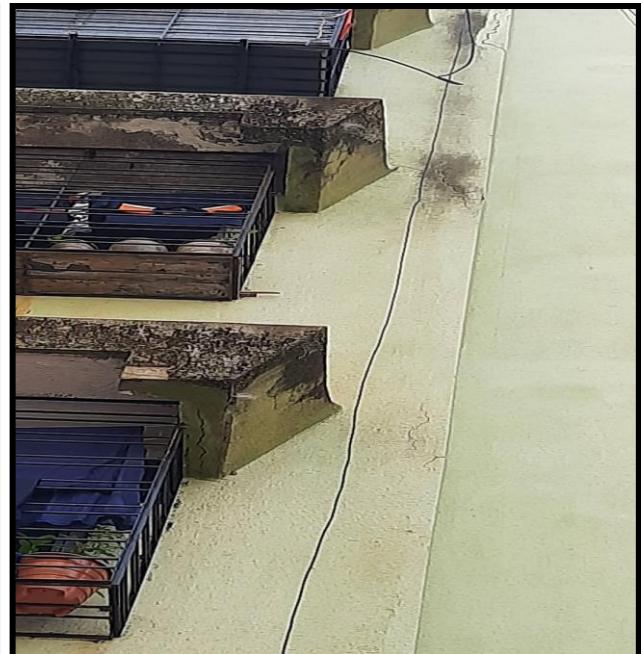
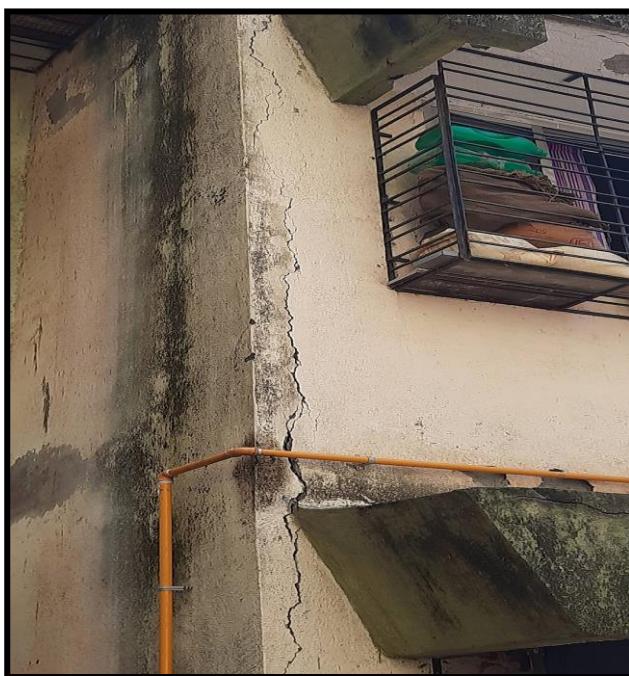
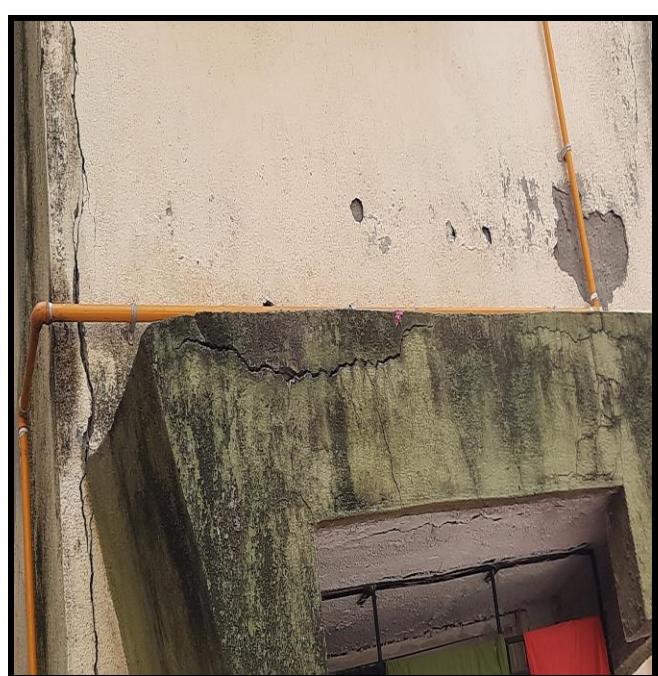
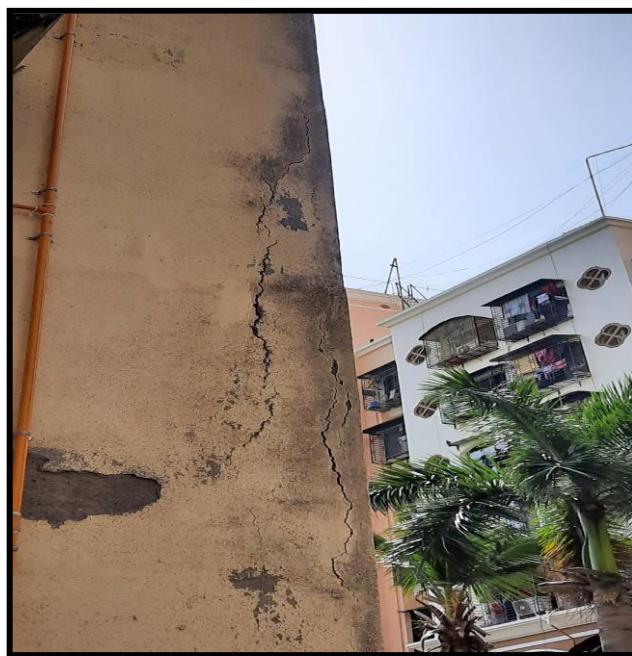
FRONT SIDE

- ❖ Structural crack observed at several places on column & chajjas.
- ❖ Vegetation growth observed at several places on wall.

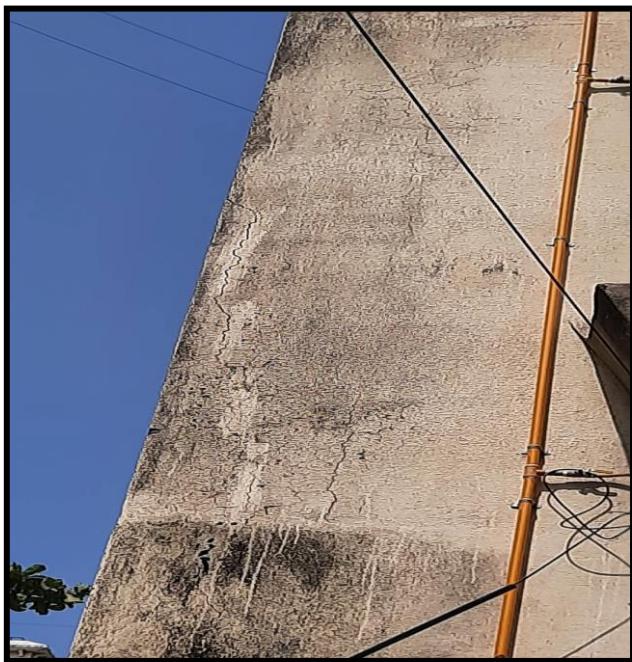
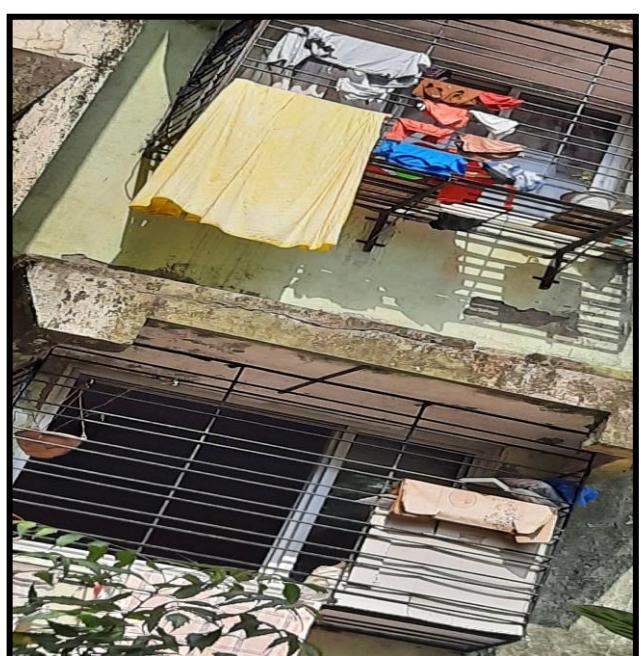
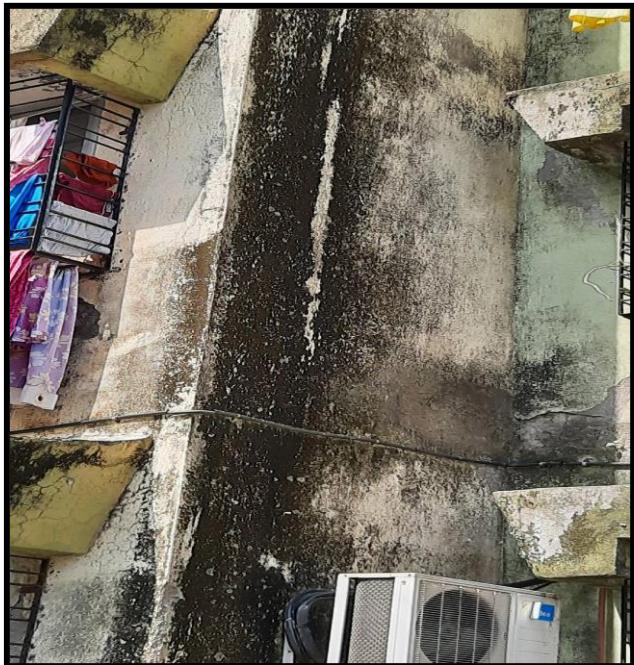
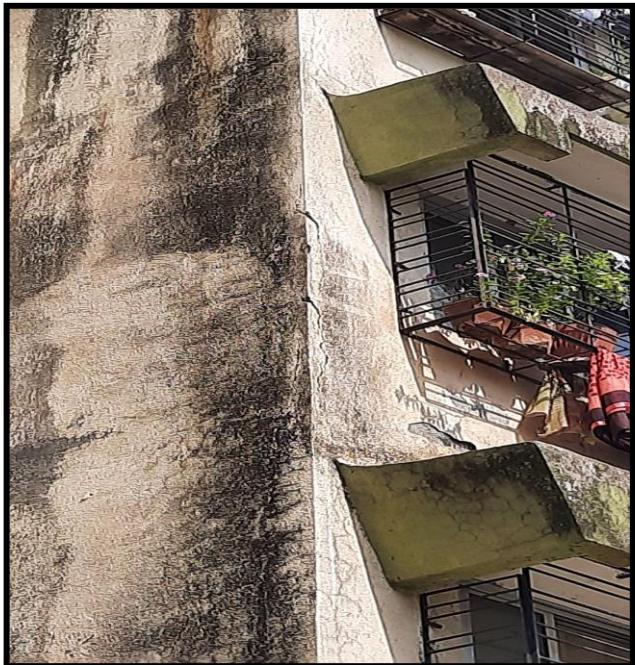
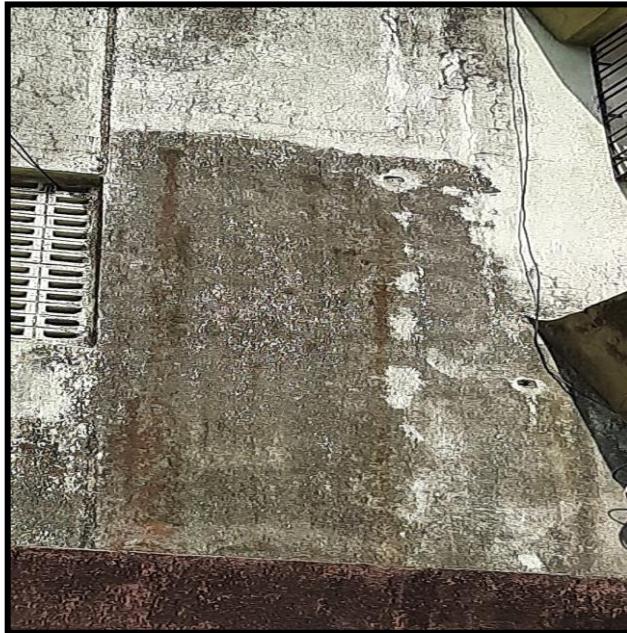
BACK SIDE

- ❖ Structural crack observed at several places on column.
- ❖ Algae observed at several places on wall.

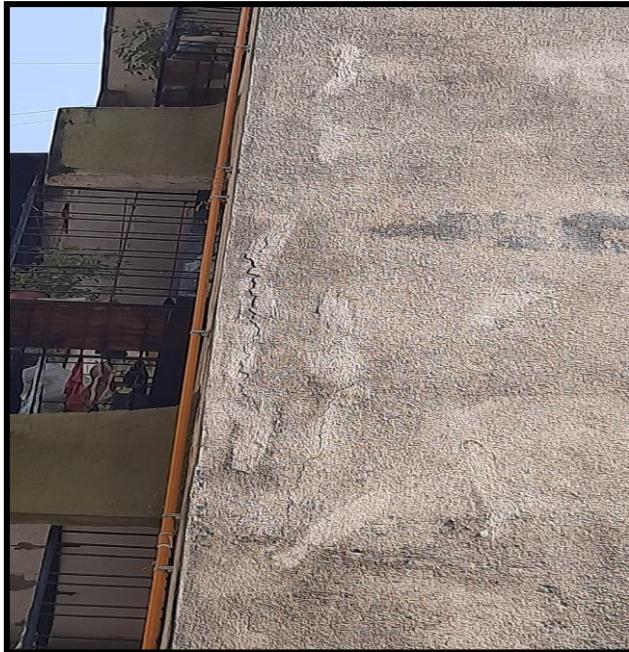
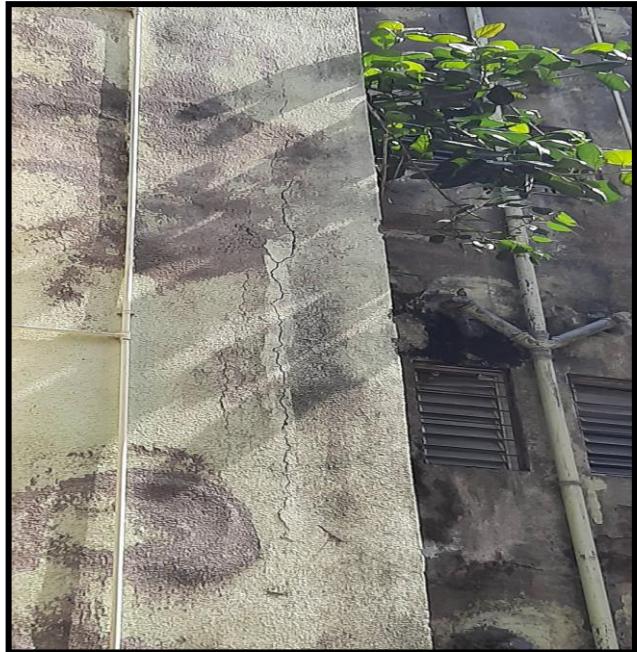
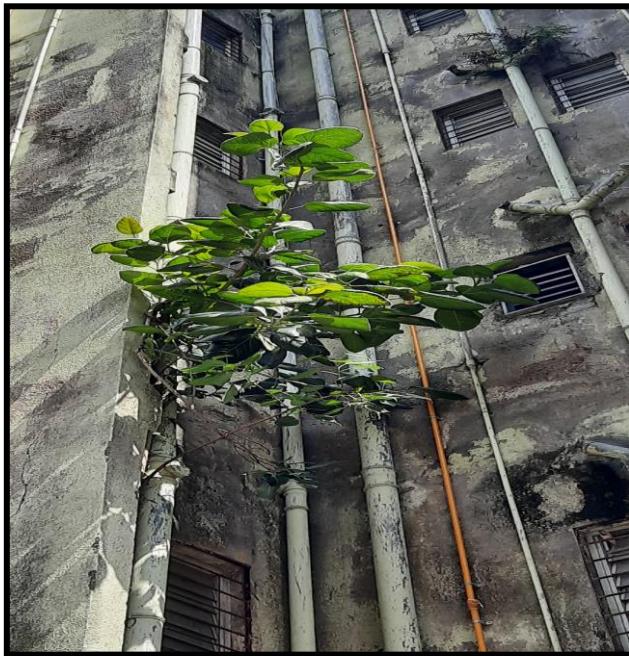
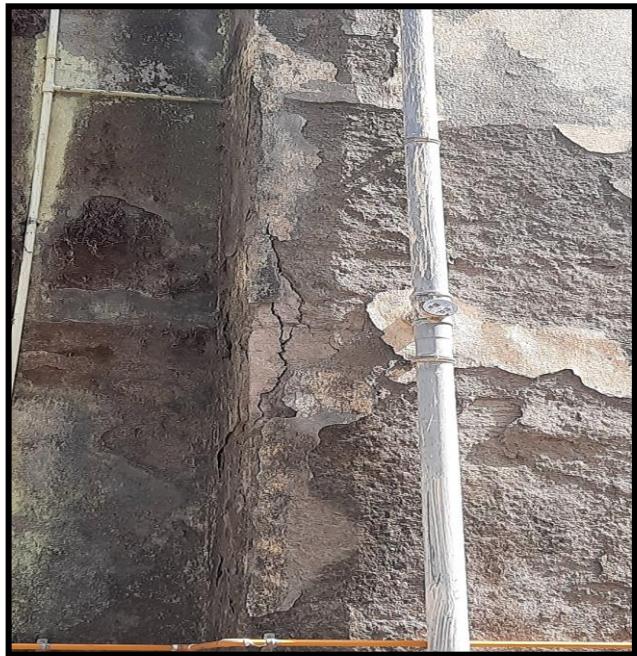
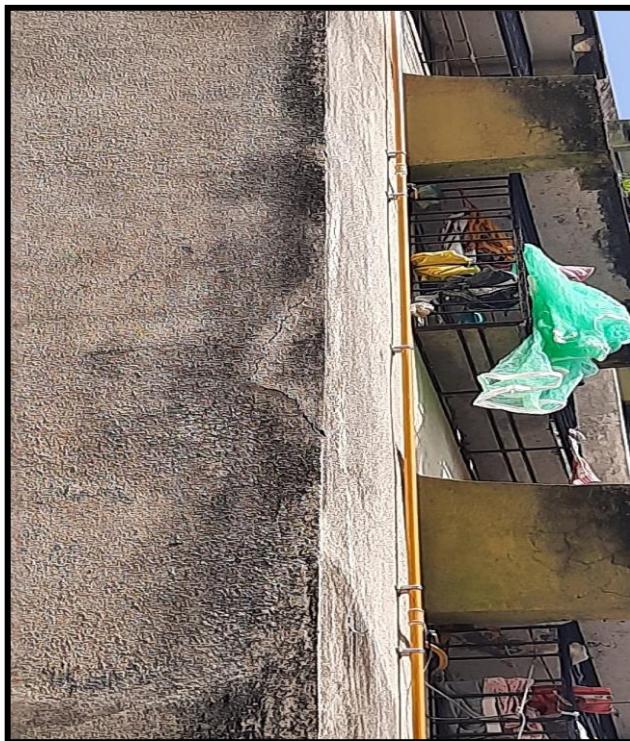
NORTH SIDE

- ❖ Structural crack observed at several places on column.
- ❖ Algae observed at several places on wall.
- ❖ Vegetation growth observed at several places on wall.

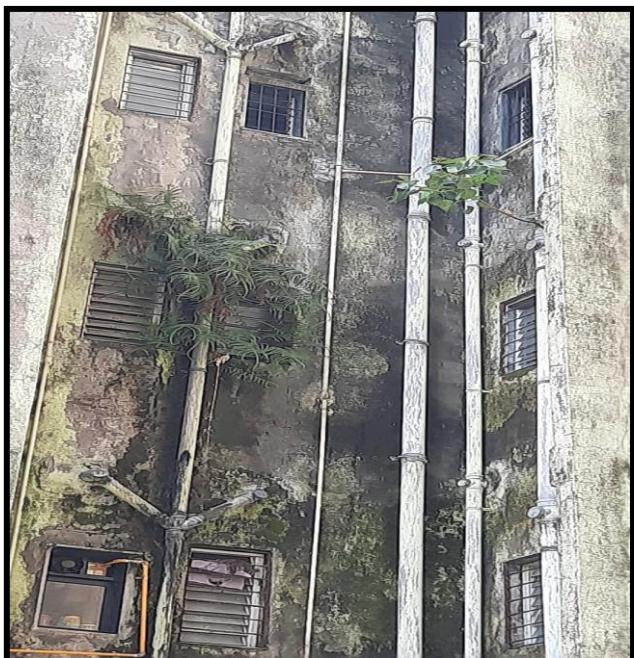
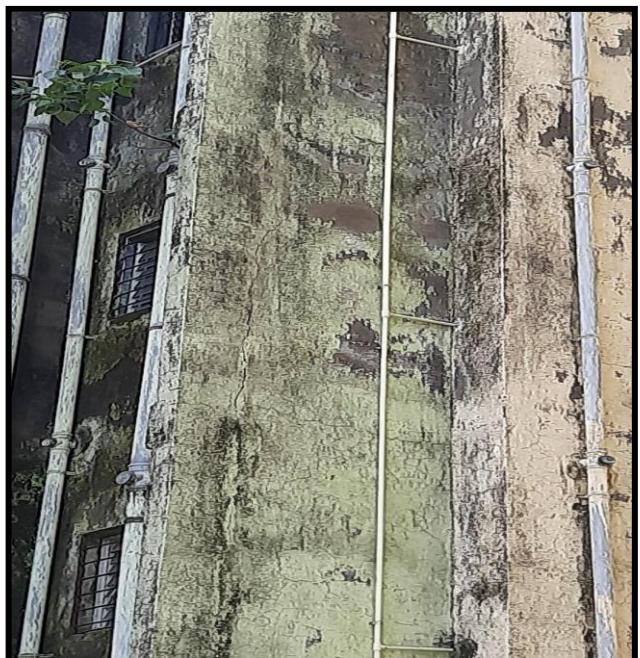
SOUTH SIDE

- ❖ Structural crack observed at several places on column.
- ❖ Major crack observed at several places on wall.
- ❖ Vegetation growth observed at several places on wall.
