STRUCTURAL AUDIT REPORT
FOR
“VISHAL SAHYADRI CO – OP HSG. SOC. LTD”,
“D3 – C WING”
SITUATED AT
SAHYADRI NAGAR, CHARKOP,
KANDIVALI (W) MUMBAI – 400 067

978/D3/LSS/2021

JULY 16, 2021

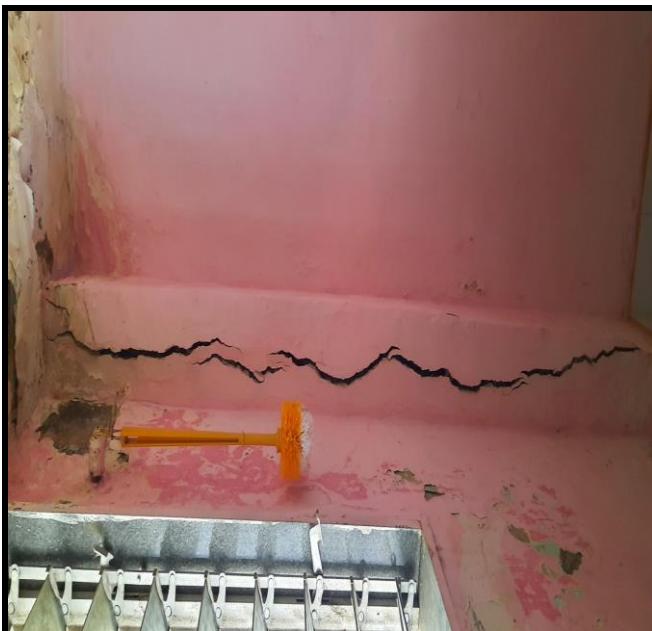
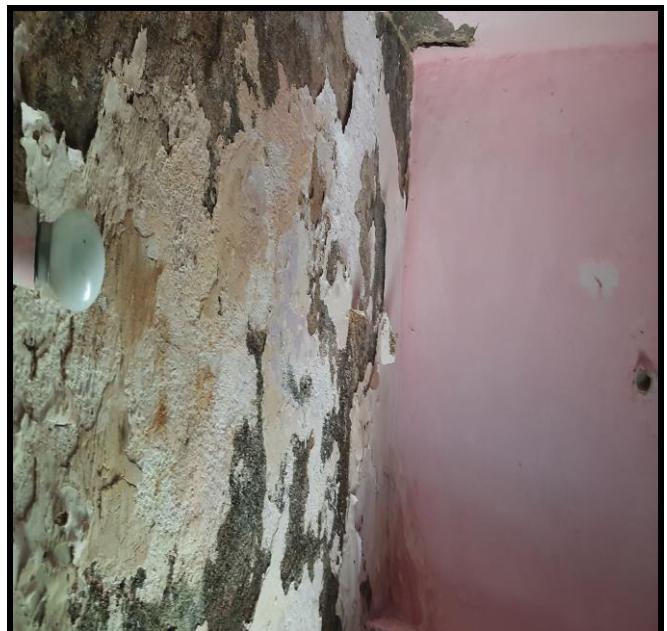
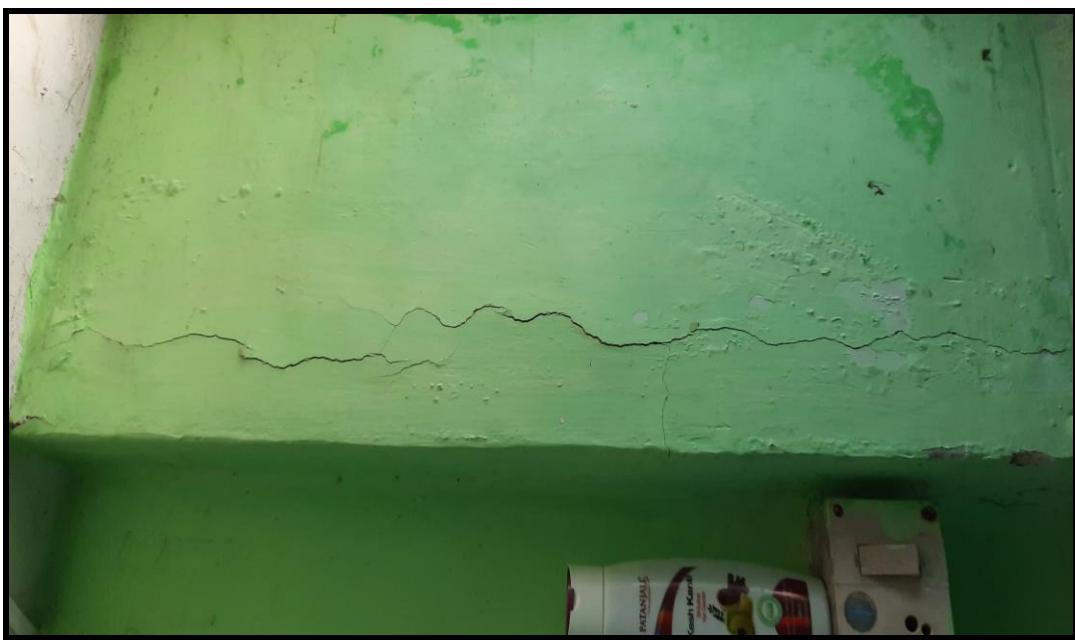
FLAT NO - 14

- ❖ **HALL** – O.K.
- ❖ **KITCHEN** – Leakage observed on wall in monsoon.
- ❖ **PASSAGE** – O.K.
- ❖ **TOILET & BATH ROOM** – Leakage mark observed on ceiling.
 - Structural crack observed on column.

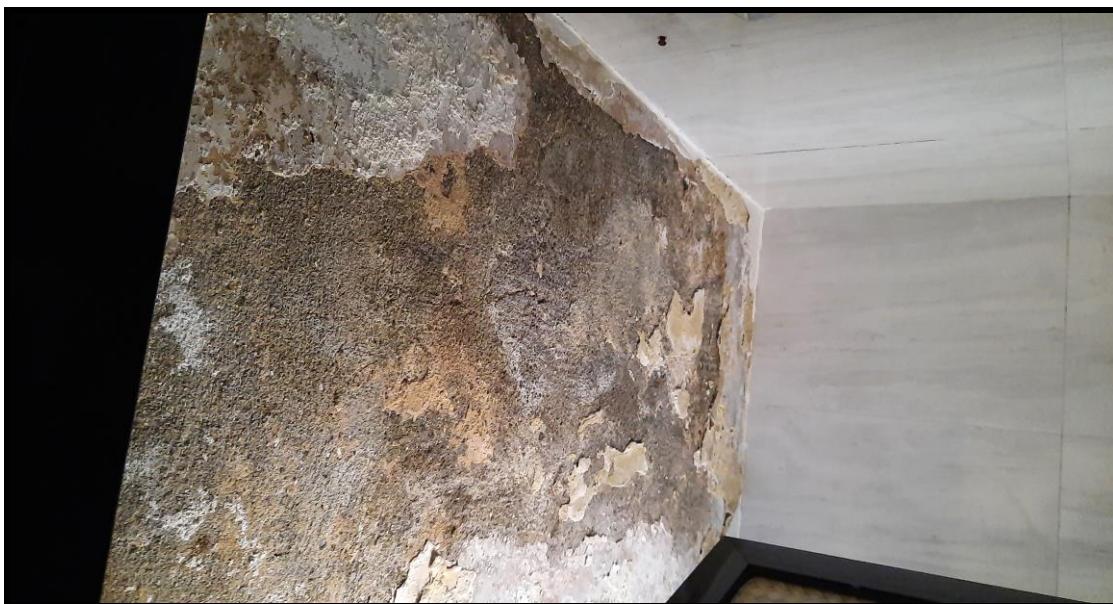
FLAT NO – 18

- ❖ **HALL** – O.K.
- ❖ **KITCHEN** – O.K.
- ❖ **PASSAGE** – Leakage mark observed on ceiling.
- ❖ **TOILET & BATH ROOM** – Leakage mark observed on ceiling.

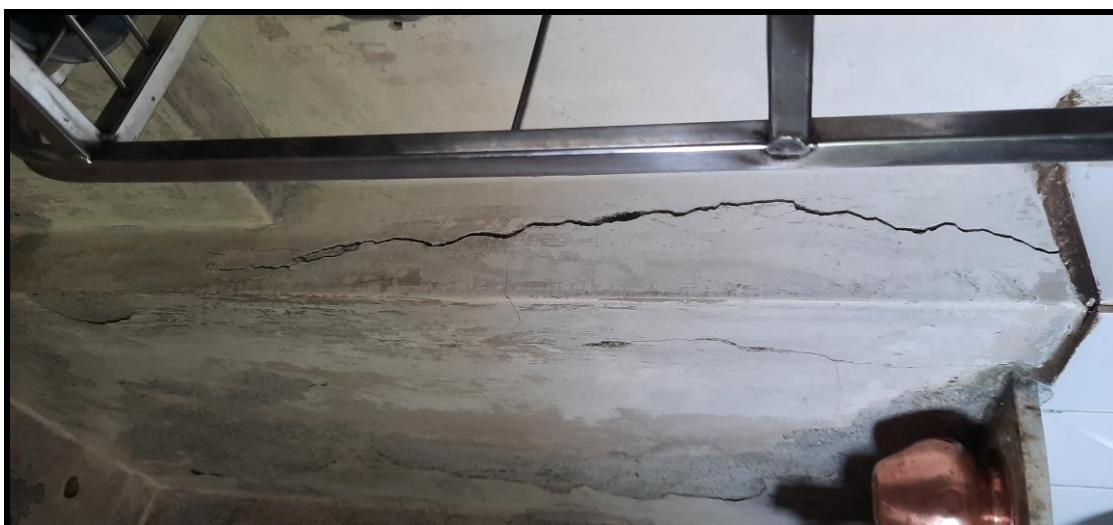
FLAT NO – 19

- ❖ **HALL** – O.K.
- ❖ **KITCHEN** – Structural crack observed on column.
- ❖ **PASSAGE** – O.K.
- ❖ **TOILET & BATH ROOM** – O.K.

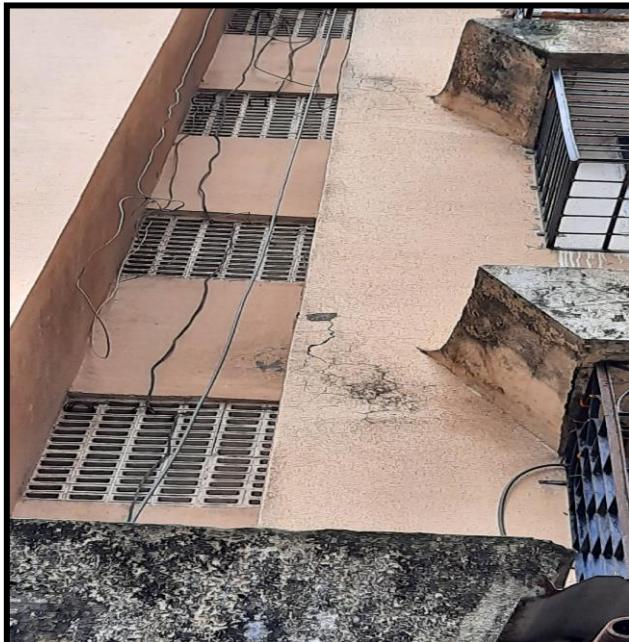
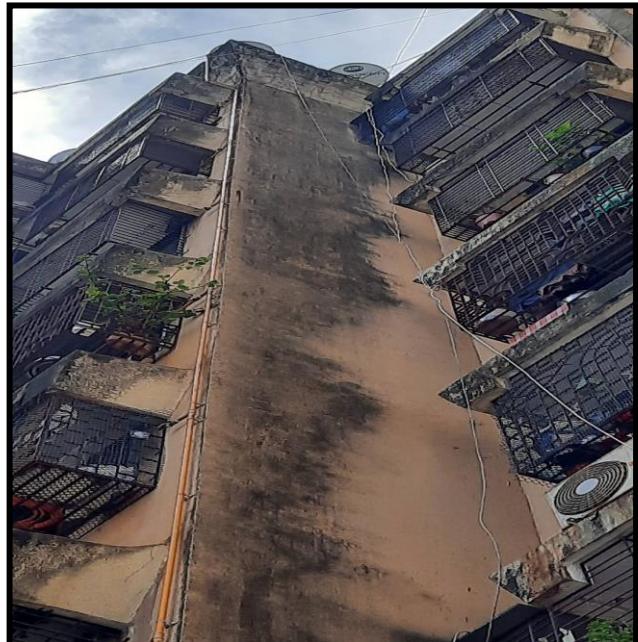
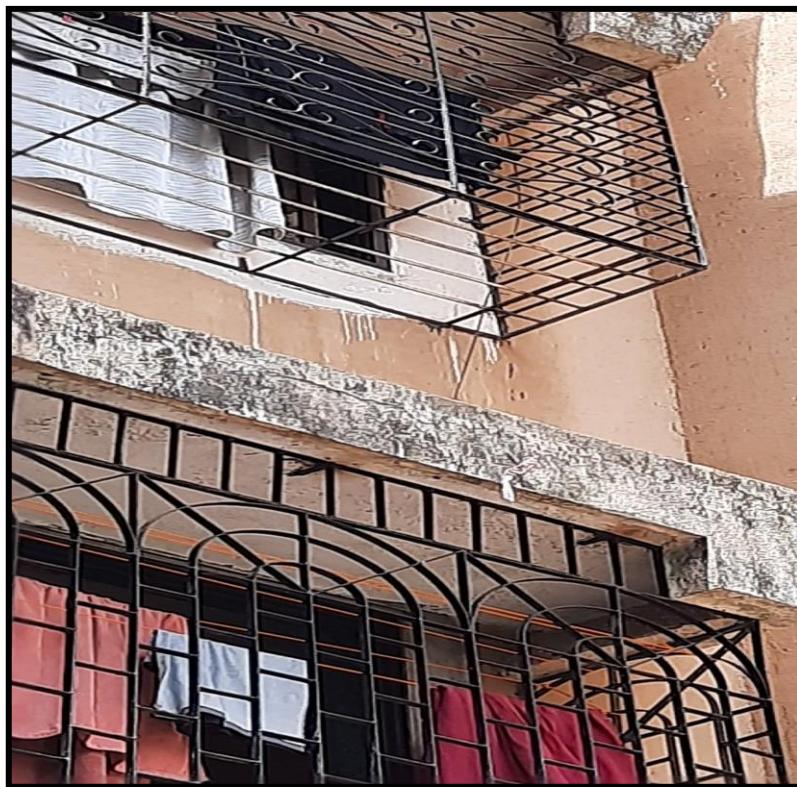
FRONT SIDE

- ❖ Structural crack observed at several places on column & chajjas.
- ❖ Algae observed at several places on wall.

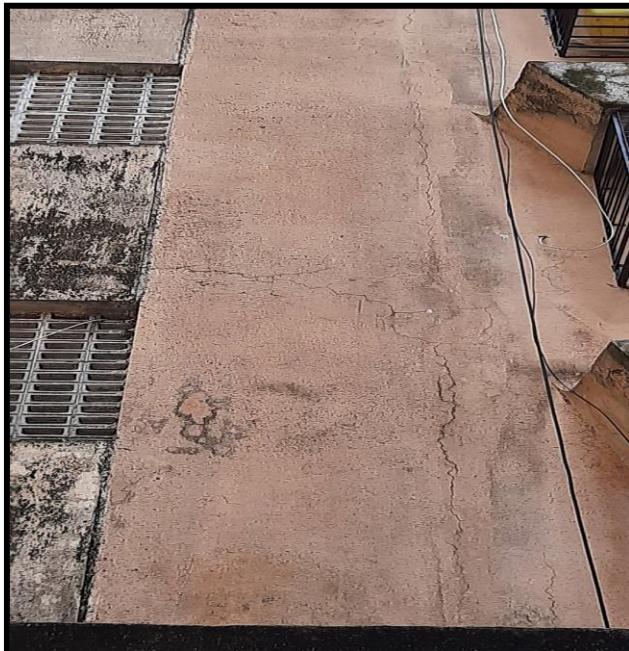
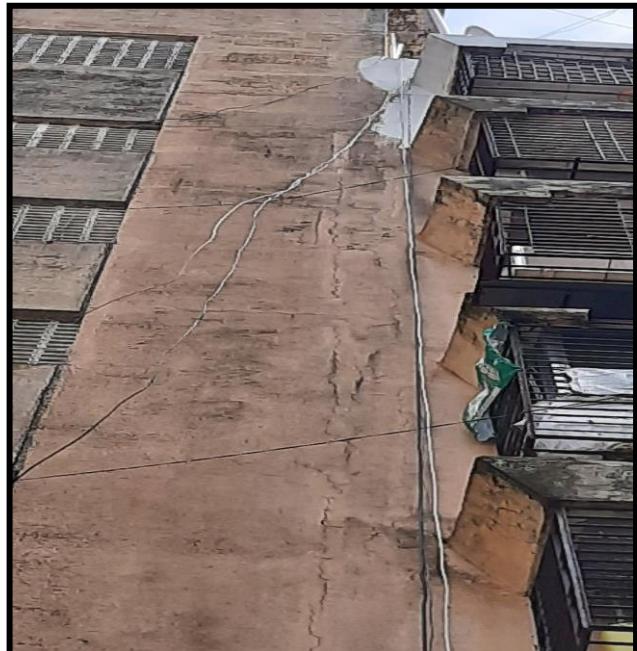
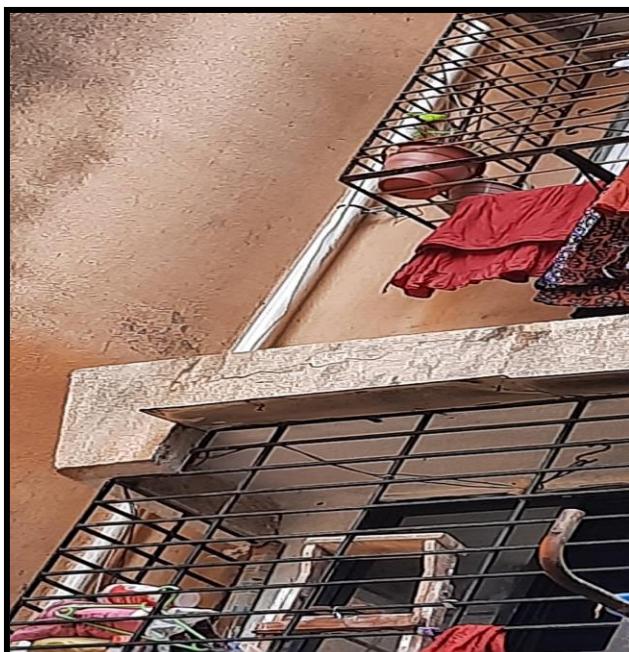
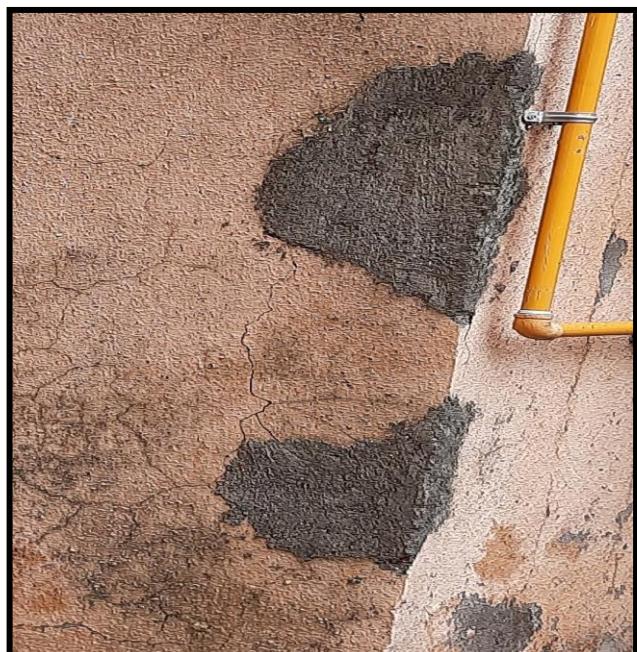
BACK SIDE

- ❖ Major crack observed at several places on wall.
- ❖ Algae observed at several places on wall.

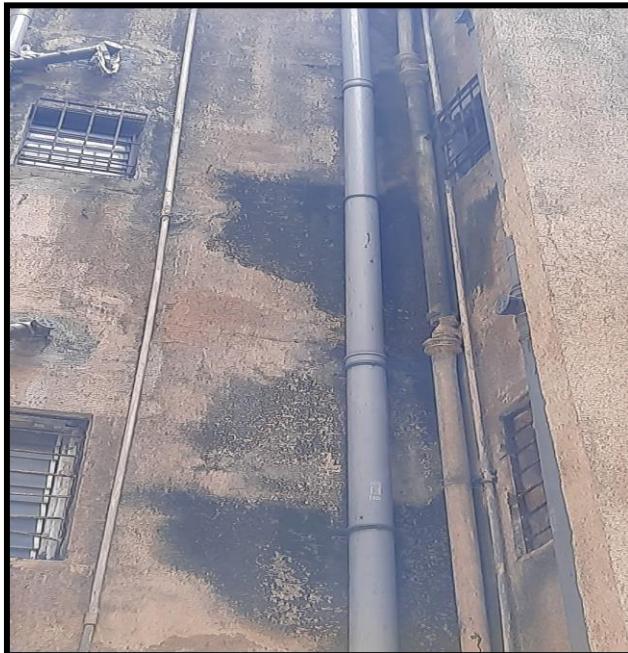
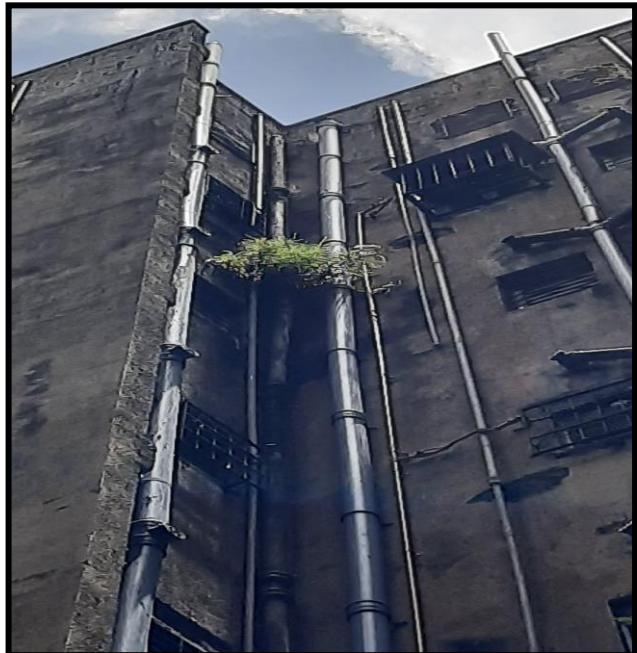
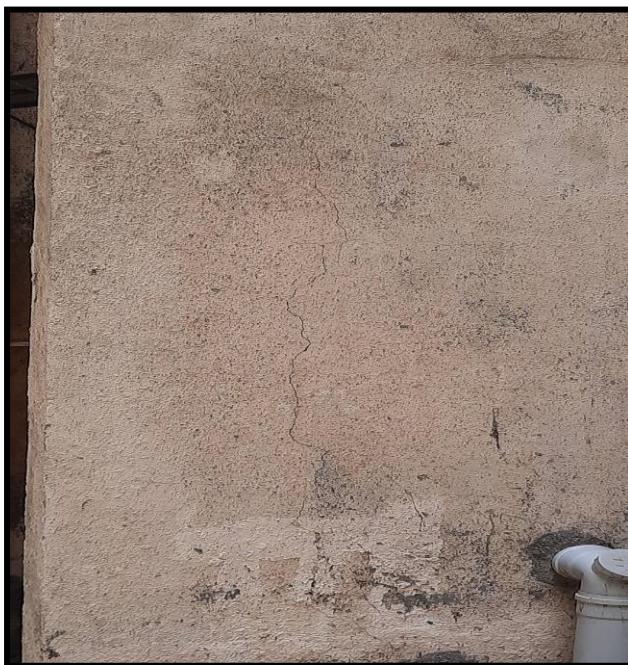
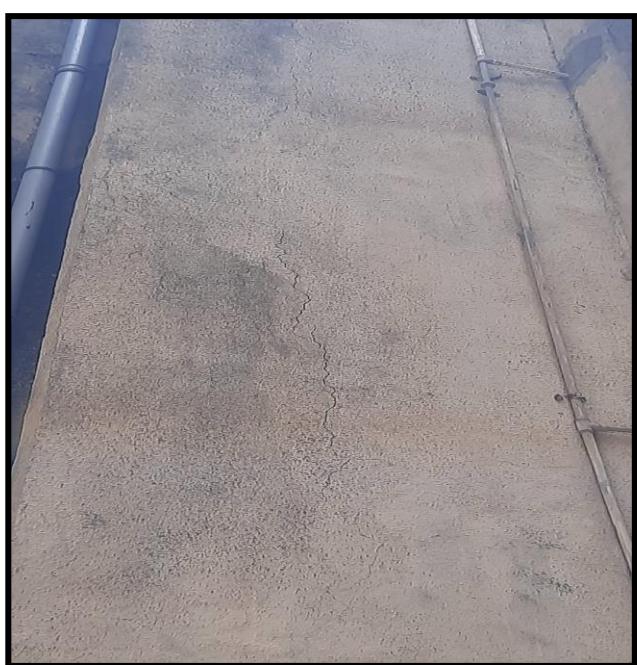
EAST SIDE

- ❖ Structural crack observed at several places on column.
- ❖ Algae observed at several places on wall.
- ❖ Vegetation growth observed at several places on wall.

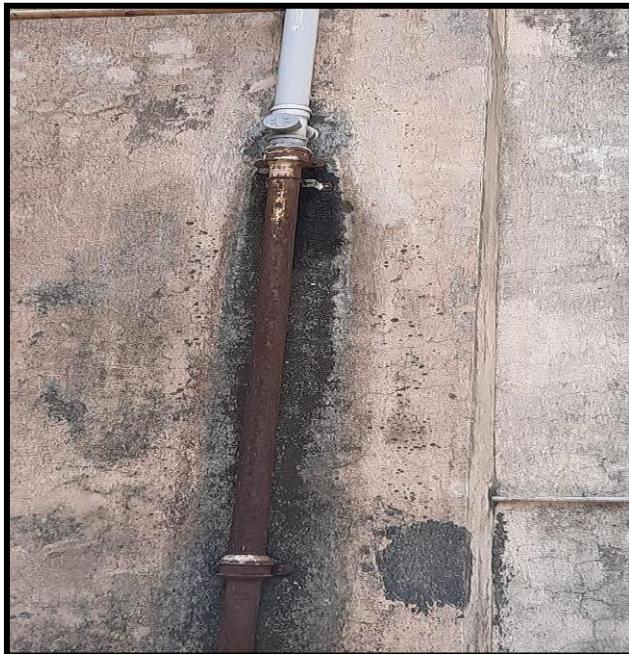
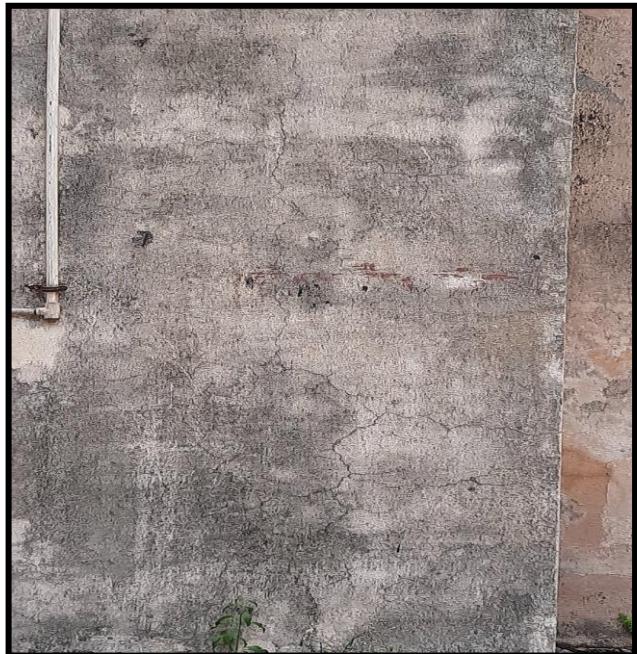
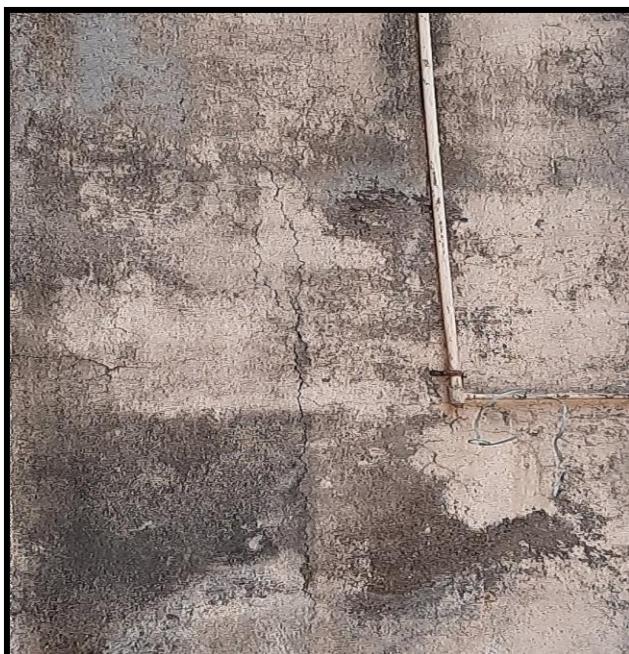
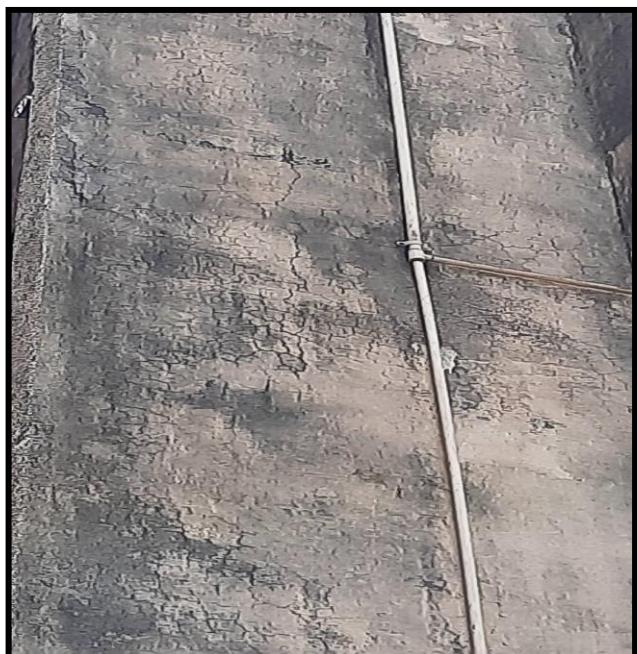
WEST SIDE

- ❖ Algae observed at several places on wall.
- ❖ Major crack observed at several places on wall.
