STRUCTURAL AUDIT REPORT  
FOR  
**“VISHAL SAHYADRI CO – OP HSG. SOC. LTD”,**  
**“D3 – E WING”**  
SITUATED AT  
SAHYADRI NAGAR, CHARKOP,  
KANDIVALI (W) MUMBAI – 400 067

978/D3/LSS/2021

JULY 16, 2021

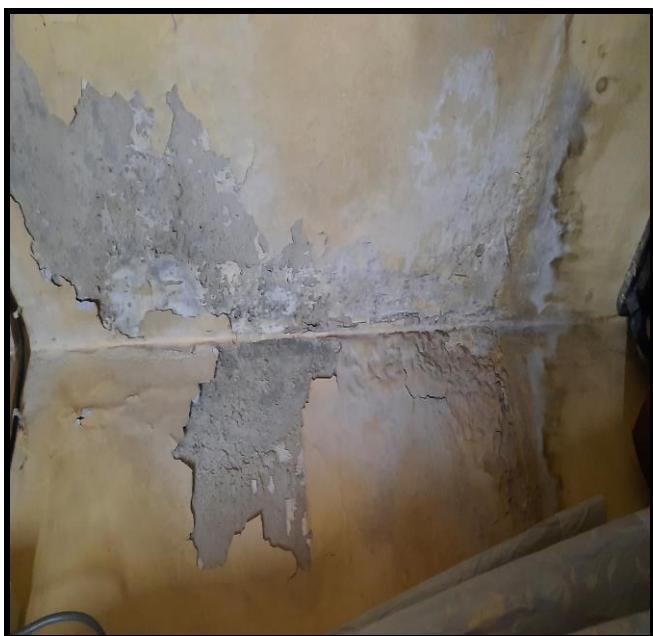
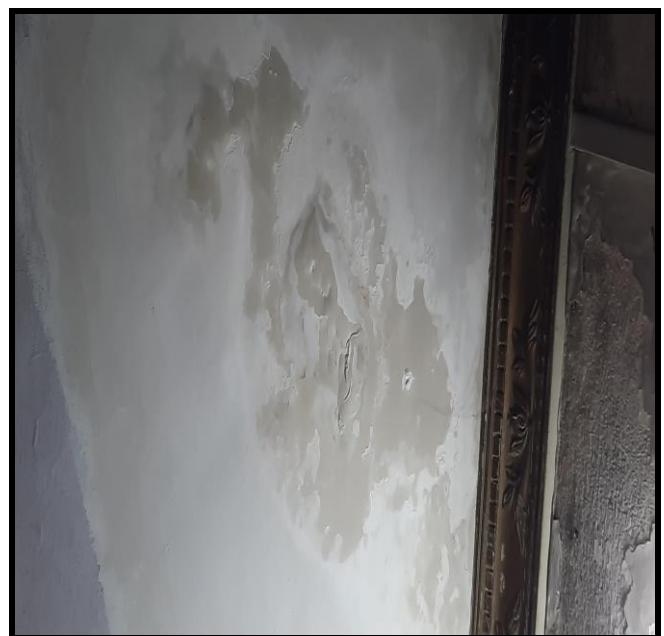
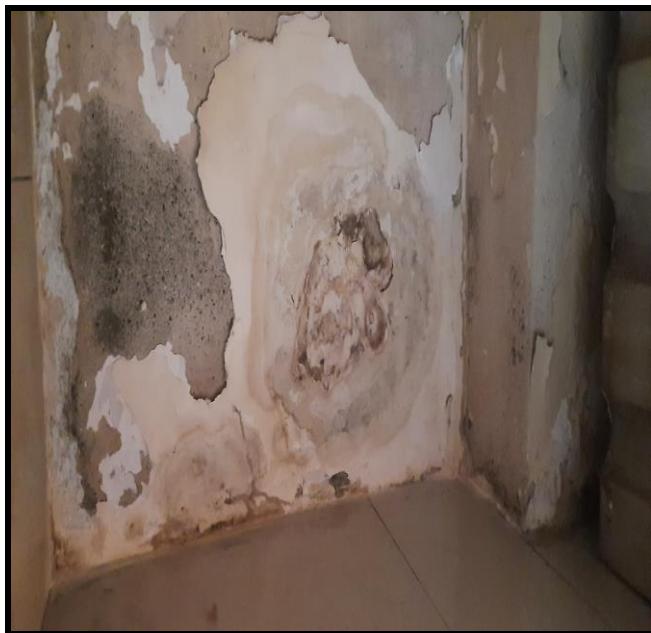
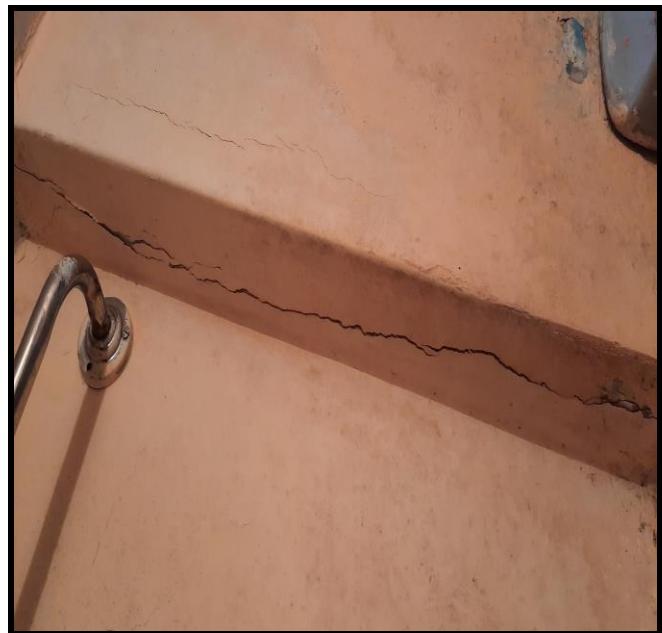
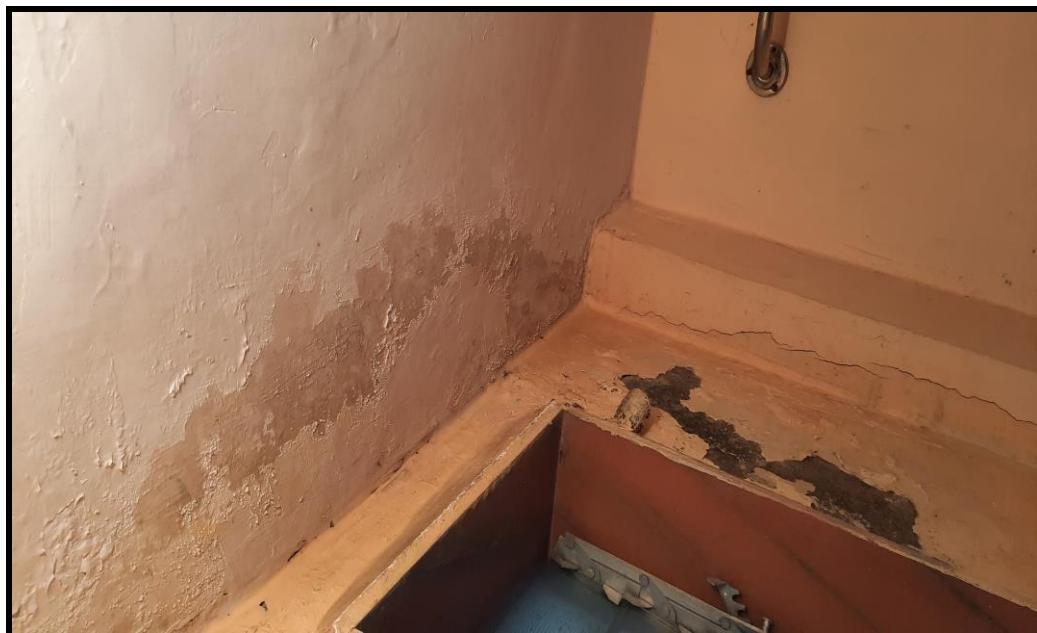
##### FLAT NO – 02

- ❖ **HALL** – Leakage mark observed on wall & ceiling.
- ❖ **KITCHEN** – O.K.
- ❖ **PASSAGE** – Leakage mark observed on ceiling.
- ❖ **TOILET & BATH ROOM** – Leakage mark observed on ceiling.
  - Structural crack observed on column.

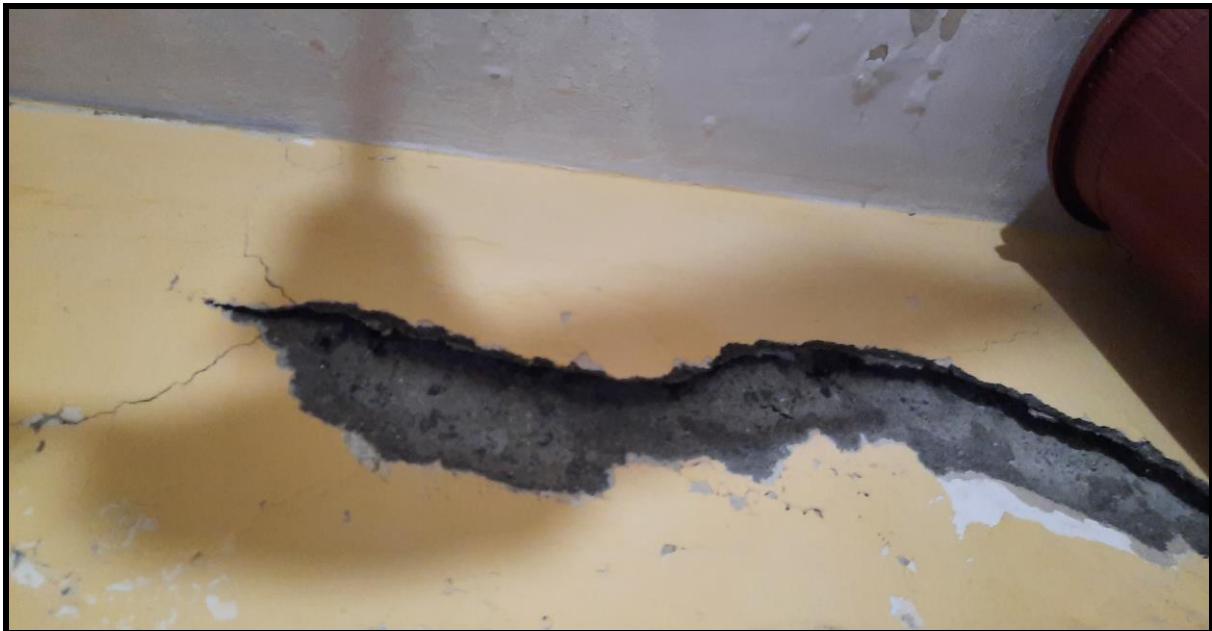
## FLAT NO – 04

- ❖ **HALL** – O.K.
- ❖ **KITCHEN** – Leakage observed on wall in monsoon.
  - Structural damage observed on beam.
- ❖ **PASSAGE** – O.K.
- ❖ **TOILET & BATH ROOM** – O.K.

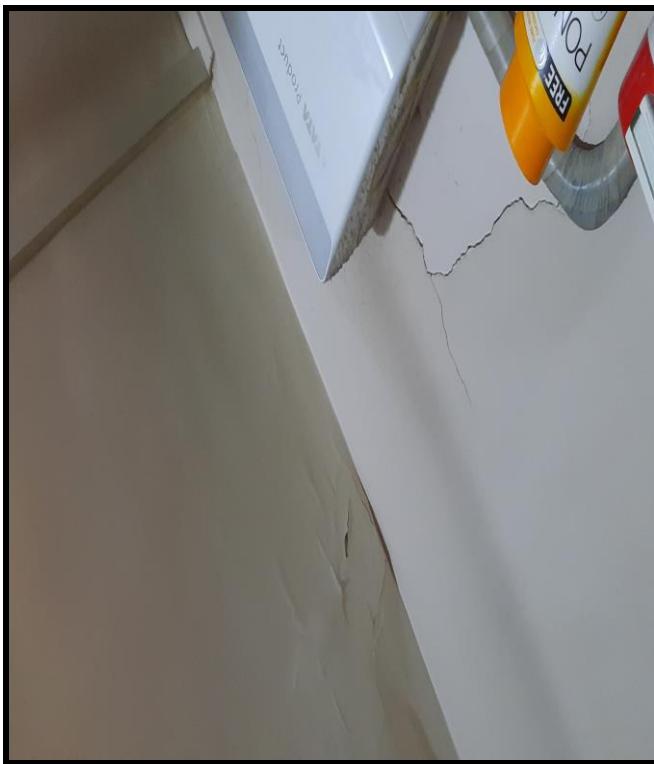
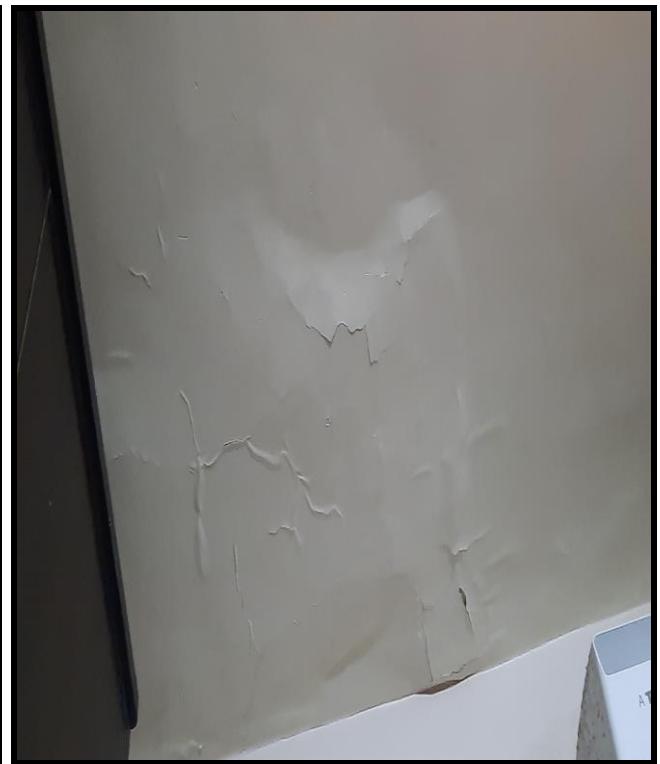
### FLAT NO – 12

- ❖ **HALL** – O.K.
- ❖ **KITCHEN** – Structural crack observed on beam & ceiling.
- ❖ **PASSAGE** – O.K.
- ❖ **TOILET & BATH ROOM** – O.K.

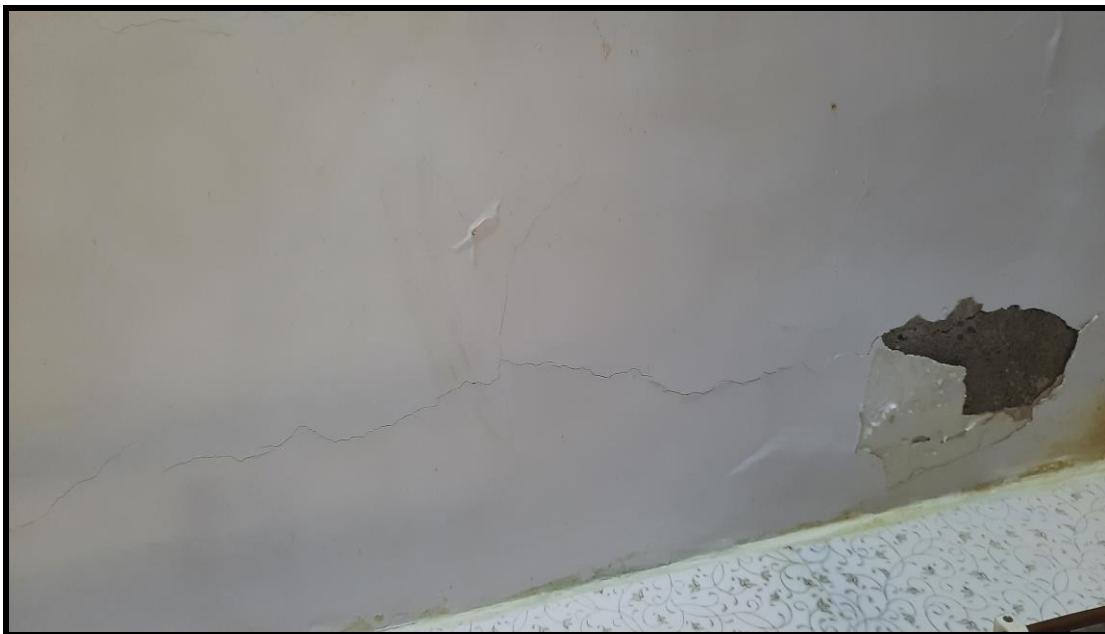
### FLAT NO – 15

- ❖ **HALL** – O.K.
- ❖ **KITCHEN** – Structural crack observed on ceiling.
- ❖ **PASSAGE** – O.K.
- ❖ **TOILET & BATH ROOM** – O.K.

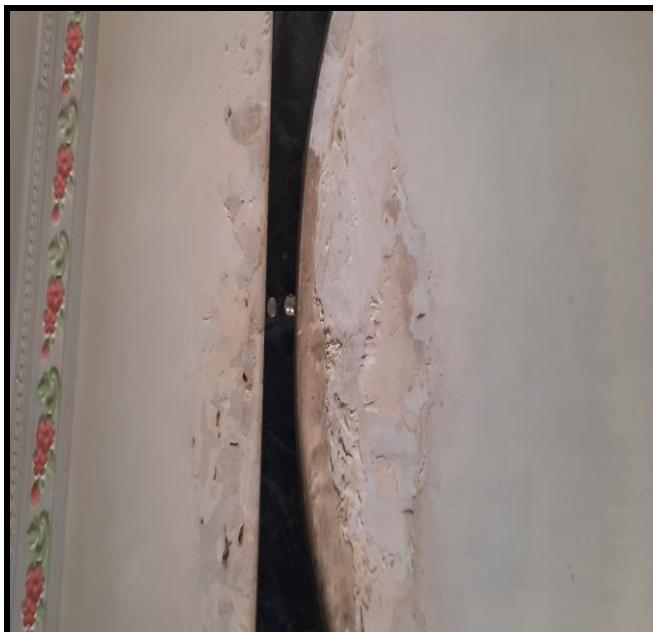
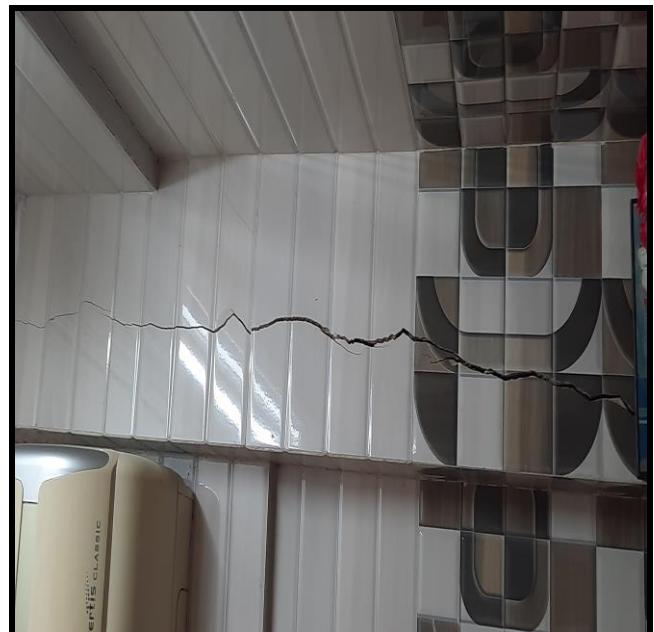
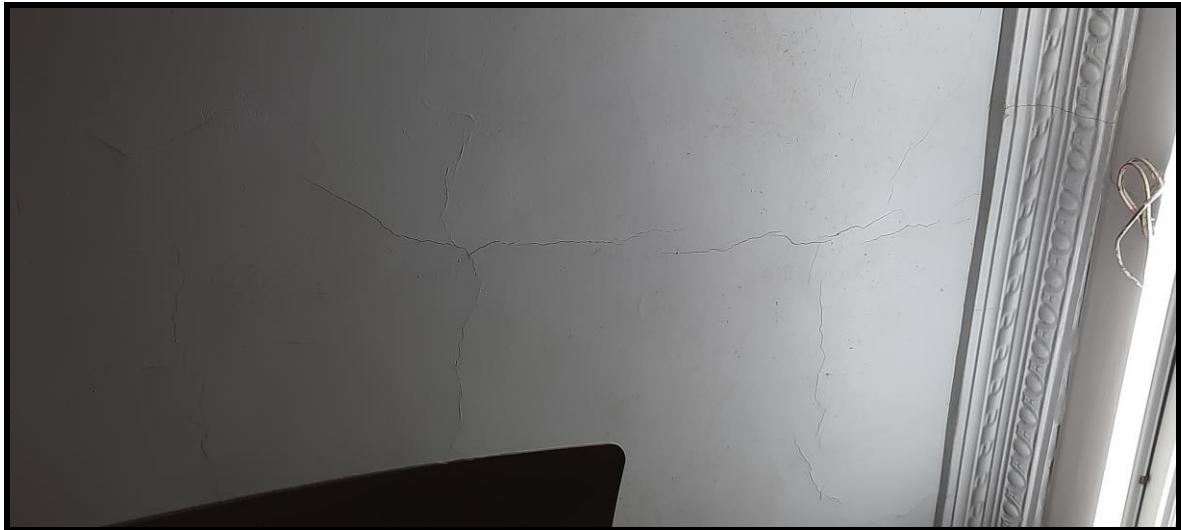
### FLAT NO - 19

- ❖ **HALL** – Leakage mark observed on wall.
- ❖ **KITCHEN** – Structural crack observed on column & ceiling.
- ❖ **PASSAGE** – O.K.
- ❖ **TOILET & BATH ROOM** – O.K.

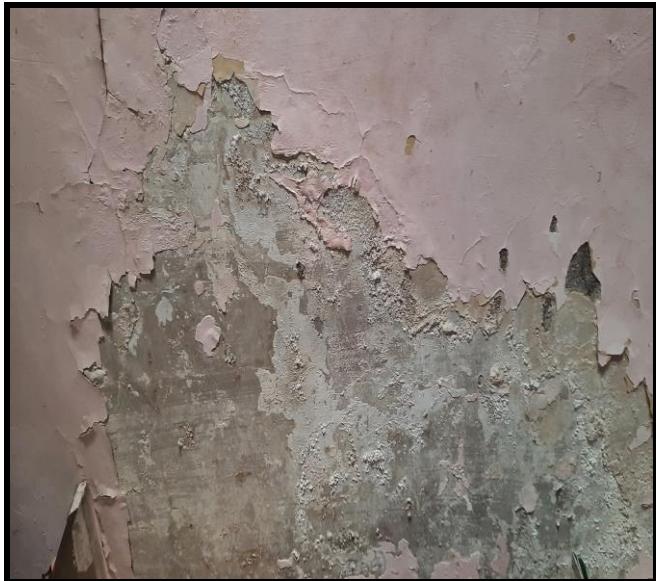
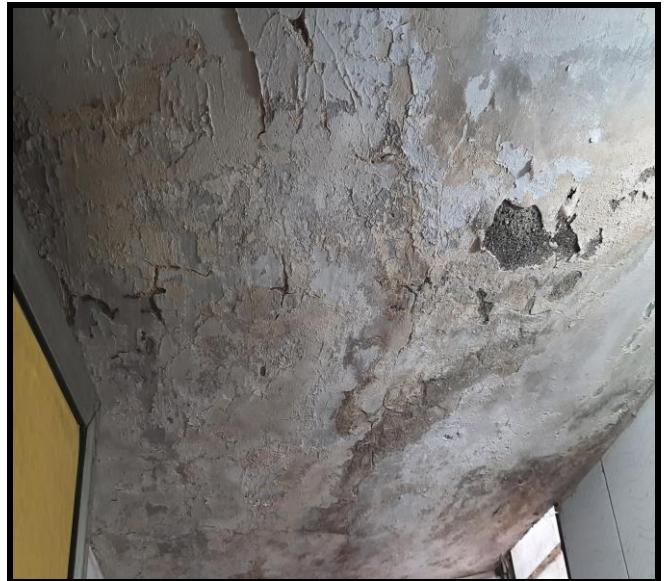
### FLAT NO - 22

- ❖ **HALL** – Leakage mark observed on wall.
- ❖ **KITCHEN** – O.K.
- ❖ **PASSAGE** – O.K.
- ❖ **TOILET & BATH ROOM** – Leakage mark observed on ceiling.

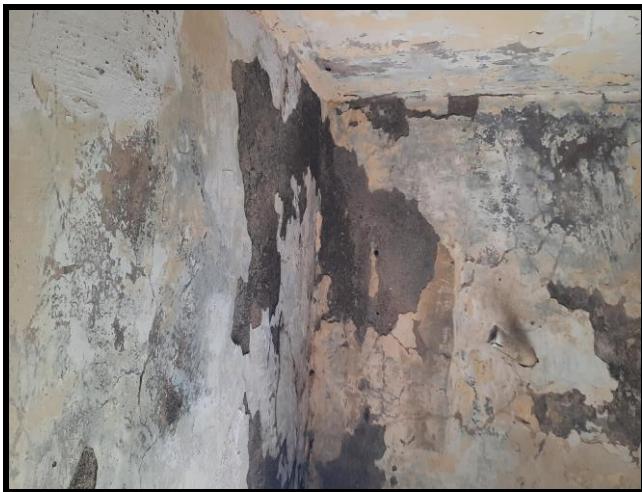
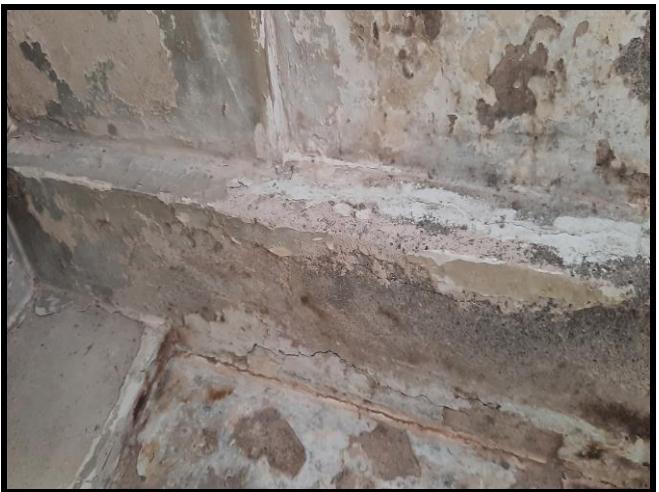
### FLAT NO - 24

- ❖ **HALL** – O.K.
- ❖ **KITCHEN** – Leakage mark observed on wall.
  - Structural crack observed on column.
- ❖ **PASSAGE** – O.K.
- ❖ **TOILET & BATH ROOM** – Leakage mark observed on wall.
  - Leakage observed on ceiling.

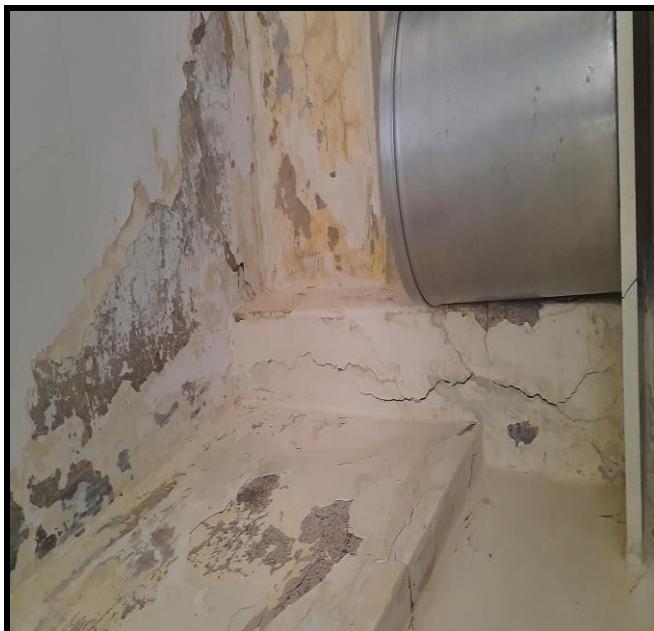
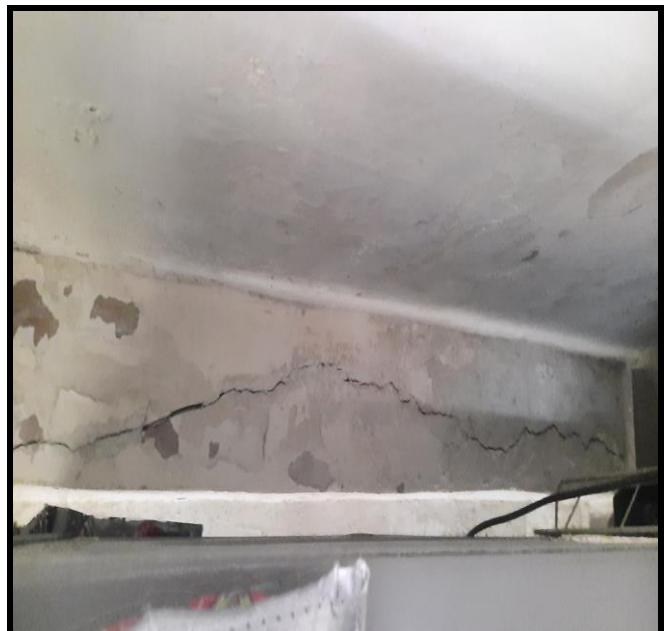
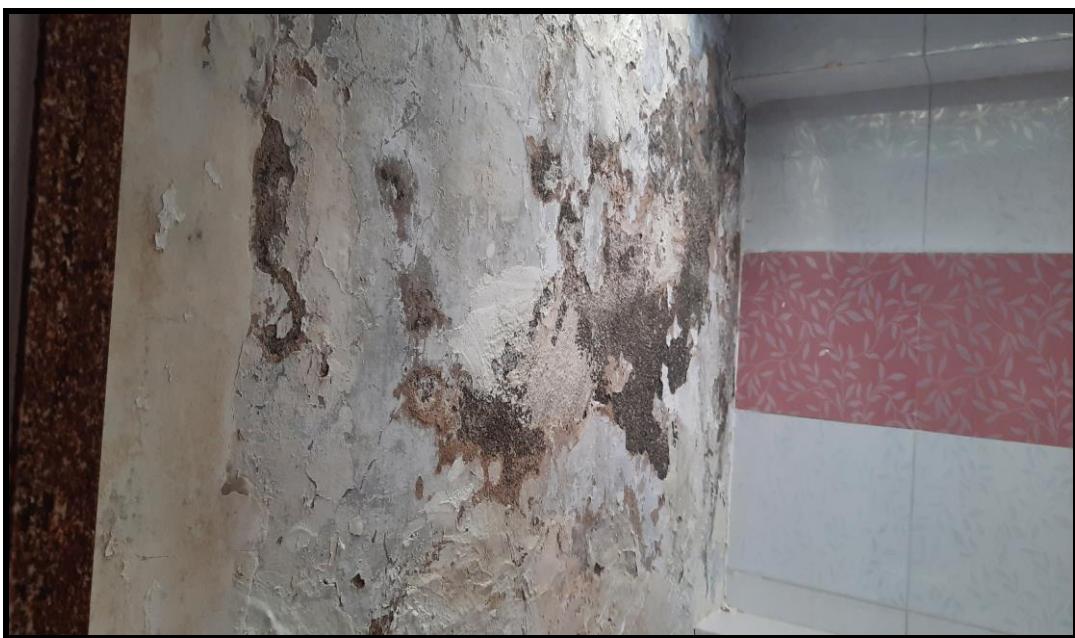
### FLAT NO - 27

- ❖ **HALL** – O.K.
- ❖ **KITCHEN** – Leakage mark observed on wall & ceiling.
  - Structural crack observed on column.
- ❖ **PASSAGE** – Leakage mark observed on ceiling.
- ❖ **TOILET & BATH ROOM** – Leakage mark observed on ceiling.

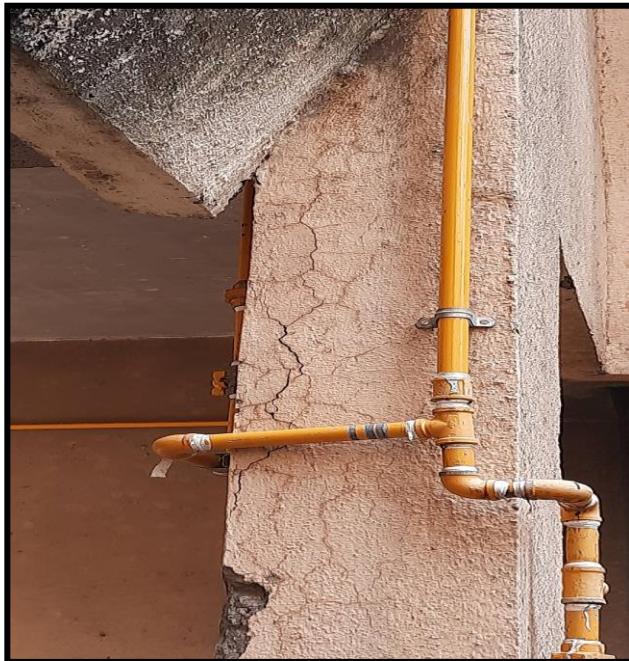
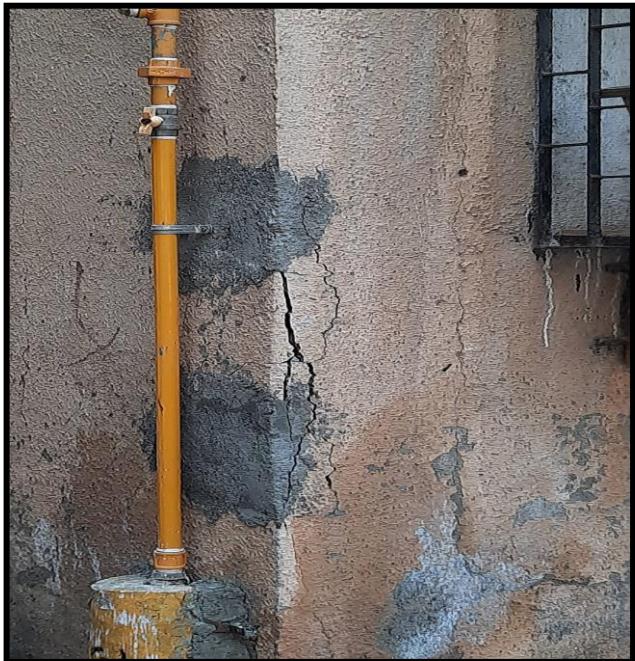
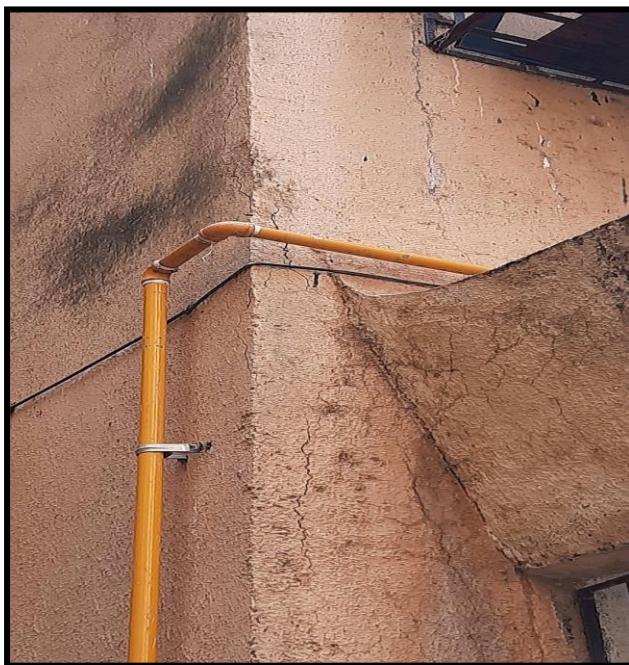
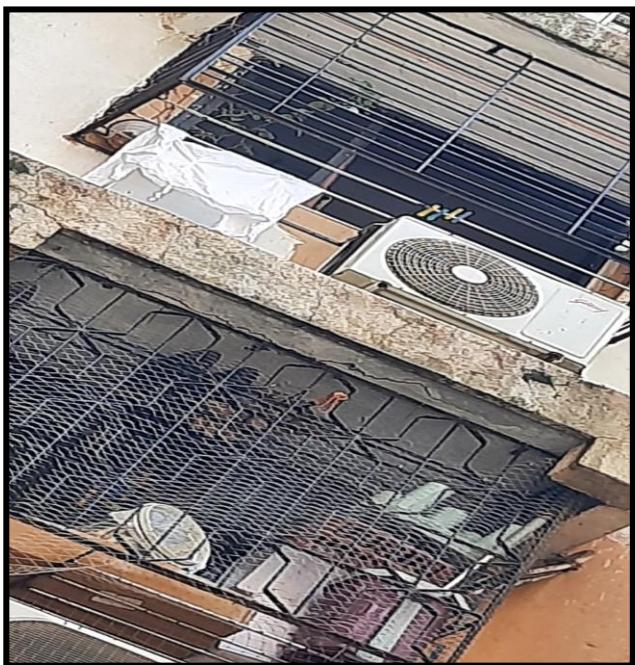
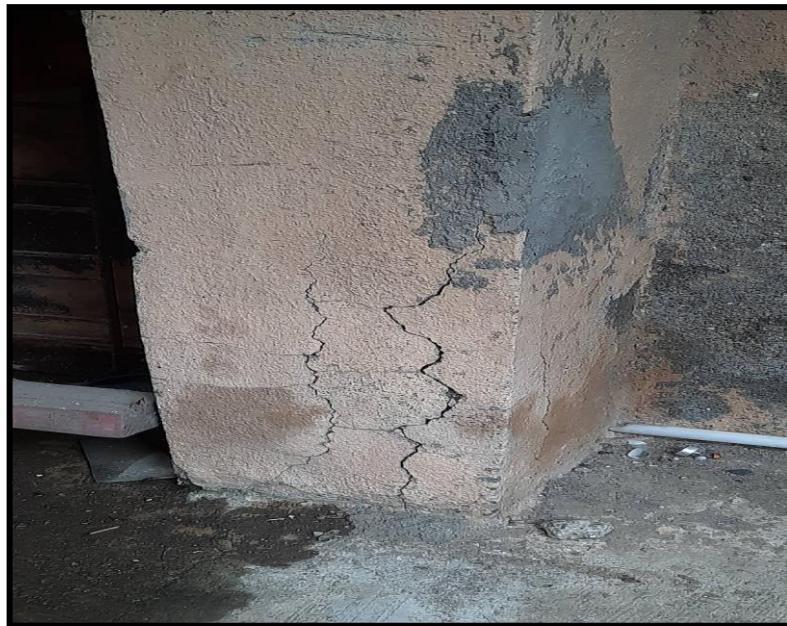
### FRONT SIDE

- ❖ Structural crack observed at several places on column & chajjas.

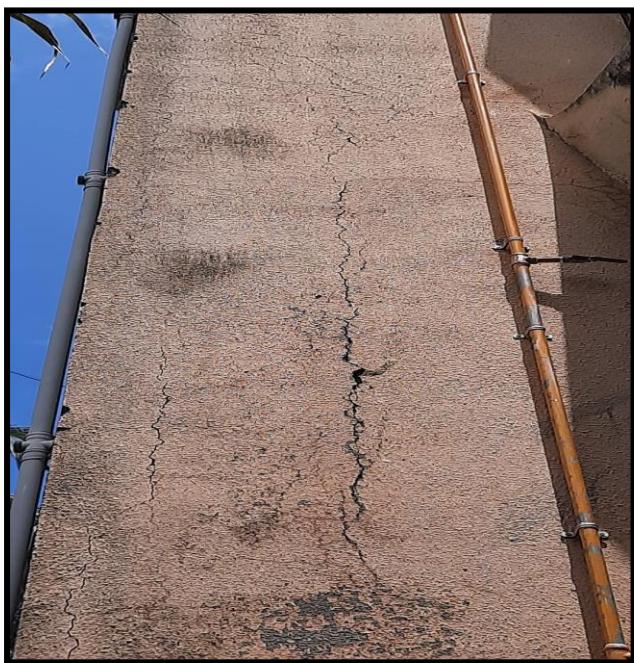
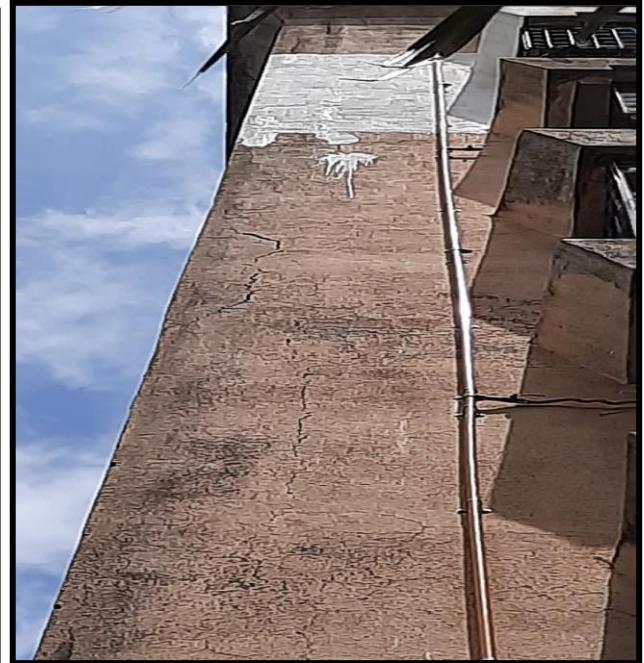
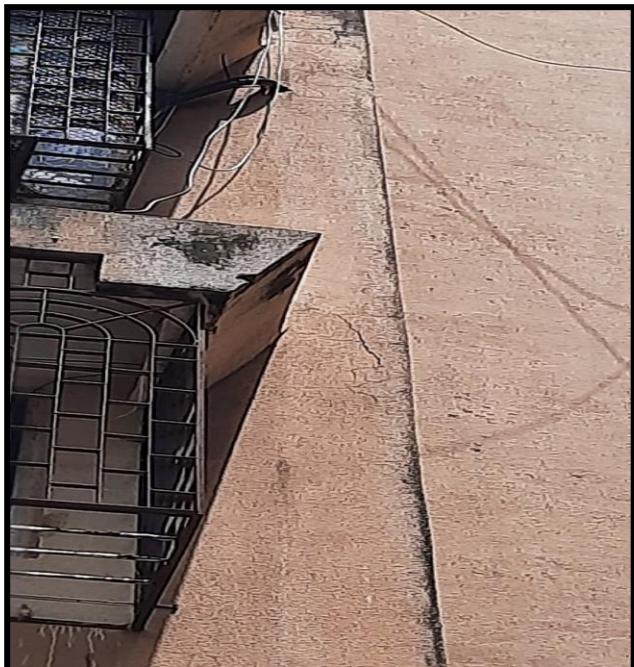
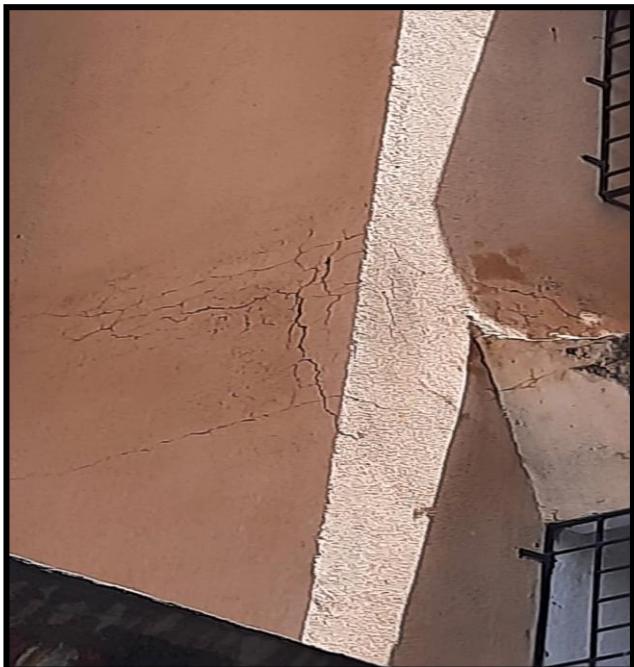
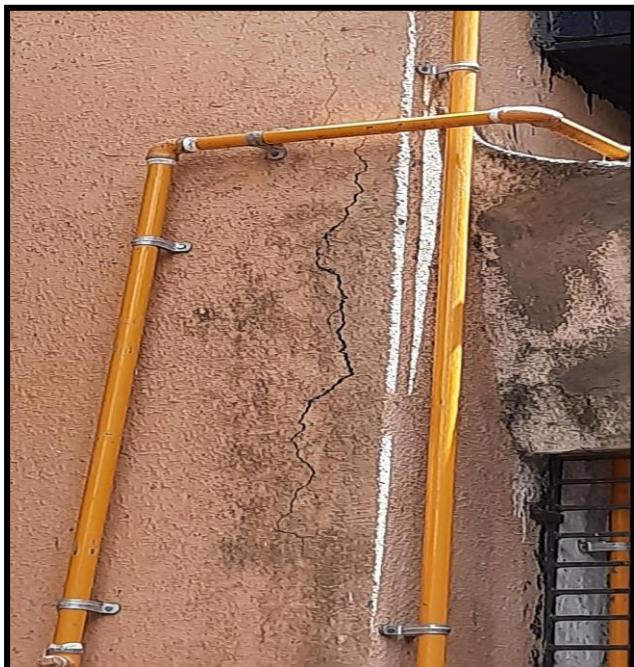
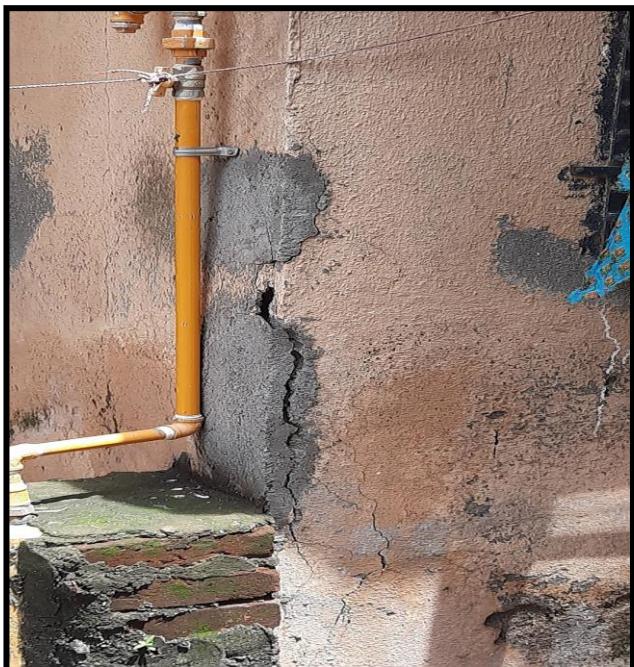
## BACK SIDE

- ❖ Structural crack observed at several places on column & chajjas.
- ❖ Major crack observed at several places on wall.

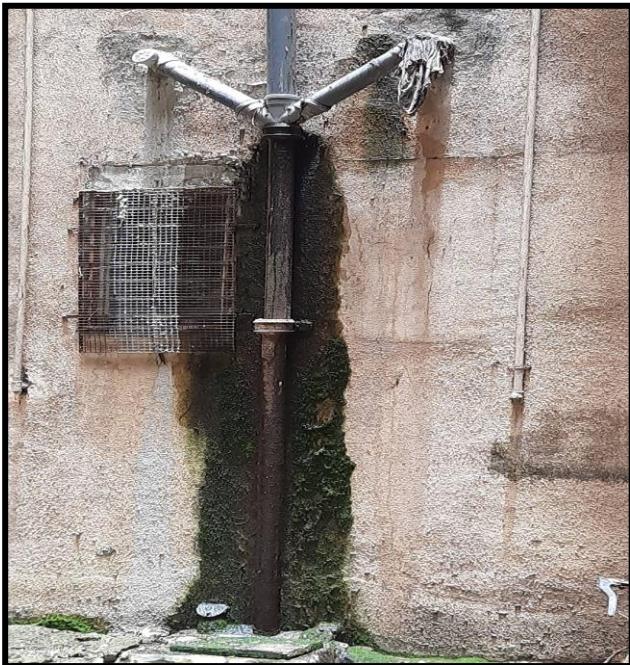
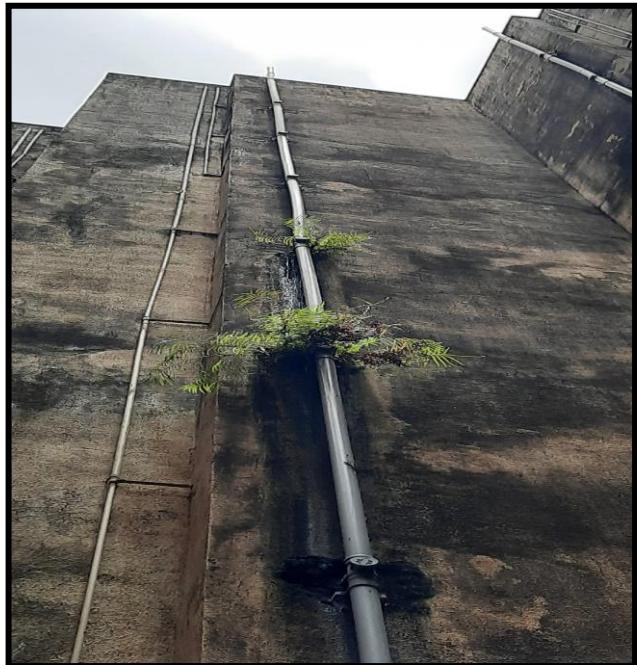
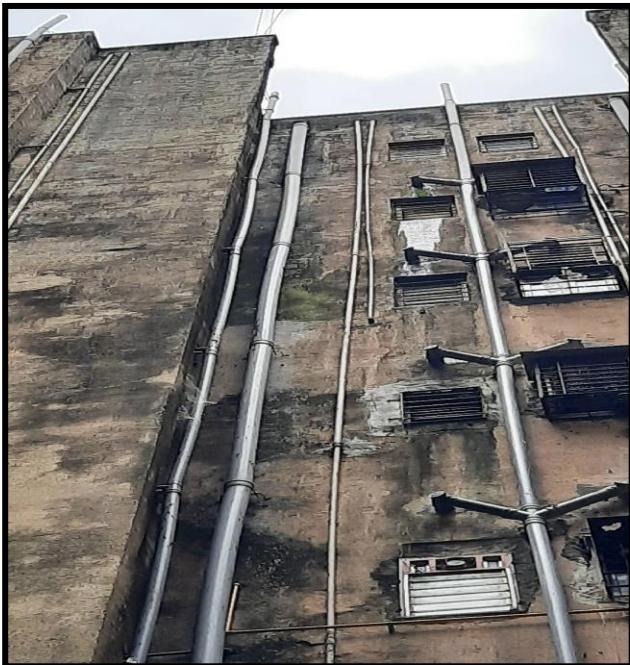
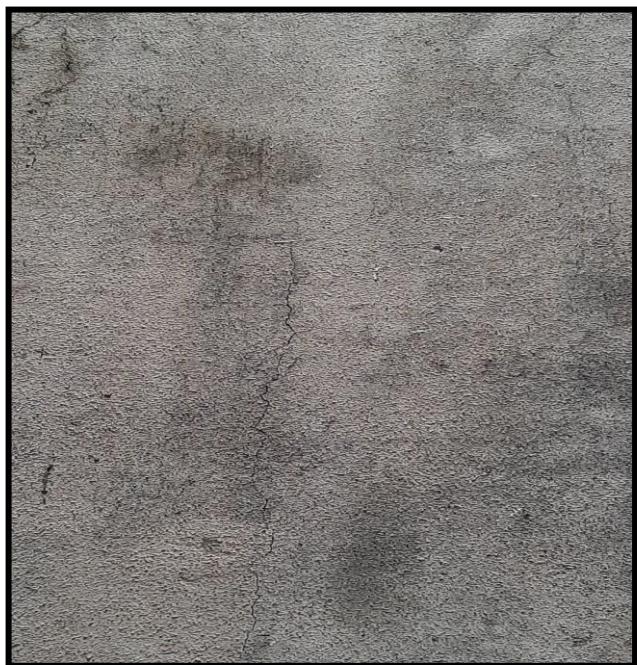
## NORTH SIDE

- ❖ Algae observed at several places on wall.
- ❖ Vegetation growth observed at several places on wall.

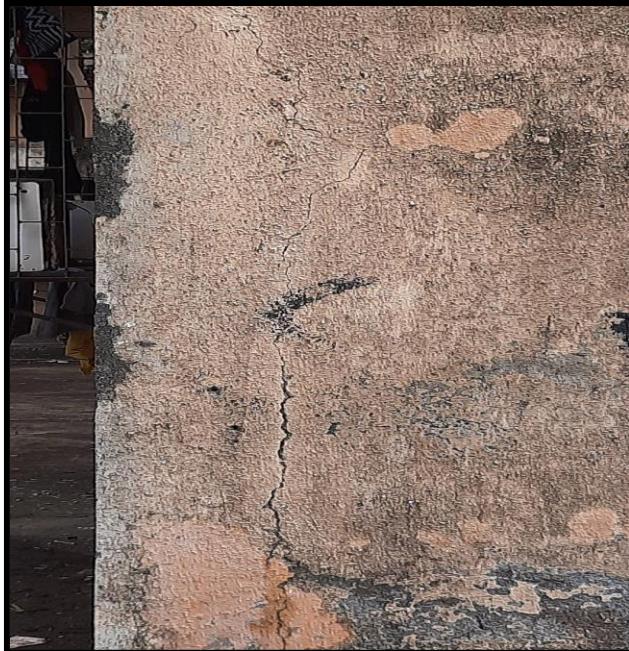
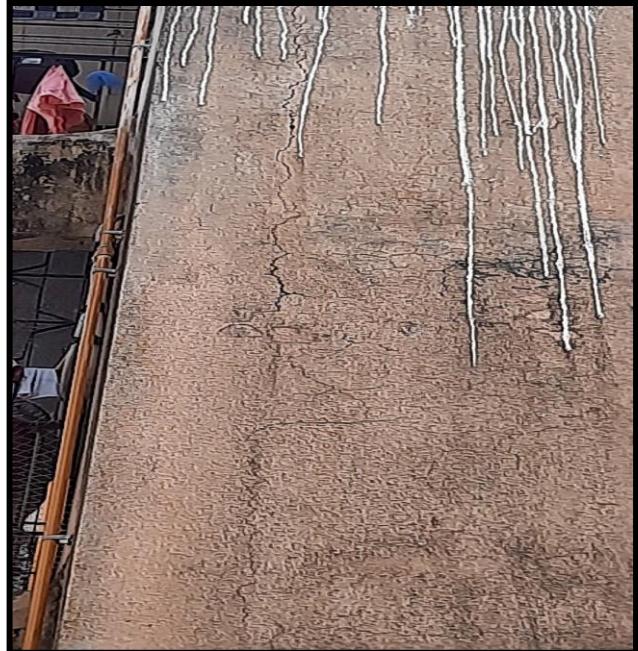
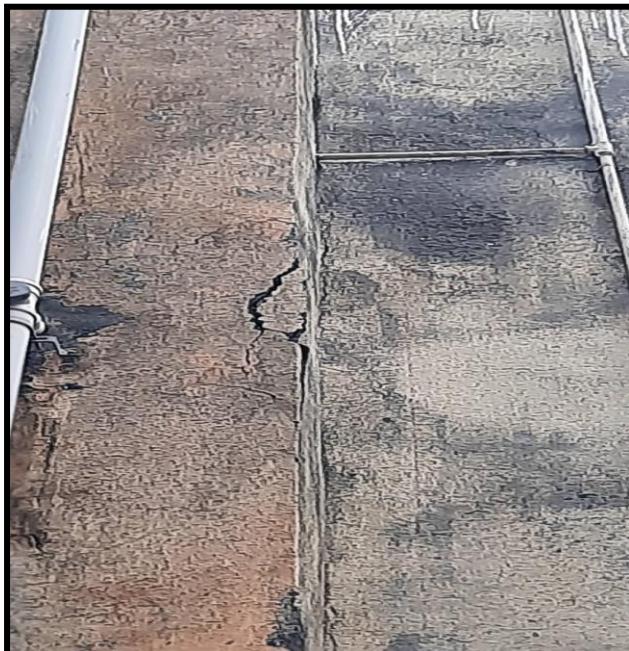
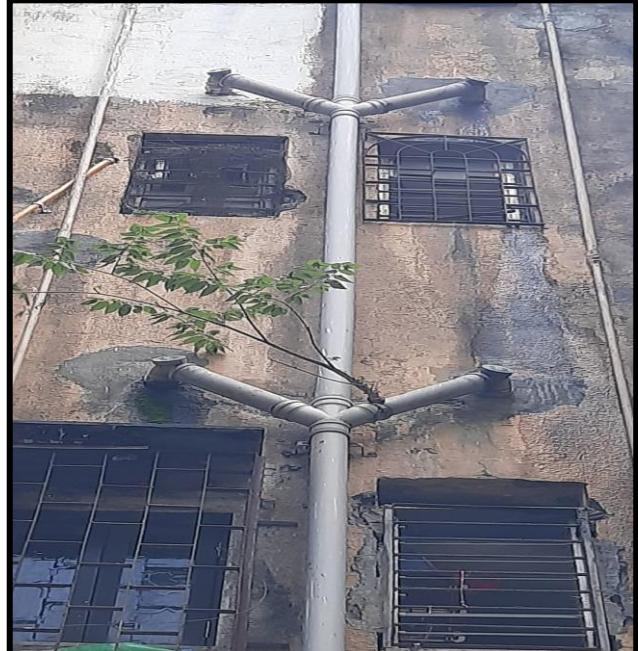
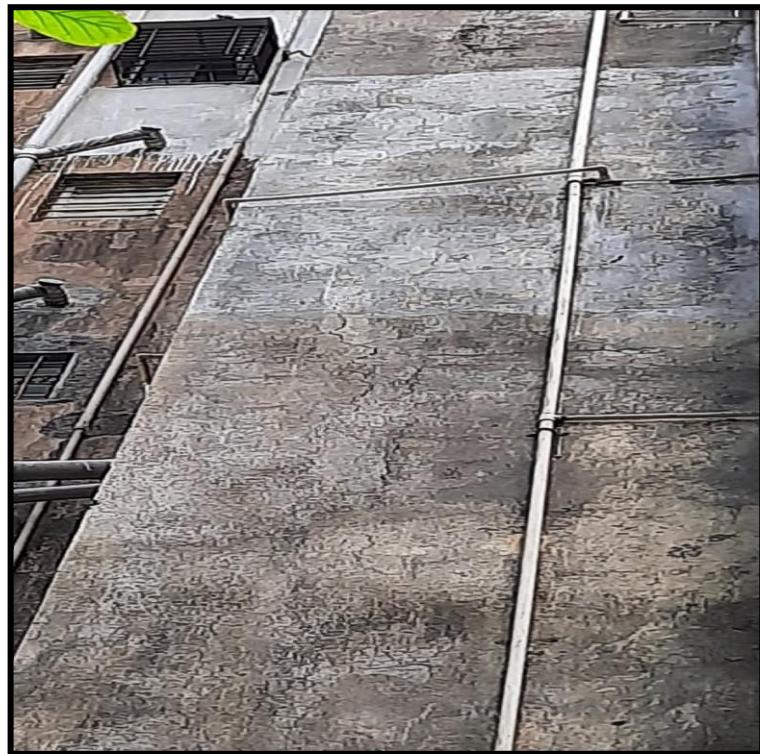
## SOUTH SIDE

- ❖ Structural crack observed at several places on column.
- ❖ Major crack observed at several places on wall.
- ❖ Algae observed at several places on wall.
- ❖ Vegetation growth observed at several places on wall.
