STRUCTURAL AUDIT REPORT
FOR
“VISHAL SAHYADRI CO – OP HSG. SOC. LTD”,
“D3 – K WING”
SITUATED AT
SAHYADRI NAGAR, CHARKOP,
KANDIVALI (W) MUMBAI – 400 067

978/D3/LSS/2021

JULY 16, 2021

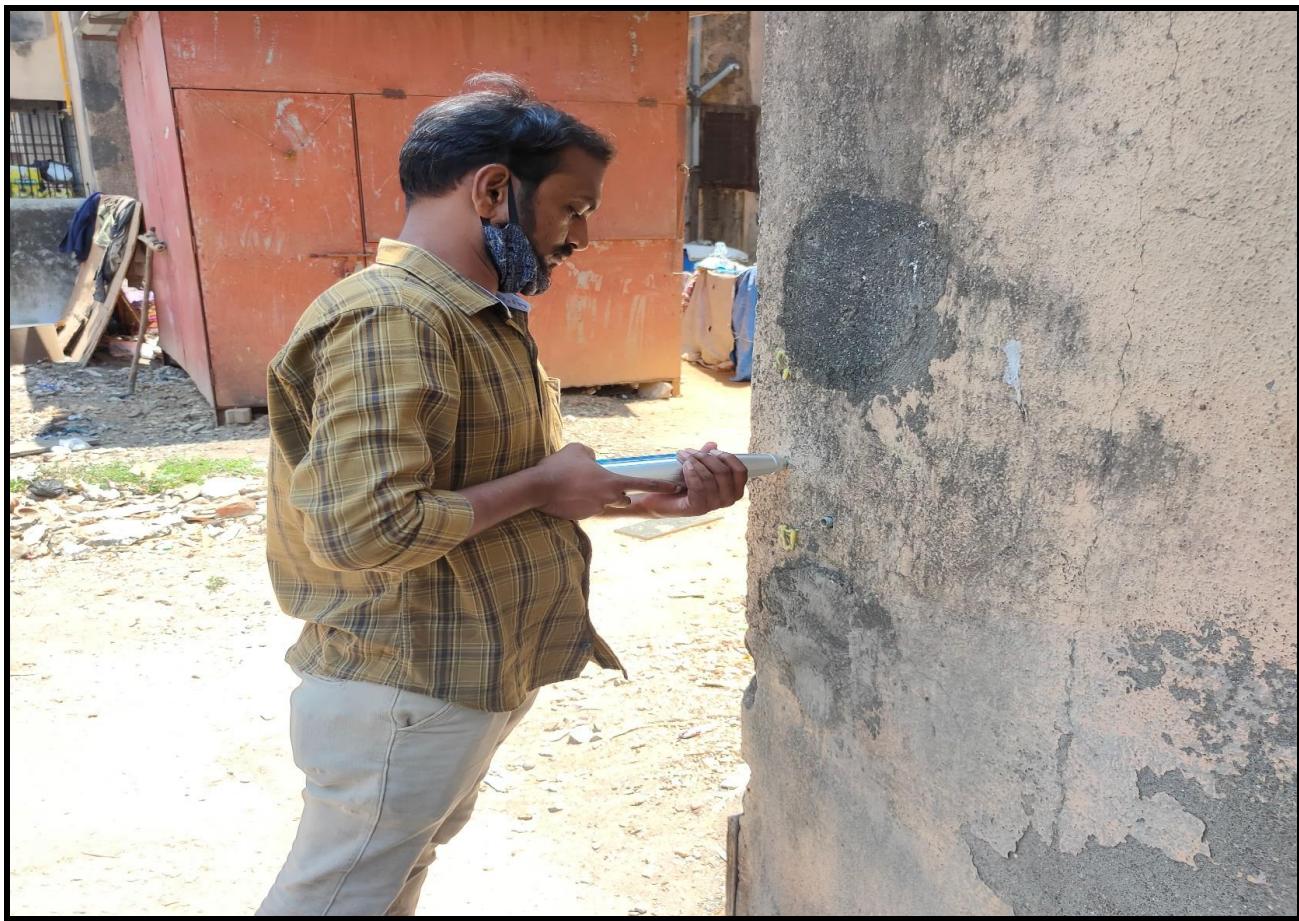
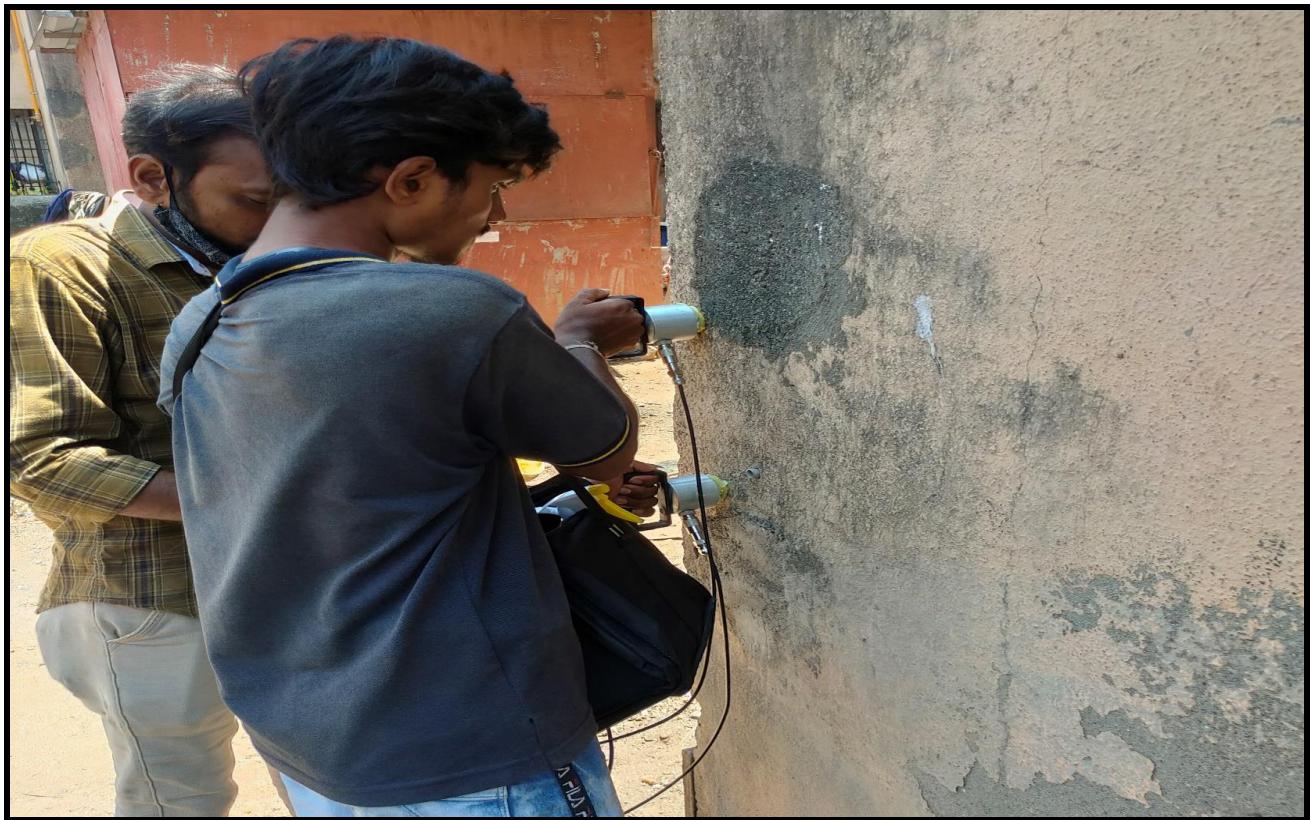
NON -DESTRUCTIVE TEST PHOTO

Rebound Hammer was tested for compressive strength at surface by Schmidt rebound hammer. Results indicate the compressive strength at surface of the RCC columns & beam in is ranging between 13.70 MPa to 18.90 MPa.

The UPV values are ranging between 2.60 Km/Sec to 3.20 Km/Sec.

Out of 4 locations 2 locations was below 3.0 Km/Sec means concrete quality is poor and 2 location ranging between 3.0 to 3.75 Km/Sec means concrete quality is doubtful.

This indicates there are progressive internal cracks in the RCC members due to corrosion of reinforced steel. These members are under distress condition.

RCC elements indicating UPV values less than 3 Km/sec needs immediate attention.

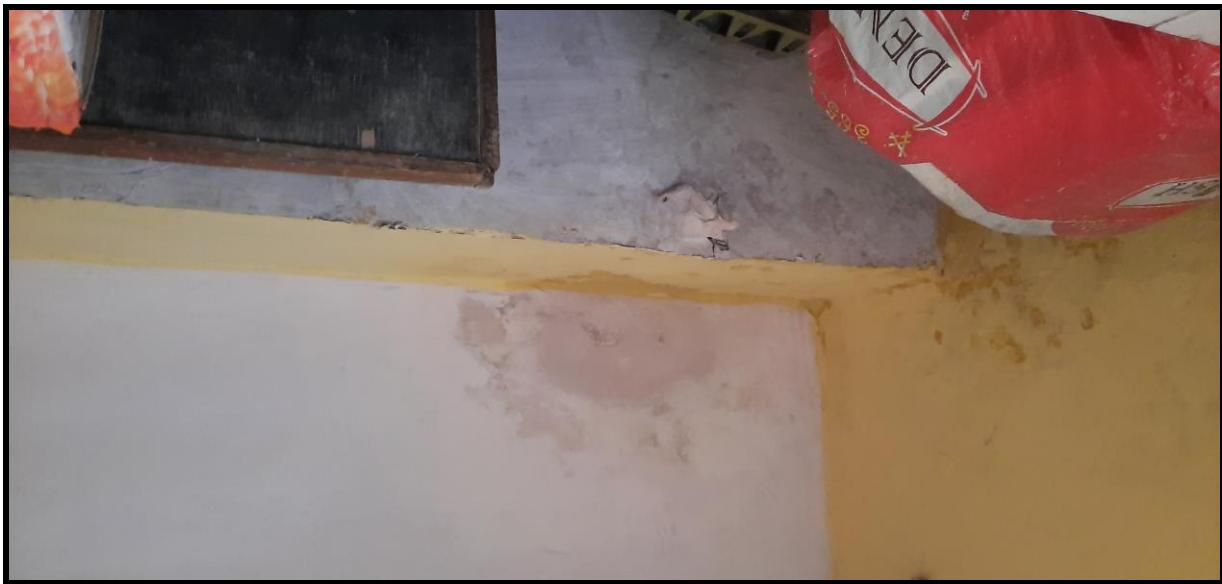
FLAT NO – 09

- ❖ **HALL** – Leakage mark observed on ceiling.
- ❖ **KITCHEN** – Dampness observed on wall in monsoon.
- ❖ **PASSAGE** – Leakage mark observed on ceiling.
- ❖ **TOILET & BATH ROOM** – O.K.

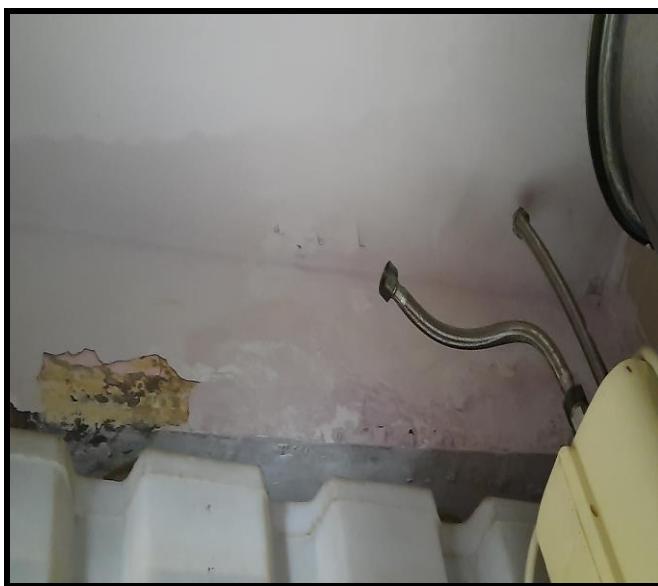
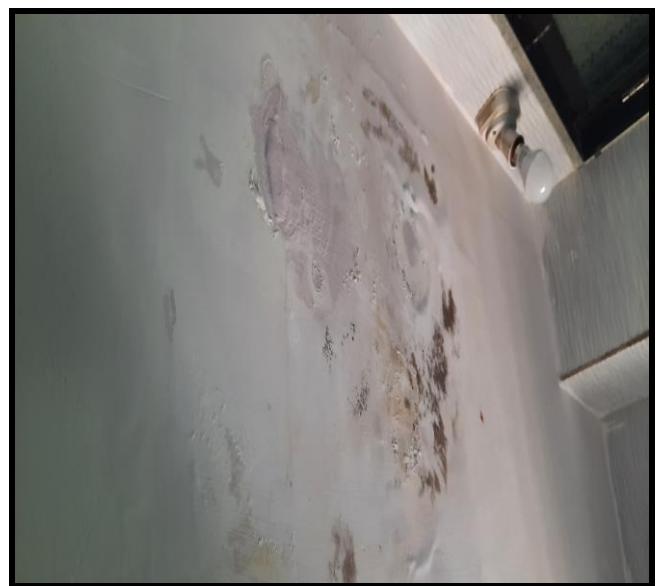
FLAT NO – 12

- ❖ **HALL** – O.K.
- ❖ **KITCHEN** – O.K.
- ❖ **PASSAGE** – Leakage mark observed on ceiling.
- ❖ **TOILET & BATH ROOM** – Leakage mark observed on ceiling.

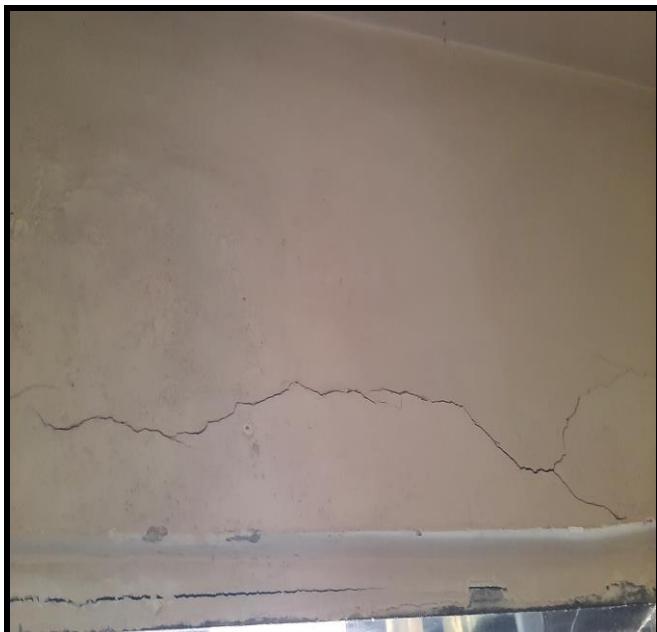
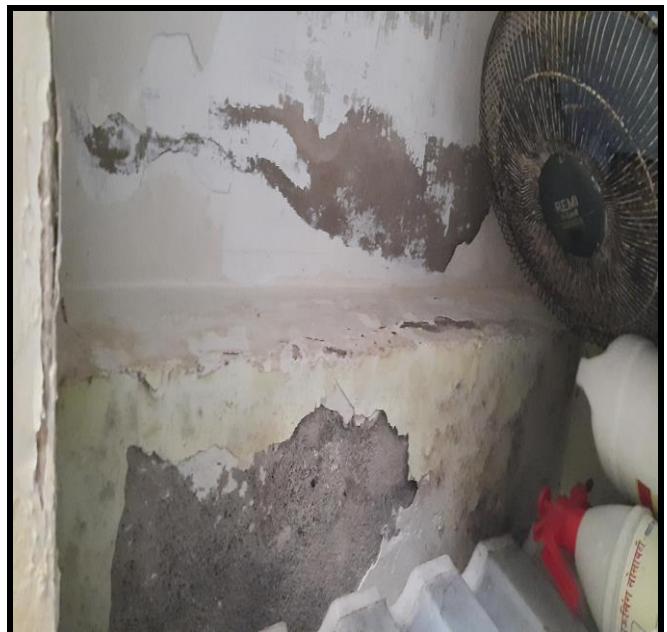
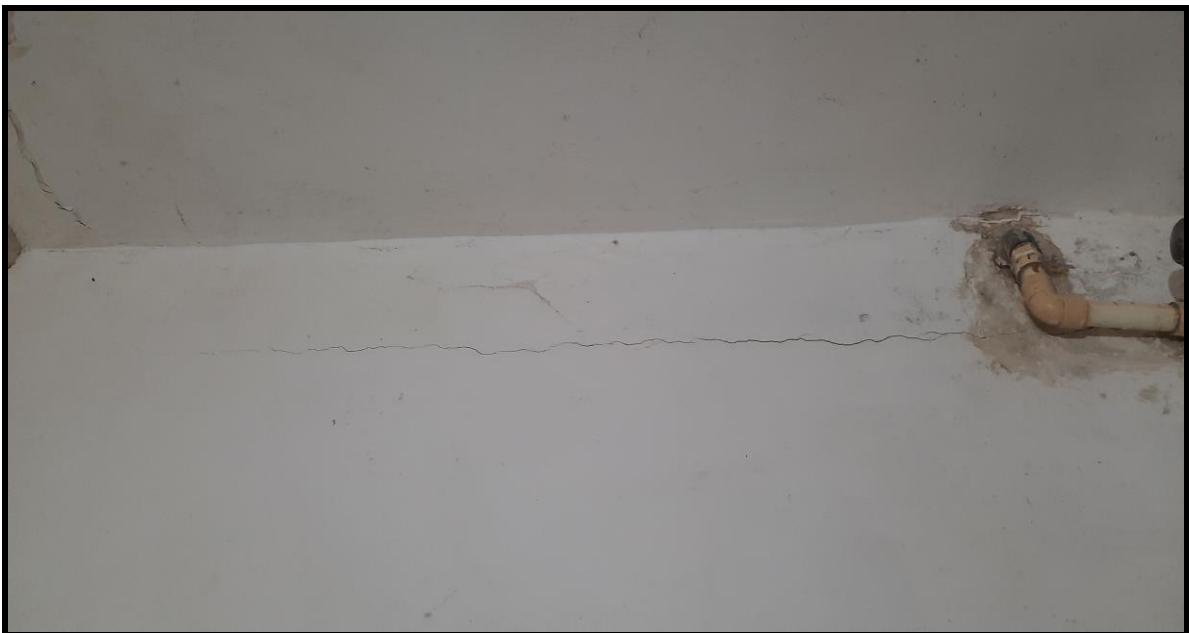
FLAT NO - 14

- ❖ **HALL** – Structural crack observed on beam.
- ❖ **KITCHEN** – Structural crack observed on column.
- ❖ **PASSAGE** – Leakage mark observed on ceiling.
- ❖ **TOILET & BATH ROOM** – O.K.

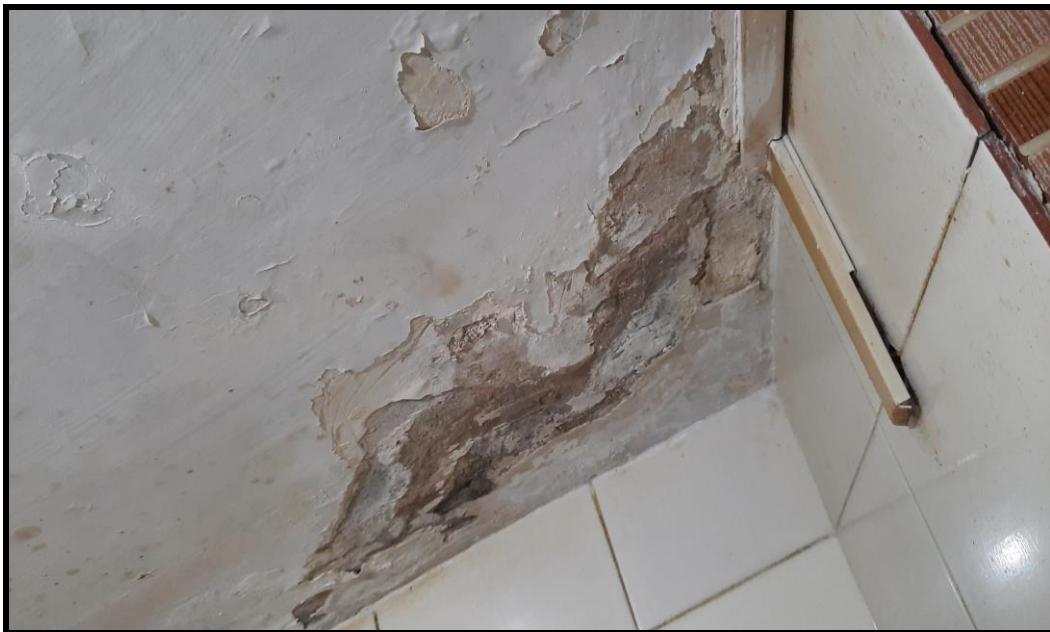
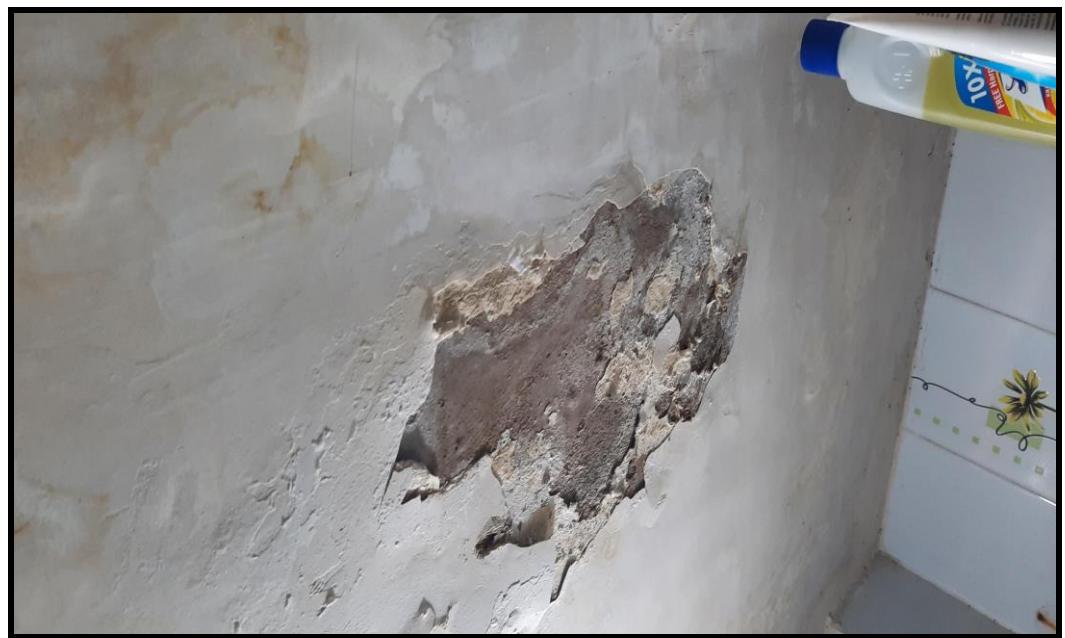
FLAT NO – 16

- ❖ **HALL** – O.K.
- ❖ **KITCHEN** – O.K.
- ❖ **PASSAGE** – O.K.
- ❖ **TOILET & BATH ROOM** – Leakage mark observed on ceiling.

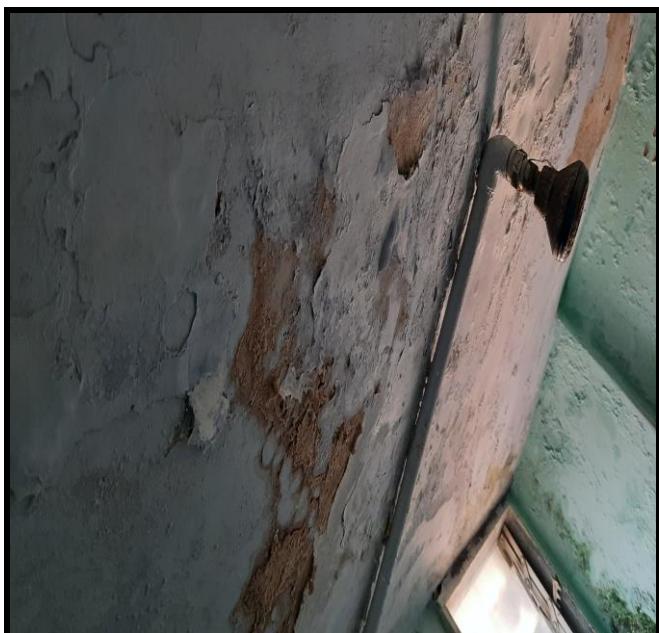
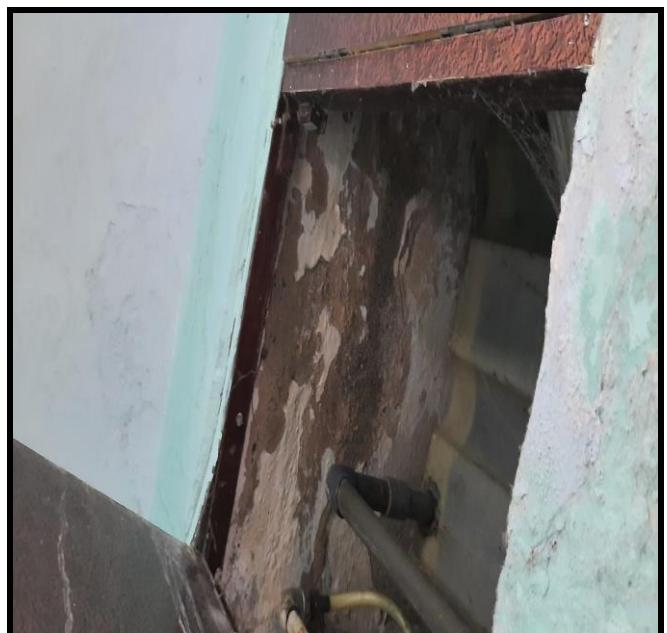
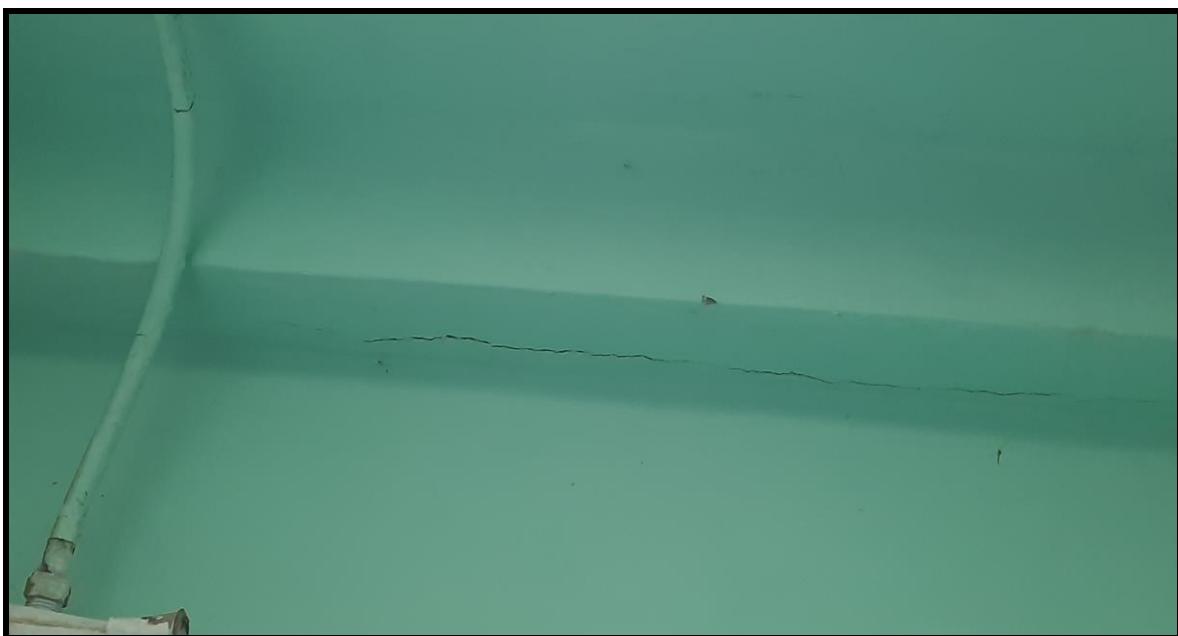
FLAT NO - 17

- ❖ **HALL** – O.K.
- ❖ **KITCHEN** – O.K.
- ❖ **PASSAGE** – Leakage mark observed on ceiling.
- ❖ **TOILET & BATH ROOM** – Leakage mark observed on ceiling.
 - Structural crack observed on column.

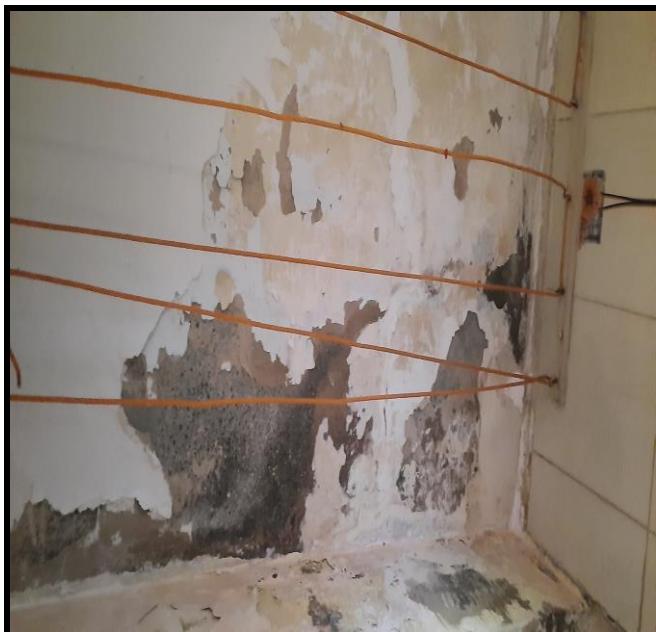
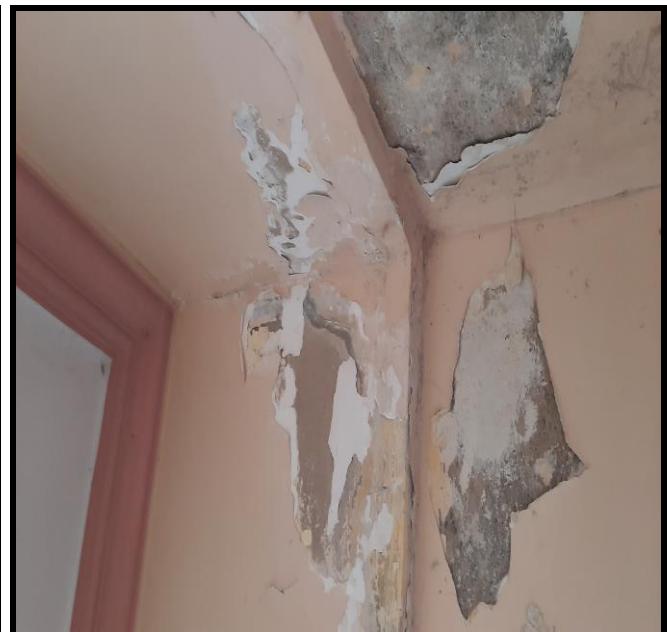
FLAT NO – 22

- ❖ **HALL** – Leakage mark observed on wall.
- ❖ **KITCHEN** – O.K.
- ❖ **PASSAGE** – Leakage mark observed on ceiling.
- ❖ **TOILET & BATH ROOM** – O.K.

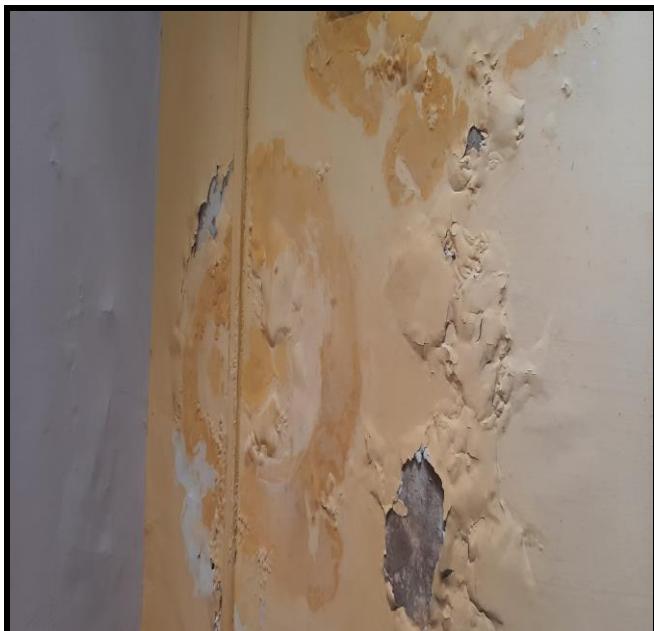
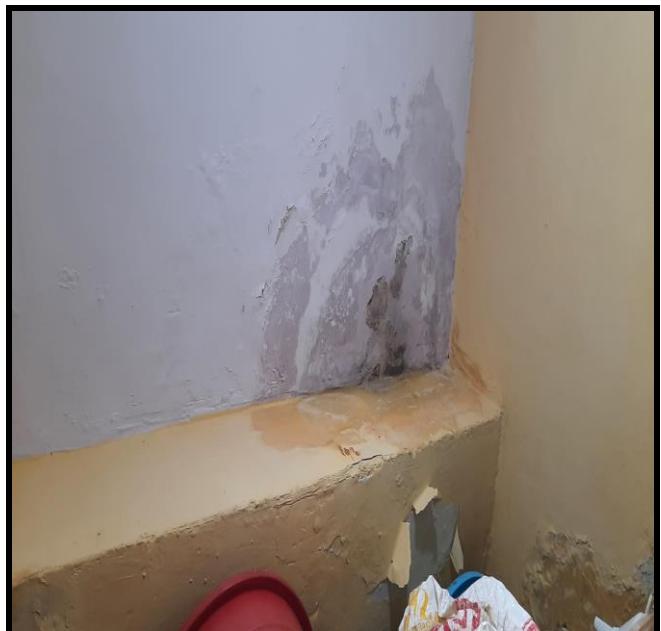
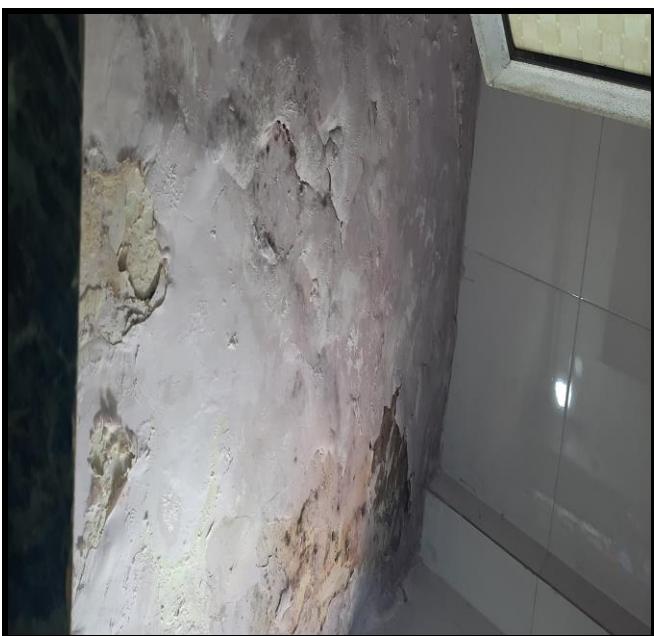
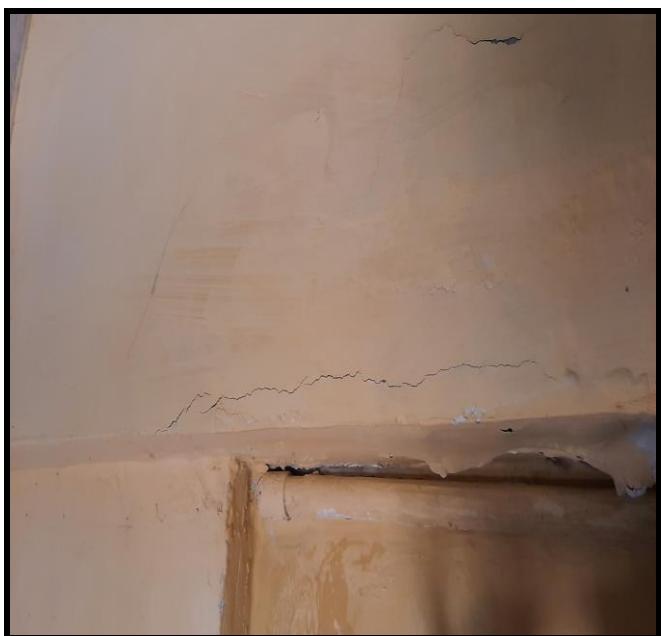
FLAT NO – 26

- ❖ **HALL** – Leakage mark observed on wall.
- ❖ **KITCHEN** – Leakage mark observed on wall.
 - Structural crack observed on column.
- ❖ **PASSAGE** – Leakage mark observed on ceiling.
- ❖ **TOILET & BATH ROOM** – Leakage mark observed on ceiling.

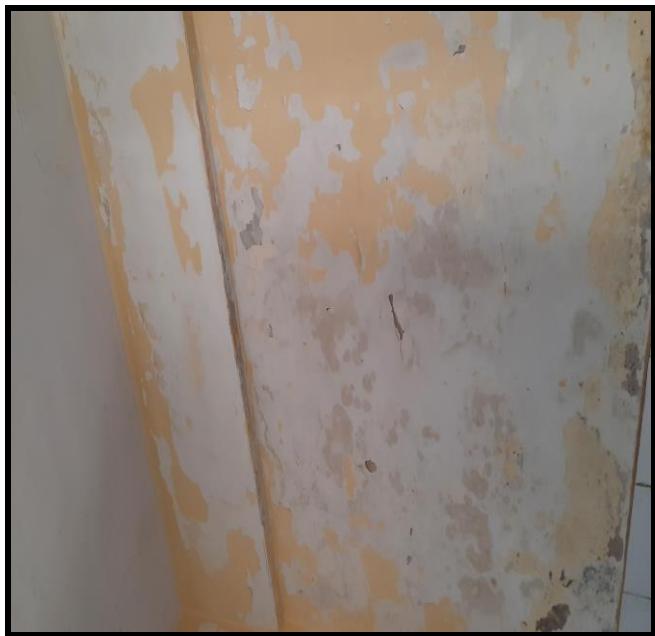
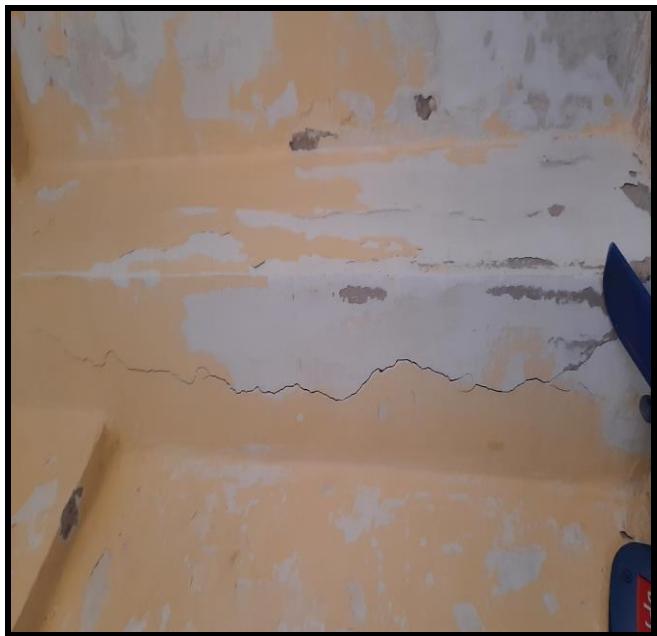
FLAT NO – 31

- ❖ **HALL** – O.K.
- ❖ **KITCHEN** – Structural crack observed on column.
 - Dampness observed on wall in monsoon.
- ❖ **PASSAGE** – O.K.
- ❖ **TOILET & BATH ROOM** – O.K.

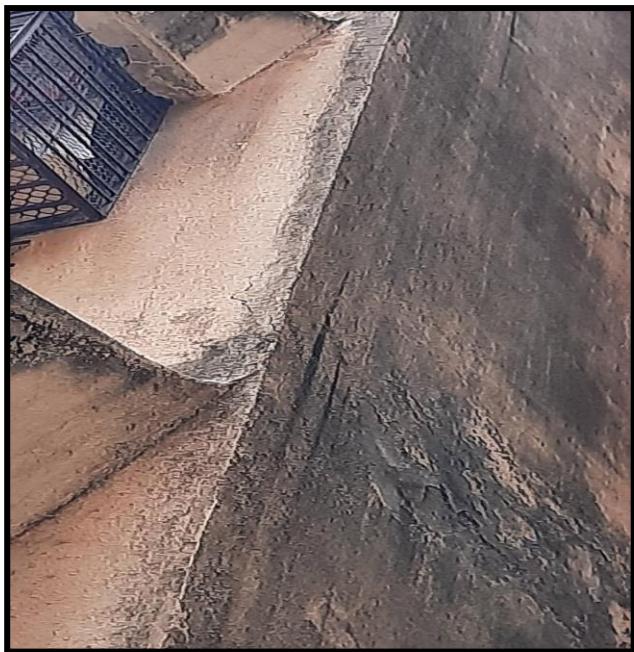
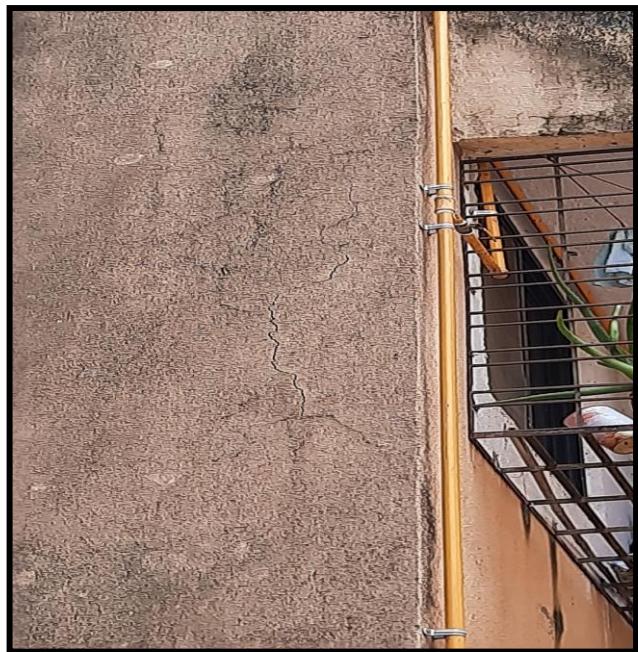
FRONT SIDE

- ❖ Structural crack observed at several places on column.
- ❖ Algae observed at several places on wall.

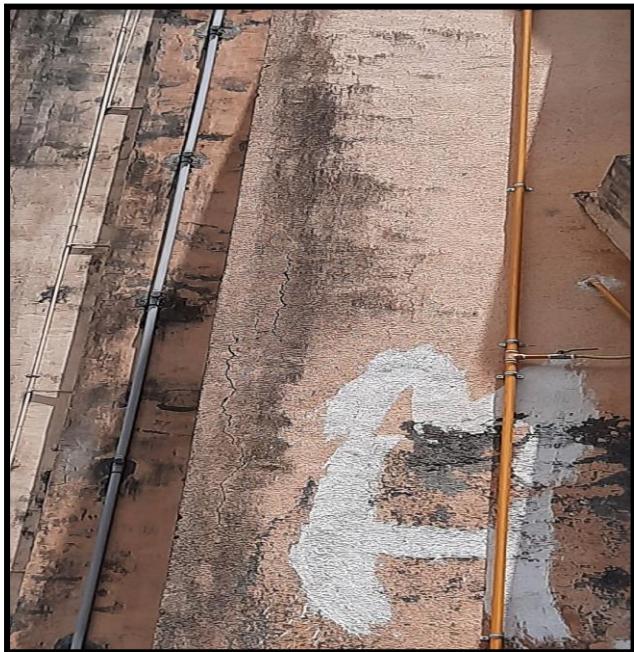
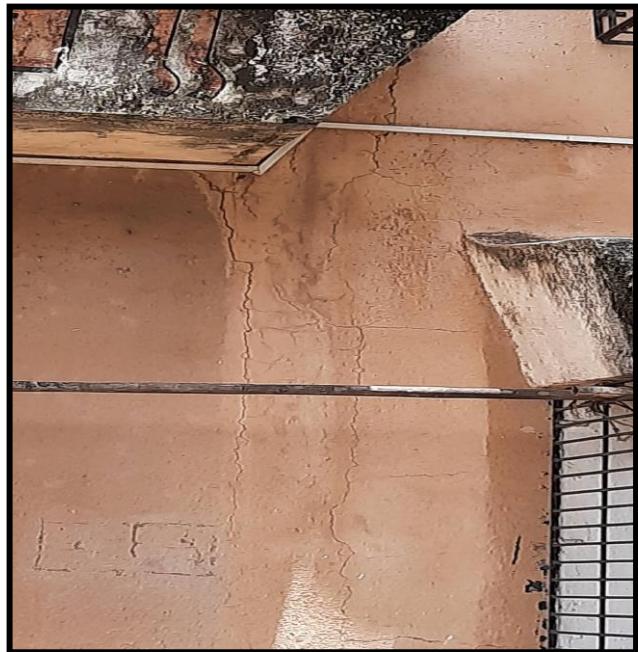
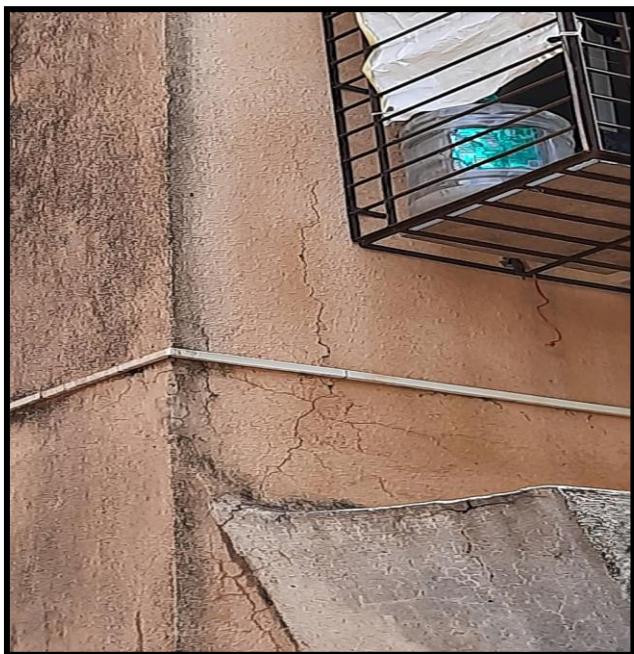
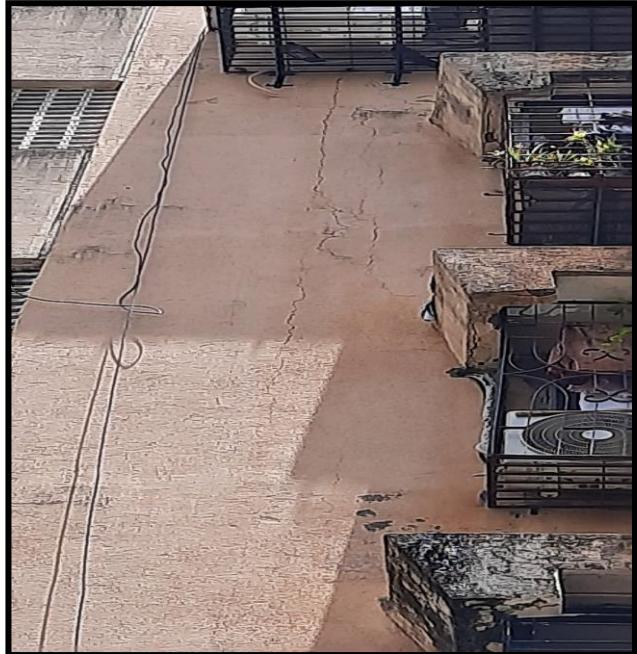
BACK SIDE

- ❖ Structural crack observed at several places on column.
- ❖ Algae observed at several places on wall.

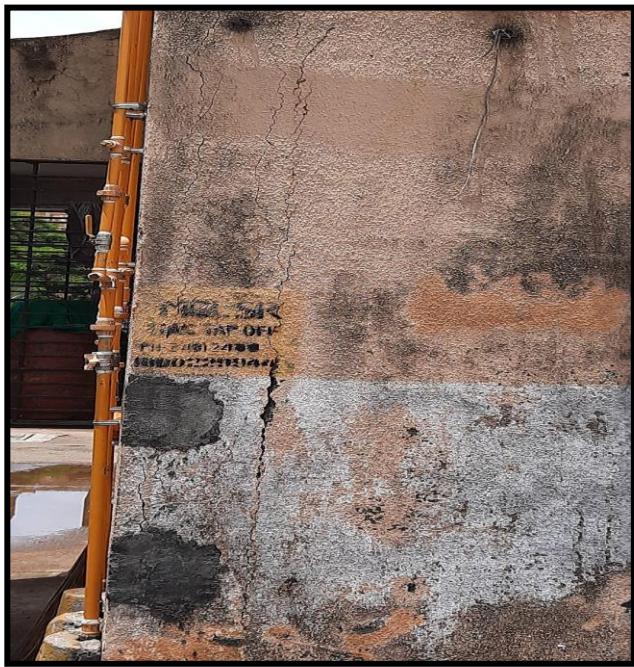
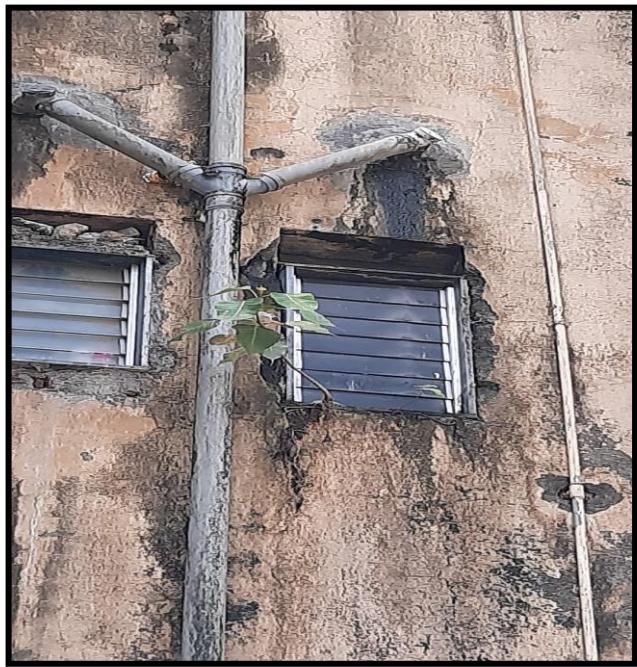
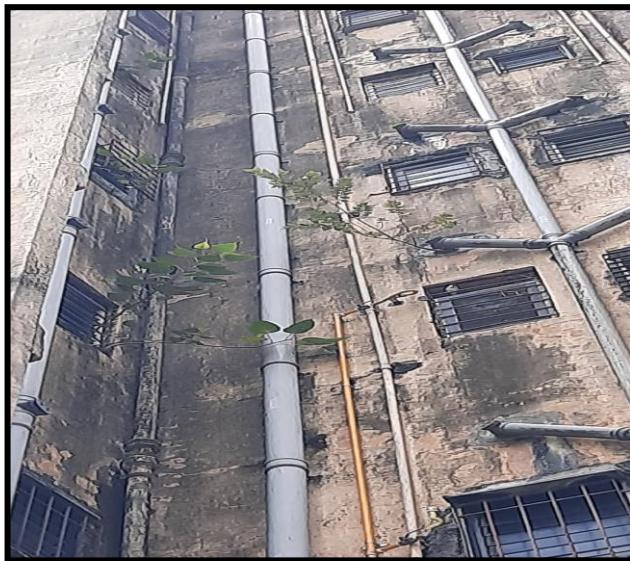
NORTH SIDE

- ❖ Structural crack observed at several places on column.
- ❖ Algae observed at several places on wall.
- ❖ Vegetation growth observed at several places on wall.

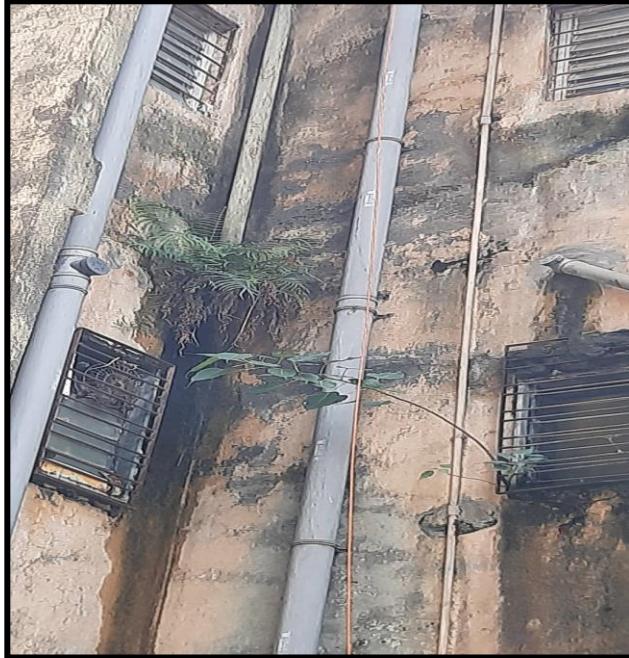
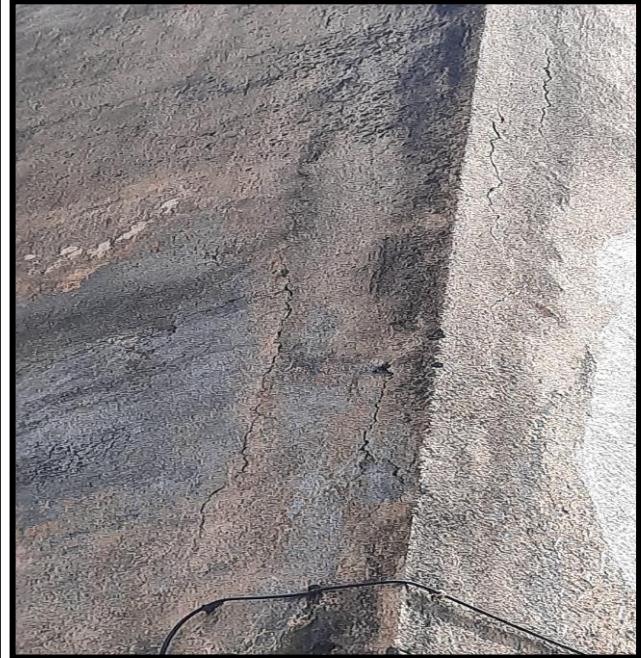
SOUTH SIDE

- ❖ Structural crack observed at several places on column.
- ❖ Major crack observed at several places on wall.
- ❖ Algae observed at several places on wall.
- ❖ Vegetation growth observed at several places on wall.
