STRUCTURAL AUDIT REPORT
FOR
“VISHAL SAHYADRI CO – OP HSG. SOC. LTD”,
“B16 – WING”
SITUATED AT
SAHYADRI NAGAR, CHARKOP,
KANDIVALI (W) MUMBAI – 400 067

PREPARED BY
LATESH S. SANKLECHA
CONSULTING STRUCTURAL ENGINEERS

978/B16/LSS/2021

JULY 24, 2021

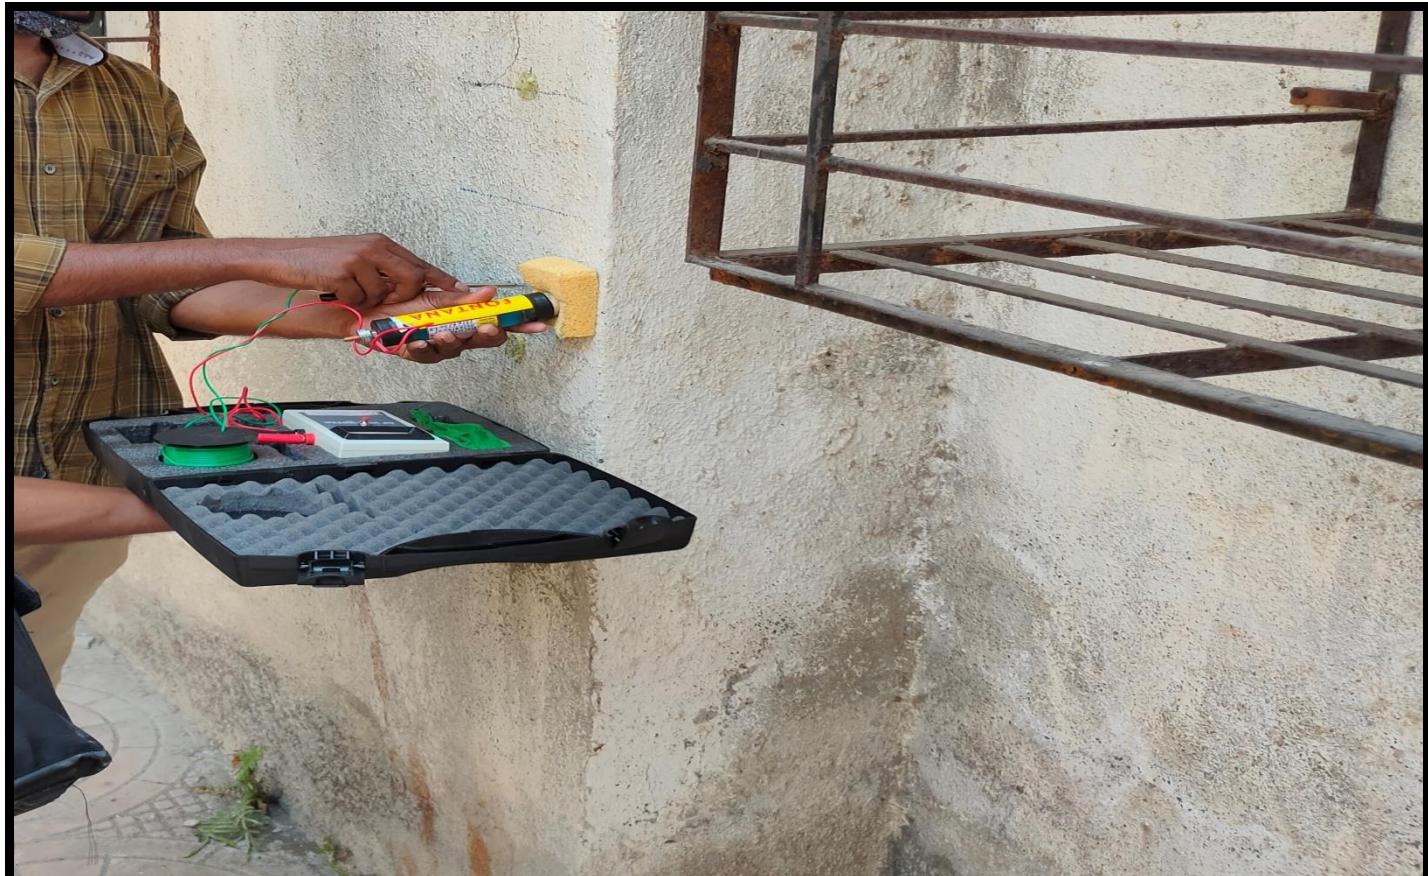
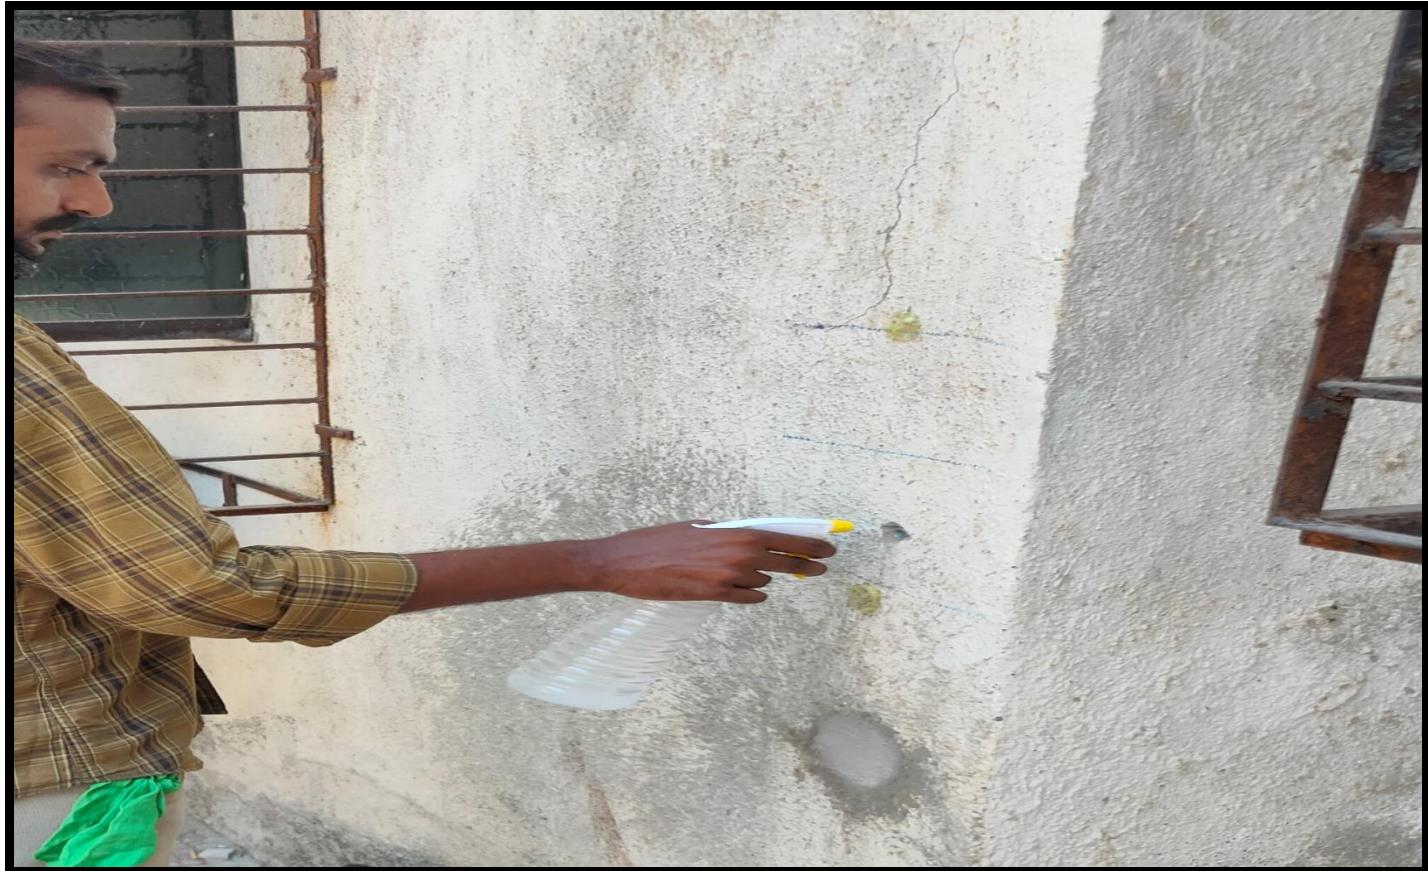
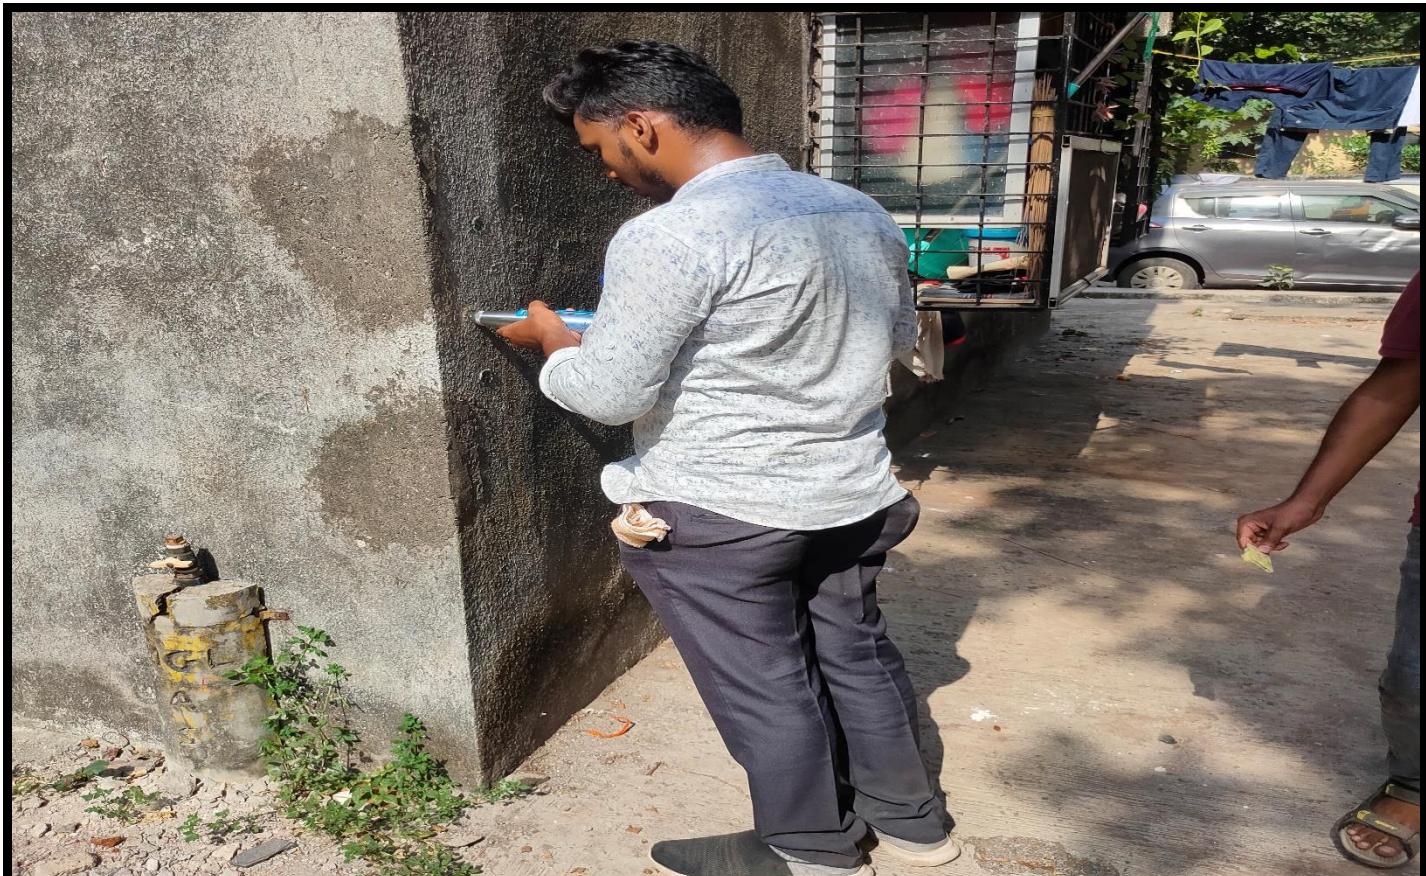
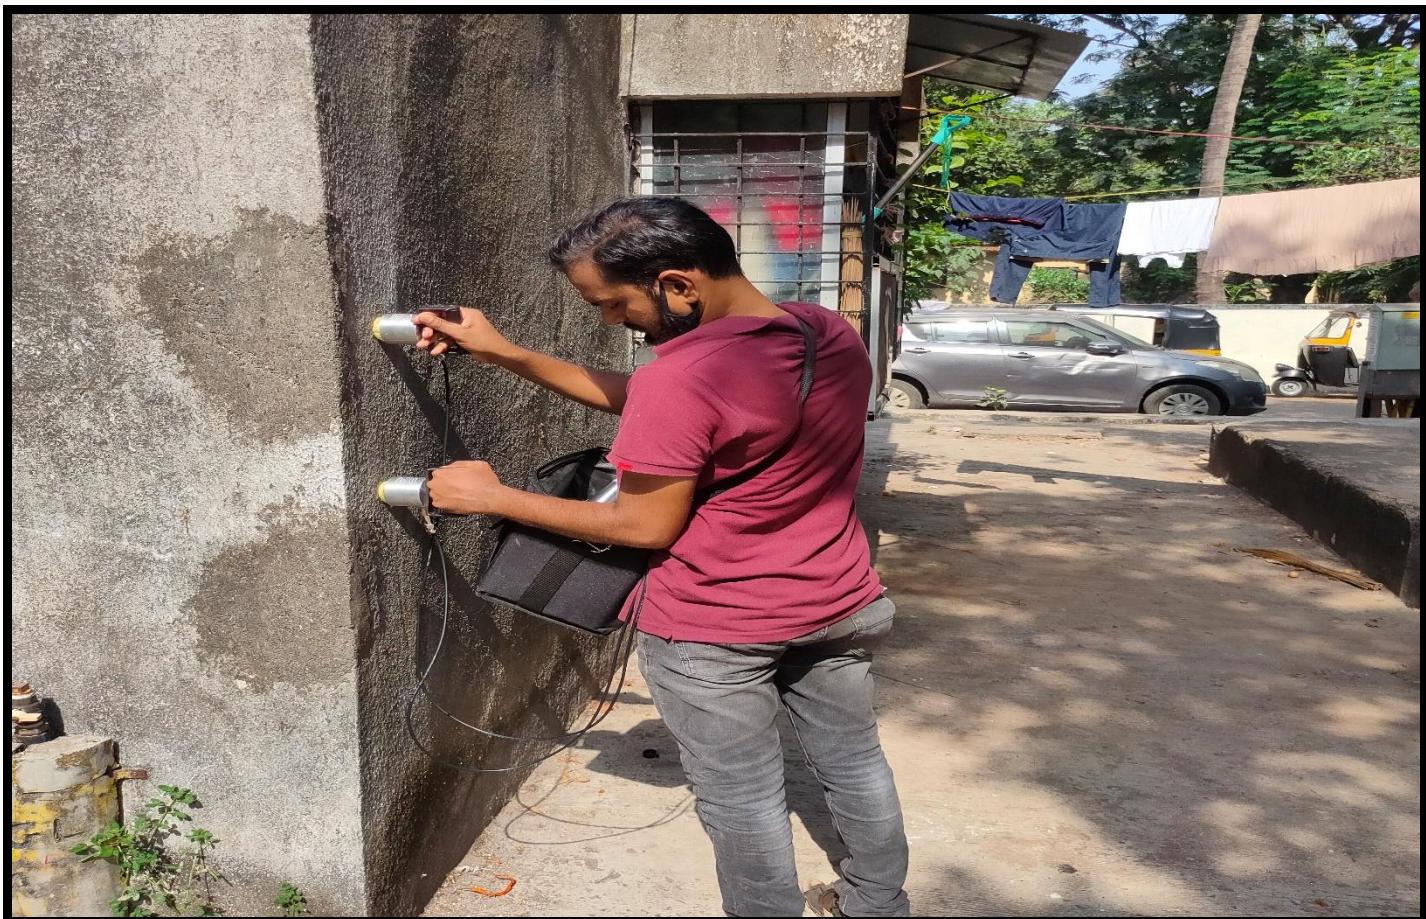
NON -DESTRUCTIVE TEST PHOTO

Rebound Hammer was tested for compressive strength at surface by Schmidt rebound hammer. Results indicate the compressive strength at surface of all the RCC columns is ranging between 10.30 MPa to 14.90 MPa.

The UPV values are ranging between 1.80 Km/Sec to 2.0 Km/Sec.

Half Cell Potential tested for corrosion activity by half – cell potential tests. Values are taken on Column. The result on tested column is – 378 mV.

Carbonation test was conducted to assess carbonation depth. Readings are taken on Column. Result indicates the carbonation penetration depth is 40.00 mm. Carbonation depths have reached to the reinforcement level in all of the RCC elements. It is essential to give a suitable anti-corrosion treatment to all the RCC members to stop further carbonation and corrosion of concrete.

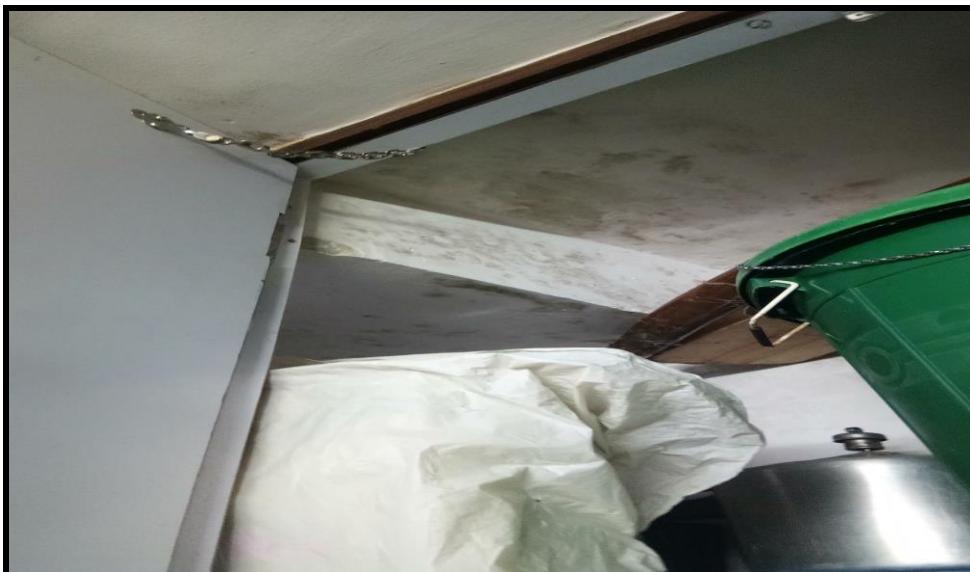
FLAT NO – 04

- ❖ **HALL** – O.K.
- ❖ **KITCHEN** – Leakage mark observed on ceiling.
- ❖ **PASSAGE** – O.K.
- ❖ **TOILET & BATH ROOM** – O.K.

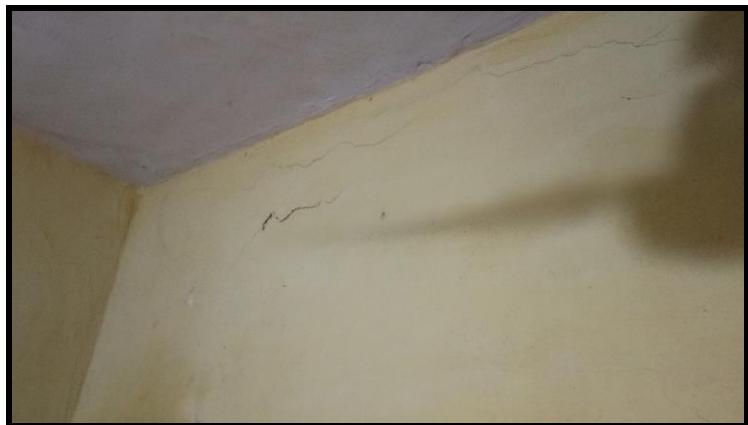
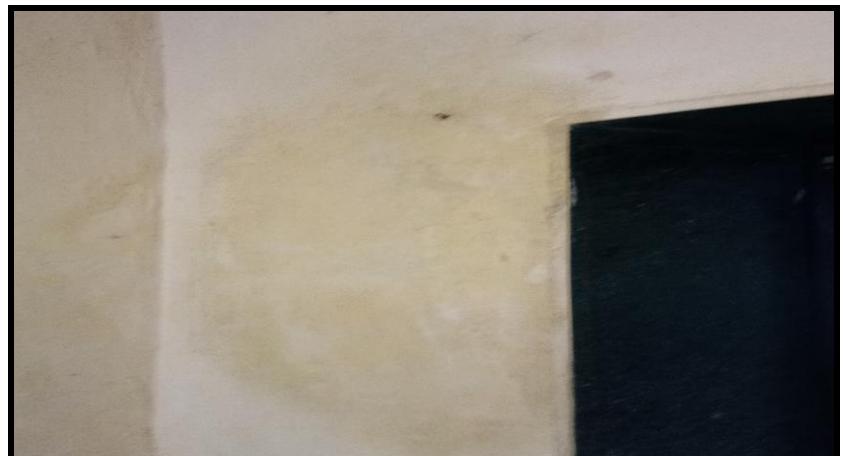
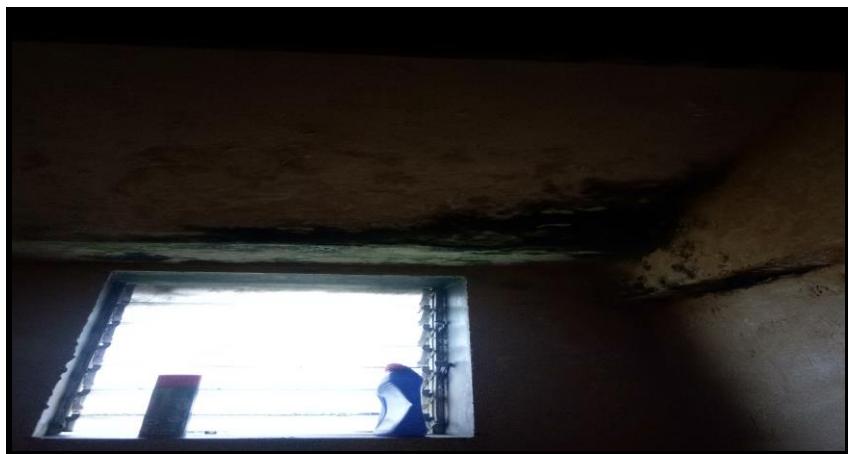
FLAT NO – 08

- ❖ **HALL** – Leakage mark observed on wall & ceiling.
- ❖ **KITCHEN** – Leakage mark observed on wall.
 - Hollow sound observed on wall.
- ❖ **PASSAGE** – Ceiling plaster get damaged & steel get exposed & corroded.
 - Hollow sound observed on wall.
- ❖ **TOILET & BATH ROOM** – Peeling of paint observed on wall.

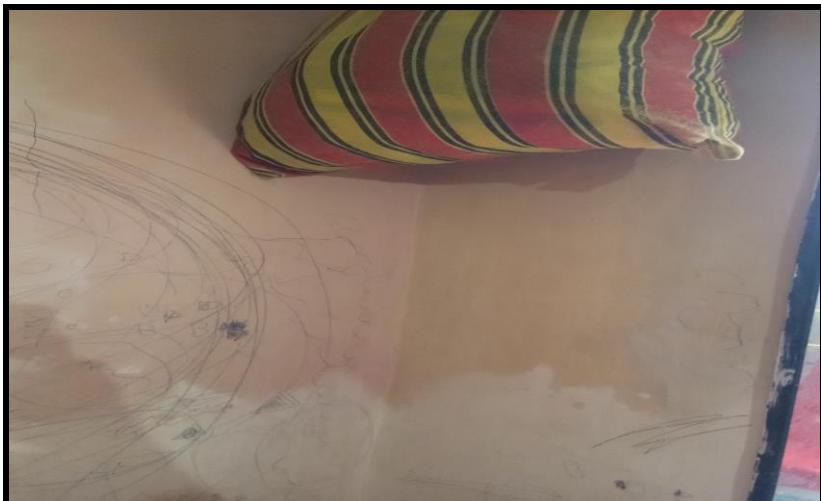
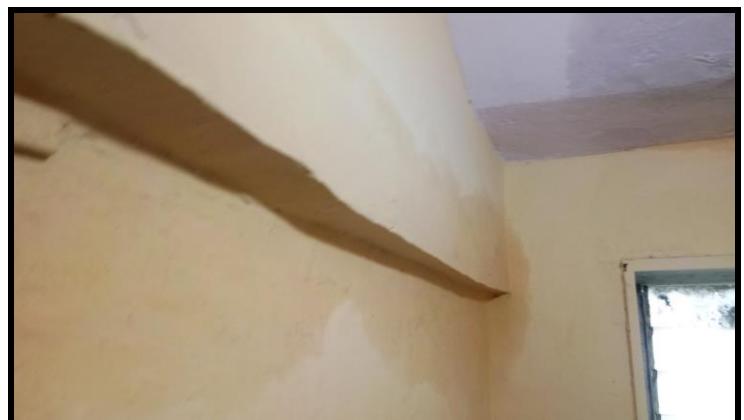
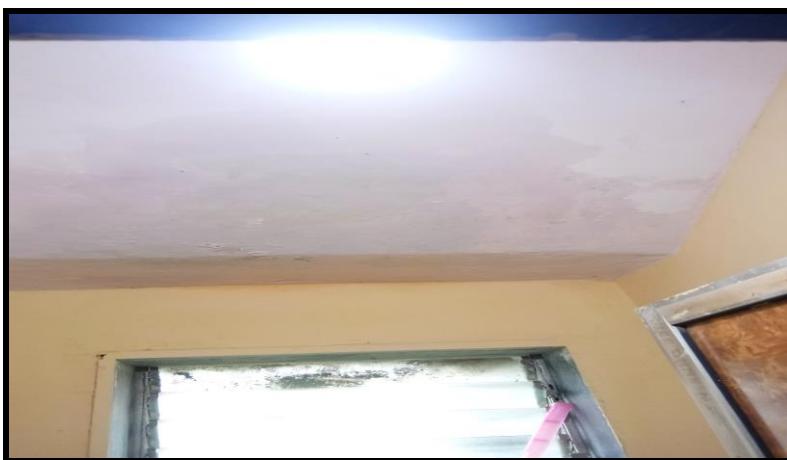
FLAT NO – 16

- ❖ **HALL** – Leakage mark observed on wall.
- ❖ **KITCHEN** – Leakage mark observed on wall.
- ❖ **PASSAGE** – Major crack observed on wall.
- ❖ **TOILET & BATH ROOM** – O.K.

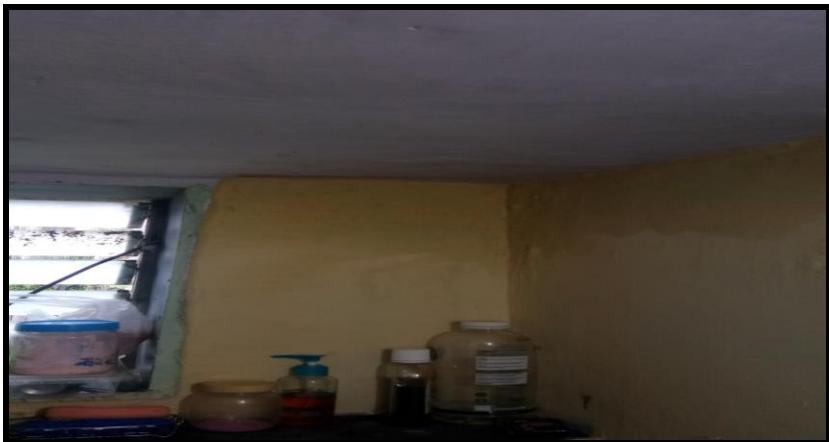
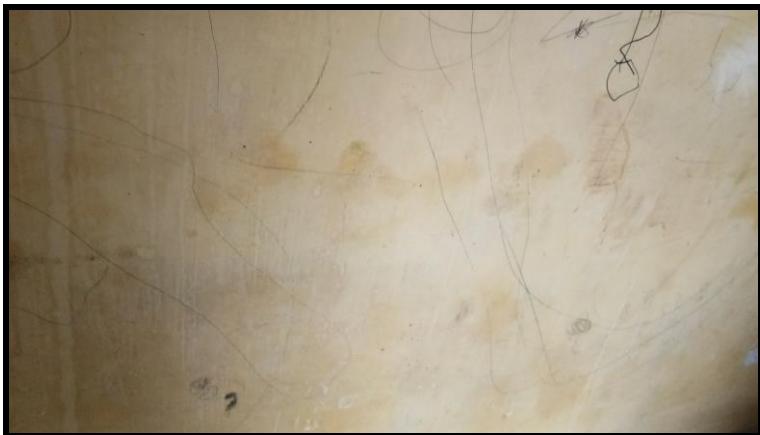
FLAT NO - 17

- ❖ **HALL** – Leakage mark observed on wall.
- ❖ **KITCHEN** – Leakage mark observed on wall & beam.
- ❖ **PASSAGE** – O.K.
- ❖ **TOILET & BATH ROOM** – O.K.

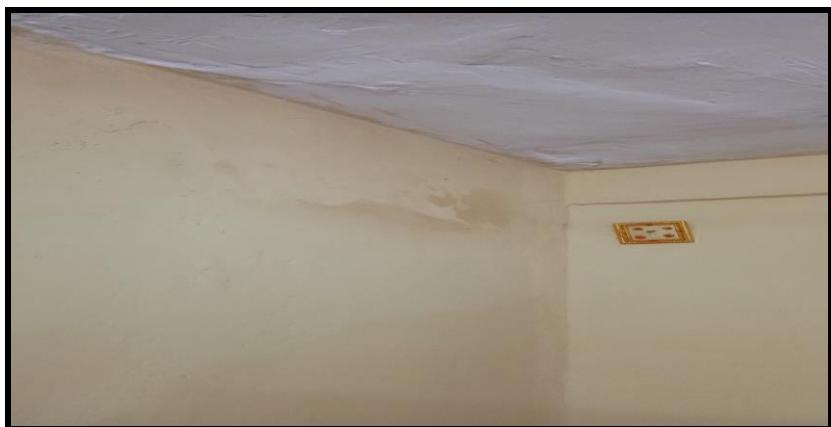
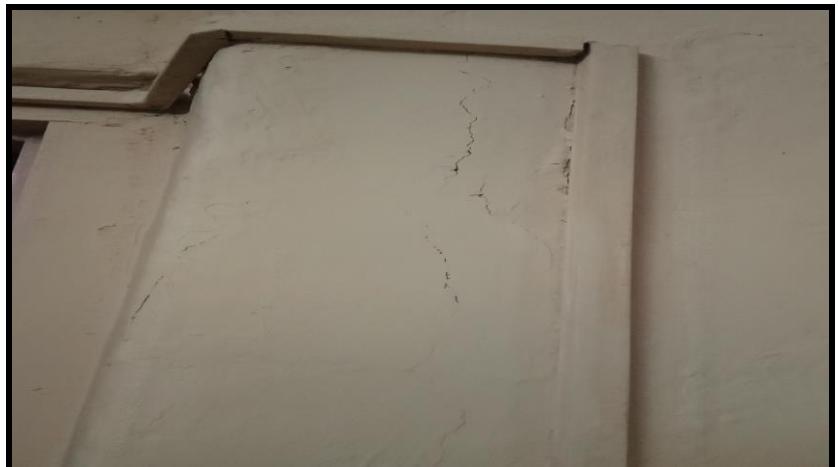
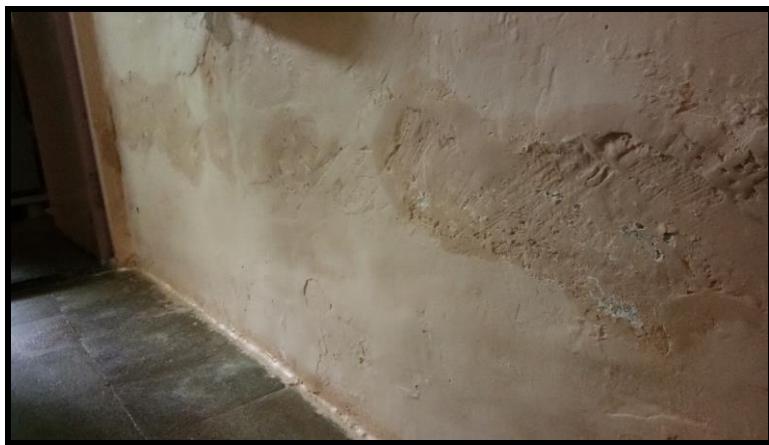
FLAT NO – 25

- ❖ **HALL** – Leakage mark observed on wall.
 - Crack observed on wall.
 - Hollow sound observed on beam.
- ❖ **KITCHEN** – Hollow sound observed on wall & beam.
- ❖ **PASSAGE** – O.K.
- ❖ **TOILET & BATH ROOM** – O.K.

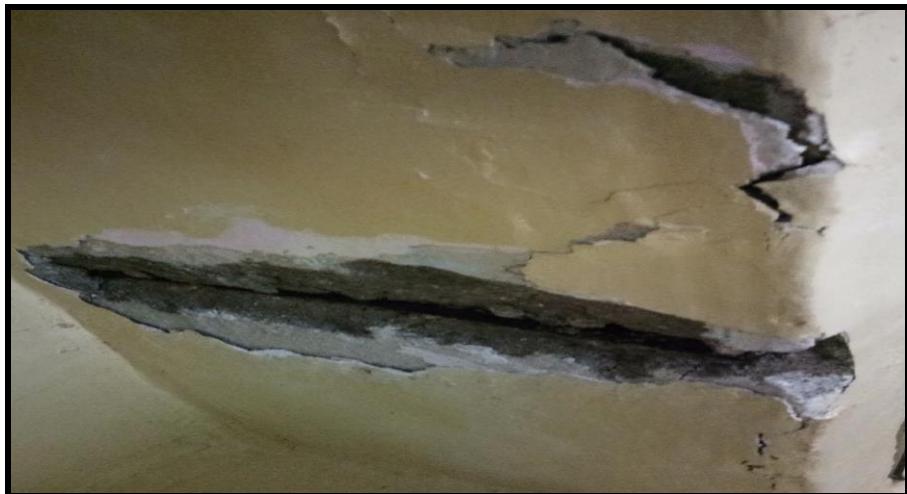
FLAT NO - 28

- ❖ **HALL** – Leakage mark observed on wall & ceiling.
- ❖ **KITCHEN** – Leakage mark observed on wall.
- ❖ **PASSAGE** – Leakage mark observed on wall.
- ❖ **TOILET & BATH ROOM** – O.K.

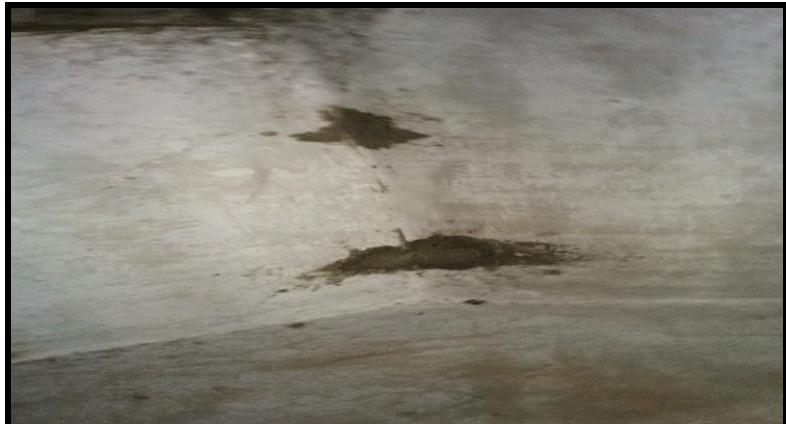
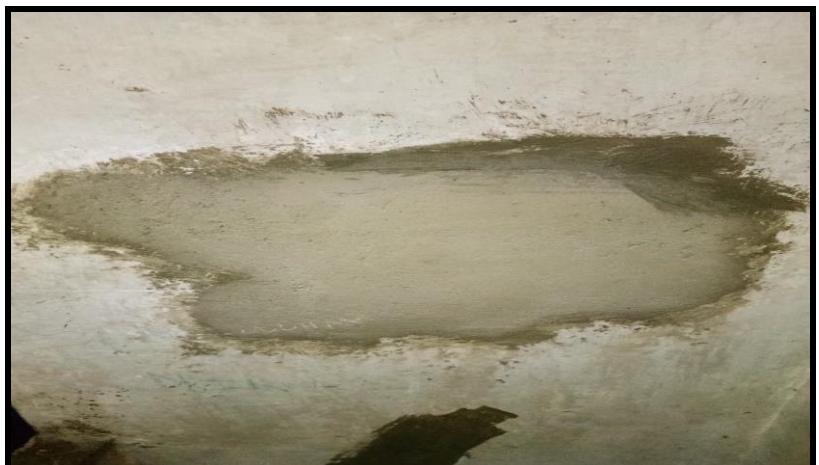
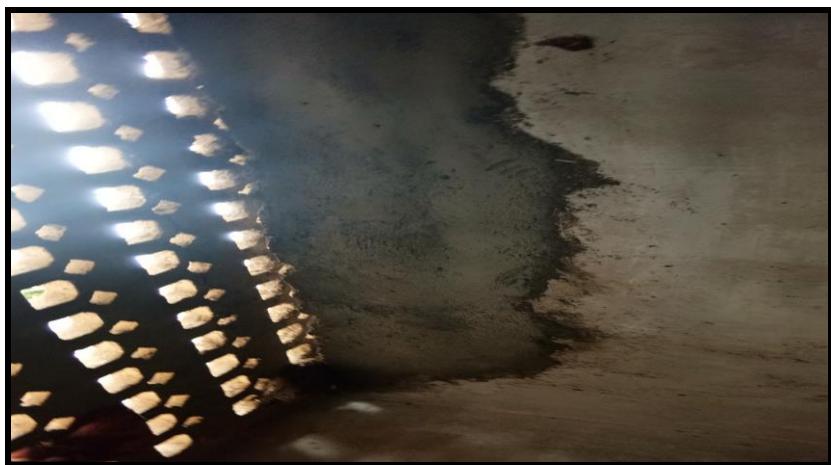
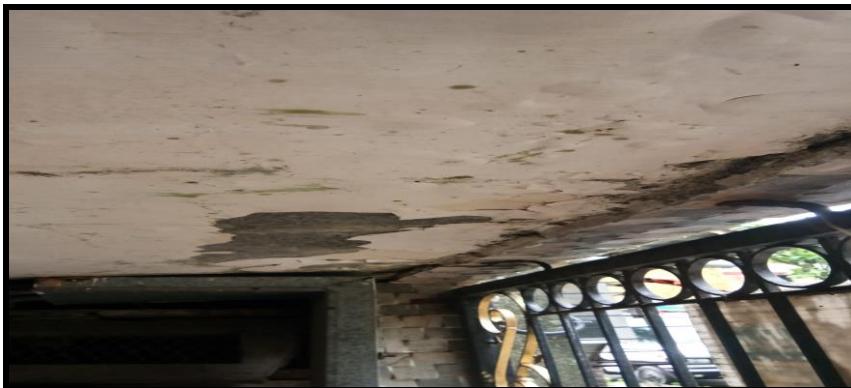
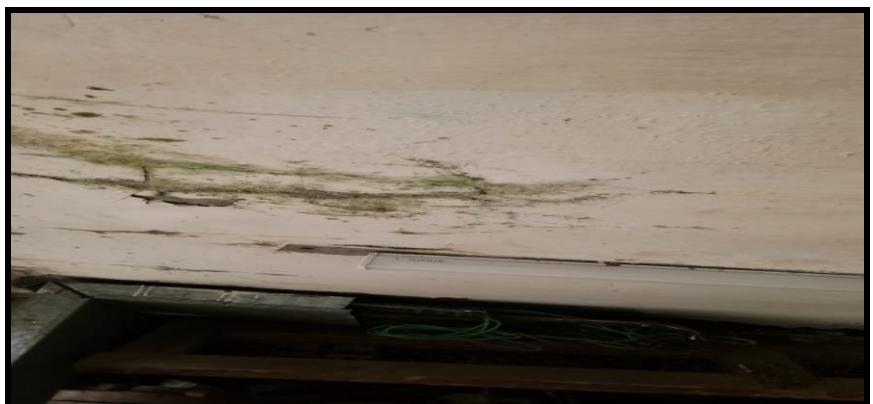
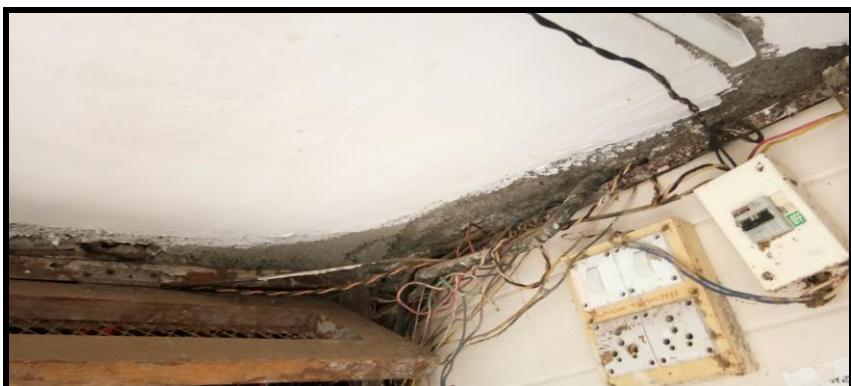
GROUND FLOOR TO FIRST FLOOR

- ❖ Patch work observed on wall.
- ❖ Peeling of paint observed on wall.

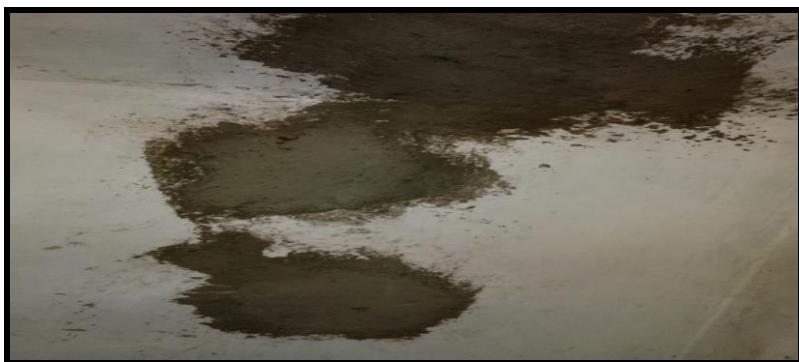
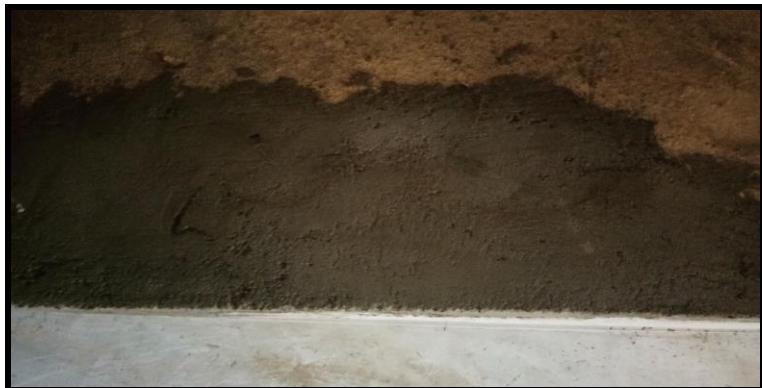
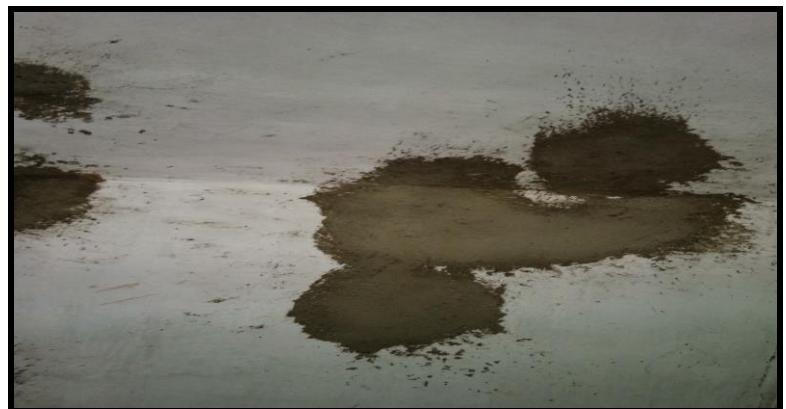
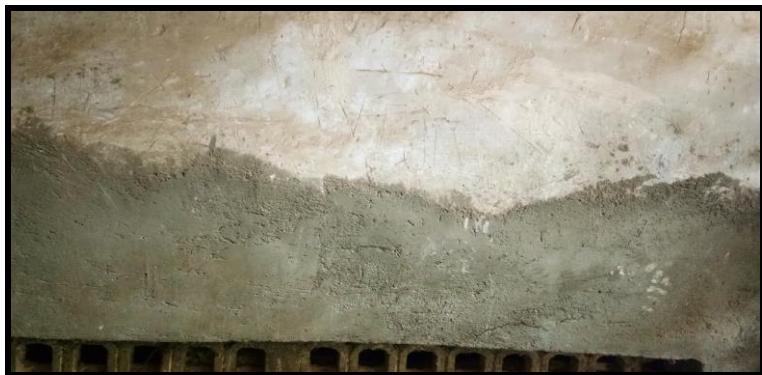
FIRST FLOOR TO SECOND FLOOR

- ❖ Patch work observed on wall.
- ❖ Peeling of paint observed on ceiling.

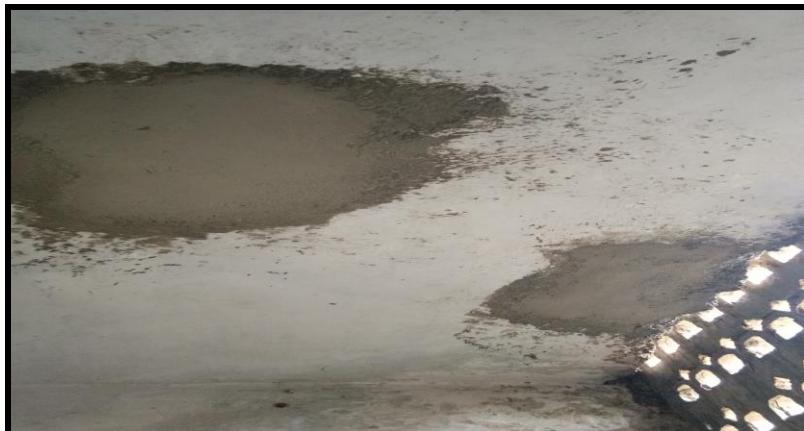
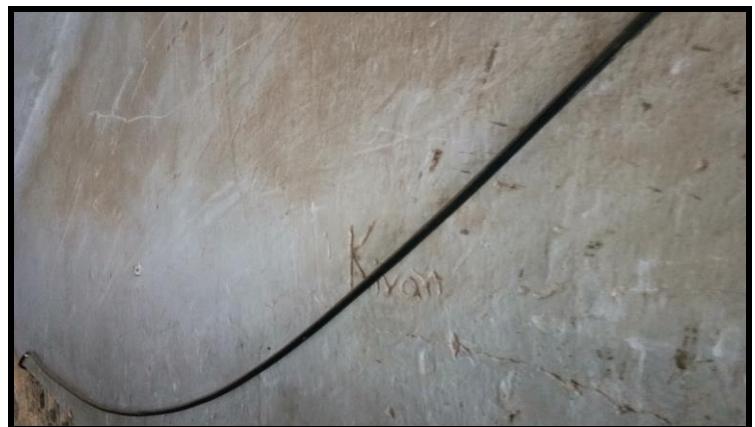
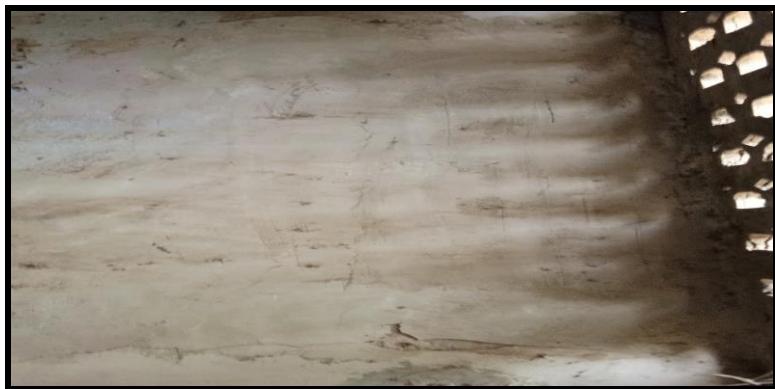
SECOND FLOOR TO THIRD FLOOR

- ❖ Patch work observed on wall.
- ❖ Peeling of paint observed on ceiling.

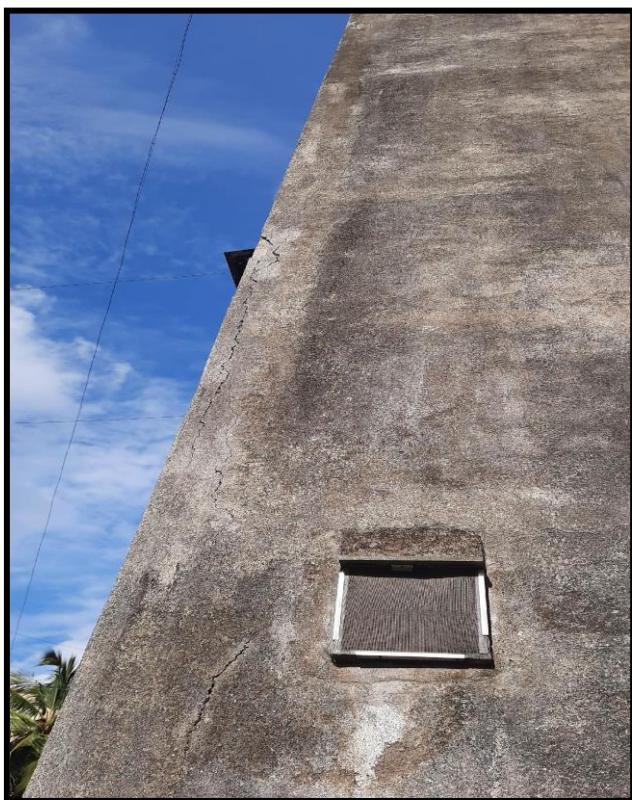
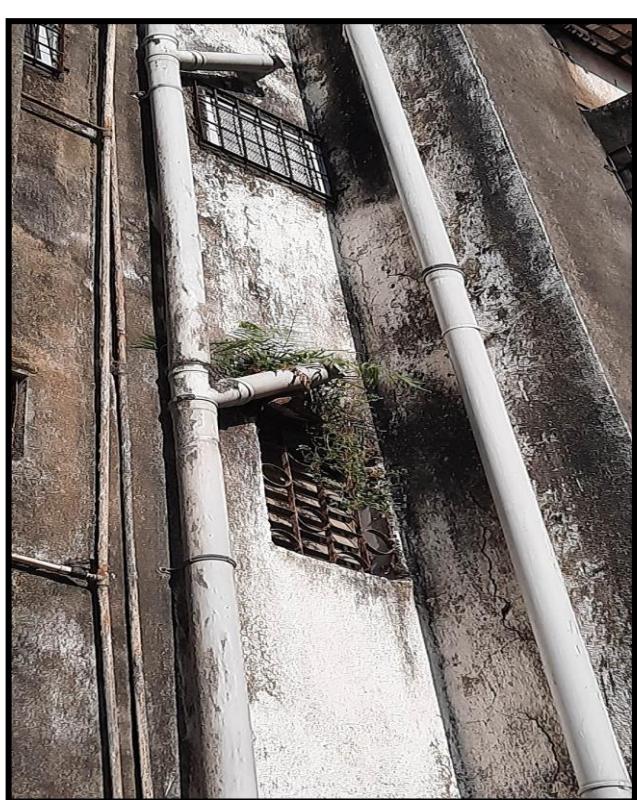
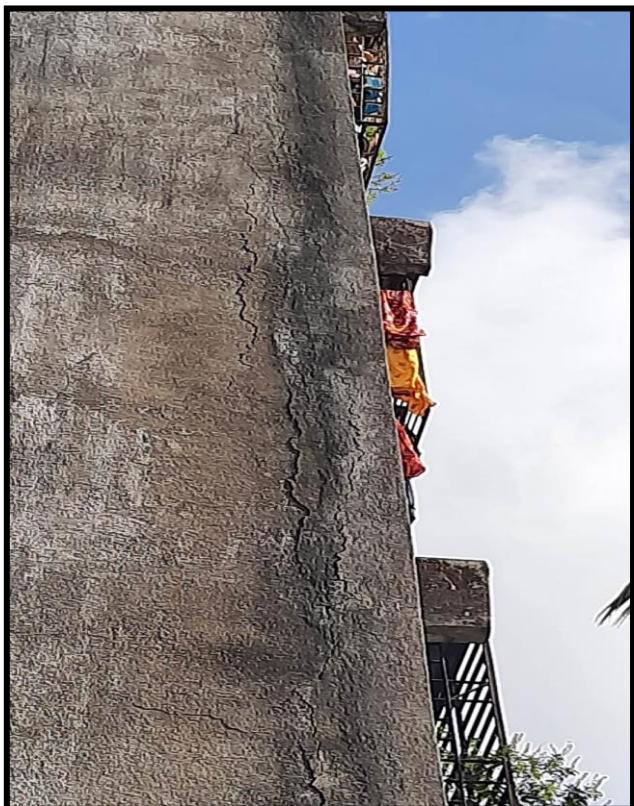
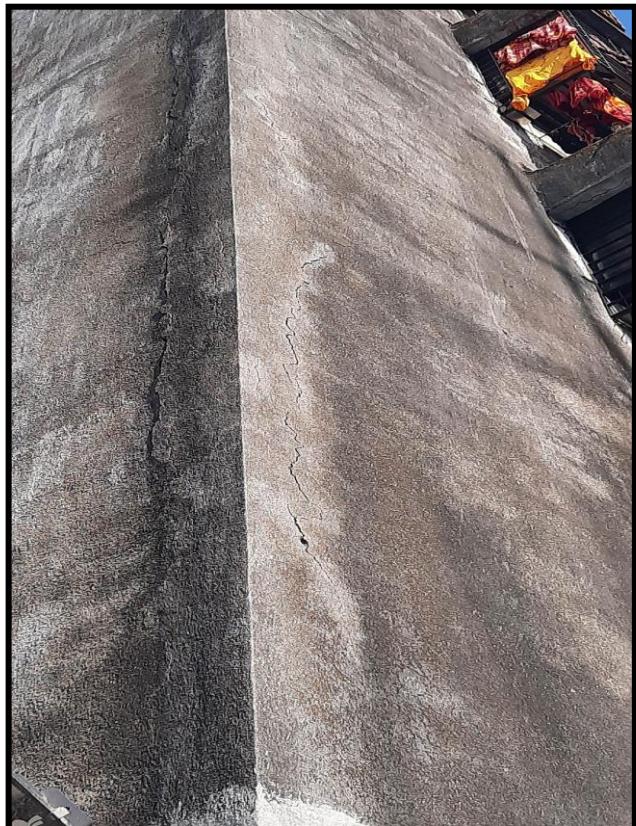
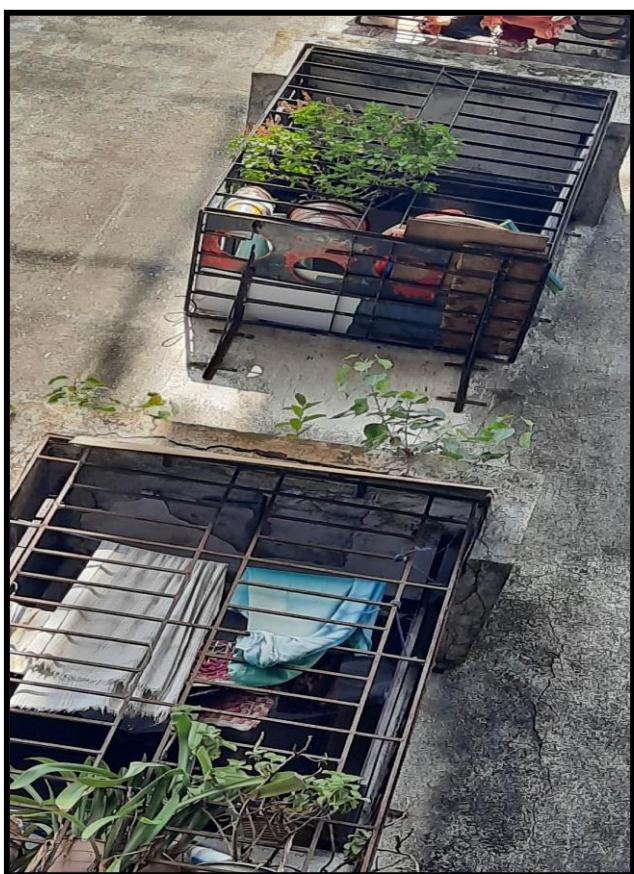
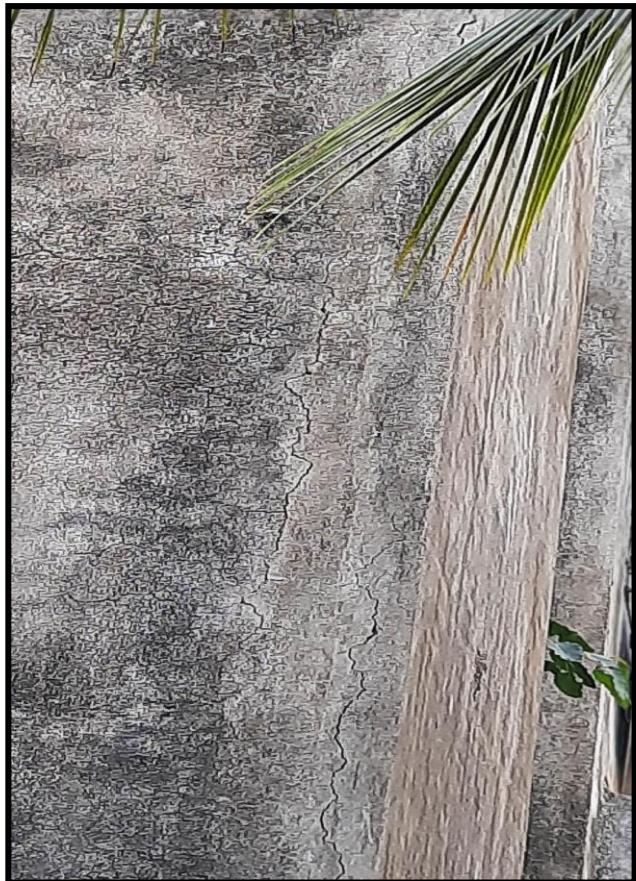
BACK SIDE

- ❖ Structural crack observed at several places on column.
- ❖ Major crack observed at several places on wall.
- ❖ Vegetation growth observed at several places on wall.

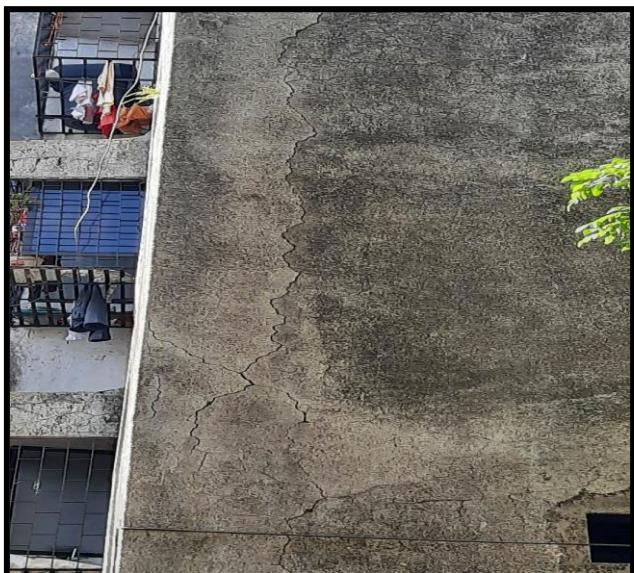
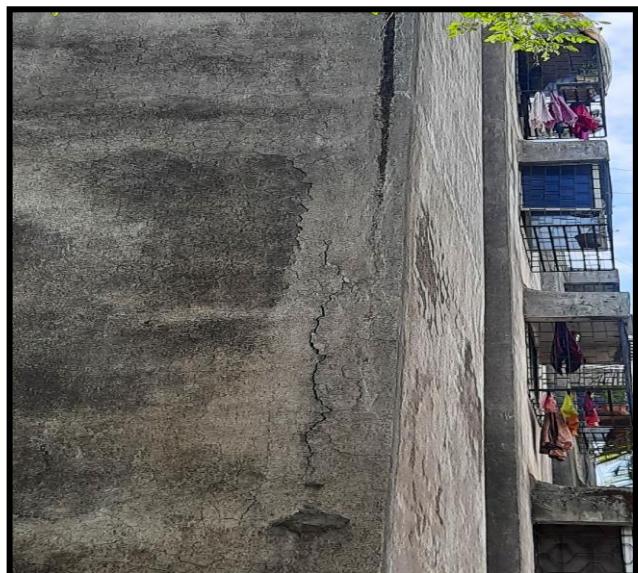
SOUTH SIDE

- ❖ Structural crack observed at several places on column.
- ❖ Major crack observed at several places on wall.
- ❖ Vegetation growth observed at several places on wall.
