STRUCTURAL AUDIT REPORT
FOR
“VISHAL SAHYADRI CO – OP HSG. SOC. LTD”,
“C13 – WING”
SITUATED AT
SAHYADRI NAGAR, CHARKOP,
KANDIVALI (W) MUMBAI – 400 067

PREPARED BY
LATESH S. SANKLECHA
CONSULTING STRUCTURAL ENGINEERS

978/B1/LSS/2021

JUNE 21, 2021

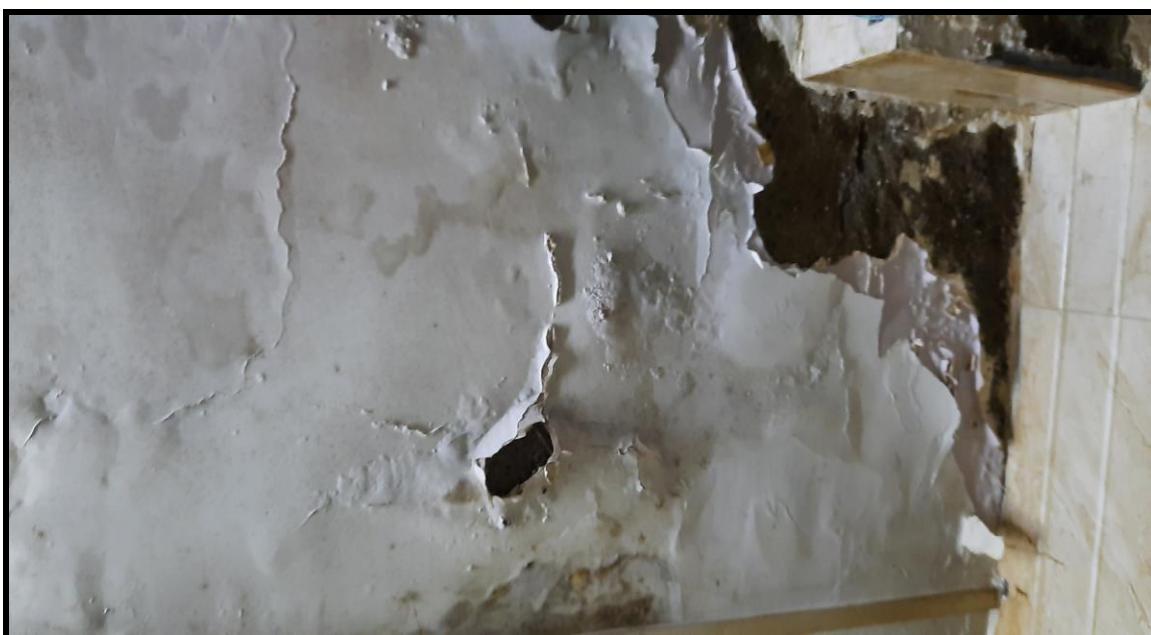
FLAT NO – 03

- ❖ **HALL** – O.K.
- ❖ **KITCHEN** – Leakage mark observed on ceiling.
 - Ceiling plaster get damaged & steel get exposed & corroded.
- ❖ **PASSAGE** – O.K.
- ❖ **TOILET & BATH ROOM** – O.K.

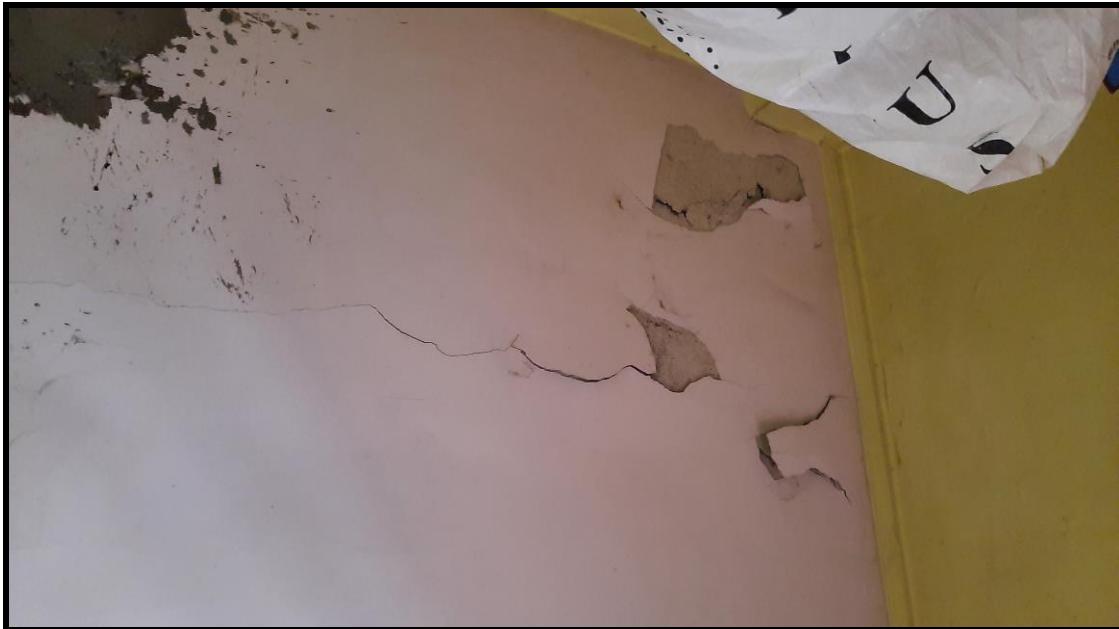
FLAT NO – 04

- ❖ **HALL** – Structural damage observed on ceiling.
 - Dampness observed on wall in monsoon.
- ❖ **KITCHEN** – O.K.
- ❖ **PASSAGE** – O.K.
- ❖ **TOILET & BATH ROOM** – O.K.

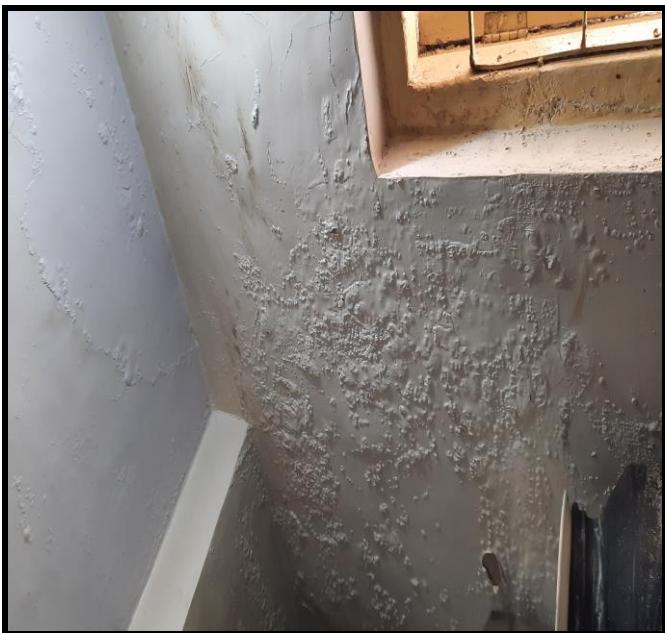
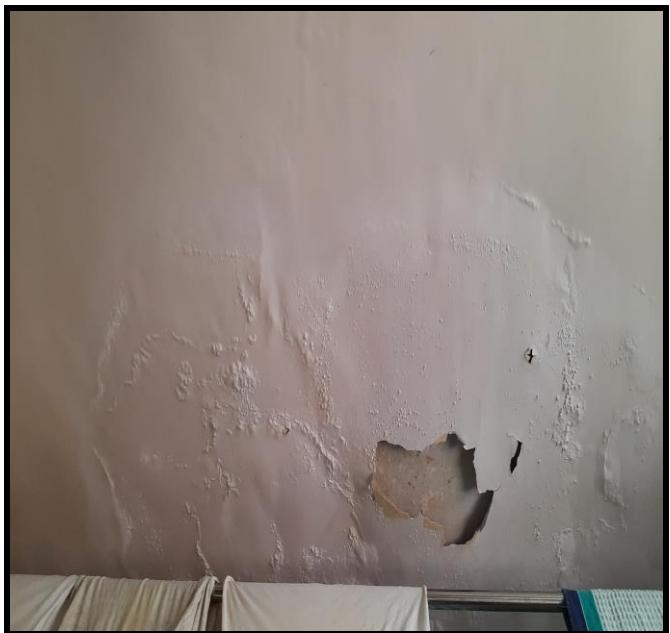
FLAT NO – 14

- ❖ **HALL** – O.K.
- ❖ **KITCHEN** – Leakage mark observed on wall & ceiling.
 - Structural crack observed on beam.
- ❖ **PASSAGE** – O.K.
- ❖ **TOILET & BATH ROOM** – Leakage mark observed on wall & ceiling.

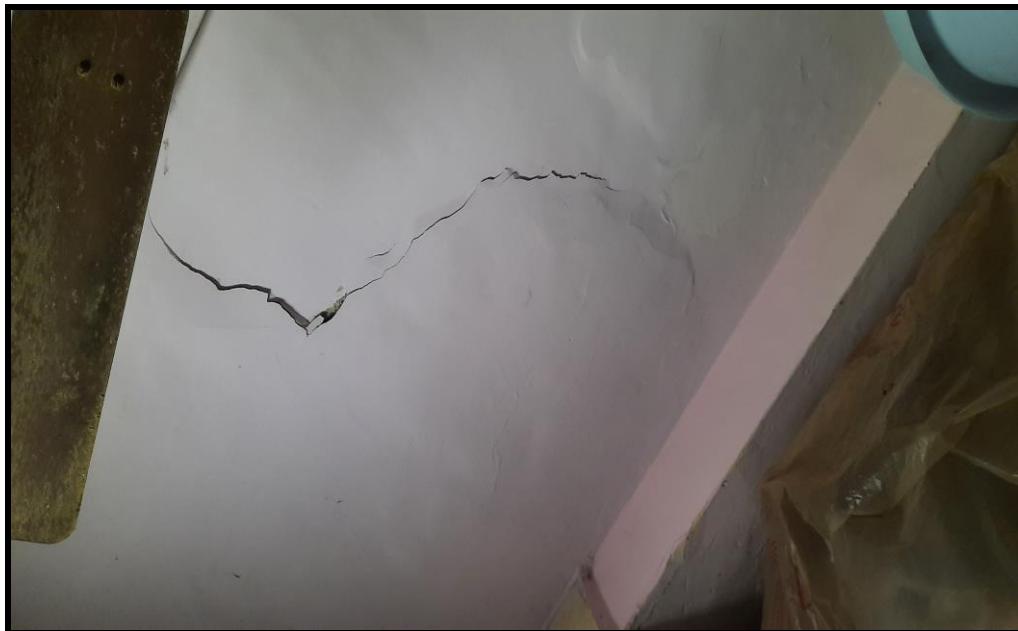
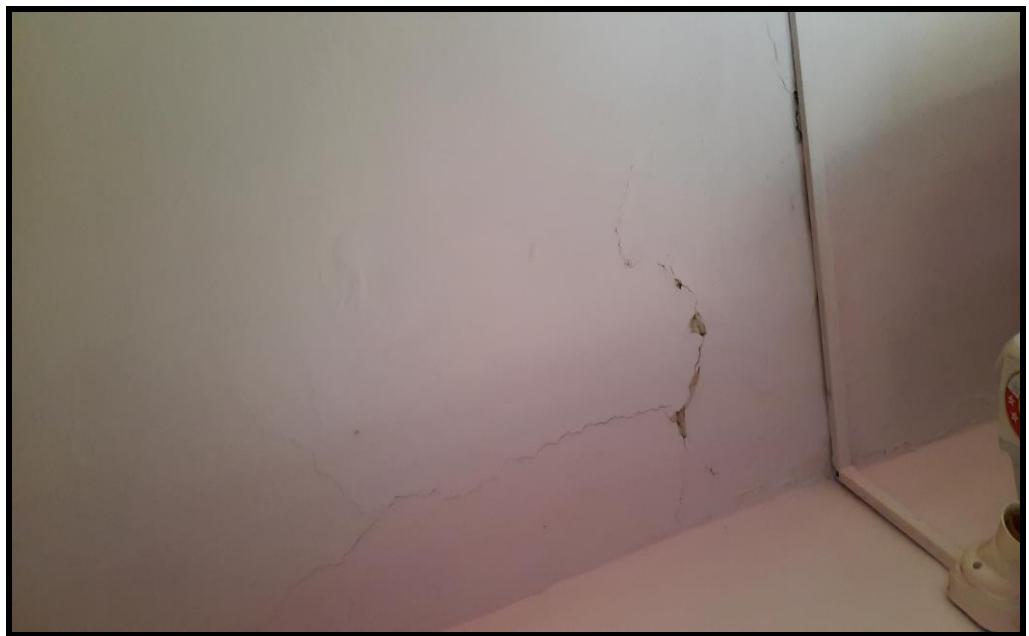
FLAT NO – 15

- ❖ **HALL** – Structural damage observed on ceiling.
- ❖ **KITCHEN** – Structural damage observed on ceiling.
- ❖ **PASSAGE** – O.K.
- ❖ **TOILET & BATH ROOM** – O.K.

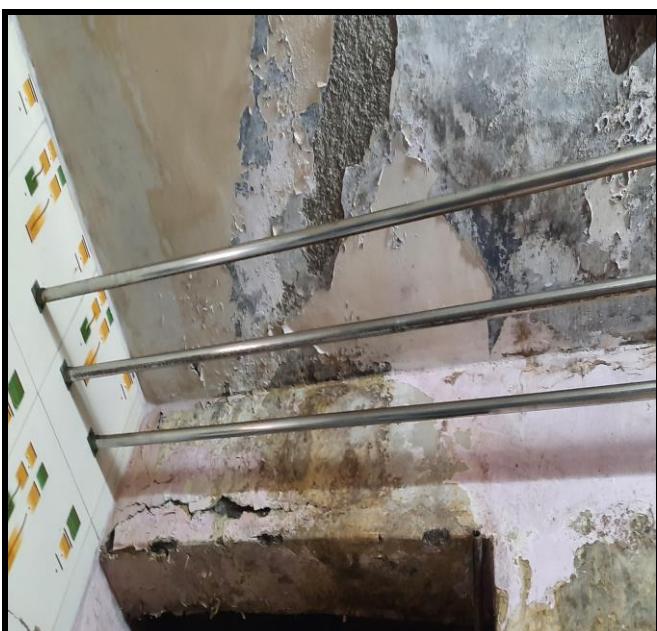
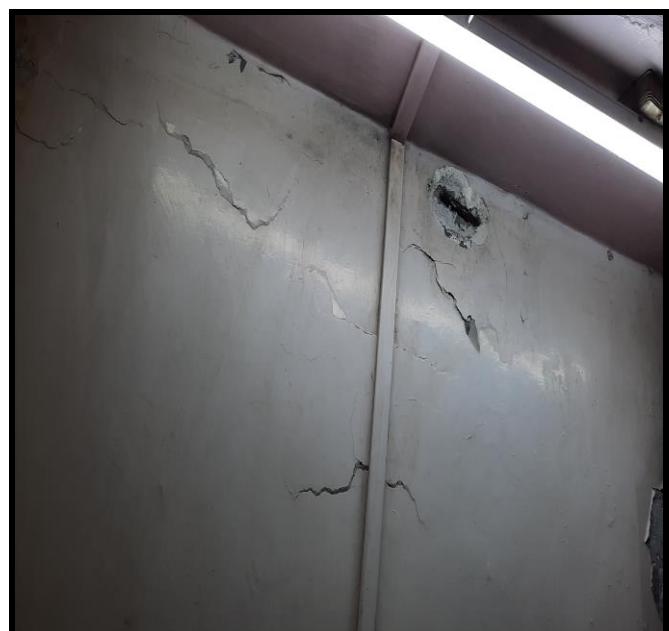
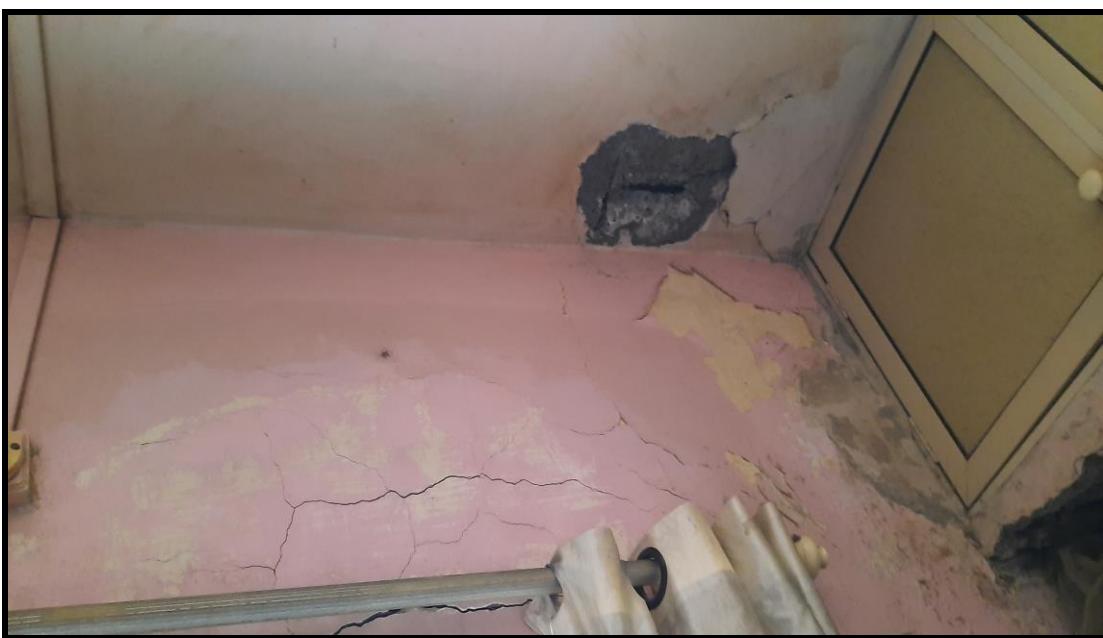
FLAT NO – 17

- ❖ **HALL** – Structural damage observed on ceiling.
 - Structural crack observed on beam.
- ❖ **KITCHEN** – Structural crack observed on beam.
 - Ceiling plaster get damaged & steel get exposed & corroded.
 - Leakage mark observed on wall & ceiling.
- ❖ **PASSAGE** – O.K.
- ❖ **TOILET & BATH ROOM** – O.K.

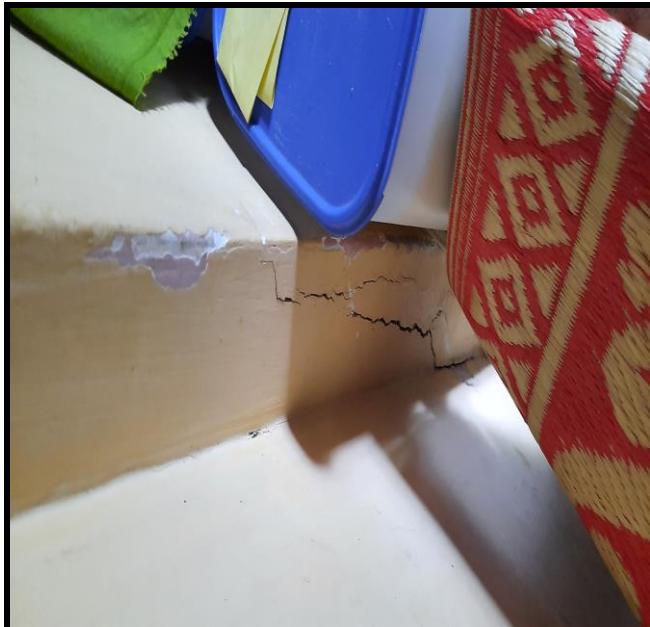
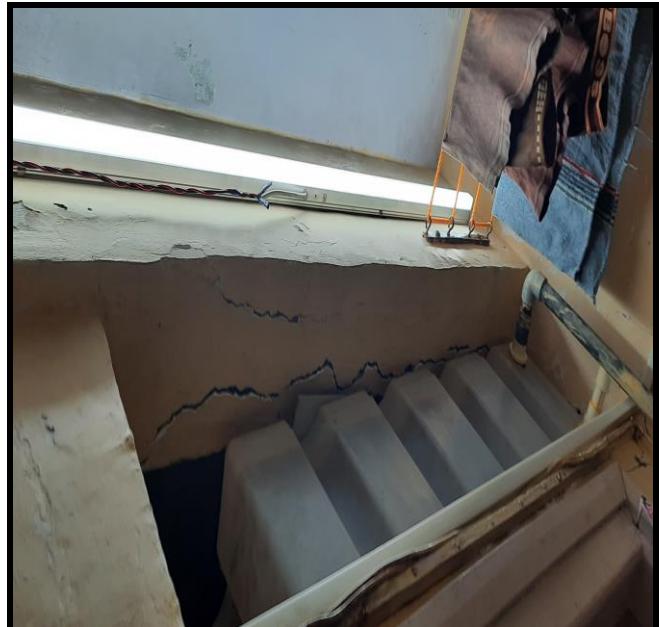
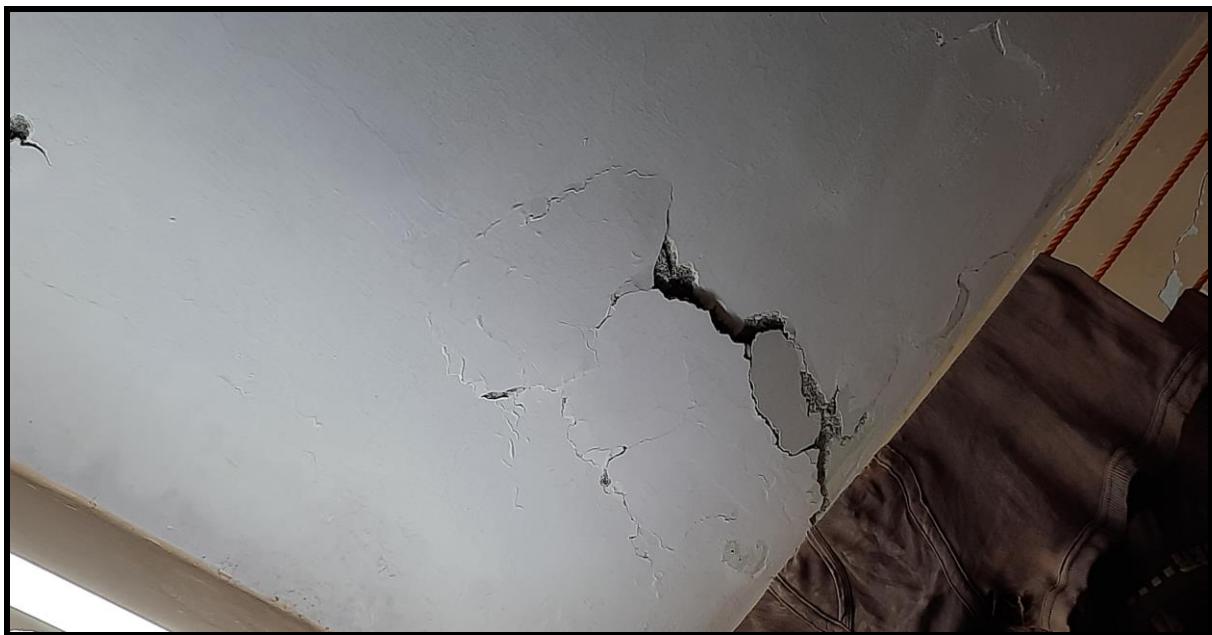
FLAT NO – 18

- ❖ **HALL** – Structural crack observed on column.
- ❖ **KITCHEN** – Structural crack observed on beam.
 - Structural damage observed on ceiling.
- ❖ **PASSAGE** – O.K.
- ❖ **TOILET & BATH ROOM** – O.K.

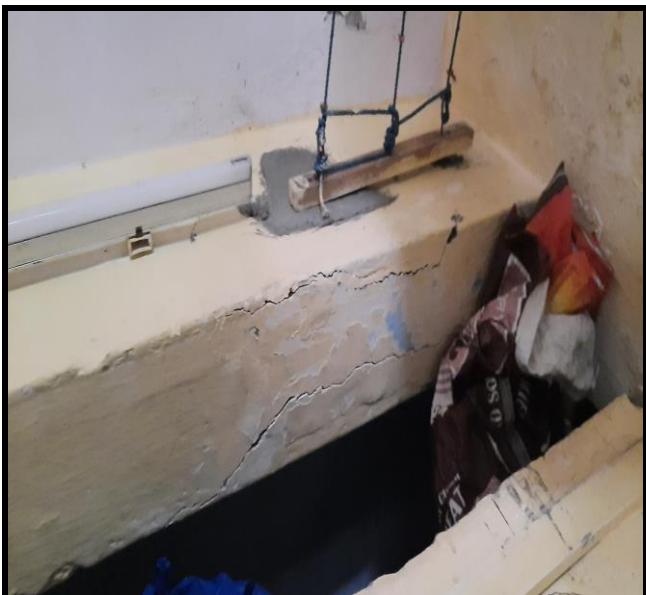
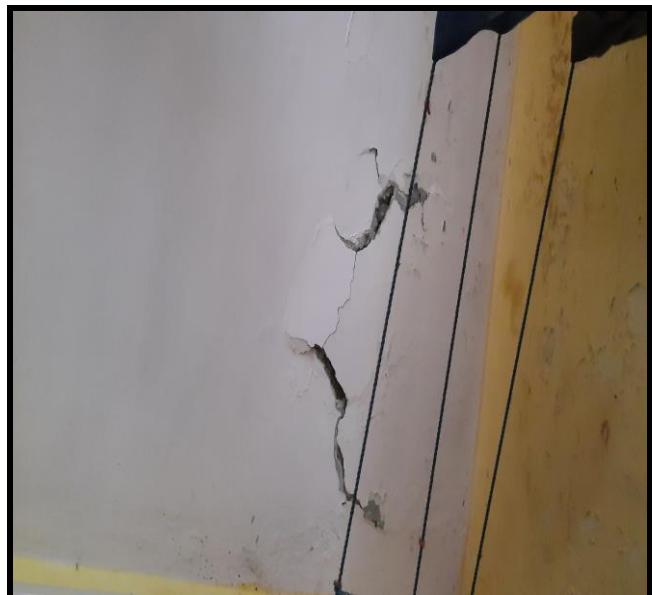
FLAT NO – 26

- ❖ **HALL** – Structural crack observed on column.
- ❖ **KITCHEN** – Structural crack observed on beam.
 - Structural damage observed on ceiling.
 - Leakage mark observed on wall.
- ❖ **PASSAGE** – O.K.
- ❖ **TOILET & BATH ROOM** – O.K.

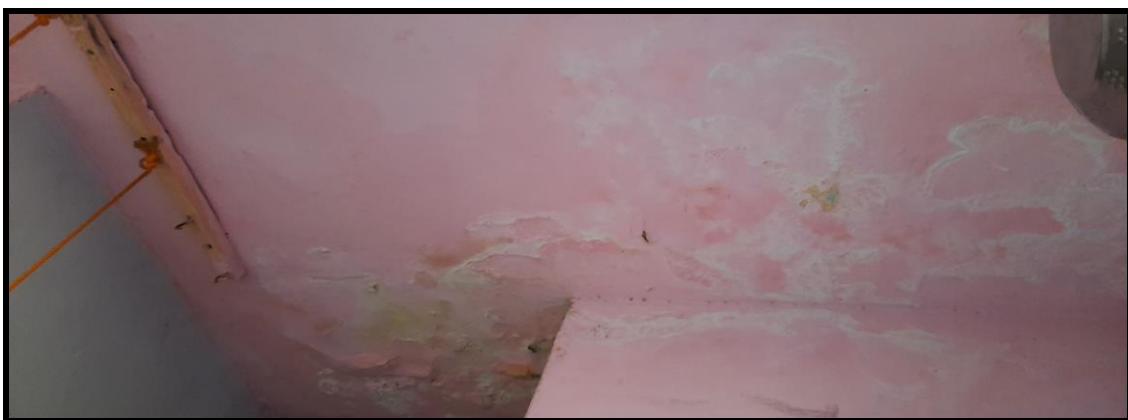
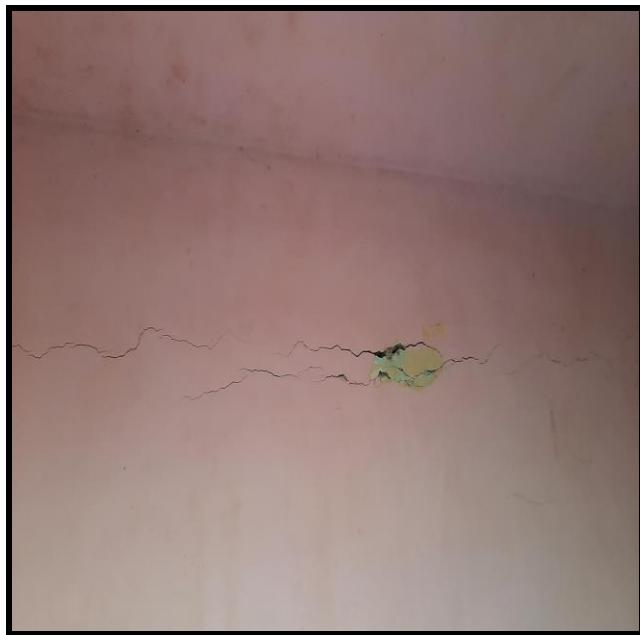
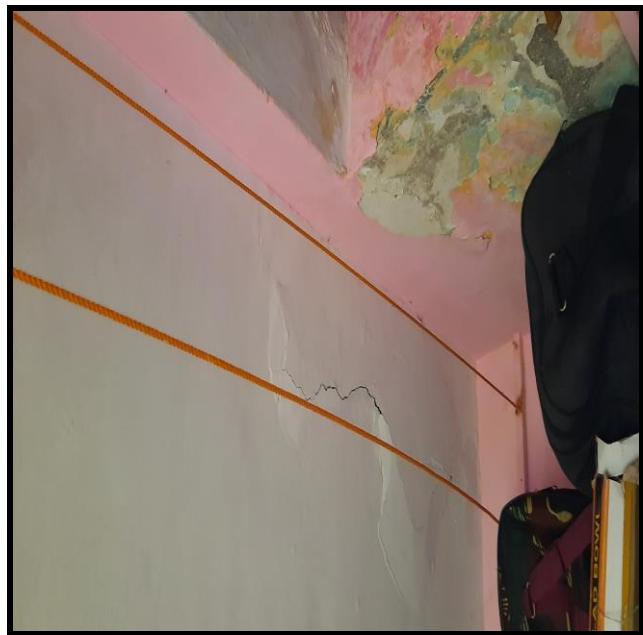
FLAT NO – 28

- ❖ **HALL** – Structural crack observed on column.
- ❖ **KITCHEN** – Structural crack observed on ceiling.
 - Leakage mark observed on wall.
- ❖ **PASSAGE** – O.K.
- ❖ **TOILET & BATH ROOM** – O.K.

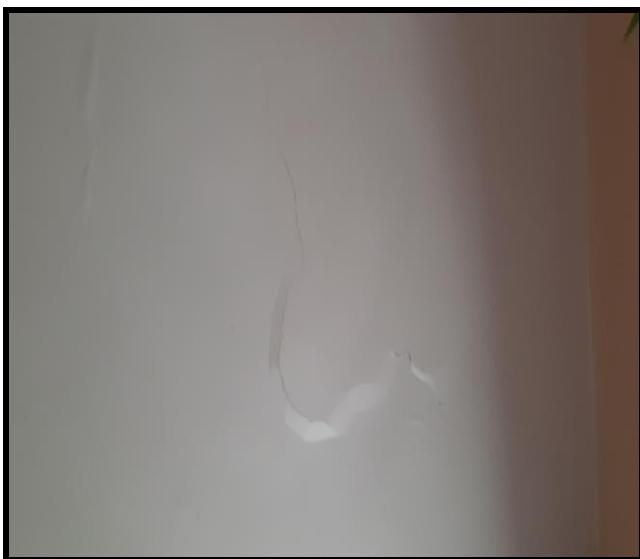
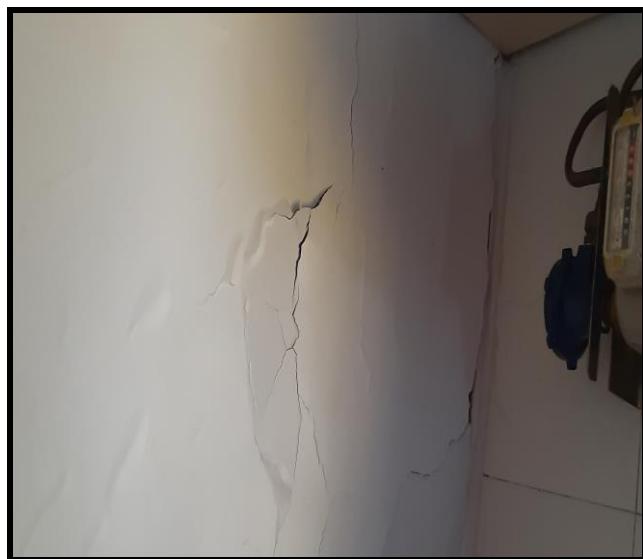
FLAT NO - 32

- ❖ **HALL** – Structural damage observed on ceiling.
- ❖ **KITCHEN** – Structural damage observed on ceiling.
- ❖ **PASSAGE** – O.K.
- ❖ **TOILET & BATH ROOM** – O.K.

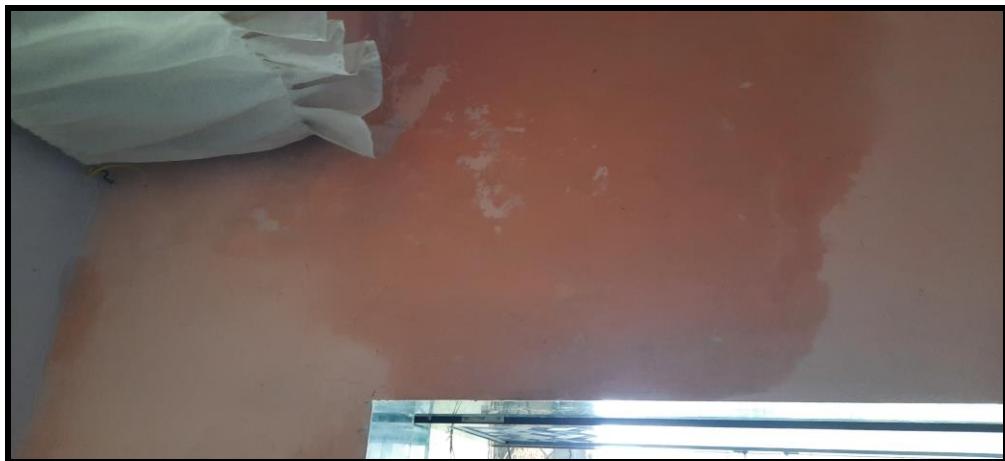
FLAT NO – 33

- ❖ **HALL** – Dampness observed on wall.
- ❖ **KITCHEN** – Dampness observed on wall in monsoon.
- ❖ **PASSAGE** – O.K.
- ❖ **TOILET & BATH ROOM** – O.K.

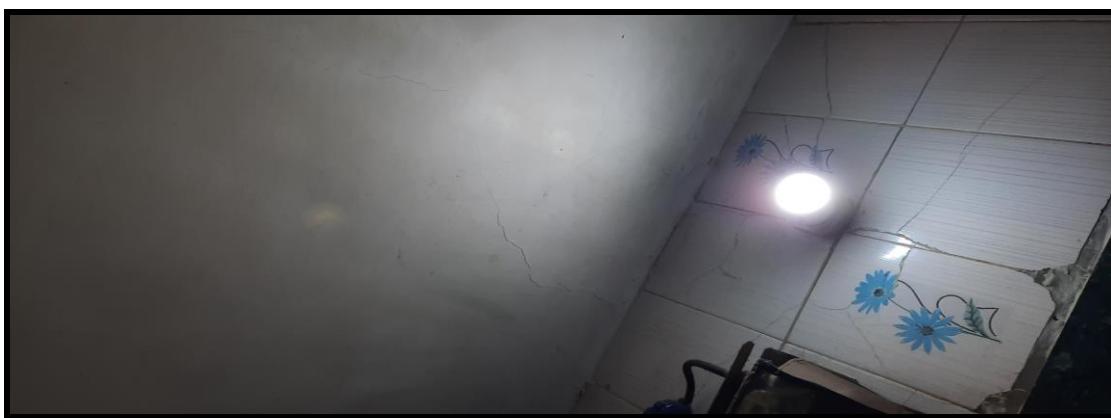
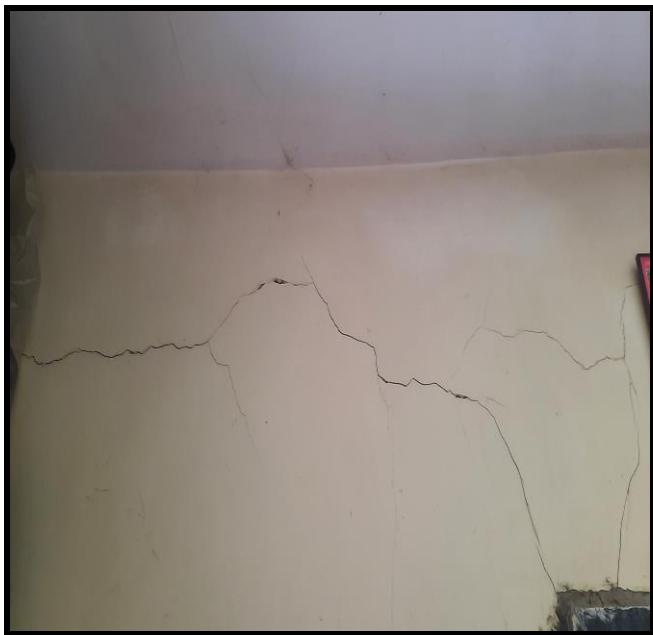
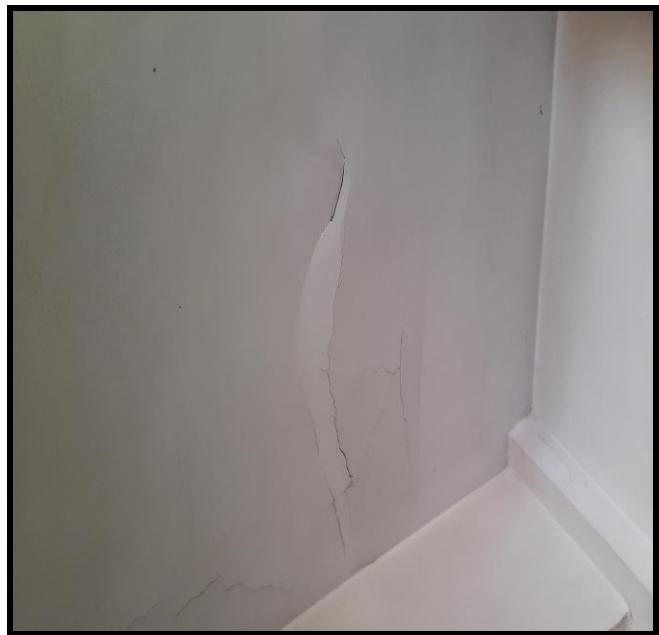
FLAT NO – 37

- ❖ **HALL** – Structural crack observed on beam & ceiling.
- ❖ **KITCHEN** – Structural crack observed on beam & ceiling.
- ❖ **PASSAGE** – O.K.
- ❖ **TOILET & BATH ROOM** – O.K.

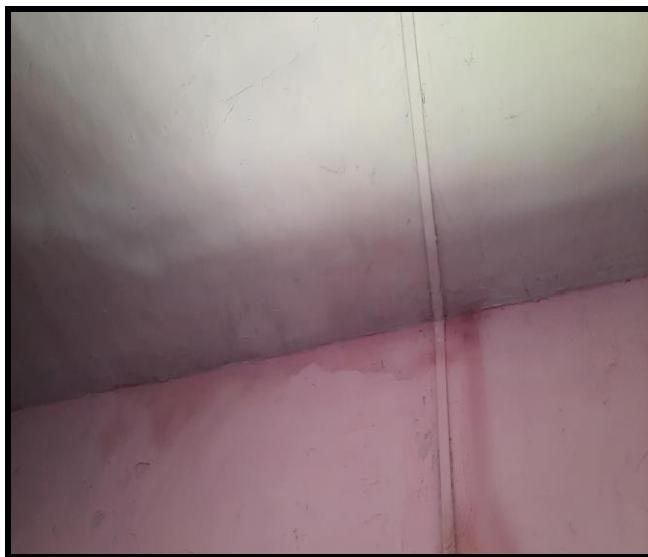
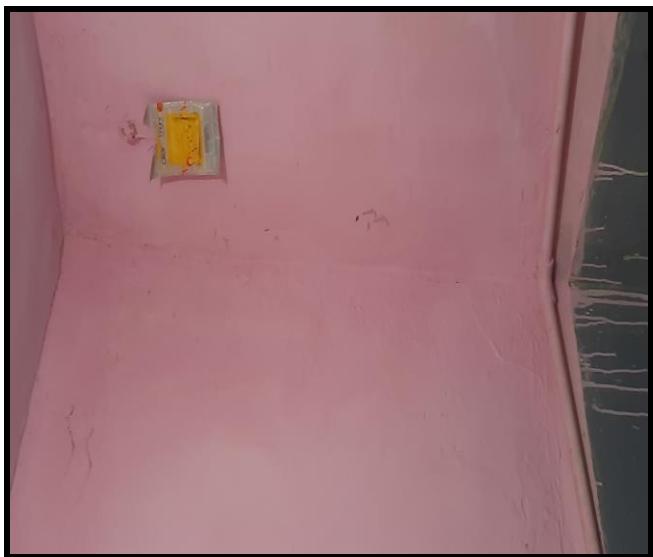
FLAT NO – 38

- ❖ **HALL** – Dampness observed on wall in monsoon.
- ❖ **KITCHEN** – Dampness observed on wall in monsoon.
- ❖ **PASSAGE** – O.K.
- ❖ **TOILET & BATH ROOM** – Dampness observed on wall in monsoon.

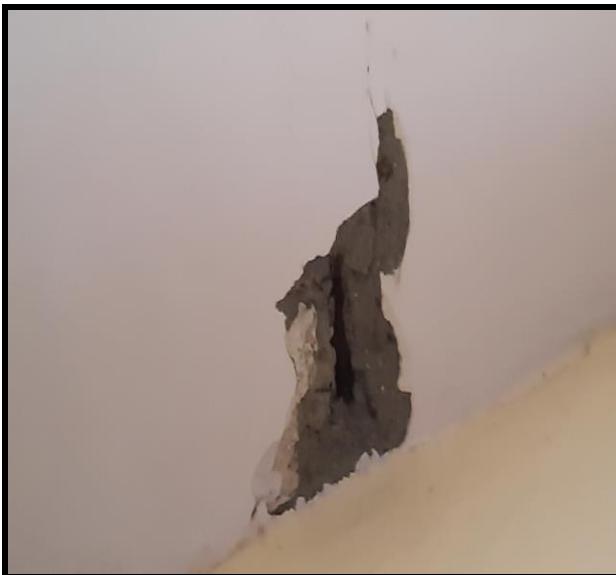
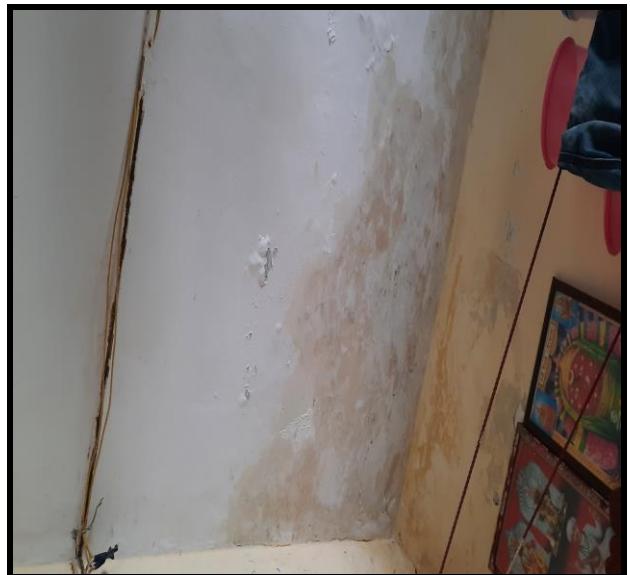
FLAT NO – 41

- ❖ **HALL** – Ceiling plaster get damaged & steel get exposed & corroded.
- ❖ **KITCHEN** – Leakage mark observed on wall & ceiling.
- ❖ **PASSAGE** – O.K.
- ❖ **TOILET & BATH ROOM** – O.K.

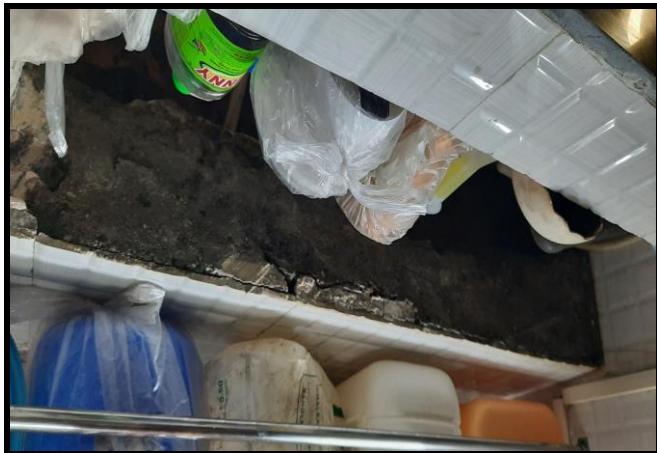
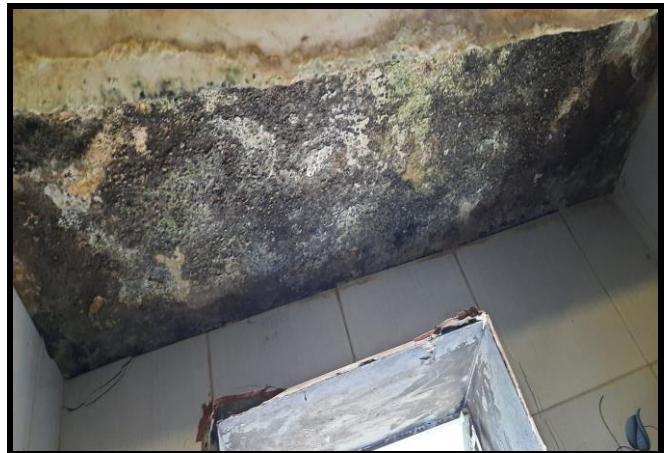
FLAT NO – 42

- ❖ **HALL** – Leakage observed on ceiling in monsoon.
- ❖ **KITCHEN** – Leakage mark observed on ceiling.
 - Structural crack observed on beam.
- ❖ **PASSAGE** – O.K.
- ❖ **TOILET & BATH ROOM** – O.K.

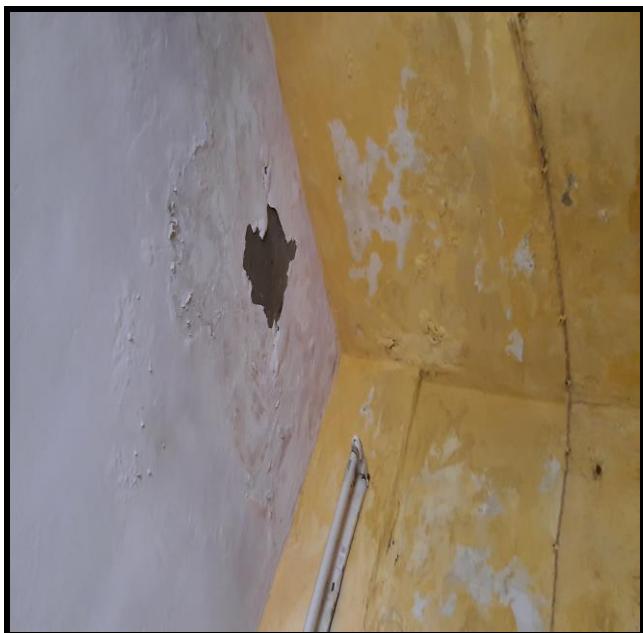
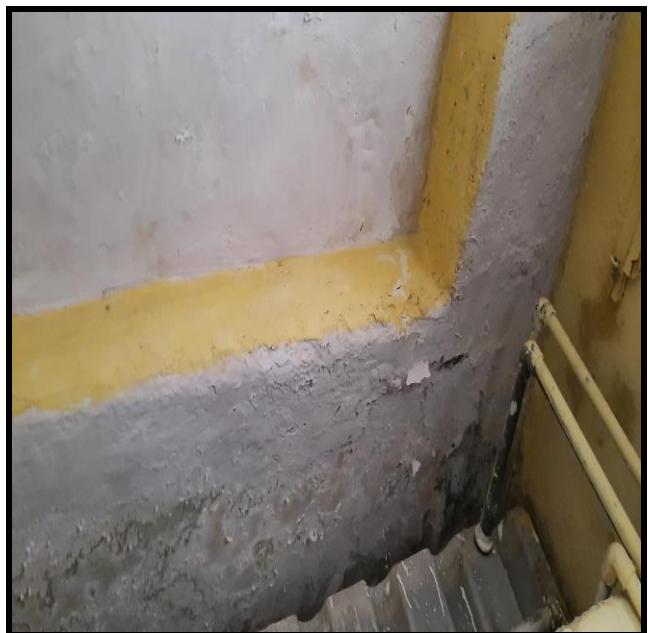
FLAT NO – 43

- ❖ **HALL** – O.K.
- ❖ **KITCHEN** – Dampness observed on wall & ceiling.
- ❖ **PASSAGE** – O.K.
- ❖ **TOILET & BATH ROOM** – O.K.

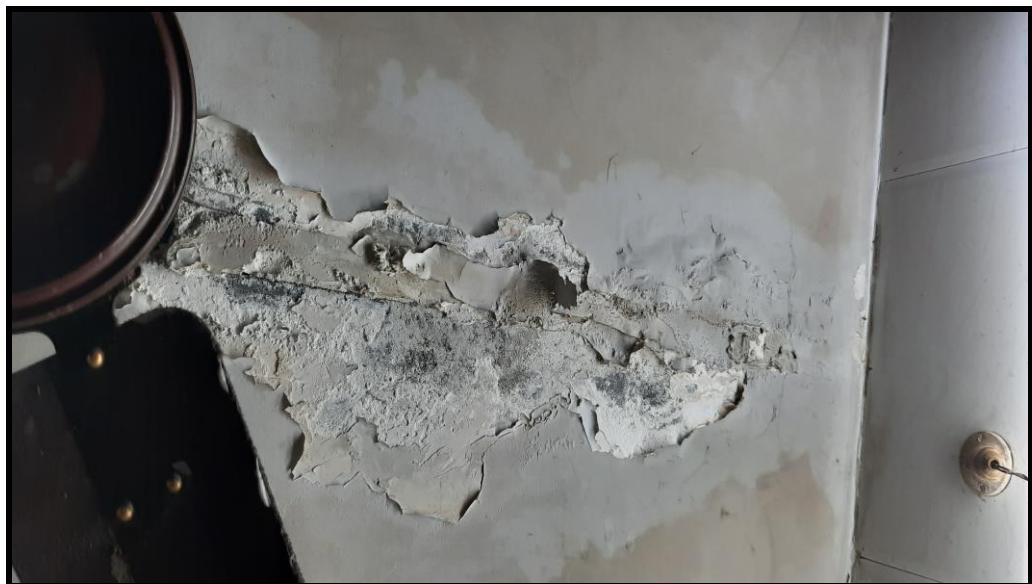
FLAT NO – 47

- ❖ **HALL** – O.K.
- ❖ **KITCHEN** – Leakage mark observed on ceiling.
- ❖ **PASSAGE** – O.K.
- ❖ **TOILET & BATH ROOM** – O.K.

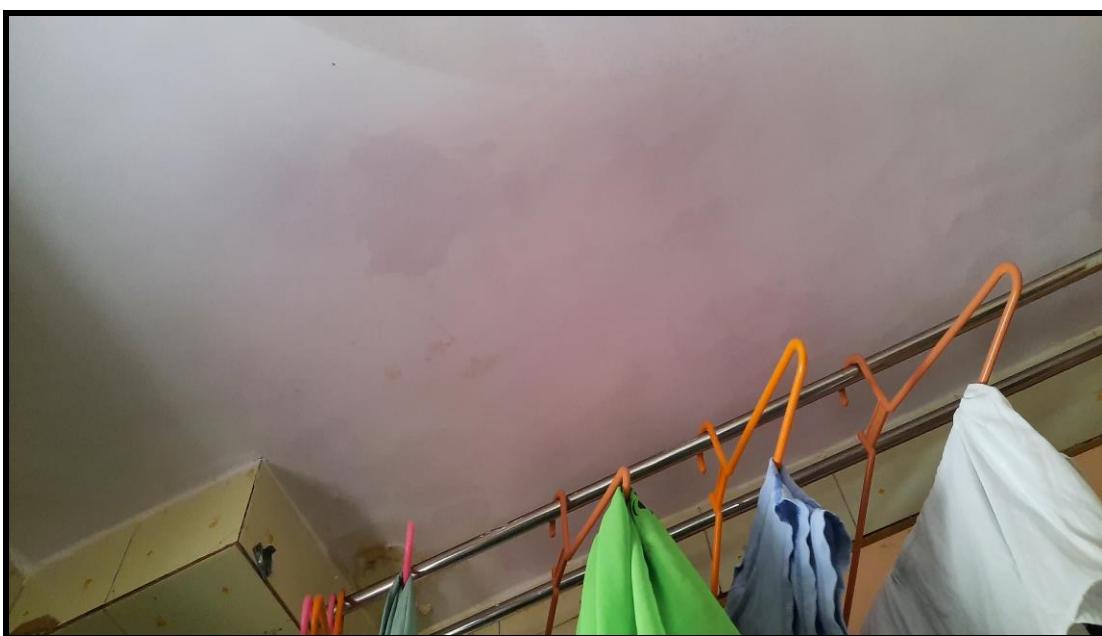
FLAT NO – 48

- ❖ **HALL** – O.K.
- ❖ **KITCHEN** – Leakage mark observed on ceiling.
- ❖ **PASSAGE** – O.K.
- ❖ **TOILET & BATH ROOM** – O.K.

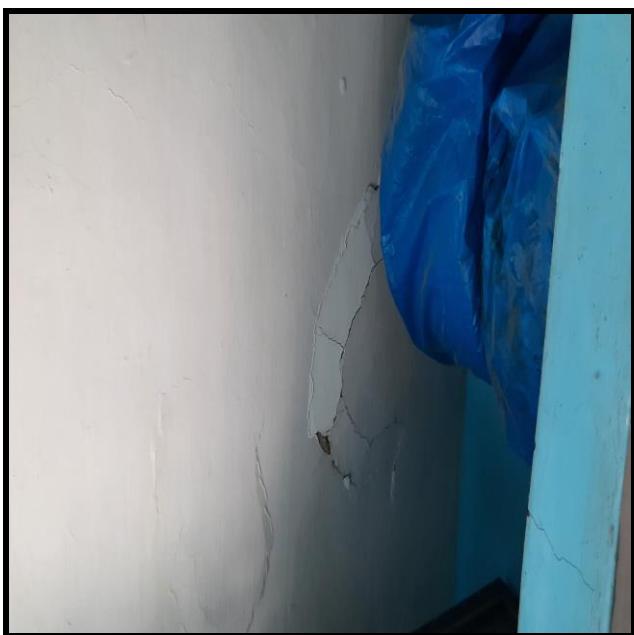
FLAT NO – 52

- ❖ **HALL** – Structural damage observed on ceiling.
 - Dampness observed on wall in monsoon.
- ❖ **KITCHEN** – Structural damage observed on ceiling.
- ❖ **PASSAGE** – O.K.
- ❖ **TOILET & BATH ROOM** – O.K.

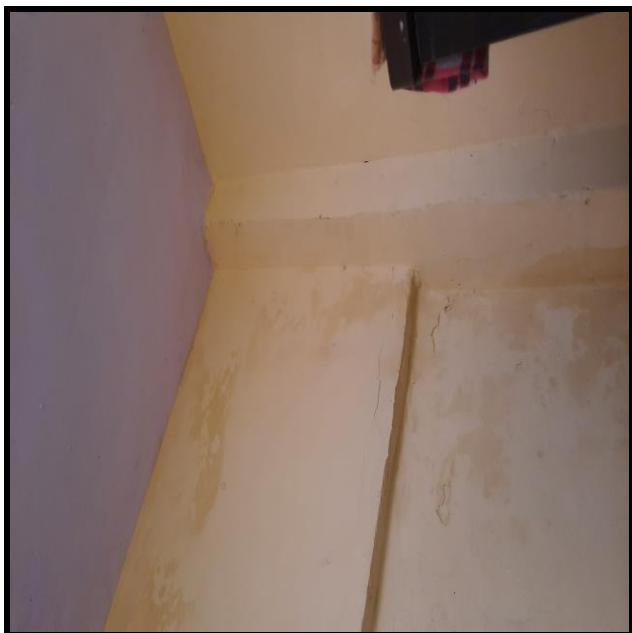
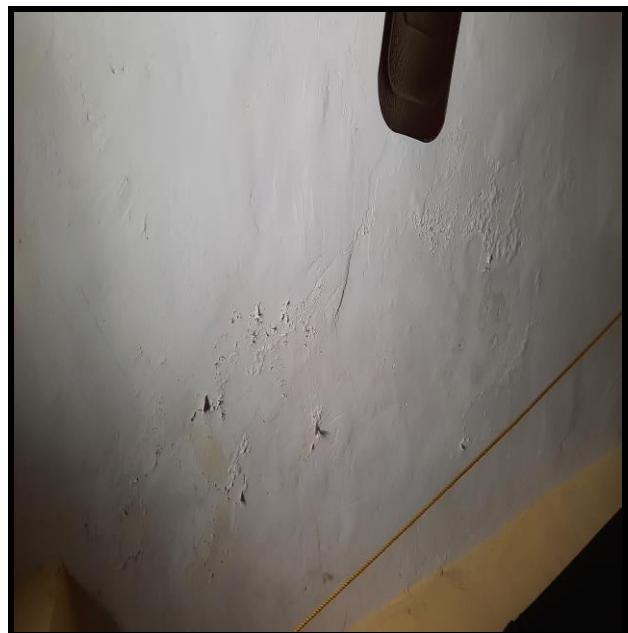
FLAT NO – 56

- ❖ **HALL** – Leakage mark observed on wall.
- ❖ **KITCHEN** – Leakage mark observed on ceiling.
- ❖ **PASSAGE** – O.K.
- ❖ **TOILET & BATH ROOM** – O.K.

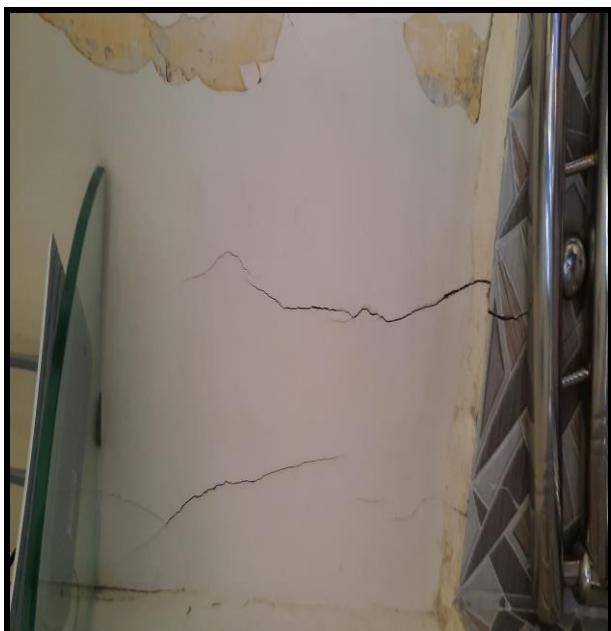
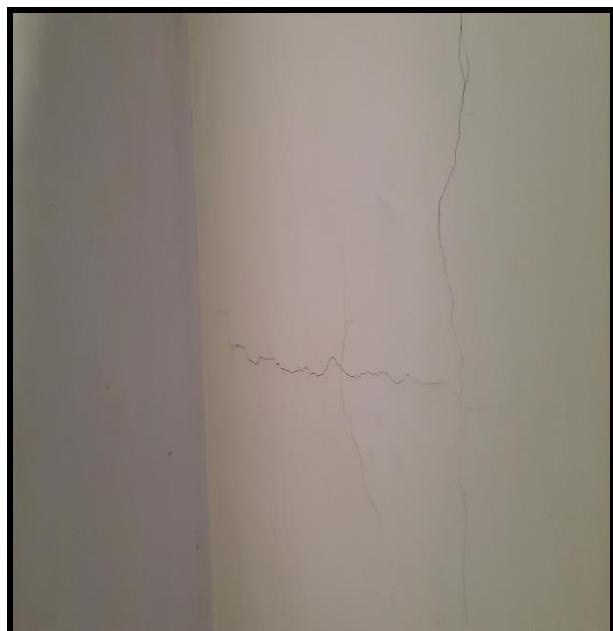
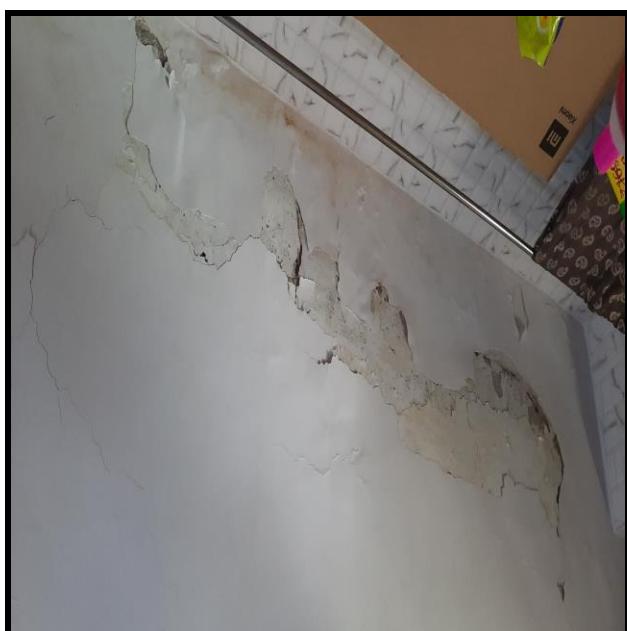
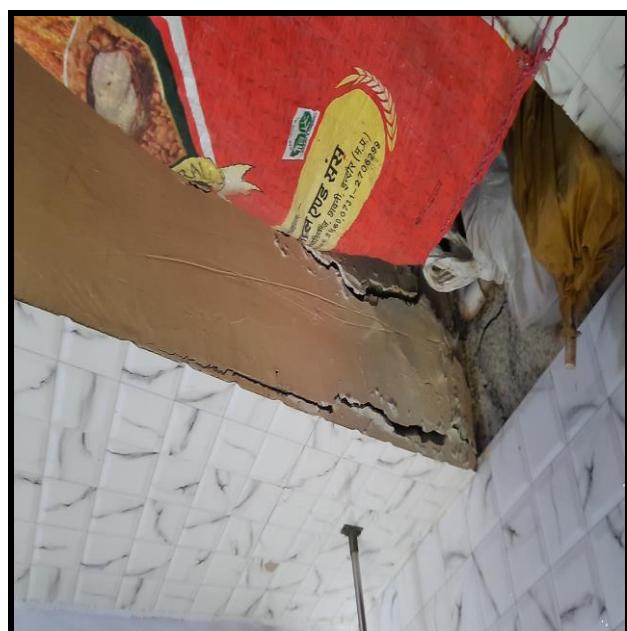
FLAT NO – 58

- ❖ **HALL** – Structural crack observed on beam & column.
- ❖ **KITCHEN** – Leakage mark observed on ceiling.
 - Structural crack observed on beam & ceiling.
- ❖ **PASSAGE** – O.K.
- ❖ **TOILET & BATH ROOM** – O.K.

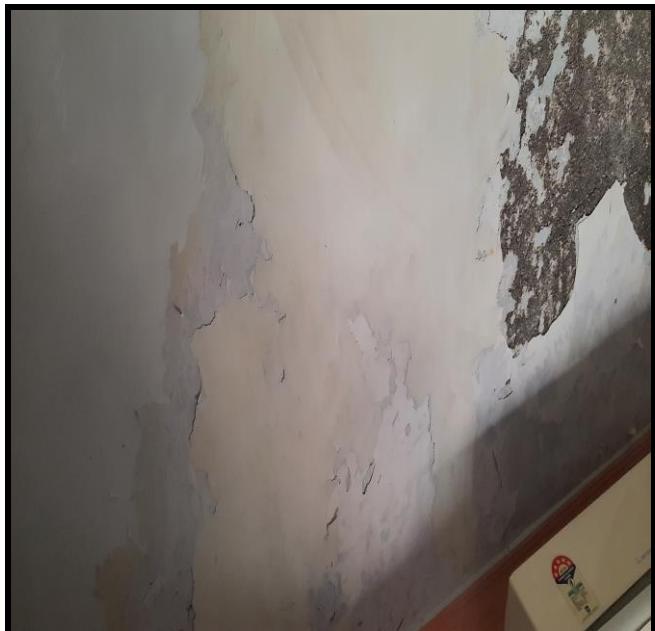
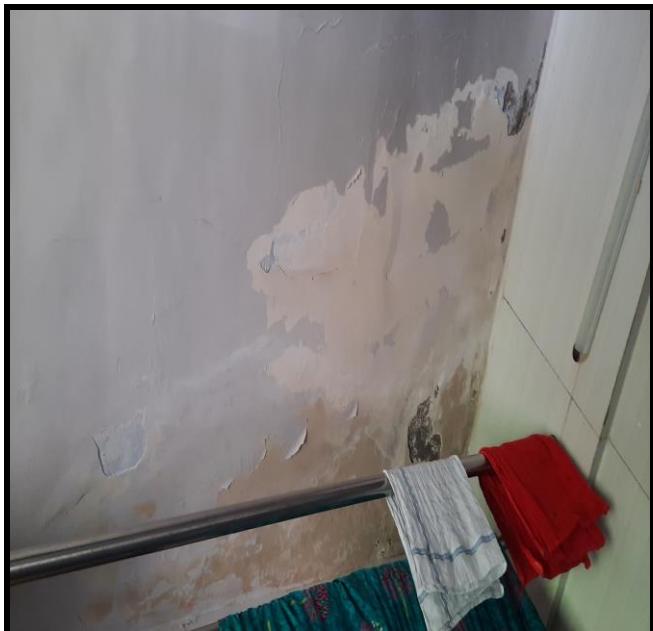
FLAT NO – 60

- ❖ **HALL** – Leakage mark observed on ceiling.
- ❖ **KITCHEN** – Leakage mark observed on ceiling.
- ❖ **PASSAGE** – O.K.
- ❖ **TOILET & BATH ROOM** – O.K.

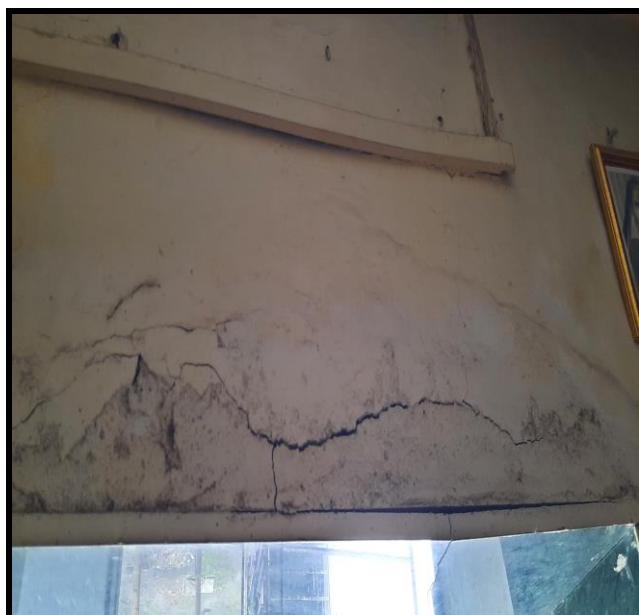
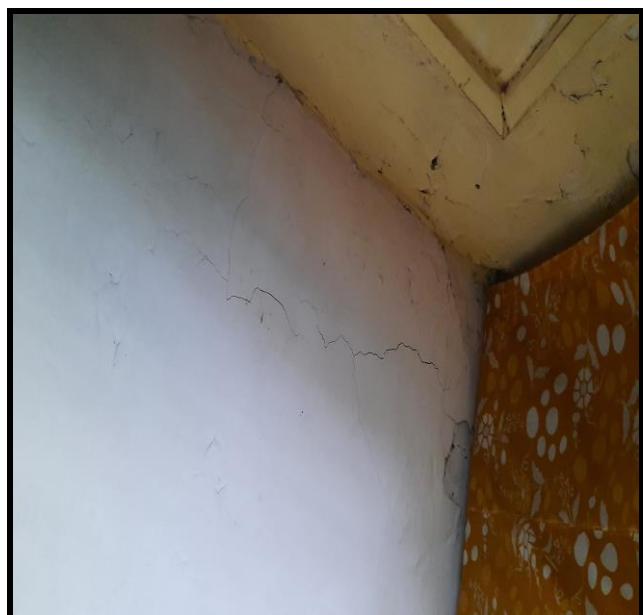
FLAT NO – 61

- ❖ **HALL** – Structural crack observed on beam, column & ceiling.
- ❖ **KITCHEN** – Structural crack observed on beam.
- ❖ **PASSAGE** – O.K.
- ❖ **TOILET & BATH ROOM** – Ceiling plaster get damaged & steel get exposed & corroded.

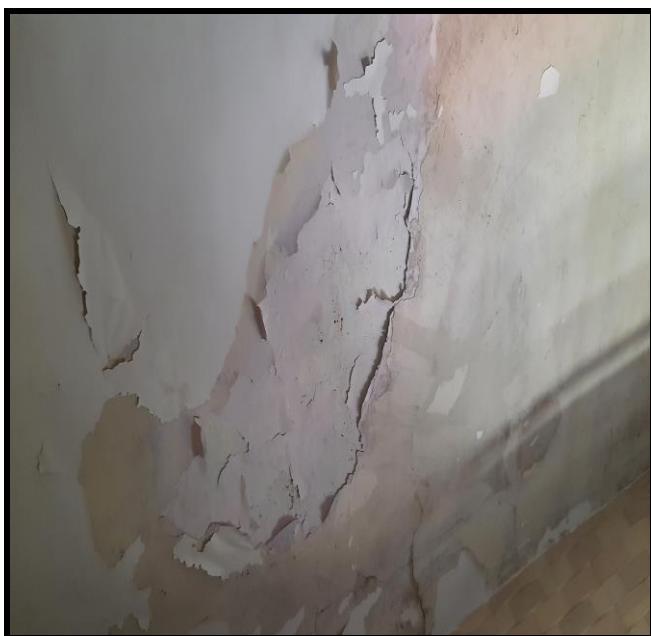
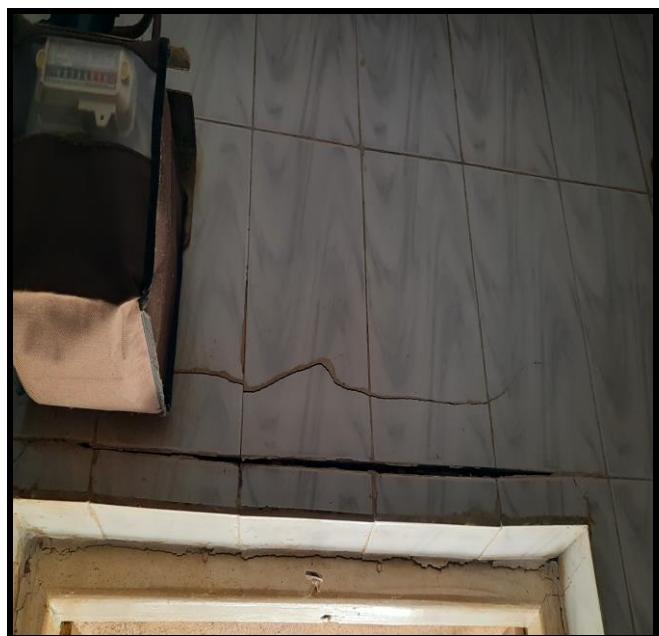
FLAT NO - 64

- ❖ **HALL** – Leakage mark observed on ceiling.
- ❖ **KITCHEN** – Structural crack observed on beam.
- ❖ **PASSAGE** – O.K.
- ❖ **TOILET & BATH ROOM** – O.K.
