STRUCTURAL AUDIT REPORT
FOR
“VISHAL SAHYADRI CO – OP HSG. SOC. LTD”,
“C13 – WING”
SITUATED AT
SAHYADRI NAGAR, CHARKOP,
KANDIVALI (W) MUMBAI – 400 067

PREPARED BY
LATESH S. SANKLECHA
CONSULTING STRUCTURAL ENGINEERS

978/B1/LSS/2021

JUNE 21, 2021

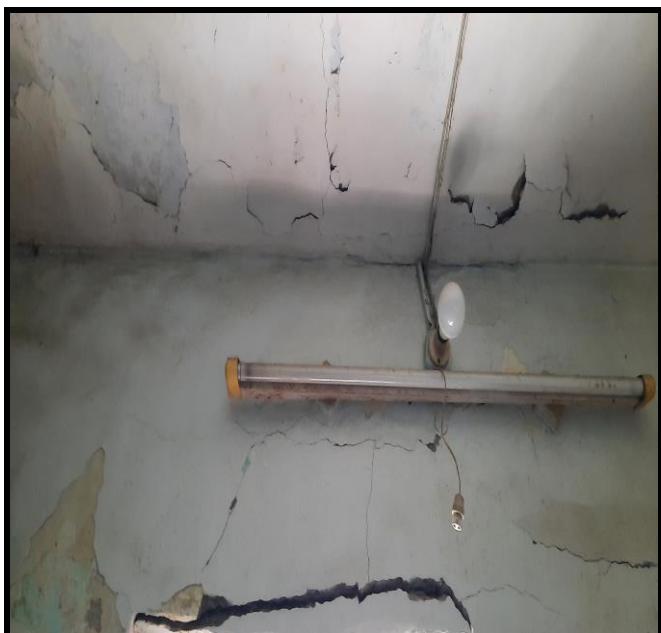
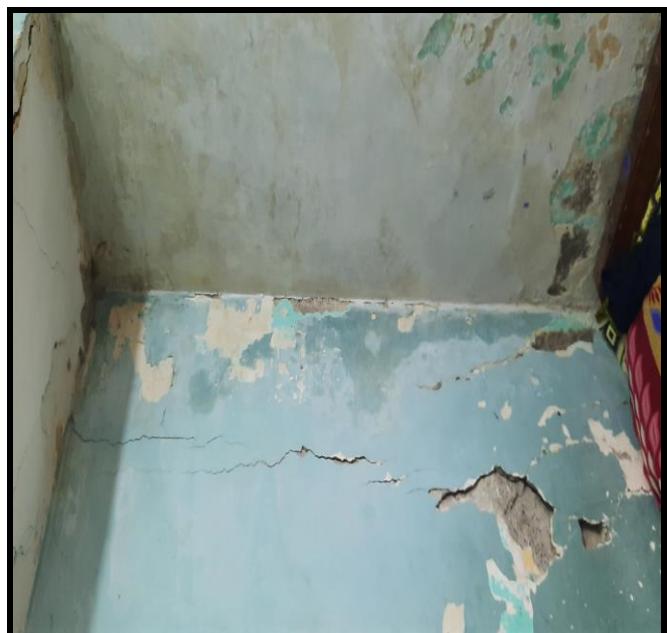
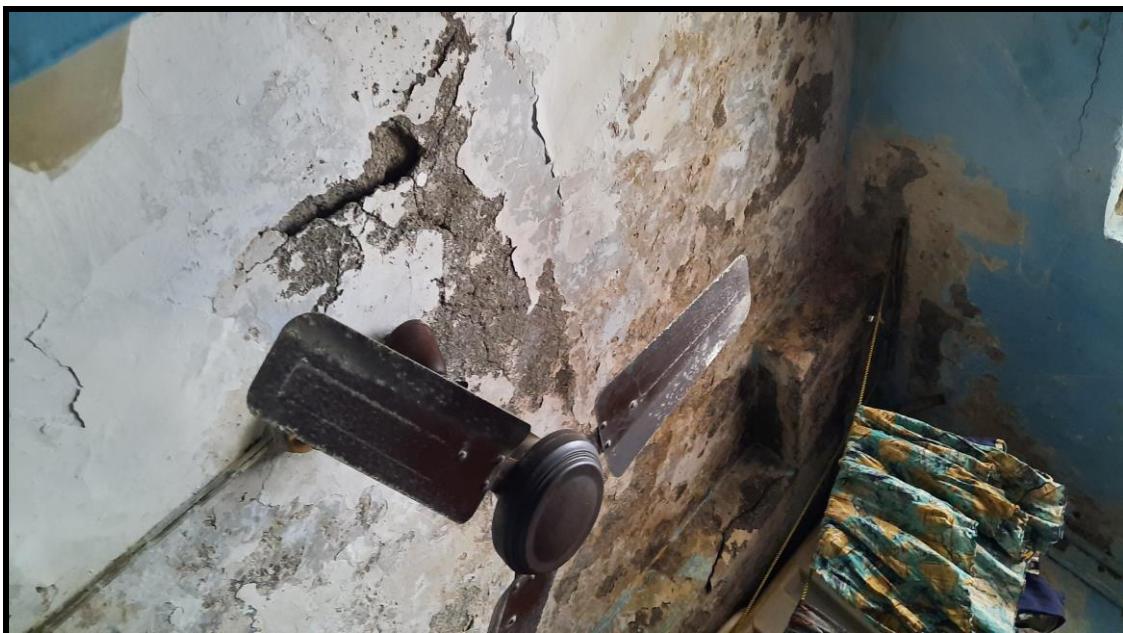
FLAT NO – 67

- ❖ **HALL** – Structural crack observed on beam & ceiling.
 - Leakage mark observed on wall & ceiling
- ❖ **KITCHEN** – Structural crack observed on beam & ceiling.
 - Leakage mark observed on ceiling
- ❖ **PASSAGE** – O.K.
- ❖ **TOILET & BATH ROOM** – O.K.

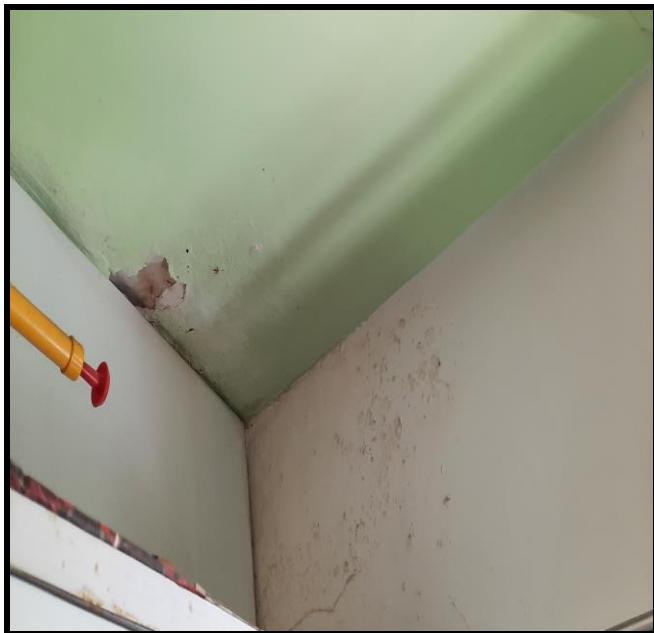
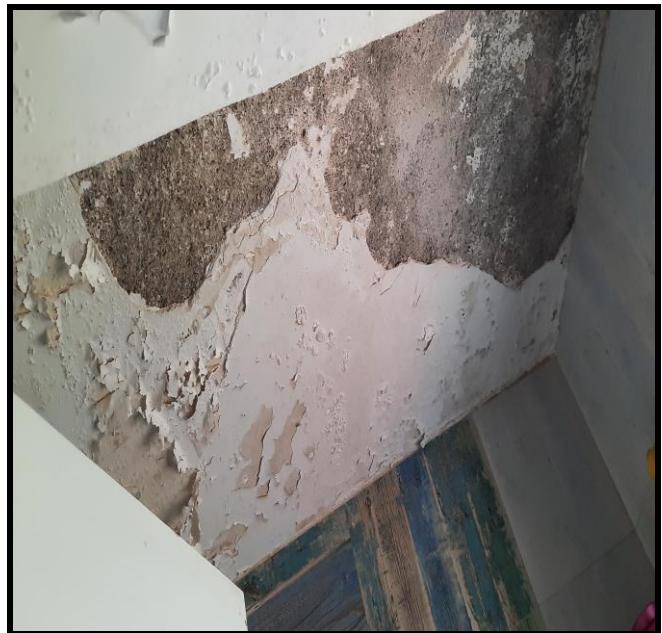
FLAT NO - 69

- ❖ **HALL** – O.K.
- ❖ **KITCHEN** – Leakage mark observed on wall & ceiling
- ❖ **PASSAGE** – O.K.
- ❖ **TOILET & BATH ROOM** – Leakage mark observed on ceiling

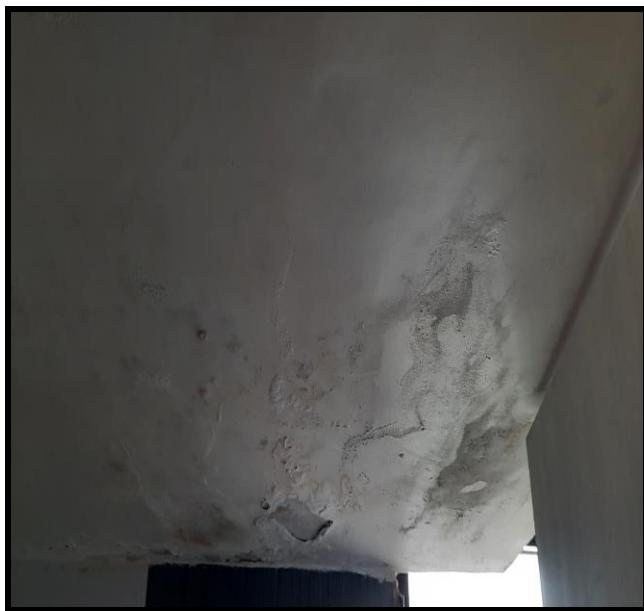
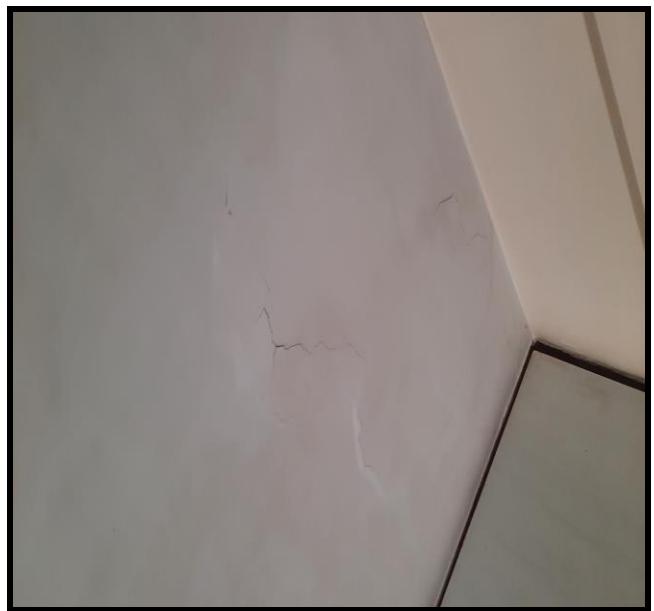
FLAT NO - 70

- ❖ **HALL** – Structural damage observed on ceiling.
- ❖ **KITCHEN** – O.K.
- ❖ **PASSAGE** – O.K.
- ❖ **TOILET & BATH ROOM** – Leakage mark observed on ceiling

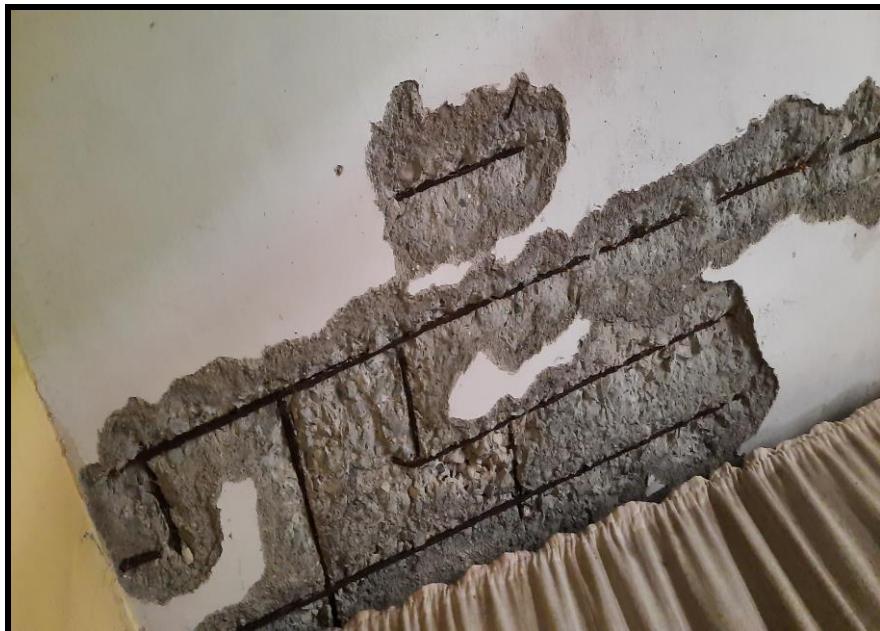
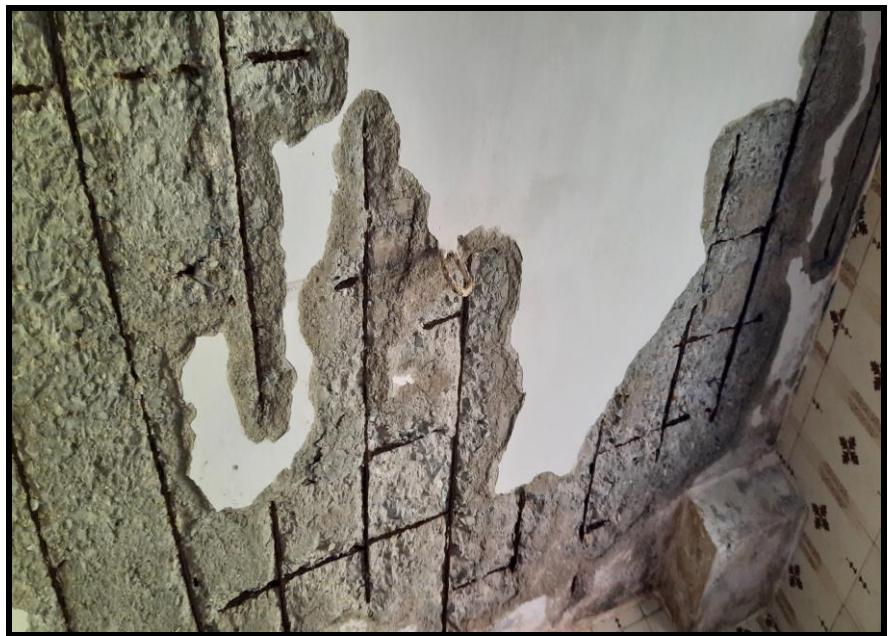
FLAT NO - 71

- ❖ **HALL** – Ceiling & beam plaster get damaged & steel get exposed & corroded.
- ❖ **KITCHEN** – Ceiling & beam plaster get damaged & steel get exposed & corroded.
- ❖ **PASSAGE** – O.K.
- ❖ **TOILET & BATH ROOM** – O.K.

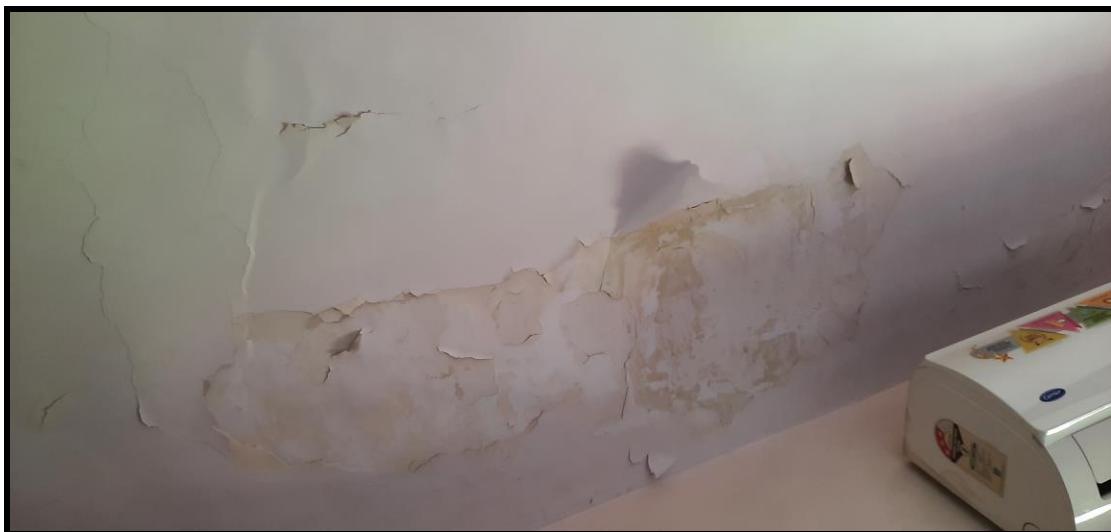
FLAT NO - 78

- ❖ **HALL** – Leakage observed on ceiling in monsoon.
- ❖ **KITCHEN** – O.K.
- ❖ **PASSAGE** – O.K.
- ❖ **TOILET & BATH ROOM** – O.K.

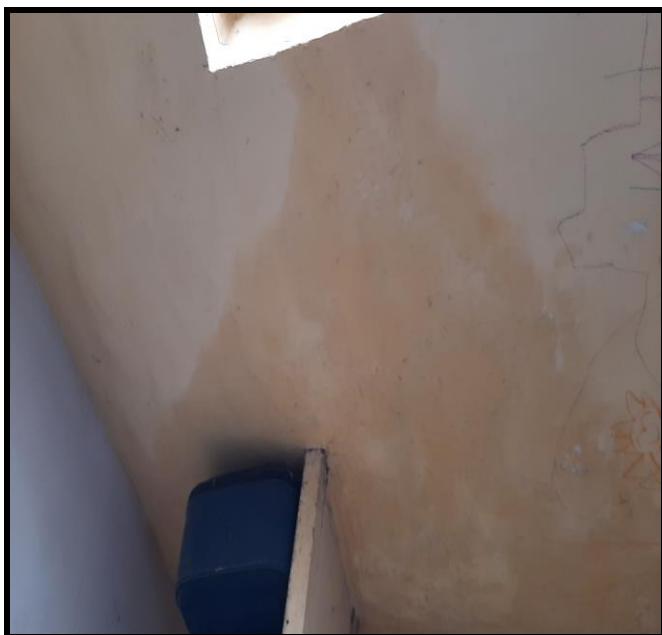
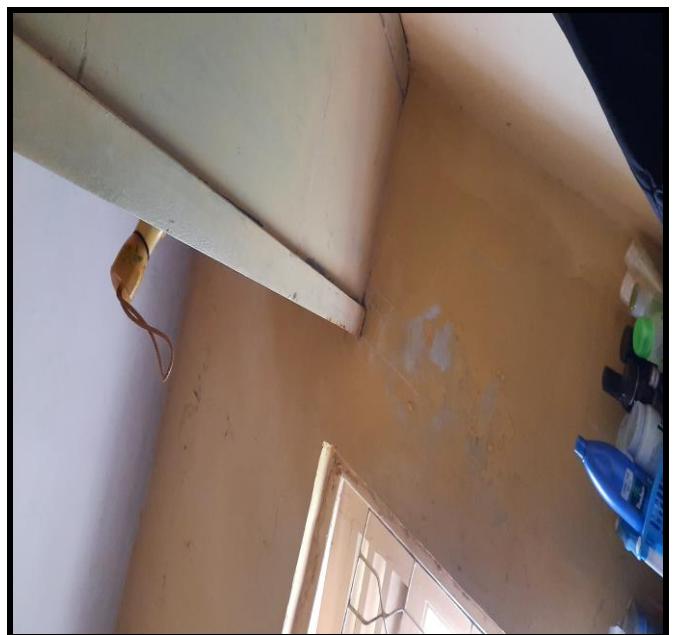
FLAT NO - 79

- ❖ **HALL** – Dampness observed on wall & ceiling.
- ❖ **KITCHEN** – O.K.
- ❖ **PASSAGE** – O.K.
- ❖ **TOILET & BATH ROOM** – O.K.

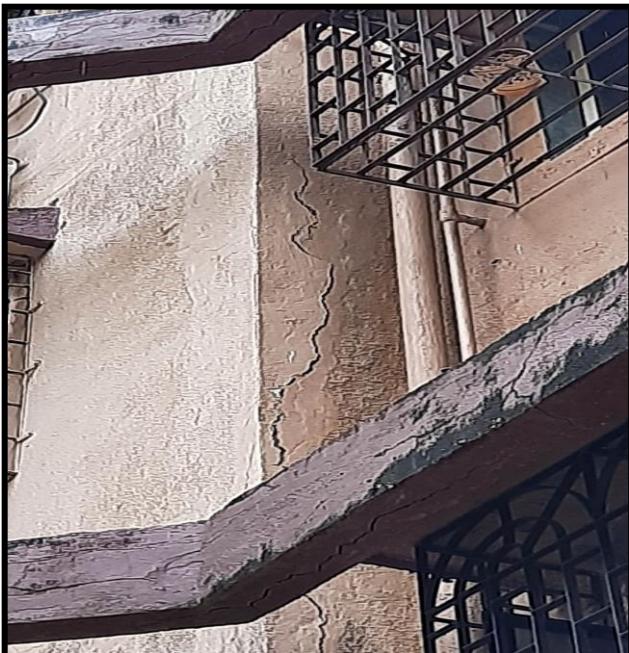
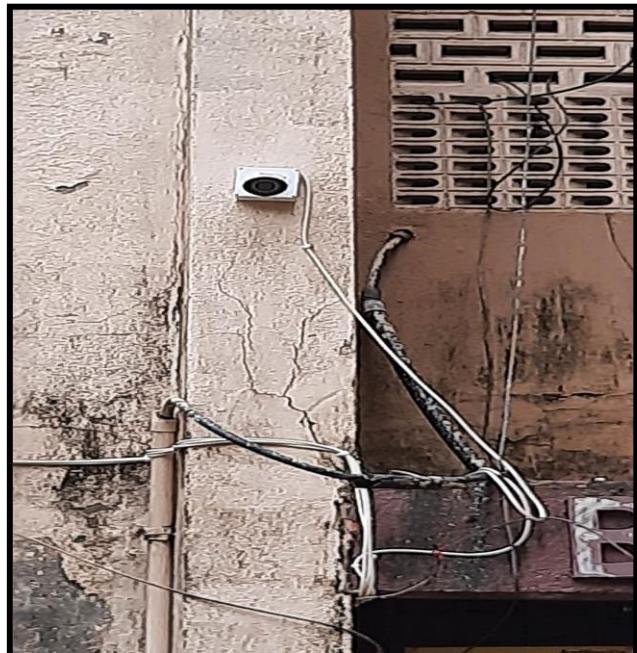
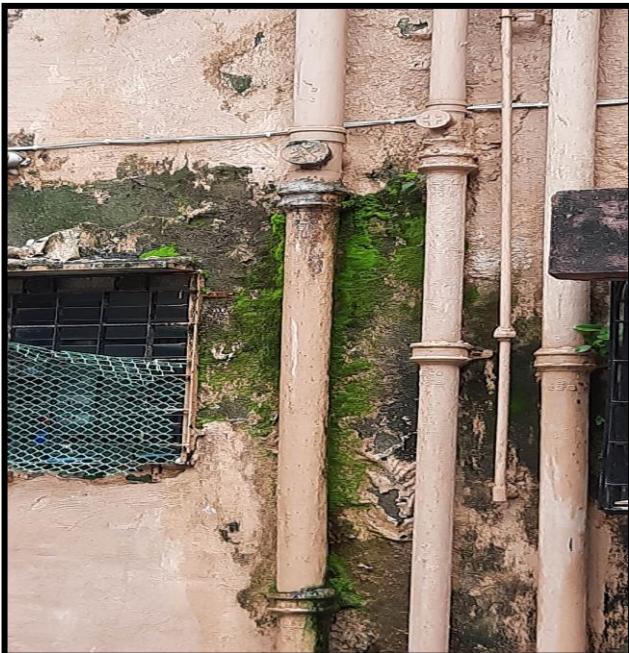
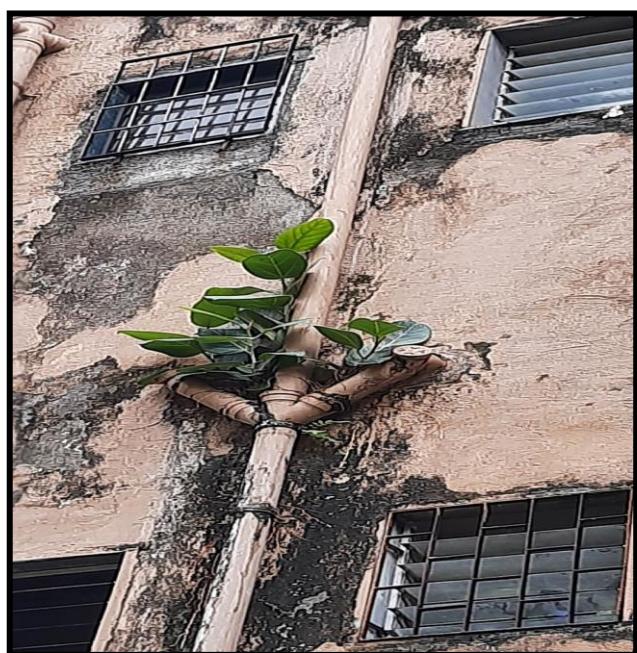
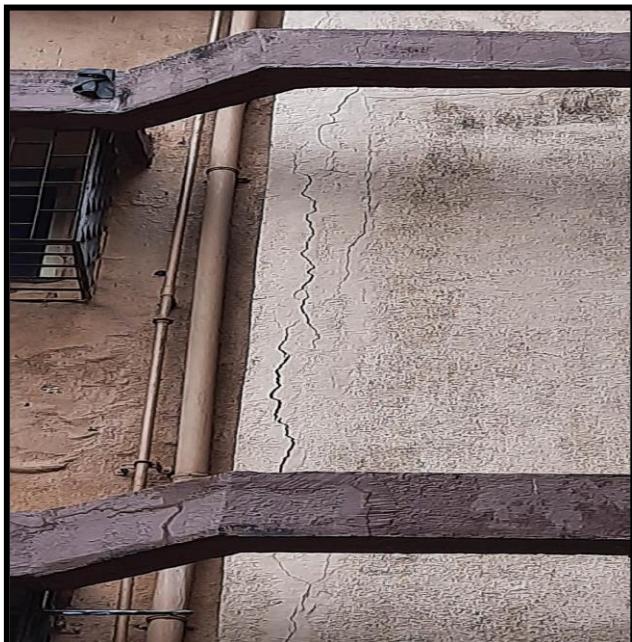
FRONT SIDE

- ❖ Structural crack observed at several places on column & chajjas.
- ❖ Major crack observed at several places on wall.
- ❖ Vegetation growth observed at several places on wall.
- ❖ Algae observed at several places on wall.

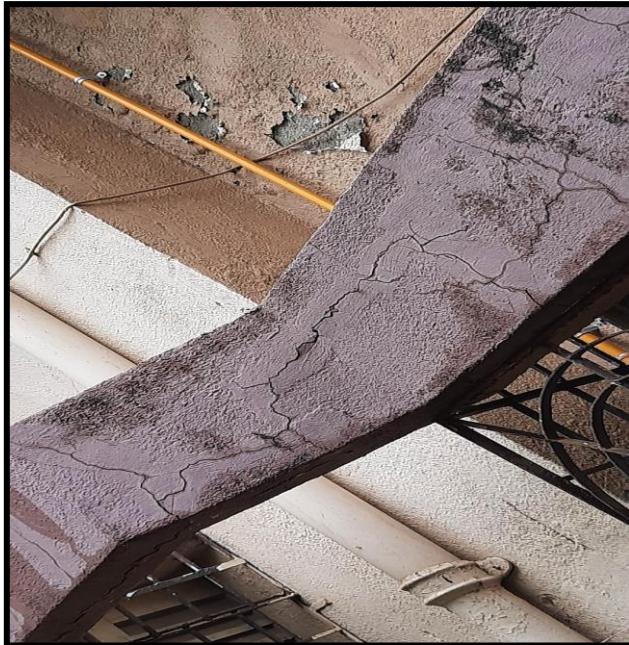
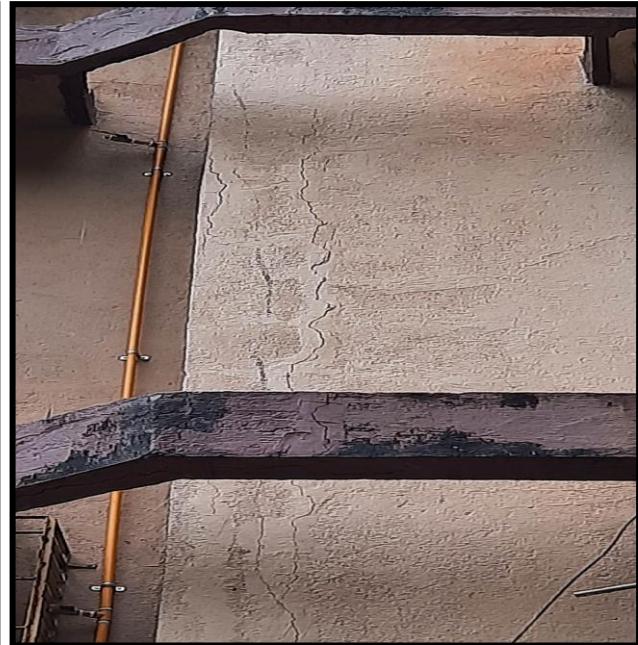
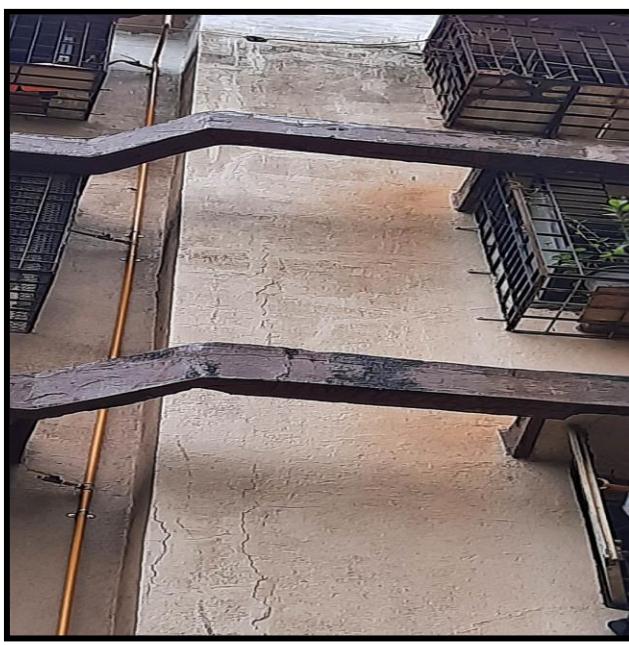
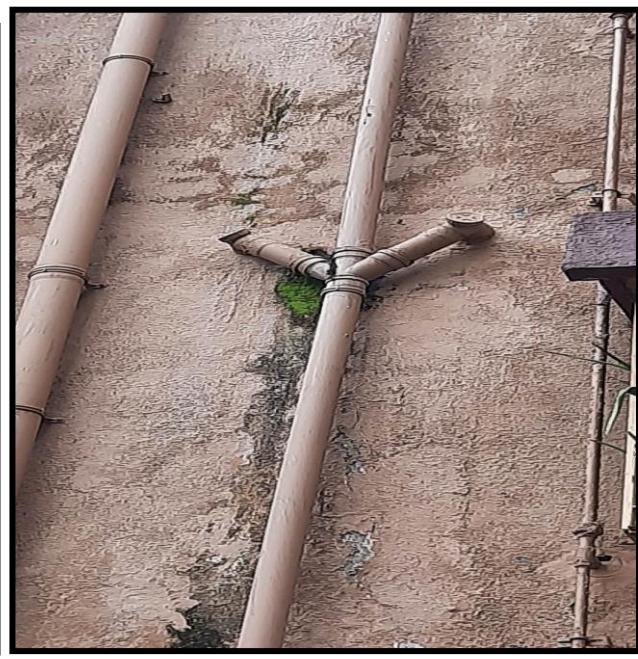
BACK SIDE

- ❖ Structural crack observed at several places on column & chajjas.
- ❖ Major crack observed at several places on wall.
- ❖ Vegetation growth observed at several places on wall.

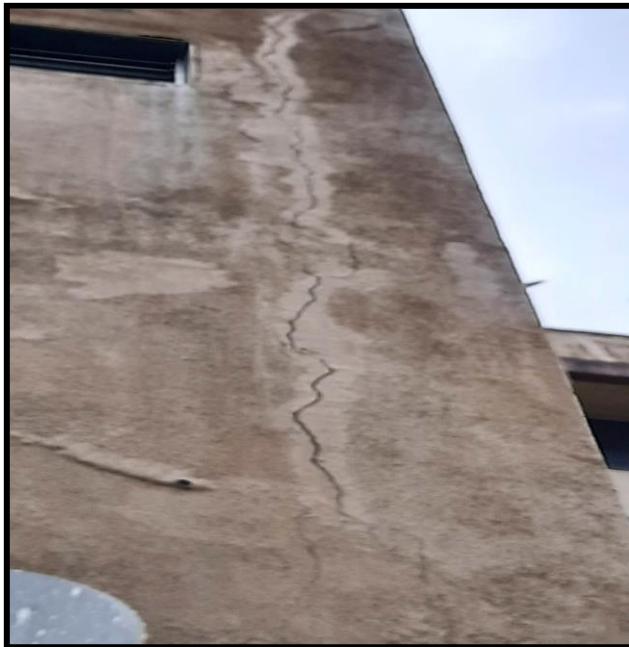
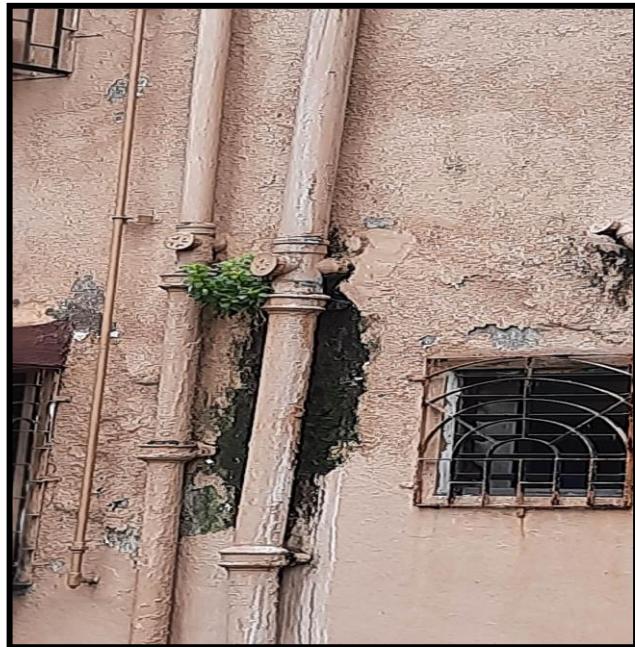
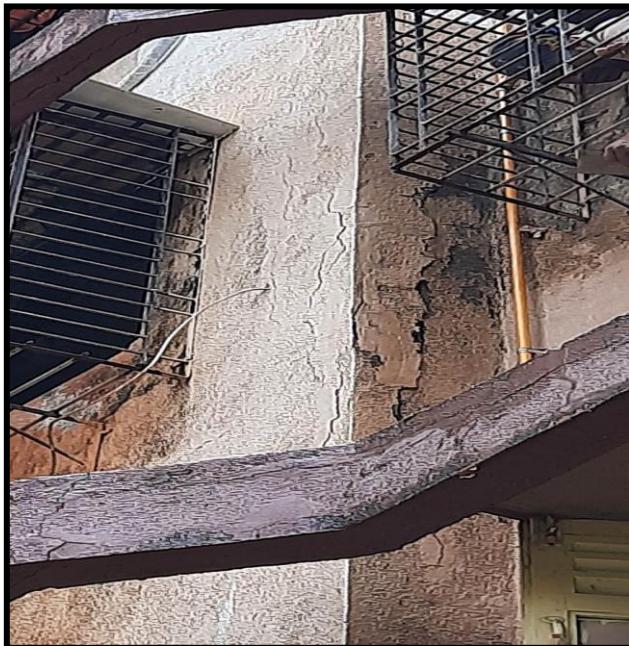
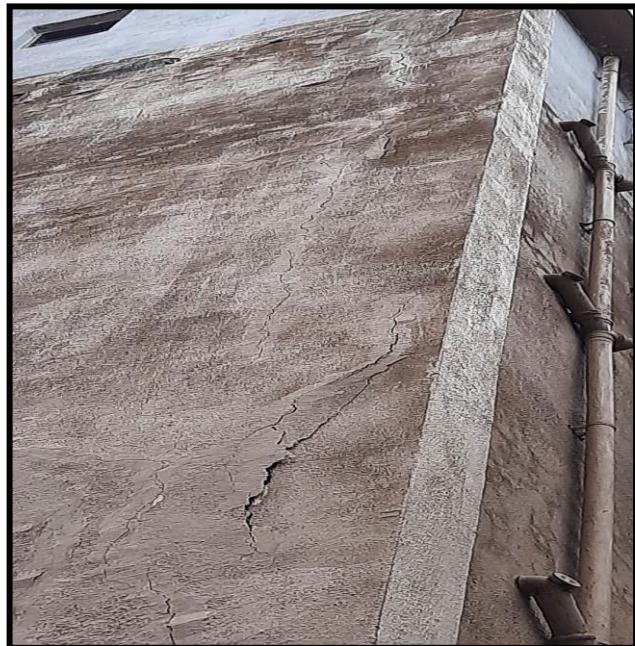
NORTH SIDE

- ❖ Structural crack observed at several places on column & chajjas.
- ❖ Major crack observed at several places on wall.
- ❖ Vegetation growth observed at several places on wall.

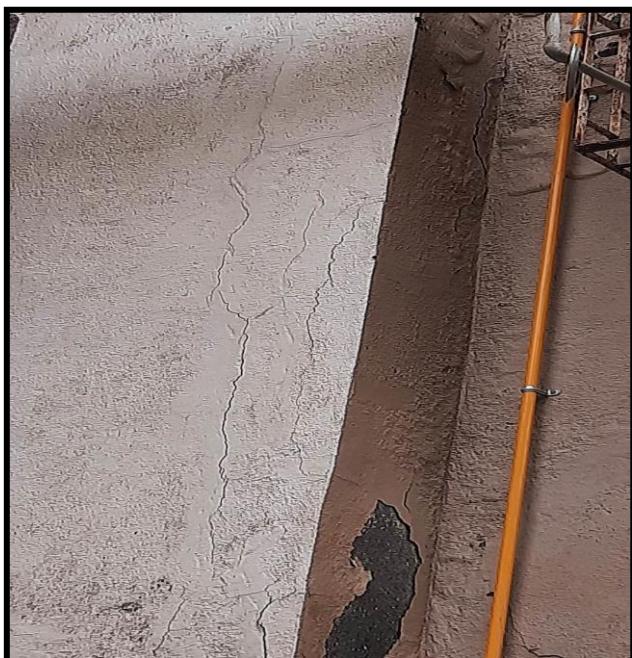
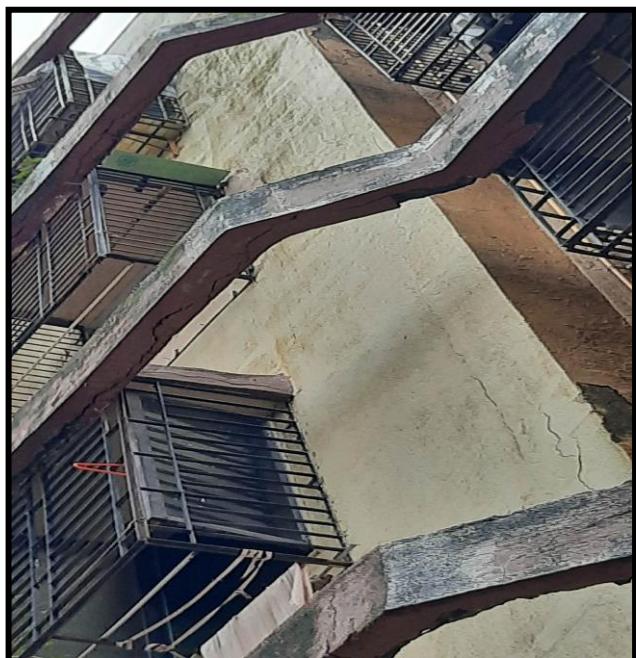
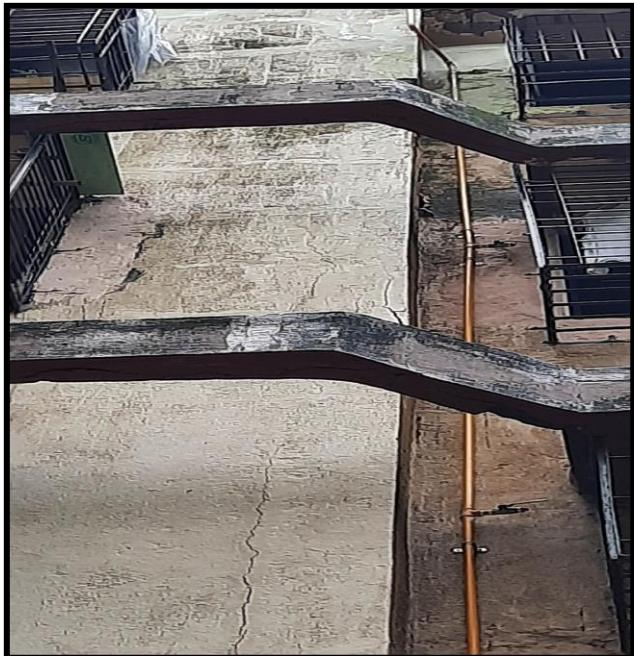
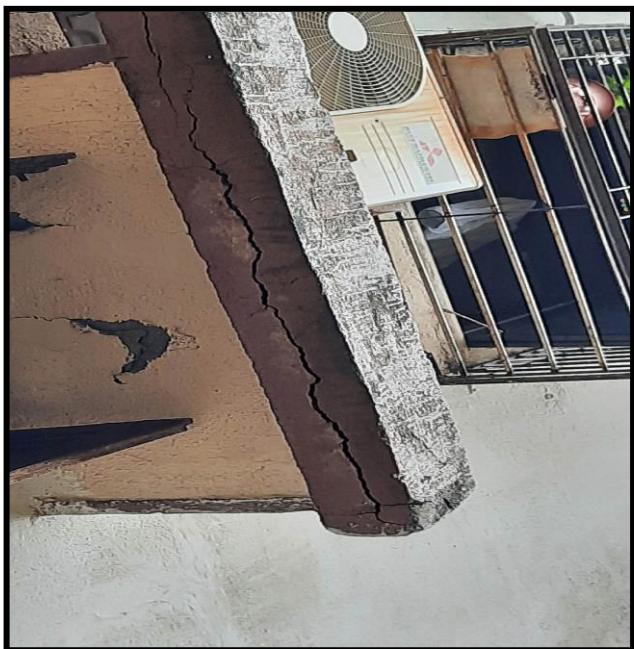
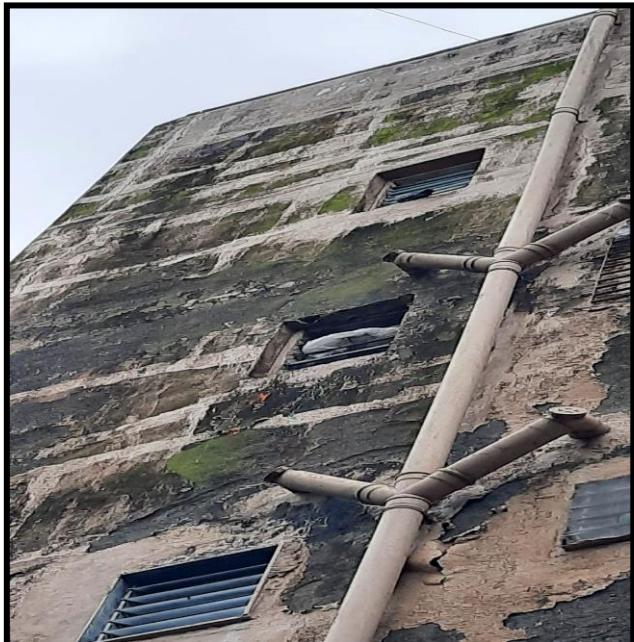
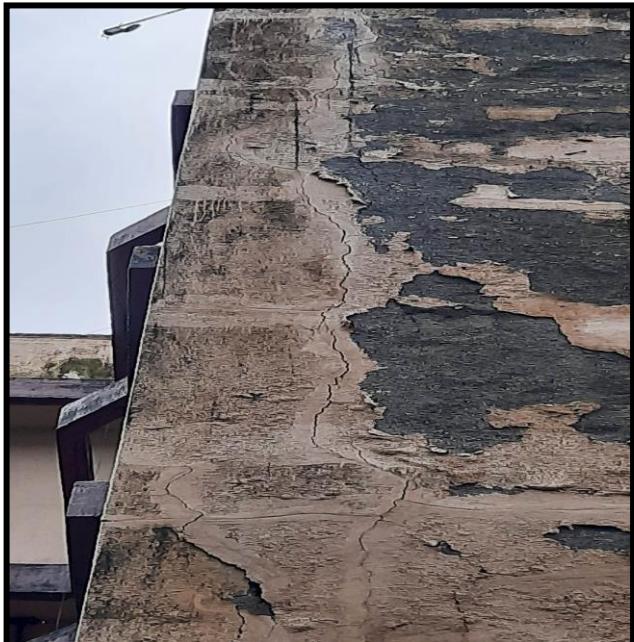
SOUTH SIDE

- ❖ Structural crack observed at several places on column & chajjas.
- ❖ Major crack observed at several places on wall.
- ❖ Algae observed at several places on wall.
