STRUCTURAL AUDIT REPORT
FOR
“VISHAL SAHYADRI CO – OP HSG. SOC. LTD”,
“B6 – WING”
SITUATED AT
SAHYADRI NAGAR, CHARKOP,
KANDIVALI (W) MUMBAI – 400 067

PREPARED BY
LATESH S. SANKLECHA
CONSULTING STRUCTURAL ENGINEERS

978/B6/LSS/2021

JULY 19, 2021

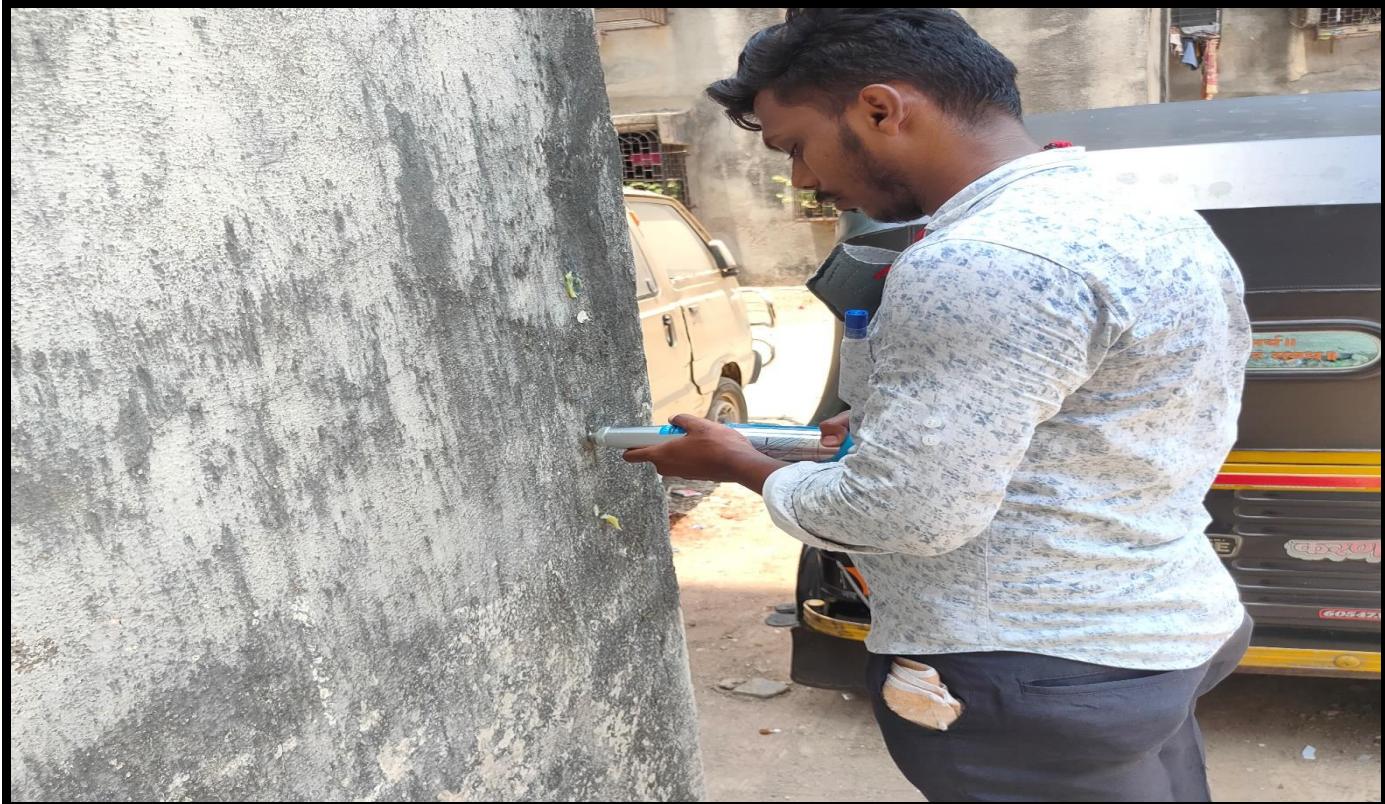
NON -DESTRUCTIVE TEST PHOTO

Rebound Hammer was tested for compressive strength at surface by Schmidt rebound hammer. Results indicate the compressive strength at surface of all the RCC columns is ranging between 13.70 MPa to 21.80 MPa.

Out of 4 locations 2 locations was below 3.0 Km/Sec means concrete quality is poor and 2 locations ranging between 3.0 to 3.75 Km/Sec means concrete quality is doubtful.

This indicates there are progressive internal cracks in the RCC members due to corrosion of reinforced steel. These members are under distress condition.

Half Cell Potential tested for corrosion activity by half – cell potential tests. Values are taken on Column. The result on tested column is – 320 mV.

Carbonation test was conducted to assess carbonation depth. Readings are taken on Column. Result indicates the carbonation penetration depth is 40.00 mm. Carbonation depths have reached to the reinforcement level in all of the RCC elements. It is essential to give a suitable anti-corrosion treatment to all the RCC members to stop further carbonation and corrosion of concrete.

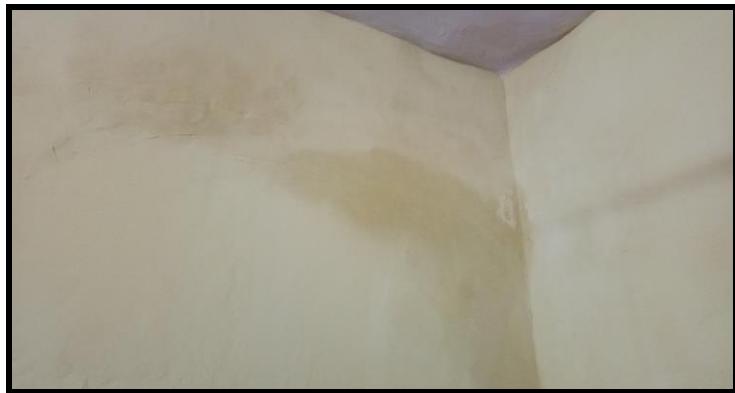
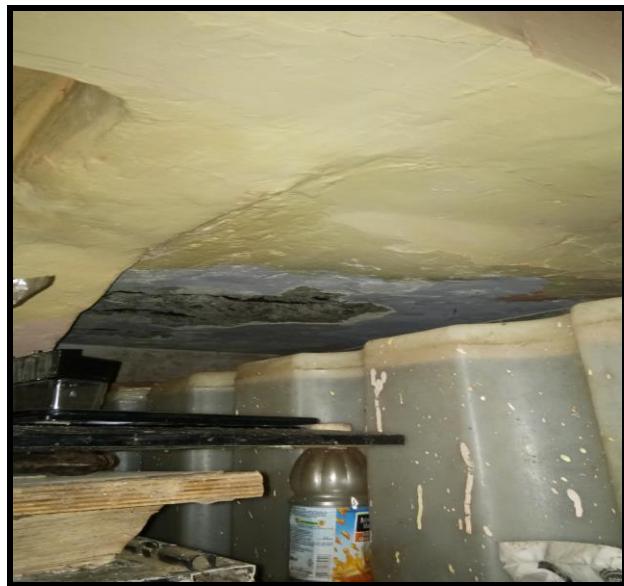
FLAT NO – 01

- ❖ **HALL** – Leakage mark observed on wall.
 - Leakage mark observed on ceiling.
 - Hallow sound observed on wall.
- ❖ **KITCHEN** – Seepage mark observed on ceiling.
- ❖ **PASSAGE** – Plaster gets removed and steel gets exposed. (It may fall)
- ❖ **TOILET & BATH ROOM** – Dampness observed on wall.
 - Peeling of paint observed on ceiling.

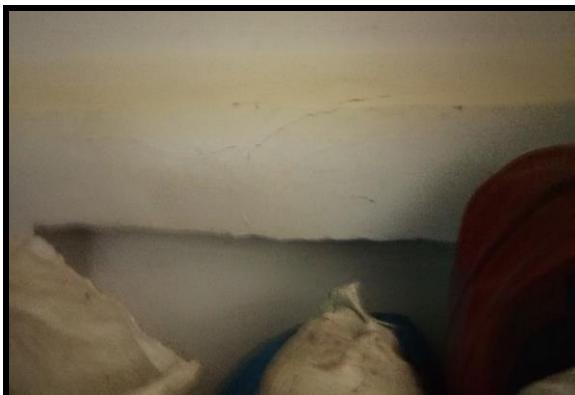
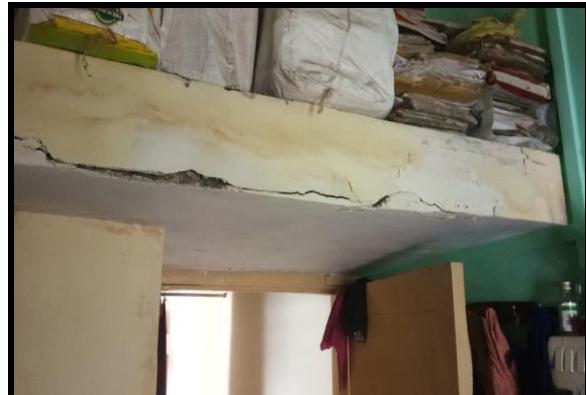
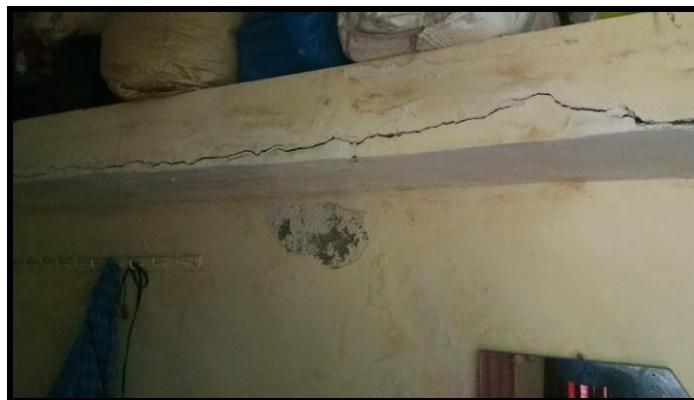
FLAT NO – 04

- ❖ **HALL** – Structural crack observed on wall.
 - Peeling of paint observed on wall.
- ❖ **KITCHEN** – Crack observed on chajjas.
- ❖ **PASSAGE** – Patch work observed on wall.
- ❖ **TOILET & BATH ROOM** – Dampness observed on wall.

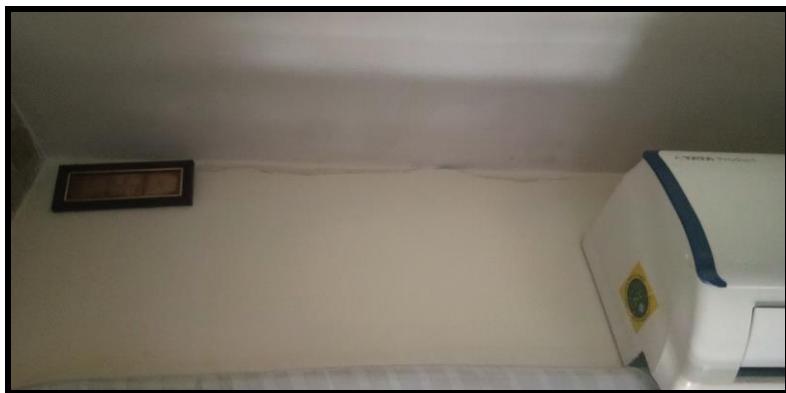
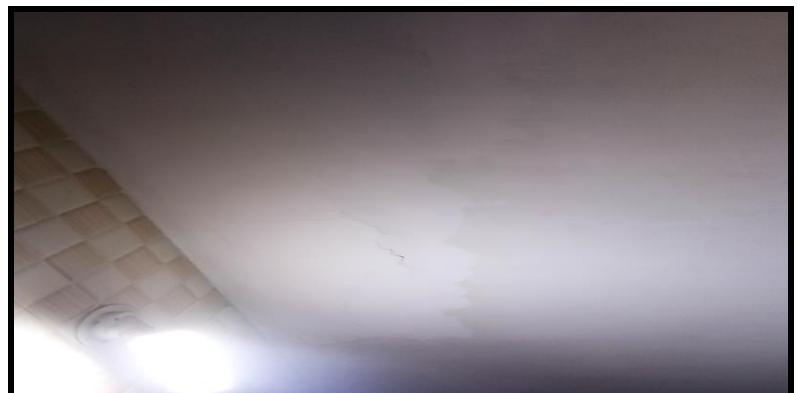
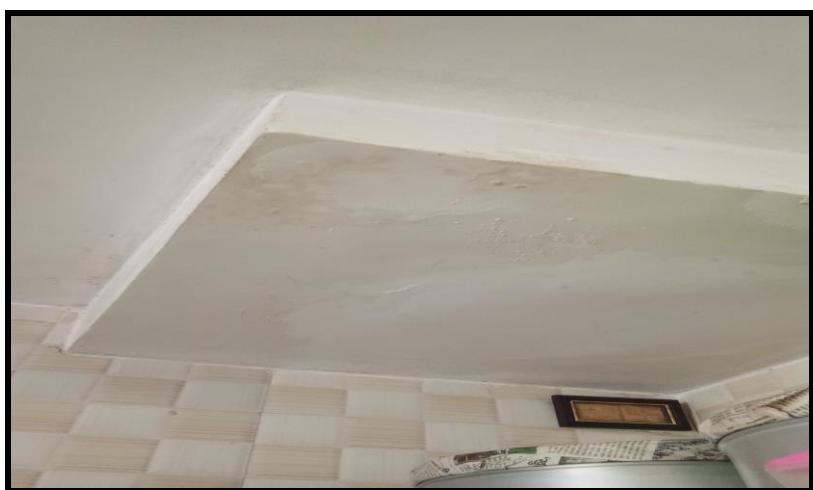
FLAT NO – 10

- ❖ **HALL** – Patch work observed on wall.
 - Peeling of paint observed on wall.
 - Hallow sound observed on wall after tapping.
- ❖ **KITCHEN** – Patch work observed on ceiling.
 - Ceiling gets damages.
- ❖ **PASSAGE** – Dampness observed on wall.
- ❖ **TOILET & BATH ROOM** – Seepage mark observed on ceiling.

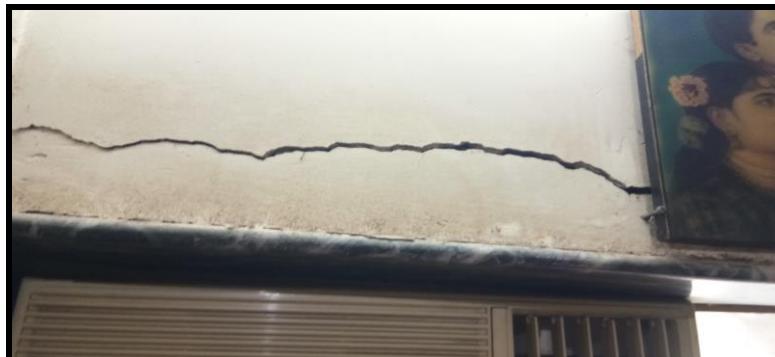
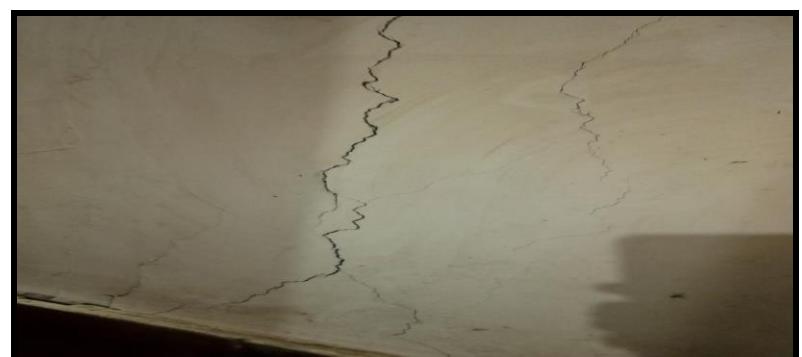
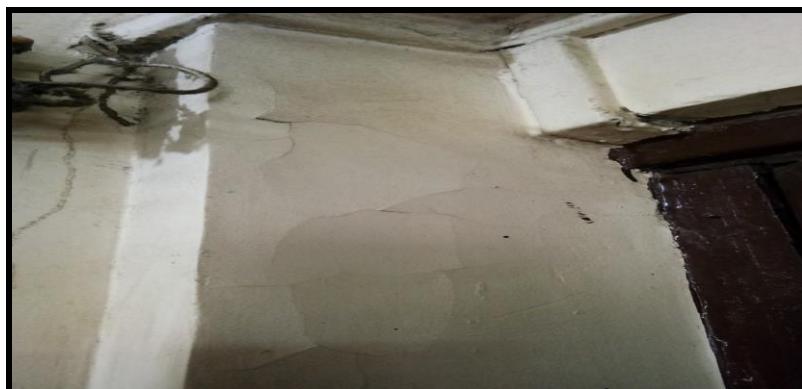
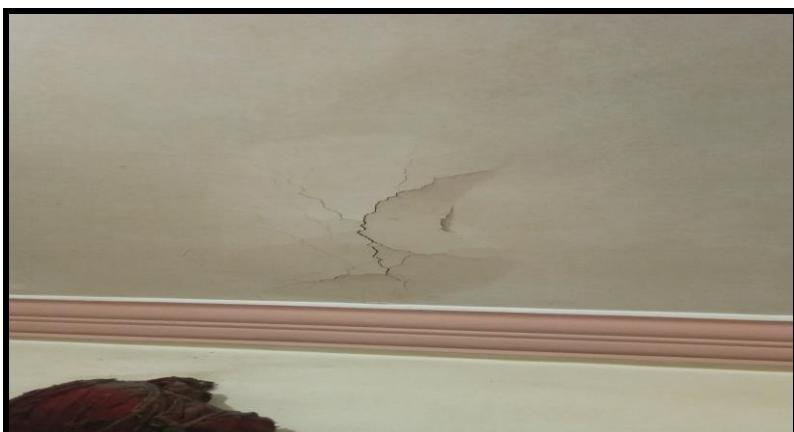
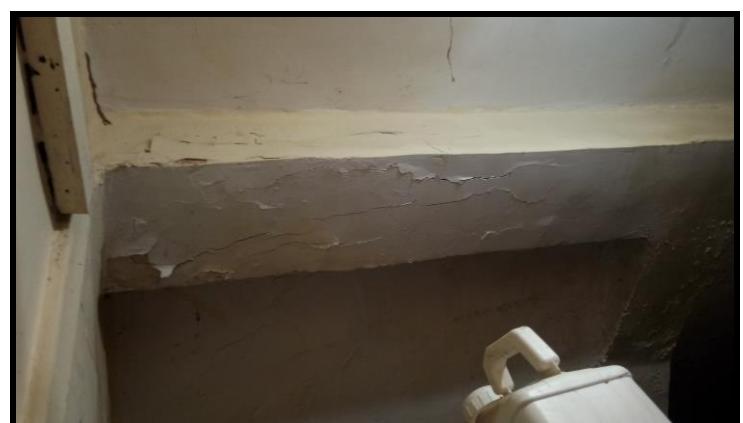
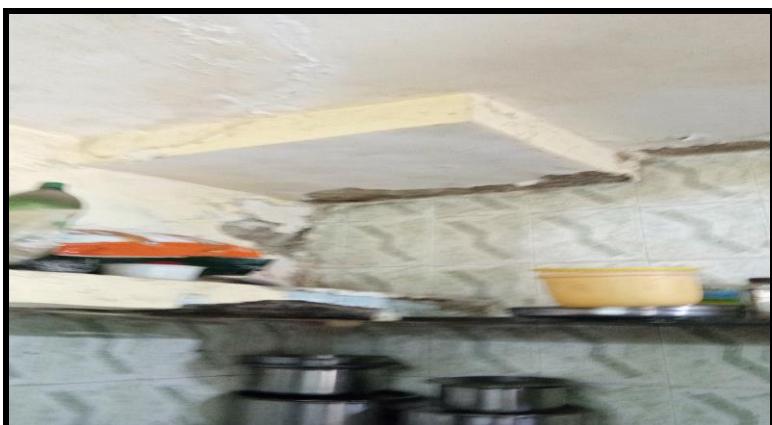
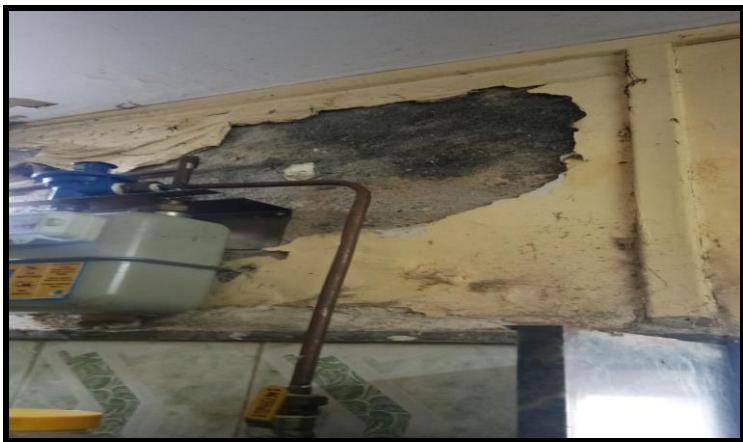
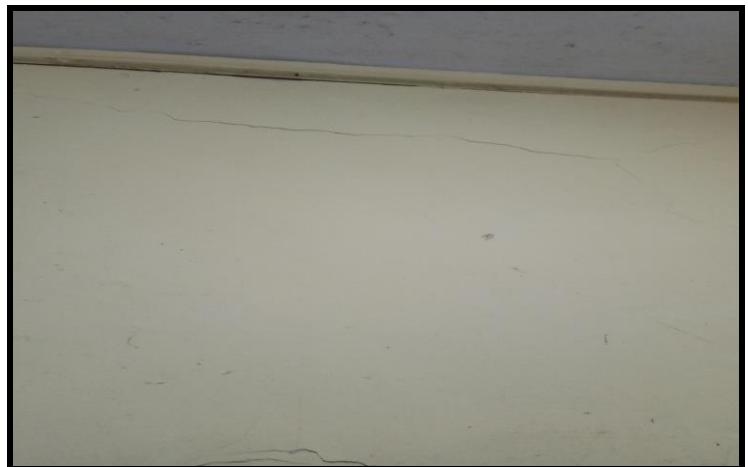
FLAT NO – 11

❖ **HALL** – Structural crack observed on wall.

- Hallow sound observed on wall after tapping. (**It may fall**)
- Ceiling gets damages.
- Hallow sound observed on beam after tapping. (**It may fall**)

❖ **KITCHEN** – Hallow sound observed on wall after tapping. (**It may fall**)

- Ceiling gets damages.
- Hallow sound observed on beam after tapping. (**It may fall**)
- Peeling of paint observed on wall.

❖ **PASSAGE** – Structural crack observed on ceiling.

- Hallow sound observed on beam after tapping. (**It may fall**)

❖ **TOILET & BATH ROOM** – Seepage mark observed on ceiling.

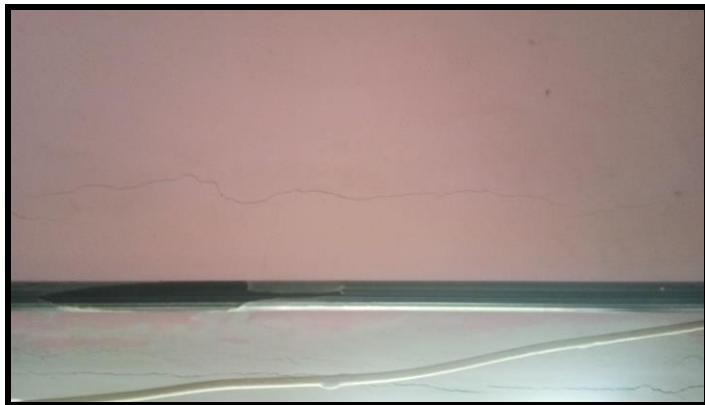
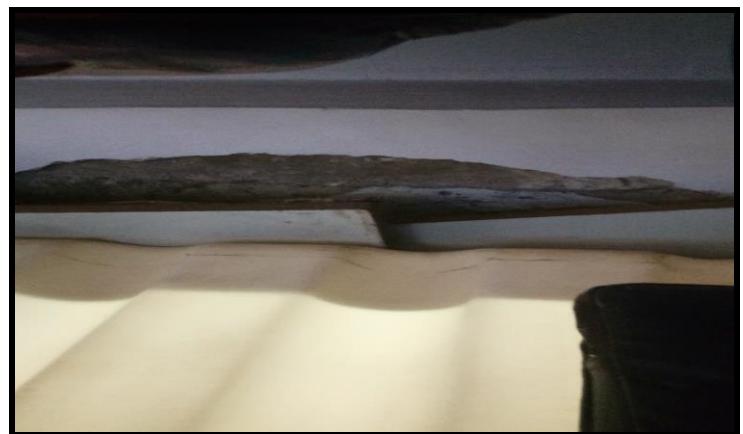
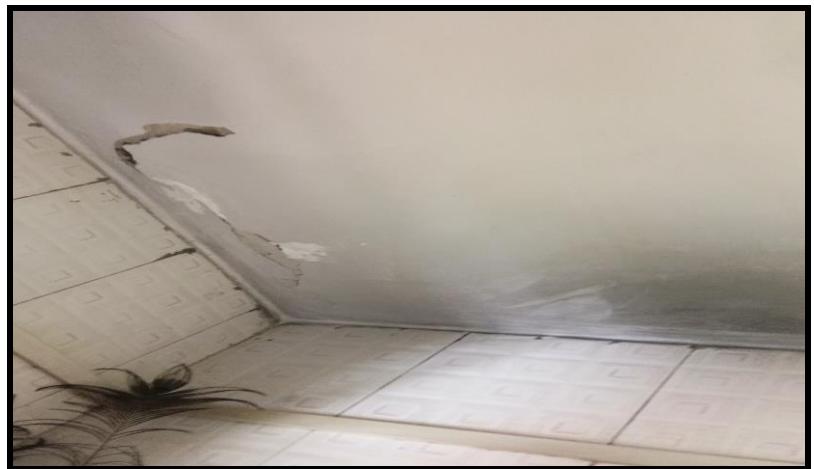
FLAT NO – 23

- ❖ **HALL** – Hallow sound observed on wall after tapping. (**It may fall**)
 - Ceiling gets damages.
- ❖ **KITCHEN** – Ceiling gets damages.
- ❖ **PASSAGE** – O.K.
- ❖ **TOILET & BATH ROOM** – O.K.

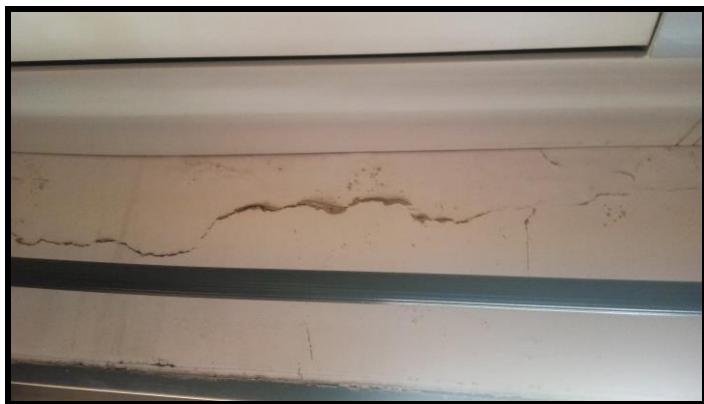
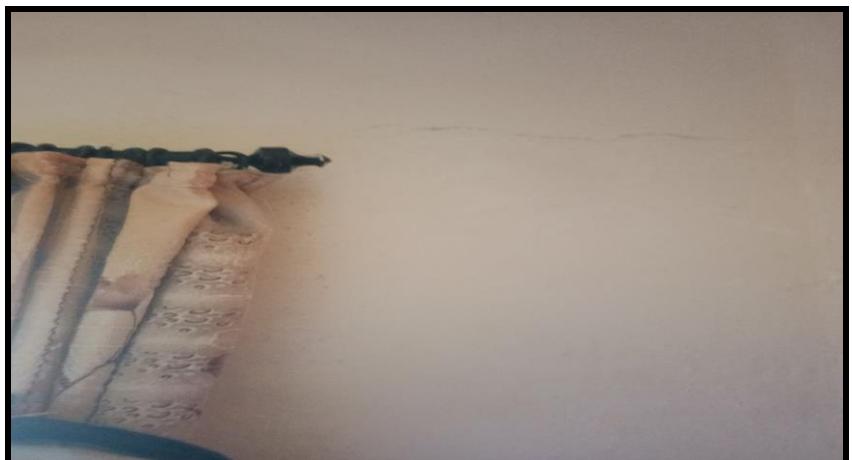
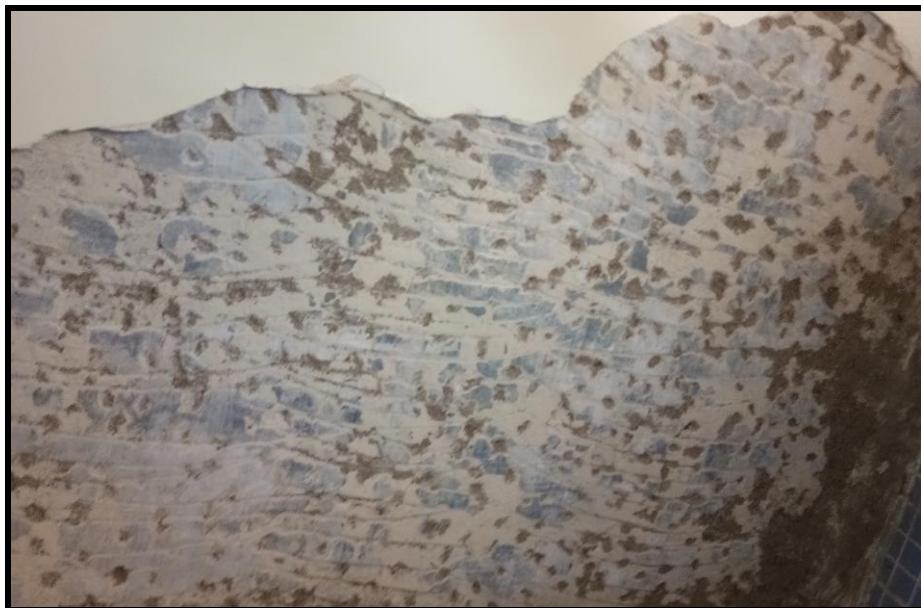
FLAT NO – 29

- ❖ **HALL** – Hallow sound observed on beam after tapping.
 - Ceiling gets damages.
 - Peeling of paint observed on wall.
 - Dampness observed on wall.
- ❖ **KITCHEN** – Ceiling gets damages
- ❖ **PASSAGE** – Dampness observed on wall.
- ❖ **TOILET & BATH ROOM** – Dampness observed on wall.
 - Peeling of paint observed on ceiling.

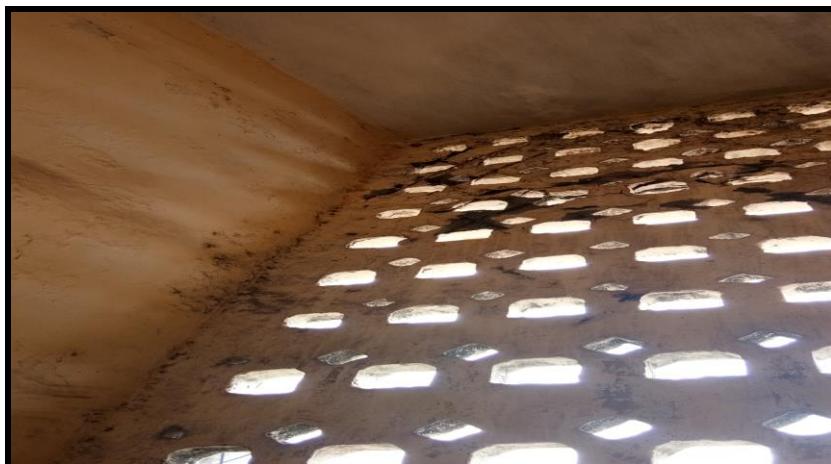
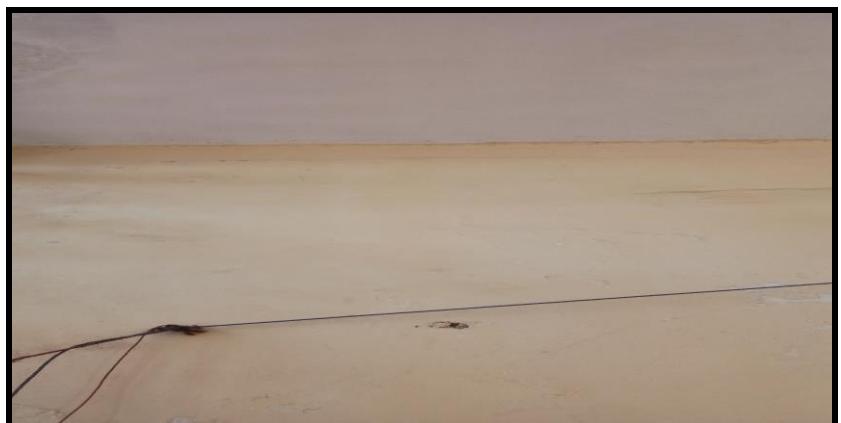
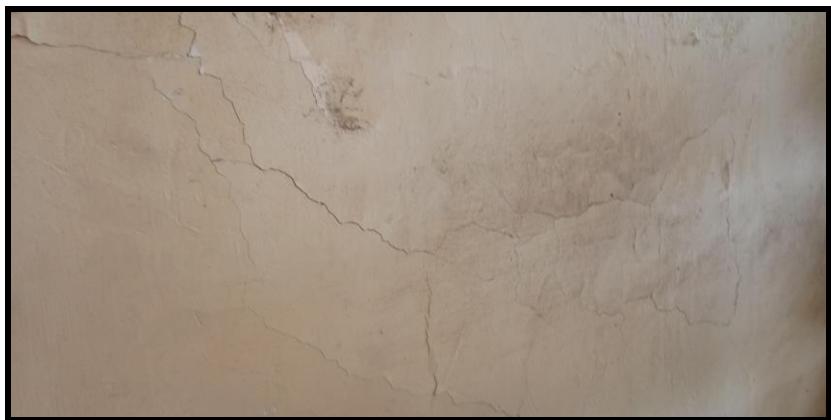
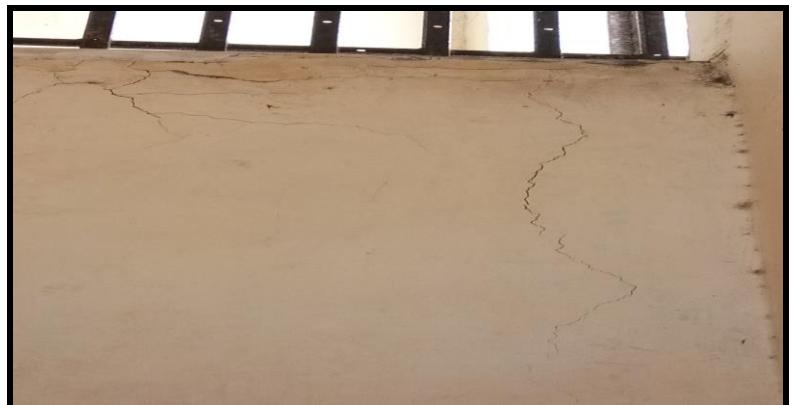
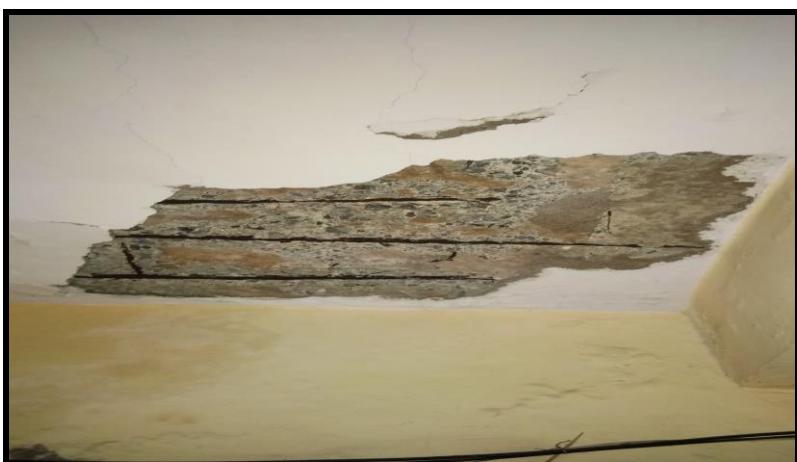
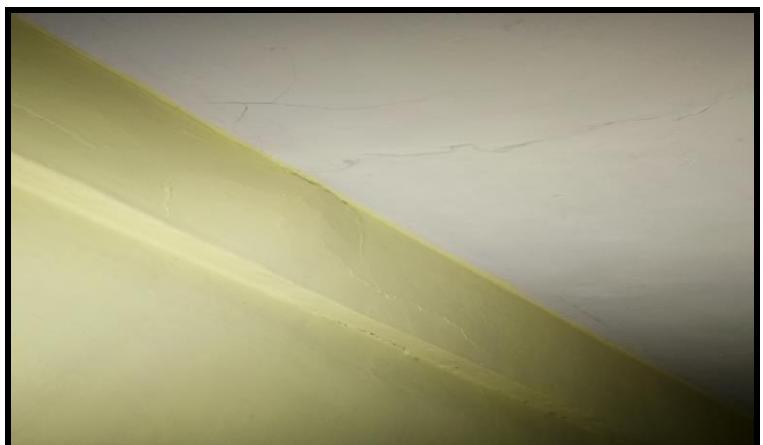
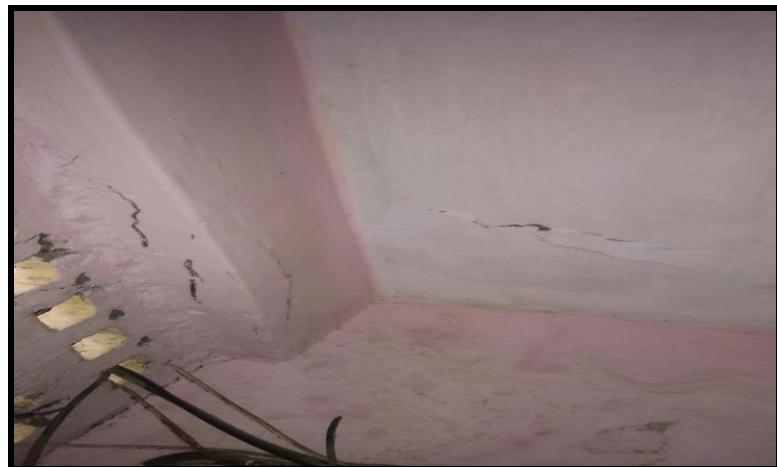
Terrace to fourth floor:-

- ❖ Structural crack observed on wall.
- ❖ Structural crack observed on beam.
- ❖ Hallow sound observed on wall.
- ❖ Hallow sound observed on beam.
- ❖ Plaster gets removed and steel gets exposed. (**It may fall**)

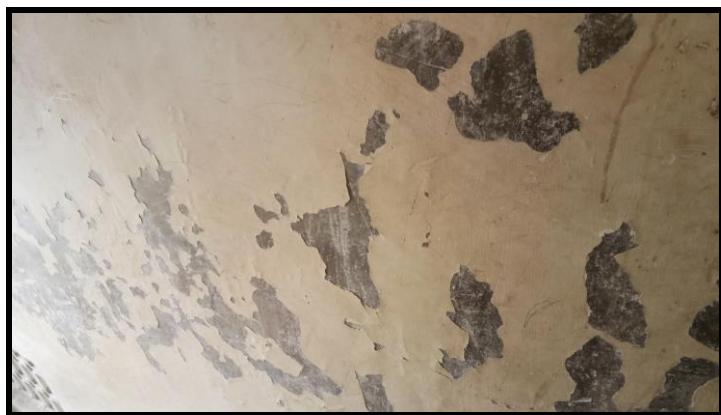
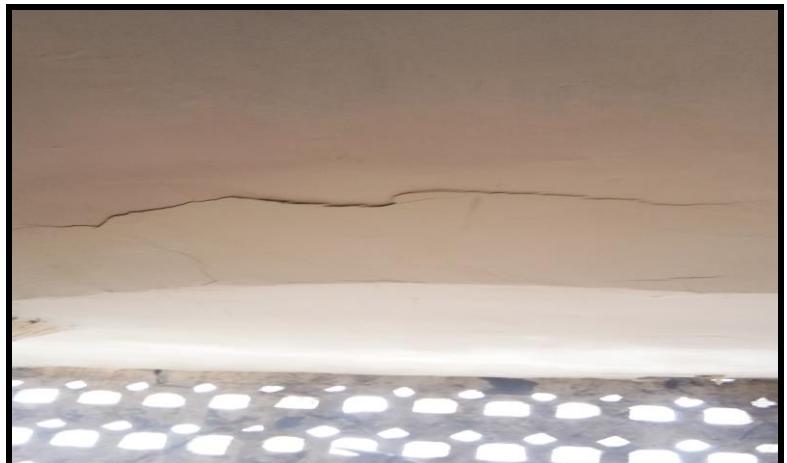
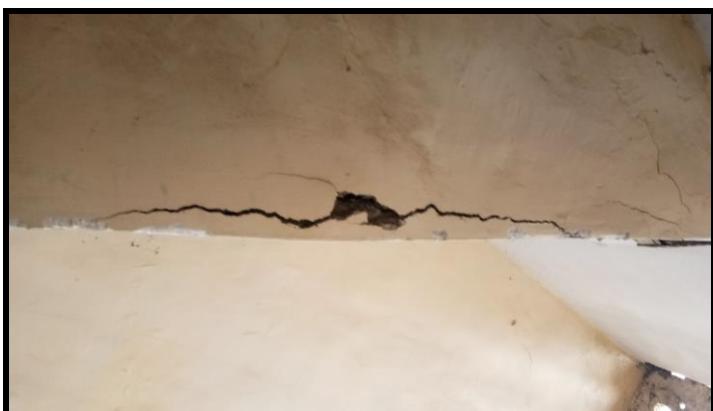
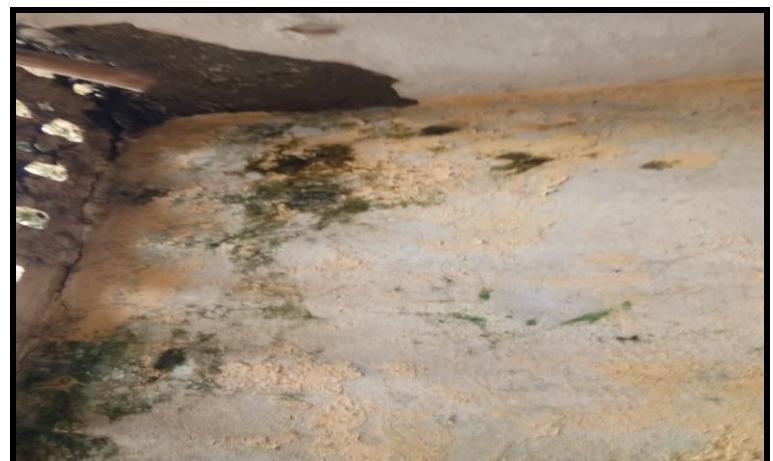
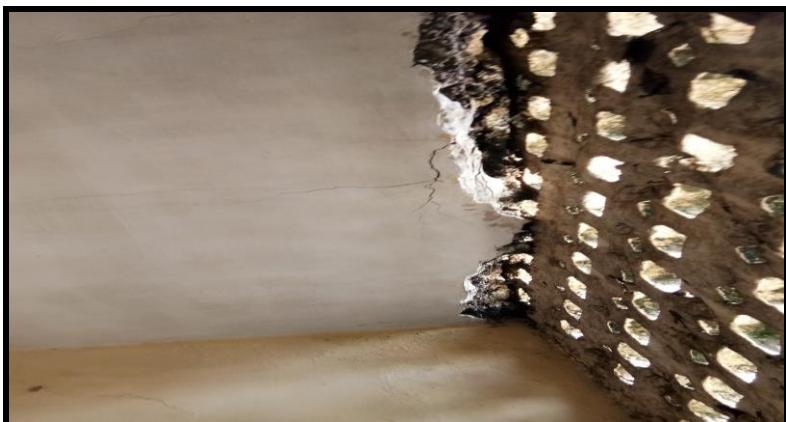
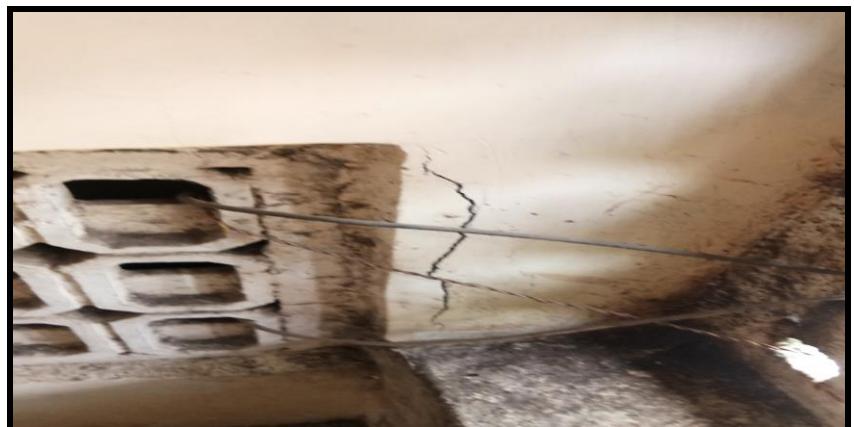
Fourth floor to third floor:-

- ❖ Peeling of paint observed on wall.
- ❖ Algae formation observed on ceiling.
- ❖ Major structural crack observed on wall.
- ❖ Hallow sound observed on wall.

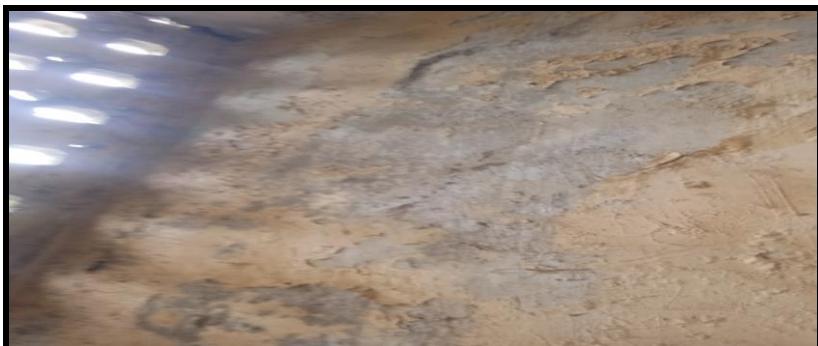
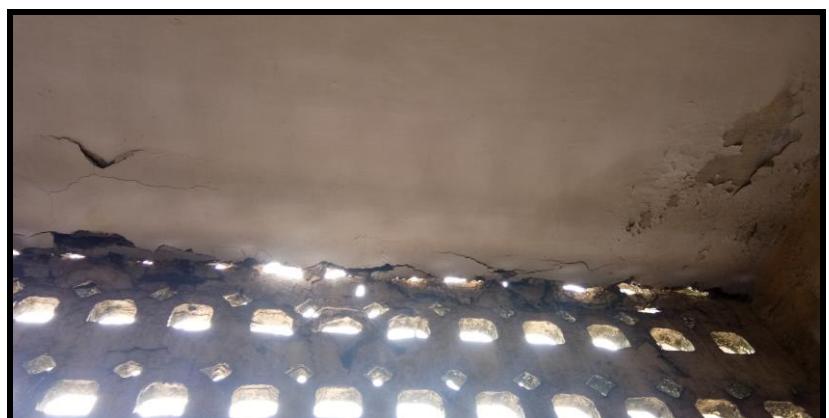
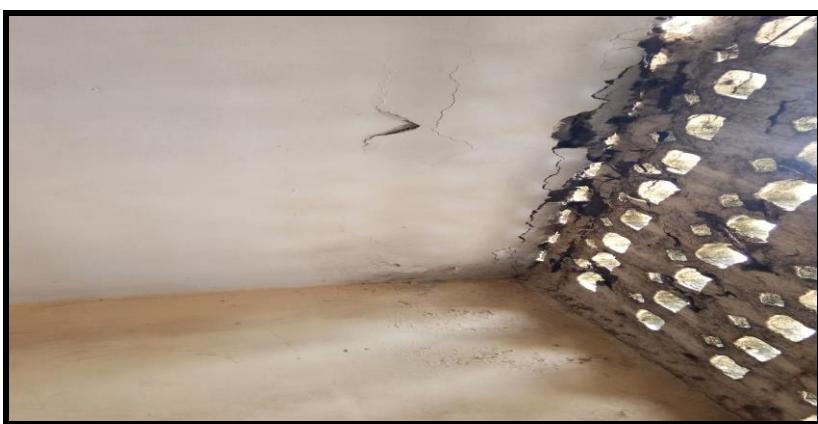
Third floor to Second floor:-

- ❖ Peeling of paint observed on wall.
- ❖ Hallow sound observed on ceiling.
- ❖ Ceiling gets damage.

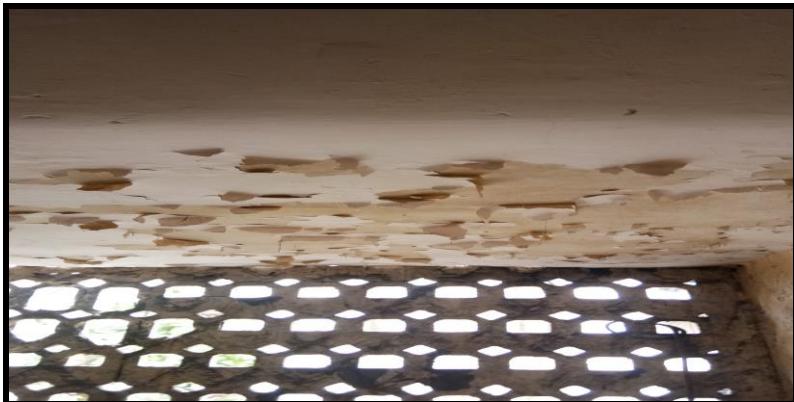
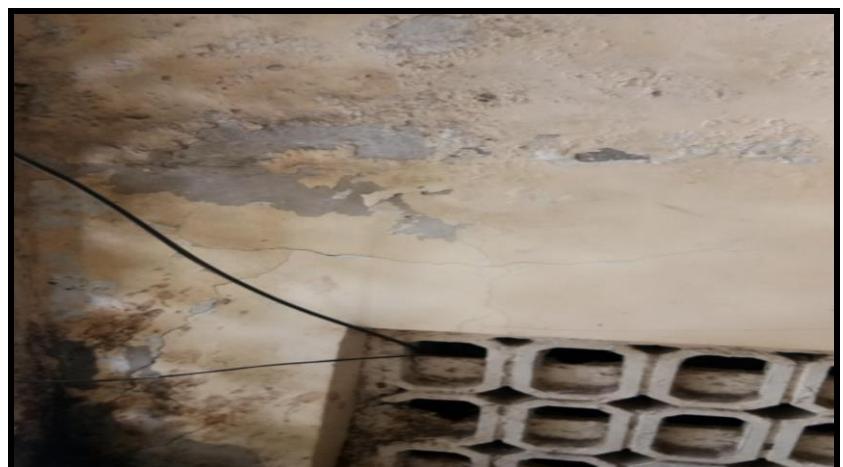
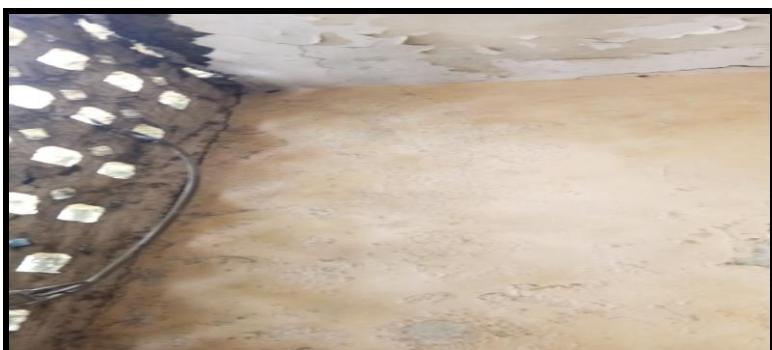
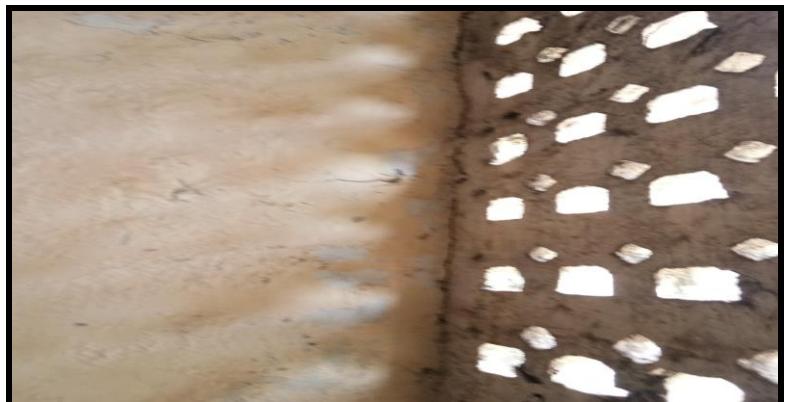
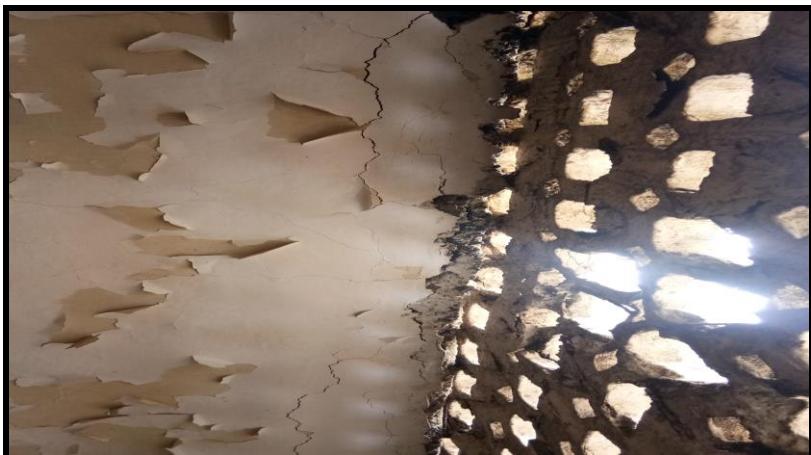
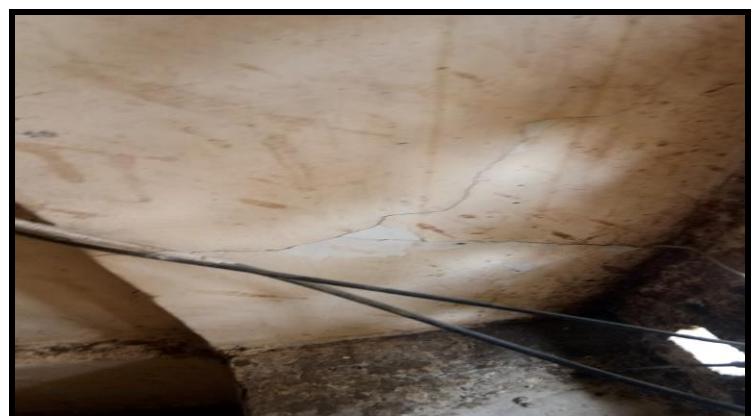
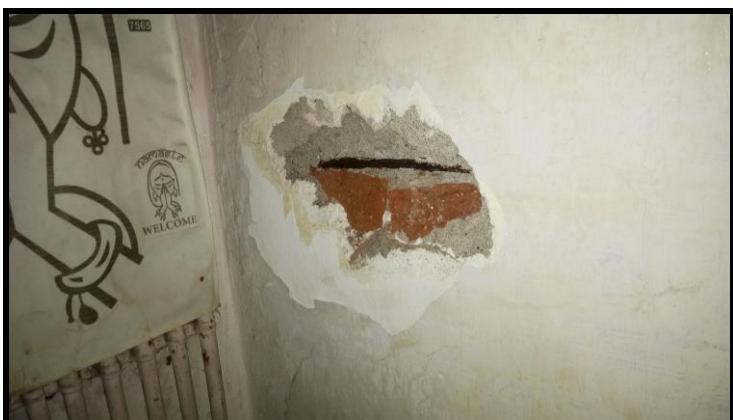
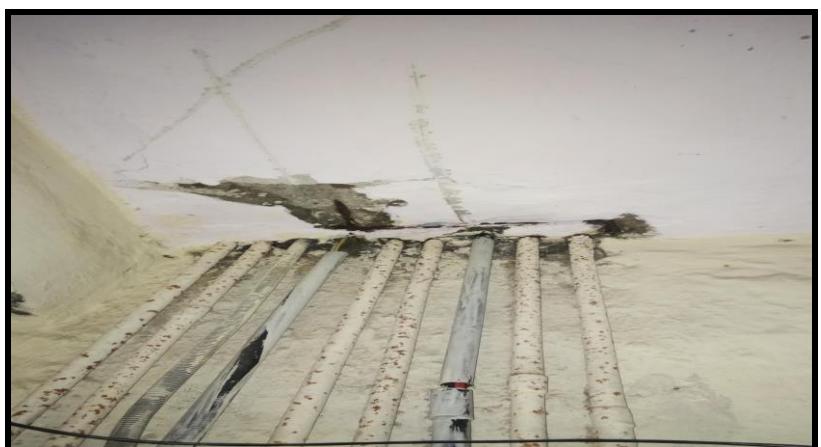
Second floor to First floor:-

- ❖ Peeling of paint observed on wall.
- ❖ Hallow sound observed on ceiling.
- ❖ Ceiling gets damage.
- ❖ Algae formation observed on ceiling.

- ❖ Major structural crack observed on wall.

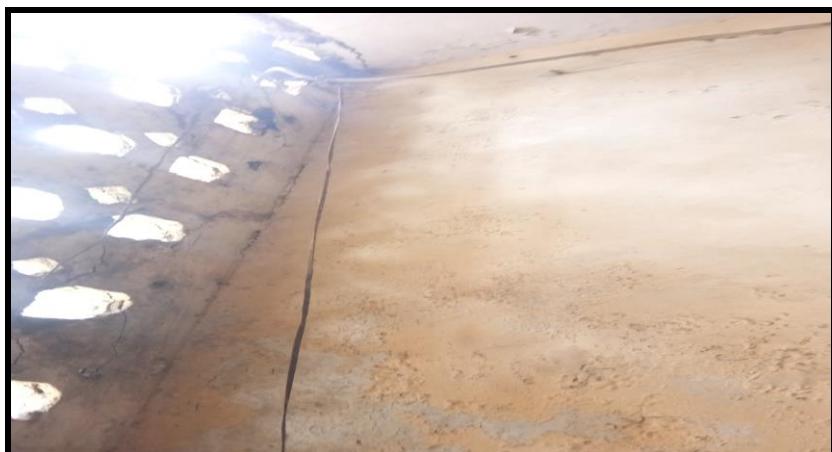
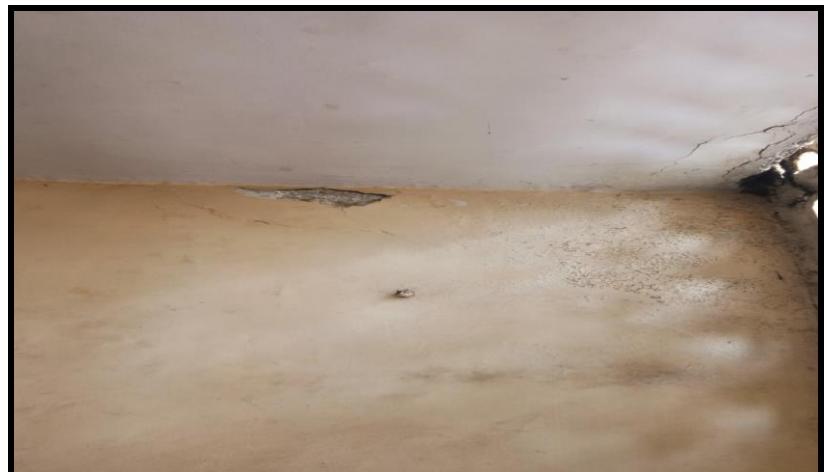
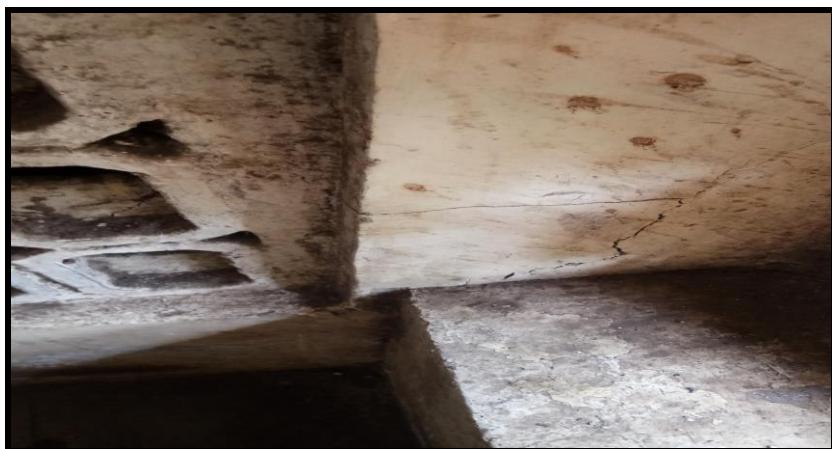
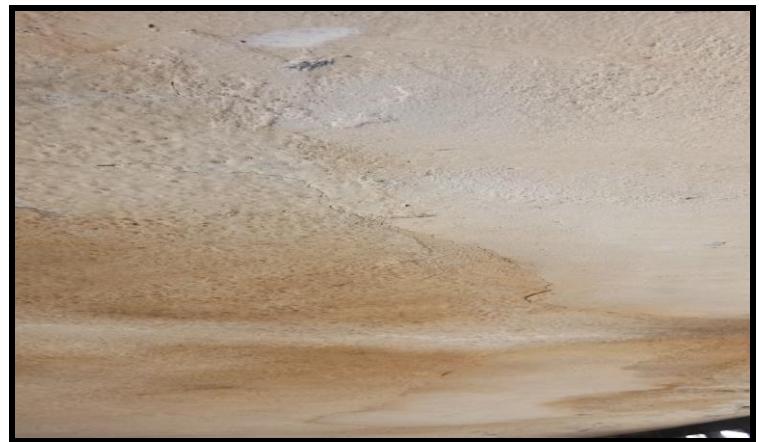
First floor to ground floor:-

- ❖ Peeling of paint observed on wall.
- ❖ Hallow sound observed on ceiling.
- ❖ Major structural crack observed on wall.

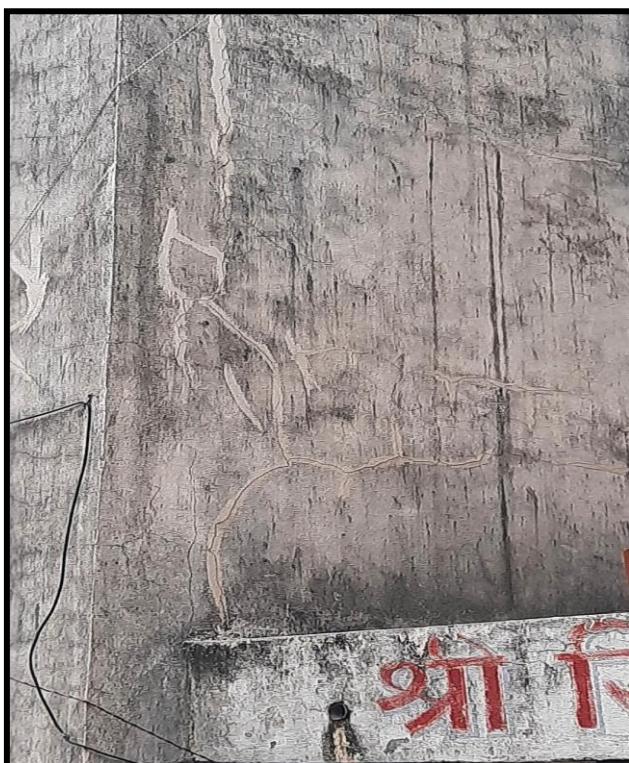
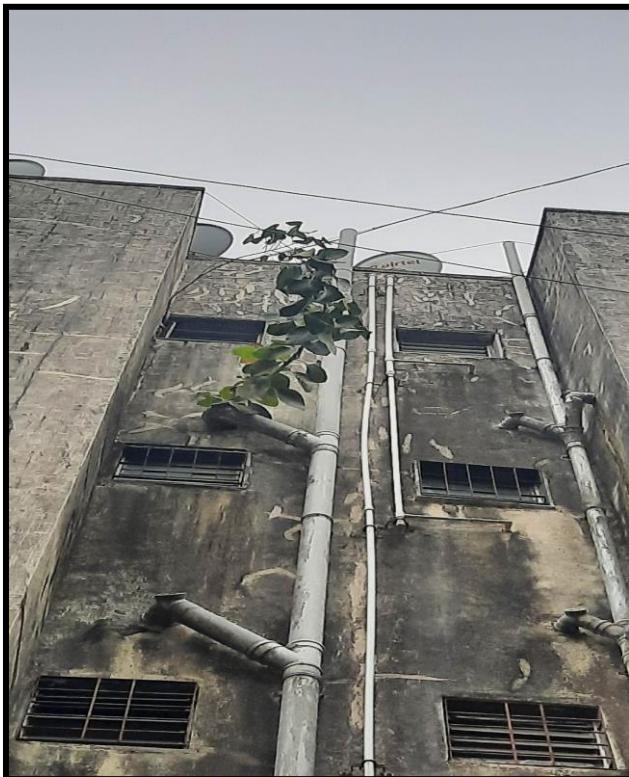
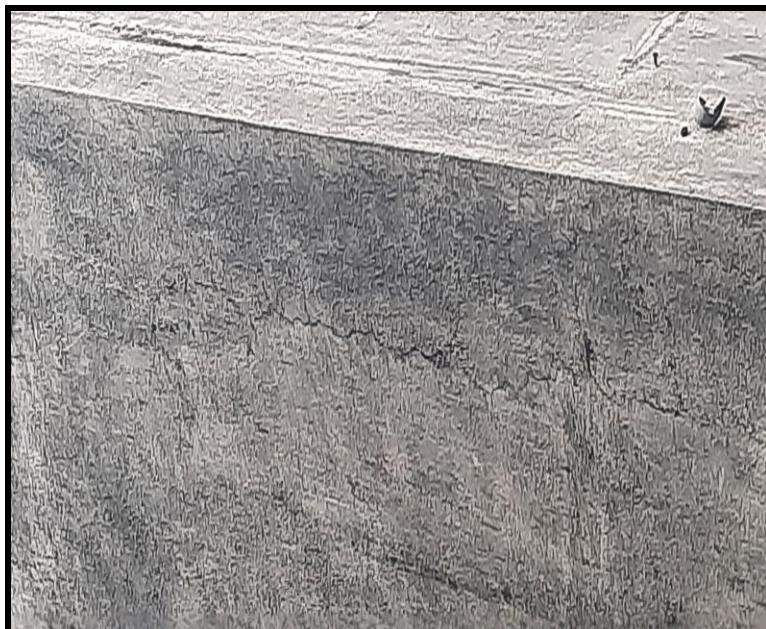
FRONT SIDE

- ❖ Structural crack observed at several places on column.
- ❖ Major crack observed at several places on wall.
- ❖ Vegetation growth observed at several places on wall.

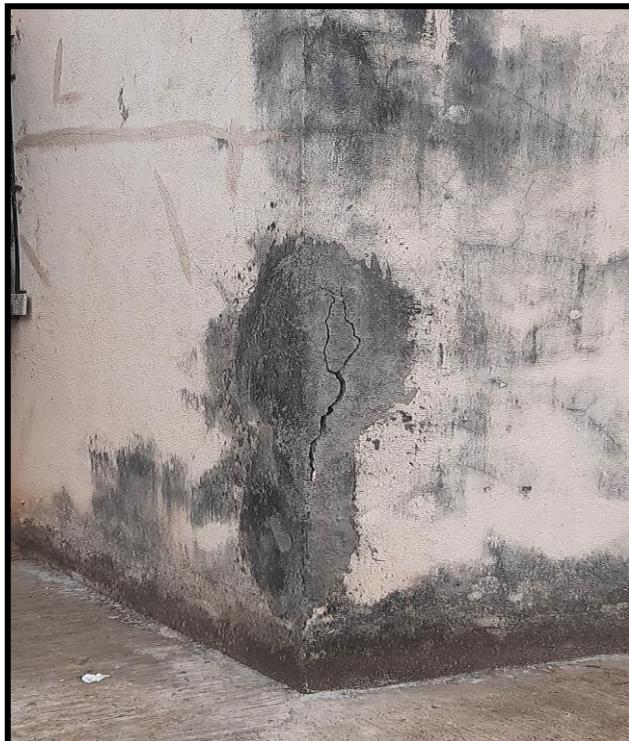
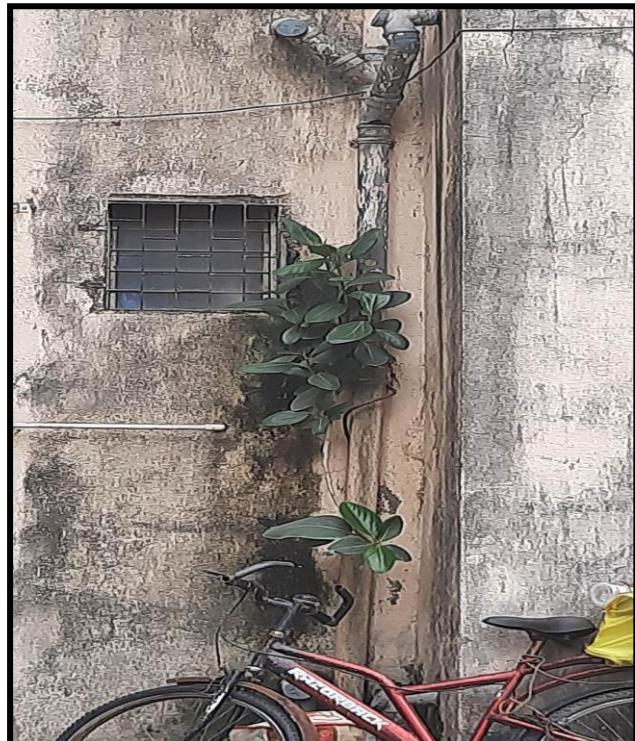
BACK SIDE

- ❖ Structural crack observed at several places on column.
- ❖ Major crack observed at several places on wall.
- ❖ Vegetation growth observed at several places on wall.
