STRUCTURAL AUDIT REPORT
FOR
“VISHAL SAHYADRI CO – OP HSG. SOC. LTD”,
“B6 – WING”
SITUATED AT
SAHYADRI NAGAR, CHARKOP,
KANDIVALI (W) MUMBAI – 400 067

PREPARED BY
LATESH S. SANKLECHA
CONSULTING STRUCTURAL ENGINEERS

978/B6/LSS/2021

JULY 19, 2021

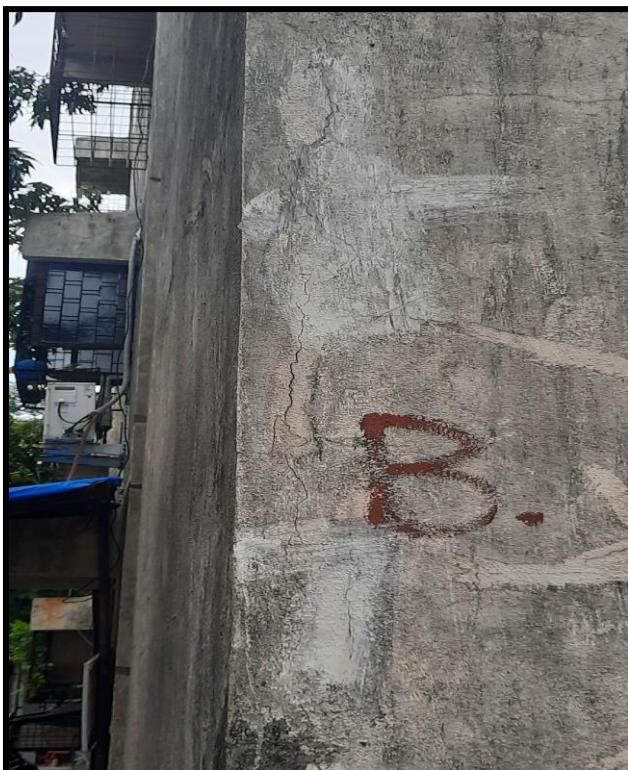
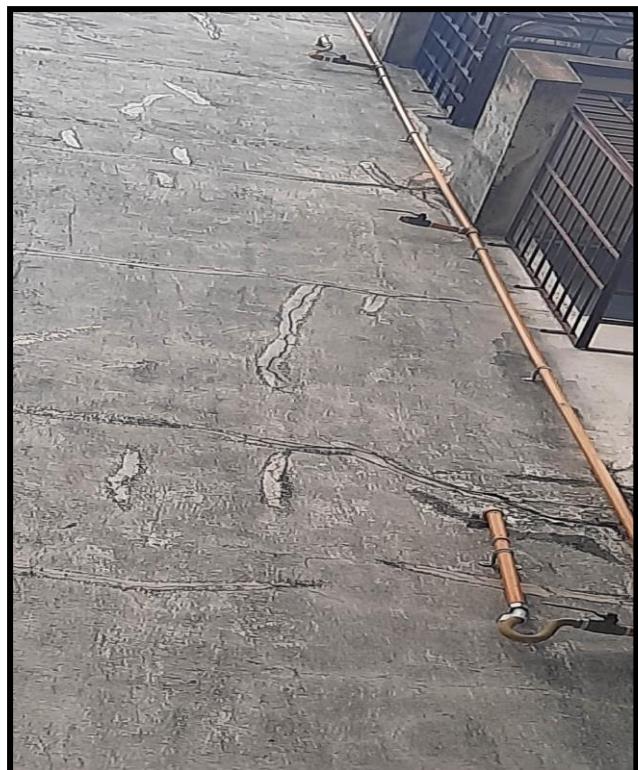
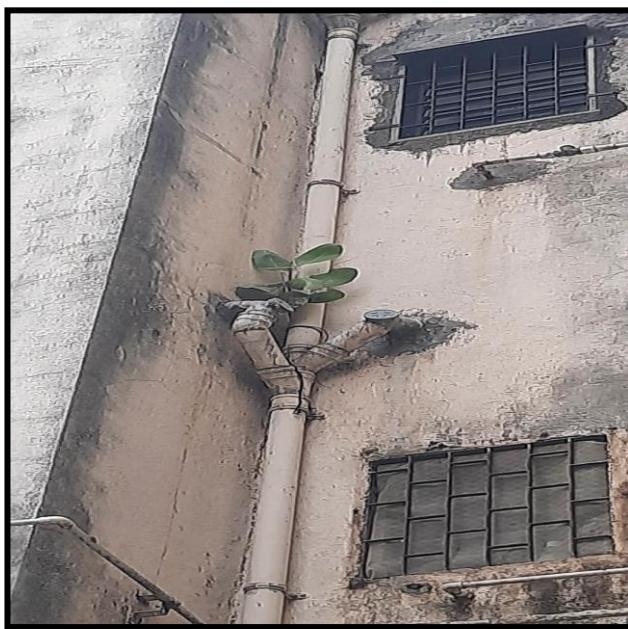
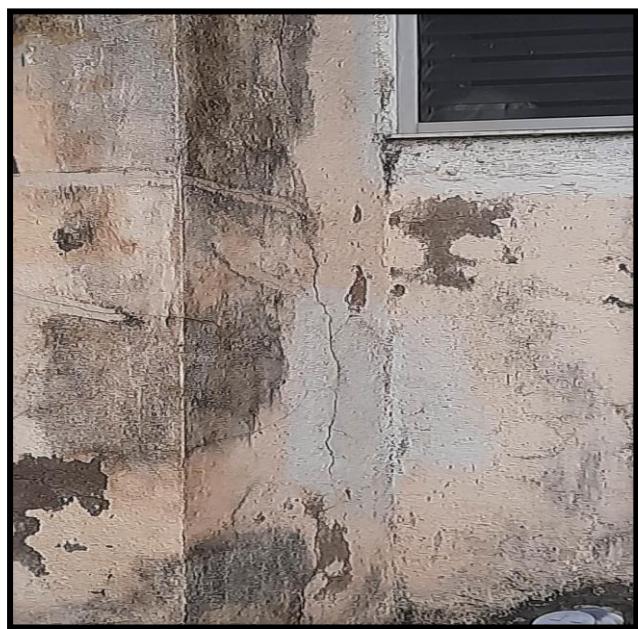
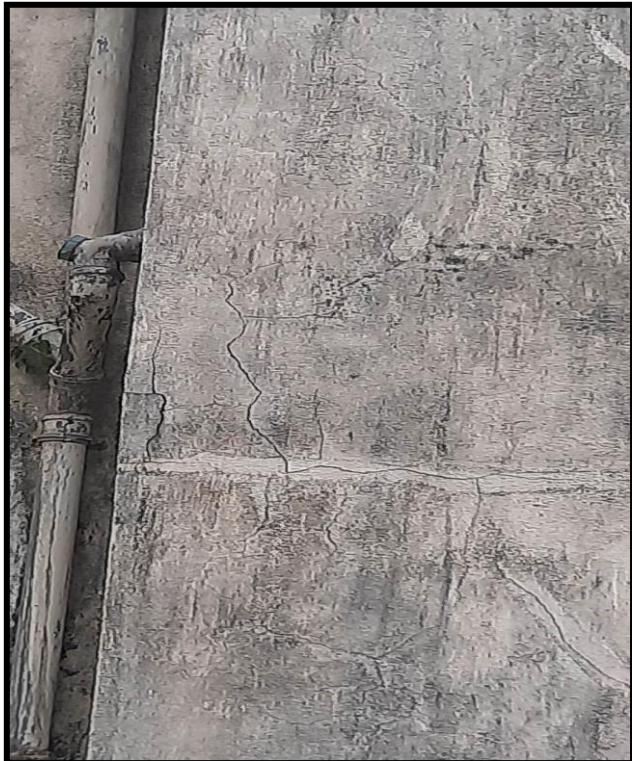
SOUTH SIDE

- ❖ Structural crack observed at several places on column.
- ❖ Major crack observed at several places on wall.
- ❖ Vegetation growth observed at several places on wall.
