STRUCTURAL AUDIT REPORT  
FOR  
**“VISHAL SAHYADRI CO – OP HSG. SOC. LTD”,**  
**“D2 – C WING”**  
SITUATED AT  
SAHYADRI NAGAR, CHARKOP,  
KANDIVALI (W) MUMBAI – 400 067

PREPARED BY  
**LATESH S. SANKLECHA**  
**CONSULTING STRUCTURAL ENGINEERS**

978/D2/LSS/2021

JULY 24, 2021

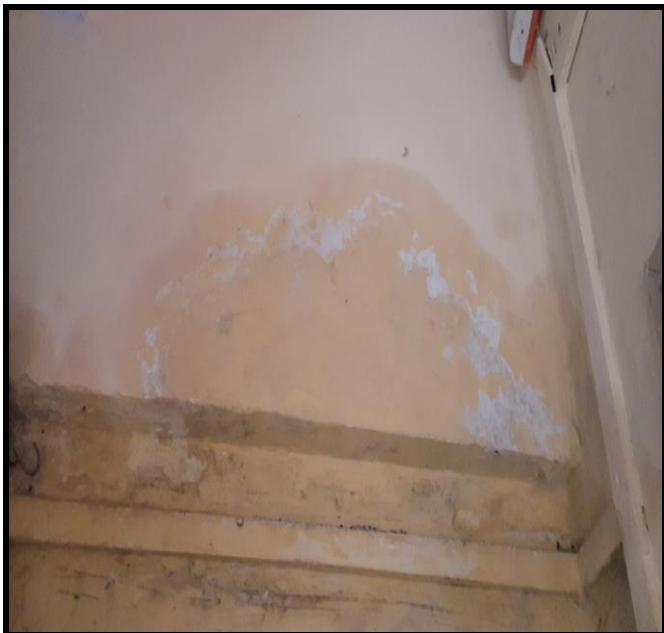
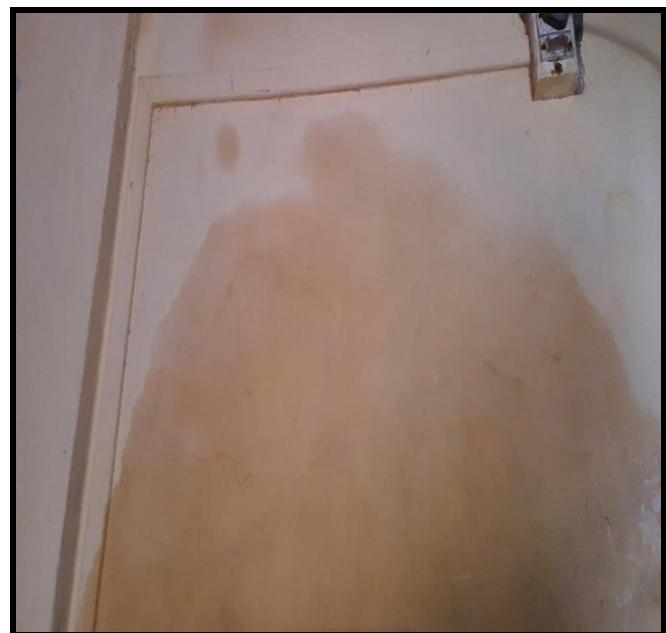
##### **FLAT NO – 02**

- ❖ **HALL** – O.K.
- ❖ **KITCHEN** – Dampness observed on wall.
- ❖ **PASSAGE** – Dampness observed on beam.
- ❖ **TOILET & BATH ROOM** – O.K.

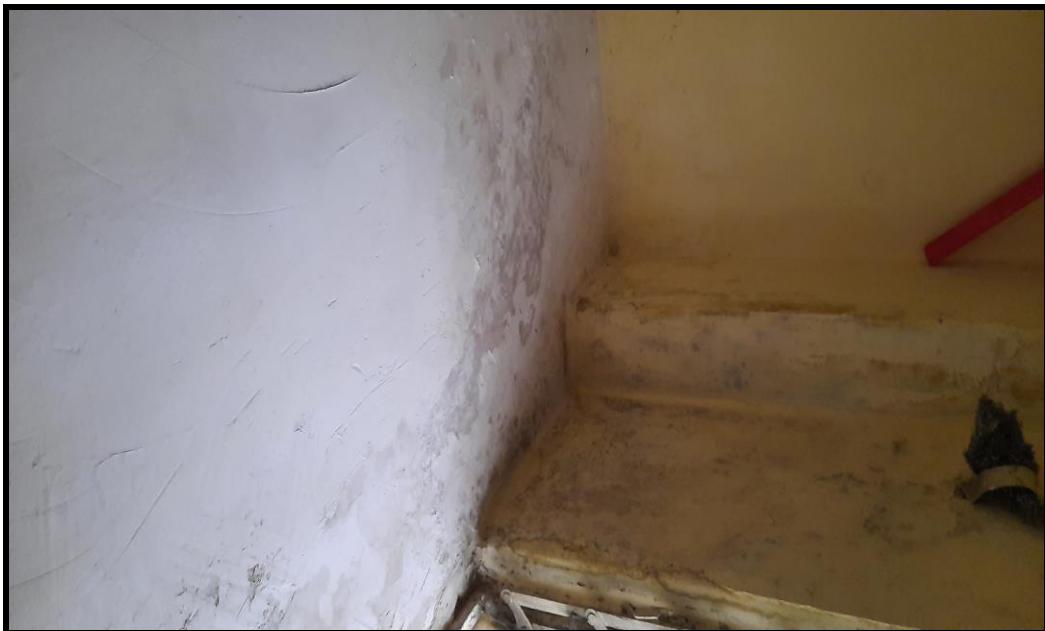
## FLAT NO – 04

- ❖ **HALL** – Dampness observed on wall in monsoon.
- ❖ **KITCHEN** – Dampness observed on wall in monsoon.
- ❖ **PASSAGE** – O.K.
- ❖ **TOILET & BATH ROOM** – Leakage mark observed on wall & ceiling.

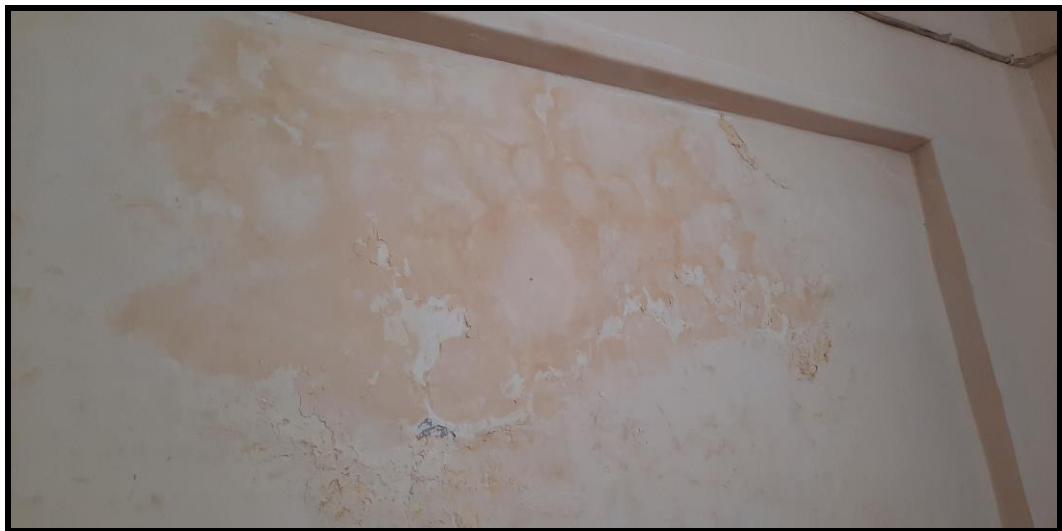
### FLAT NO – 201

- ❖ **HALL** – Leakage mark observed on wall.
- ❖ **KITCHEN** – O.K.
- ❖ **PASSAGE** – O.K.
- ❖ **TOILET & BATH ROOM** – O.K.

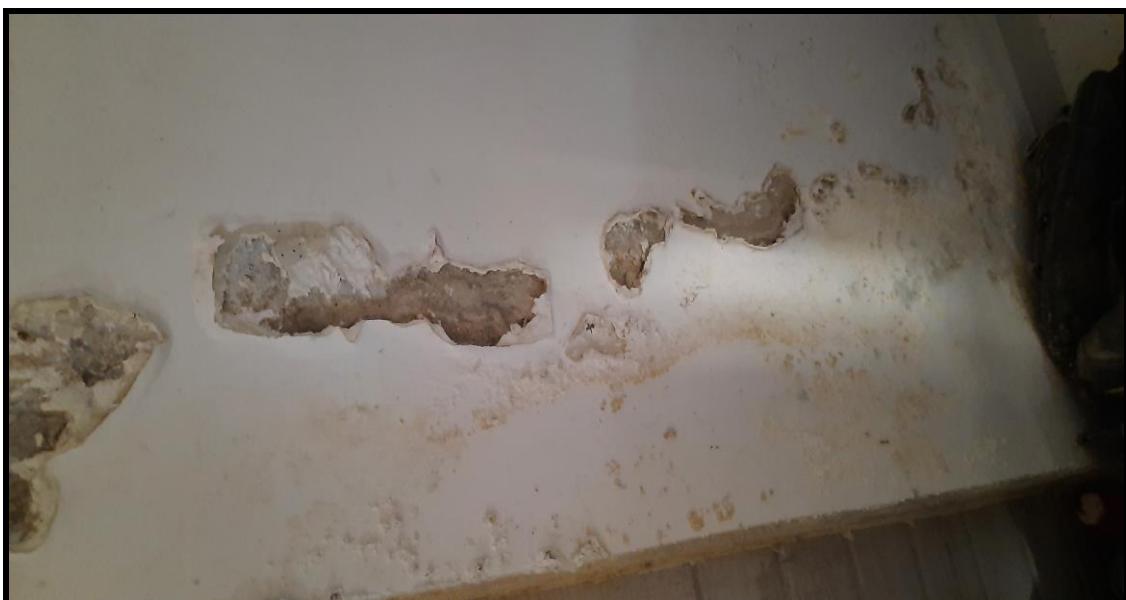
### FLAT NO – 203

- ❖ **HALL** – Leakage mark observed on column.
- ❖ **KITCHEN** – O.K.
- ❖ **PASSAGE** – O.K.
- ❖ **TOILET & BATH ROOM** – Leakage mark observed on ceiling.

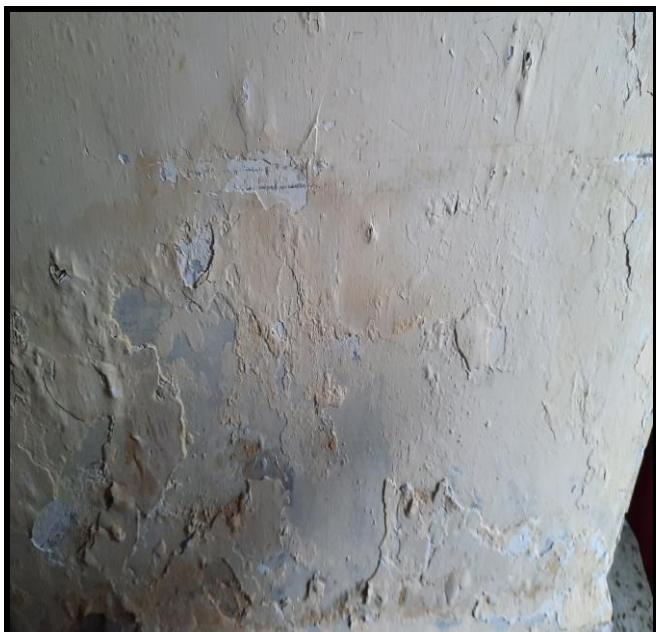
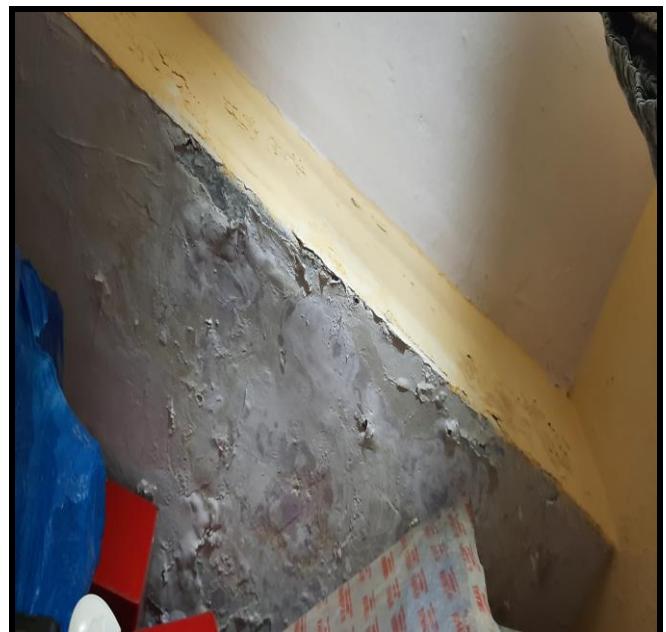
### FLAT NO – 304

- ❖ **HALL** – Leakage mark observed on wall.
- ❖ **KITCHEN** – Dampness observed on wall in monsoon.
- ❖ **PASSAGE** – Leakage mark observed on ceiling.
- ❖ **TOILET & BATH ROOM** – O.K.

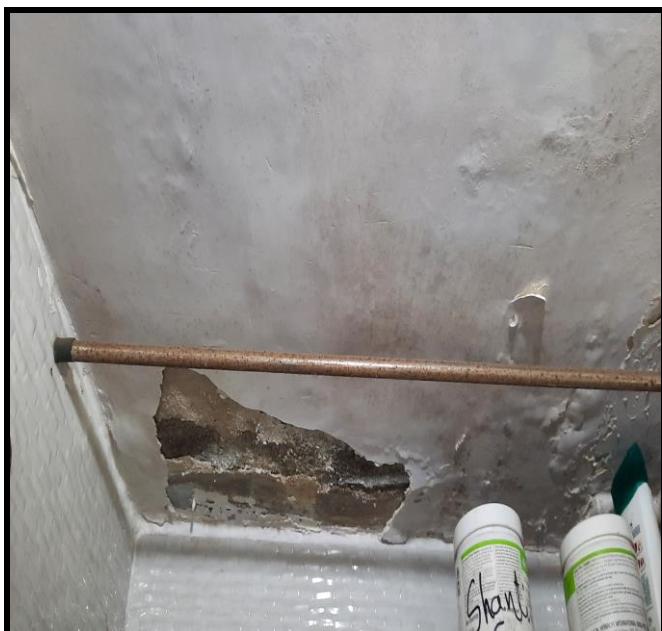
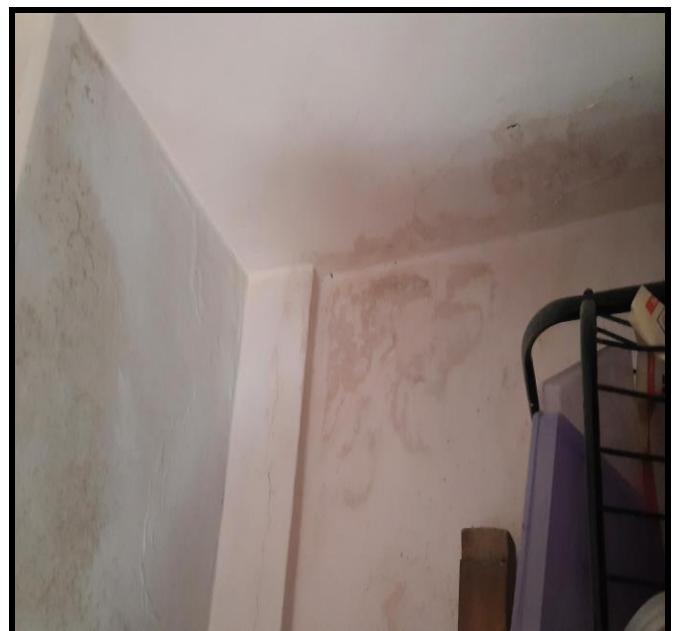
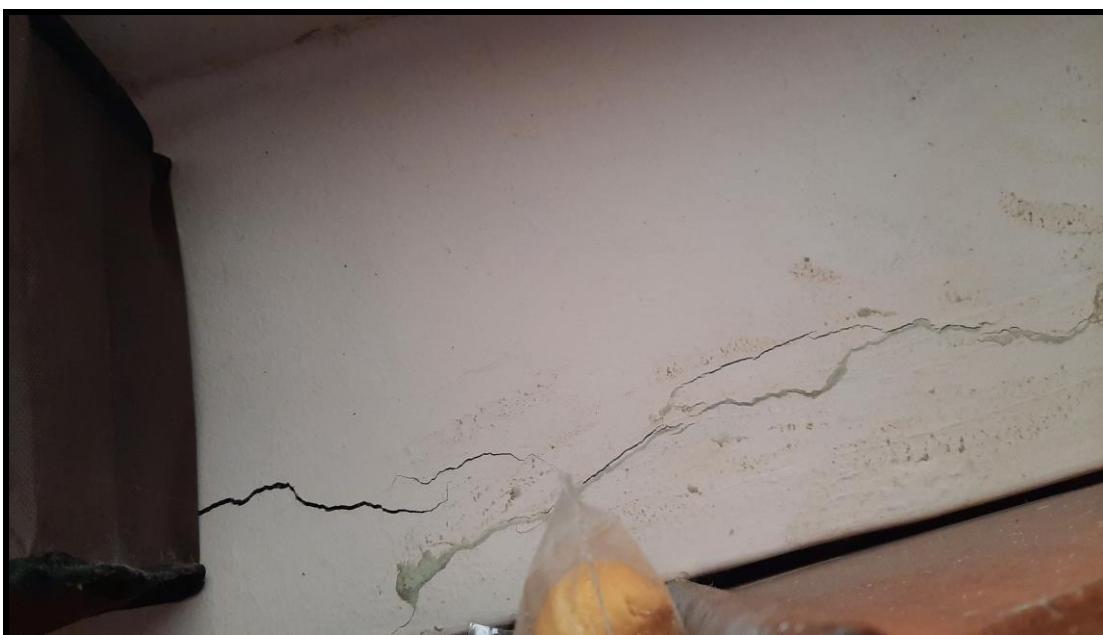
### FLAT NO – 401

- ❖ **HALL** – O.K.
- ❖ **KITCHEN** – Leakage mark observed on wall.
  - Structural crack observed on column.
- ❖ **PASSAGE** – O.K.
- ❖ **TOILET & BATH ROOM** – Leakage mark observed on ceiling.

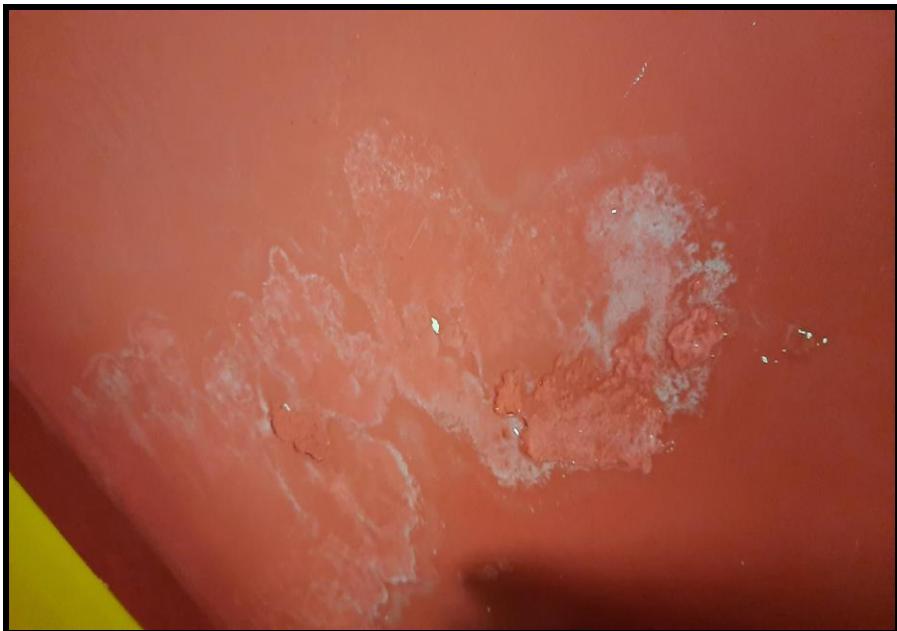
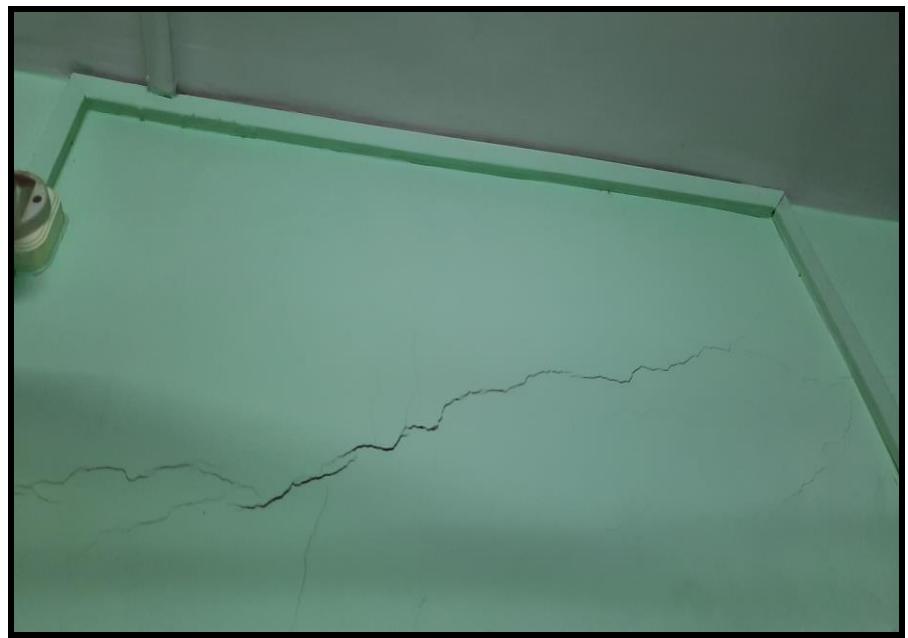
## FLAT NO – 404

- ❖ **HALL** – Leakage mark observed on wall.
- ❖ **KITCHEN** – Structural crack observed on beam.
- ❖ **PASSAGE** – O.K.
- ❖ **TOILET & BATH ROOM** – O.K.

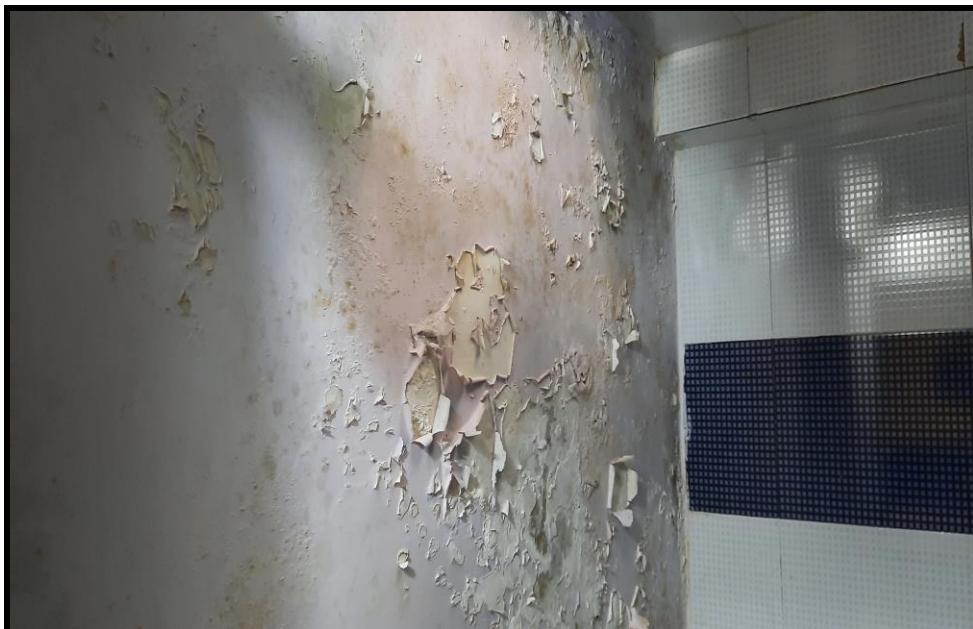
### FLAT NO – 501

- ❖ **HALL** – Leakage observed on wall in monsoon.
- ❖ **KITCHEN** – Leakage observed on wall in monsoon.
- ❖ **PASSAGE** – O.K.
- ❖ **TOILET & BATH ROOM** – Leakage mark observed on ceiling.

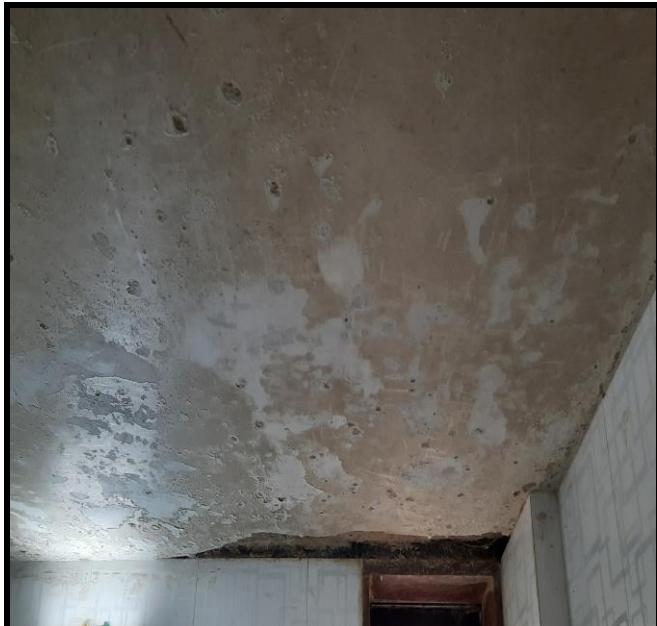
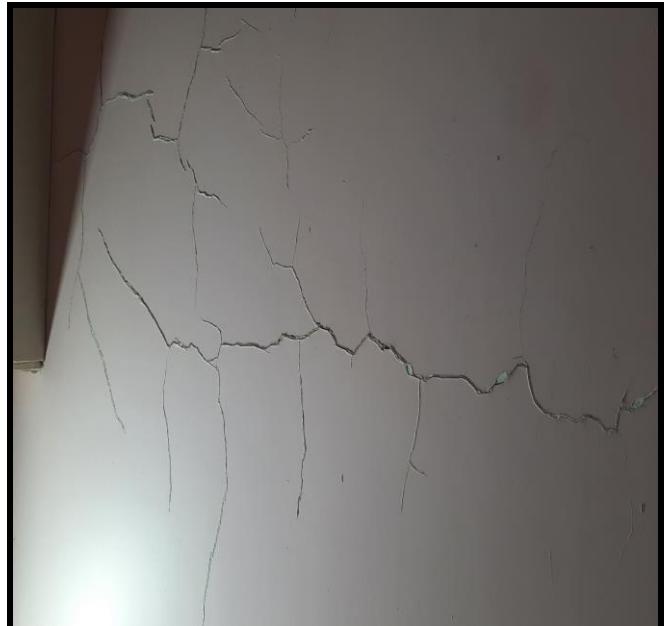
### FLAT NO – 603

- ❖ **HALL** – O.K.
- ❖ **KITCHEN** – Major crack observed on wall.
- ❖ **PASSAGE** – O.K.
- ❖ **TOILET & BATH ROOM** – Leakage mark observed on ceiling.

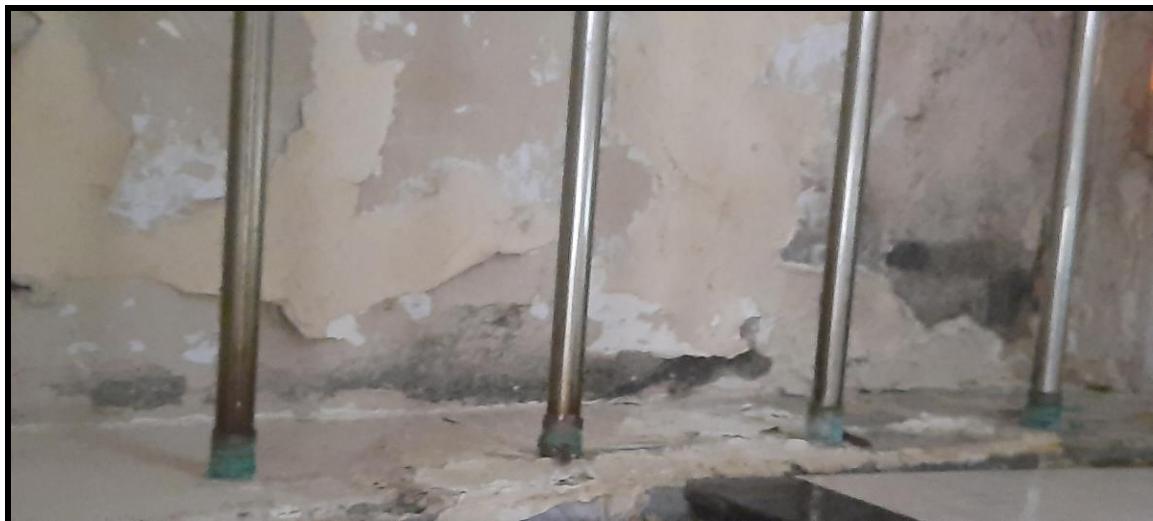
### FLAT NO – 604

- ❖ **HALL** – Leakage observed on wall in monsoon.
- ❖ **KITCHEN** – O.K.
- ❖ **PASSAGE** – Leakage mark observed on ceiling.
- ❖ **TOILET & BATH ROOM** – O.K.

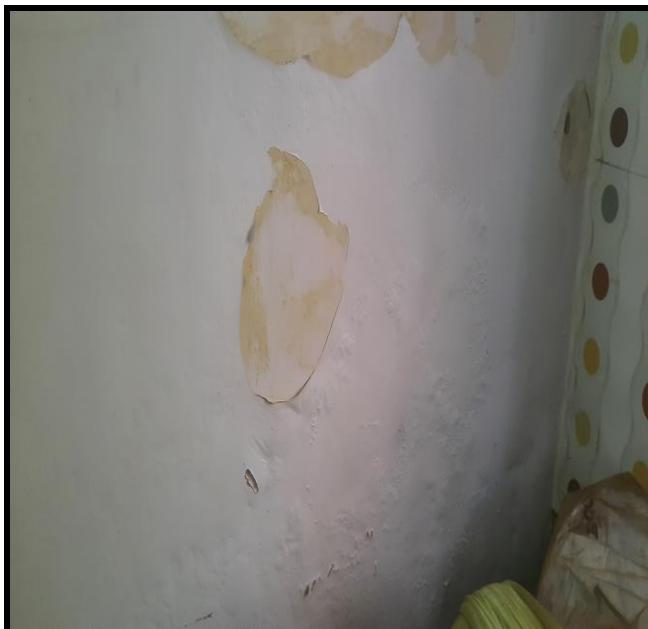
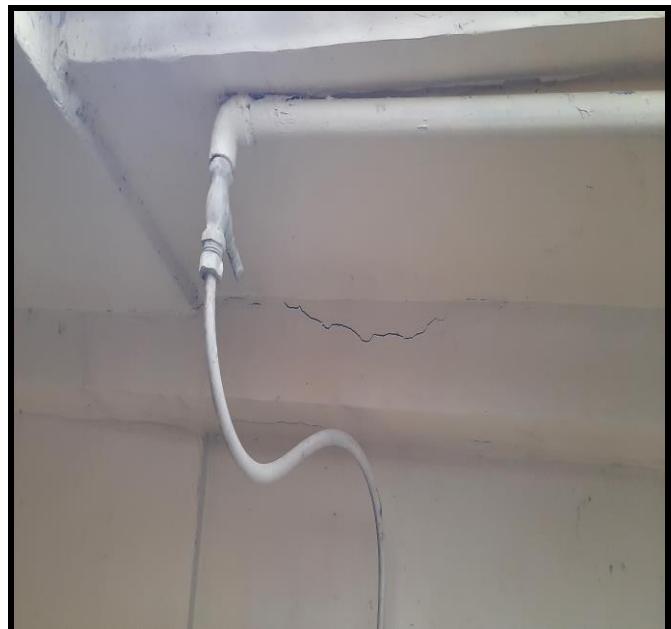
### FLAT NO – 703

- ❖ **HALL** – O.K.
- ❖ **KITCHEN** – Leakage mark observed on ceiling.
- ❖ **PASSAGE** – O.K.
- ❖ **TOILET & BATH ROOM** – Structural crack observed on column.

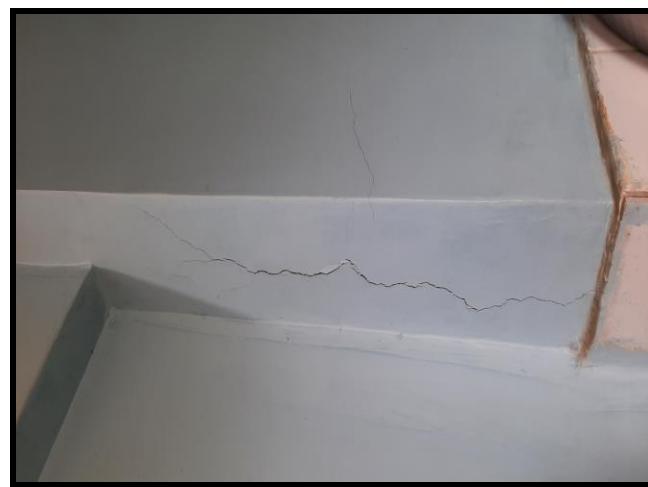
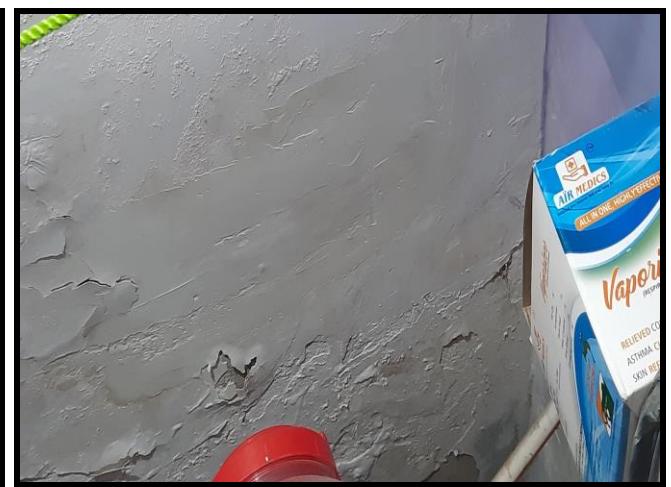
### FLAT NO – 704

- ❖ **HALL** – Leakage observed on ceiling in monsoon.
- ❖ **KITCHEN** – Leakage observed on wall & ceiling in monsoon.
  - Structural crack observed on column.
- ❖ **PASSAGE** – Leakage mark observed on ceiling.
- ❖ **TOILET & BATH ROOM** – O.K.

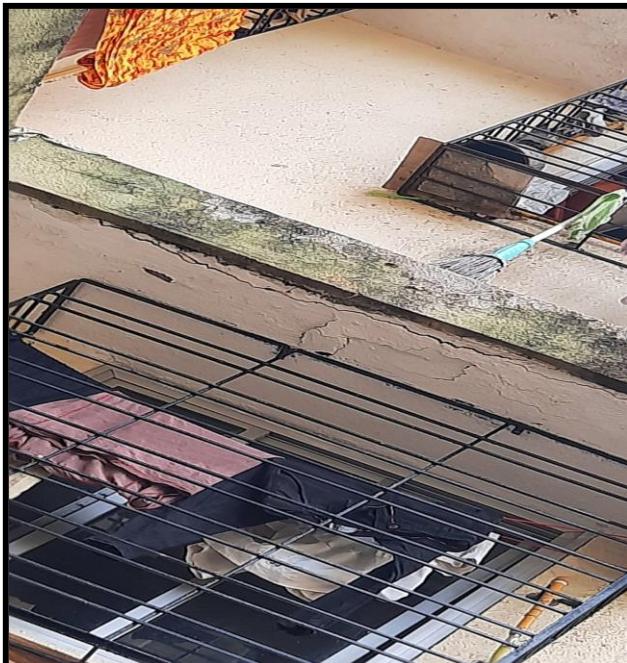
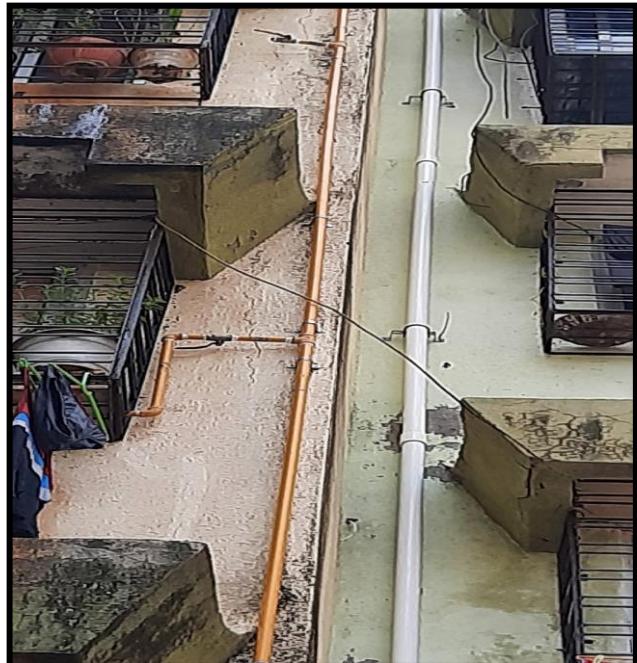
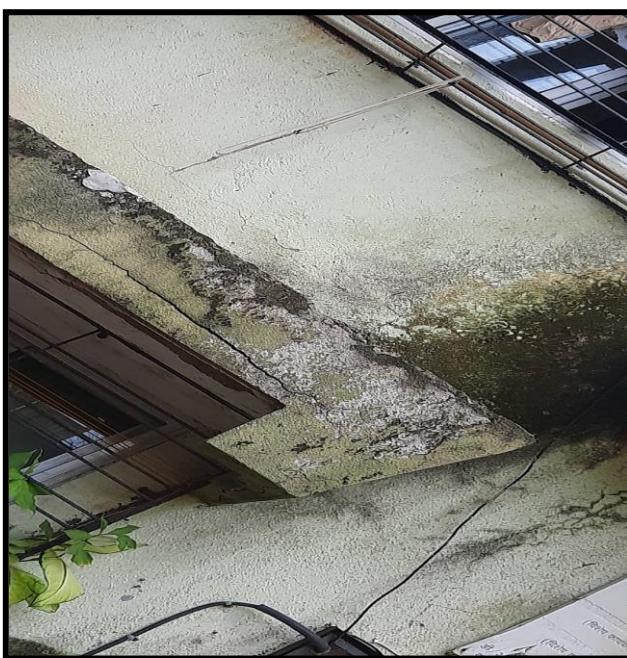
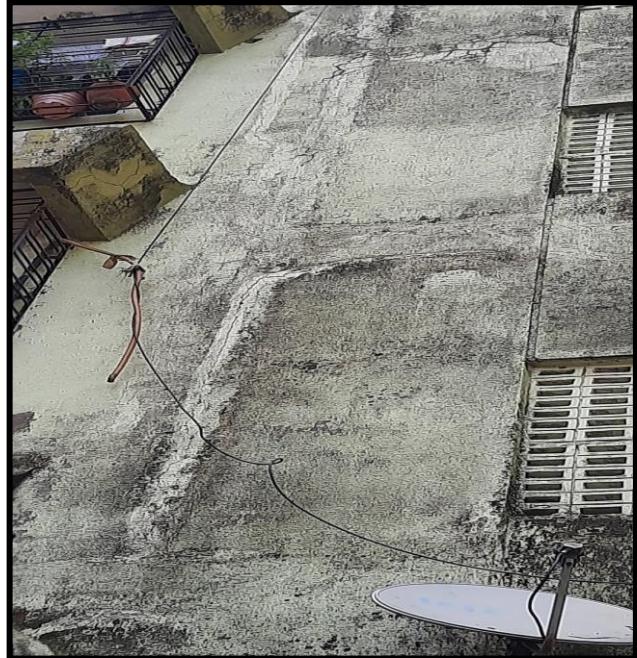
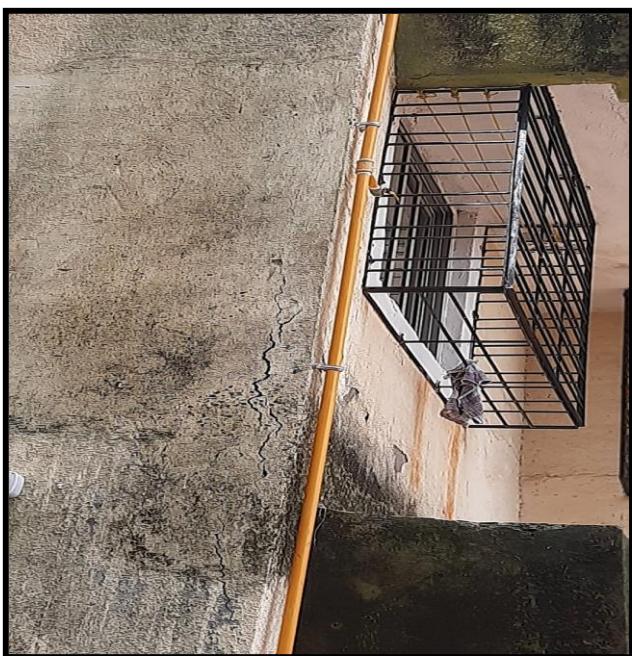
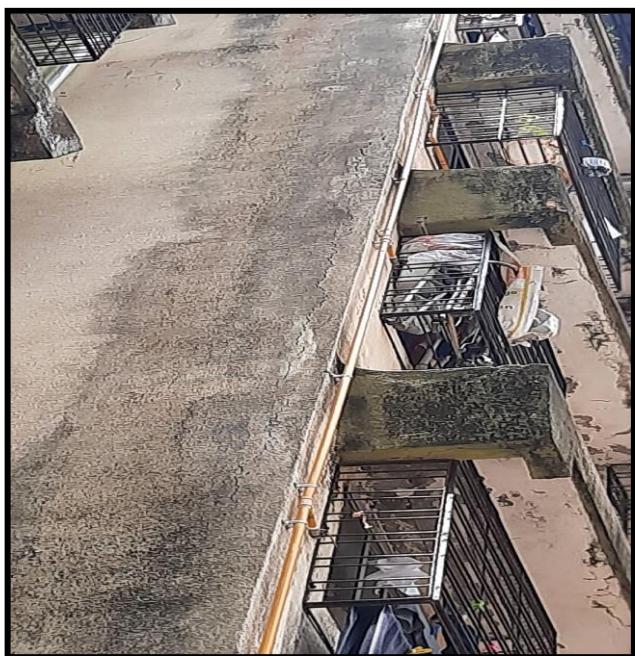
### FRONT SIDE

- ❖ Structural crack observed at several places on column & chajjas.
- ❖ Major crack observed at several places on wall.
- ❖ Algae observed at several places on wall.

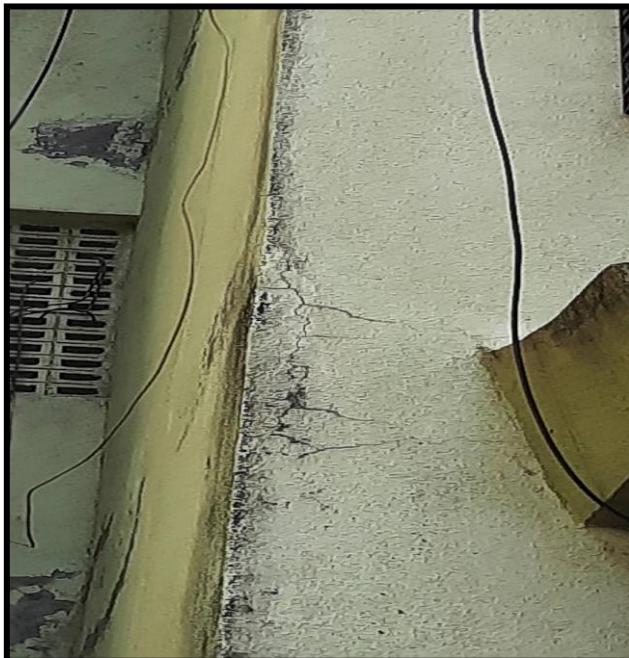
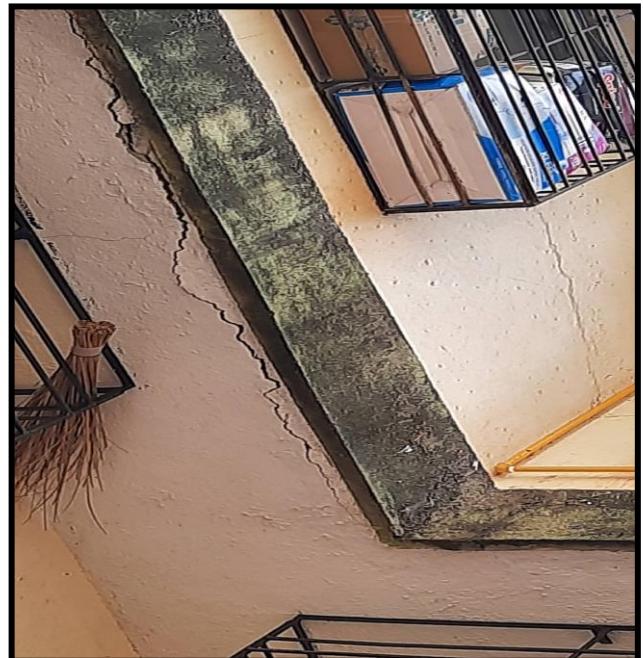
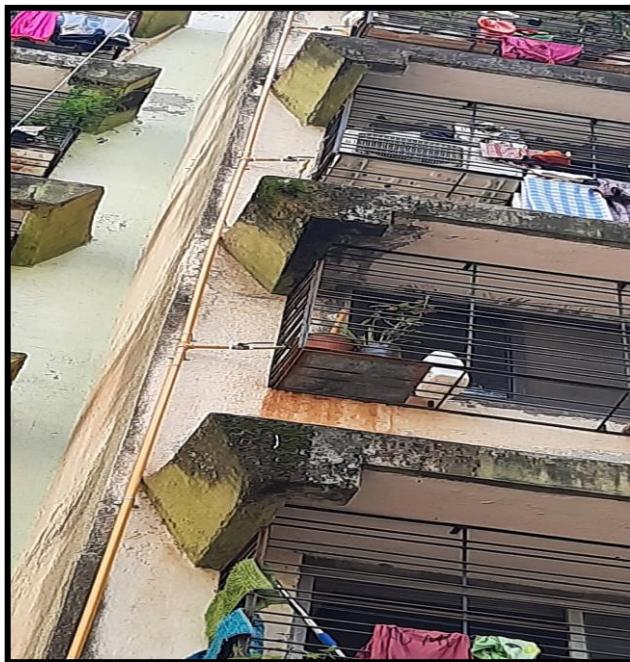
## BACK SIDE

- ❖ Structural crack observed at several places on column & chajjas.
- ❖ Algae observed at several places on wall.

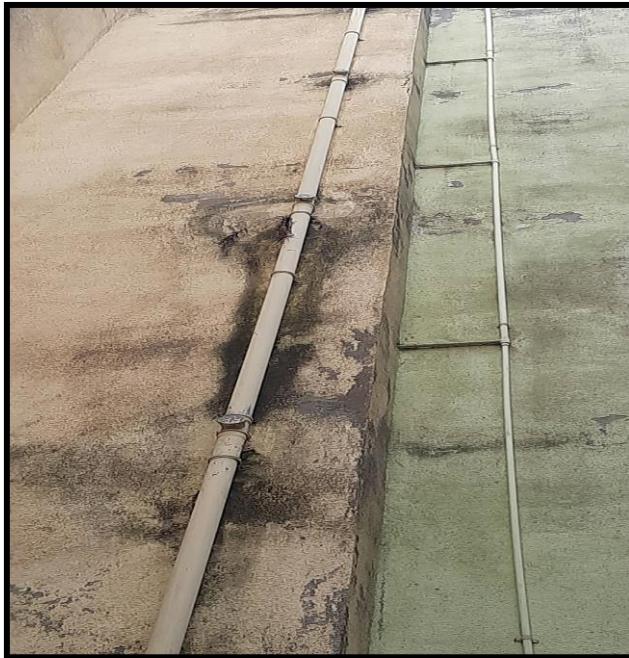
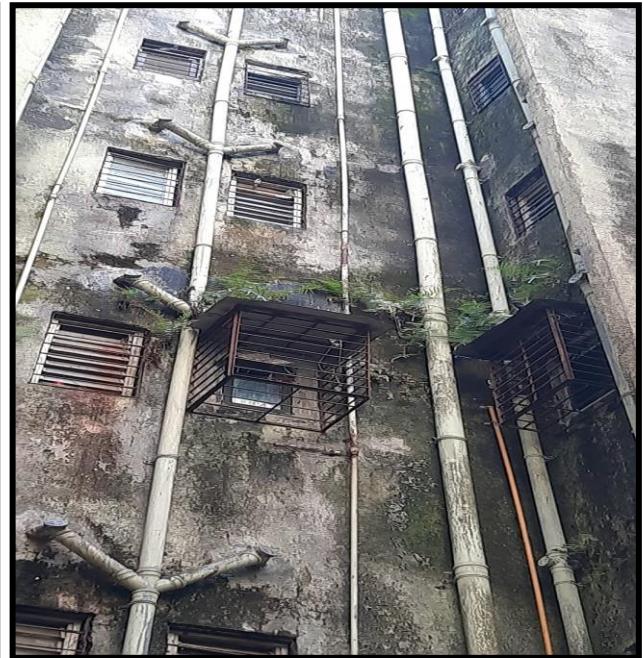
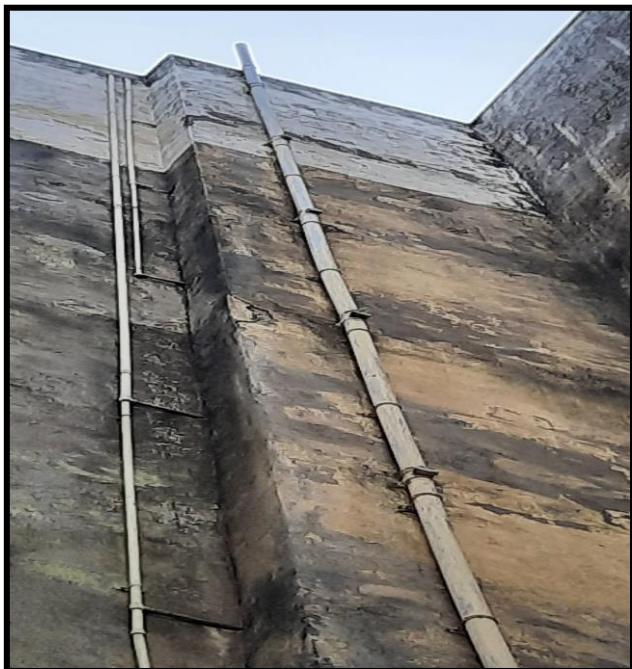
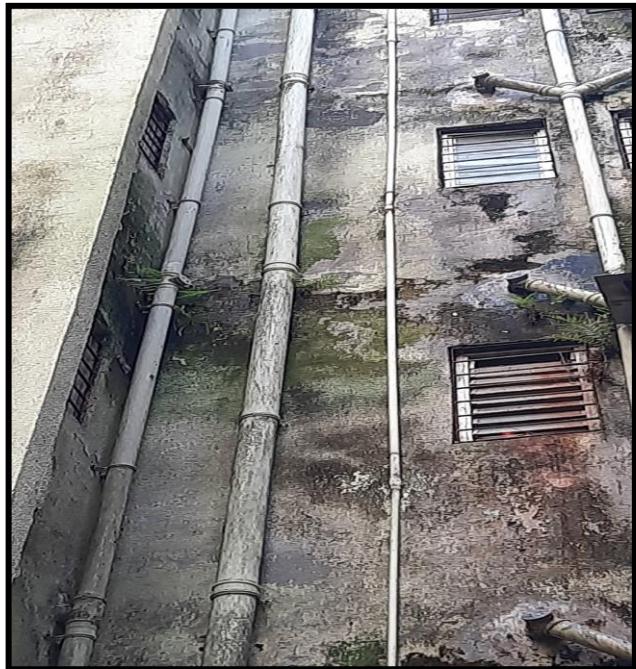
## EAST SIDE

- ❖ Structural crack observed at several places on column.
- ❖ Major crack observed at several places on wall.
- ❖ Algae observed at several places on wall.
- ❖ Vegetation growth observed at several places on wall.

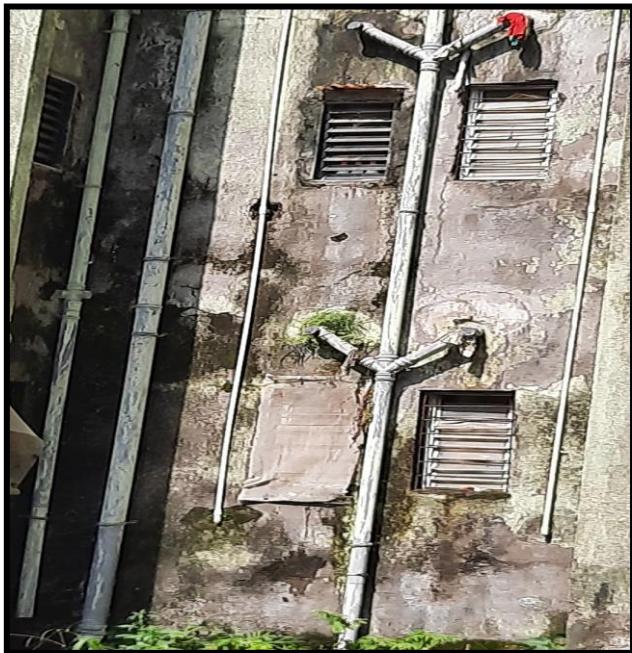
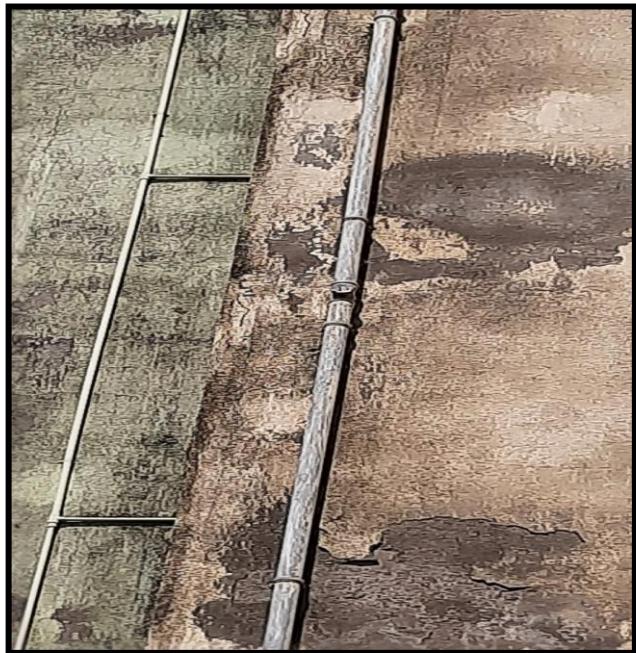
## WEST SIDE

- ❖ Major crack observed at several places on wall.
- ❖ Vegetation growth observed at several places on wall.
