STRUCTURAL AUDIT REPORT
FOR
“VISHAL SAHYADRI CO – OP HSG. SOC. LTD”,
“B11 – WING”
SITUATED AT
SAHYADRI NAGAR, CHARKOP,
KANDIVALI (W) MUMBAI – 400 067

978/B11/LSS/2021

JULY 24, 2021

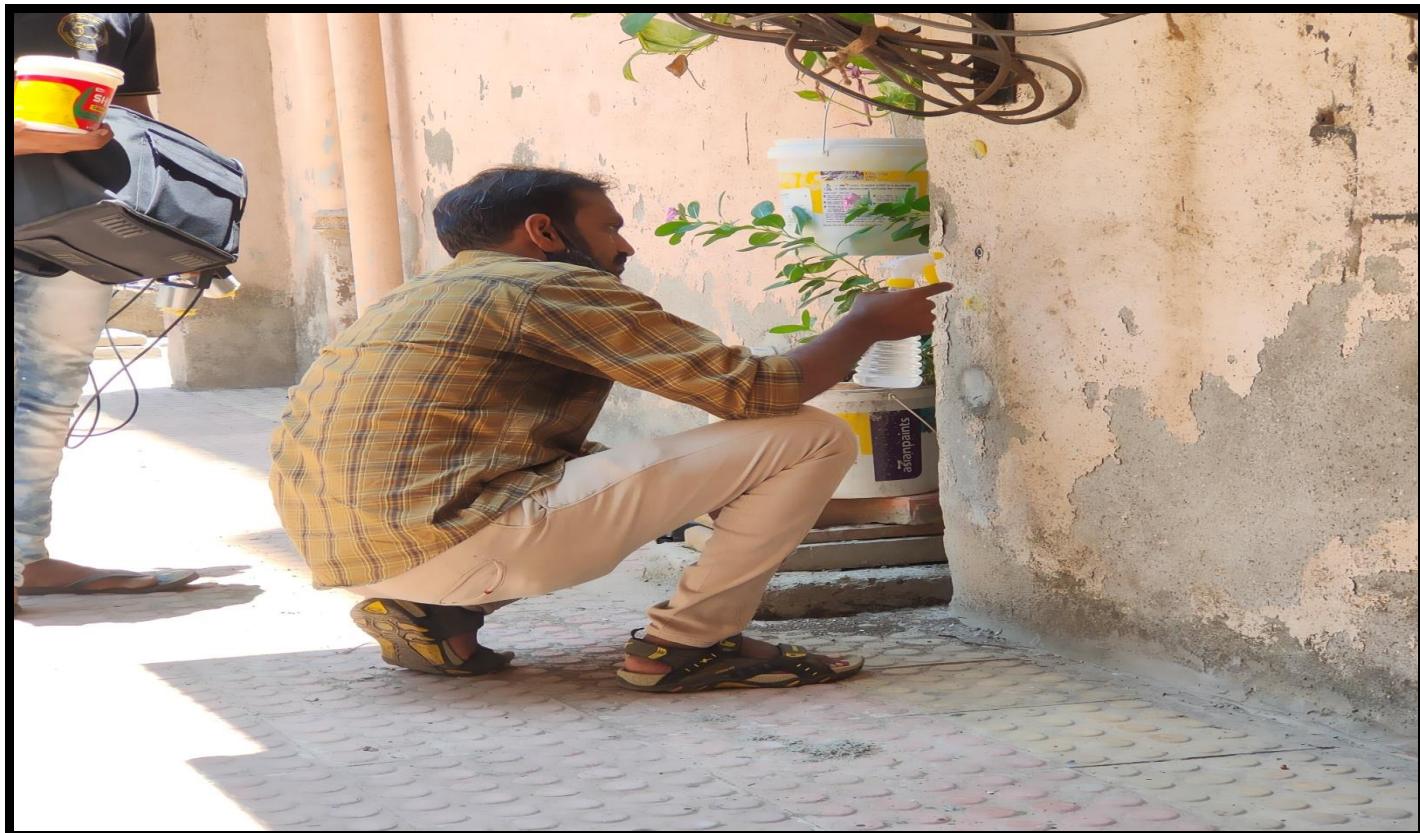
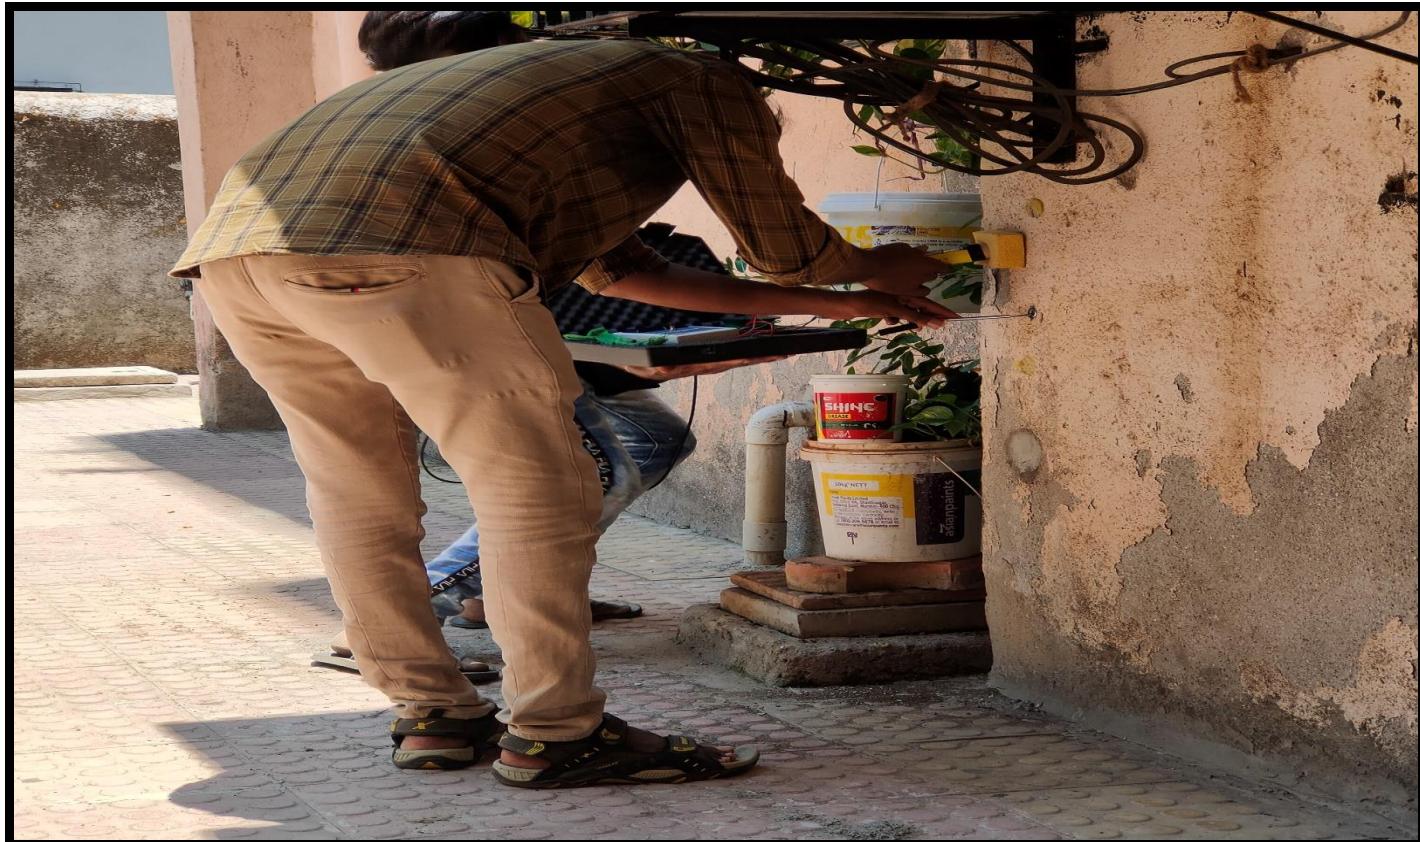
NON -DESTRUCTIVE TEST PHOTO

Rebound Hammer was tested for compressive strength at surface by Schmidt rebound hammer. Results indicate the compressive strength at surface of all the RCC columns is ranging between 12.50 MPa to 17.50 MPa.

The UPV values are ranging between 2.0 Km/Sec to 2.50 Km/Sec.

Out of 4 locations all 4 locations was below 3.0 Km/Sec means concrete quality is poor.

This indicates there are progressive internal cracks in the RCC members due to corrosion of reinforced steel. These members are under distress condition.

Half Cell Potential tested for corrosion activity by half – cell potential tests. Values are taken on Column. The result on tested column is – 337 mV.

This indicates the probability of corrosion is 50% on tested column steel reinforcement.

Carbonation test was conducted to assess carbonation depth. Readings are taken on Column. Result indicates the carbonation penetration depth is 35.00 mm. Carbonation depths have reached to the reinforcement level in all of the RCC elements. It is essential to give a suitable anti-corrosion treatment to all the RCC members to stop further carbonation and corrosion of concrete.

RCC elements indicating UPV values less than 3 Km/sec needs immediate attention.

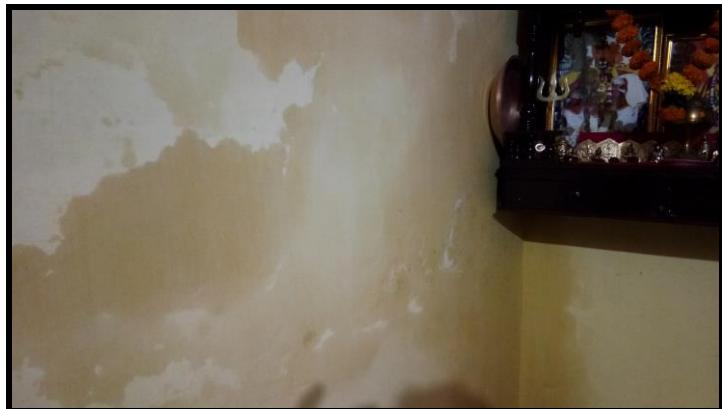
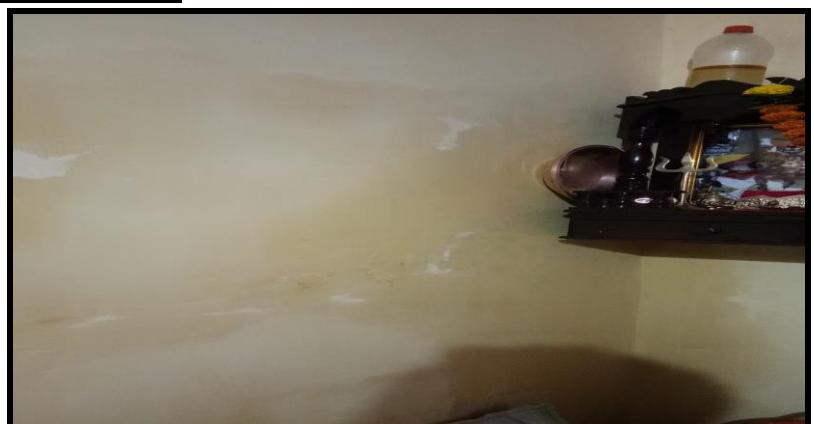
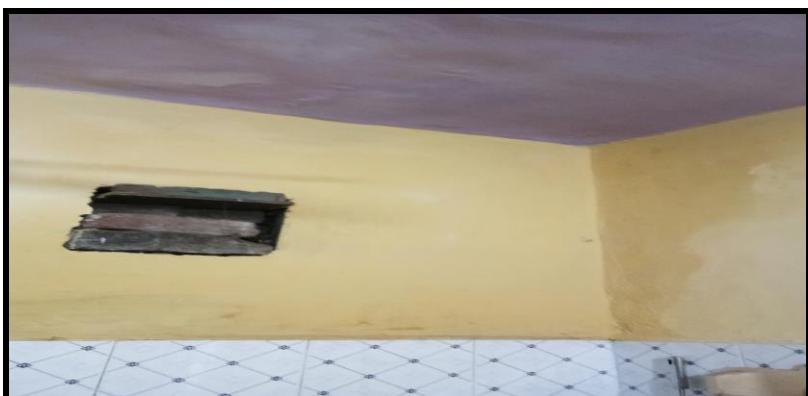
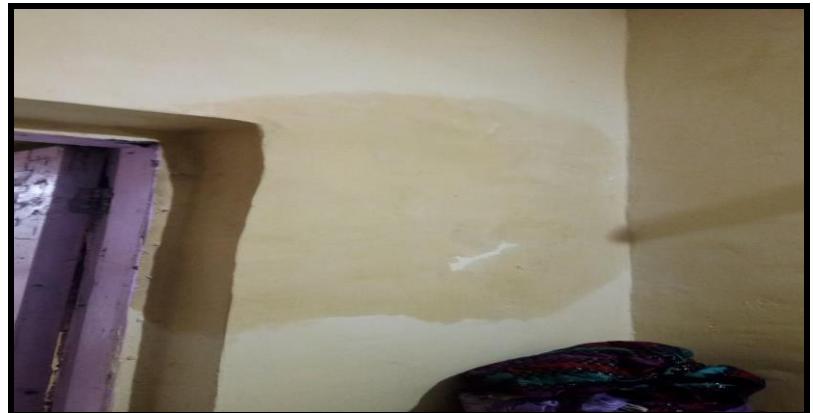
FLAT NO – 01

- ❖ **HALL** – Leakage mark observed on wall. (**It may fall**)
 - Peeling of paint observed on wall.
- ❖ **KITCHEN** – Seepage mark observed on wall.
 - Dampness observed on wall.
- ❖ **PASSAGE** – Peeling of paint observed on wall.
 - Plaster gets removed and steel gets exposed. (**It may fall**)
- ❖ **TOILET & BATH ROOM** – Dampness observed on ceiling.
 - Hallow sound observed on beam.

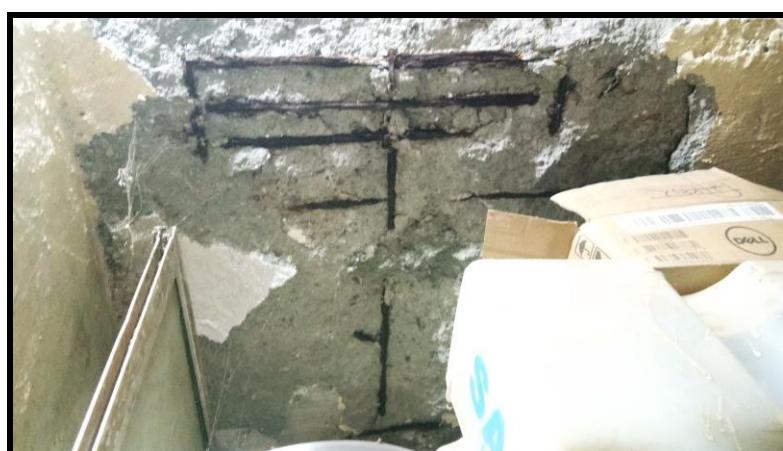
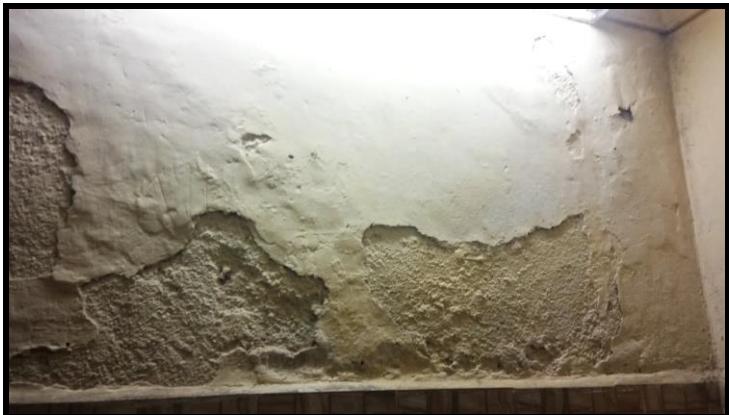
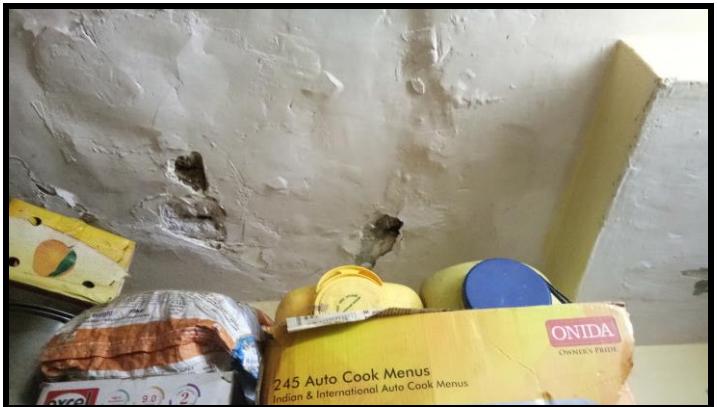
FLAT NO - 05

- ❖ **HALL** – Crack observed on wall.
 - Major structural crack observed on wall.
- ❖ **KITCHEN** – Leakage mark observed on beam.
- ❖ **PASSAGE** – Plaster gets removed and steel exposed.
- ❖ **TOILET & BATH ROOM** – Peeling of paint observed on wall.
 - Dampness observed on wall.

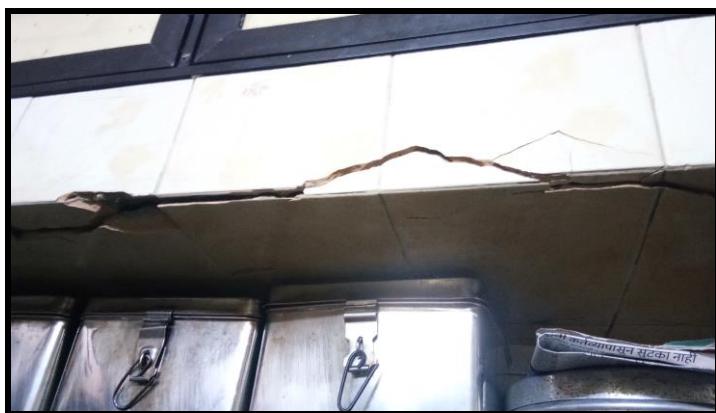
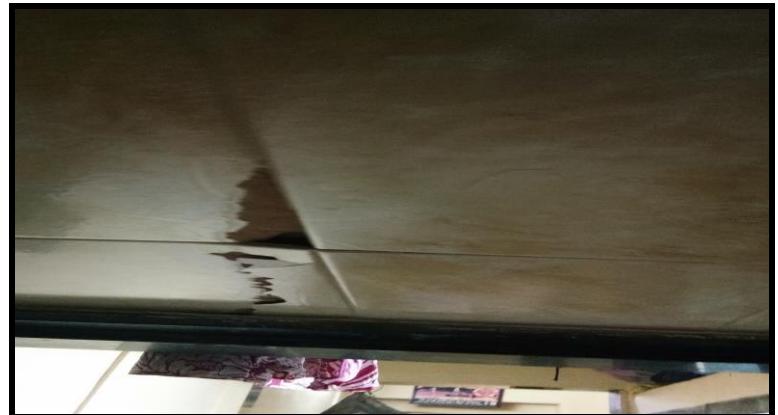
FLAT NO – 07

- ❖ **HALL** – Peeling of paint observed on wall.
 - Seepage mark observed on ceiling.
- ❖ **KITCHEN** – Structural crack observed on beam.
- ❖ **PASSAGE** – Dampness observed on wall.
 - Seepage mark observed on ceiling.
- ❖ **TOILET & BATH ROOM** – Peeling of paint observed on ceiling.

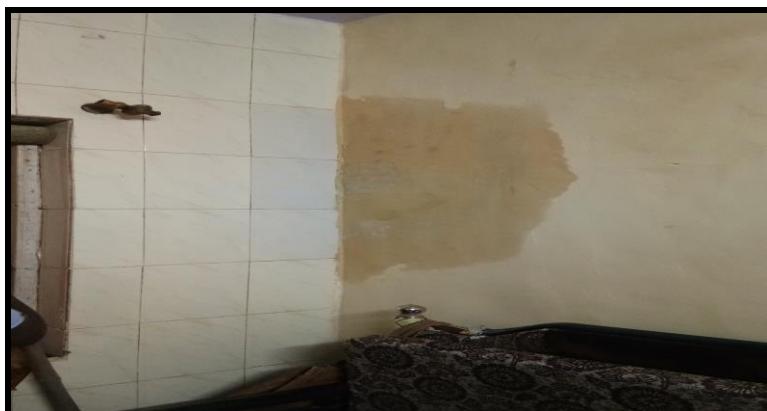
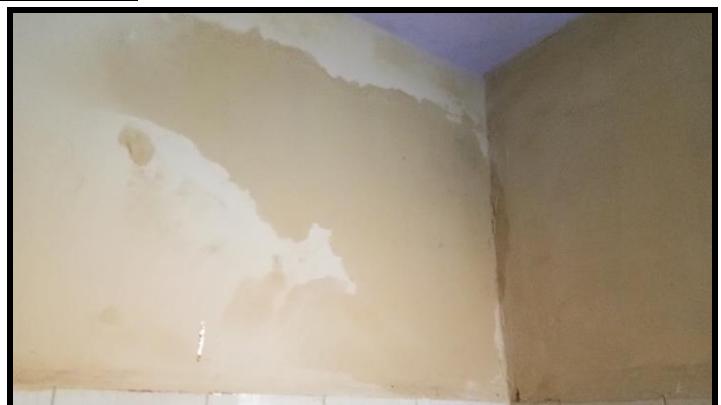
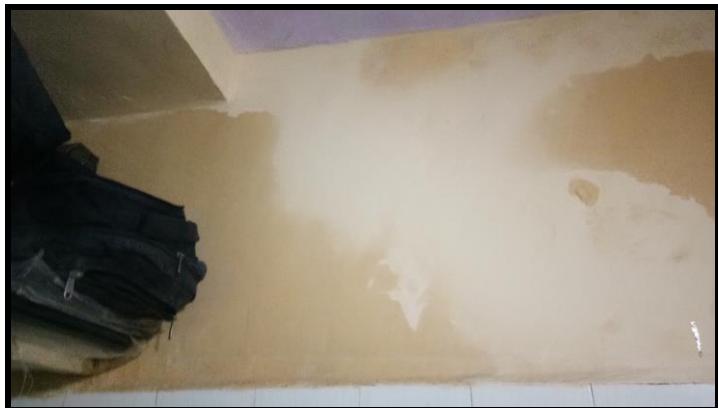
FLAT NO – 17

- ❖ **HALL** – Leakage mark observed on wall.
 - Seepage mark observed on ceiling.
- ❖ **KITCHEN** – Leakage mark observed on wall.
- ❖ **PASSAGE** – Seepage mark observed on wall.
- ❖ **TOILET & BATH ROOM** – Dampness observed on ceiling.

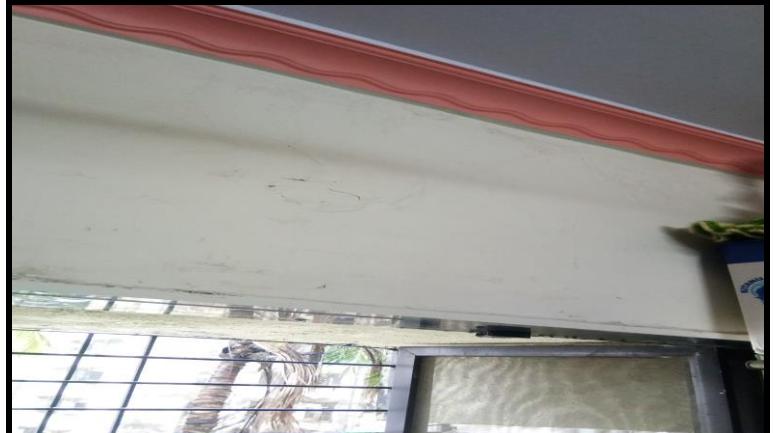
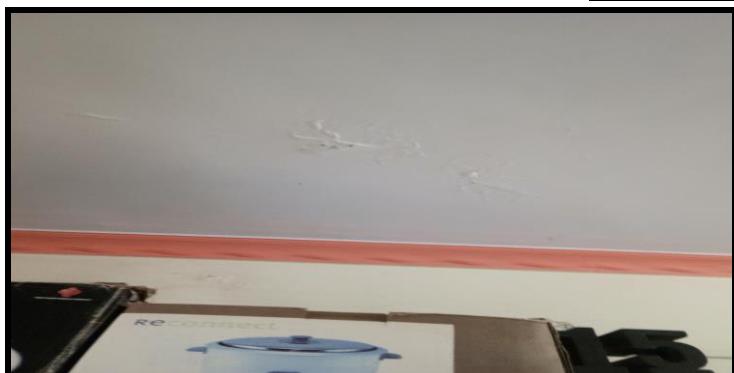
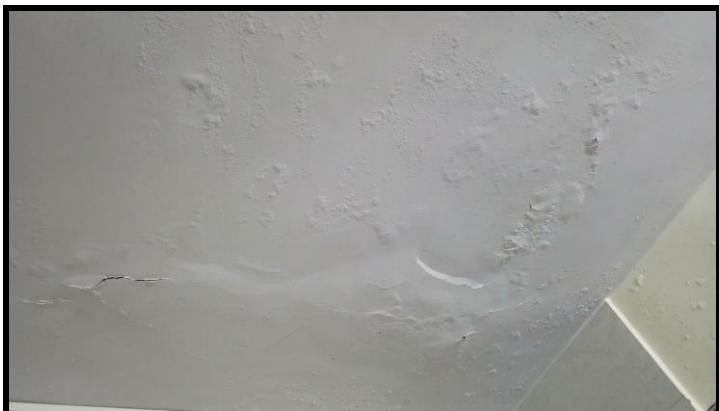
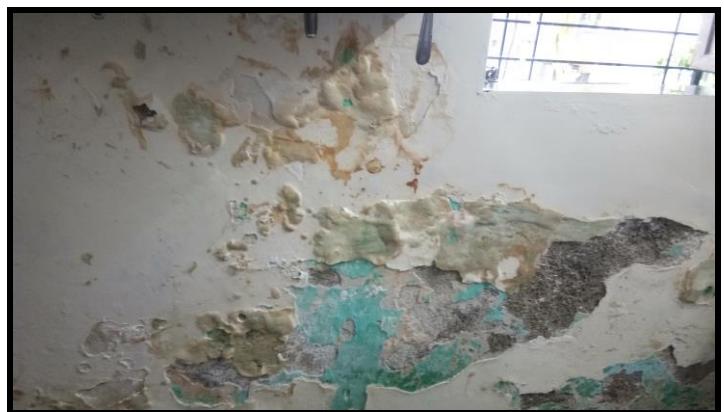
FLAT NO – 21

- ❖ **HALL** – Leakage mark observed on wall.
 - Seepage mark observed on ceiling.
- ❖ **KITCHEN** – Dampness observed on ceiling.
- ❖ **PASSAGE** – Seepage mark observed on wall.
- ❖ **TOILET & BATH ROOM** – Dampness observed on wall.
 - Peeling of paint observed on ceiling.

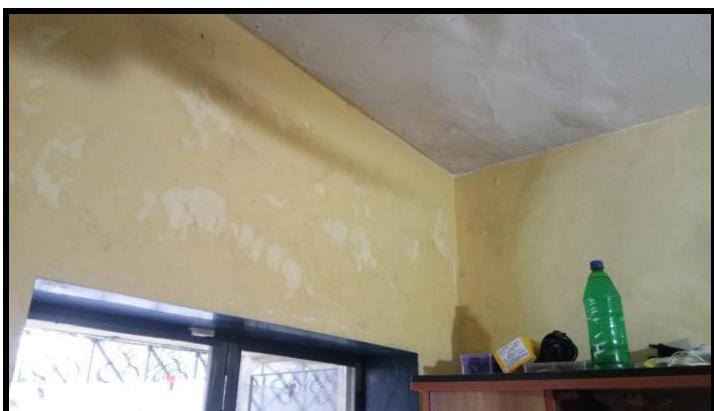
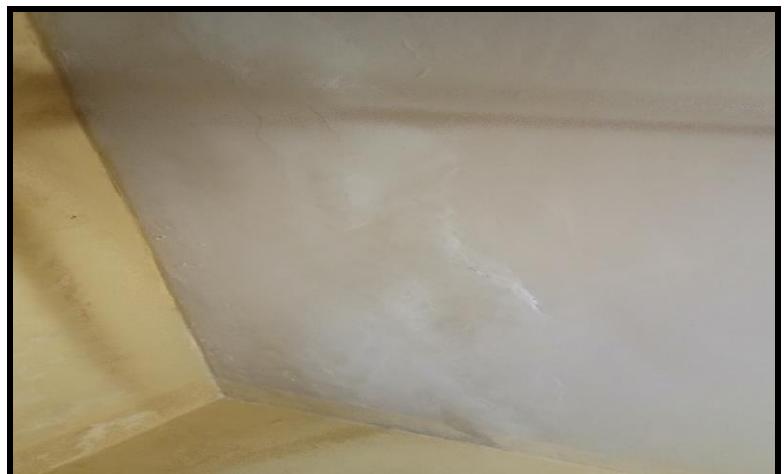
FLAT NO – 27

- ❖ **HALL** – O.K.
- ❖ **KITCHEN** – Seepage mark observed on wall.
 - Leakage mark observed on ceiling.
- ❖ **PASSAGE** – Dampness observed on wall.
- ❖ **TOILET & BATH ROOM** – Seepage mark observed on wall.

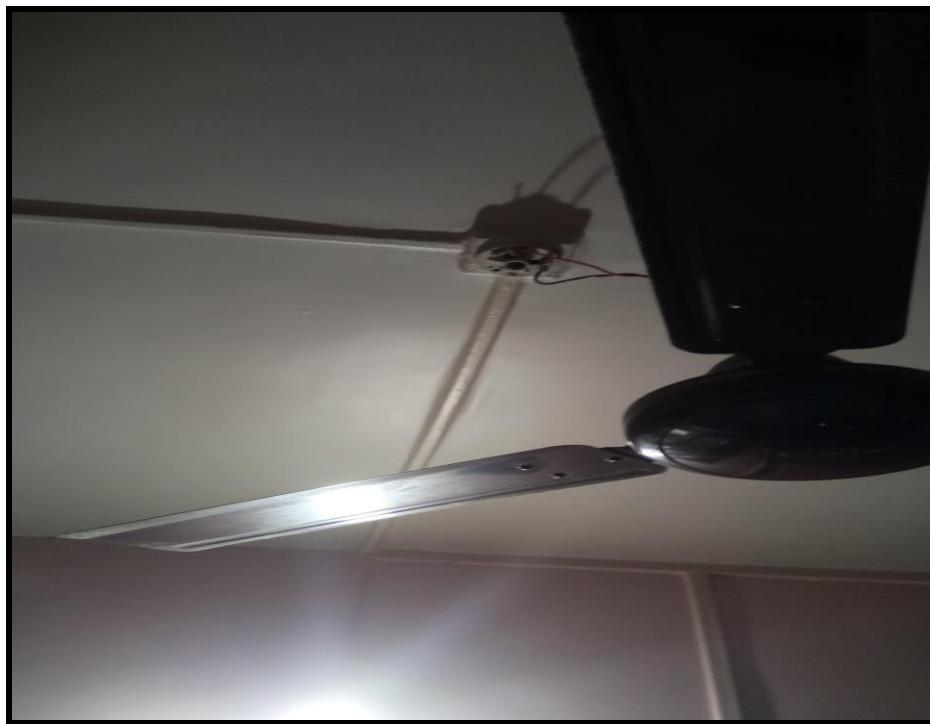
❖ TOILET & BATH ROOM – O.K.

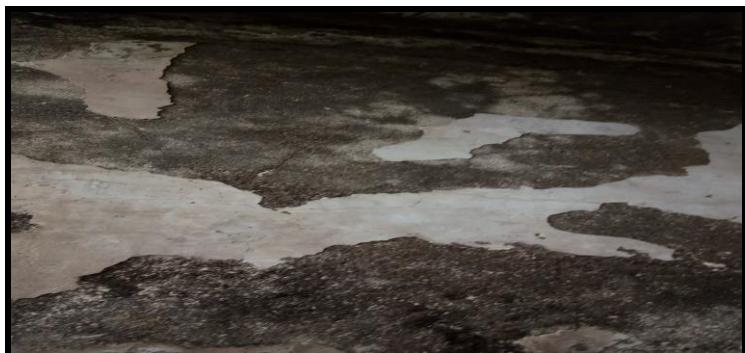
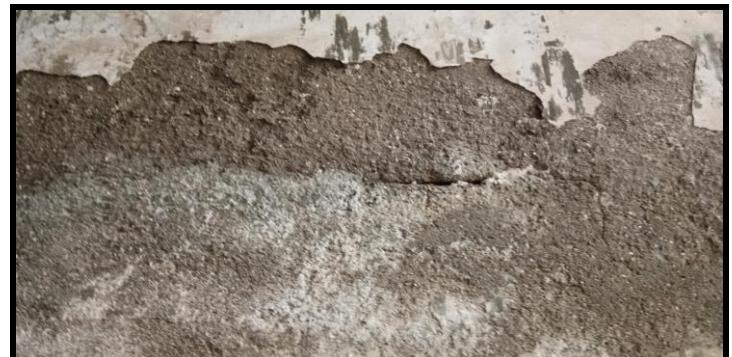
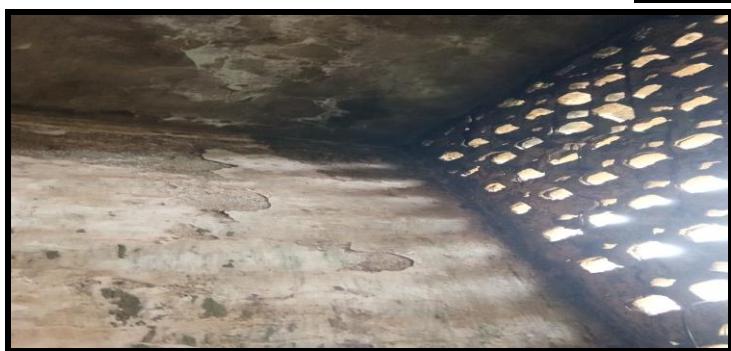
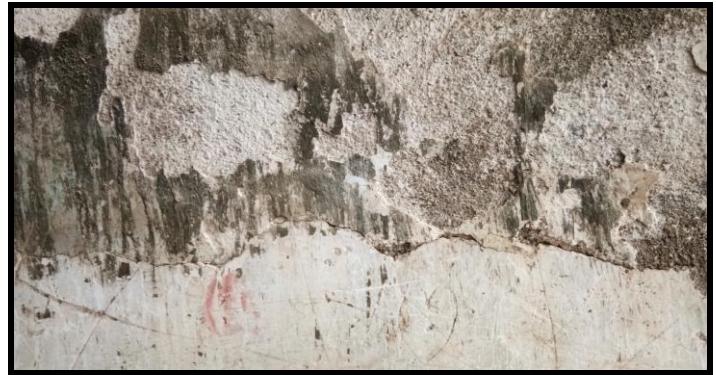
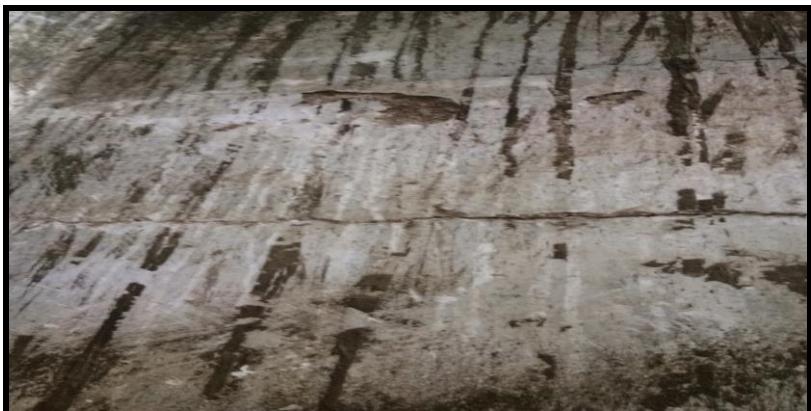
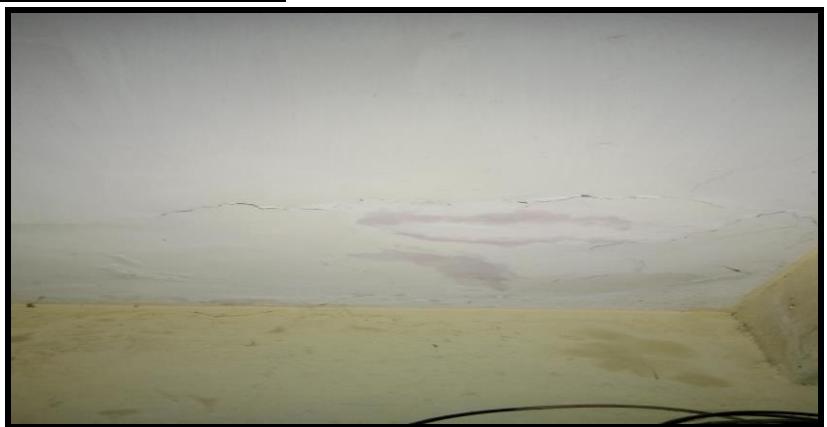
Terrace to fourth floor:-

- ❖ Peeling of paint observed on wall.
- ❖ Crack observed on wall.
- ❖ Seepage mark observed on ceiling.
- ❖ Major structural crack observed on wall.

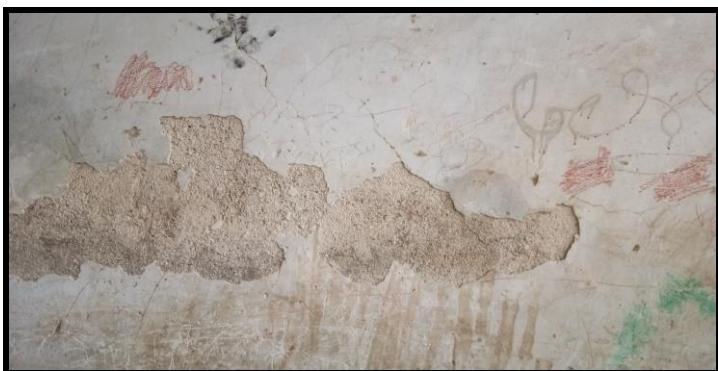
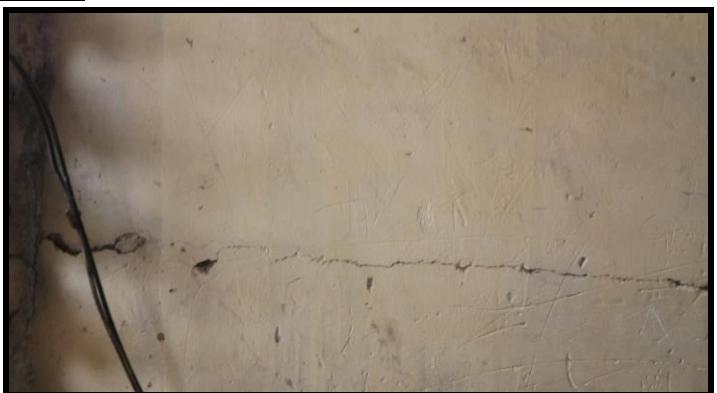
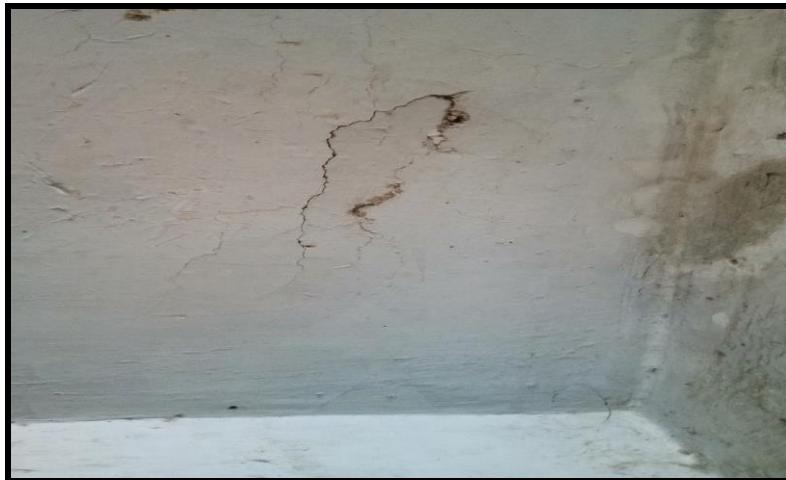
Fourth floor to Third floor:-

- ❖ Peeling of paint observed on wall.
- ❖ Crack observed on wall.

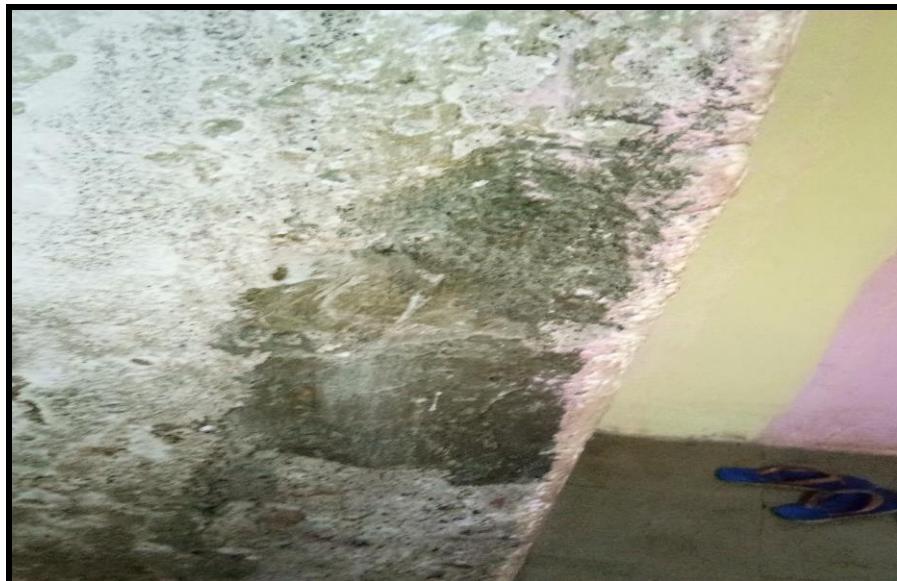
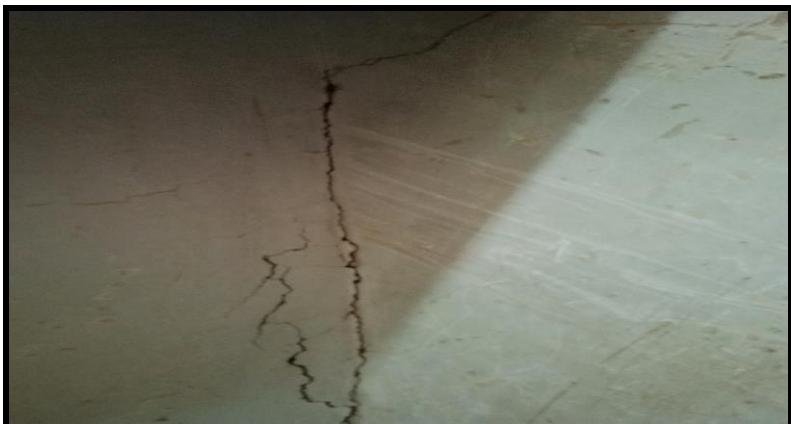
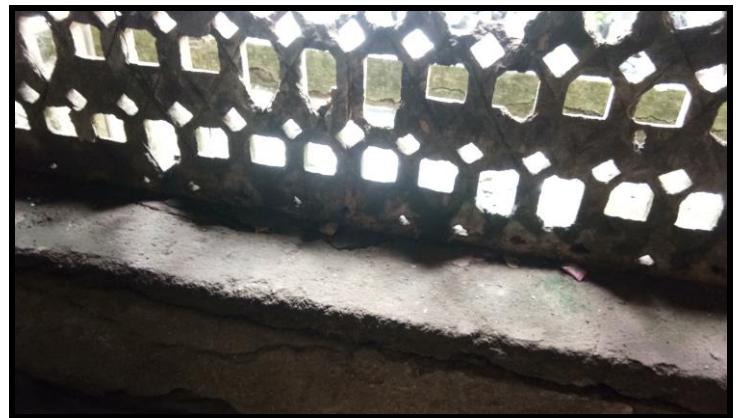
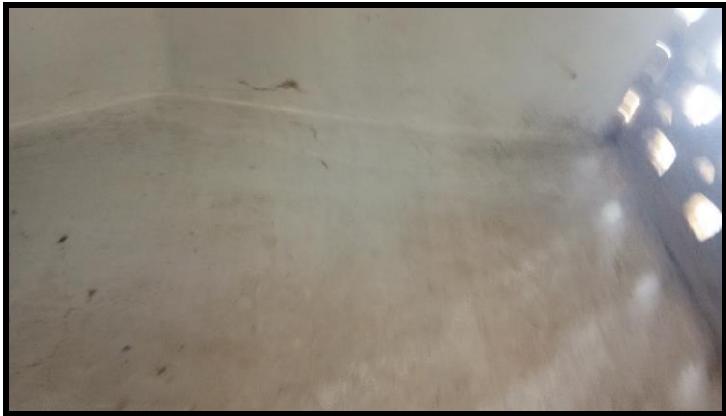
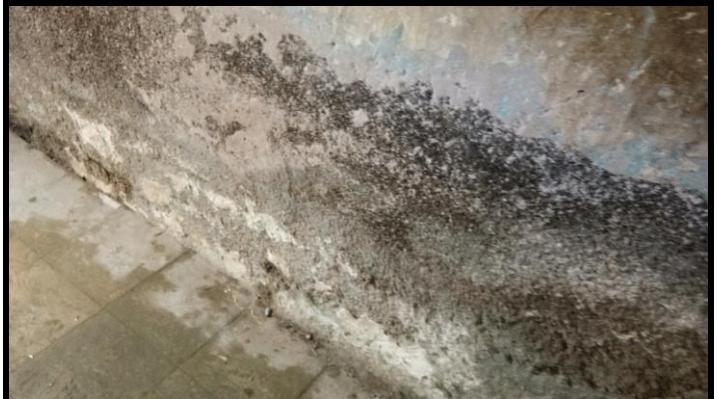
First floor to Ground floor:-

- ❖ Algae formation observed on wall.
- ❖ Seepage mark observed on wall.
- ❖ Dampness observed on ceiling.
- ❖ Major structural crack observed on ceiling.

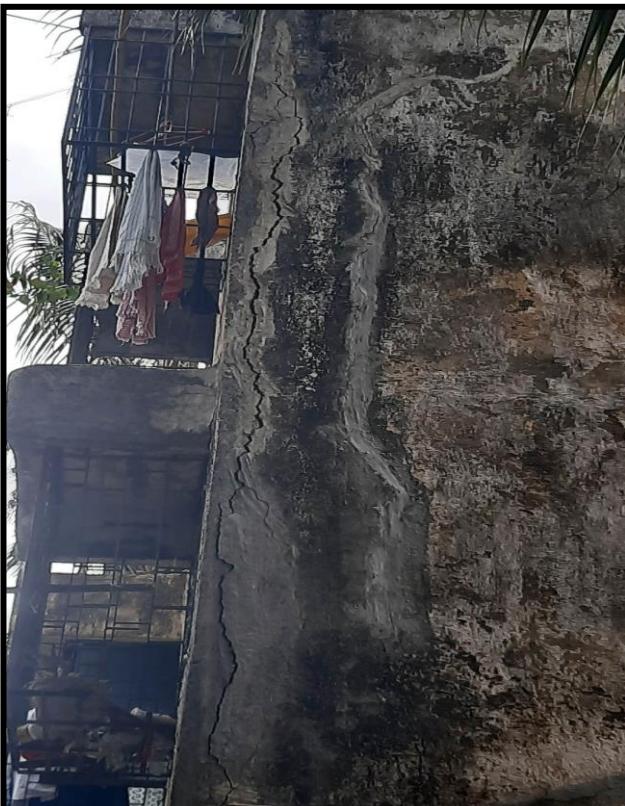
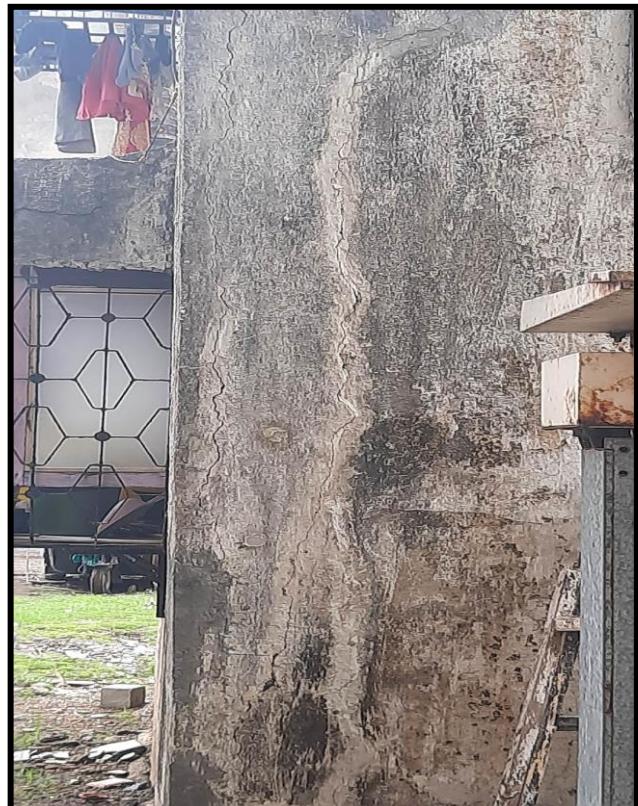
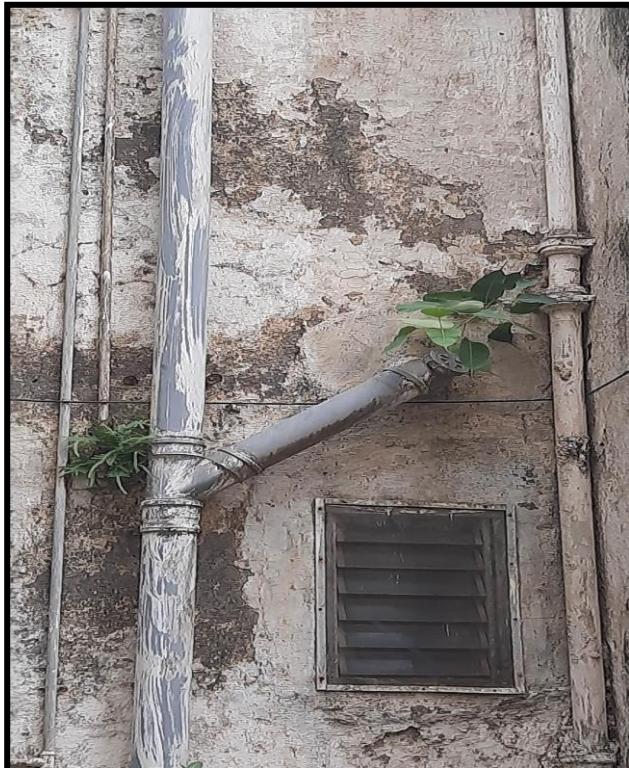
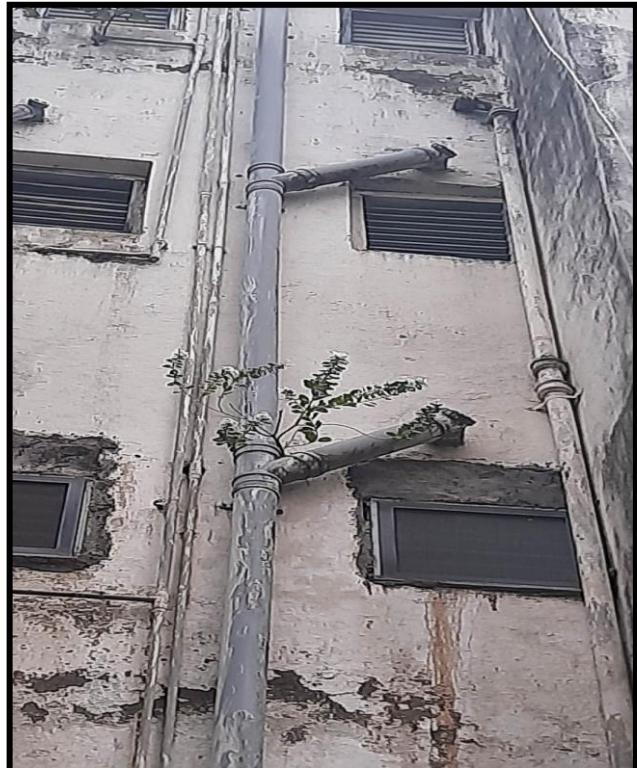
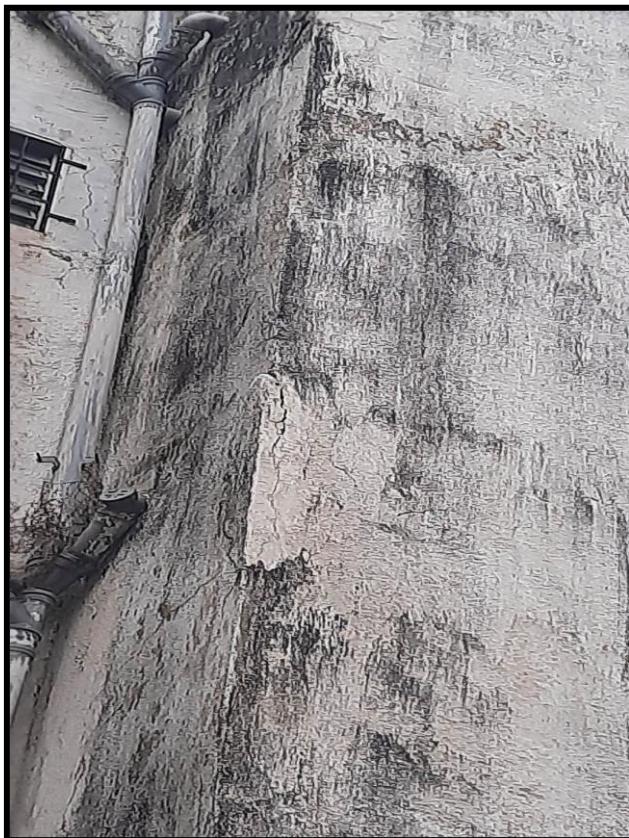
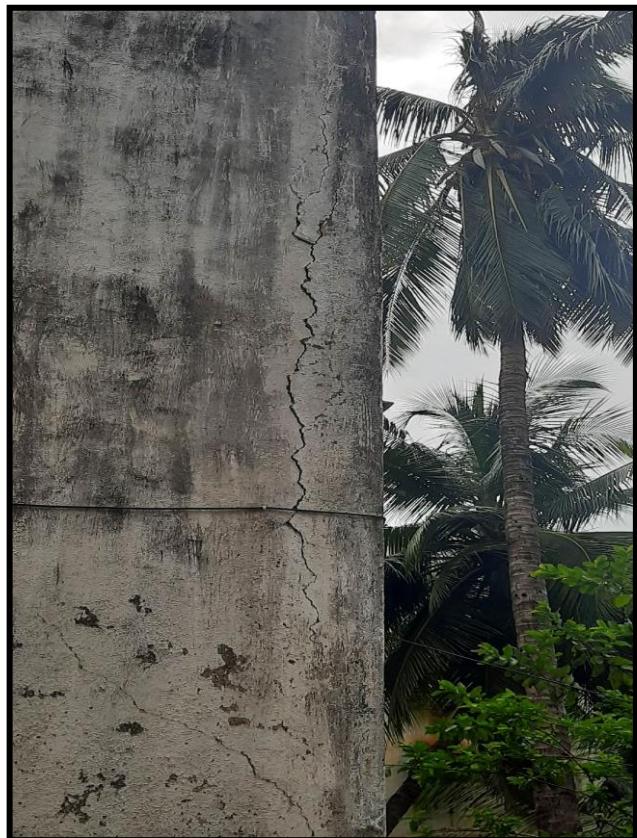
FRONT SIDE

- ❖ Structural crack observed at several places on column.
- ❖ Major crack observed at several places on wall.
- ❖ Vegetation growth observed at several places on wall.

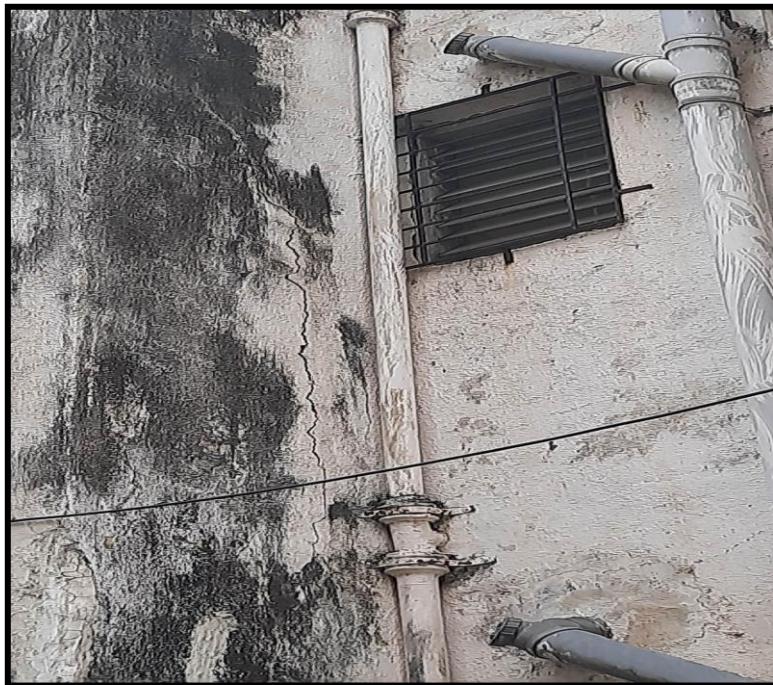
BACK SIDE

- ❖ Structural crack observed at several places on column.
- ❖ Major crack observed at several places on wall.
- ❖ Vegetation growth observed at several places on wall.

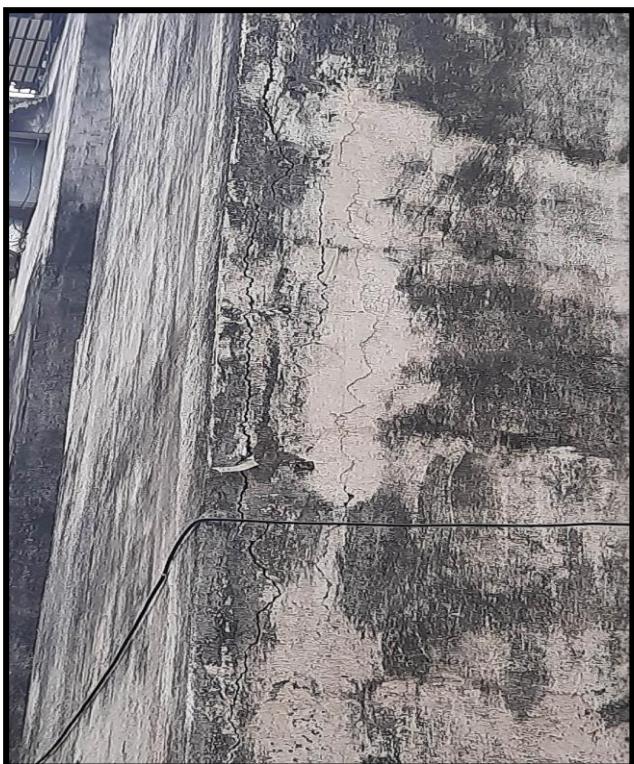
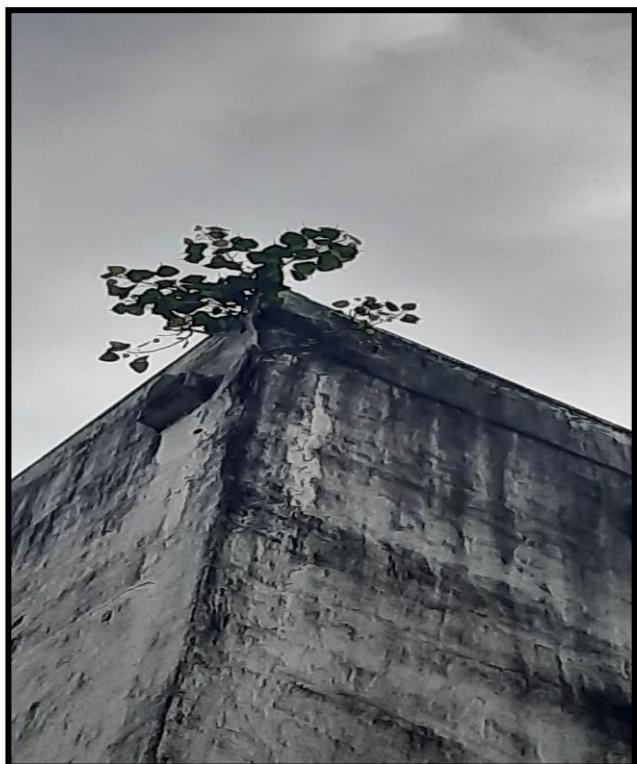
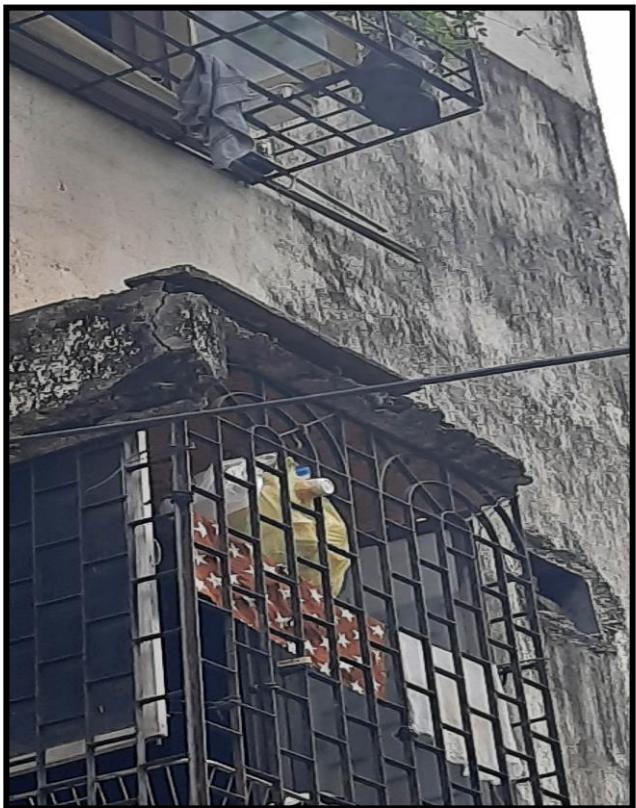
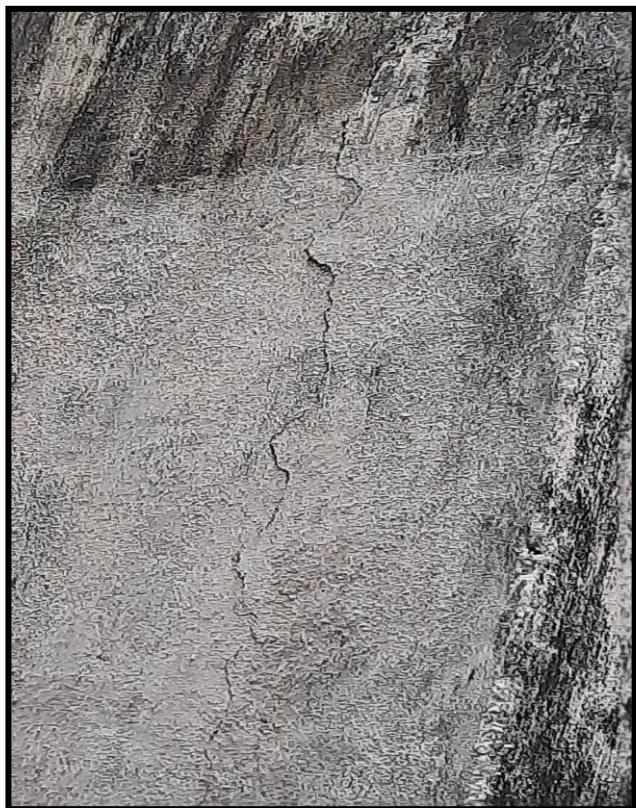
NORTH SIDE

- ❖ Structural crack observed at several places on column.
- ❖ Major crack observed at several places on wall.
- ❖ Vegetation growth observed at several places on wall.

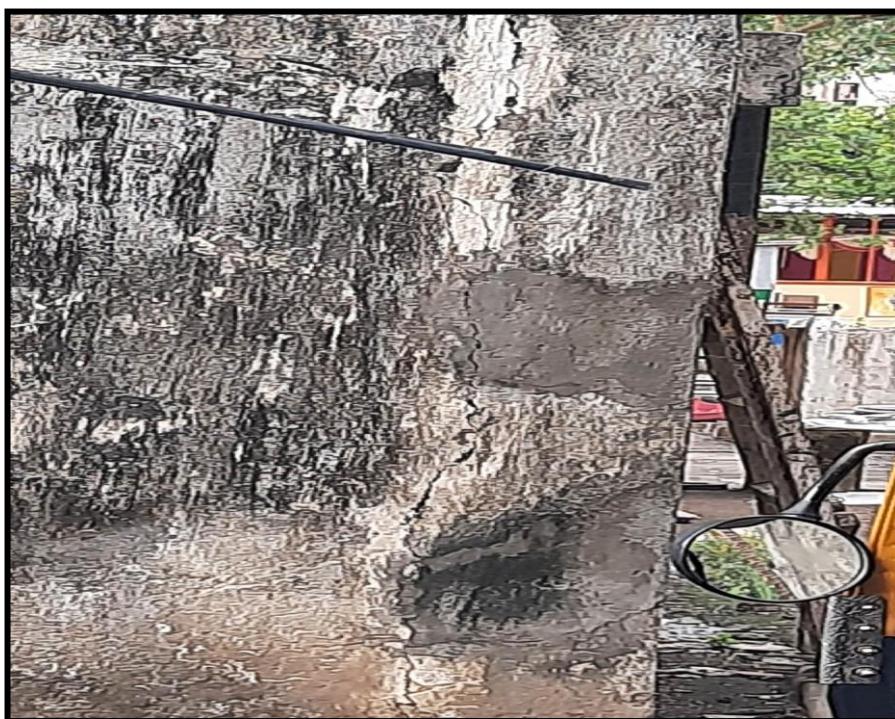
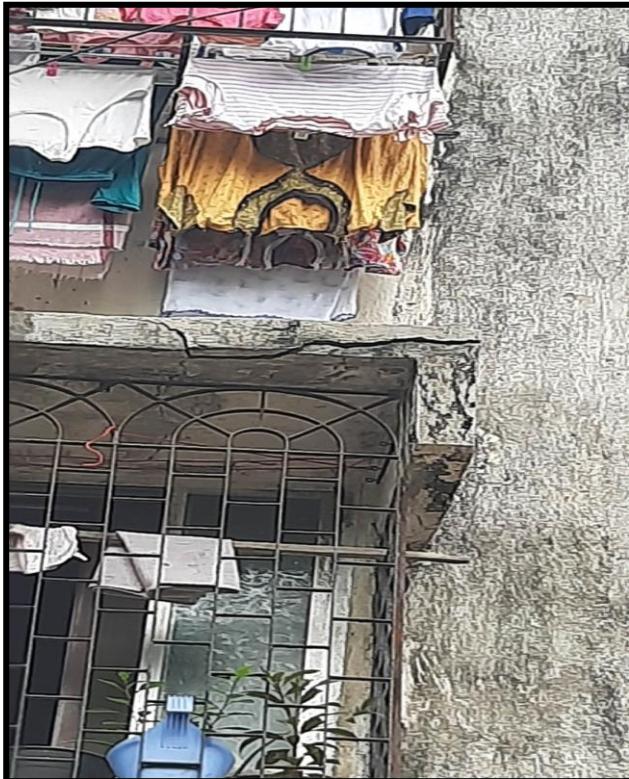
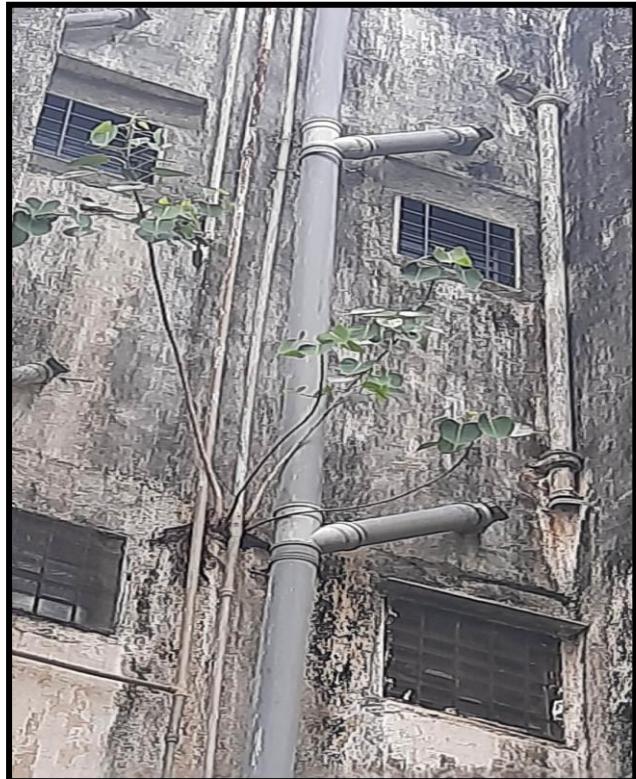
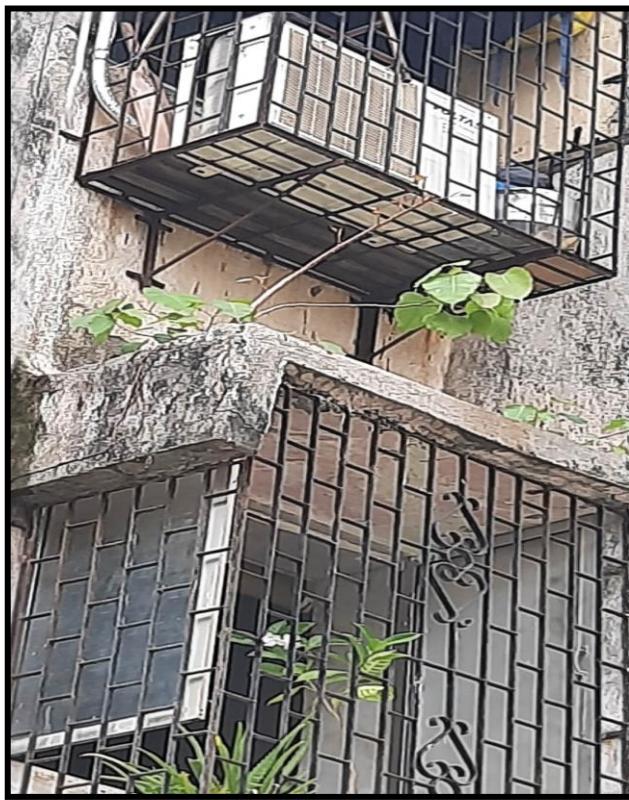
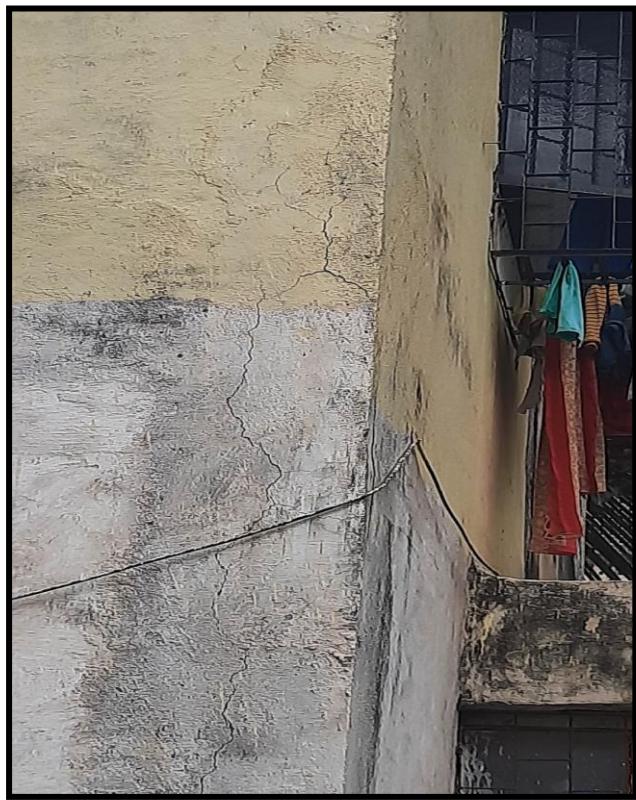
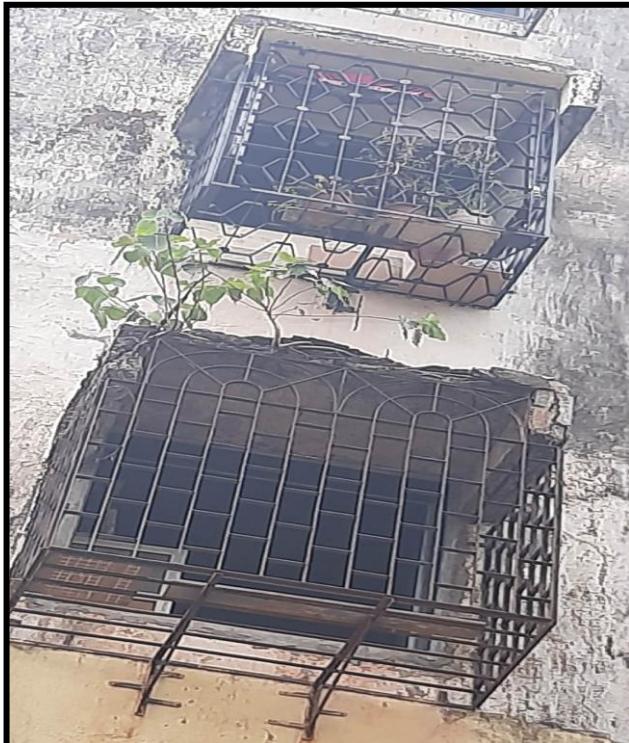
SOUTH SIDE

- ❖ Structural crack observed at several places on column.
- ❖ Major crack observed at several places on wall.
- ❖ Vegetation growth observed at several places on wall.
