STRUCTURAL AUDIT REPORT
FOR
“VISHAL SAHYADRI CO – OP HSG. SOC. LTD”,
“D2 – F WING”
SITUATED AT
SAHYADRI NAGAR, CHARKOP,
KANDIVALI (W) MUMBAI – 400 067

PREPARED BY
LATESH S. SANKLECHA
CONSULTING STRUCTURAL ENGINEERS

978/D2/LSS/2021

JULY 24, 2021

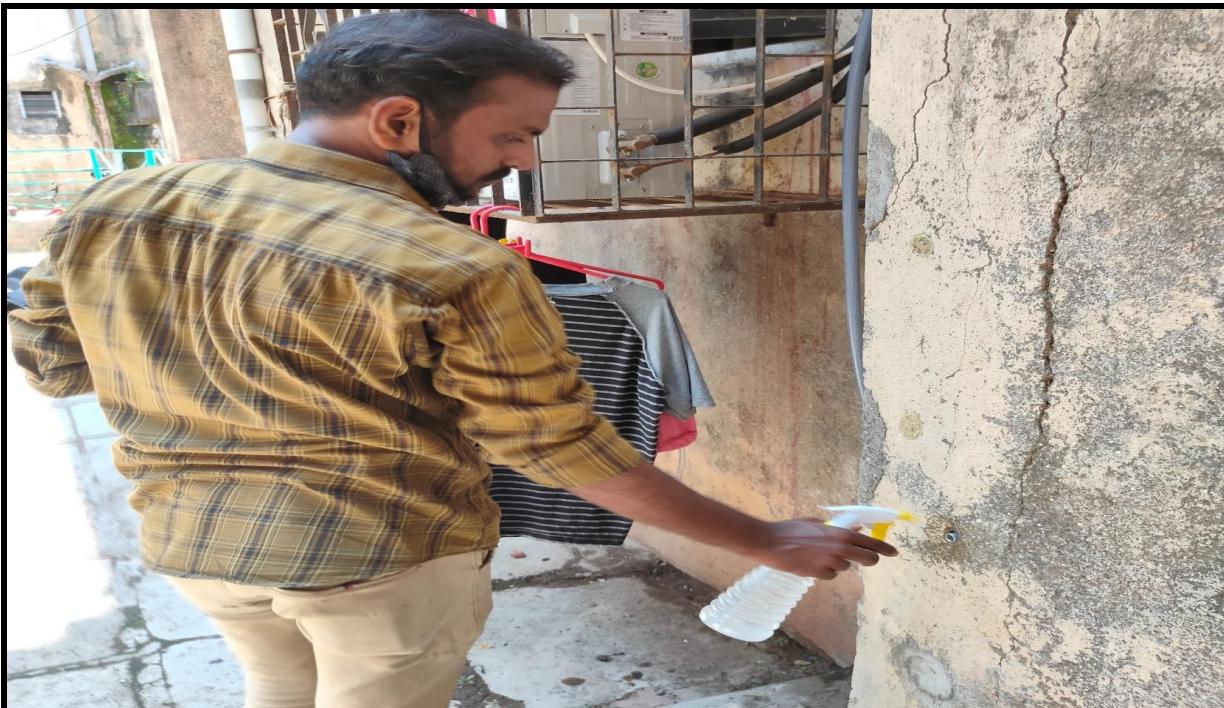
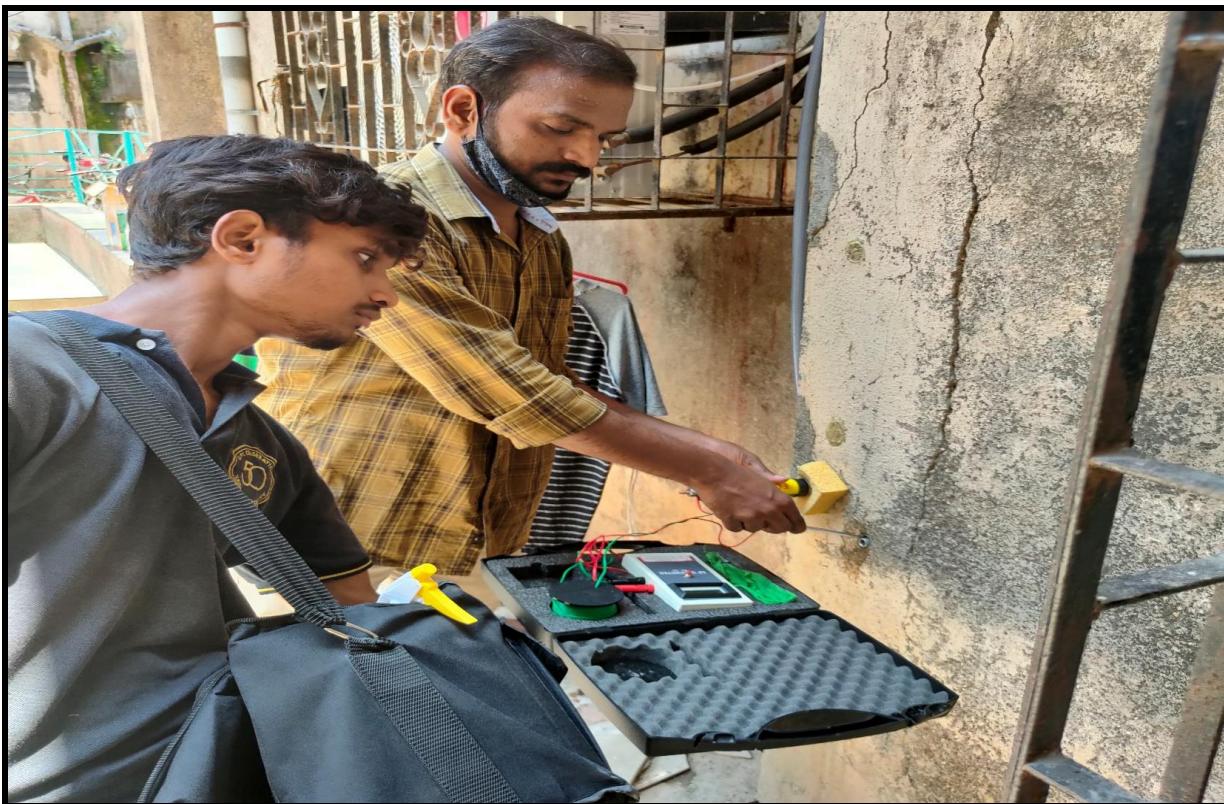
NON -DESTRUCTIVE TEST PHOTO

Rebound Hammer was tested for compressive strength at surface by Schmidt rebound hammer. Results indicate the compressive strength at surface of the RCC columns & beam in is ranging between 14.90 MPa to 20.30 MPa.

The UPV values are ranging between 2.50 Km/Sec to 3.10 Km/Sec.

Out of 4 locations 2 locations was below 3.0 Km/Sec means concrete quality is poor and 2 location ranging between 3.0 to 3.75 Km/Sec means concrete quality is doubtful.

This indicates there are progressive internal cracks in the RCC members due to corrosion of reinforced steel. These members are under distress condition.

RCC elements indicating UPV values less than 3 Km/sec needs immediate attention.

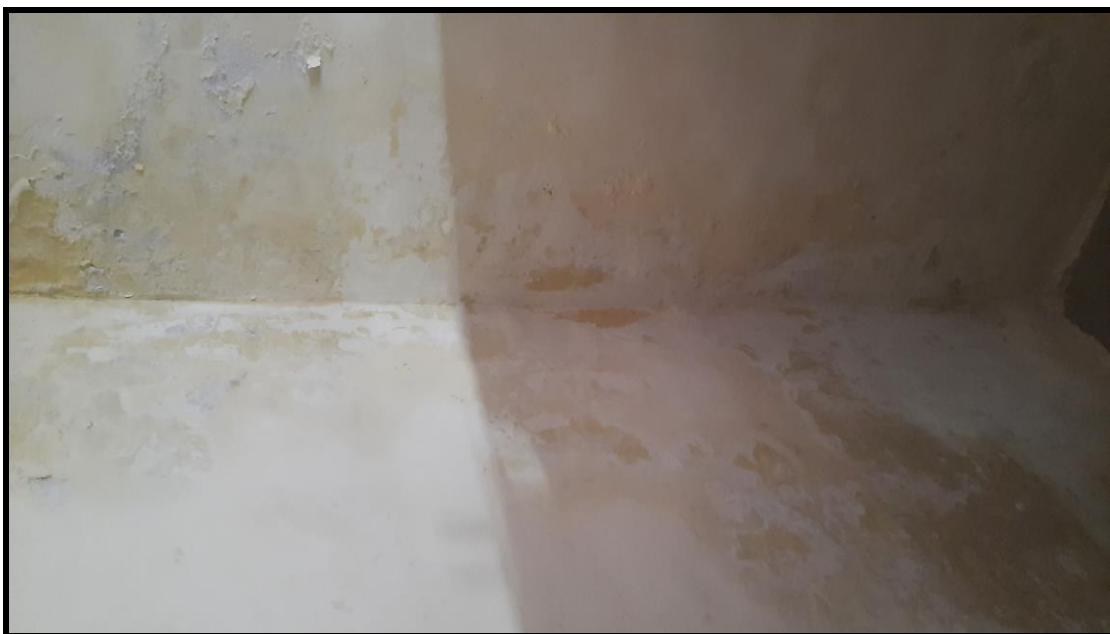
FLAT NO – 02

- ❖ **HALL** – Leakage mark observed on wall.
- ❖ **KITCHEN** – O.K.
- ❖ **PASSAGE** – O.K.
- ❖ **TOILET & BATH ROOM** – O.K.

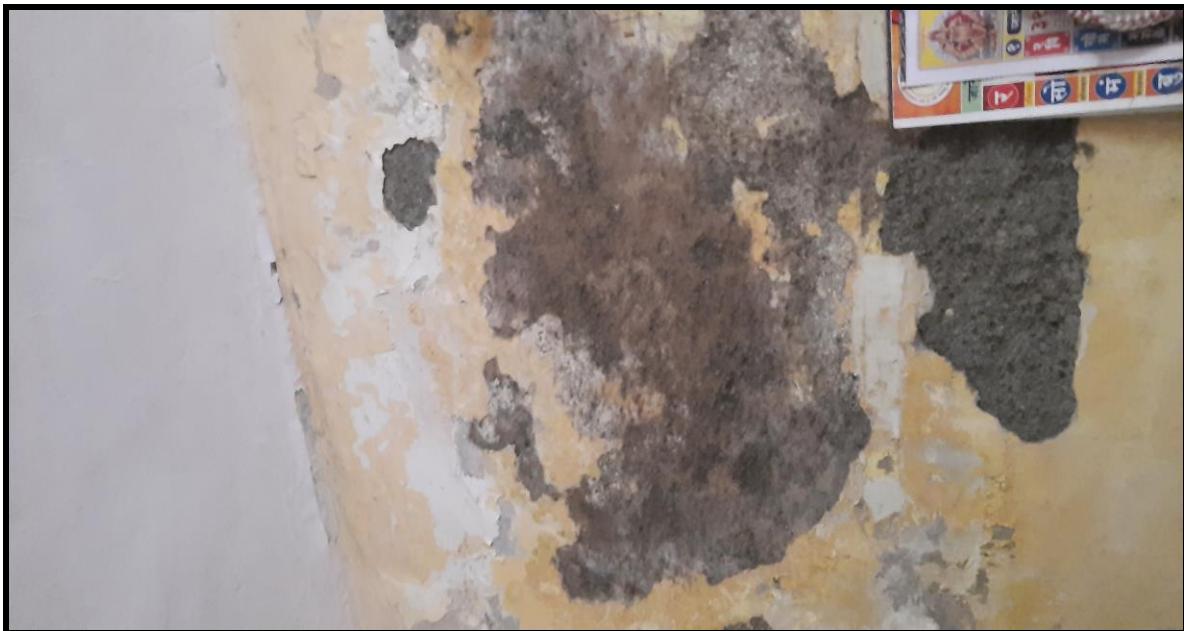
FLAT NO – 04

- ❖ **HALL** – Leakage mark observed on wall.
- ❖ **KITCHEN** – O.K.
- ❖ **PASSAGE** – O.K.
- ❖ **TOILET & BATH ROOM** – O.K.

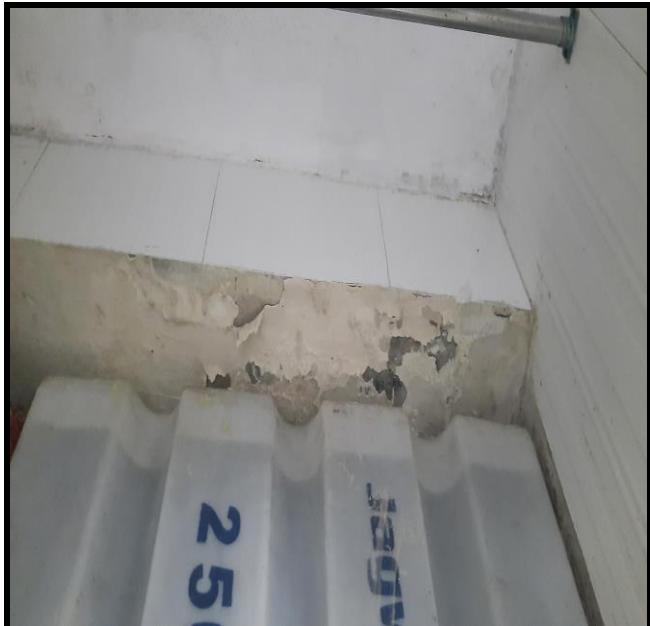
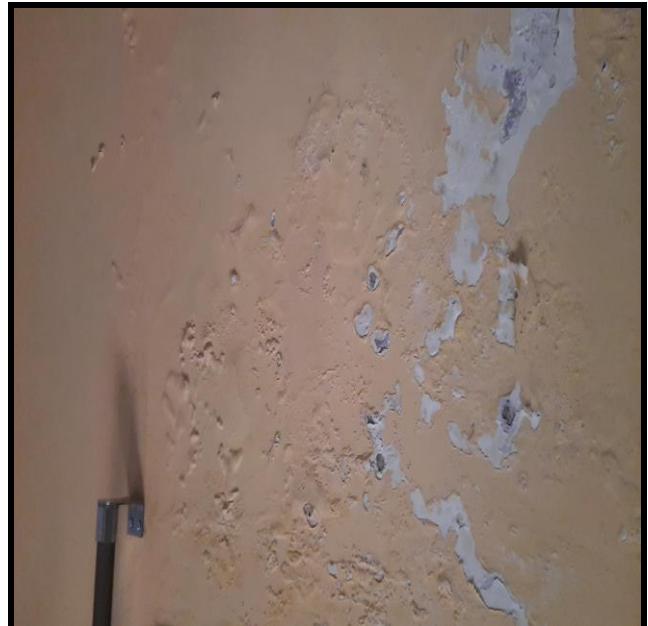
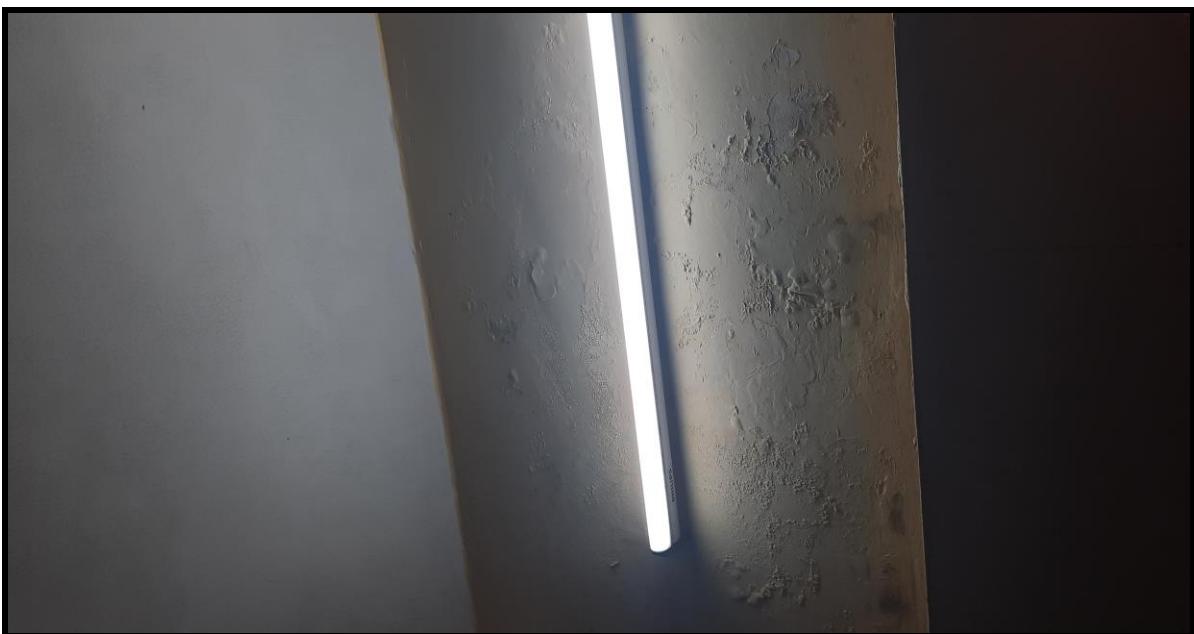
FLAT NO – 101

- ❖ **HALL** – Leakage mark observed on wall.
- ❖ **KITCHEN** – O.K.
- ❖ **PASSAGE** – Leakage mark observed on ceiling.
- ❖ **TOILET & BATH ROOM** – O.K.

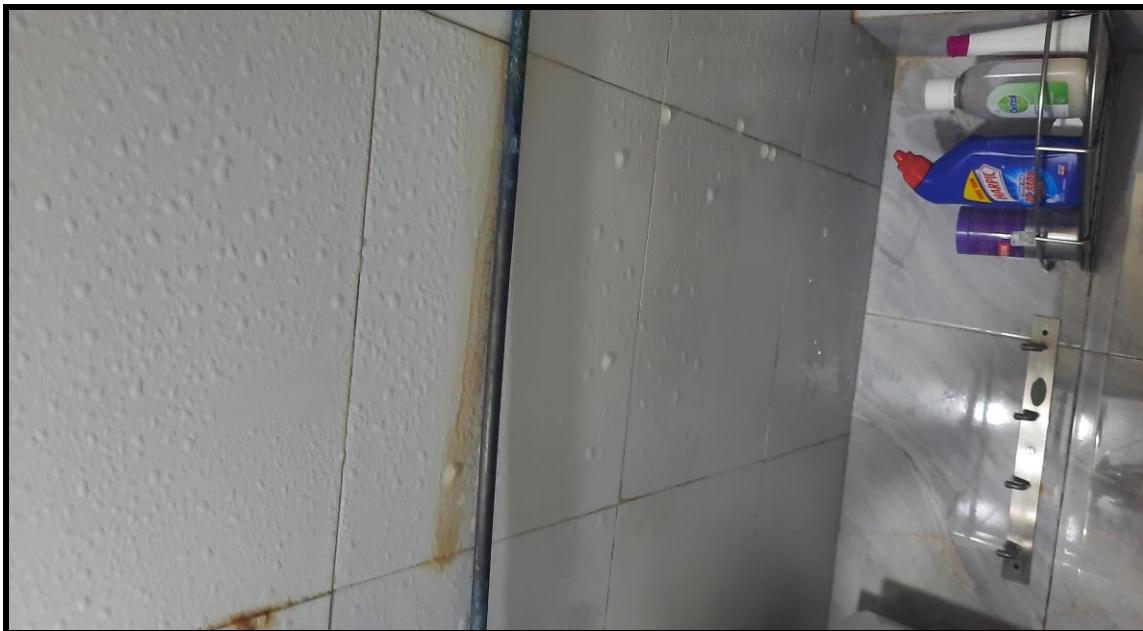
FLAT NO – 103

- ❖ **HALL** – O.K.
- ❖ **KITCHEN** – O.K.
- ❖ **PASSAGE** – O.K.
- ❖ **TOILET & BATH ROOM** – Leakage observed on ceiling.

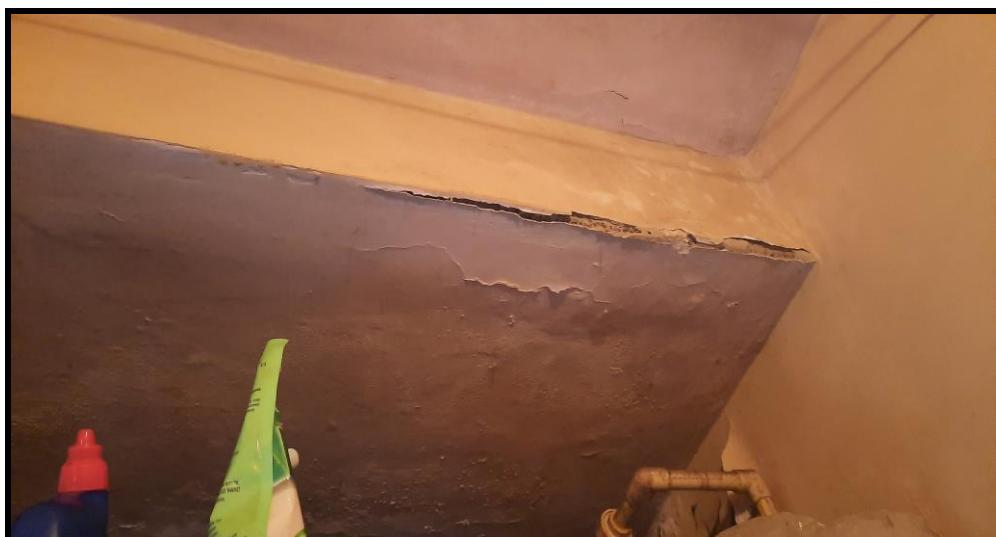
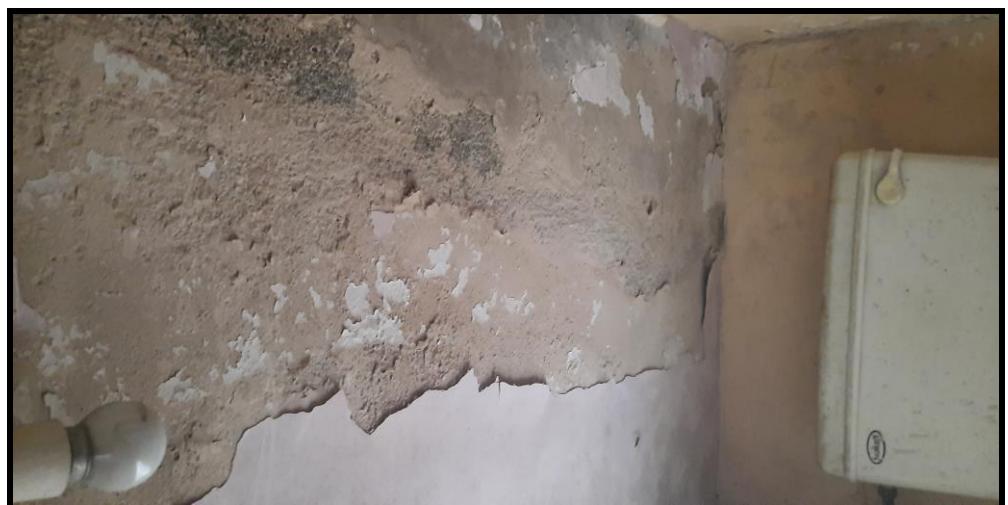
FLAT NO – 204

- ❖ **HALL** – O.K.
- ❖ **KITCHEN** – Leakage mark observed on wall.
- ❖ **PASSAGE** – Leakage mark observed on ceiling.
- ❖ **TOILET & BATH ROOM** – Leakage mark observed on ceiling.

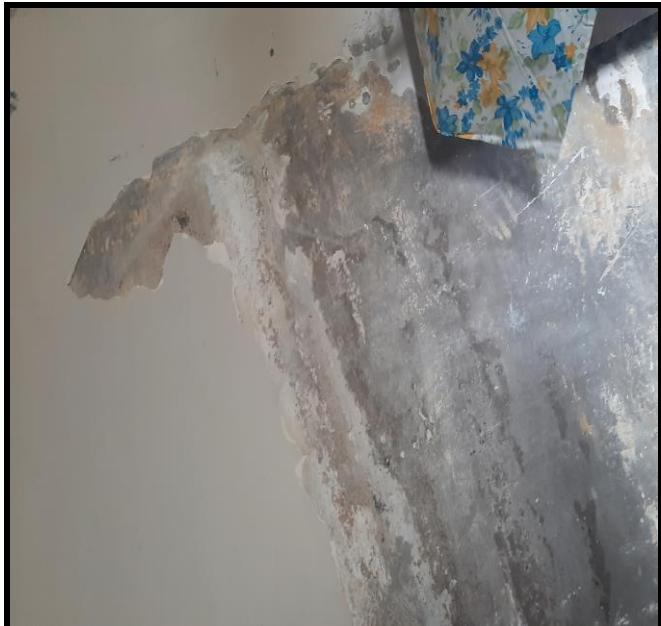
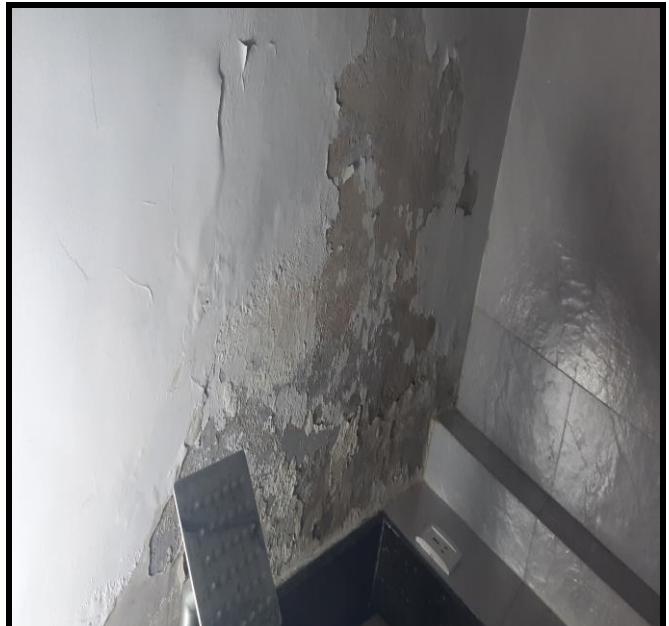
FLAT NO – 302

- ❖ **HALL** – Leakage mark observed on wall.
- ❖ **KITCHEN** – O.K.
- ❖ **PASSAGE** – O.K.
- ❖ **TOILET & BATH ROOM** – Leakage mark observed on ceiling.

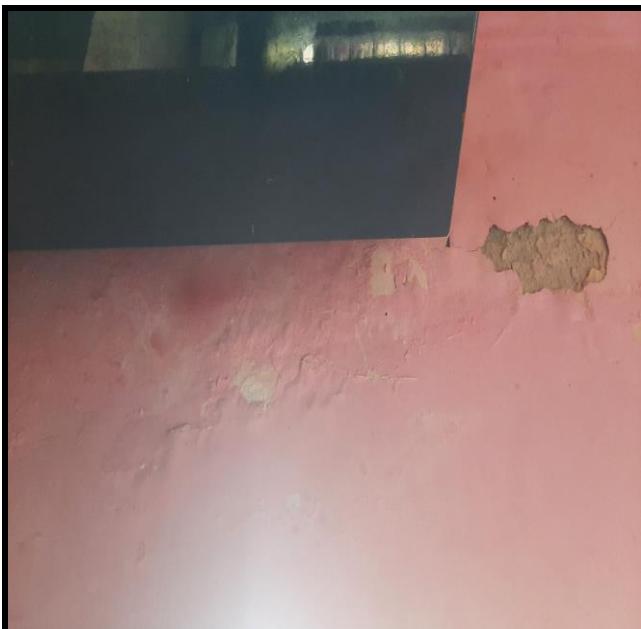
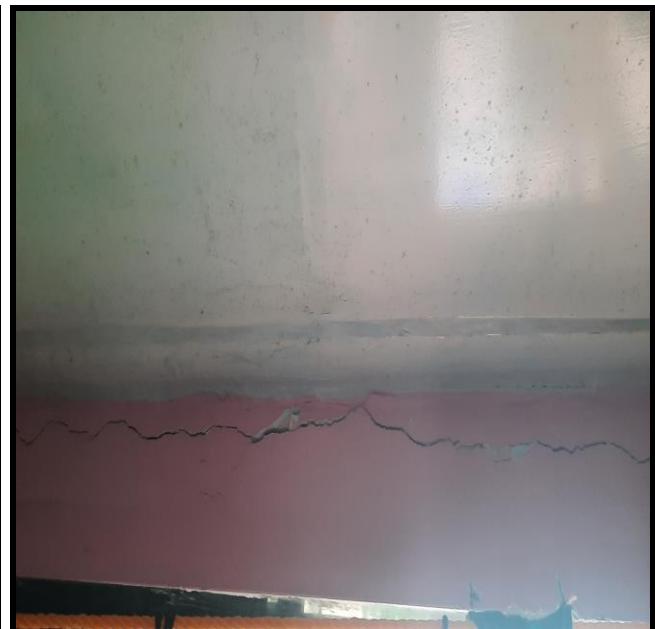
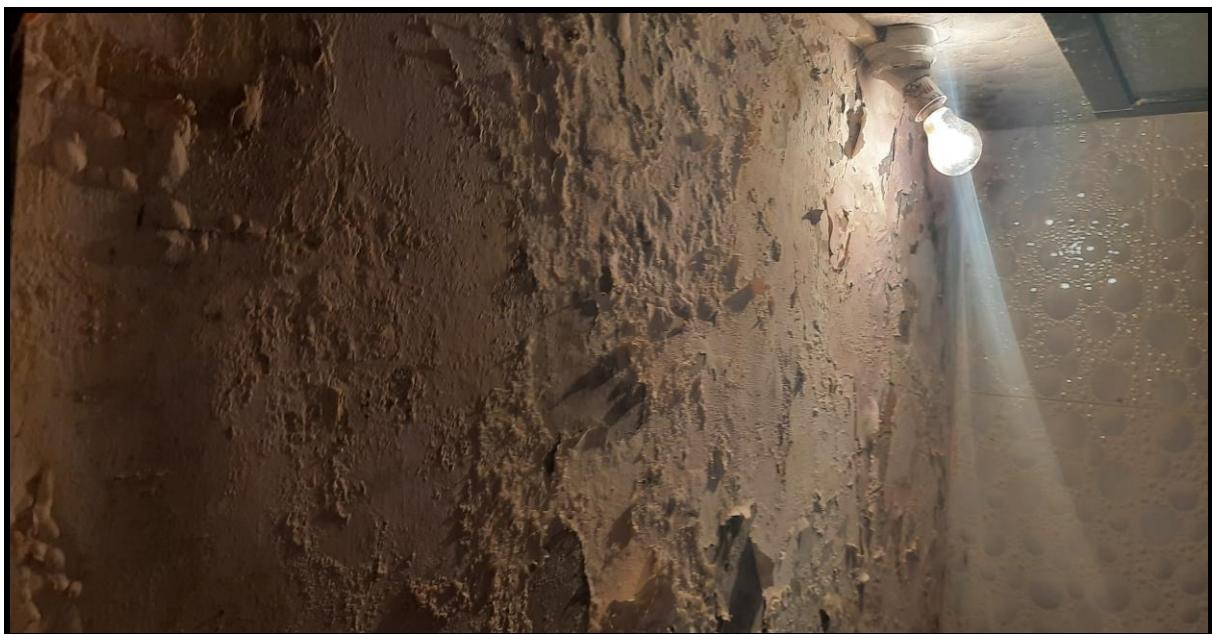
FLAT NO – 402

- ❖ **HALL** – Leakage mark observed on wall.
- ❖ **KITCHEN** – Structural crack observed on beam.
- ❖ **PASSAGE** – O.K.
- ❖ **TOILET & BATH ROOM** – Leakage mark observed on ceiling.

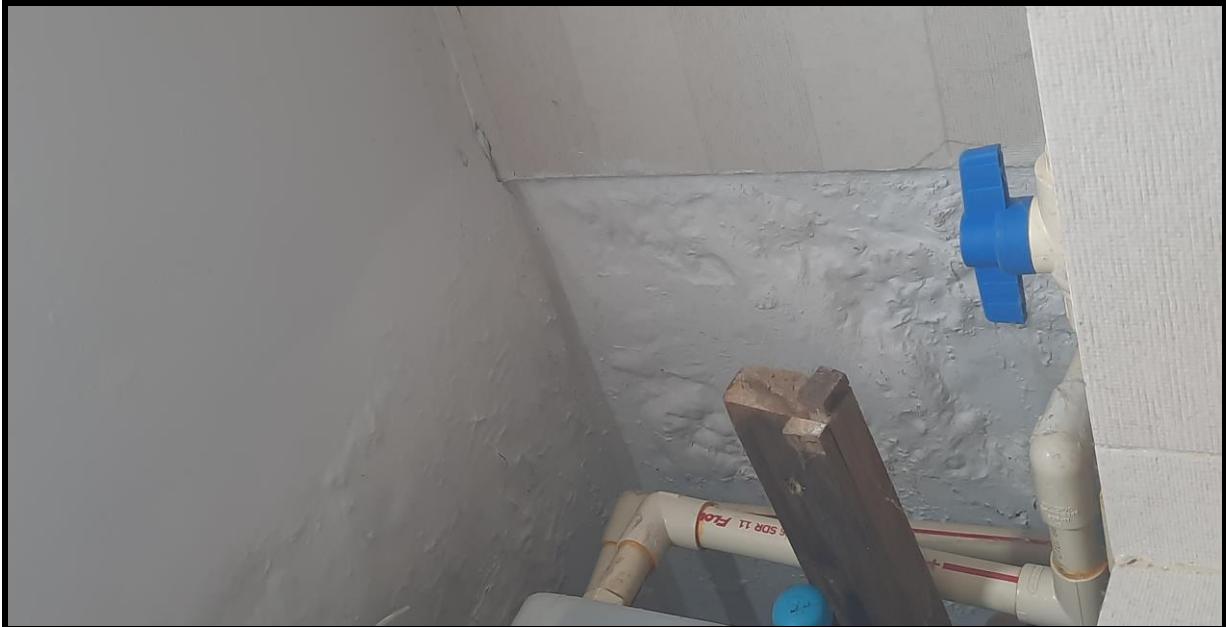
FLAT NO – 602

- ❖ **HALL** – O.K.
- ❖ **KITCHEN** – O.K.
- ❖ **PASSAGE** – Leakage mark observed on ceiling.
- ❖ **TOILET & BATH ROOM** – O.K.

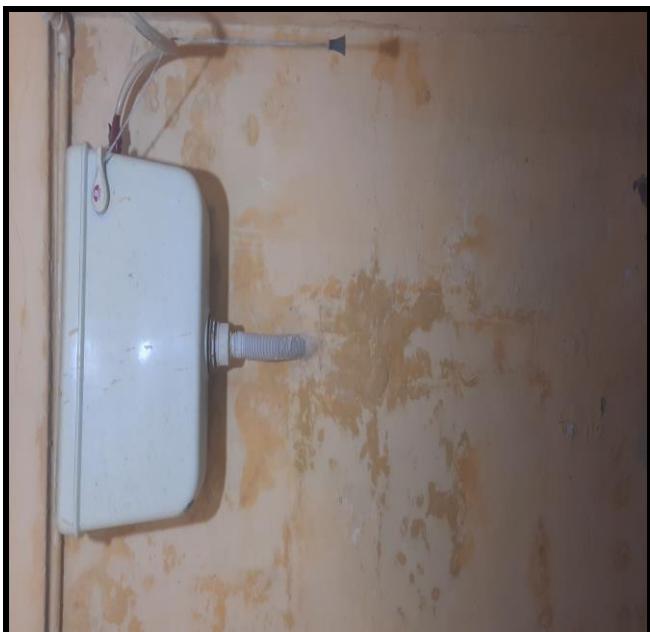
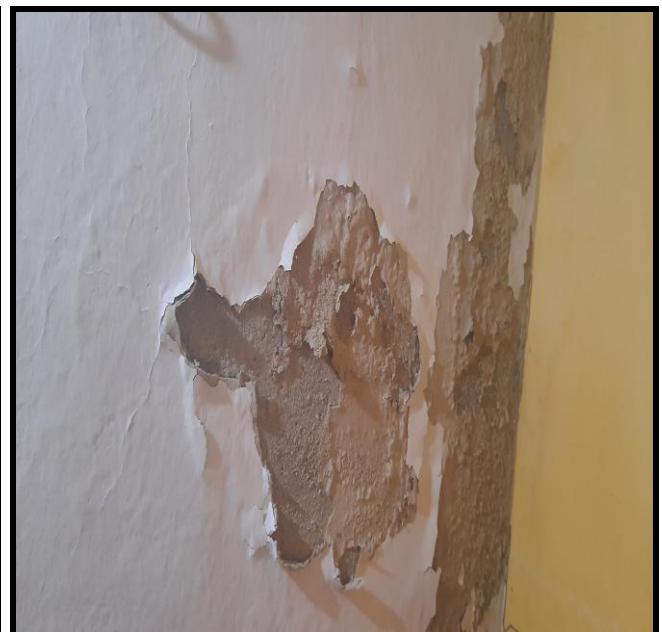
FLAT NO – 703

- ❖ **HALL** – Dampness observed on wall in monsoon.
- ❖ **KITCHEN** – Leakage mark observed on ceiling.
- ❖ **PASSAGE** – O.K.
- ❖ **TOILET & BATH ROOM** – Leakage mark observed on wall.

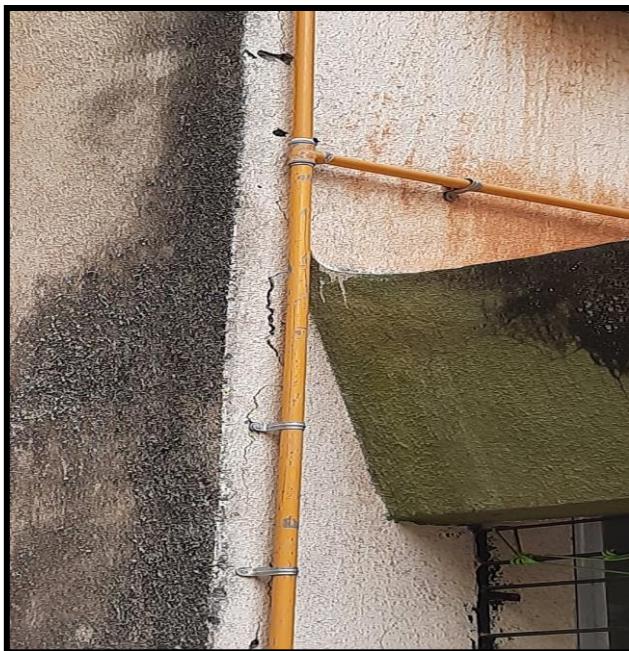
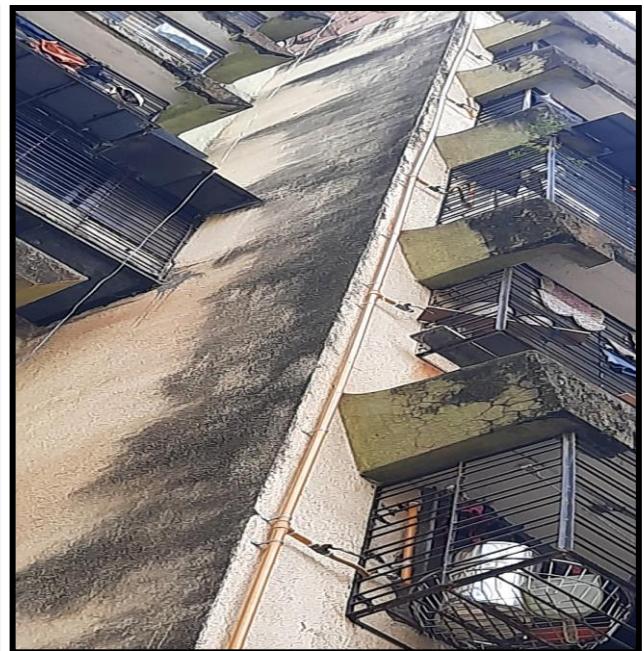
FRONT SIDE

- ❖ Structural crack observed at several places on column.
- ❖ Major crack observed at several places on wall.

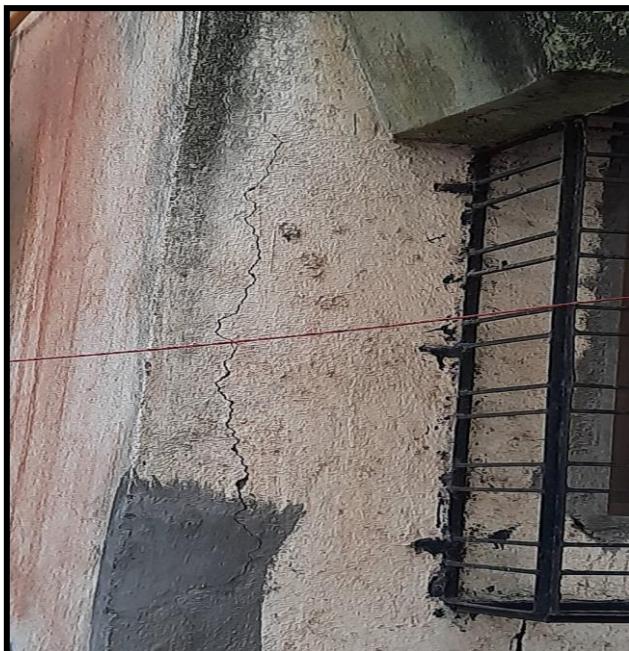
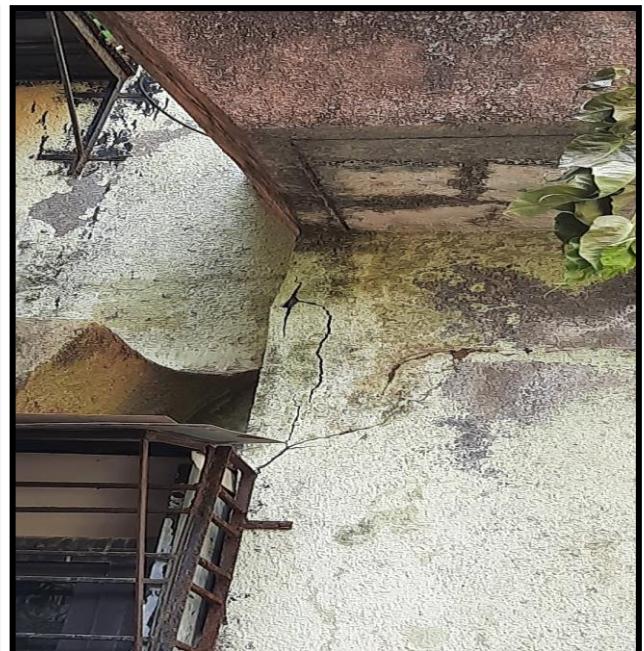
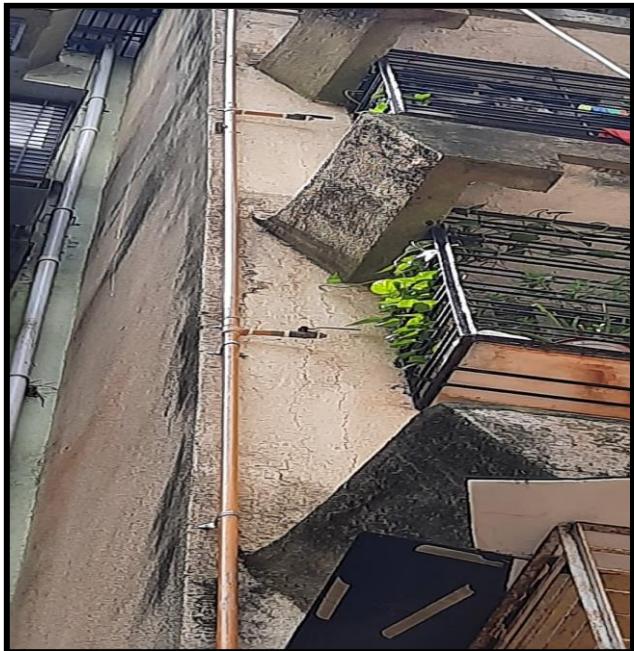
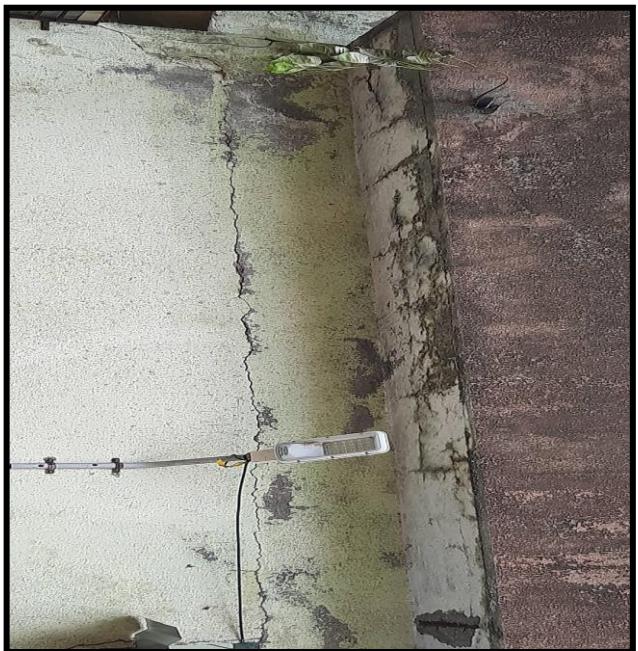
BACK SIDE

- ❖ Structural crack observed at several places on column & chajjas.

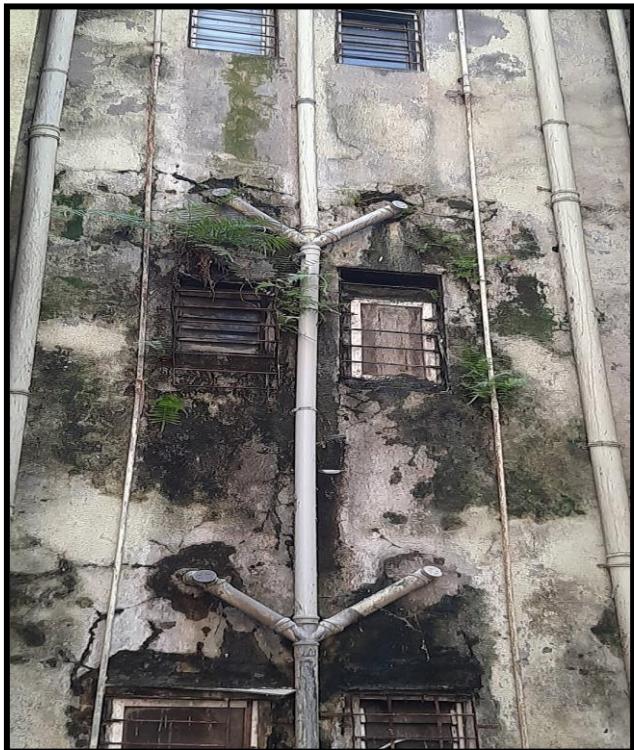
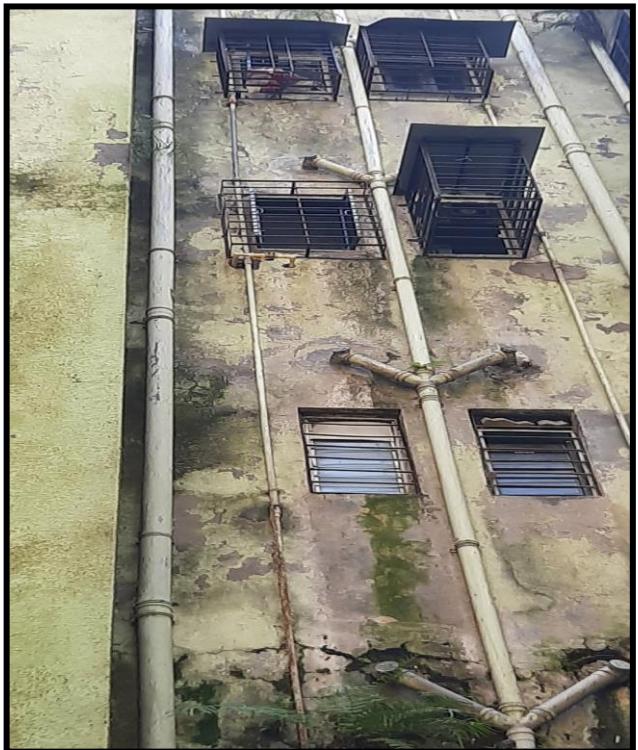
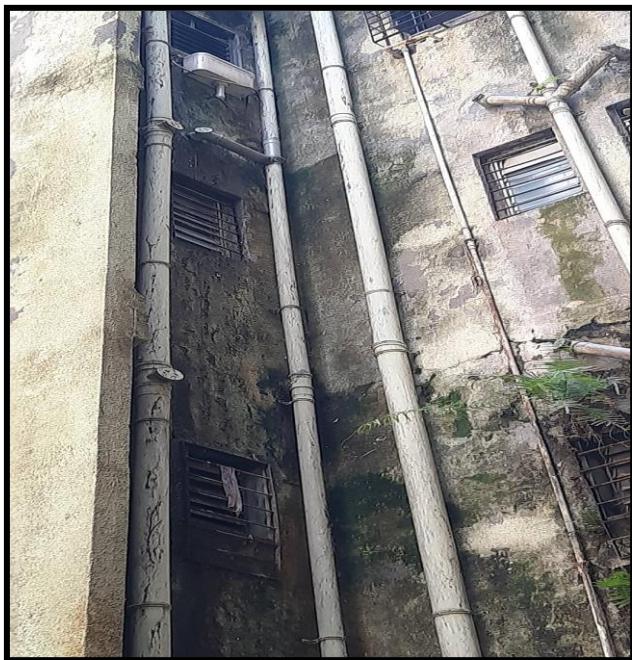
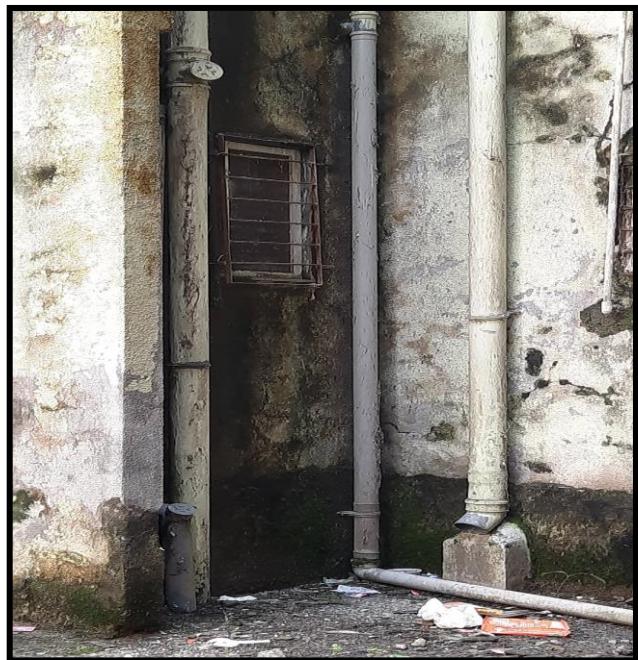
EAST SIDE

- ❖ Vegetation growth observed at several places on wall.
- ❖ Algae observed at several places on wall.

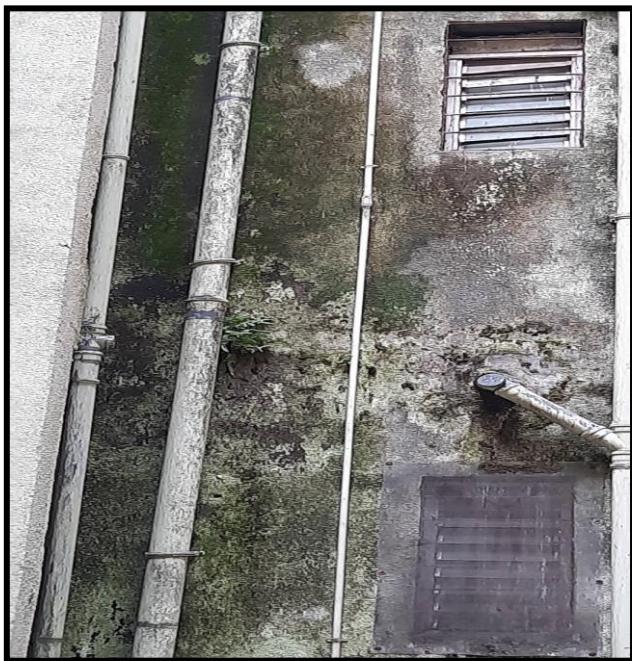
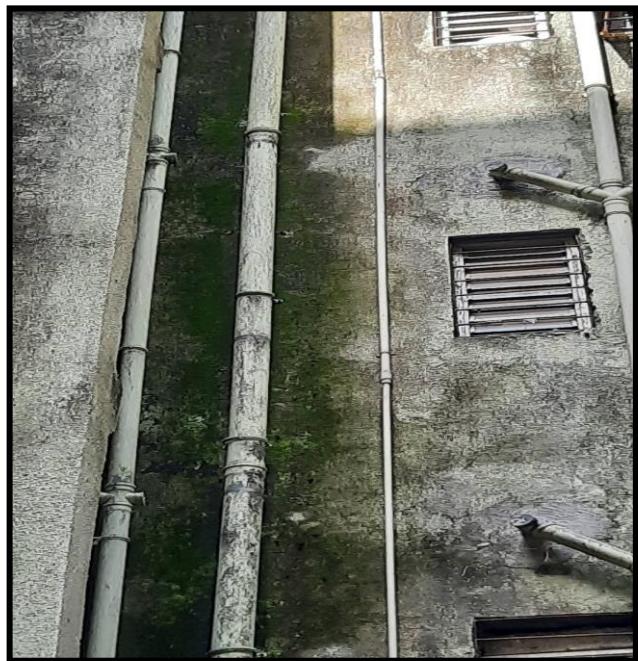
WEST SIDE

- ❖ Algae observed at several places on wall.
- ❖ Vegetation growth observed at several places on wall.
