STRUCTURAL AUDIT REPORT
FOR
“VISHAL SAHYADRI CO – OP HSG. SOC. LTD”,
“D3 – J WING”
SITUATED AT
SAHYADRI NAGAR, CHARKOP,
KANDIVALI (W) MUMBAI – 400 067

978/D3/LSS/2021

JULY 16, 2021

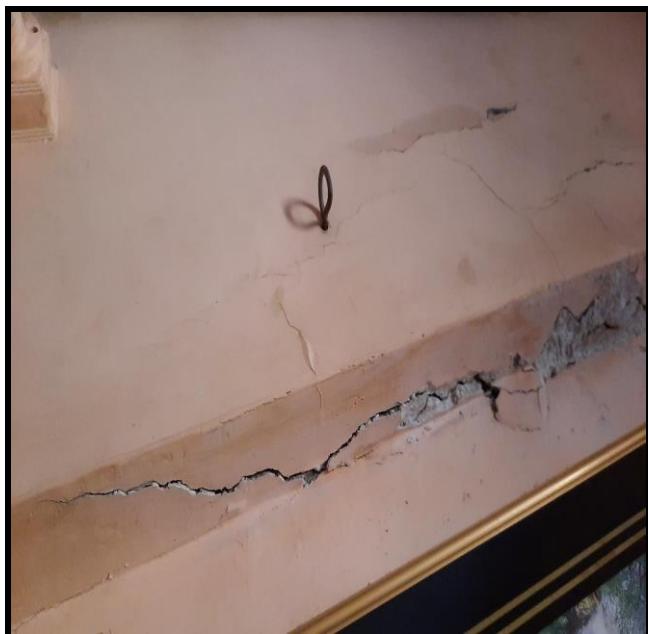
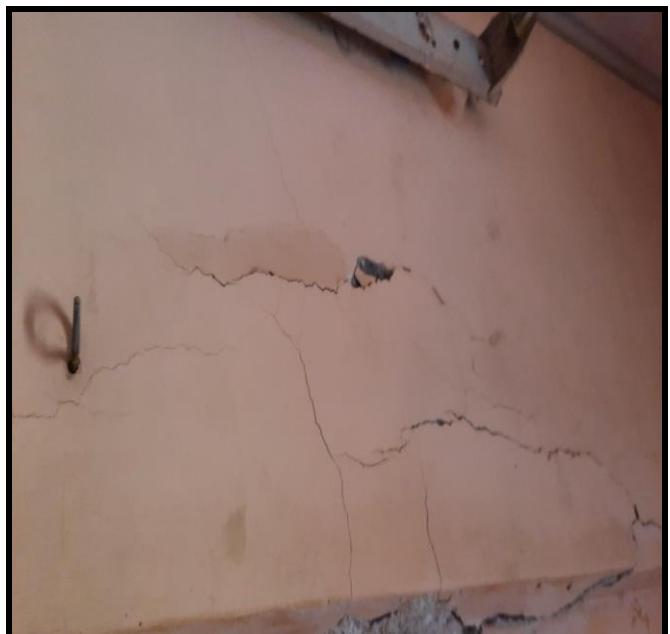
FLAT NO – 01

- ❖ **HALL** – Structural crack observed on beam.
 - Leakage observed on wall in monsoon.
- ❖ **KITCHEN** – O.K.
- ❖ **PASSAGE** – O.K.
- ❖ **TOILET & BATH ROOM** – O.K.

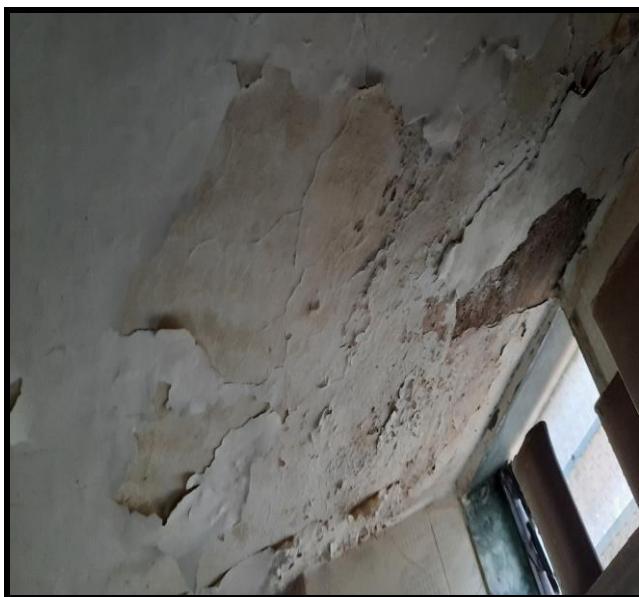
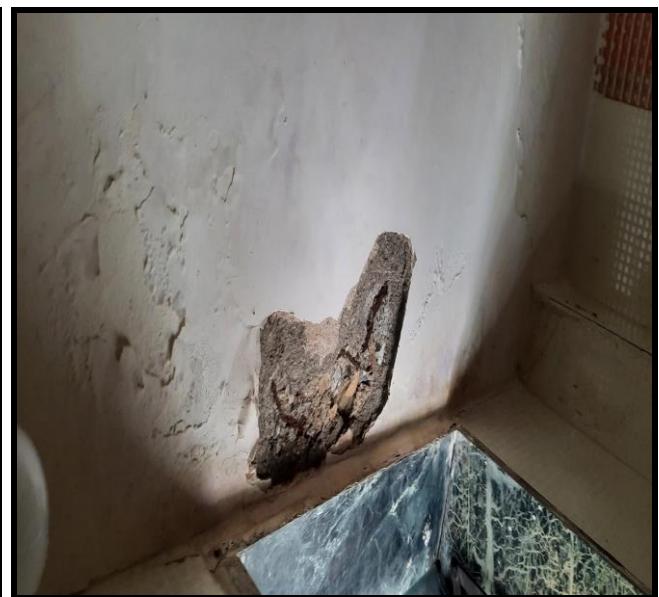
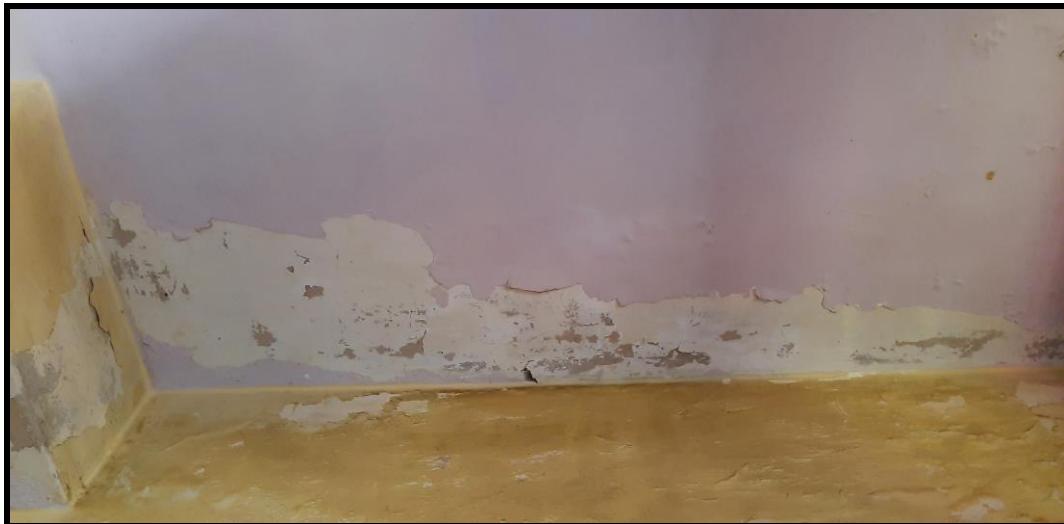
FLAT NO - 08

- ❖ **HALL** – Leakage observed on wall in monsoon.
- ❖ **KITCHEN** – Leakage mark observed on ceiling.
- ❖ **PASSAGE** – O.K.
- ❖ **TOILET & BATH ROOM** – Leakage mark observed on ceiling.
 - Ceiling plaster get damaged & steel get exposed & corroded.

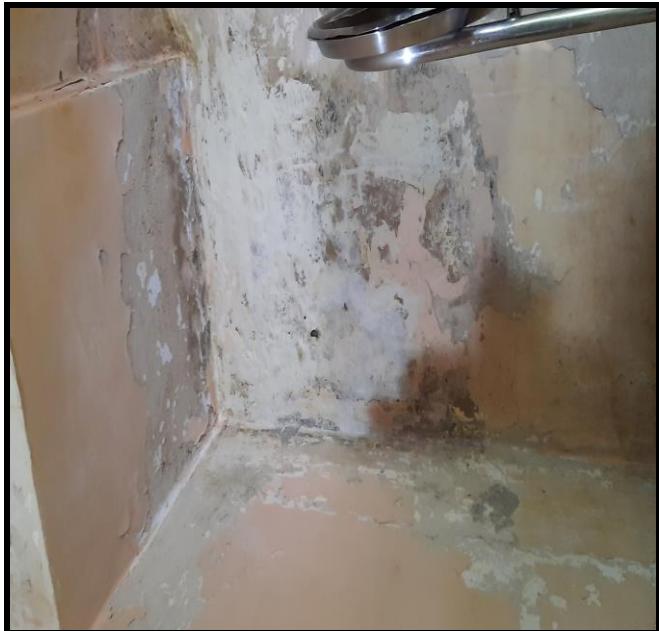
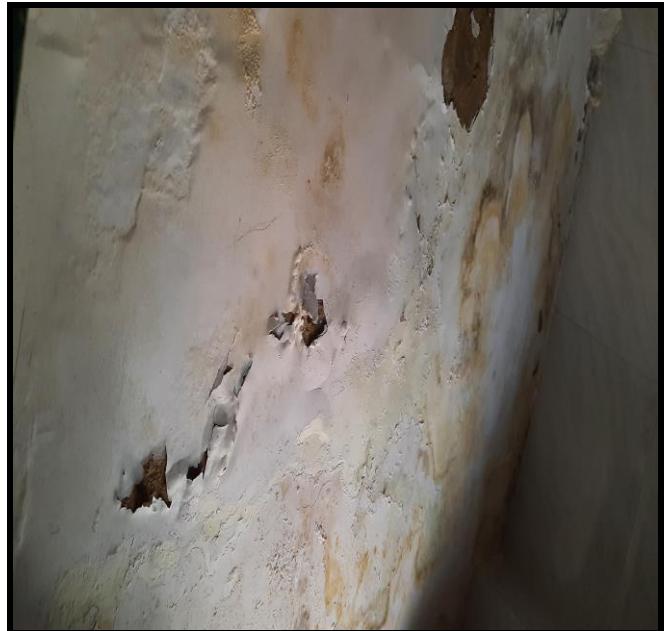
FLAT NO – 14

- ❖ **HALL** – Structural damage observed on ceiling.
- ❖ **KITCHEN** – Leakage mark observed on ceiling.
- ❖ **PASSAGE** – O.K.
- ❖ **TOILET & BATH ROOM** – Leakage mark observed on ceiling.

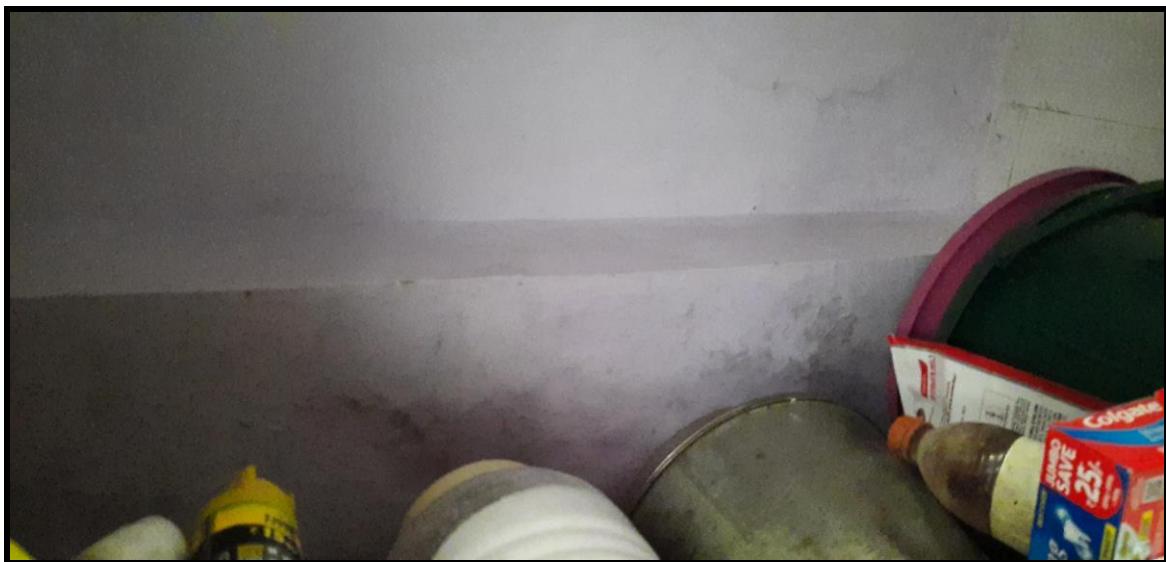
FLAT NO – 18

- ❖ **HALL** – O.K.
- ❖ **KITCHEN** – O.K.
- ❖ **PASSAGE** – Leakage mark observed on ceiling.
- ❖ **TOILET & BATH ROOM** – O.K.

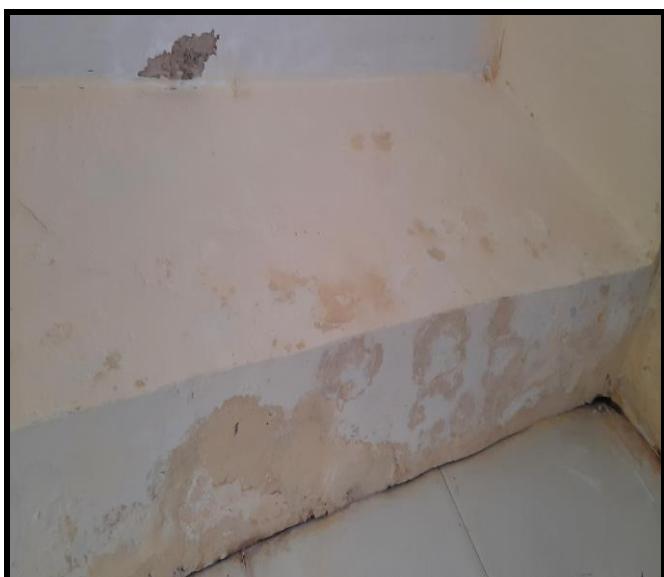
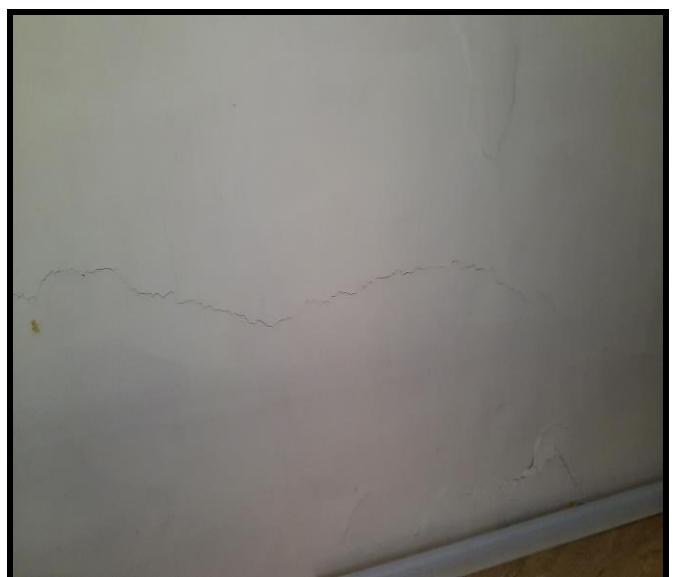
FLAT NO – 19

- ❖ **HALL** – Leakage mark observed on beam.
- ❖ **KITCHEN** – Structural crack observed on ceiling.
- ❖ **PASSAGE** – O.K.
- ❖ **TOILET & BATH ROOM** – O.K.

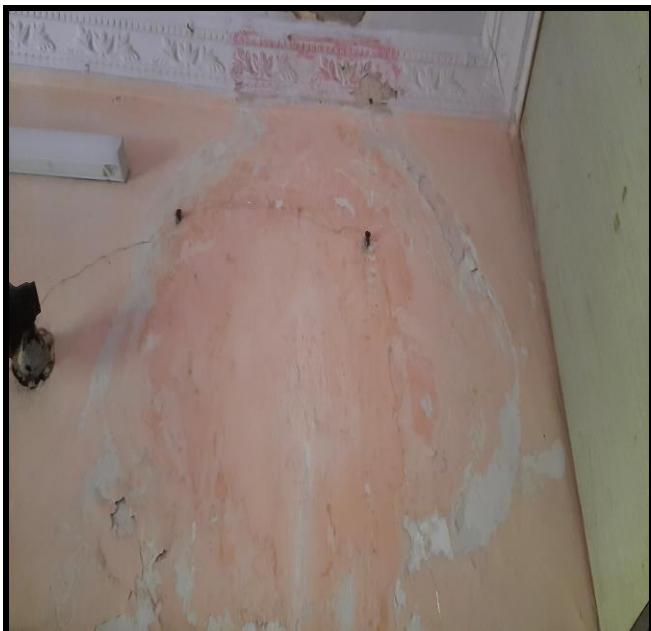
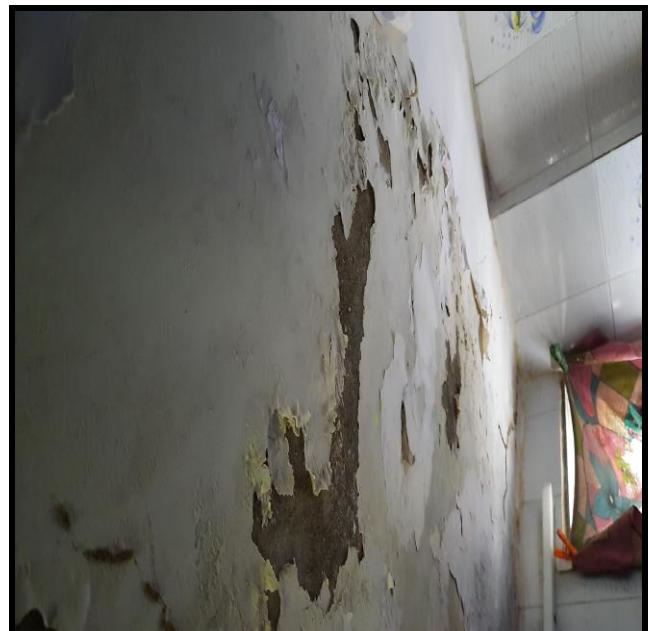
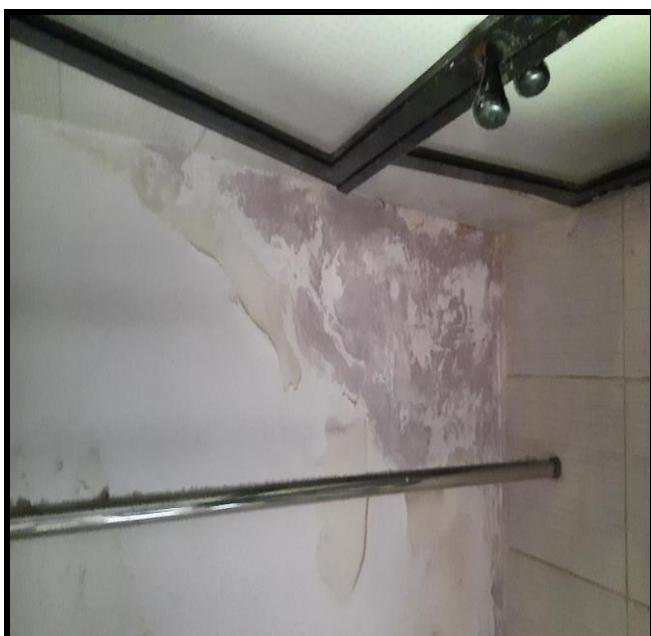
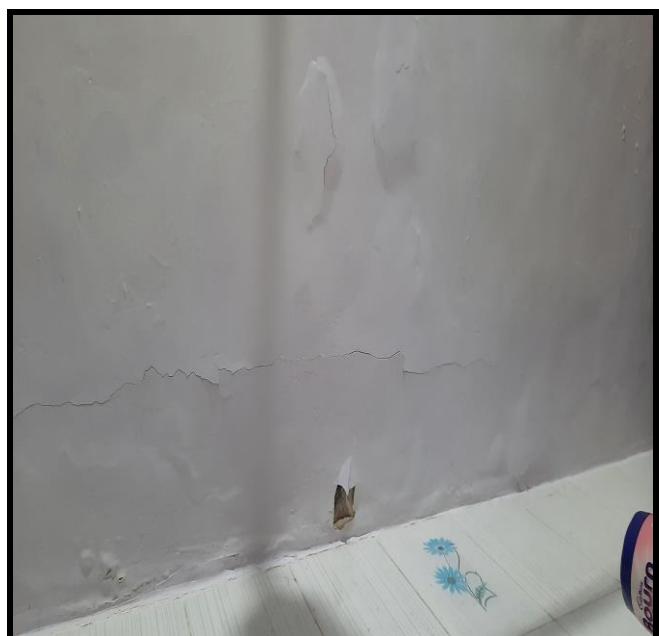
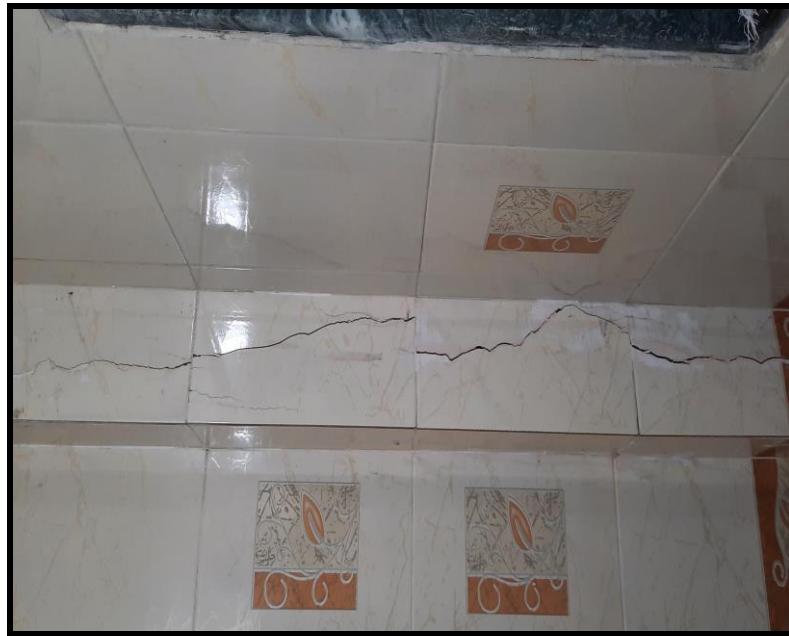
FLAT NO – 23

- ❖ **HALL** – Leakage mark observed on wall.
- ❖ **KITCHEN** – Structural crack observed on ceiling.
- ❖ **PASSAGE** – Leakage mark observed on ceiling.
- ❖ **TOILET & BATH ROOM** – Leakage mark observed on ceiling.
 - Structural crack observed on column.

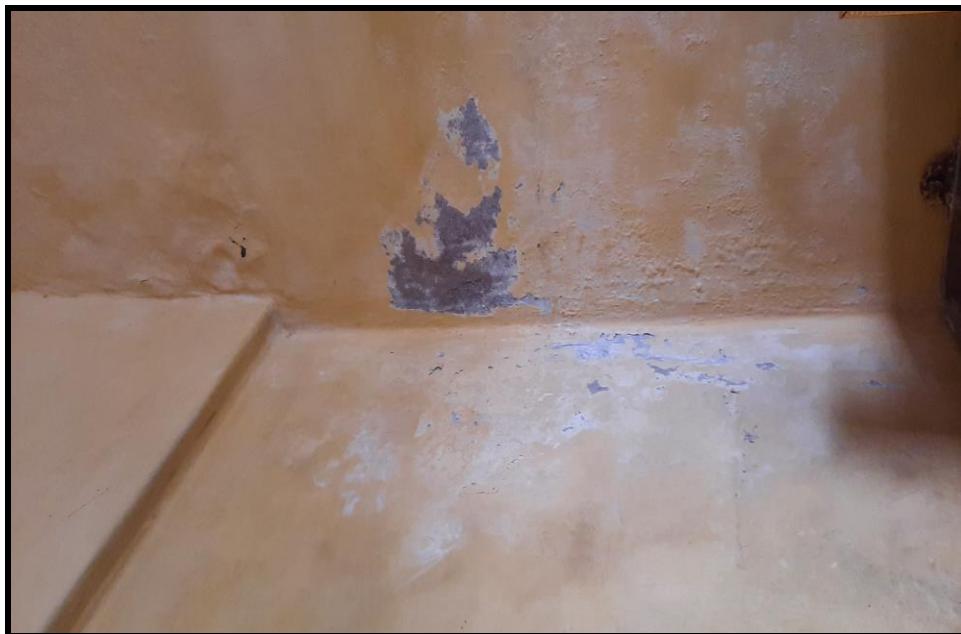
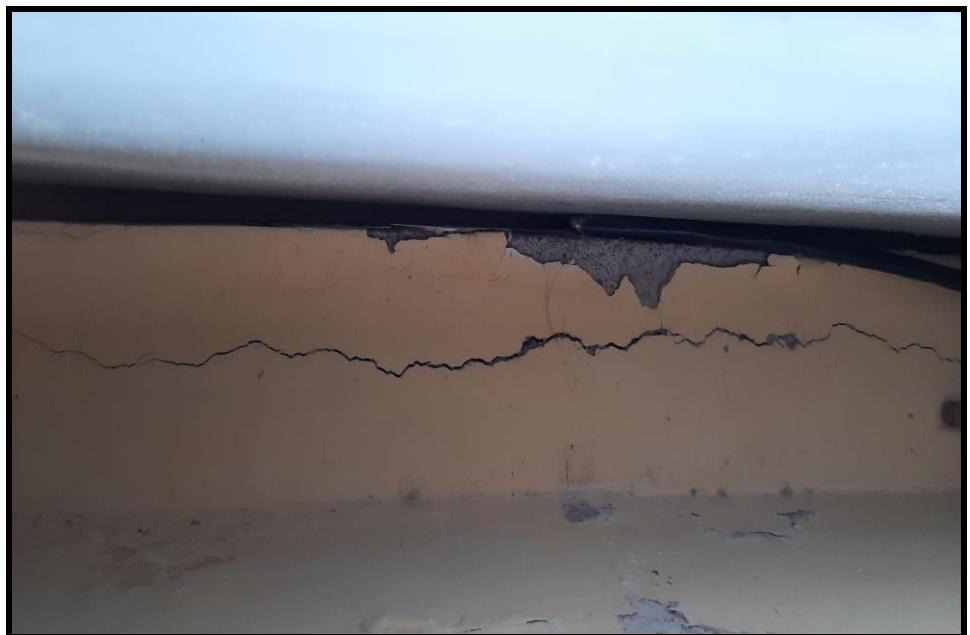
FLAT NO – 28

- ❖ **HALL** – Leakage mark observed on wall & ceiling.
- ❖ **KITCHEN** – Structural crack observed on column.
- ❖ **PASSAGE** – O.K.
- ❖ **TOILET & BATH ROOM** – O.K.

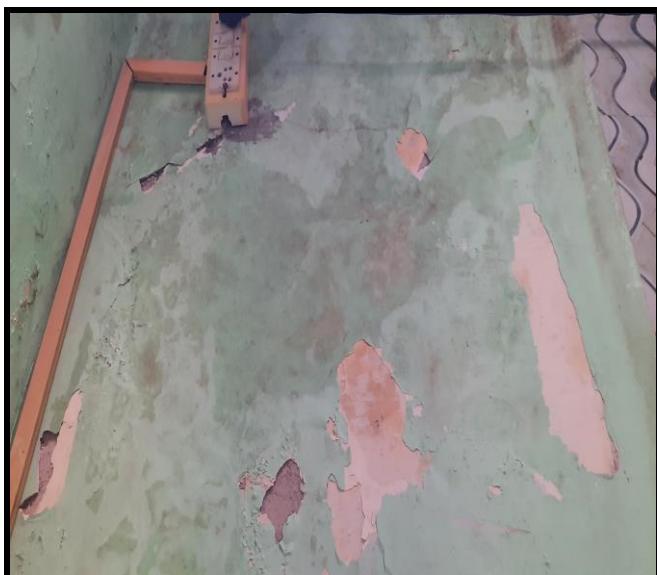
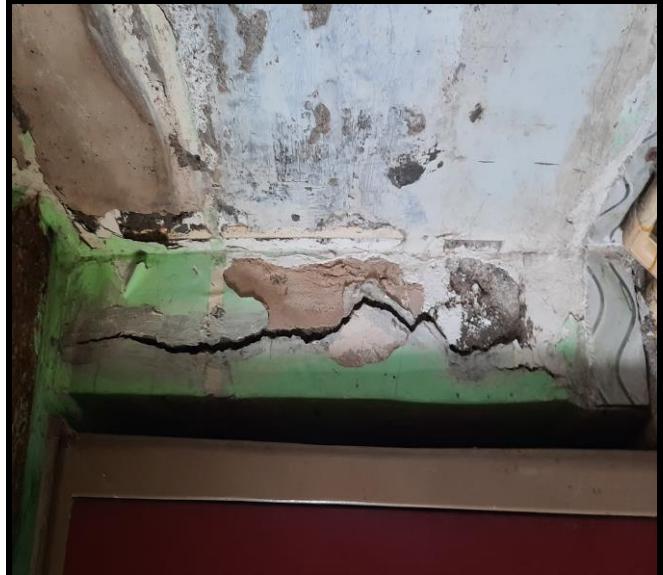
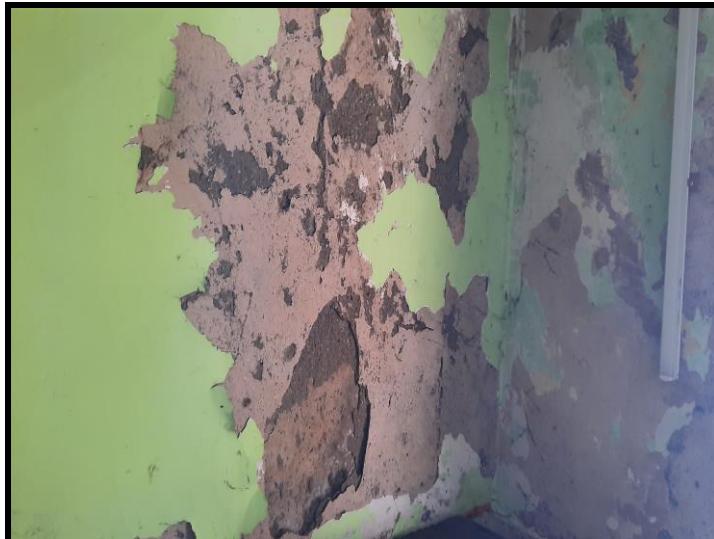
FLAT NO – 31

- ❖ **HALL** – Leakage observed on wall in monsoon.
- ❖ **KITCHEN** – Leakage mark observed on wall & ceiling.
 - Structural crack observed on column.
- ❖ **PASSAGE** – Leakage mark observed on ceiling.
- ❖ **TOILET & BATH ROOM** – O.K.

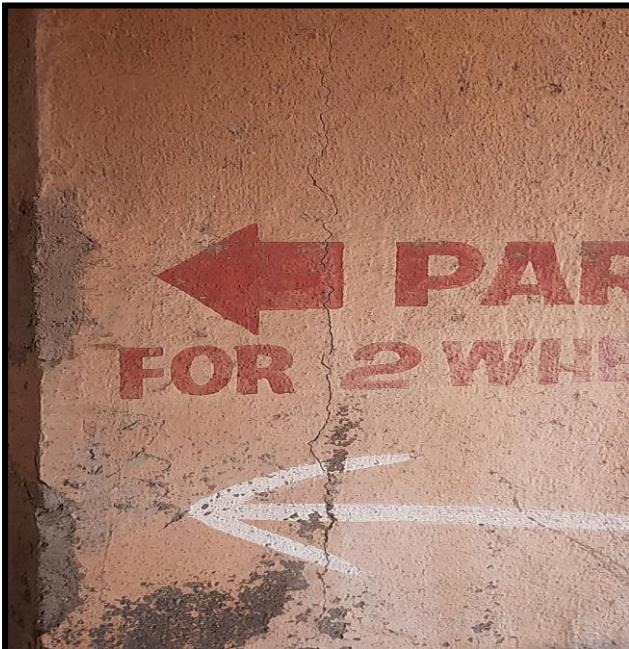
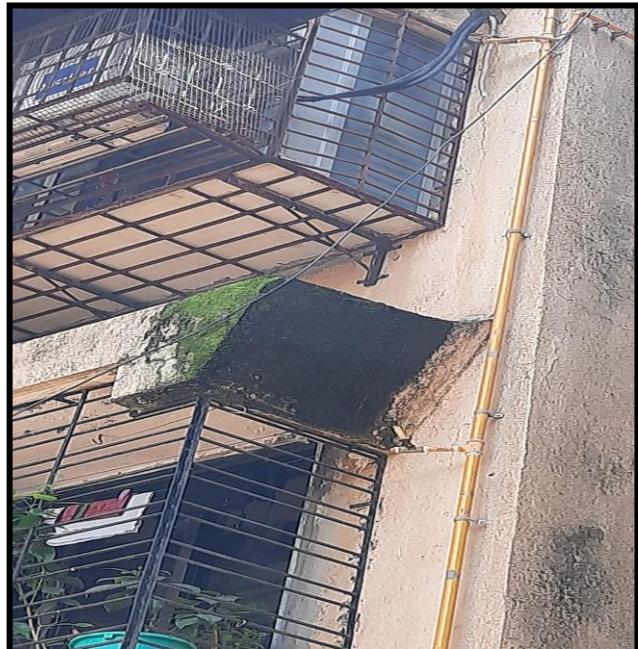
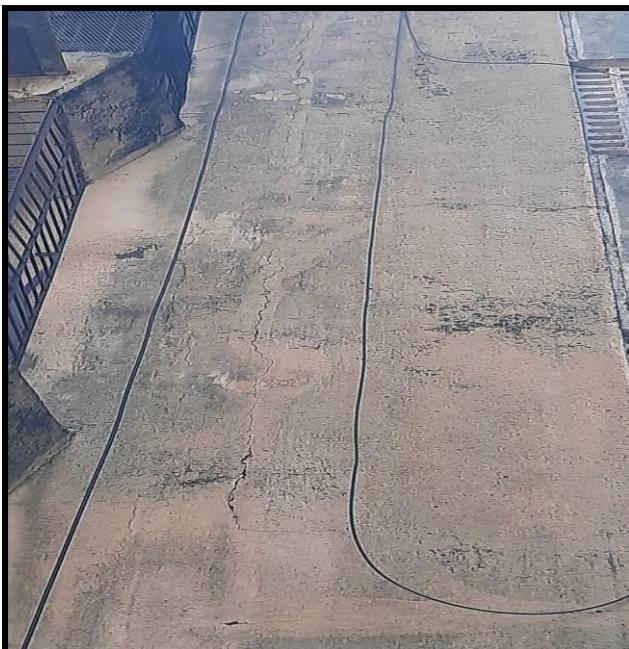
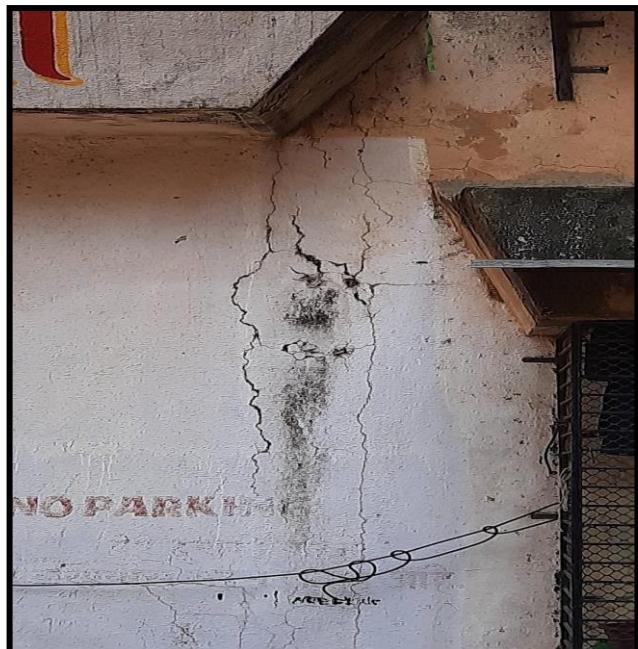
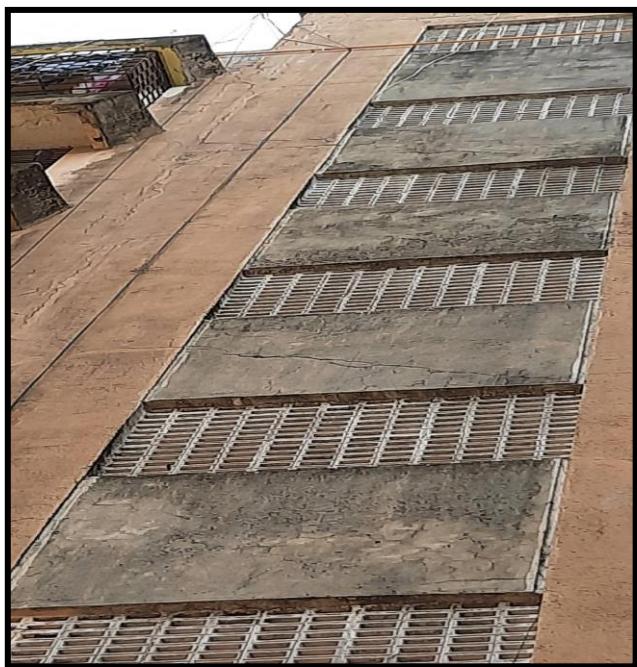
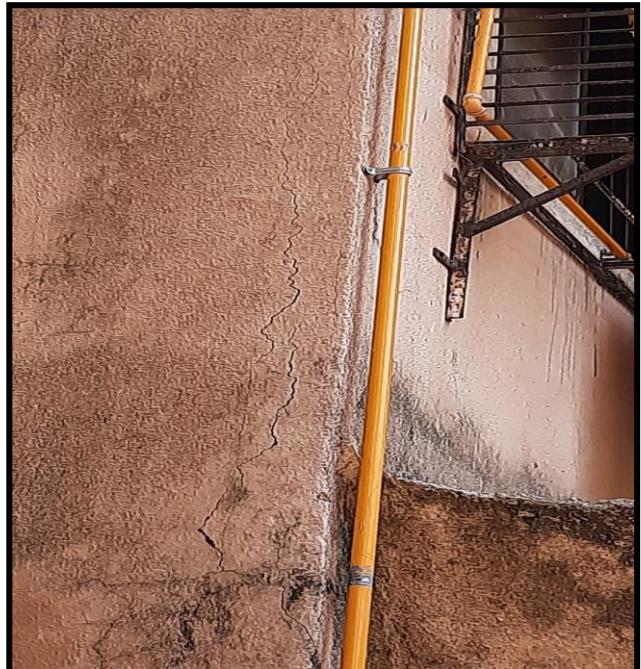
FRONT SIDE

- ❖ Structural crack observed at several places on column & chajjas.
- ❖ Algae observed at several places on wall.

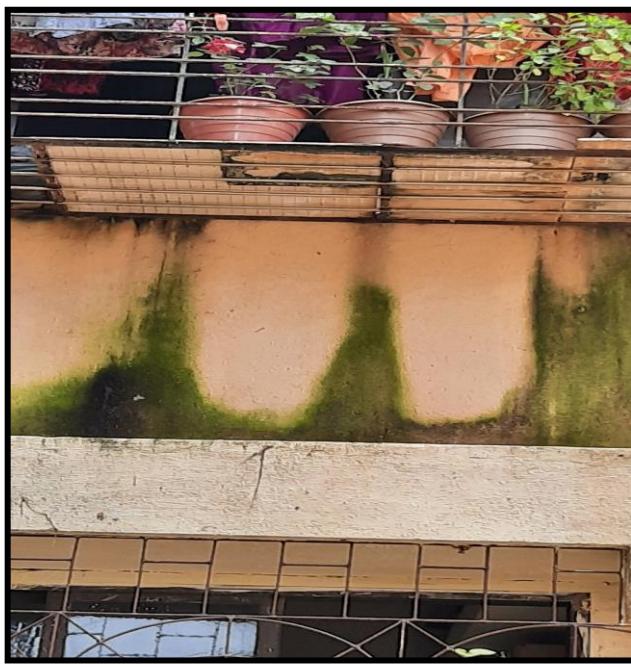
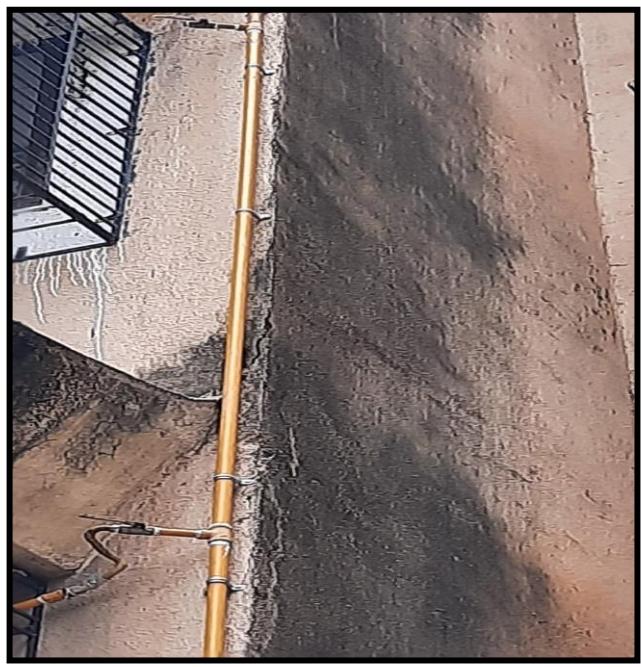
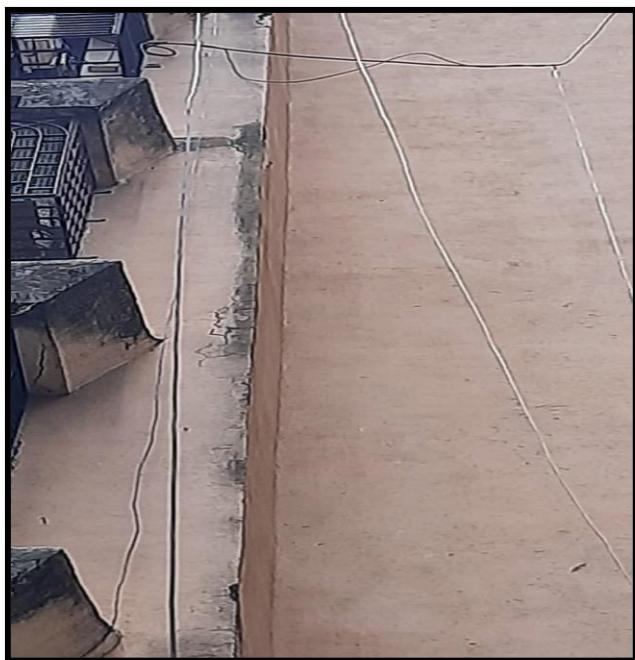
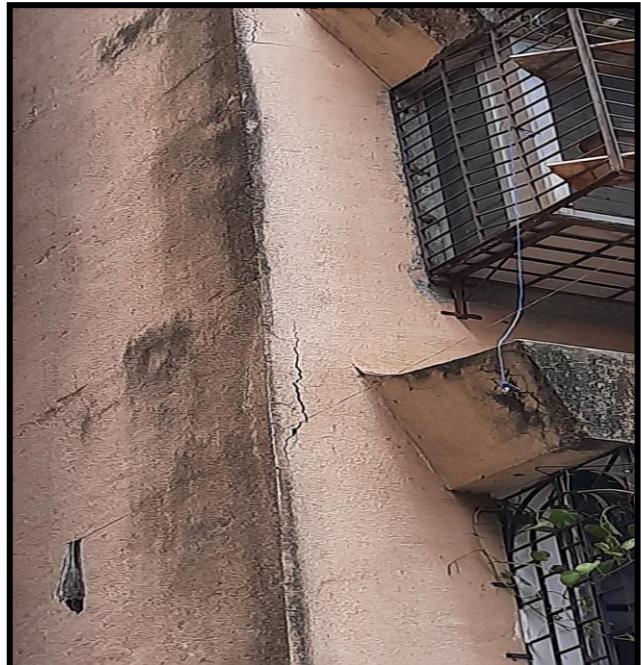
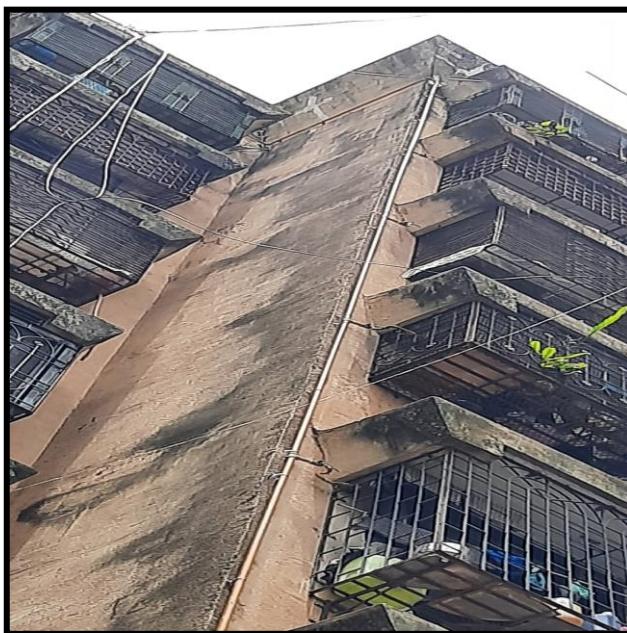
BACK SIDE

- ❖ Structural crack observed at several places on column & chajjas.
- ❖ Algae observed on wall.

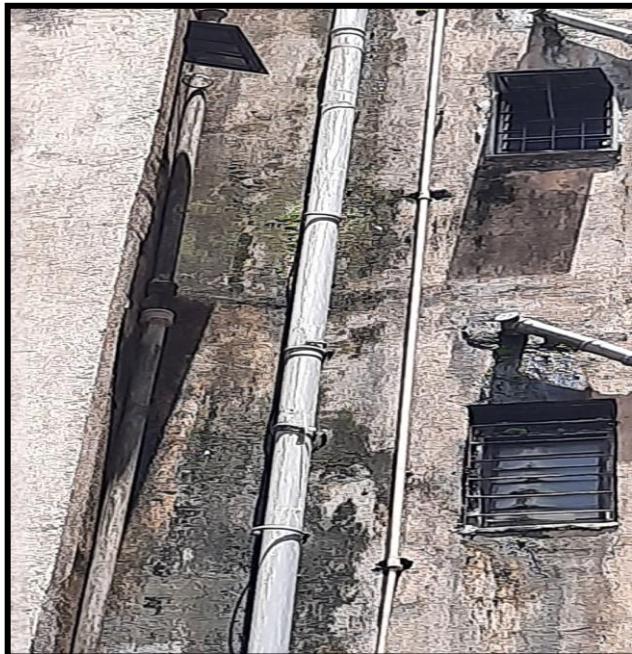
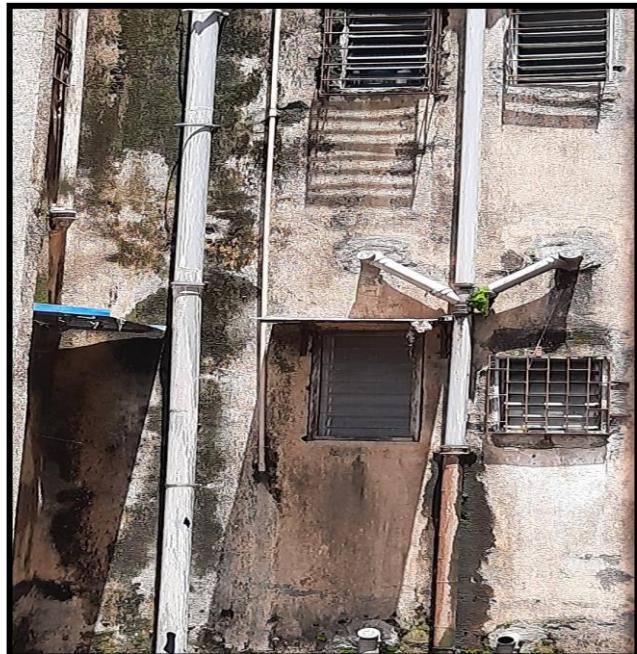
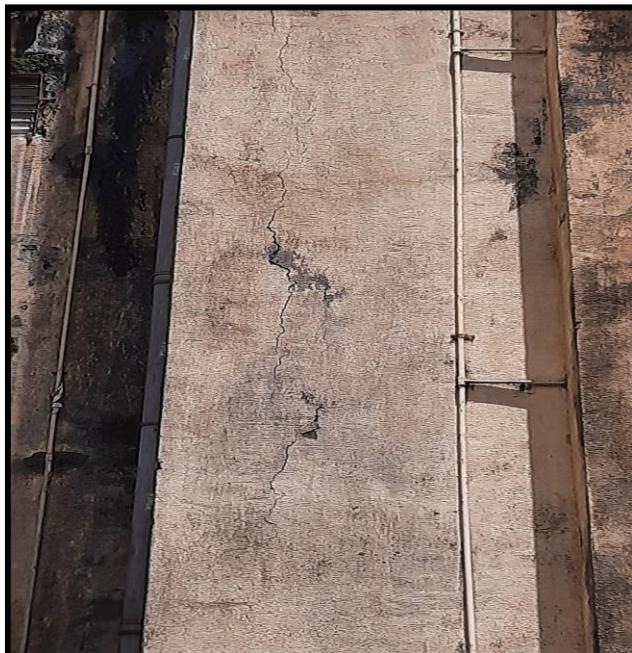
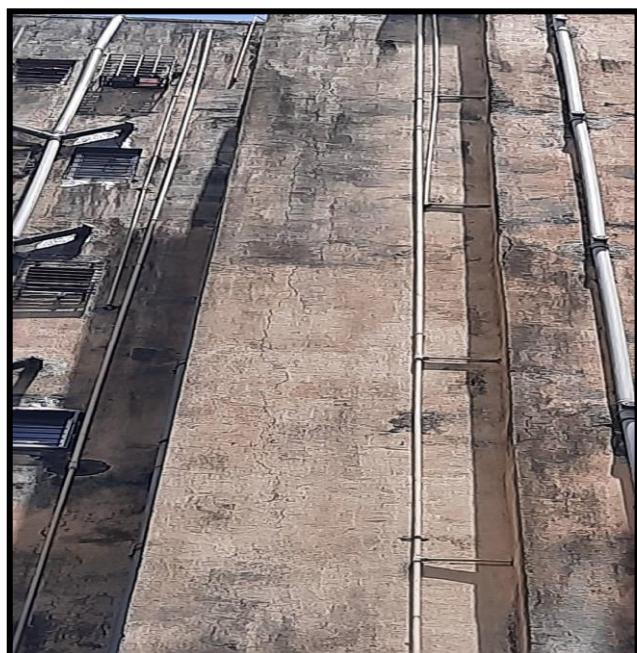
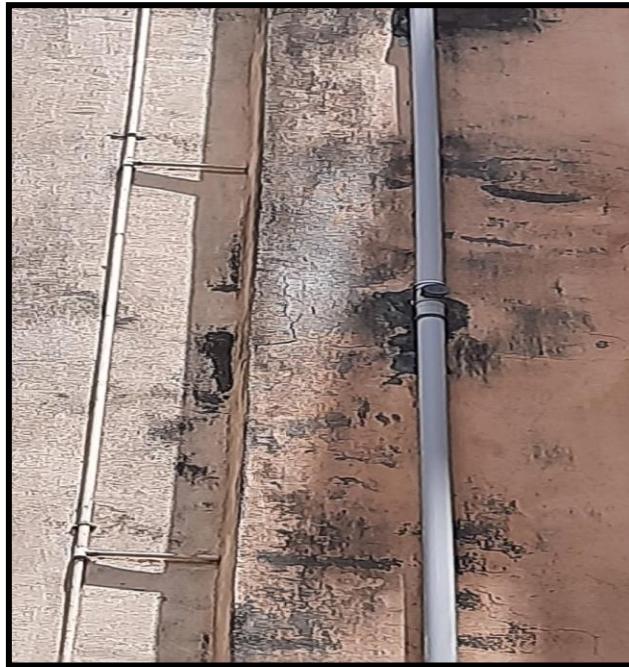
EAST SIDE

- ❖ Structural crack observed at several places on column.
- ❖ Algae observed at several places on wall.

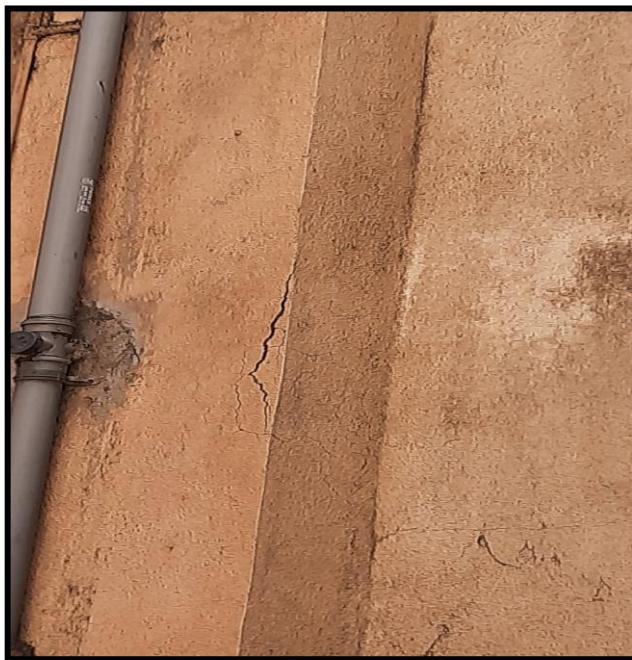
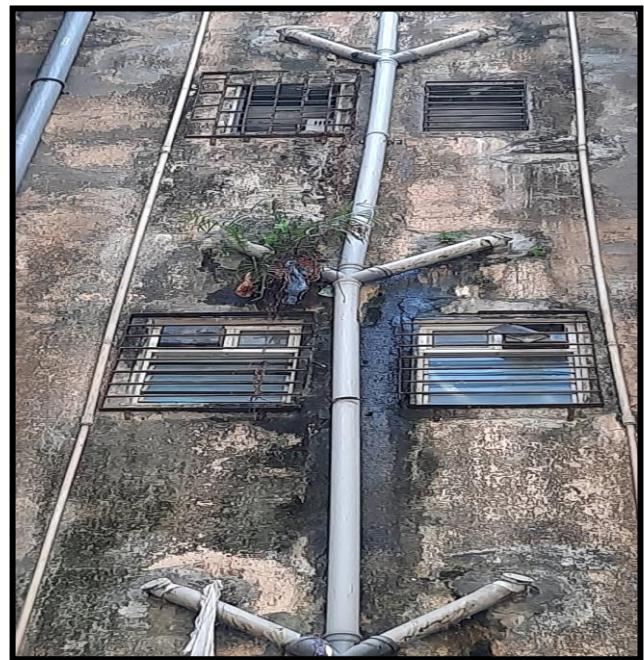
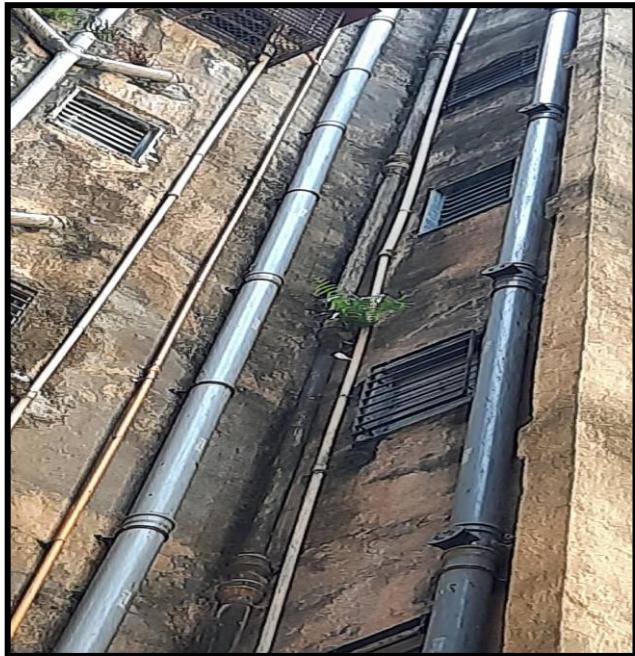
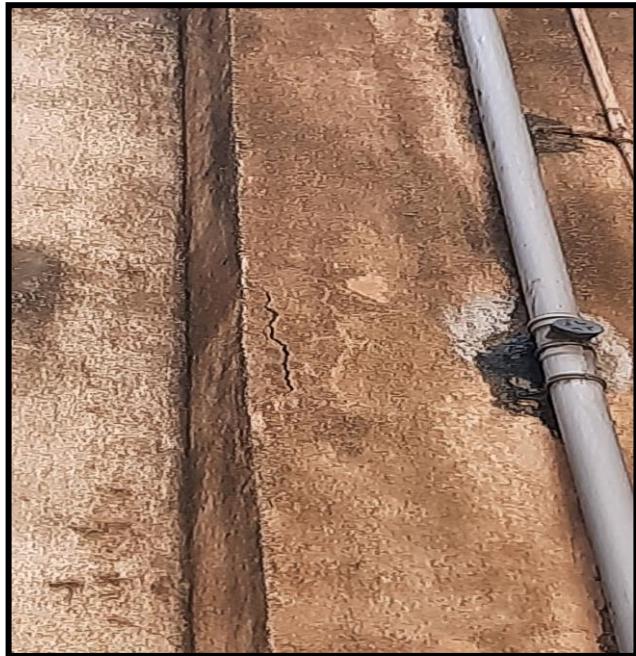
WEST SIDE

- ❖ Structural crack observed at several places on column.
- ❖ Algae observed at several places on wall.
- ❖ Vegetation growth observed at several places on wall.
