STRUCTURAL AUDIT REPORT
FOR
“VISHAL SAHYADRI CO – OP HSG. SOC. LTD”,
“B15 – WING”
SITUATED AT
SAHYADRI NAGAR, CHARKOP,
KANDIVALI (W) MUMBAI – 400 067

978/B15/LSS/2021

JULY 24, 2021

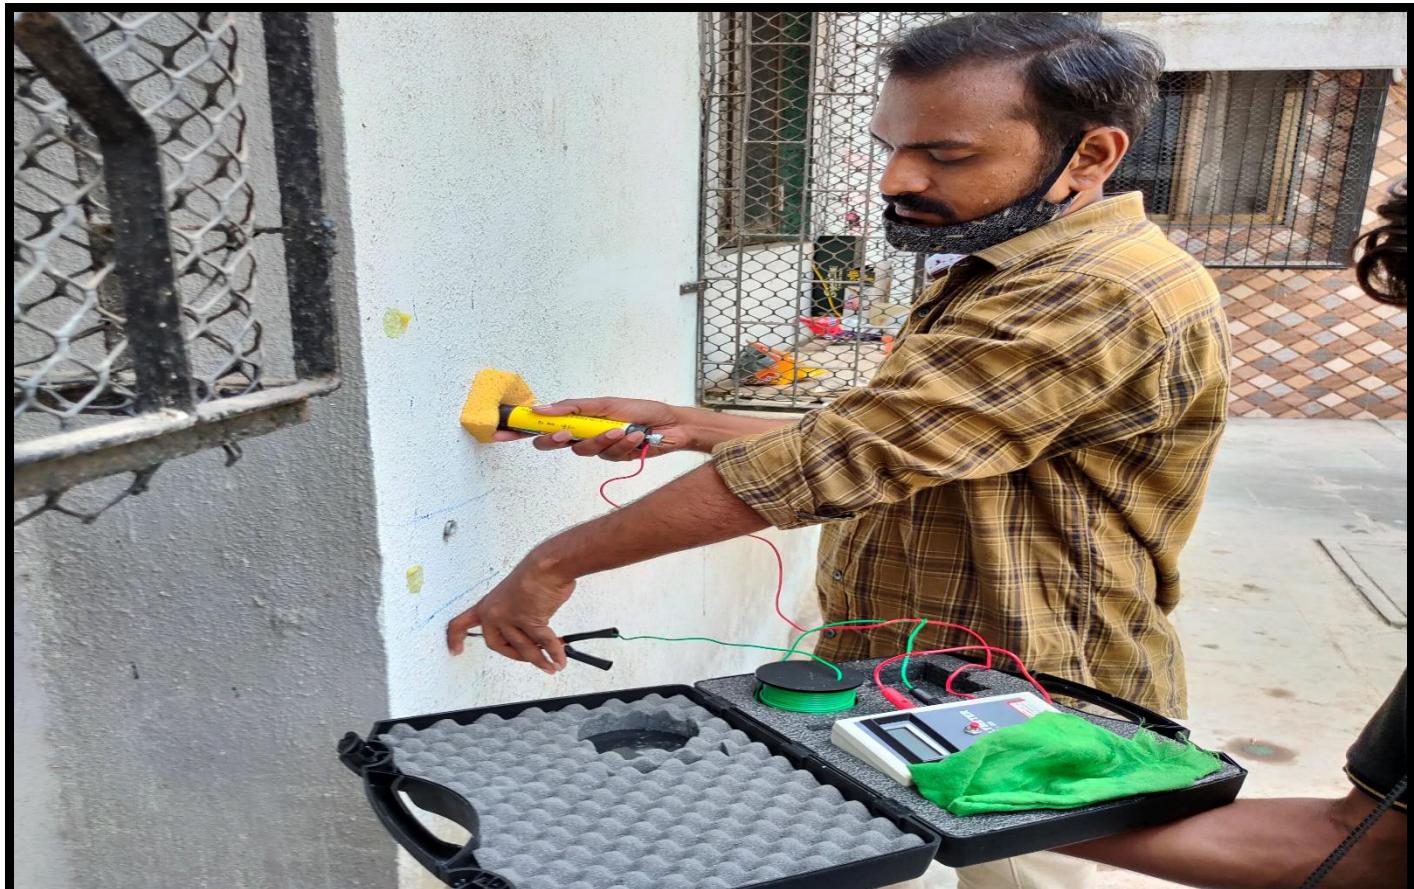
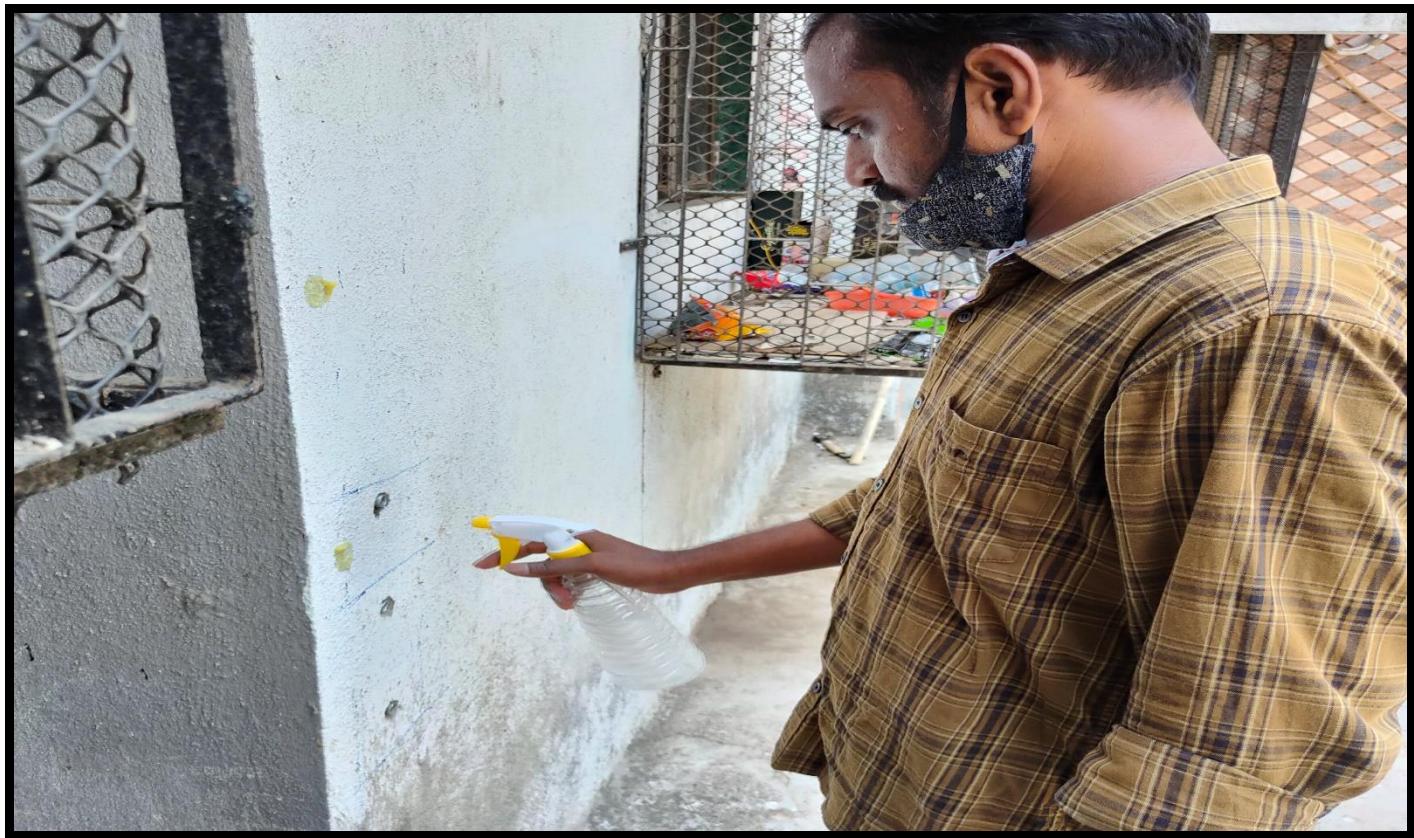
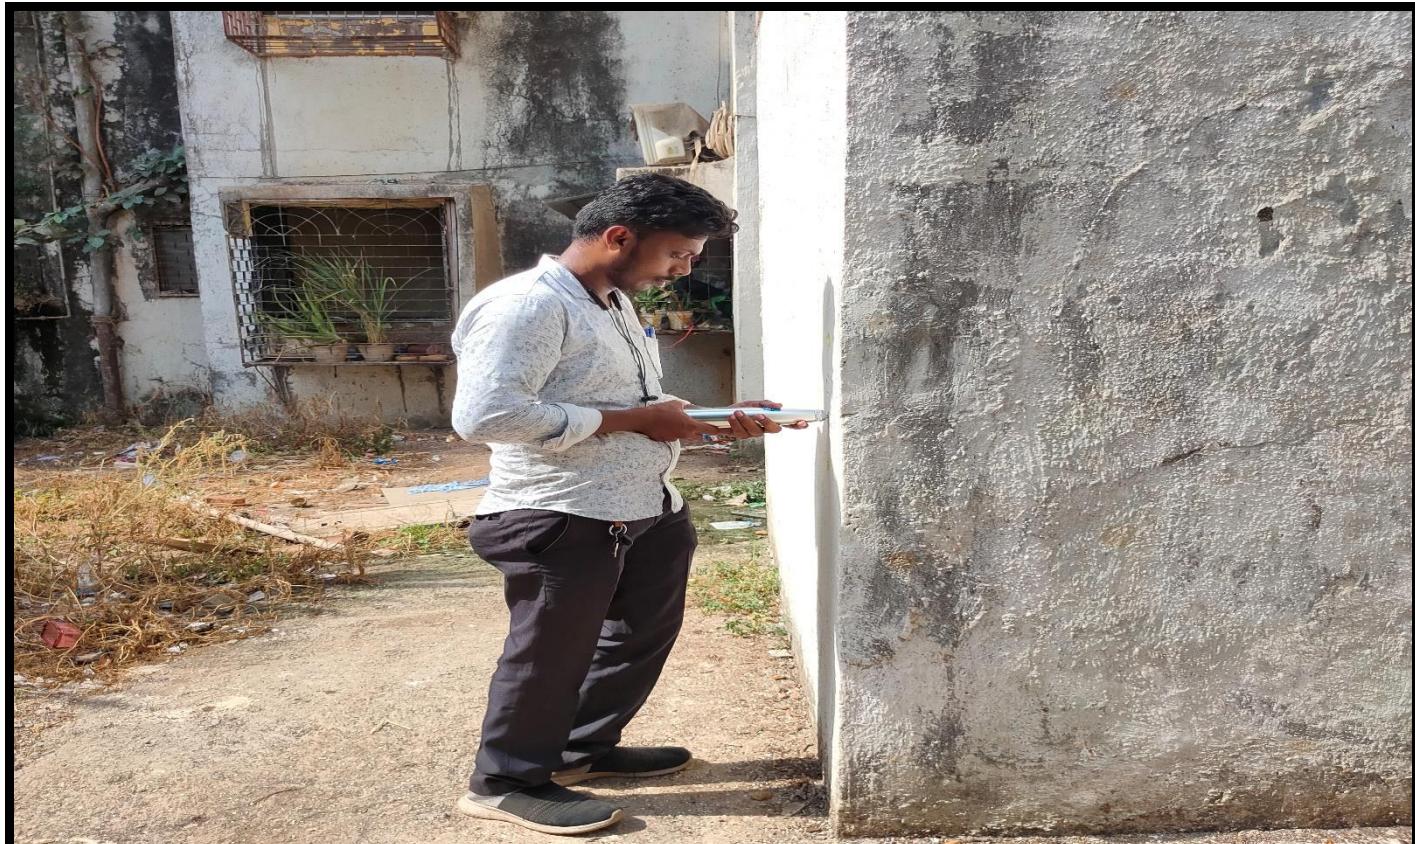
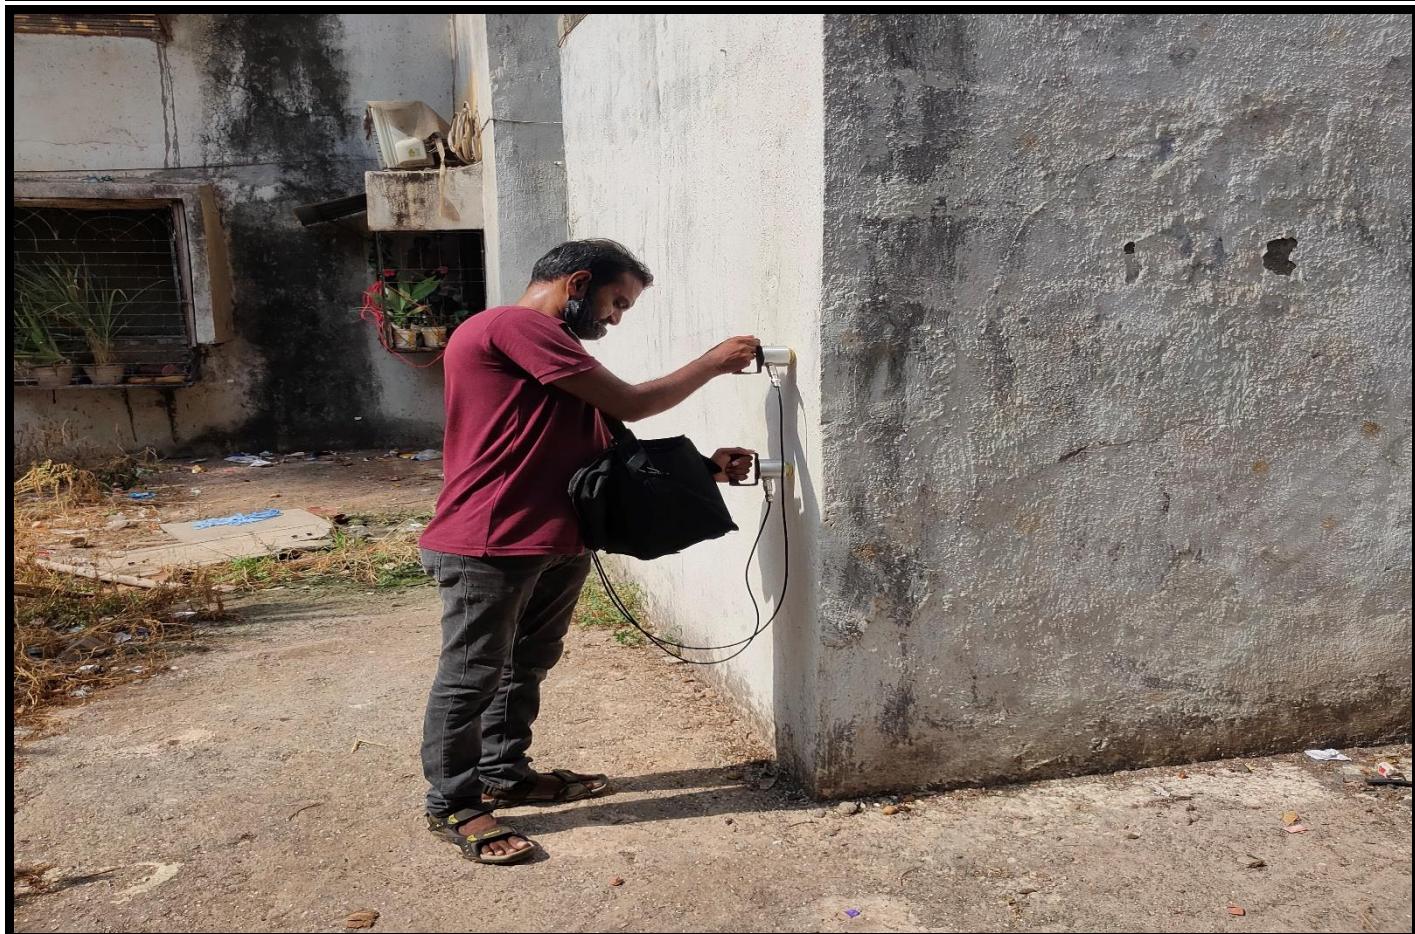
NON – DESTRUCTIVE TEST PHOTO

Rebound Hammer was tested for compressive strength at surface by Schmidt rebound hammer. Results indicate the compressive strength at surface of all the RCC columns is ranging between 12.50 MPa to 20.30 MPa.

Out of 4 locations 3 locations was below 3.0 Km/Sec means concrete quality is poor and 1 location ranging between 3.0 to 3.75 Km/Sec means concrete quality is doubtful.

This indicates there are progressive internal cracks in the RCC members due to corrosion of reinforced steel. These members are under distress condition.

Half Cell Potential tested for corrosion activity by half – cell potential tests. Values are taken on Column. The result on tested column is – 359 mV.

This indicates the probability of corrosion is 90% on tested column steel reinforcement.

Carbonation test was conducted to assess carbonation depth. Readings are taken on Column. Result indicates the carbonation penetration depth is 40.00 mm. Carbonation depths have reached to the reinforcement level in all of the RCC elements. It is essential to give a suitable anti-corrosion treatment to all the RCC members to stop further carbonation and corrosion of concrete.

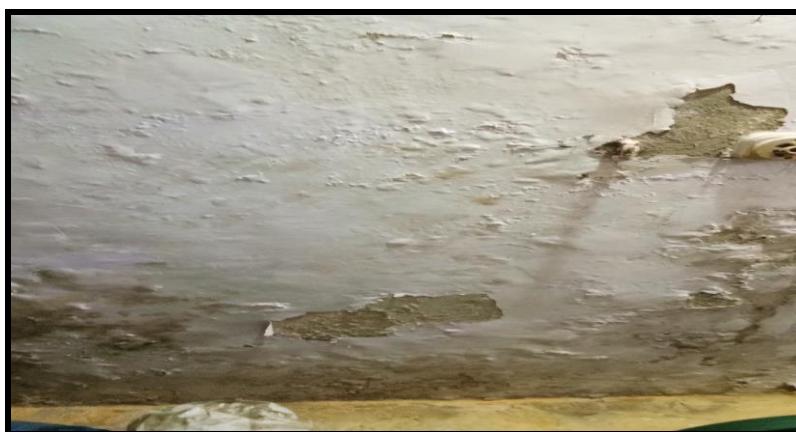
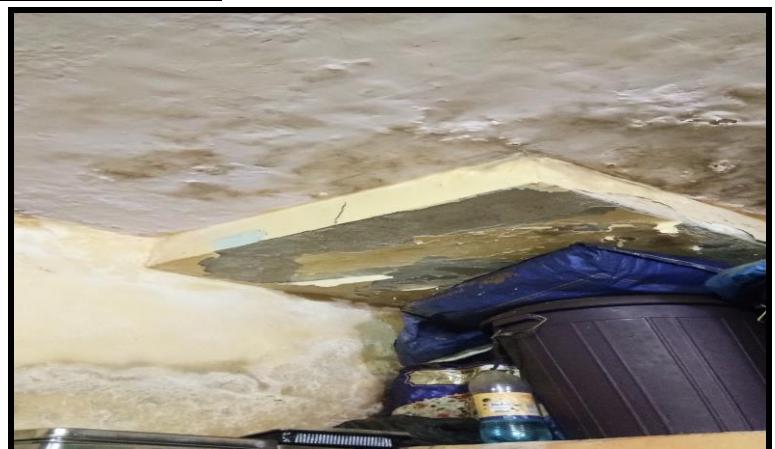
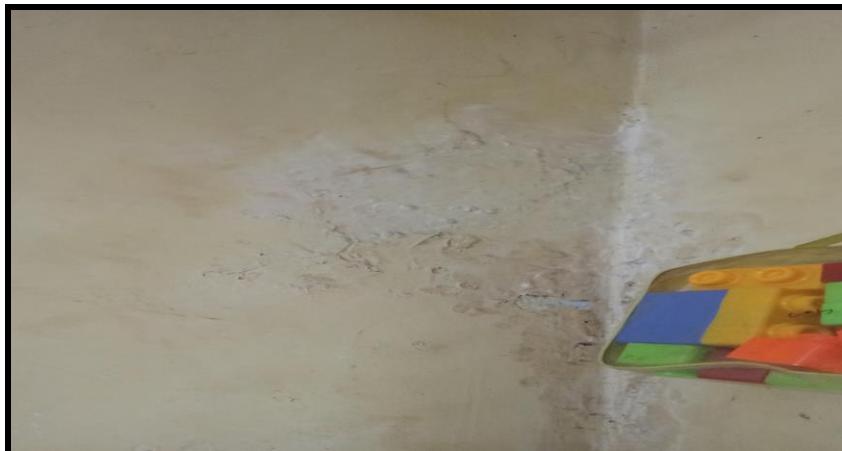
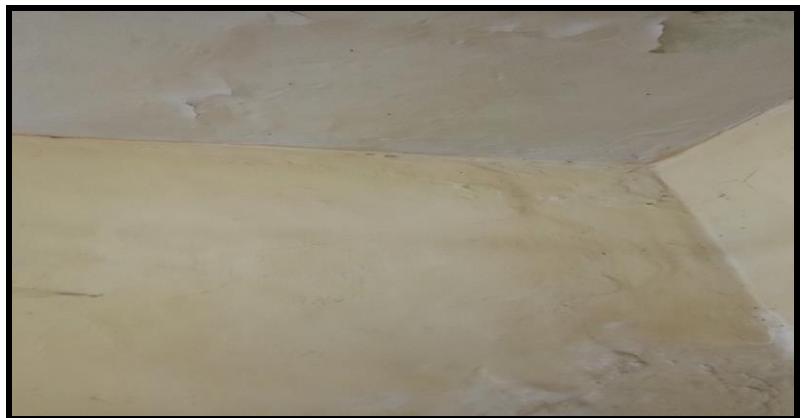
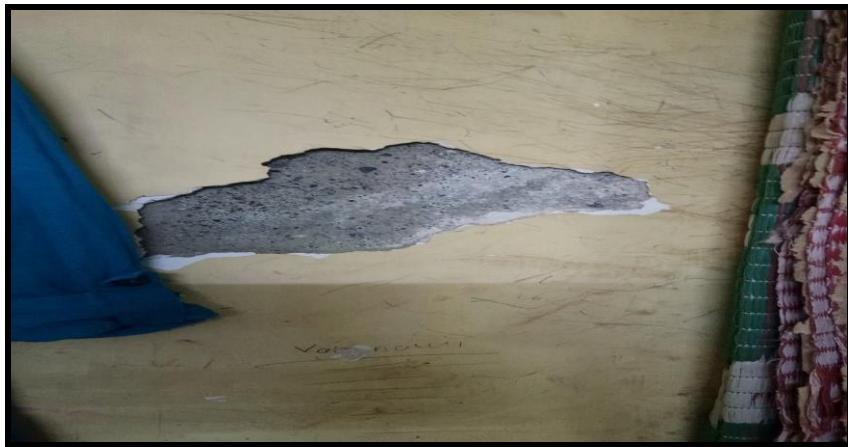
FLAT NO – 04

- ❖ **HALL** – Hallow sound observed on wall after tapping.
 - Seepage mark observed on wall.
- ❖ **KITCHEN** – Major structural crack observed on wall.
 - Leakage mark observed on ceiling.
 - Seepage mark observed on ceiling.
- ❖ **PASSAGE** – Seepage mark observed on wall.
 - Crack observed on wall.
- ❖ **TOILET & BATH ROOM** – Seepage mark observed on wall.

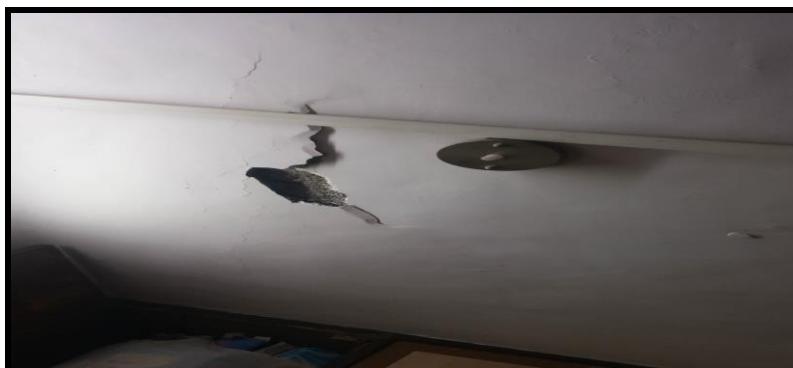
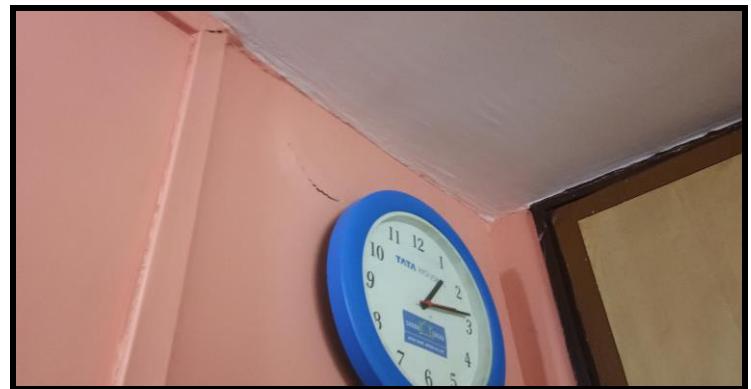
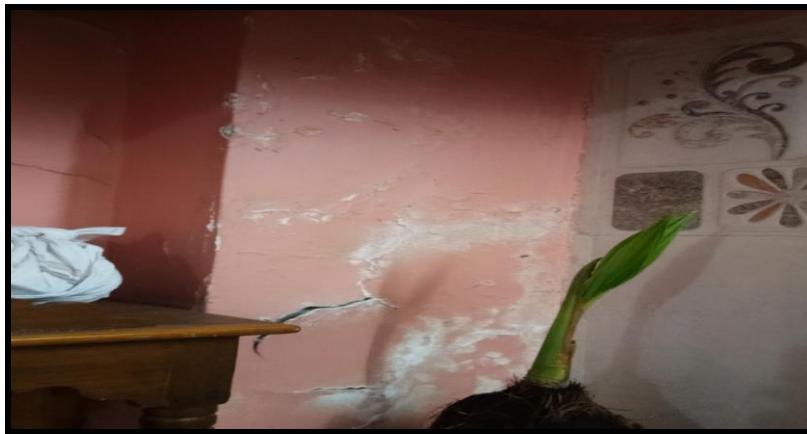
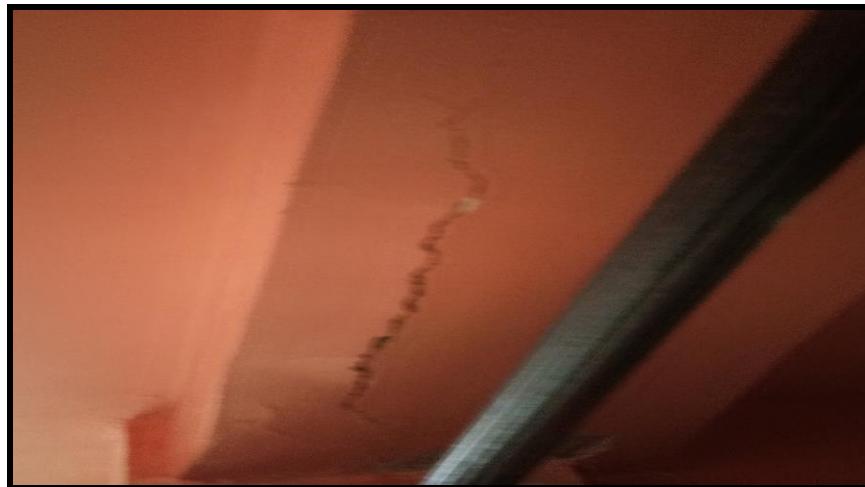
FLAT NO - 09

❖ **HALL** – Ceiling gets damage.

- Leakage mark observed on wall.
- Seepage mark observed on wall.
- Leakage mark observed on ceiling.

❖ **KITCHEN** – Dampness observed on ceiling.

❖ **PASSAGE** – Structural Crack observed on beam.

❖ **TOILET & BATH ROOM** – Structural Crack observed on beam.

- Structural Crack observed on column.
- Leakage mark observed on ceiling.

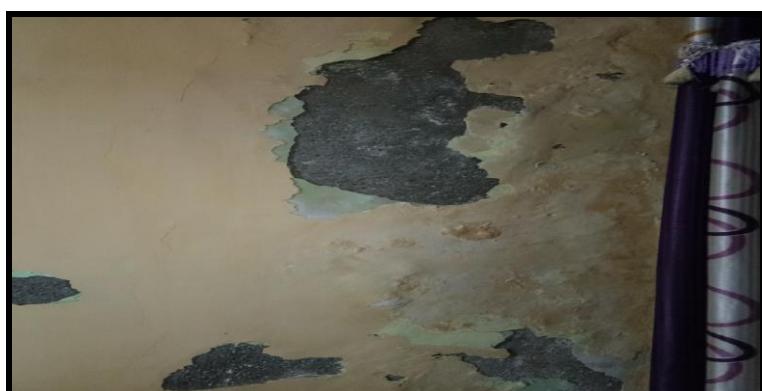
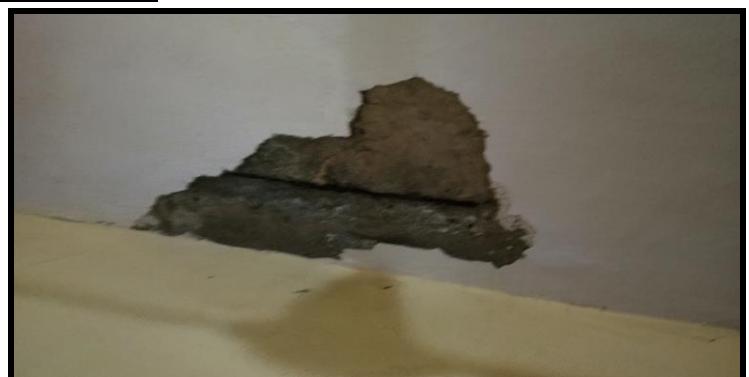
FLAT NO – 10

- ❖ **HALL** – Structural Crack observed on beam.
 - Leakage mark observed on ceiling.
 - Leakage mark observed on beam.
 - Ceiling gets damage.
- ❖ **KITCHEN** – Structural Crack observed on beam.
 - Crack observed on beam.
- ❖ **PASSAGE** – Structural Crack observed on beam.
- ❖ **TOILET & BATH ROOM** – Dampness observed on beam.

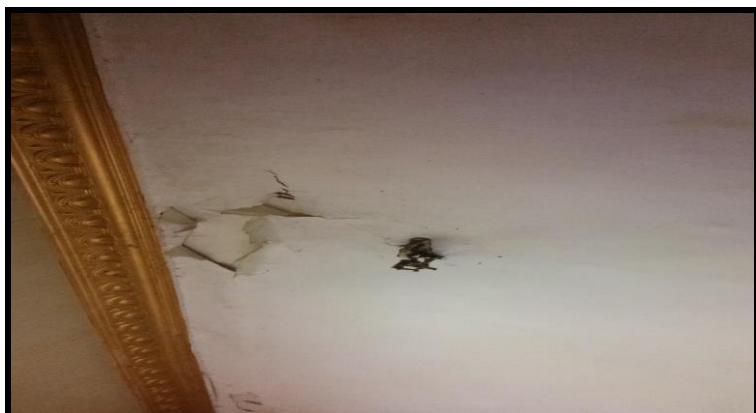
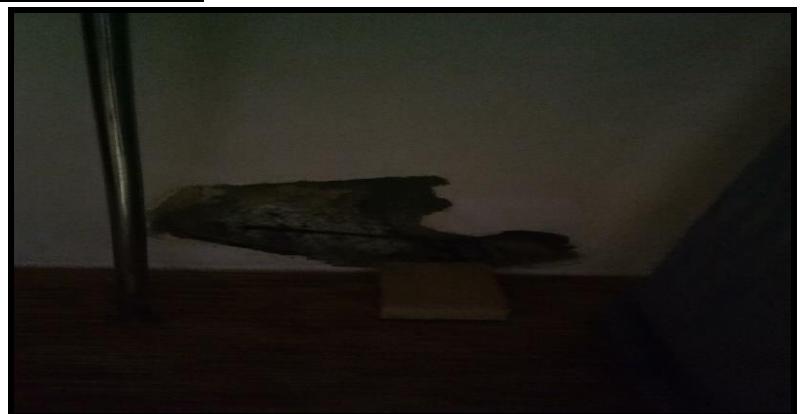
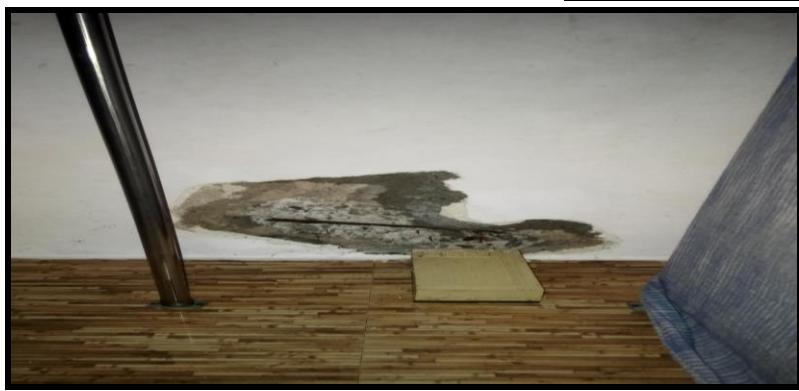
FLAT NO – 15

- ❖ **HALL** – Leakage mark observed on ceiling.
 - Seepage mark observed on ceiling.
 - Peeling of paint observed on wall.
- ❖ **KITCHEN** – Peeling of paint observed on ceiling.
- ❖ **PASSAGE** – Plaster gets removed and steel gets corroded.
- ❖ **TOILET & BATH ROOM** – Plaster gets removed and steel gets corroded.

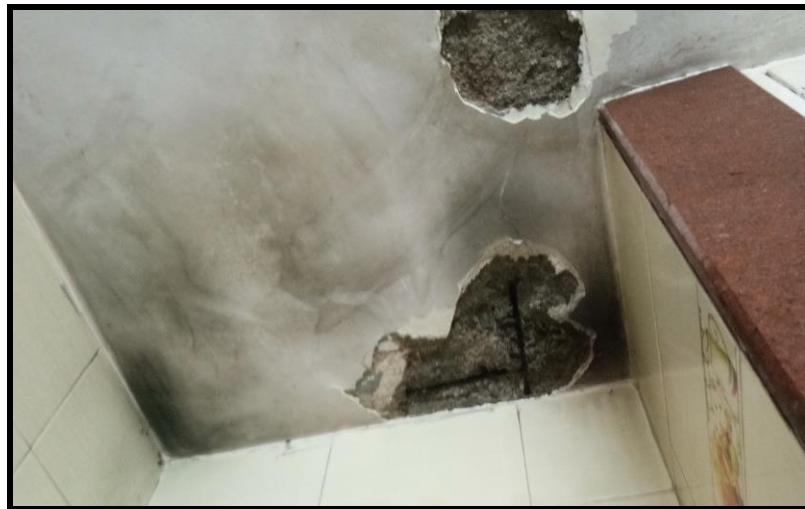
FLAT NO - 16

- ❖ **HALL** – Leakage mark observed on wall.
 - Peeling of paint observed on wall.
 - Seepage mark observed on ceiling.
- ❖ **KITCHEN** – Structural Crack observed on beam.
 - Structural Crack observed on column.
- ❖ **PASSAGE** – Plaster gets removed and steel gets corroded.
- ❖ **TOILET & BATH ROOM** – Leakage mark observed on wall.

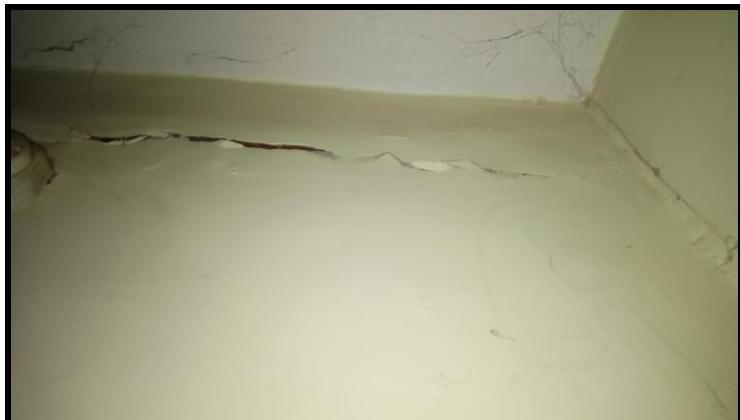
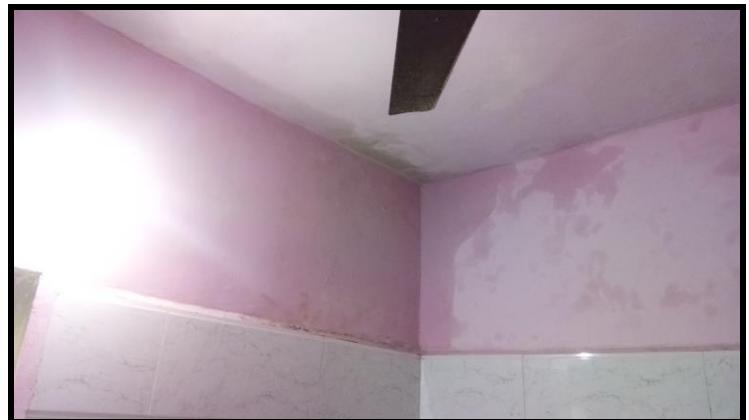
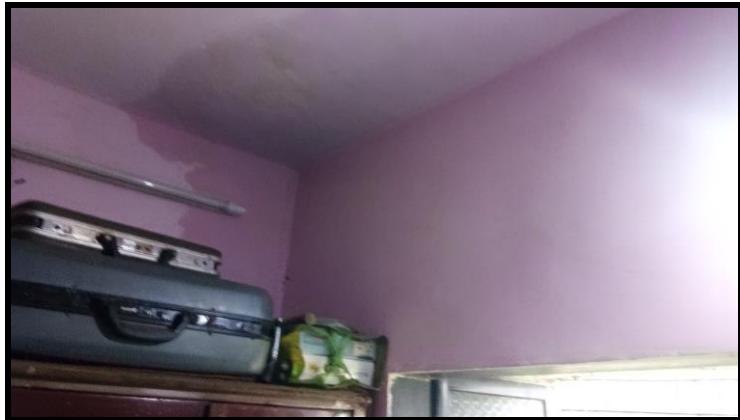
FLAT NO – 20

- ❖ **HALL** – Leakage mark observed on wall.
 - Peeling of paint observed on wall.
 - Seepage mark observed on ceiling.
- ❖ **KITCHEN** – Structural Crack observed on beam.
 - Structural Crack observed on column.
- ❖ **PASSAGE** – Leakage mark observed on ceiling.
- ❖ **TOILET & BATH ROOM** – Dampness observed on wall.
 - Peeling of paint observed on wall.

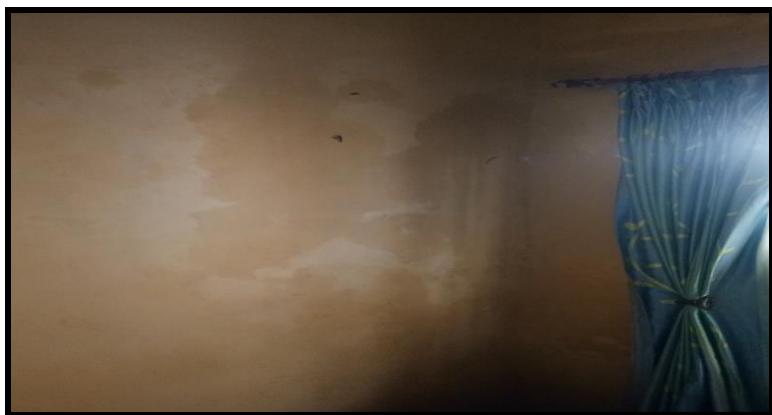
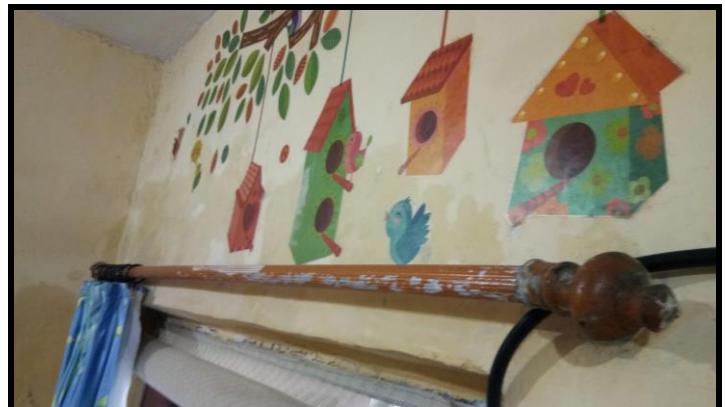
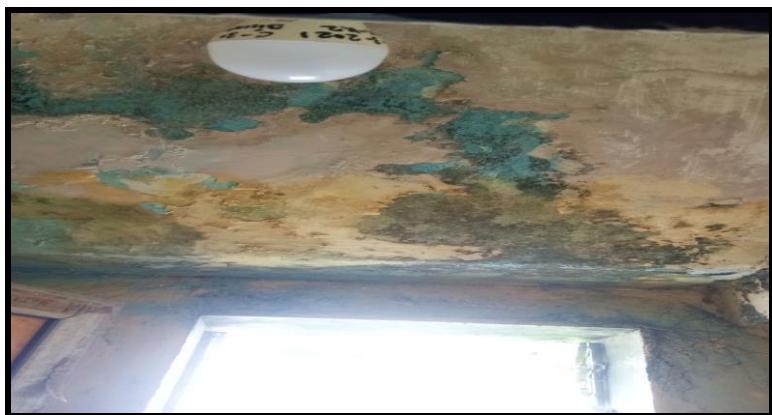
FLAT NO - 22

- ❖ **HALL** – Leakage mark observed on ceiling.
 - Structural Crack observed on column.
 - Crack observed on wall.
- ❖ **KITCHEN** – Crack observed on wall.
- ❖ **PASSAGE** – Plaster gets removed and steel gets corroded.
- ❖ **TOILET & BATH ROOM** – Plaster gets removed and steel gets corroded.
 - Leakage mark observed on ceiling.

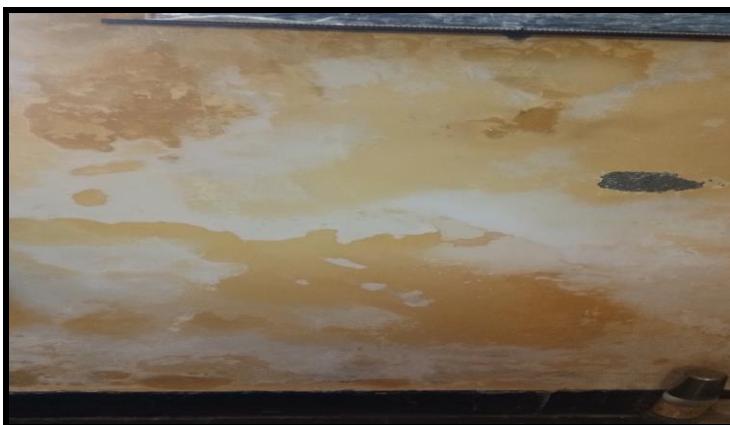
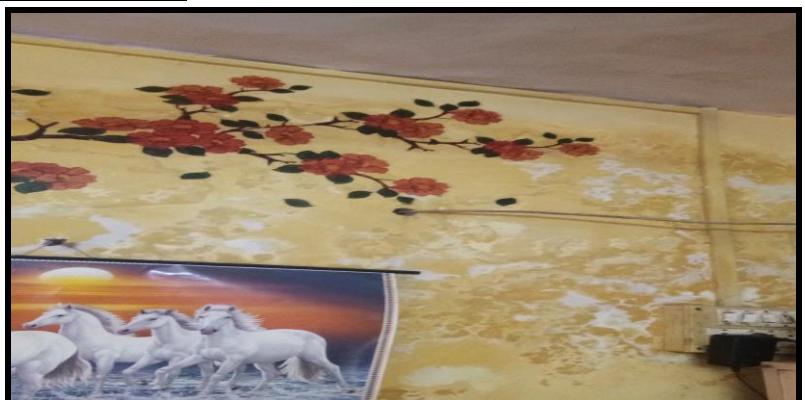
FLAT NO – 28

- ❖ **HALL** – Leakage mark observed on ceiling.
- ❖ **KITCHEN** – Crack observed on wall.
- ❖ **PASSAGE** – Leakage mark observed on ceiling.
- ❖ **TOILET & BATH ROOM** – Crack observed on wall.
 - Peeling of paint observed on wall.

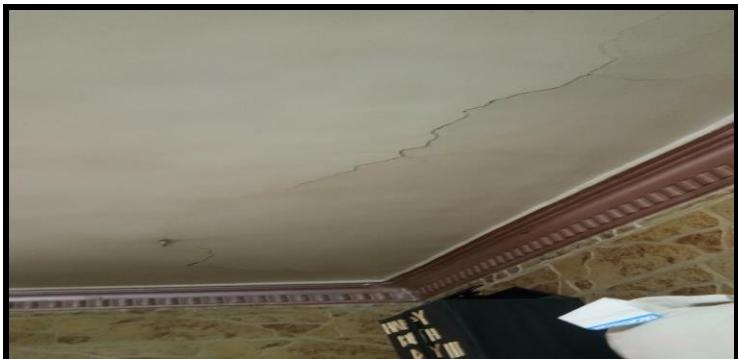
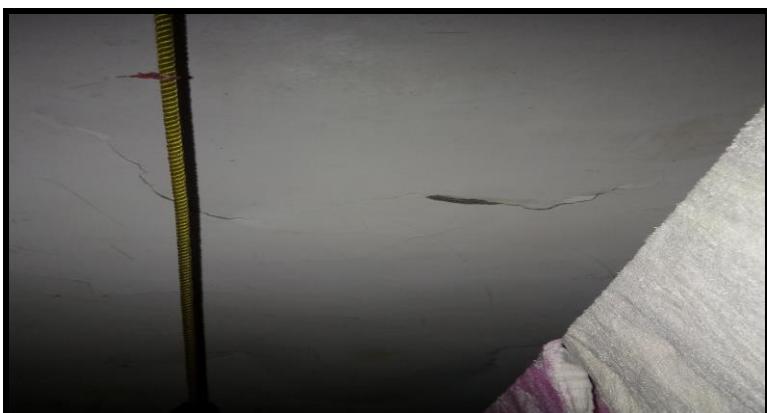
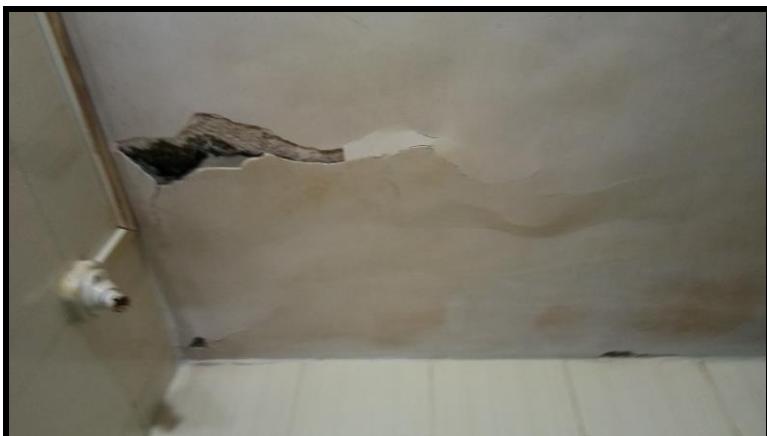
STAIRCASE

Terrace to Fourth floor:-

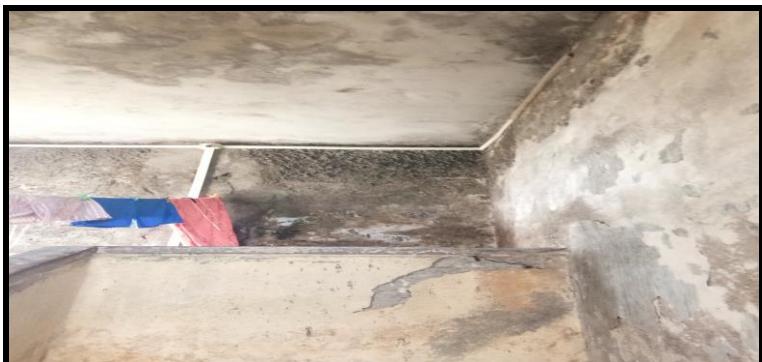
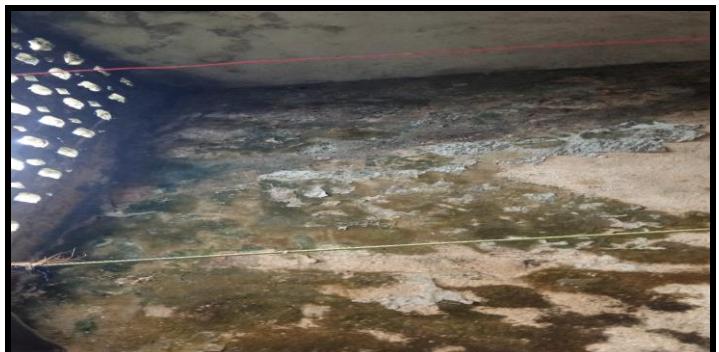
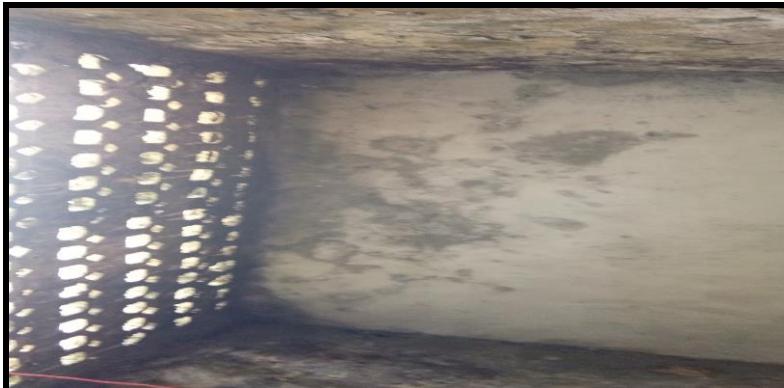
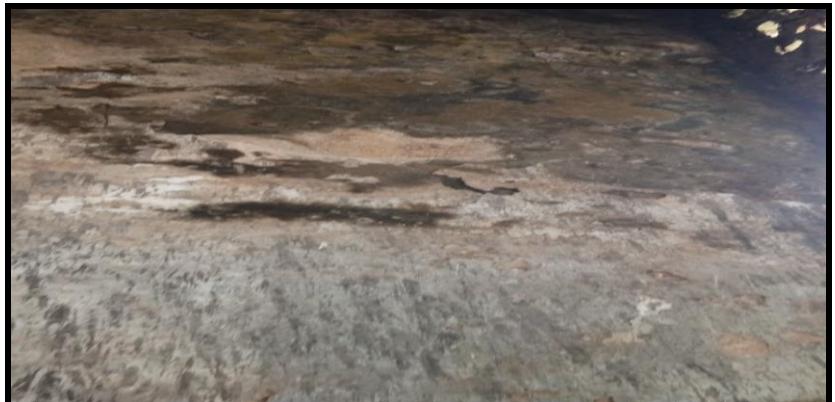
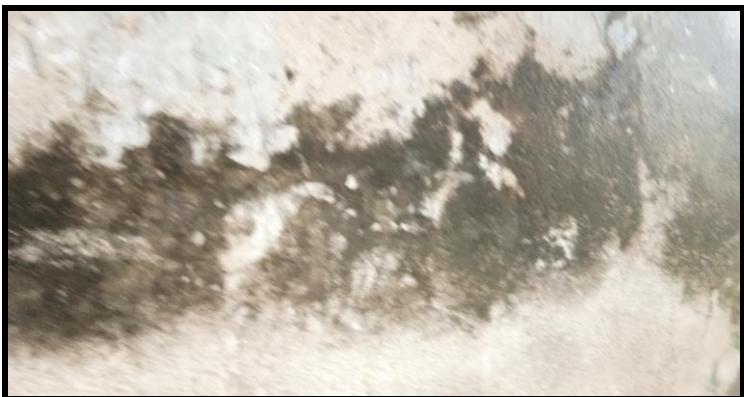
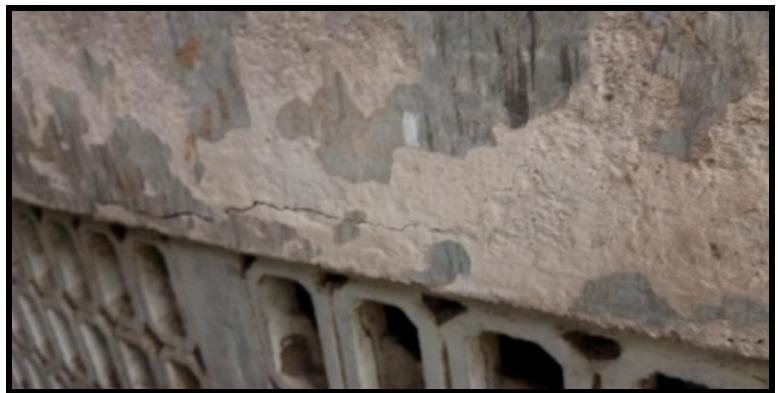
- ❖ Seepage mark observed on wall.
- ❖ Algae formation observed on wall.
- ❖ Peeling of paint observed on wall.

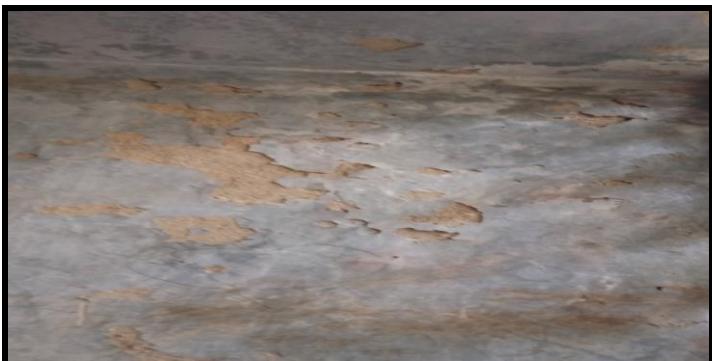
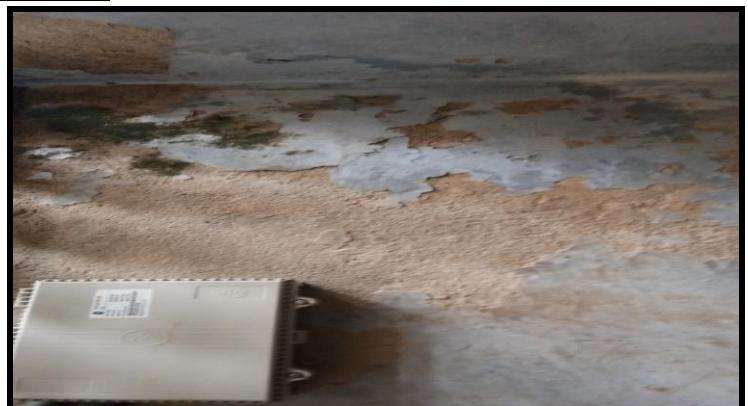
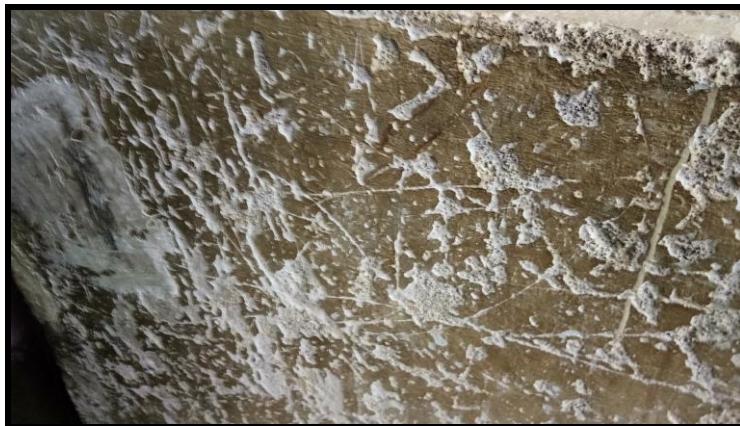
Fourth floor to Third floor:-

- ❖ Peeling of paint observed on wall.
- ❖ Algae formation observed on wall.

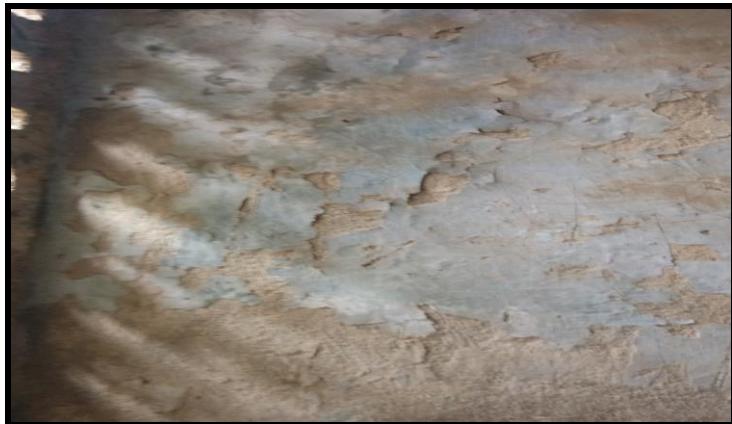
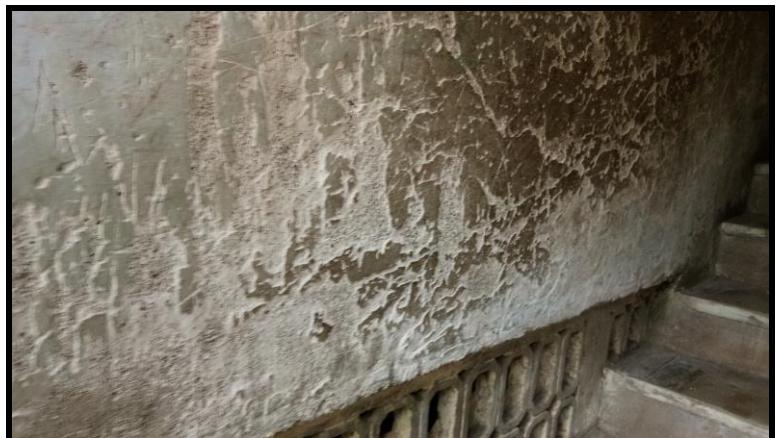
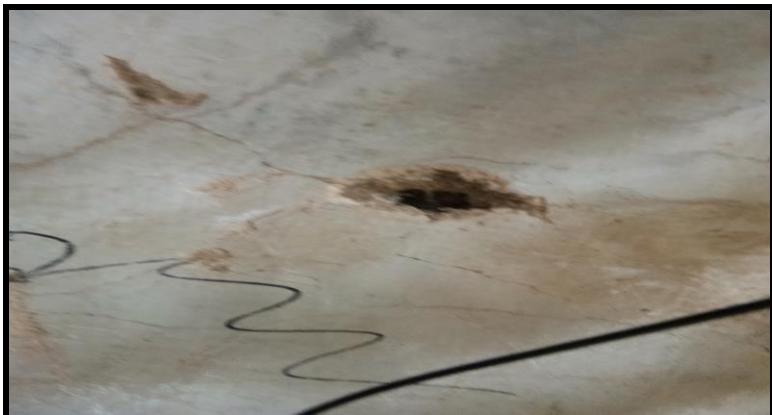
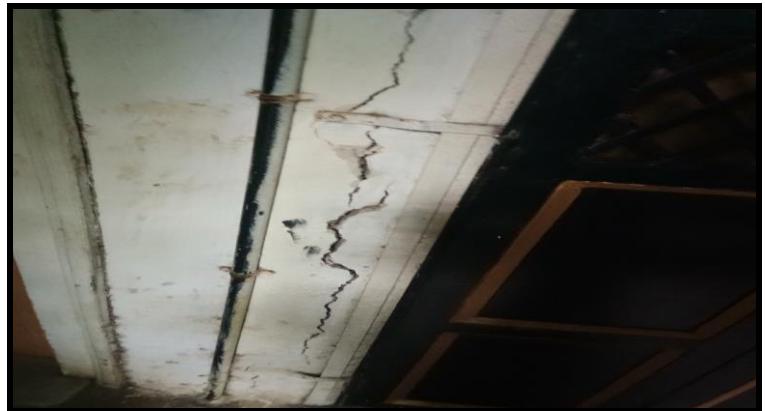
Third floor to Second floor:-

- ❖ Peeling of paint observed on wall.
- ❖ Crack observed on wall.
- ❖ Major structural crack observed on beam.

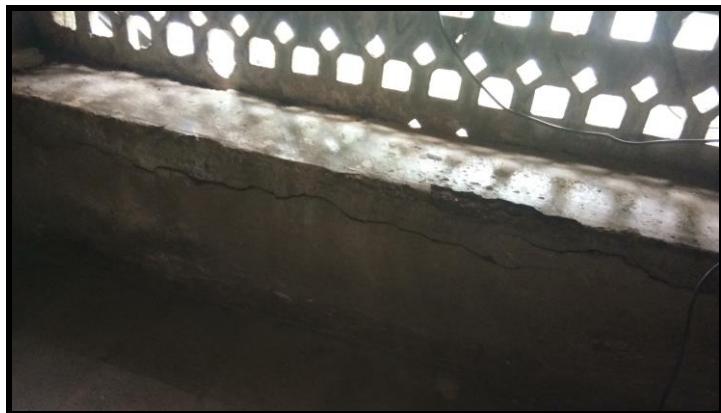
First floor to Ground floor:-

- ❖ Major structural crack observed on cantilever beam.
- ❖ Plaster gets removed and steel gets exposed.

- Remove old & crack loose concrete.
- Clean the exposed reinforcement.
- Apply Anti-rusting coat to the reinforcement
- Apply bonding coat to the old concrete.
- Replace the removed concrete with polymer base mortar under the strict supervision of a Consulting Engineer.

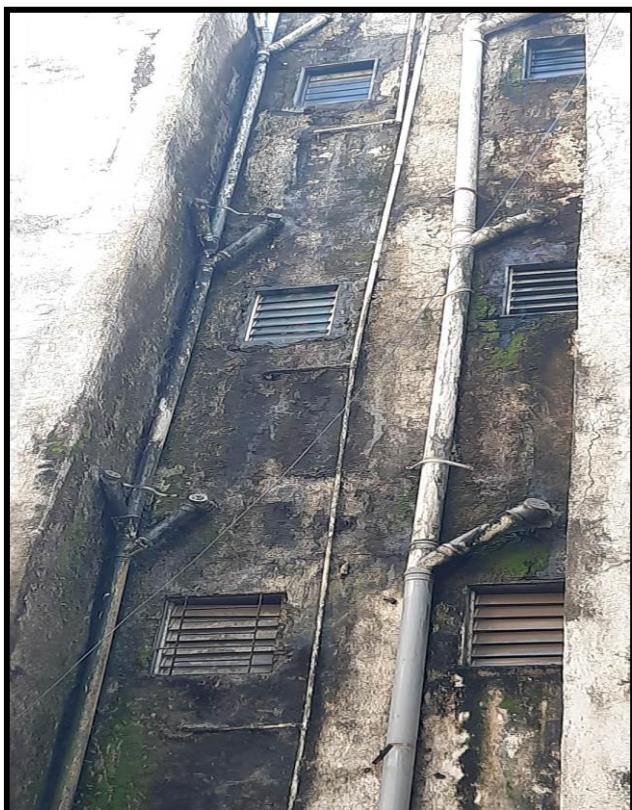
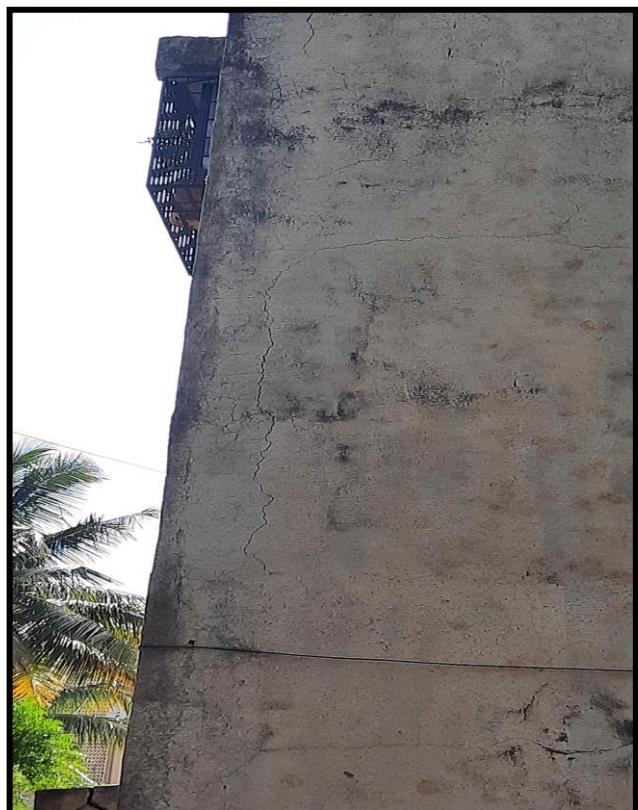
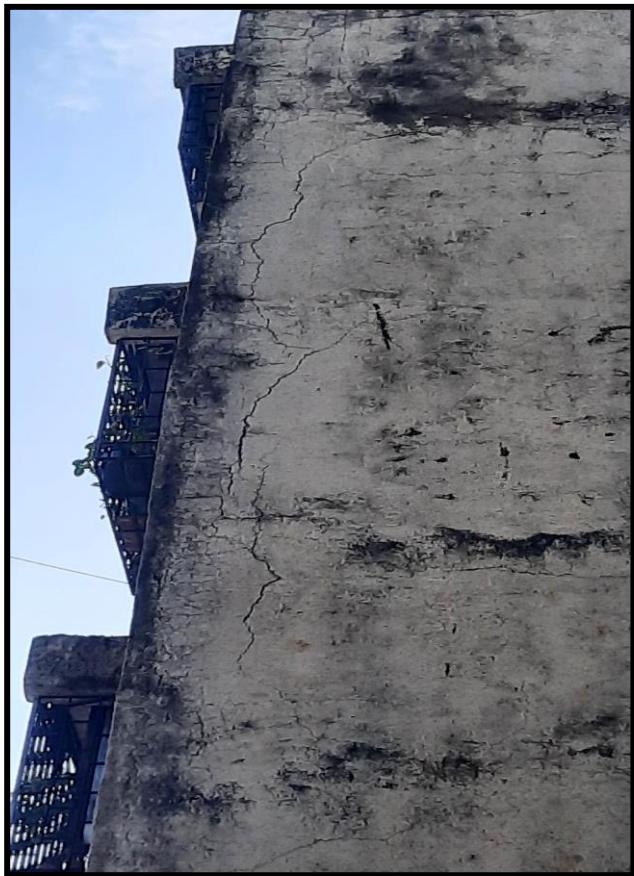
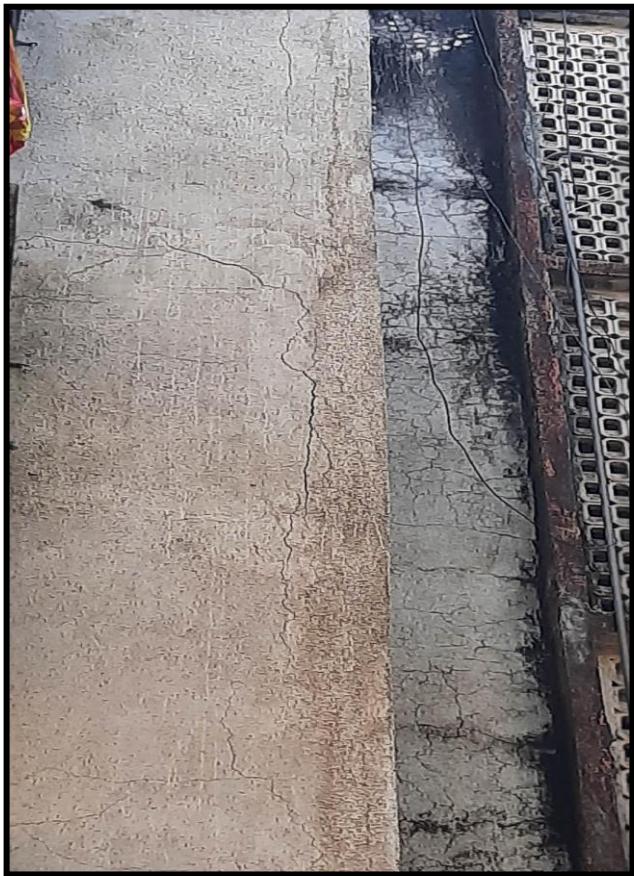
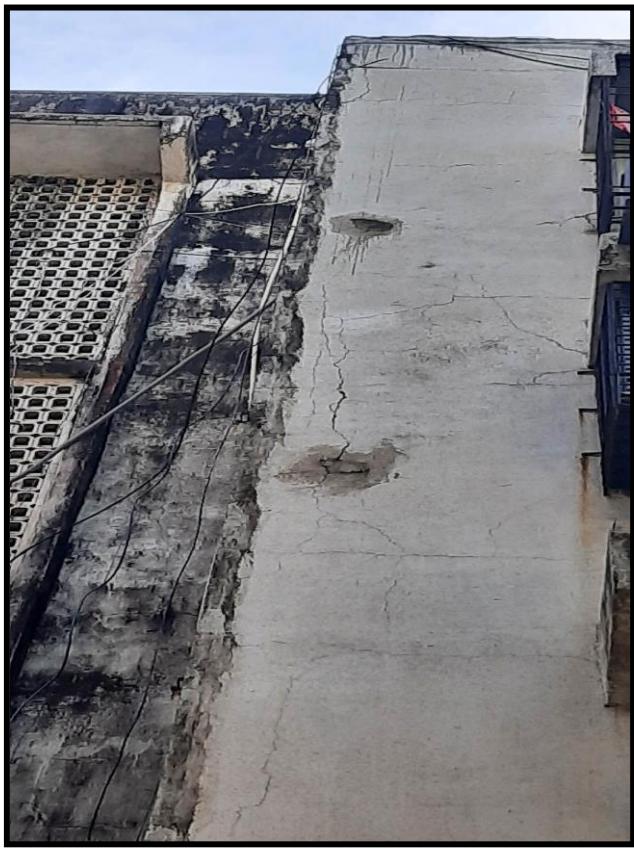
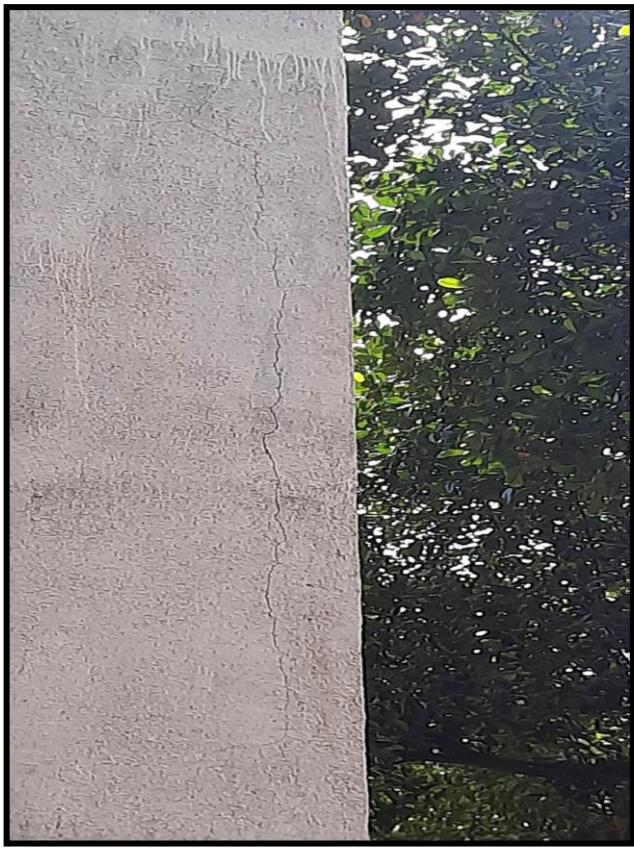
FRONT SIDE

- ❖ Structural crack observed at several places on column.
- ❖ Major crack observed at several places on wall.
- ❖ Vegetation growth observed at several places on wall.
