STRUCTURAL AUDIT REPORT
FOR
“VISHAL SAHYADRI CO – OP HSG. SOC. LTD”,
“B15 – WING”
SITUATED AT
SAHYADRI NAGAR, CHARKOP,
KANDIVALI (W) MUMBAI – 400 067

978/B15/LSS/2021

JULY 24, 2021

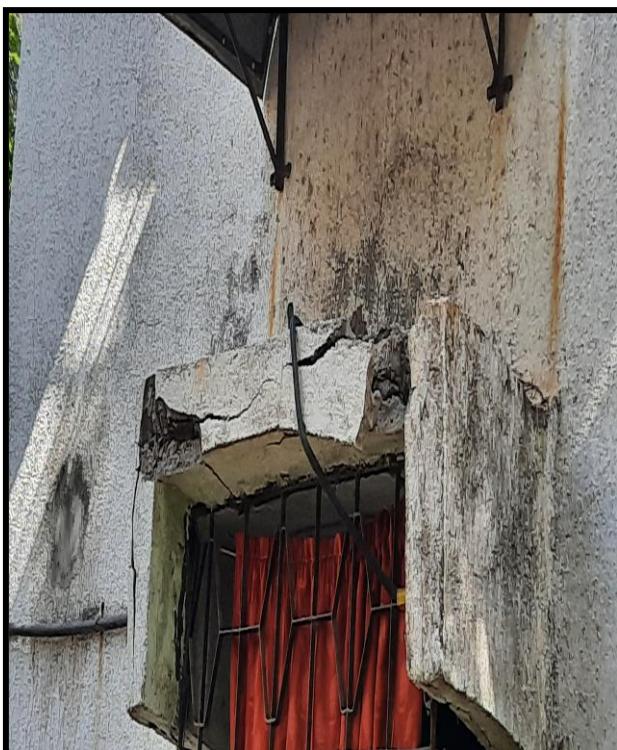
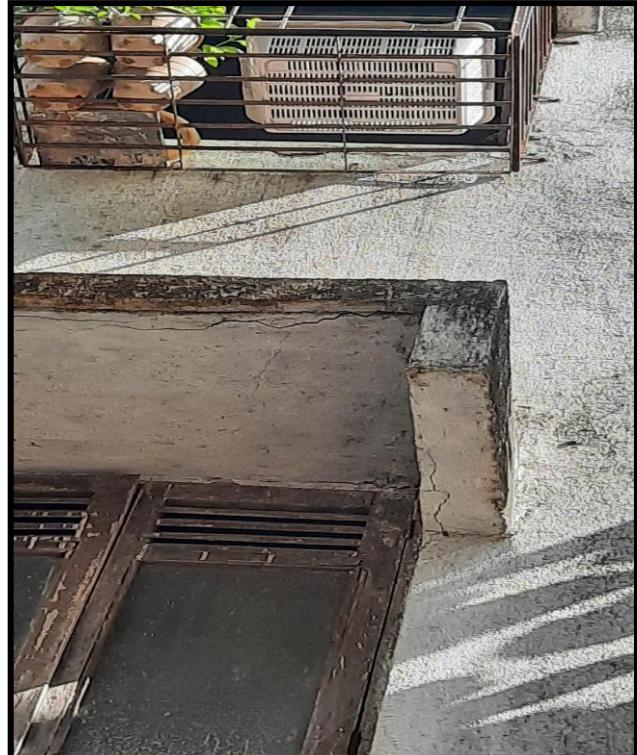
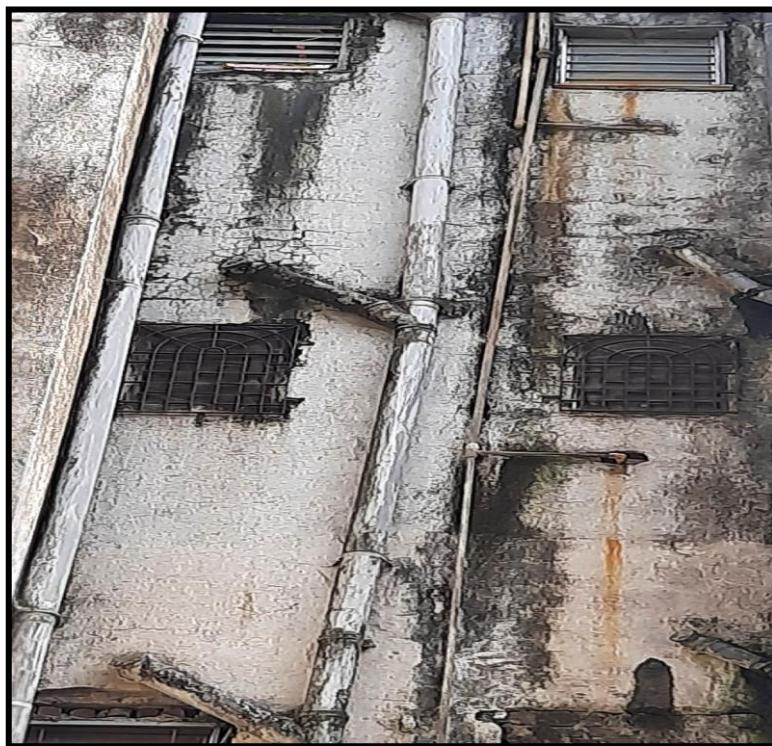
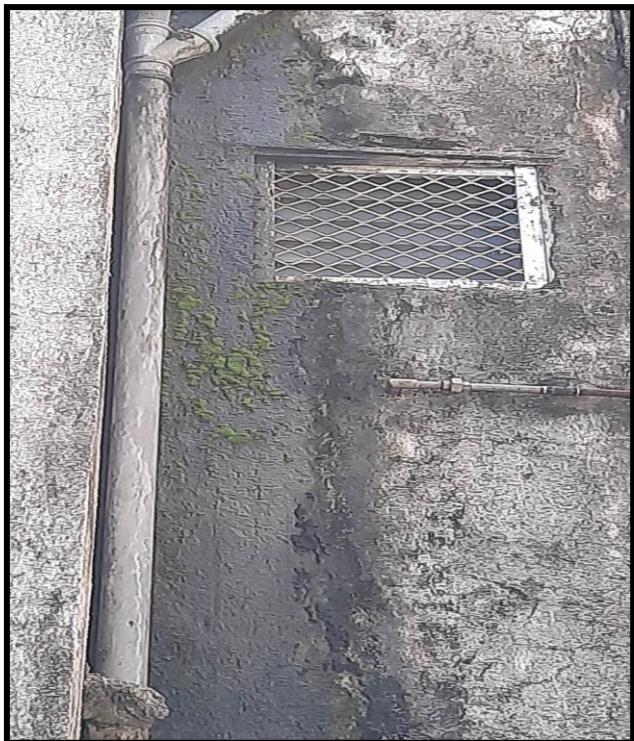
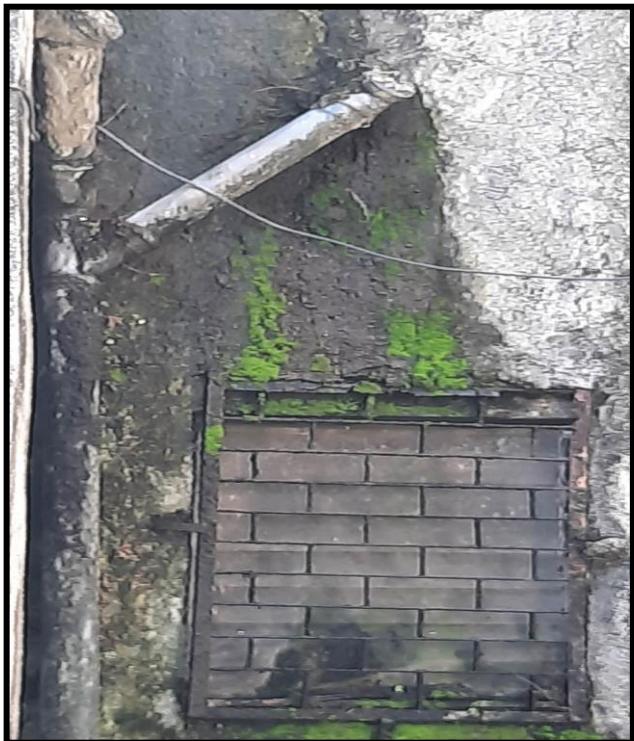
BACK SIDE

- ❖ Structural crack observed at several places on column.
- ❖ Major crack observed at several places on wall.
- ❖ Vegetation growth observed at several places on wall.

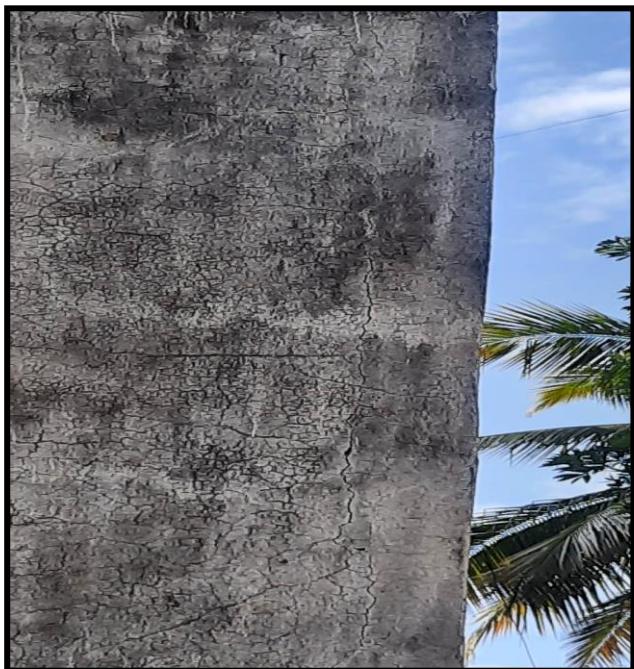
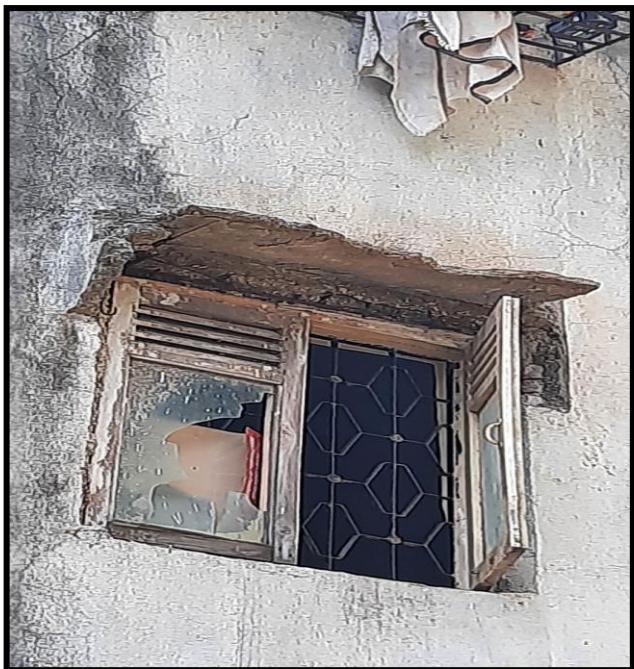
SOUTH SIDE

- ❖ Structural crack observed at several places on column.
- ❖ Major crack observed at several places on wall.
