STRUCTURAL AUDIT REPORT  
FOR  
**“VISHAL SAHYADRI CO – OP HSG. SOC. LTD”,**  
**“D3 – L WING”**  
SITUATED AT  
SAHYADRI NAGAR, CHARKOP,  
KANDIVALI (W) MUMBAI – 400 067

978/D3/LSS/2021

JULY 16, 2021

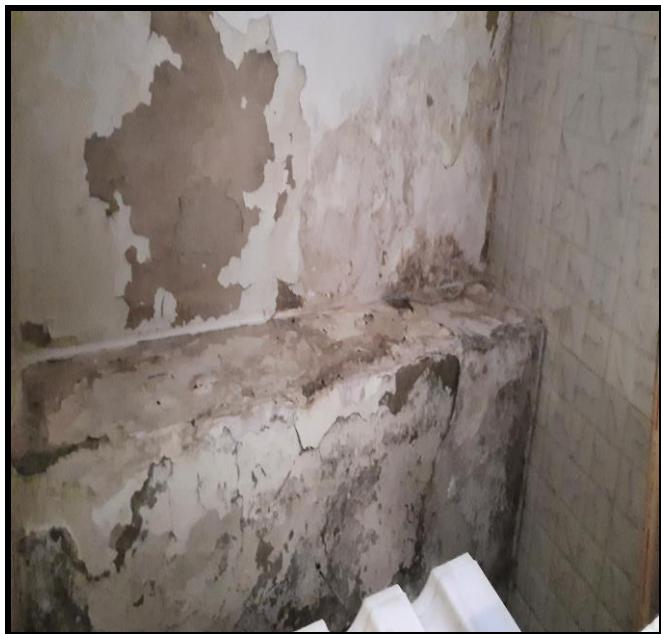
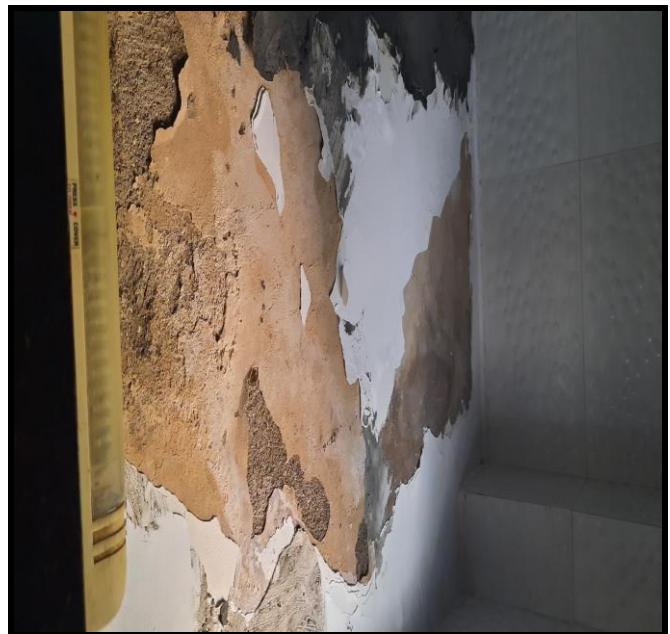
### FLAT NO – 08

- ❖ **HALL** – O.K.
- ❖ **KITCHEN** – O.K.
- ❖ **PASSAGE** – Leakage mark observed on ceiling.
- ❖ **TOILET & BATH ROOM** – Leakage mark observed on ceiling.

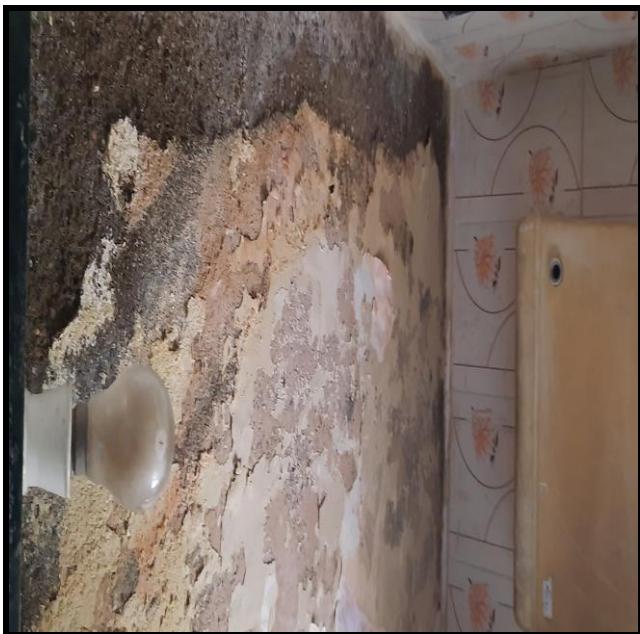
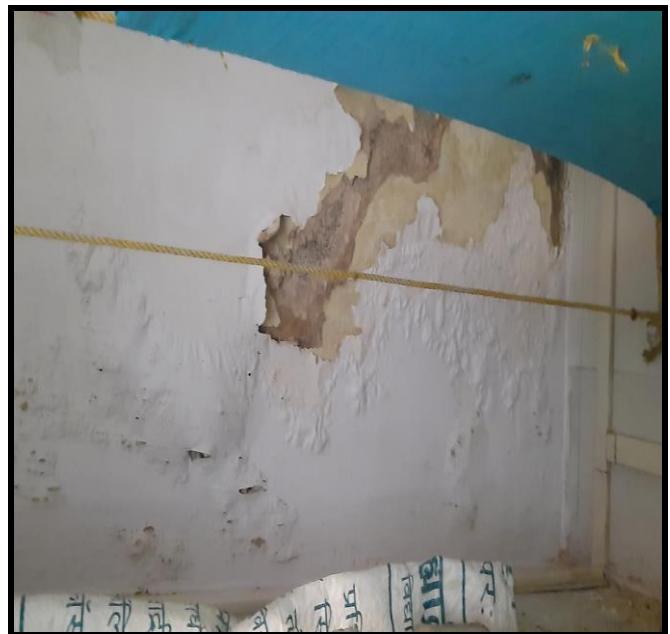
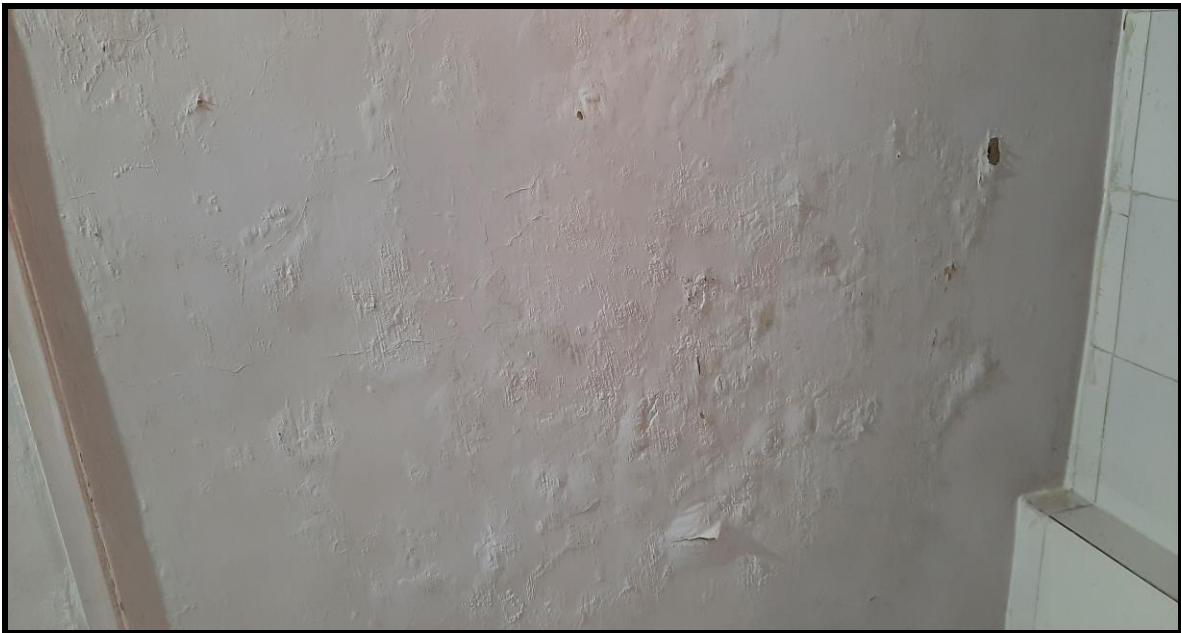
### FLAT NO – 10

- ❖ **HALL** – O.K.
- ❖ **KITCHEN** – Leakage mark observed on ceiling.
- ❖ **PASSAGE** – Leakage mark observed on ceiling.
- ❖ **TOILET & BATH ROOM** – Leakage mark observed on ceiling.

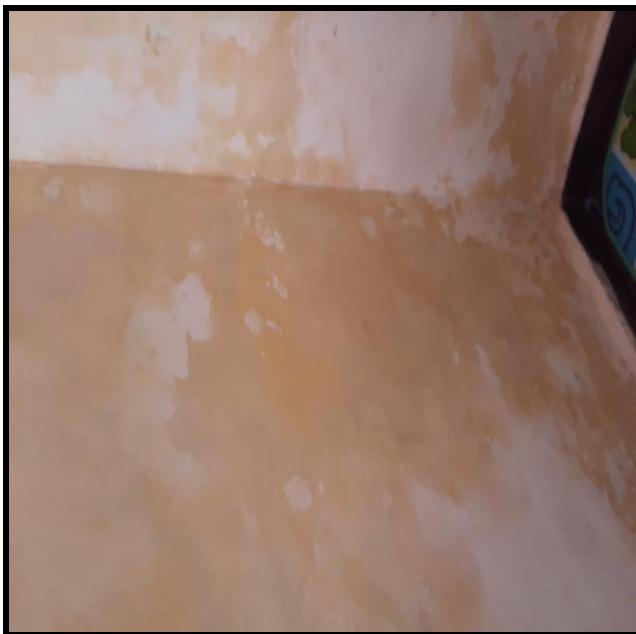
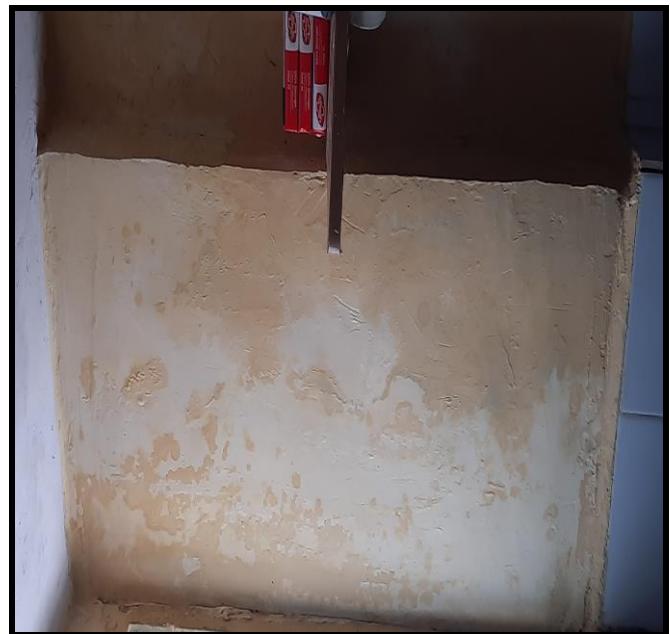
### FLAT NO – 13

- ❖ **HALL** – Dampness observed on wall.
- ❖ **KITCHEN** – O.K.
- ❖ **PASSAGE** – O.K.
- ❖ **TOILET & BATH ROOM** – Dampness observed on wall.

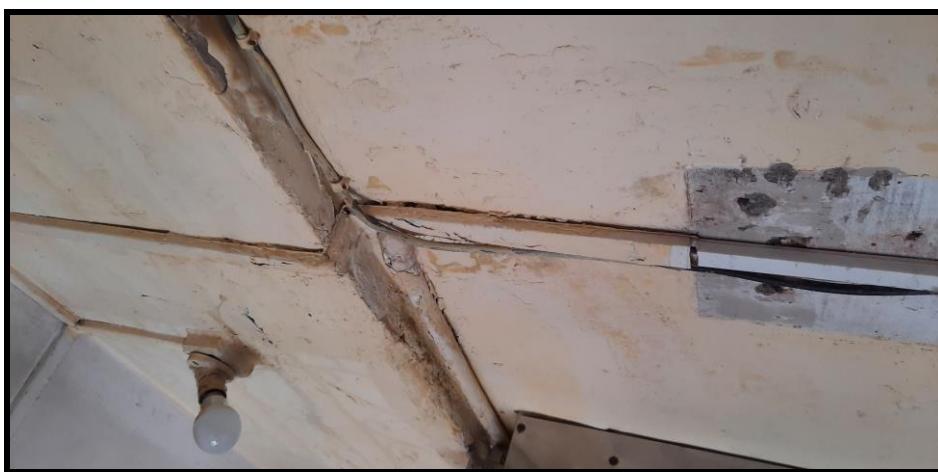
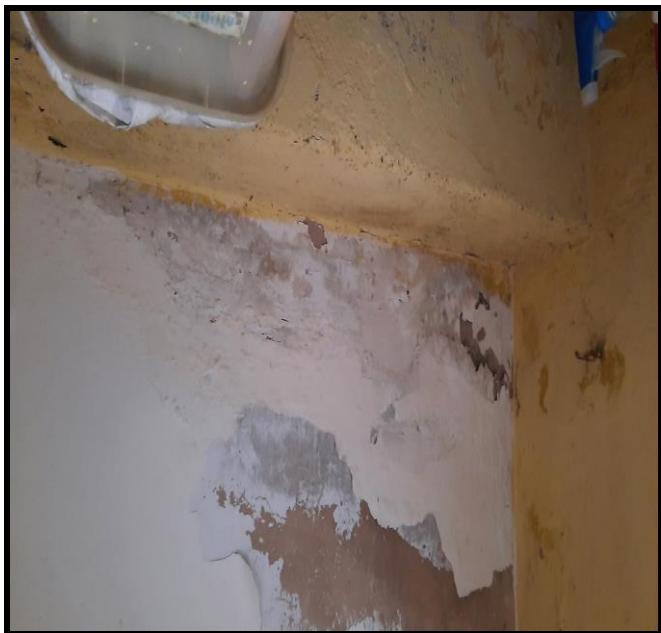
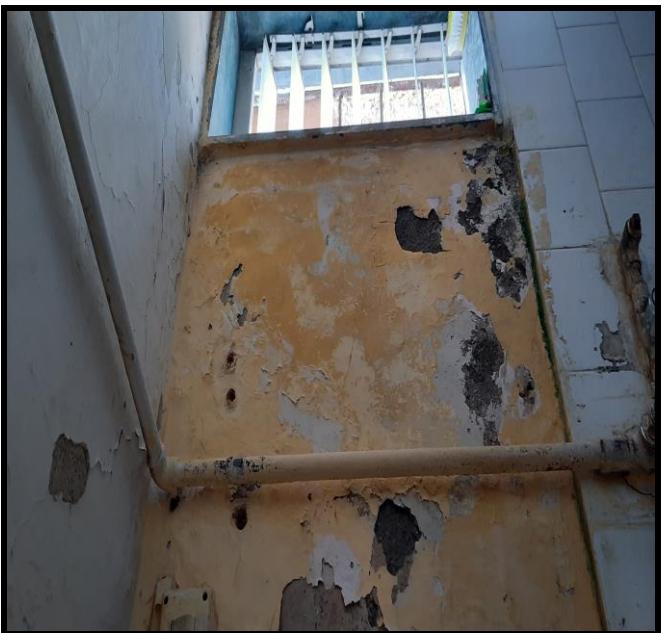
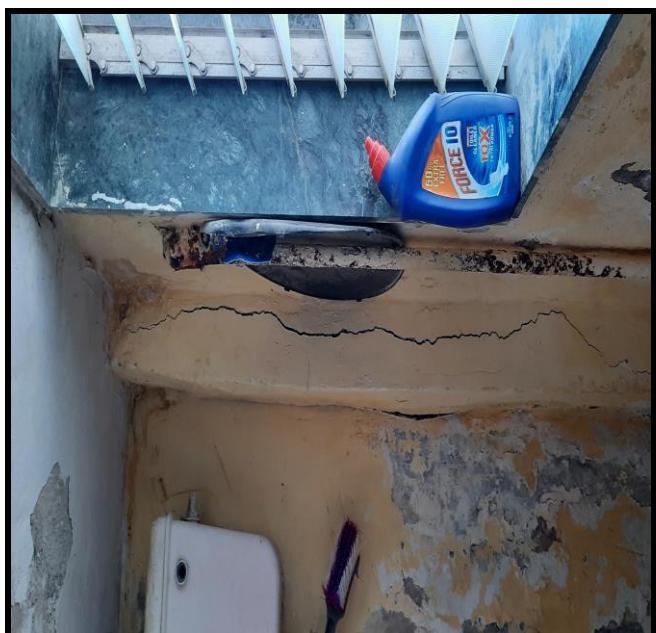
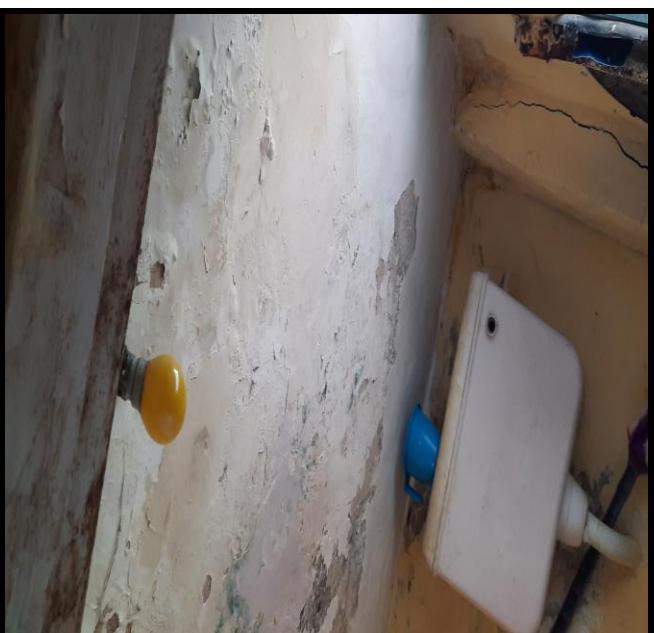
### FLAT NO – 15

- ❖ **HALL** – O.K.
- ❖ **KITCHEN** – Leakage mark observed on wall.
- ❖ **PASSAGE** – Leakage mark observed on wall & ceiling.
- ❖ **TOILET & BATH ROOM** – Leakage mark observed on wall & ceiling.
  - Structural crack observed on column.

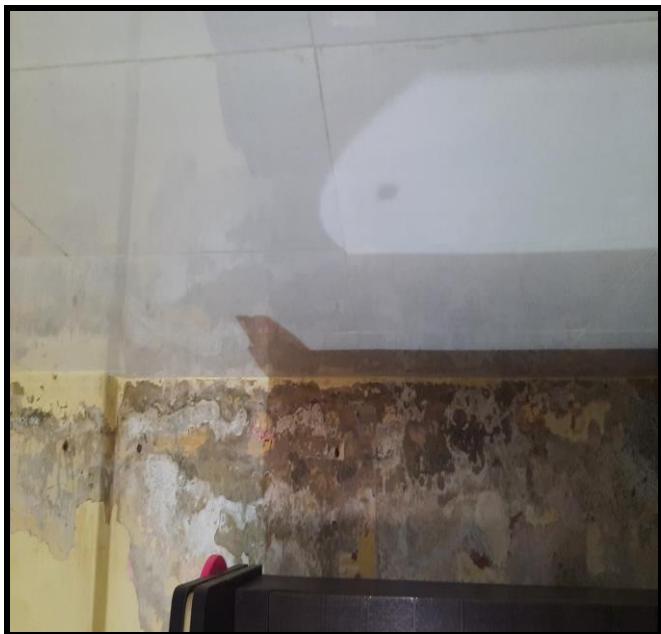
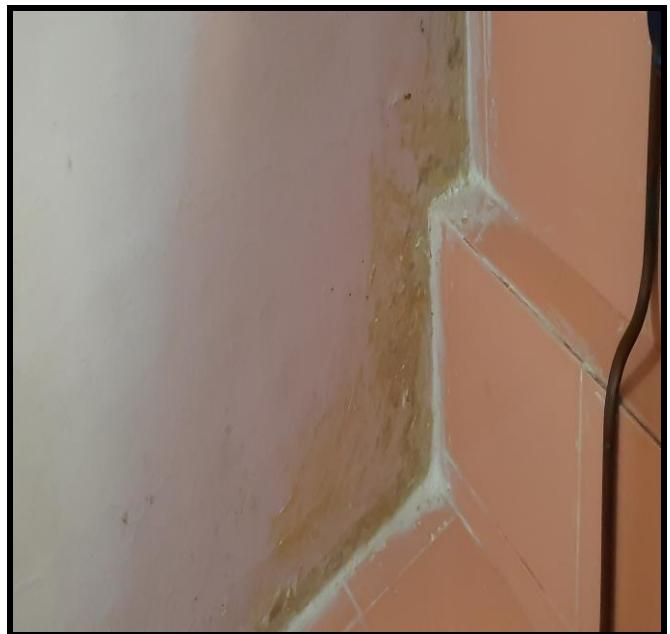
### FLAT NO – 20

- ❖ **HALL** – Leakage mark observed on wall.
- ❖ **KITCHEN** – Leakage mark observed on ceiling.
- ❖ **PASSAGE** – Leakage observed in ceiling in monsoon.
- ❖ **TOILET & BATH ROOM** – O.K.

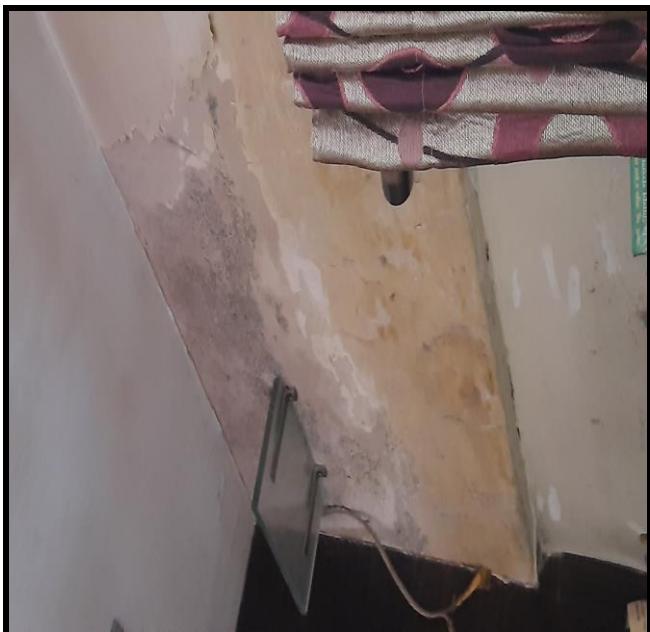
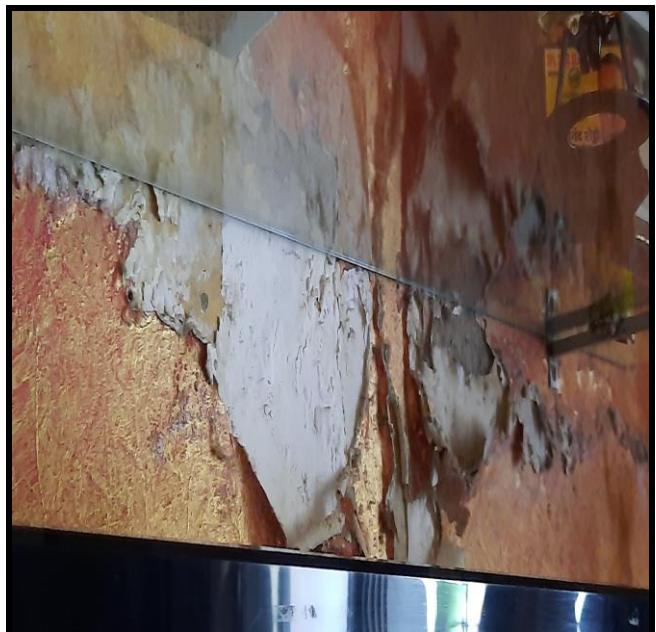
### FLAT NO – 21

- ❖ **HALL** – Leakage mark observed on wall.
- ❖ **KITCHEN** – O.K.
- ❖ **PASSAGE** – O.K.
- ❖ **TOILET & BATH ROOM** – O.K.

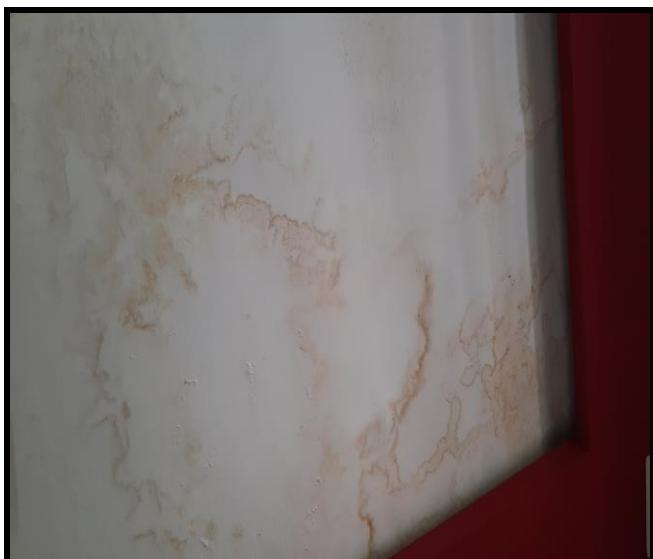
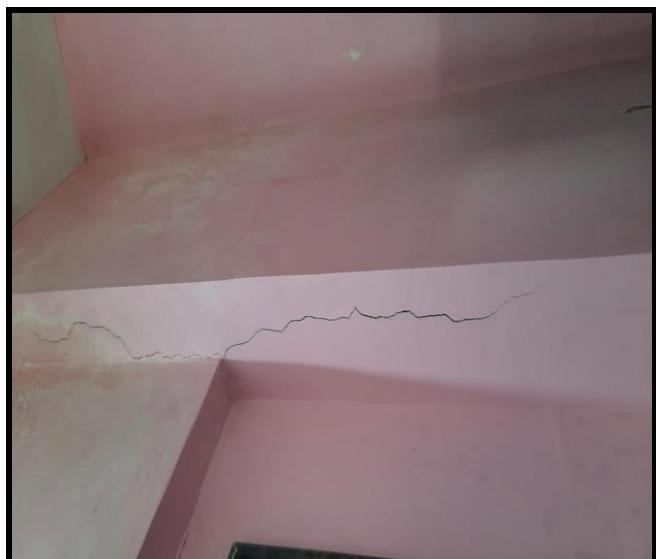
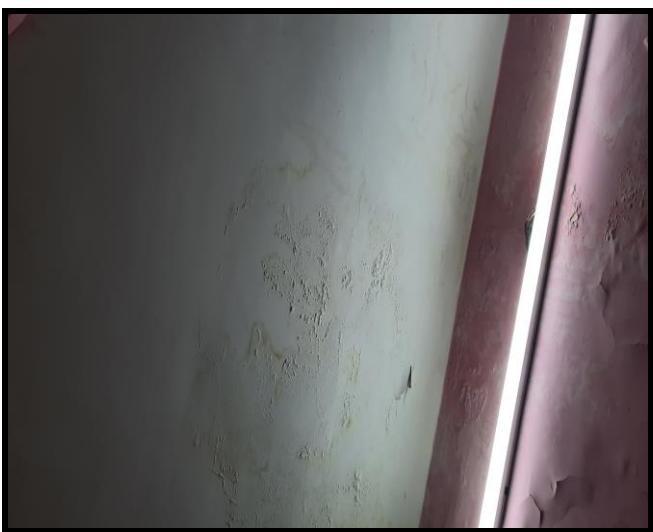
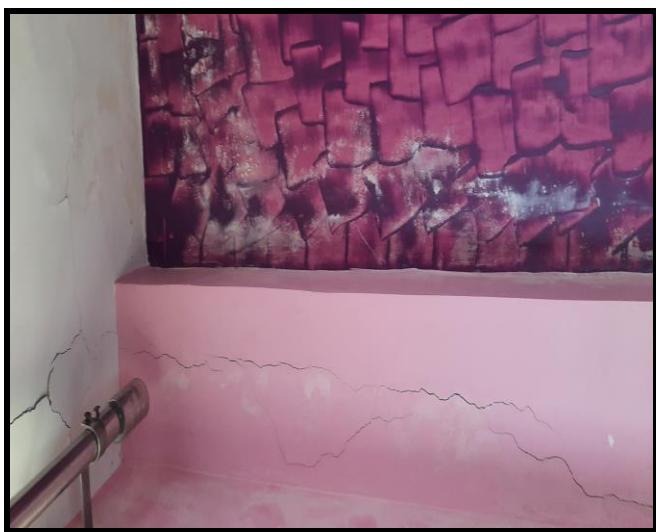
### FLAT NO – 30

- ❖ **HALL** – Leakage mark observed on ceiling.
- ❖ **KITCHEN** – Leakage mark observed on wall & ceiling.
  - Structural crack observed on column.
- ❖ **PASSAGE** – O.K.
- ❖ **TOILET & BATH ROOM** – Leakage observed in ceiling in monsoon.

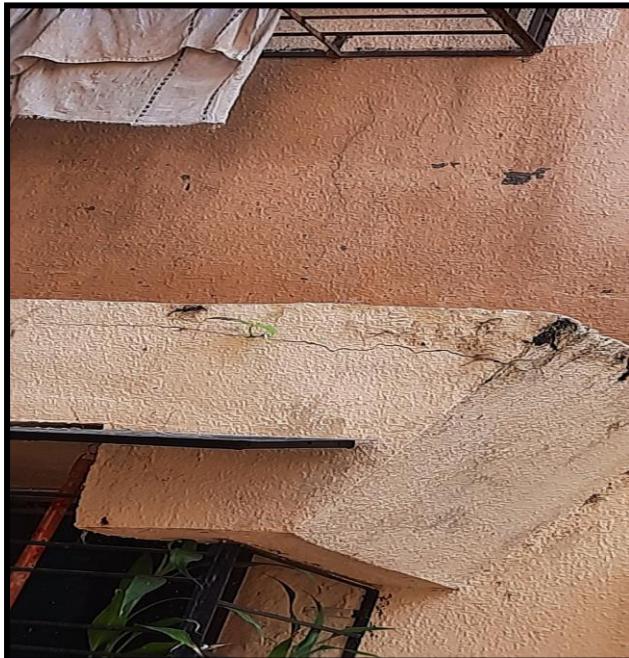
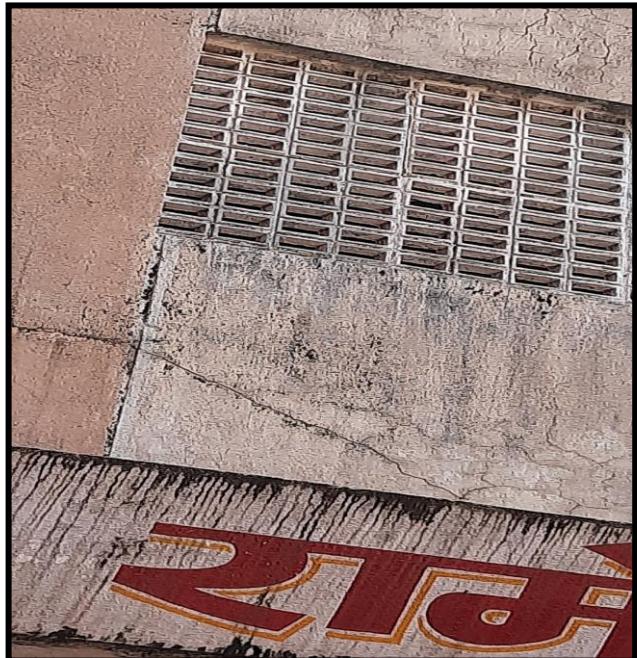
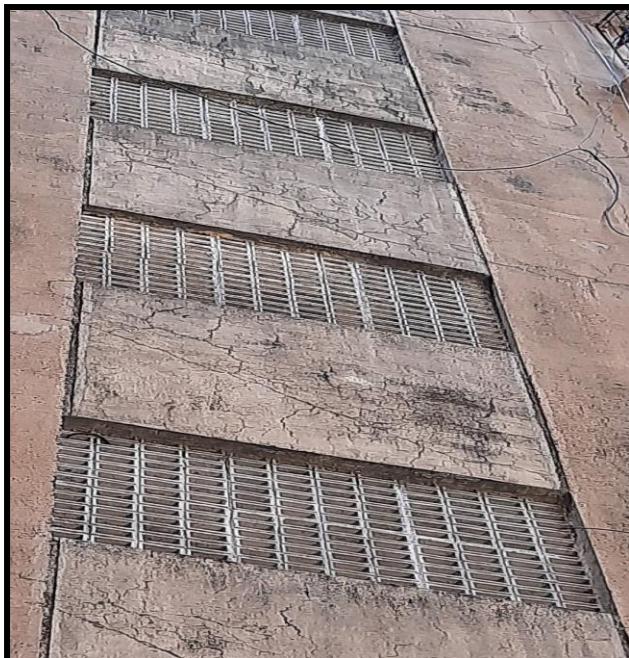
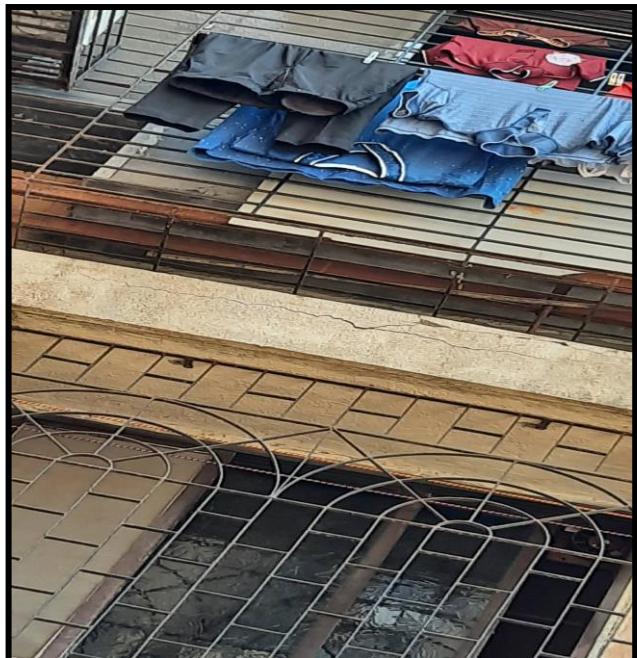
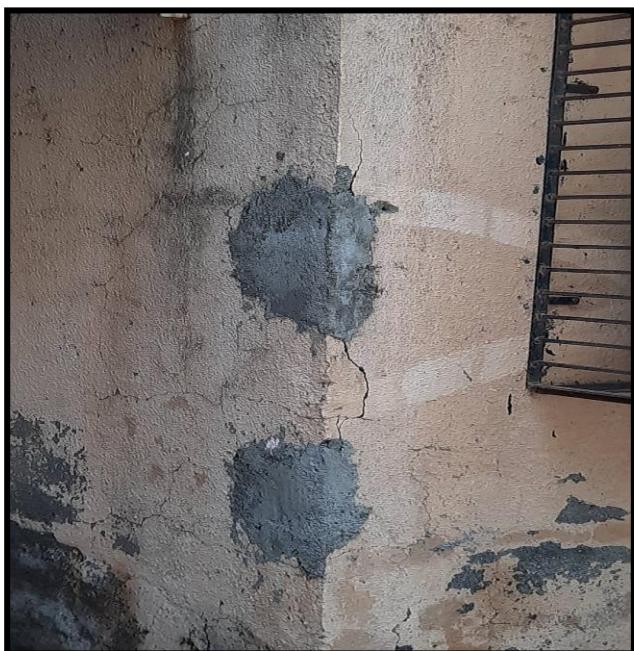
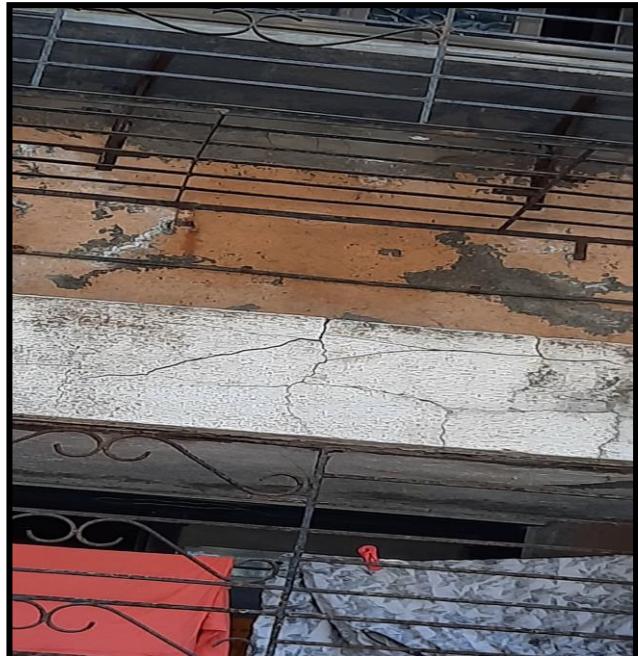
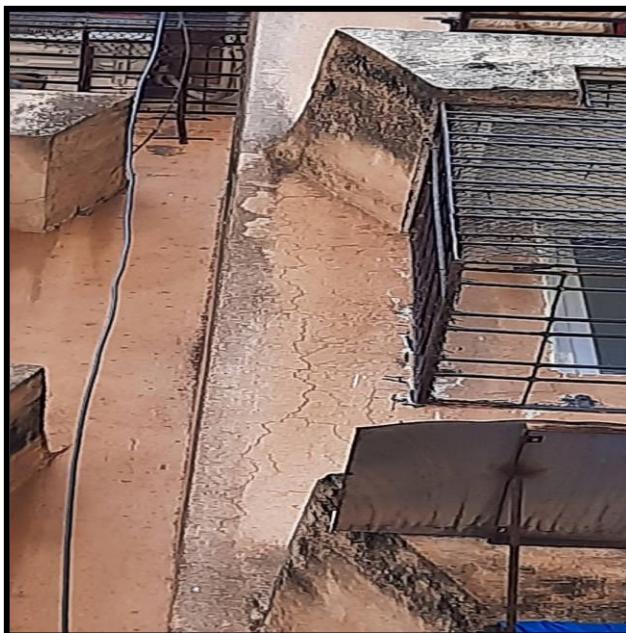
### FRONT SIDE

- ❖ Structural crack observed at several places on column & chajjas.
- ❖ Algae observed at several places on wall.

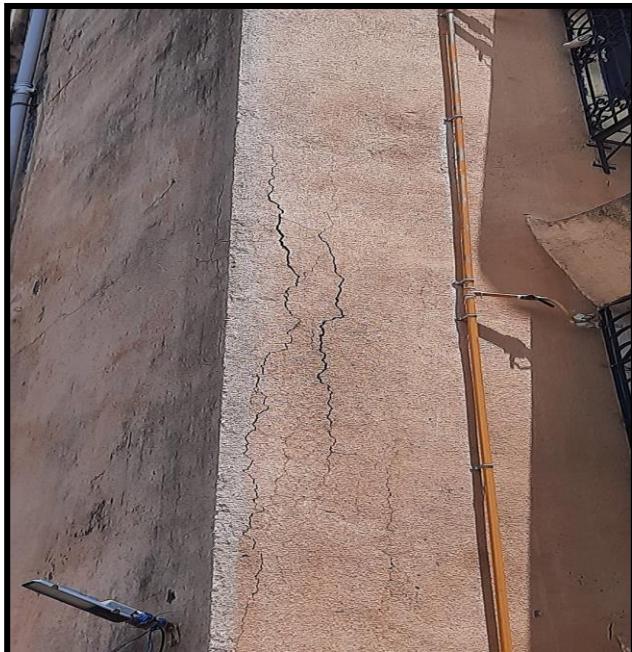
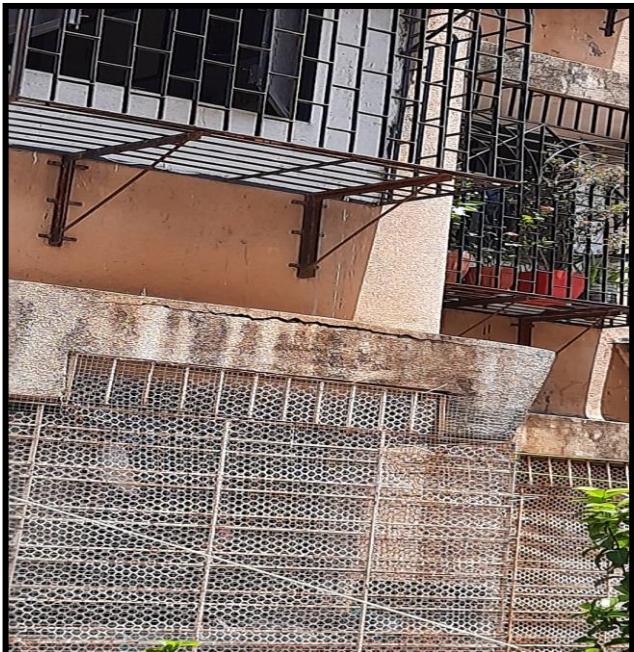
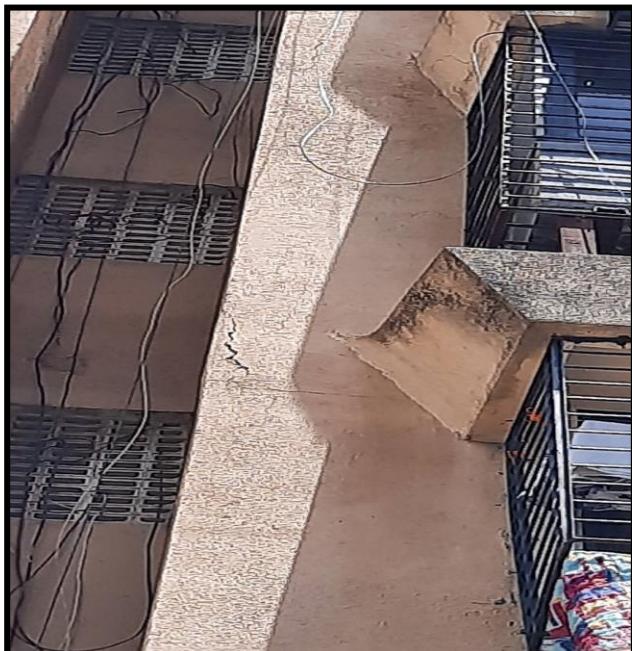
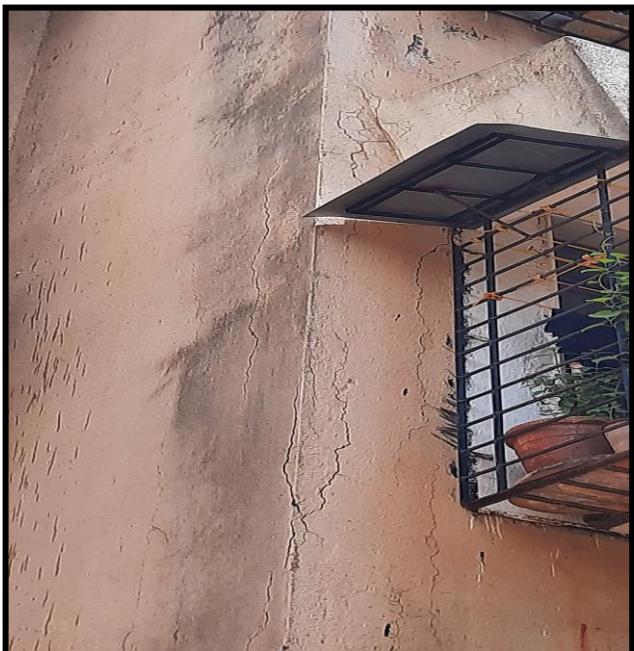
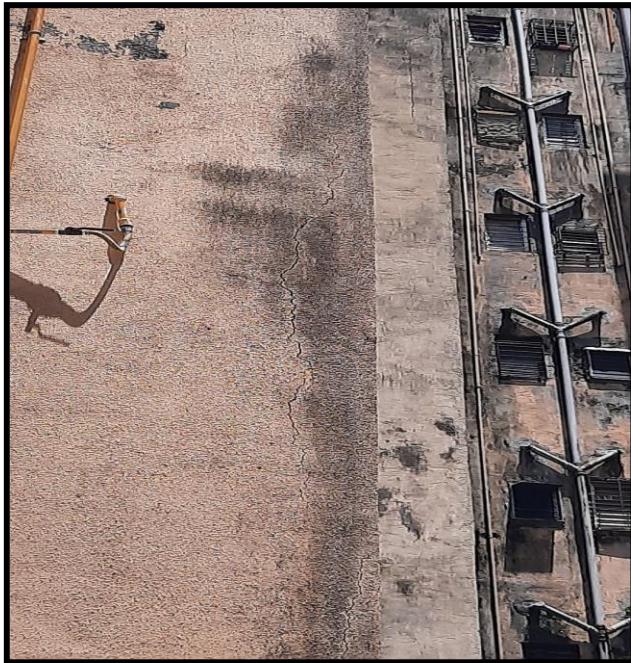
## BACK SIDE

- ❖ Structural crack observed at several places on column & chajjas.

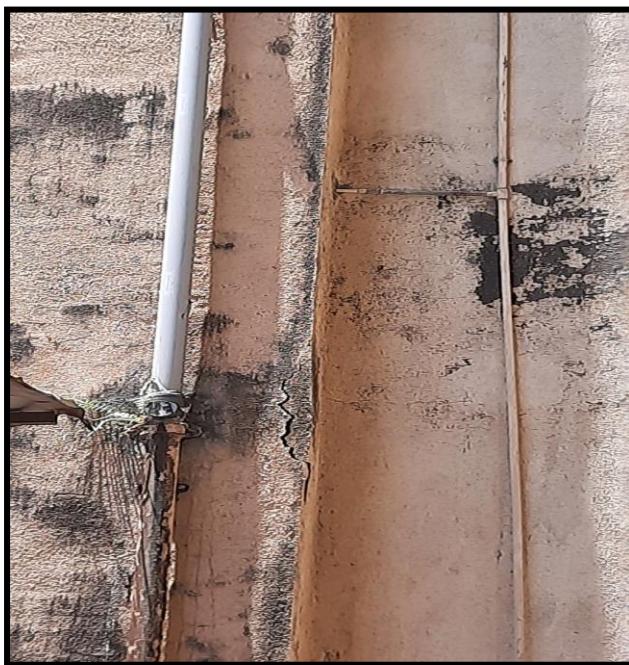
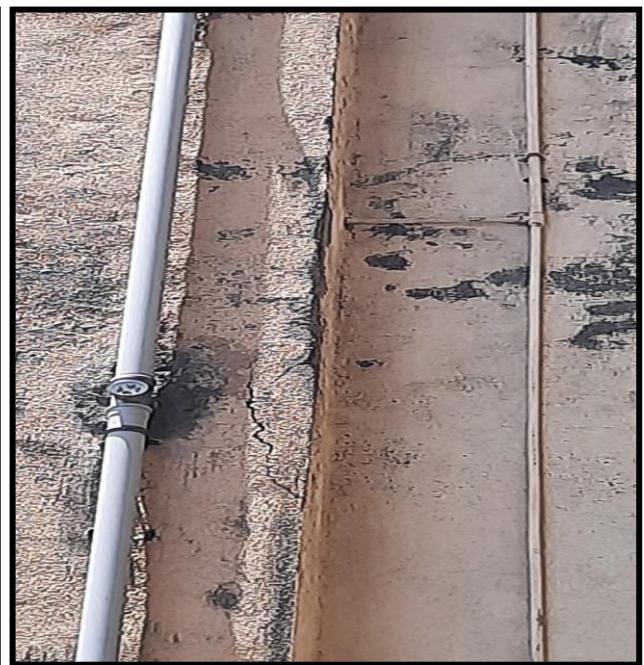
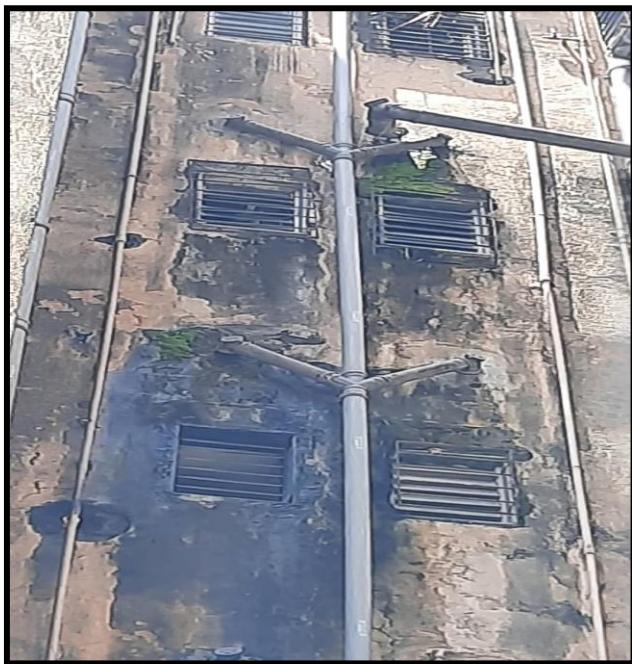
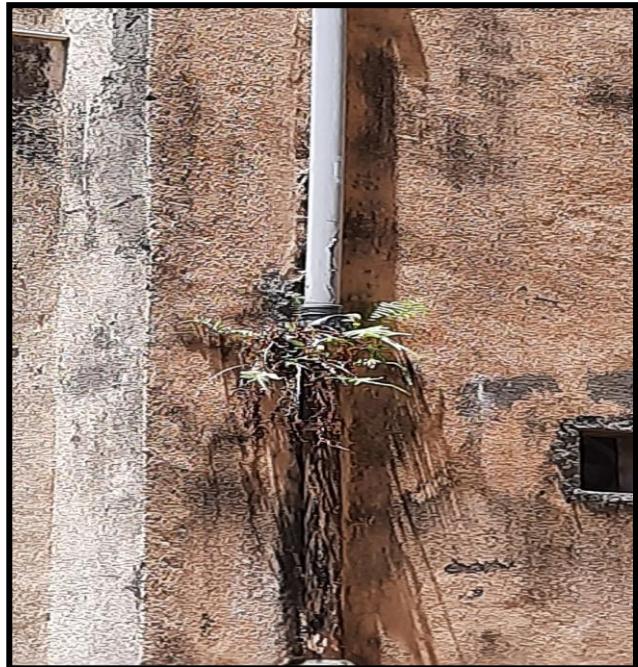
## NORTH SIDE

- ❖ Structural crack observed at several places on column.
- ❖ Algae observed at several places on wall.
- ❖ Vegetation growth observed at several places on wall.

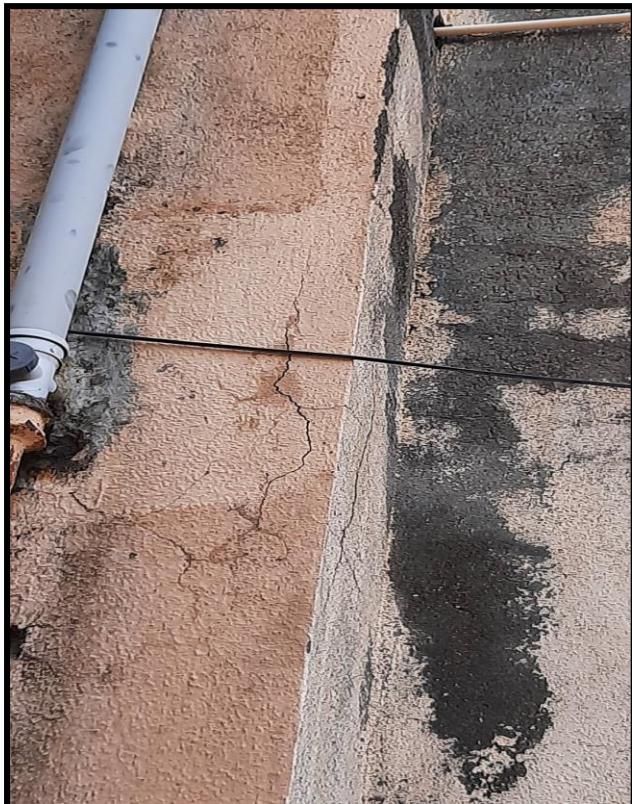
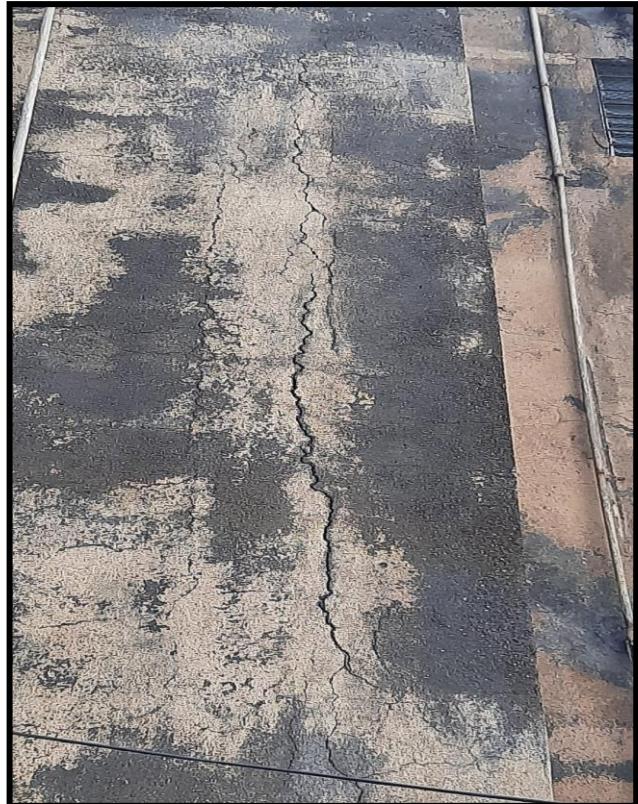
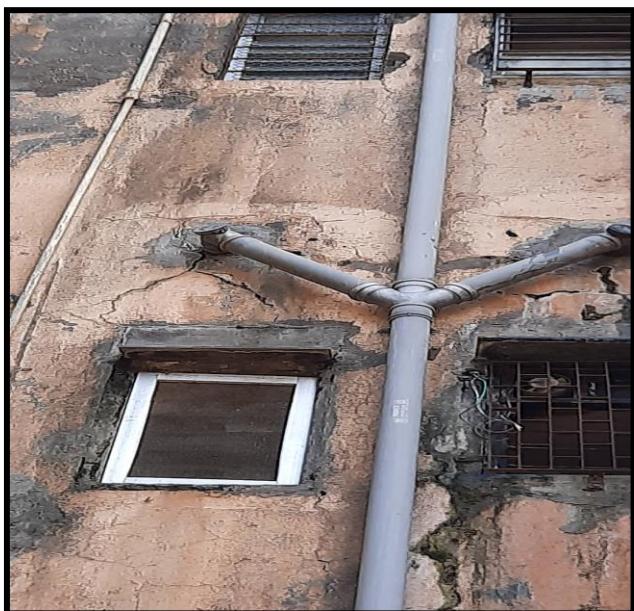
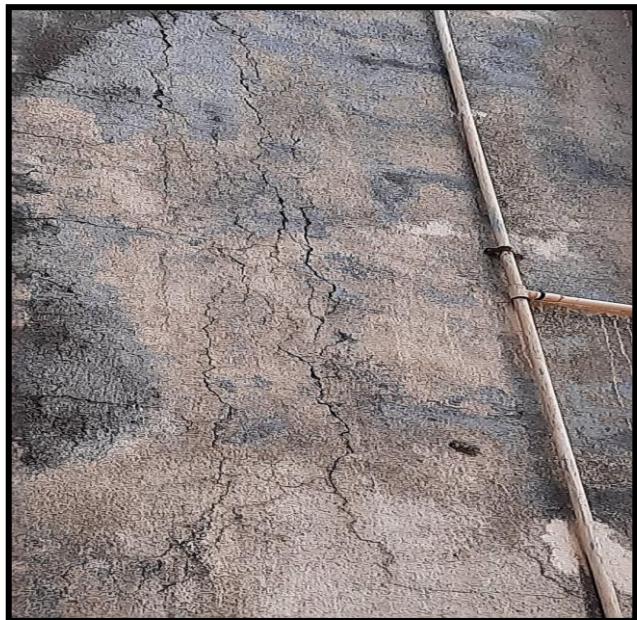
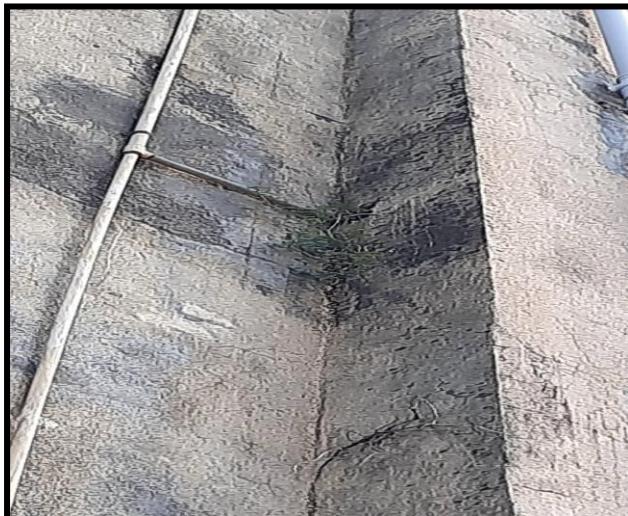
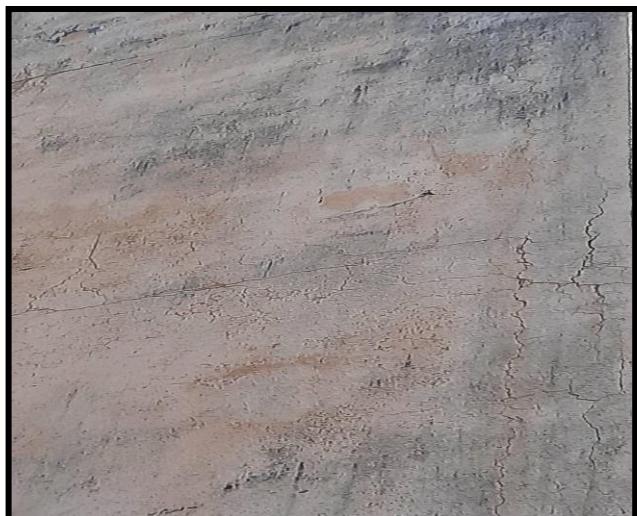
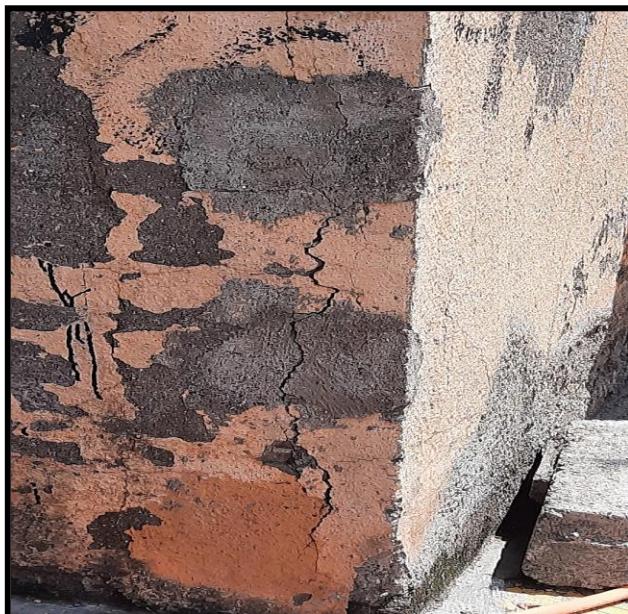
## SOUTH SIDE

- ❖ Structural crack observed at several places on column & chajjas.
- ❖ Major crack observed at several places on wall.
