STRUCTURAL AUDIT REPORT
FOR
“VISHAL SAHYADRI CO – OP HSG. SOC. LTD”,
“D2 – G WING”
SITUATED AT
SAHYADRI NAGAR, CHARKOP,
KANDIVALI (W) MUMBAI – 400 067

978/D2/LSS/2021

JULY 24, 2021

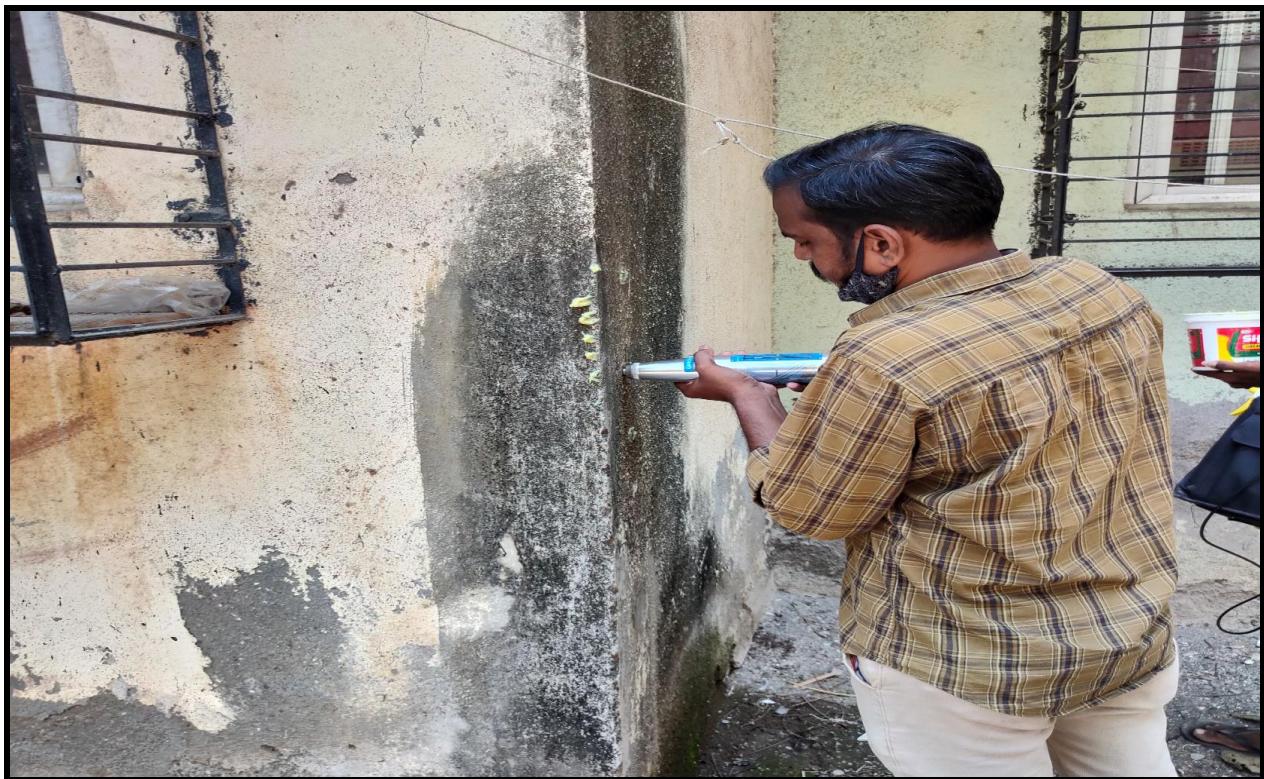
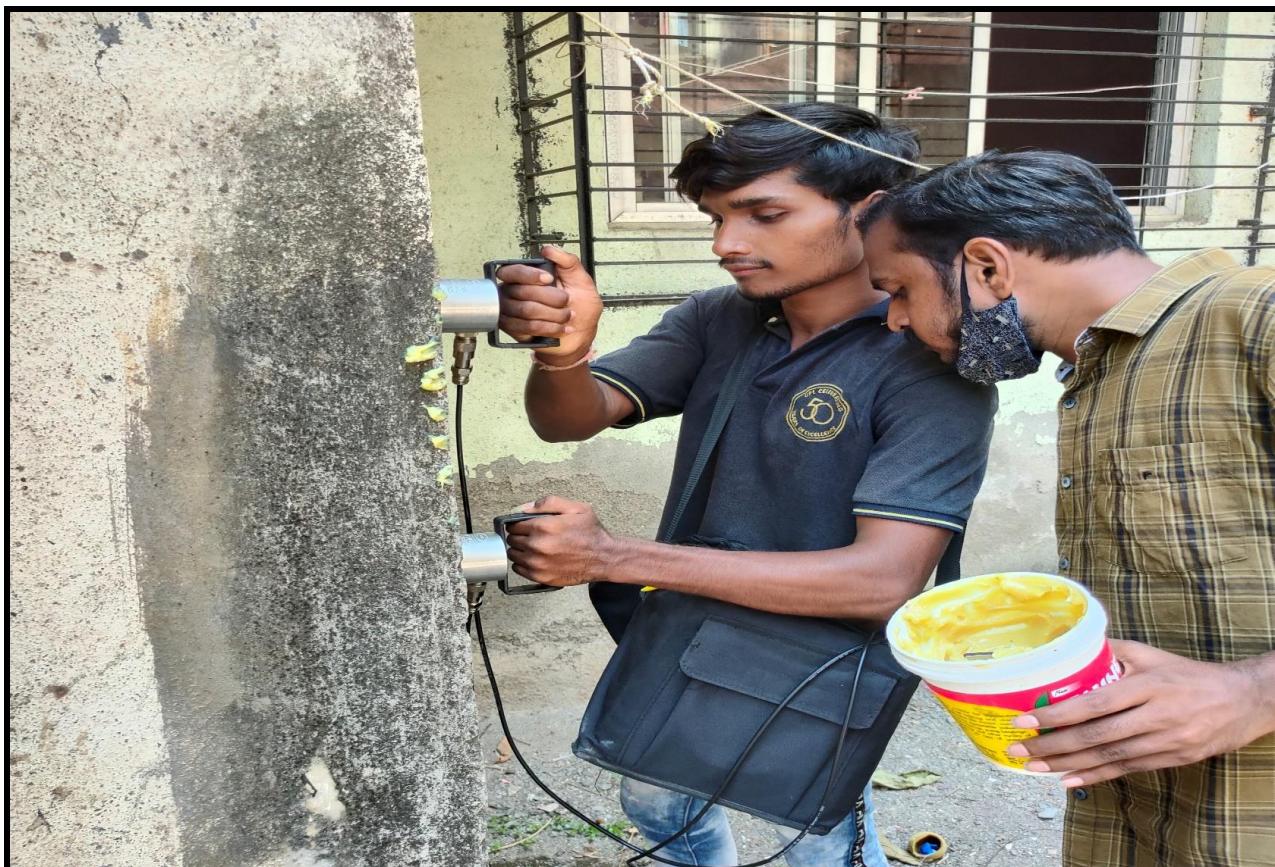
NON -DESTRUCTIVE TEST PHOTO

Rebound Hammer was tested for compressive strength at surface by Schmidt rebound hammer. Results indicate the compressive strength at surface of the RCC columns & beam in is ranging between 14.90 MPa to 20.30 MPa.

The UPV values are ranging between 2.50 Km/Sec to 3.10 Km/Sec.

Out of 4 locations 2 locations was below 3.0 Km/Sec means concrete quality is poor and 2 location ranging between 3.0 to 3.75 Km/Sec means concrete quality is doubtful.

This indicates there are progressive internal cracks in the RCC members due to corrosion of reinforced steel. These members are under distress condition.

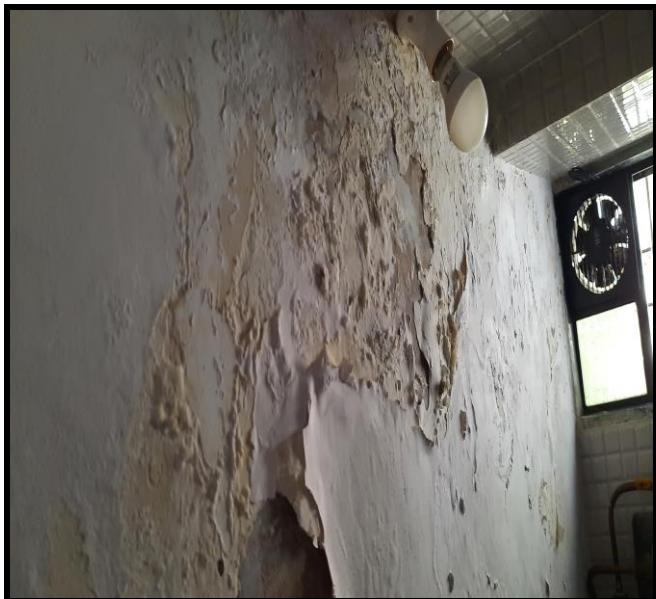
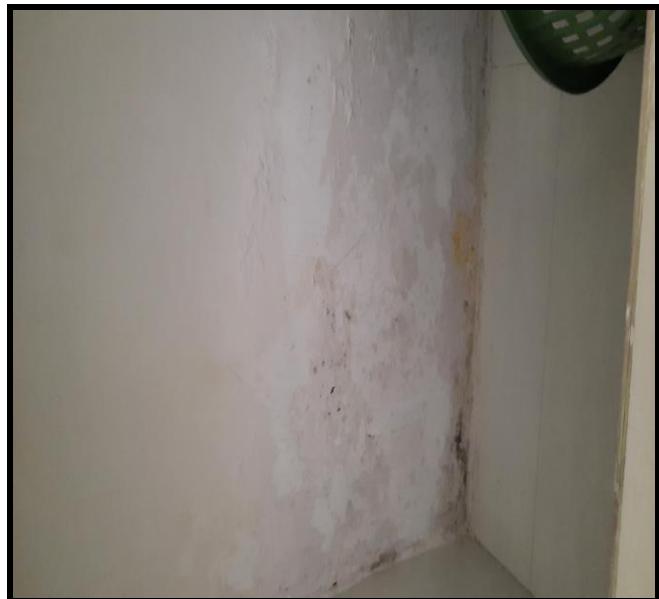
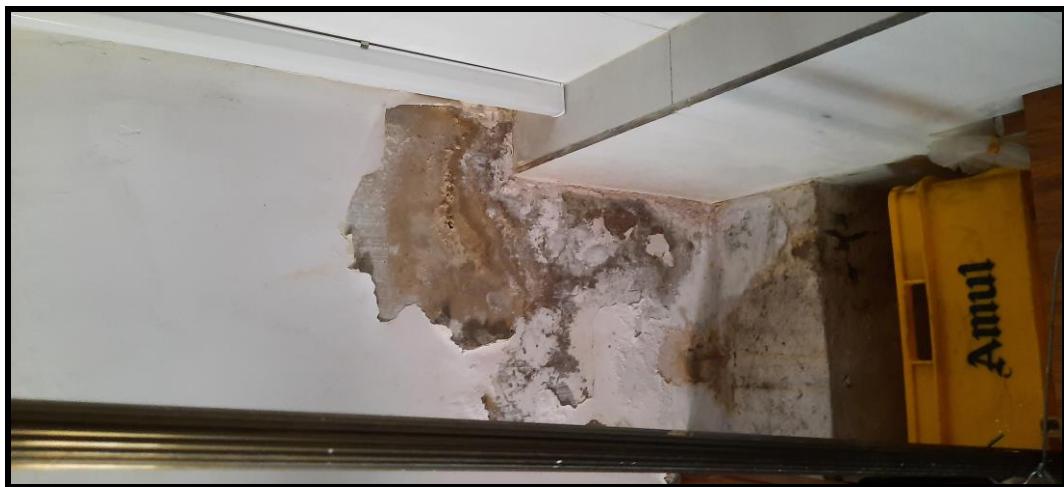
FLAT NO – 01

- ❖ **HALL** – O.K.
- ❖ **KITCHEN** – Leakage observed on ceiling.
- ❖ **PASSAGE** – Leakage mark observed on ceiling.
- ❖ **TOILET & BATH ROOM** – Leakage mark observed on ceiling.

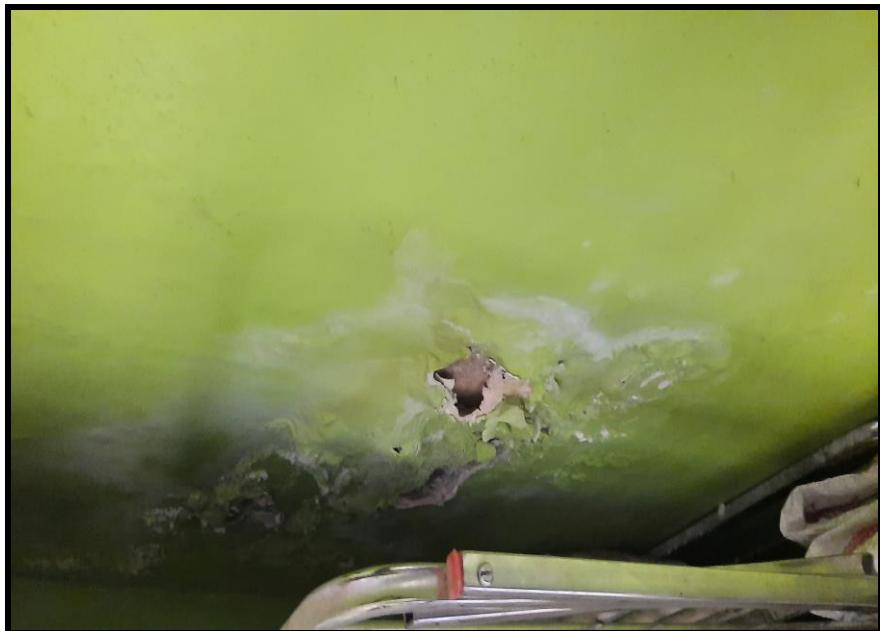
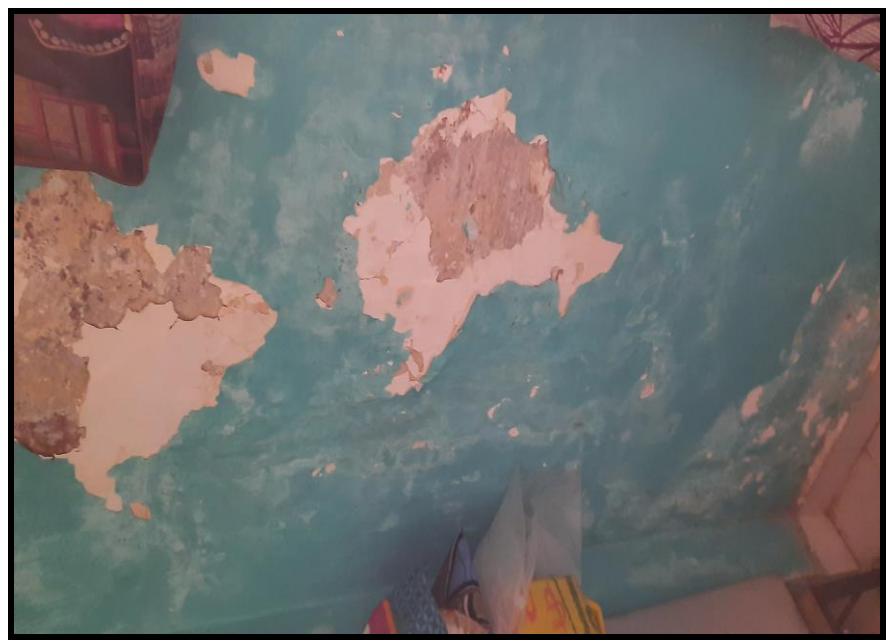
FLAT NO – 02

- ❖ **HALL** – Leakage mark observed on wall.
- ❖ **KITCHEN** – Leakage mark observed on wall.
- ❖ **PASSAGE** – O.K.
- ❖ **TOILET & BATH ROOM** – O.K.

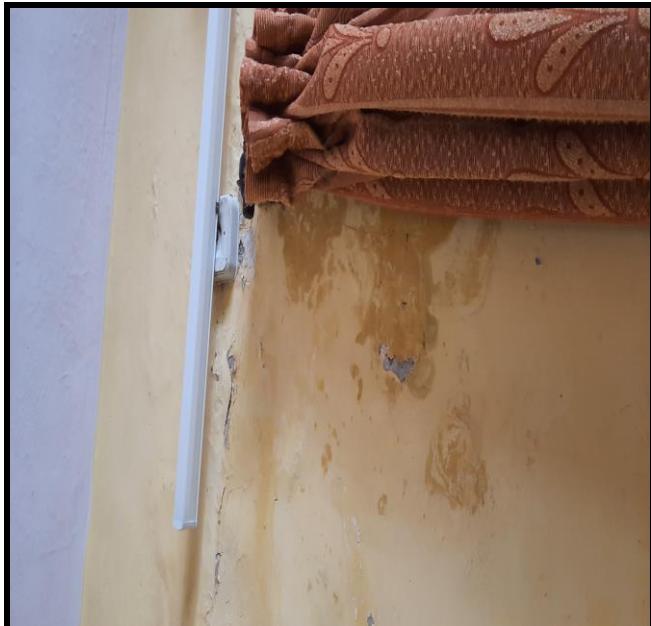
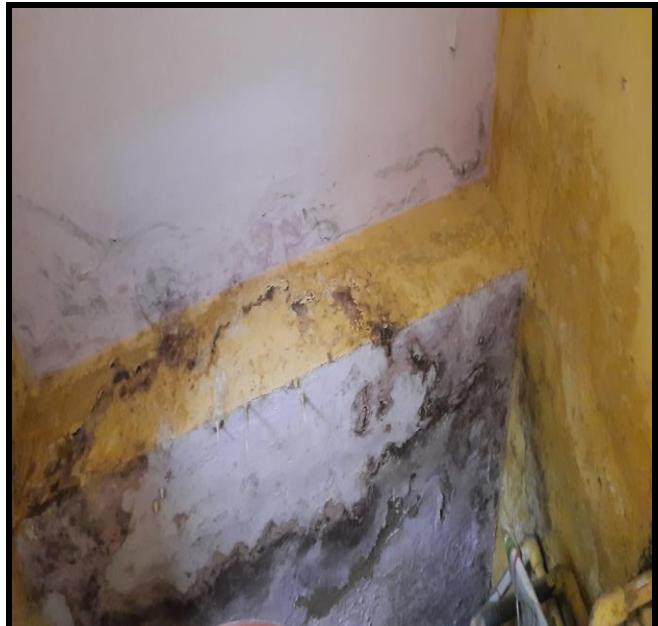
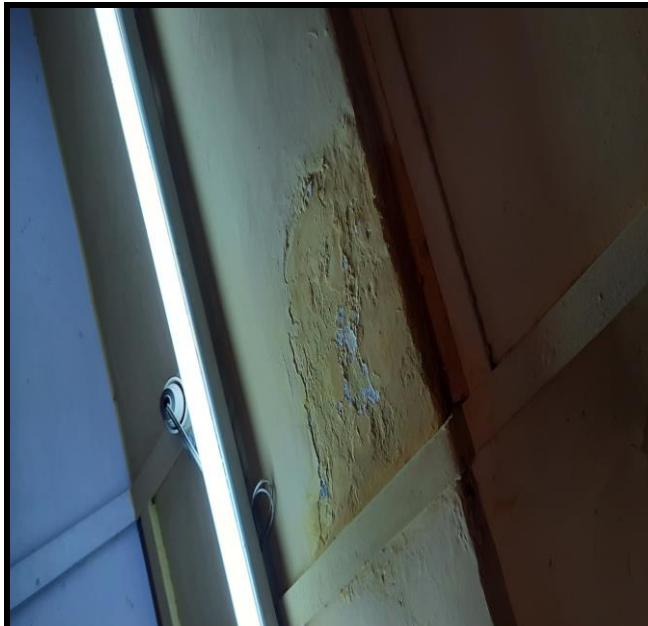
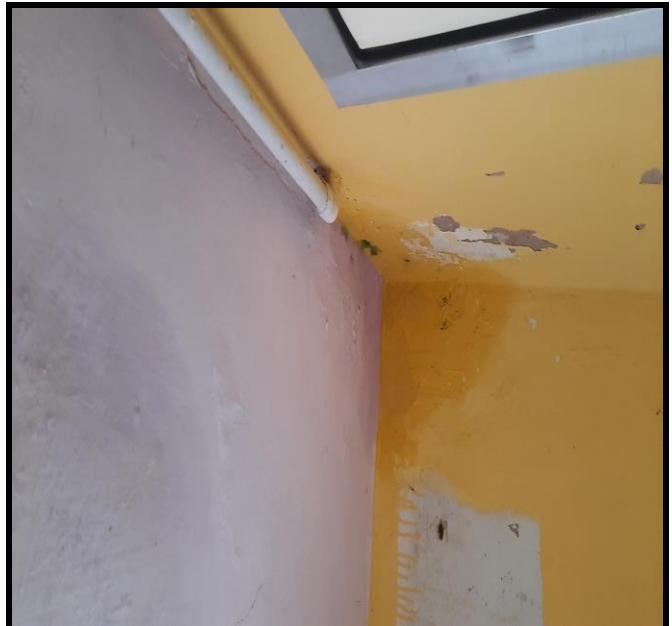
FLAT NO – 102

- ❖ **HALL** – Dampness observed on wall.
- ❖ **KITCHEN** – Dampness observed on wall.
- ❖ **PASSAGE** – Leakage observed on ceiling.
- ❖ **TOILET & BATH ROOM** – Dampness observed on wall & ceiling.

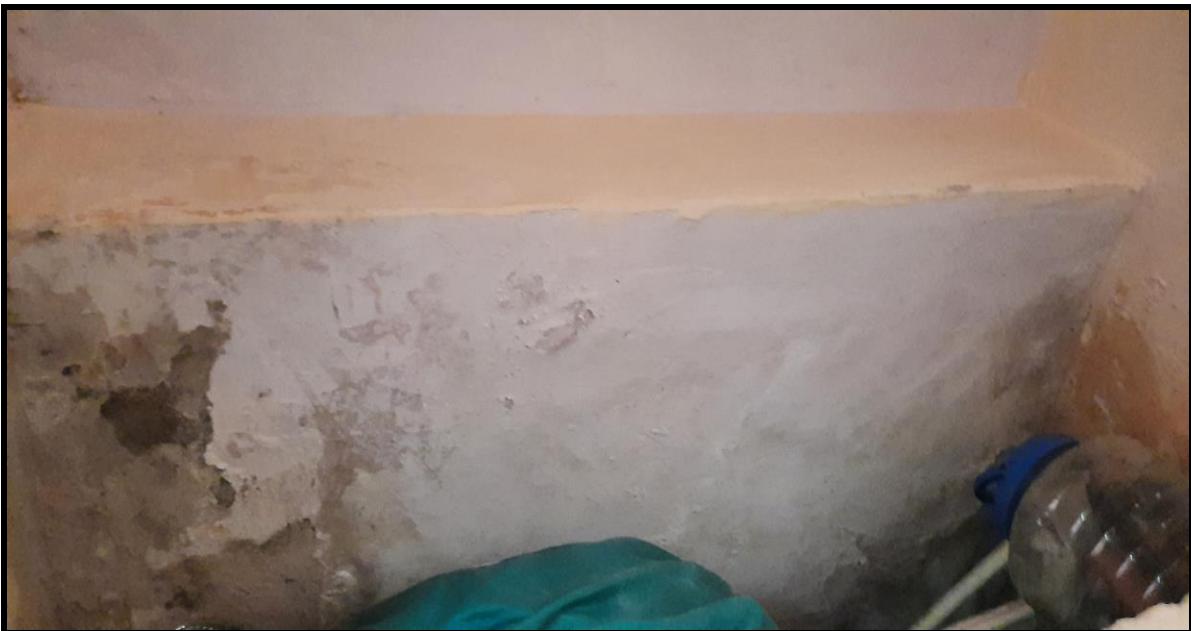
FLAT NO – 104

- ❖ **HALL** – O.K.
- ❖ **KITCHEN** – O.K.
- ❖ **PASSAGE** – Leakage mark observed on ceiling.
- ❖ **TOILET & BATH ROOM** – O.K.

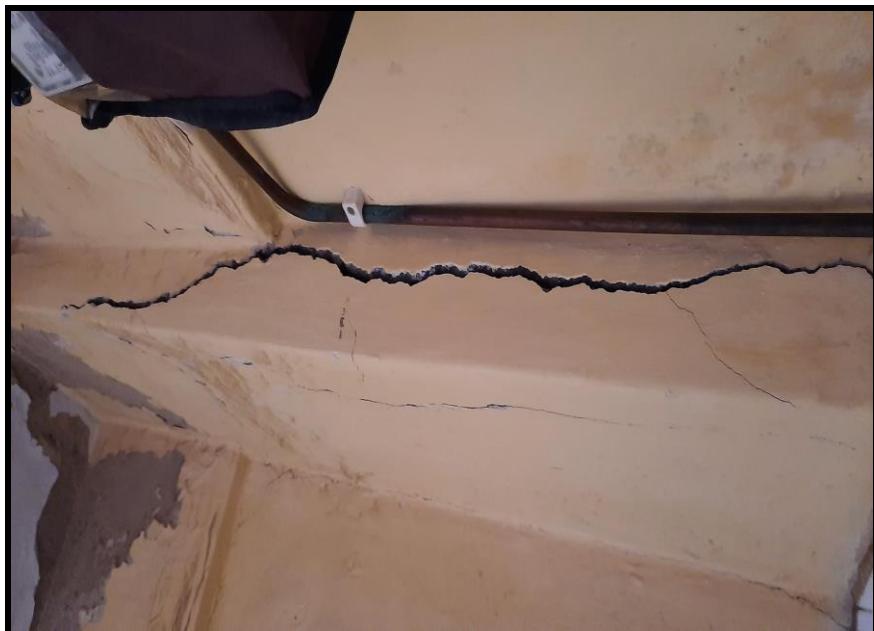
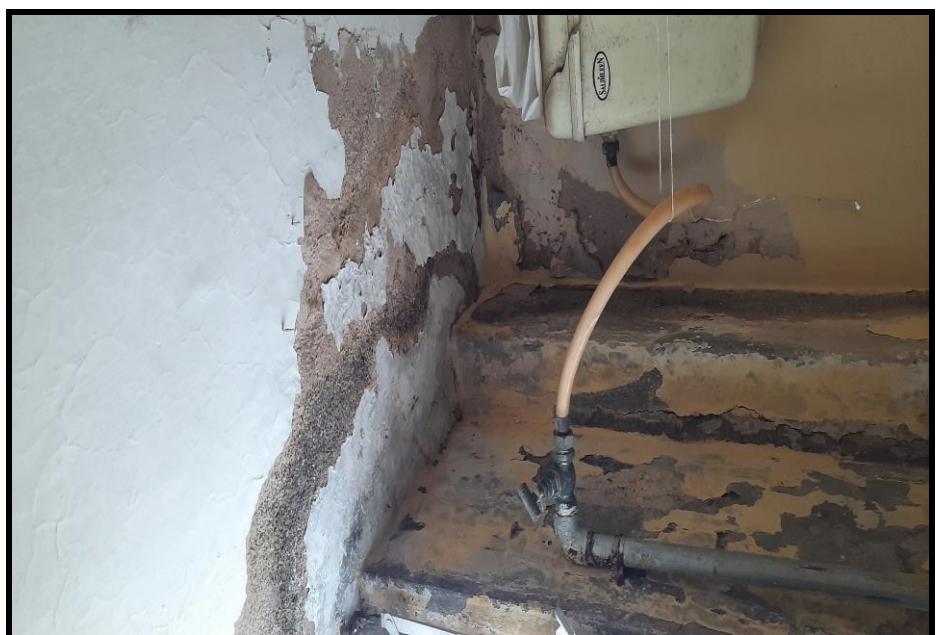
FLAT NO – 202

- ❖ **HALL** – O.K.
- ❖ **KITCHEN** – Structural crack observed on column.
- ❖ **PASSAGE** – O.K.
- ❖ **TOILET & BATH ROOM** – Leakage mark observed on wall & ceiling.
 - Structural crack observed on column.

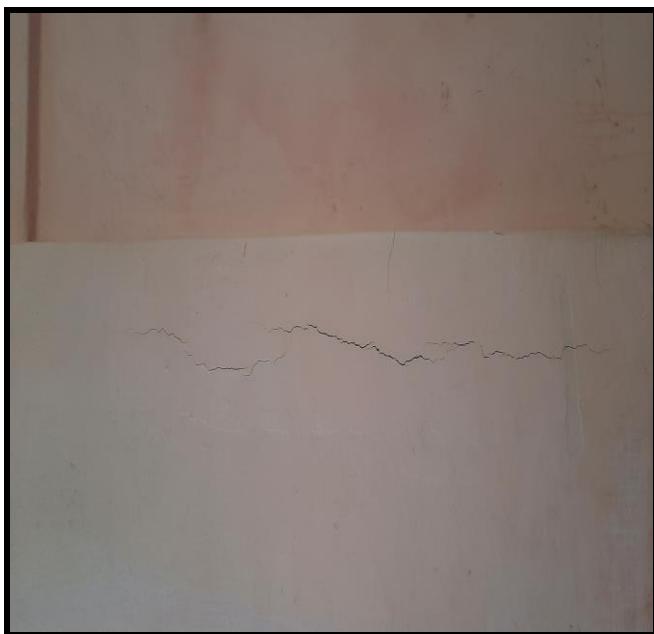
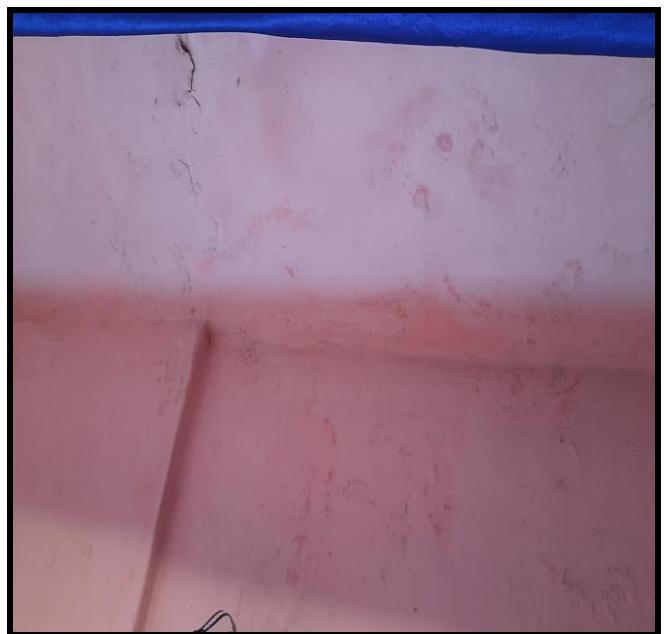
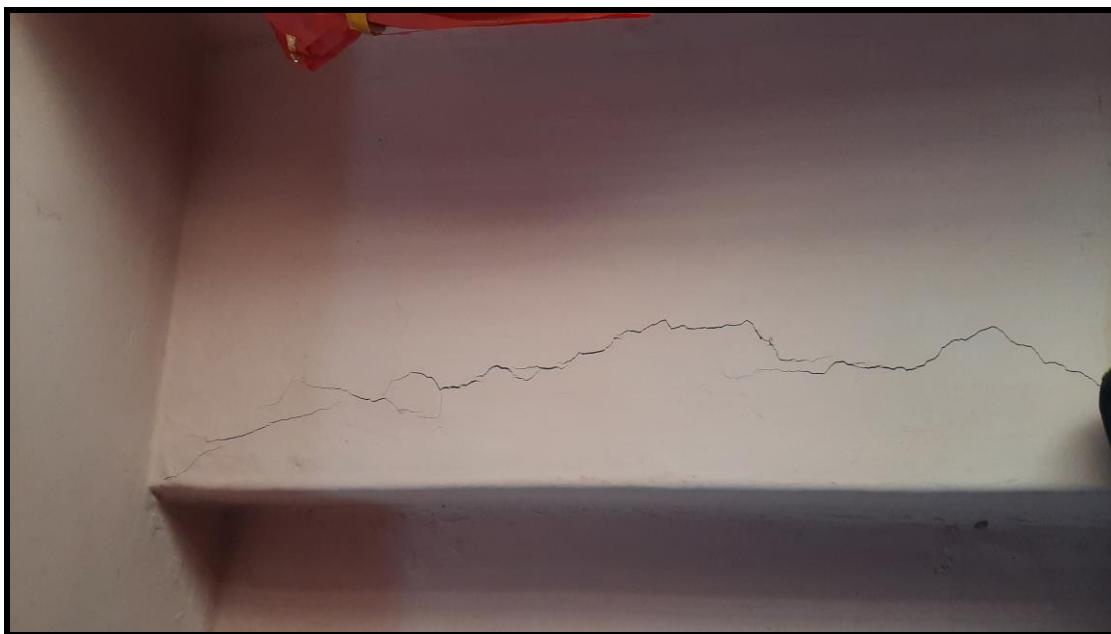
FLAT NO – 203

- ❖ **HALL** – Structural crack observed on column.
 - Leakage mark observed on wall.
- ❖ **KITCHEN** – Leakage observed on wall in monsoon.
 - Structural crack observed on column.
- ❖ **PASSAGE** – O.K.
- ❖ **TOILET & BATH ROOM** – O.K.

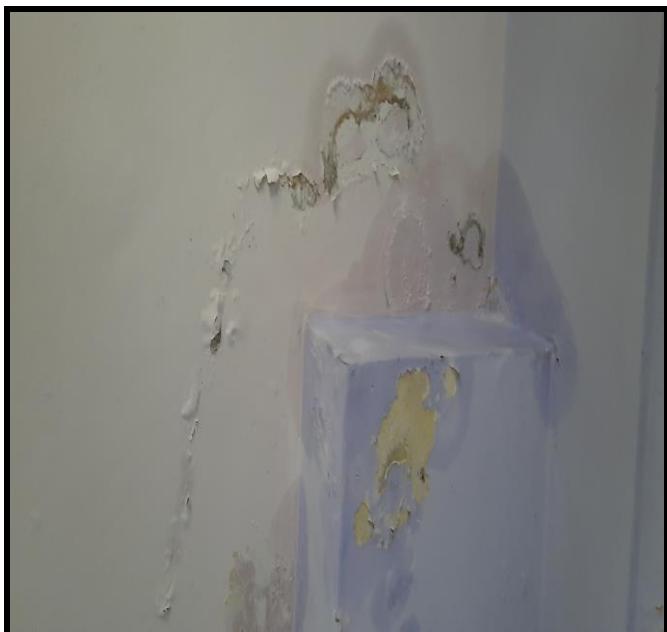
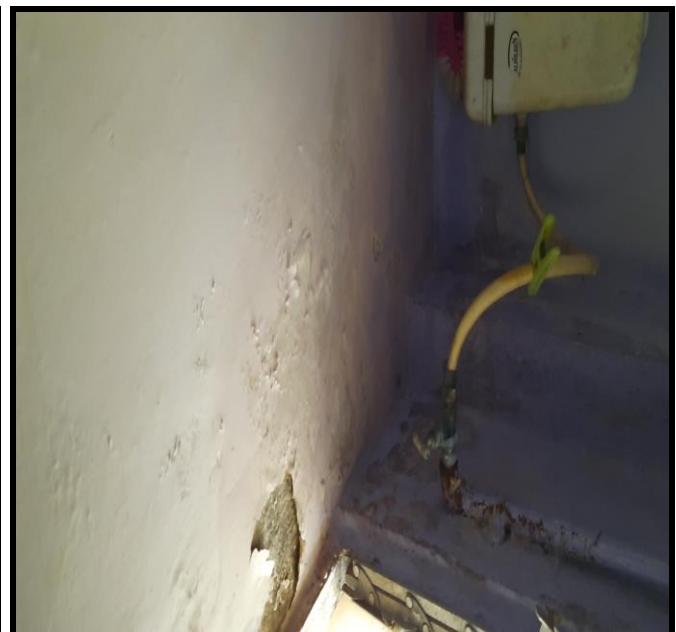
FLAT NO – 304

- ❖ **HALL** – O.K.
- ❖ **KITCHEN** – Dampness observed on ceiling.
- ❖ **PASSAGE** – O.K.
- ❖ **TOILET & BATH ROOM** – Dampness observed on wall & ceiling.

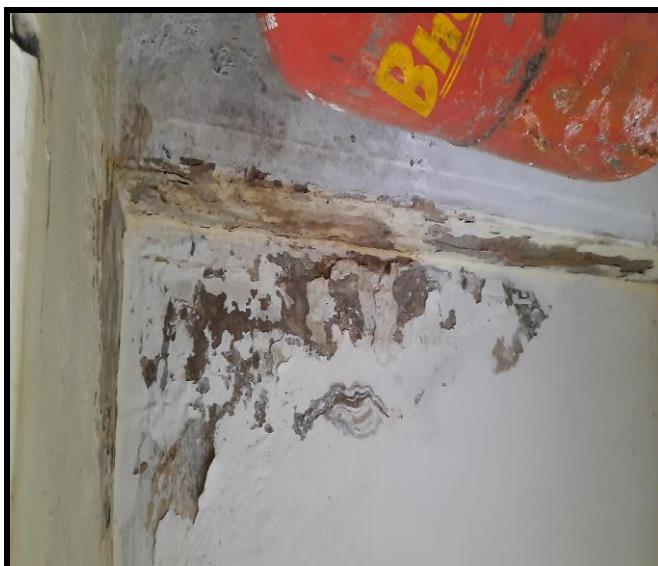
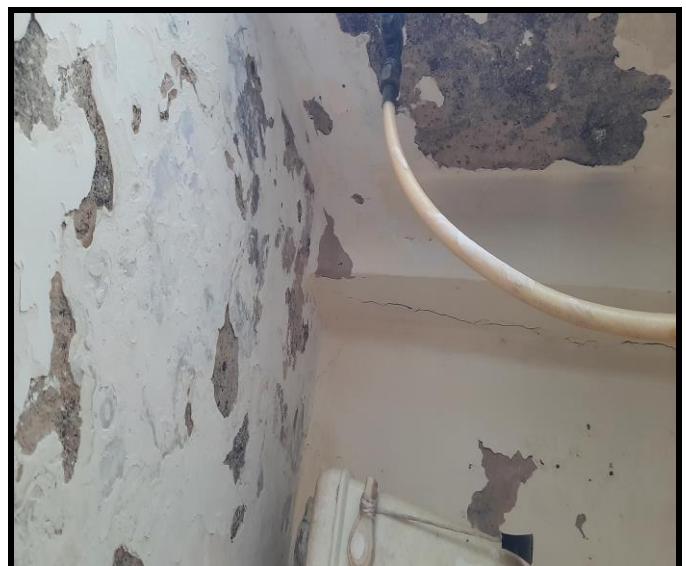
FLAT NO – 401

- ❖ **HALL** – O.K.
- ❖ **KITCHEN** – Leakage mark observed on wall.
- ❖ **PASSAGE** – Leakage mark observed on ceiling.
- ❖ **TOILET & BATH ROOM** – Leakage mark observed on ceiling.
 - Structural crack observed on column.

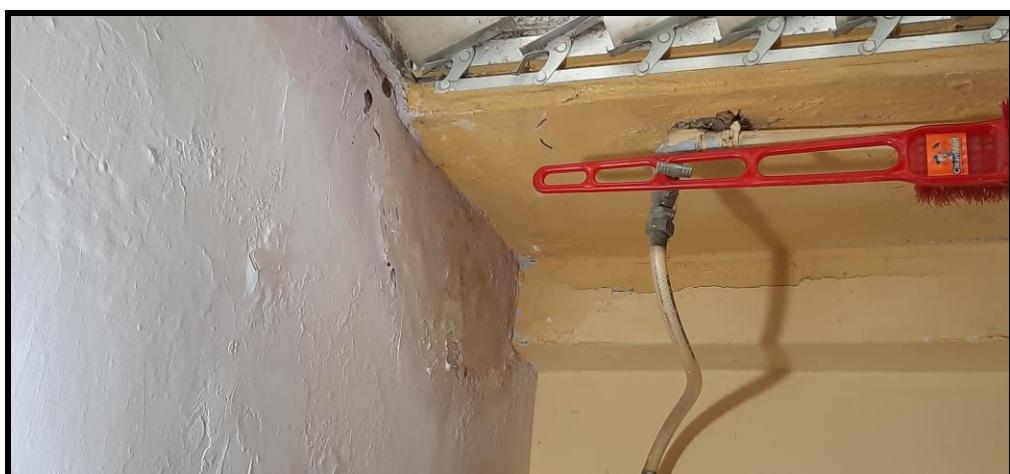
FLAT NO – 403

- ❖ **HALL** – O.K.
- ❖ **KITCHEN** – O.K.
- ❖ **PASSAGE** – O.K.
- ❖ **TOILET & BATH ROOM** – Dampness observed on wall & ceiling.
 - Structural crack observed on column.

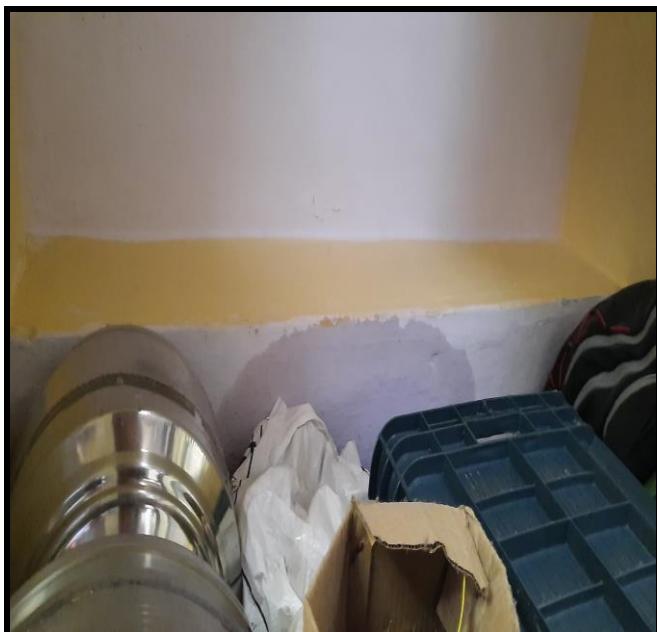
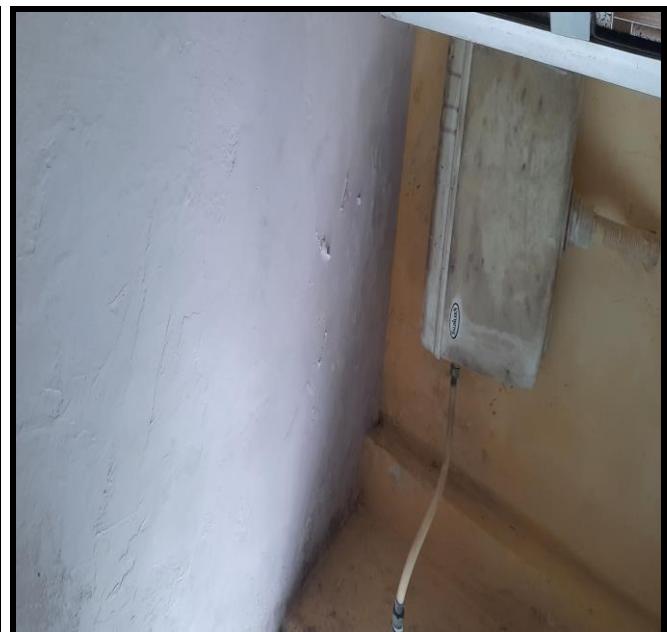
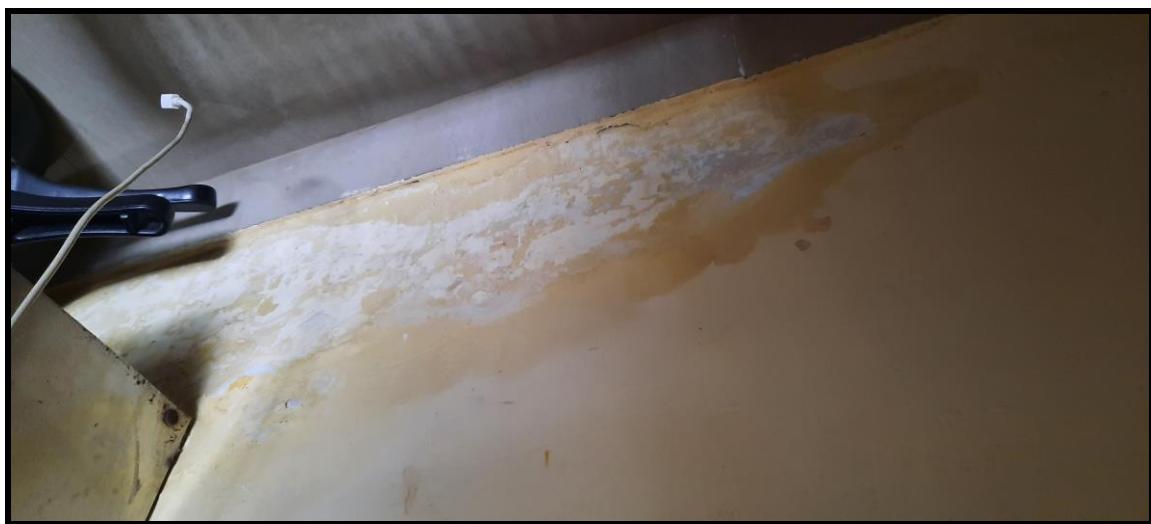
FLAT NO – 504

- ❖ **HALL** – Dampness observed on ceiling.
- ❖ **KITCHEN** – Dampness observed on wall.
- ❖ **PASSAGE** – Dampness observed on ceiling.
- ❖ **TOILET & BATH ROOM** – Dampness observed on wall & ceiling.

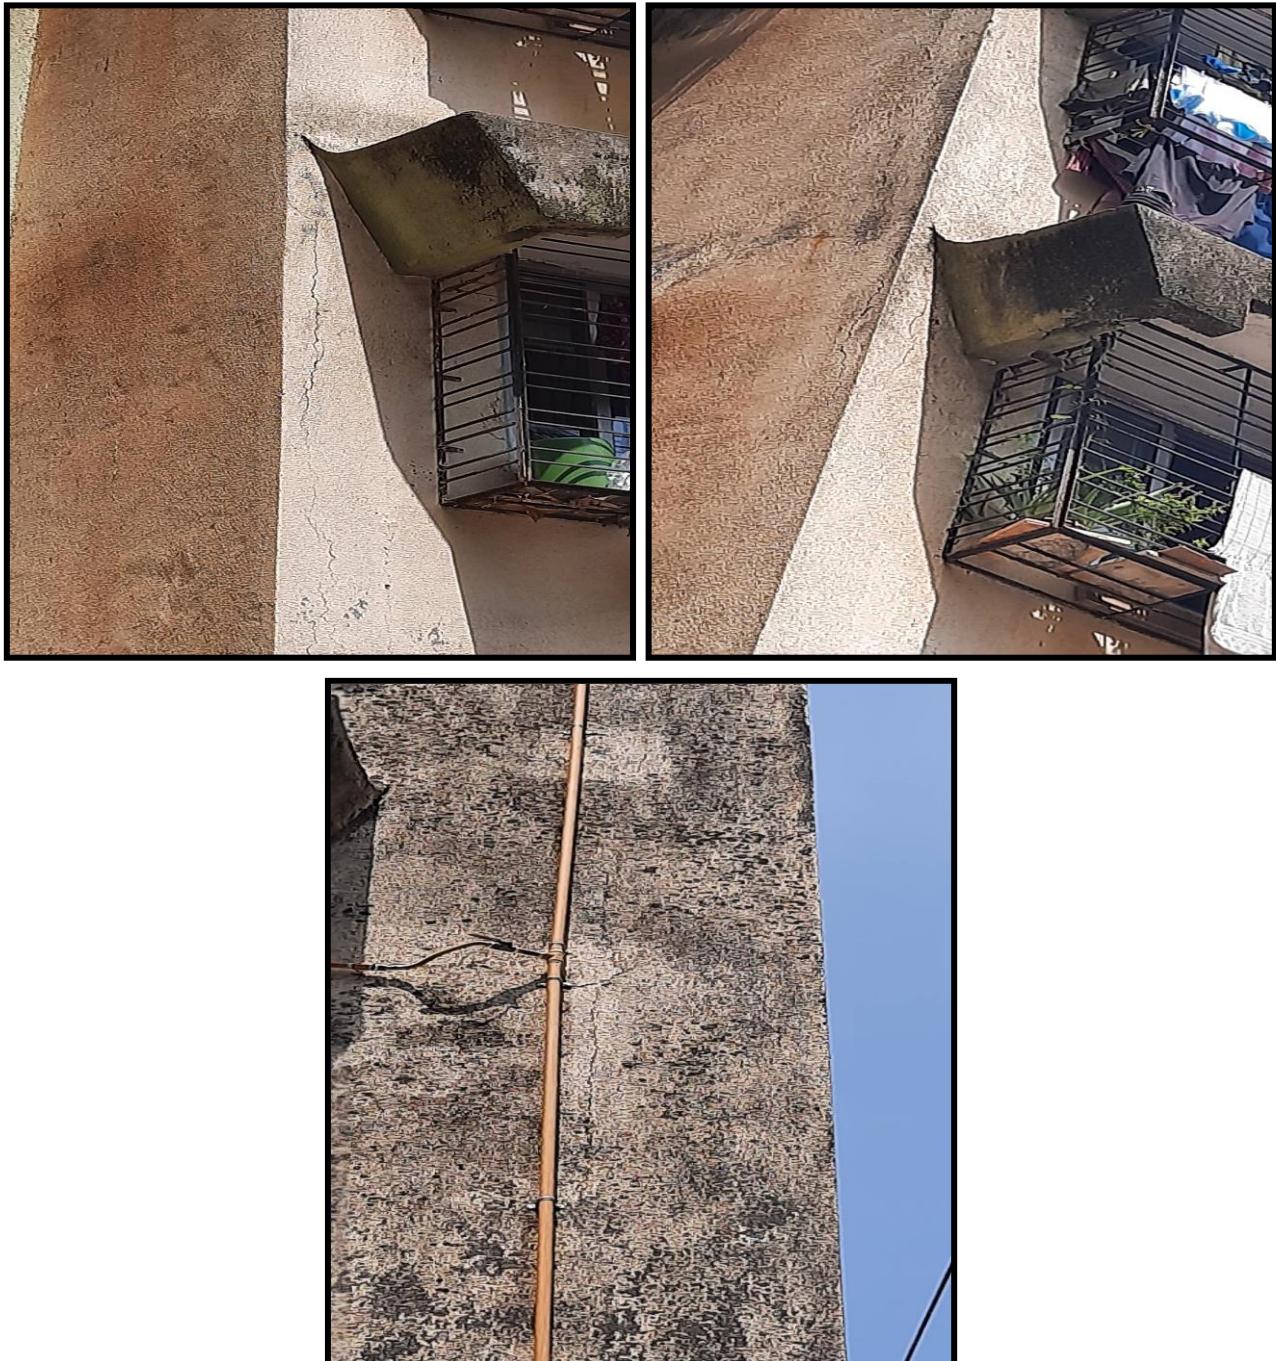
FRONT SIDE

- ❖ Structural crack observed at several places on column.

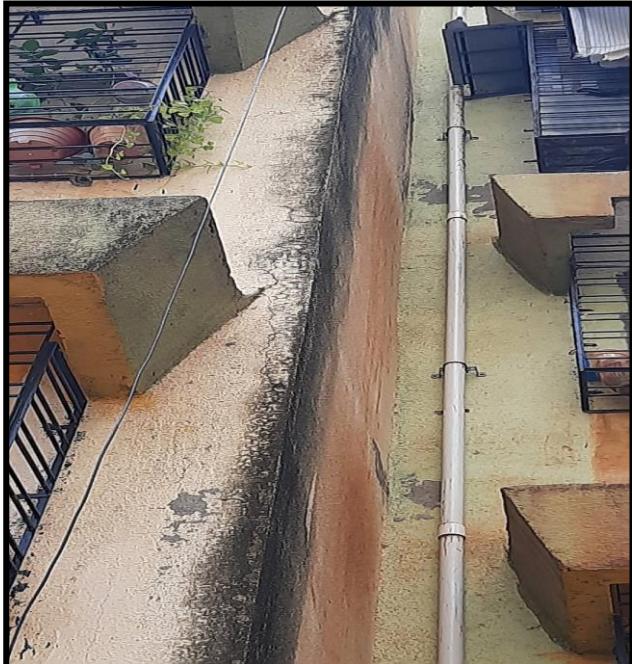
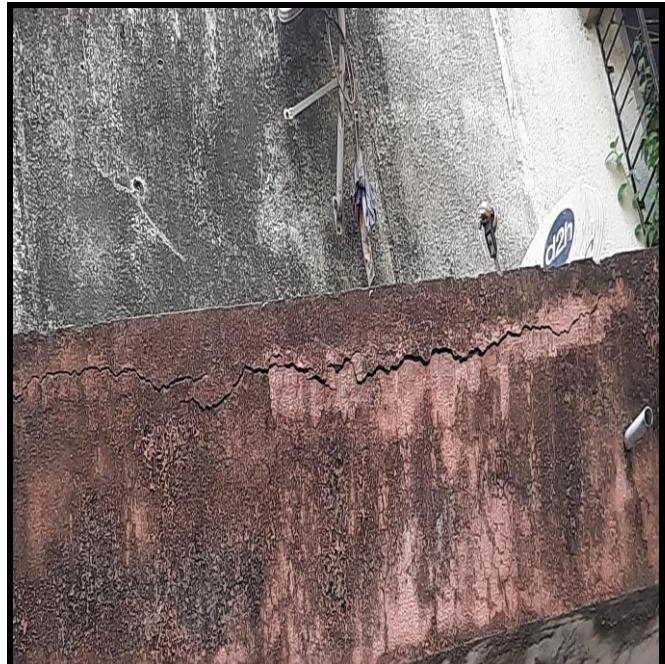
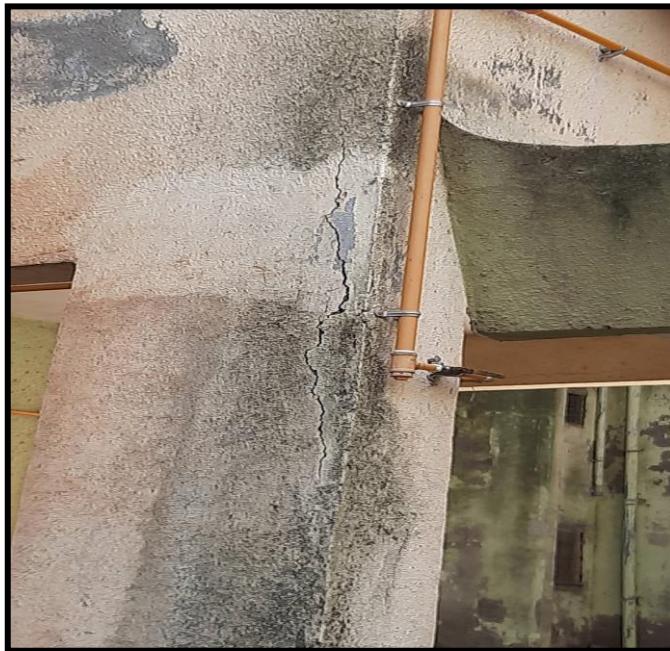
BACK SIDE

- ❖ Structural crack observed at several places on column & chajjas.
- ❖ Major crack observed at several places on wall.

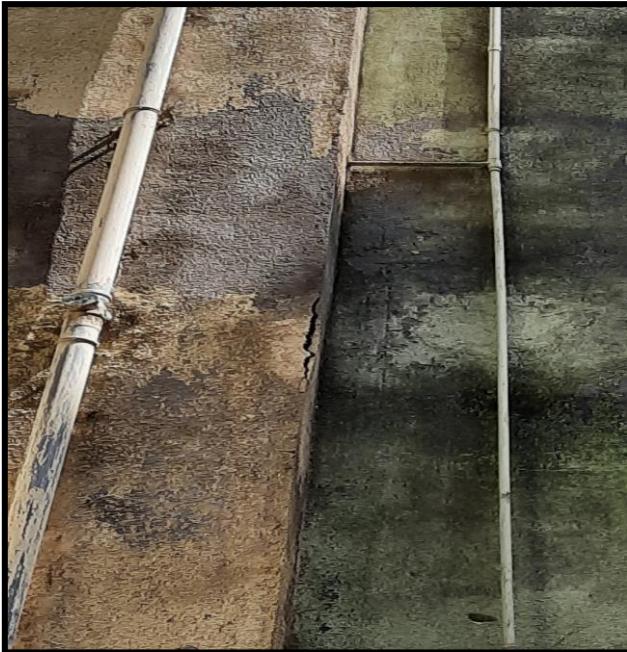
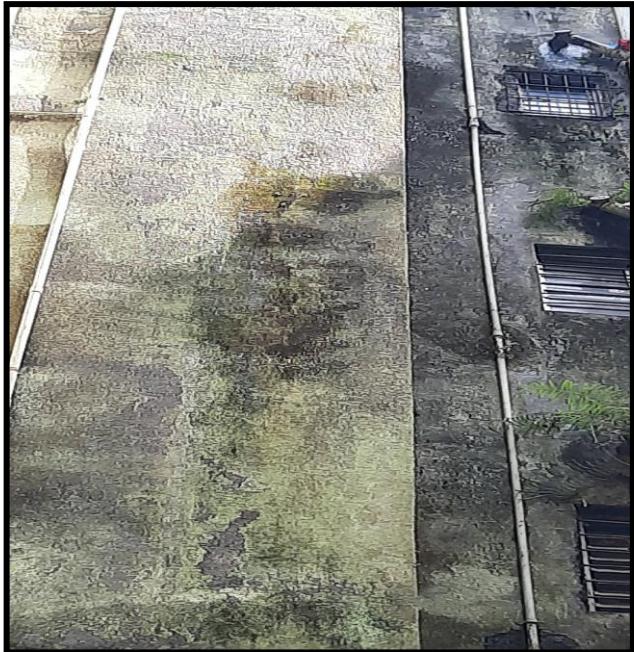
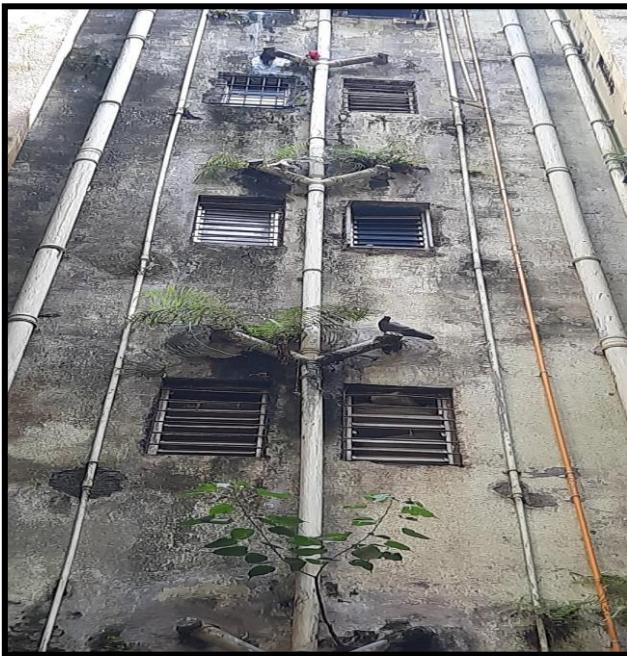
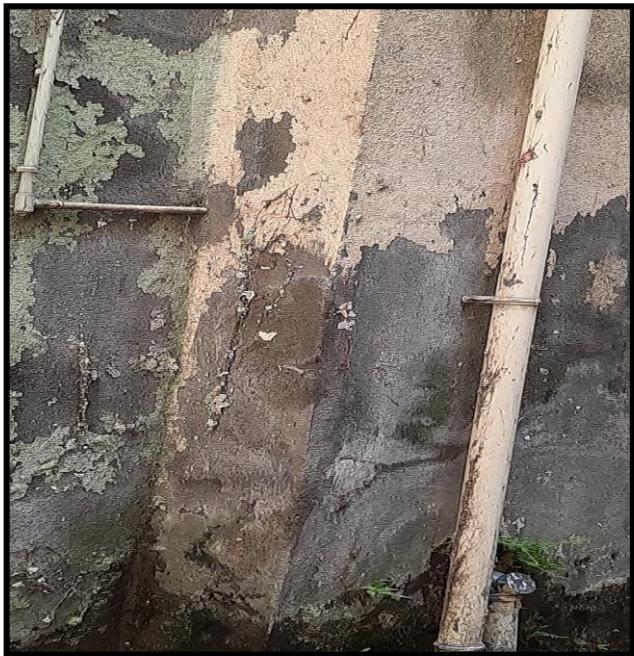
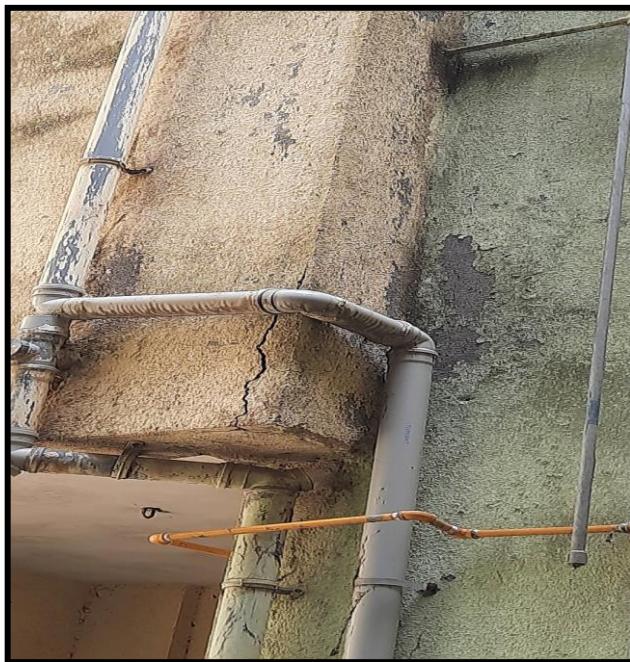
NORTH SIDE

- ❖ Structural crack observed at several places on column.
- ❖ Algae observed at several places on wall.
- ❖ Vegetation growth observed at several places on wall.

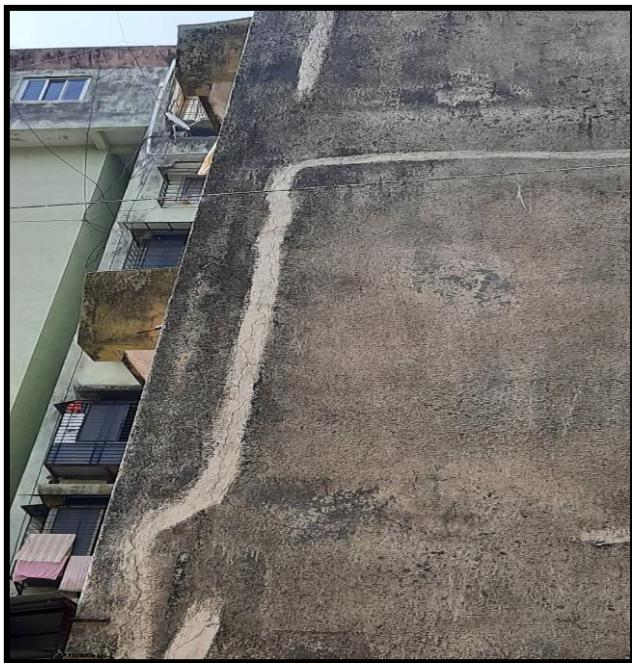
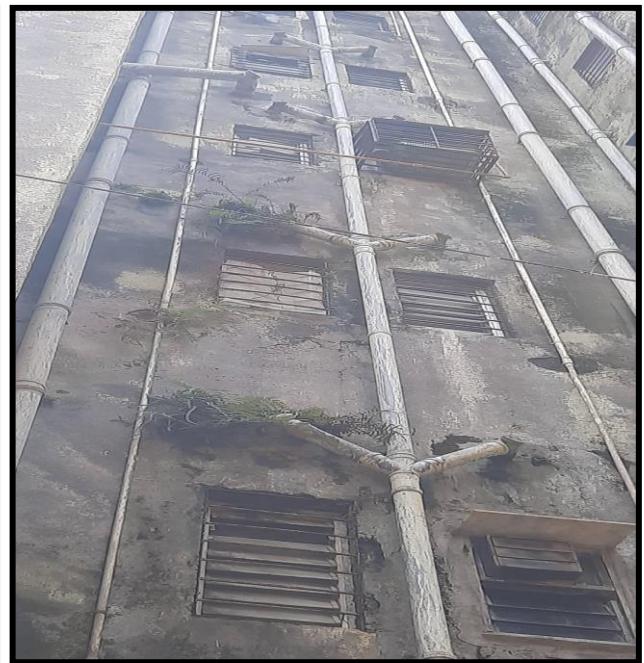
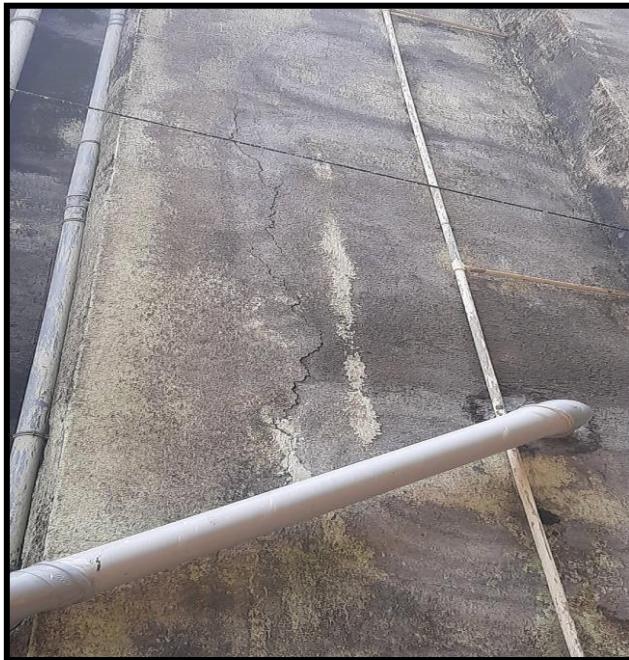
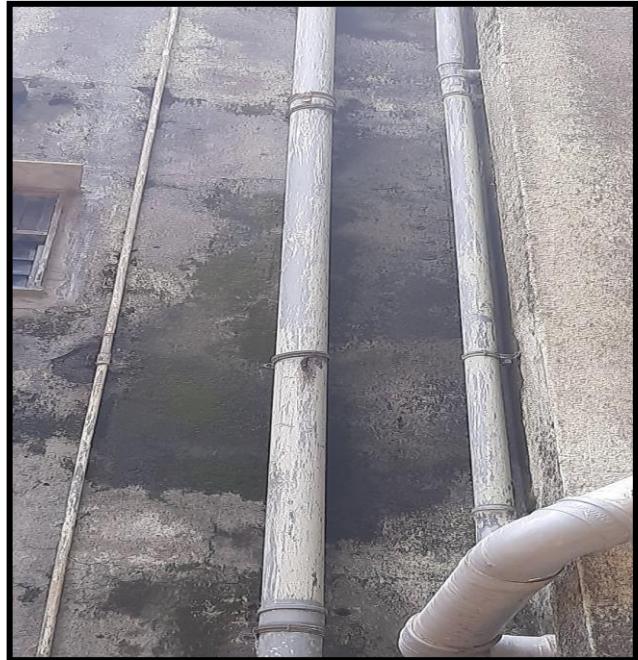
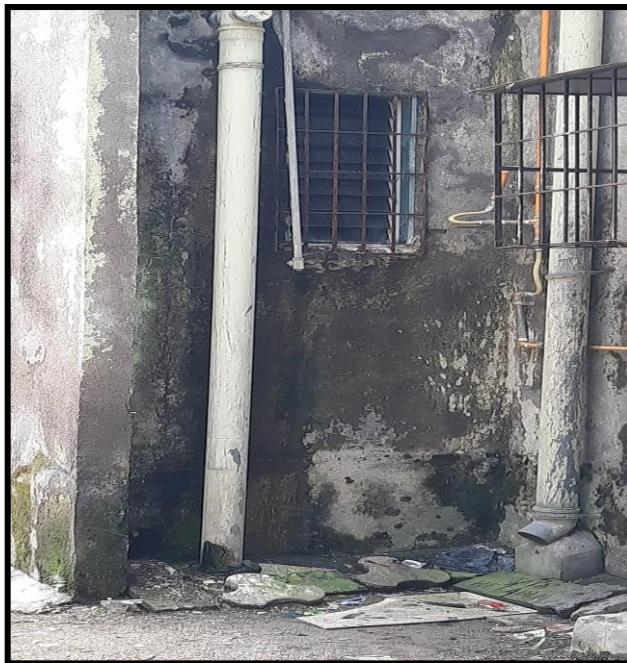
SOUTH SIDE

- ❖ Structural crack observed at several places on column.
- ❖ Algae observed at several places on wall.
- ❖ Vegetation growth observed at several places on wall.
