STRUCTURAL AUDIT REPORT  
FOR  
**“VISHAL SAHYADRI CO – OP HSG. SOC. LTD”,**  
**“D2 – J WING”**  
SITUATED AT  
SAHYADRI NAGAR, CHARKOP,  
KANDIVALI (W) MUMBAI – 400 067

978/D2/LSS/2021

JULY 24, 2021

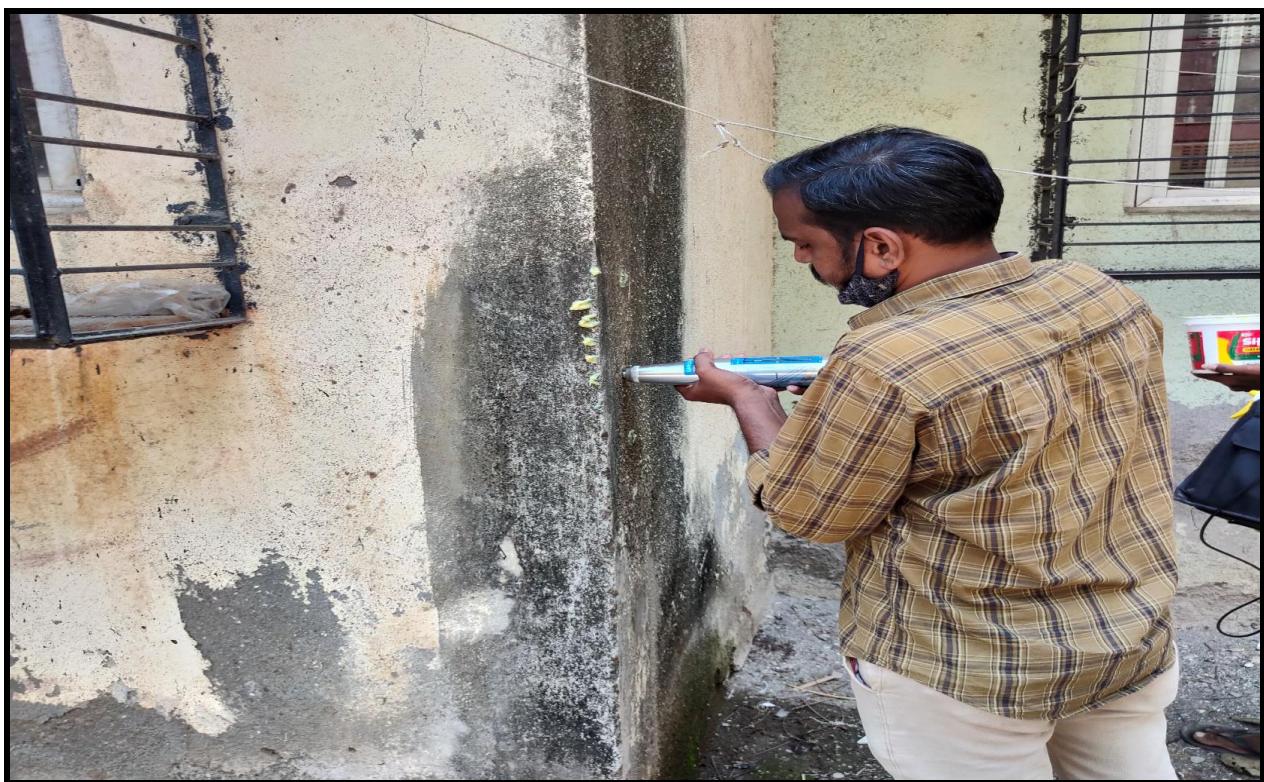
## NON -DESTRUCTIVE TEST PHOTO

Rebound Hammer was tested for compressive strength at surface by Schmidt rebound hammer. Results indicate the compressive strength at surface of the RCC columns & beam in is ranging between 14.90 MPa to 20.30 MPa.

The UPV values are ranging between 2.50 Km/Sec to 3.10 Km/Sec.

Out of 4 locations 2 locations was below 3.0 Km/Sec means concrete quality is poor and 2 location ranging between 3.0 to 3.75 Km/Sec means concrete quality is doubtful.

This indicates there are progressive internal cracks in the RCC members due to corrosion of reinforced steel. These members are under distress condition.

Half Cell Potential tested for corrosion activity by half – cell potential tests. Value is taken on Column. The result on tested column is – 341 mV.

This indicates the probability of corrosion is 50% on tested column steel reinforcement.

Carbonation test was conducted to assess carbonation depth. Readings are taken on Column. Result indicates the carbonation penetration depth is 40.00 mm. Carbonation depths have reached to the reinforcement level in all of the RCC elements. It is essential to give a suitable anti-corrosion treatment to all the RCC members to stop further carbonation and corrosion of concrete.

Overall, condition of concrete is good, but distressed RCC member's needs immediate repair with suitable repair system.

RCC elements indicating UPV values less than 3 Km/sec needs immediate attention.

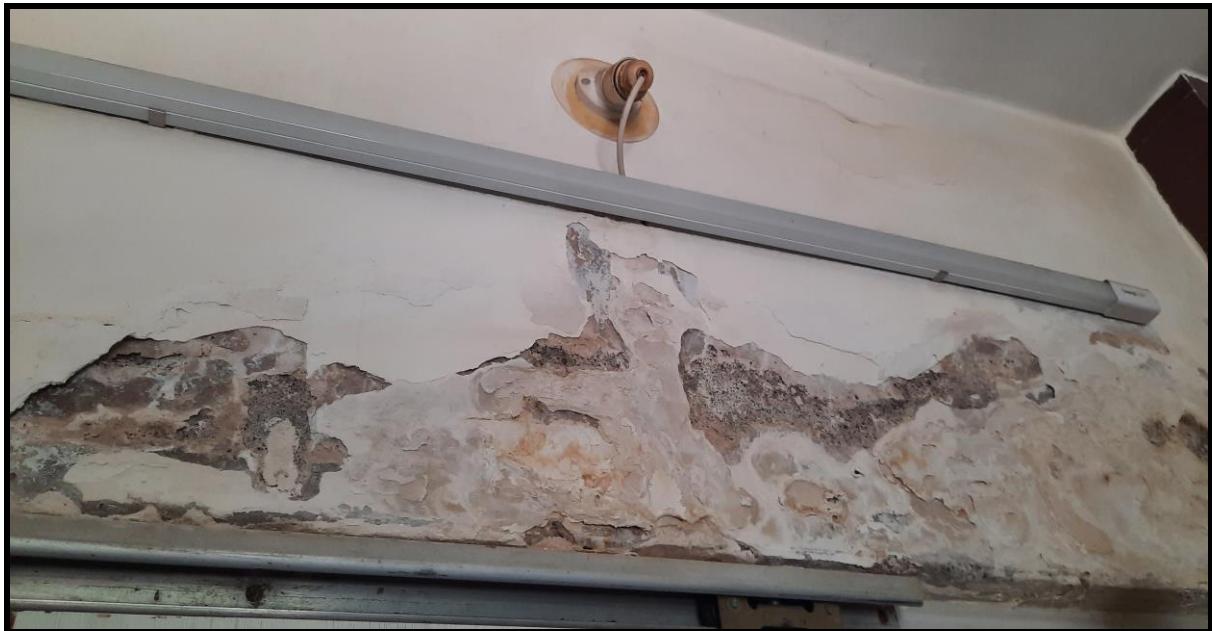
### FLAT NO – 104

- ❖ **HALL** – O.K.
- ❖ **KITCHEN** – Leakage mark observed on beam.
- ❖ **PASSAGE** – O.K.
- ❖ **TOILET & BATH ROOM** – O.K.

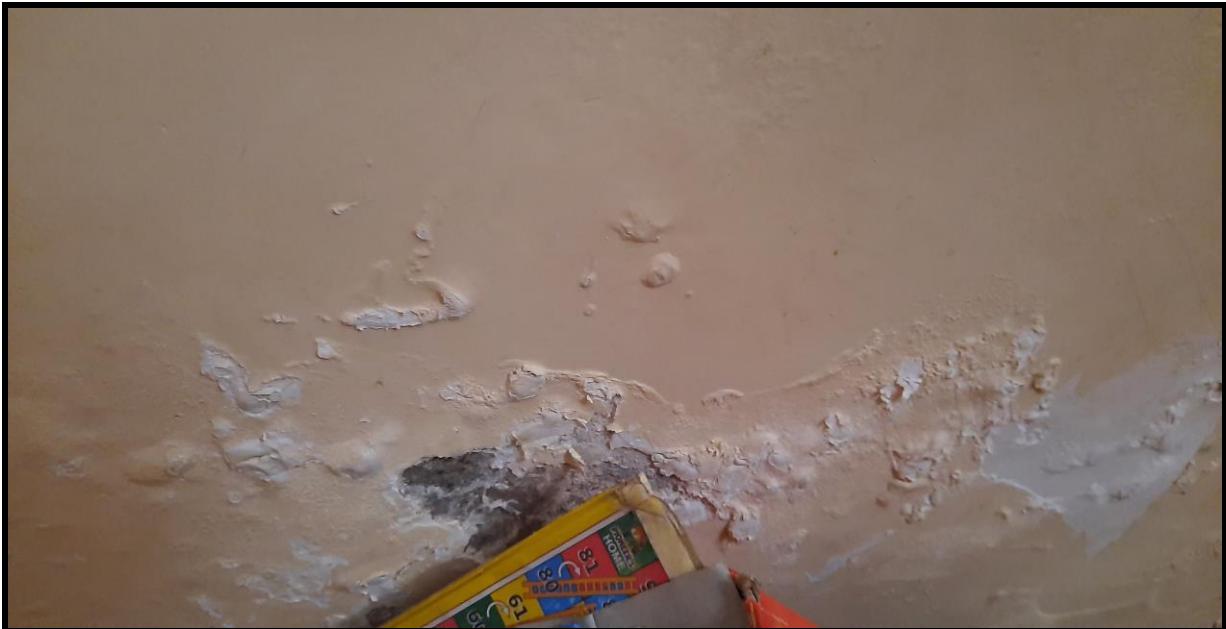
### FLAT NO – 202

- ❖ **HALL** – Seepage observed on wall.
- ❖ **KITCHEN** – O.K.
- ❖ **PASSAGE** – O.K.
- ❖ **TOILET & BATH ROOM** – O.K.

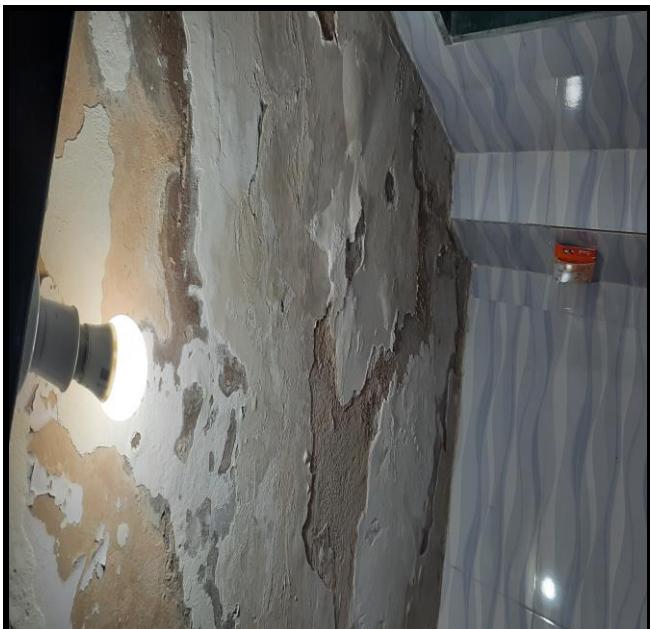
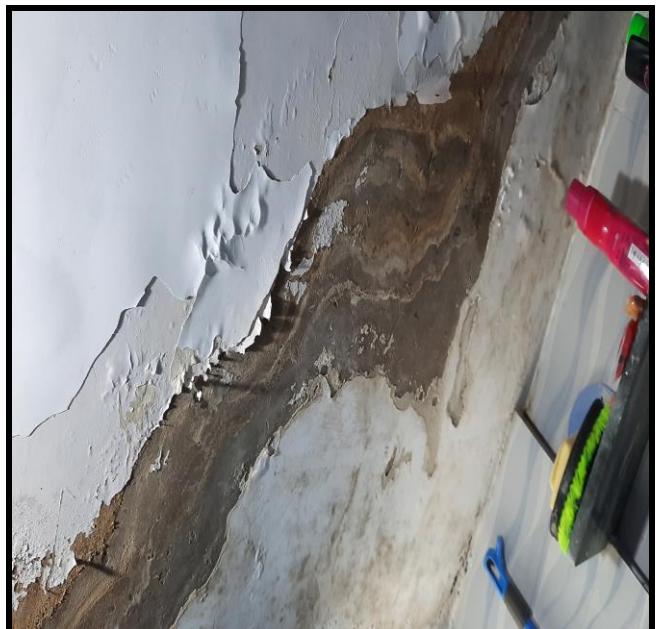
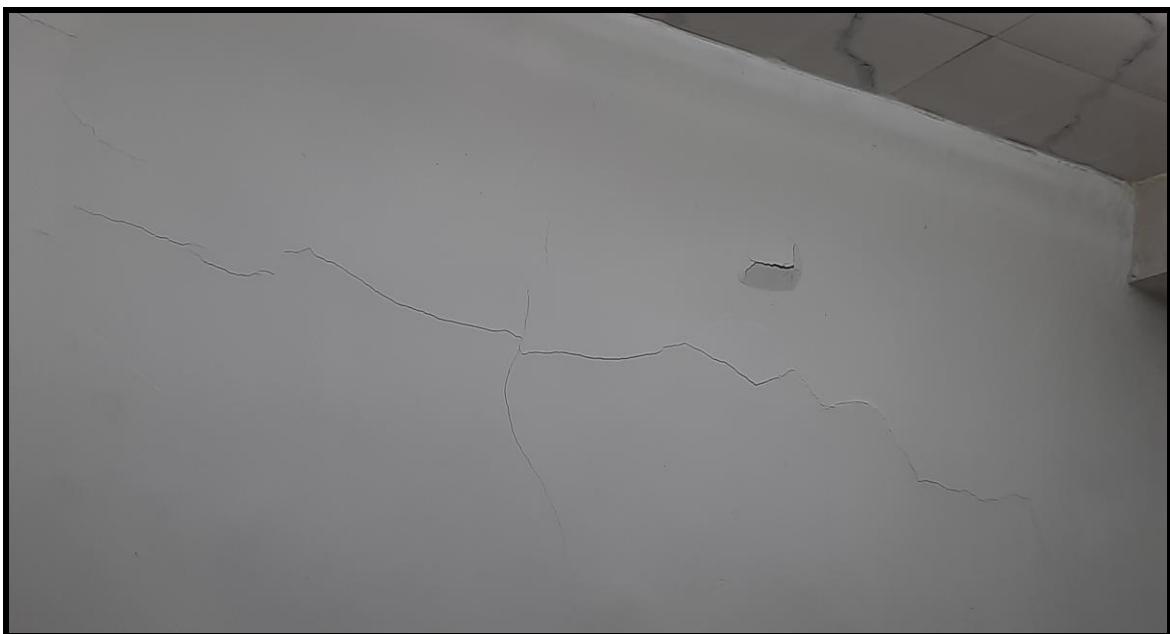
### FLAT NO – 301

- ❖ **HALL** – O.K.
- ❖ **KITCHEN** – Structural crack observed on ceiling.
- ❖ **PASSAGE** – O.K.
- ❖ **TOILET & BATH ROOM** – Leakage mark observed on ceiling.

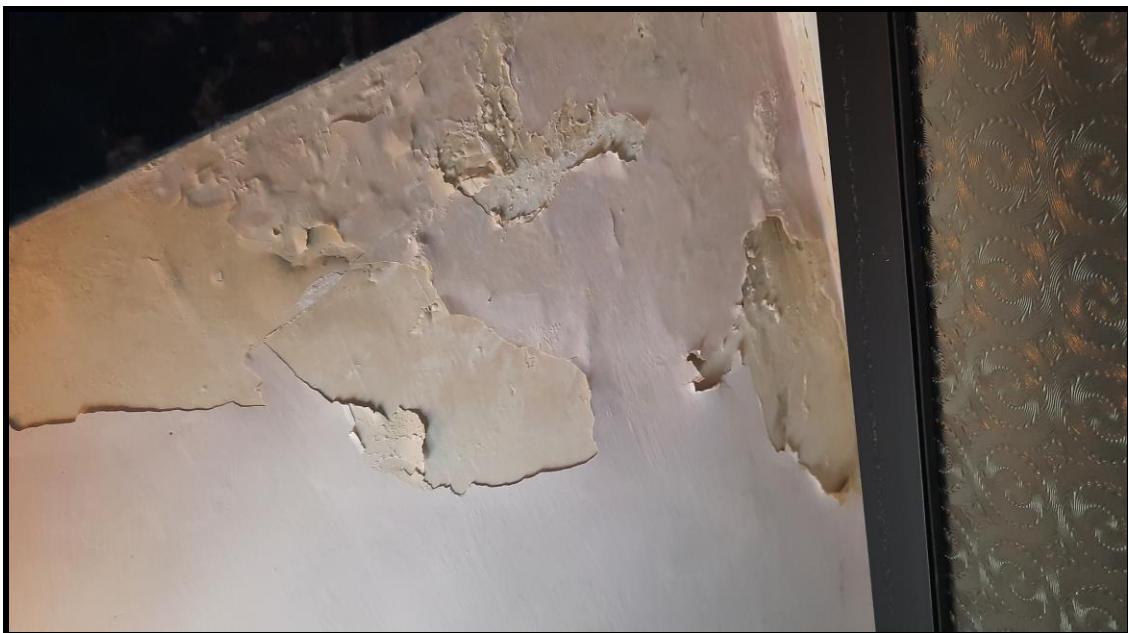
## FLAT NO – 304

- ❖ **HALL** – O.K.
- ❖ **KITCHEN** – O.K.
- ❖ **PASSAGE** – O.K.
- ❖ **TOILET & BATH ROOM** – Leakage mark observed on ceiling.

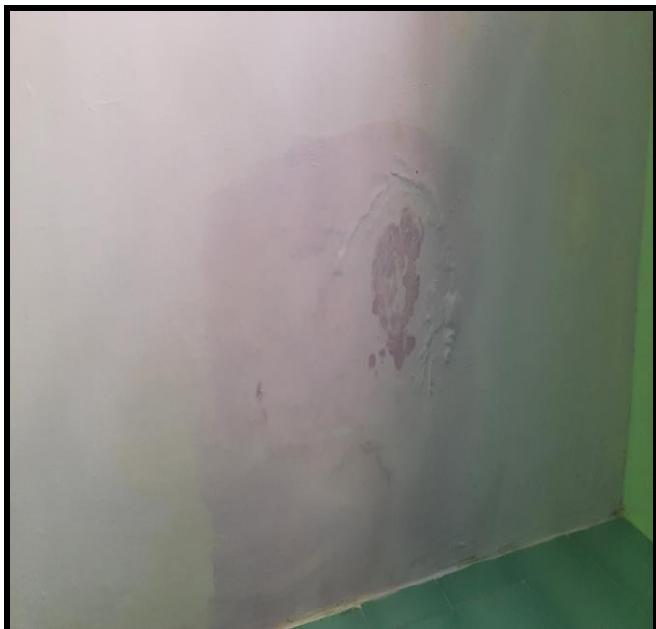
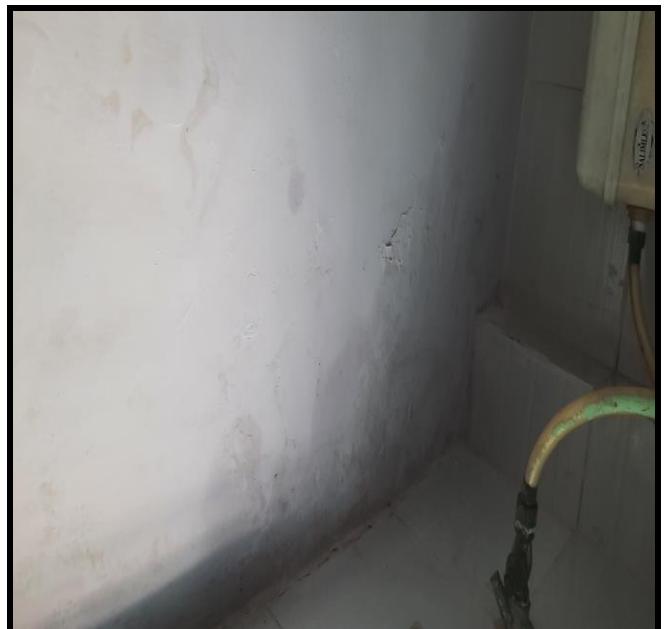
### FLAT NO – 402

- ❖ **HALL** – O.K.
- ❖ **KITCHEN** – Dampness observed on ceiling.
- ❖ **PASSAGE** – O.K.
- ❖ **TOILET & BATH ROOM** – Dampness observed on ceiling.

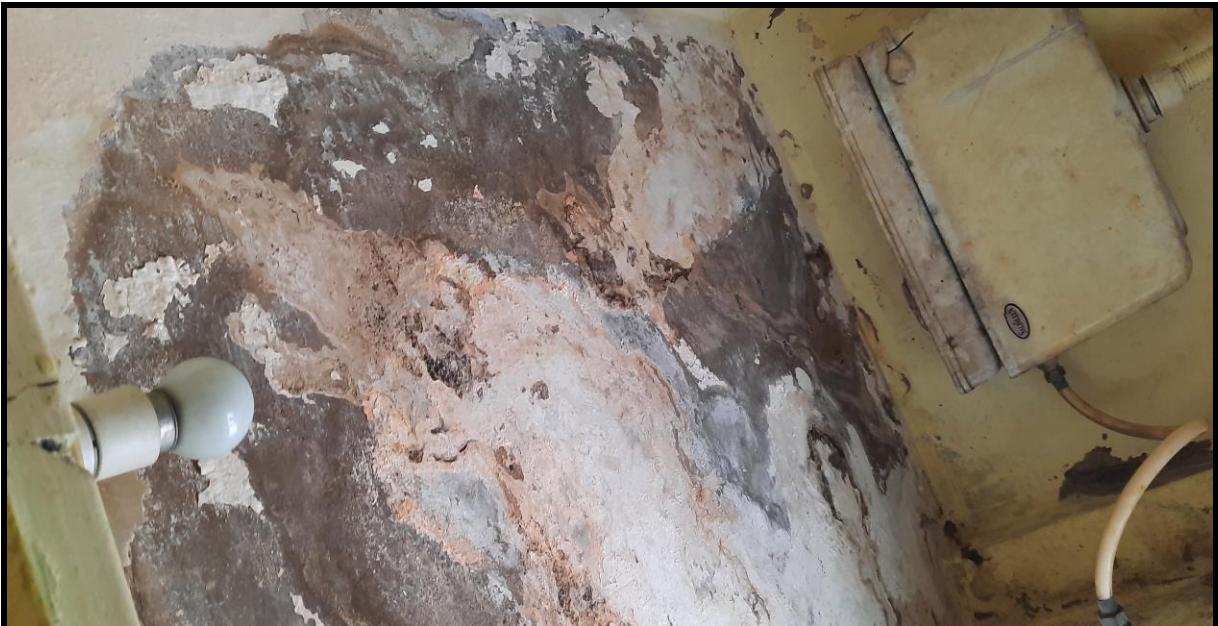
### FLAT NO – 502

- ❖ **HALL** – Dampness observed on wall in monsoon.
- ❖ **KITCHEN** – Dampness observed on wall in monsoon.
- ❖ **PASSAGE** – O.K.
- ❖ **TOILET & BATH ROOM** – Leakage mark observed on ceiling.

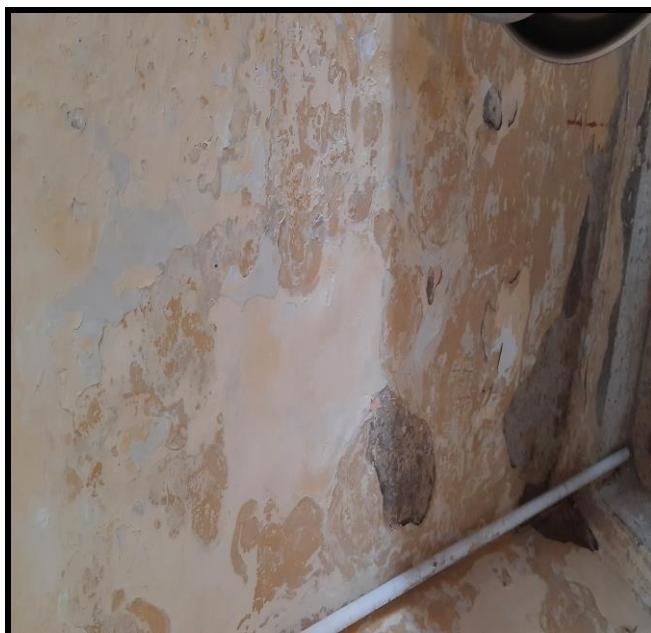
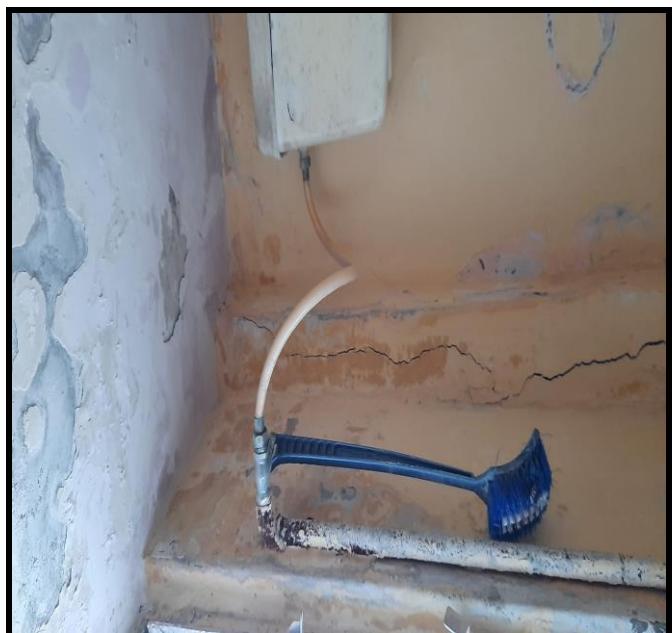
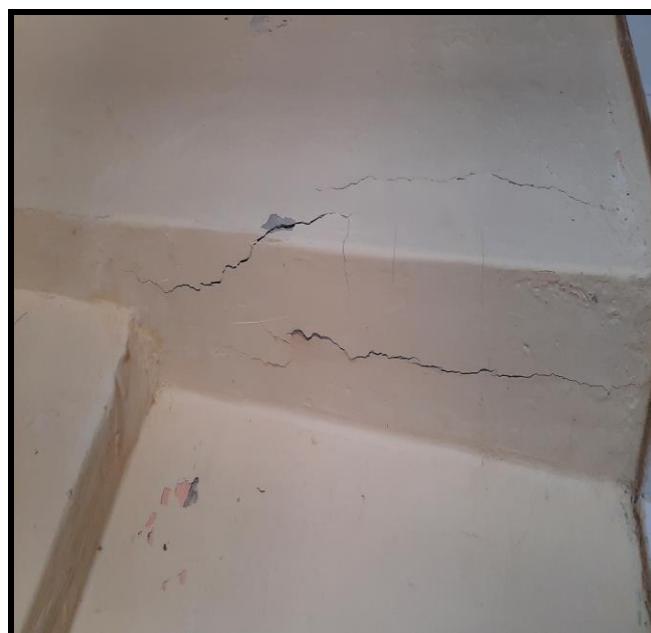
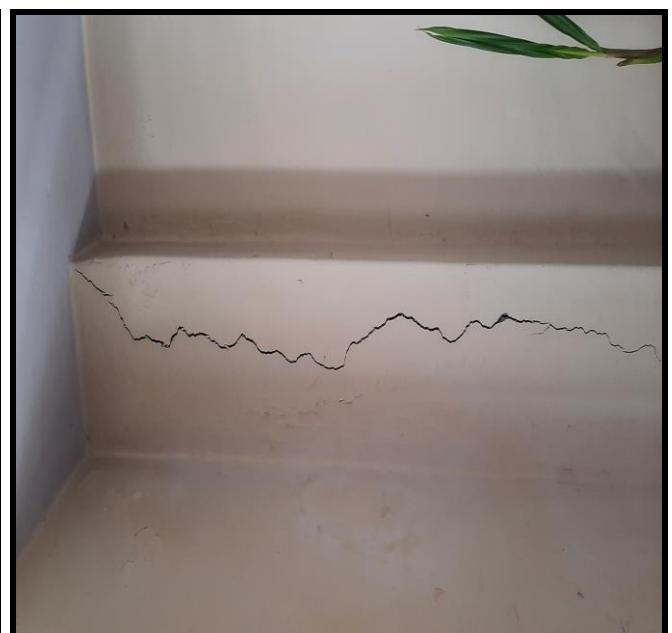
### FLAT NO – 603

- ❖ **HALL** – Leakage mark observed on wall.
- ❖ **KITCHEN** – Structural crack observed on column.
- ❖ **PASSAGE** – O.K.
- ❖ **TOILET & BATH ROOM** – Leakage mark observed on wall & ceiling.
  - Structural crack observed on column.

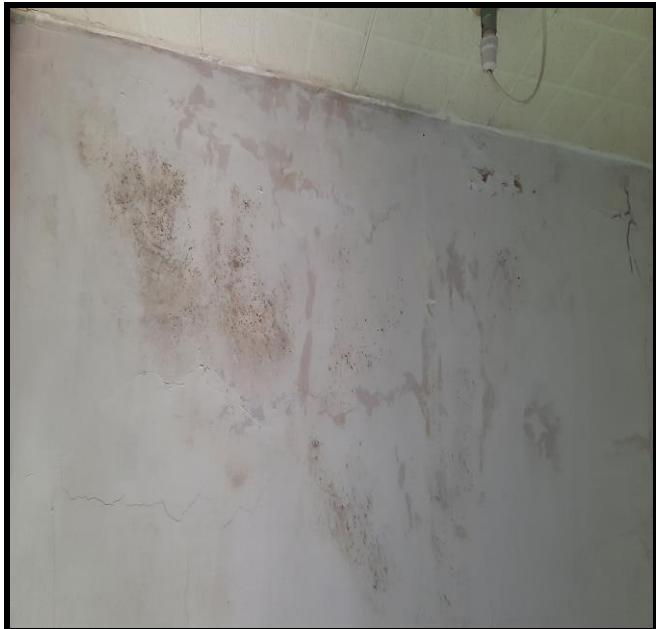
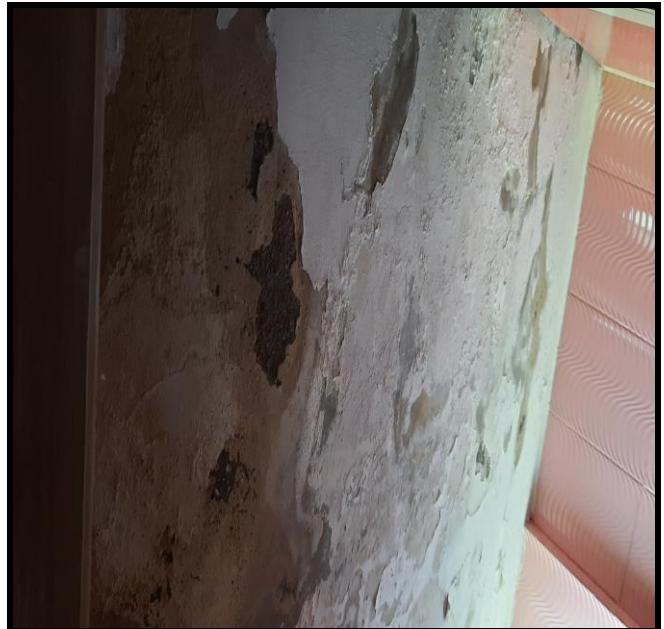
### FLAT NO – 701

- ❖ **HALL** – Leakage observed on ceiling in monsoon.
- ❖ **KITCHEN** – Leakage mark observed on ceiling.
- ❖ **PASSAGE** – O.K.
- ❖ **TOILET & BATH ROOM** – Leakage mark observed on ceiling.

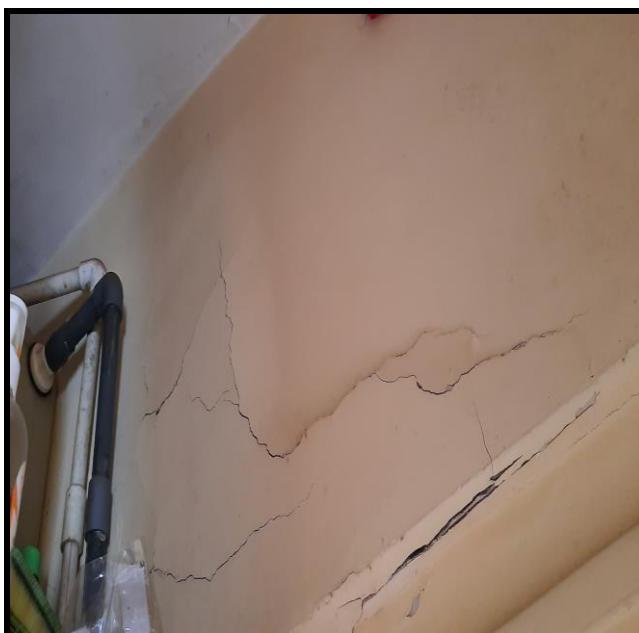
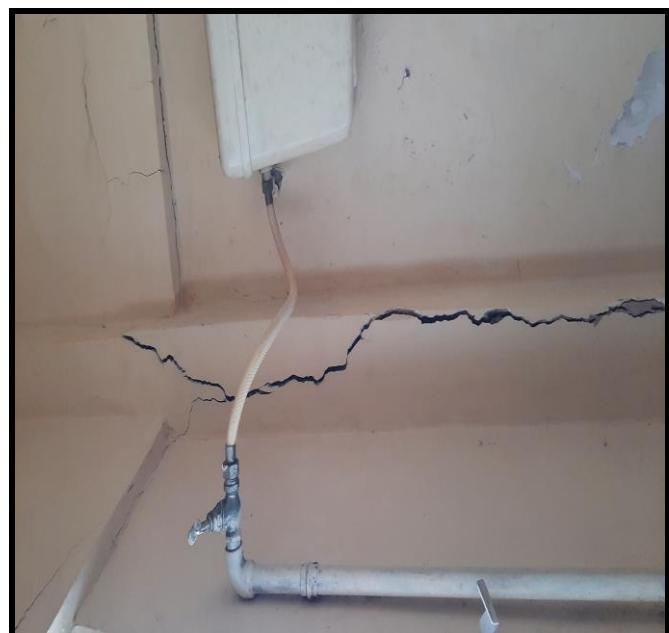
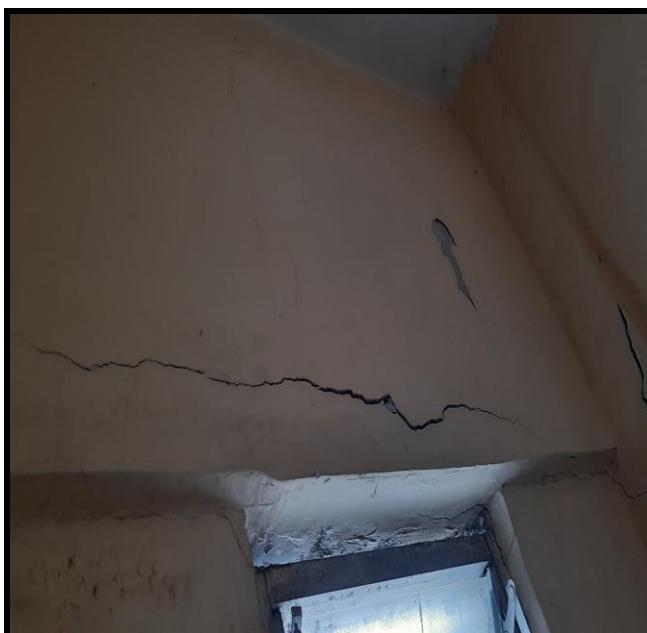
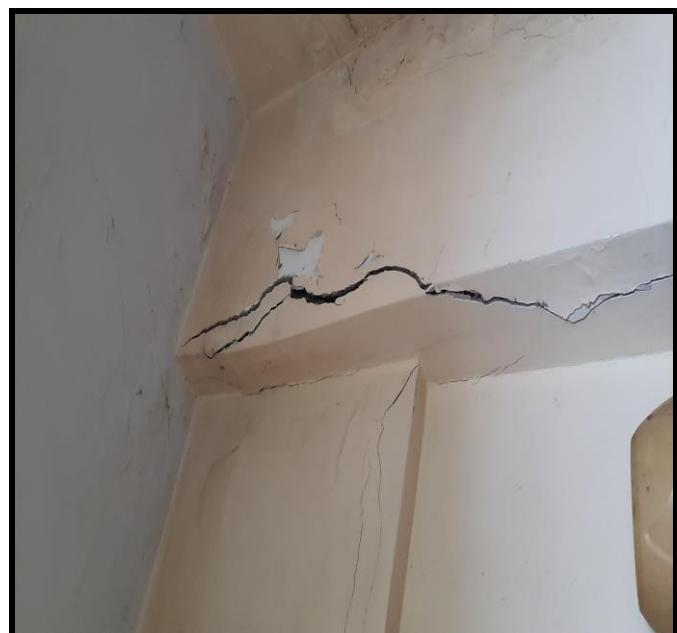
## FLAT NO – 704

- ❖ **HALL** – O.K.
- ❖ **KITCHEN** – Leakage observed on ceiling in monsoon.
  - Structural crack observed on beam & column.
- ❖ **PASSAGE** – Leakage observed on ceiling in monsoon.
  - Structural crack observed on beam.
- ❖ **TOILET & BATH ROOM** – Leakage observed on ceiling in monsoon.
  - Structural crack observed on beam & column.

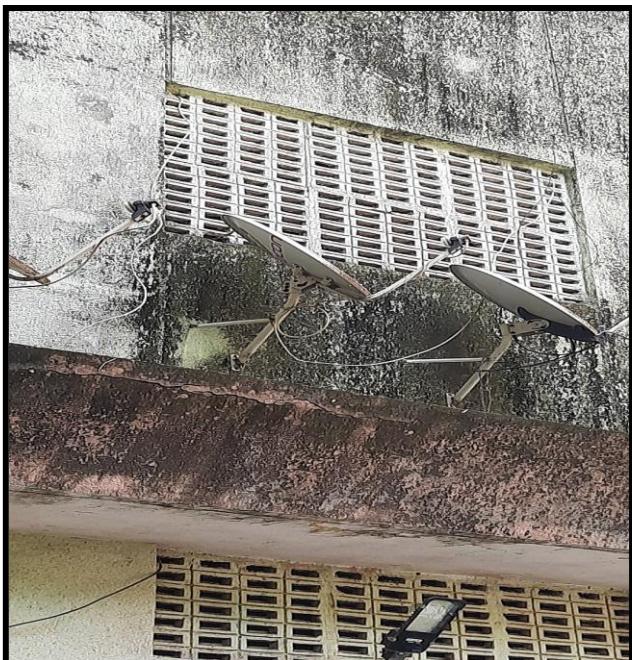
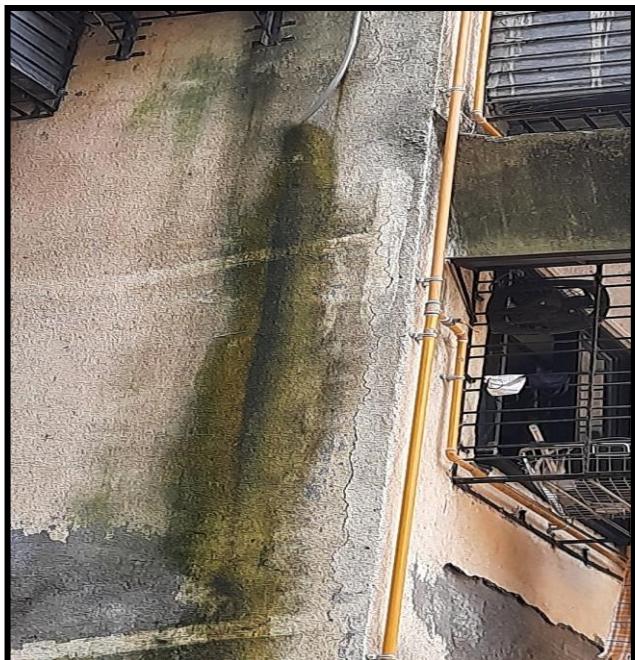
### FRONT SIDE

- ❖ Structural crack observed at several places on column.
- ❖ Algae observed at several places on wall.

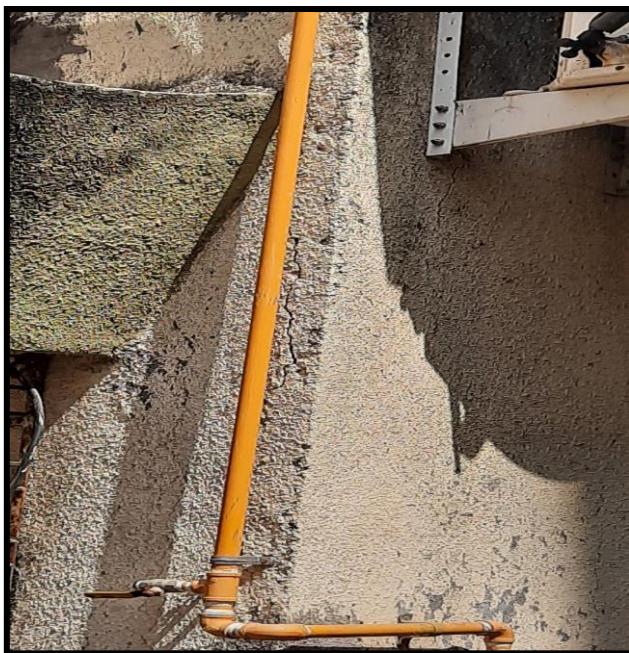
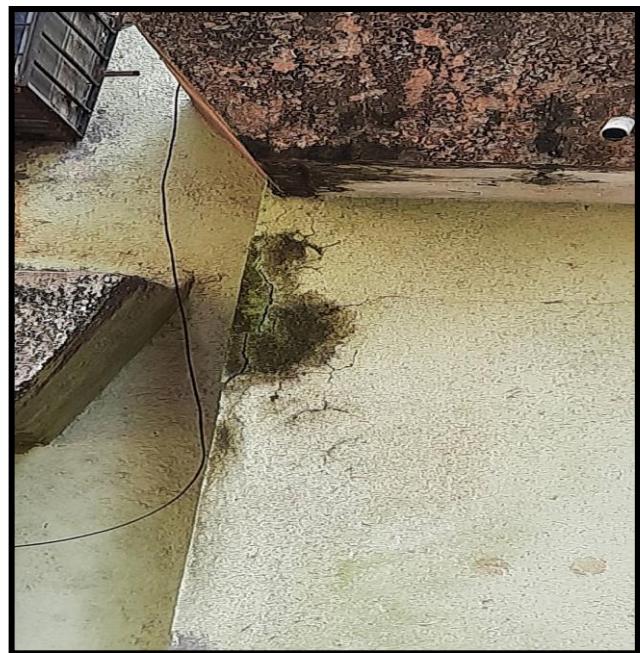
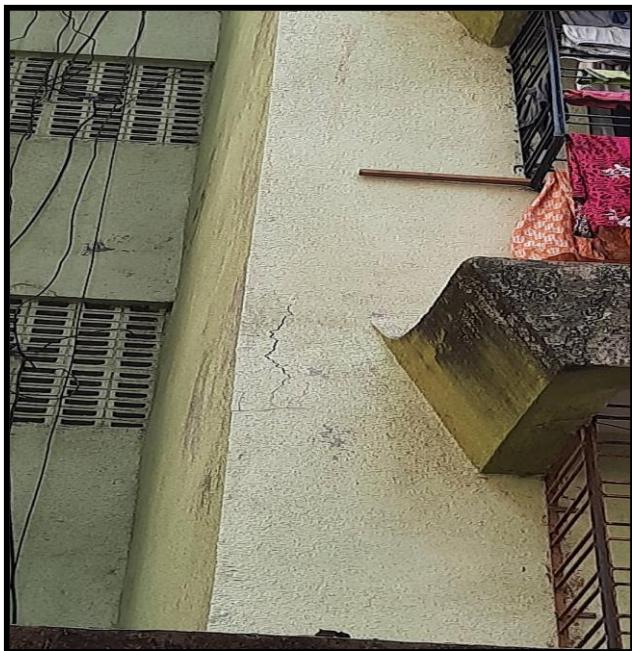
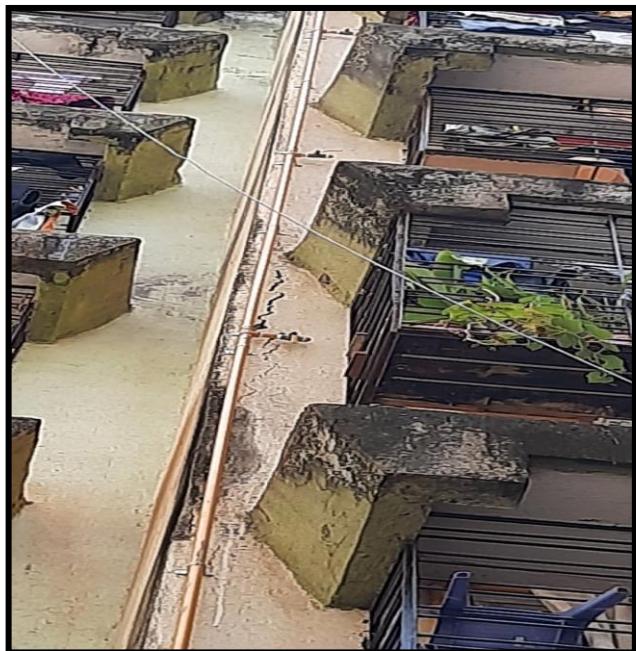
### BACK SIDE

- ❖ Structural crack observed at several places on column.

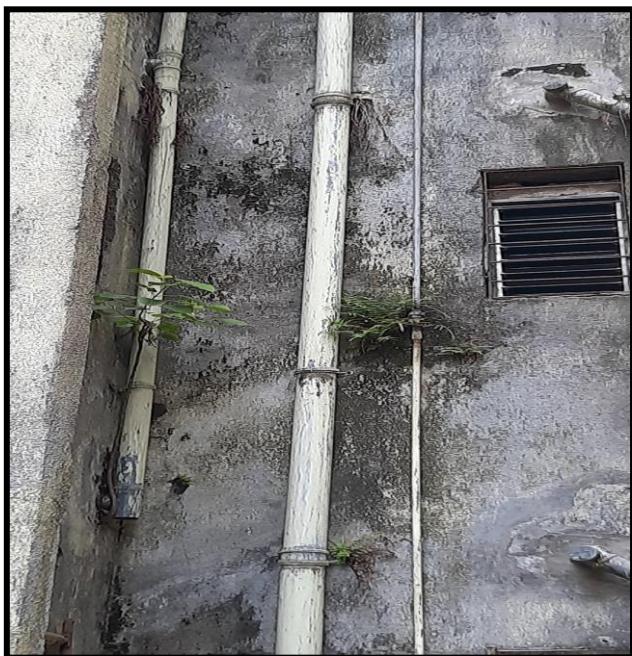
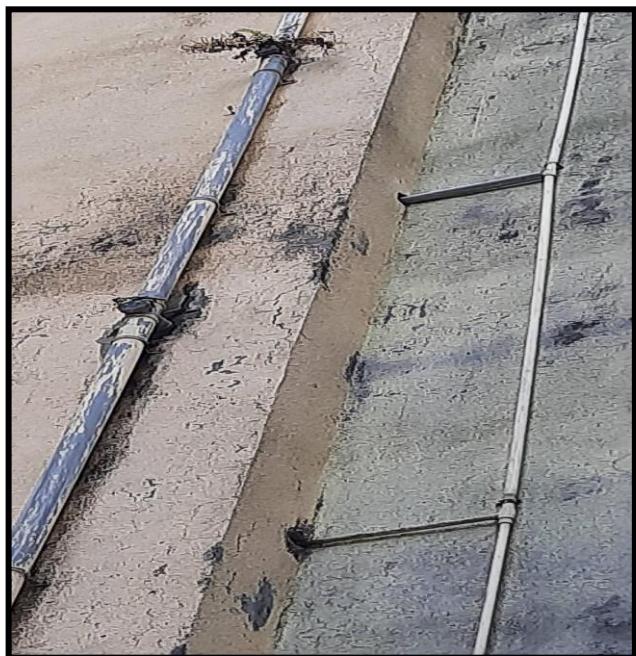
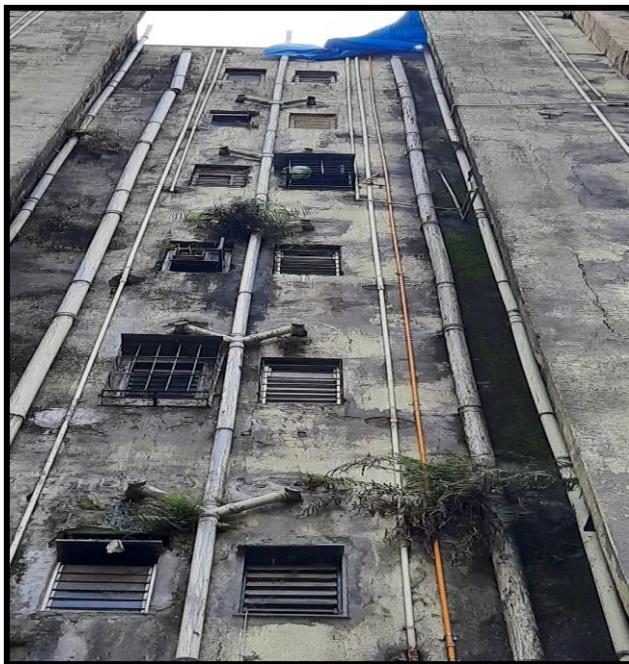
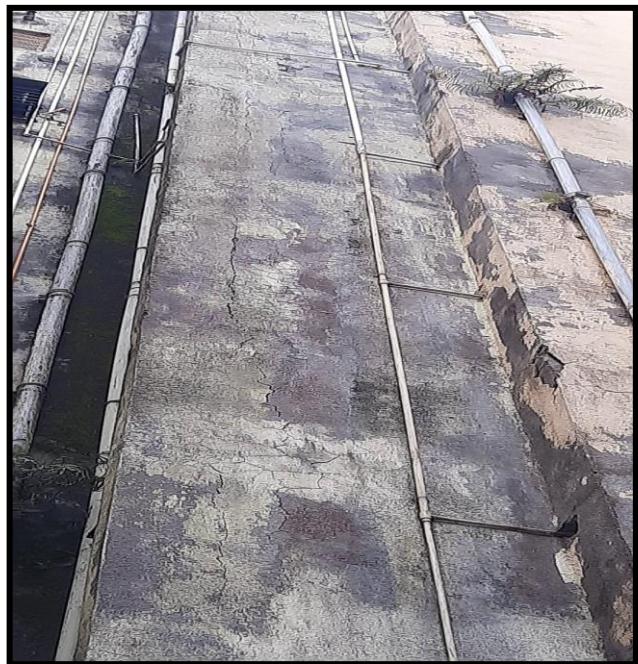
## EAST SIDE

- ❖ Structural crack observed at several places on column.
- ❖ Major crack observed at several places on wall.
- ❖ Vegetation growth observed at several places on wall.

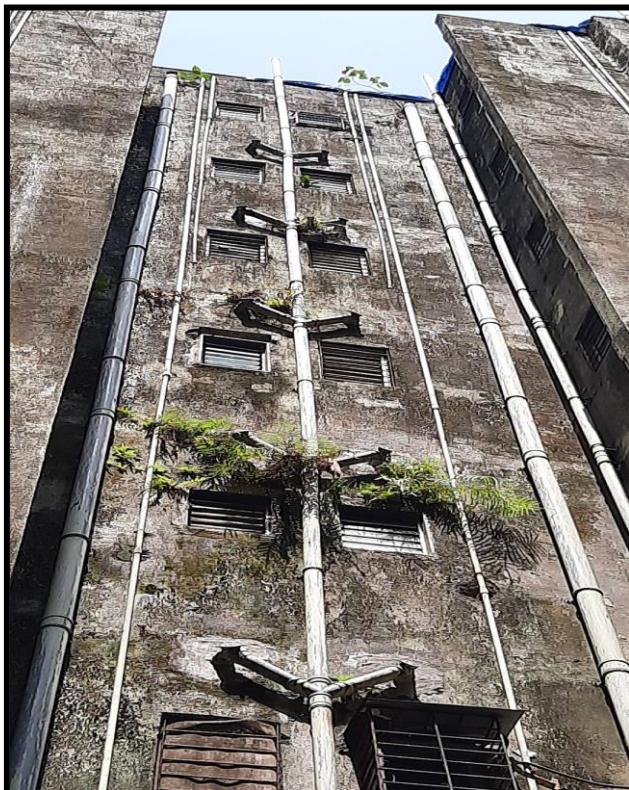
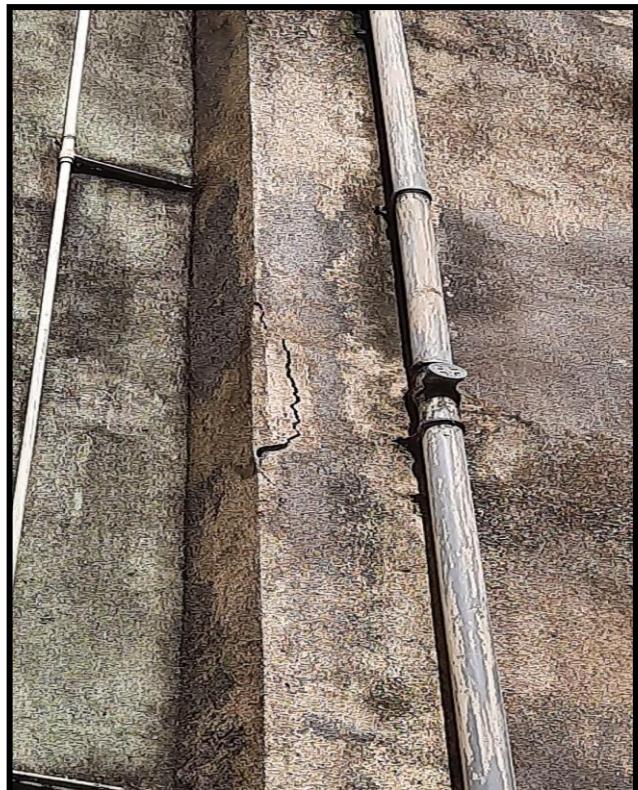
## WEST SIDE

- ❖ Structural crack observed at several places on column.
- ❖ Vegetation growth observed at several places on wall.
