STRUCTURAL AUDIT REPORT
FOR
“VISHAL SAHYADRI CO – OP HSG. SOC. LTD”,
“D2 – L WING”
SITUATED AT
SAHYADRI NAGAR, CHARKOP,
KANDIVALI (W) MUMBAI – 400 067

978/D2/LSS/2021

JULY 24, 2021

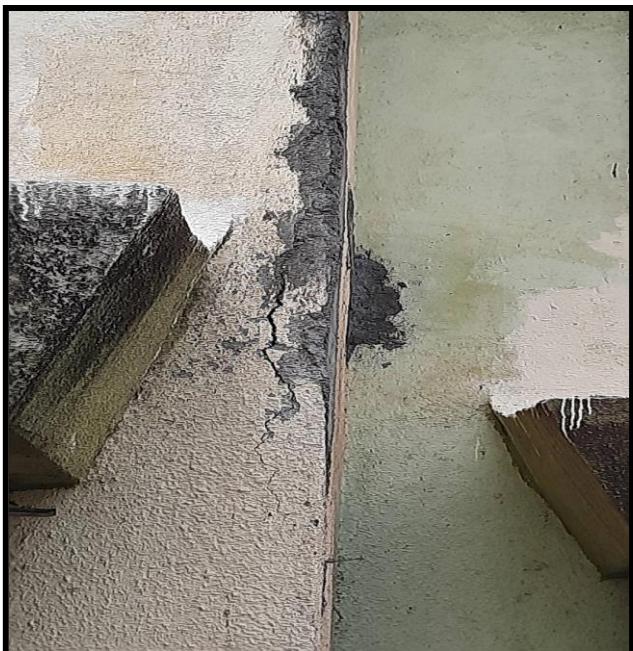
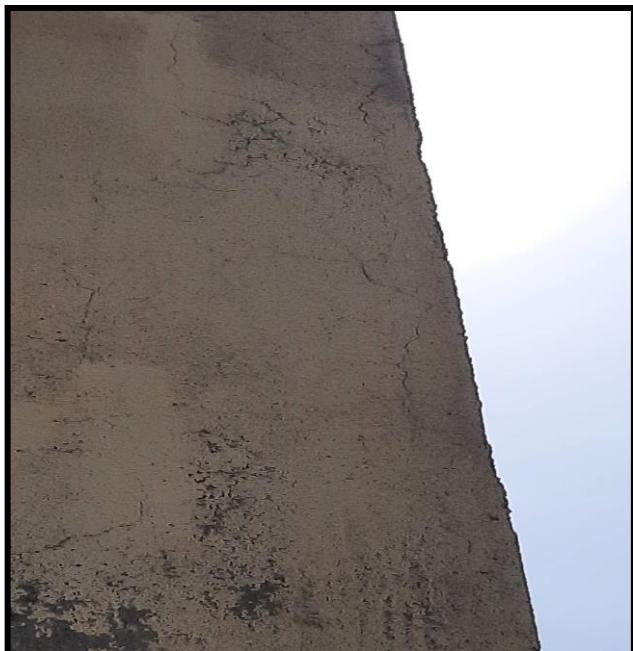
FRONT SIDE

- ❖ Structural crack observed at several places on column.
- ❖ Major crack observed at several places on wall.

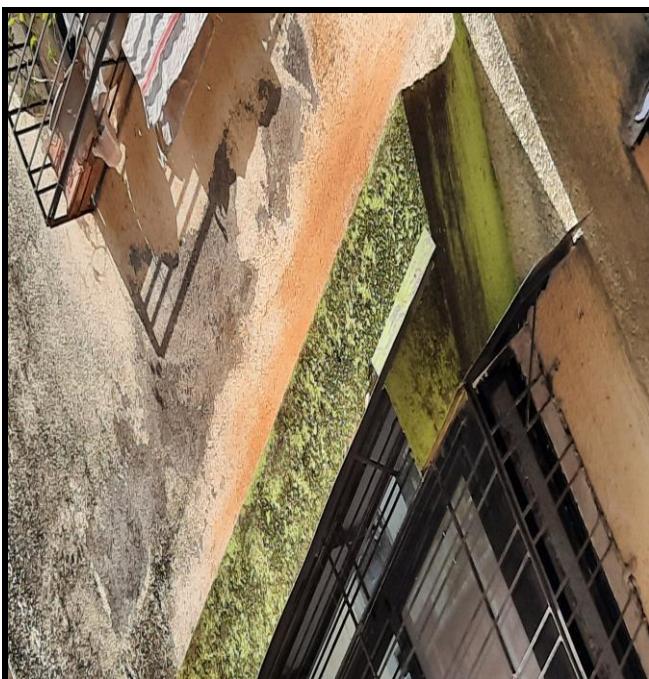
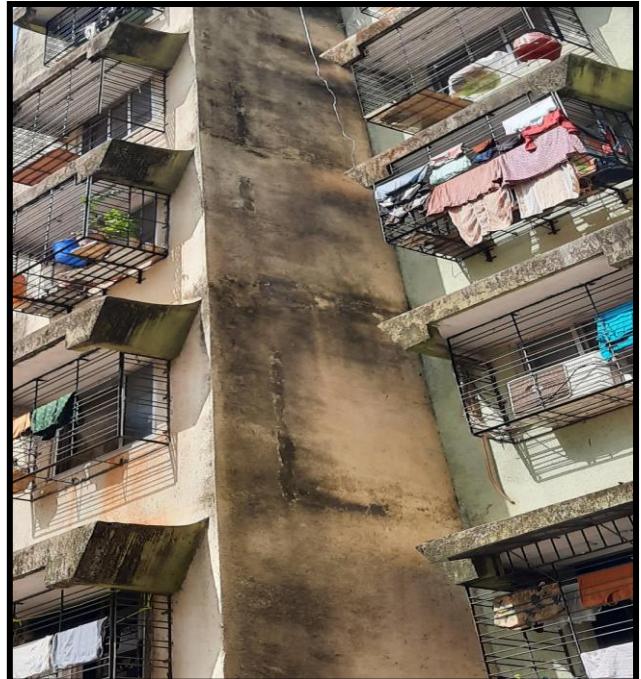
BACK SIDE

- ❖ Algae observed at several places on wall.

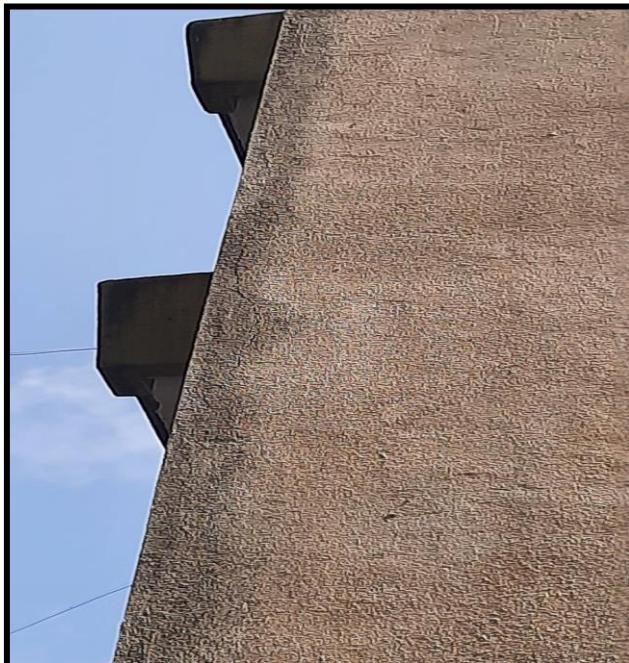
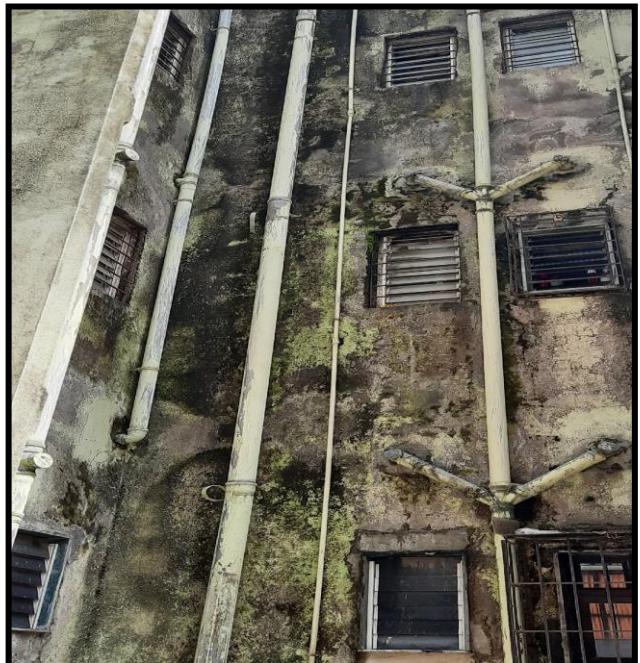
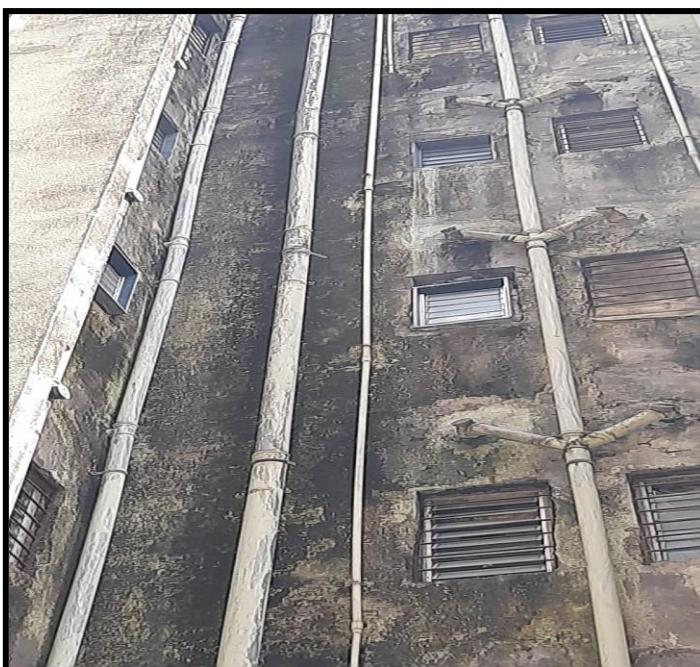
NORTH SIDE

- ❖ Structural crack observed at several places on column.
- ❖ Algae observed at several places on wall.

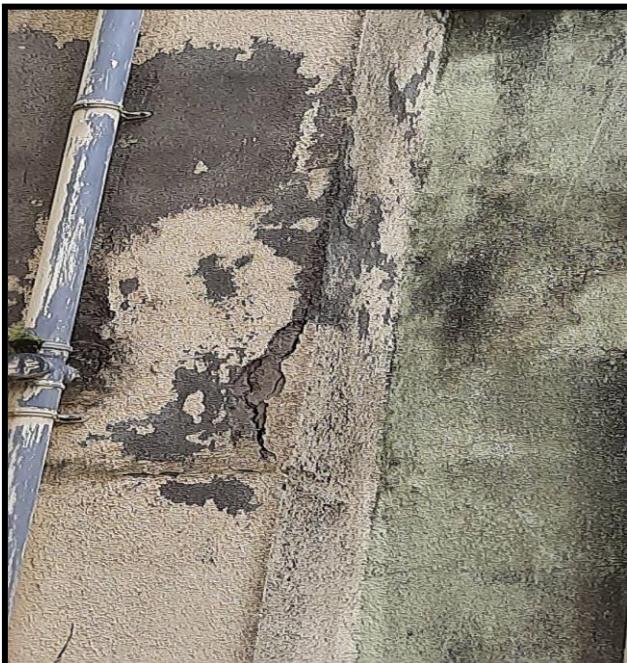
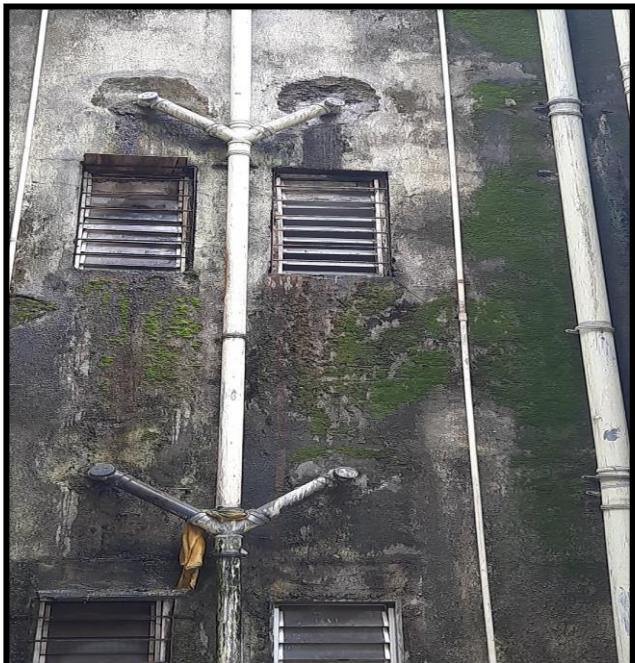
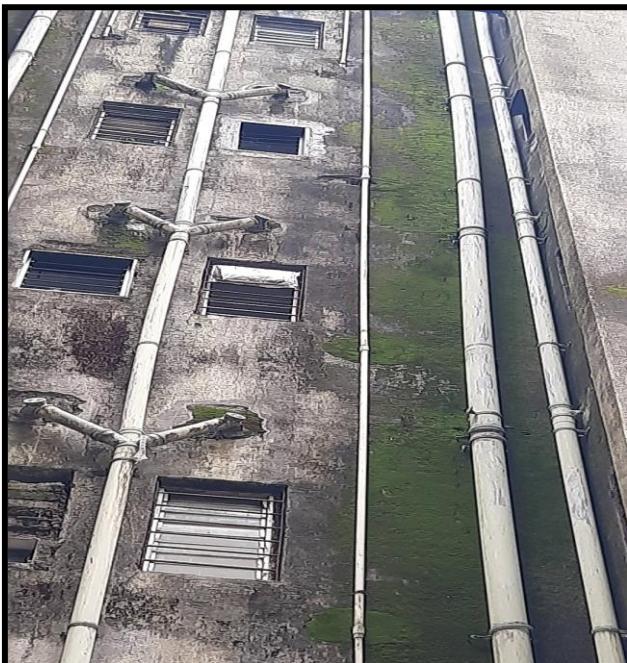
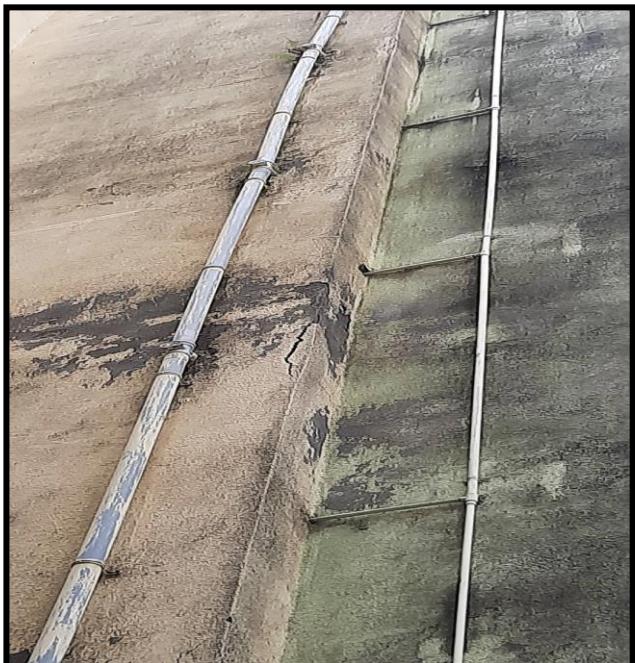
SOUTH SIDE

- ❖ Structural crack observed at several places on column.
- ❖ Algae observed at several places on wall.
