STRUCTURAL AUDIT REPORT
FOR
“VISHAL SAHYADRI CO – OP HSG. SOC. LTD”,
“C2 – WING”
SITUATED AT
SAHYADRI NAGAR, CHARKOP,
KANDIVALI (W) MUMBAI – 400 067

978/C2/LSS/2021

JUNE 21, 2021

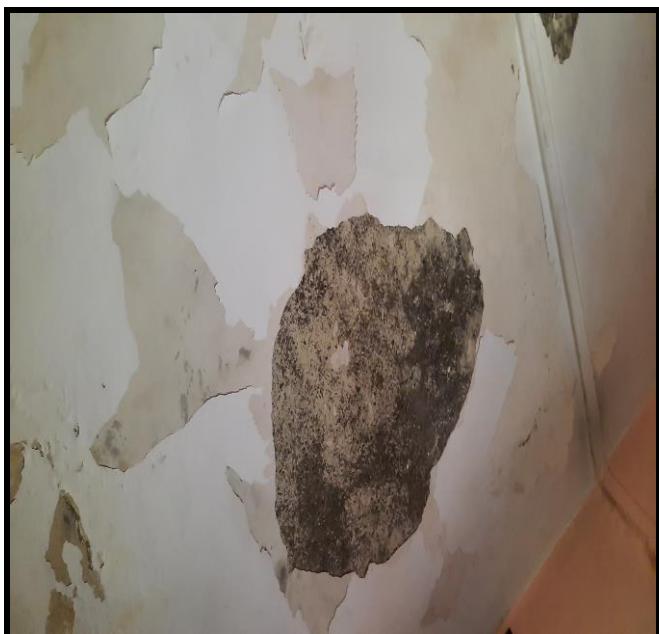
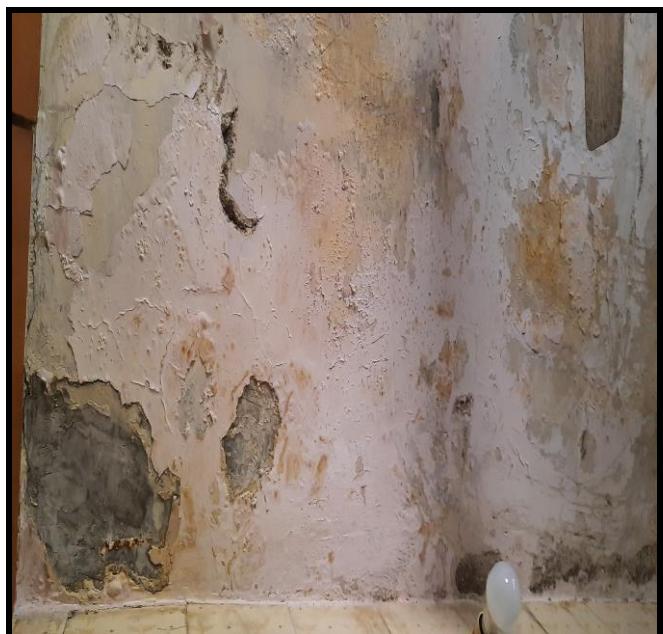
FLAT NO – 02

- ❖ **HALL** – Leakage mark observed on ceiling.
- ❖ **KITCHEN** – Leakage mark observed on ceiling.
- ❖ **PASSAGE** – O.K.
- ❖ **TOILET & BATH ROOM** – O.K.

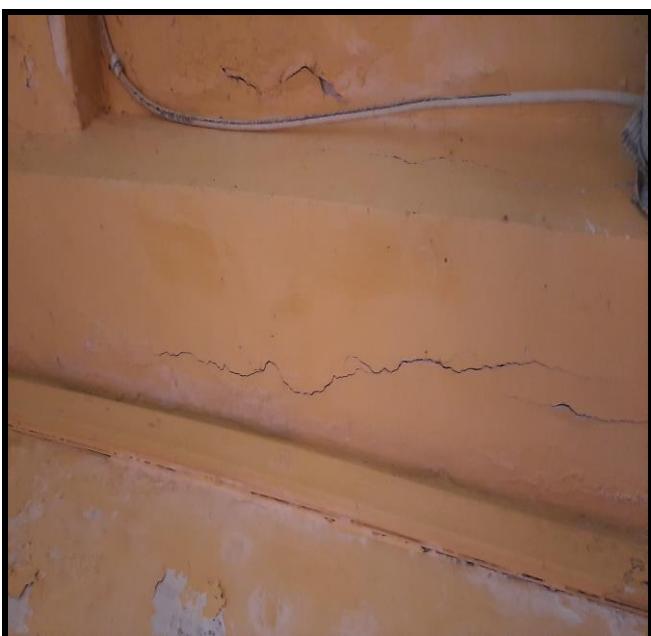
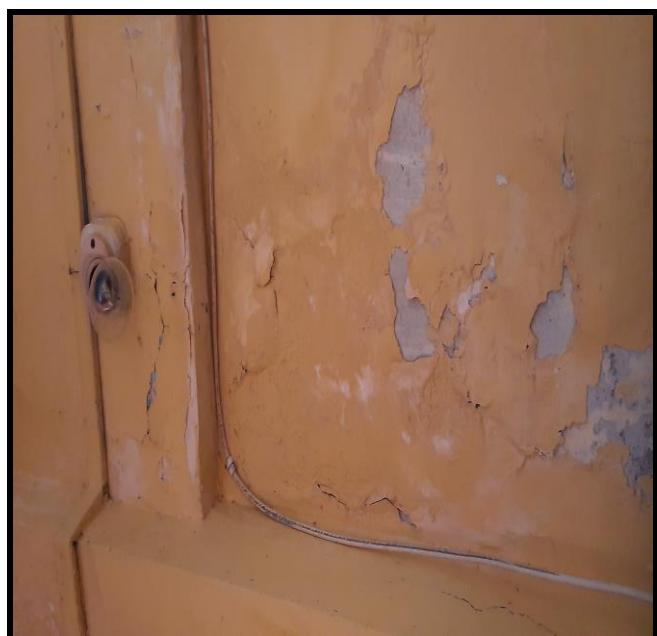
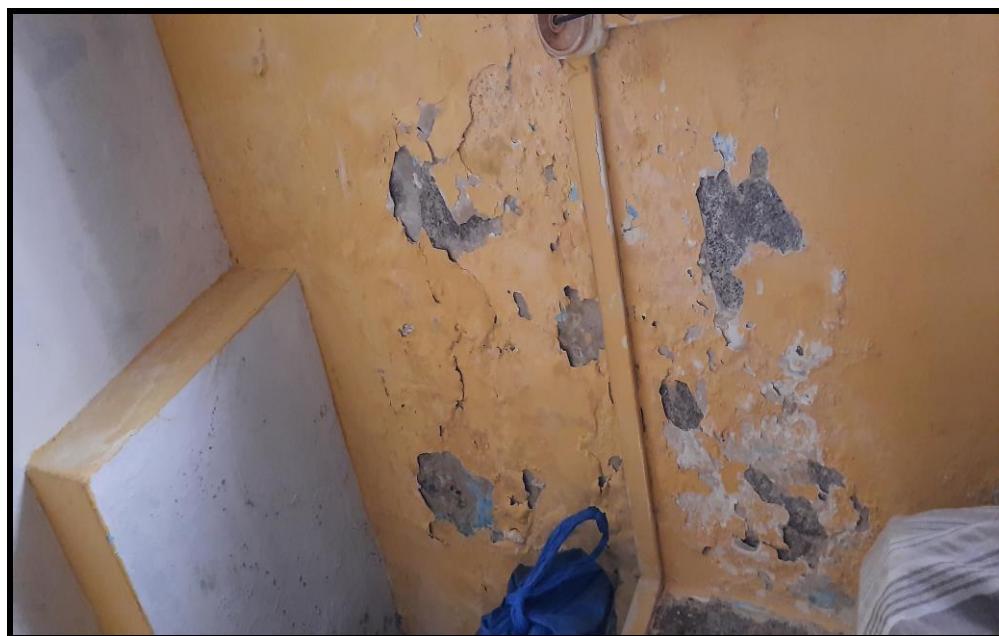
FLAT NO – 04

- ❖ **HALL** – Leakage mark observed on wall.
 - Structural crack observed on column.
- ❖ **KITCHEN** – Structural crack observed on beam.
 - Leakage mark observed on wall & ceiling.
- ❖ **PASSAGE** – O.K.
- ❖ **TOILET & BATH ROOM** – O.K.

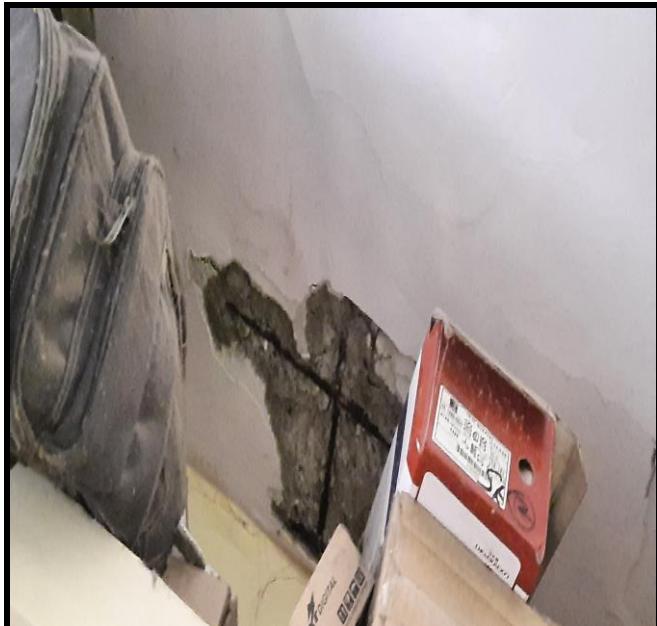
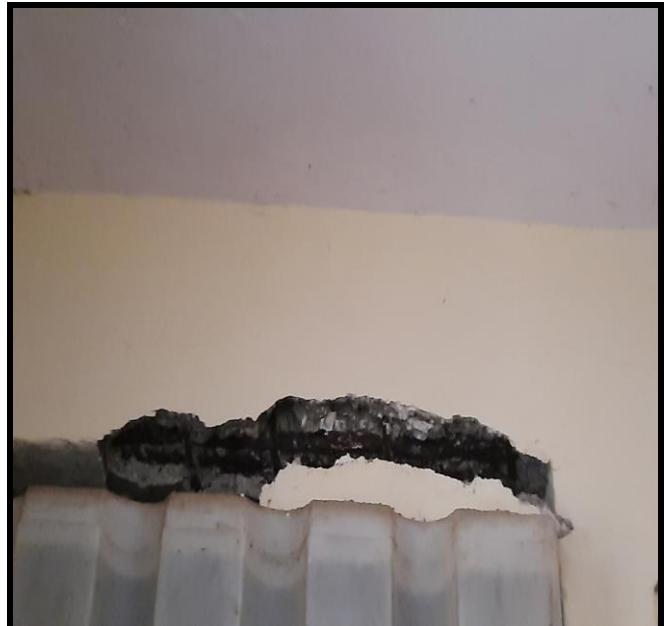
FLAT NO – 9

- ❖ **HALL** – Ceiling plaster get damaged & steel get exposed & corroded.
- ❖ **KITCHEN** – Ceiling plaster get damaged & steel get exposed & corroded.
- ❖ **PASSAGE** – O.K.
- ❖ **TOILET & BATH ROOM** – O.K.

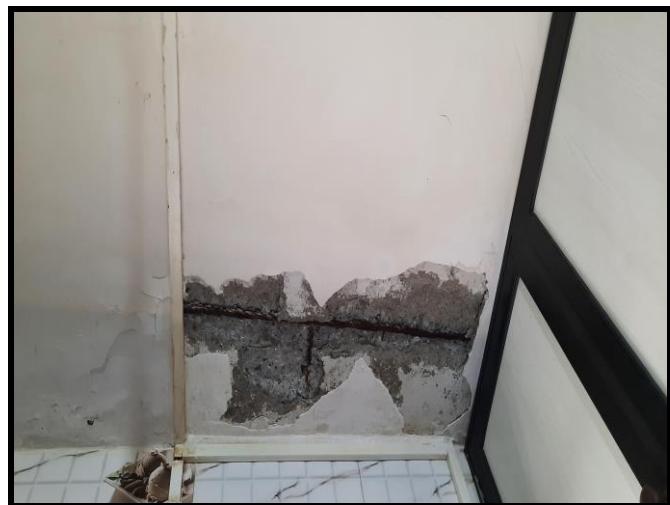
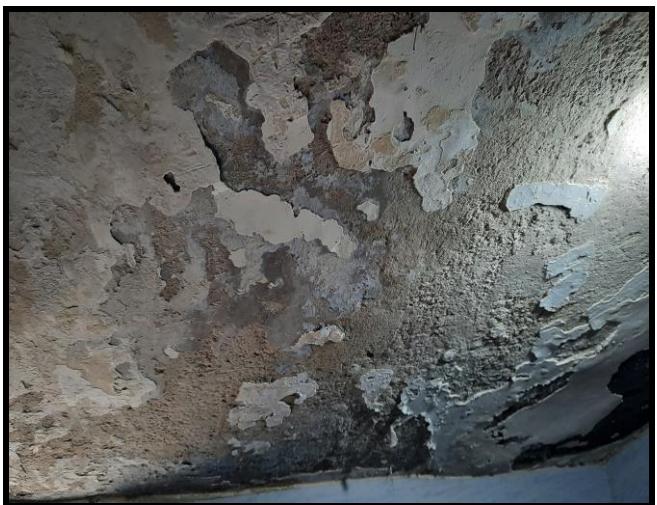
FLAT NO – 14

- ❖ **HALL** – O.K.
- ❖ **KITCHEN** – Ceiling plaster get damaged & steel get exposed & corroded.
- ❖ **PASSAGE** – O.K.
- ❖ **TOILET & BATH ROOM** – Leakage observed on ceiling in monsoon.

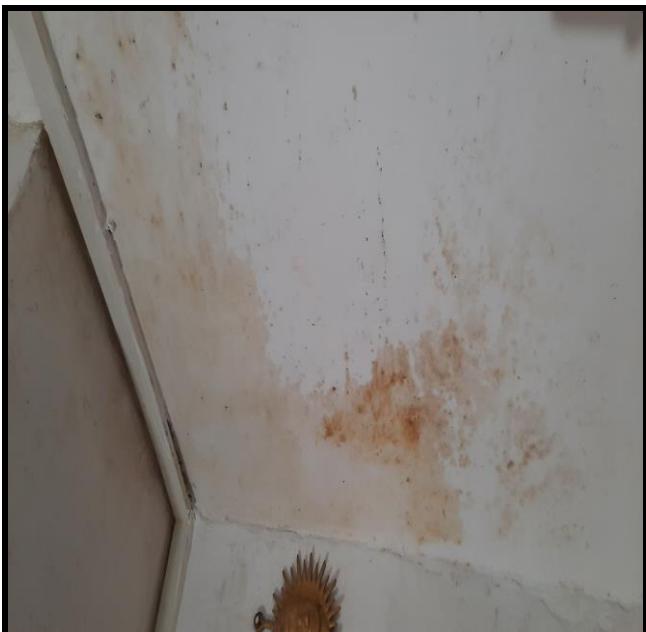
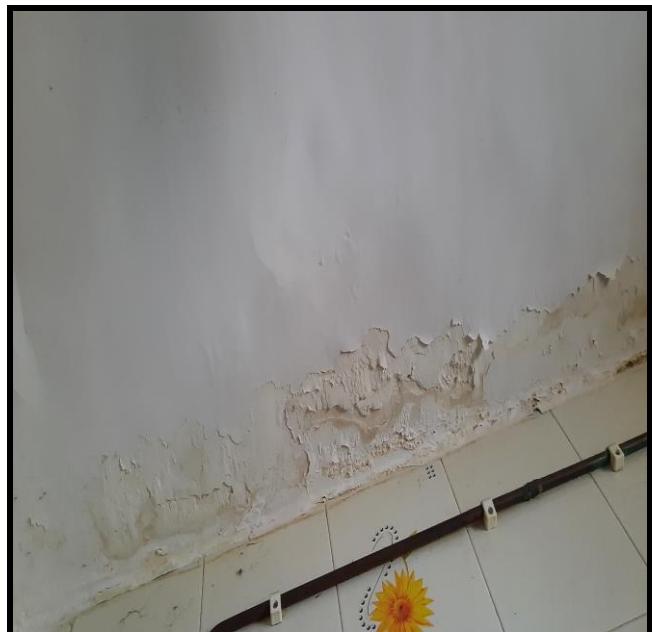
FLAT NO – 18

- ❖ **HALL** – Dampness observed wall in monsoon.
- ❖ **KITCHEN** – Leakage mark observed on ceiling.
- ❖ **PASSAGE** – O.K.
- ❖ **TOILET & BATH ROOM** – O.K.

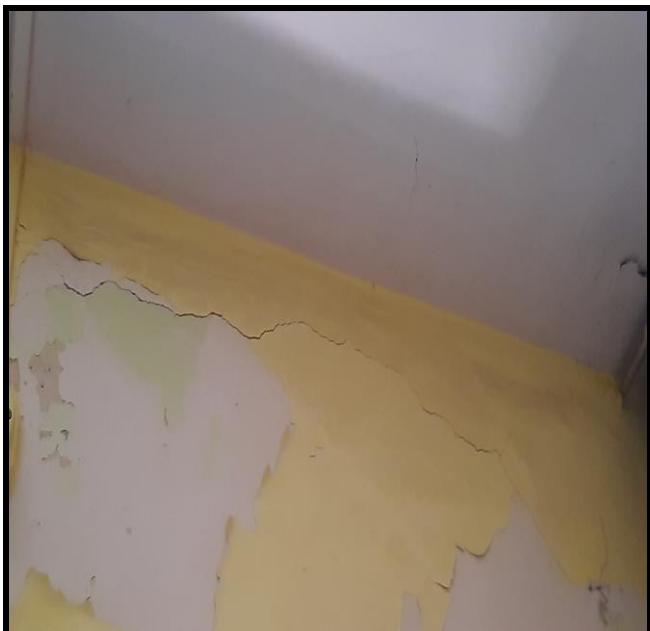
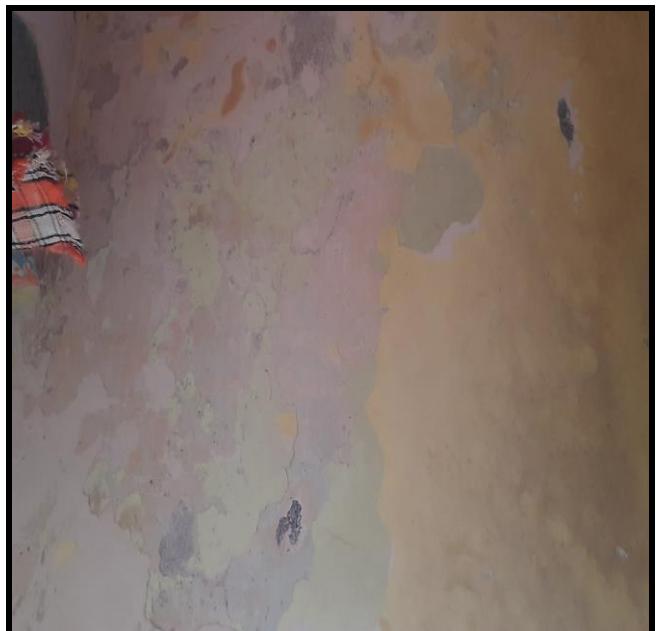
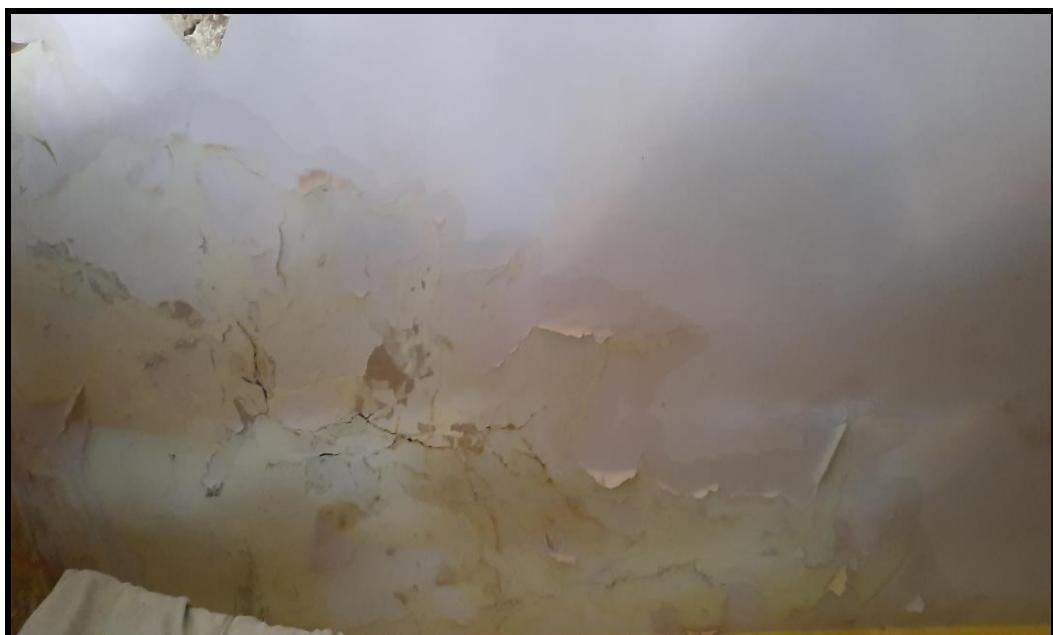
FLAT NO – 25

- ❖ **HALL** – Leakage mark observed on wall.
 - Structural crack observed on beam.
- ❖ **KITCHEN** – Leakage mark observed on ceiling.
 - Structural crack observed on ceiling.
- ❖ **PASSAGE** – O.K.
- ❖ **TOILET & BATH ROOM** – O.K.

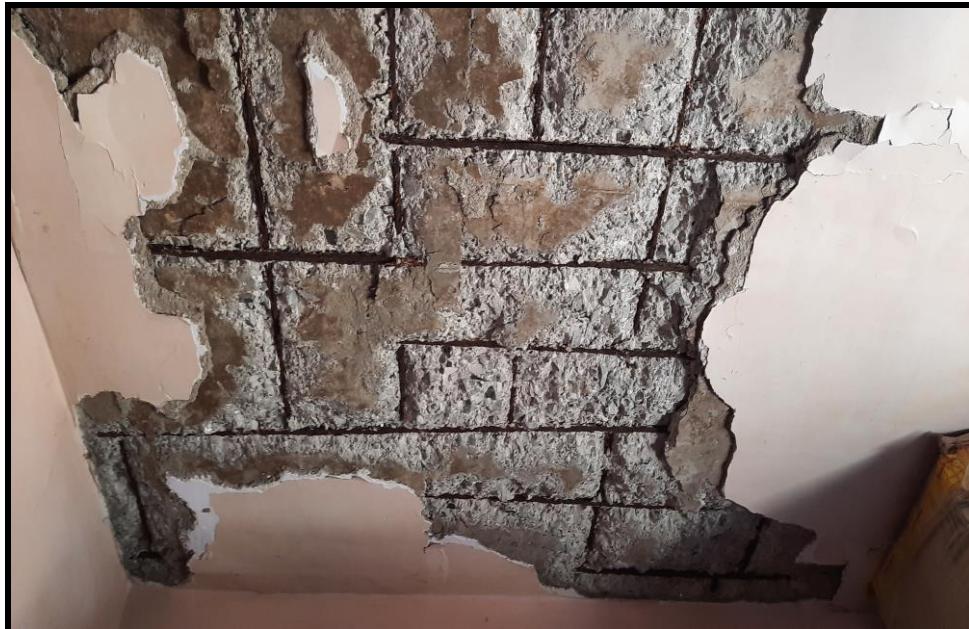
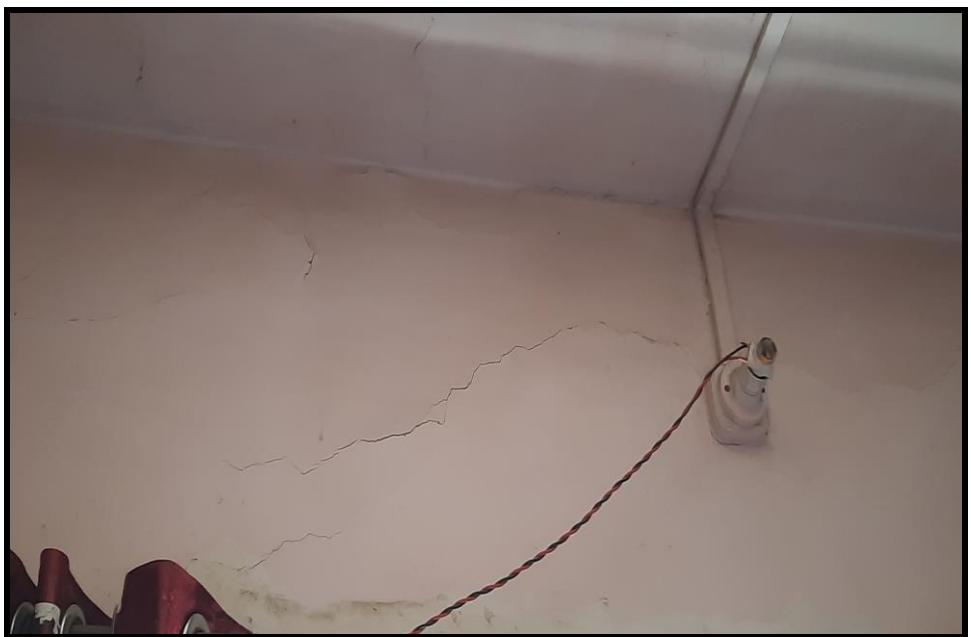
FLAT NO – 30

- ❖ **HALL** – Ceiling plaster get damaged & steel get exposed & corroded.
 - Structural crack observed on beam.
- ❖ **KITCHEN** – O.K.
- ❖ **PASSAGE** – O.K.
- ❖ **TOILET & BATH ROOM** – O.K.

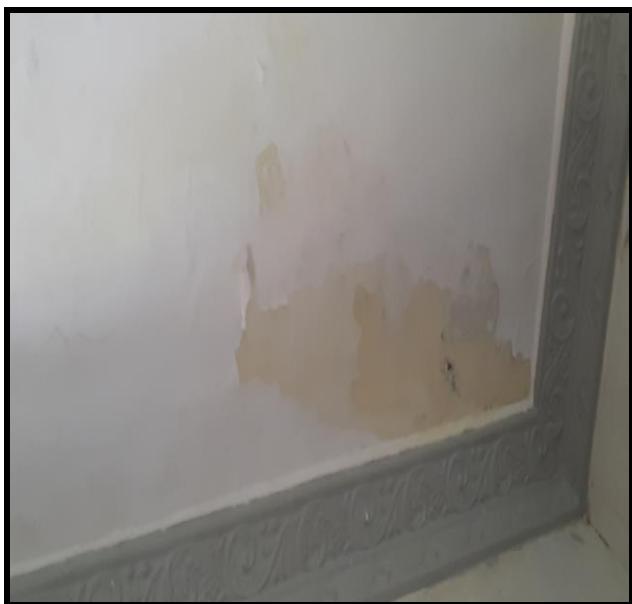
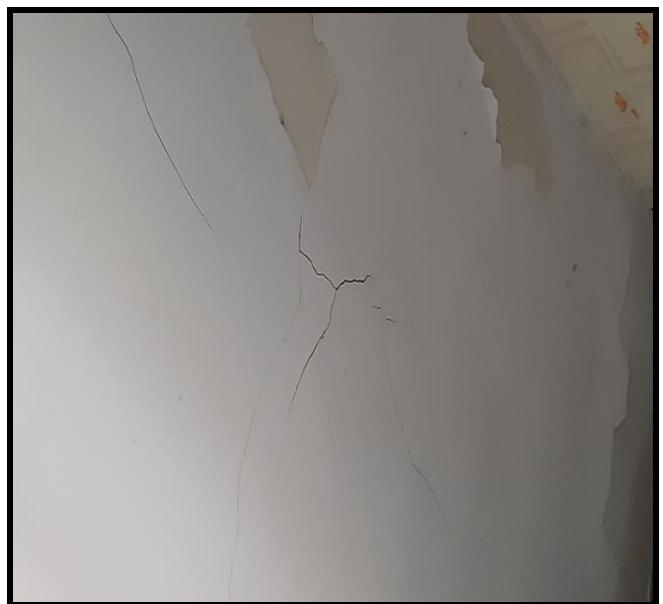
FLAT NO – 34

- ❖ **HALL** – Leakage observed wall in monsoon.
- ❖ **KITCHEN** – Leakage observed wall in monsoon.
 - Structural crack observed on ceiling.
- ❖ **PASSAGE** – O.K.
- ❖ **TOILET & BATH ROOM** – O.K.

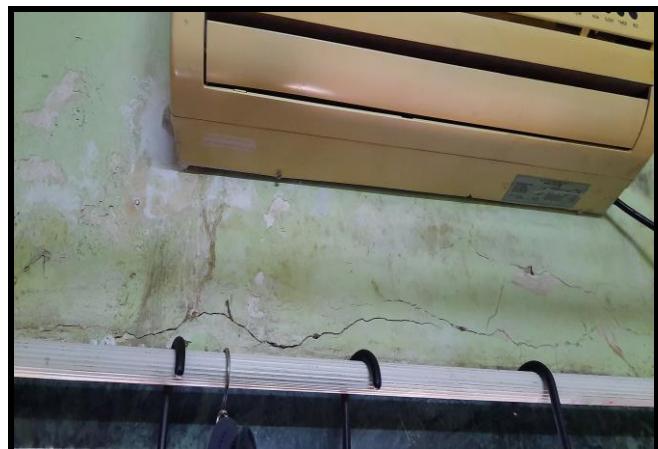
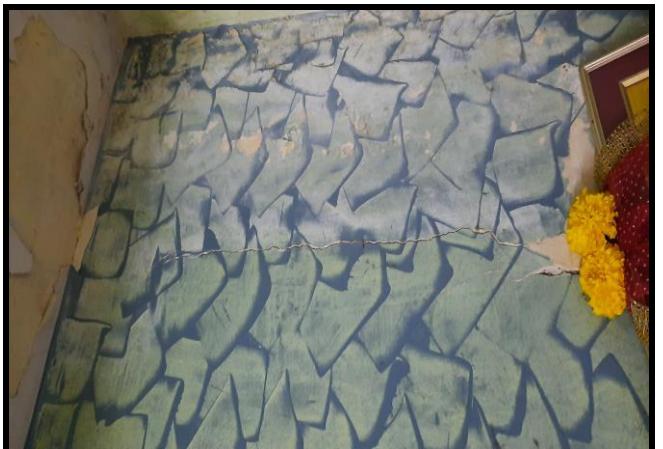
FLAT NO – 38

- ❖ **HALL** – Structural crack observed on ceiling & beam.
- ❖ **KITCHEN** – O.K.
- ❖ **PASSAGE** – O.K.
- ❖ **TOILET & BATH ROOM** – O.K.

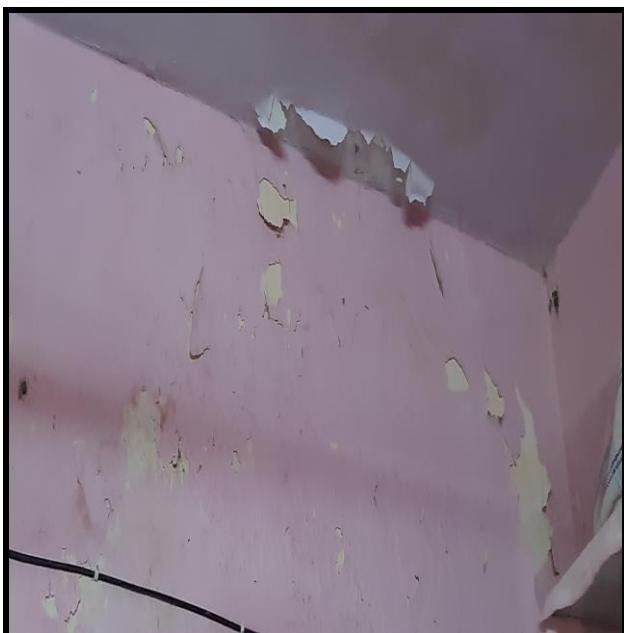
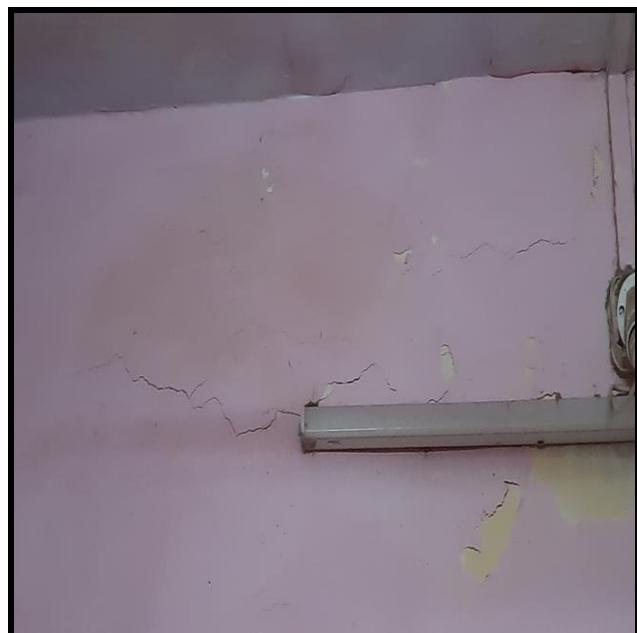
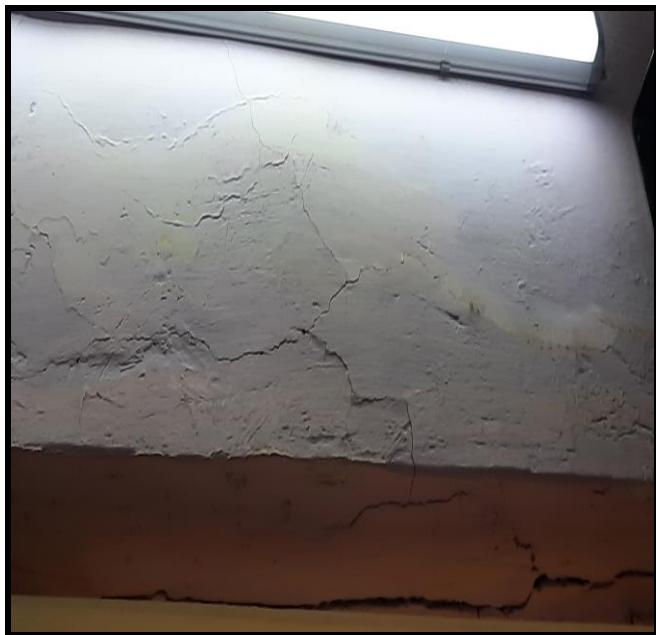
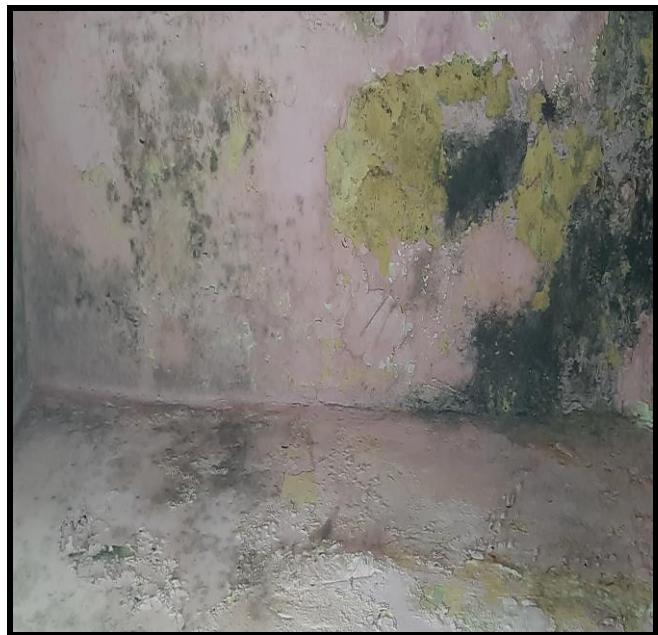
FLAT NO – 48

- ❖ **HALL** – Dampness observed on ceiling in monsoon.
 - Structural crack observed on beam.
- ❖ **KITCHEN** – Structural crack observed on beam.
 - Leakage mark observed on wall & ceiling.
- ❖ **PASSAGE** – O.K.
- ❖ **TOILET & BATH ROOM** – Algae observed on wall.

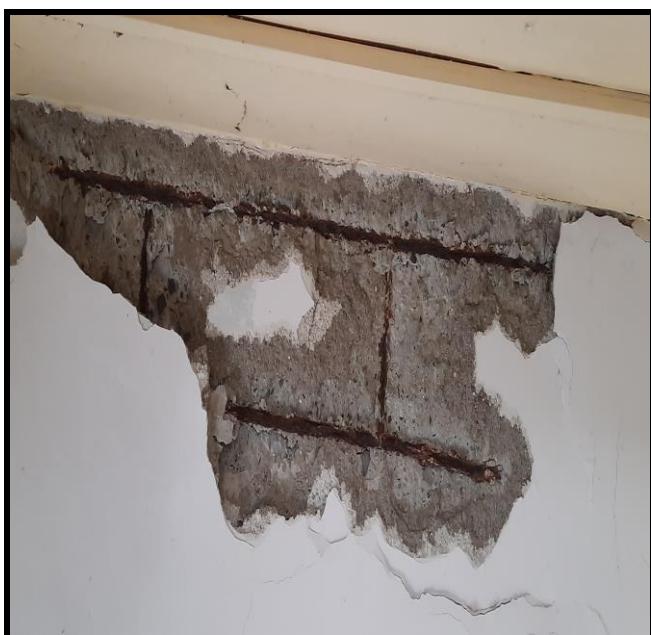
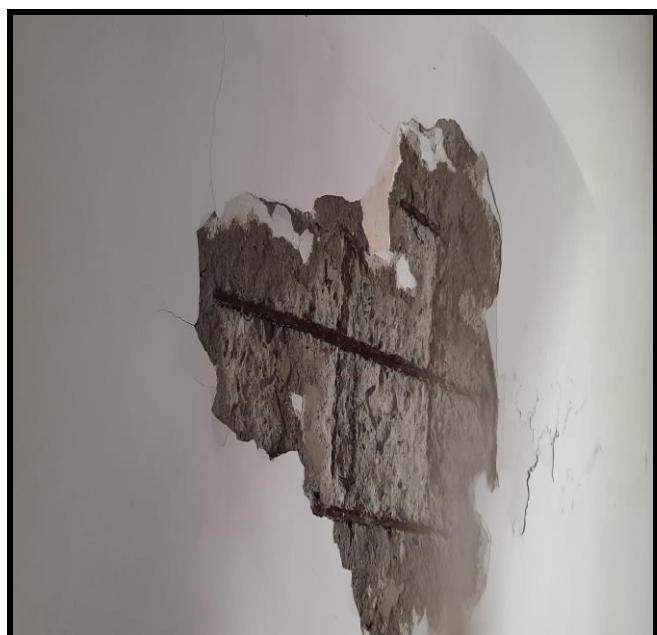
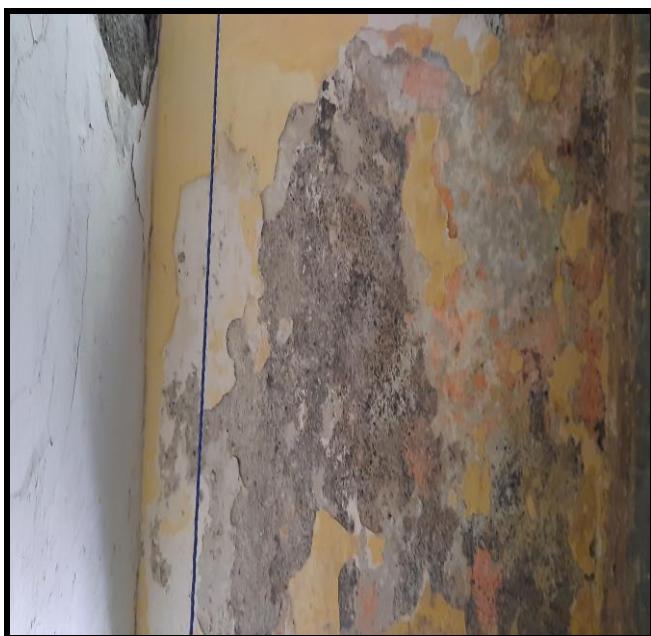
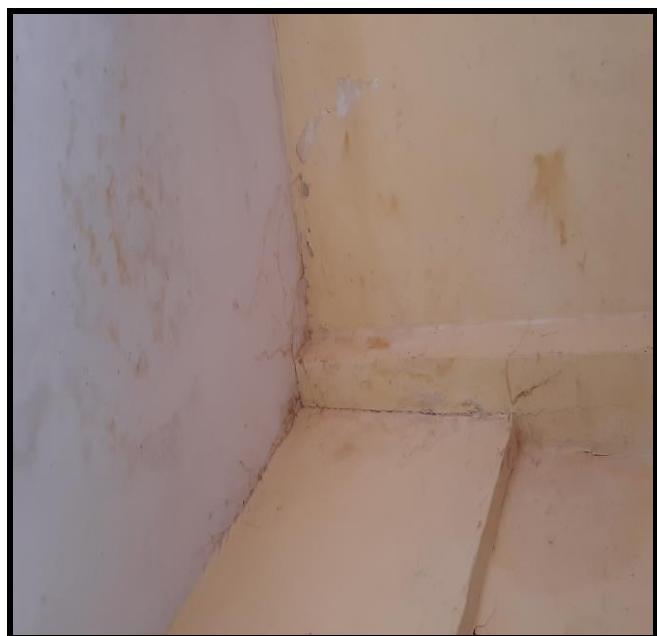
FLAT NO – 53

- ❖ **HALL** – Leakage mark observed on ceiling.
 - Ceiling plaster get damaged & steel get exposed & corroded.
- ❖ **KITCHEN** – Leakage mark observed on ceiling.
- ❖ **PASSAGE** – O.K.
- ❖ **TOILET & BATH ROOM** – O.K.

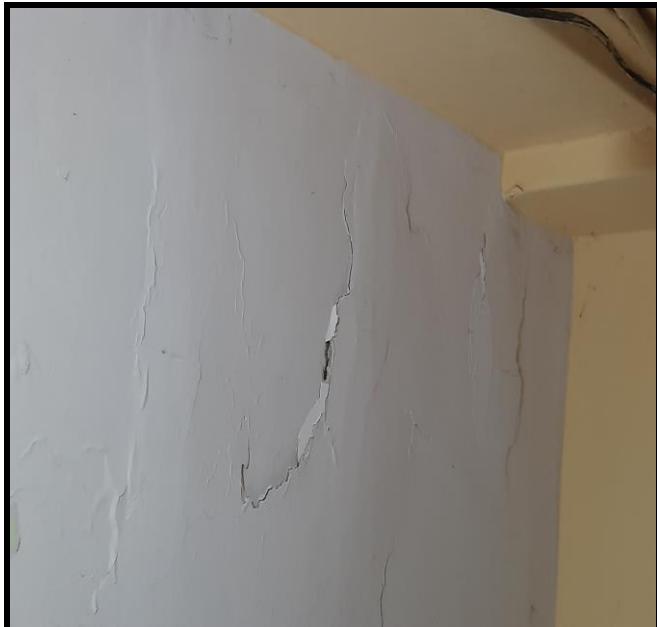
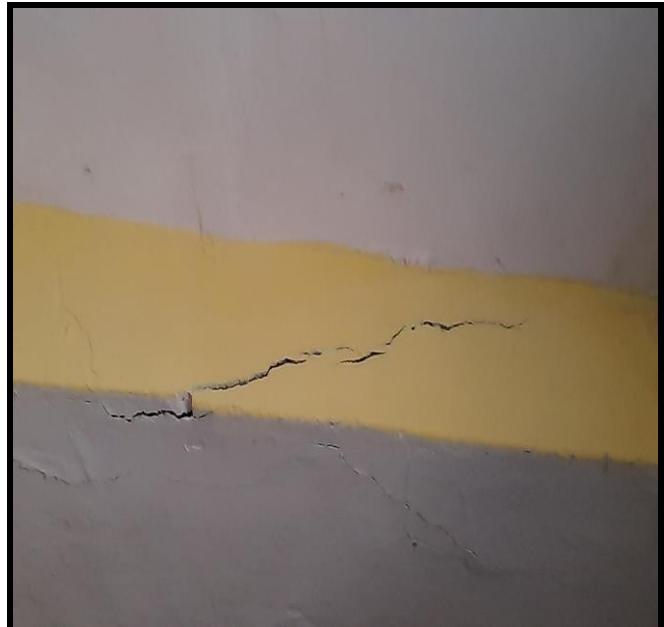
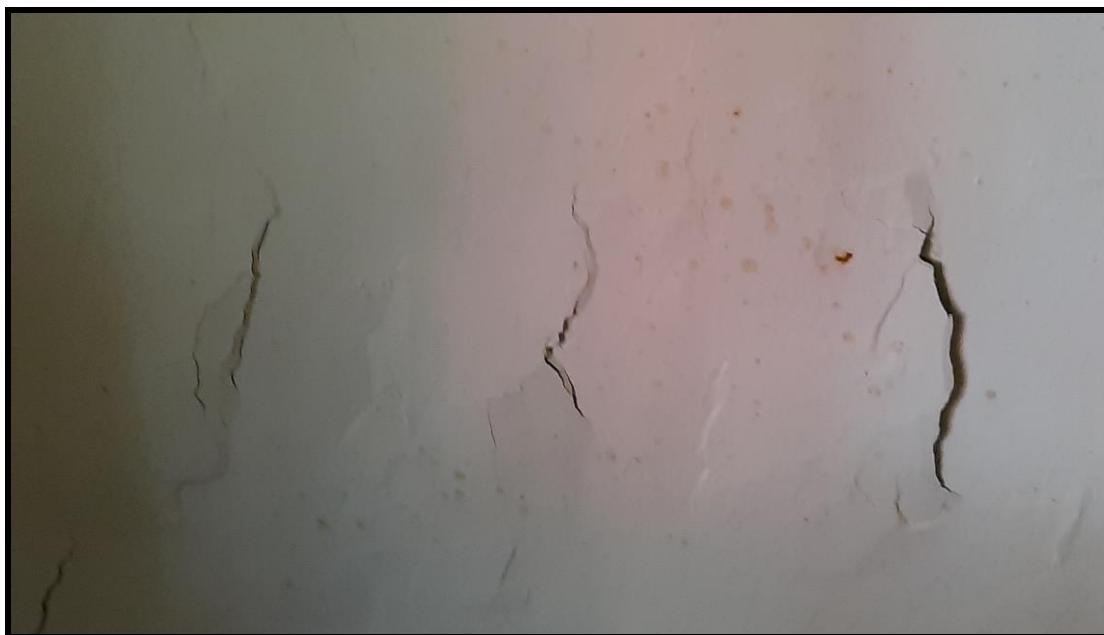
FLAT NO – 54

- ❖ **HALL** – Structural damage observed on ceiling.
- ❖ **KITCHEN** – Structural damage observed on ceiling.
 - Structural crack observed on beam.
- ❖ **PASSAGE** – O.K.
- ❖ **TOILET & BATH ROOM** – O.K.

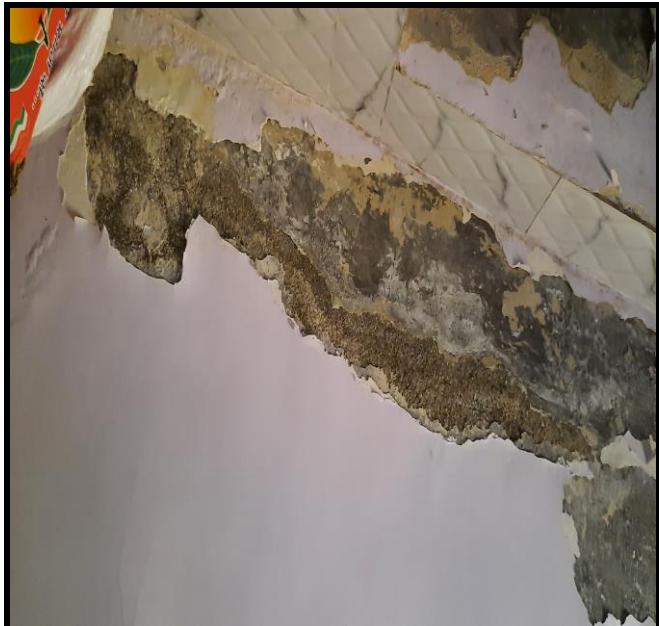
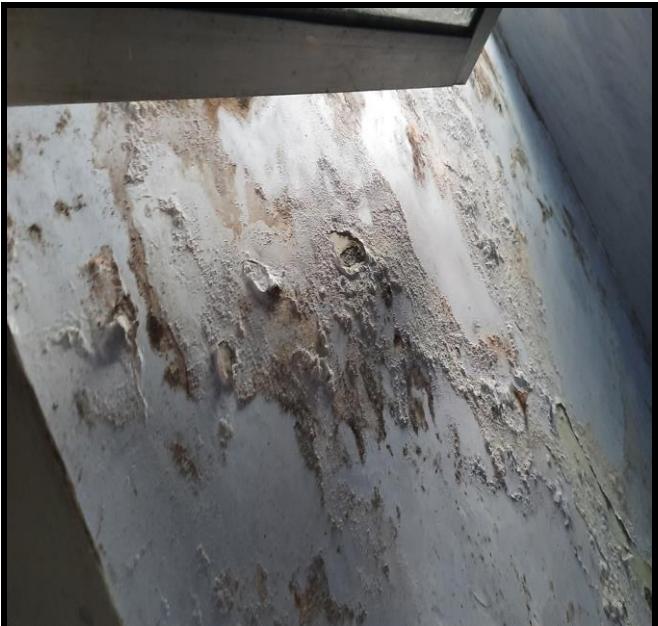
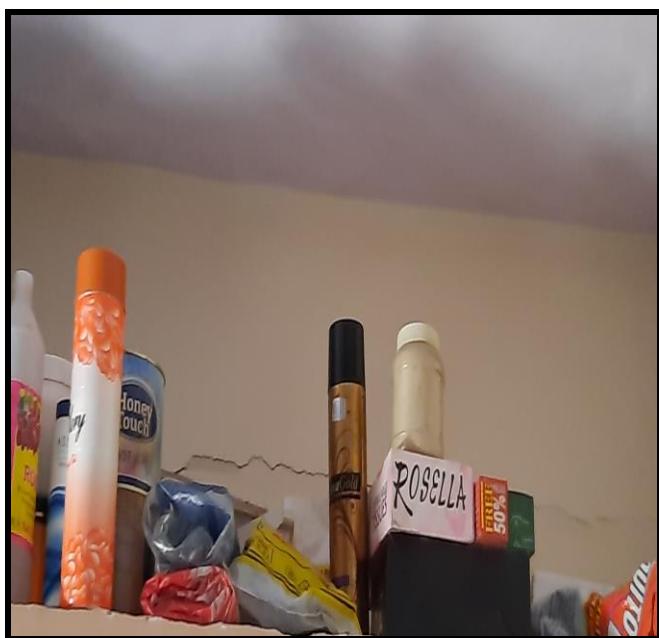
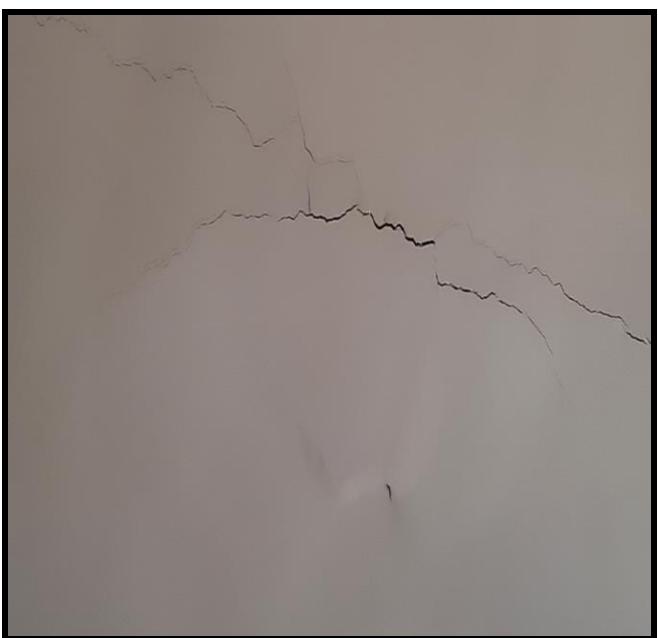
FLAT NO – 59

- ❖ **HALL** – Structural crack observed on beam & ceiling.
- ❖ **KITCHEN** – Leakage mark observed on ceiling.
- ❖ **PASSAGE** – O.K.
- ❖ **TOILET & BATH ROOM** – O.K.

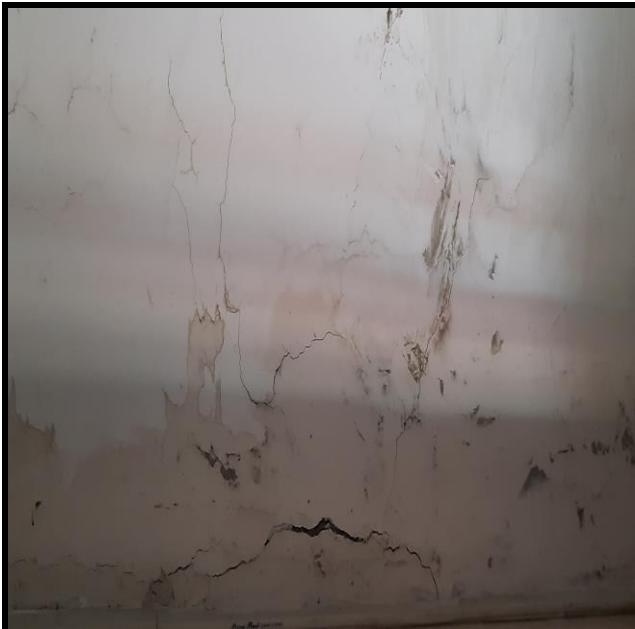
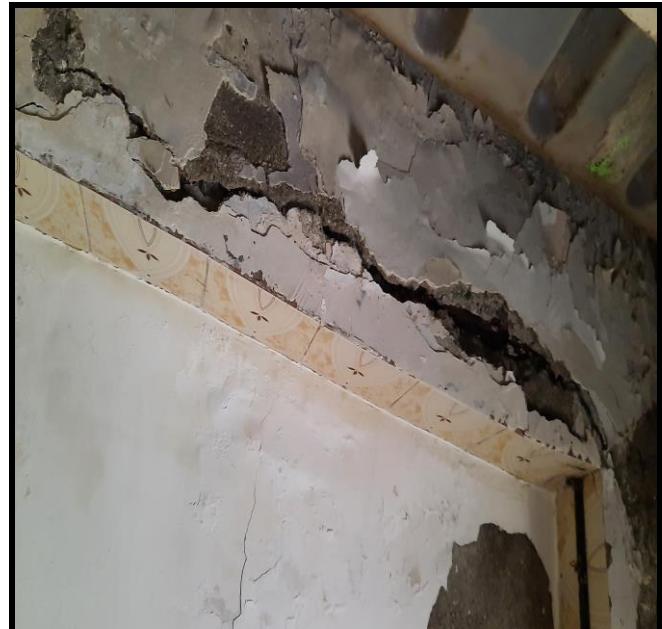
FLAT NO – 61

- ❖ **HALL** – Leakage mark observed on ceiling.
 - Structural crack observed on ceiling.
- ❖ **KITCHEN** – Ceiling plaster get damaged & steel get exposed & corroded.
- ❖ **PASSAGE** – O.K.
- ❖ **TOILET & BATH ROOM** – O.K.

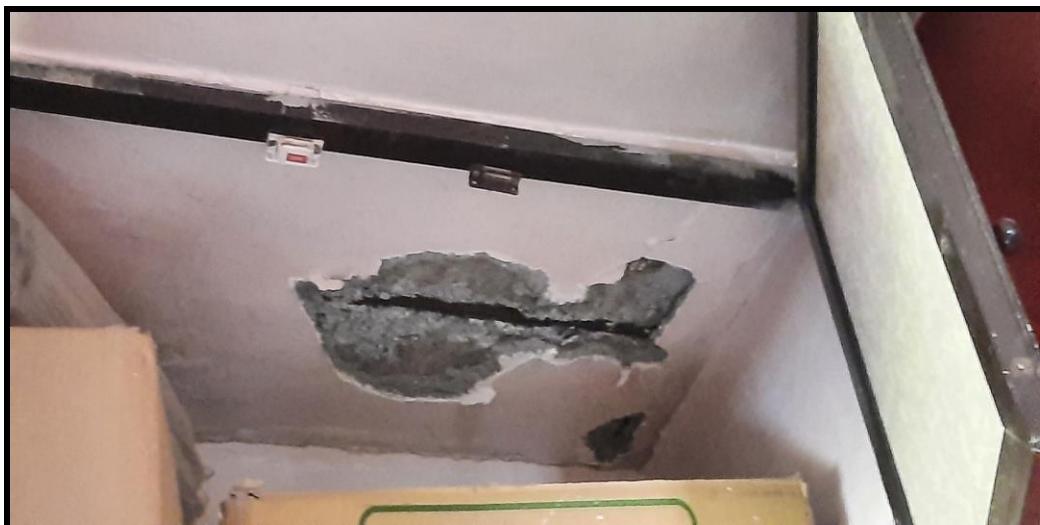
FLAT NO – 63

- ❖ **HALL** – Ceiling plaster get damaged & steel get exposed & corroded.
- ❖ **KITCHEN** – Ceiling plaster get damaged & steel get exposed & corroded.
- ❖ **PASSAGE** – O.K.
- ❖ **TOILET & BATH ROOM** – Leakage observed on ceiling.

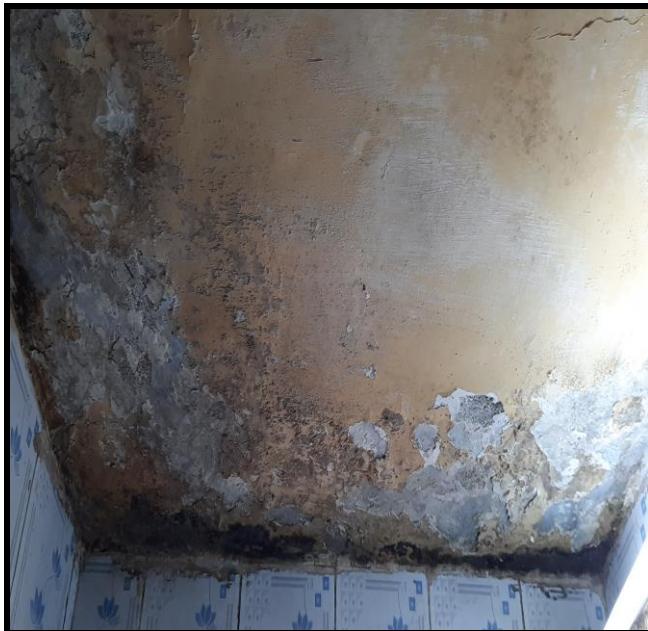
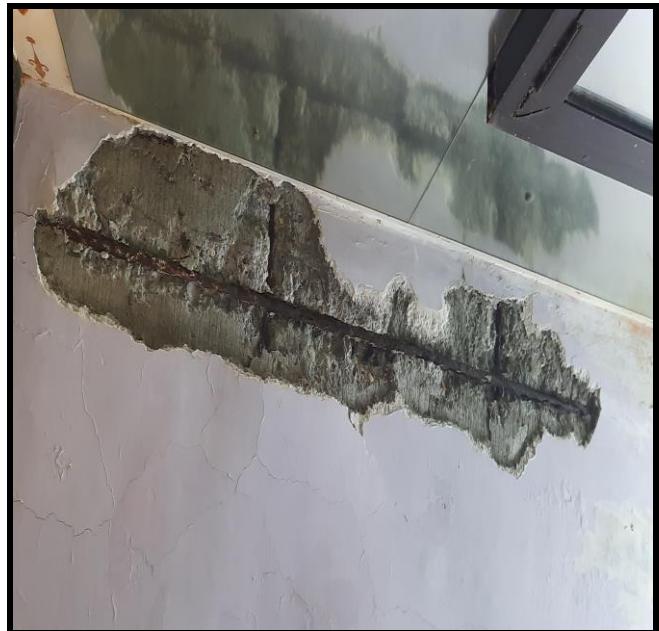
FLAT NO – 66

- ❖ **HALL** – O.K.
- ❖ **KITCHEN** – Leakage mark observed on ceiling.
- ❖ **PASSAGE** – O.K.
- ❖ **TOILET & BATH ROOM** – Leakage mark observed on ceiling.

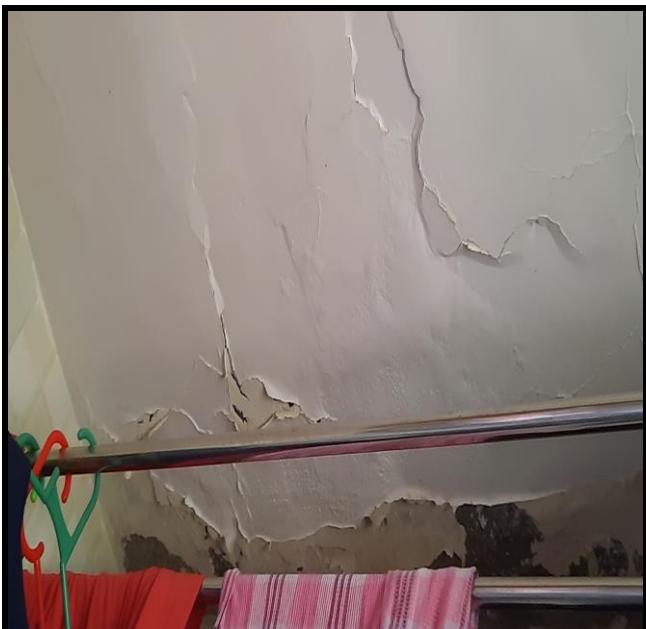
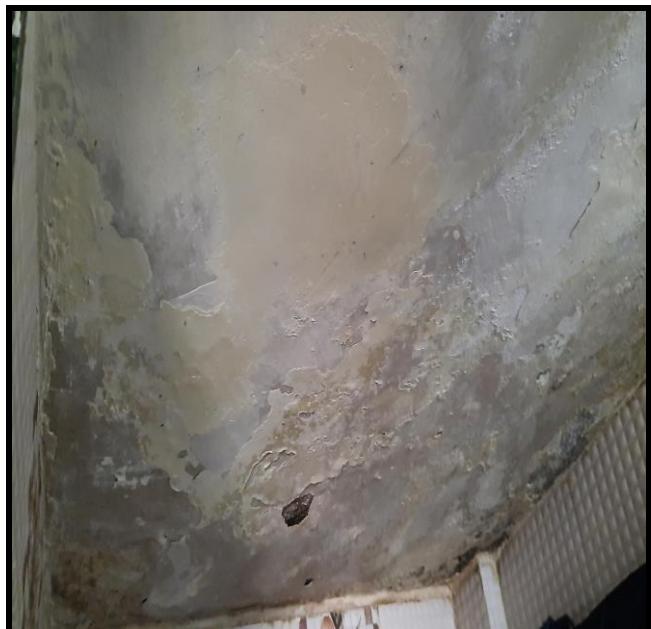
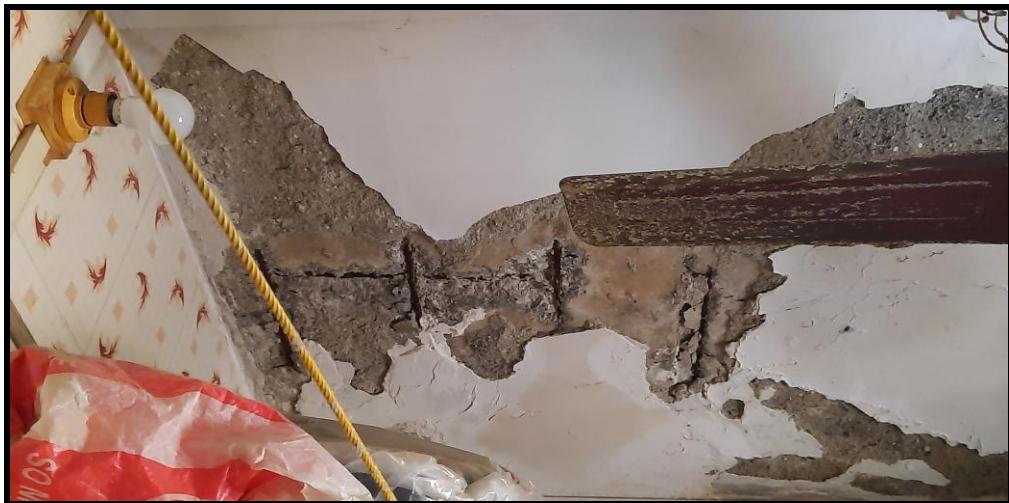
FLAT NO – 72

- ❖ **HALL** – Leakage observed on wall in monsoon.
- ❖ **KITCHEN** – Ceiling plaster get damaged & steel get exposed & corroded.
- ❖ **PASSAGE** – O.K.
- ❖ **TOILET & BATH ROOM** – O.K.

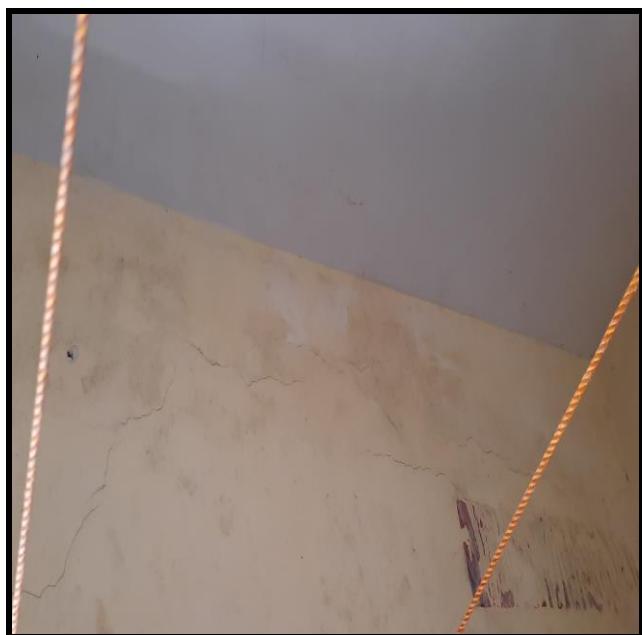
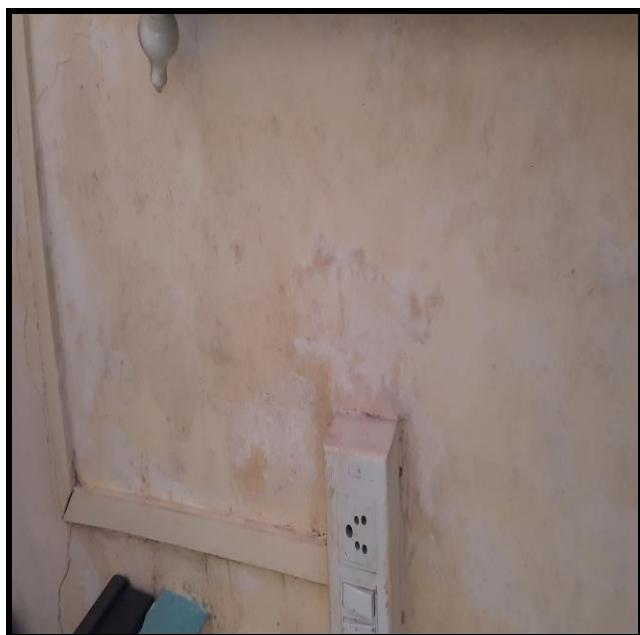
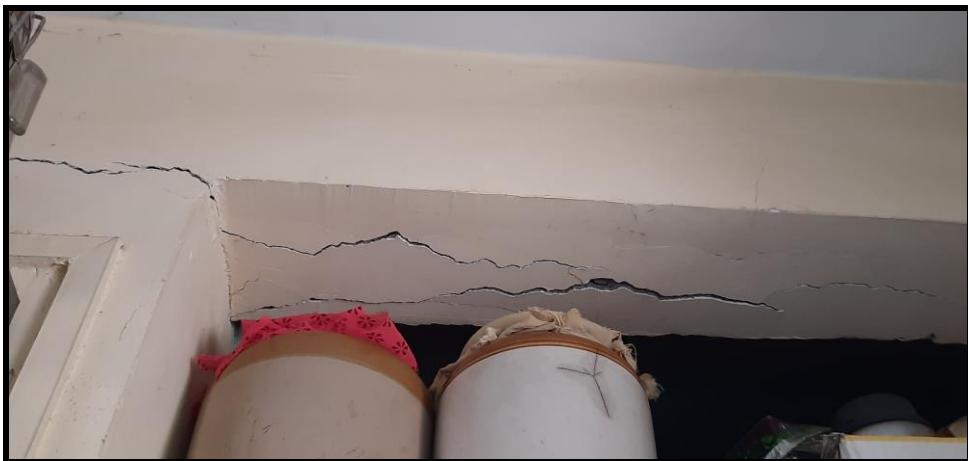
FLAT NO – 80

- ❖ **HALL** – Structural crack observed on beam.
 - Leakage mark observed on wall.
- ❖ **KITCHEN** – Structural crack observed on beam.
- ❖ **PASSAGE** – O.K.
- ❖ **TOILET & BATH ROOM** – O.K.

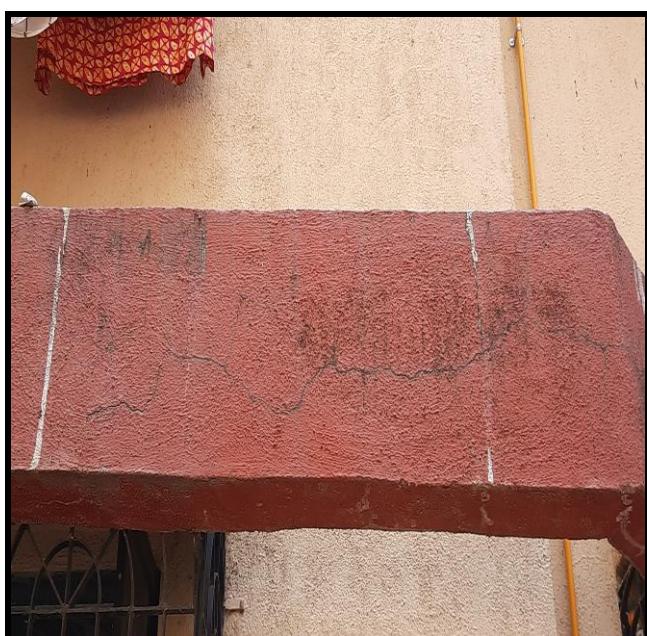
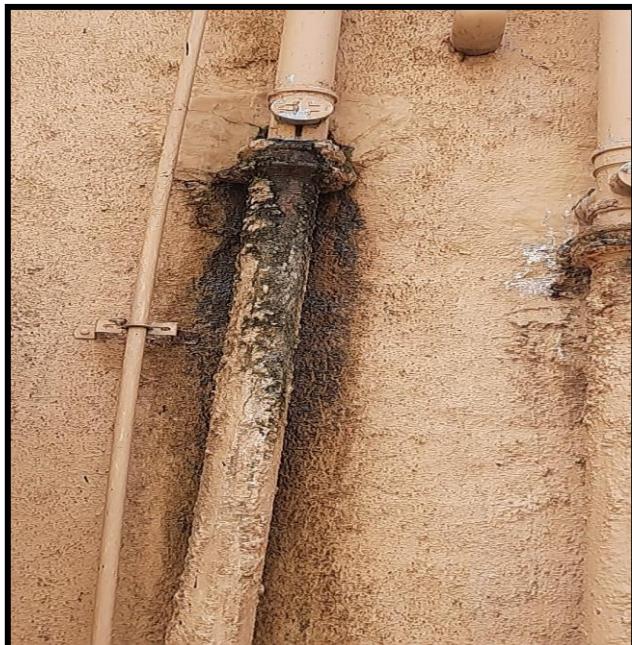
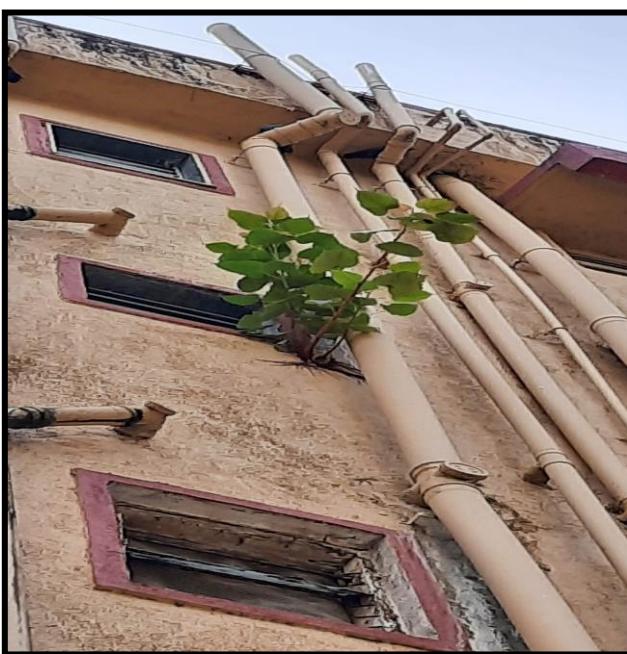
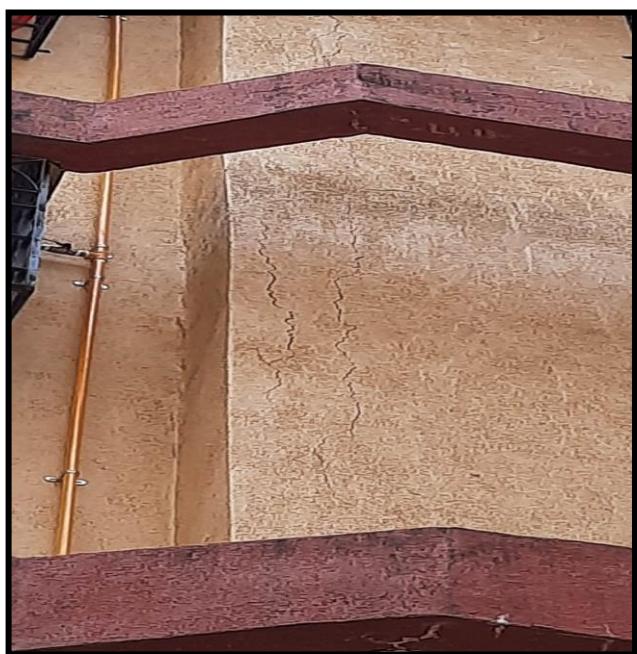
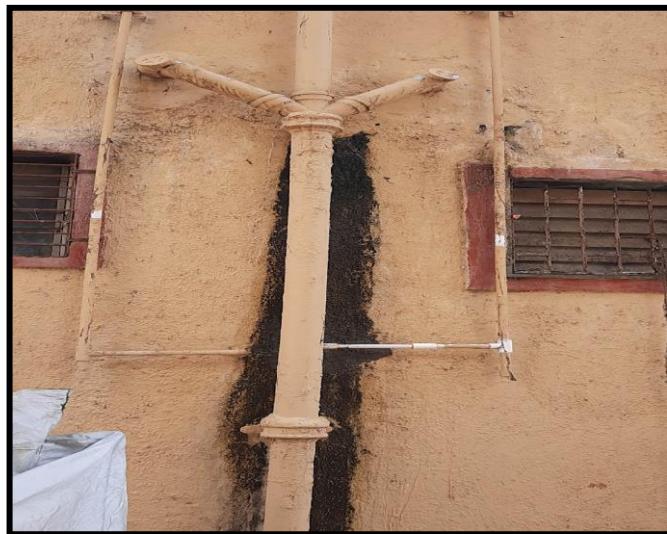
FRONT SIDE

- ❖ Structural crack observed at several places on column.
- ❖ Major crack observed at several places on wall.
- ❖ Vegetation growth observed at several places on wall.
