STRUCTURAL AUDIT REPORT
FOR
“VISHAL SAHYADRI CO – OP HSG. SOC. LTD”,
“C2 – WING”
SITUATED AT
SAHYADRI NAGAR, CHARKOP,
KANDIVALI (W) MUMBAI – 400 067

978/C2/LSS/2021

JUNE 21, 2021

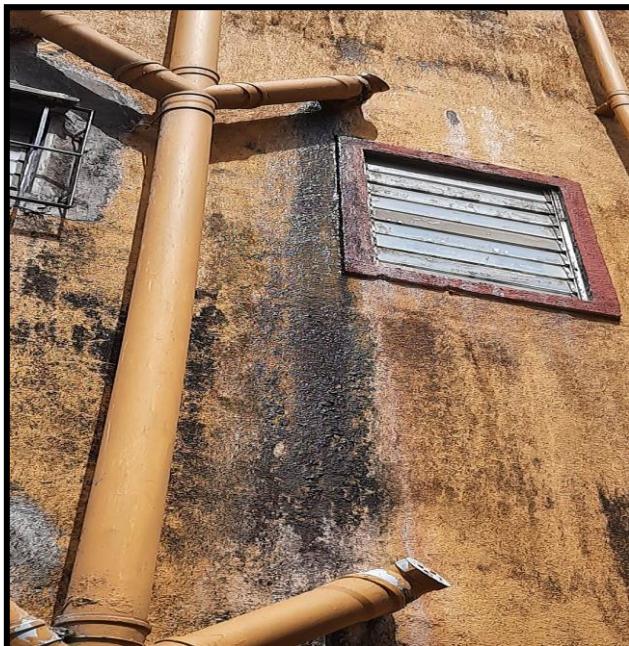
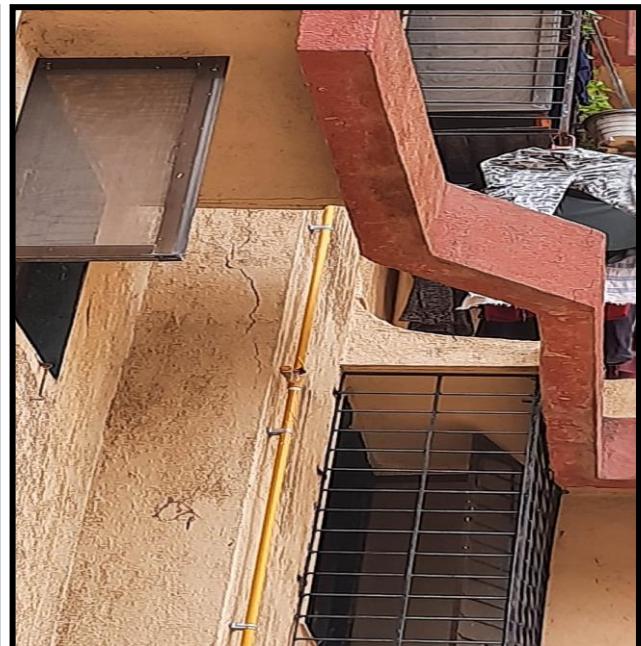
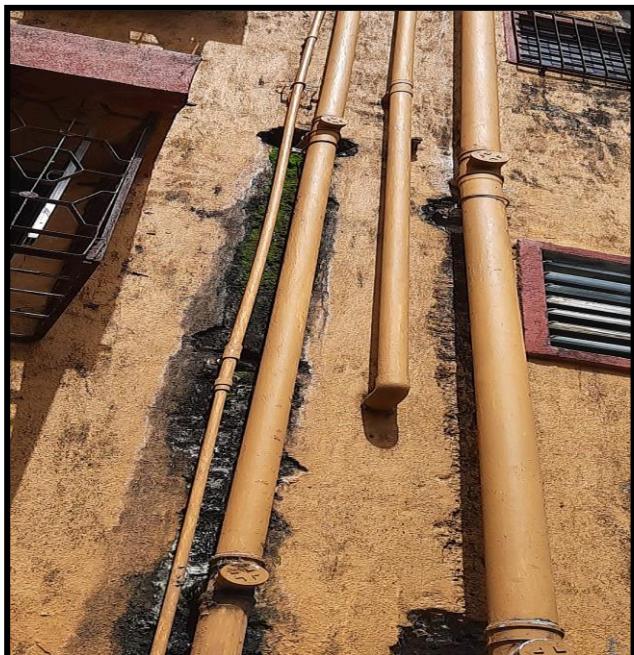
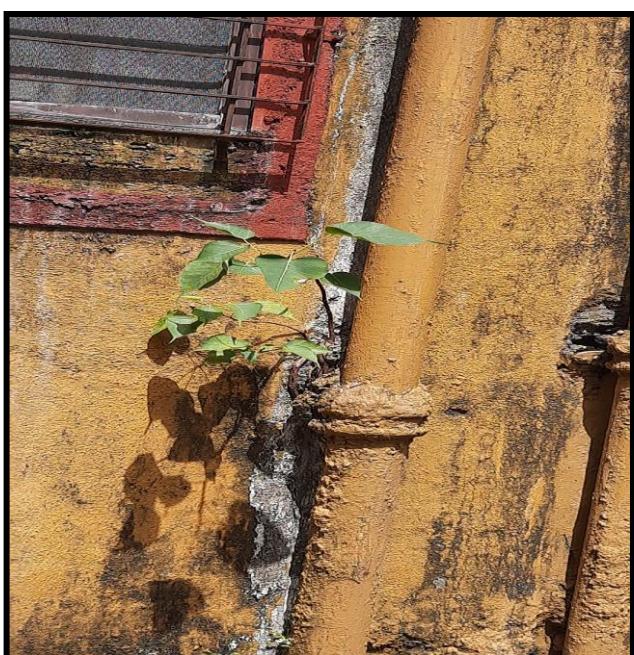
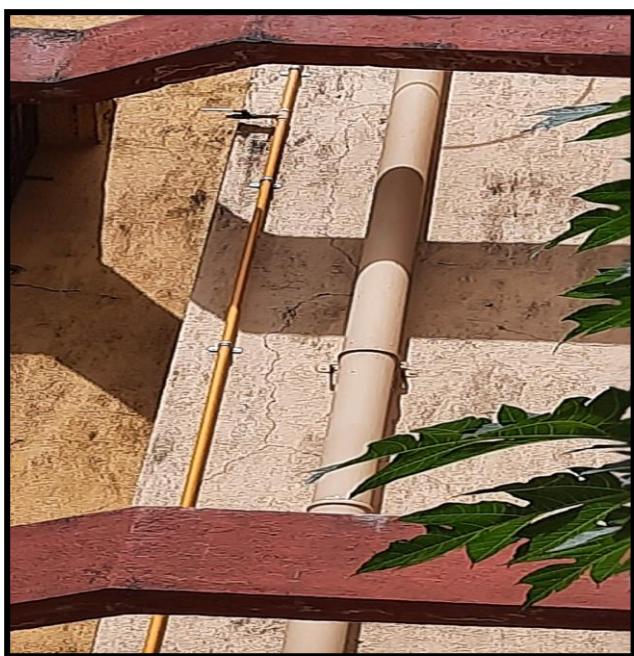
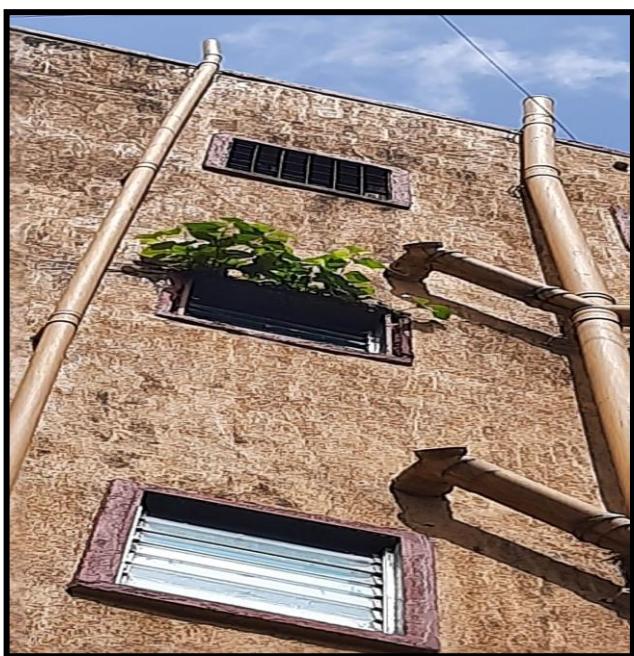
BACK SIDE

- ❖ Structural crack observed at several places on column & chajjas.
- ❖ Major crack observed at several places on wall.
- ❖ Vegetation growth observed at several places on wall.

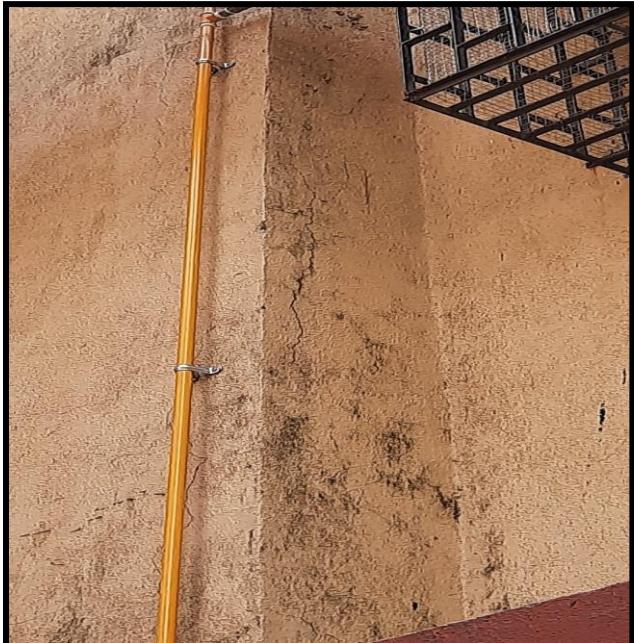
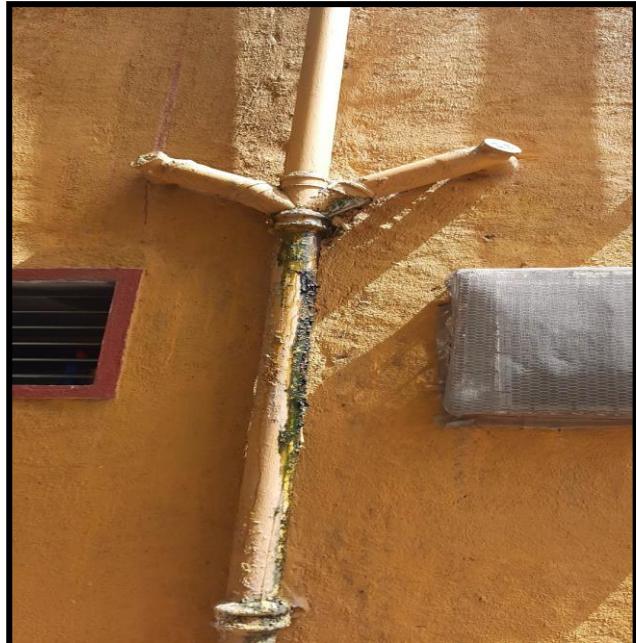
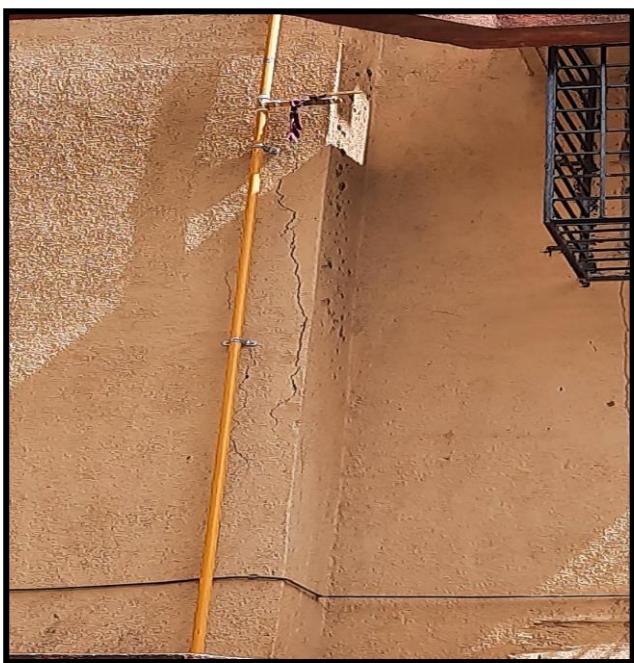
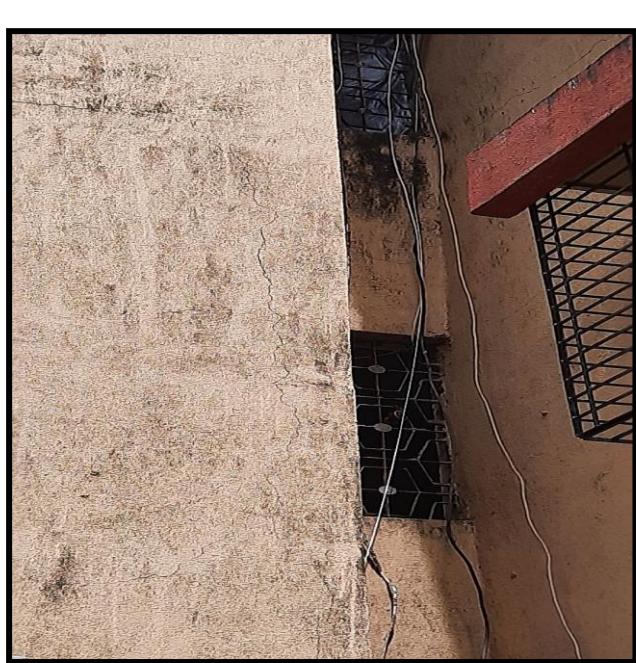
NORTH SIDE

- ❖ Structural crack observed at several places on column.
- ❖ Major crack observed at several places on wall.

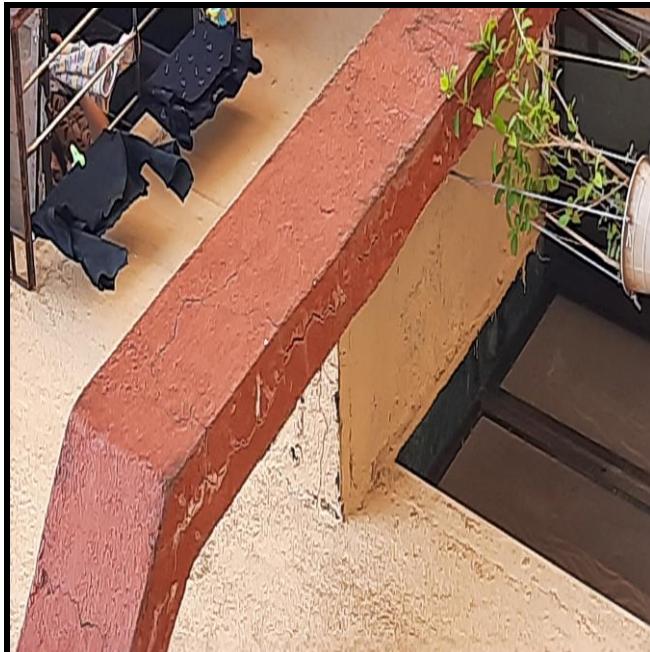
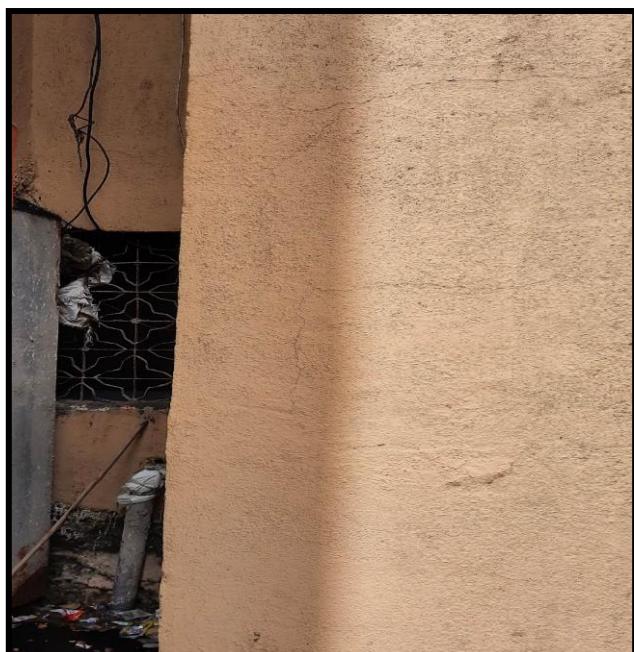
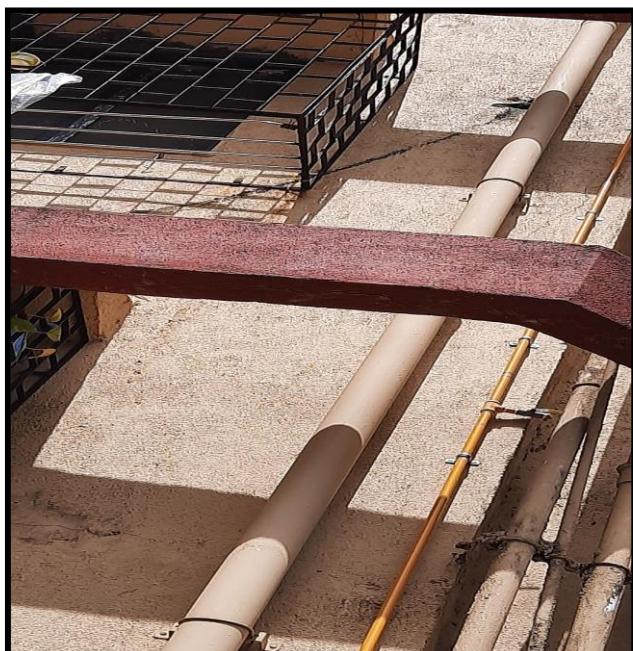
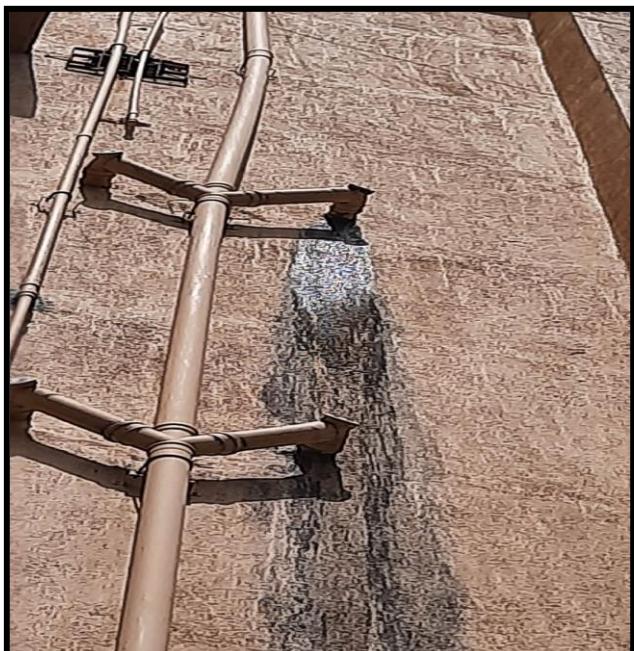
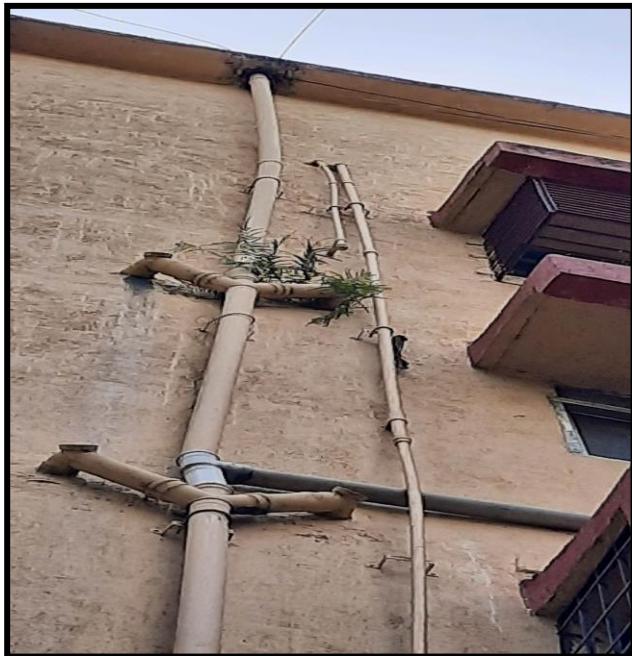
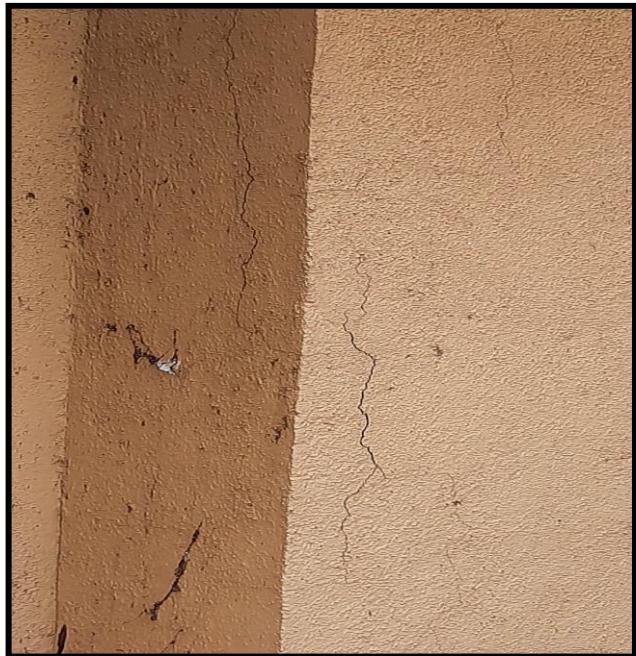
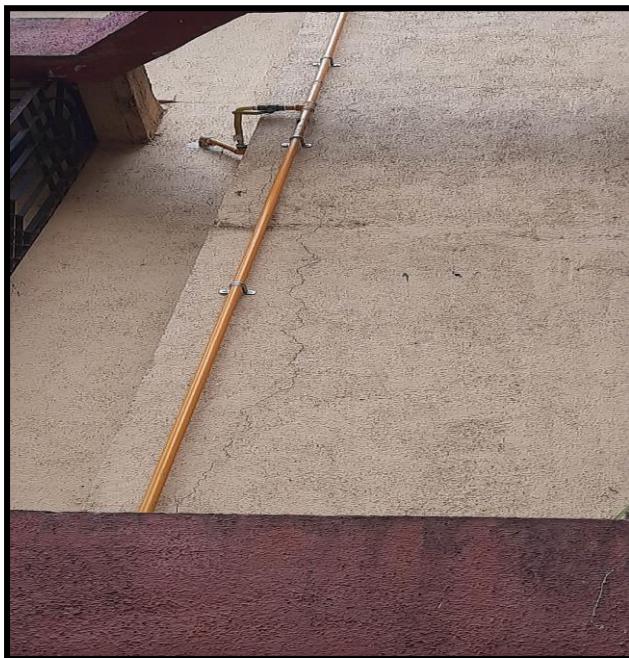
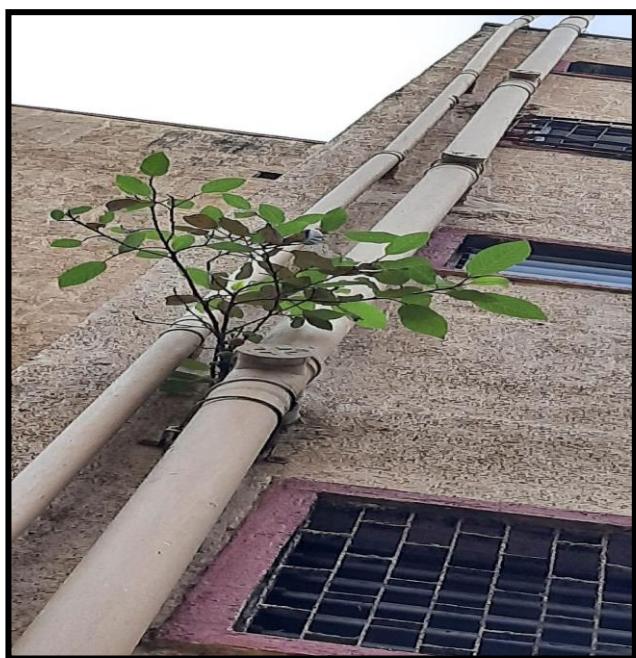
SOUTH SIDE

- ❖ Structural crack observed at several places on column & chajjas.
- ❖ Major crack observed at several places on wall.
- ❖ Vegetation growth observed at several places on wall.
